## Multi-Position Safety Camera

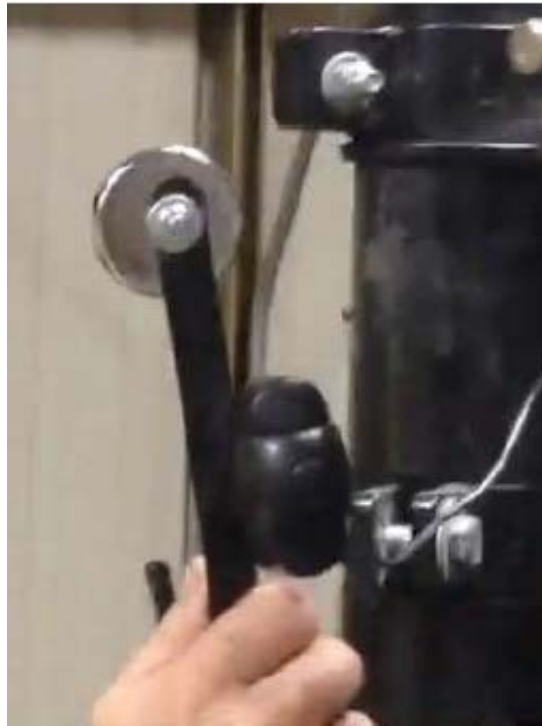
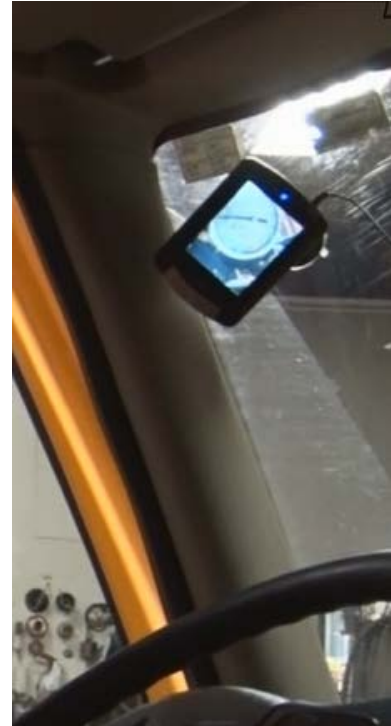
There are multiple operations where critical information is located on the outside of a truck where an operator is unable to see. When using the slide-in injection sprayer, an operator needs to see the pressure gauge mounted on the sprayer in the back and also needs to see where they are spraying, and rear view mirrors don't always give the best view. The Multi-Position Safety Camera can be mounted anywhere on the truck using magnets with the view screen located in the cab.

The Multi-Position Safety Camera provides many benefits to the department. Through the camera an operator can monitor the pressure gauges to ensure correct usage and be warned if pressures are not in proper ranges. The camera simplifies work by eliminating guesswork when spot and guardrail spraying. It improves safety by allowing the operator to see unforeseen hazards, as well as gauge where the vehicle is in relation to the work they are completing.
