Antire Hill Safety Improvements

The following safety improvements will be installed on both sides of the road to give drivers ample notice and enough time to adjust their speeds and navigate this curve safely.

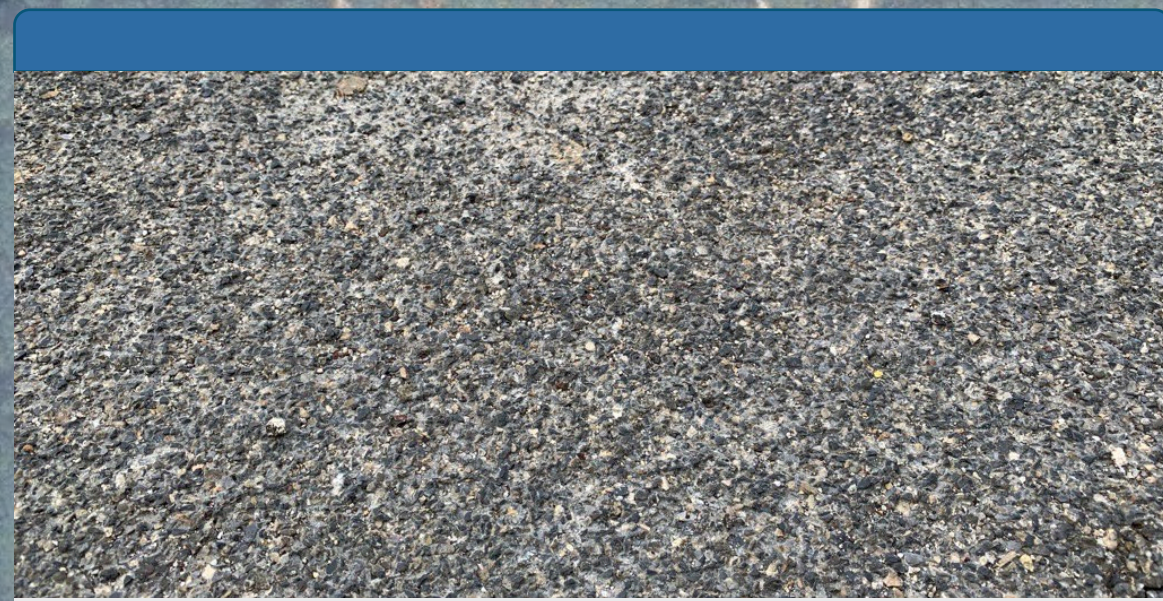
Surface treatment to help vehicles grip the road better.

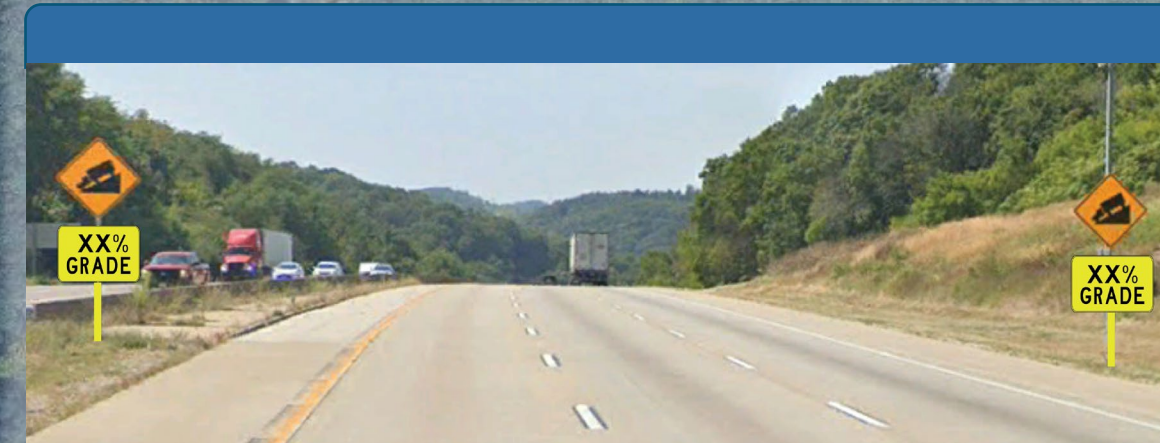
Add percent grade plaques and retroreflective strips.

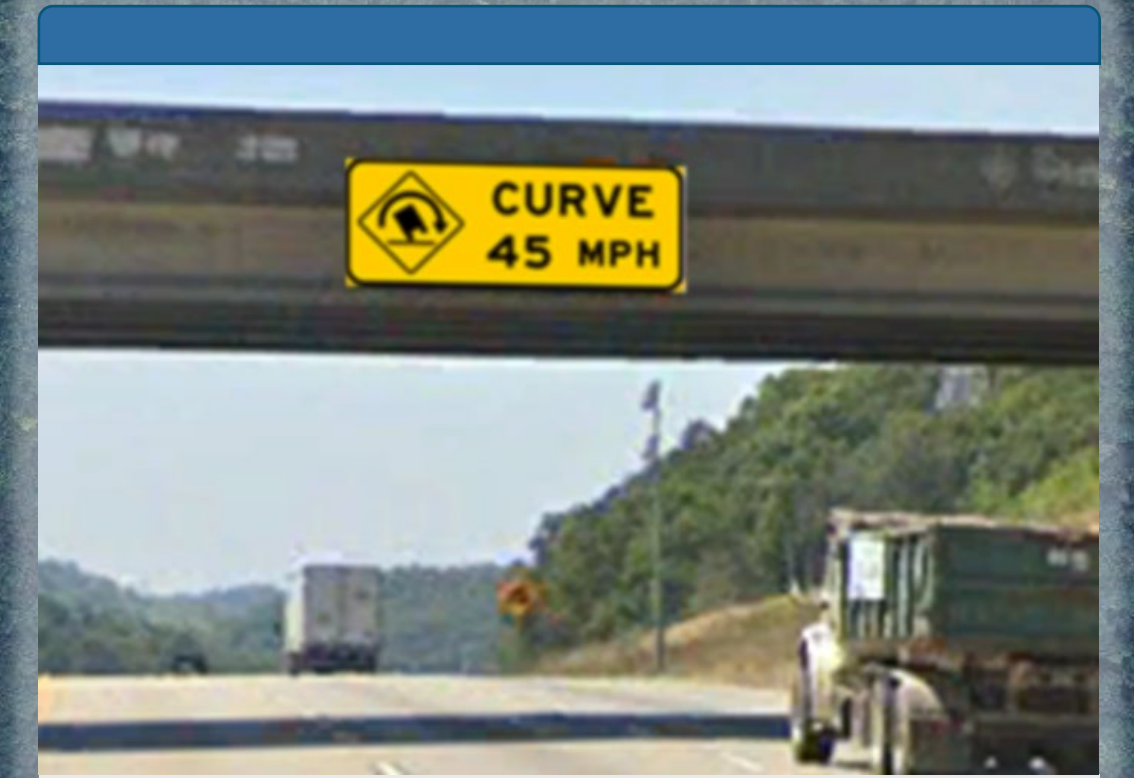
Replace overhead steep grade sign with truck overturning sign.

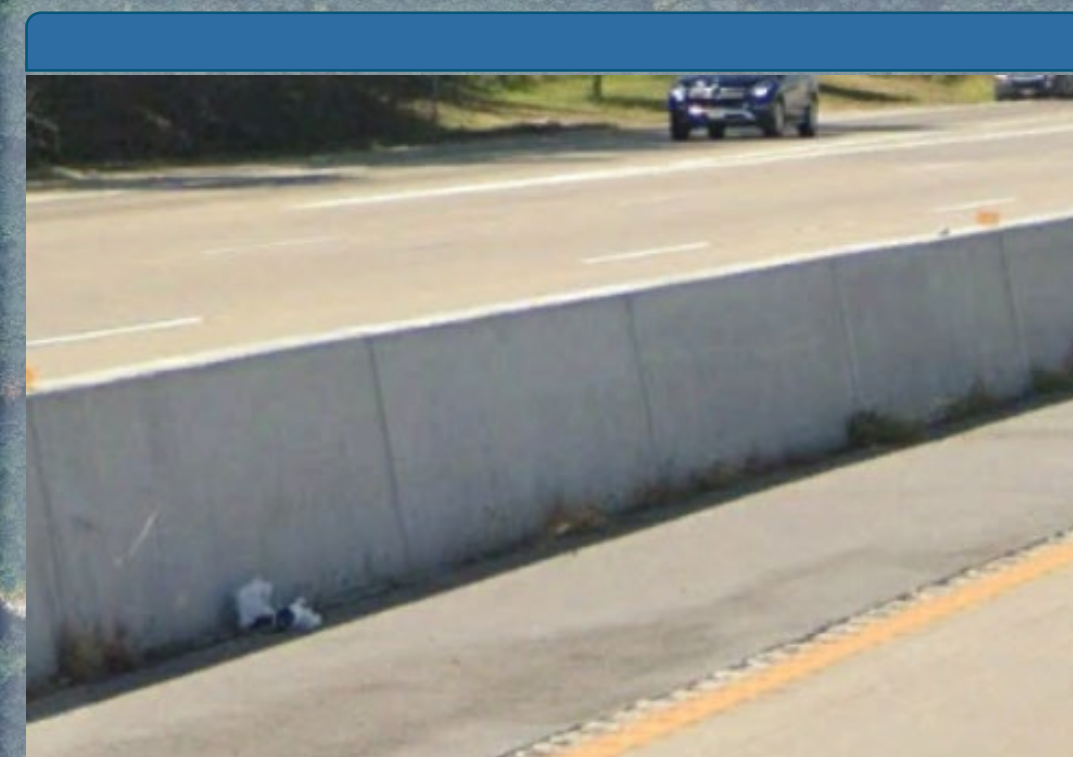
Replace median barrier.

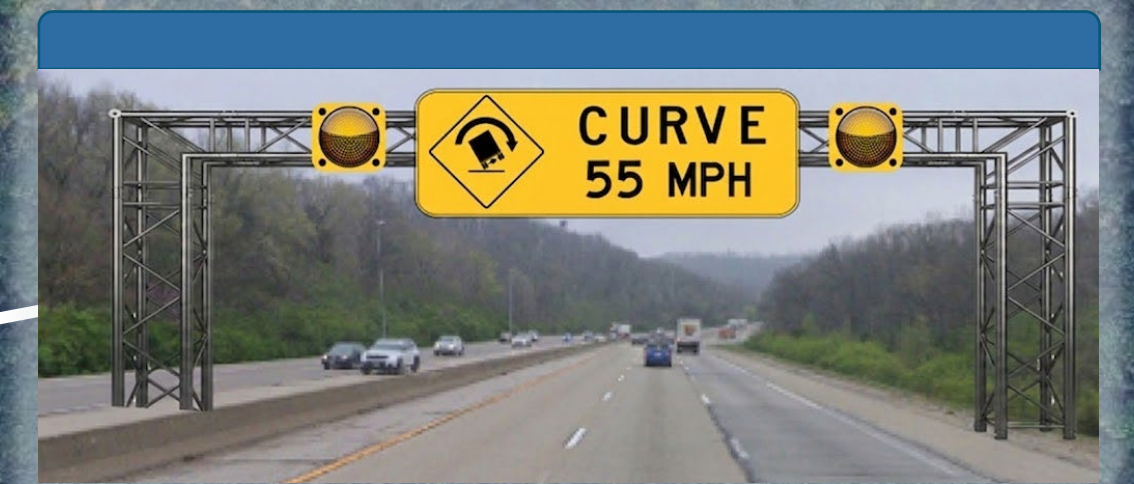
Add flashing curve warning sign for trucks.

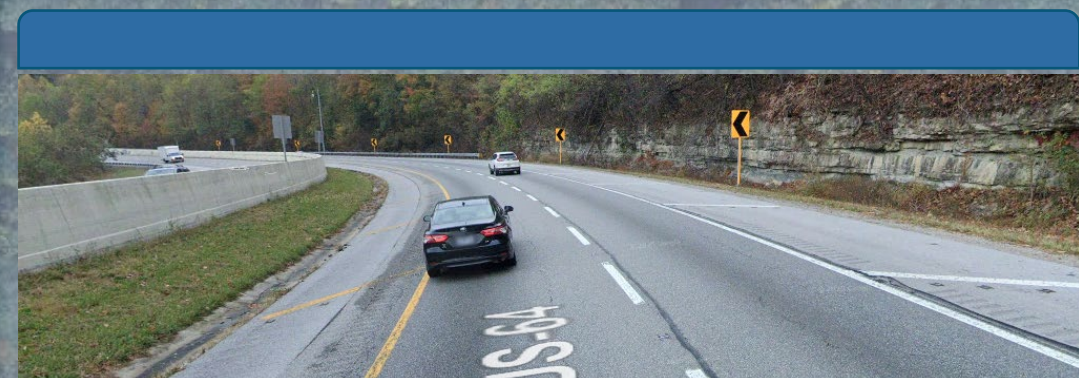
Modifying lane striping.

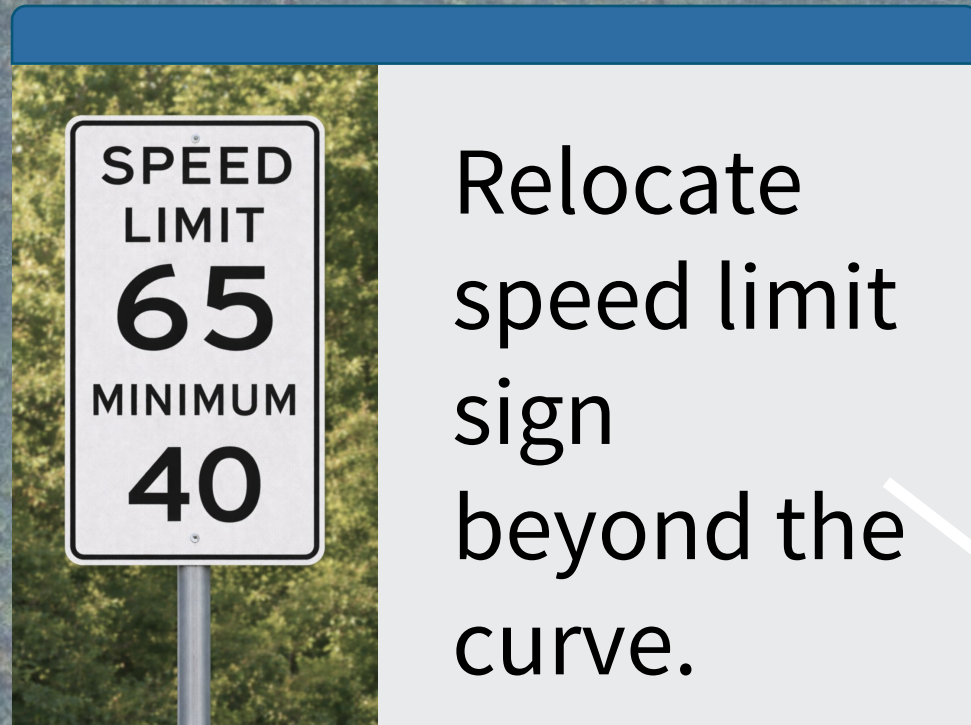
Relocate speed limit sign beyond the curve.

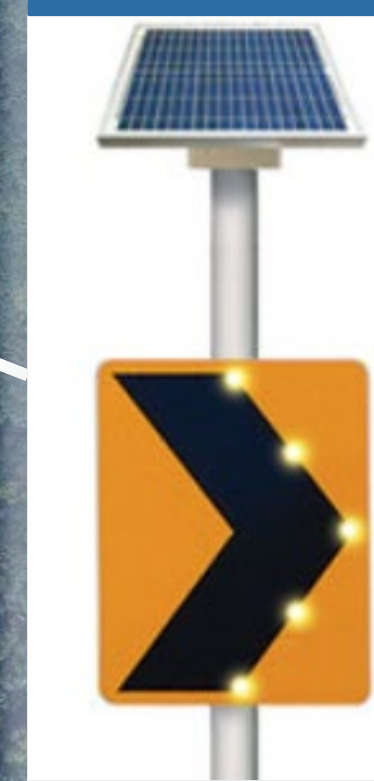
Add oversized flashing chevrons with retroreflective strips.
