# FEDERAL HIGHWAY ADMINISTRATION PROVEN SAFETY COUNTERMEASURES

**Rectangular Rapid Flashing Beacons (RRFB)**  
A marked crosswalk or pedestrian warning sign can improve safety for pedestrians crossing the road, but at times may not be sufficient for drivers to visibly locate crossing locations and yield to pedestrians. To enhance pedestrian conspicuity and increase driver awareness at uncontrolled, marked crosswalks, transportation agencies can install a pedestrian actuated Rectangular Rapid Flashing Beacon (RRFB) to accompany a pedestrian warning sign. RRFBs consist of two, rectangular-shaped yellow indications, each with a light-emitting diode (LED)-array-based light source.<sup>1</sup> RRFBs flash with an alternating high frequency when activated to enhance conspicuity of pedestrians at the crossing to drivers.

**Medians and Pedestrian Refuge Islands in Urban and Suburban Areas**  
A **median** is the area between opposing lanes of traffic, excluding turn lanes. Medians in urban and suburban areas can be defined by pavement markings, raised medians, or islands to separate motorized and non-motorized road users.  
A **pedestrian refuge island** (or crossing area) is a median wi

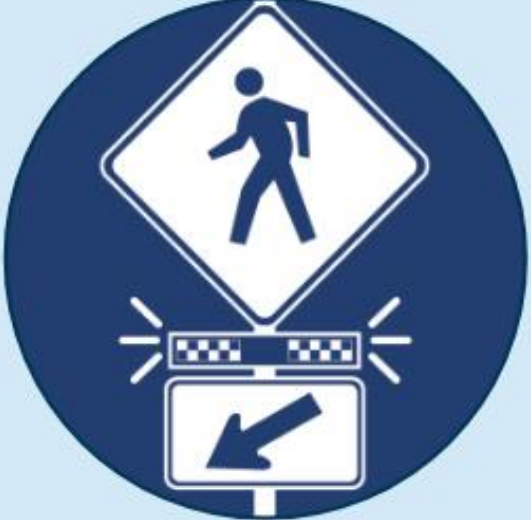
RRFBs used at a trail crossing.  
Source: LJB

**Applications**  
The RRFB is applicable to many types of pedestrian crossings but is particularly effective at multilane crossings with speed limits less than 40 miles per hour.<sup>2</sup> Research suggests RRFBs can result in motorist yielding rates as high as 98 percent at marked crosswalks, but varies depending on the location, posted speed limit, pedestrian crossing distance, one- versus two-way road, and the number of travel lanes.<sup>3</sup> RRFBs can also accompany school or trail crossing warning signs.  
RRFBs are placed on both sides of a crosswalk below the pedestrian crossing sign and above the diagonal downward arrow plaque pointing at the crossing.<sup>1</sup> The flashing pattern can be activated with pushbuttons or passive (e.g., video or infrared) pedestrian detection, and should be unlit when not activated.

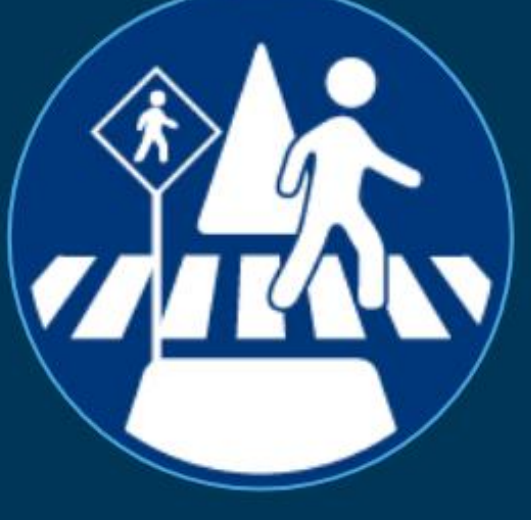
**Safety Benefits:**  
**Median with Marked Crosswalk**  
**46%**  
reduction in pedestrian crashes.<sup>2</sup>

**Pedestrian Refuge Island**  
**56%**  
reduction in pedestrian crashes.<sup>2</sup>

- Mid-block crossings.
- Approaches to multilane intersections.
- Areas near transit stops or other pedestrian-focused sites.

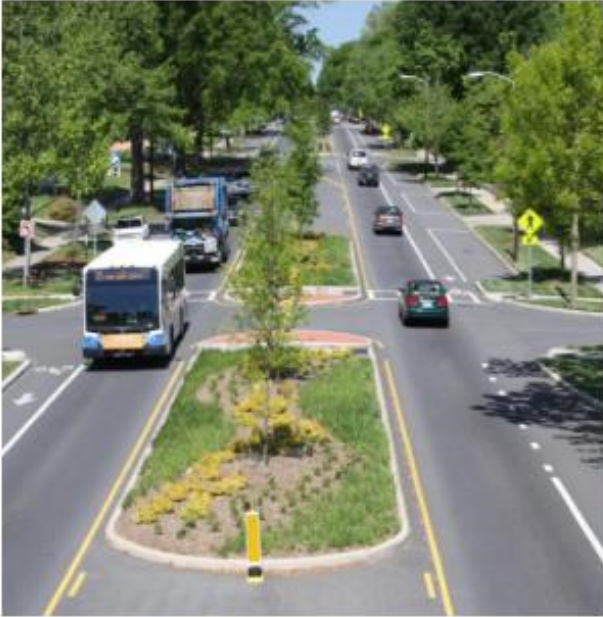
Example of a road with a median and pedestrian refuge islands.  
Source: City of Charlotte, NC

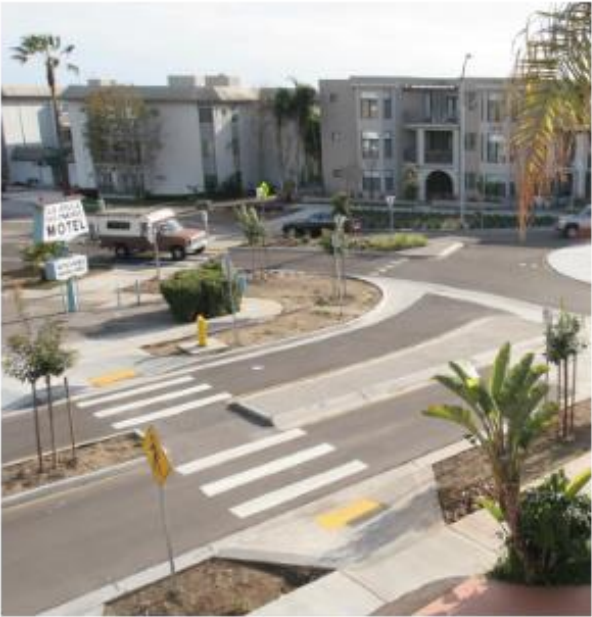
Median and pedestrian refuge island near a roundabout. Source: [www.pedbikeimages.org](http://www.pedbikeimages.org) / Dan Burden
