8 Bridge Rail Alternatives Considered

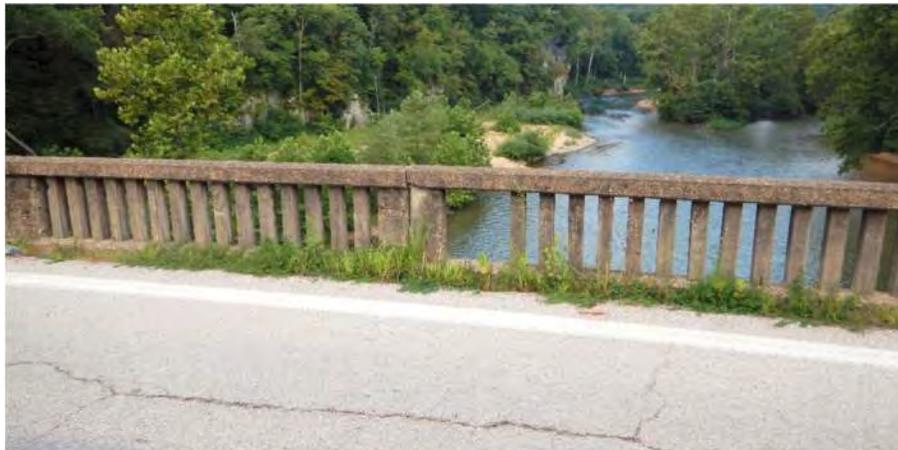
Figure 8-1. Existing Current River Bridge Rail – Front Face

The existing rail for the bridge over the Current River is a continuous concrete curb and rail supported on concrete spindles. The concrete curb was originally 7” above the roadway surface but subsequent overlays have nearly buried the entire curb. The rail height is 36 inches above the curb for most of the bridge length reaching 39 inches tall at the posts at each pier. The front of the rail and the typical condition can be seen in Figure 8-1. The back of the rail and a typical post can be seen in Figure 8-2.

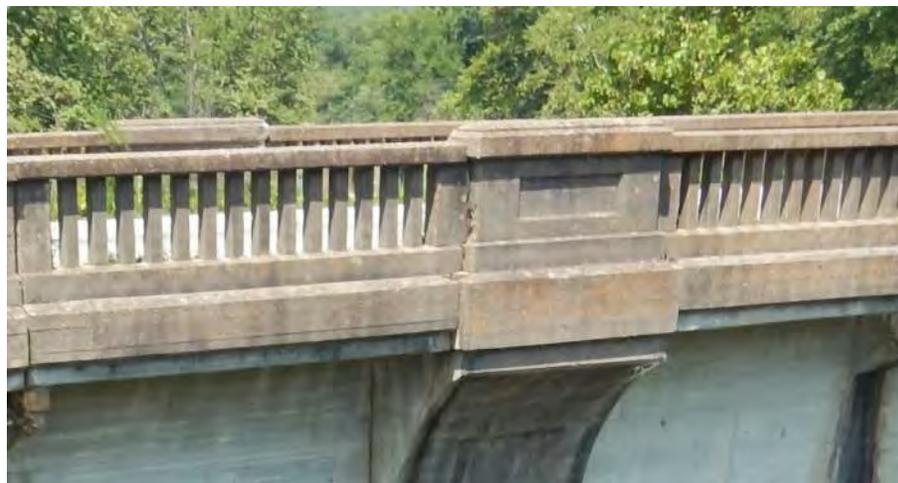
Figure 8-2. Existing Current River Bridge Rail – Back Face with Post

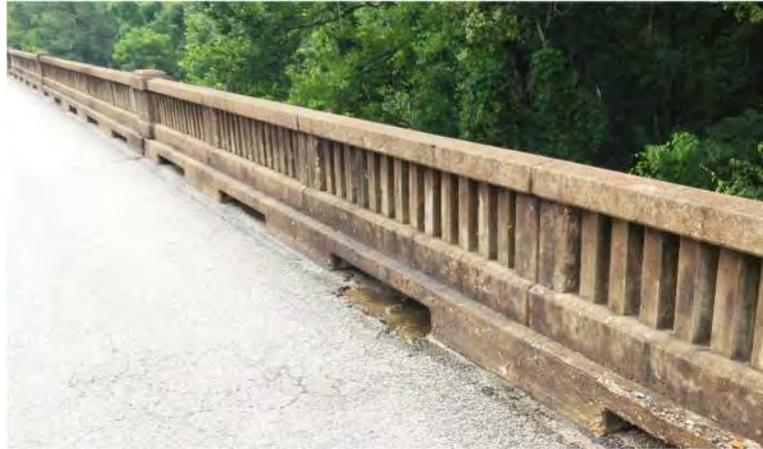
Figure 8-3. Existing Spring Valley Bridge Rail – Front Face

The existing rail on the bridge over the Spring Valley is similar to the rail over the Current River except the curb is not continuous and allows roadway drainage to flow over the side of the deck. The height of the intermittent curb is 9” above the deck. The rail height is 30 inches above the curb with posts at various points along the bridge reaching 33 inches tall. A view of the curb, rail and a post can be seen in Figure 8-3.

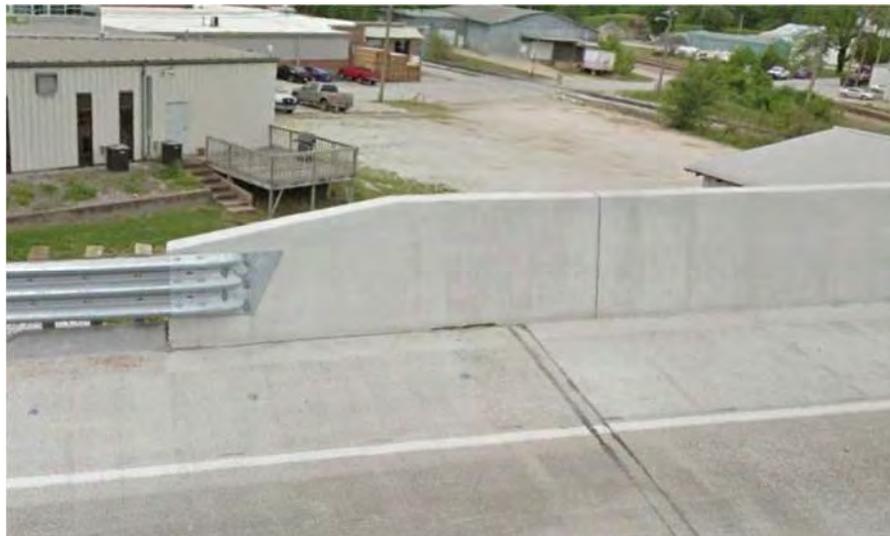
Figure 8-4. MoDOT Type D Concrete Barrier Curb

One option for the replacement of the bridge rail is the MoDOT Type D barrier curb. This is a 42 inch tall concrete barrier with a single sloping front face. It is the standard barrier curb used on most new construction in the state at this time. The height of this barrier combined with the solid face will limit the sight of the traveling public. The appearance of this barrier curb is a departure in form compared to the existing rail. A formliner pattern can be applied to the back side of this barrier only. This barrier curb is the least cost option considered for this project at approximately \$105 per linear foot if formliner is not used. A typical view of this type of barrier can be seen in Figure 8-4.

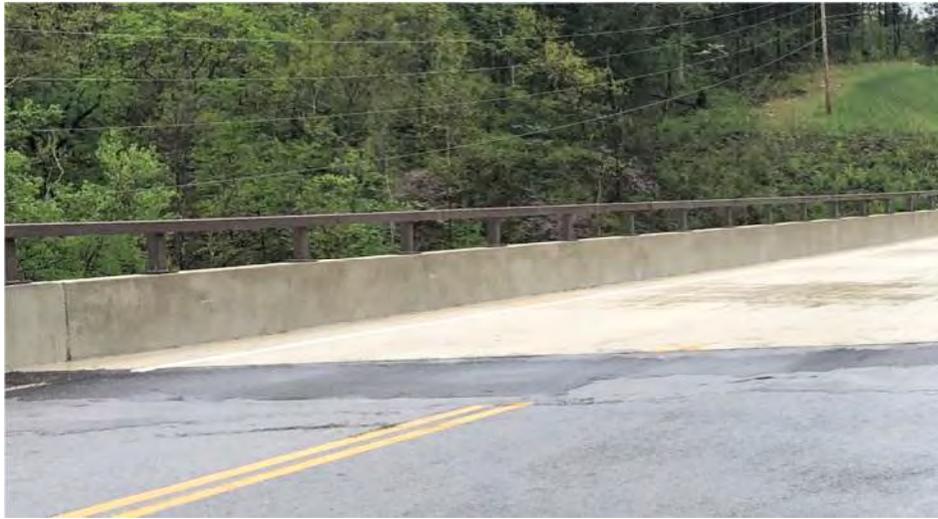
Figure 8-5. Vertical Concrete Barrier and Steel Tube Rail – Front Face

This bridge rail option consists of a 24 inch tall concrete barrier with an 18 inch tall single steel tube rail bolted to the top. This barrier is in place on the bridge carrying Route 19 over Sinking Creek. The overall height of the barrier / railing is 42 inches, but the open rail allows improved site lines from the bridge. The appearance of this barrier curb is a departure from the existing rail but matches the other bridge in the historic district on this route. A formliner pattern can be applied to the back side of this barrier only and a broken fin type pattern was used on the bridge over Sinking Creek. The average bid for this barrier and rail in January 2017 was \$190 per linear foot plus the cost of formliner. This rail was used in the cost estimates shown in Section 9 and a unit cost of \$200 per linear foot for the concrete barrier and rail combination was assumed. Views of this type of barrier in place on the bridge over Sinking Creek can be seen in Figure 8-5 and Figure 8-6.

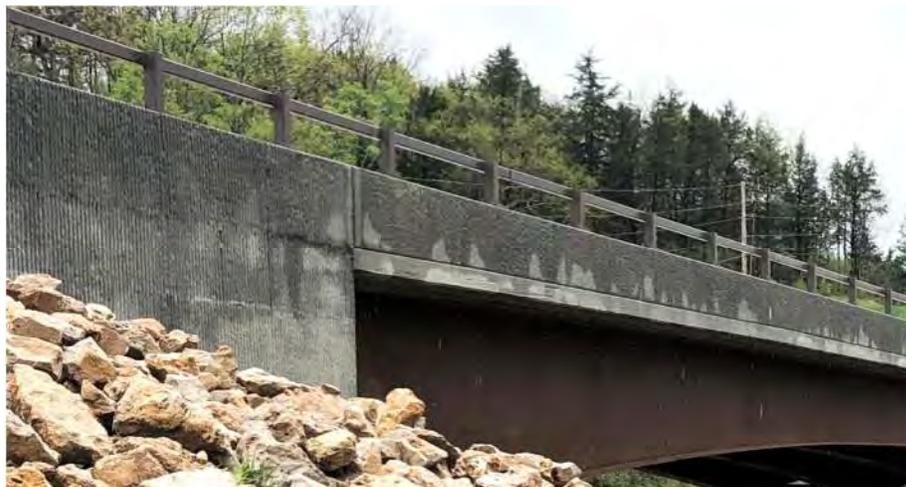
Figure 8-6. Vertical Concrete Barrier and Steel Tube Rail – Back Face

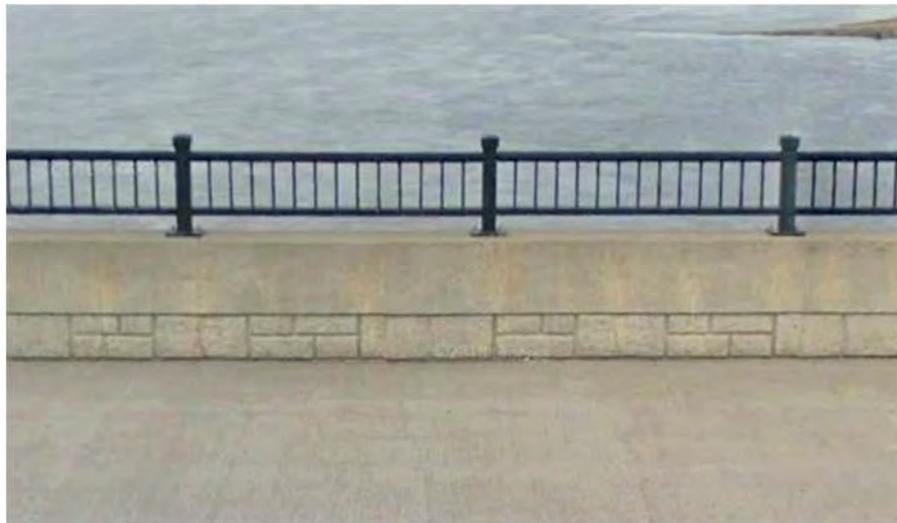
Figure 8-7. Corral Rail and Steel Rail

This bridge rail option consists of a 32 inch tall concrete barrier with a solid top rail and recessed lower portion. This rail is based on the Kansas DOT Corral Rail. The concrete barrier can be topped with a decorative or structural steel rail. This barrier is in use on the bridge carrying Route 19 over the Missouri River in Hermann, MO. The height of the concrete barrier would limit site lines from the bridge but not as severely as the standard MoDOT Type D barrier curb. A formliner pattern can be applied to the back side of this barrier and to the front side in the recessed portion only; the solid top rail cannot have formliner. The bids for this barrier and rail in August 2015 varied considerably. The winning bid for the combined barrier and rail was \$180 per linear foot not including formliner and is estimated to cost approximately \$230 per linear foot in 2019. A view of this type of barrier on the bridge in Hermann, MO can be seen in Figure 8-7.

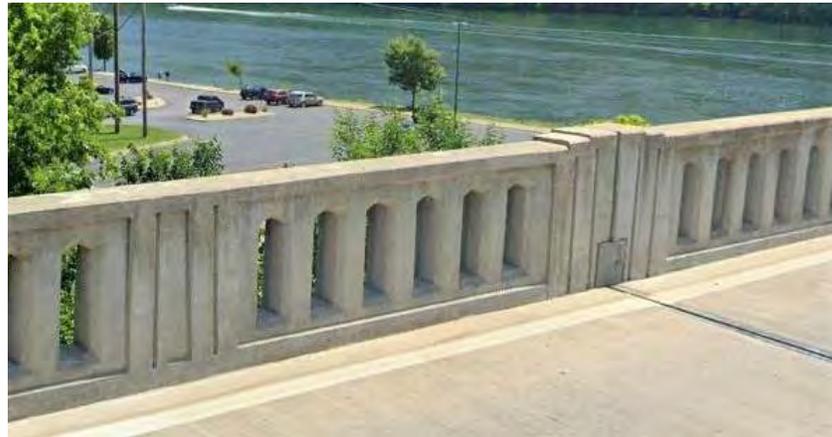
Figure 8-8. Open Concrete Curb and Rail with Concrete Posts – Front Face

This bridge rail option is a 42 inch tall concrete barrier with a solid curb and top rail and includes a 6 inch wide “window” every 18 inches. The barrier height and thickness can be increased at points of interest to create the look of posts. This barrier is in use on the bridge carrying Route 76 over Lake Taneycomo in Branson, MO which was also a historic arch structure. The height of the concrete barrier could limit site lines from the bridge but the windows will allow a similar view as the existing bridge rail. The appearance of this rail is the closest to the existing rail of the options considered during this study. The average bid for this barrier in October 2009 was \$185 per linear foot and is estimated to cost approximately \$240 per linear foot in 2019. Views of this type of barrier on the bridge in Branson, MO can be seen in Figure 8-8 and Figure 8-9.

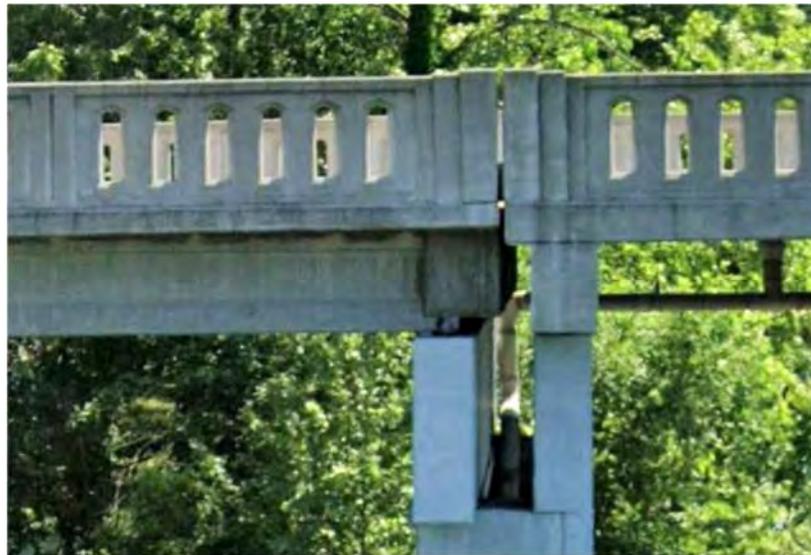
Figure 8-9. Open Concrete Curb and Rail with Concrete Posts – Back Face

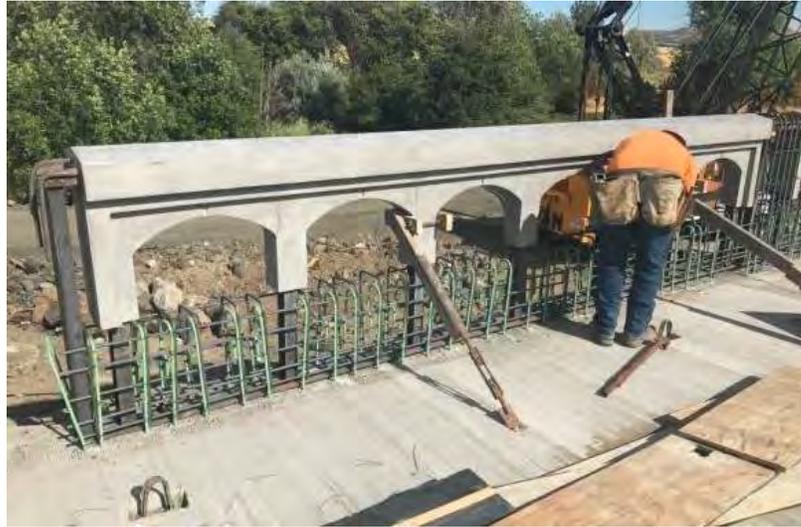
Figure 8-10. Oregon DOT Stealth Rail Installation

Recently, the Oregon DOT replaced some historic rail on a bridge in the Columbia River Highway District using a “stealth” rail. The rail consisted of a structural steel rail connected to the bridge deck surrounded by a precast concrete shell formed to mimic the shape of the existing bridge rail. The rail they utilized met design standards for safety and was designed for a TL-4 loading but was not crash tested. To remove snag hazards in the original bridge rail configuration, various shadow lines were included in the new rail and a continuous curb was included along the bottom to increase safety. ODOT is in the process of having their stealth rail design crash tested at a research facility in Texas. A “stealth” rail configuration similar to the existing bridge rail could be designed for this project. The thin spindles of the existing bridge rails may limit the effectiveness of this approach. The cost of this rail option was not available during preparation of this report but is expected to exceed the other options considered. Views of the stealth rail used by ODOT can be seen in Figure 8-10 and Figure 8-11.

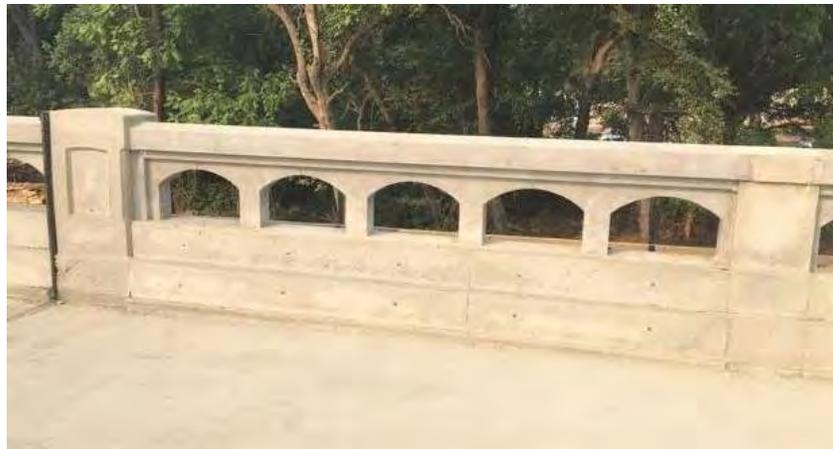
Figure 8-11. Oregon DOT Stealth Rail Complete-In-Place
