Productivity

Prepared by Transportation Planning
Missouri Department of Transportation

Wing Camera [Video](#)

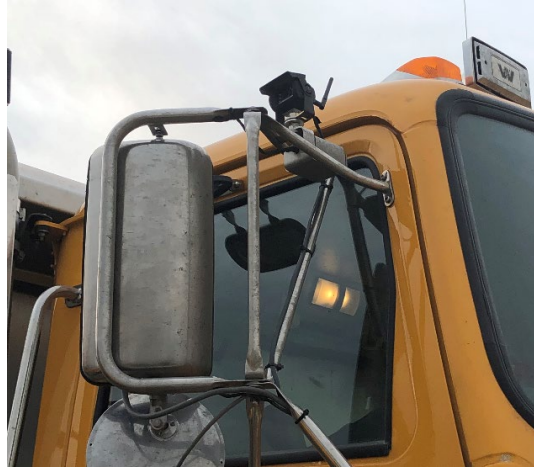
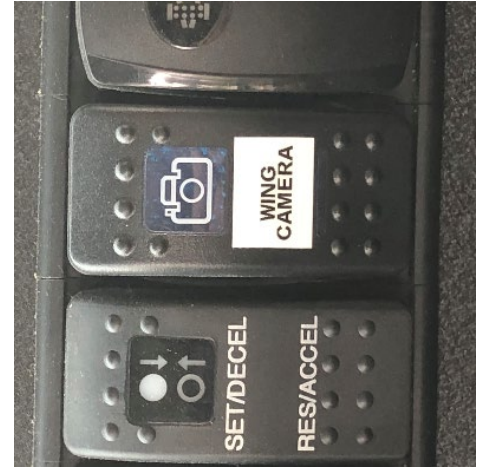
When a wing plow is attached to a snow plow in the up position, it is impossible to see out the passenger window while plowing or when pulling out of an intersection. This requires lowering and raising the wing every time or continuously driving with it down. Both of which could inadvertently damage a car, sign, mailbox, or anything along the roadway. With a backup camera mounted to the top of the passenger side mirror, you can see over the front mounted wing plow, making it easier to see cars or other obstructions while plowing.

Drivers can now use the camera to see over the wing in places they could not see before. This keeps the public and MoDOT drivers safer and reduces claims for damages.
