Missouri Department of Transportation

STRUCTURAL REHABILITATION CHECKLIST

Bridge No.: **A6500**

Route: **I-70**

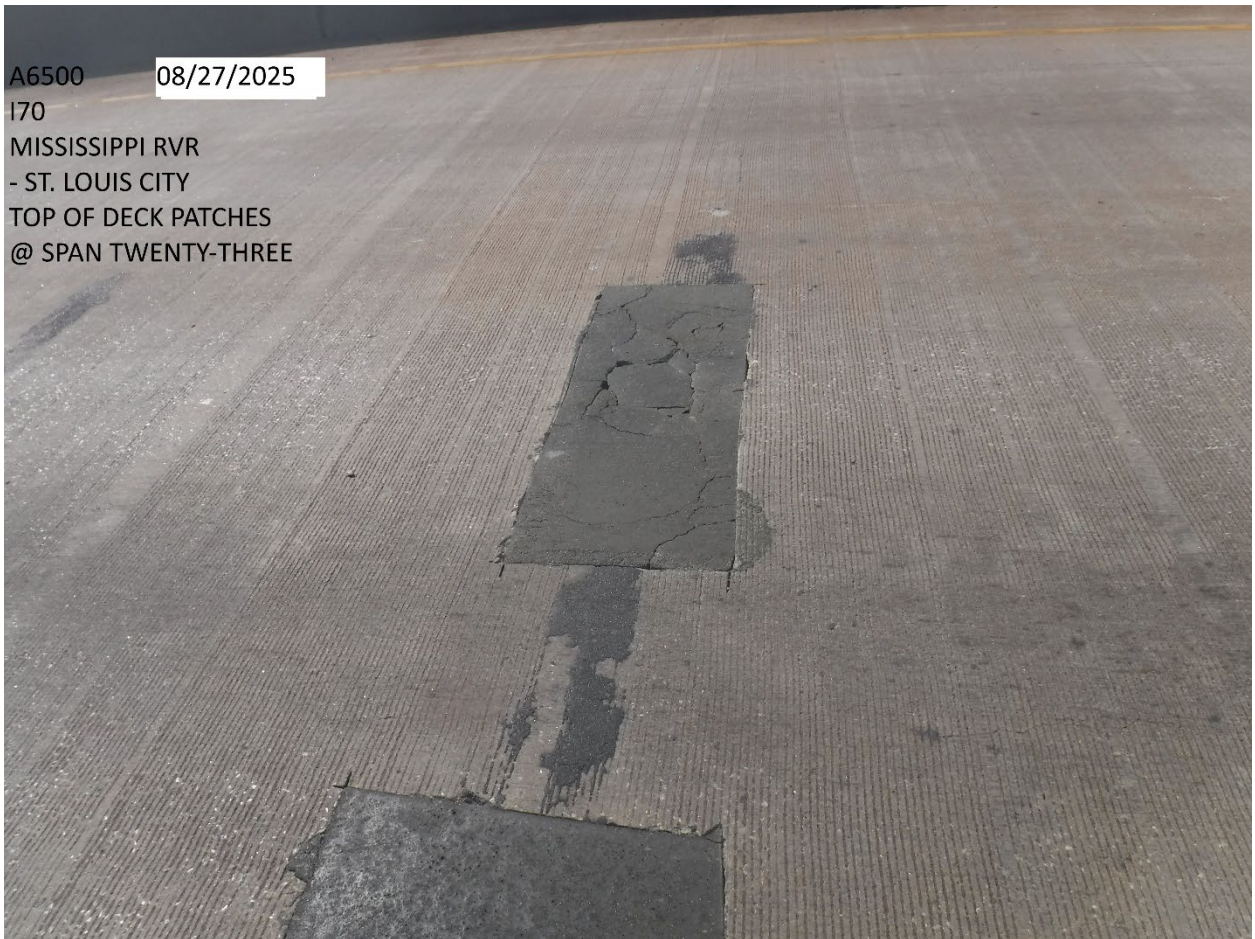
TOP OF DECK PATCHES

@ SPAN TWENTY-THREE

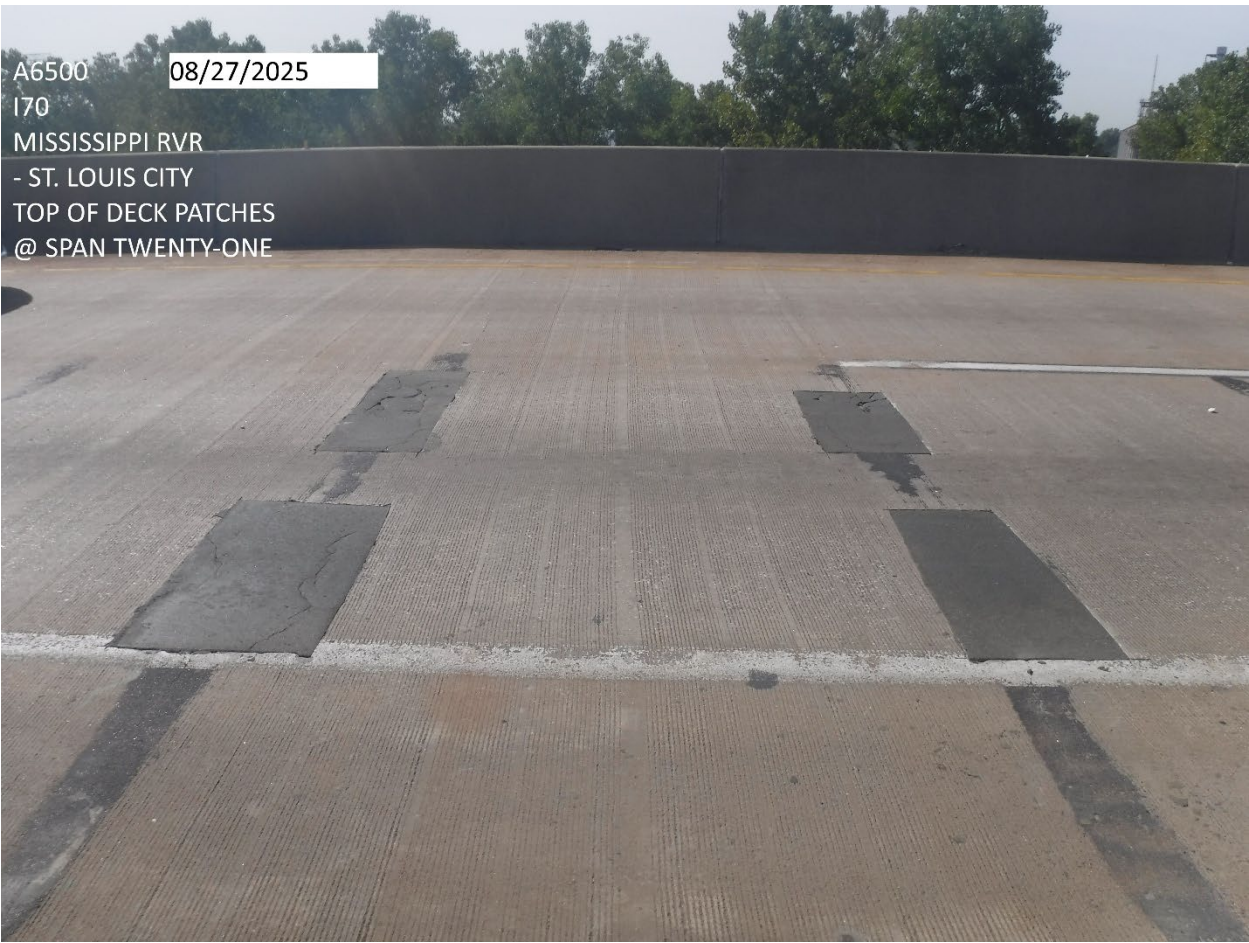
A6500
I70
MISSISSIPPI RVR
- ST. LOUIS CITY
TOP OF DECK PATCHES
@ SPAN TWENTY-ONE

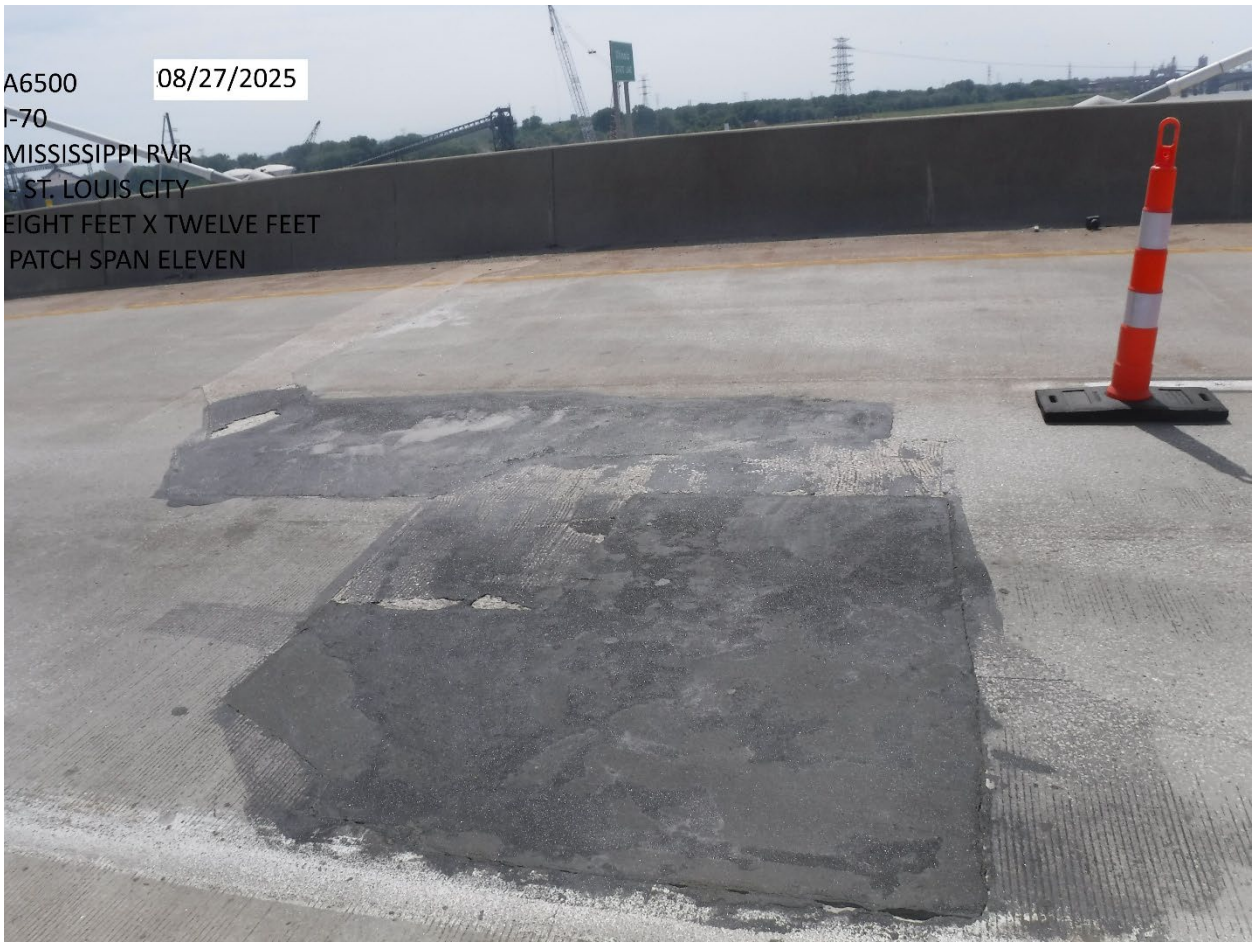
EIGHT FEET X TWELVE FEET

PATCH SPAN ELEVEN

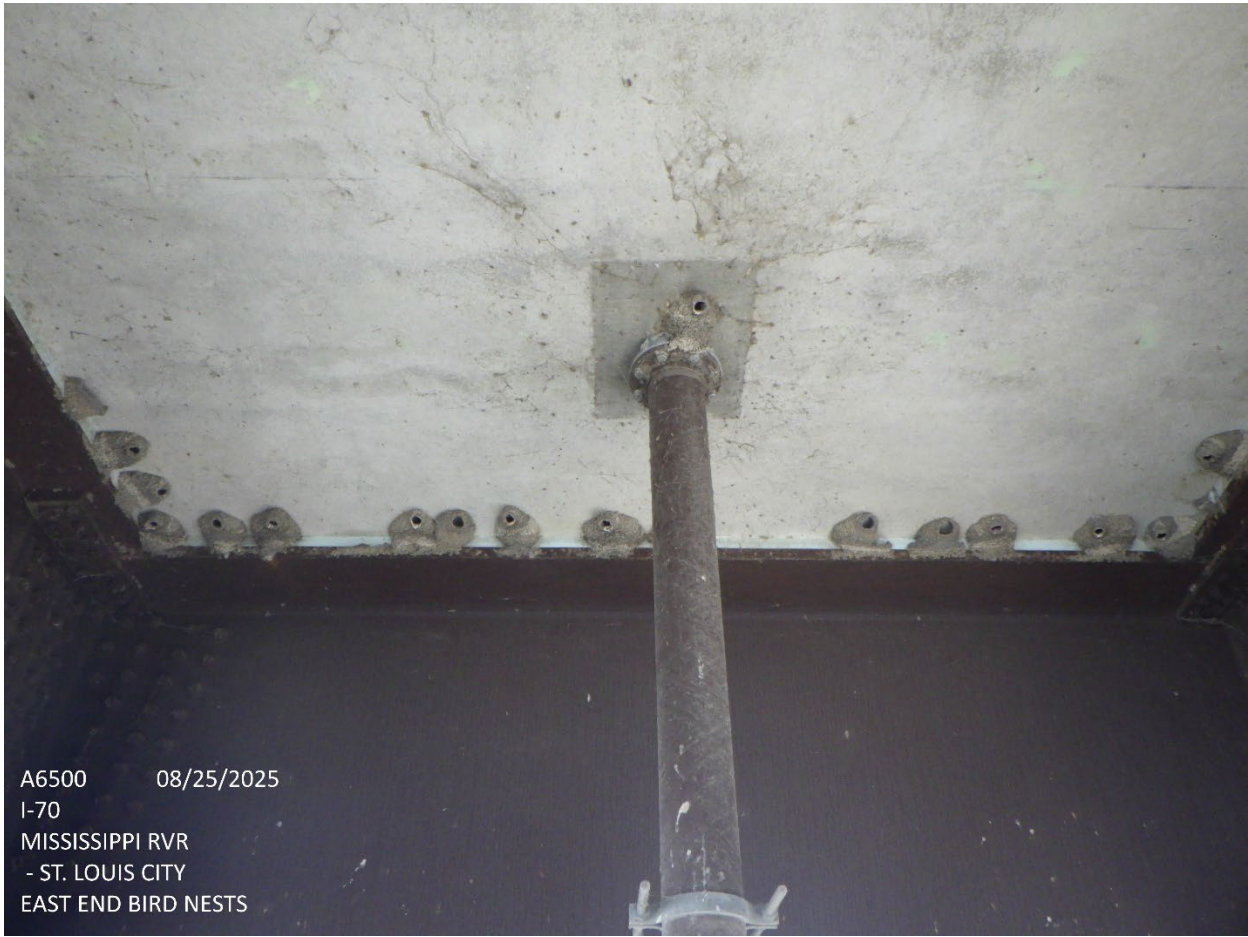
A6500 08/25/2025
I-70
MISSISSIPPI RVR
- ST. LOUIS CITY
EAST END BIRD NESTS

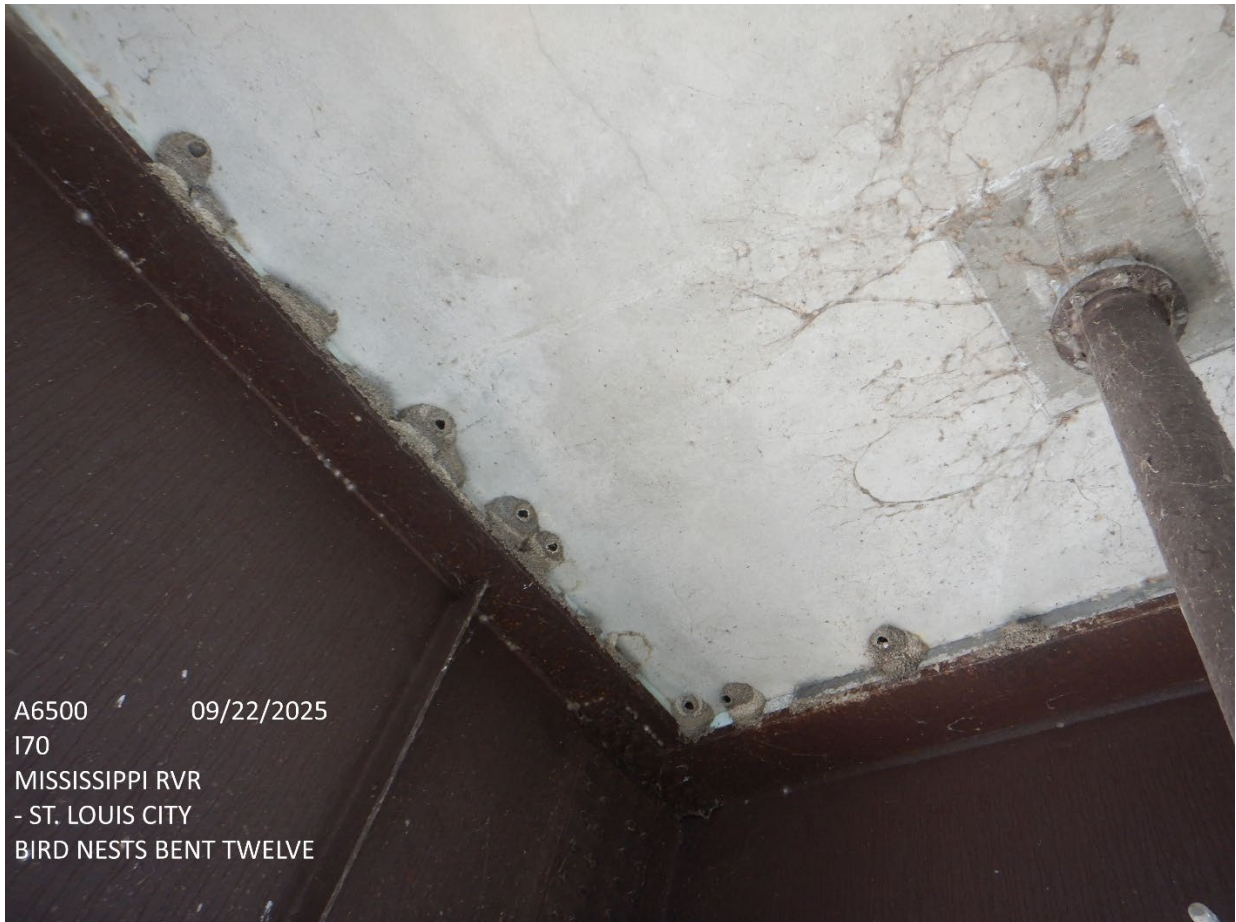
A6500 09/22/2025
I70
MISSISSIPPI RVR
- ST. LOUIS CITY
BIRD NESTS BENT TWELVE

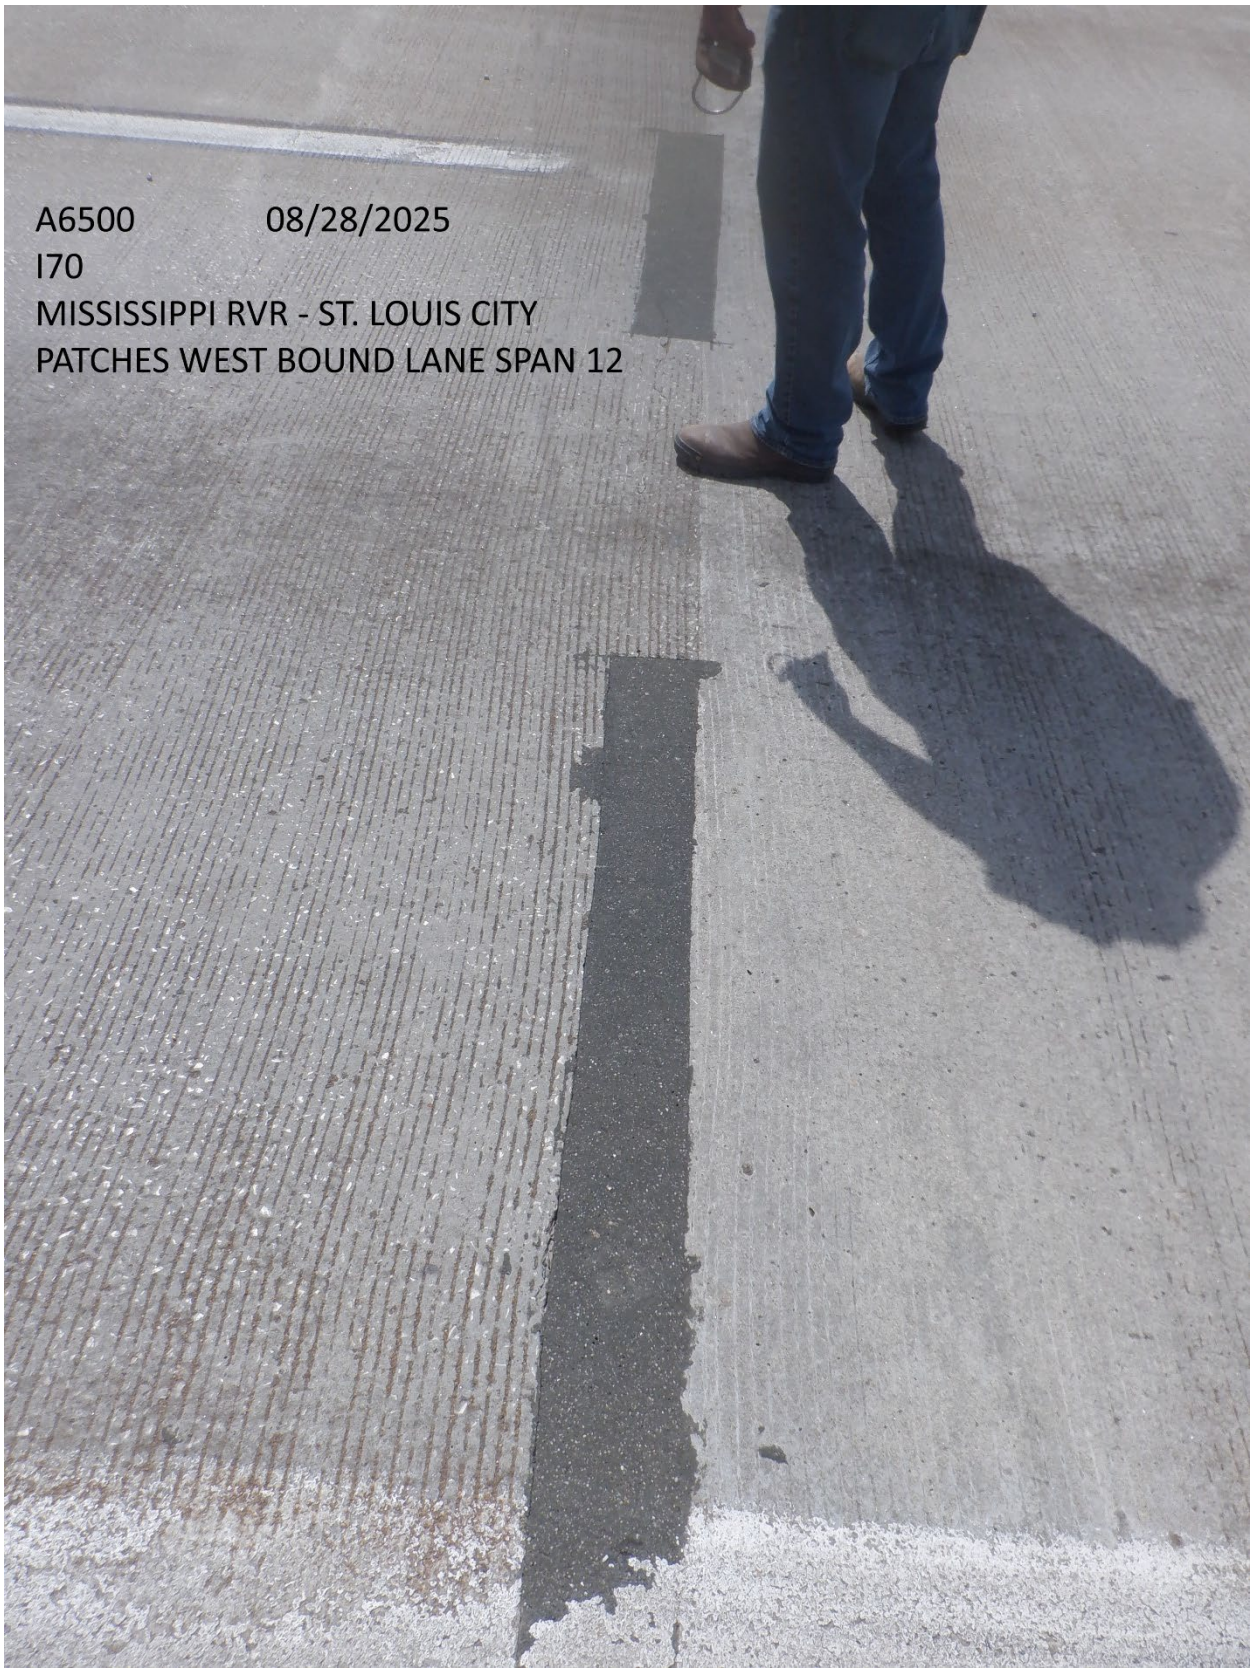
PATCHES WEST BOUND LANE SPAN 12

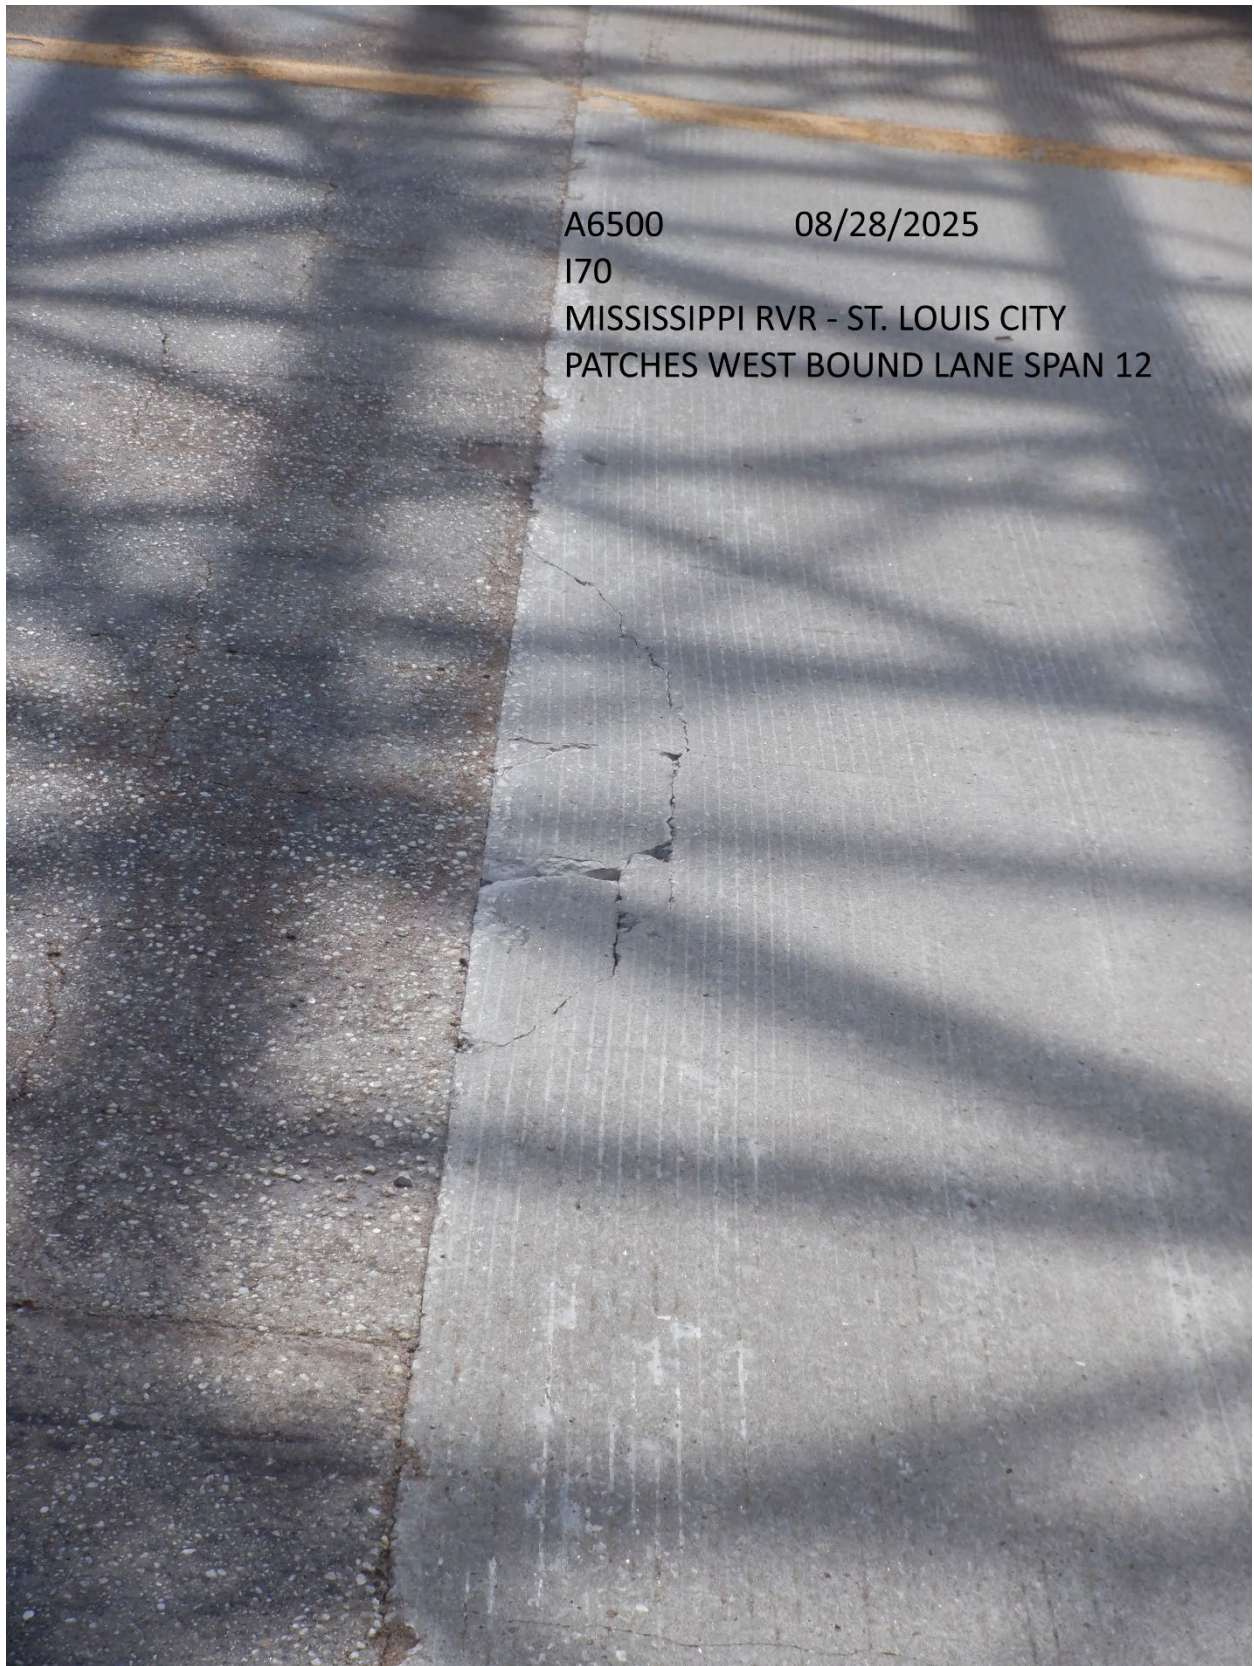
PATCHES WEST BOUND LANE SPAN 12

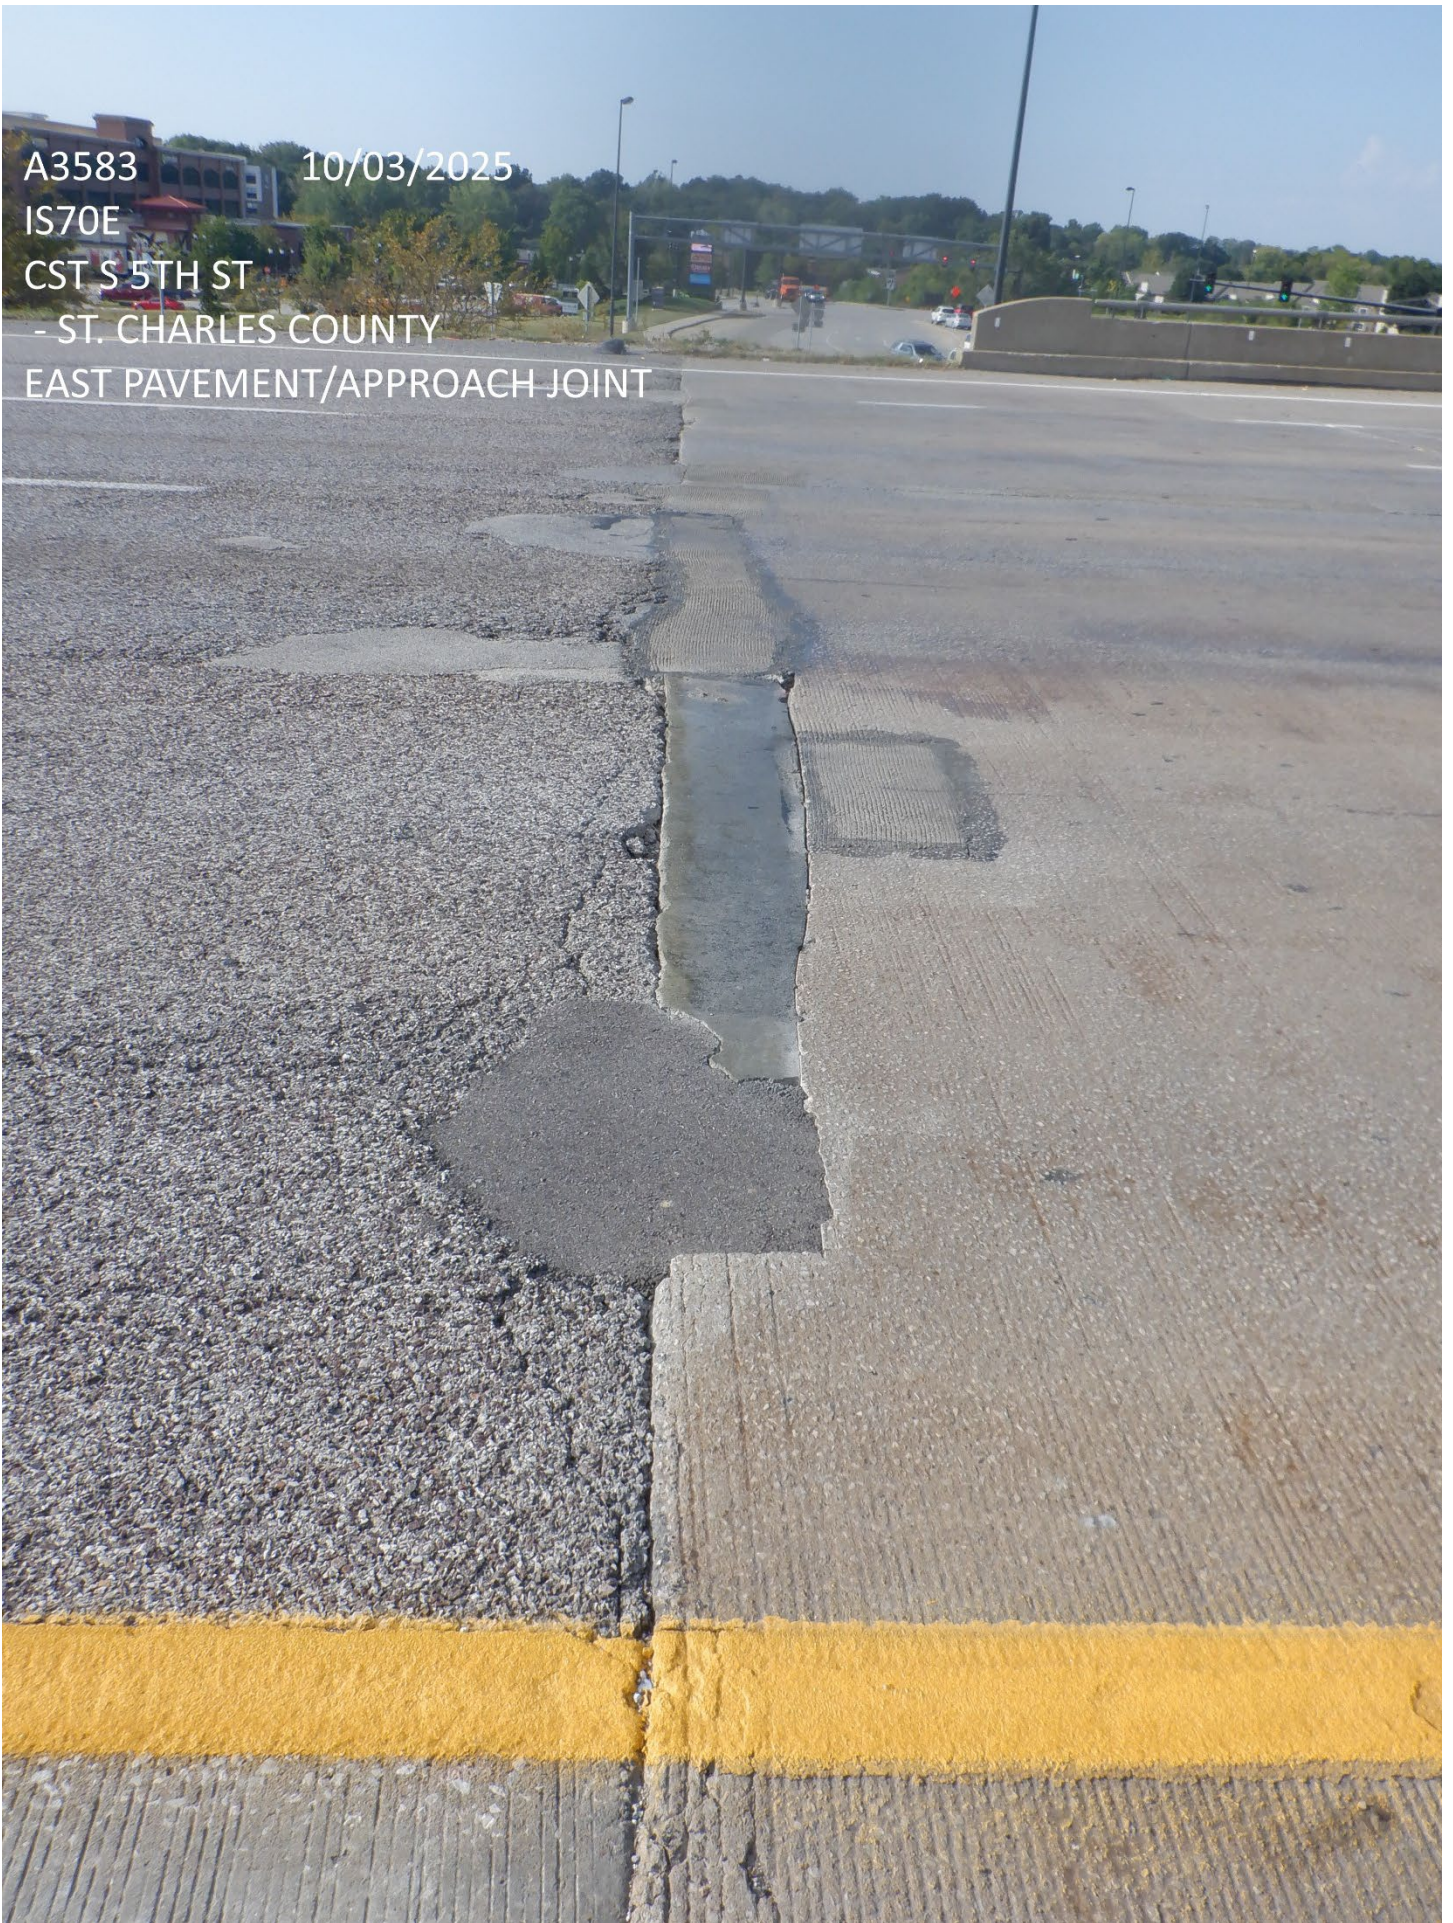
A3583 10/03/2025
IS70E
CST S 5TH ST
- ST. CHARLES COUNTY
EAST PAVEMENT/APPROACH JOINT

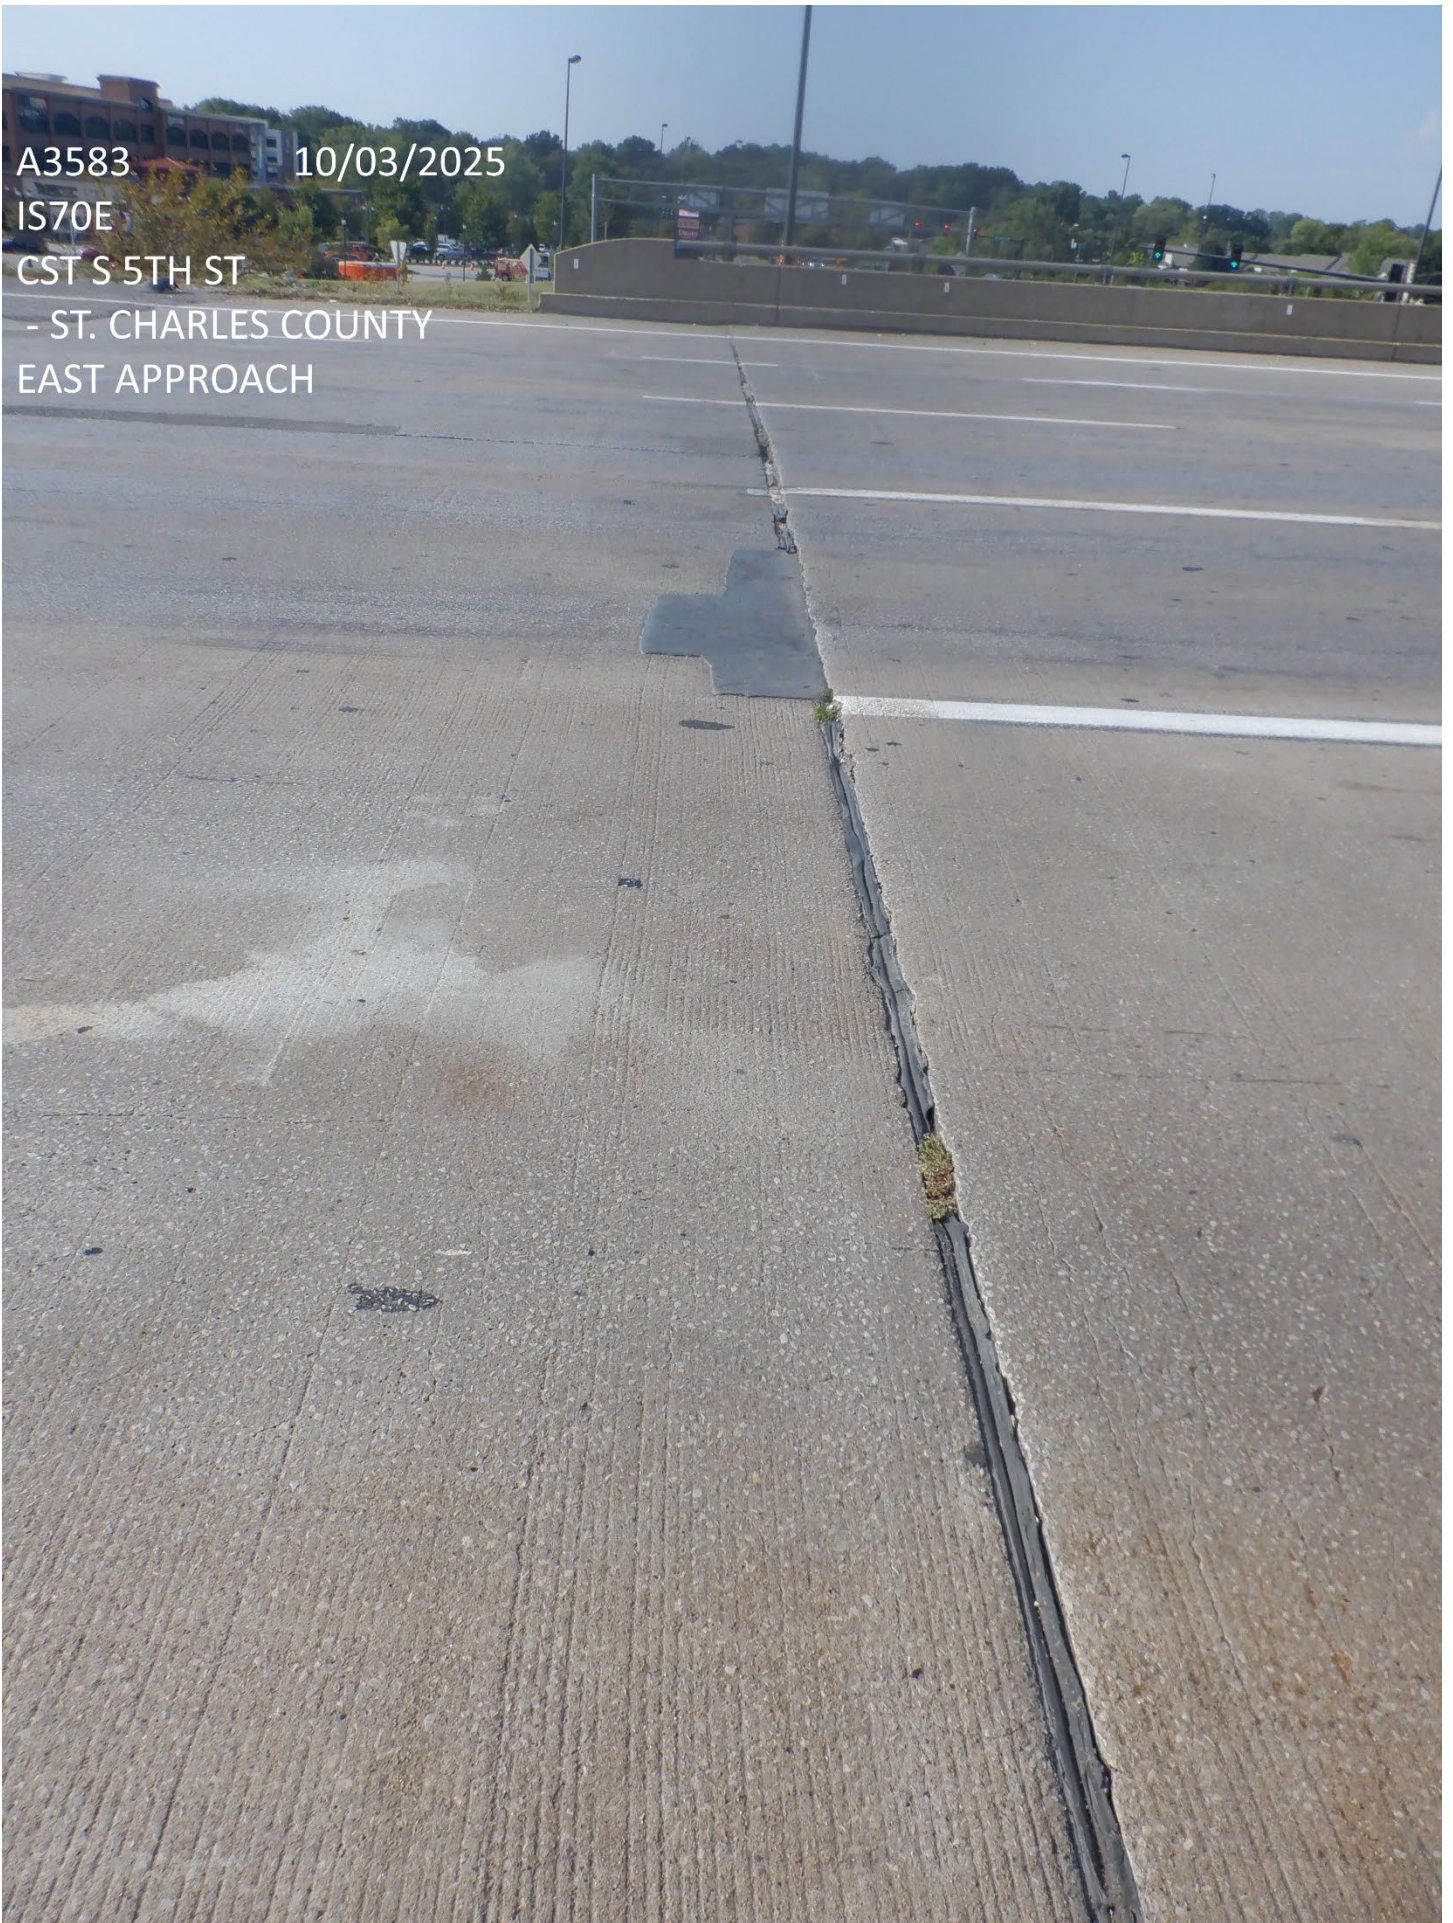
A3583 10/03/2025
IS70E
CST S 5TH ST
- ST. CHARLES COUNTY
EAST APPROACH

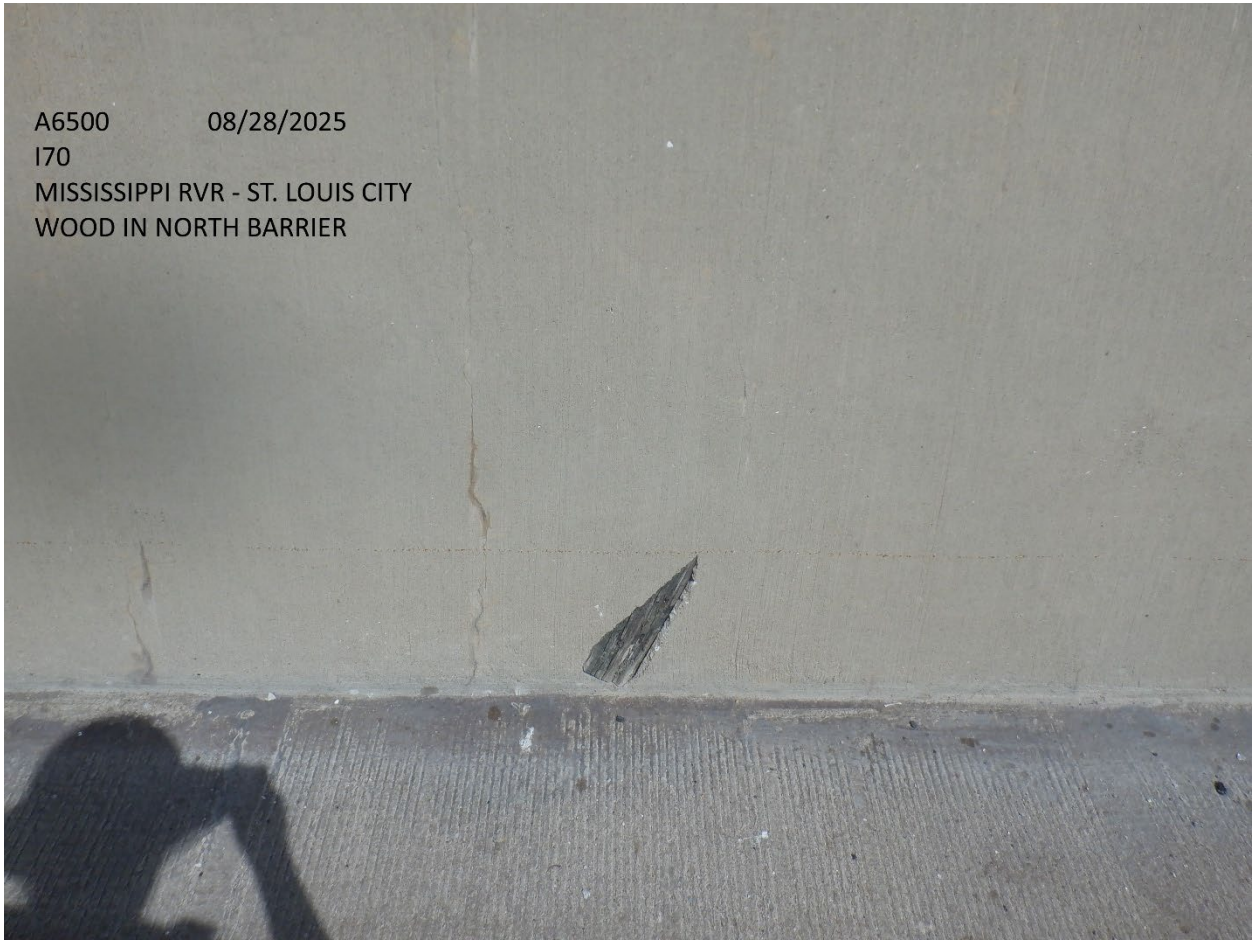
A6500 08/28/2025
170
MISSISSIPPI RVR - ST. LOUIS CITY
WOOD IN NORTH BARRIER

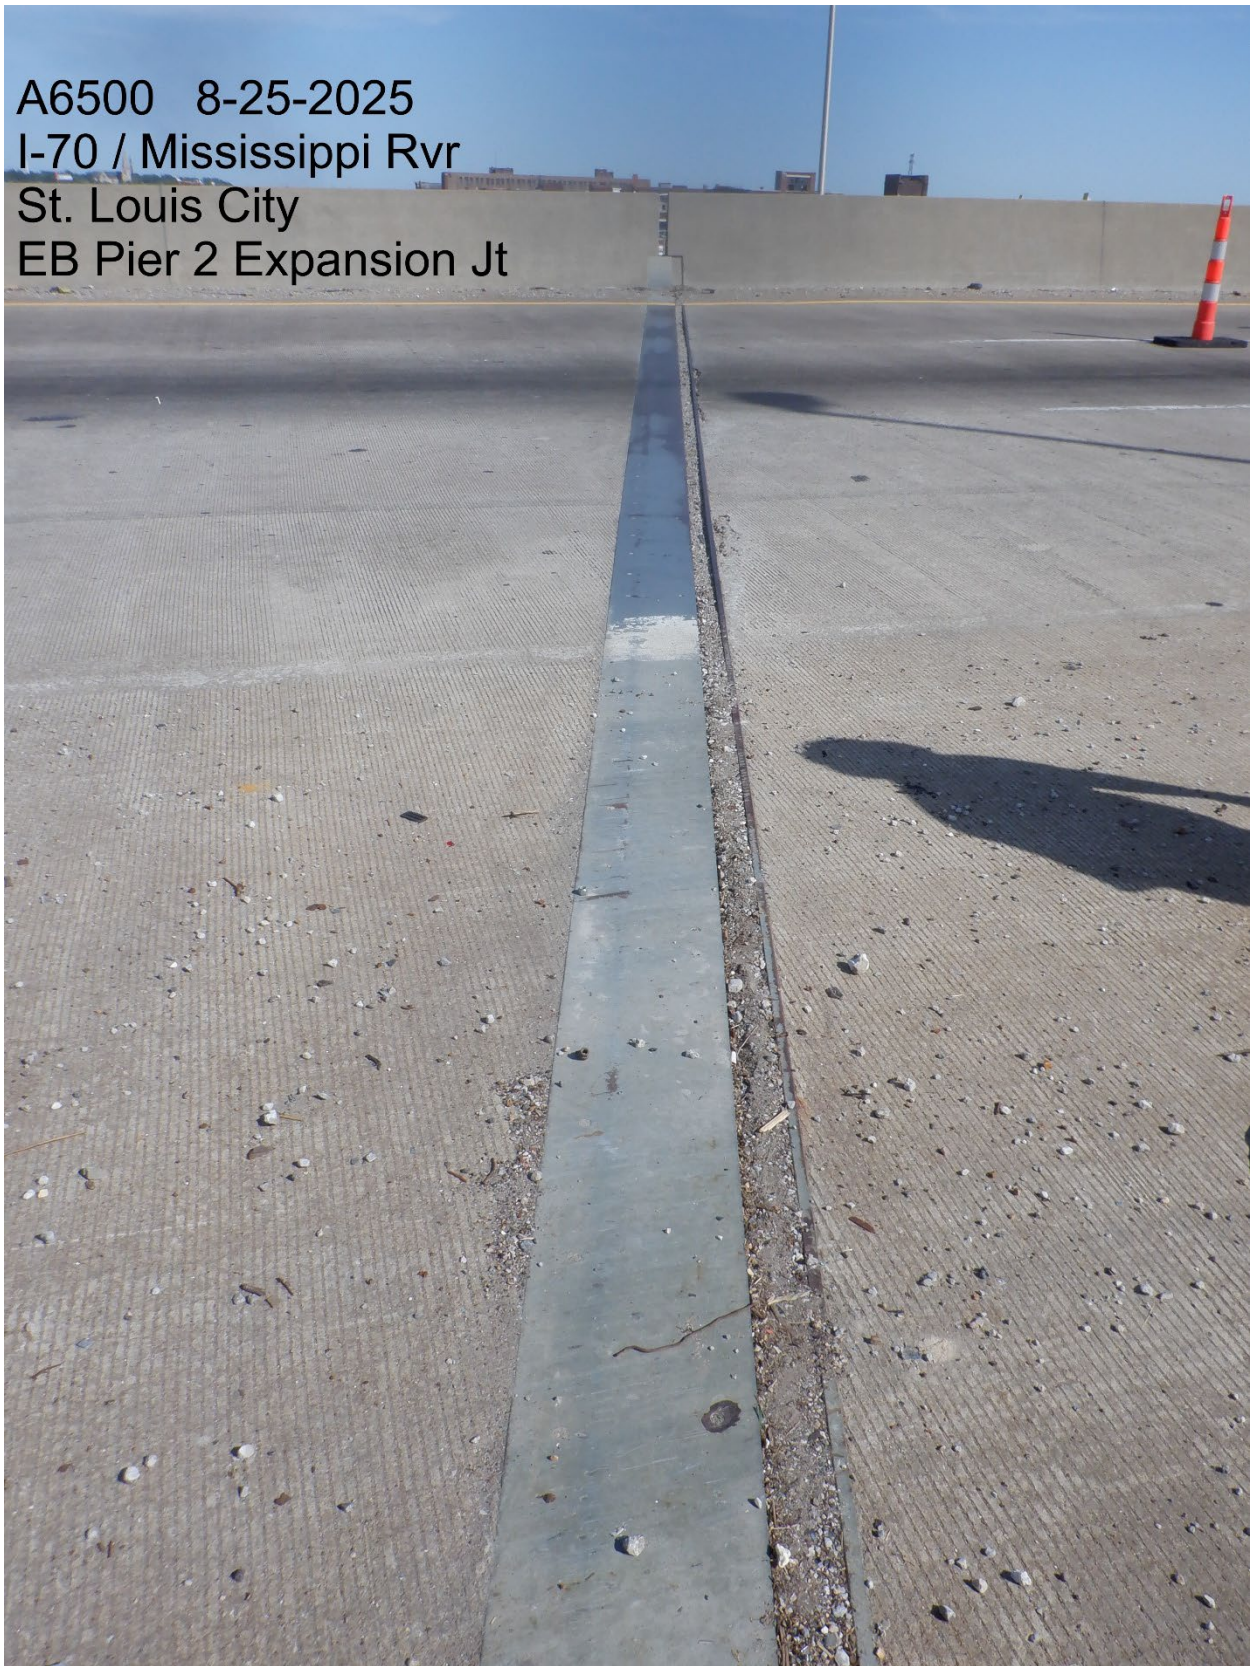
A6500 8-25-2025
I-70 / Mississippi Rvr
St. Louis City
EB Pier 2 Expansion Jt

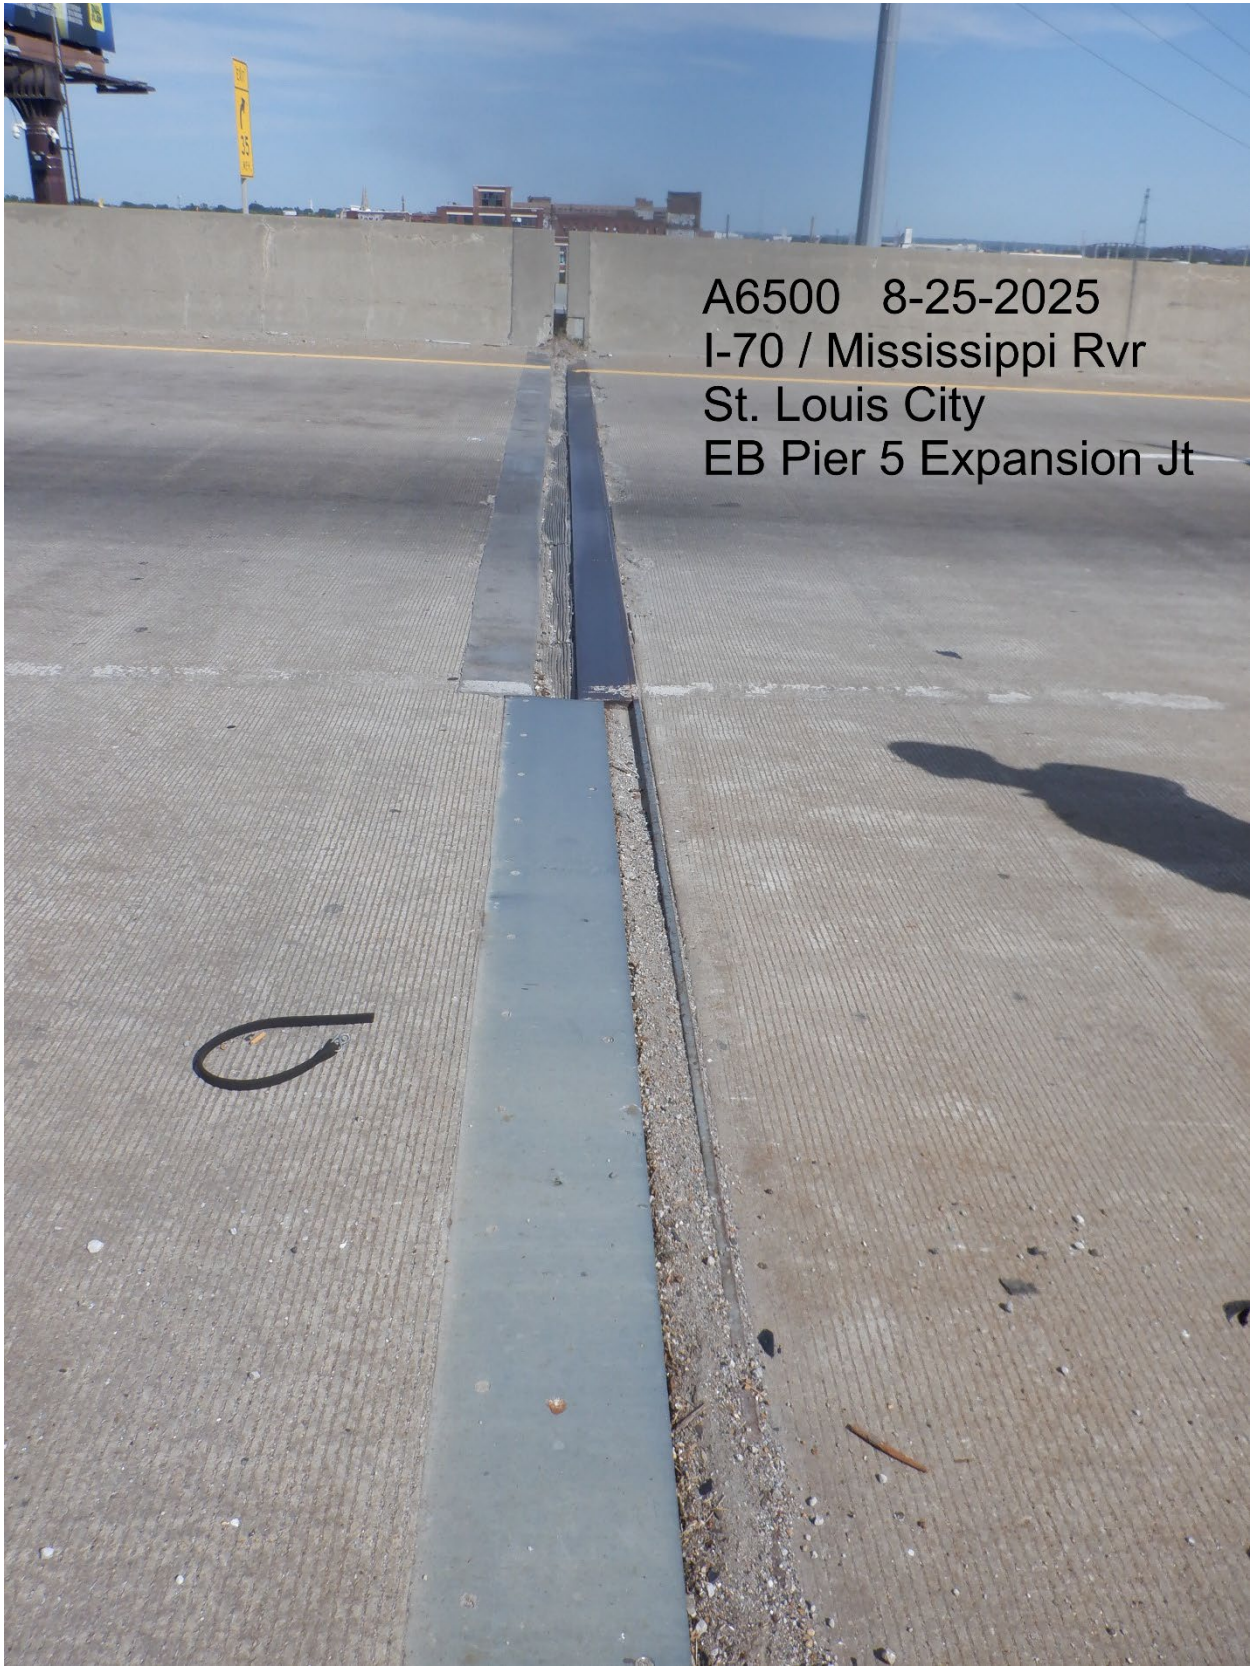
A6500 8-25-2025
I-70 / Mississippi Rvr
St. Louis City
EB Pier 5 Expansion Jt

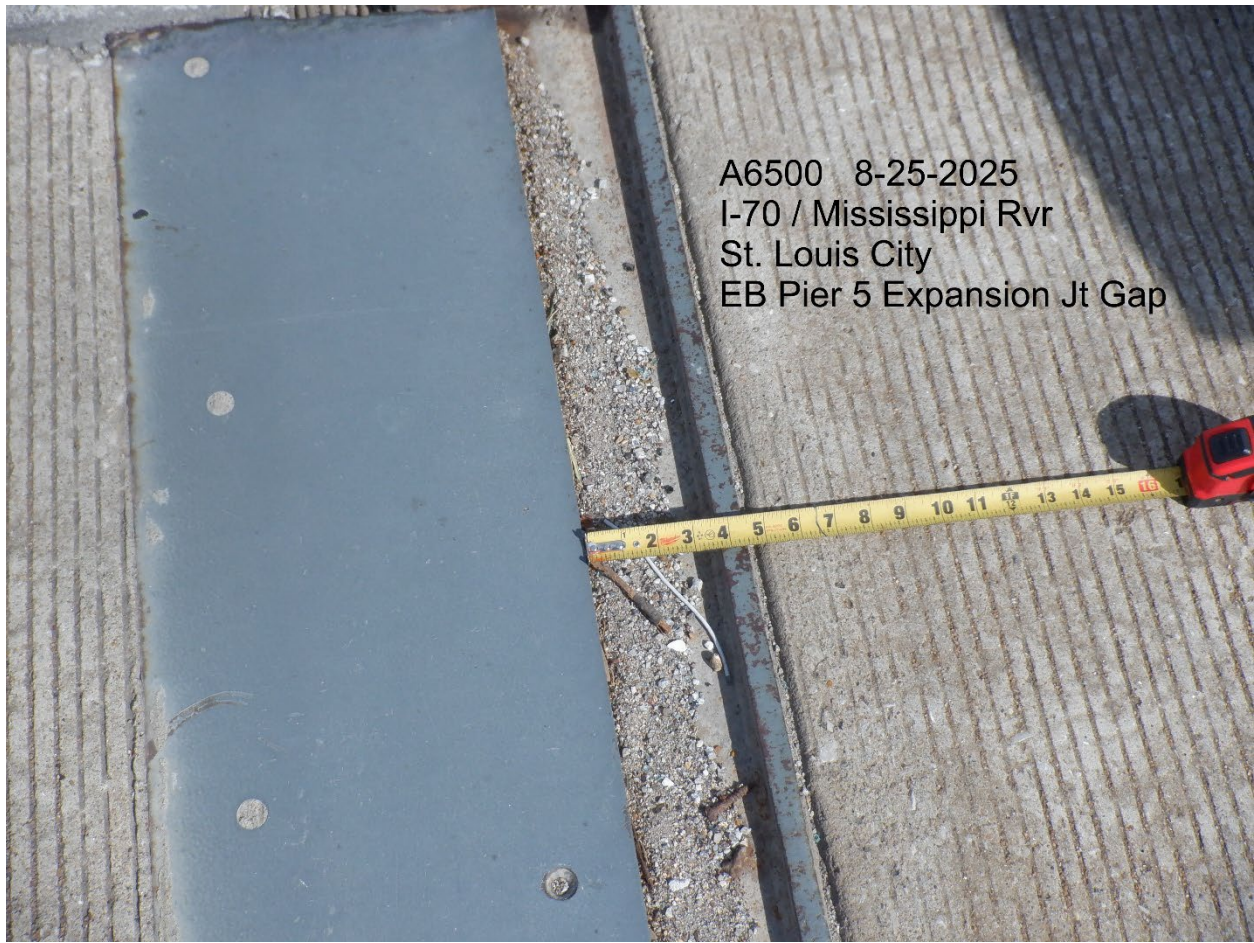
A6500 8-25-2025
I-70 / Mississippi Rvr
St. Louis City
EB Pier 5 Expansion Jt Gap
