Missouri Department of Transportation

STRUCTURAL REHABILITATION CHECKLIST

Bridge No.: **A6500**

Route: **I-70**

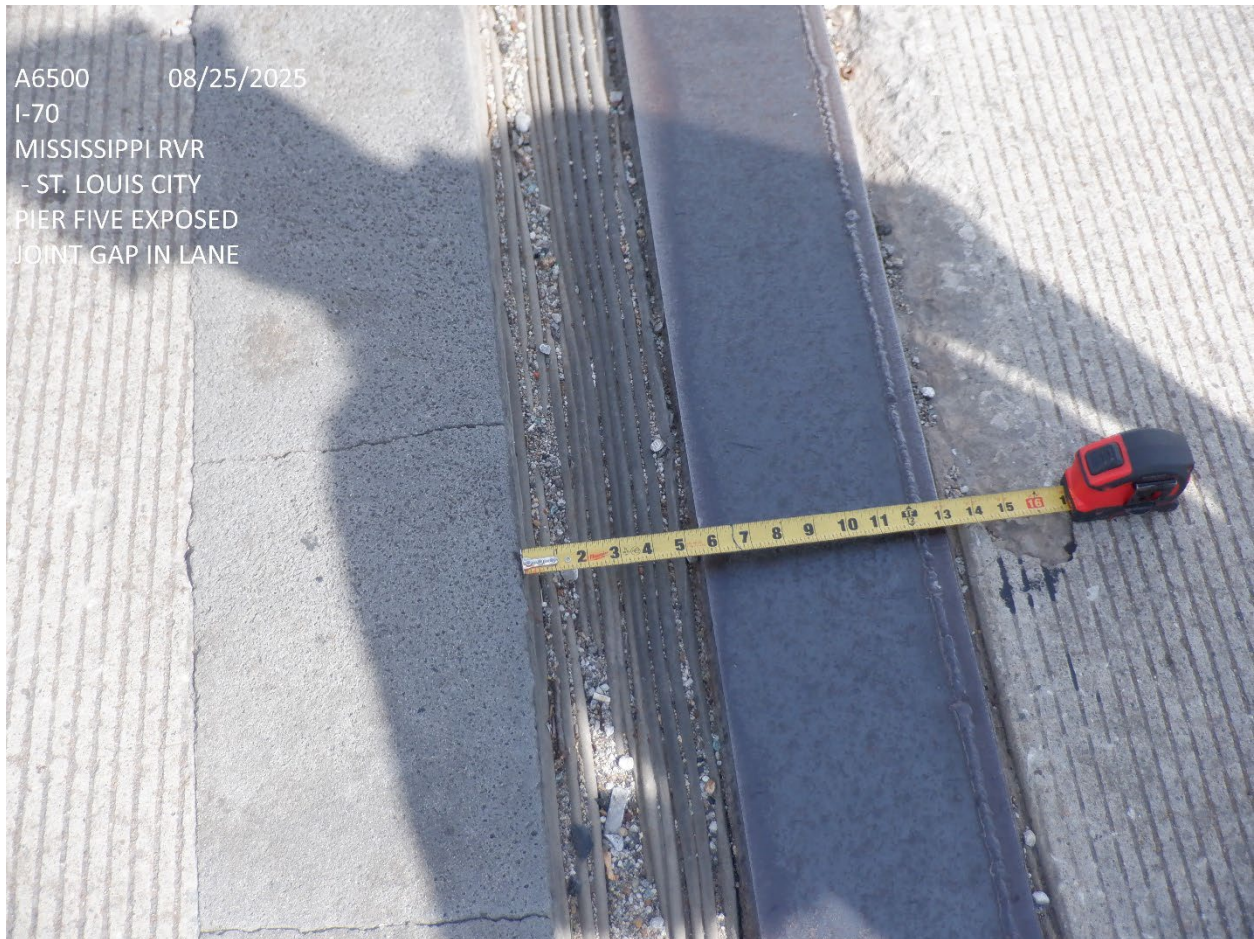
A6500 08/25/2025
I-70
MISSISSIPPI RVR
- ST. LOUIS CITY
PIER FIVE EXPOSED
JOINT GAP IN LANE

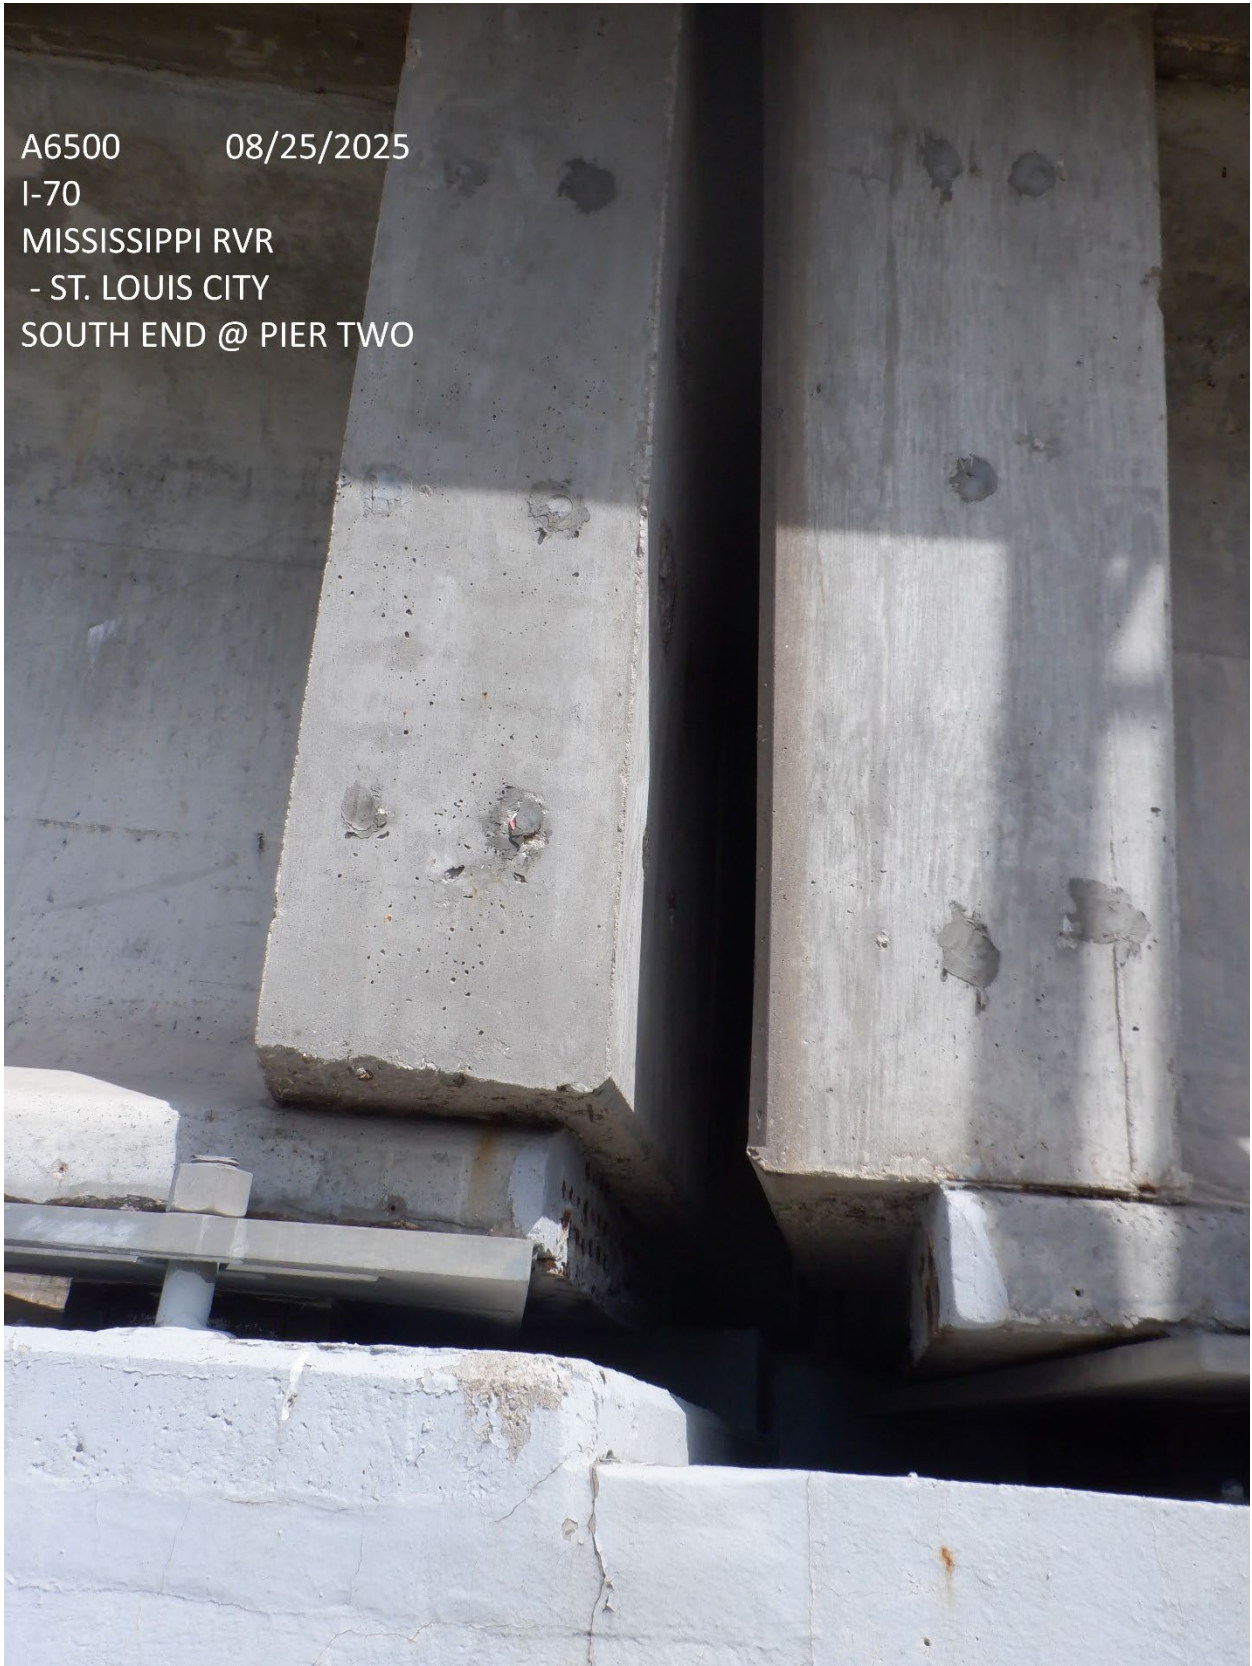
A6500 08/25/2025
I-70
MISSISSIPPI RVR
- ST. LOUIS CITY
SOUTH END @ PIER TWO

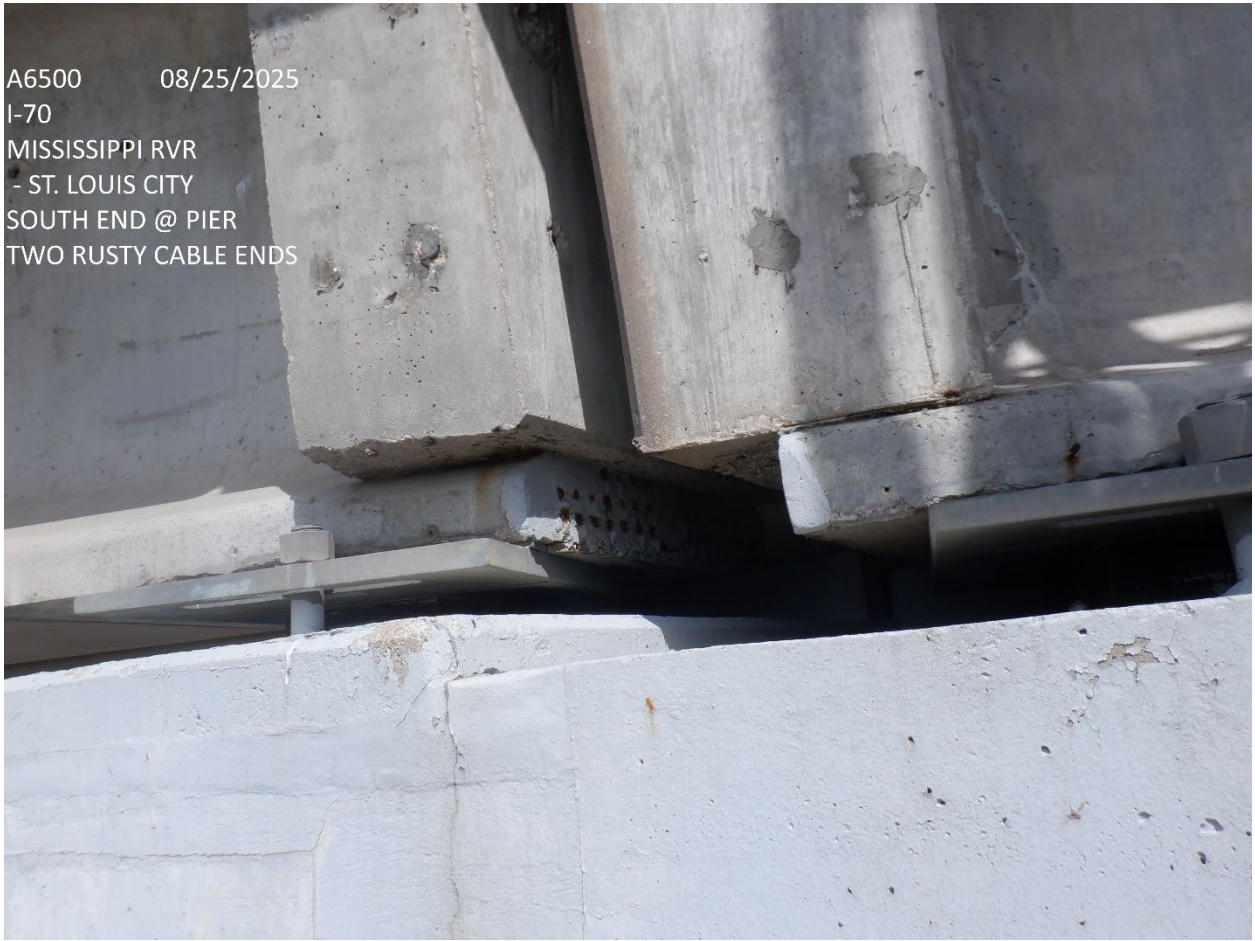
A6500 08/25/2025
I-70
MISSISSIPPI RVR
- ST. LOUIS CITY
SOUTH END @ PIER
TWO RUSTY CABLE ENDS

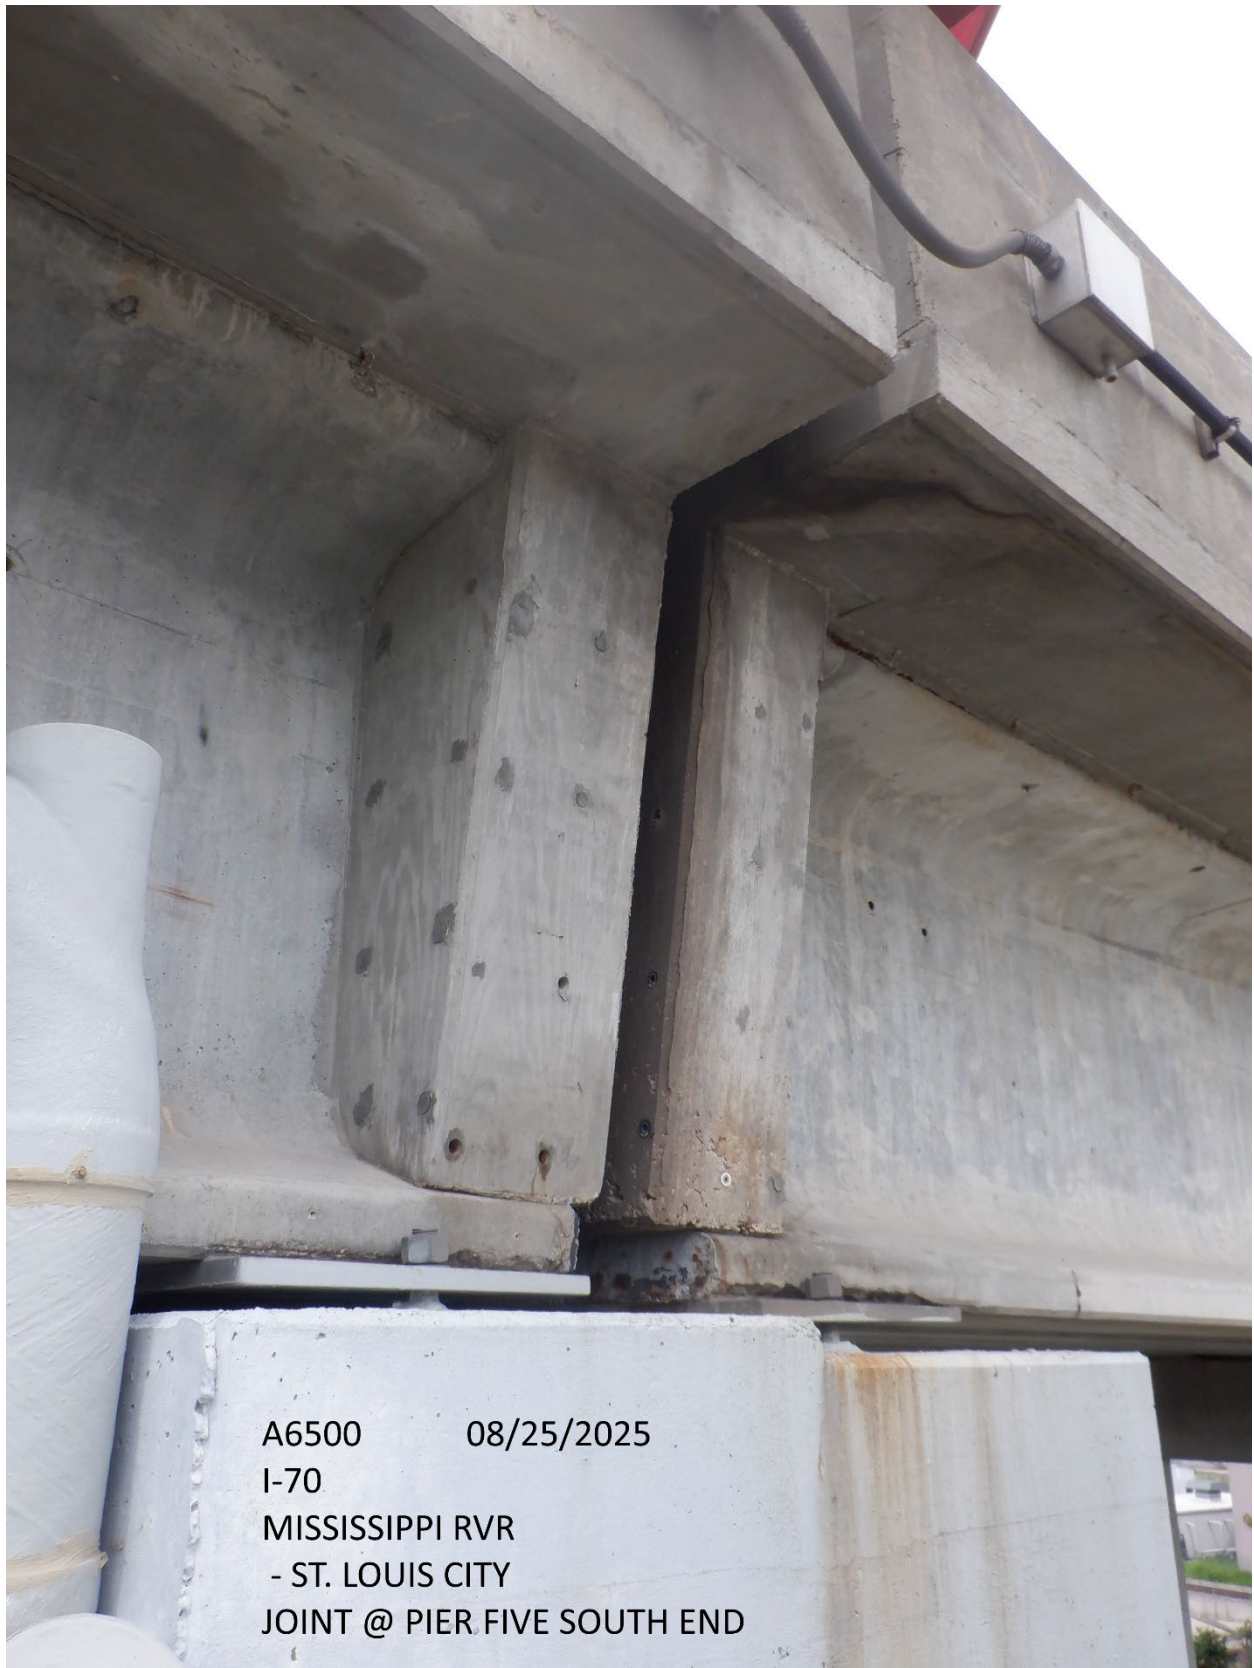
A6500 08/25/2025
I-70
MISSISSIPPI RVR
- ST. LOUIS CITY
JOINT @ PIER FIVE SOUTH END

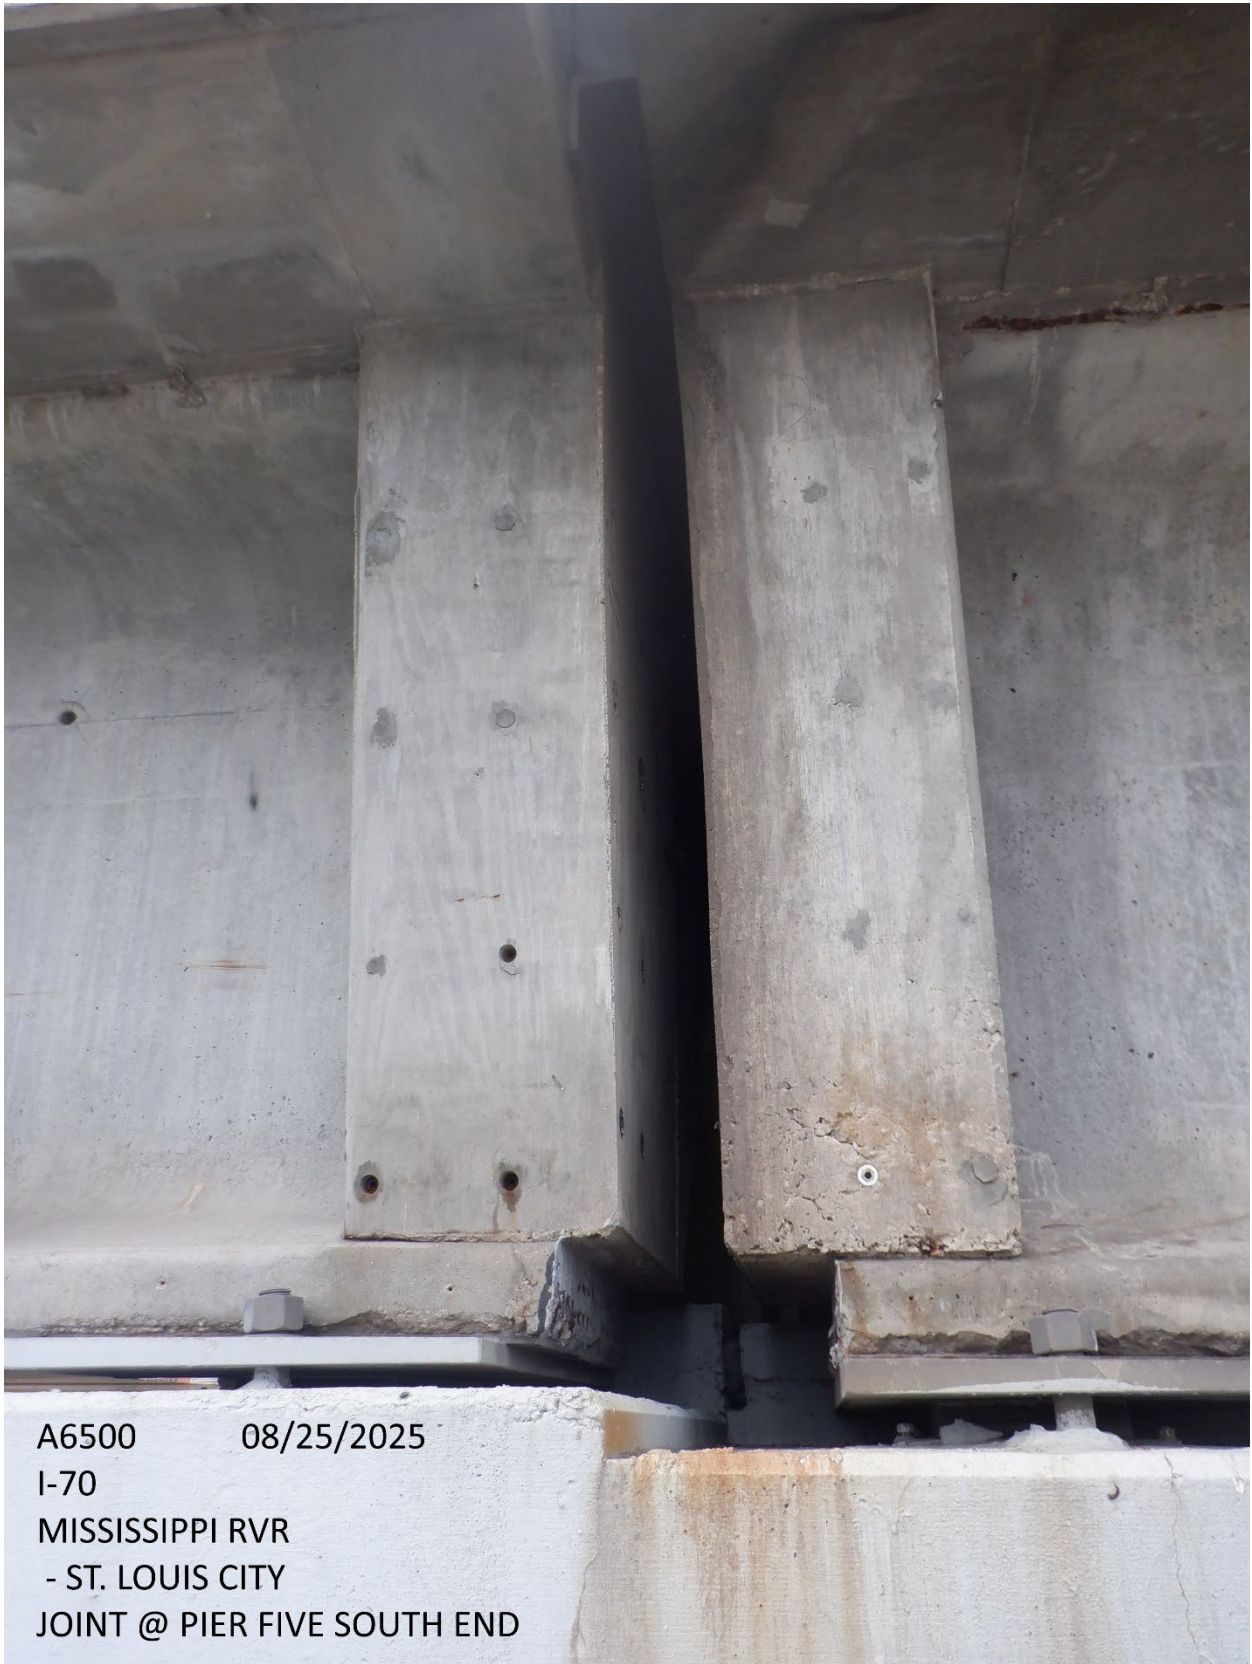
A6500 08/25/2025
I-70
MISSISSIPPI RVR
- ST. LOUIS CITY
JOINT @ PIER FIVE SOUTH END

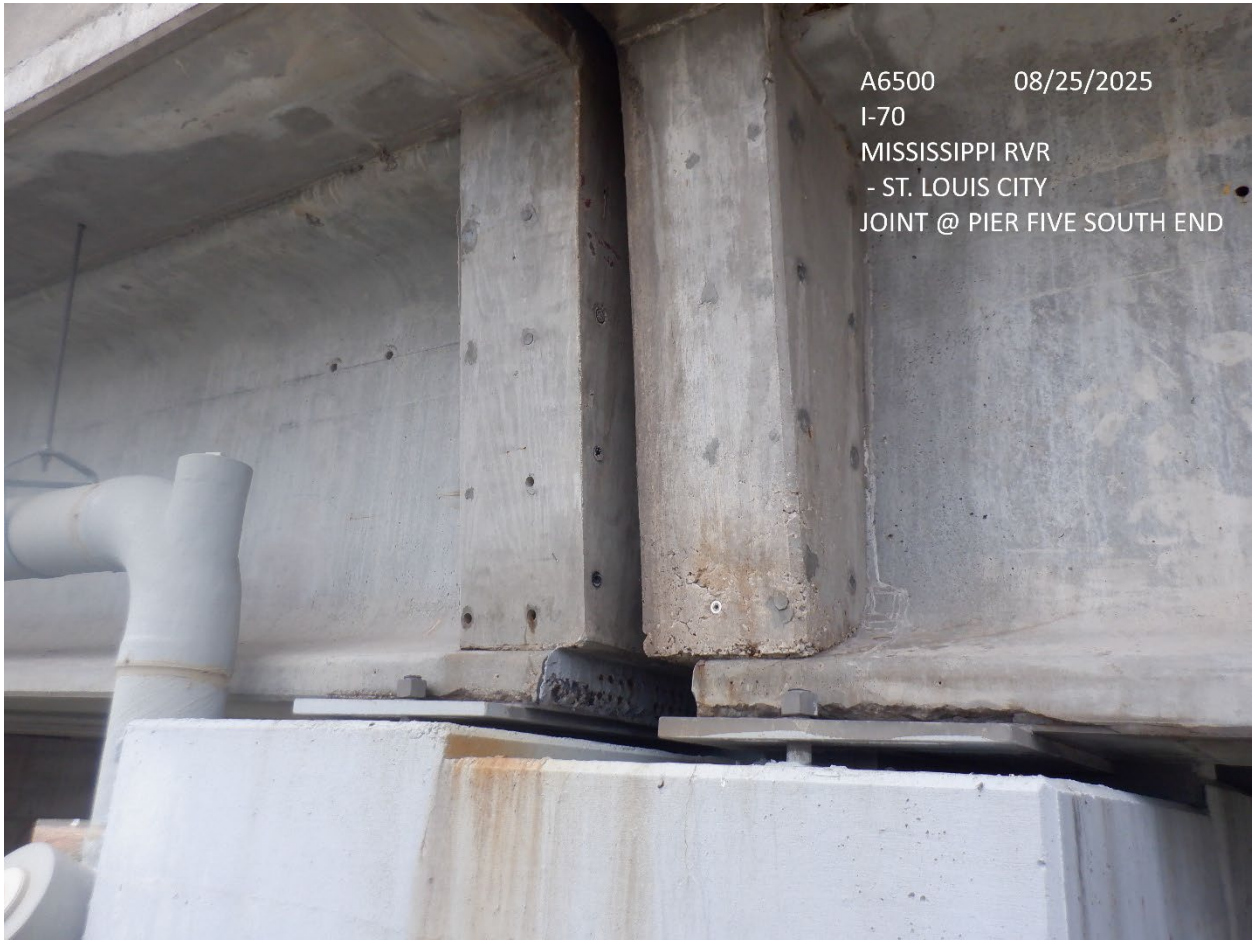
A6500 08/25/2025
I-70
MISSISSIPPI RVR
- ST. LOUIS CITY
JOINT @ PIER FIVE SOUTH END

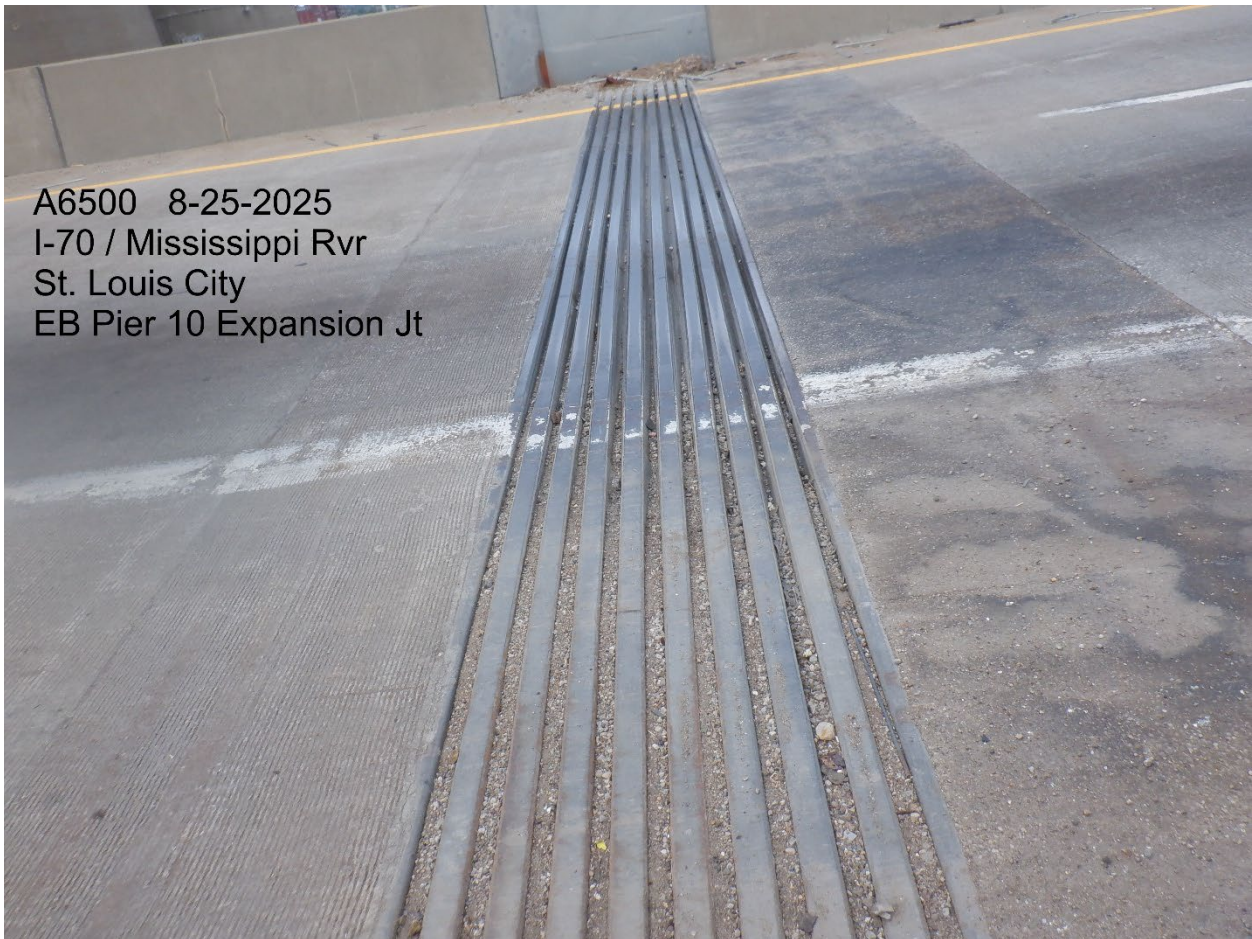
A6500 8-25-2025
I-70 / Mississippi Rvr
St. Louis City
EB Pier 10 Expansion Jt

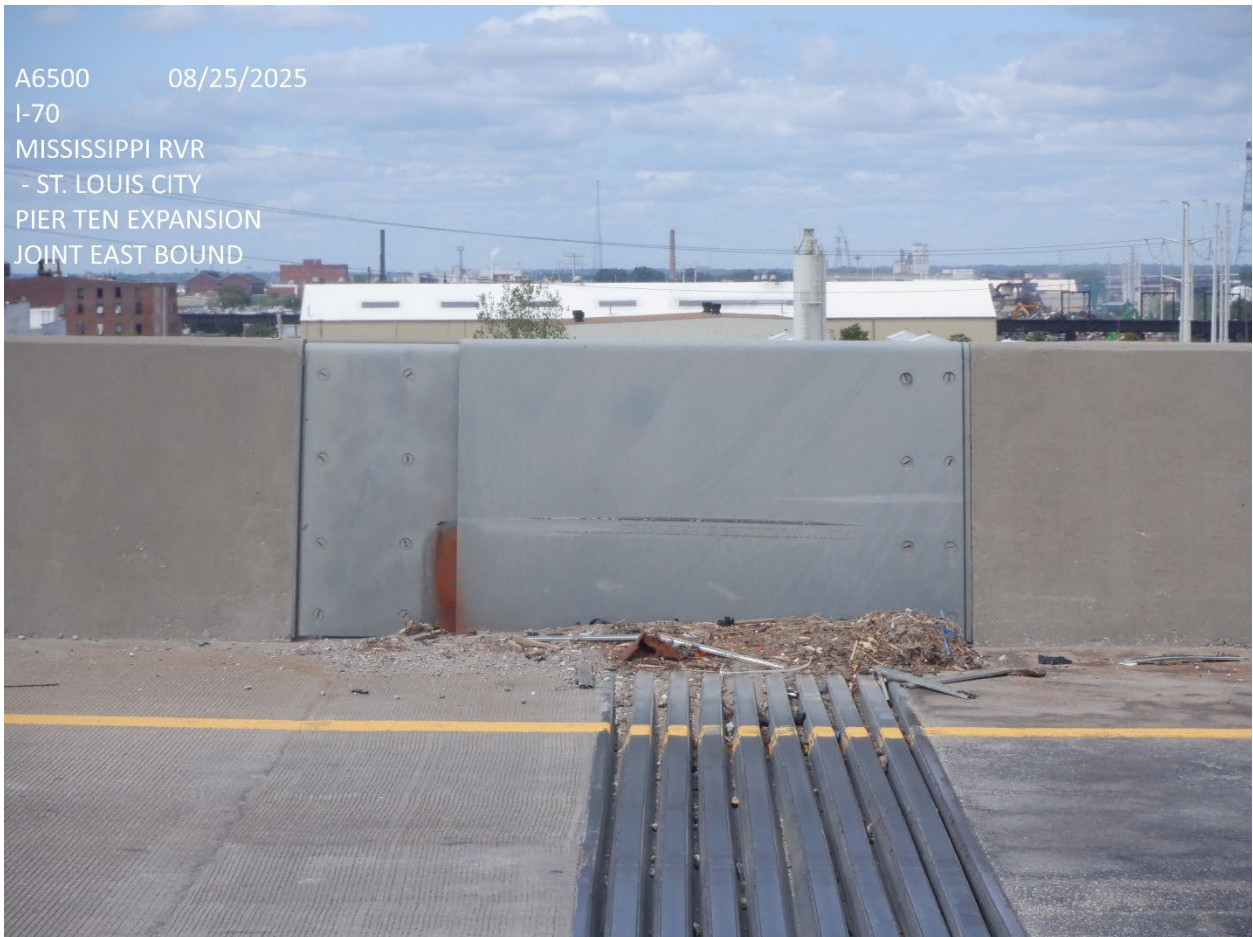
A6500 08/25/2025
I-70
MISSISSIPPI RVR
- ST. LOUIS CITY
PIER TEN EXPANSION
JOINT EAST BOUND

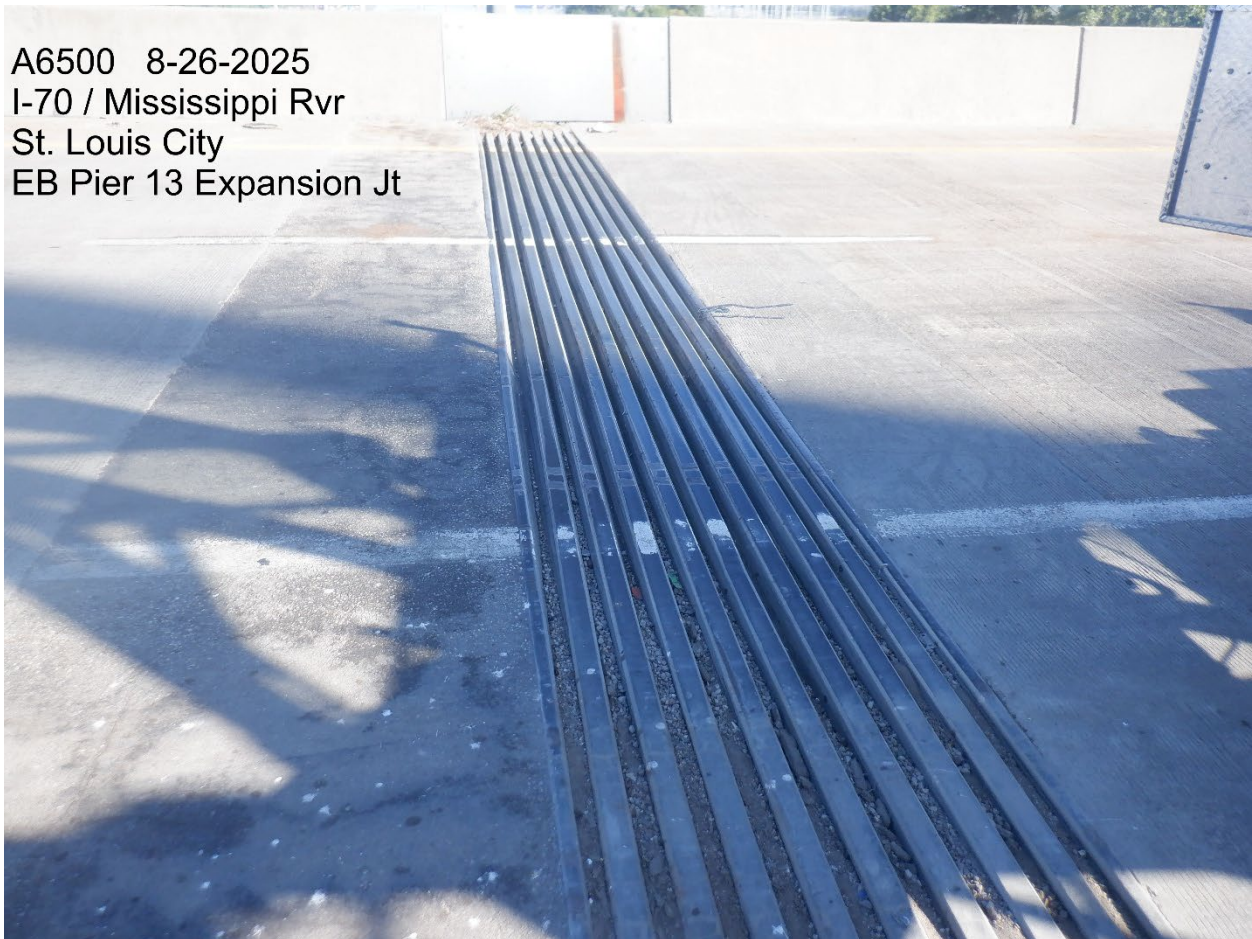
A6500 8-26-2025
I-70 / Mississippi Rvr
St. Louis City
EB Pier 13 Expansion Jt

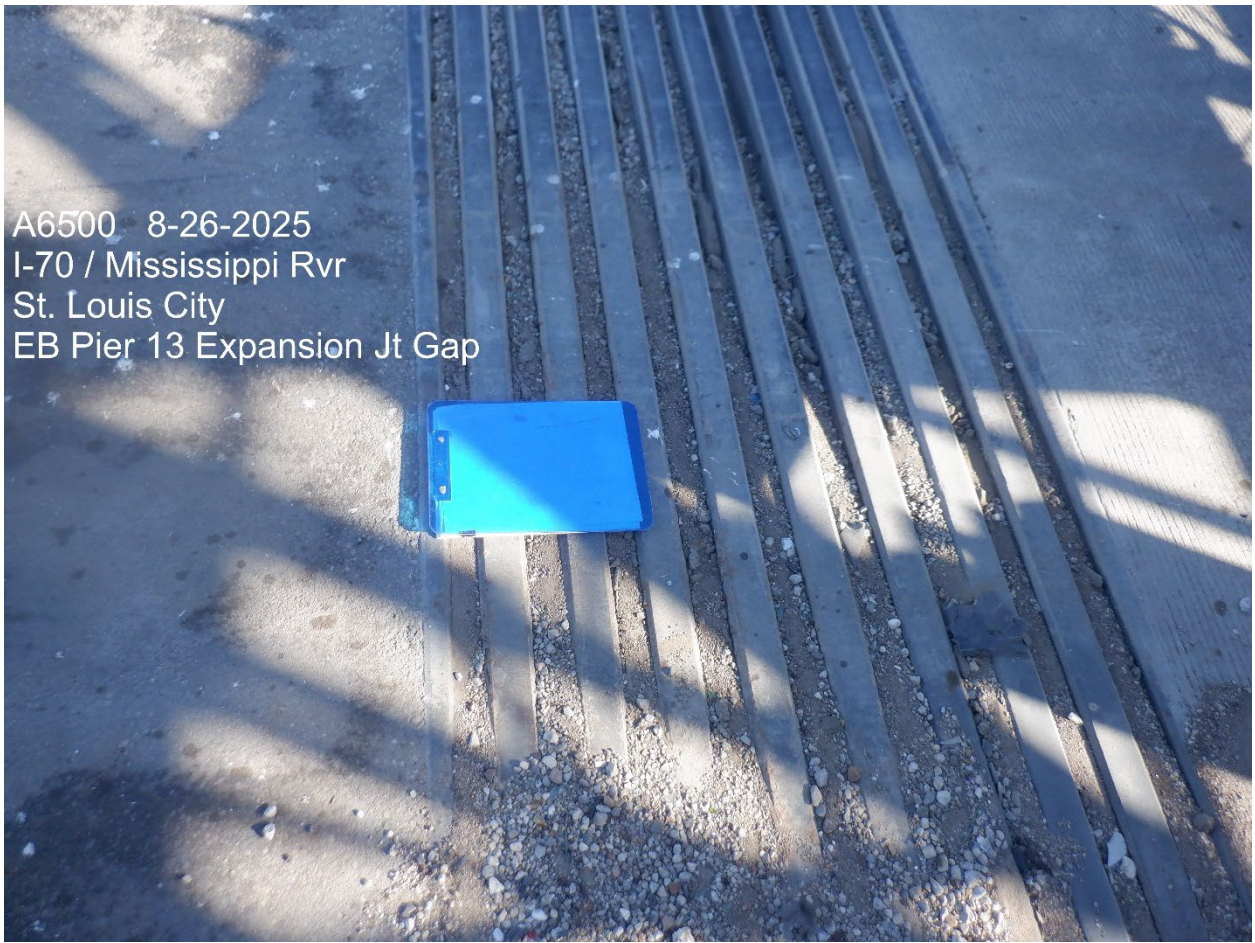
A6500 8-26-2025
I-70 / Mississippi Rvr
St. Louis City
EB Pier 13 Expansion Jt Gap

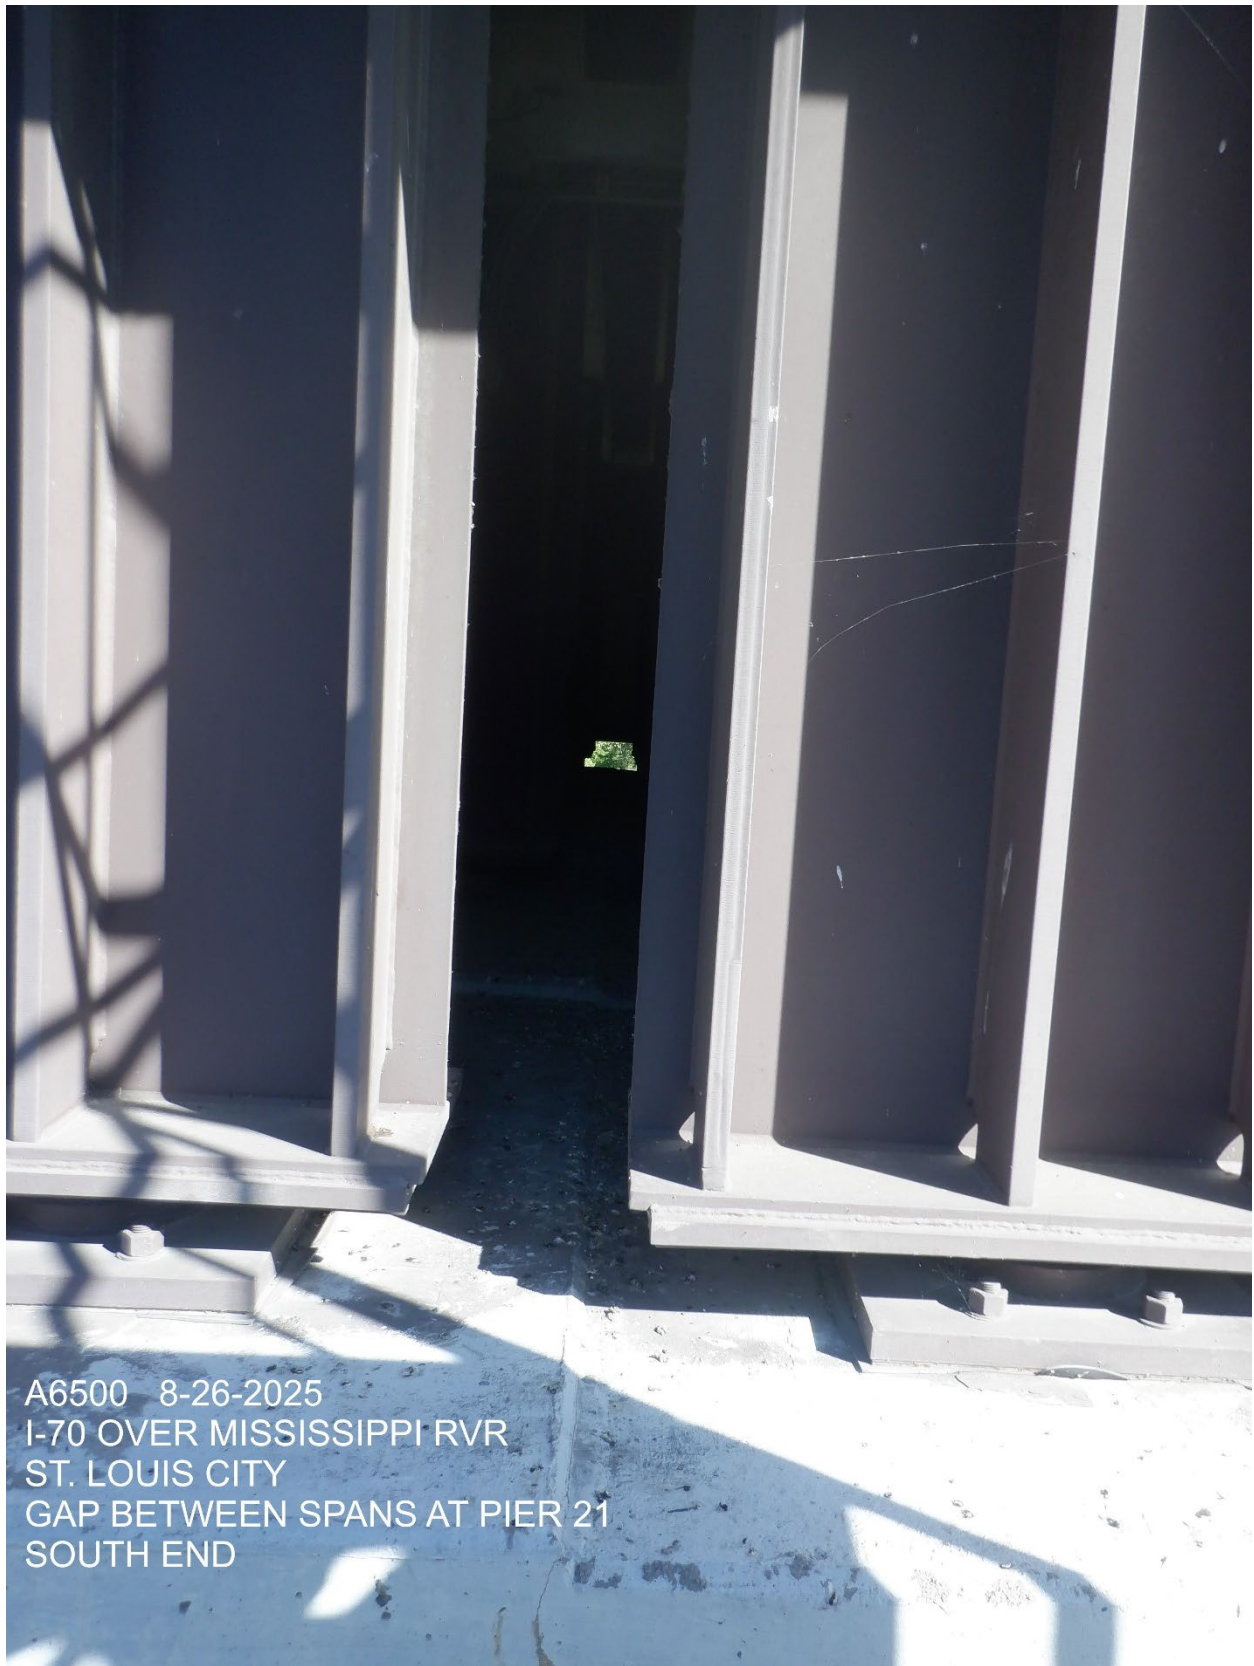
A6500 8-26-2025
I-70 OVER MISSISSIPPI RVR
ST. LOUIS CITY
GAP BETWEEN SPANS AT PIER 21
SOUTH END

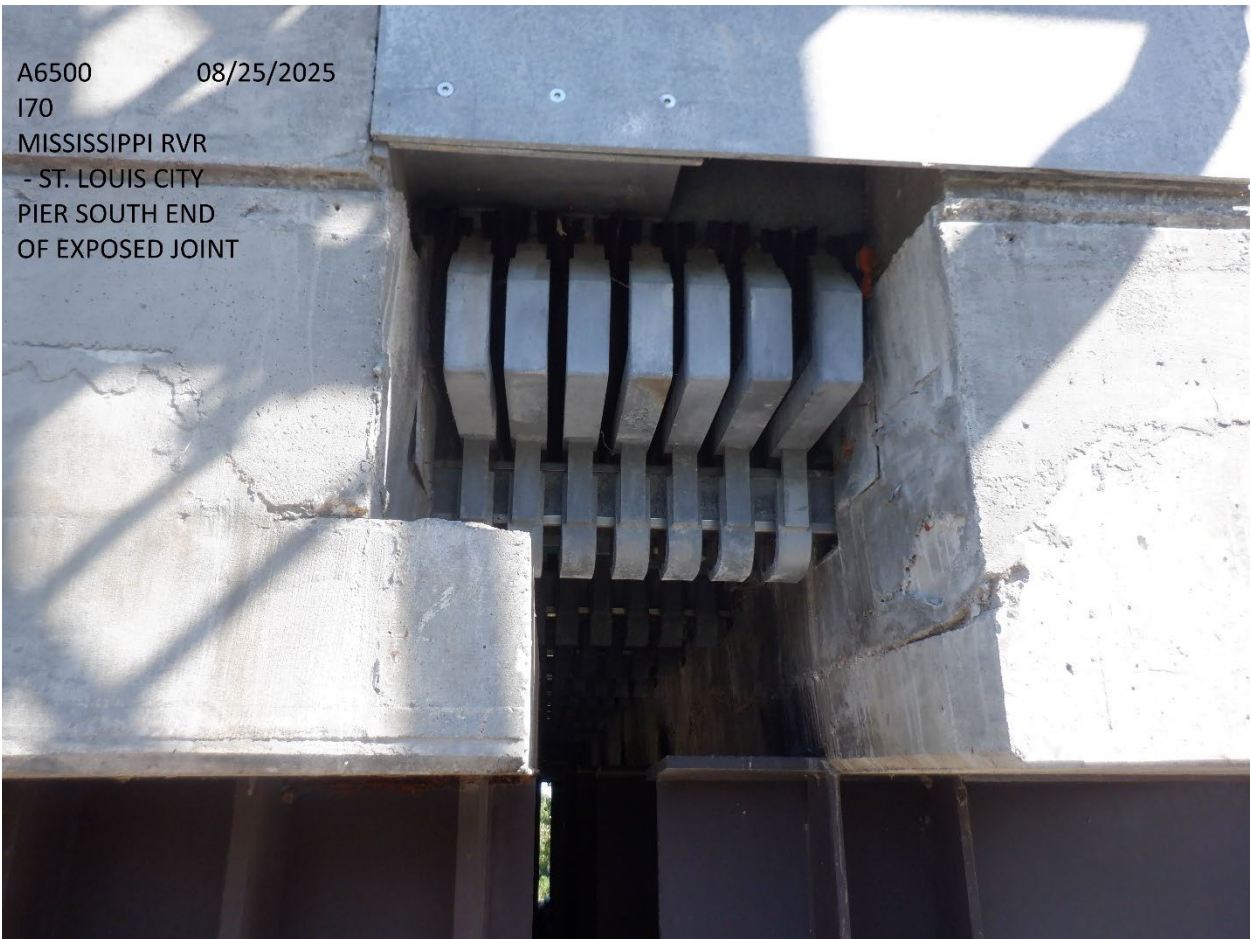
A6500 08/25/2025
I70
MISSISSIPPI RVR
- ST. LOUIS CITY
PIER SOUTH END
OF EXPOSED JOINT

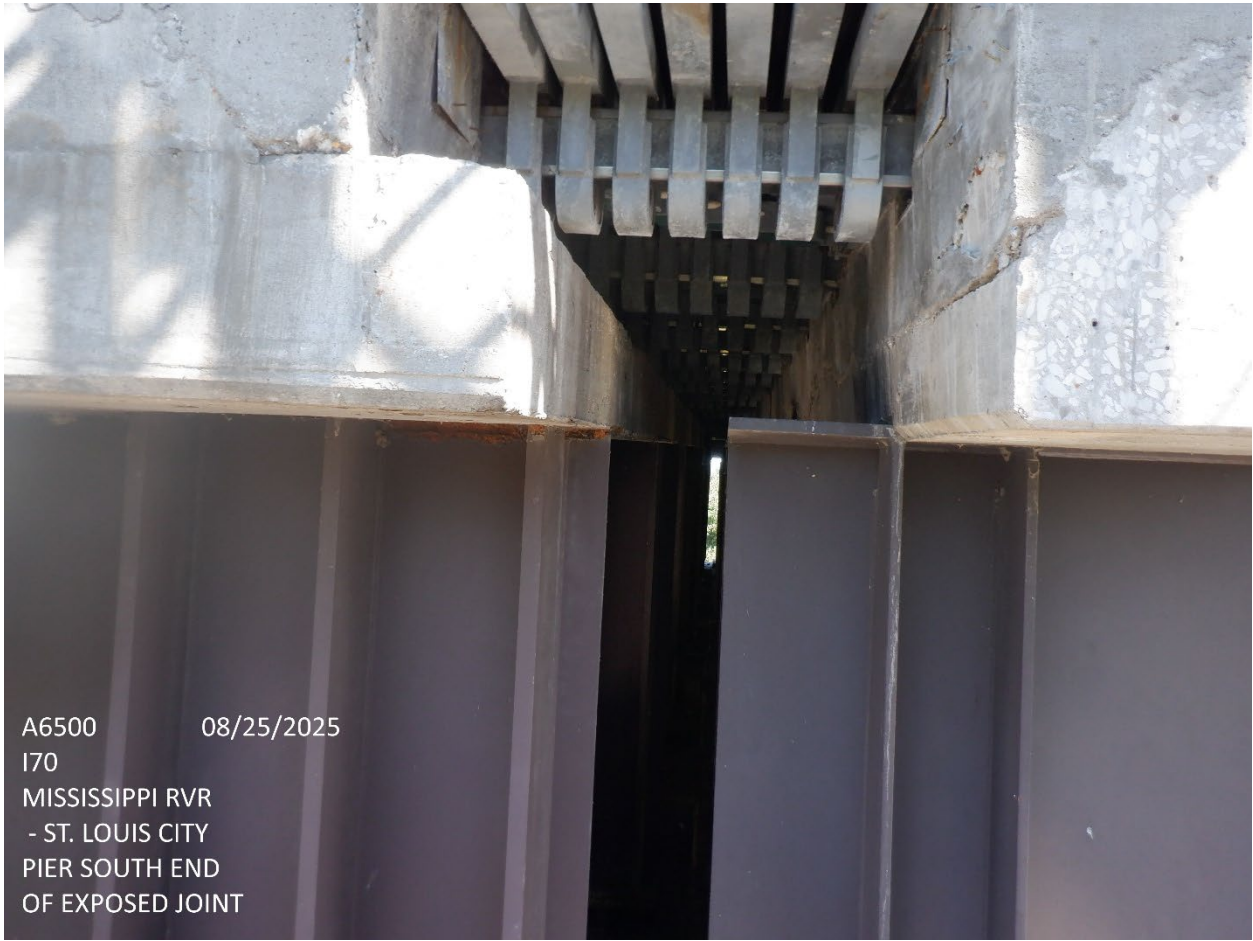
A6500 08/25/2025
I70
MISSISSIPPI RVR
- ST. LOUIS CITY
PIER SOUTH END
OF EXPOSED JOINT

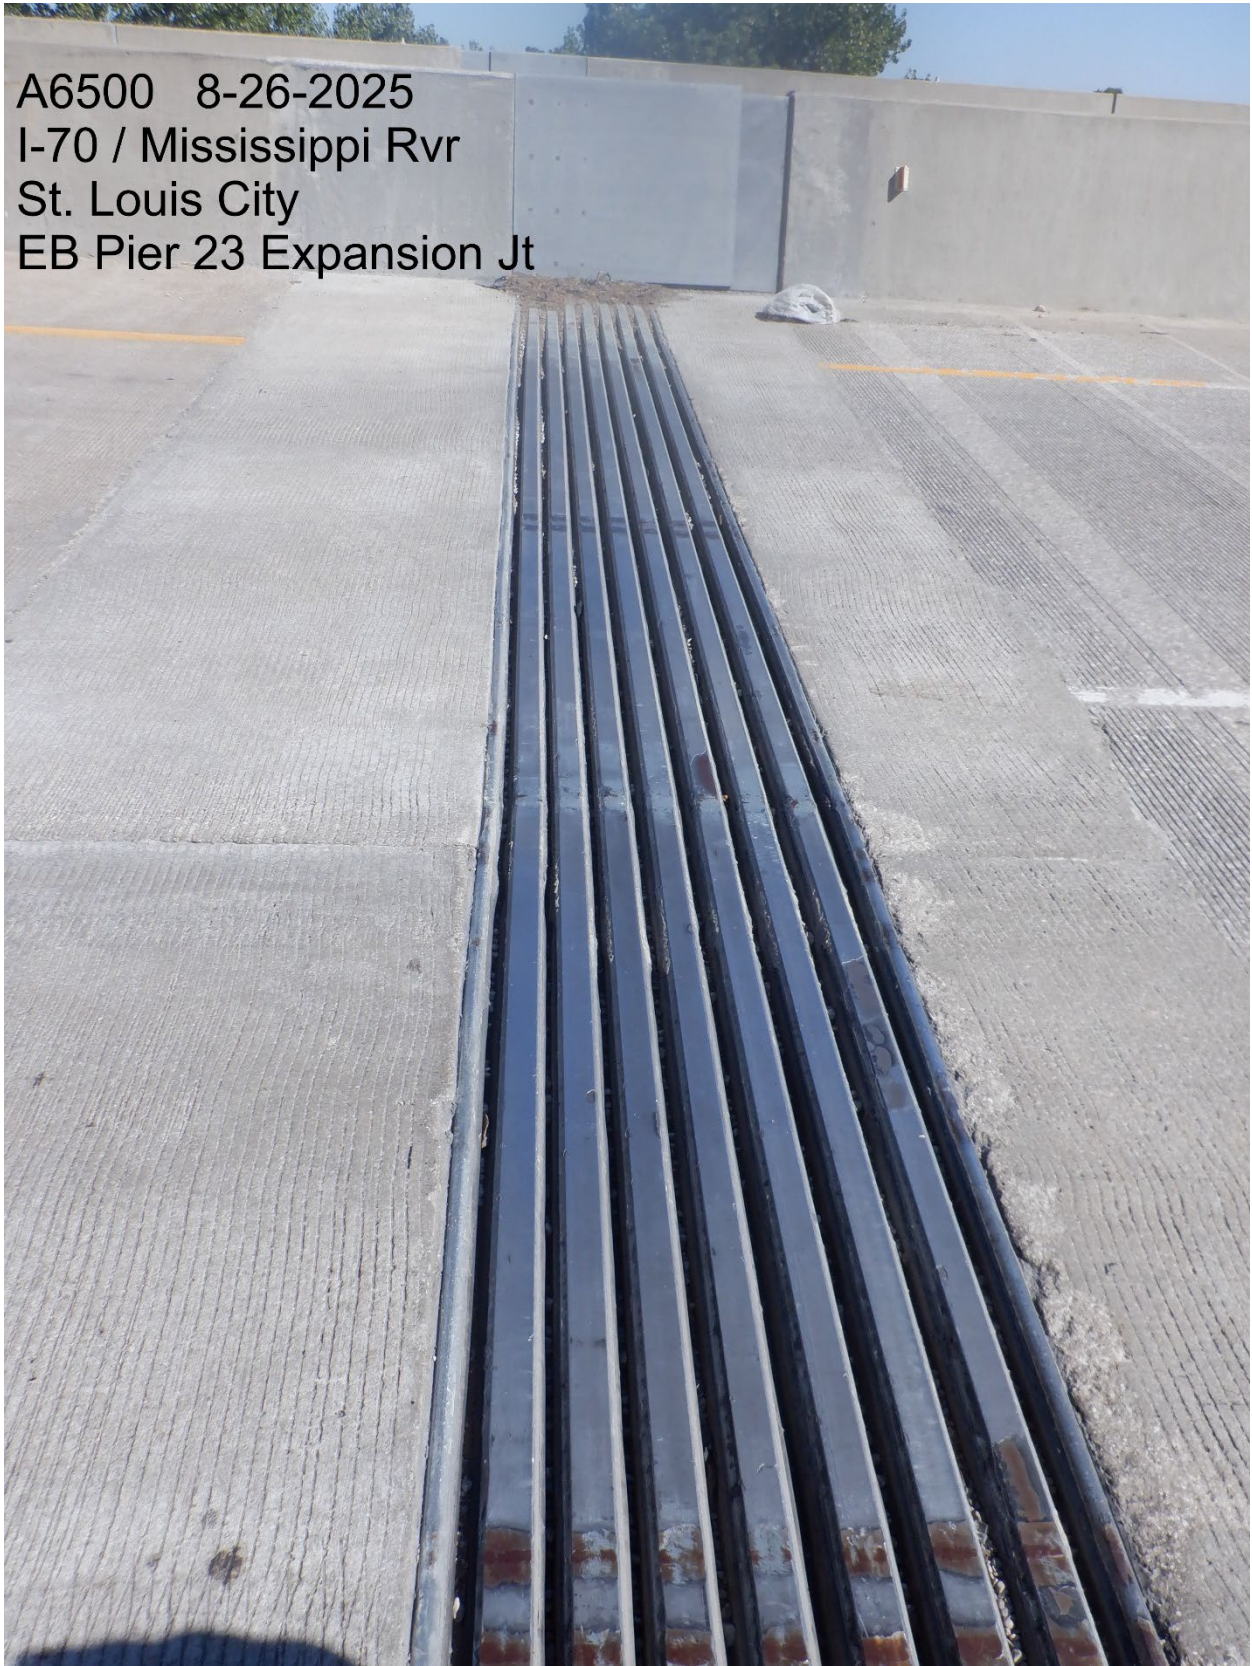
A6500 8-26-2025
I-70 / Mississippi Rvr
St. Louis City
EB Pier 23 Expansion Jt
