Missouri Department of Transportation

STRUCTURAL REHABILITATION CHECKLIST

Bridge No.: **A6500**

Route: **I-70**

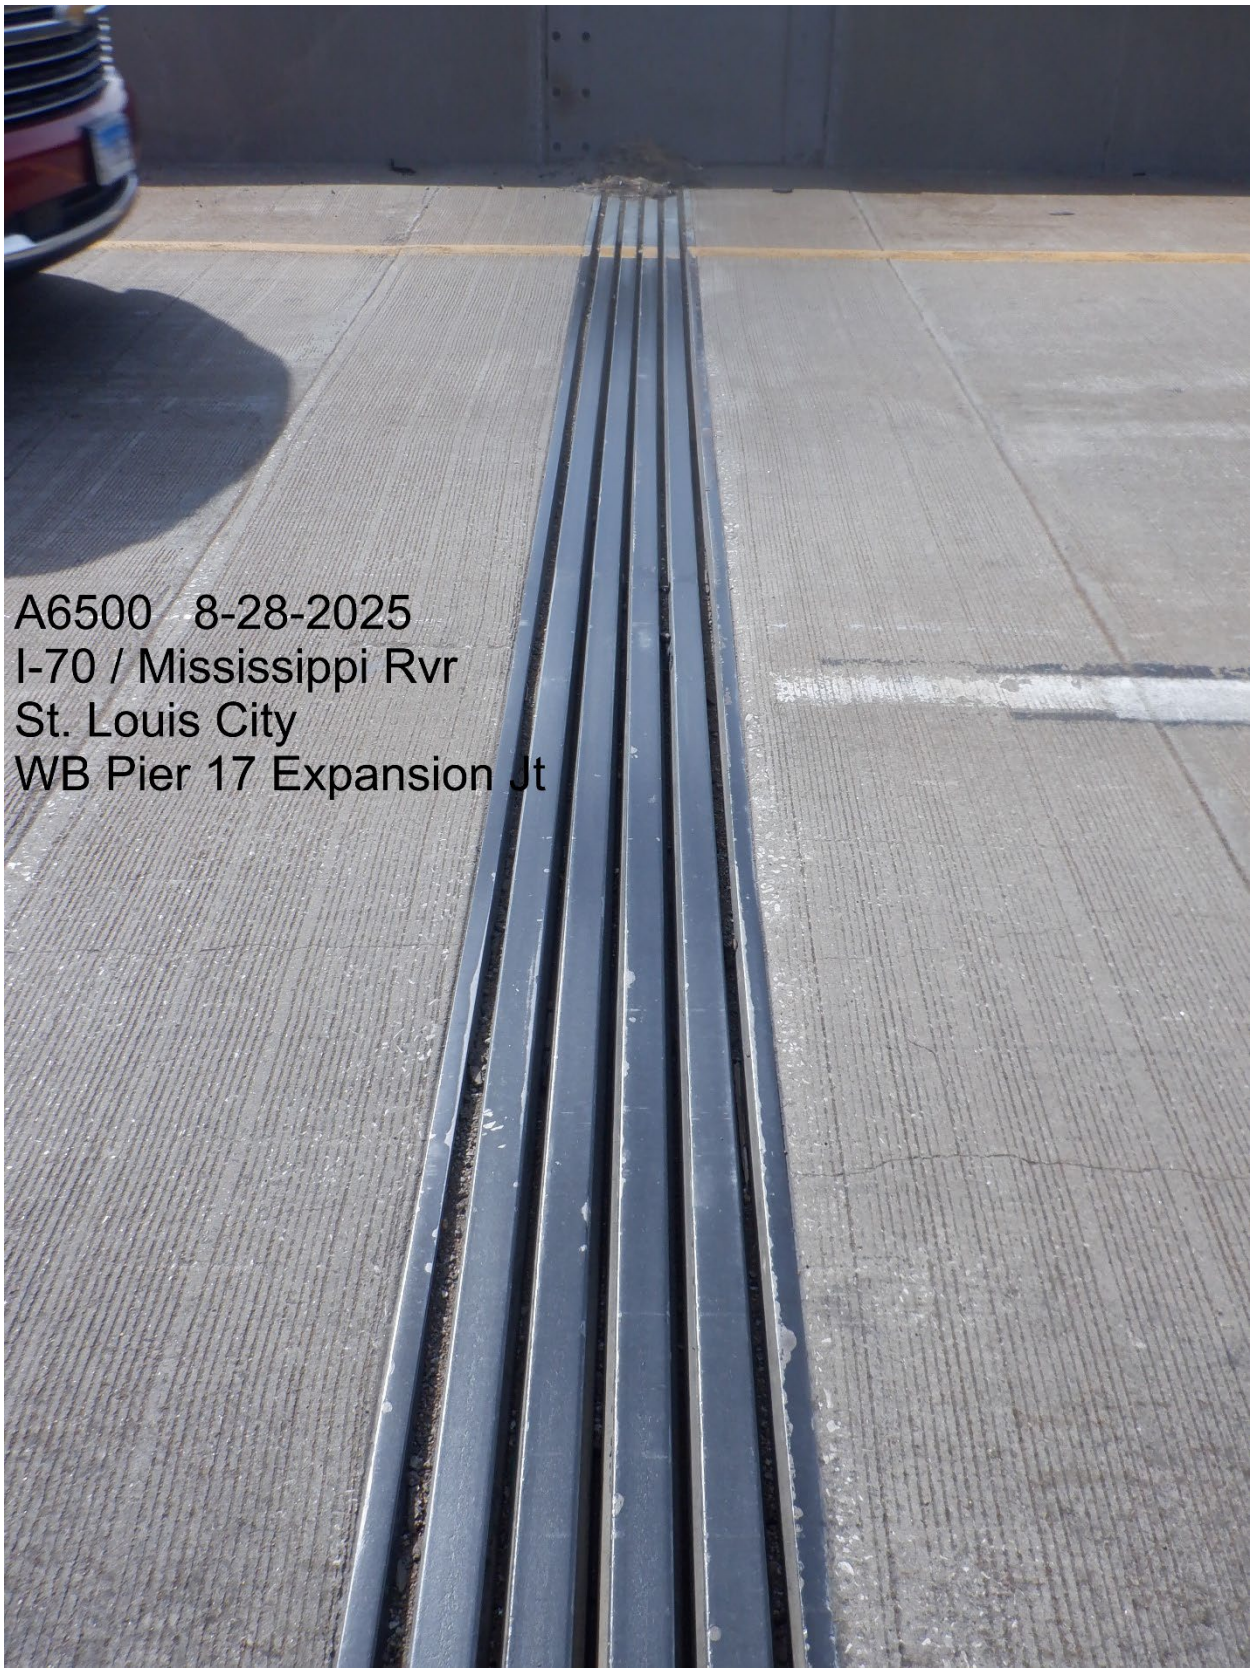
A6500 8-28-2025
I-70 / Mississippi Rvr
St. Louis City
WB Pier 17 Expansion Jt

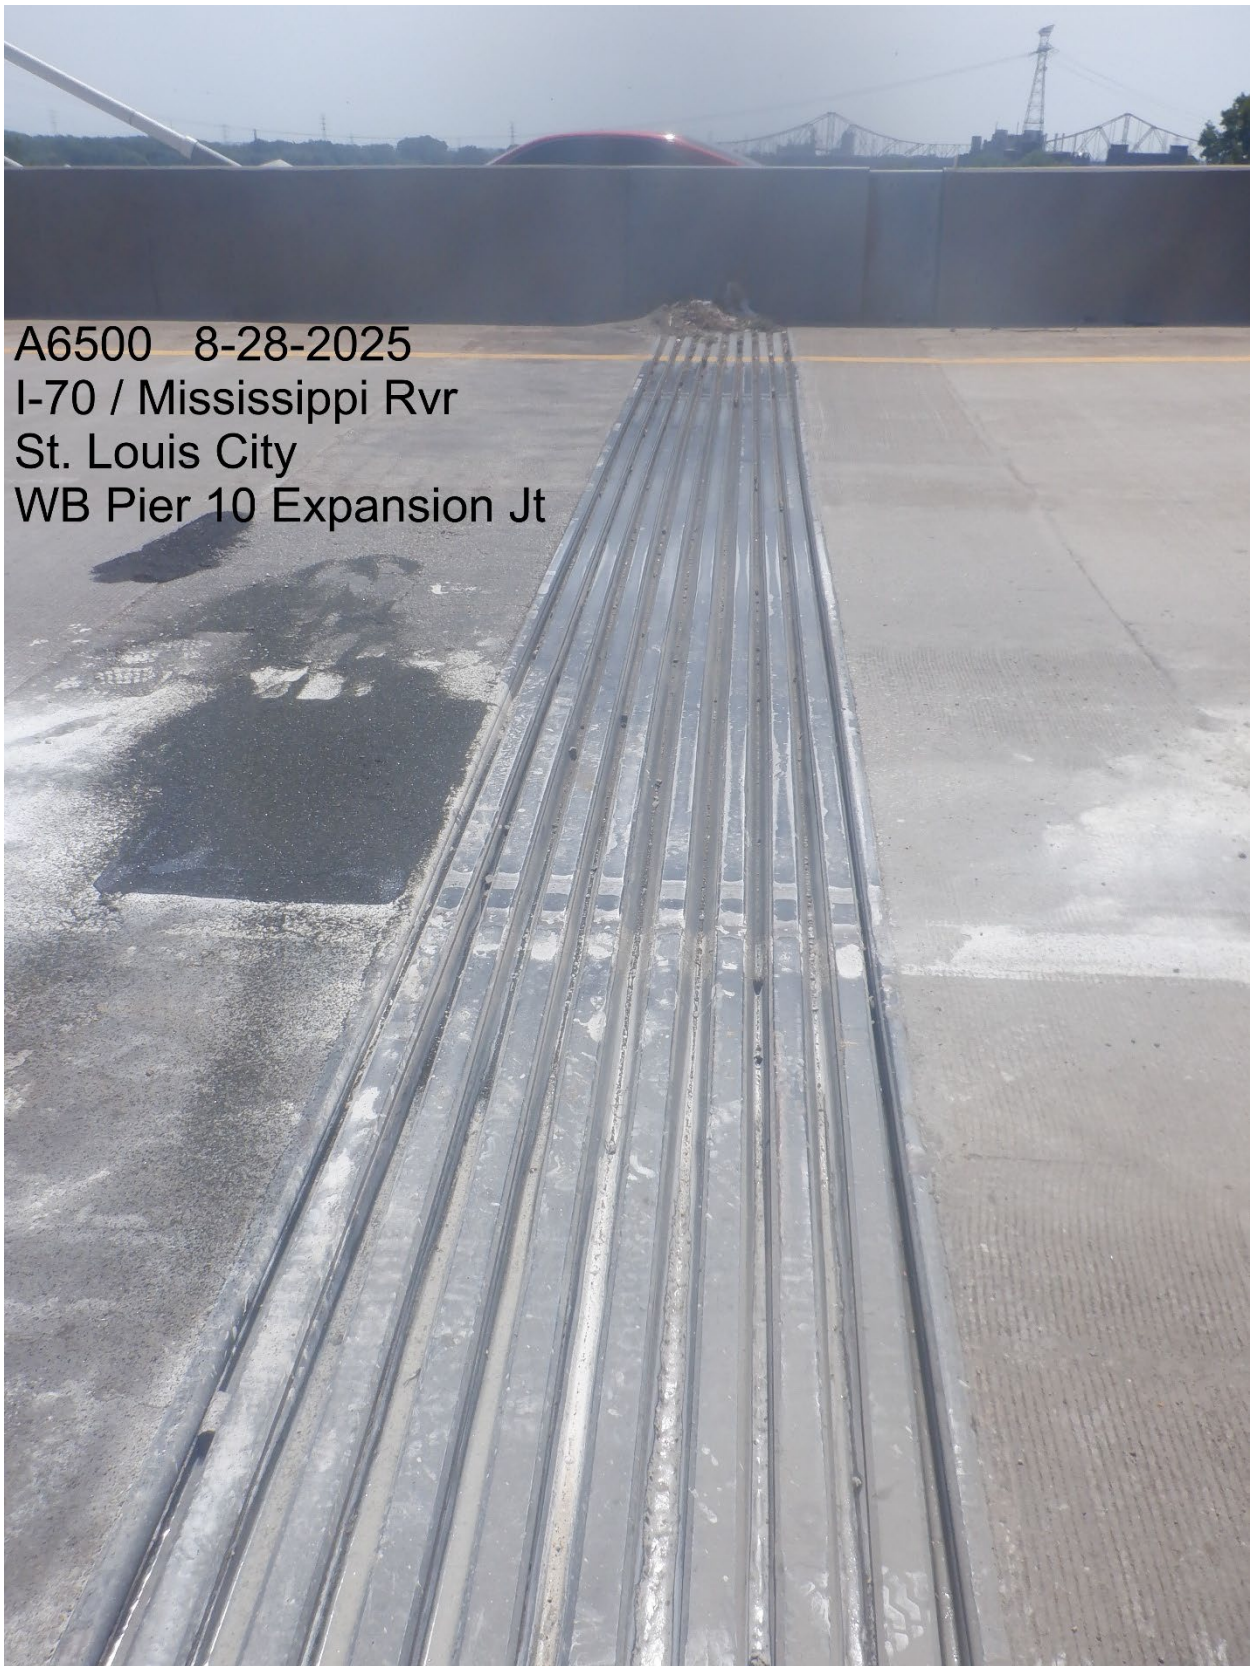
A6500 8-28-2025
I-70 / Mississippi Rvr
St. Louis City
WB Pier 10 Expansion Jt

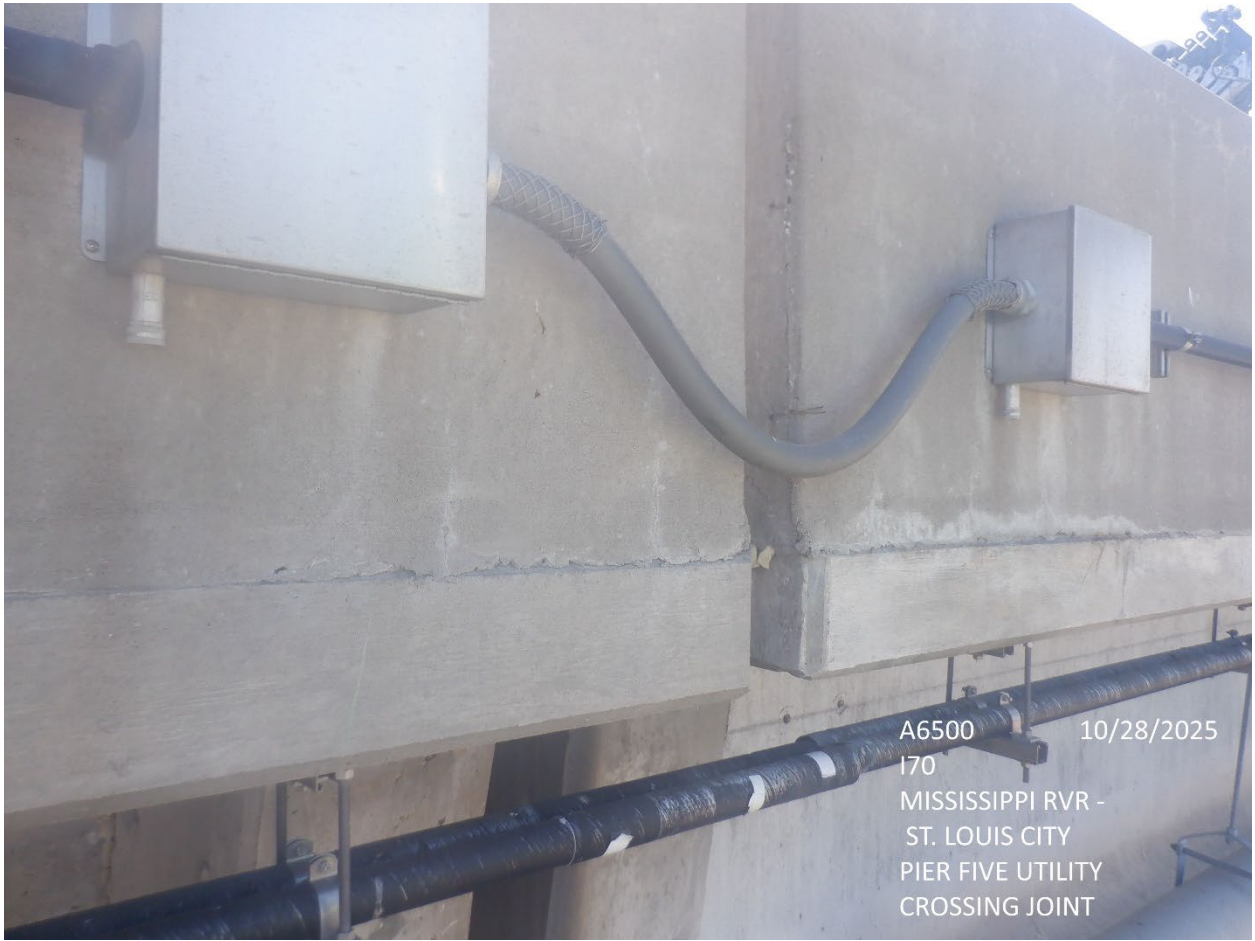
A6500 10/28/2025
170
MISSISSIPPI RVR -
ST. LOUIS CITY
PIER FIVE UTILITY
CROSSING JOINT

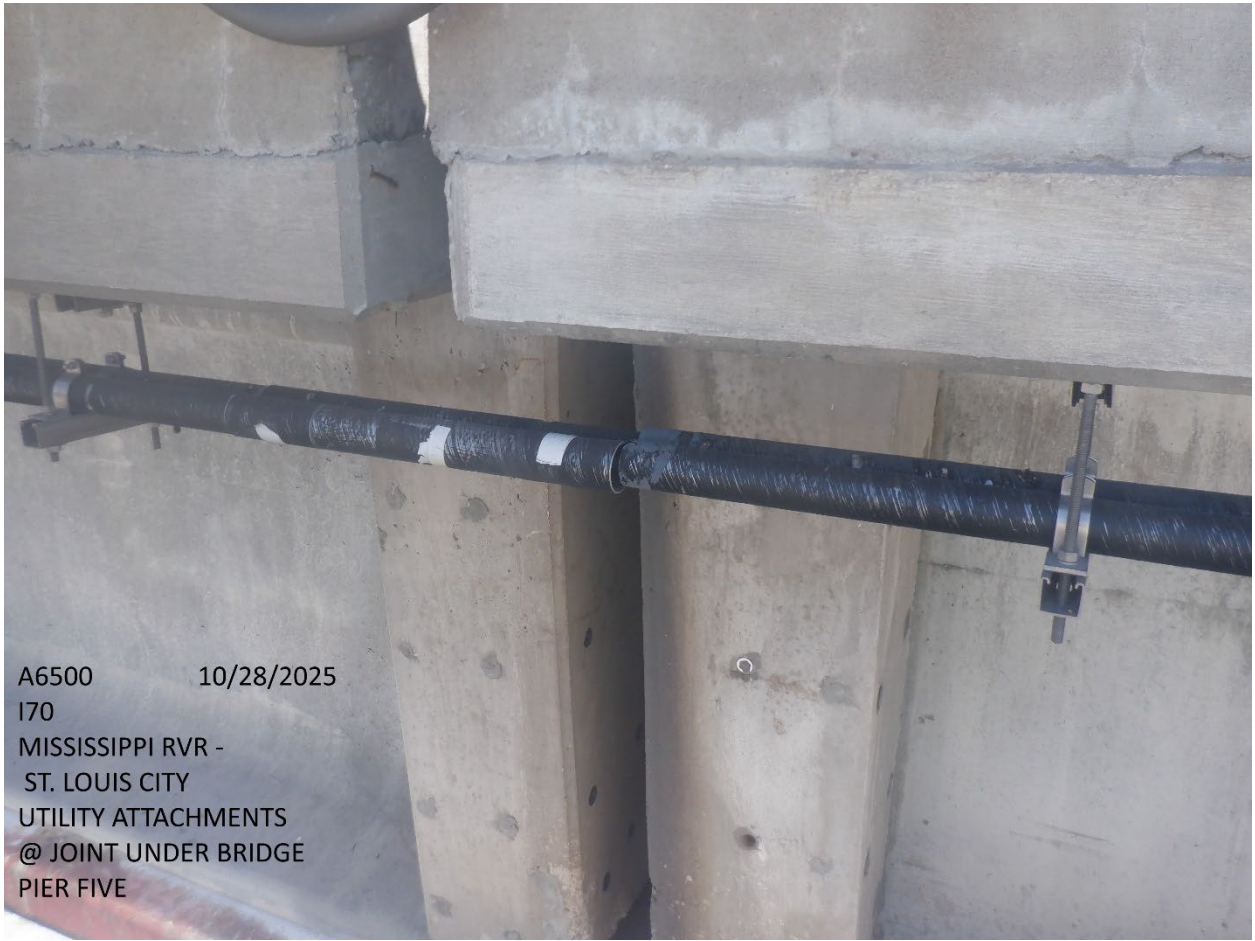
A6500 10/28/2025
170
MISSISSIPPI RVR -
ST. LOUIS CITY
UTILITY ATTACHMENTS
@ JOINT UNDER BRIDGE
PIER FIVE

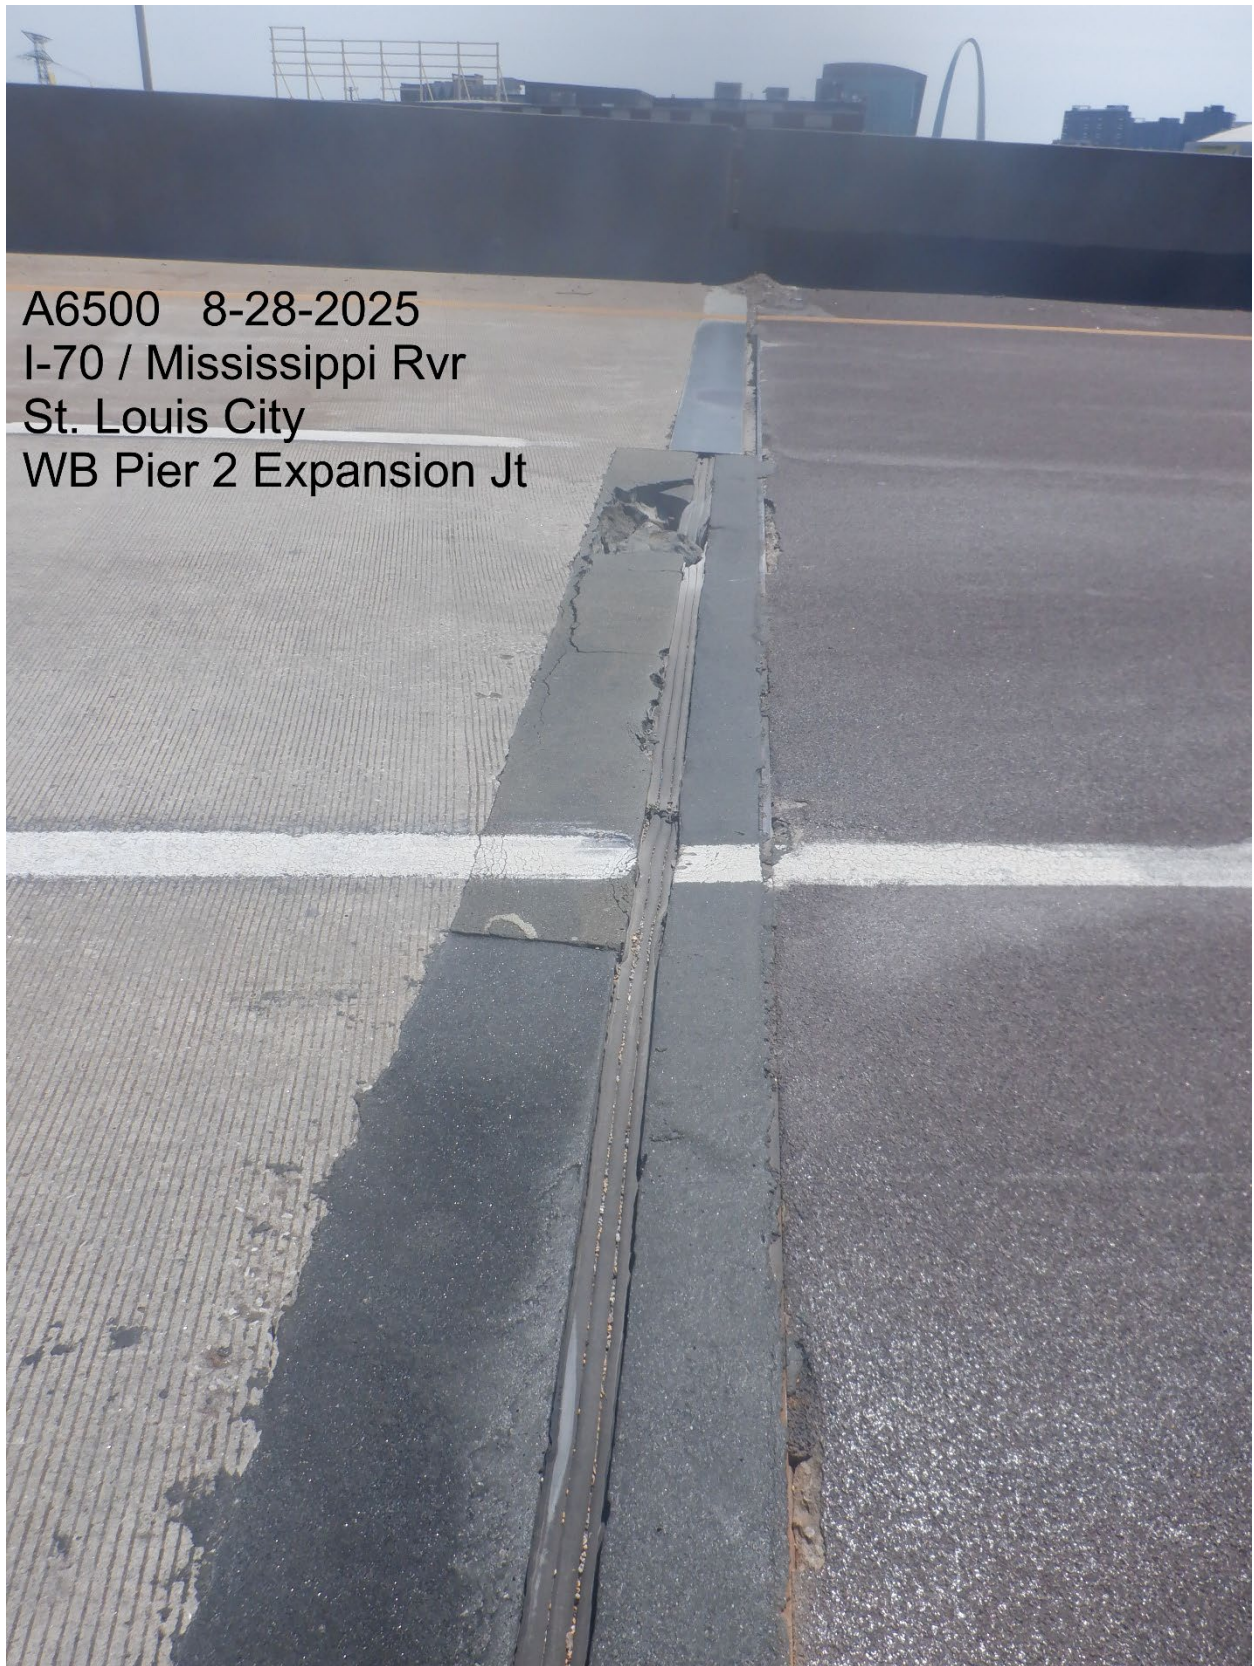
A6500 8-28-2025
I-70 / Mississippi Rvr
St. Louis City
WB Pier 2 Expansion Jt

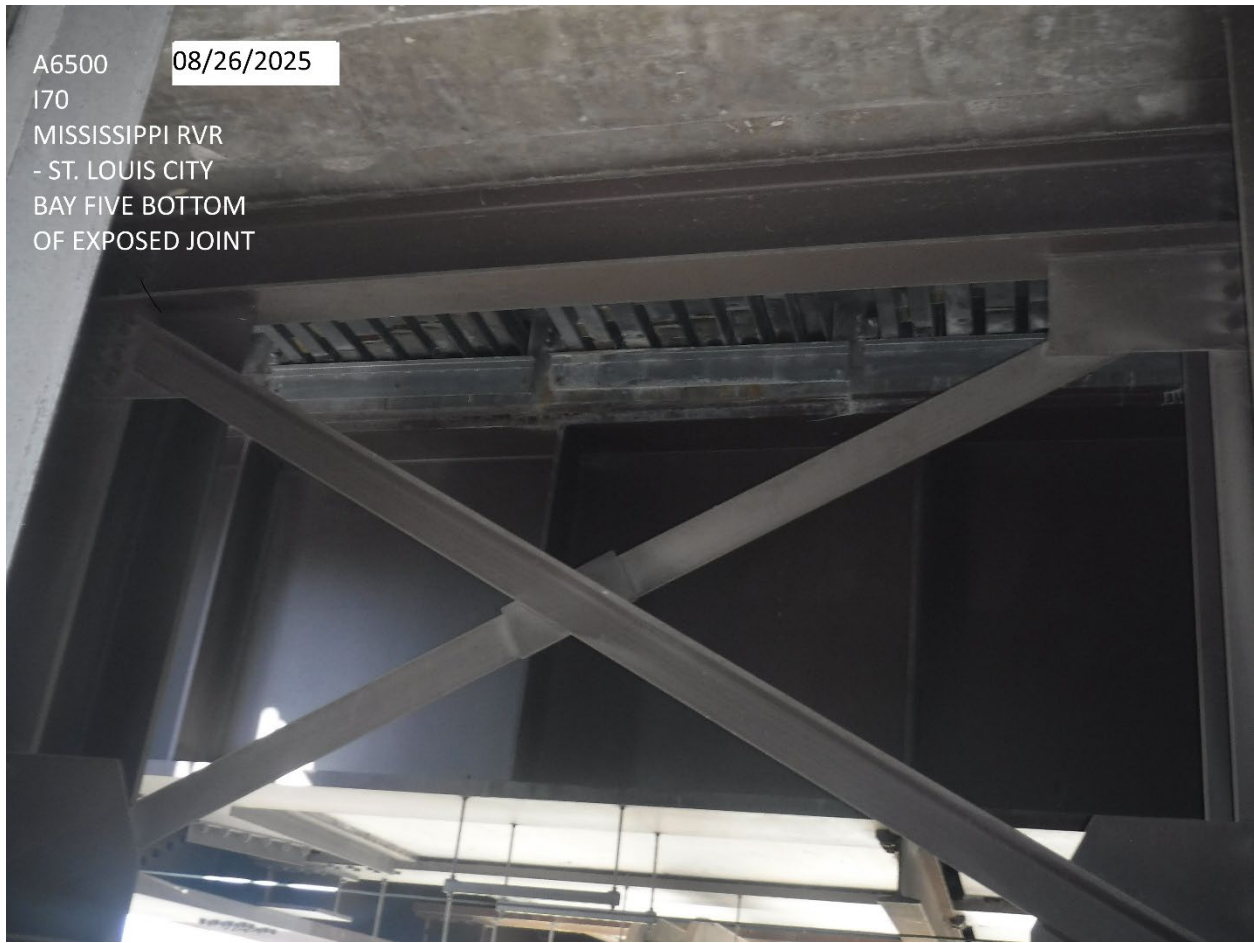
A6500 08/26/2025
I70
MISSISSIPPI RVR
- ST. LOUIS CITY
BAY FIVE BOTTOM
OF EXPOSED JOINT

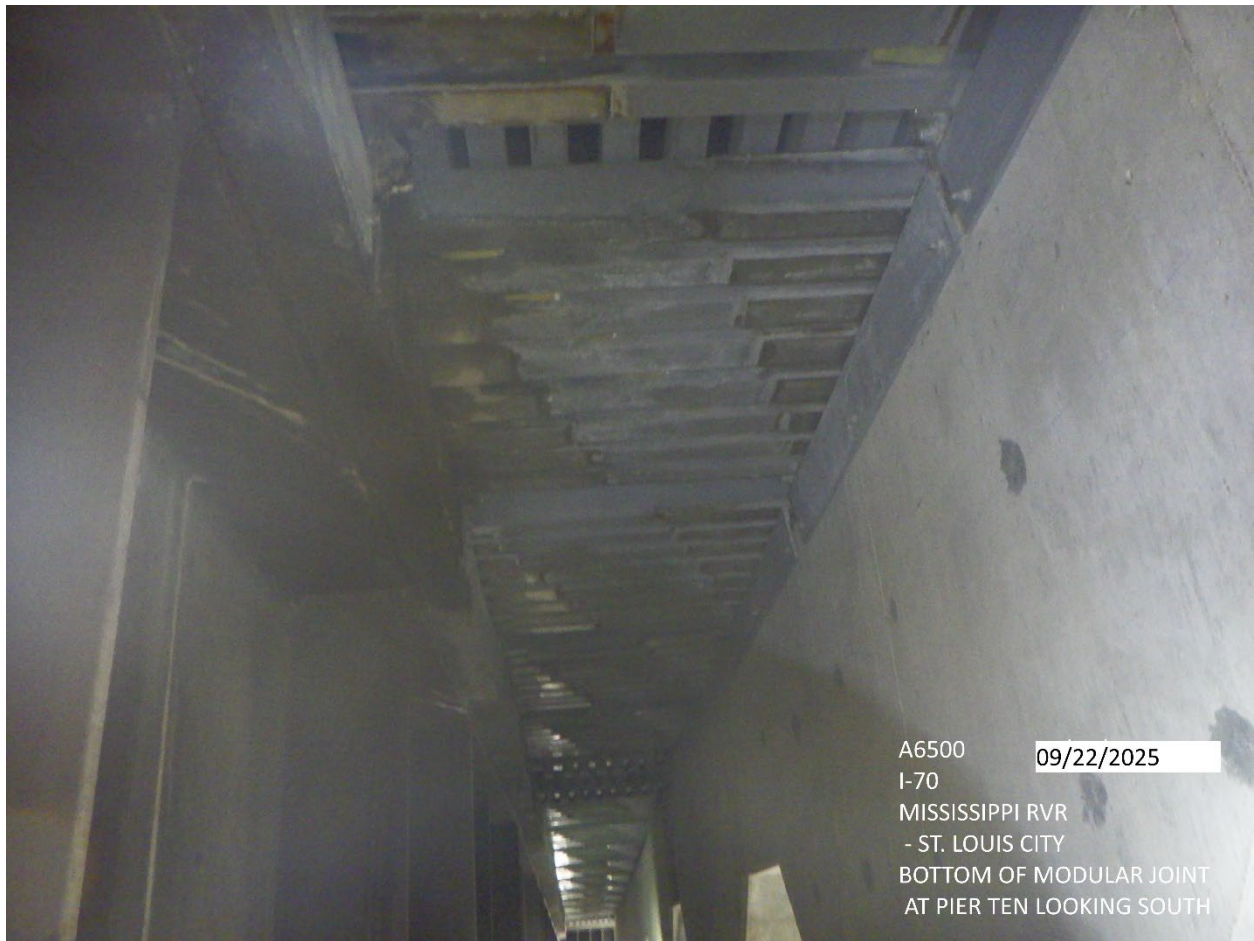
A6500 09/22/2025
I-70
MISSISSIPPI RVR
- ST. LOUIS CITY
BOTTOM OF MODULAR JOINT
AT PIER TEN LOOKING SOUTH

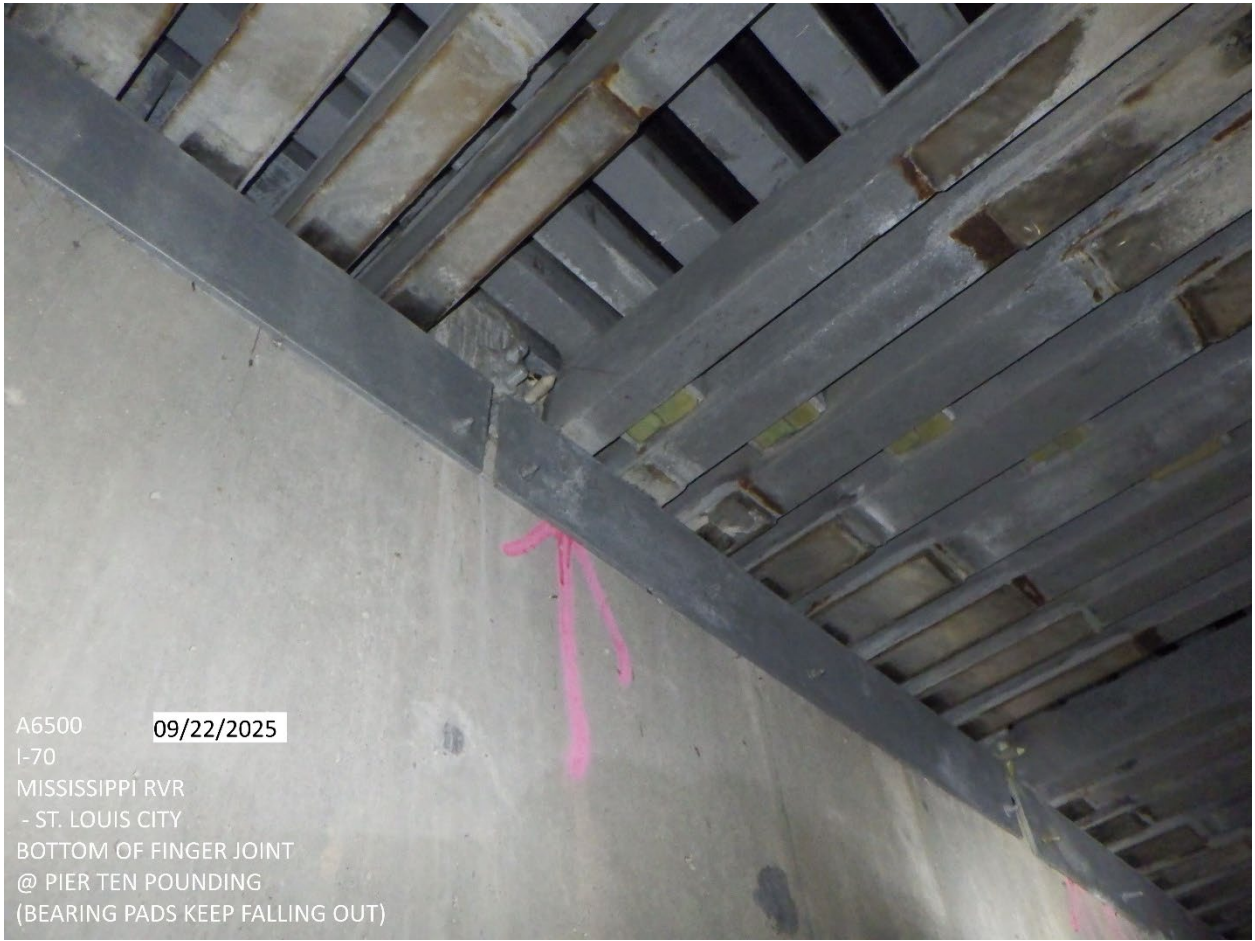
A6500 09/22/2025
I-70
MISSISSIPPI RVR
- ST. LOUIS CITY
BOTTOM OF FINGER JOINT
@ PIER TEN POUNDING
(BEARING PADS KEEP FALLING OUT)

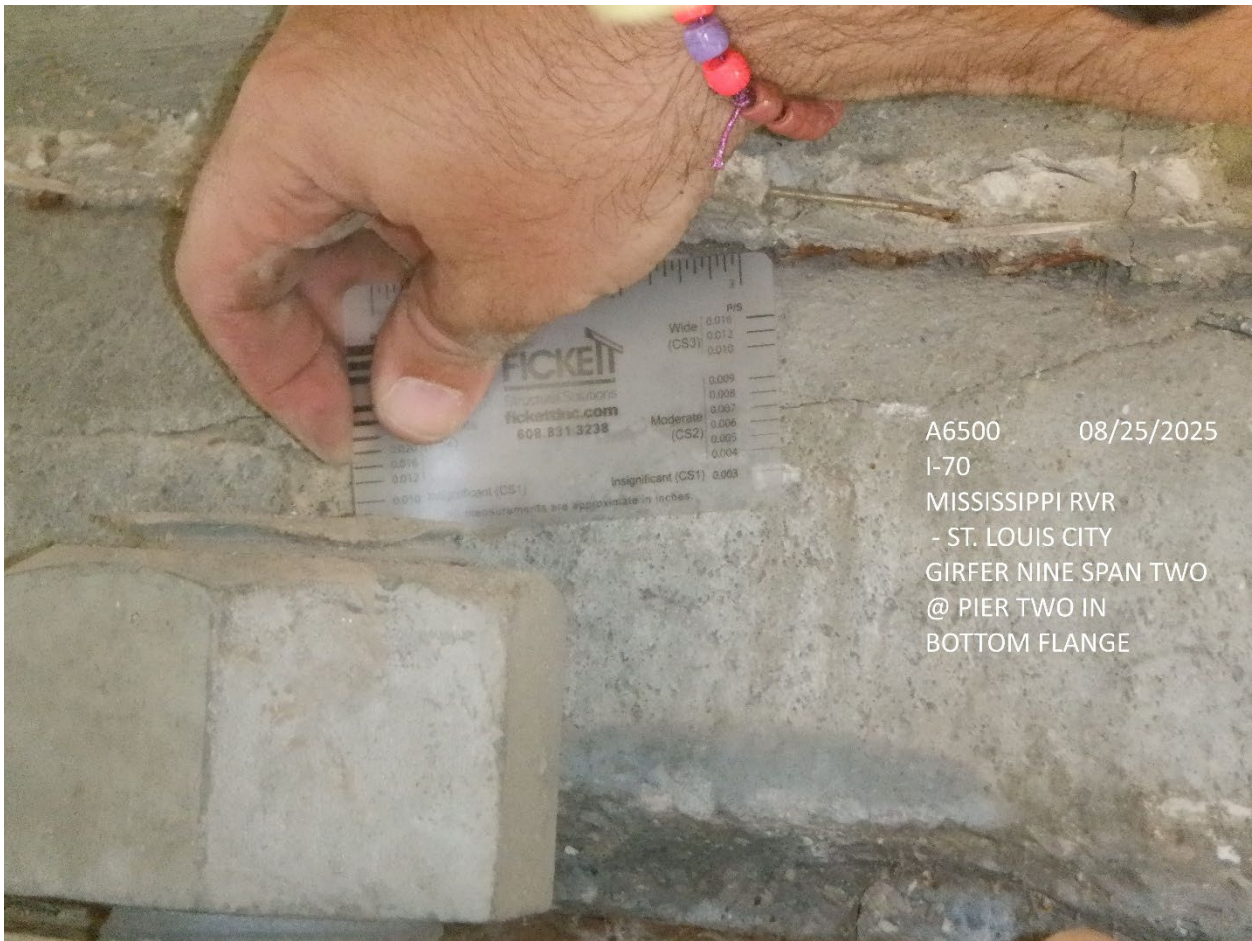
A6500 08/25/2025
I-70
MISSISSIPPI RVR
- ST. LOUIS CITY
GIRDER NINE SPAN TWO
@ PIER TWO IN
BOTTOM FLANGE

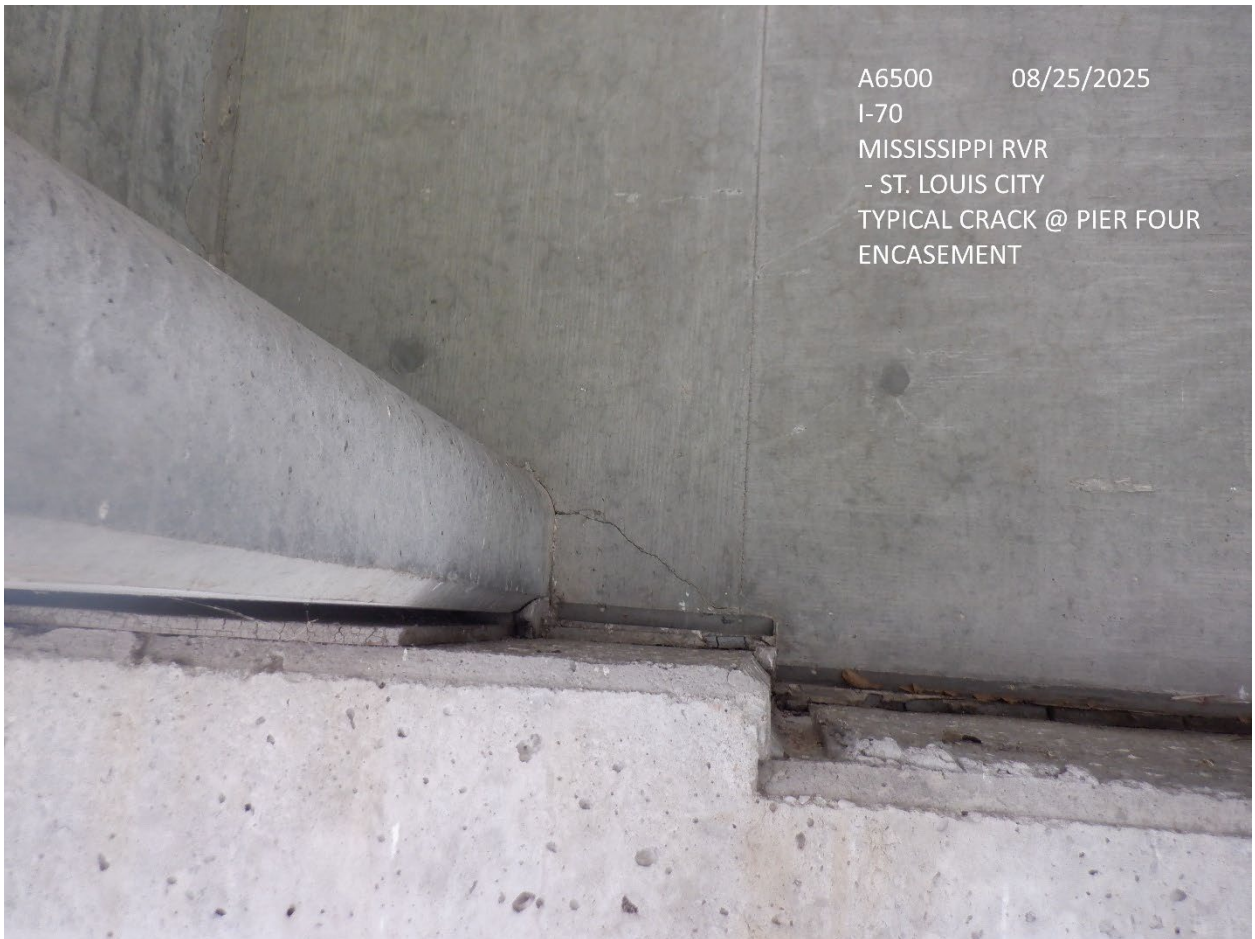
A6500 08/25/2025
I-70
MISSISSIPPI RVR
- ST. LOUIS CITY
TYPICAL CRACK @ PIER FOUR
ENCASEMENT

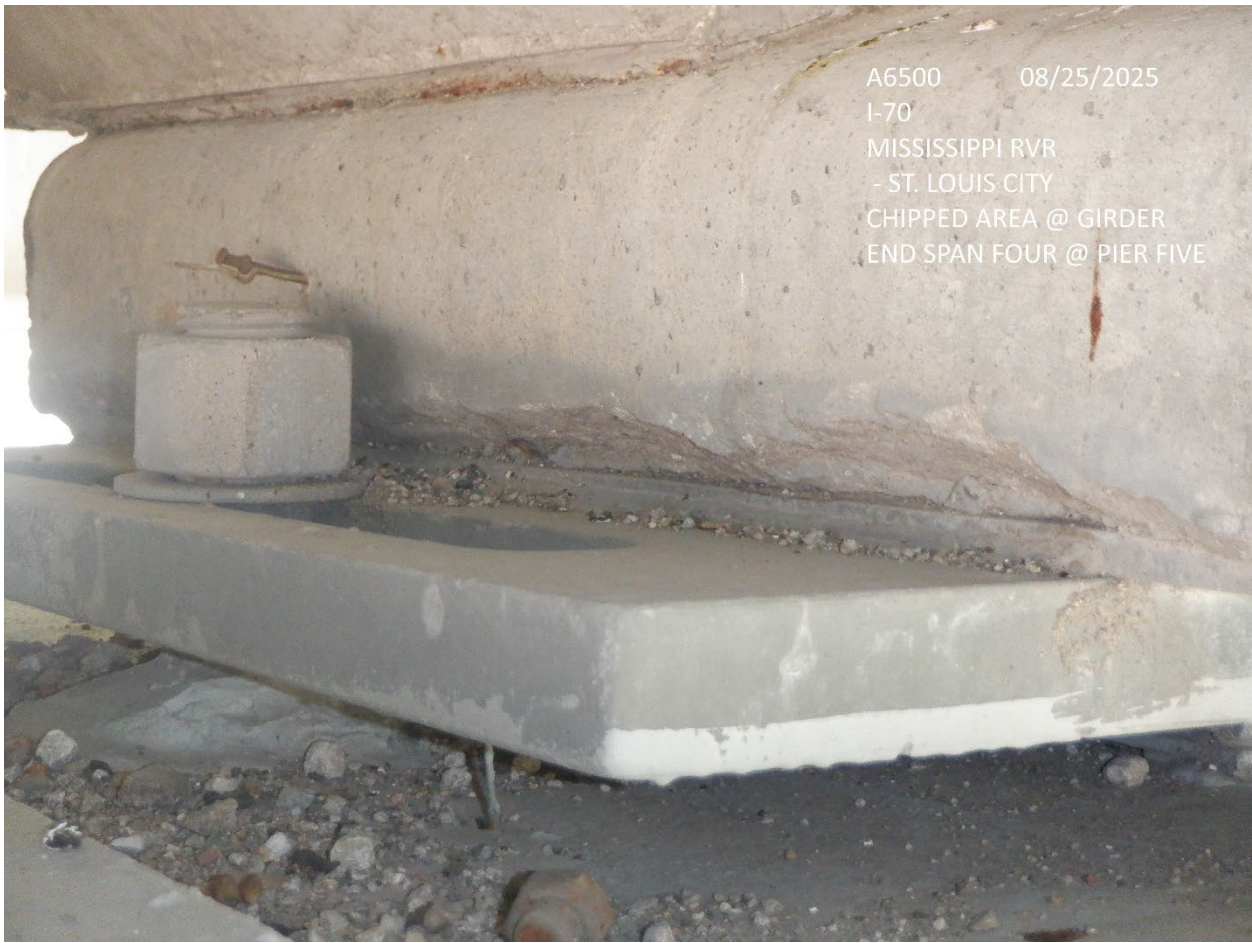
A6500 08/25/2025
I-70
MISSISSIPPI RVR
- ST. LOUIS CITY
CHIPPED AREA @ GIRDER
END SPAN FOUR @ PIER FIVE

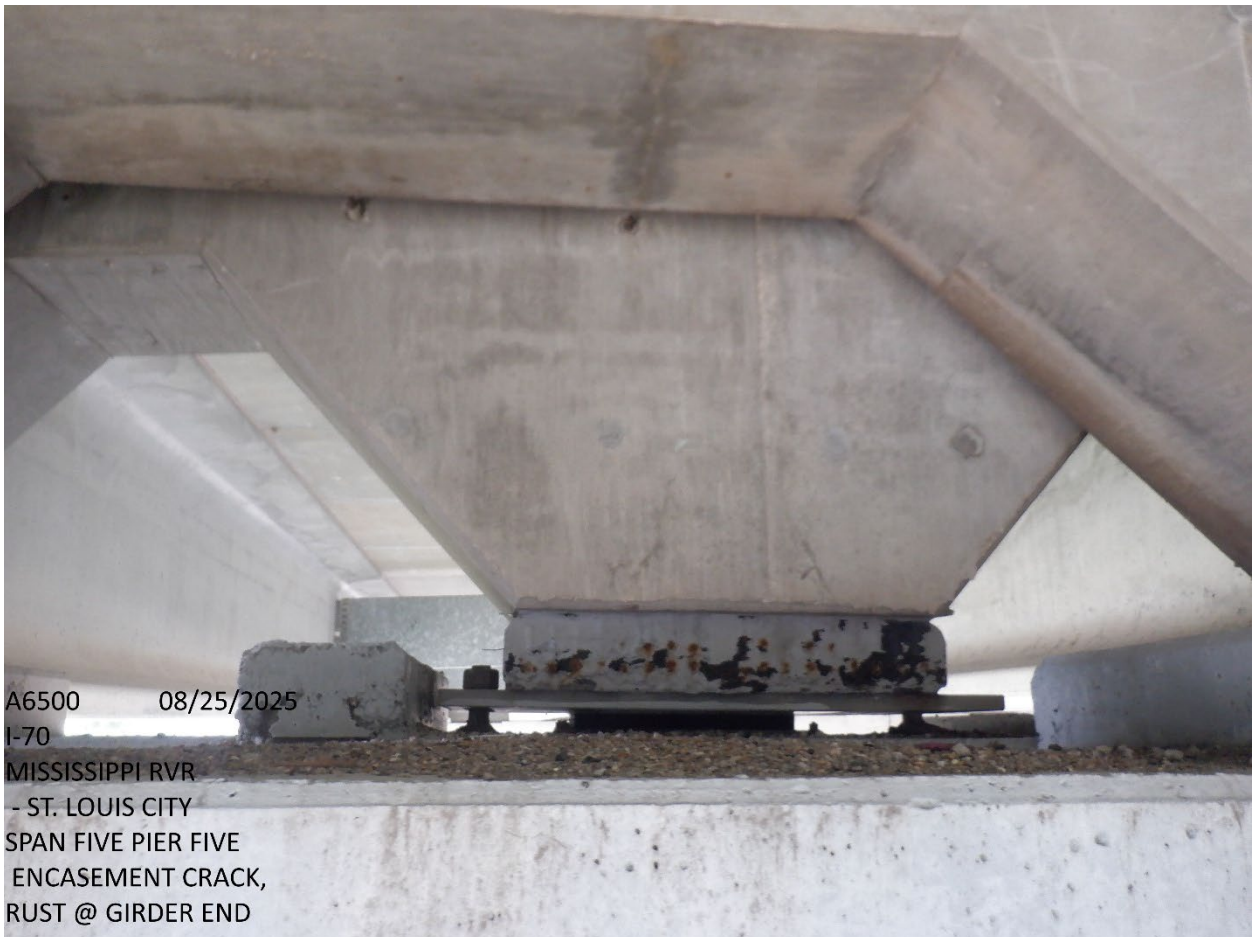
A6500 08/25/2025
I-70
MISSISSIPPI RVR
- ST. LOUIS CITY
SPAN FIVE PIER FIVE
ENCASEMENT CRACK,
RUST @ GIRDER END

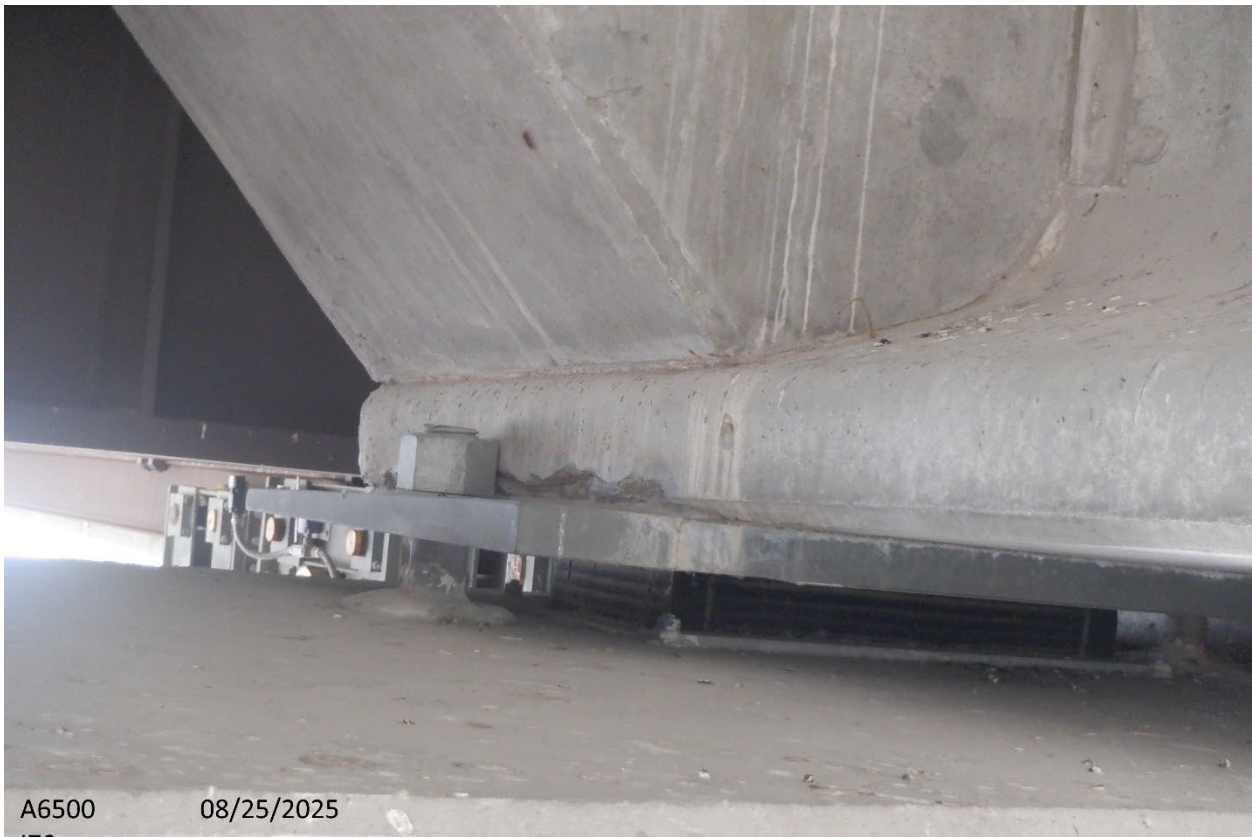
A6500 08/25/2025
I70
MISSISSIPPI RVR - ST. LOUIS CITY
PIER 10 CHIPPED GIRDSERS

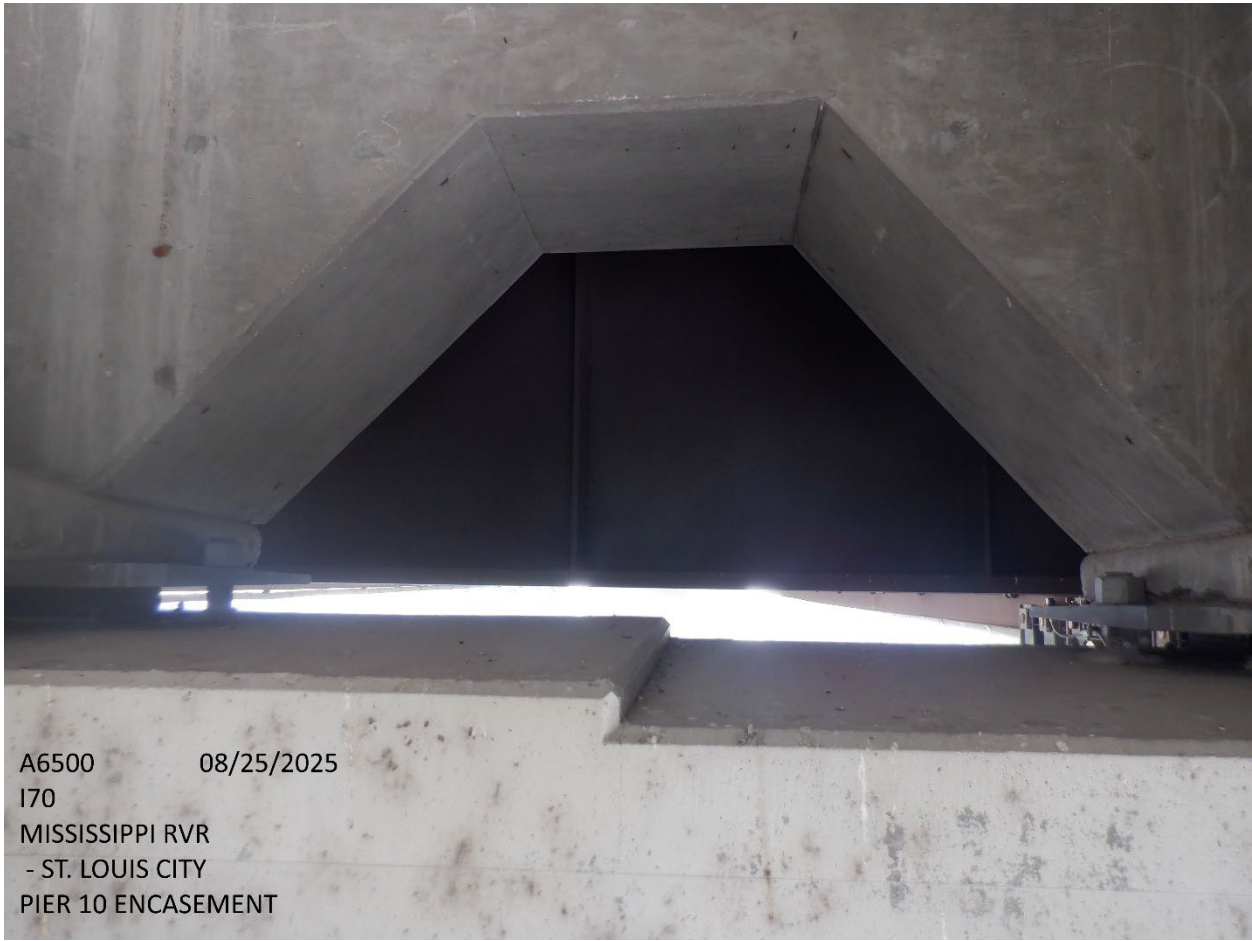
A6500 08/25/2025
I70
MISSISSIPPI RVR
- ST. LOUIS CITY
PIER 10 ENCASEMENT

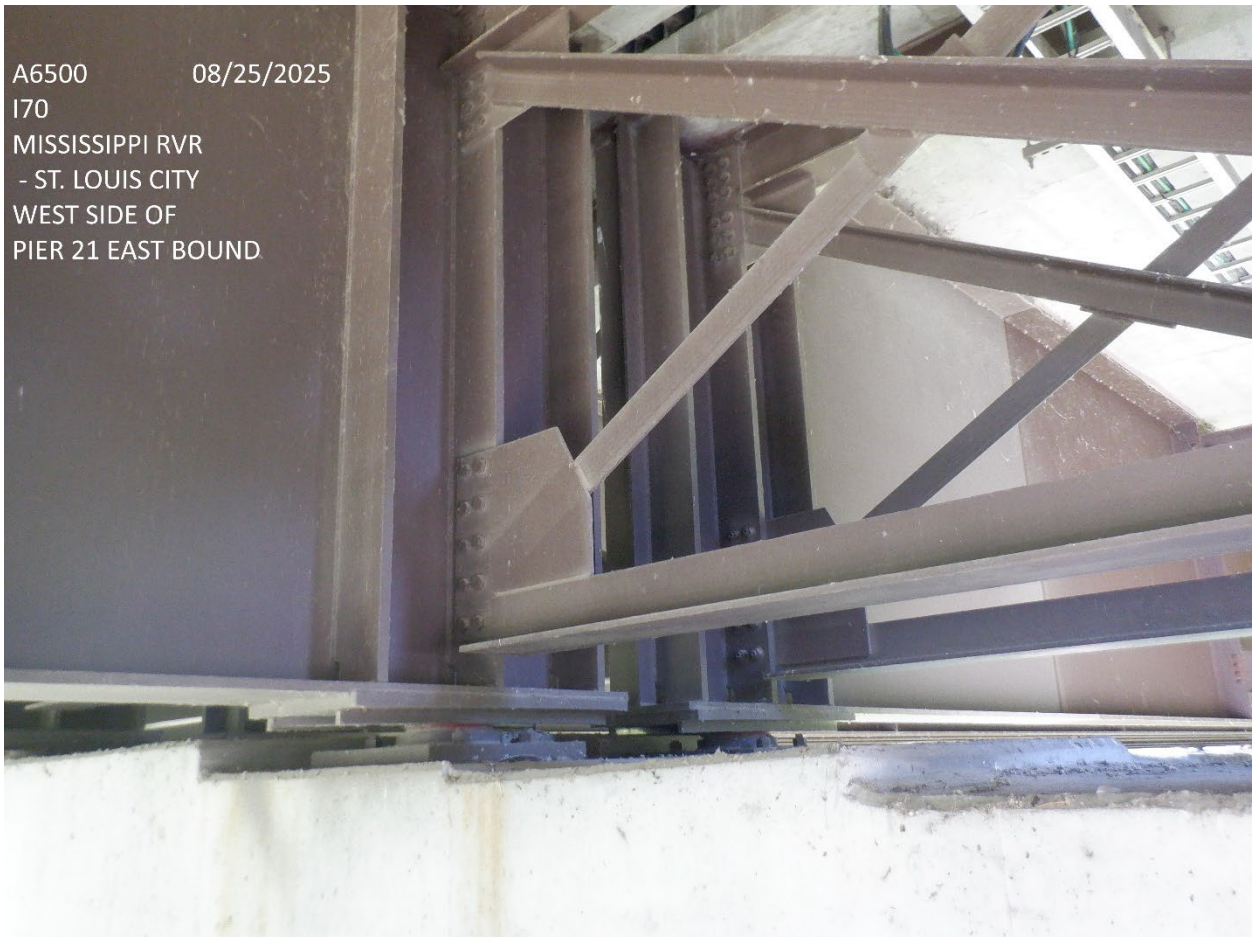
A6500 08/25/2025
I70
MISSISSIPPI RVR
- ST. LOUIS CITY
WEST SIDE OF
PIER 21 EAST BOUND

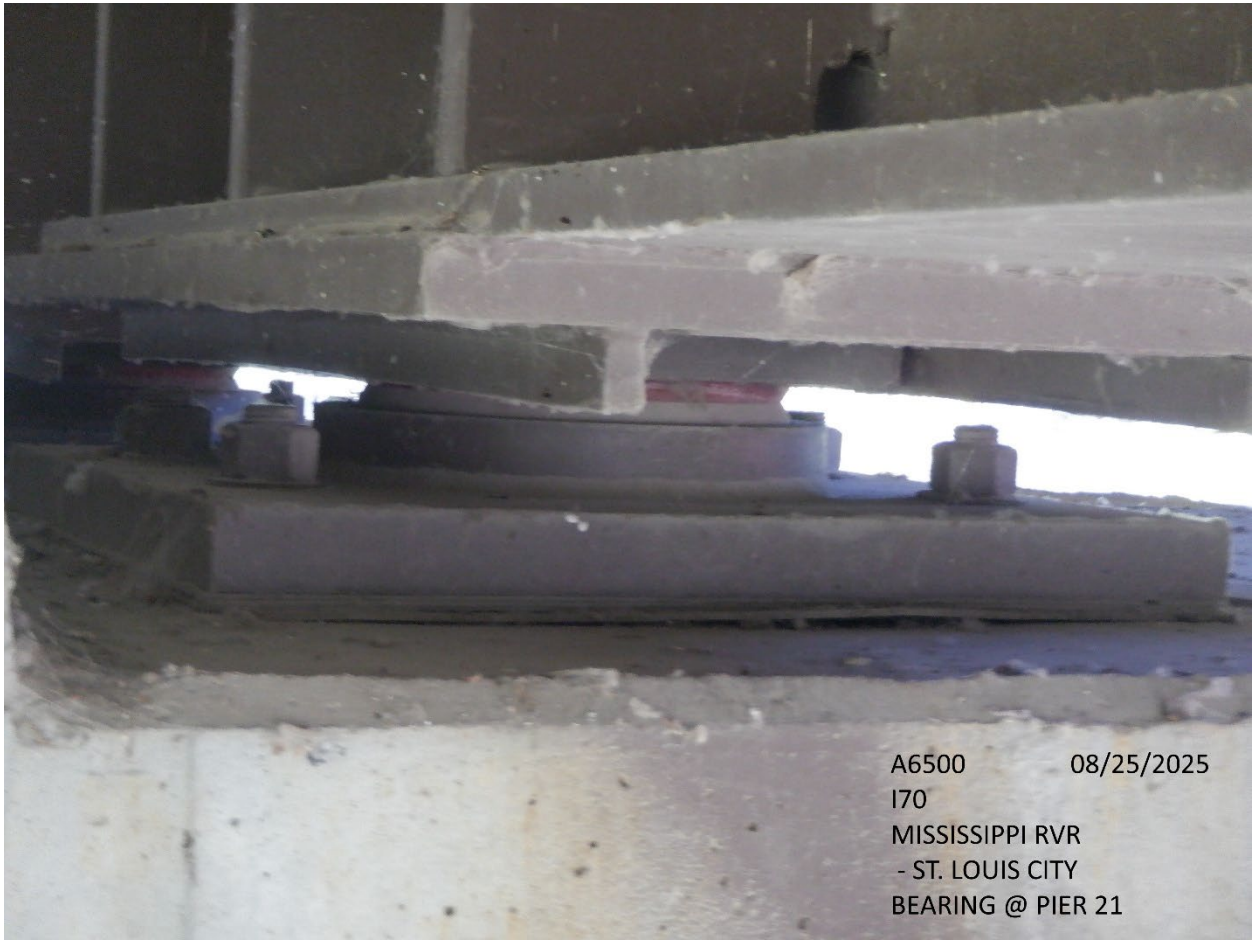
A6500 08/25/2025
I70
MISSISSIPPI RVR
- ST. LOUIS CITY
BEARING @ PIER 21

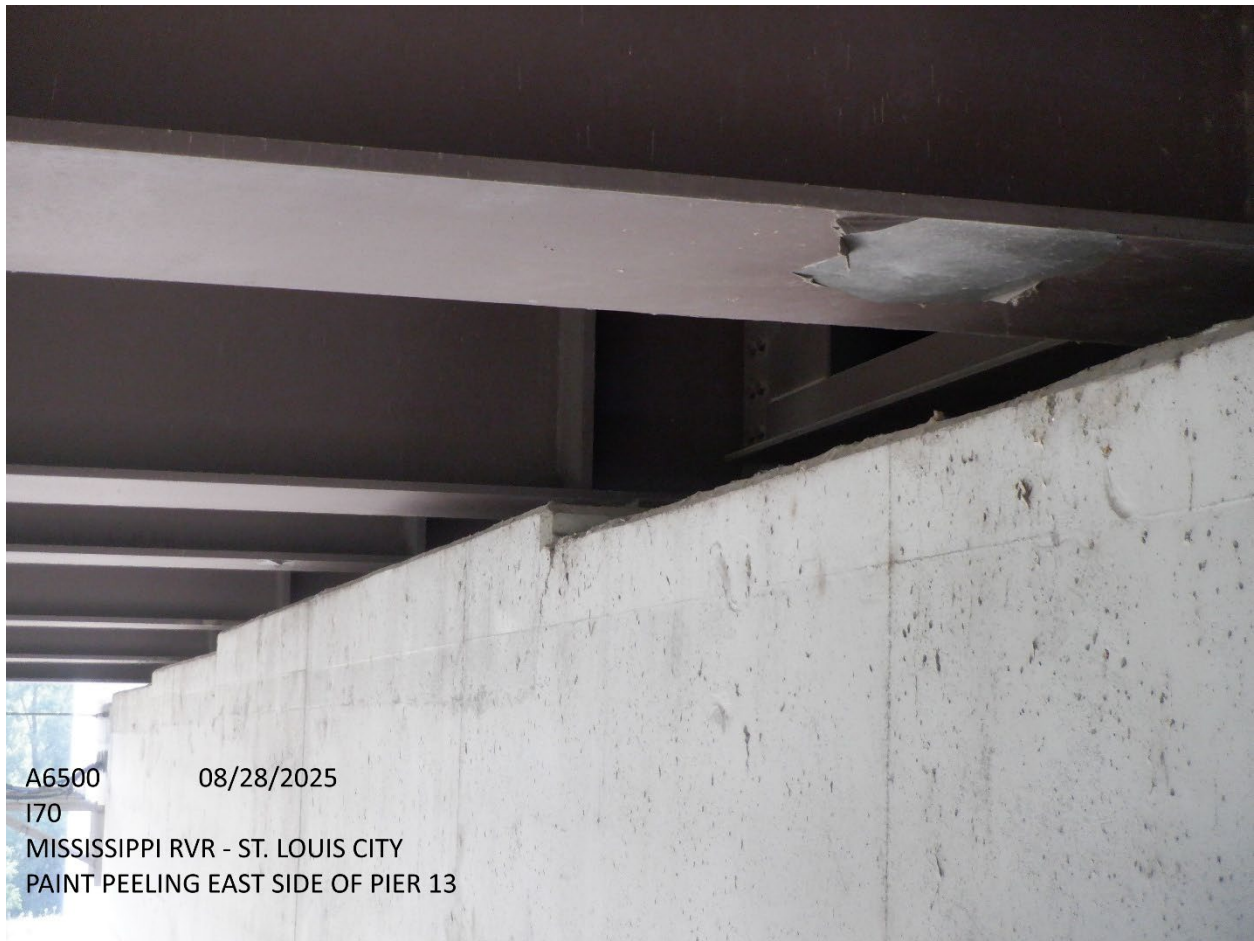
A6500 08/28/2025
I70
MISSISSIPPI RVR - ST. LOUIS CITY
PAINT PEELING EAST SIDE OF PIER 13
