Missouri Department of Transportation

STRUCTURAL REHABILITATION CHECKLIST

Bridge No.: **A6500**

Route: **I-70**

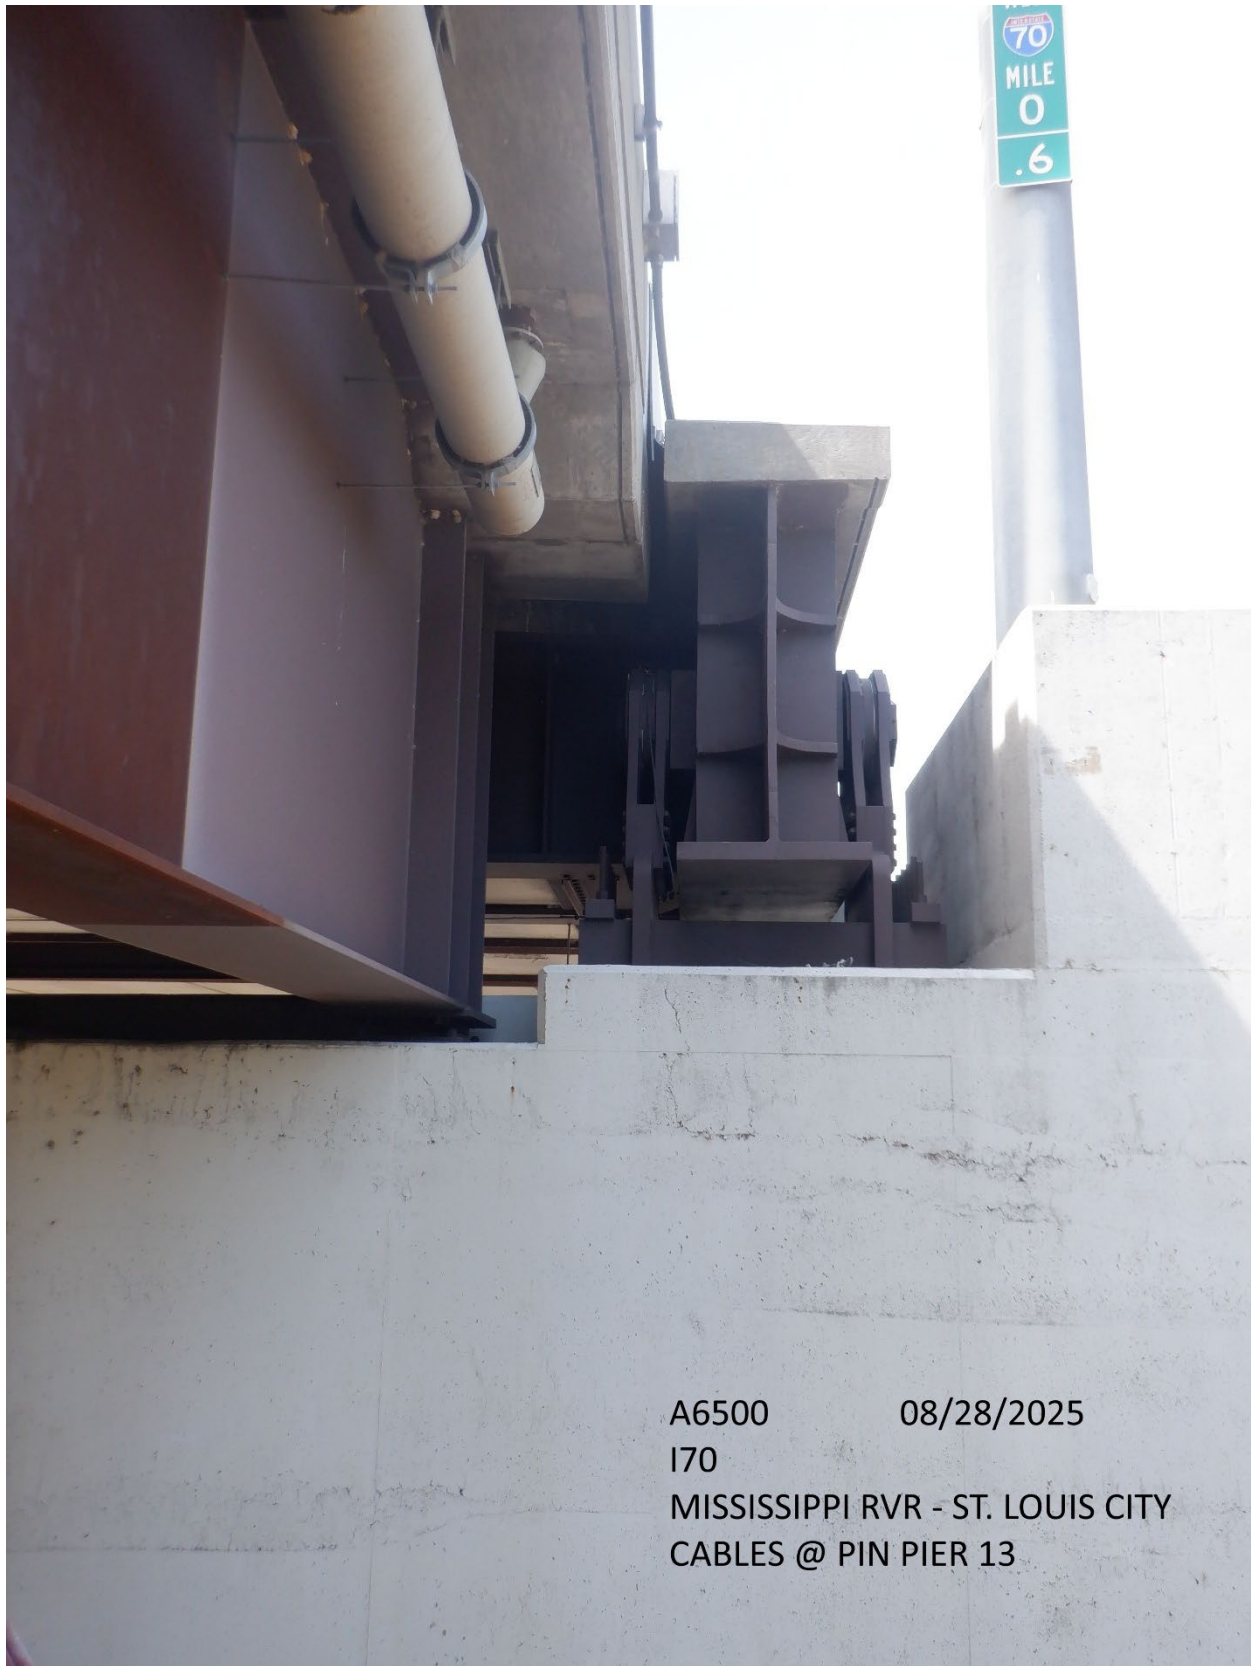
A6500 08/28/2025
I70
MISSISSIPPI RVR - ST. LOUIS CITY
CABLES @ PIN PIER 13

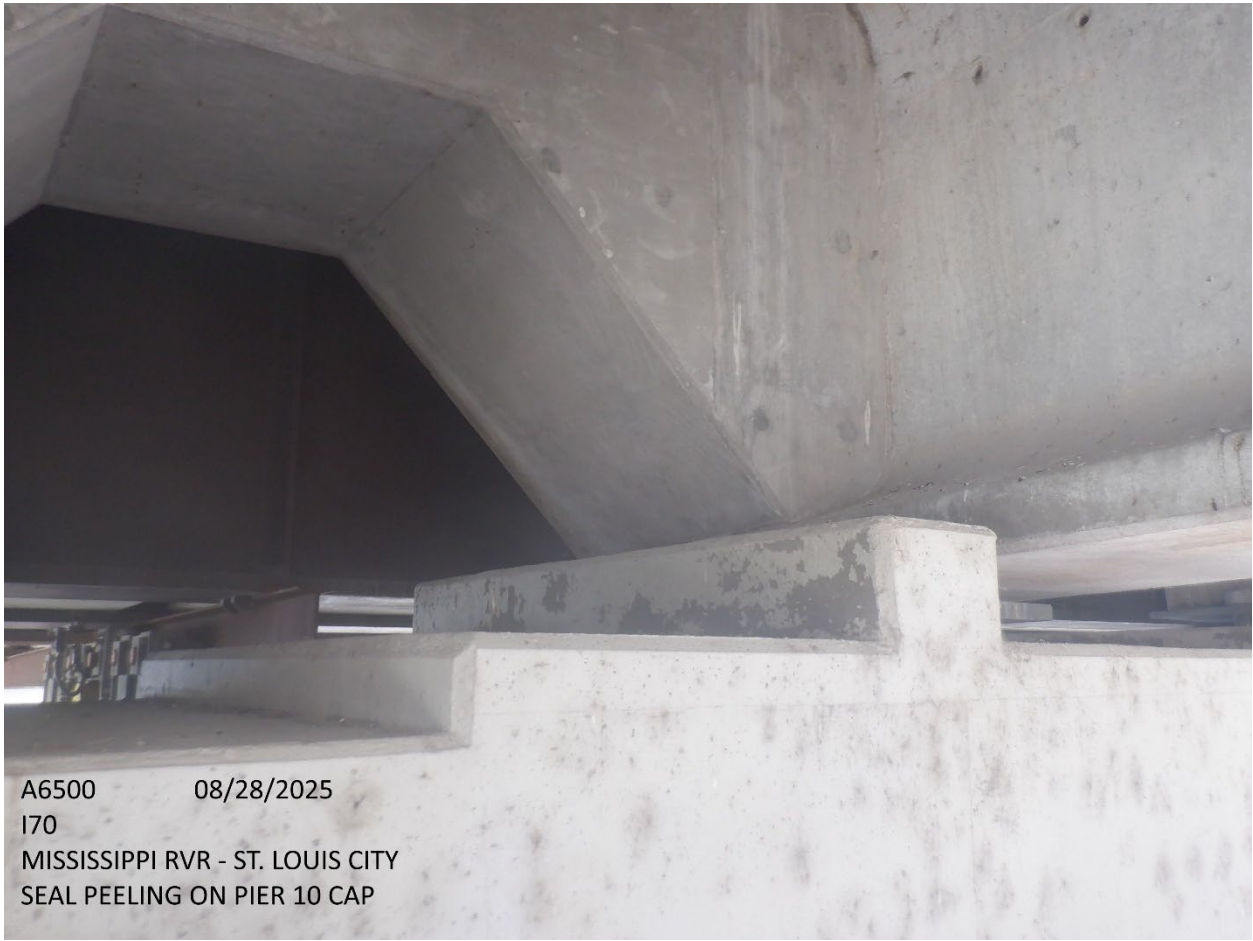
A6500 08/28/2025
I70
MISSISSIPPI RVR - ST. LOUIS CITY
SEAL PEELING ON PIER 10 CAP

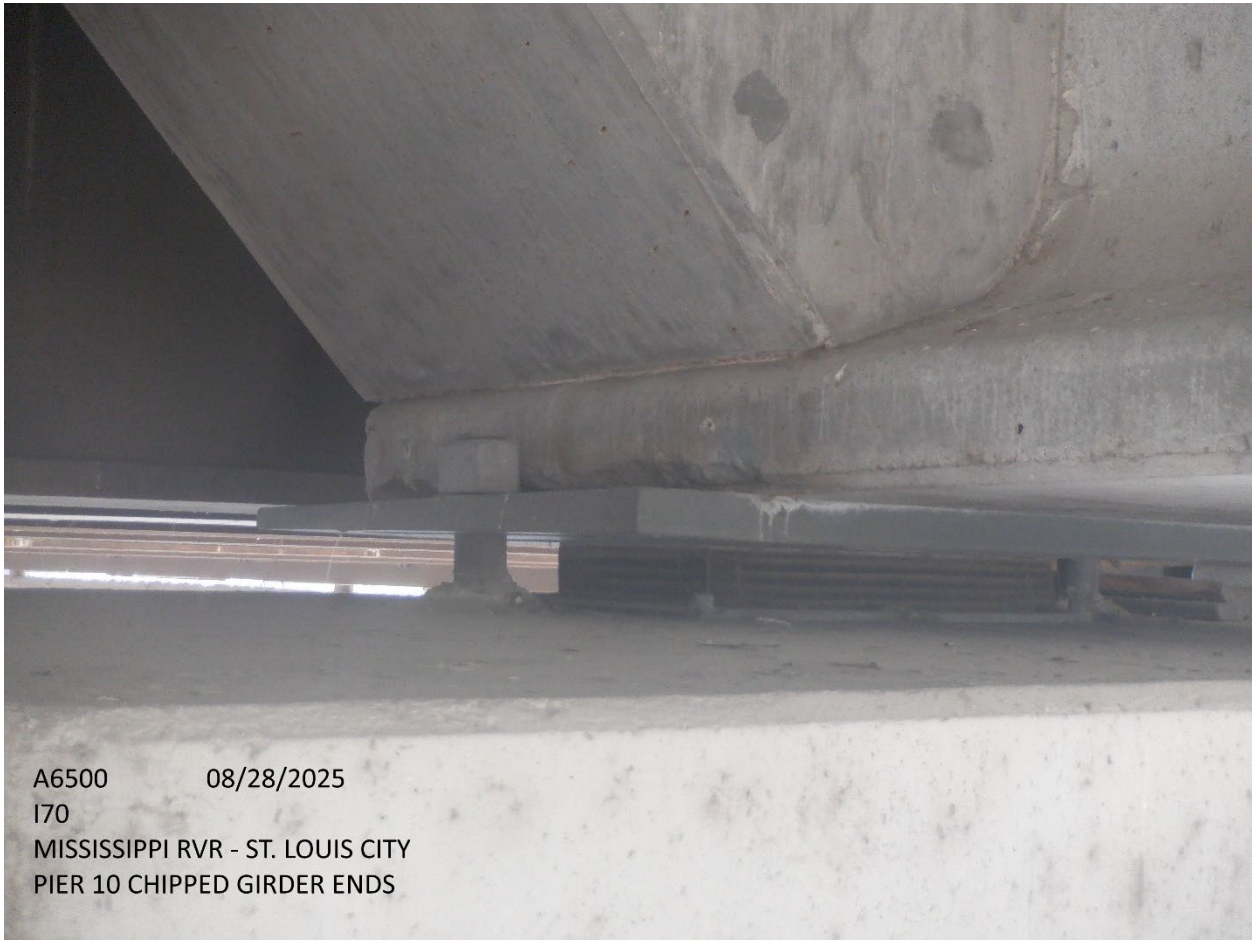
A6500 08/28/2025
I70
MISSISSIPPI RVR - ST. LOUIS CITY
PIER 10 CHIPPED GIRDER ENDS

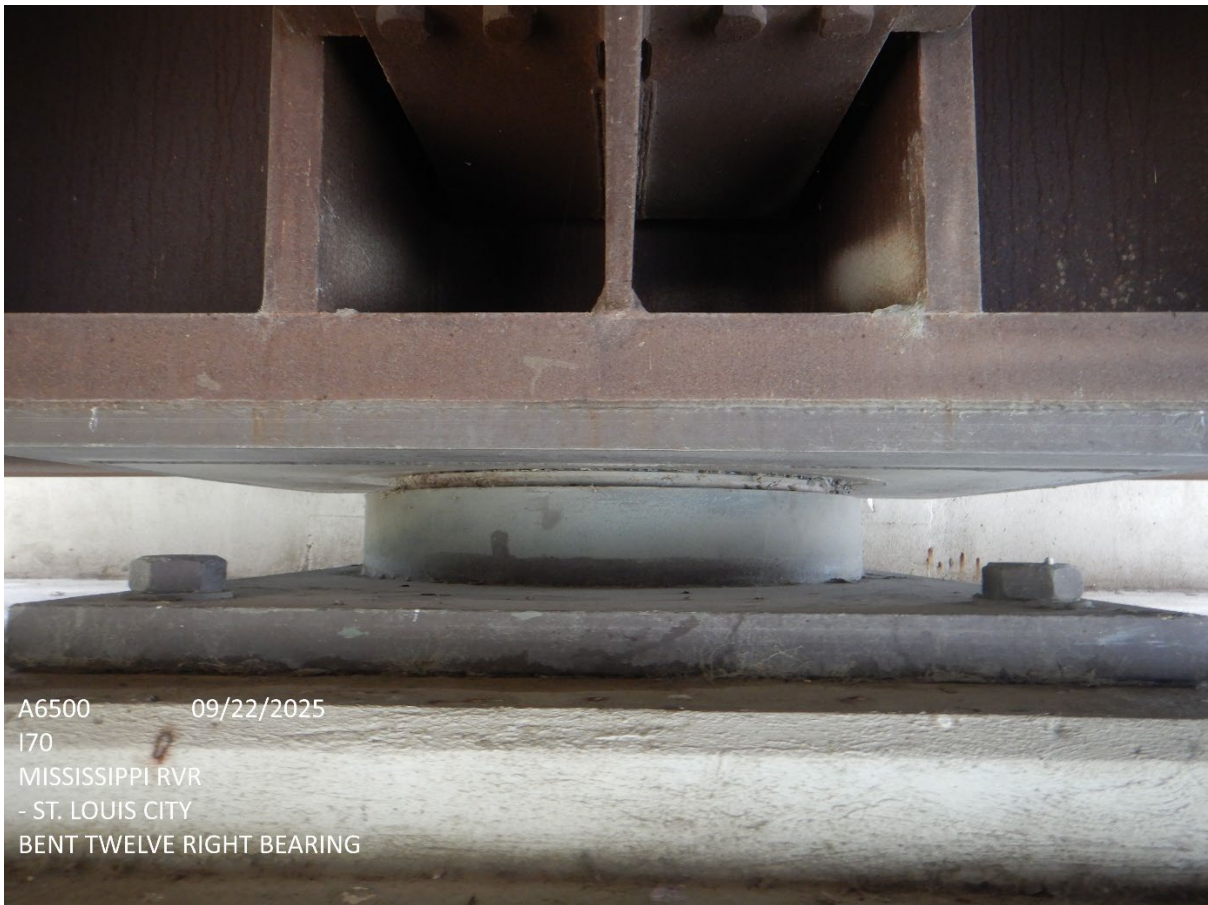
A6500 09/22/2025
I70
MISSISSIPPI RVR
- ST. LOUIS CITY
BENT TWELVE RIGHT BEARING

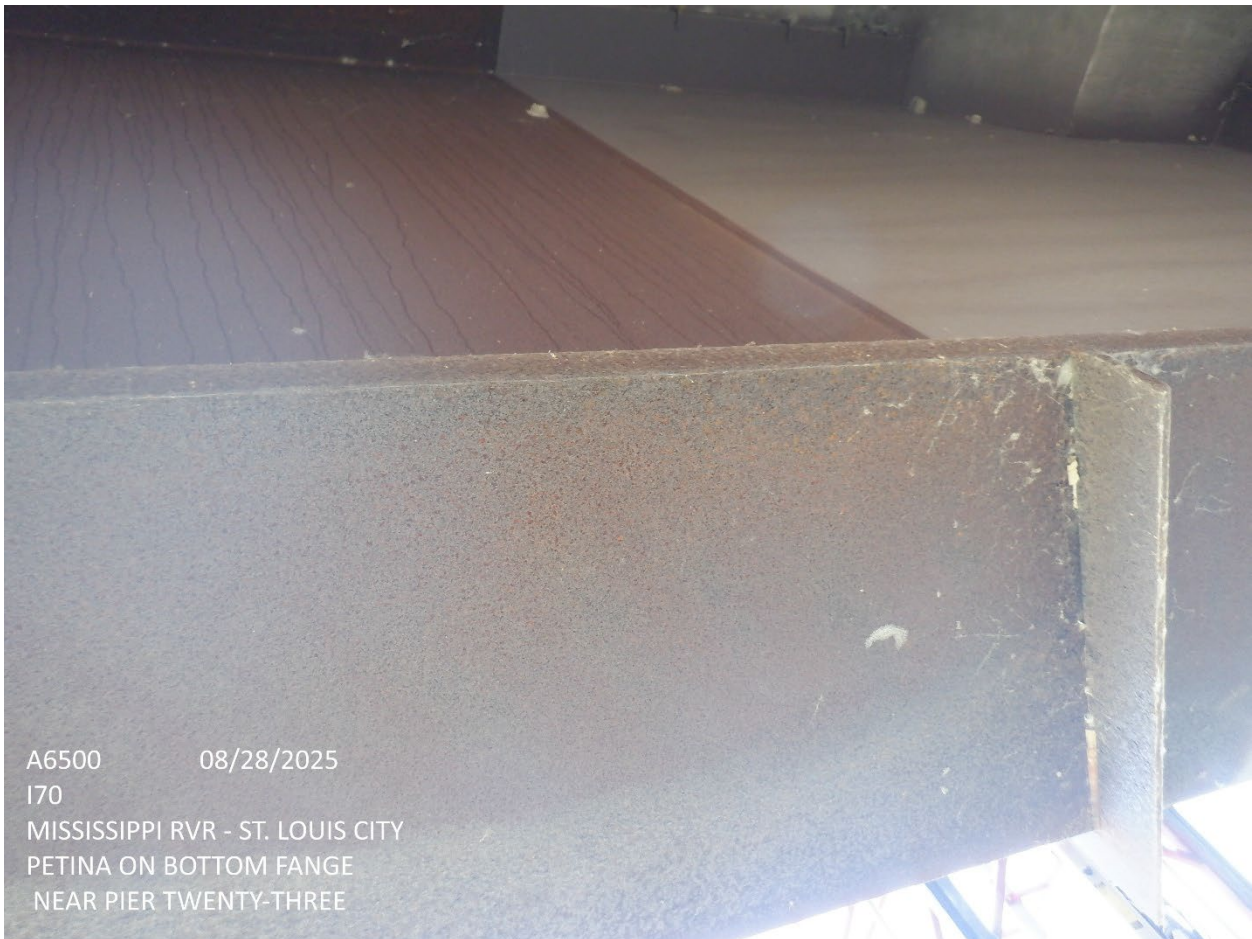
A6500 08/28/2025
I70
MISSISSIPPI RVR - ST. LOUIS CITY
PETINA ON BOTTOM FLANGE
NEAR PIER TWENTY-THREE

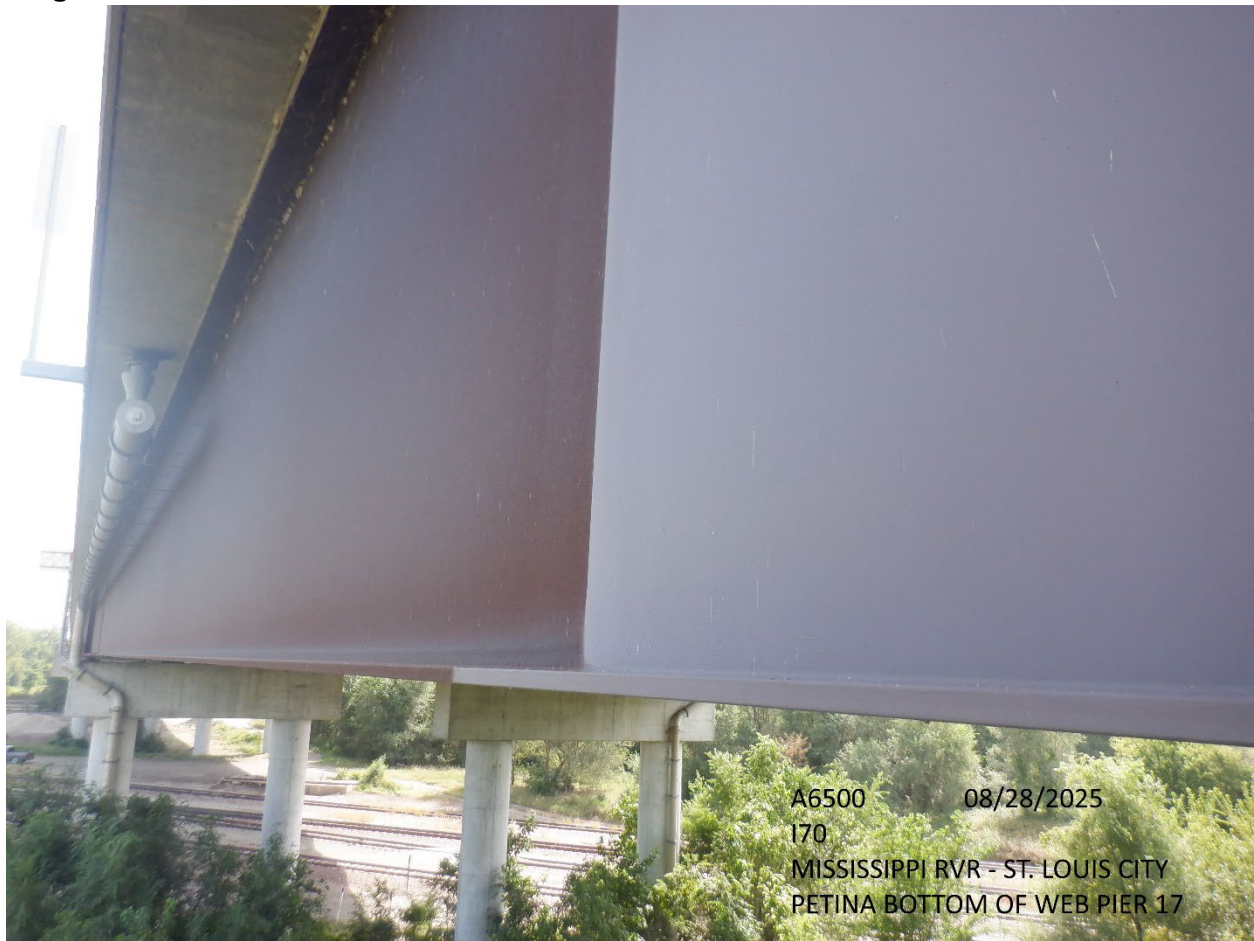
A6500 08/28/2025
170
MISSISSIPPI RVR - ST. LOUIS CITY
PETINA BOTTOM OF WEB PIER 17

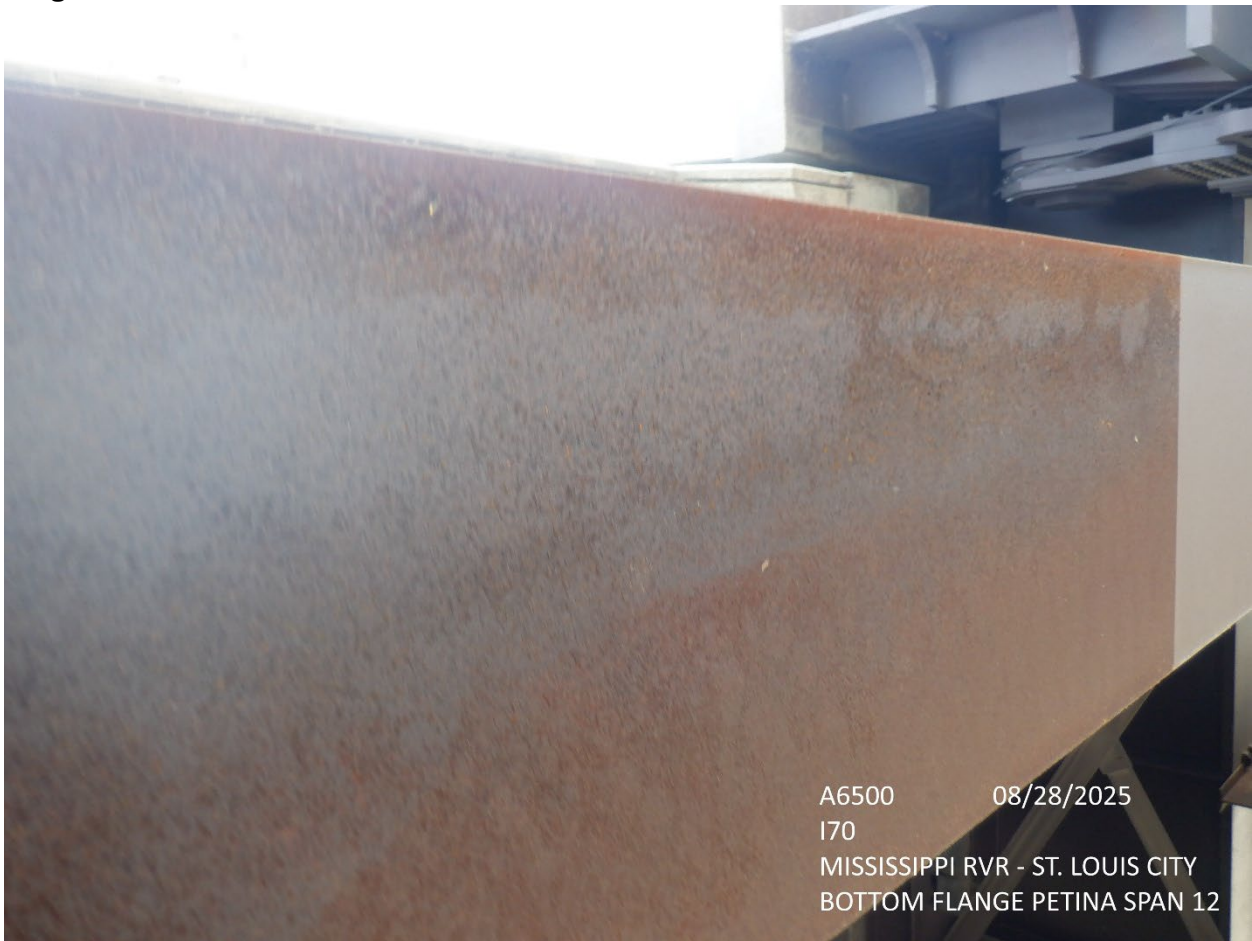
A6500 08/28/2025
I70
MISSISSIPPI RVR - ST. LOUIS CITY
BOTTOM FLANGE PETINA SPAN 12

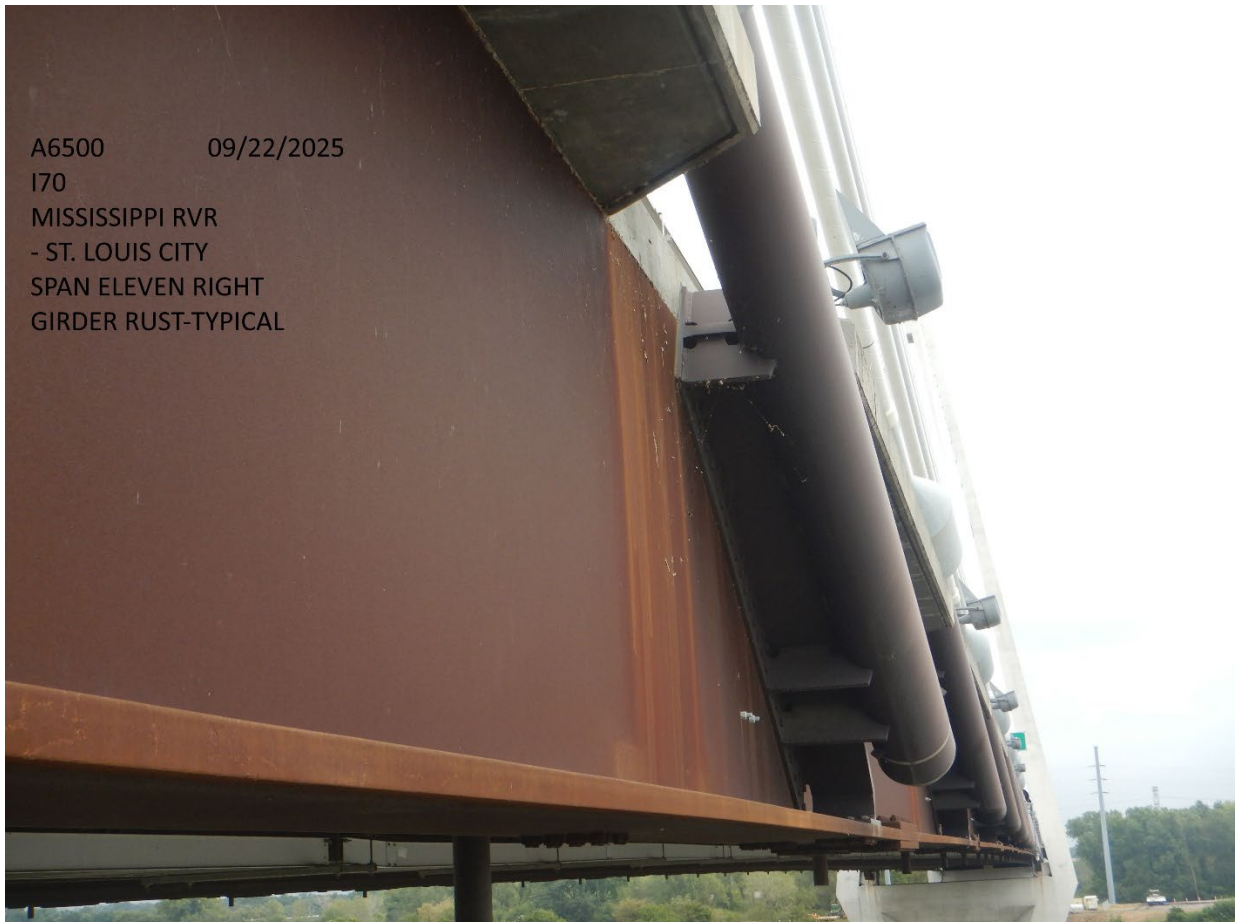
A6500 09/22/2025
I70
MISSISSIPPI RVR
- ST. LOUIS CITY
SPAN ELEVEN RIGHT
GIRDER RUST-TYPICAL

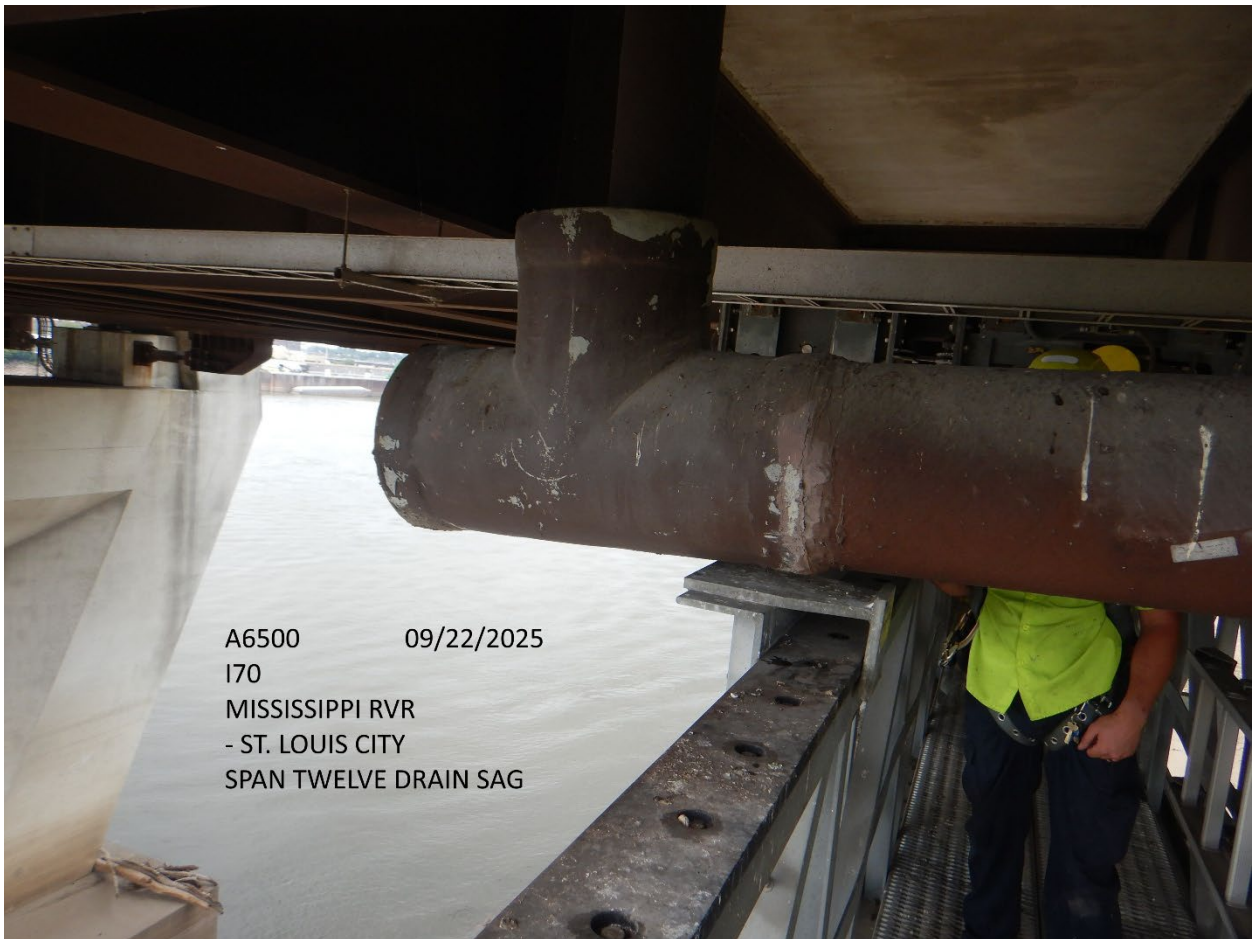
A6500 09/22/2025
I70
MISSISSIPPI RVR
- ST. LOUIS CITY
SPAN TWELVE DRAIN SAG

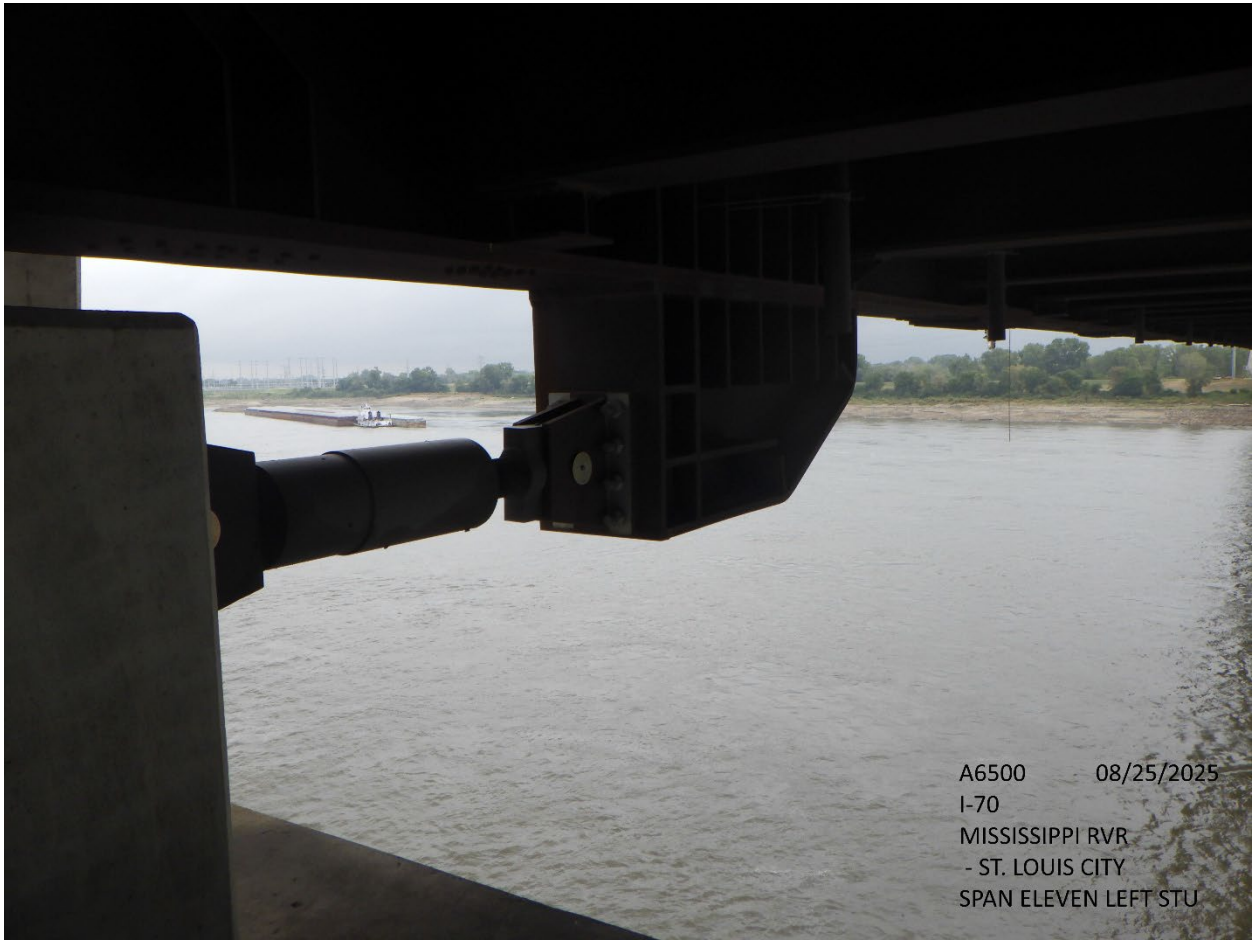
A6500 08/25/2025
I-70
MISSISSIPPI RVR
- ST. LOUIS CITY
SPAN ELEVEN LEFT STU

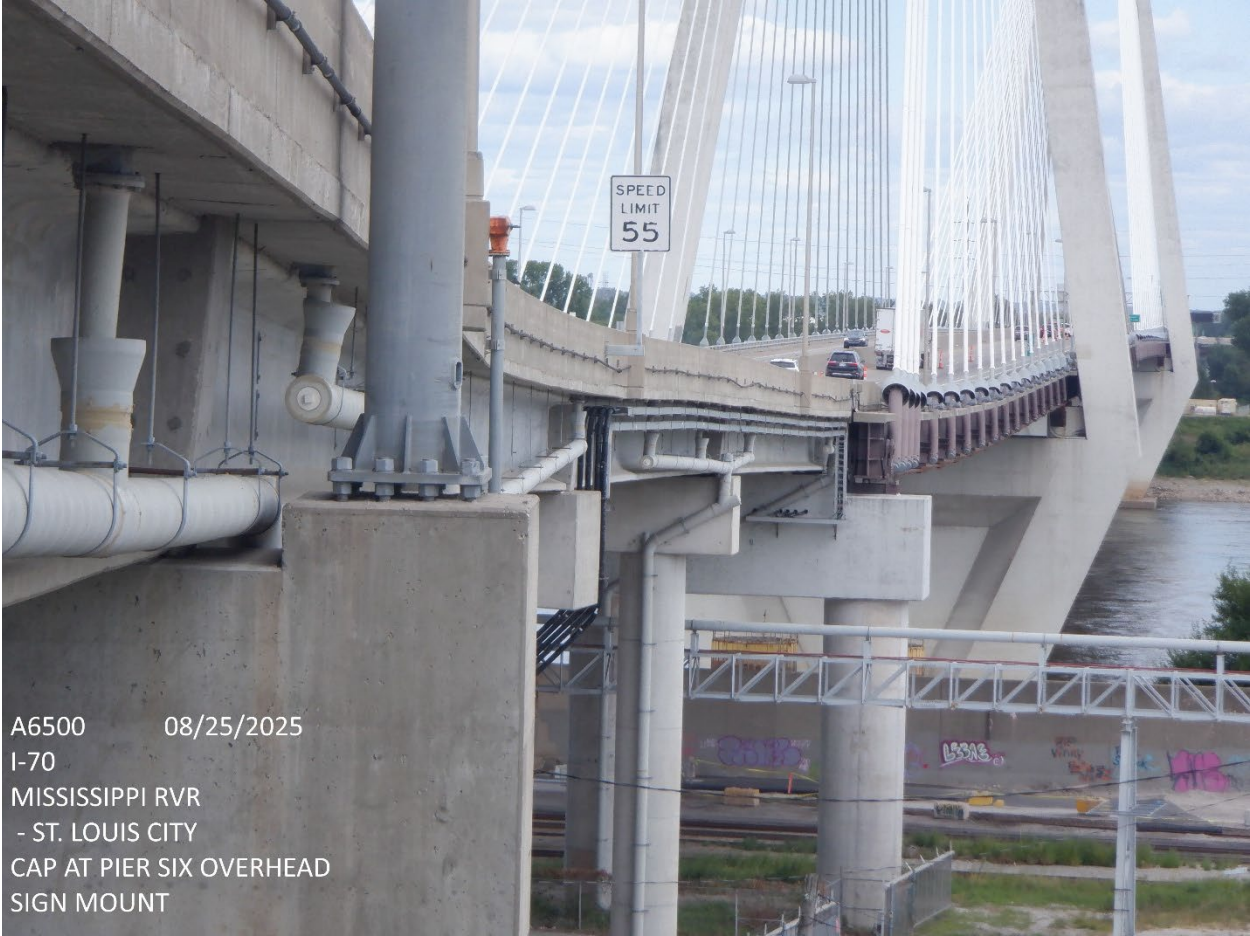
A6500 08/25/2025
I-70
MISSISSIPPI RVR
- ST. LOUIS CITY
CAP AT PIER SIX OVERHEAD
SIGN MOUNT

Piers to Seal at Sign Trusses

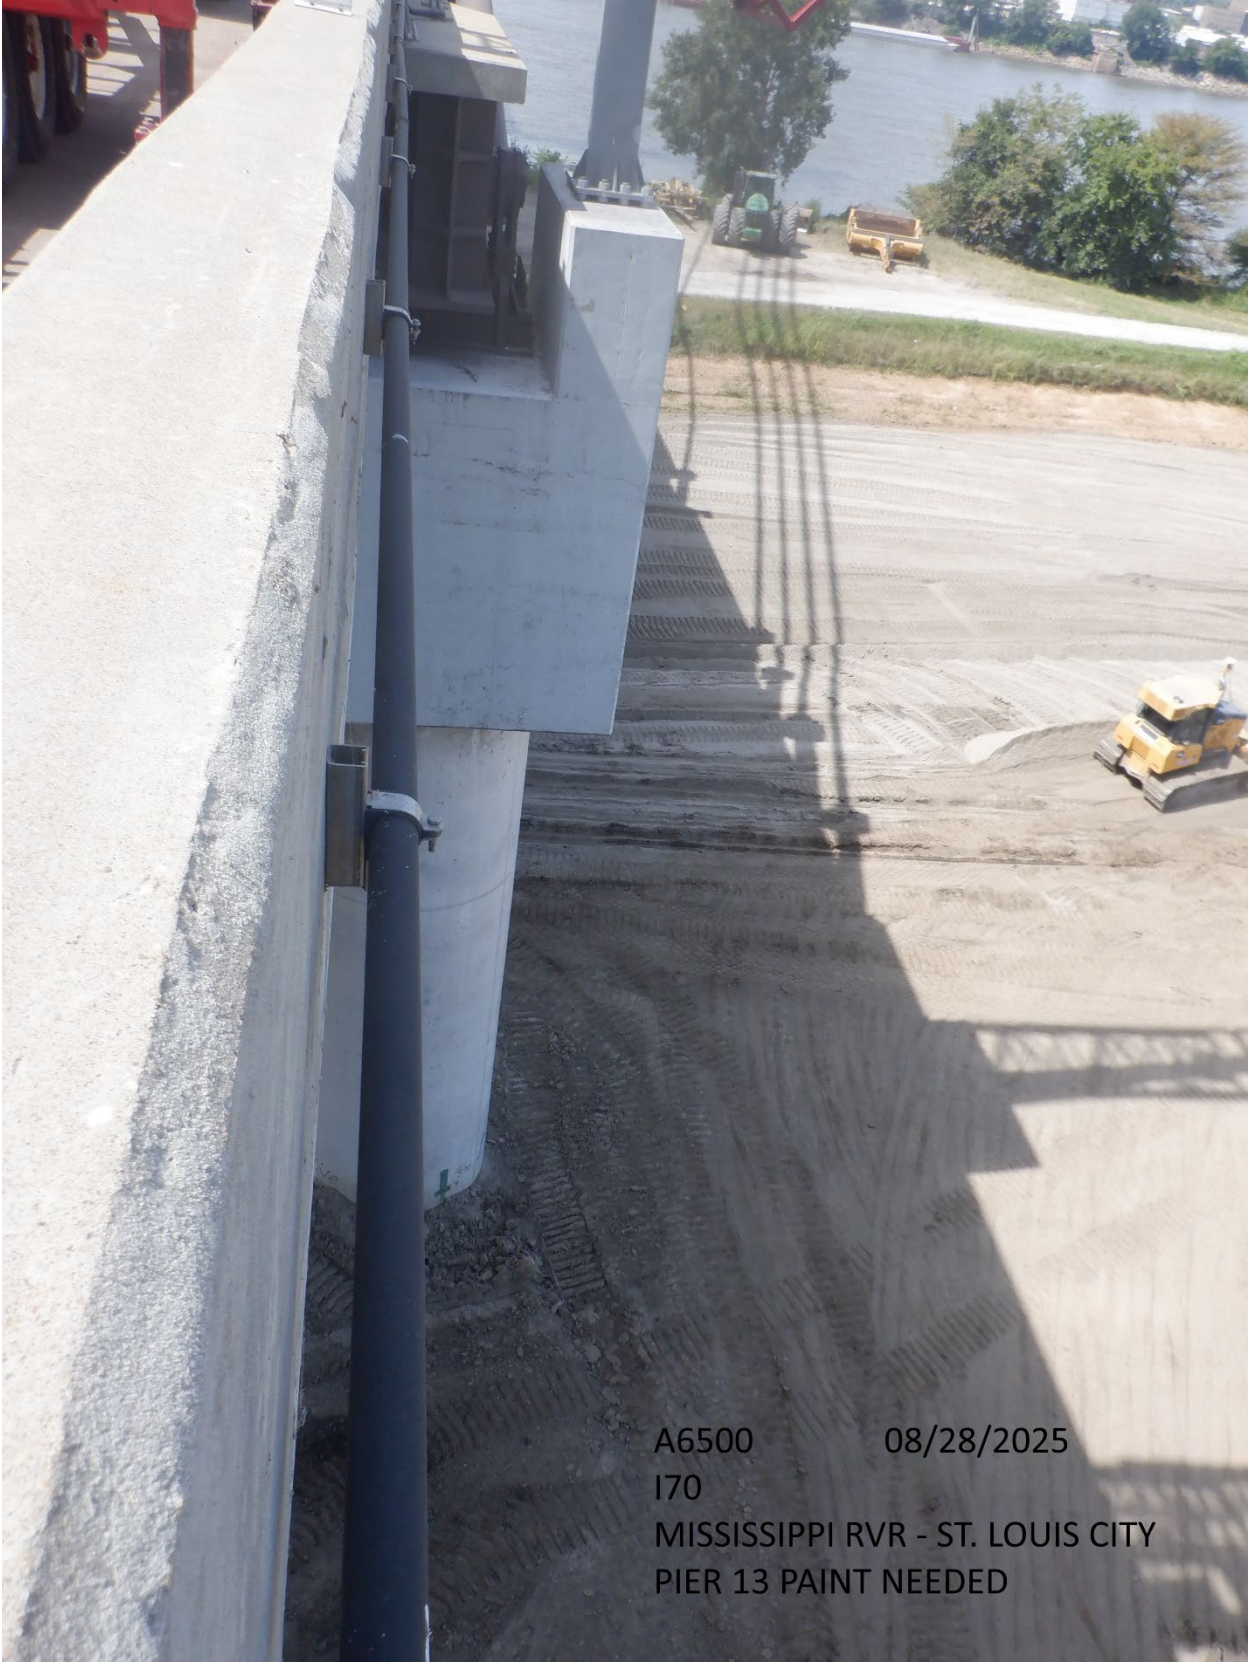
A6500 08/28/2025
170
MISSISSIPPI RVR - ST. LOUIS CITY
PIER 13 PAINT NEEDED

Piers to Seal at Sign Trusses

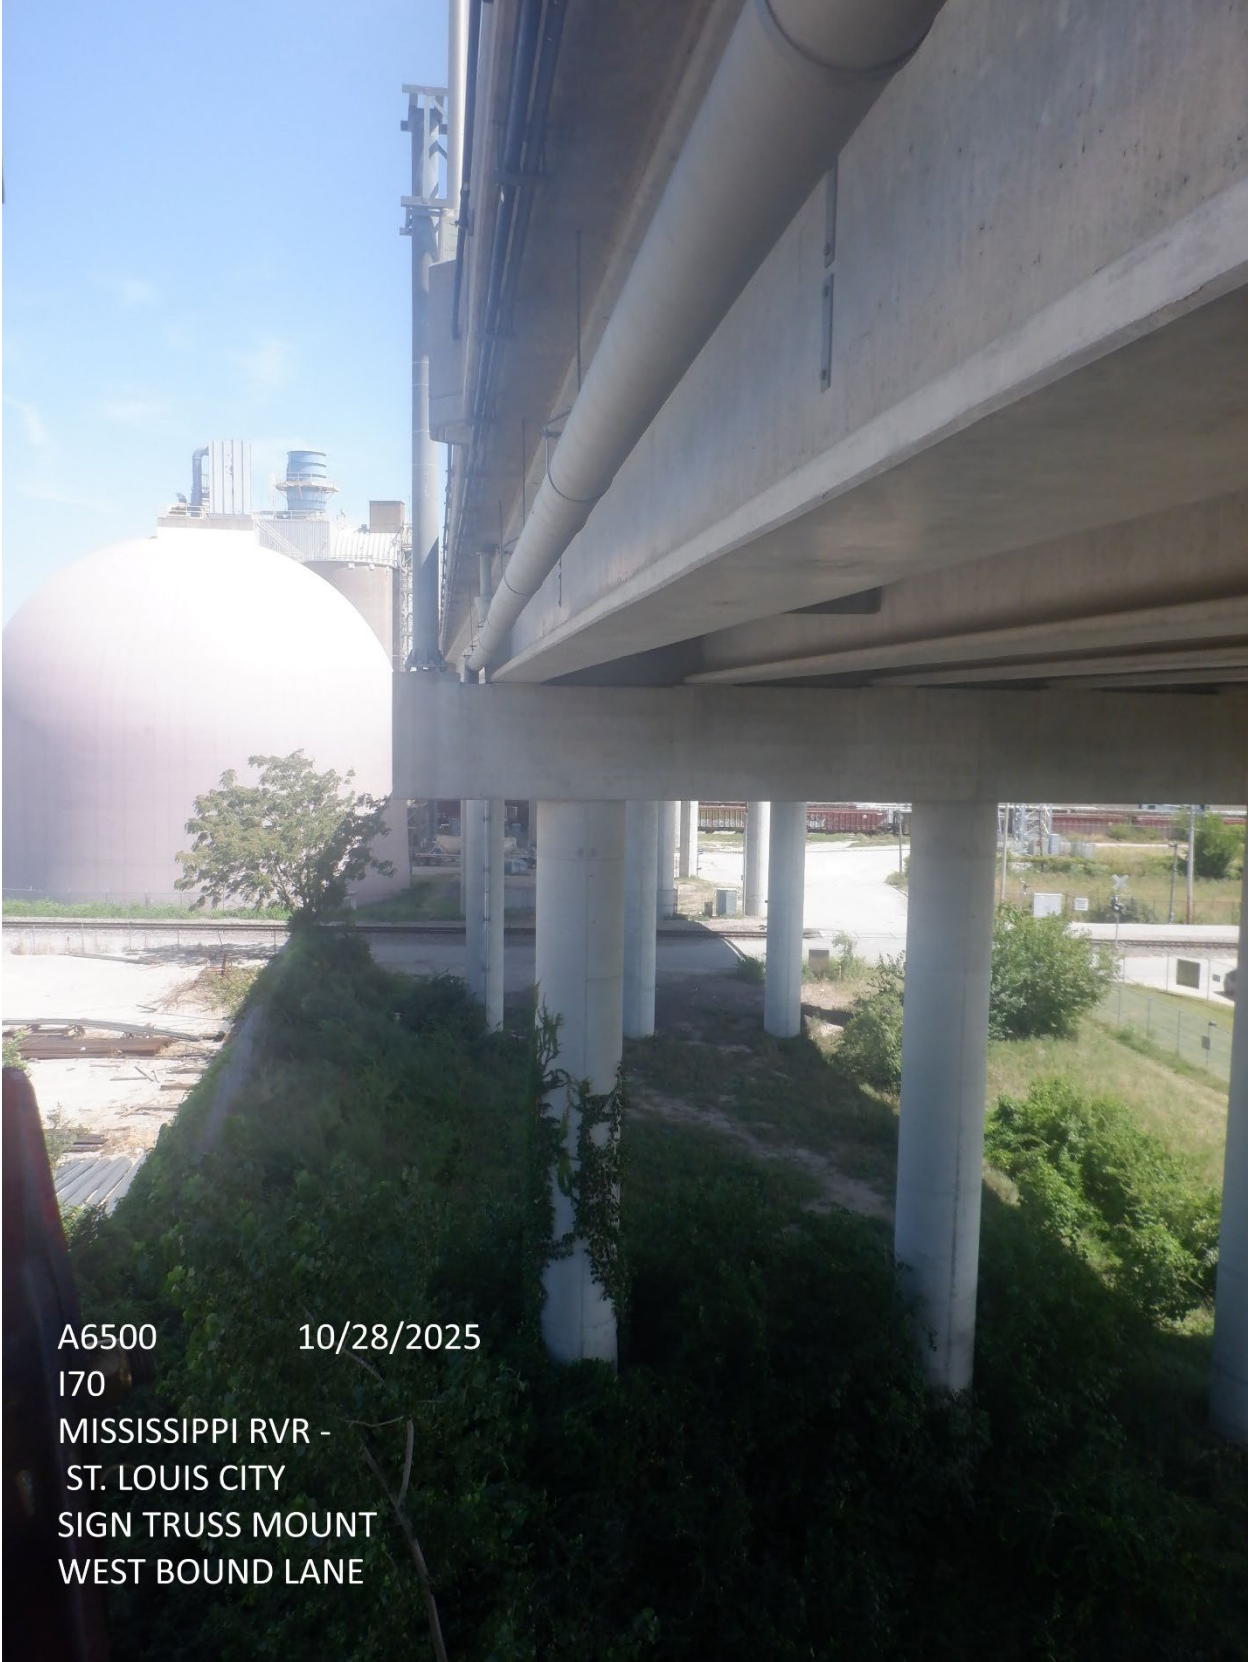
A6500 10/28/2025
I70
MISSISSIPPI RVR -
ST. LOUIS CITY
SIGN TRUSS MOUNT
WEST BOUND LANE

Piers to Seal at Sign Trusses

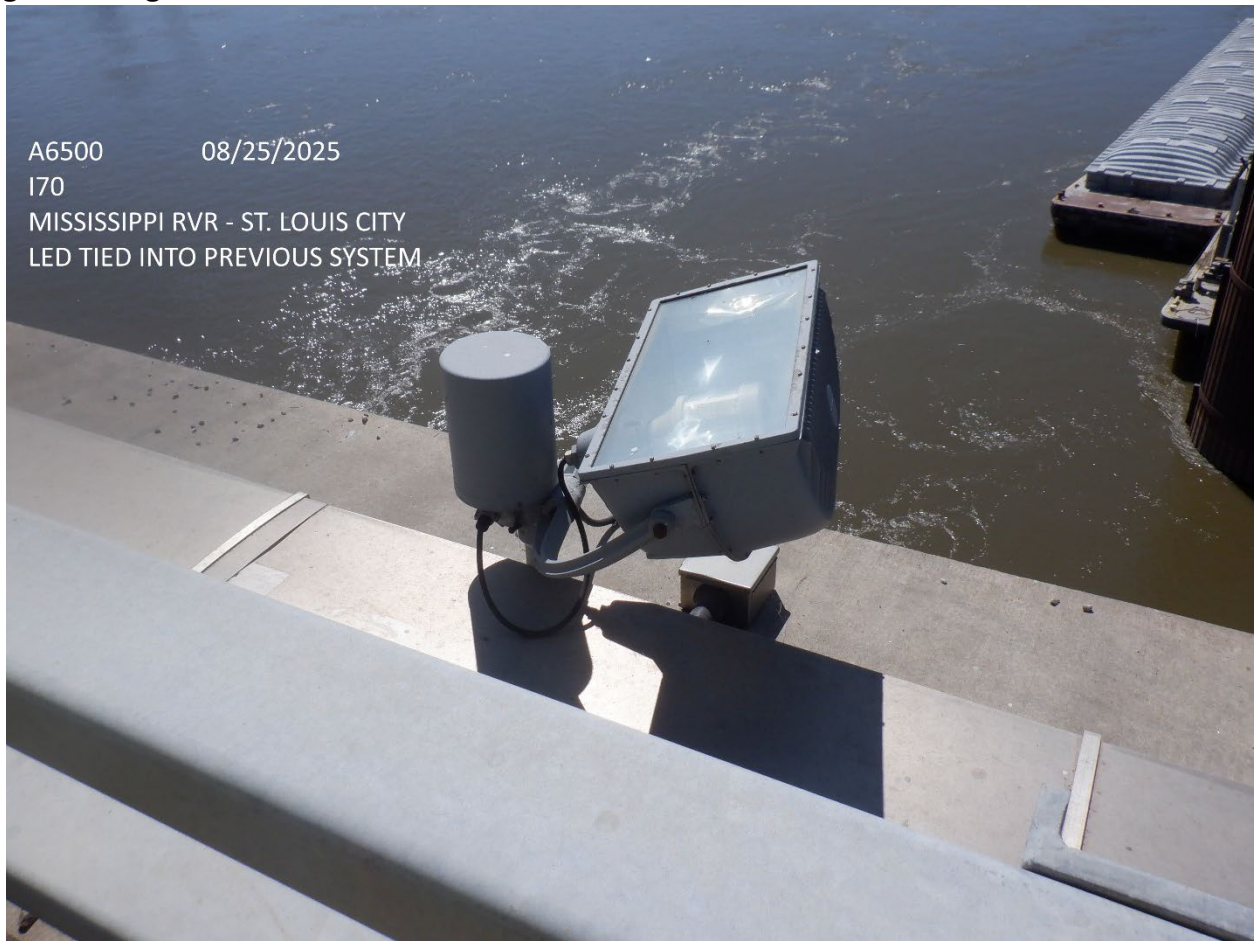
A6500 08/25/2025
I70
MISSISSIPPI RVR - ST. LOUIS CITY
LED TIED INTO PREVIOUS SYSTEM

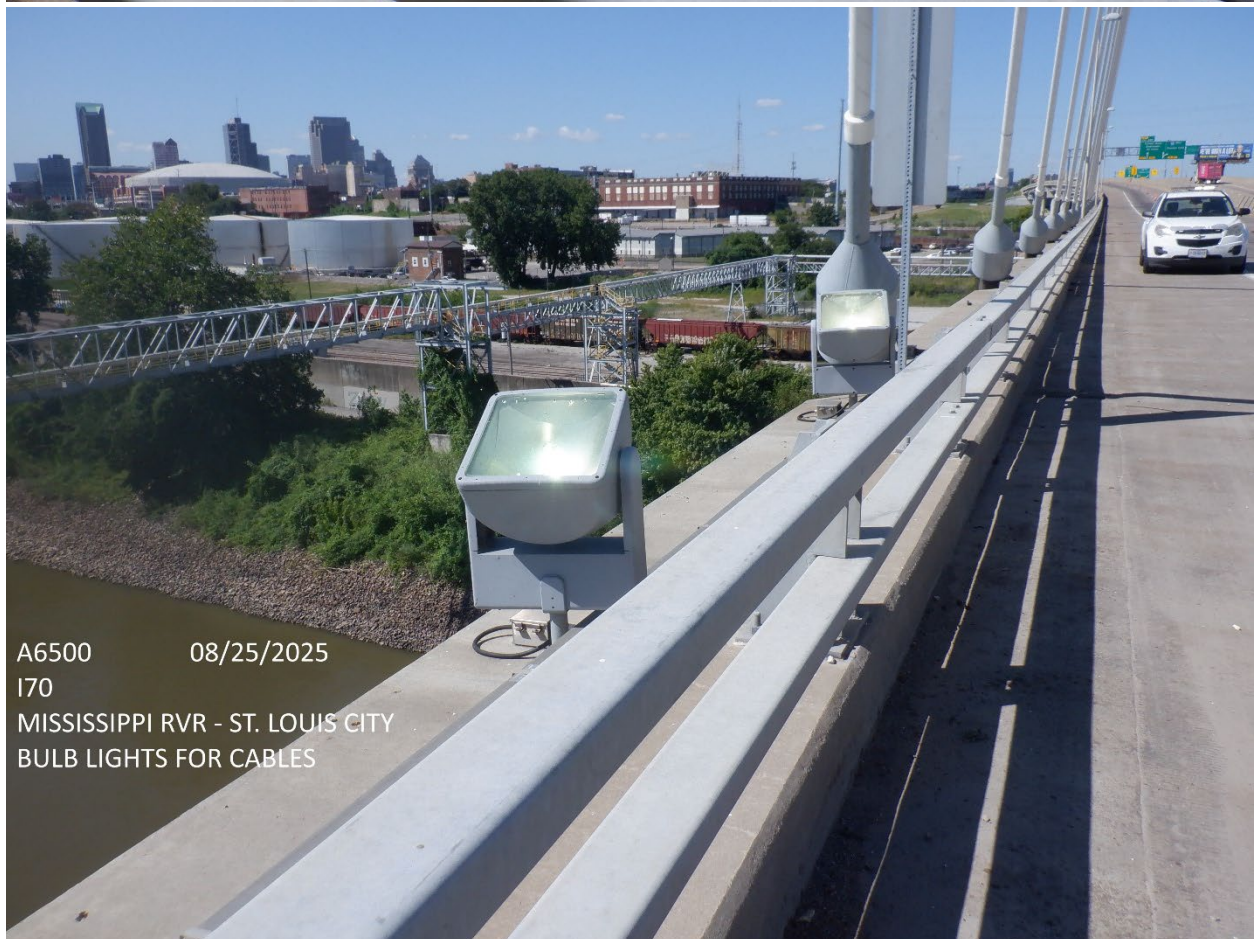
A6500 08/25/2025
I70
MISSISSIPPI RVR - ST. LOUIS CITY
BULB LIGHTS FOR CABLES

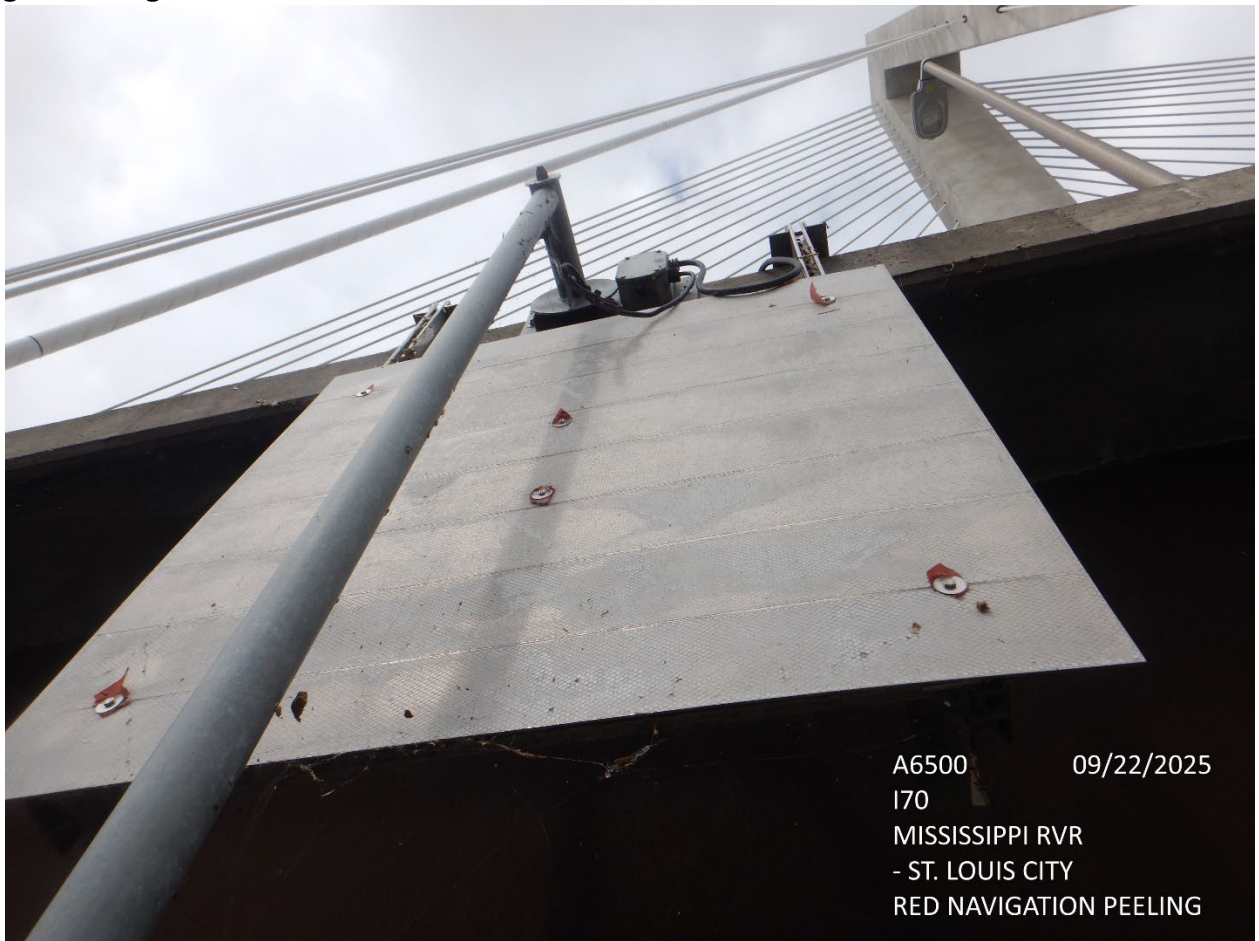
A6500 09/22/2025
I70
MISSISSIPPI RVR
- ST. LOUIS CITY
RED NAVIGATION PEELING
