Missouri Department of Transportation

STRUCTURAL REHABILITATION CHECKLIST

Bridge No.: **A6500**

Route: **I-70**

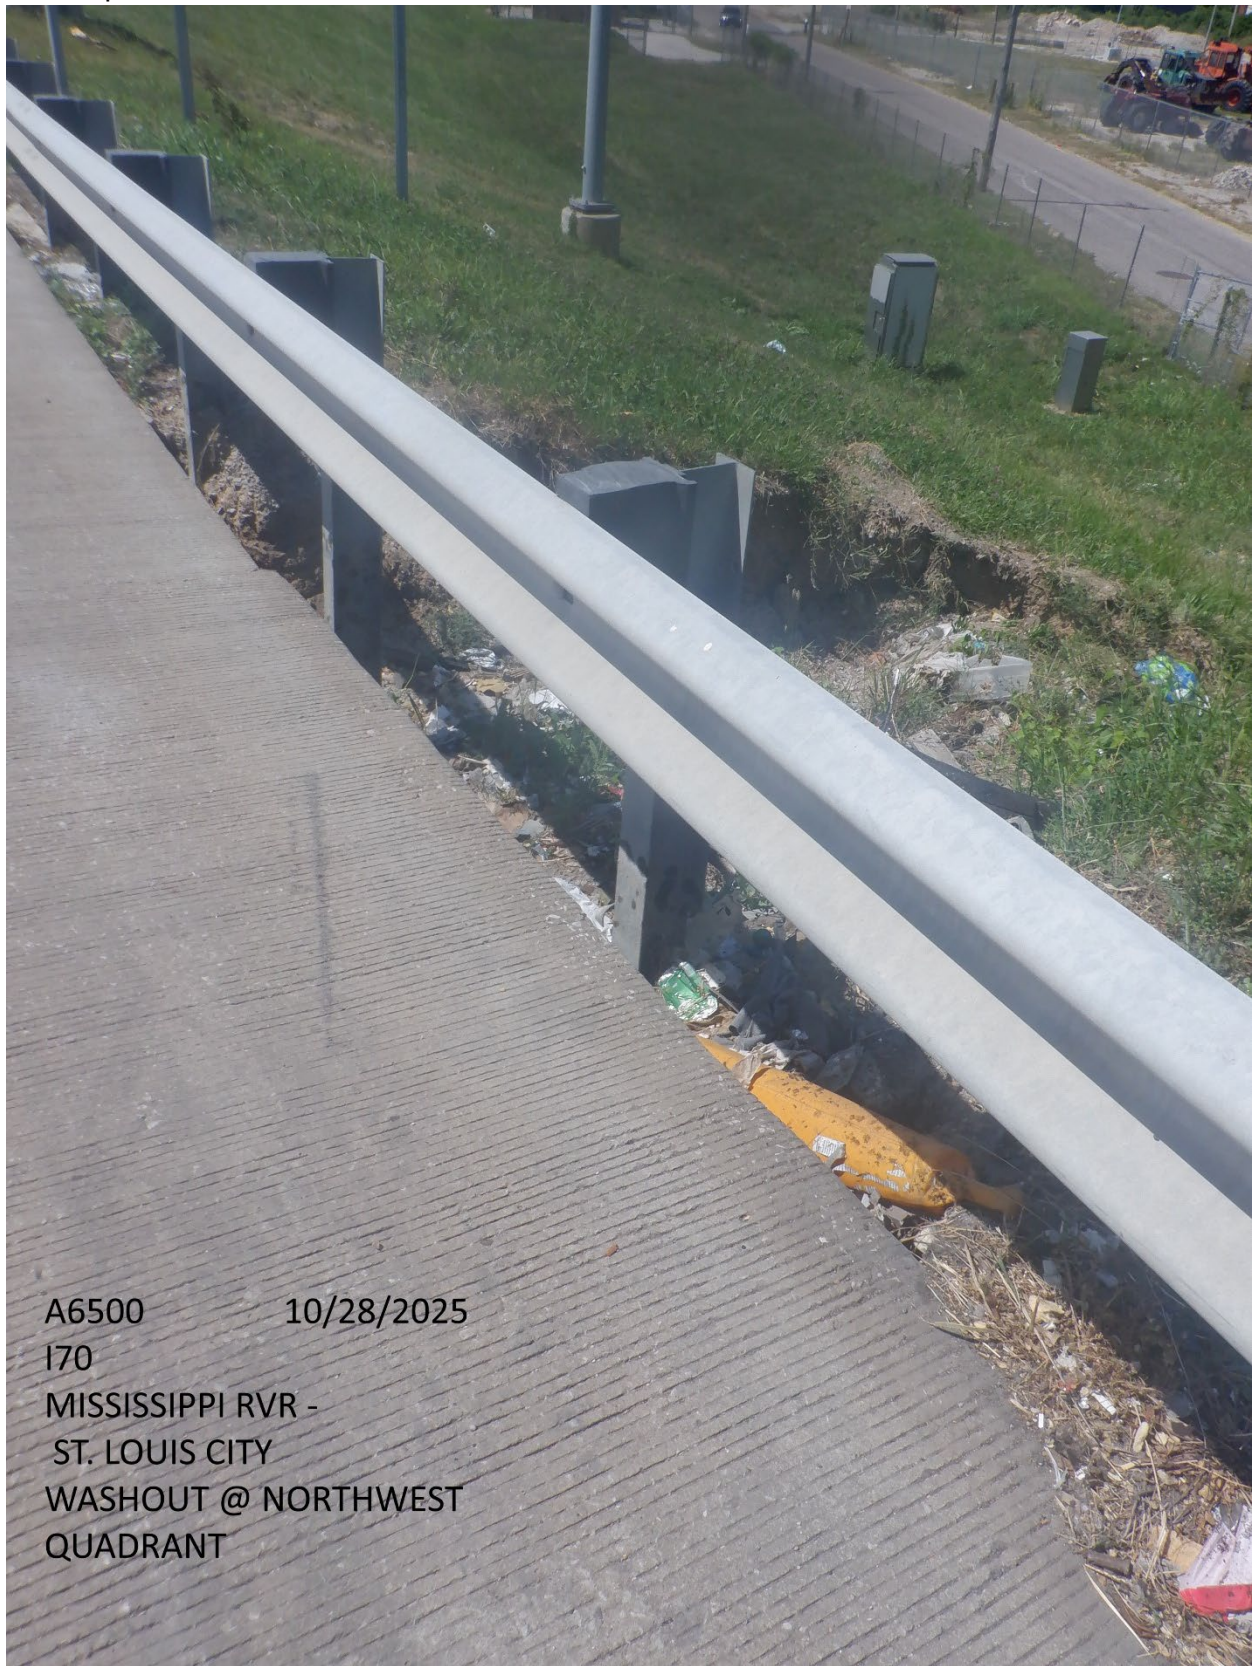
A6500 10/28/2025
I70
MISSISSIPPI RVR -
ST. LOUIS CITY
WASHOUT @ NORTHWEST
QUADRANT

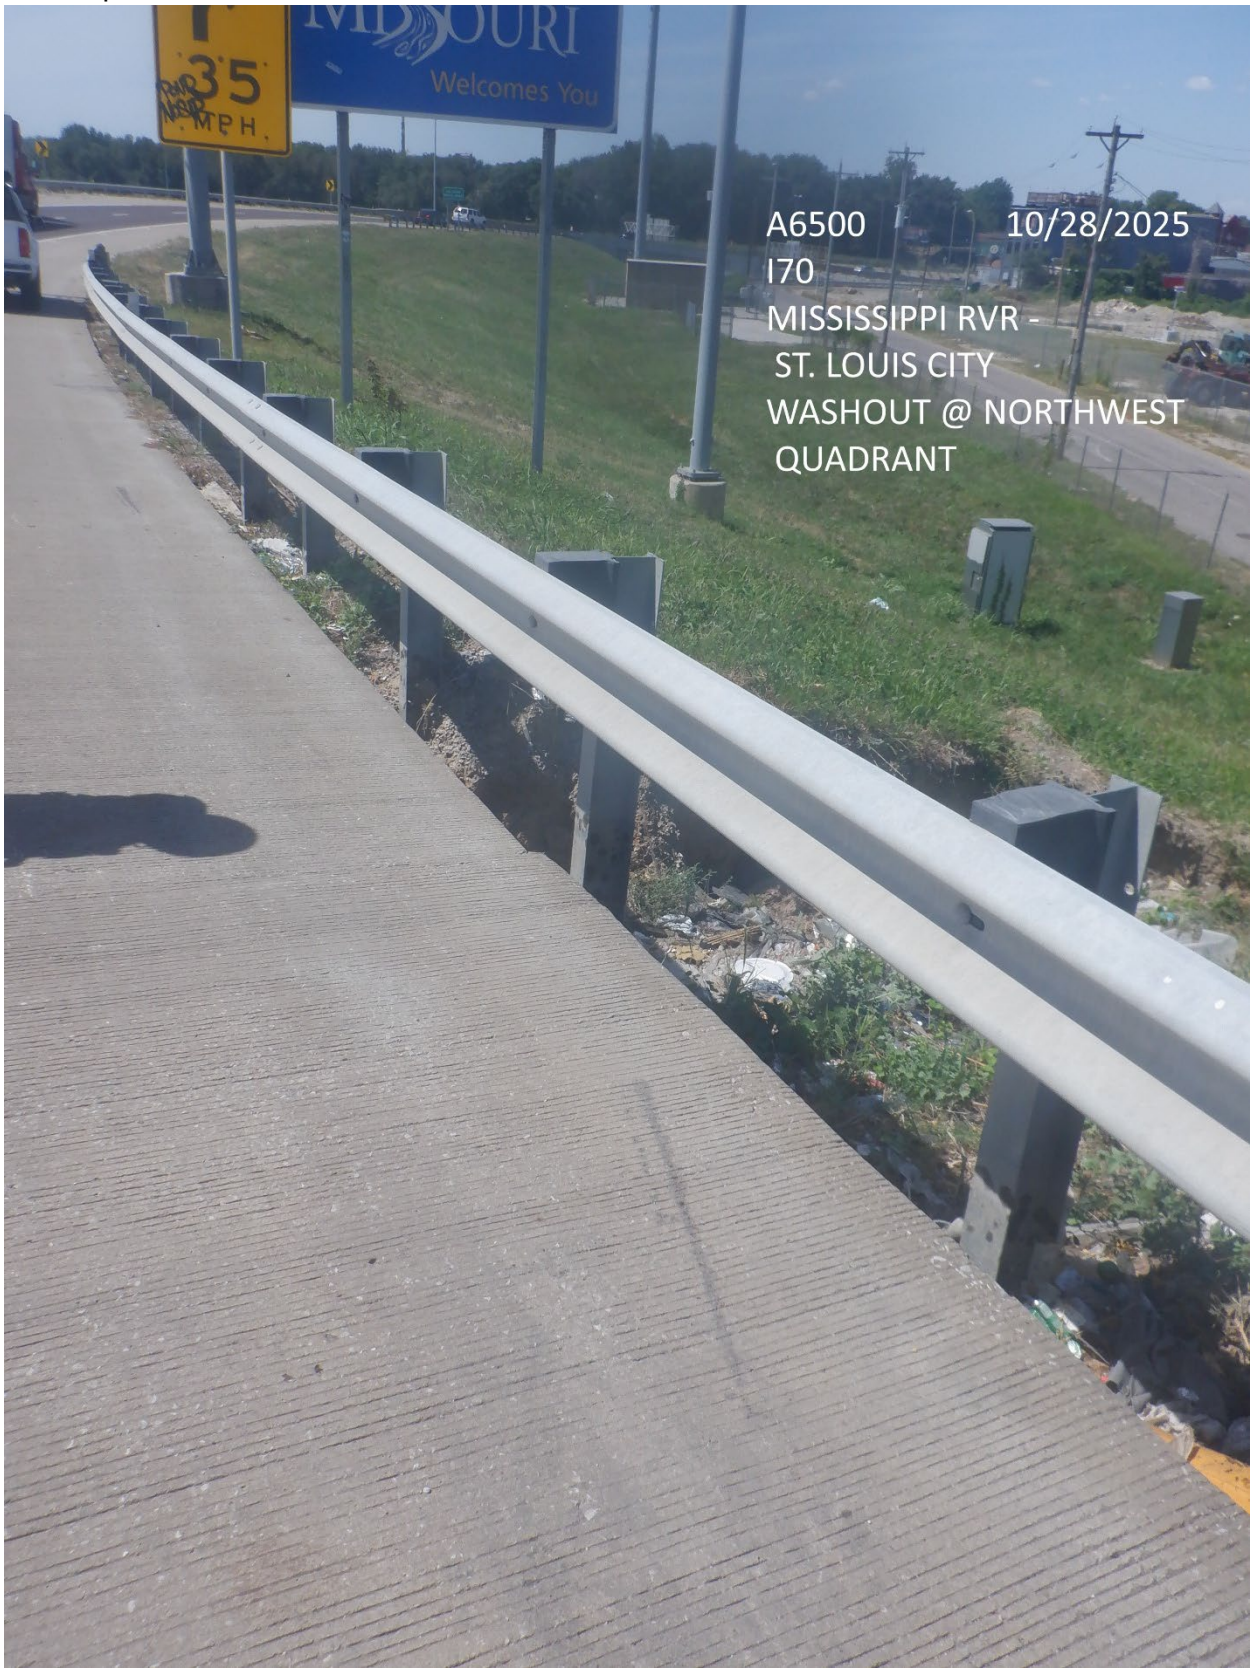
A650 10/28/2025
I70
MISSISSIPPI RVR -
ST. LOUIS CITY
WASHOUT @ NORTHWEST
QUADRANT

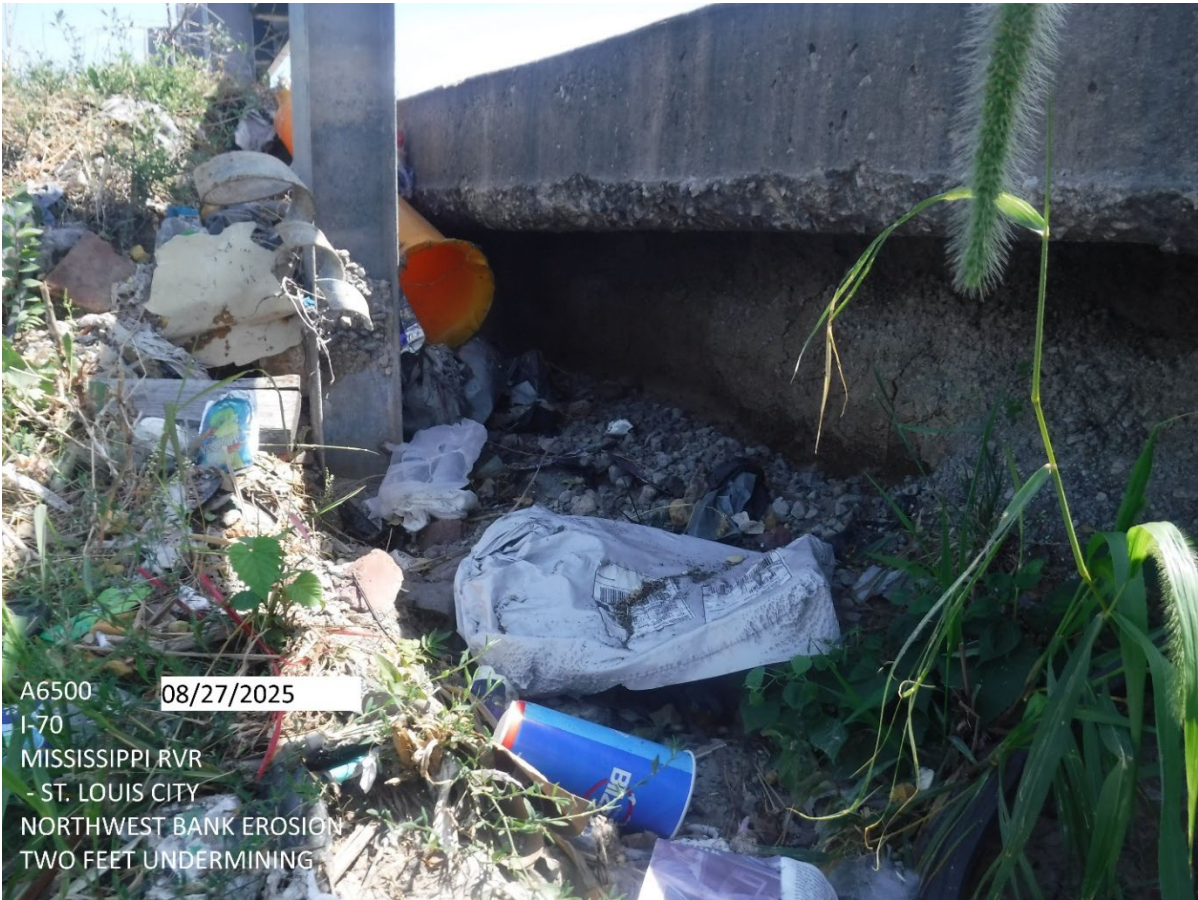
A6500 08/27/2025
I-70
MISSISSIPPI RVR
- ST. LOUIS CITY
NORTHWEST BANK EROSION
TWO FEET UNDERMINING

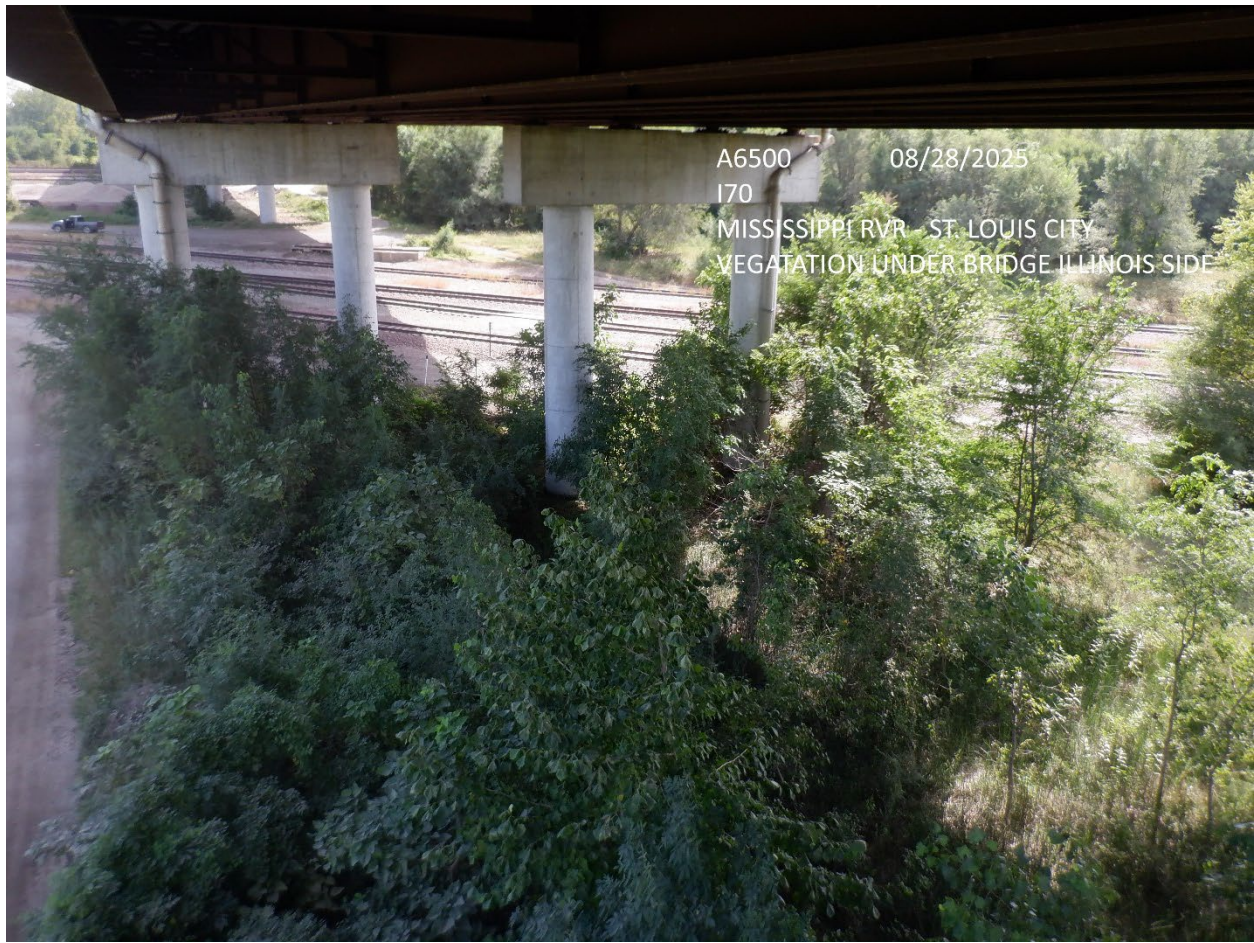
A6500 08/28/2025
I70
MISSISSIPPI RVR - ST. LOUIS CITY
VEGATATION UNDER BRIDGE ILLINOIS SIDE

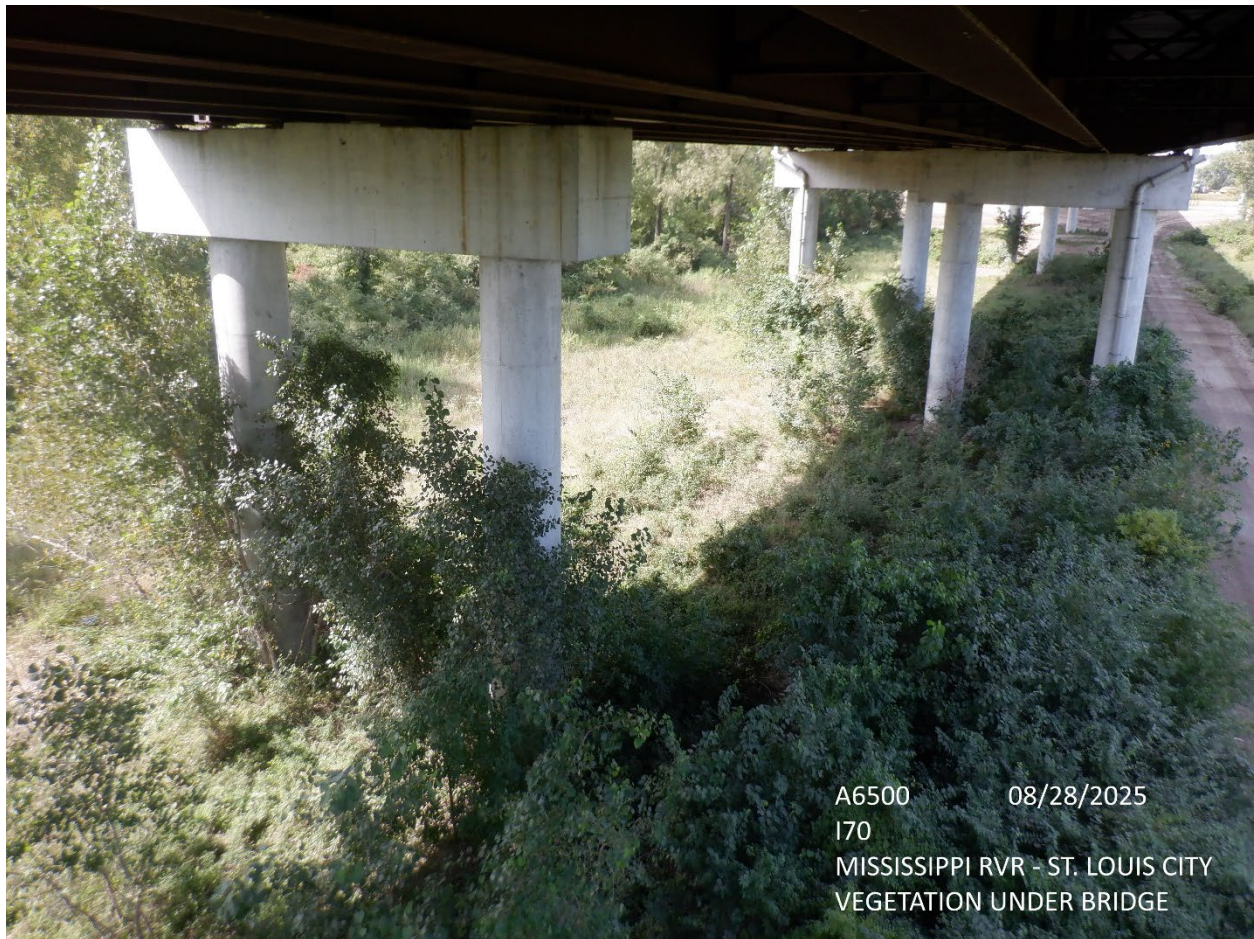
A6500 08/28/2025
I70
MISSISSIPPI RVR - ST. LOUIS CITY
VEGATATION UNDER BRIDGE

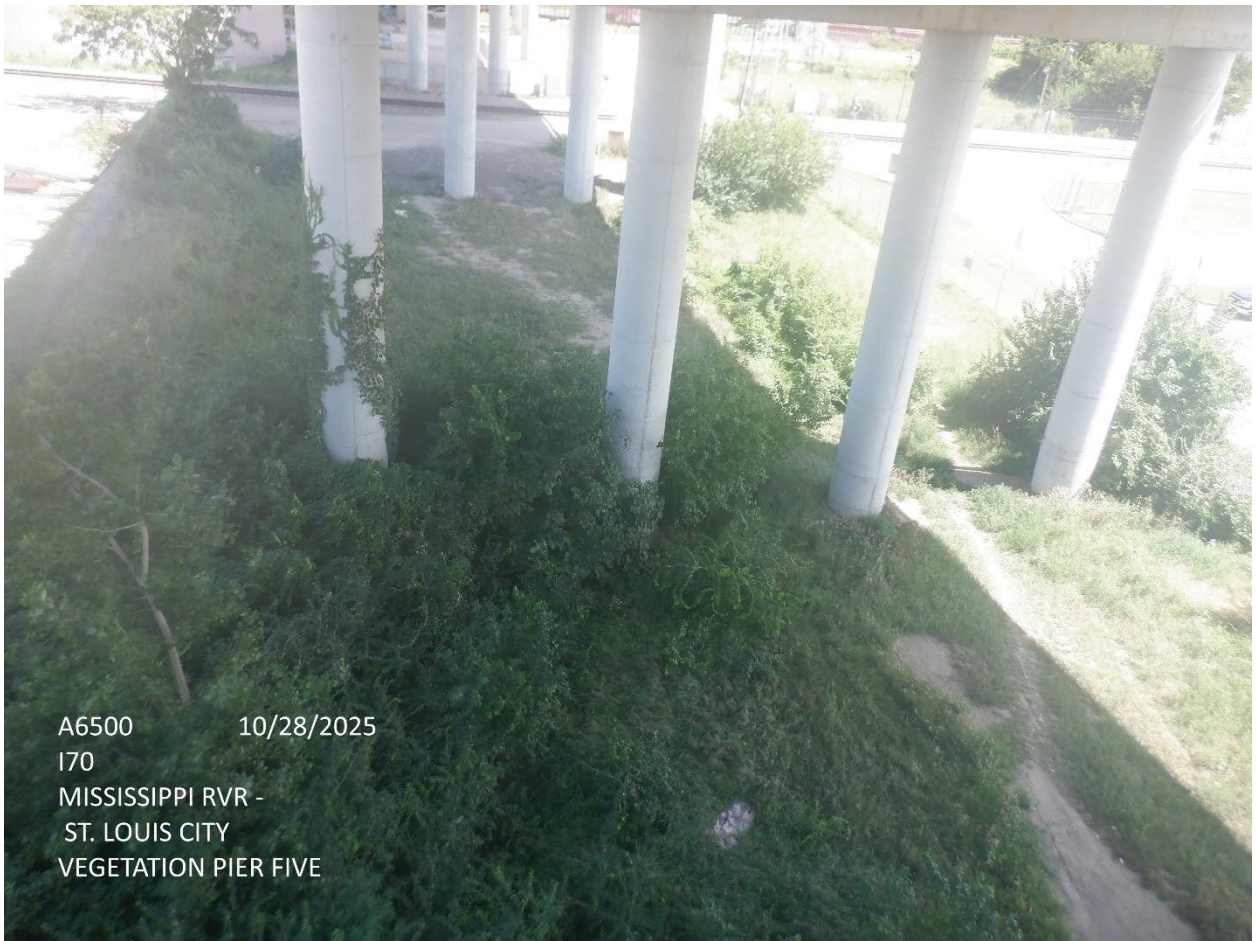
A6500 10/28/2025
I70
MISSISSIPPI RVR -
ST. LOUIS CITY
VEGETATION PIER FIVE

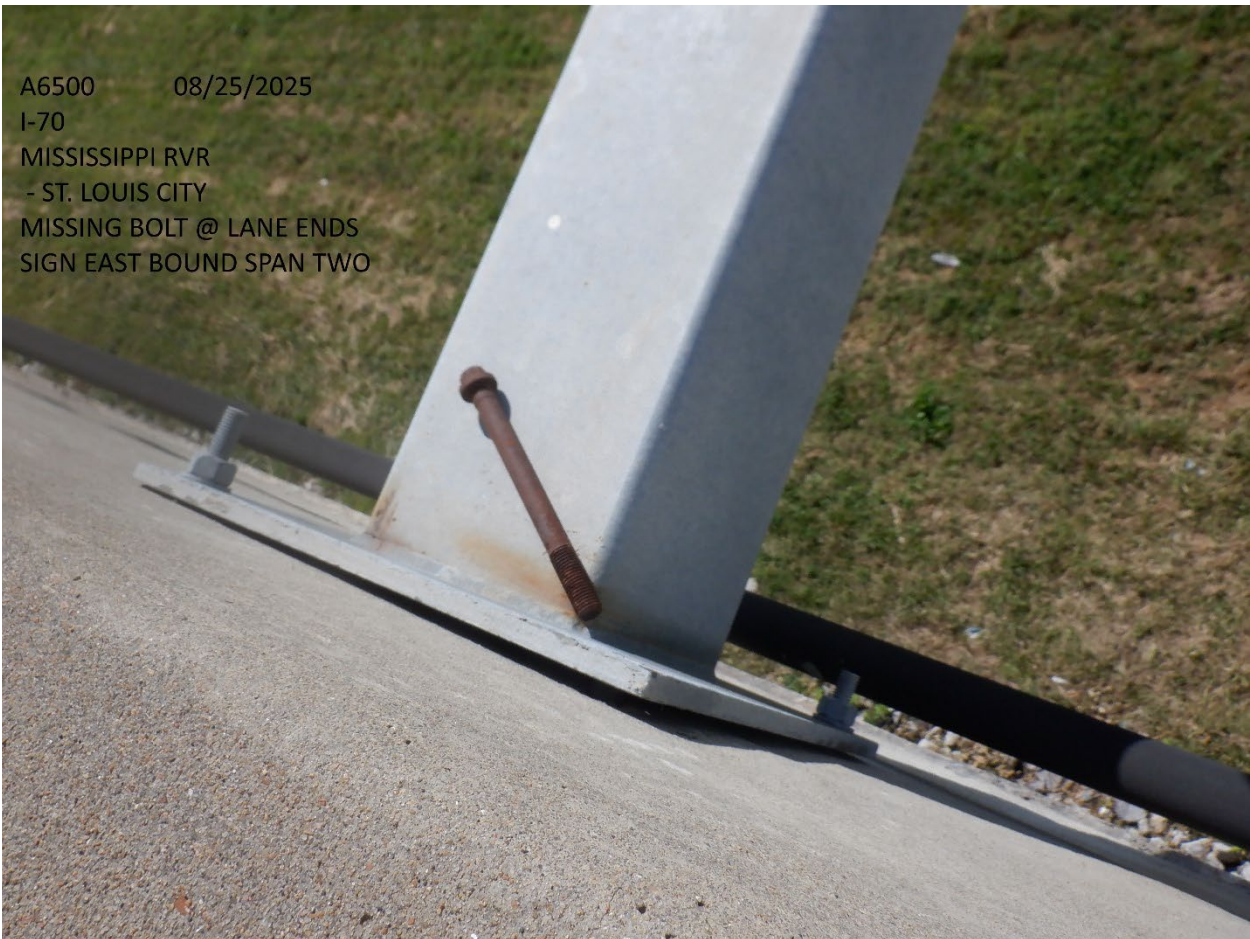
A6500 08/25/2025
I-70
MISSISSIPPI RVR
- ST. LOUIS CITY
MISSING BOLT @ LANE ENDS
SIGN EAST BOUND SPAN TWO

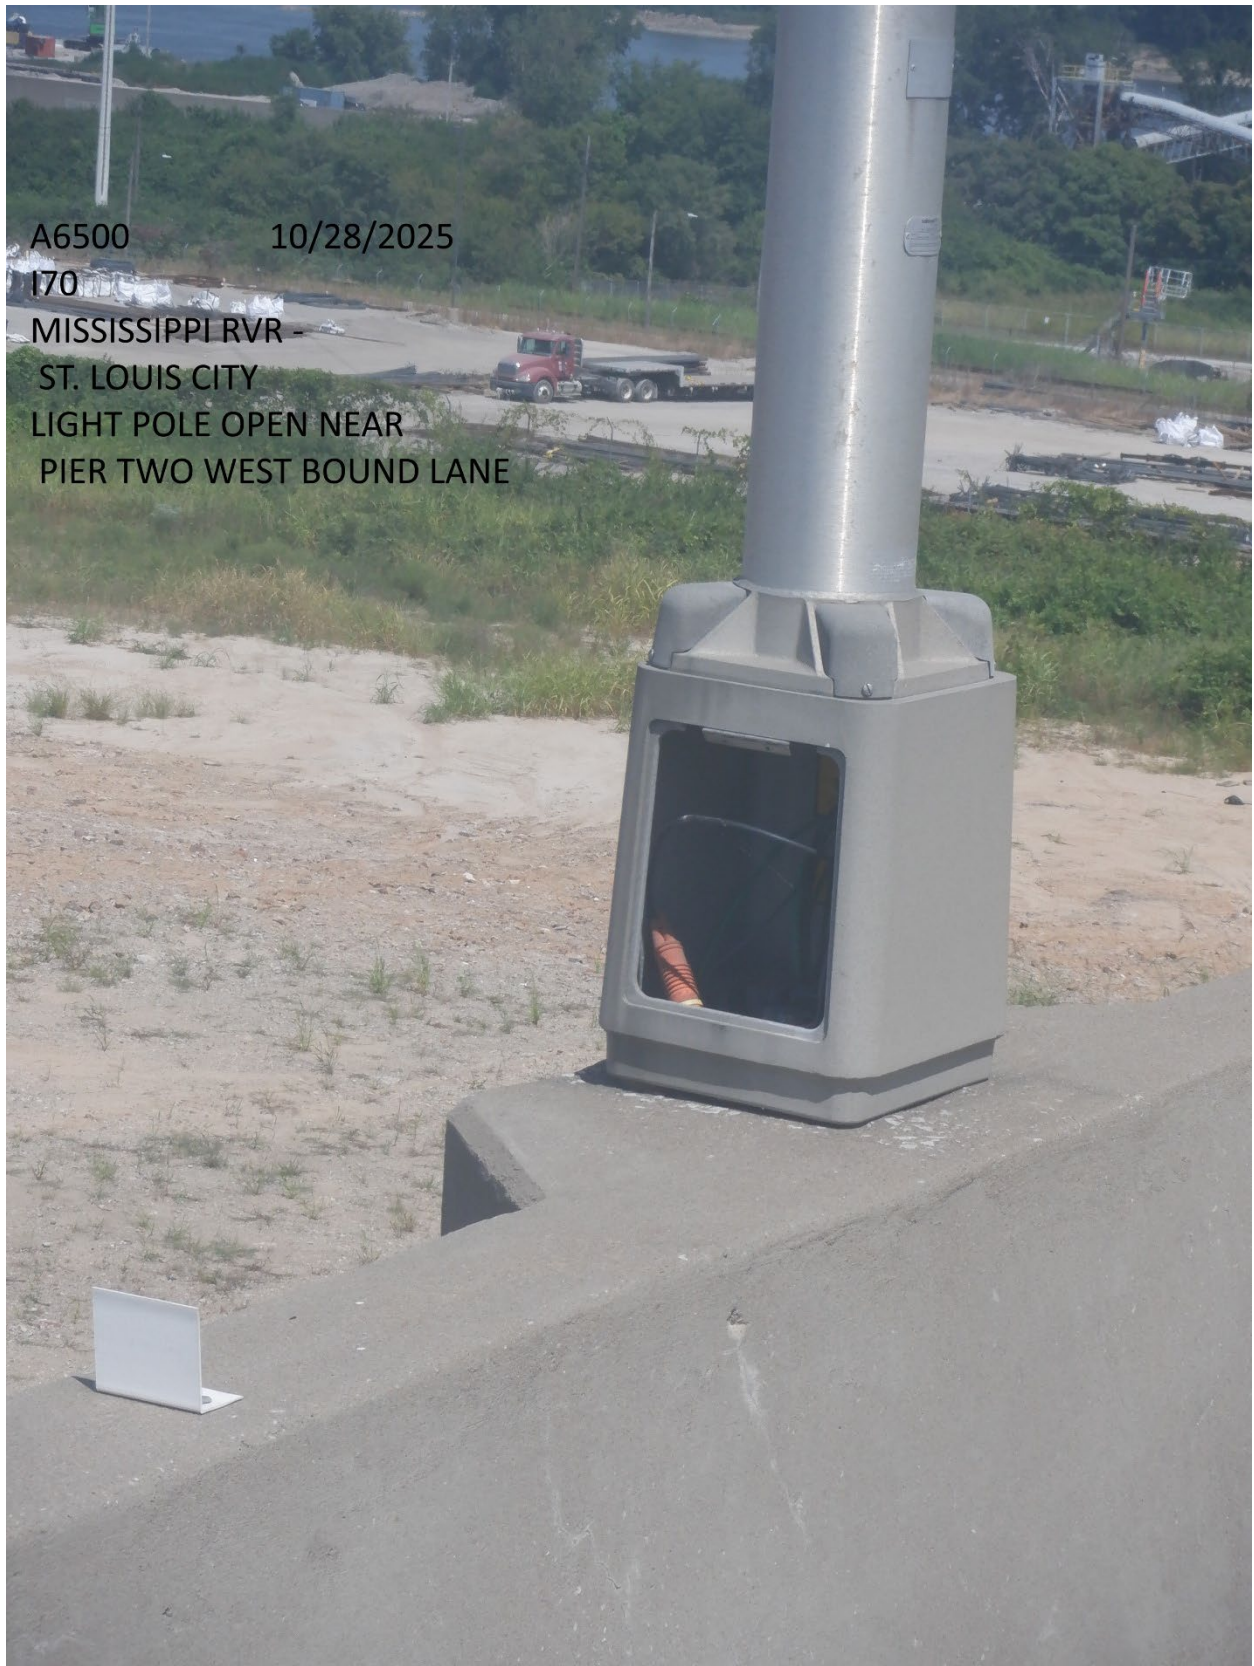
A6500 10/28/2025
I70
MISSISSIPPI RVR -
ST. LOUIS CITY
LIGHT POLE OPEN NEAR
PIER TWO WEST BOUND LANE

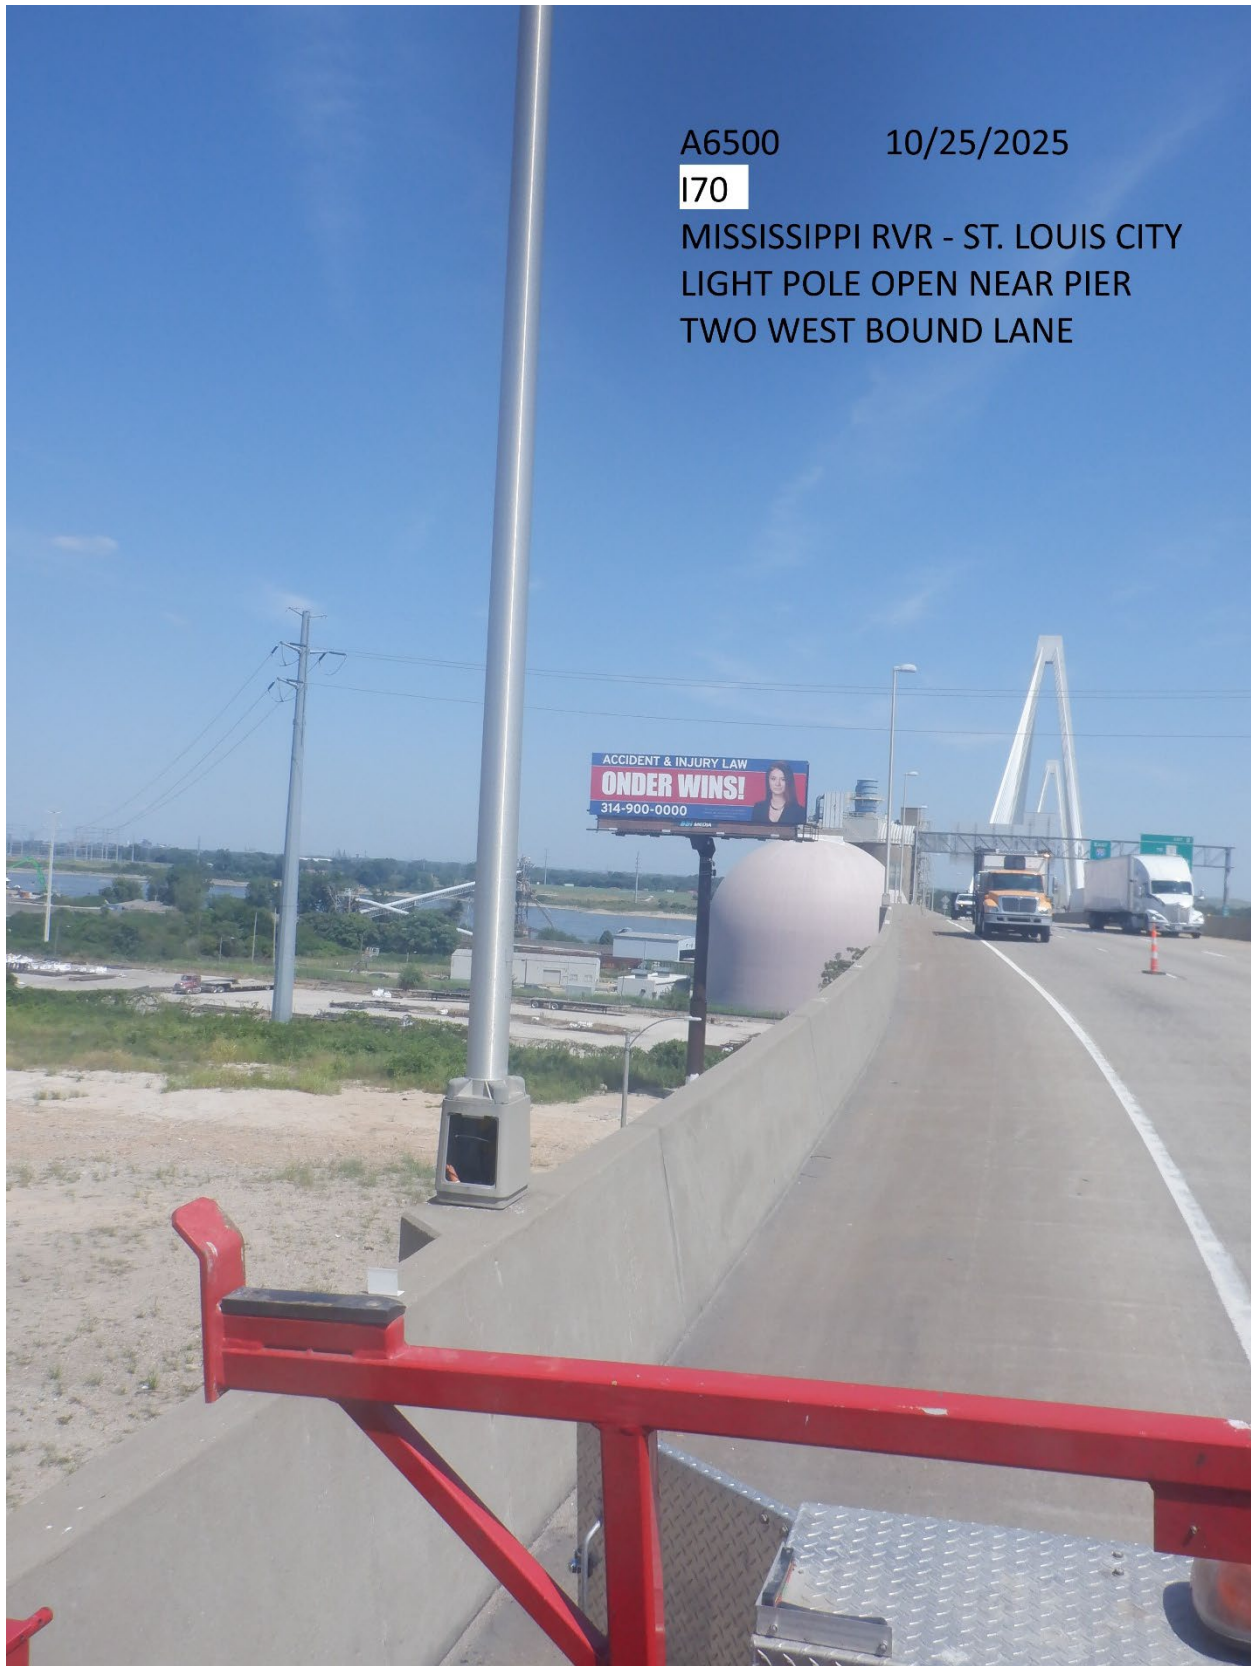
MISSISSIPPI RVR - ST. LOUIS CITY
LIGHT POLE OPEN NEAR PIER
TWO WEST BOUND LANE

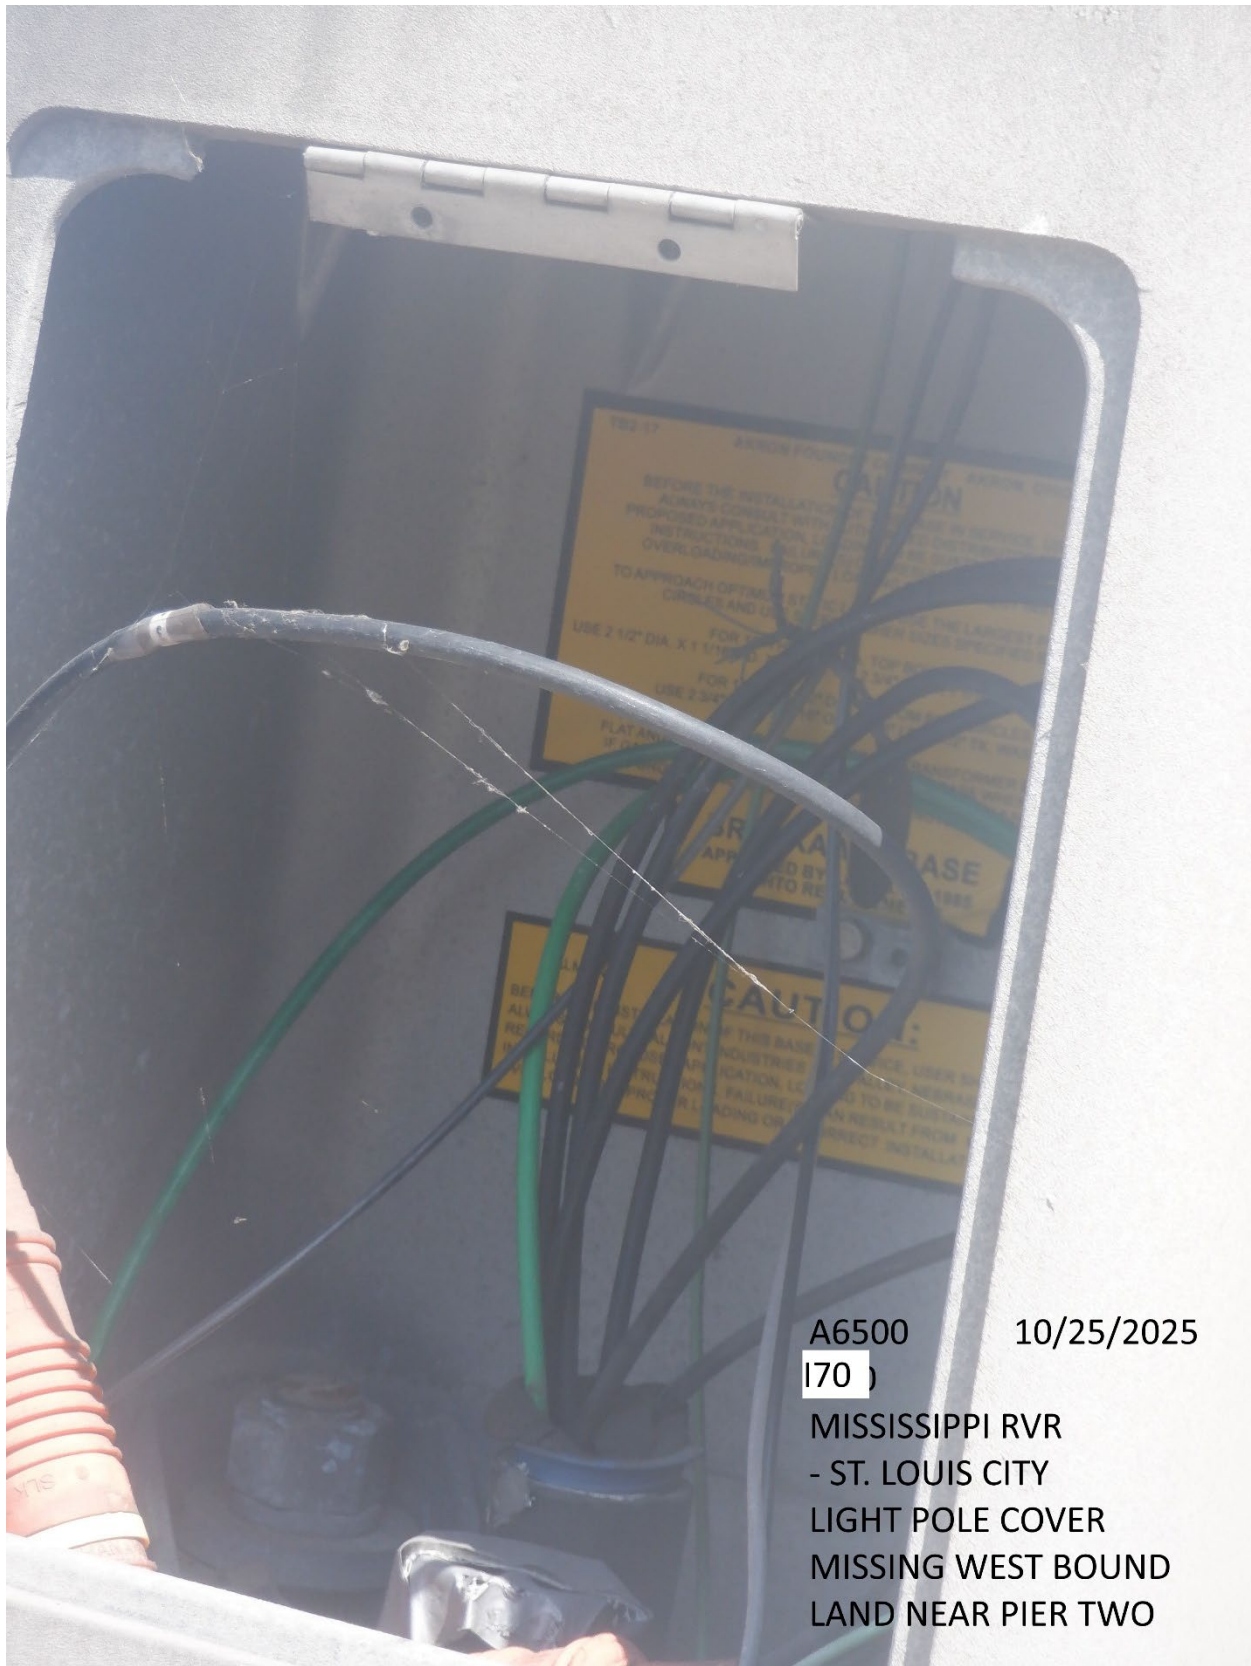
MISSISSIPPI RVR
- ST. LOUIS CITY
LIGHT POLE COVER
MISSING WEST BOUND
LAND NEAR PIER TWO

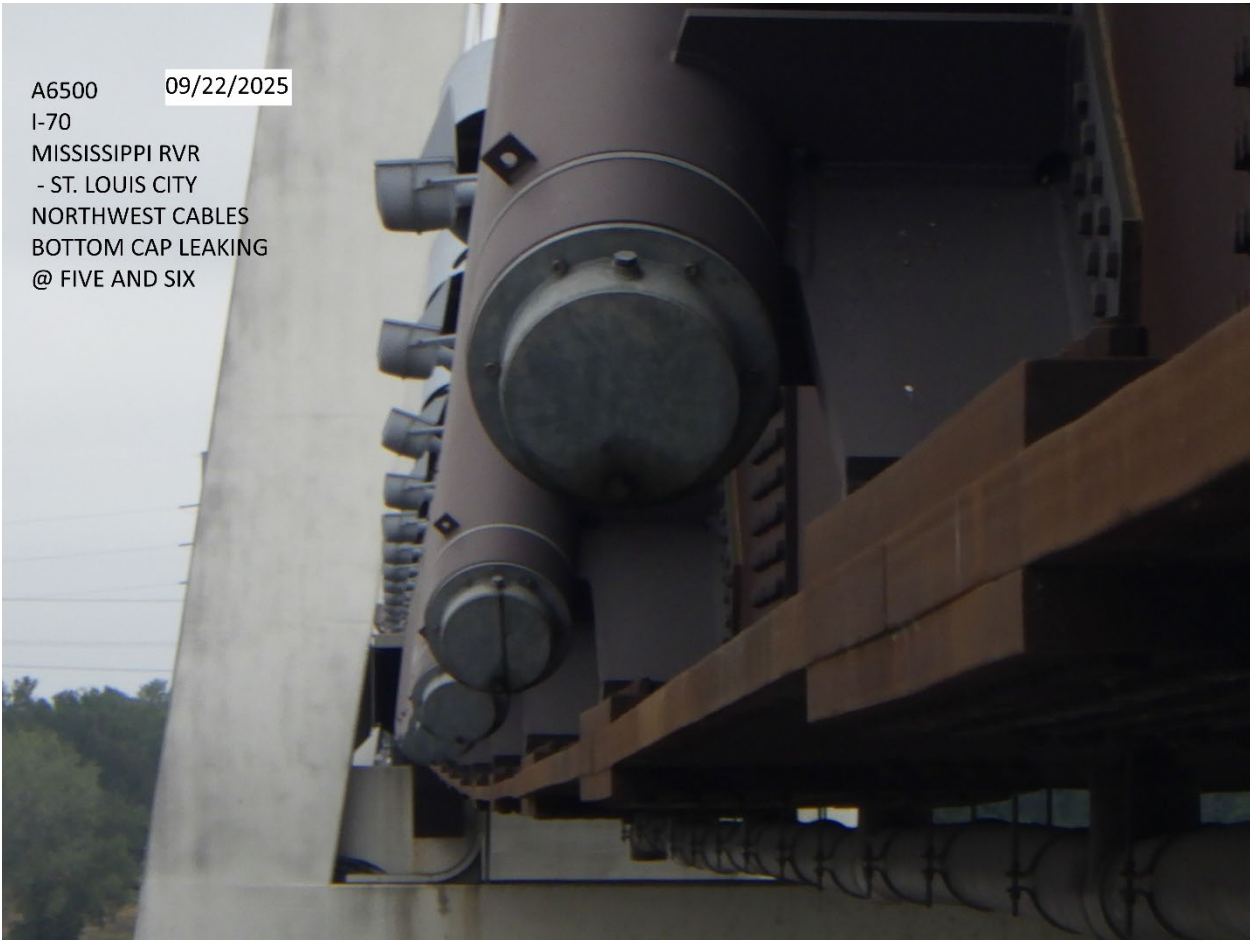
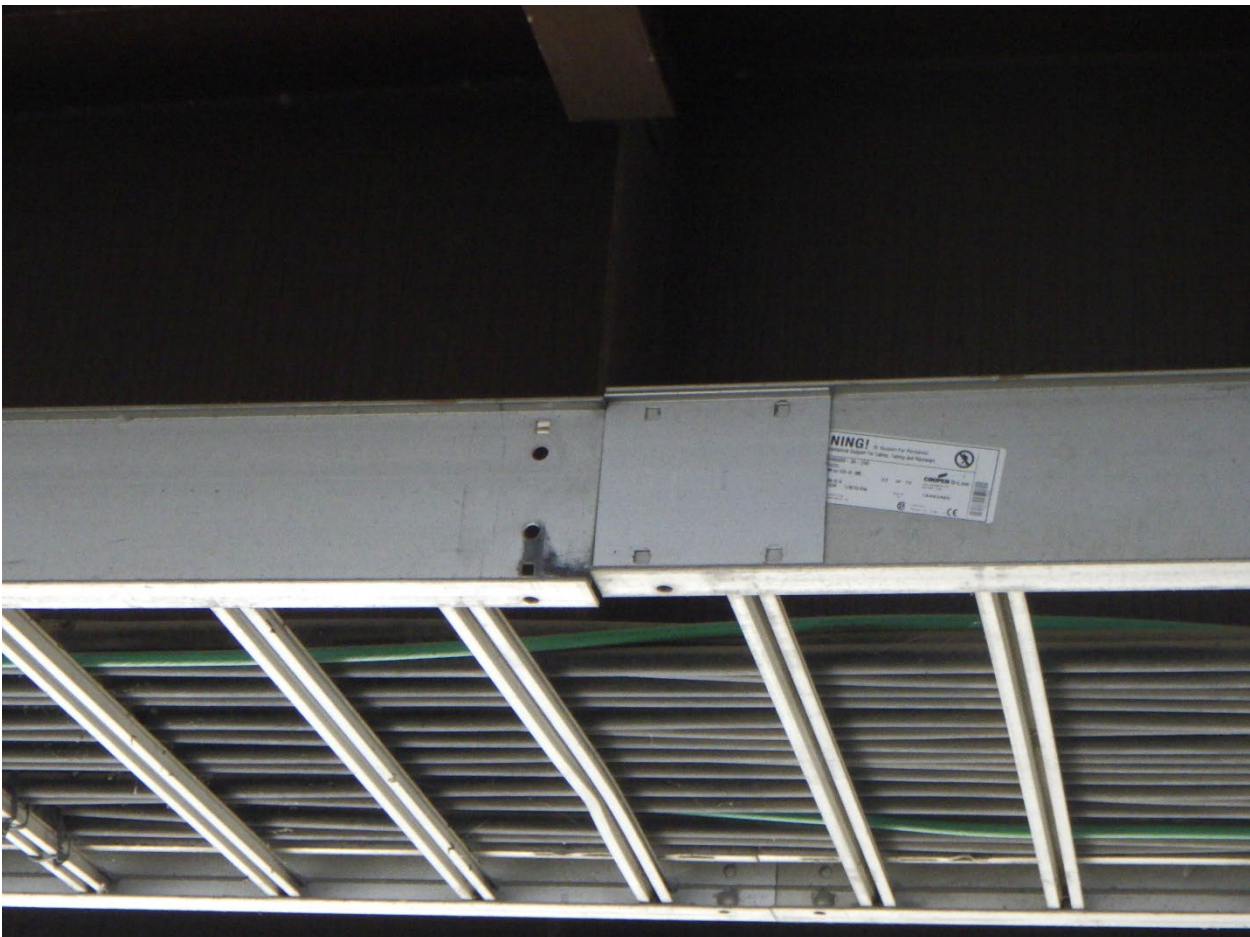
A6500 09/22/2025
I-70
MISSISSIPPI RVR
- ST. LOUIS CITY
NORTHWEST CABLES
BOTTOM CAP LEAKING
@ FIVE AND SIX
