L0962 I 70 Cooper Co.  
Joint at L8, span 13  
Eastbound lane failing  
9-24-13

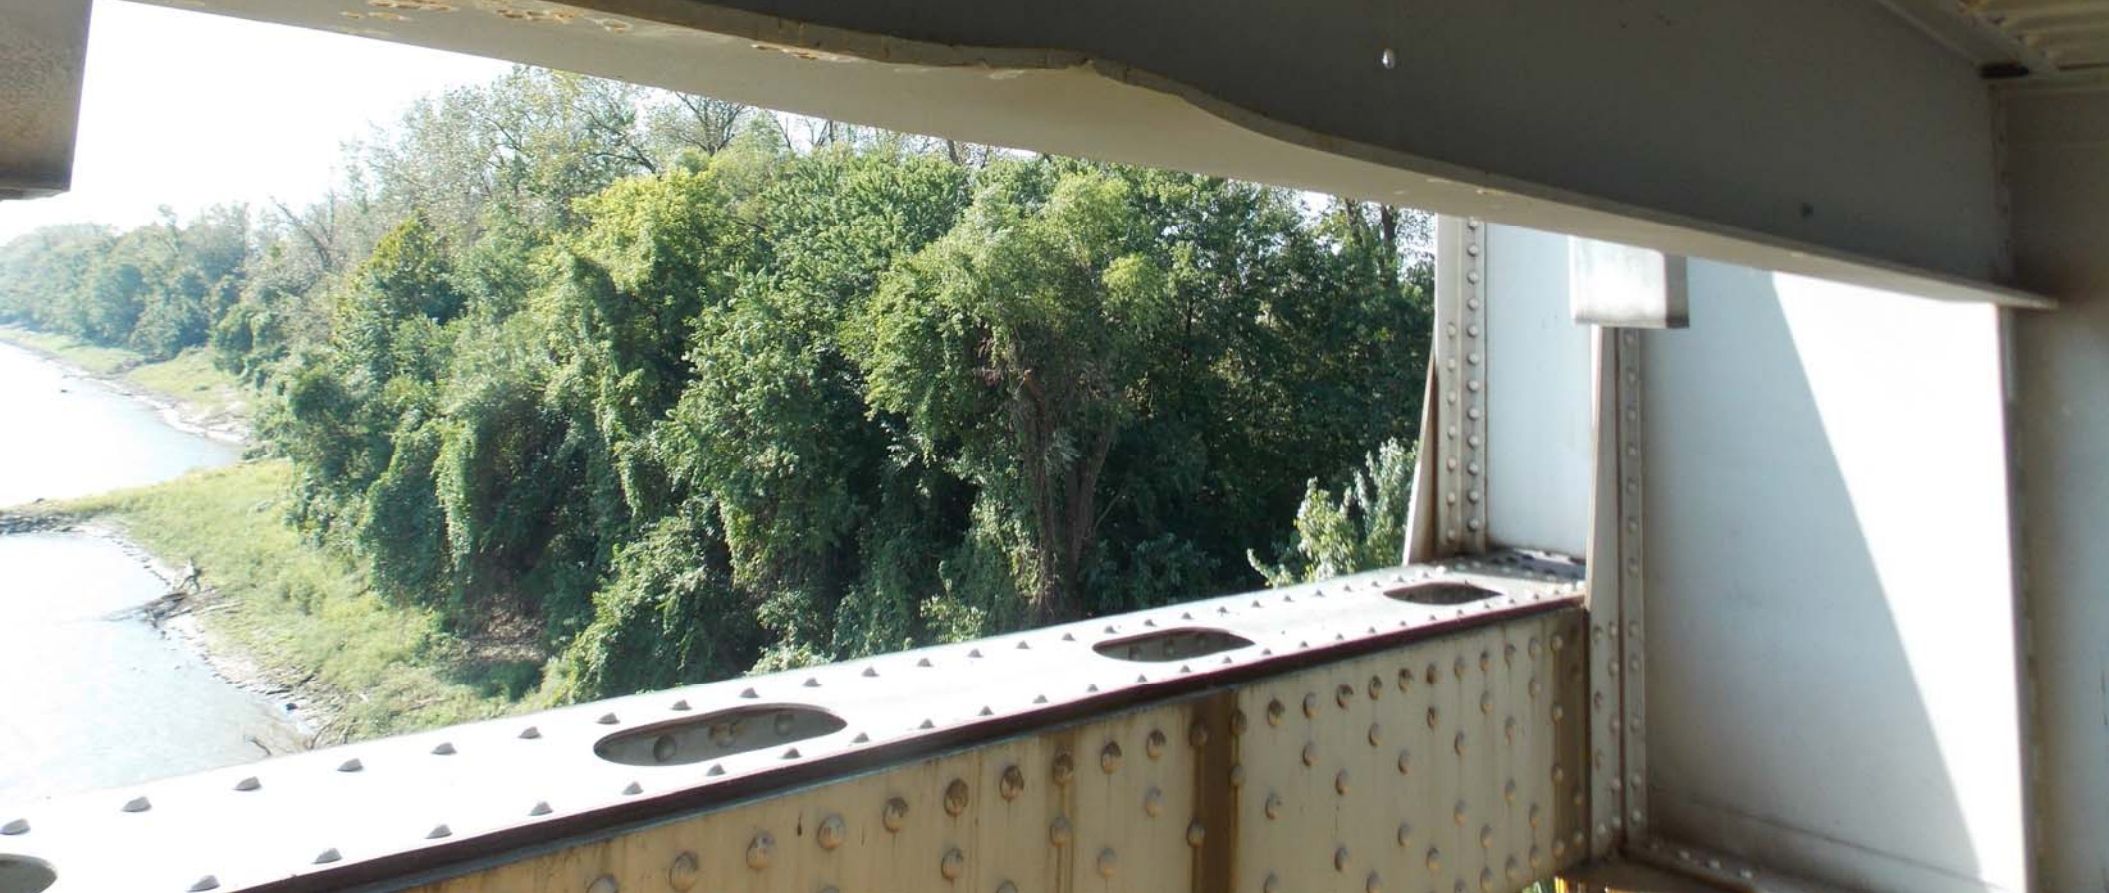
**L0962 I 70 Cooper Co.  
L7, L8 stringer 9 bent  
near center at bottom flange  
9-24-13**

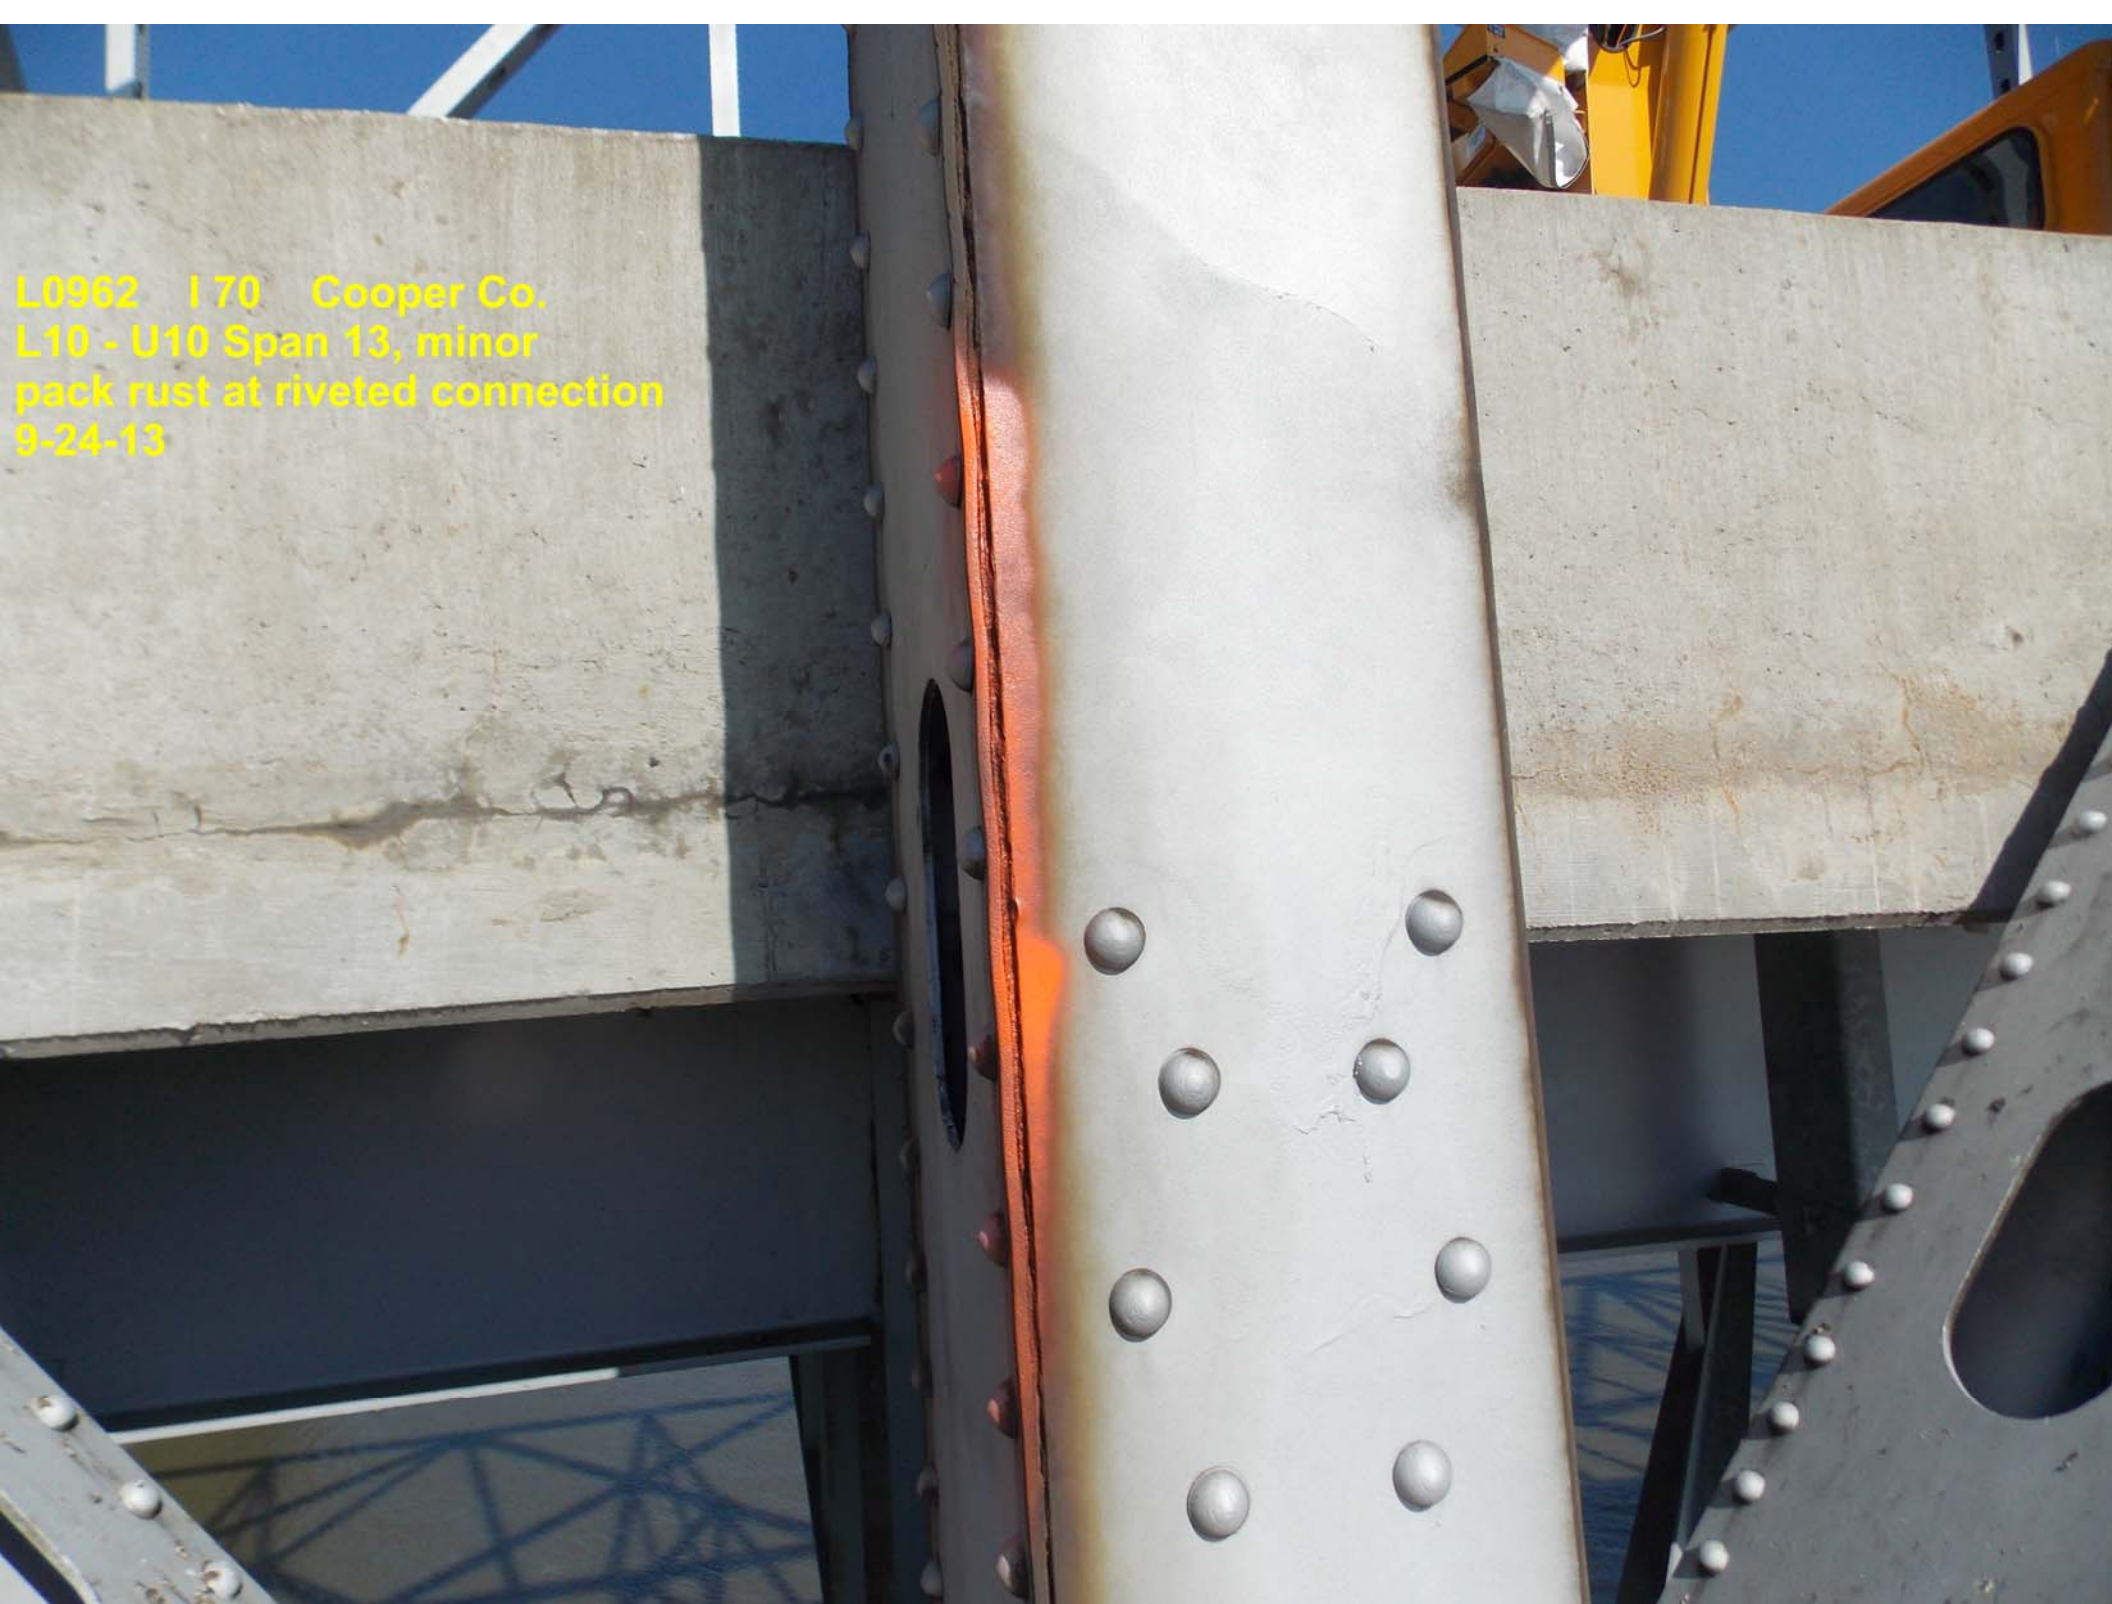
L0962 I 70 Cooper Co.  
L10 - U10 Span 13, minor  
pack rust at riveted connection  
9-24-13

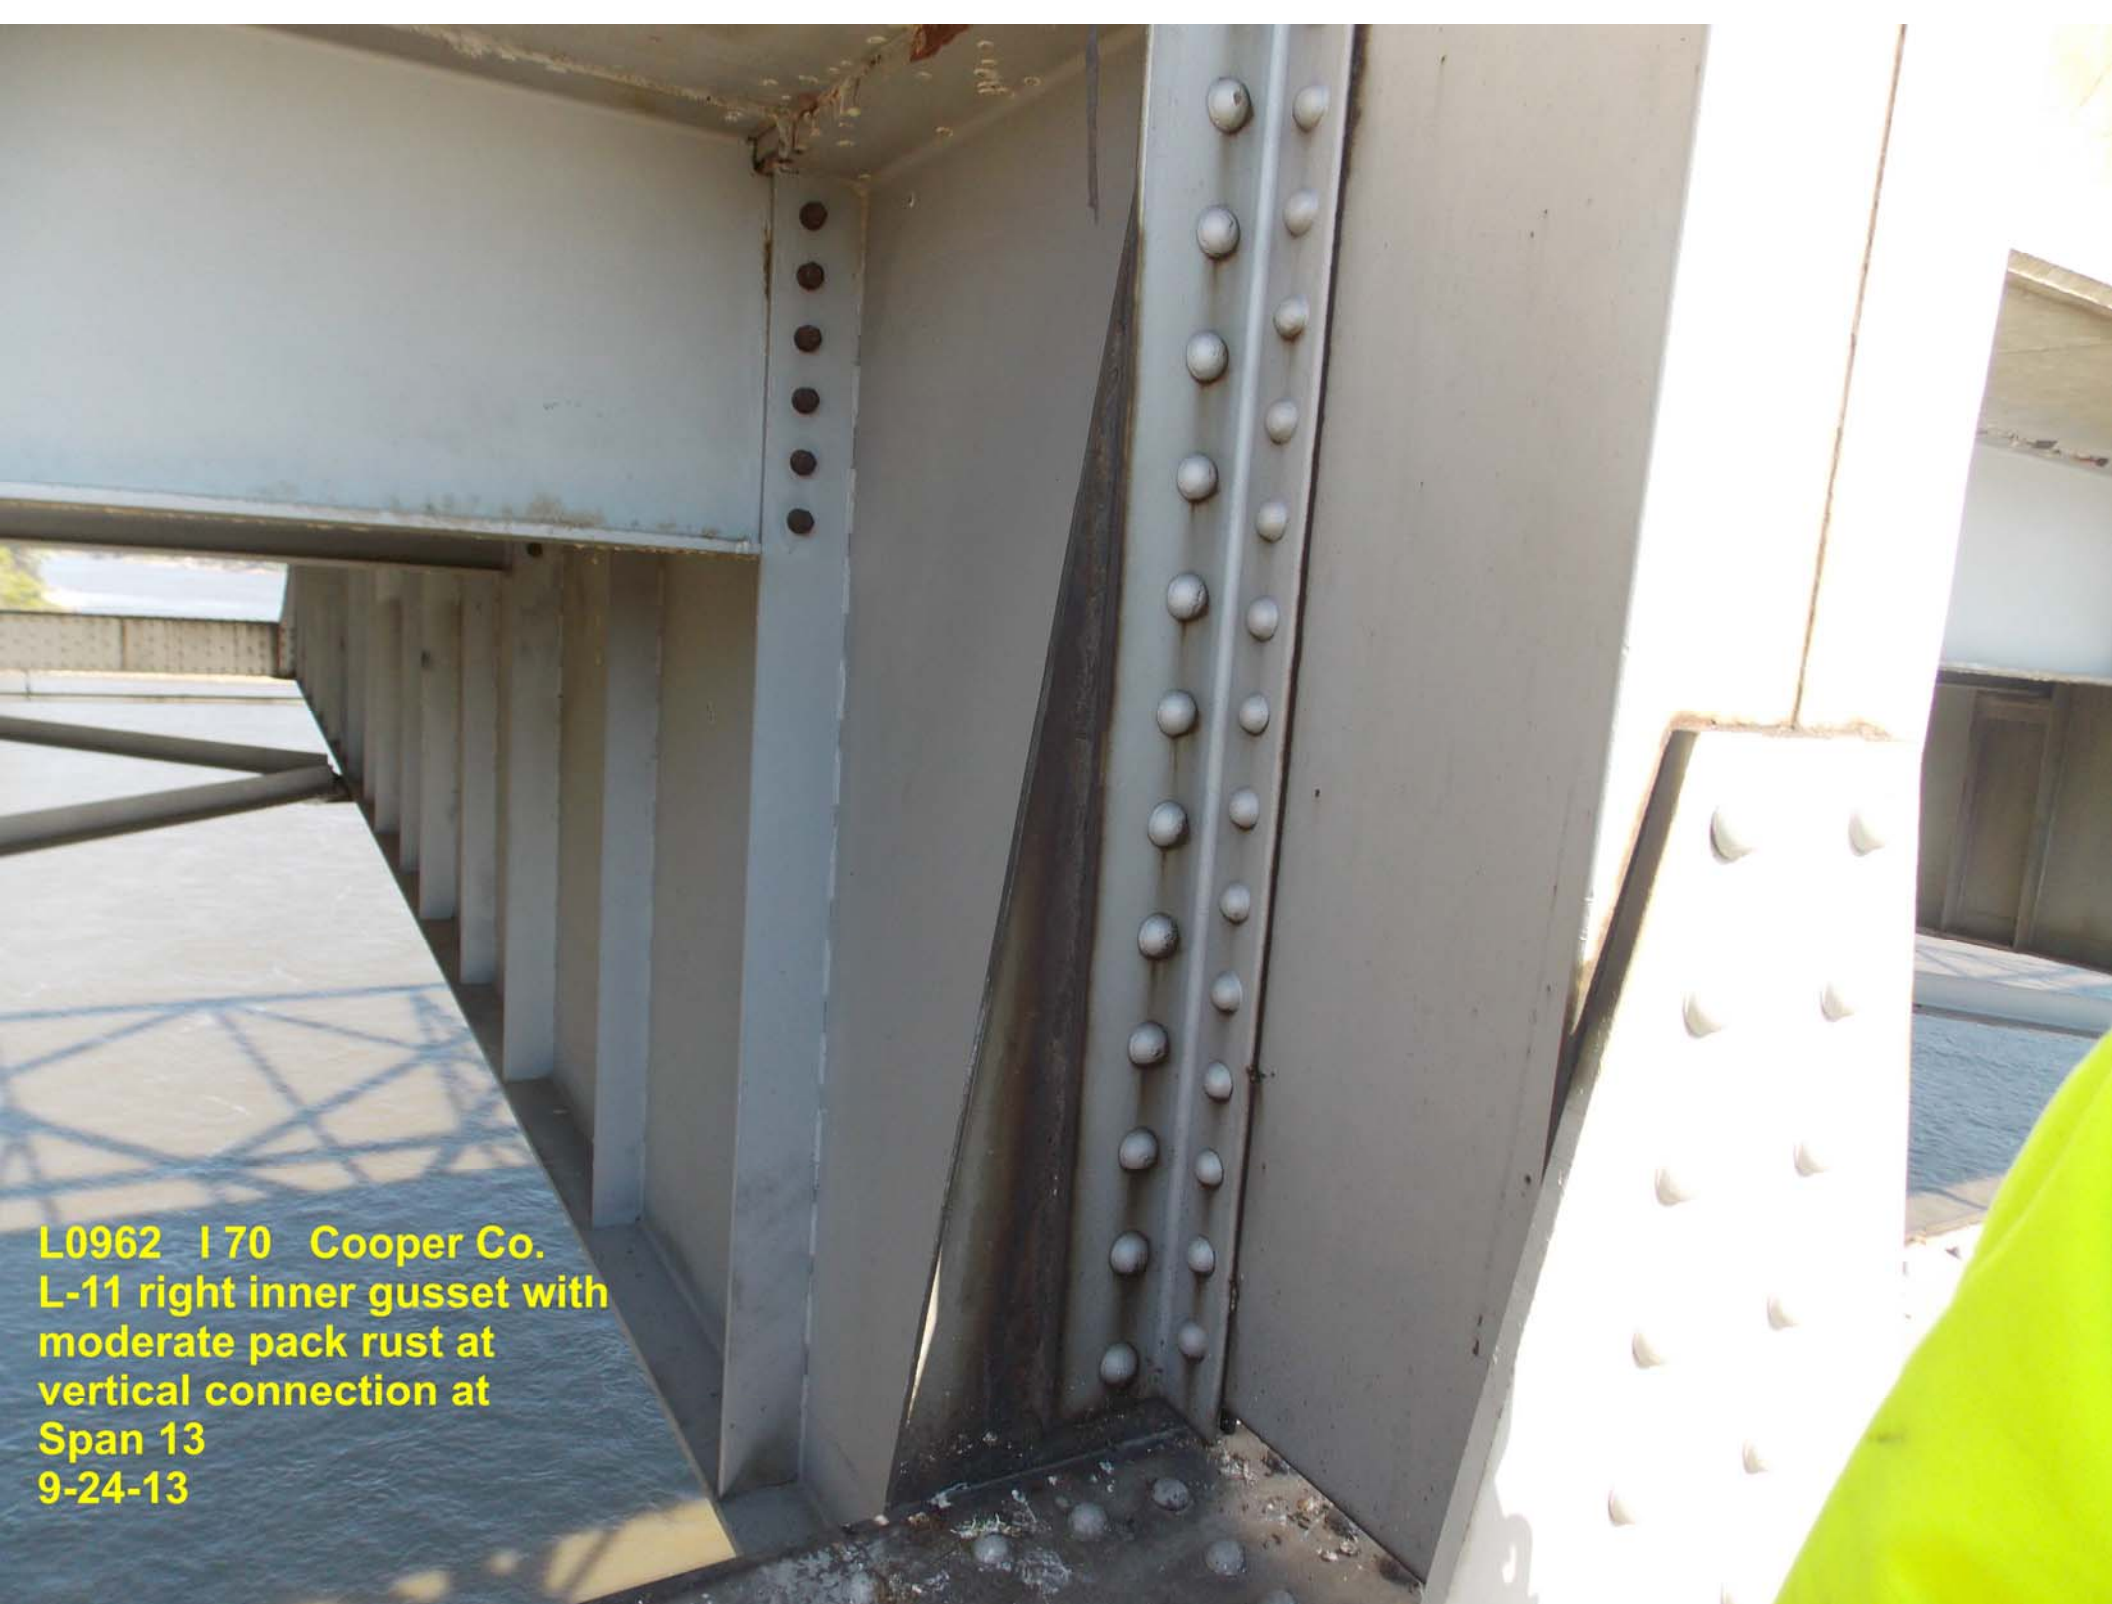
L0962 I 70 Cooper Co.  
L-11 right inner gusset with  
moderate pack rust at  
vertical connection at  
Span 13  
9-24-13

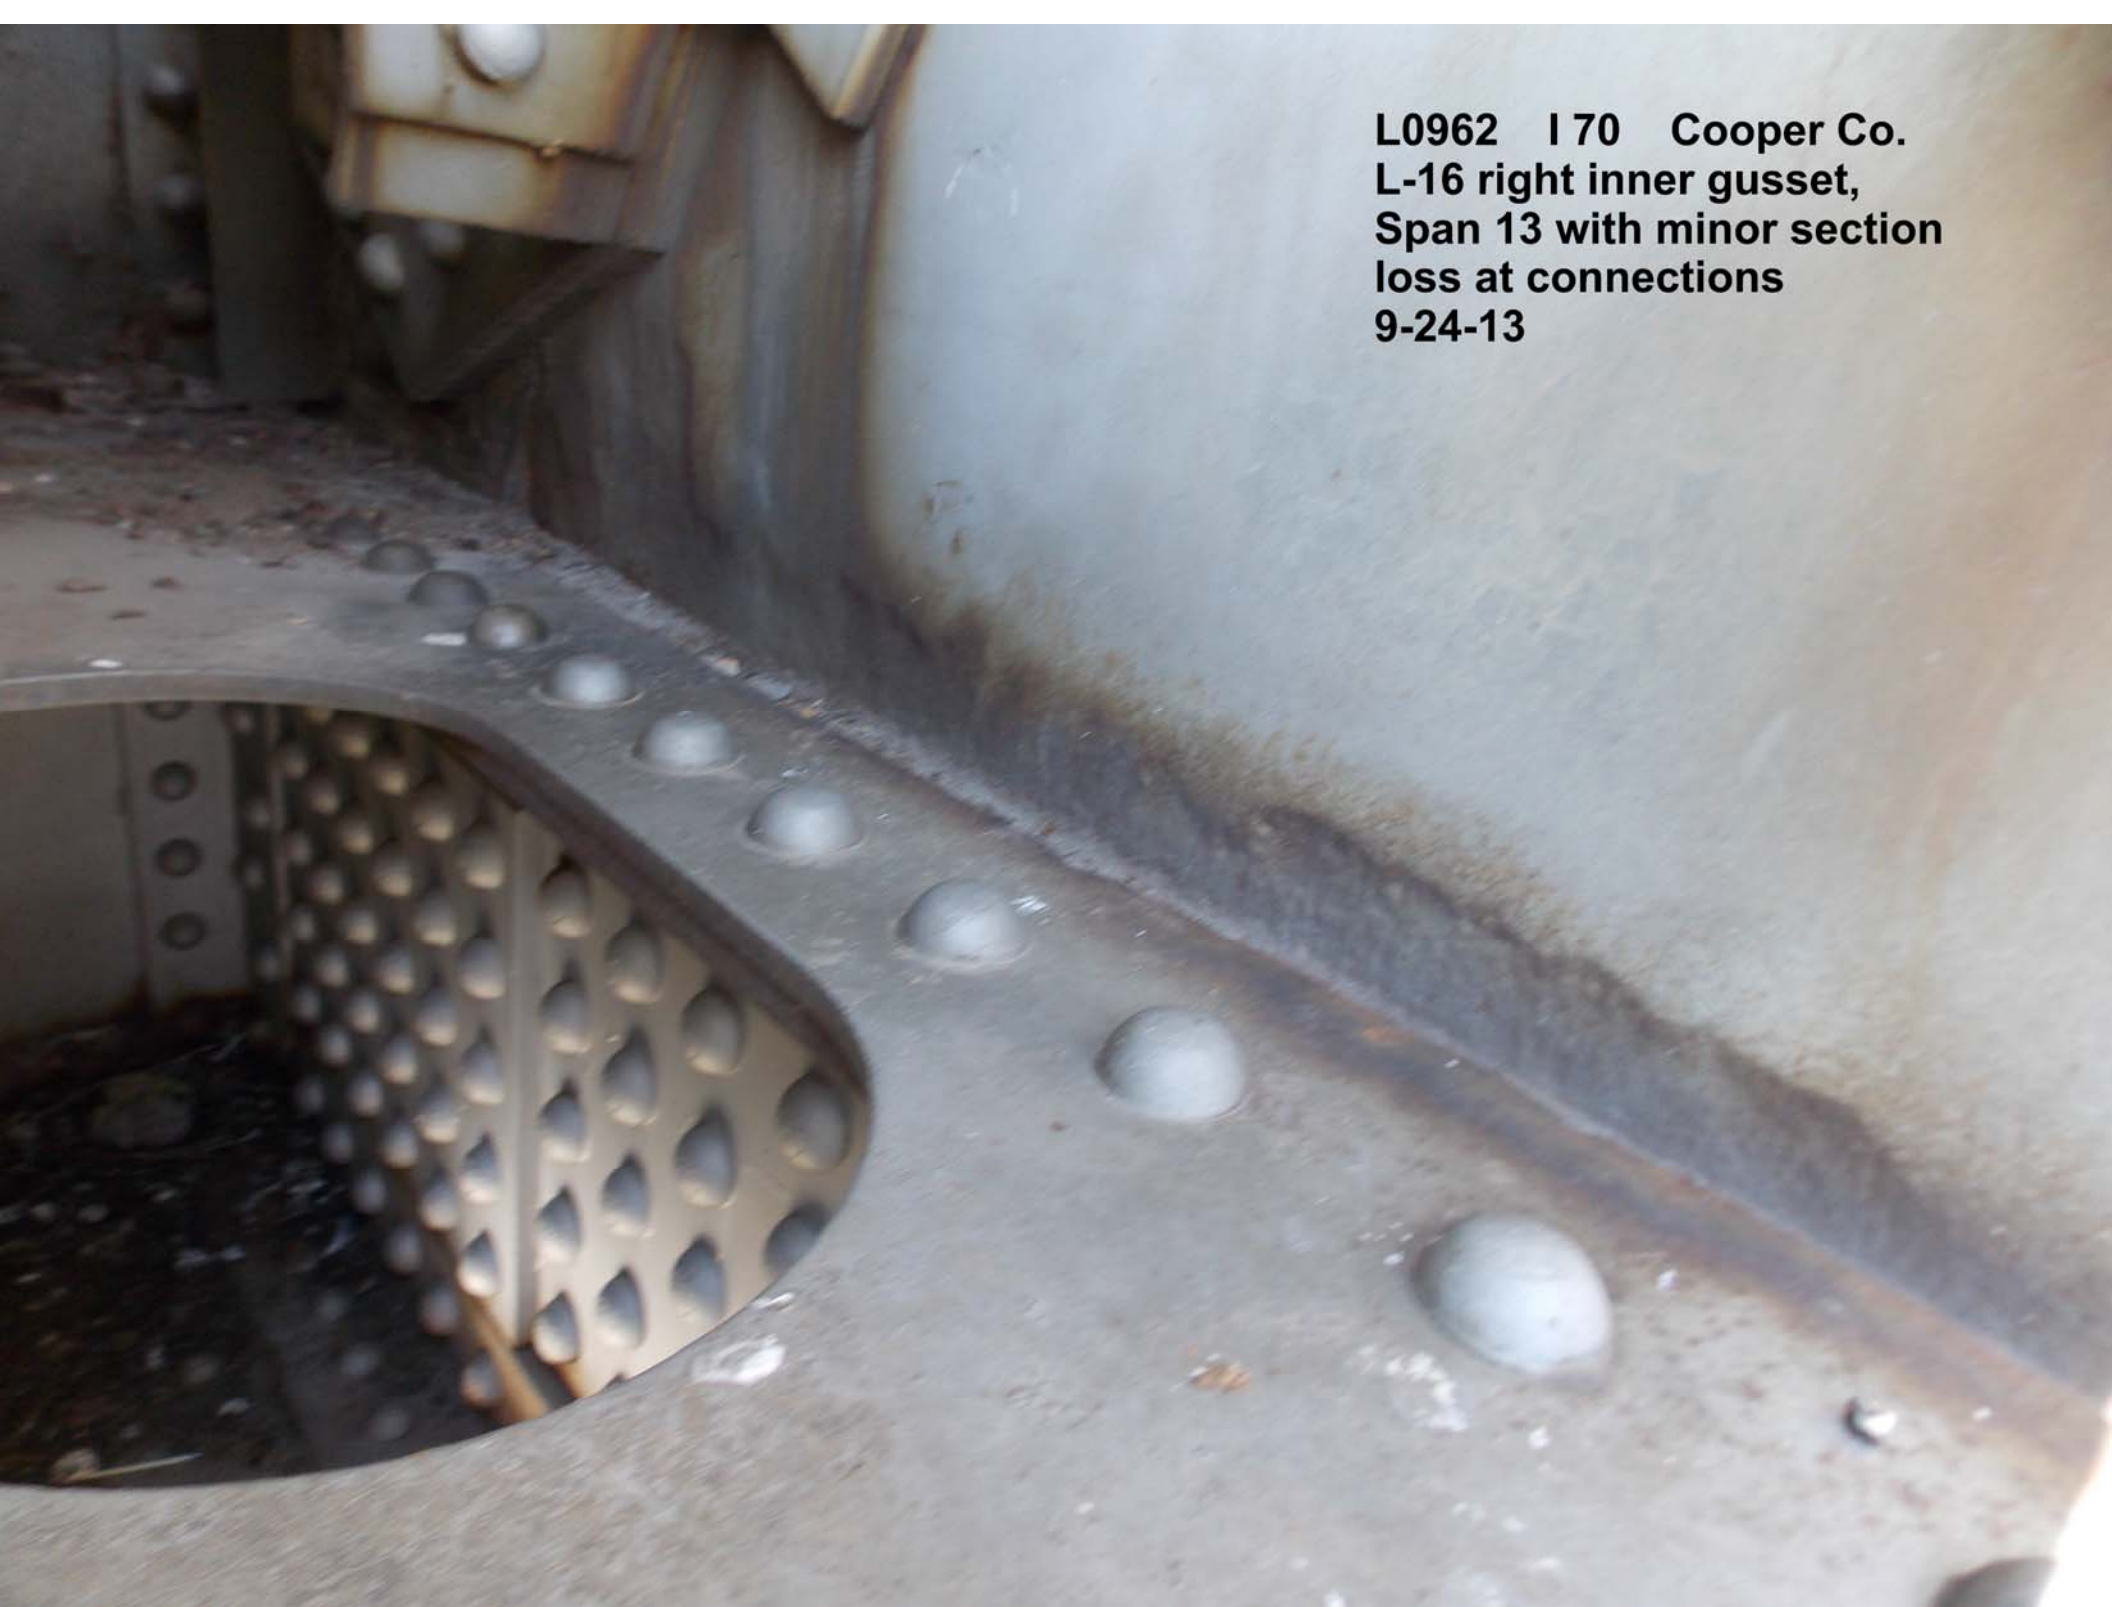
**L0962 I 70 Cooper Co.  
L-16 right inner gusset,  
Span 13 with minor section  
loss at connections  
9-24-13**

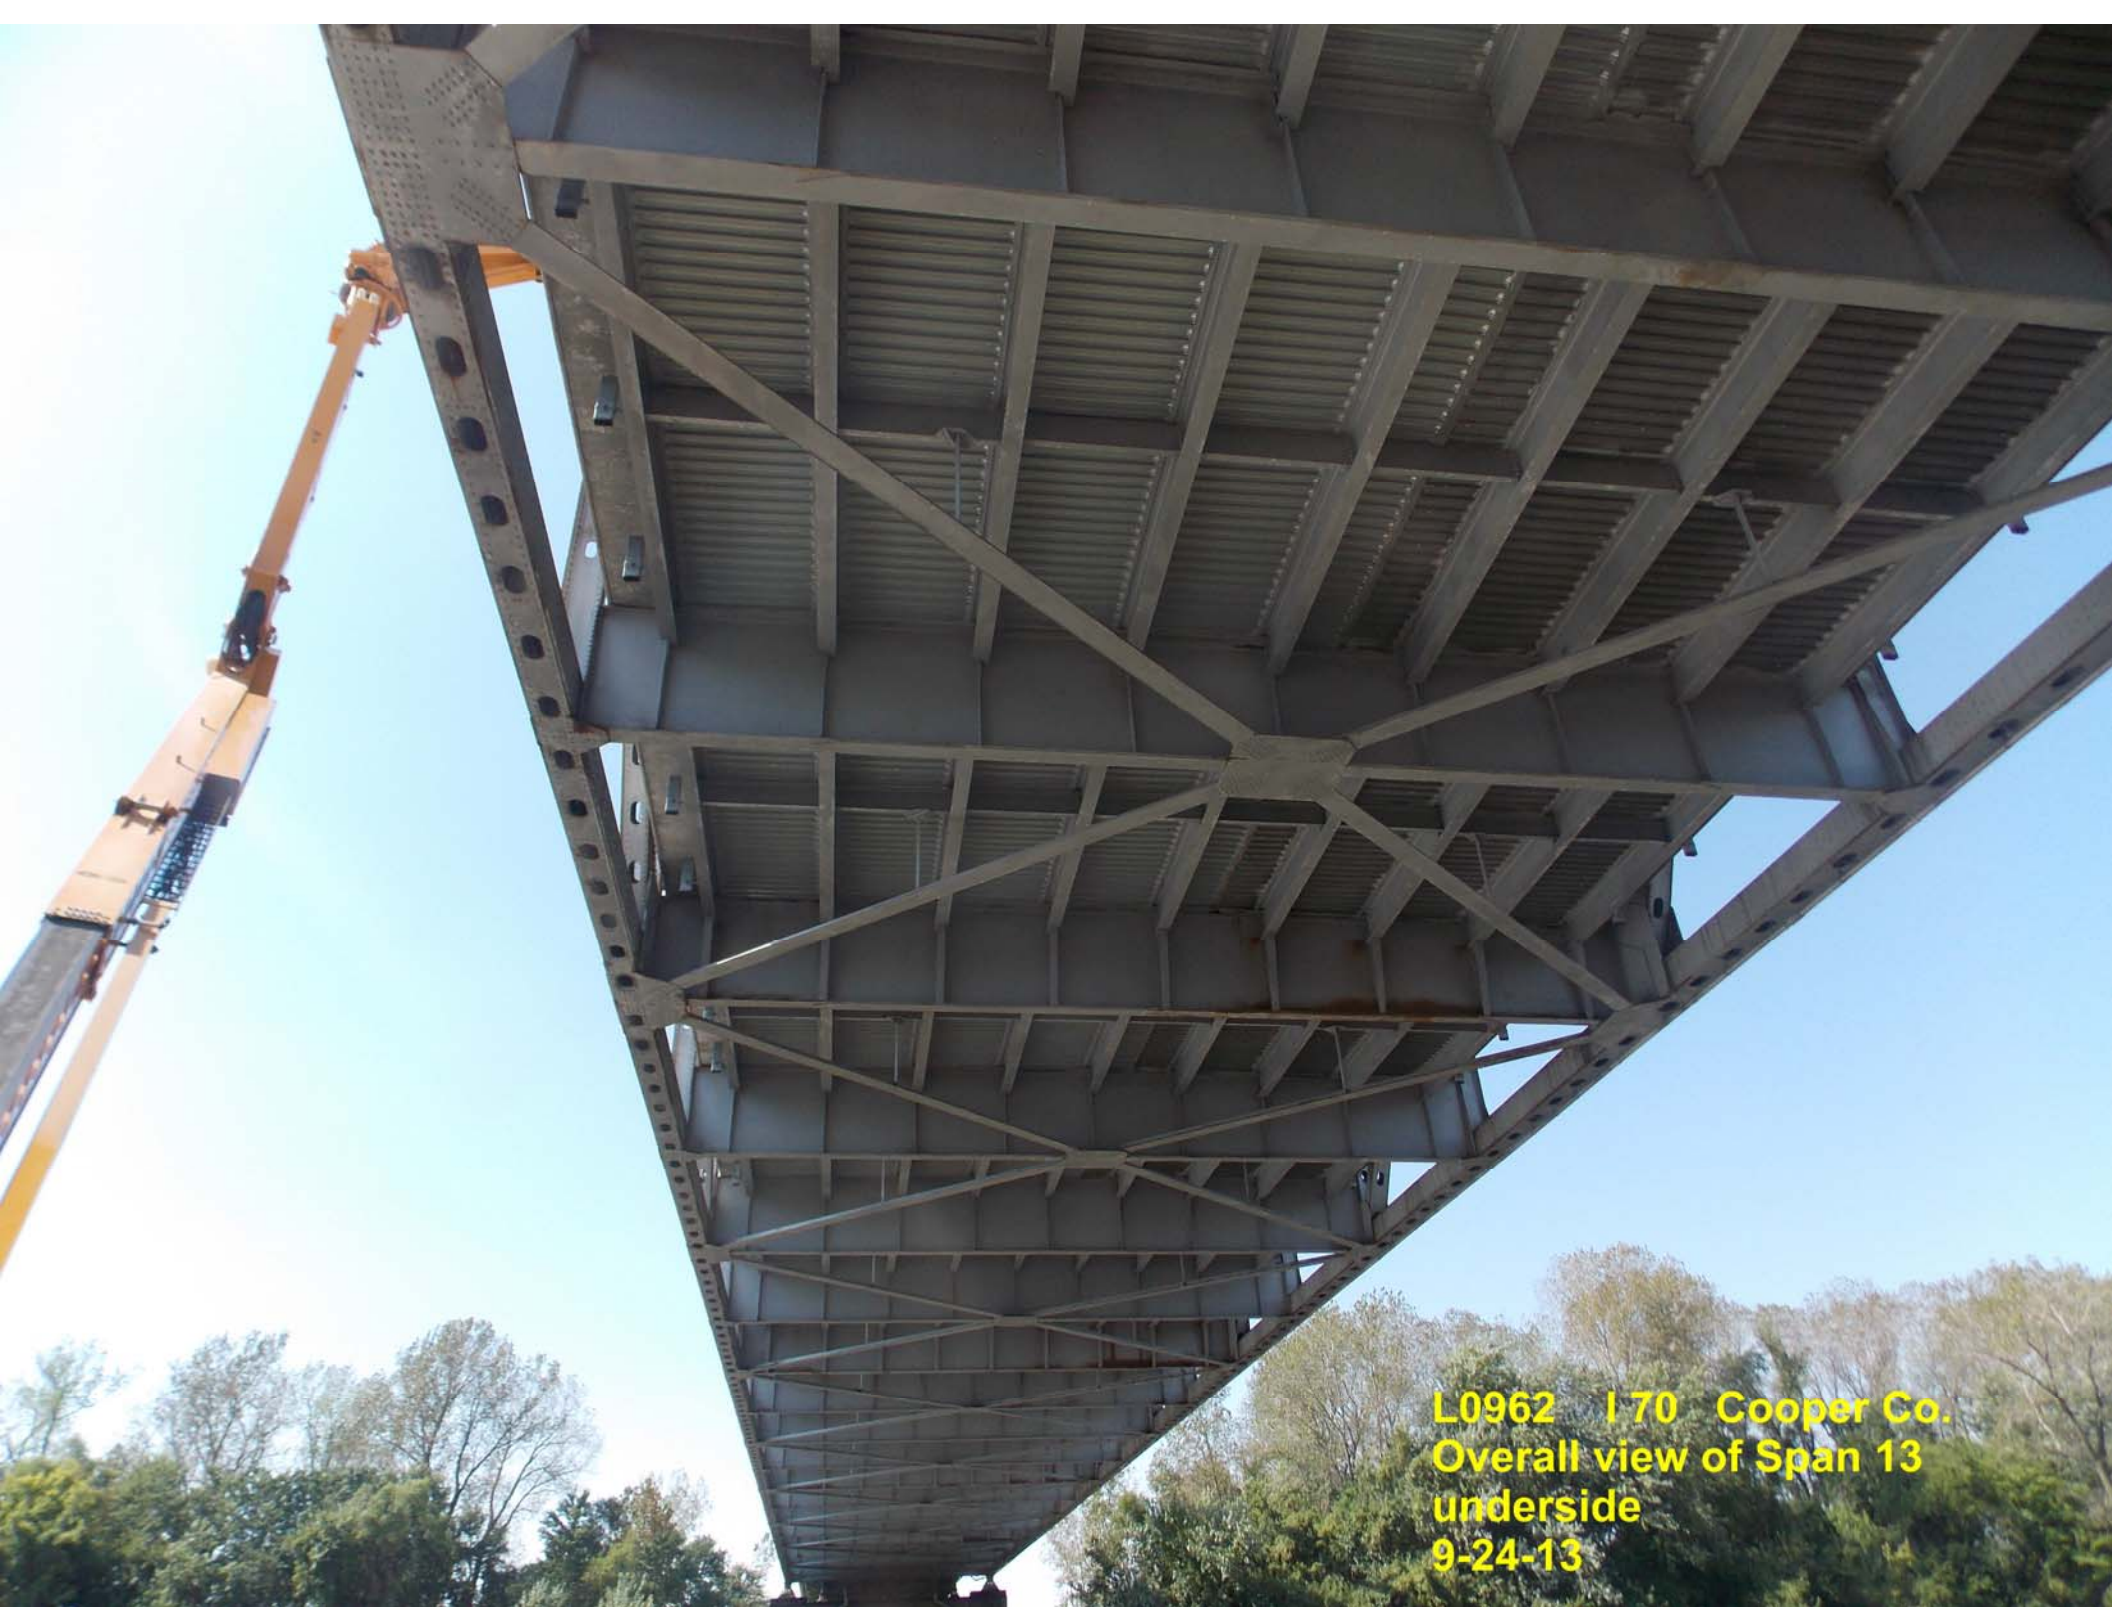
L0962 I 70 Cooper Co.  
Overall view of Span 13  
underside  
9-24-13

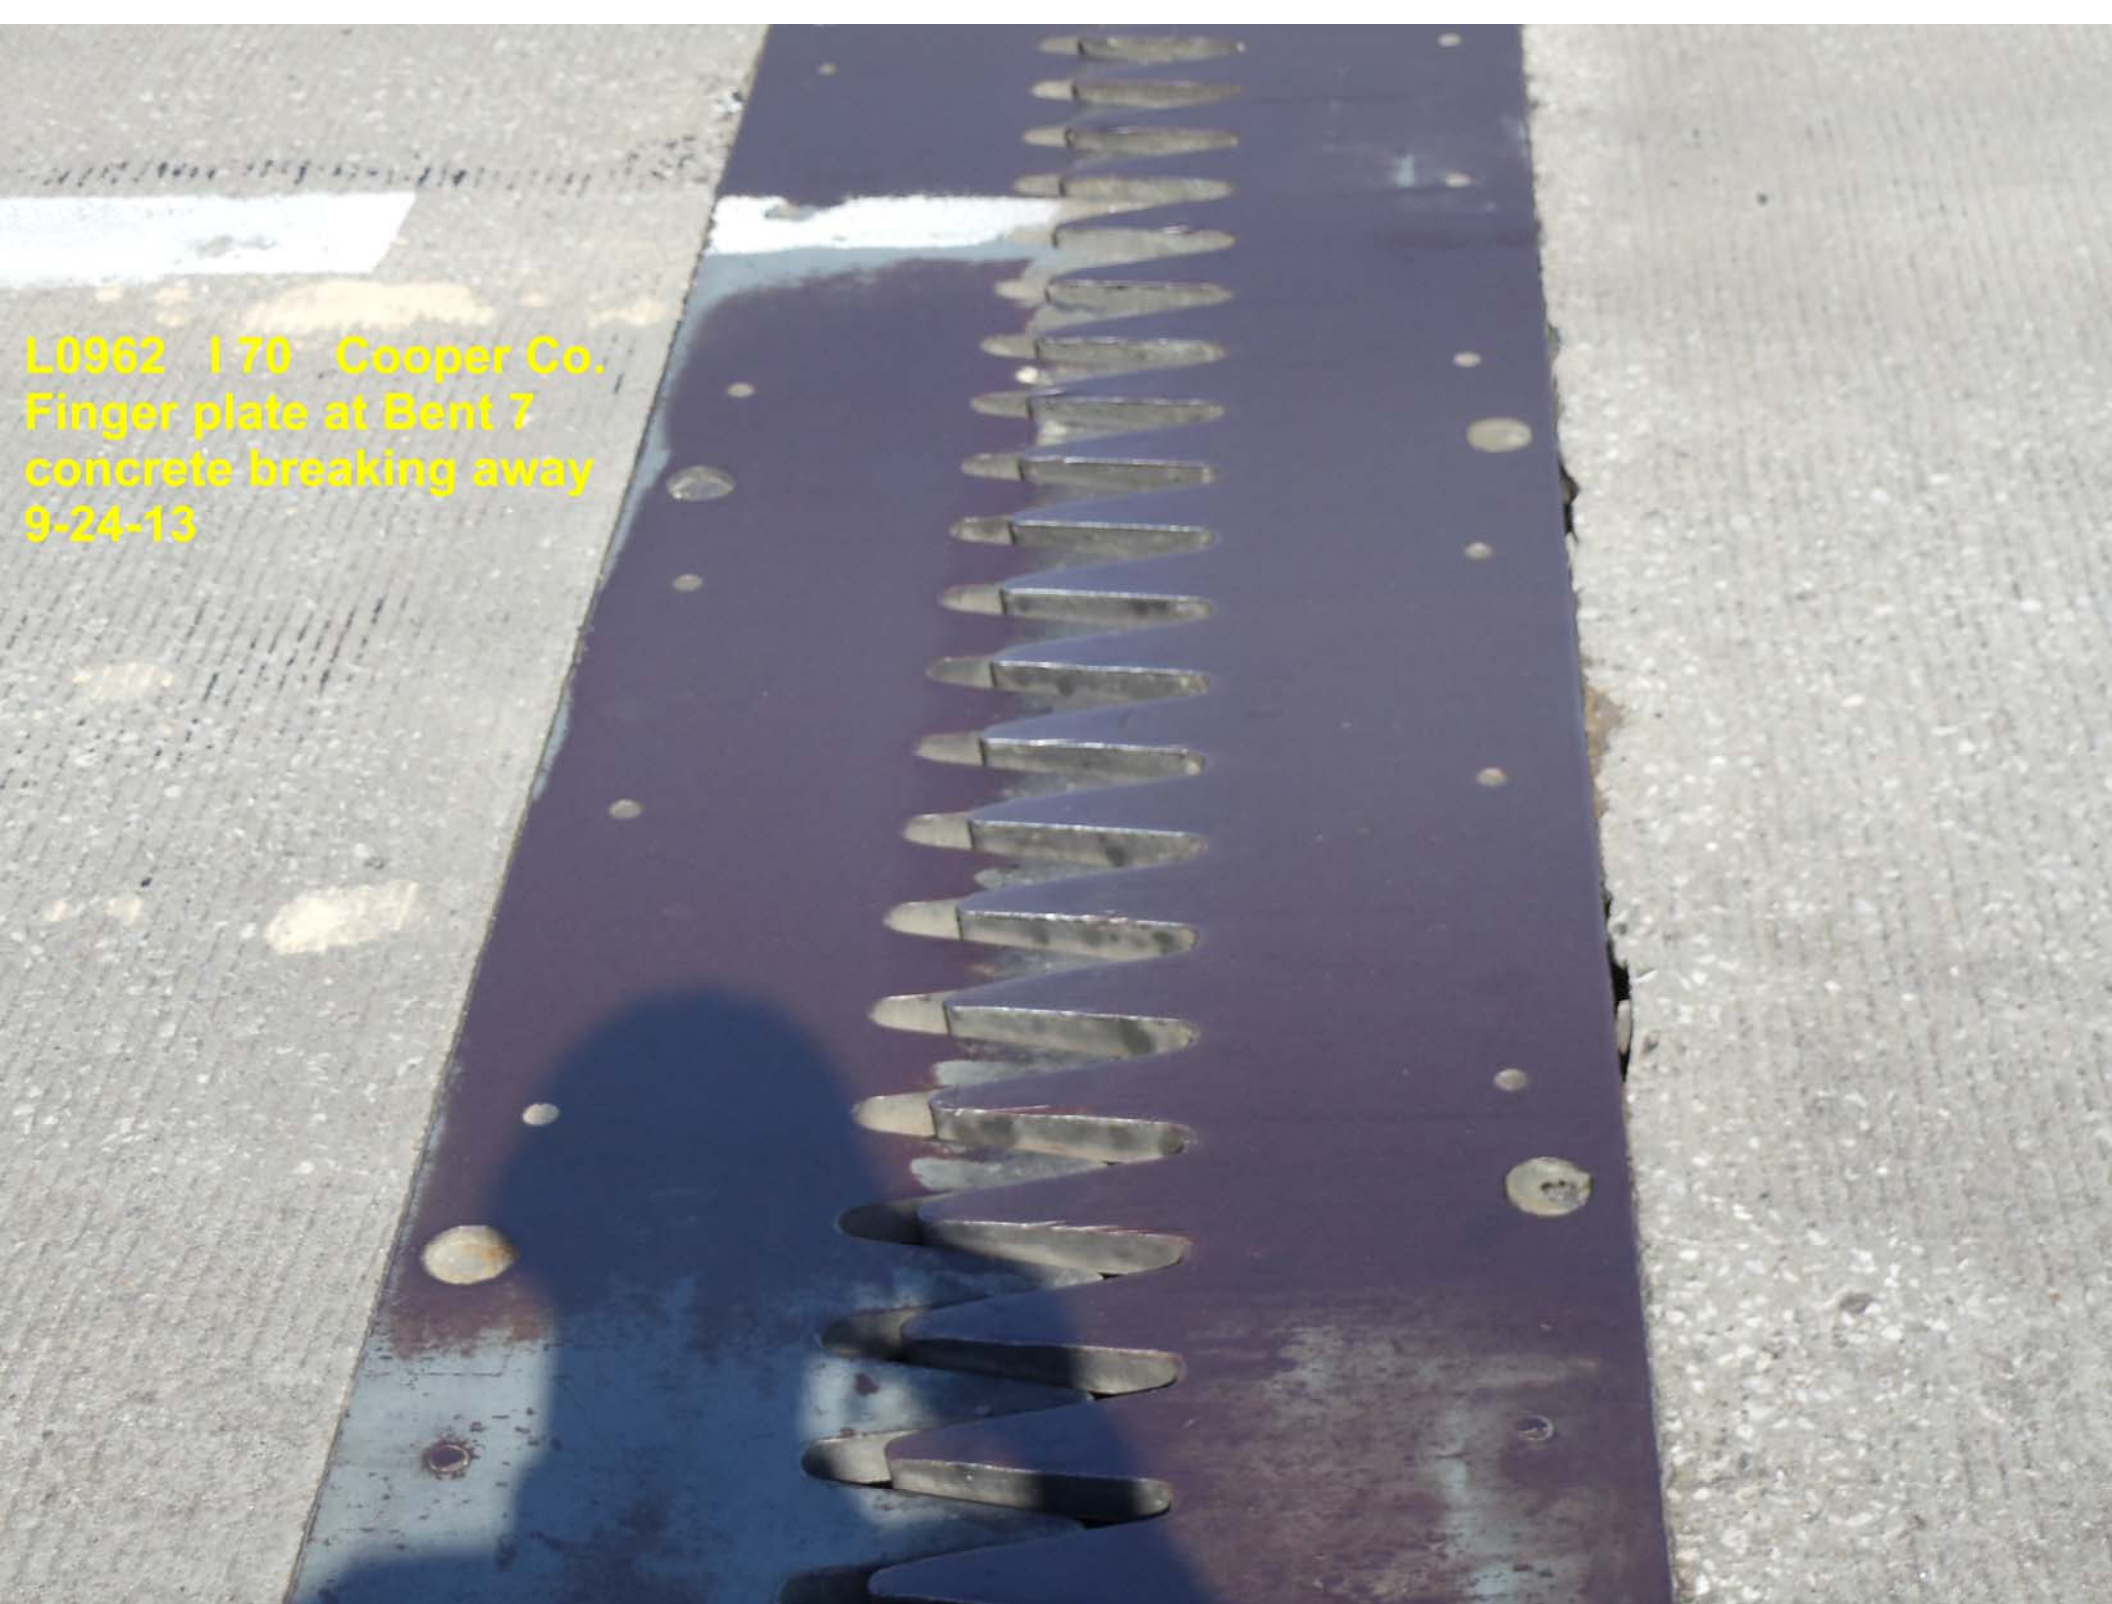
L0962 170 Cooper Co.  
Finger plate at Bent 7  
concrete breaking away  
9-24-13

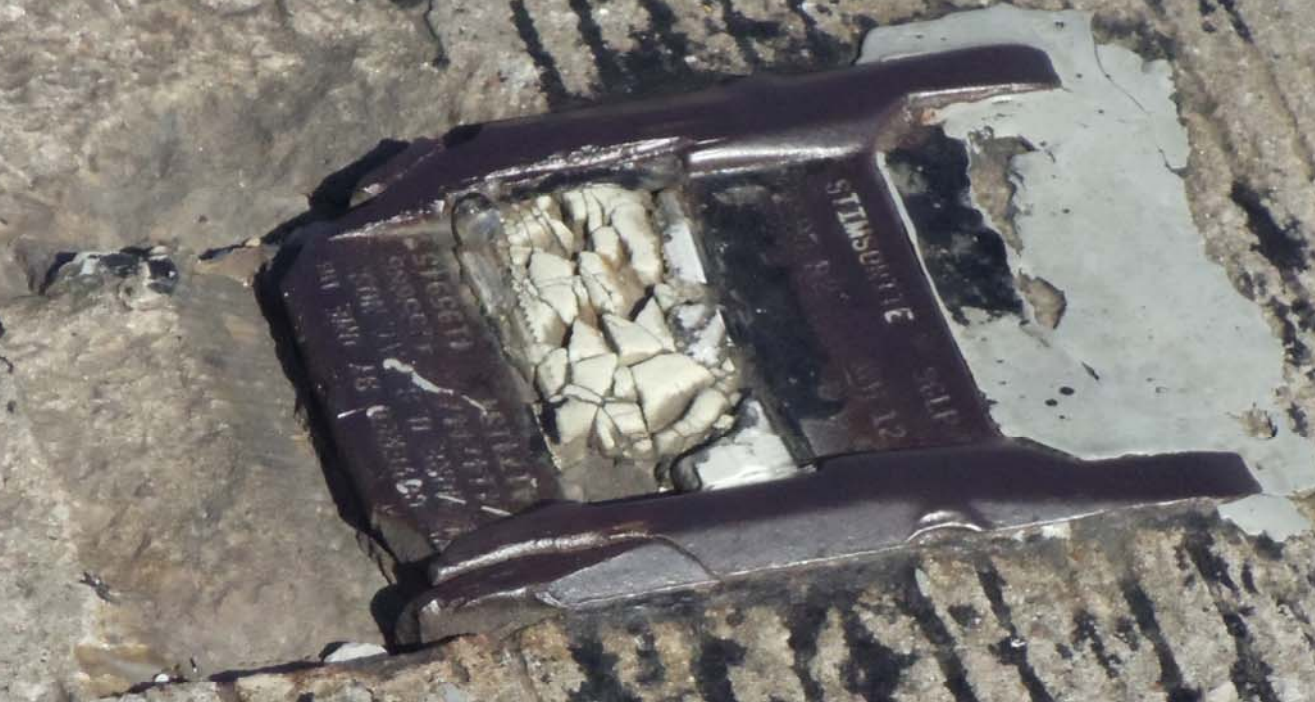
L0962 I 70 Cooper Co.  
Damage RPM  
9-24-13

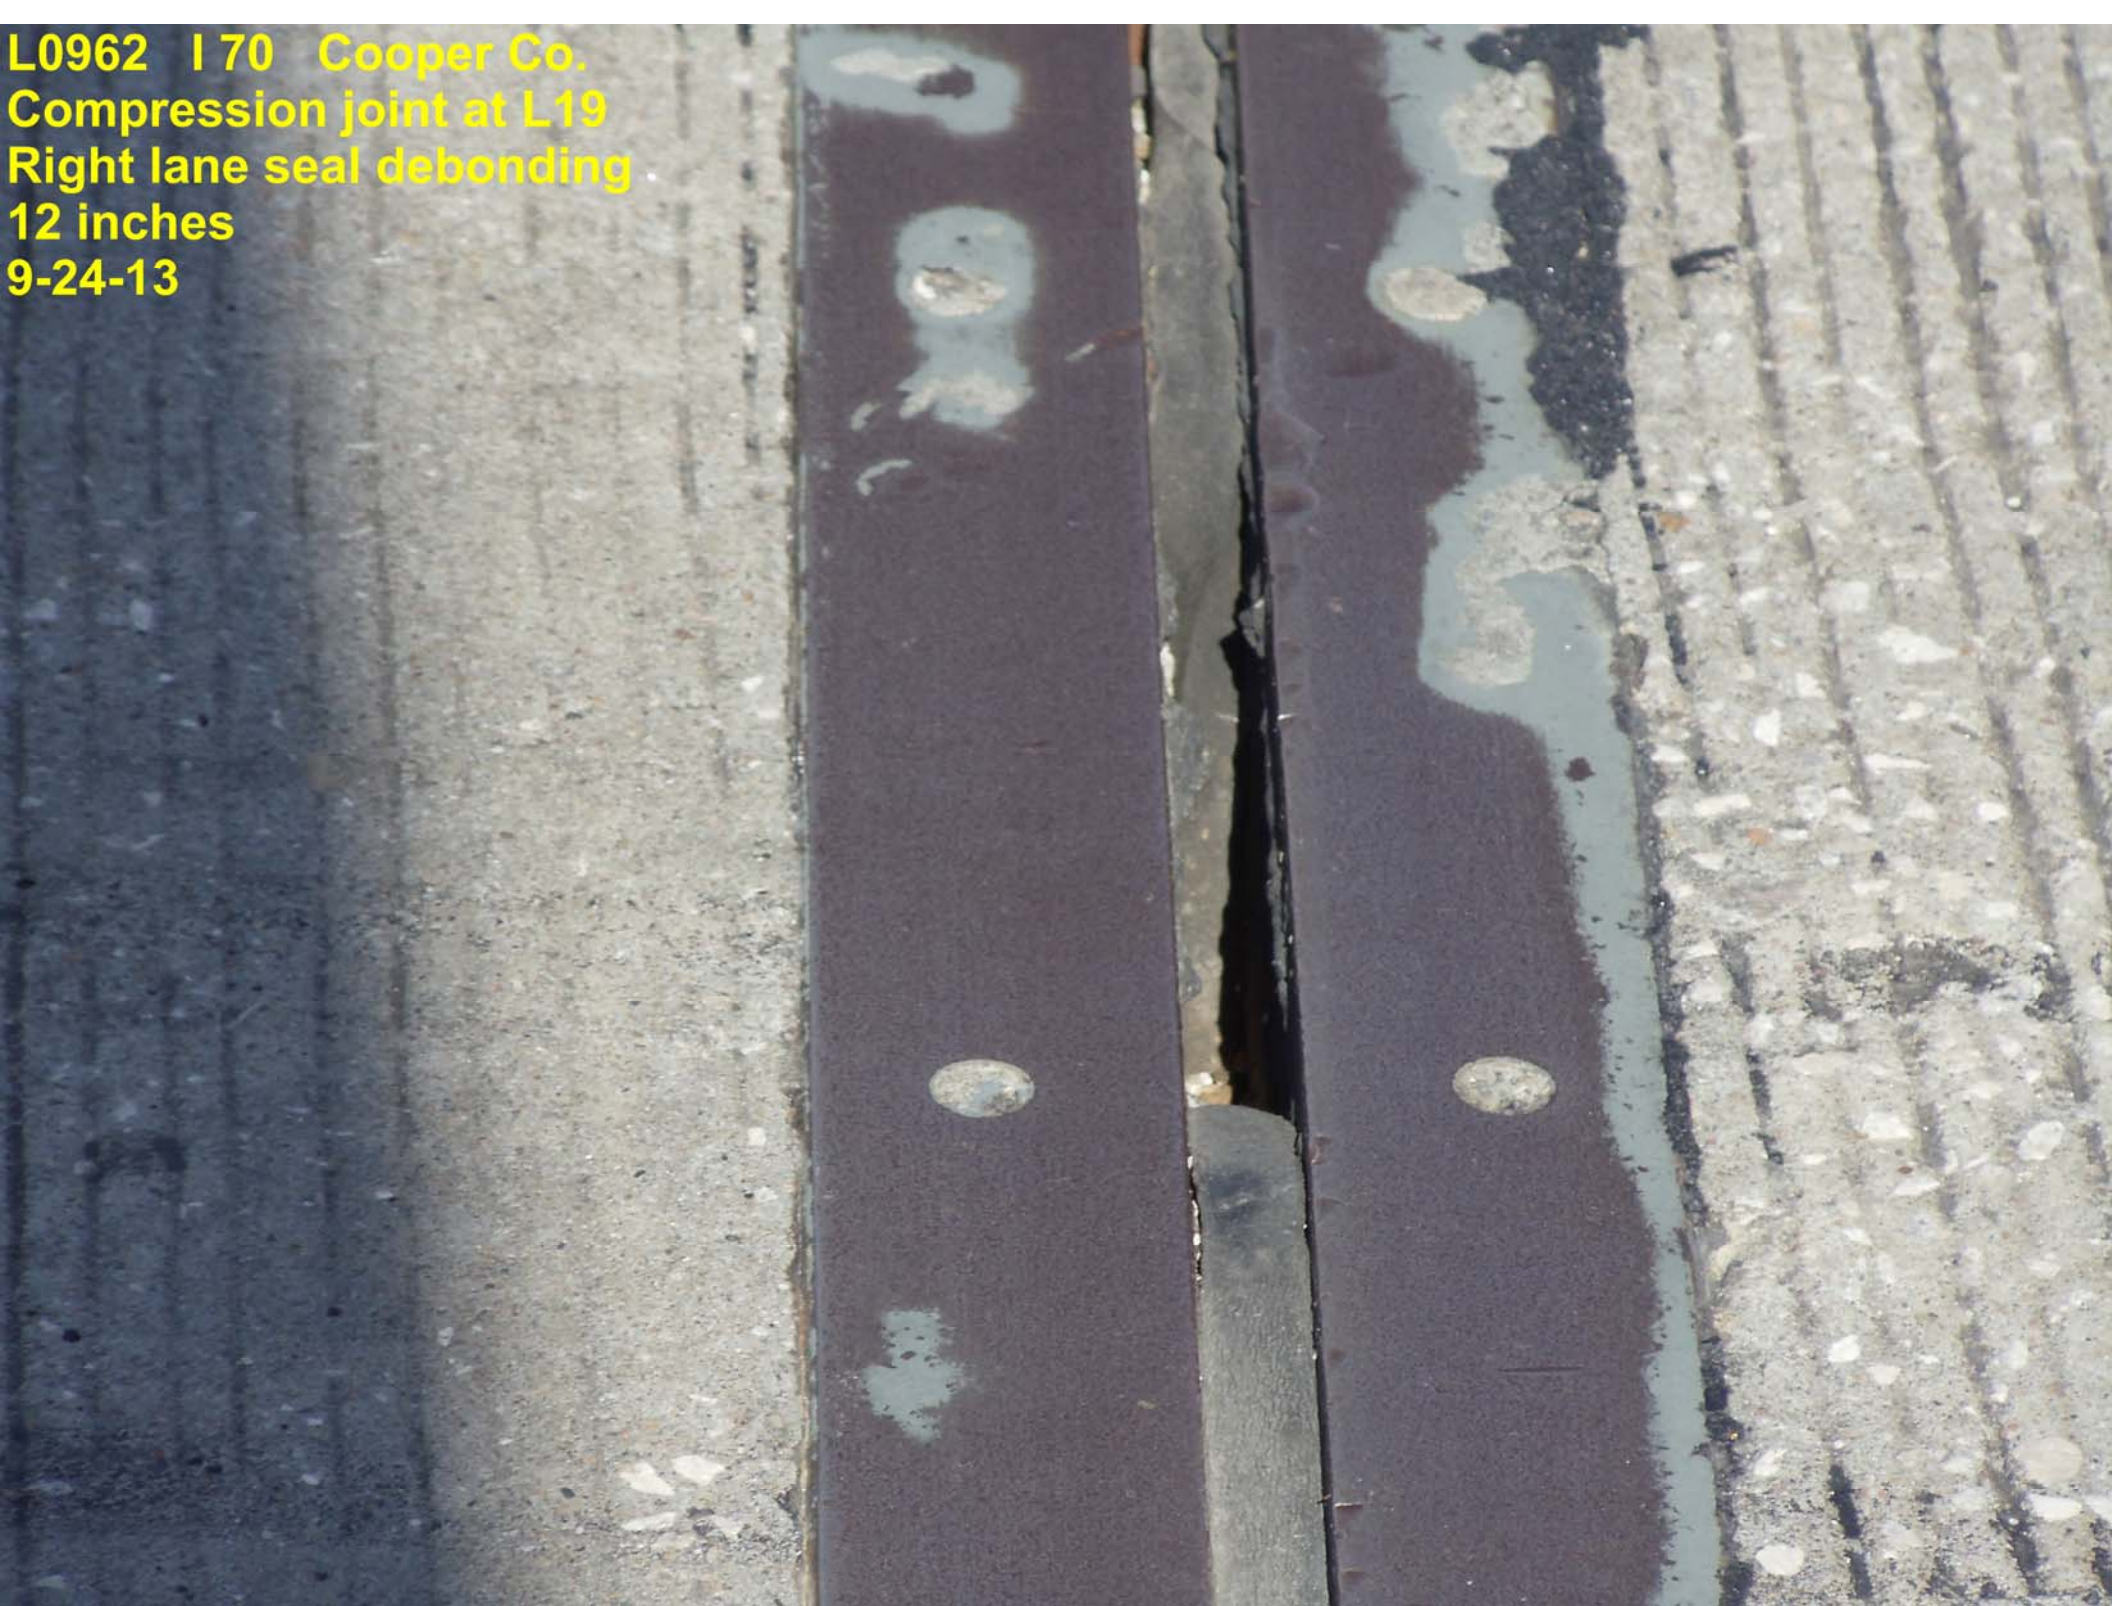
L0962 I 70 Cooper Co.  
Pier cup at L20  
9-24-13
