L0962 I 70 Cooper Co.  
Joint at L8, span 13  
Eastbound lane failing  
9-24-13

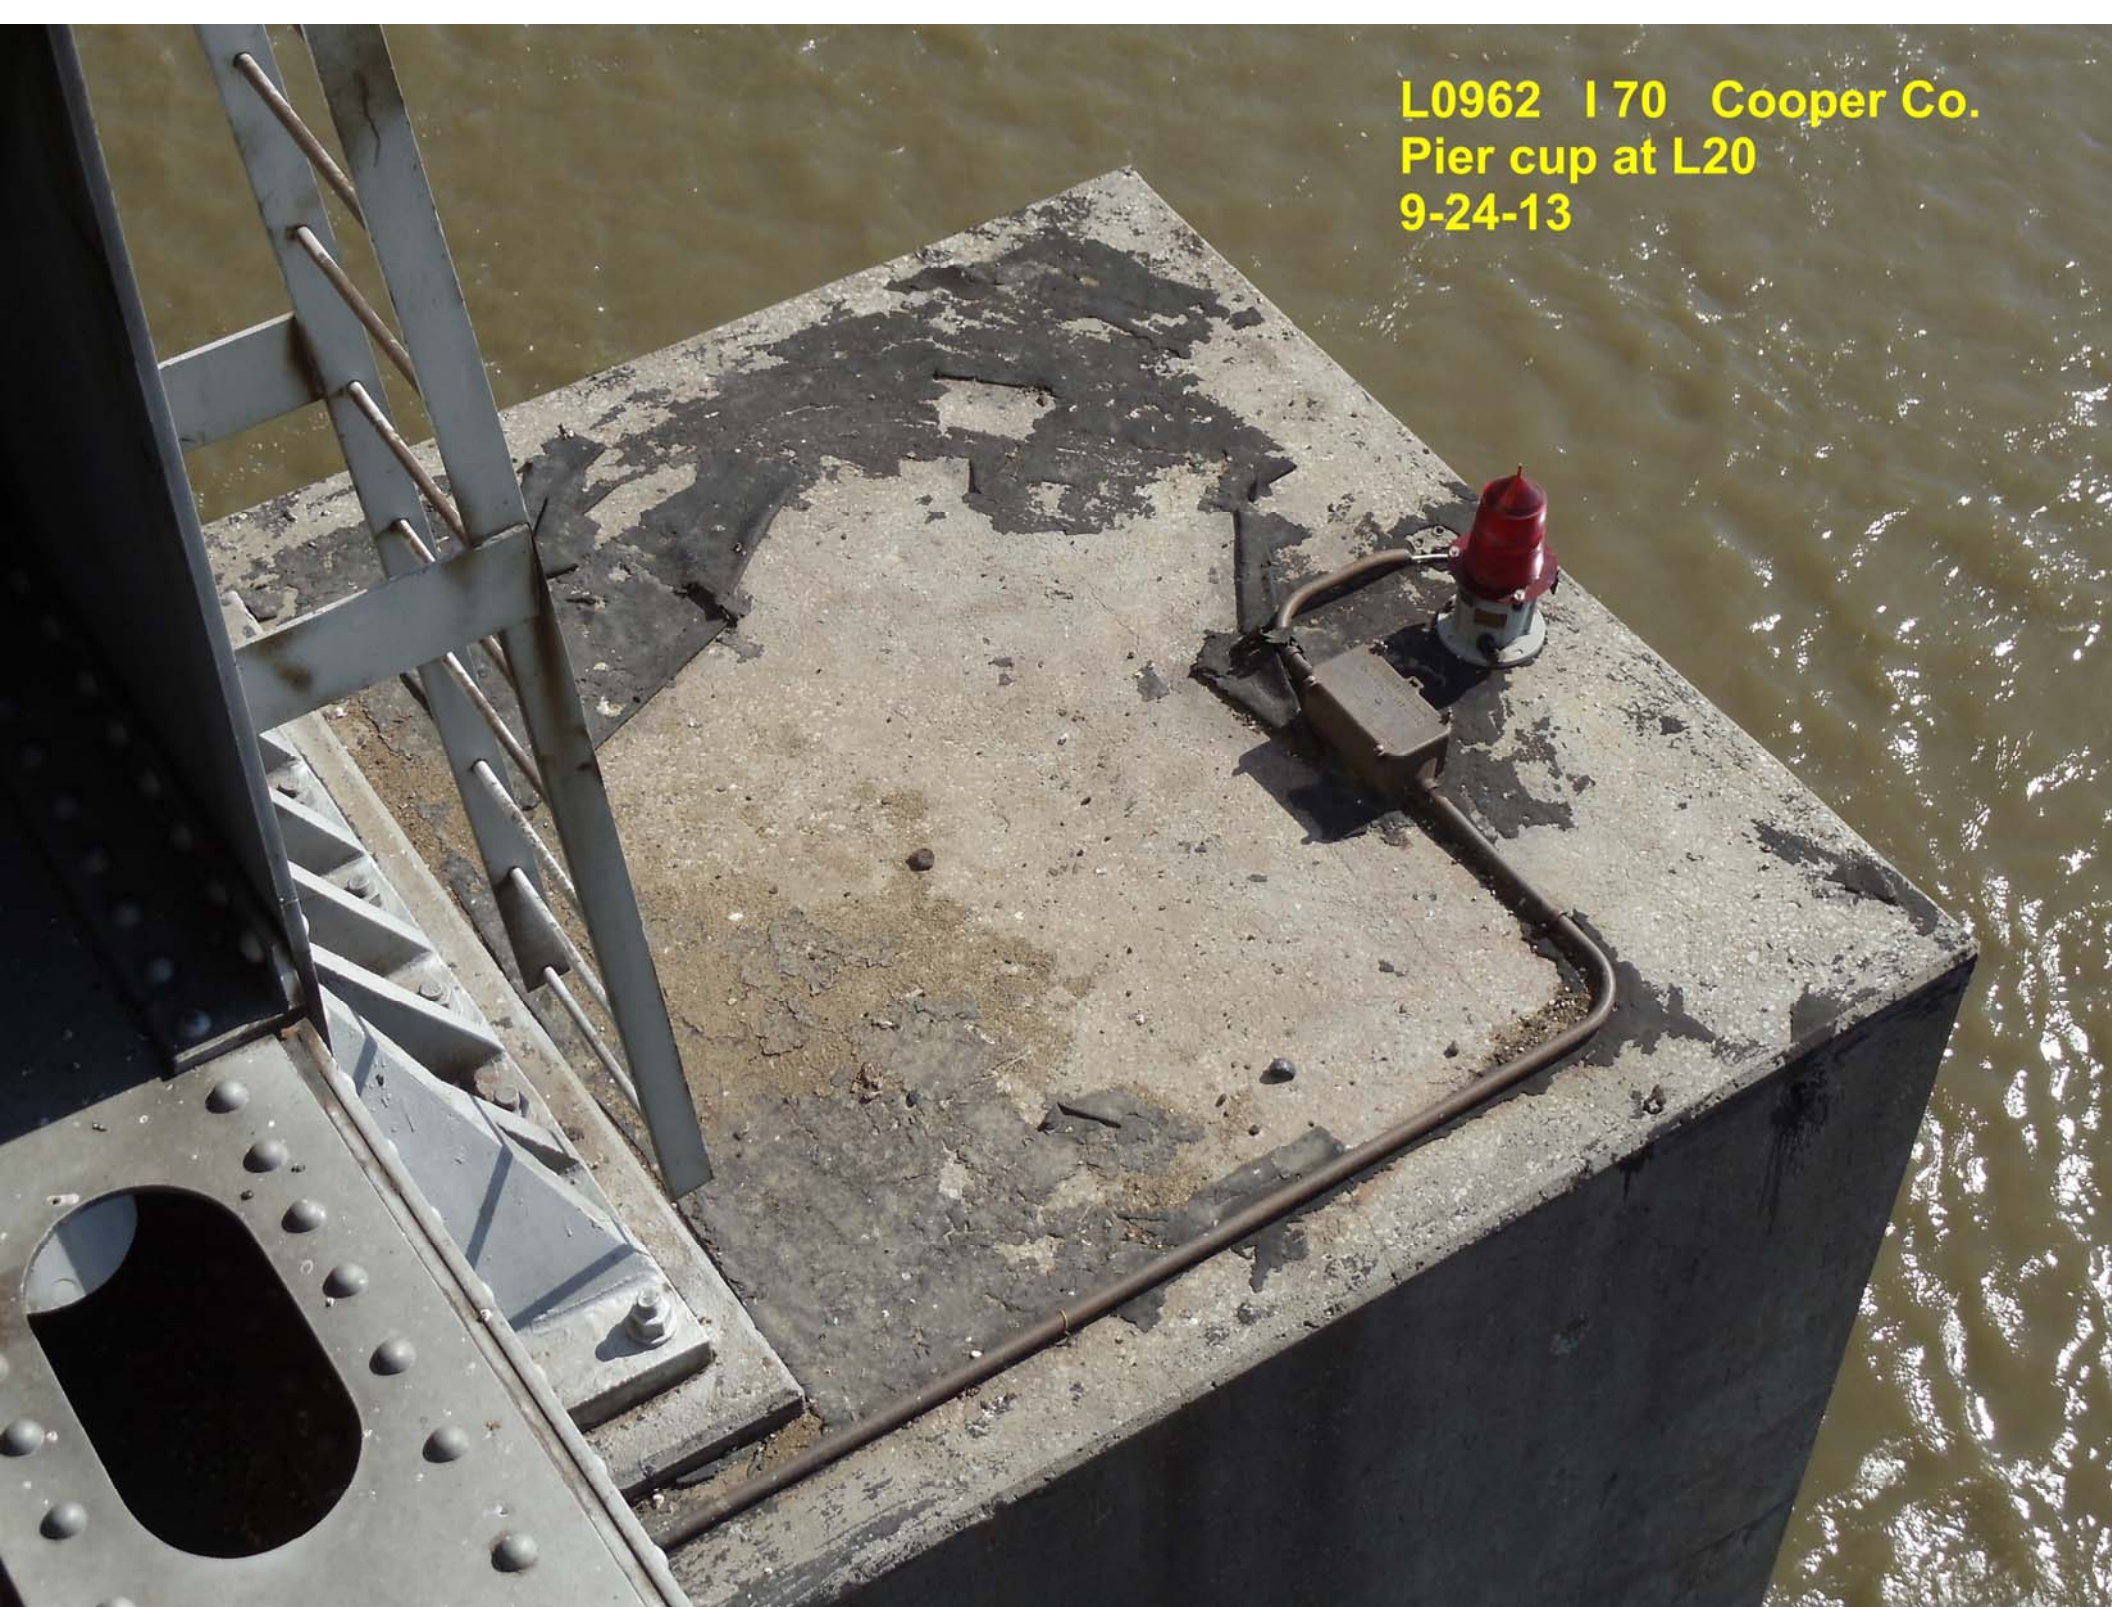
L0962 I 70 Cooper Co.  
Compression joint at L19  
good condition  
9-24-13

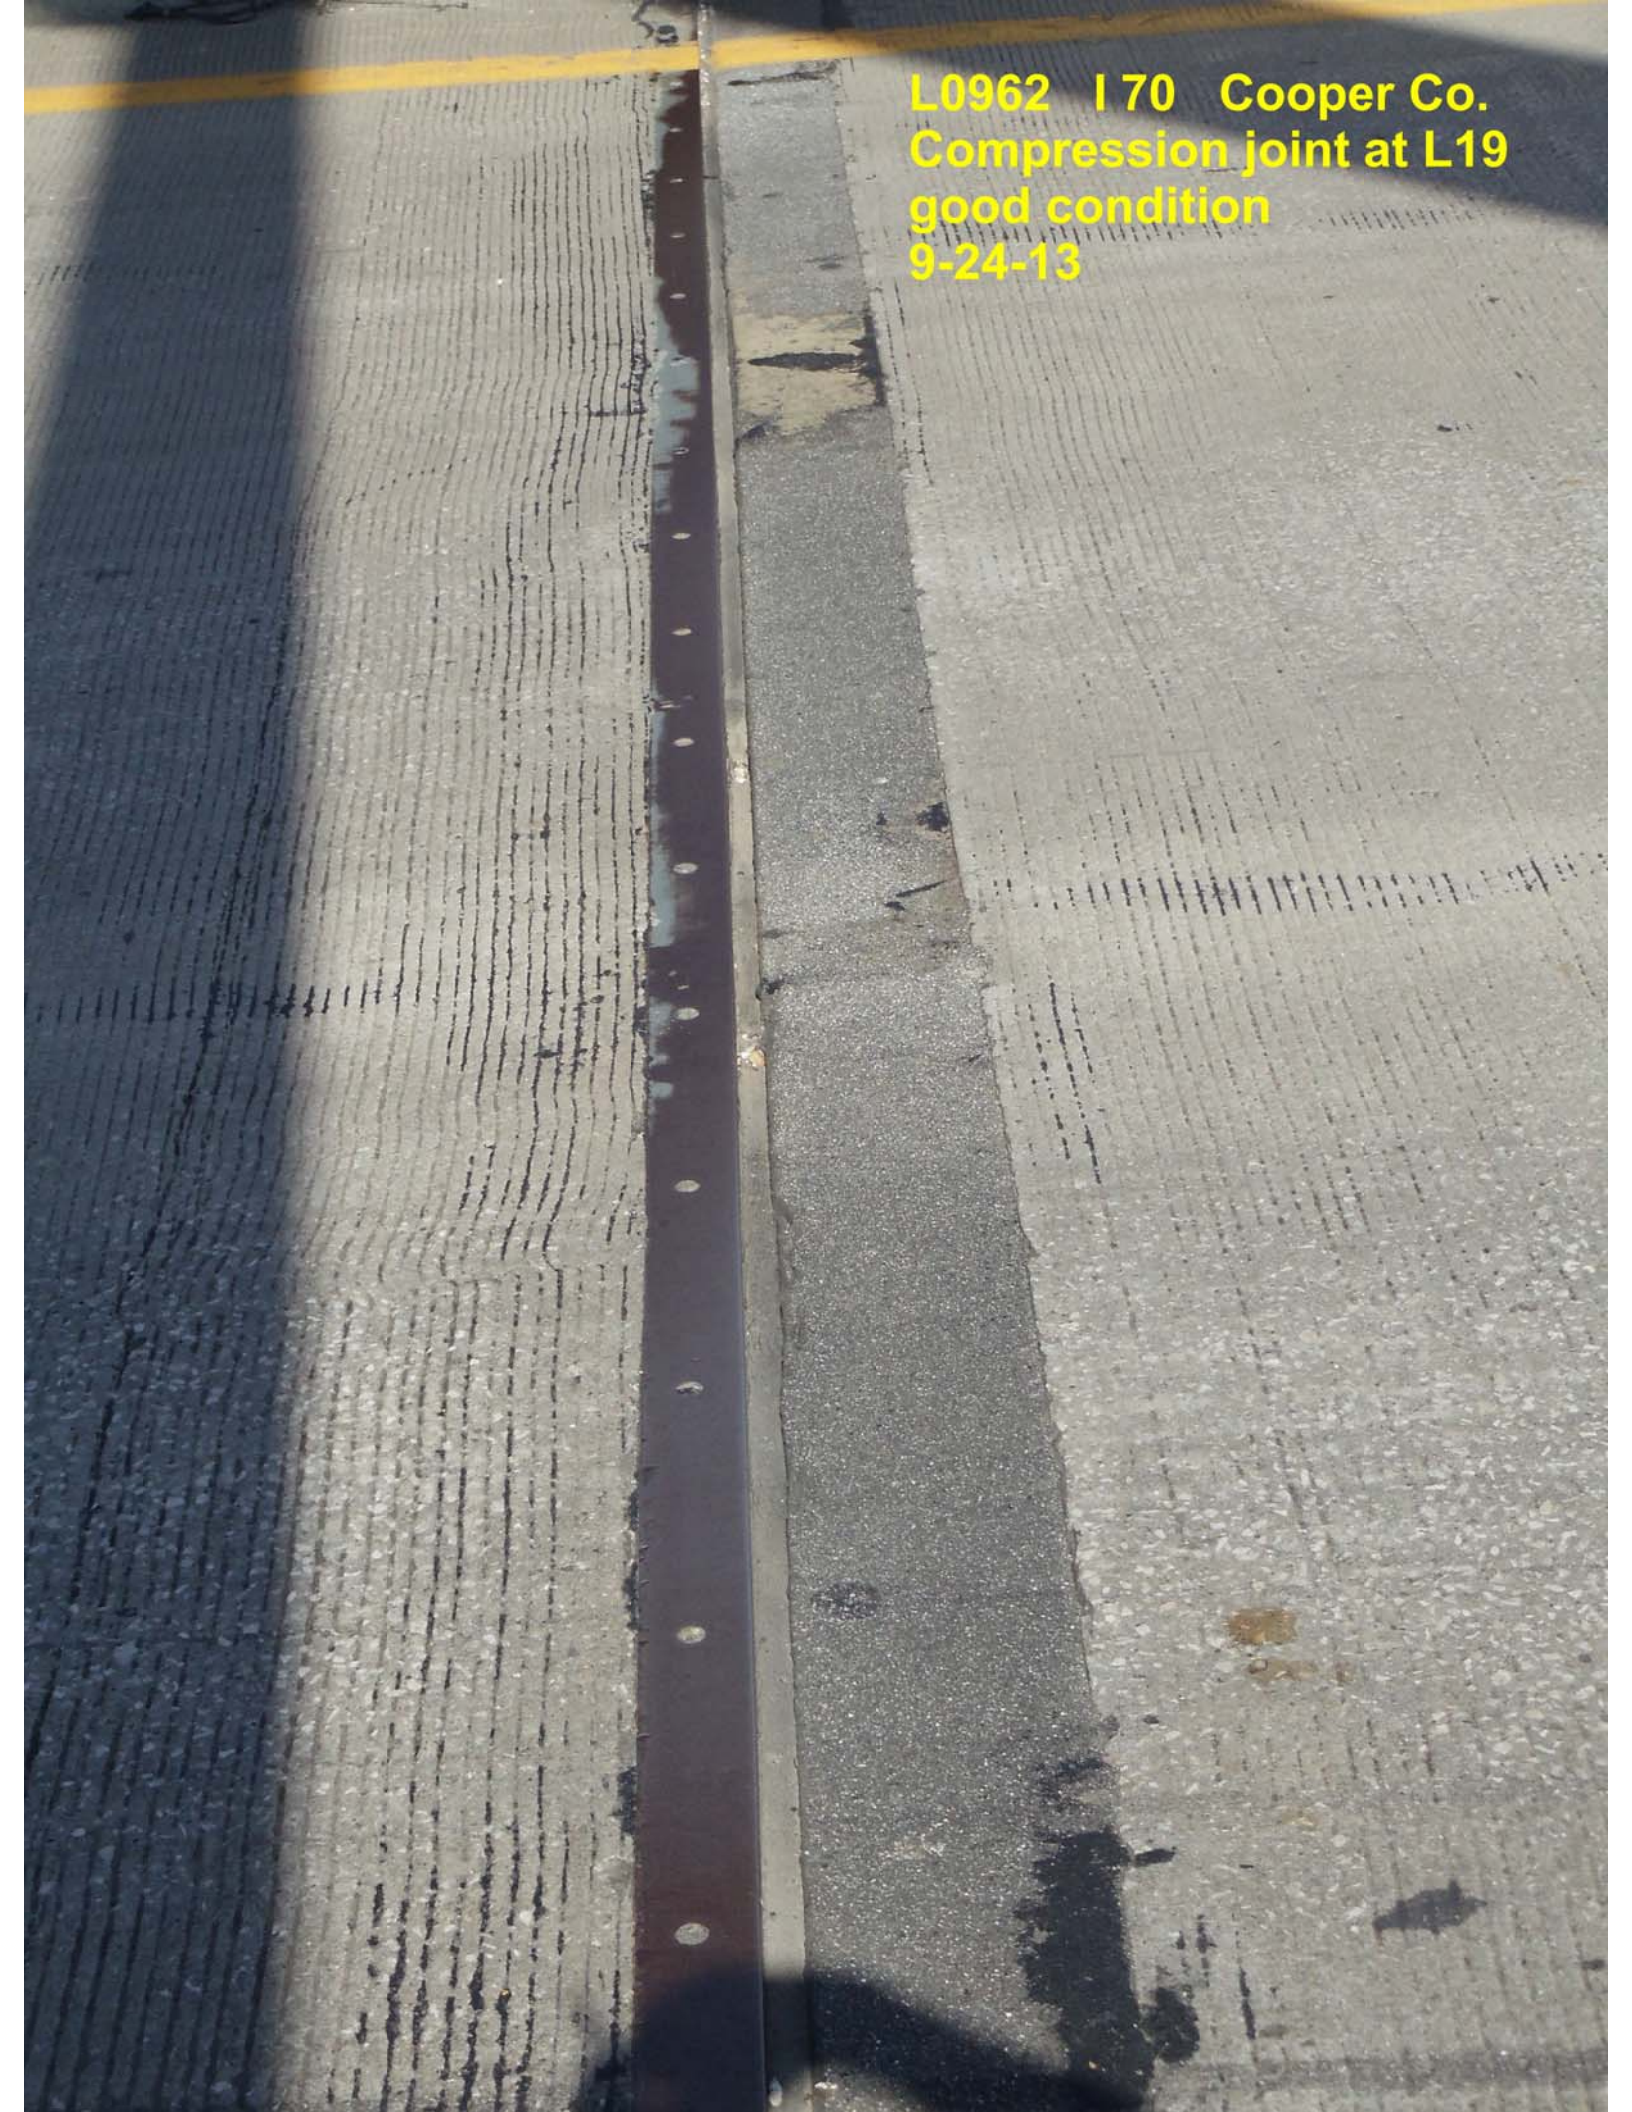
L0962 I 70 Cooper Co.  
Compression joint at L16  
good condition  
9-24-13

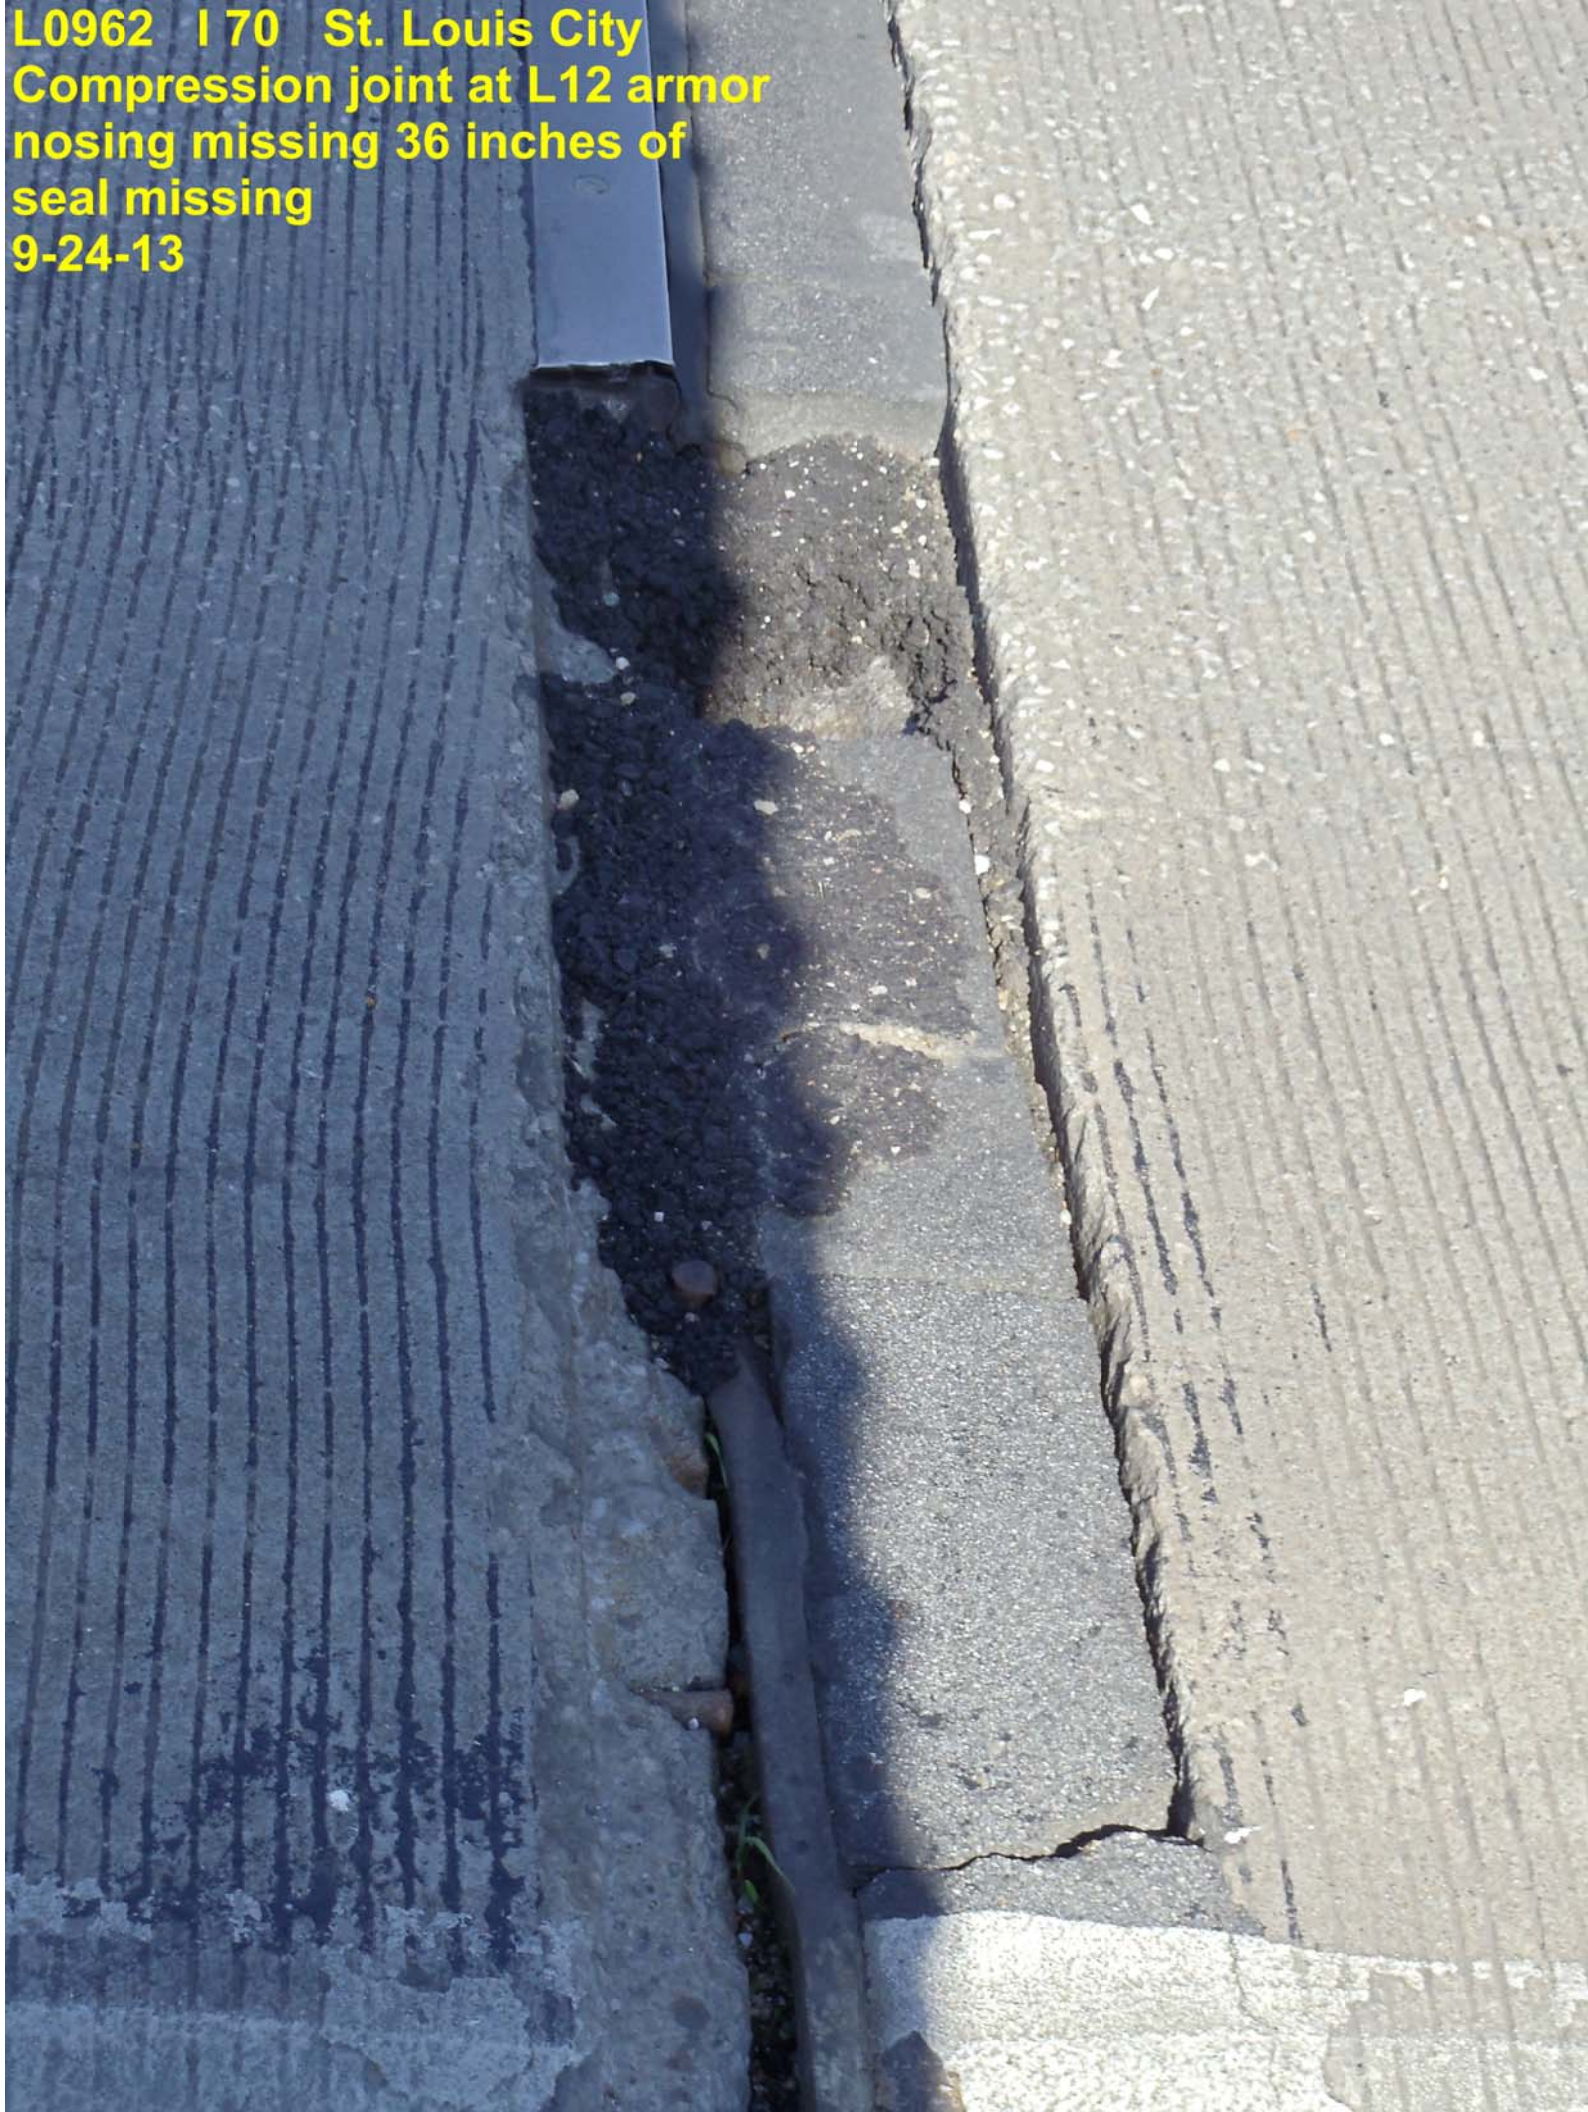
L0962 I 70 Cooper Co.  
Compression joint at L8  
good condition  
9-24-13

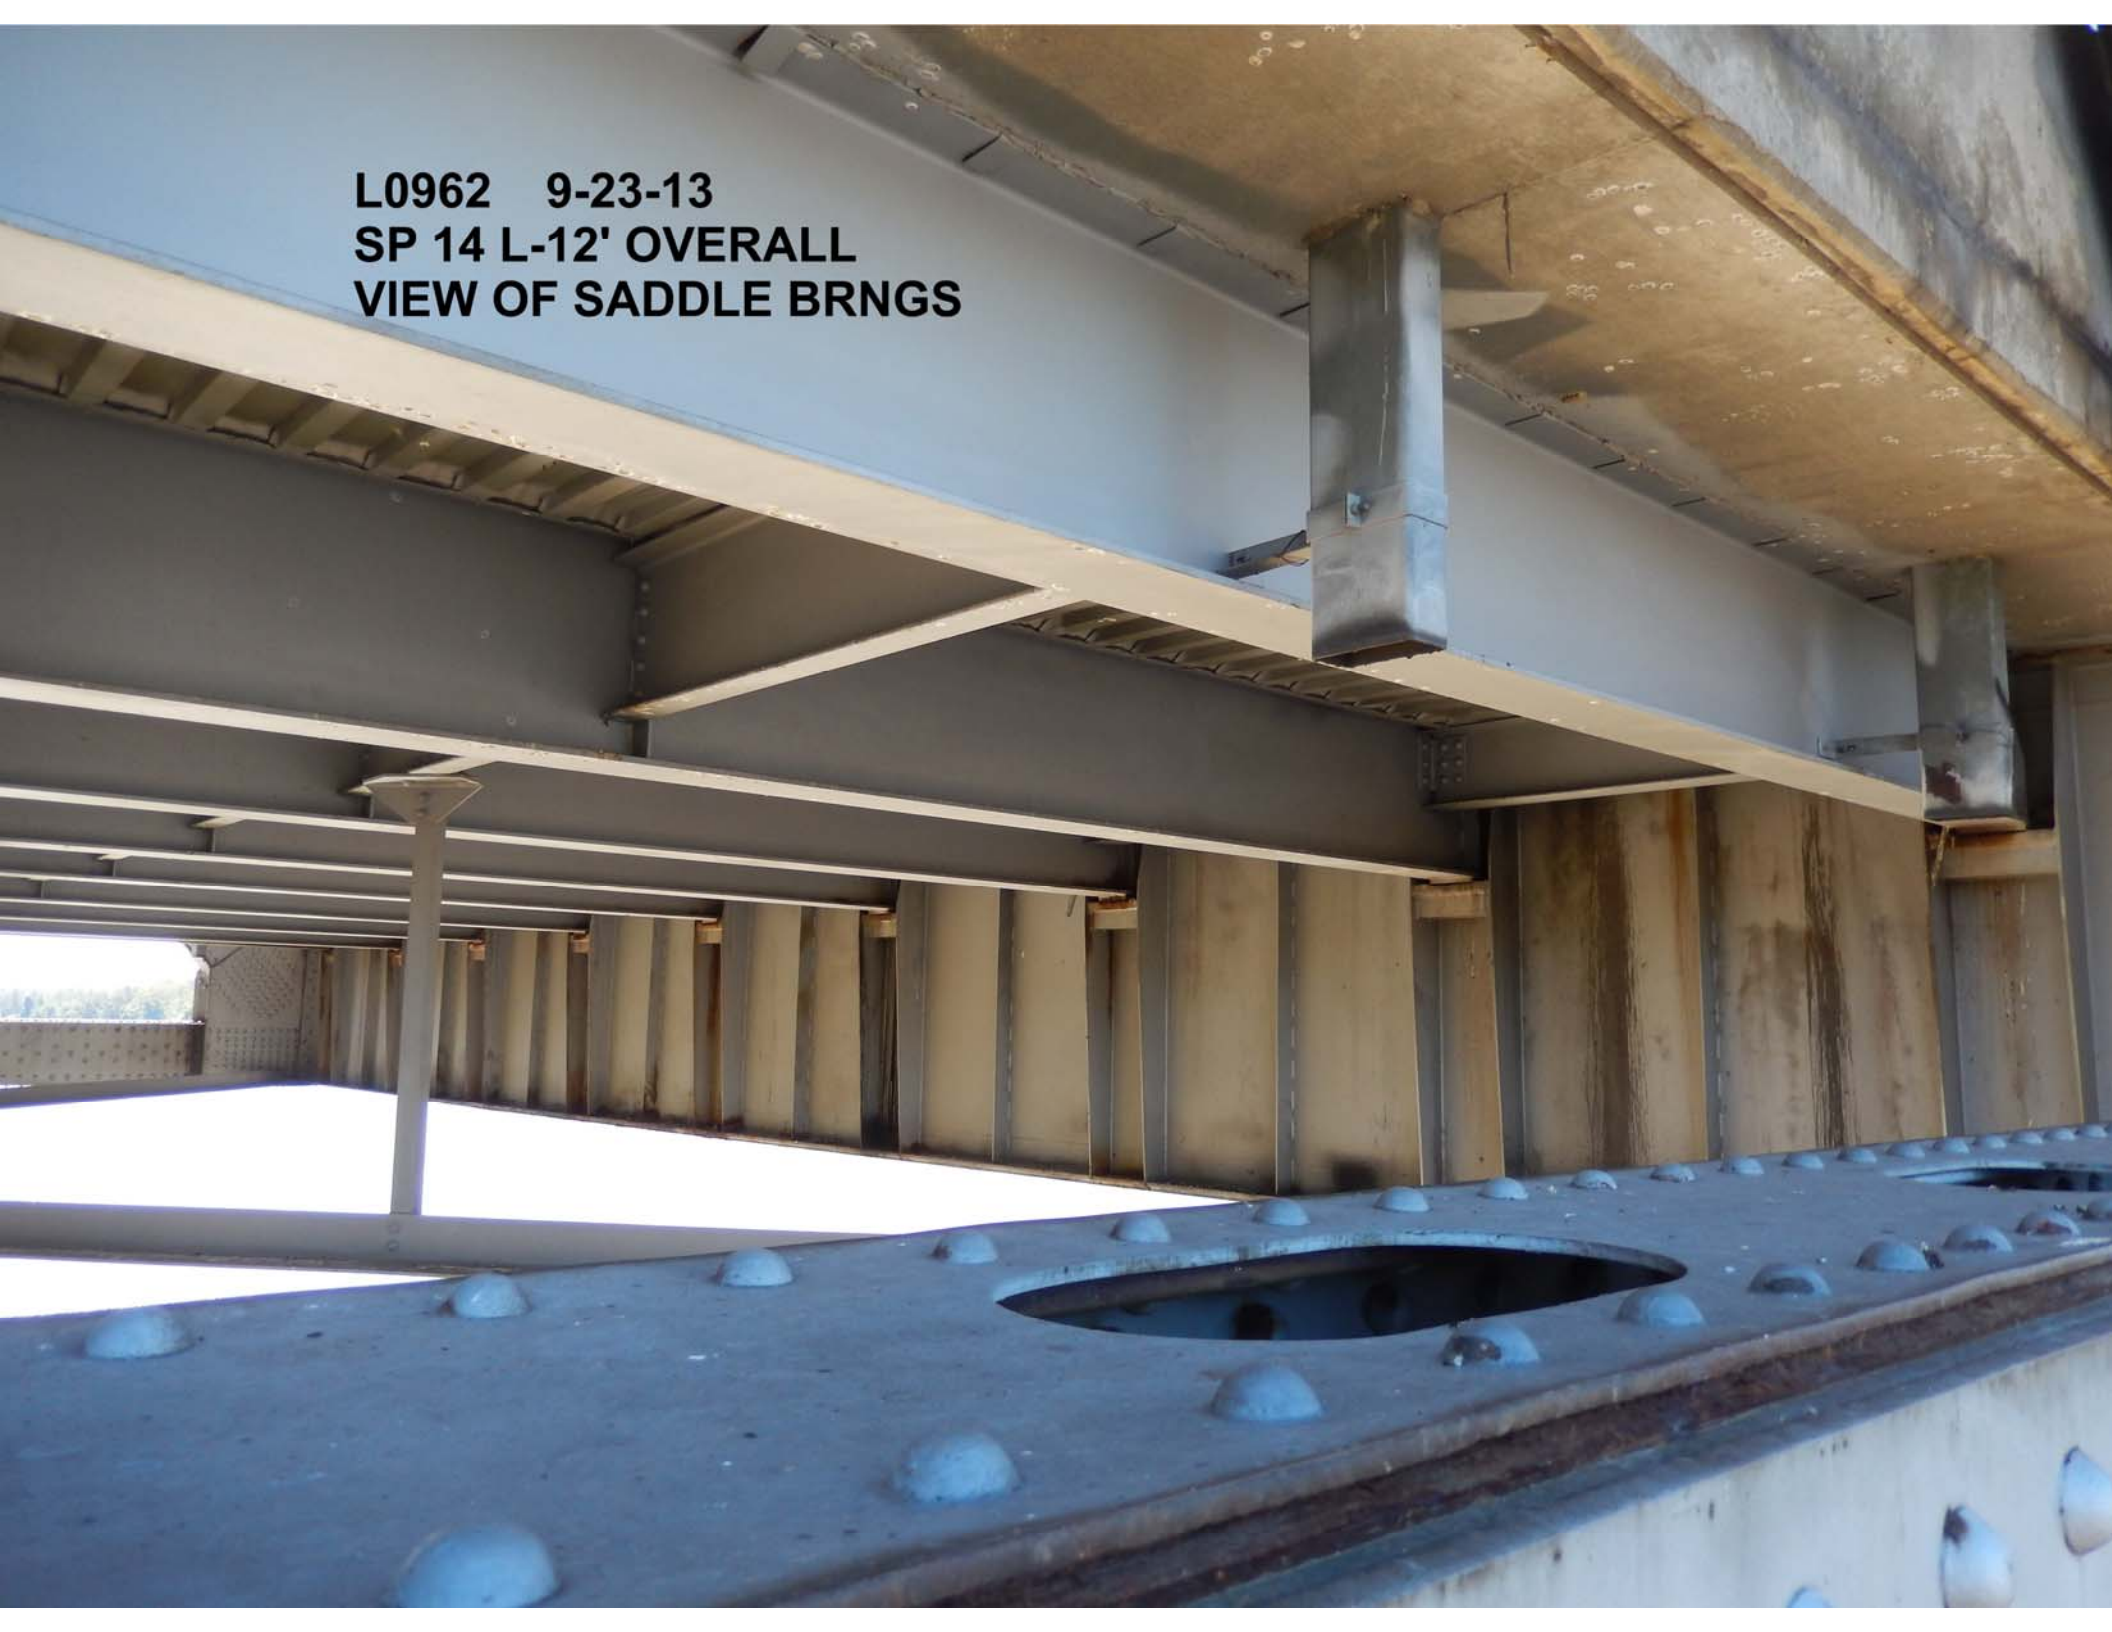
L0962 9-23-13

SP 14 L-11' LEFT BTTM RIVET  
HEAD SHEARED OFF THRU  
INSIDE GUSS

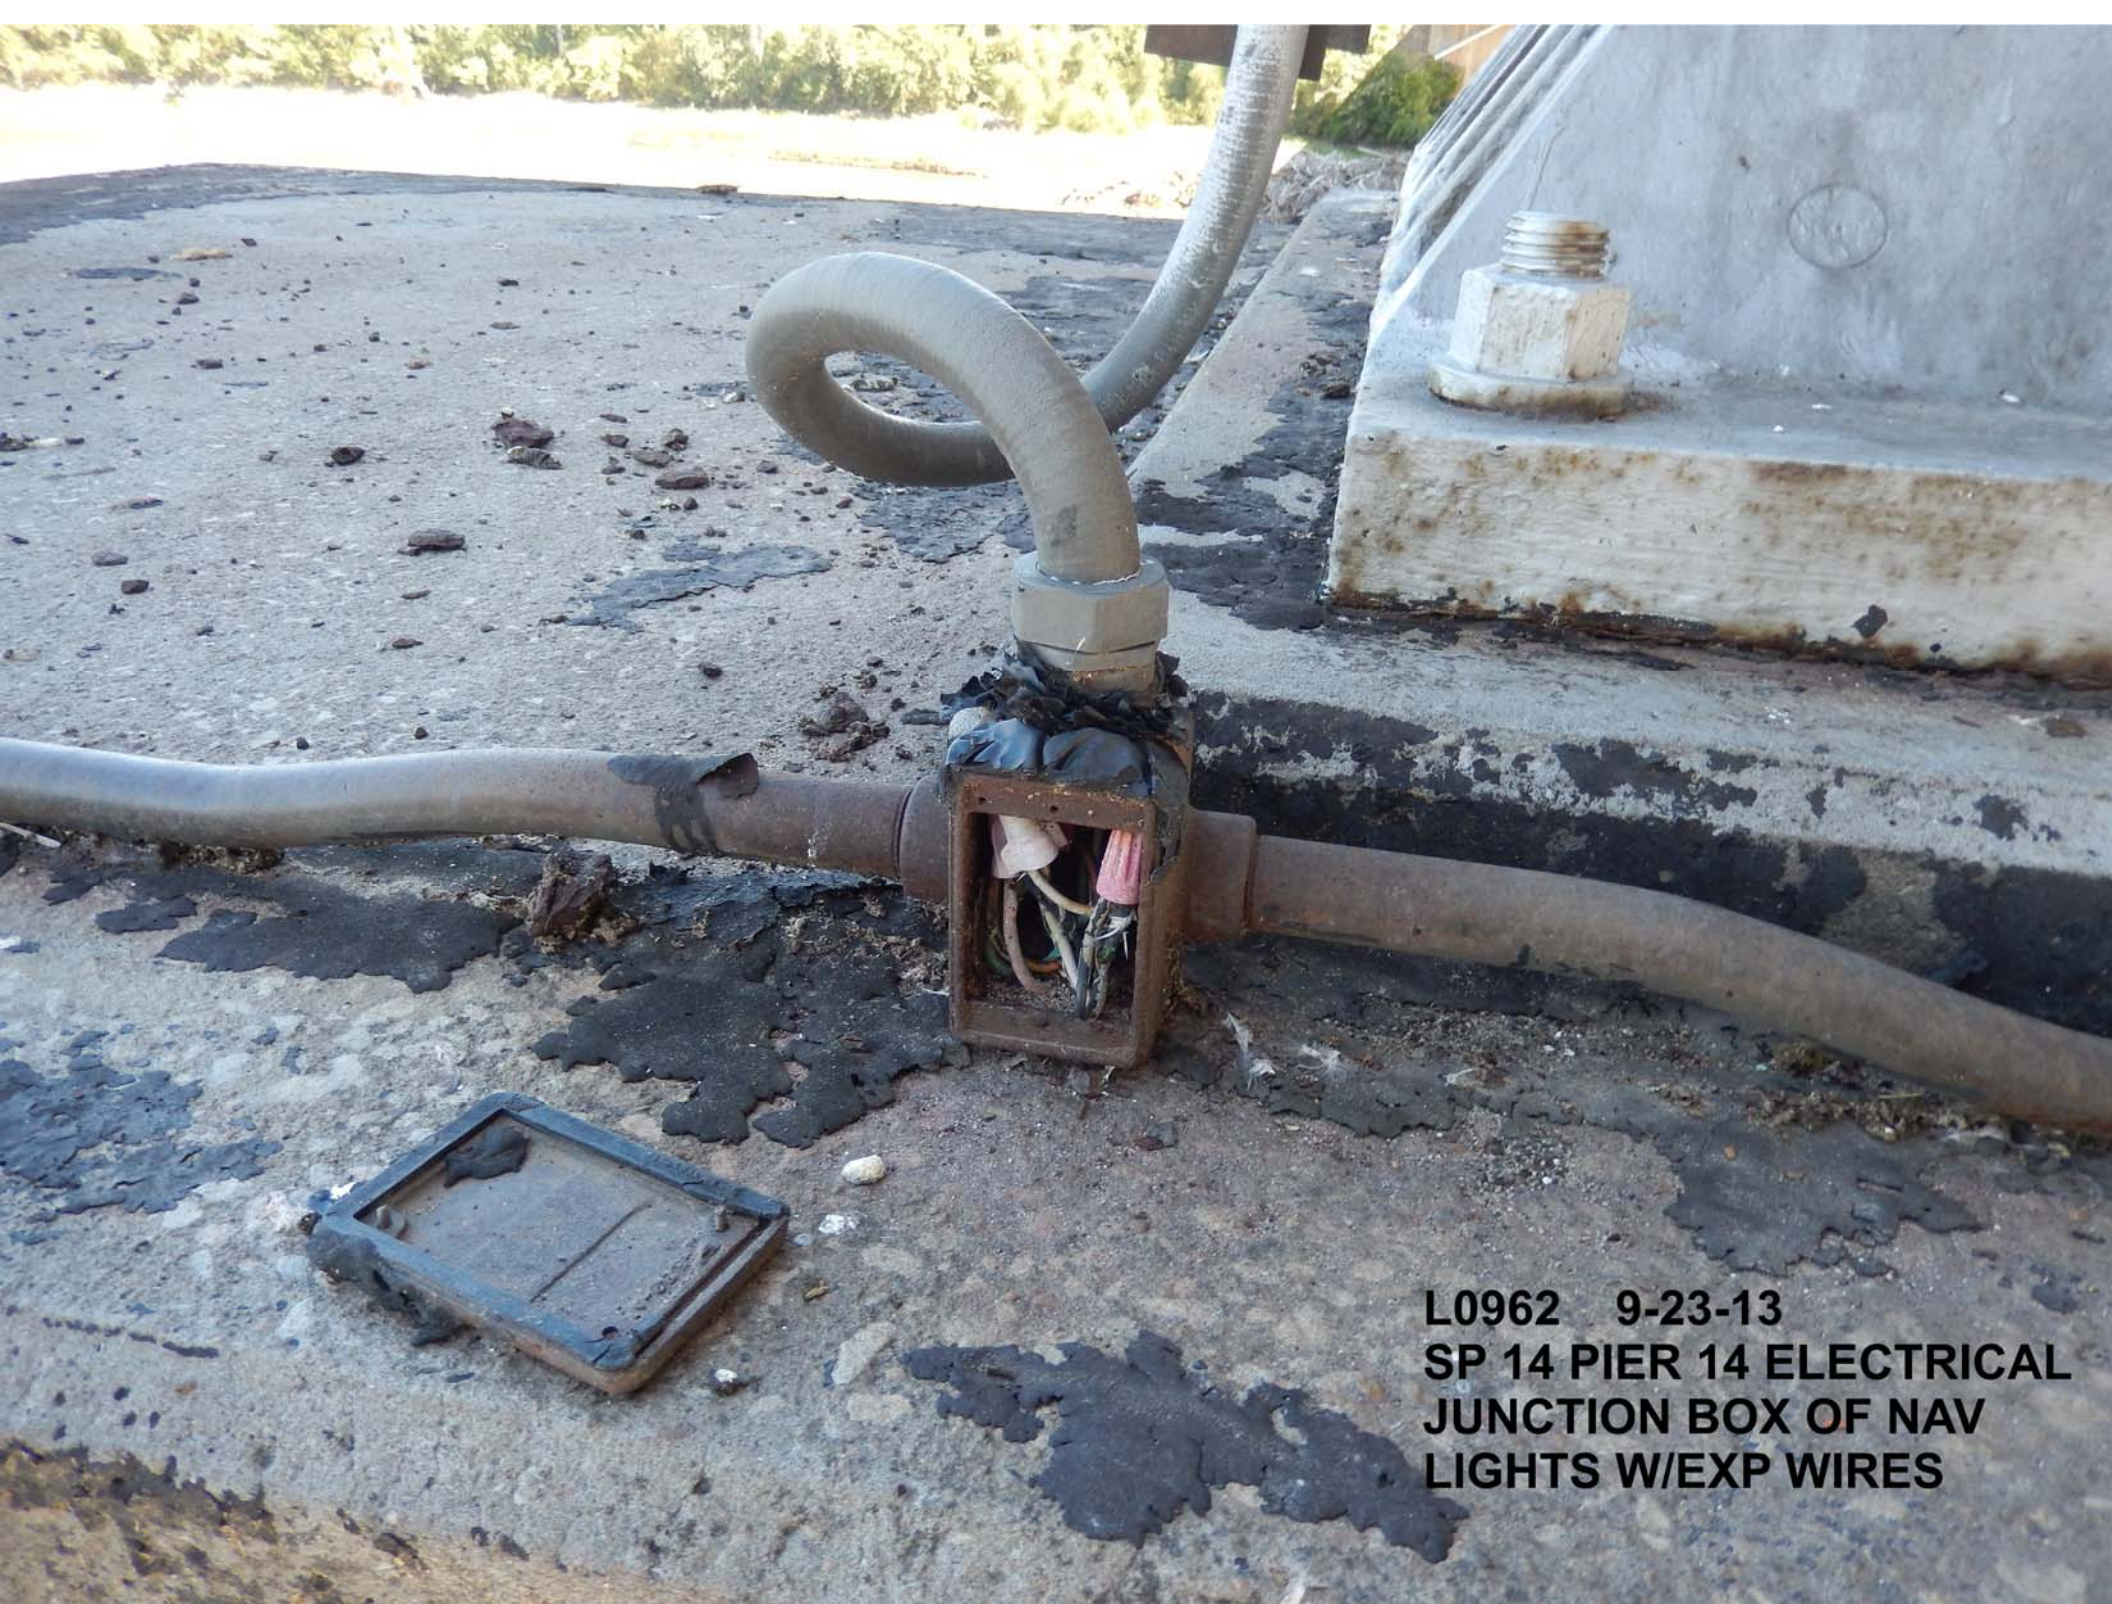
L0962 9-23-13  
SP 14 PIER 14 ELECTRICAL  
JUNCTION BOX OF NAV  
LIGHTS W/EXP WIRES

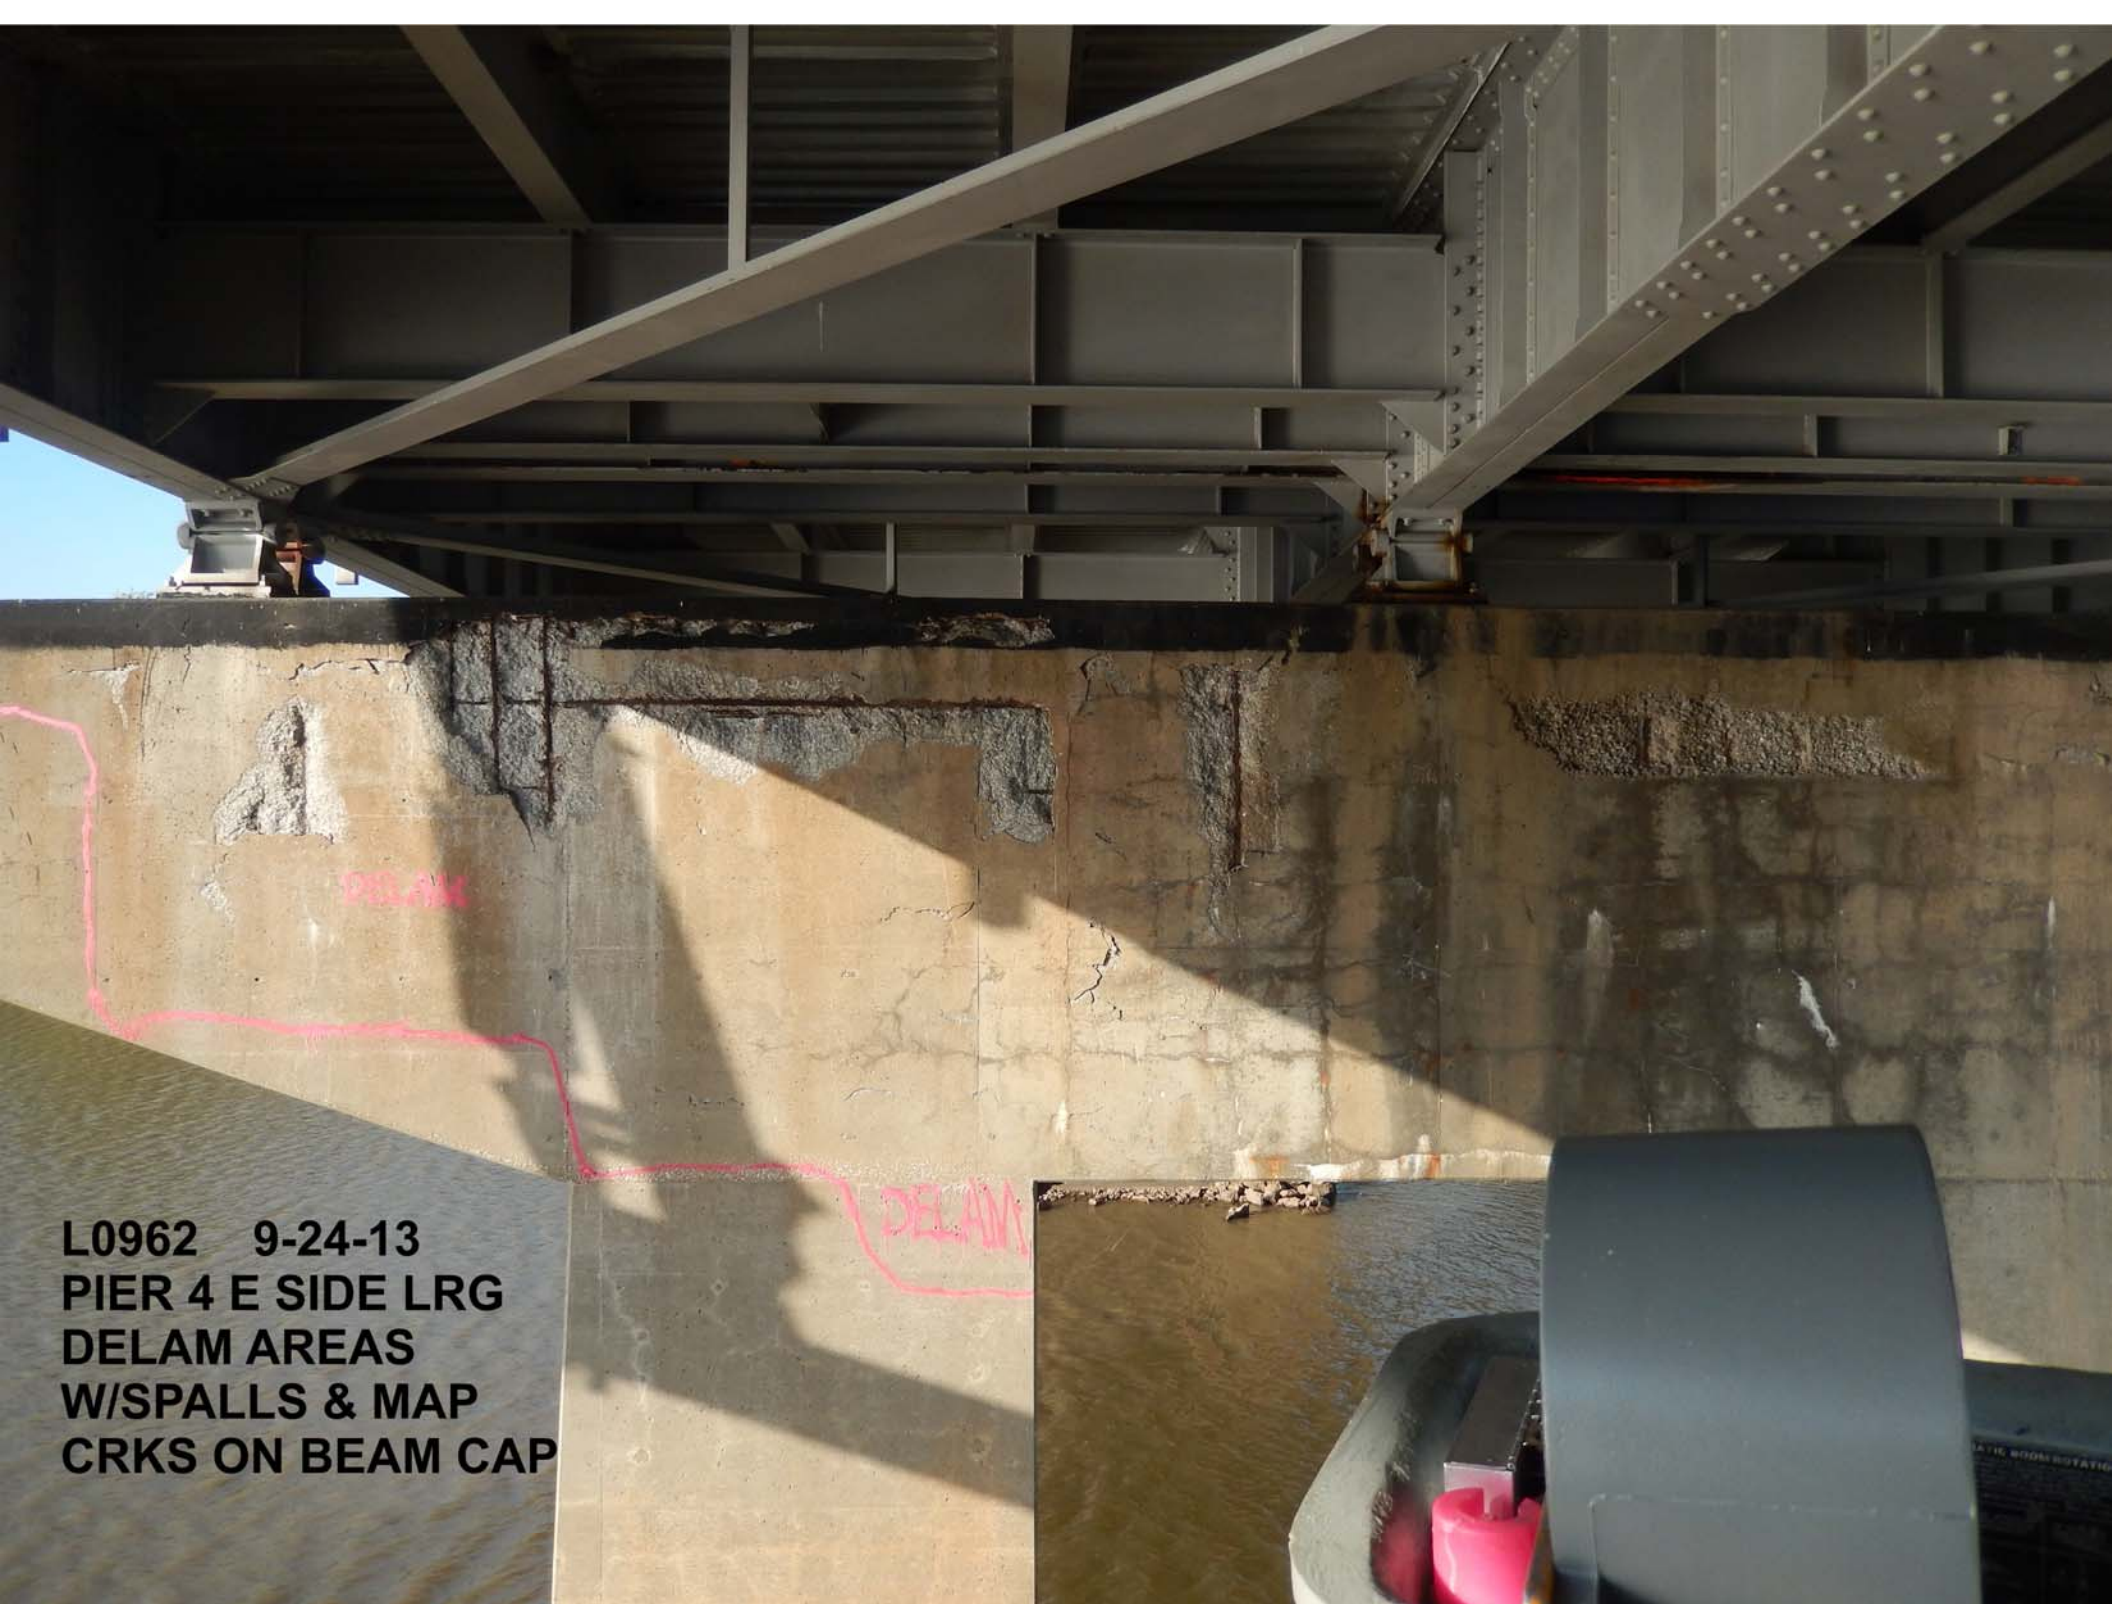
**L0962 9-24-13  
PIER 4 E SIDE LRG  
DELAM AREAS  
W/SPALLS & MAP  
CRKS ON BEAM CAP**
