L0962 I 70 Cooper Co.  
Joint at L8, span 13  
Eastbound lane failing  
9-24-13

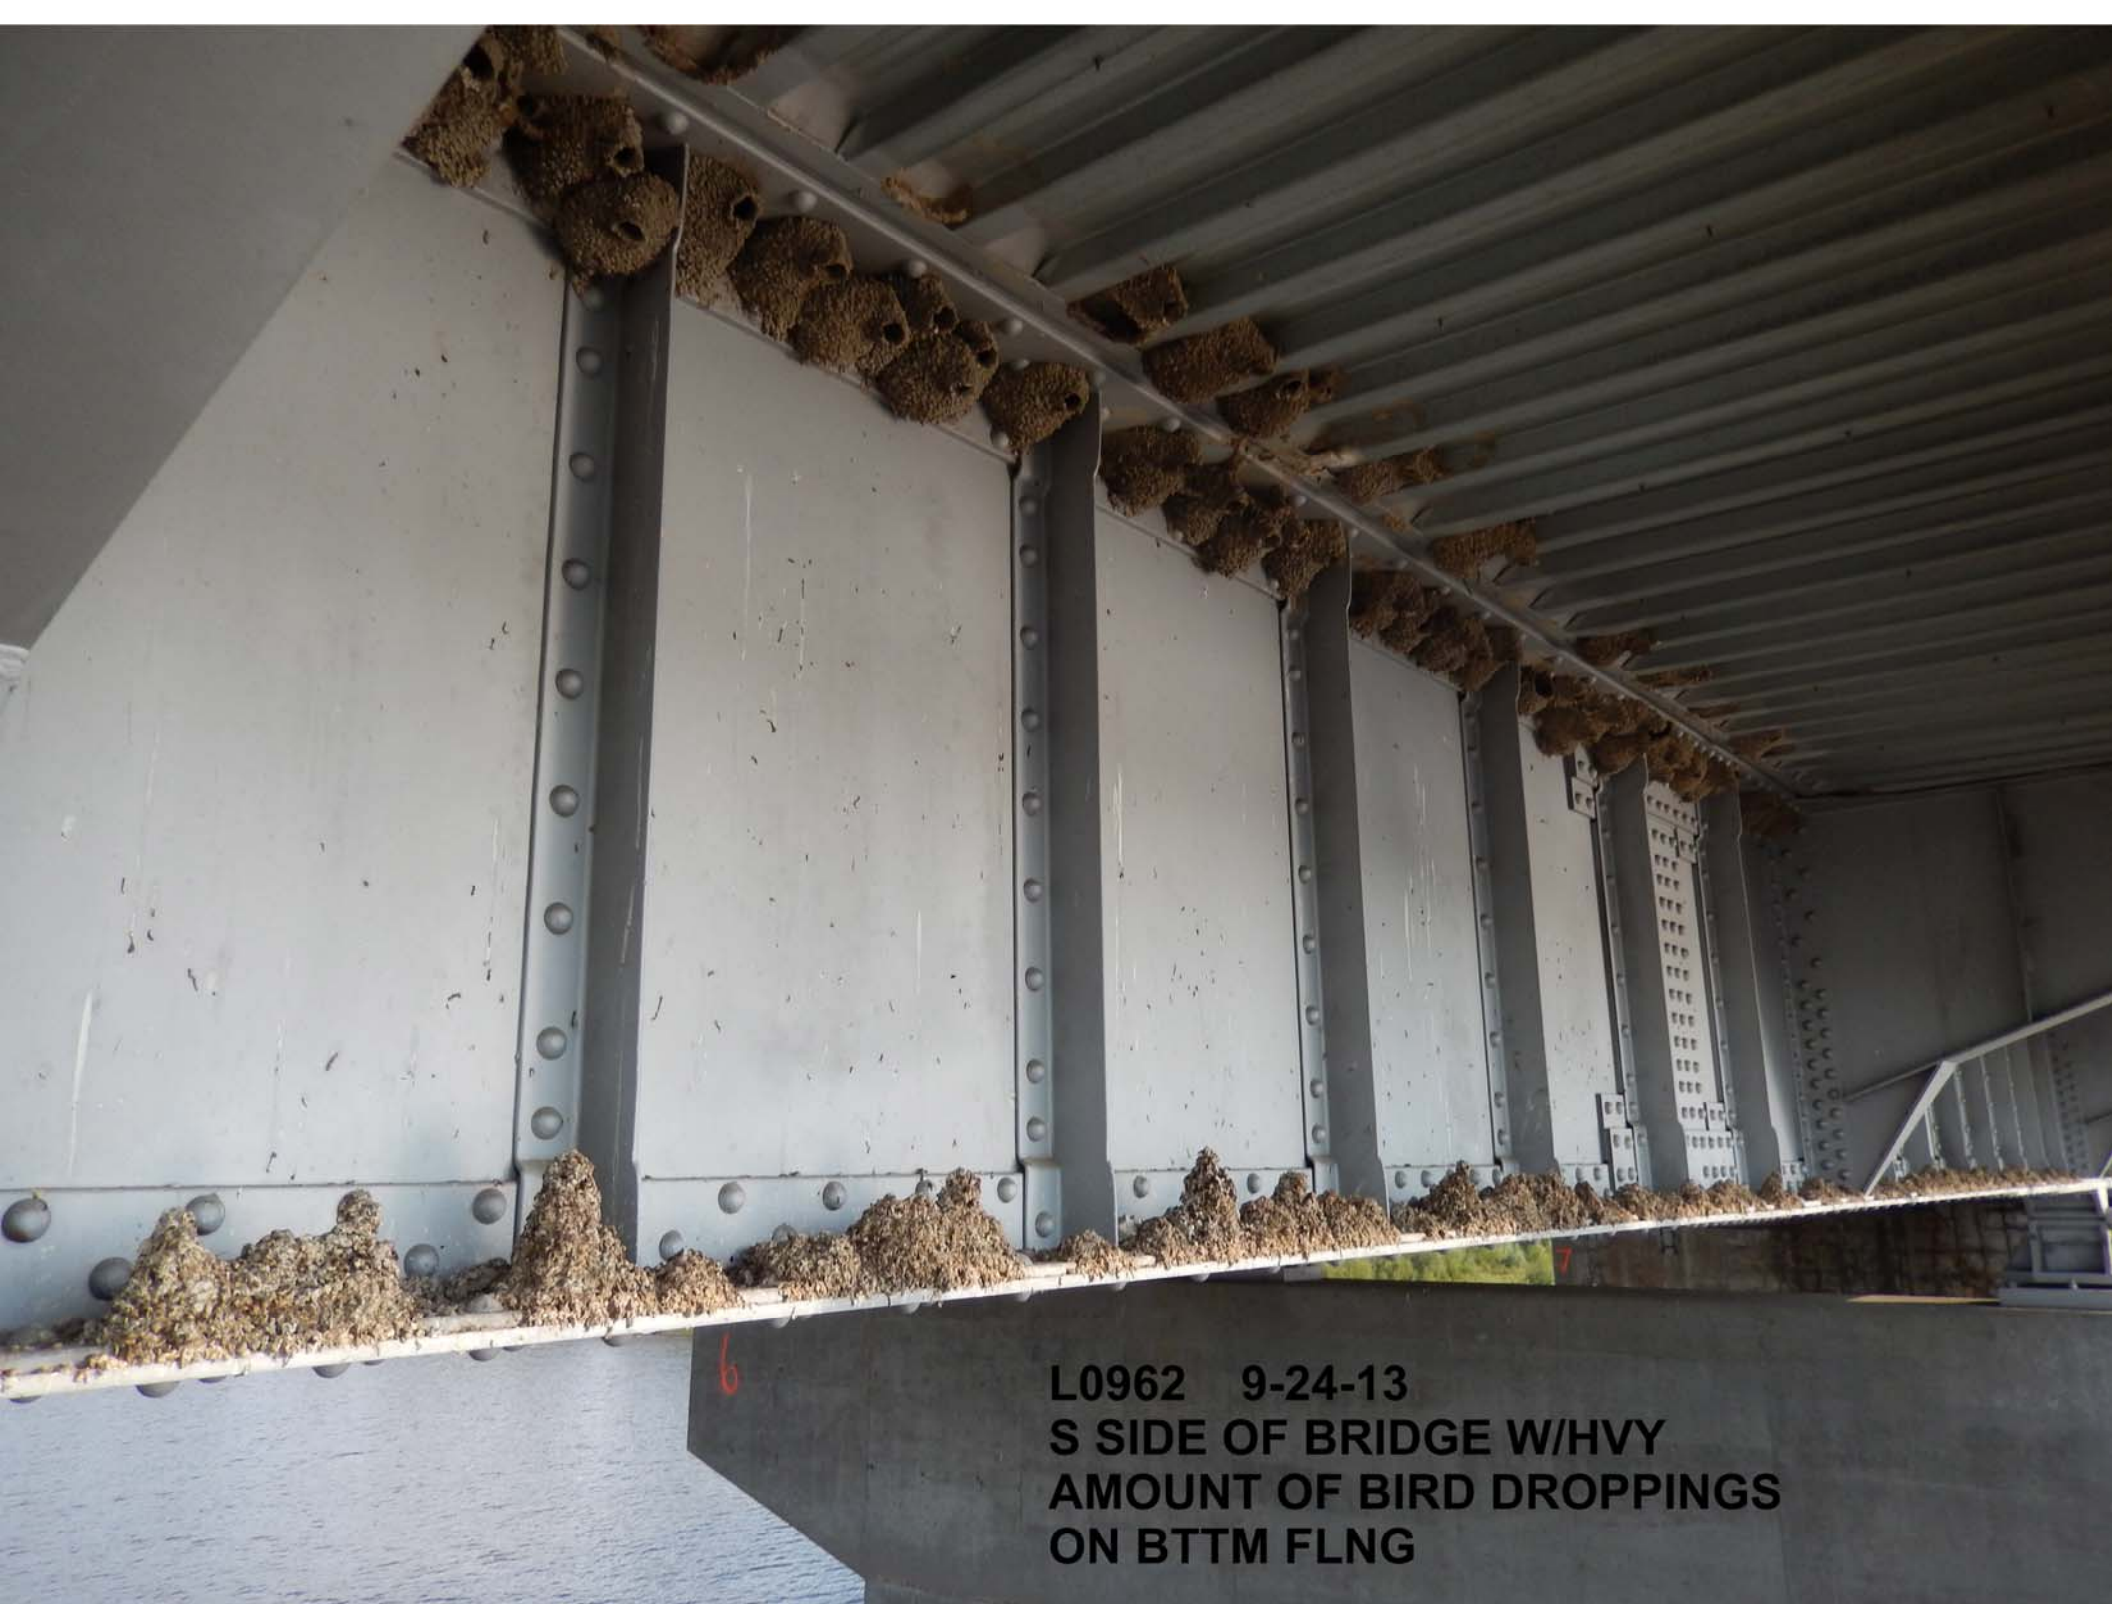
L0962 9-24-13  
S SIDE OF BRIDGE W/HVY  
AMOUNT OF BIRD DROPPINGS  
ON BTTM FLNG

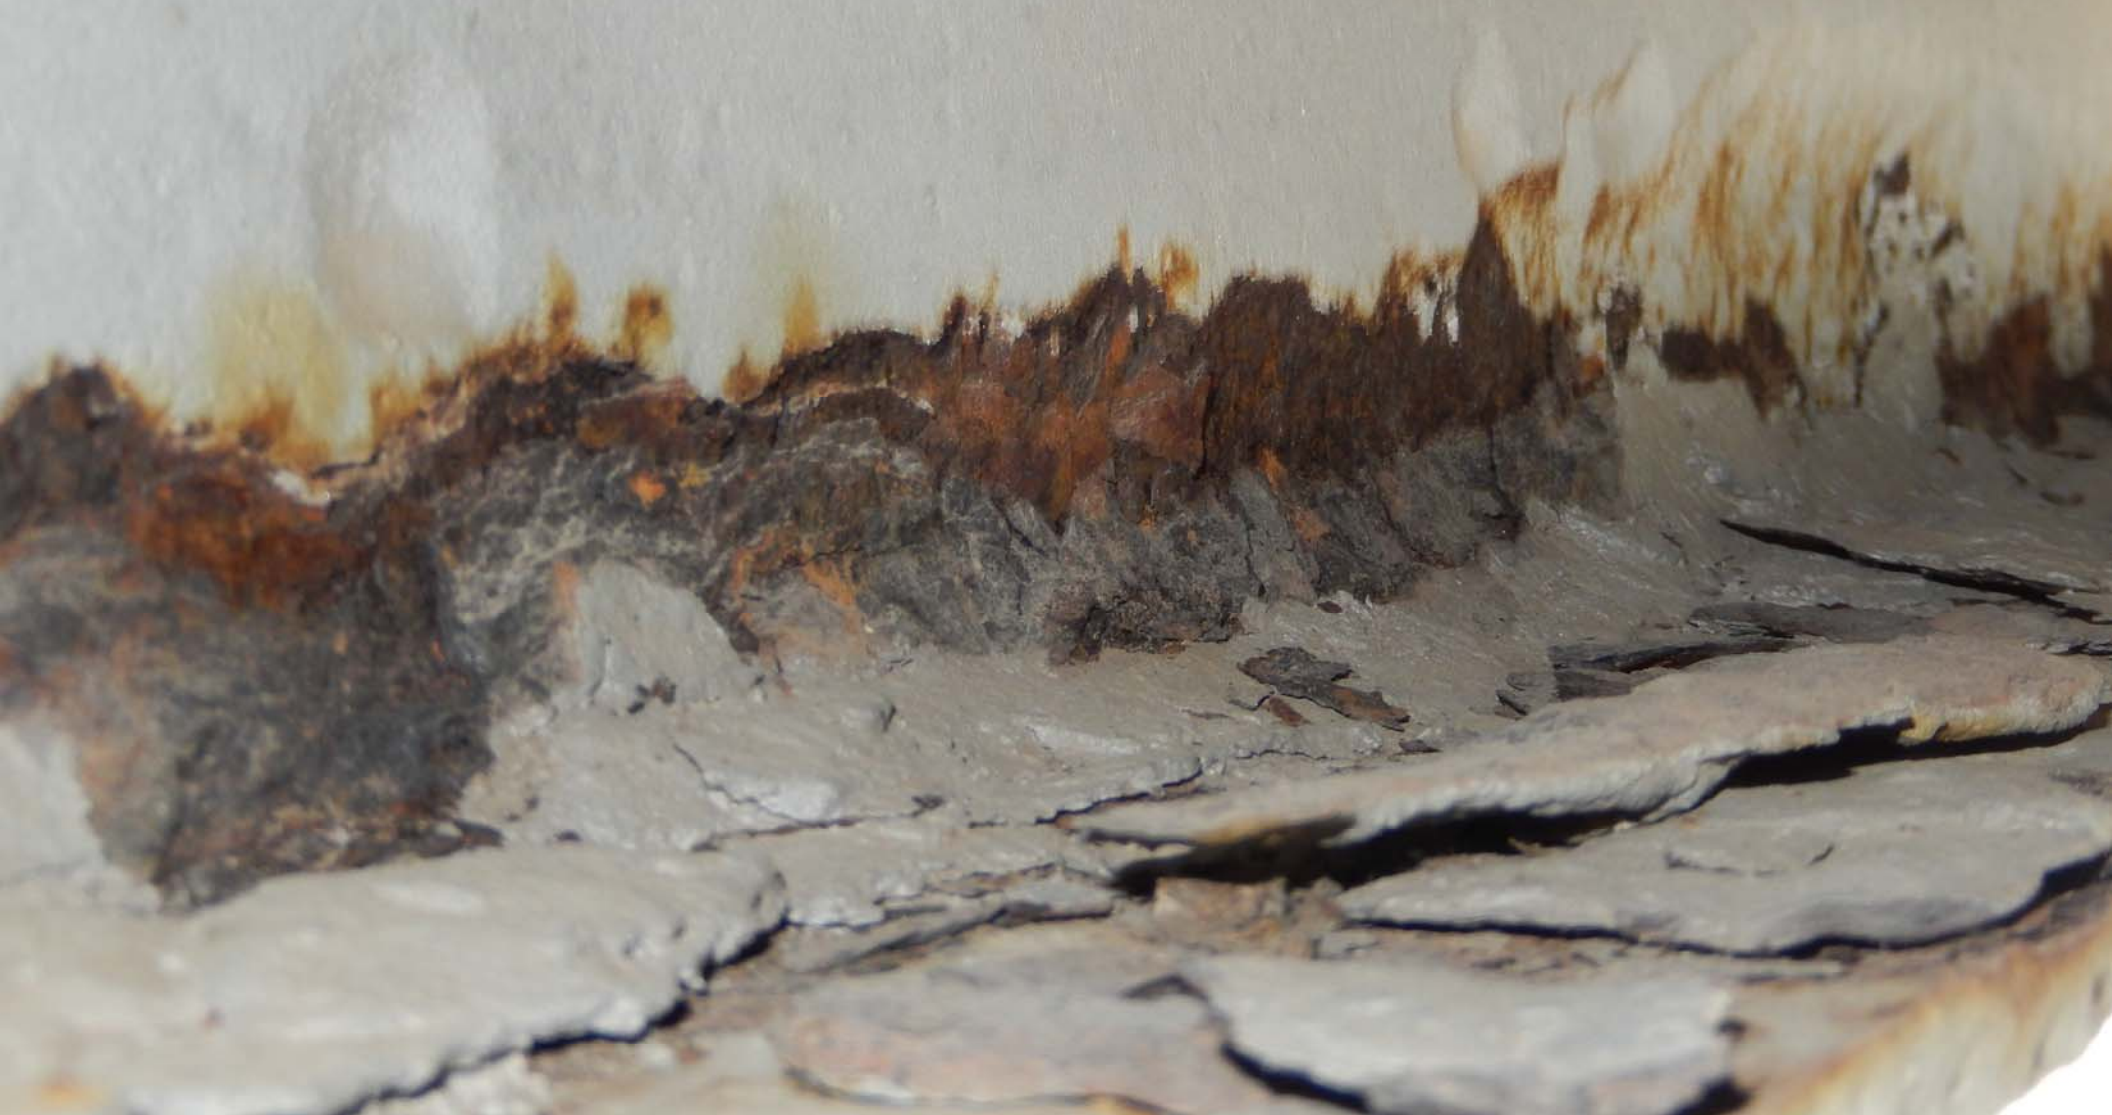
**L0962 9-24-13  
PIER 7 FLBM W SIDE ALONG  
BTTM FLNG W/SL 30%- 50%  
REMAINING THRUOUT  
ENTIRE MEMBER**

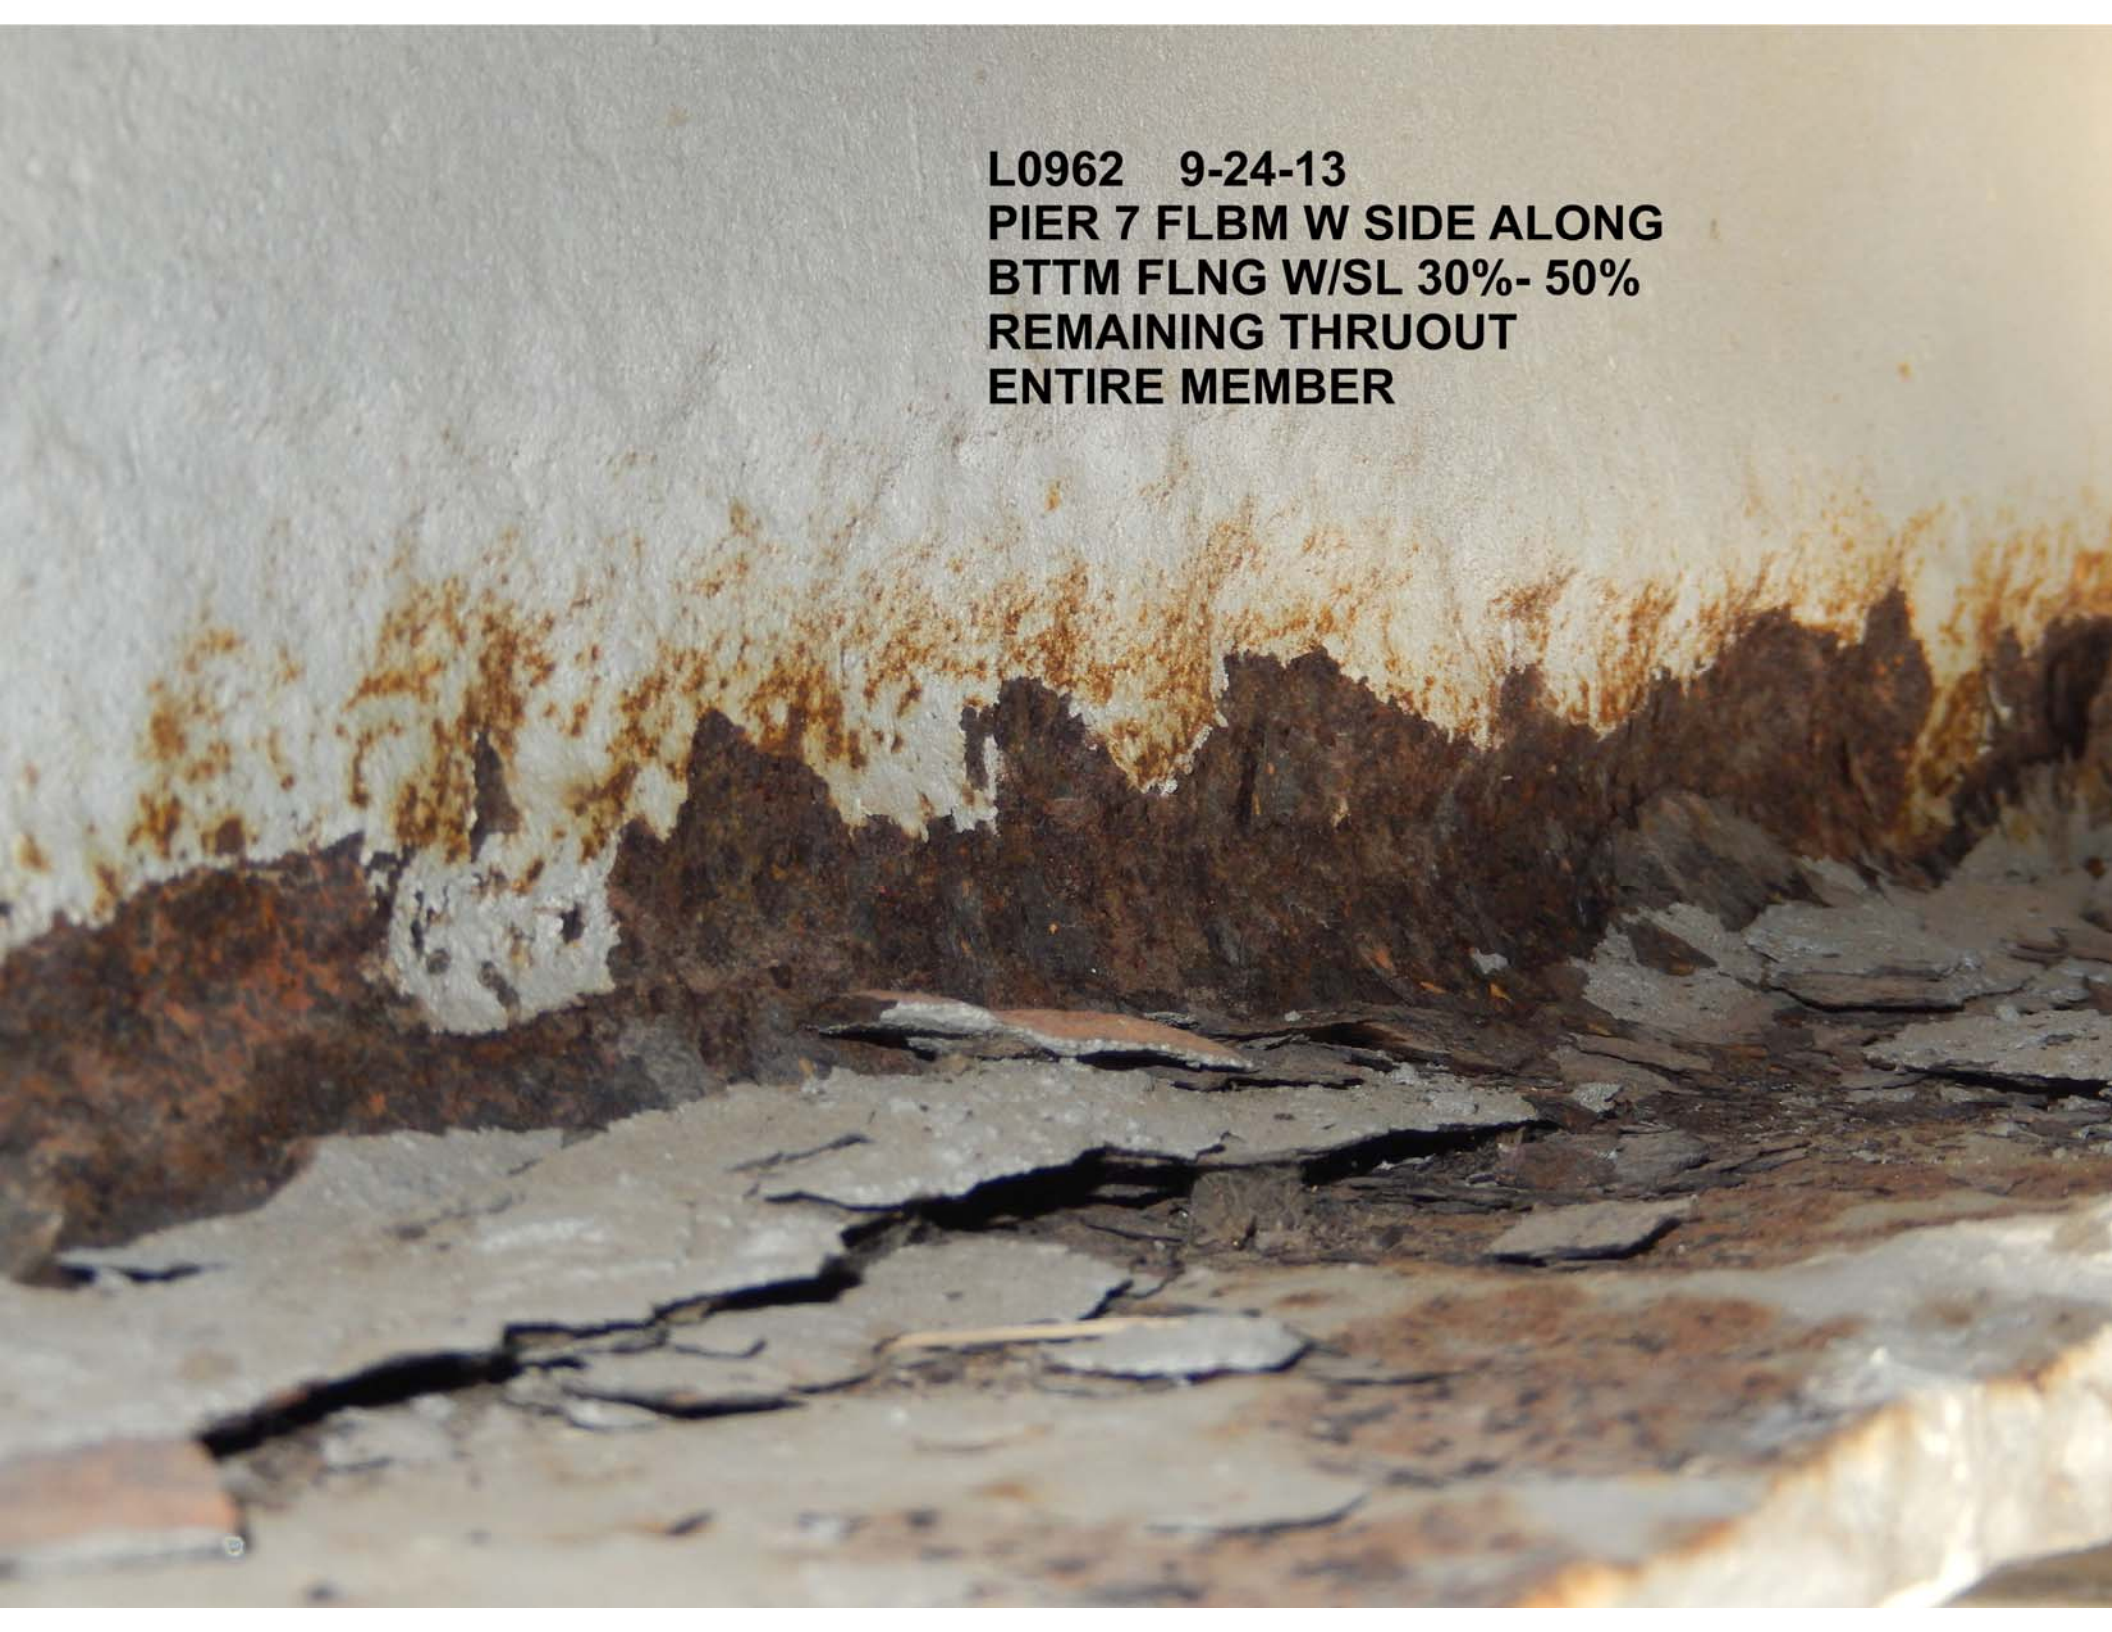
**L0962 9-24-13  
PIER 7 FLBM W SIDE ALONG  
BTTM FLNG W/SL 30%- 50%  
REMAINING THRUOUT  
ENTIRE MEMBER**

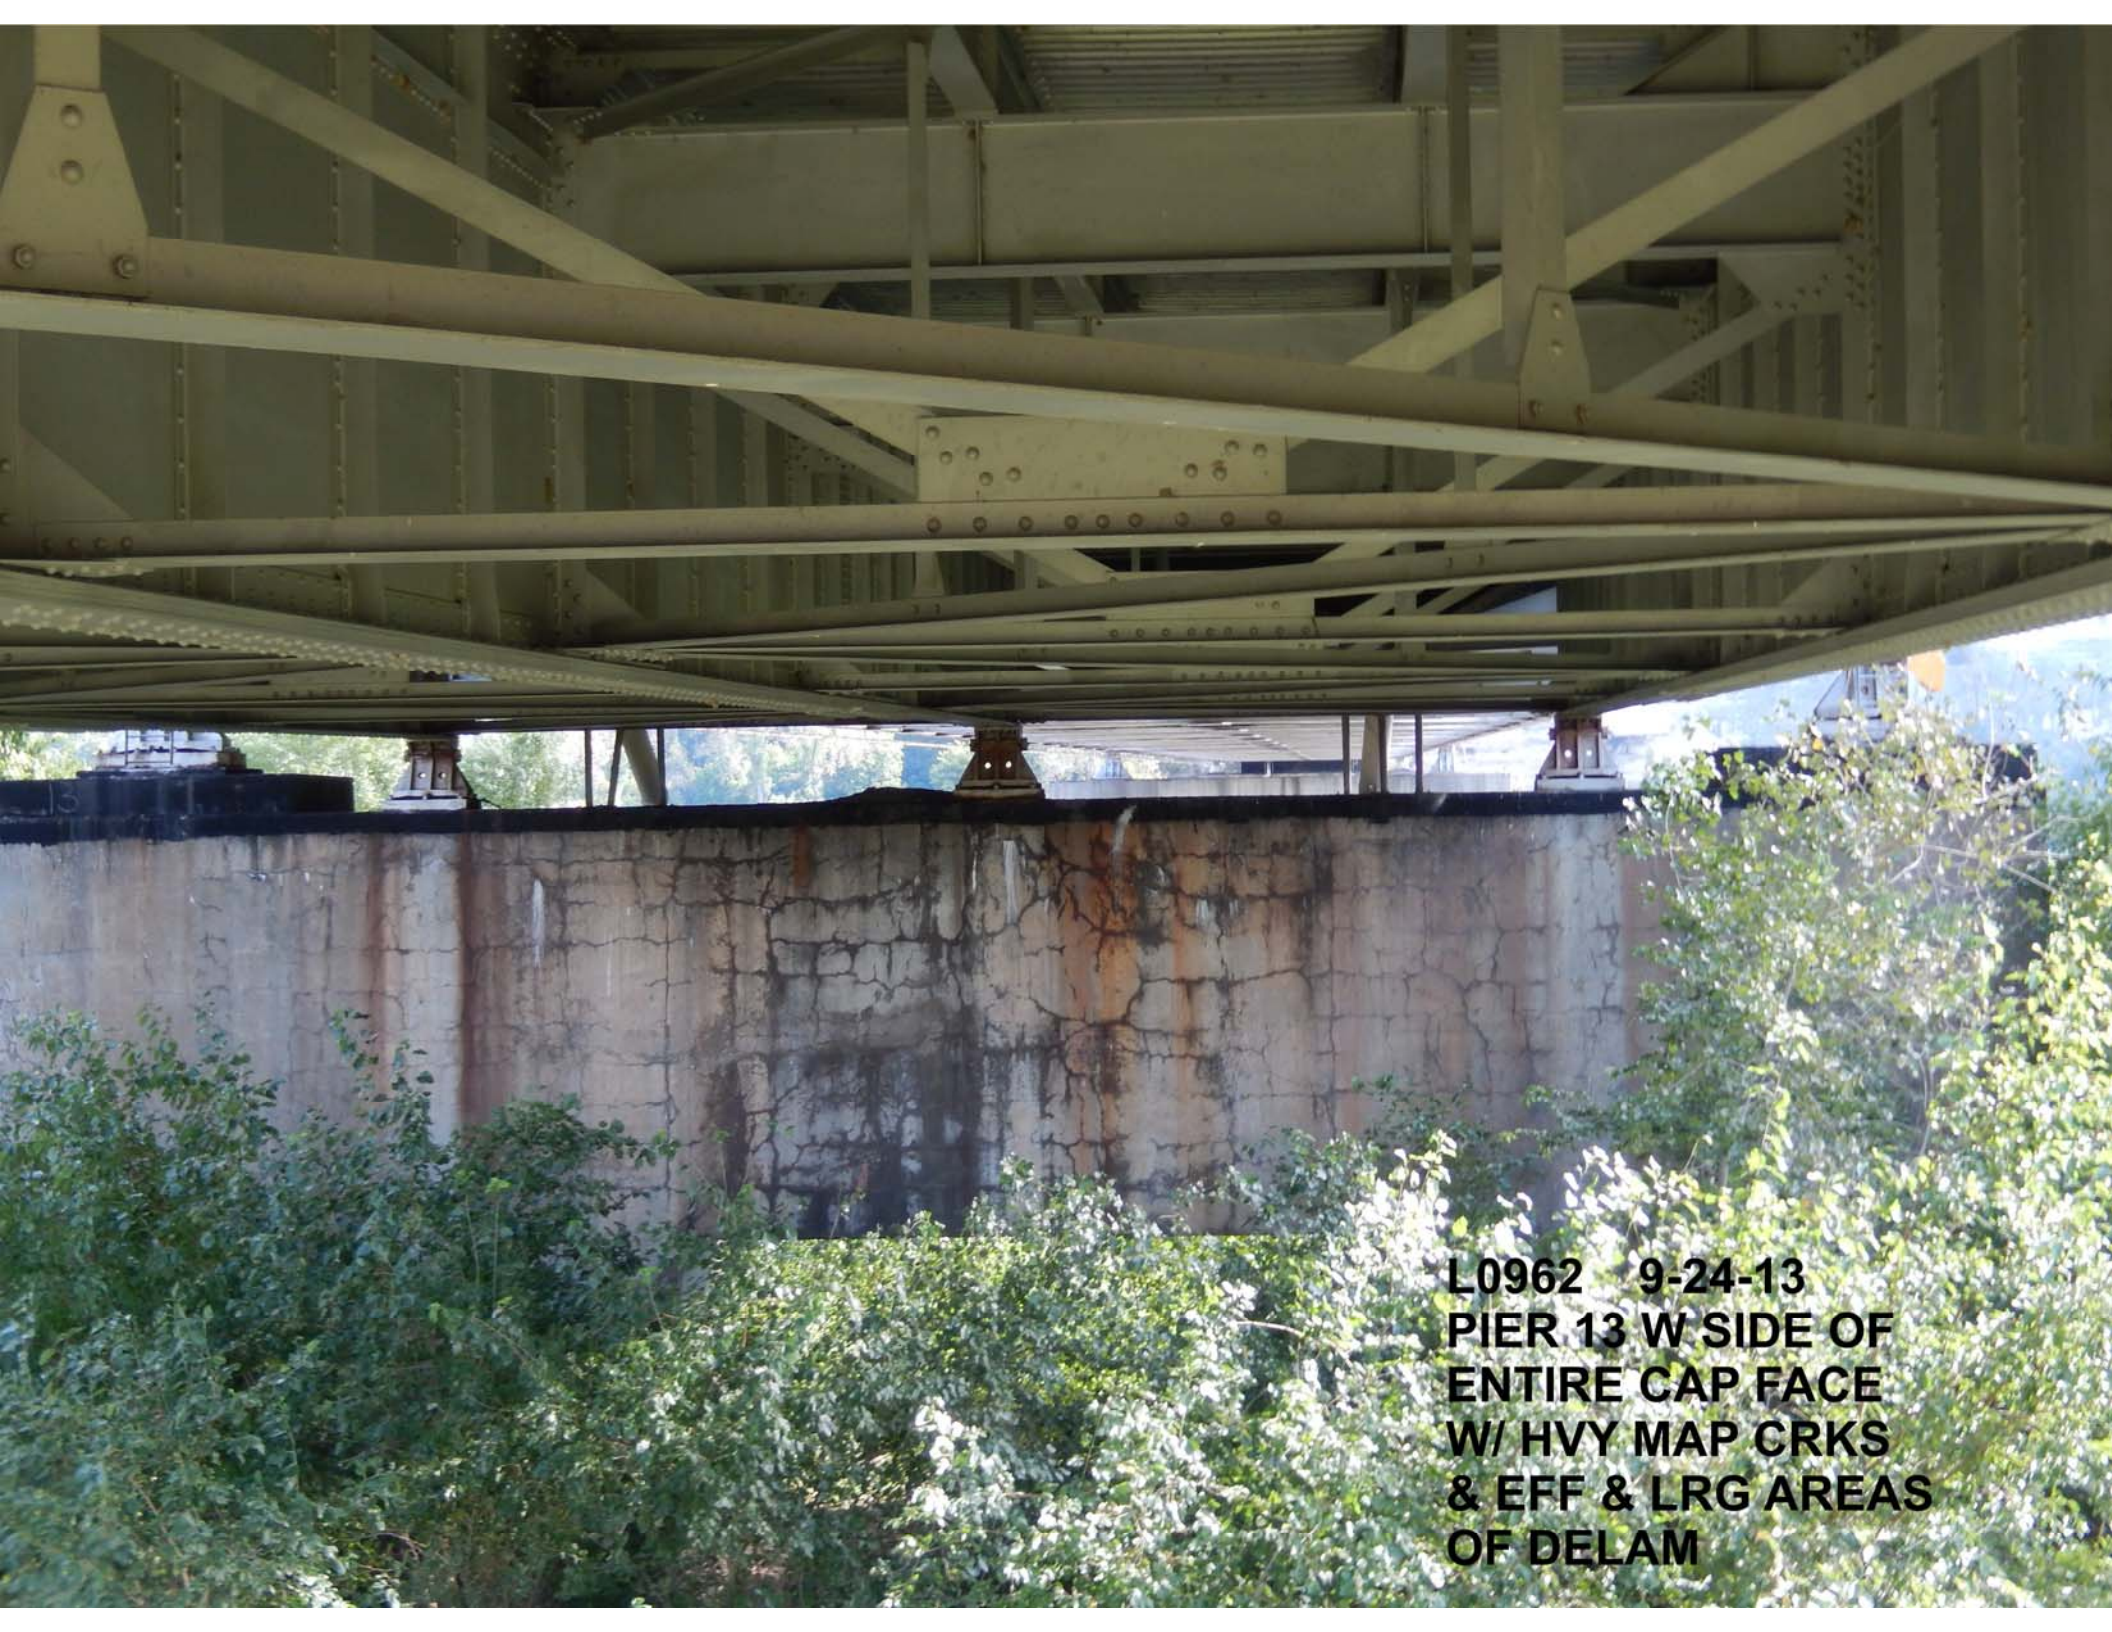
**L0962 9-24-13  
PIER 13 W SIDE OF  
ENTIRE CAP FACE  
W/ HVY MAP CRKS  
& EFF & LRG AREAS  
OF DELAM**

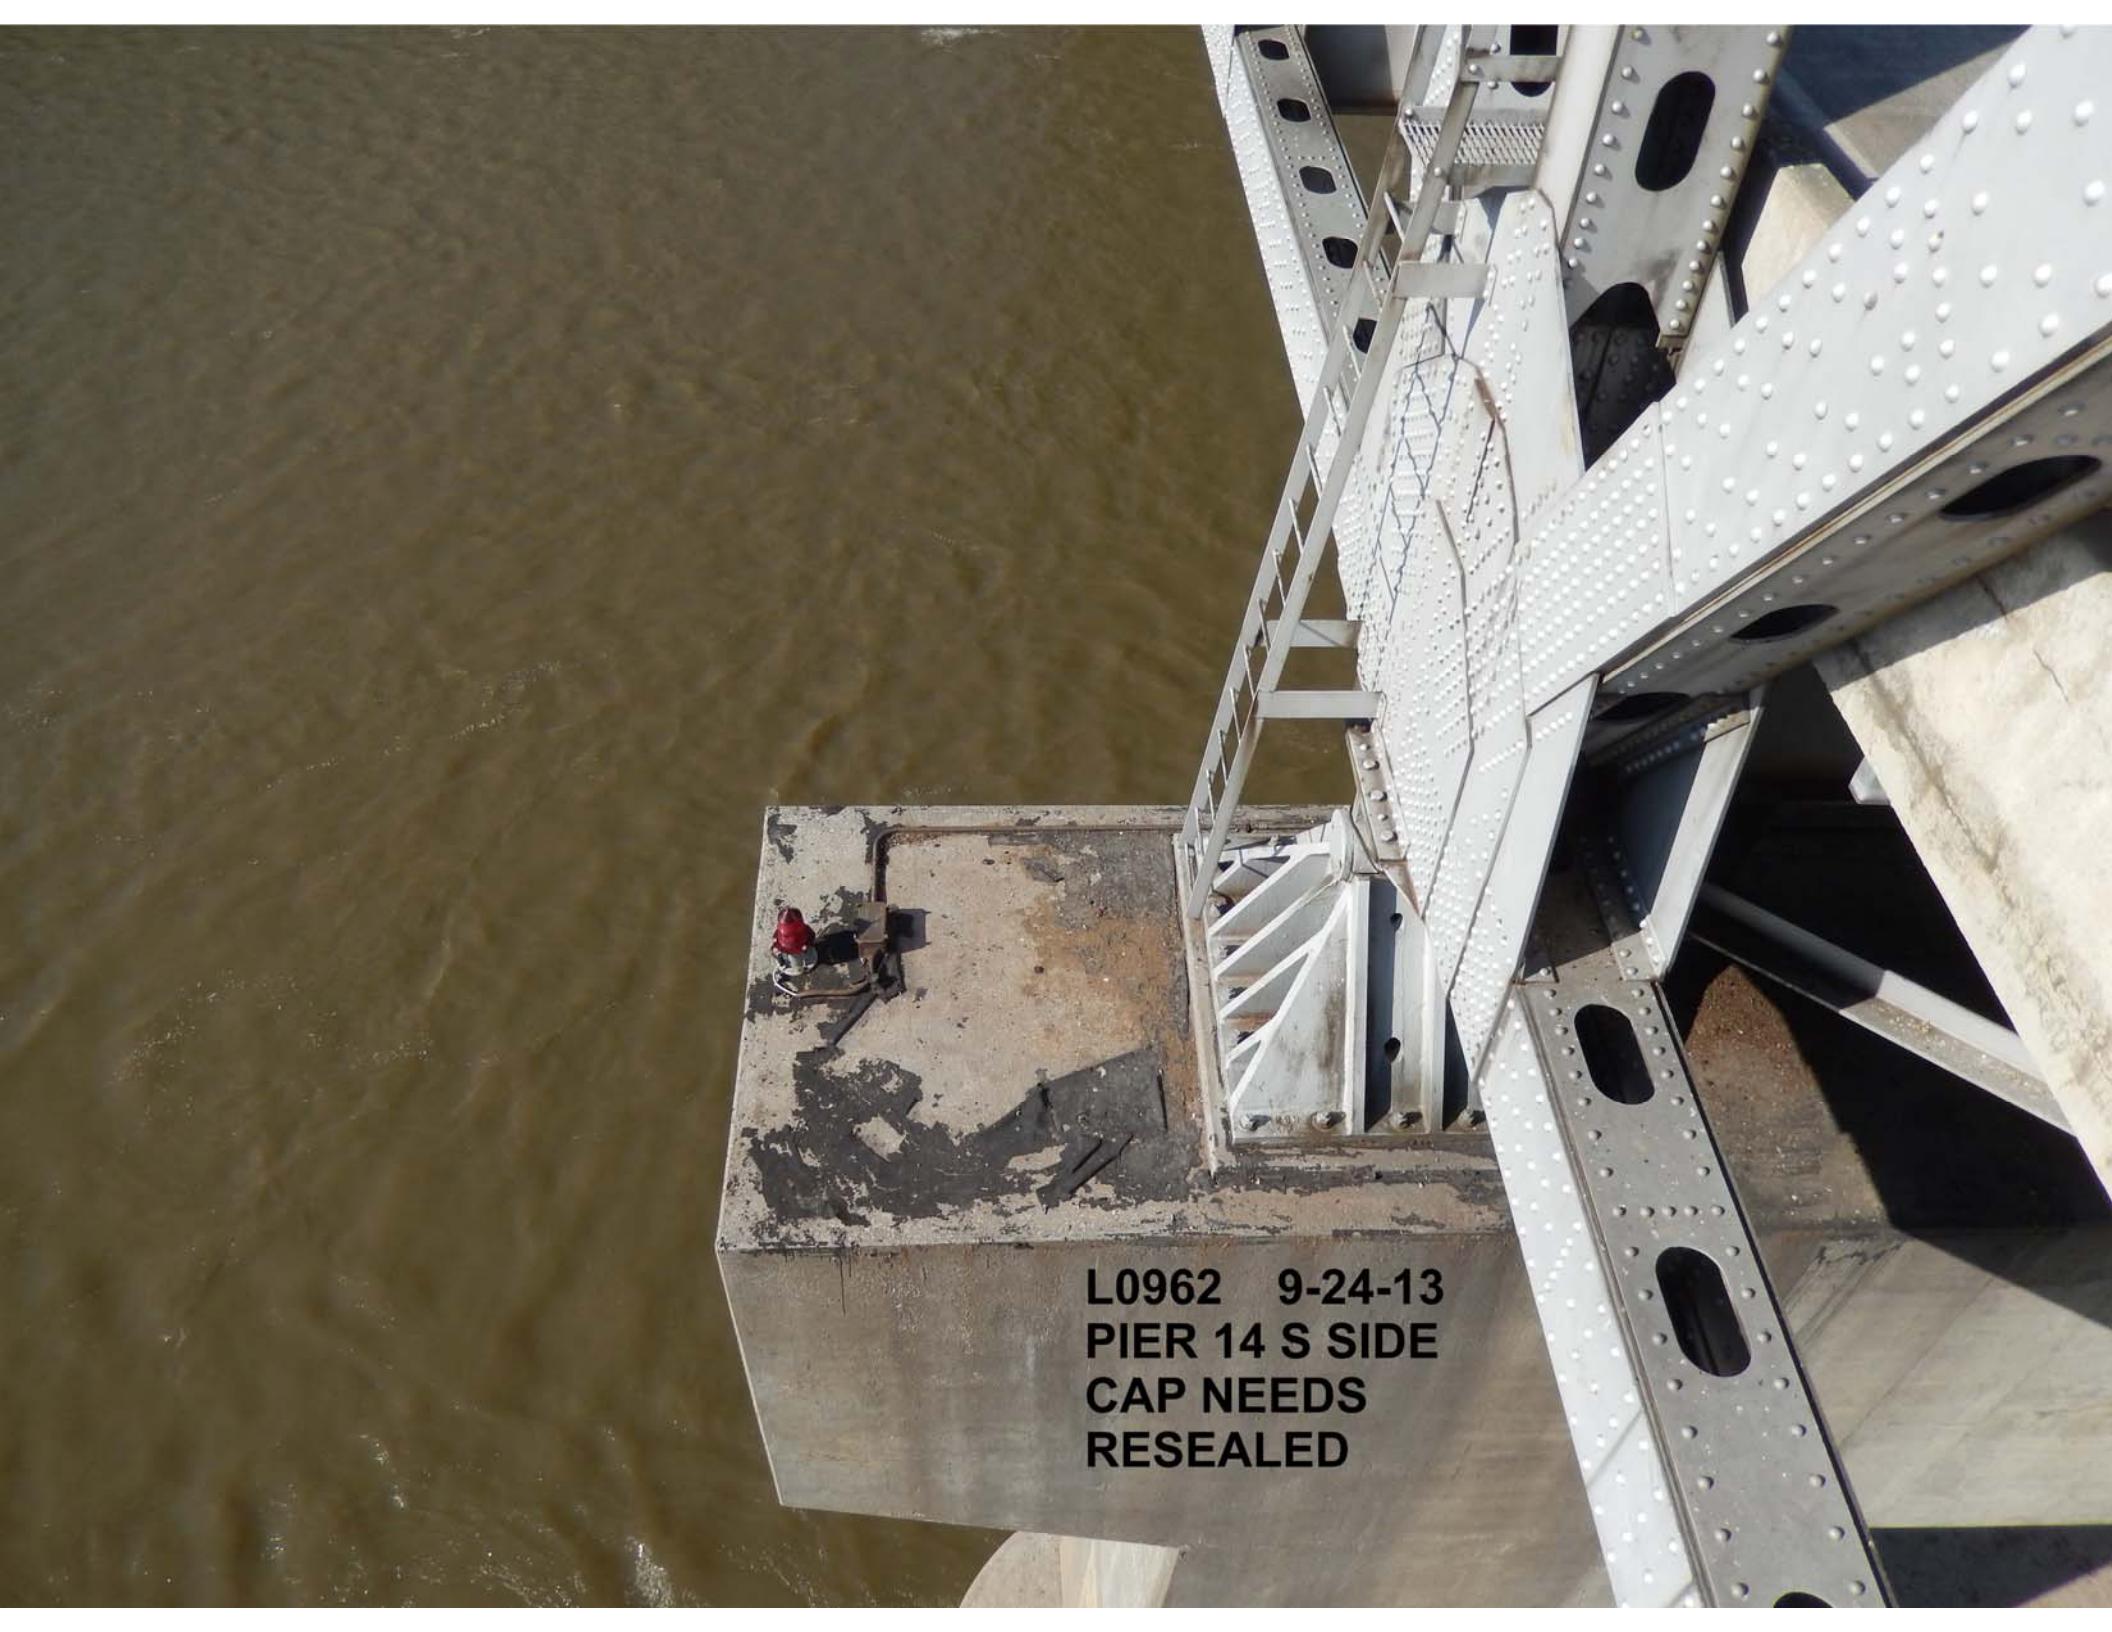
**L0962 9-24-13  
PIER 14 S SIDE  
CAP NEEDS  
RESEALED**

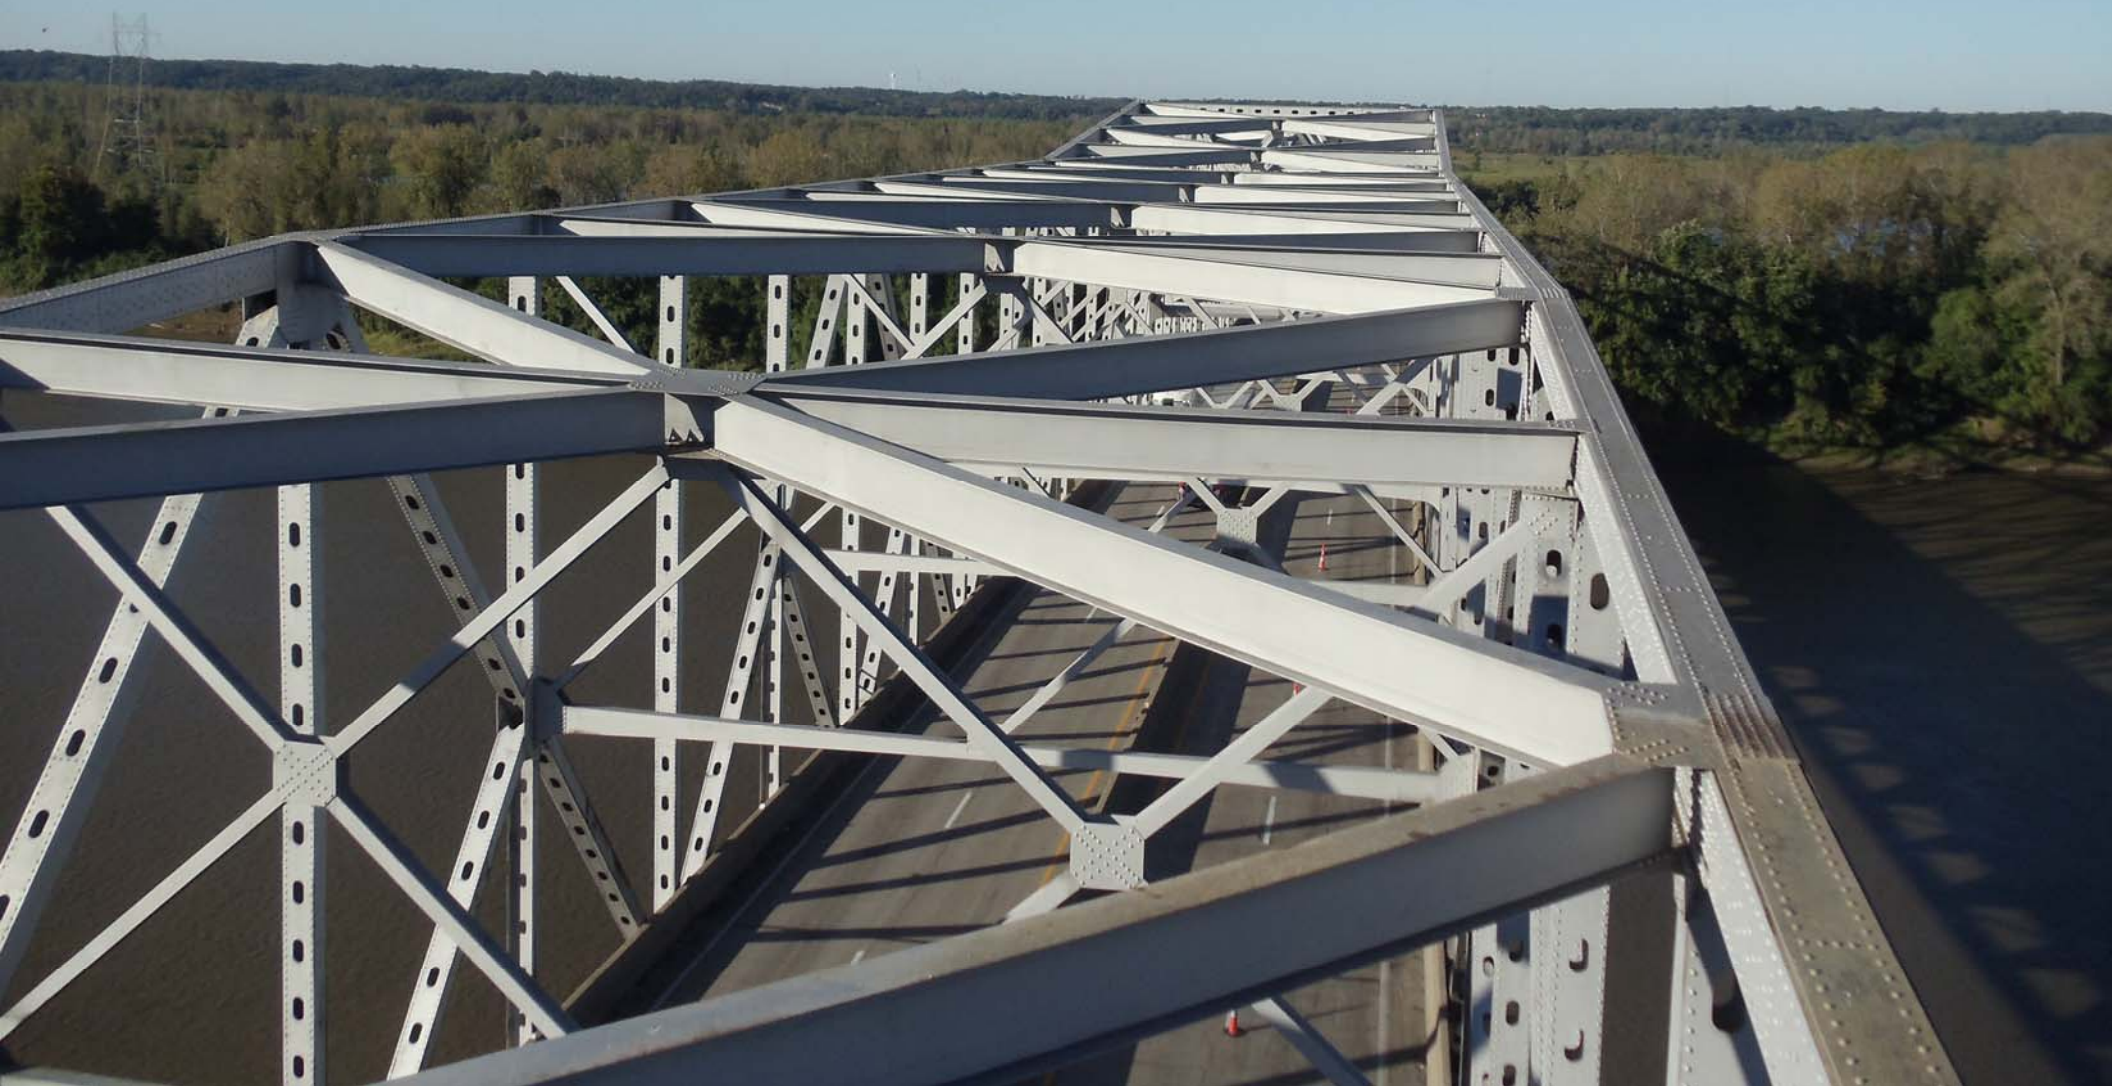
**L0962      9-23-13 B**  
**SP 14 U-7' LEFT UPPER LATERAL**  
**W/ MINOR DISTORTION OF FLNG**

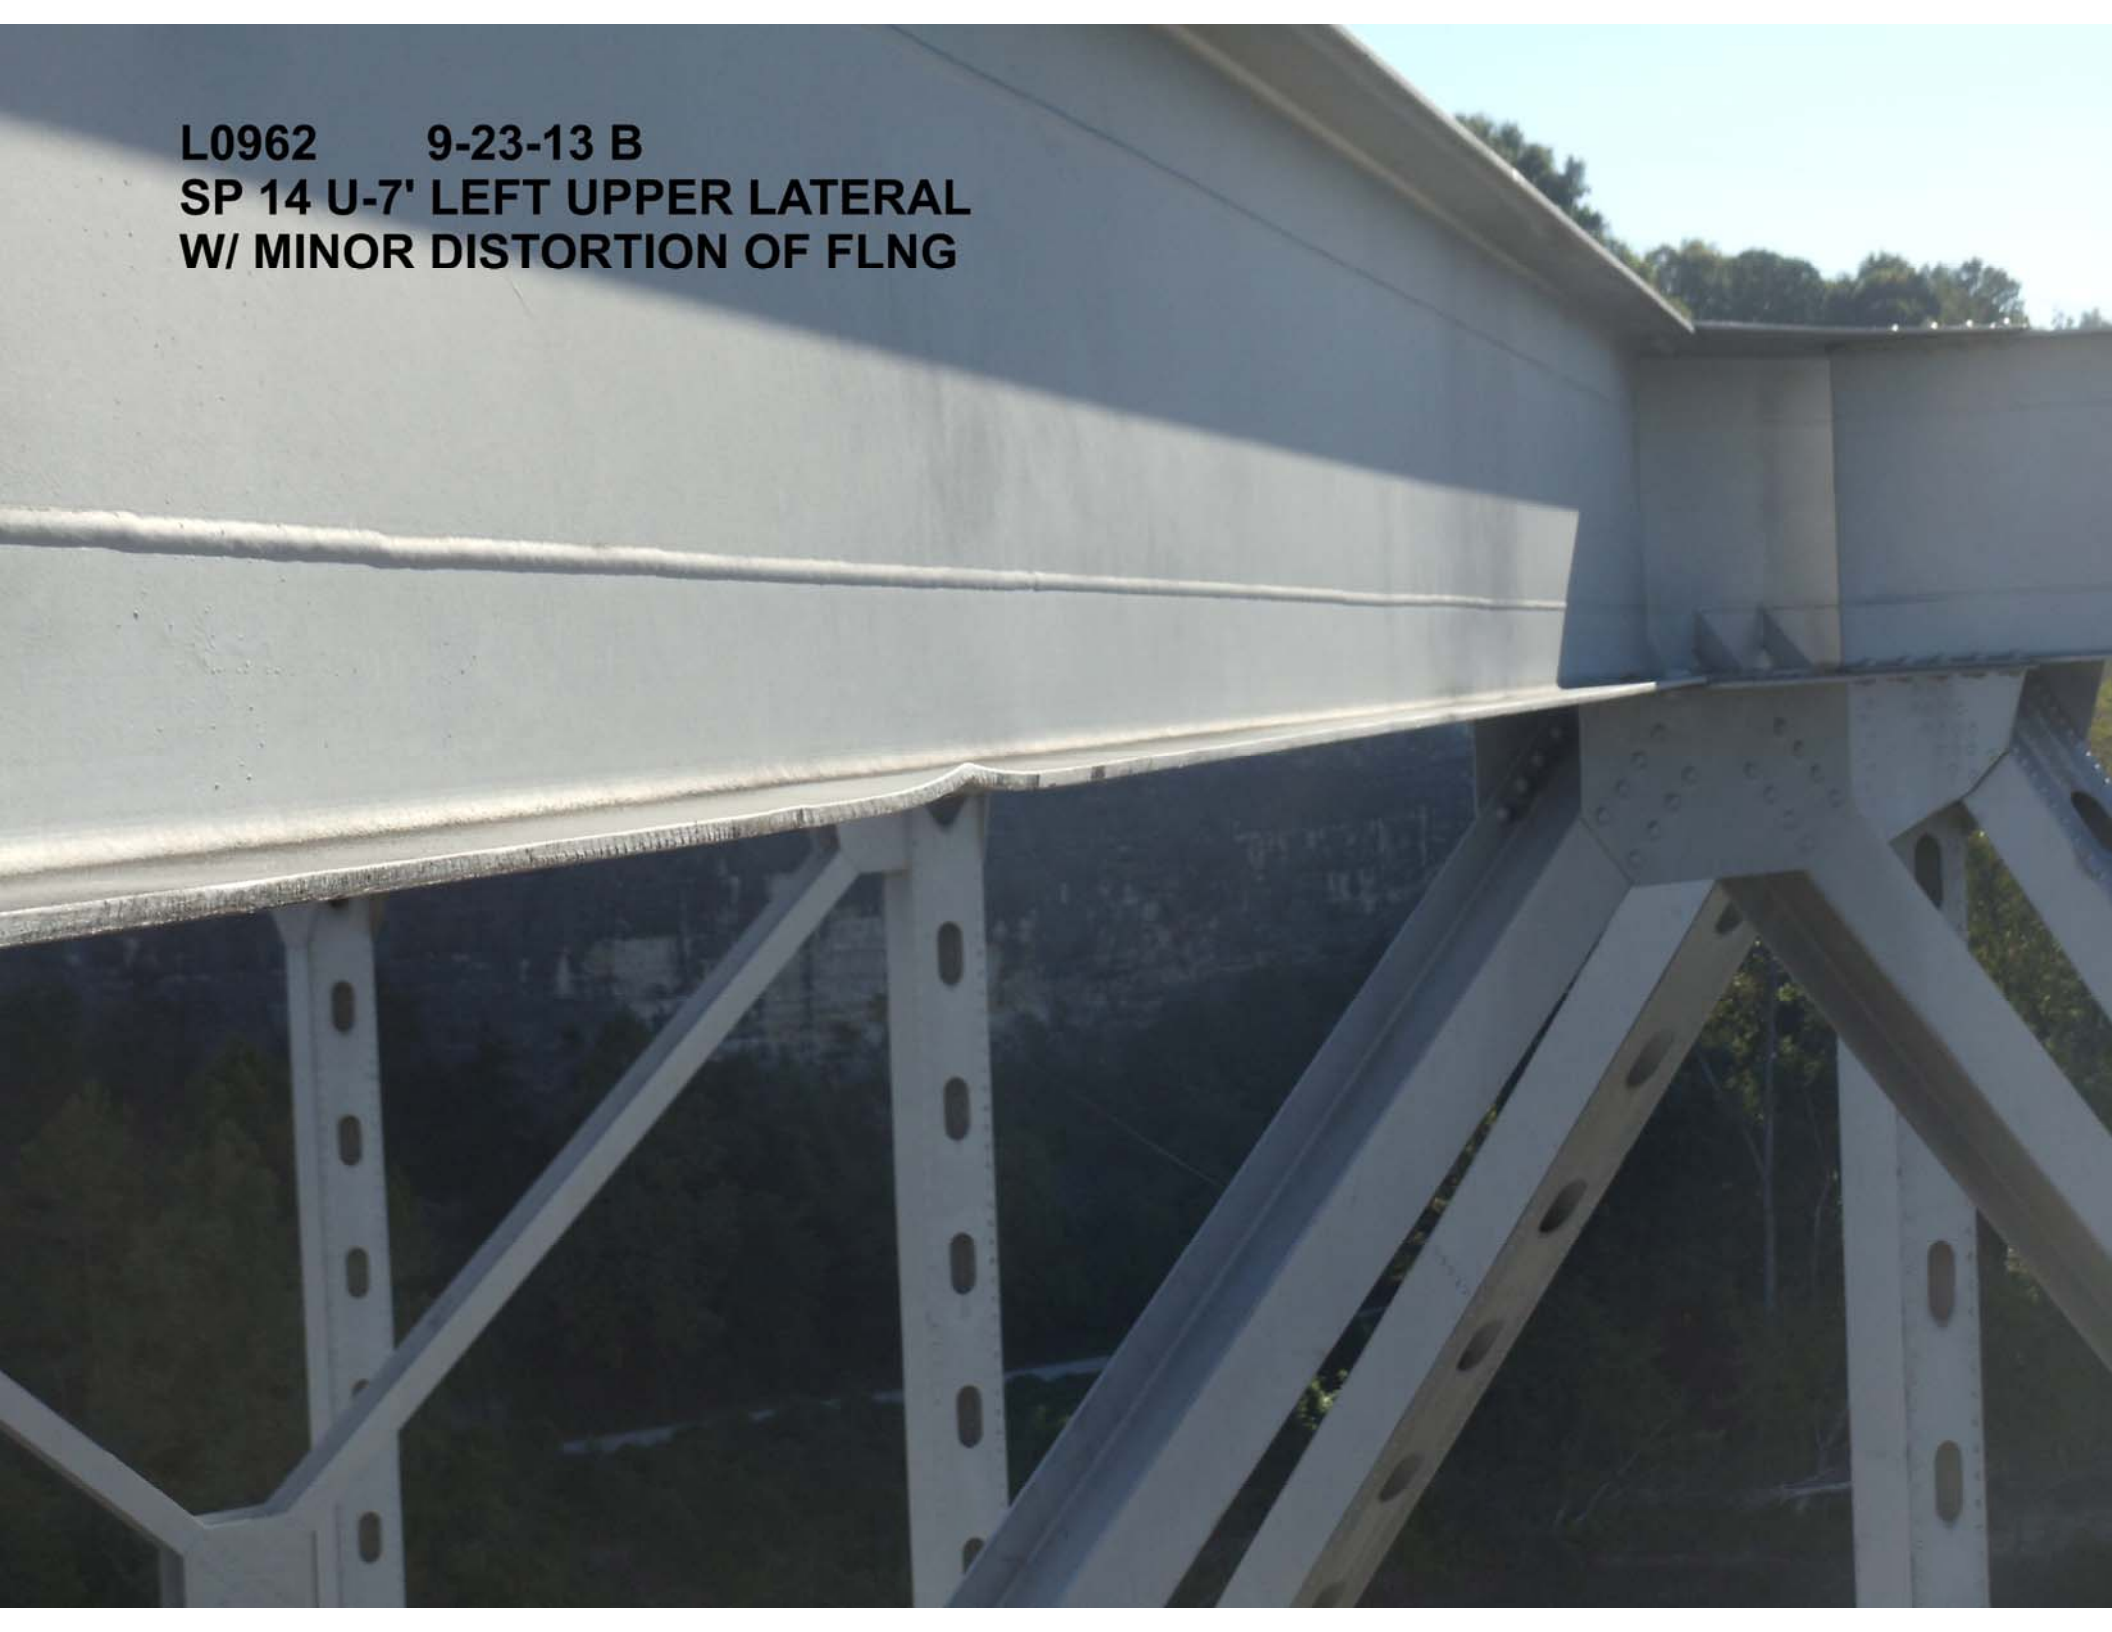
**L0962      9-23-13 B**  
**SP 14 U-8' LEFT TOP GUSS**  
**W/ MINOR DISTORTION**
