L0962 I 70 Cooper Co.  
Joint at L8, span 13  
Eastbound lane failing  
9-24-13

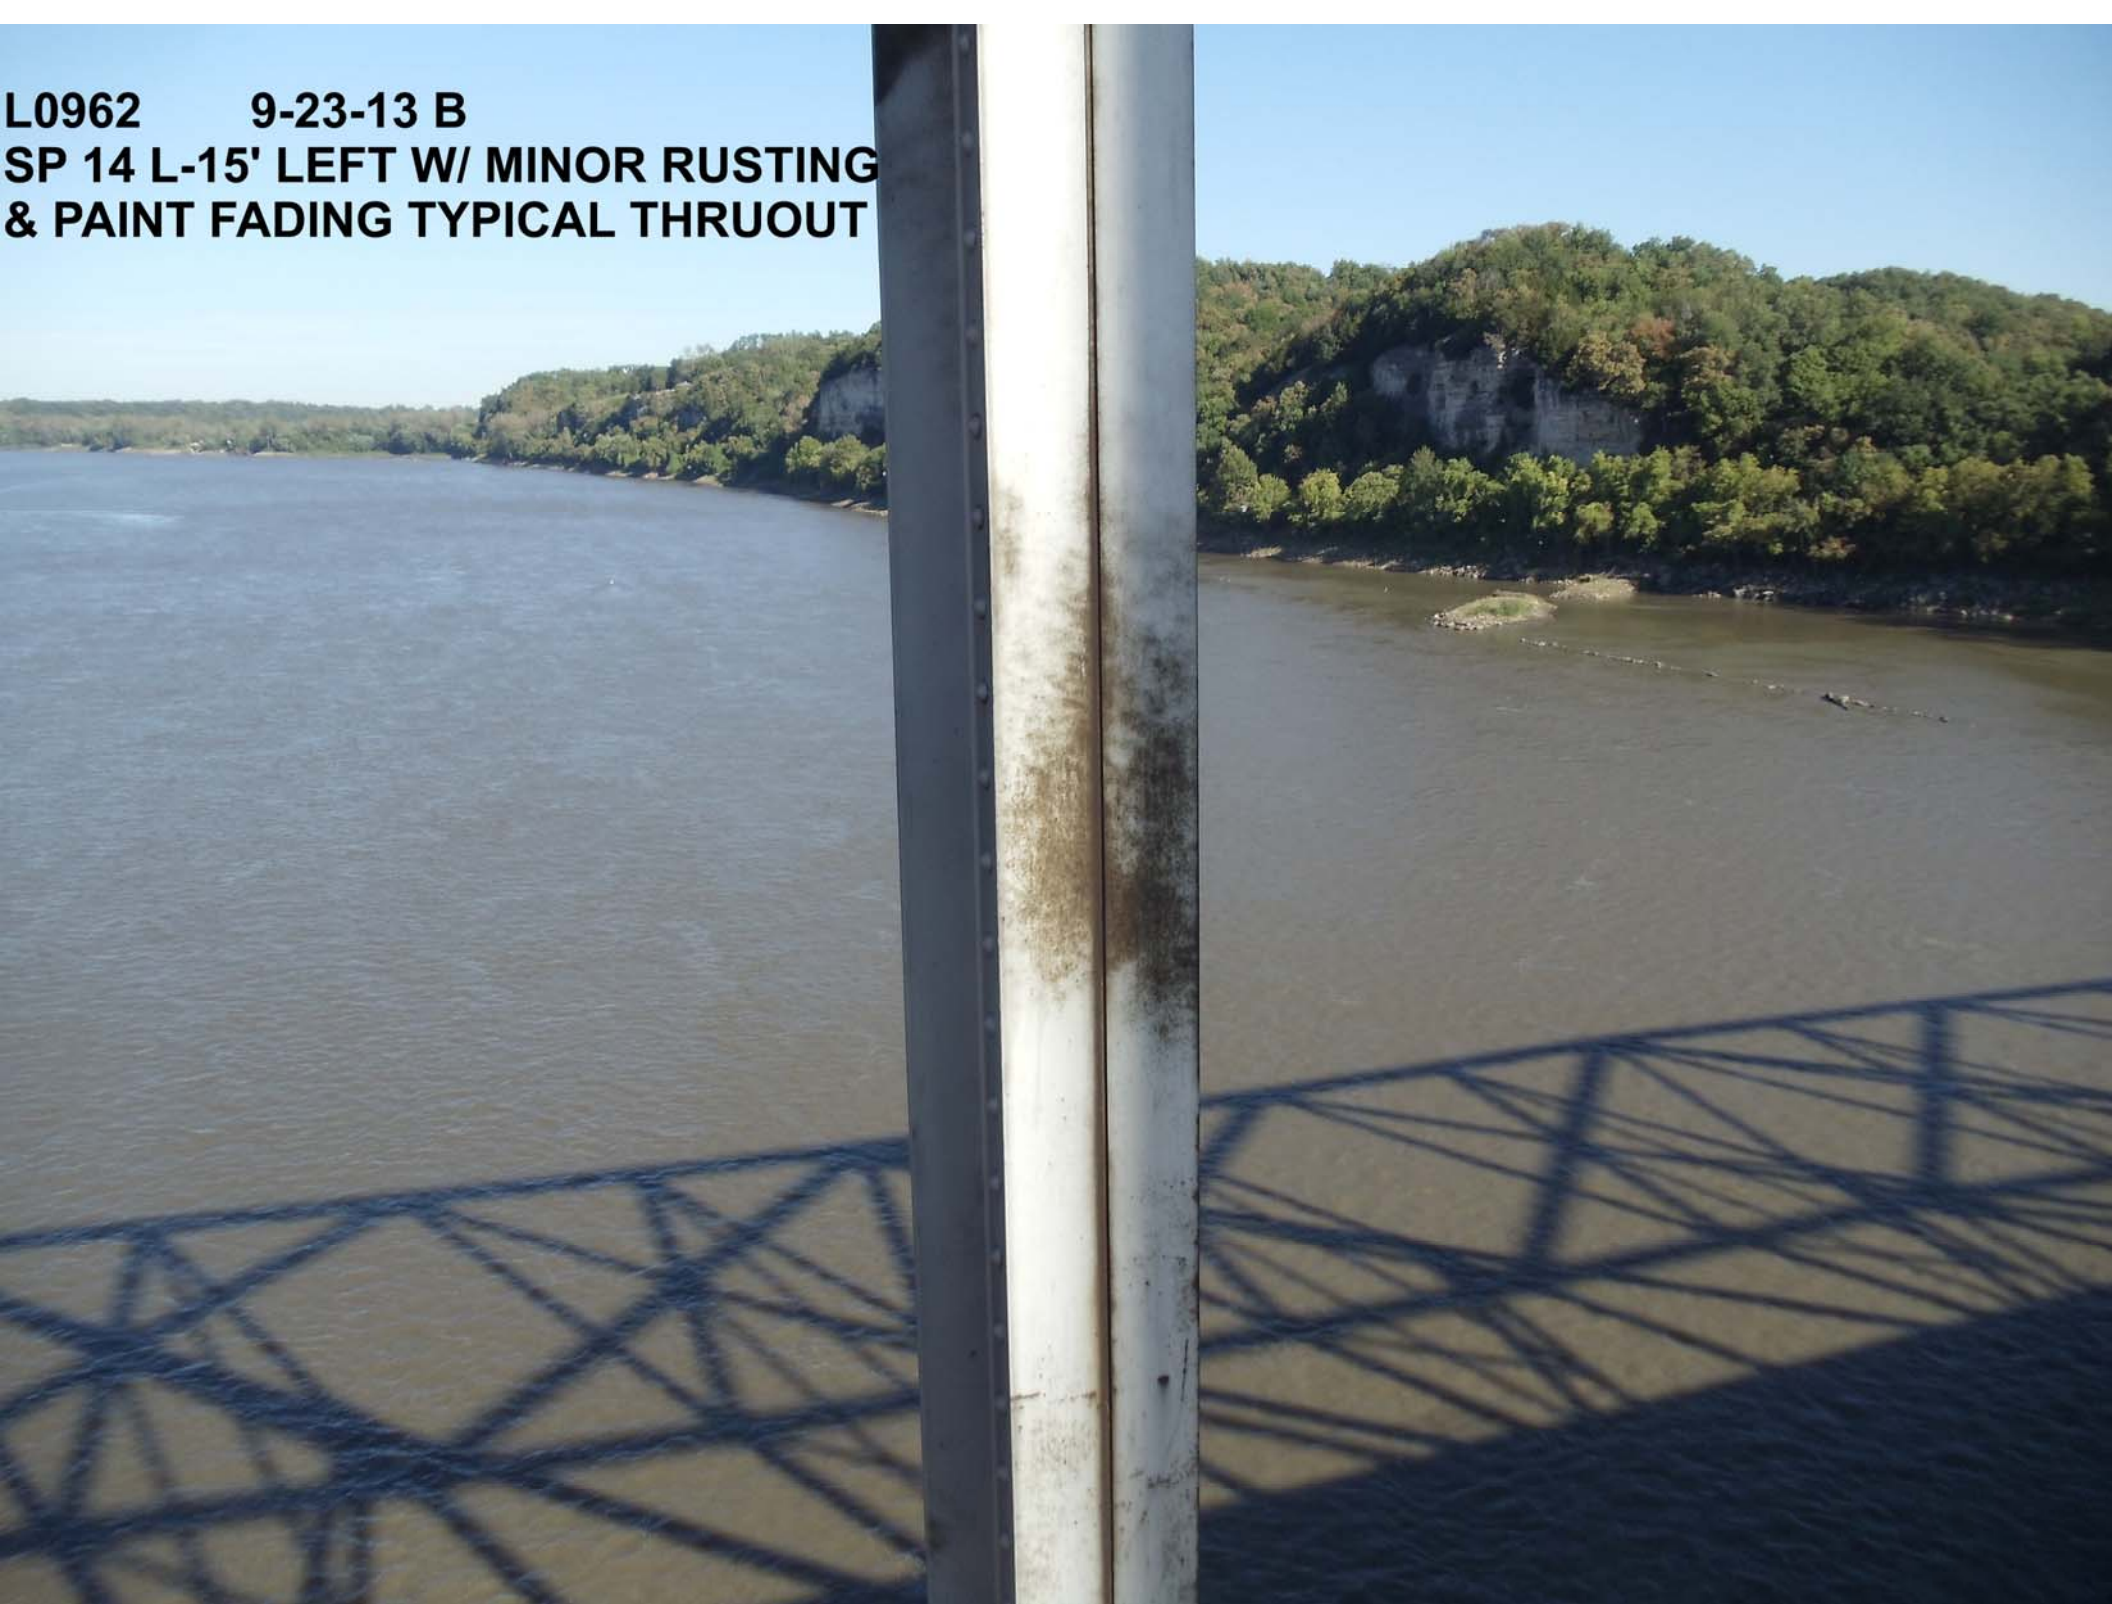
**L0962      9-23-13 B**  
**SP 13 L-19 LEFT W/ FERN'S GROWING**  
**IN DIAG. CONNECTION PLATE**

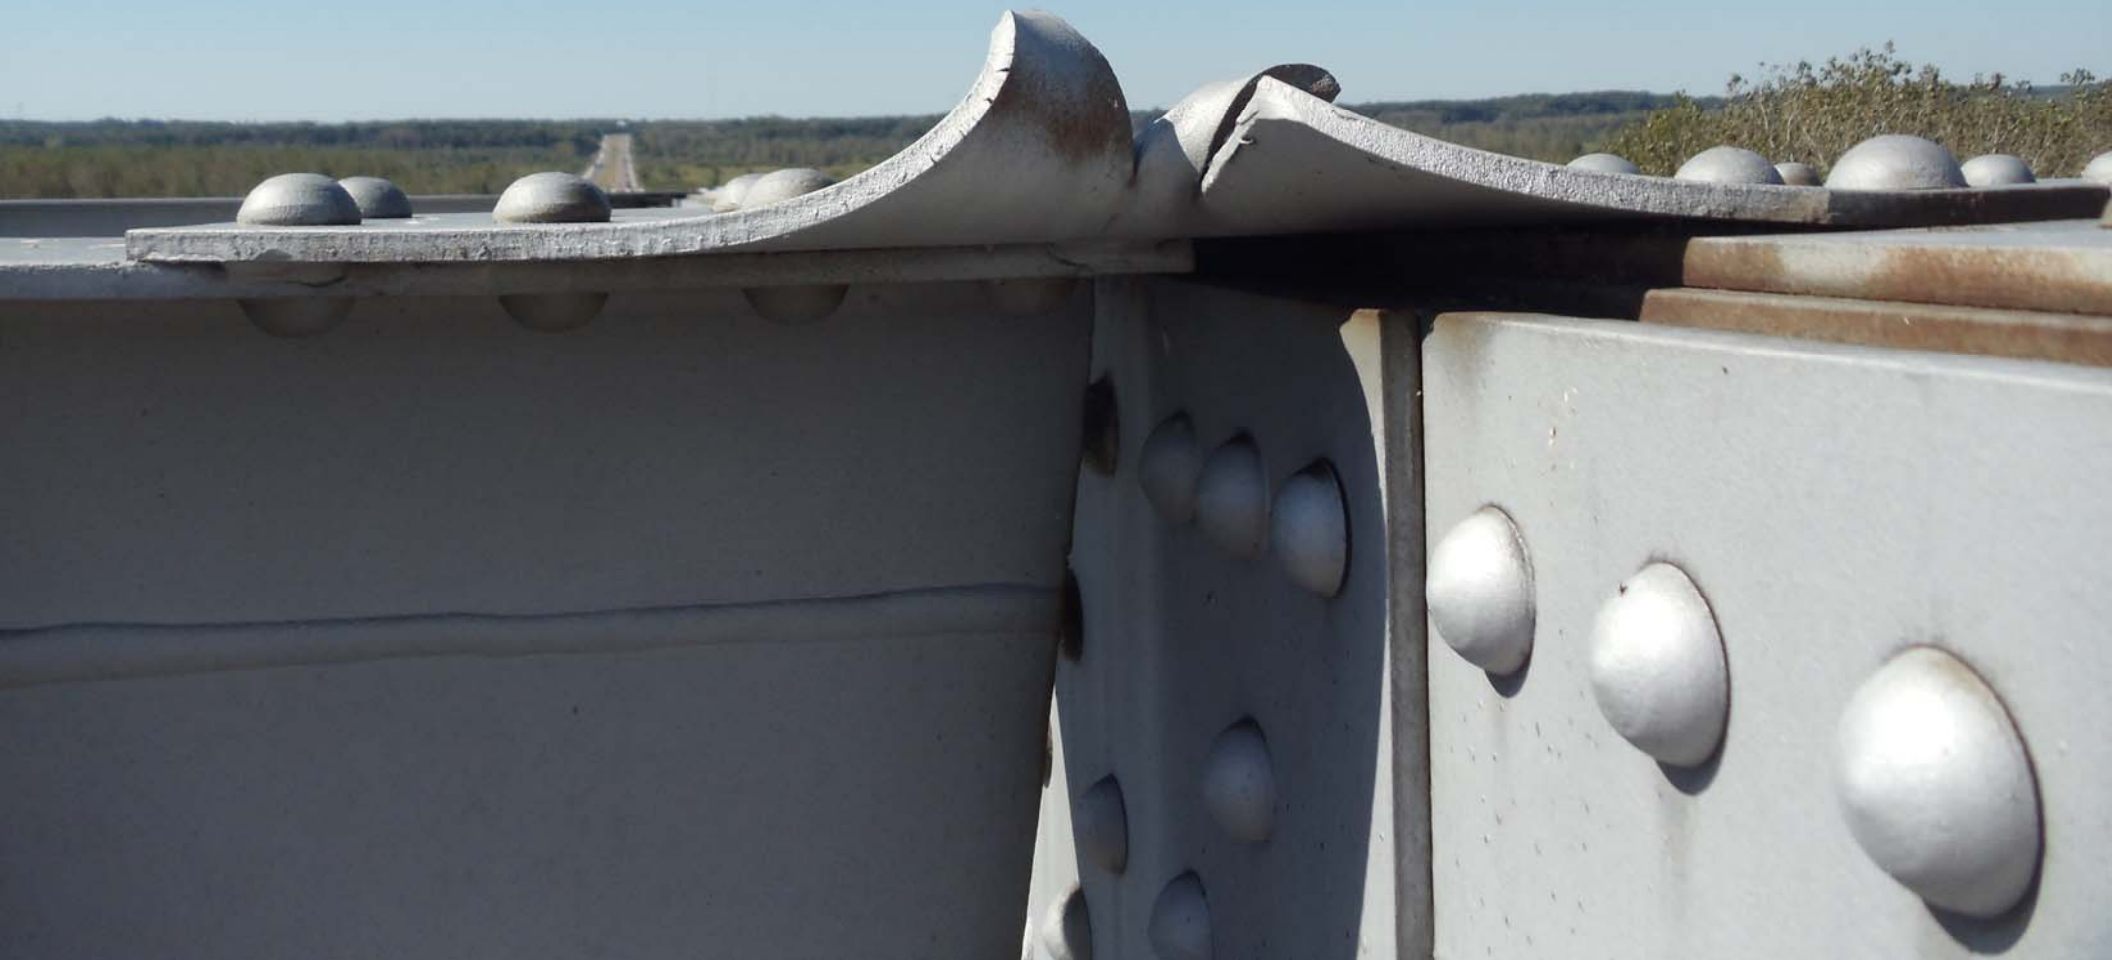
**L0962      9-23-13 B**  
**SP 13 U-7 LEFT W/ 3" RIP IN TOP GUSS**  
**NO CRK BEYOND DAMAGED AREA**

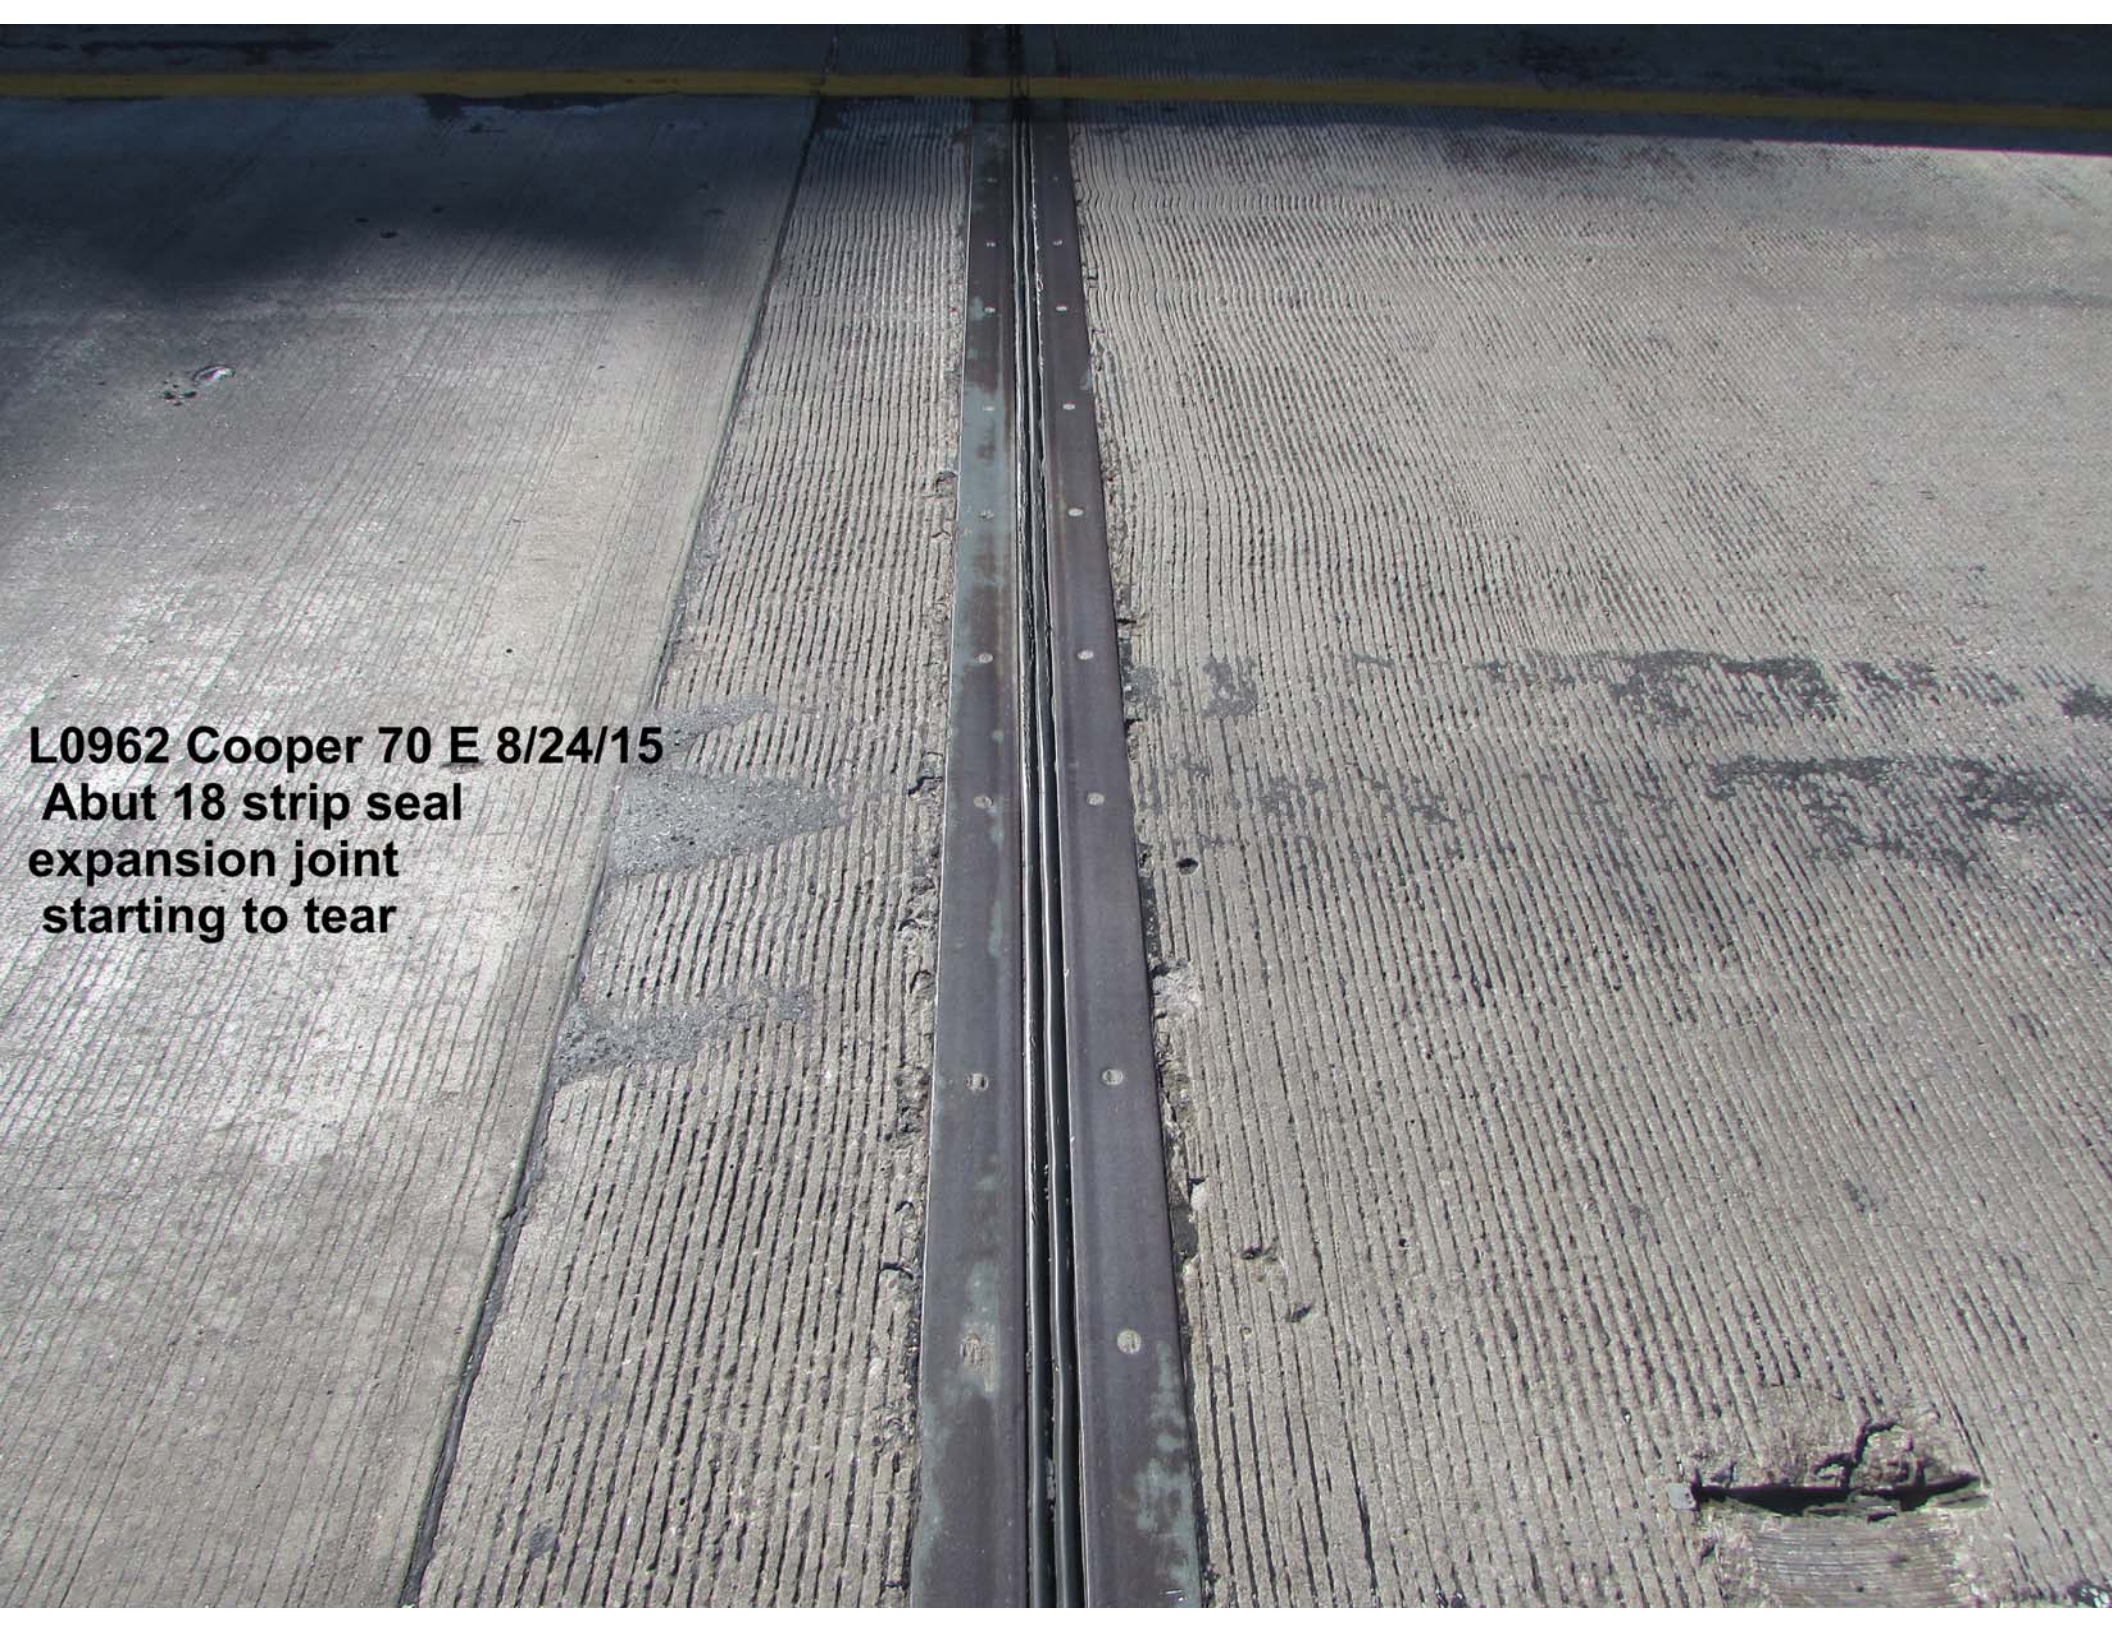
**L0962 Cooper 70 E 8/24/15**  
**Abut 18 strip seal**  
**expansion joint**  
**starting to tear**

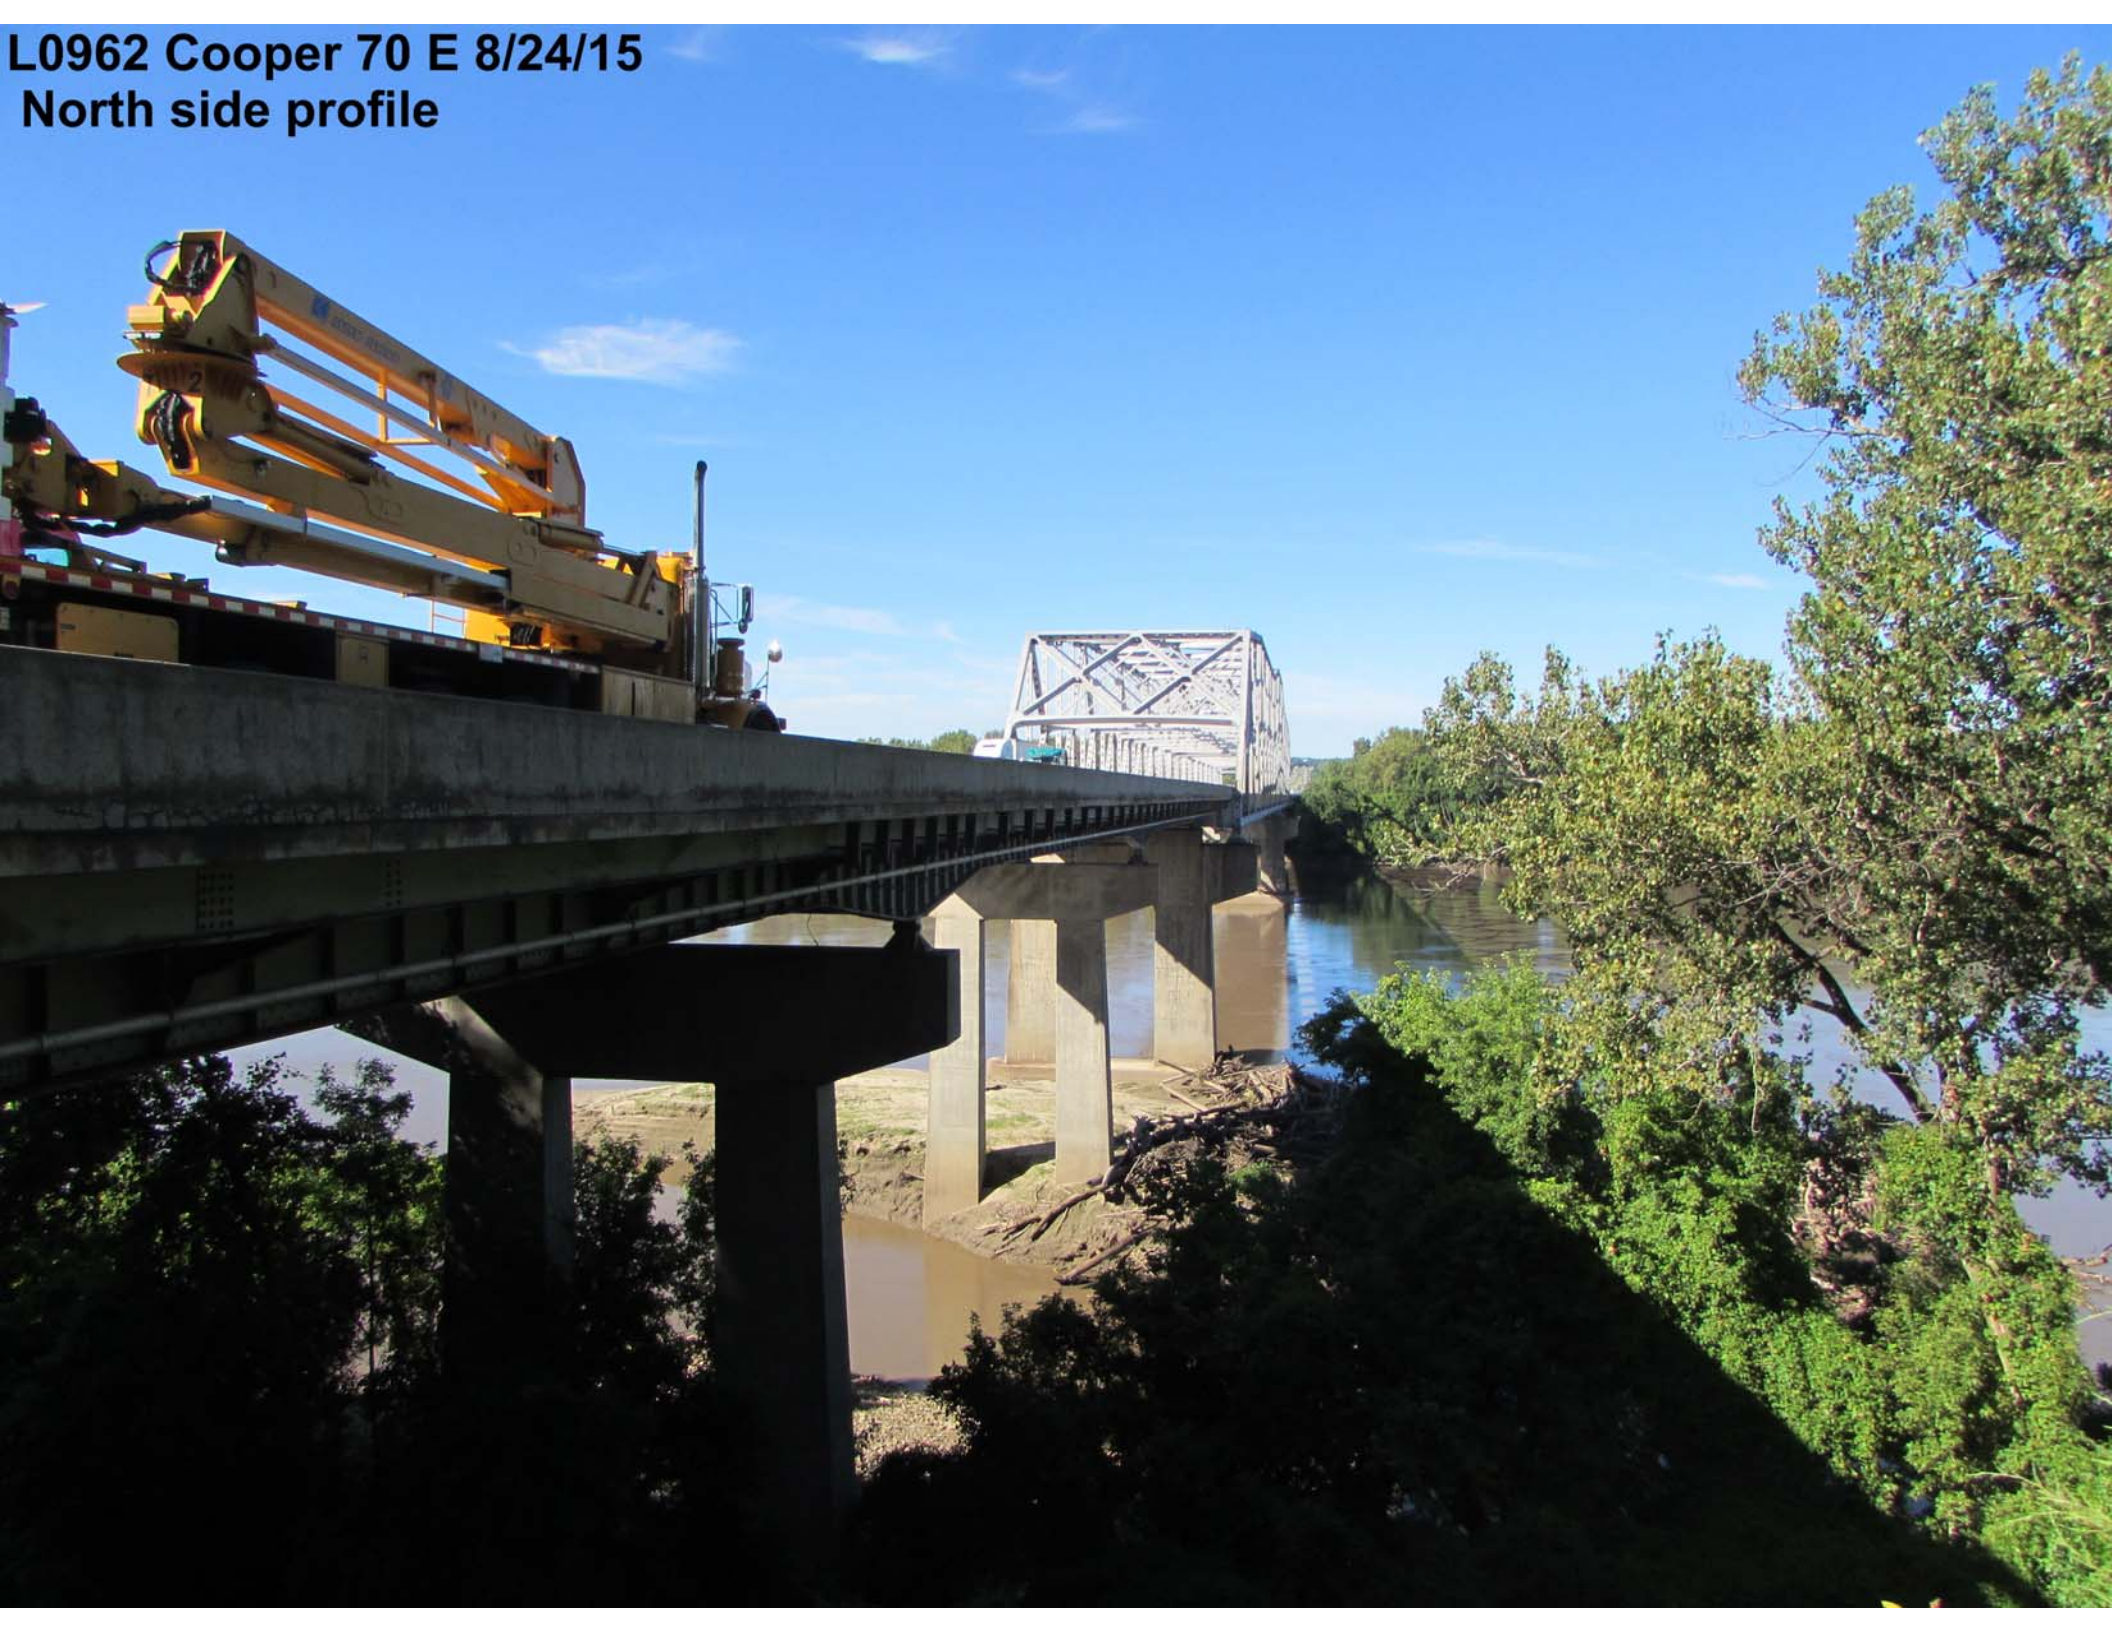
**L0962 Cooper 70 E 8/24/15**  
**Abut 18 rockers**  
**tipped west seal**  
**peeling spalls few in cap**

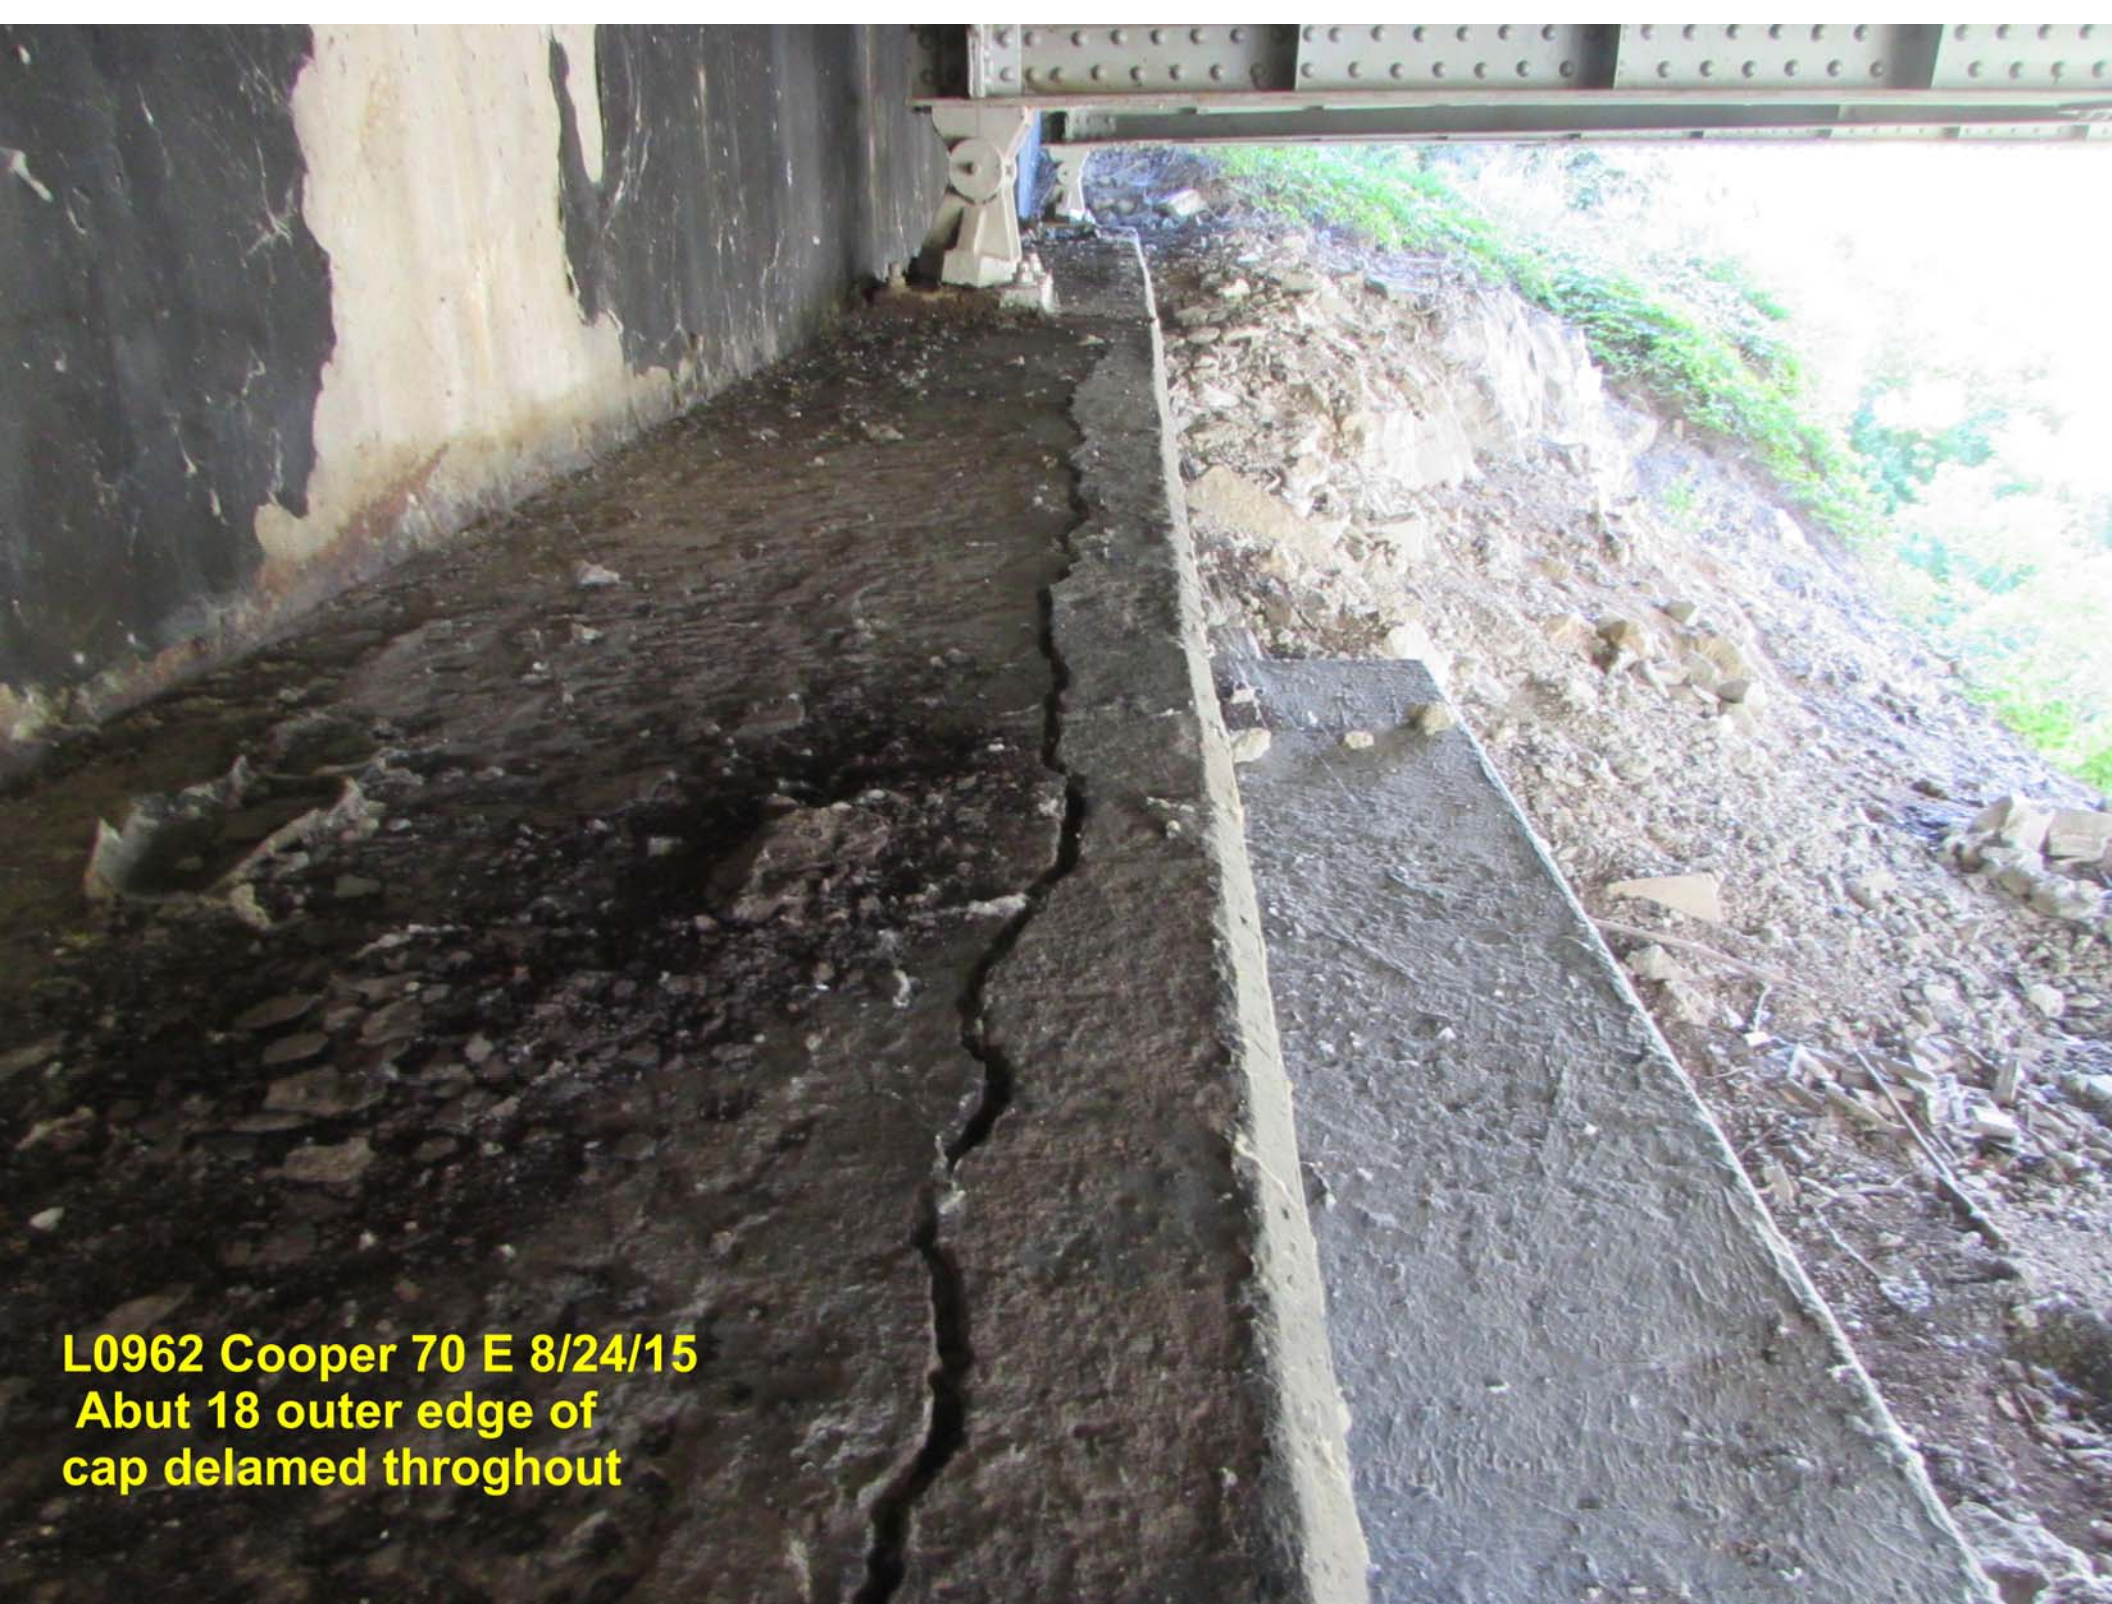
**L0962 Cooper 70 E 8/24/15**  
**Abut 18 outer edge of**  
**cap delamed throghout**

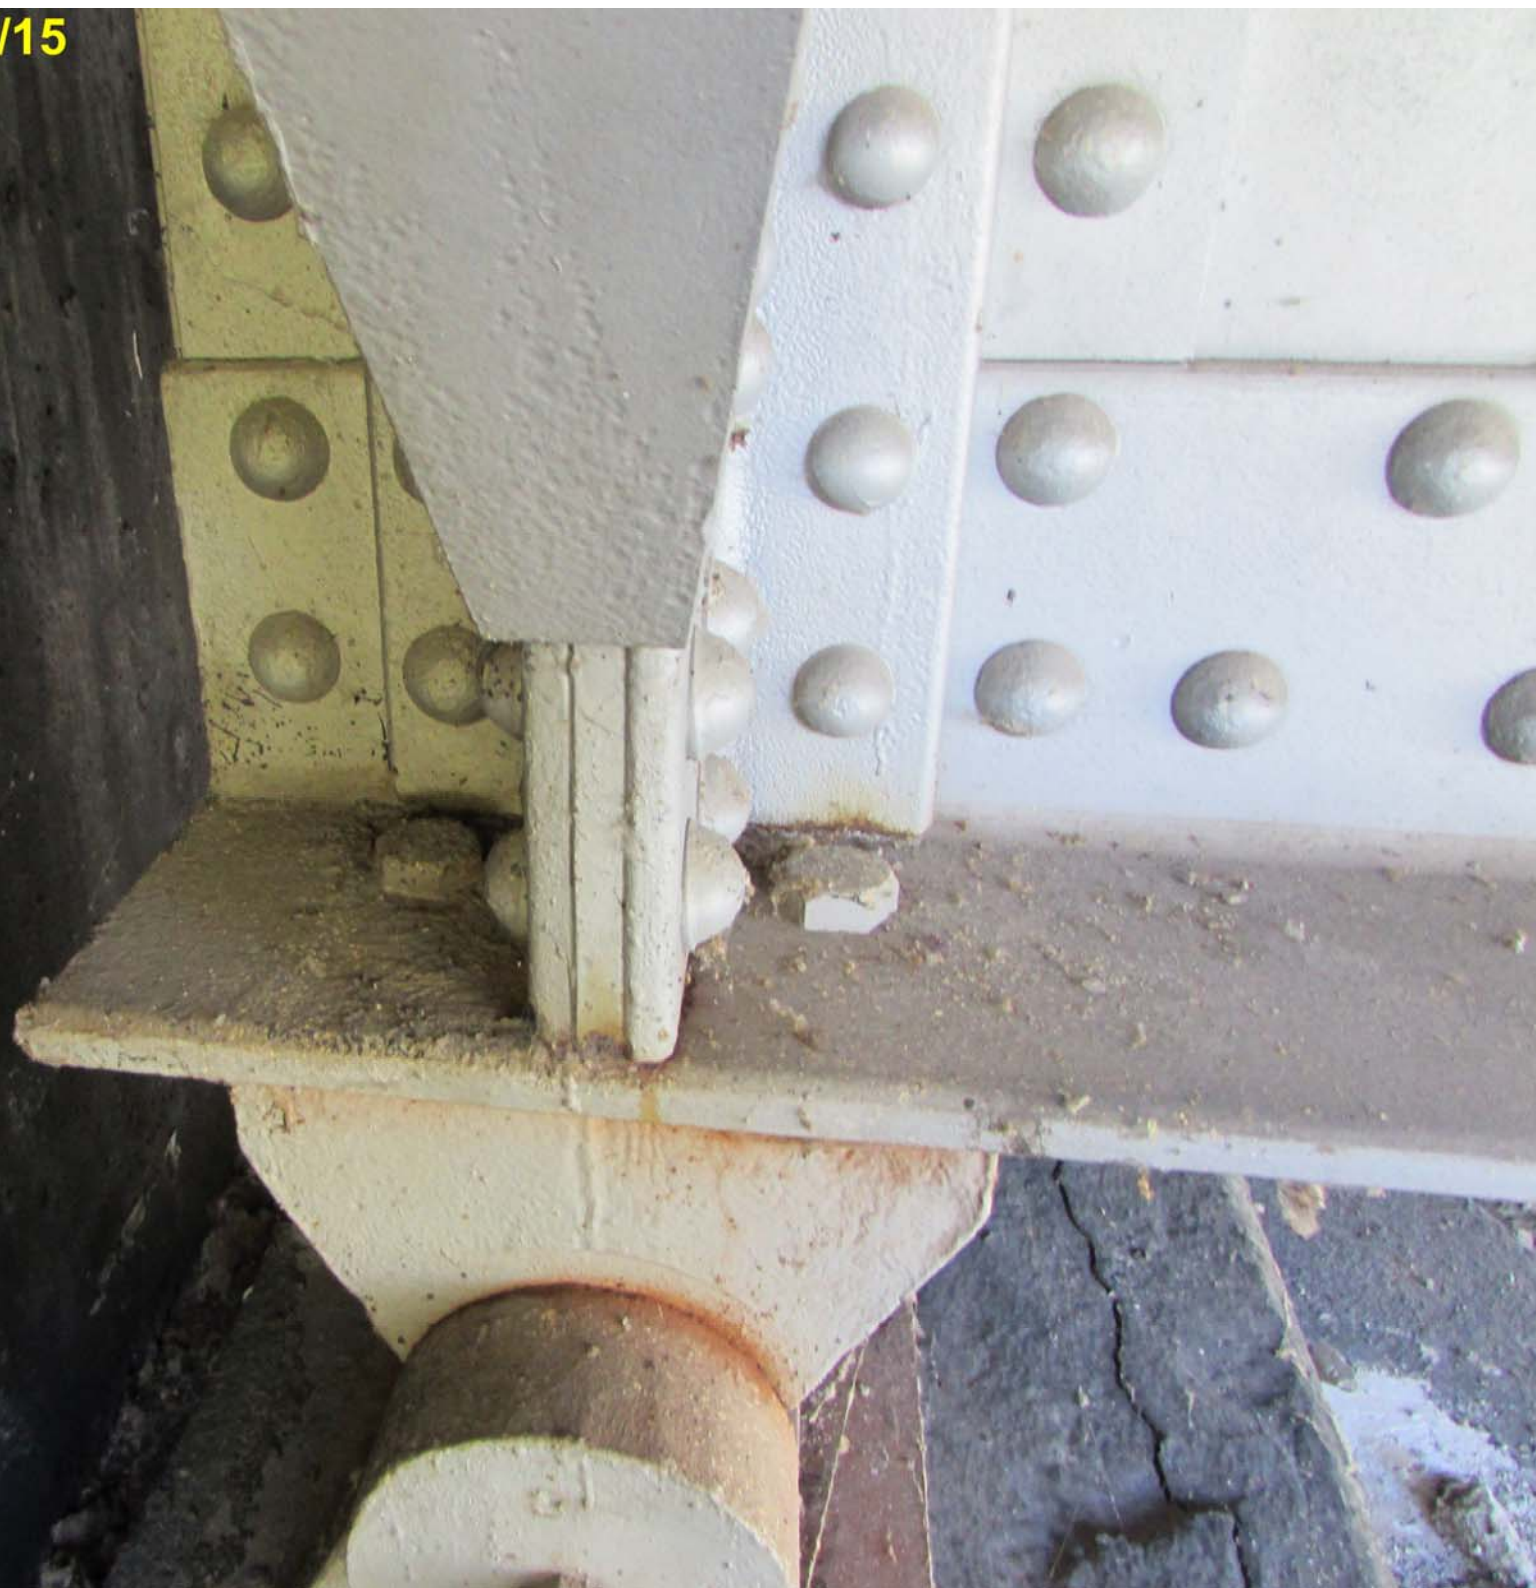
**L0962 Cooper 70 E 8/24/15**  
**Span 16 north side of girder 2**  
**with moderate rusting**  
**in bottom of SIP form**

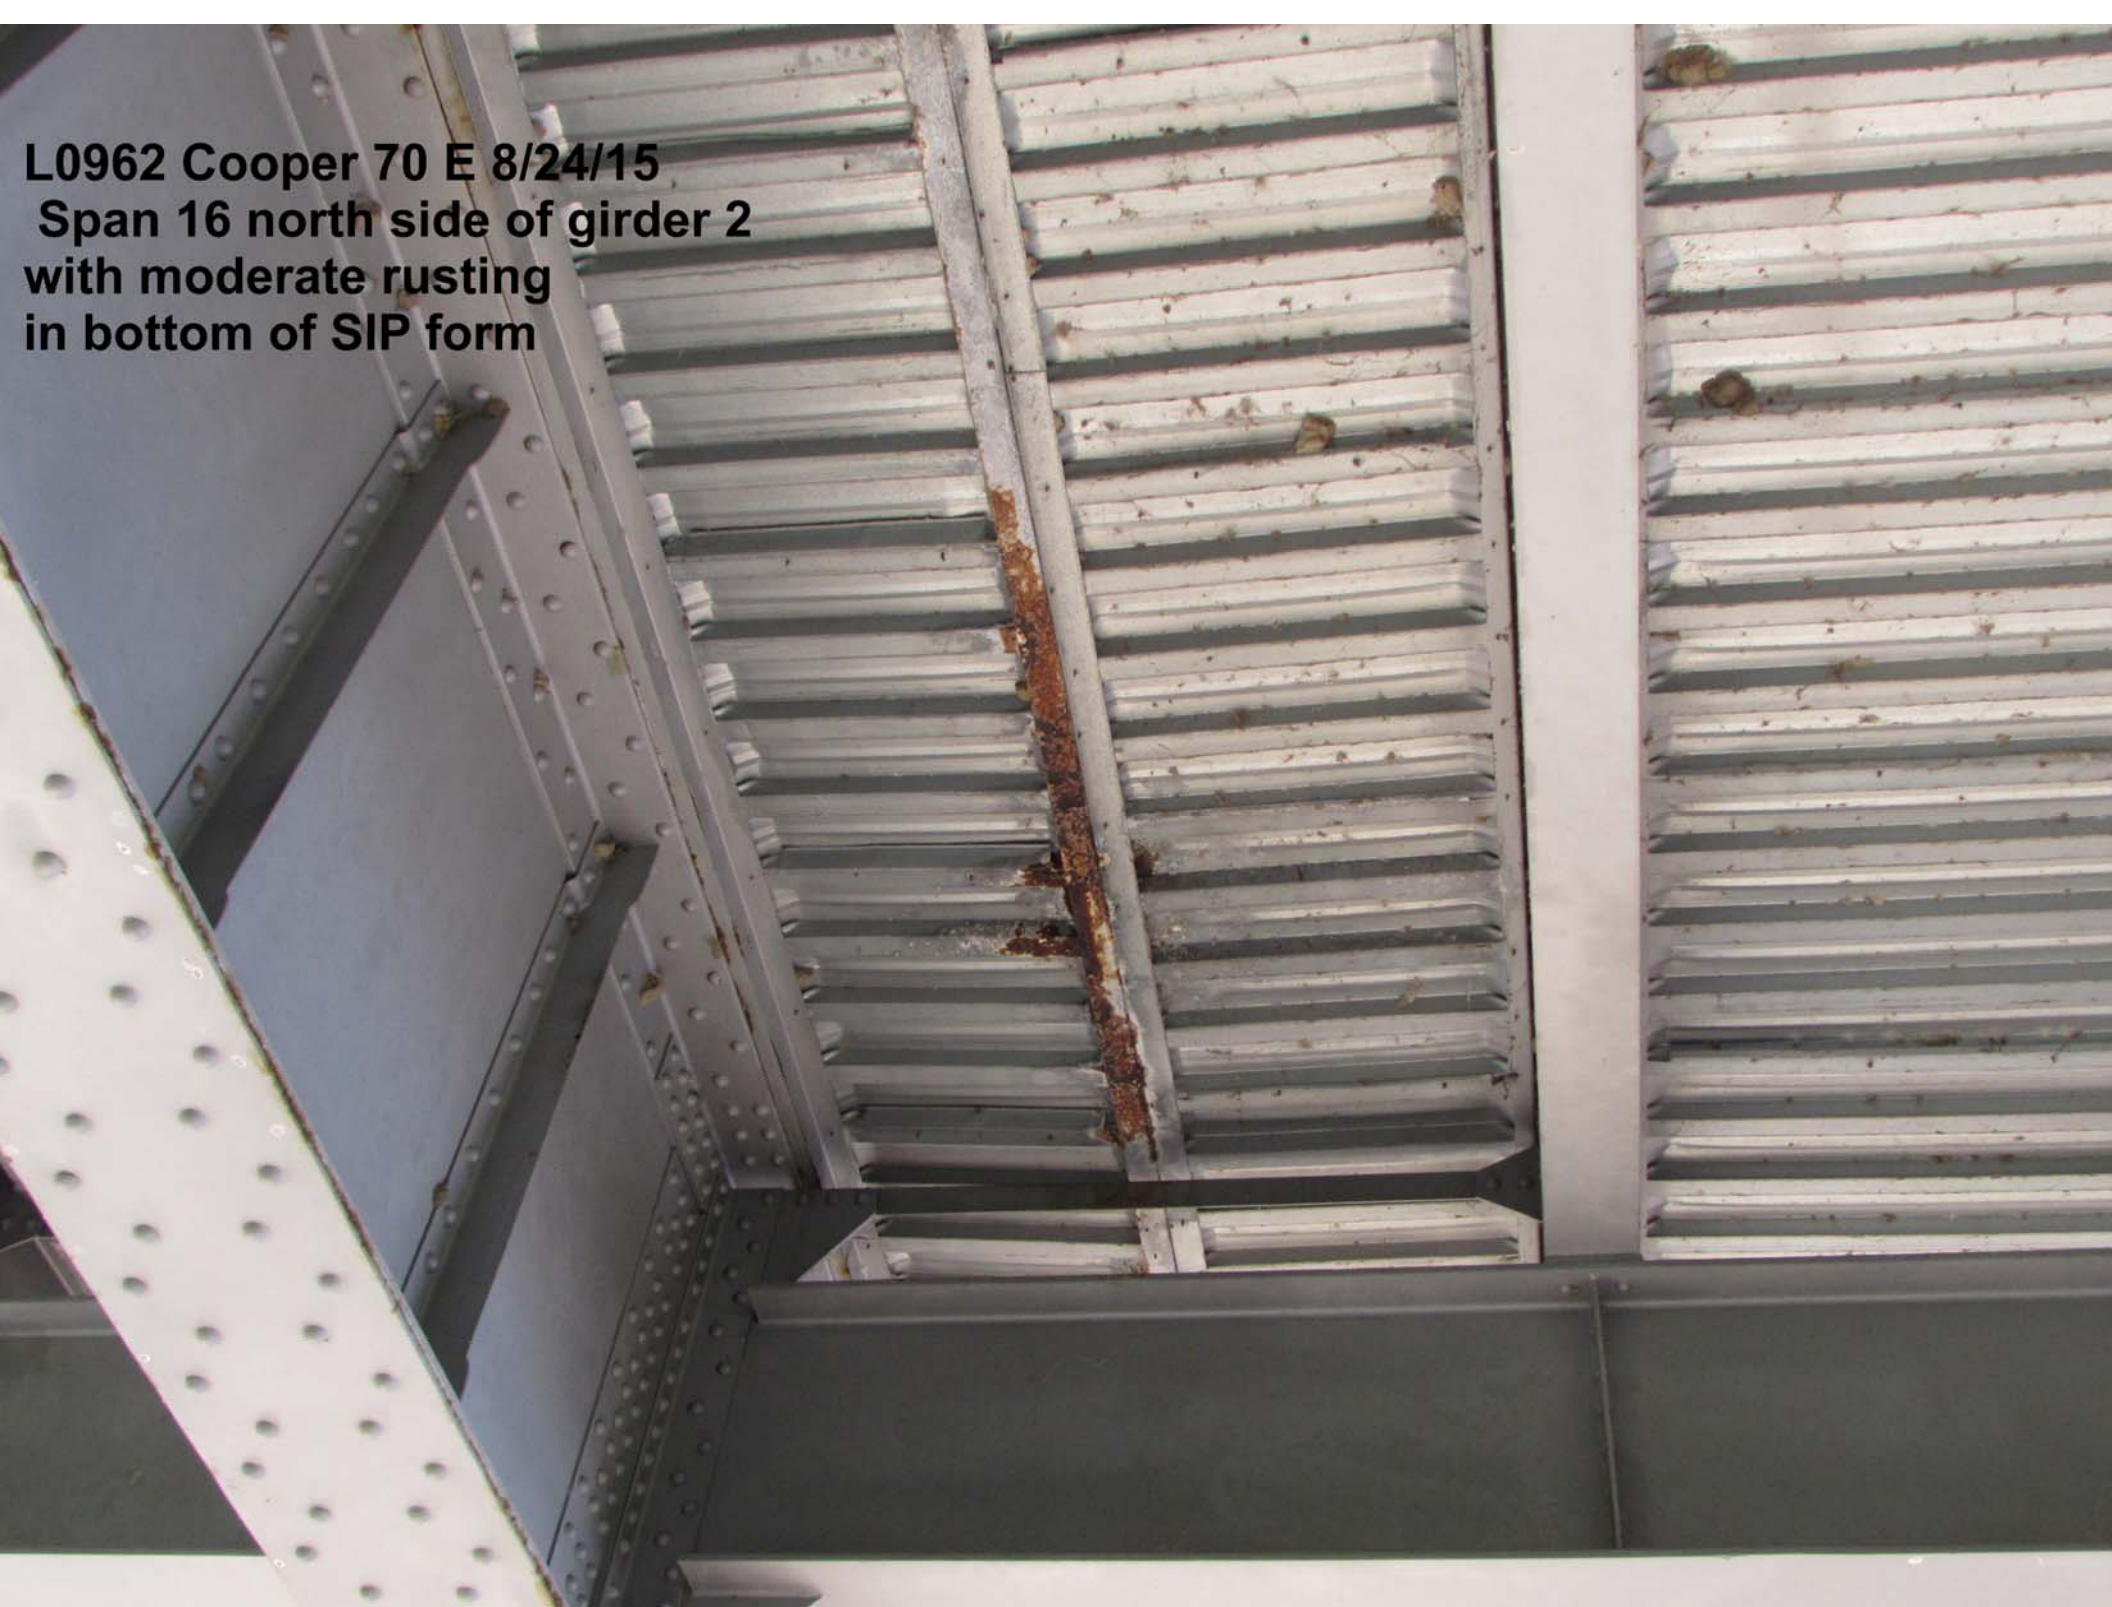
**L0962 Cooper 70 E 8/24/15**  
**Debris piled up north**  
**side of piers 15 and 16**
