L0962 I 70 Cooper Co.  
Joint at L8, span 13  
Eastbound lane failing  
9-24-13

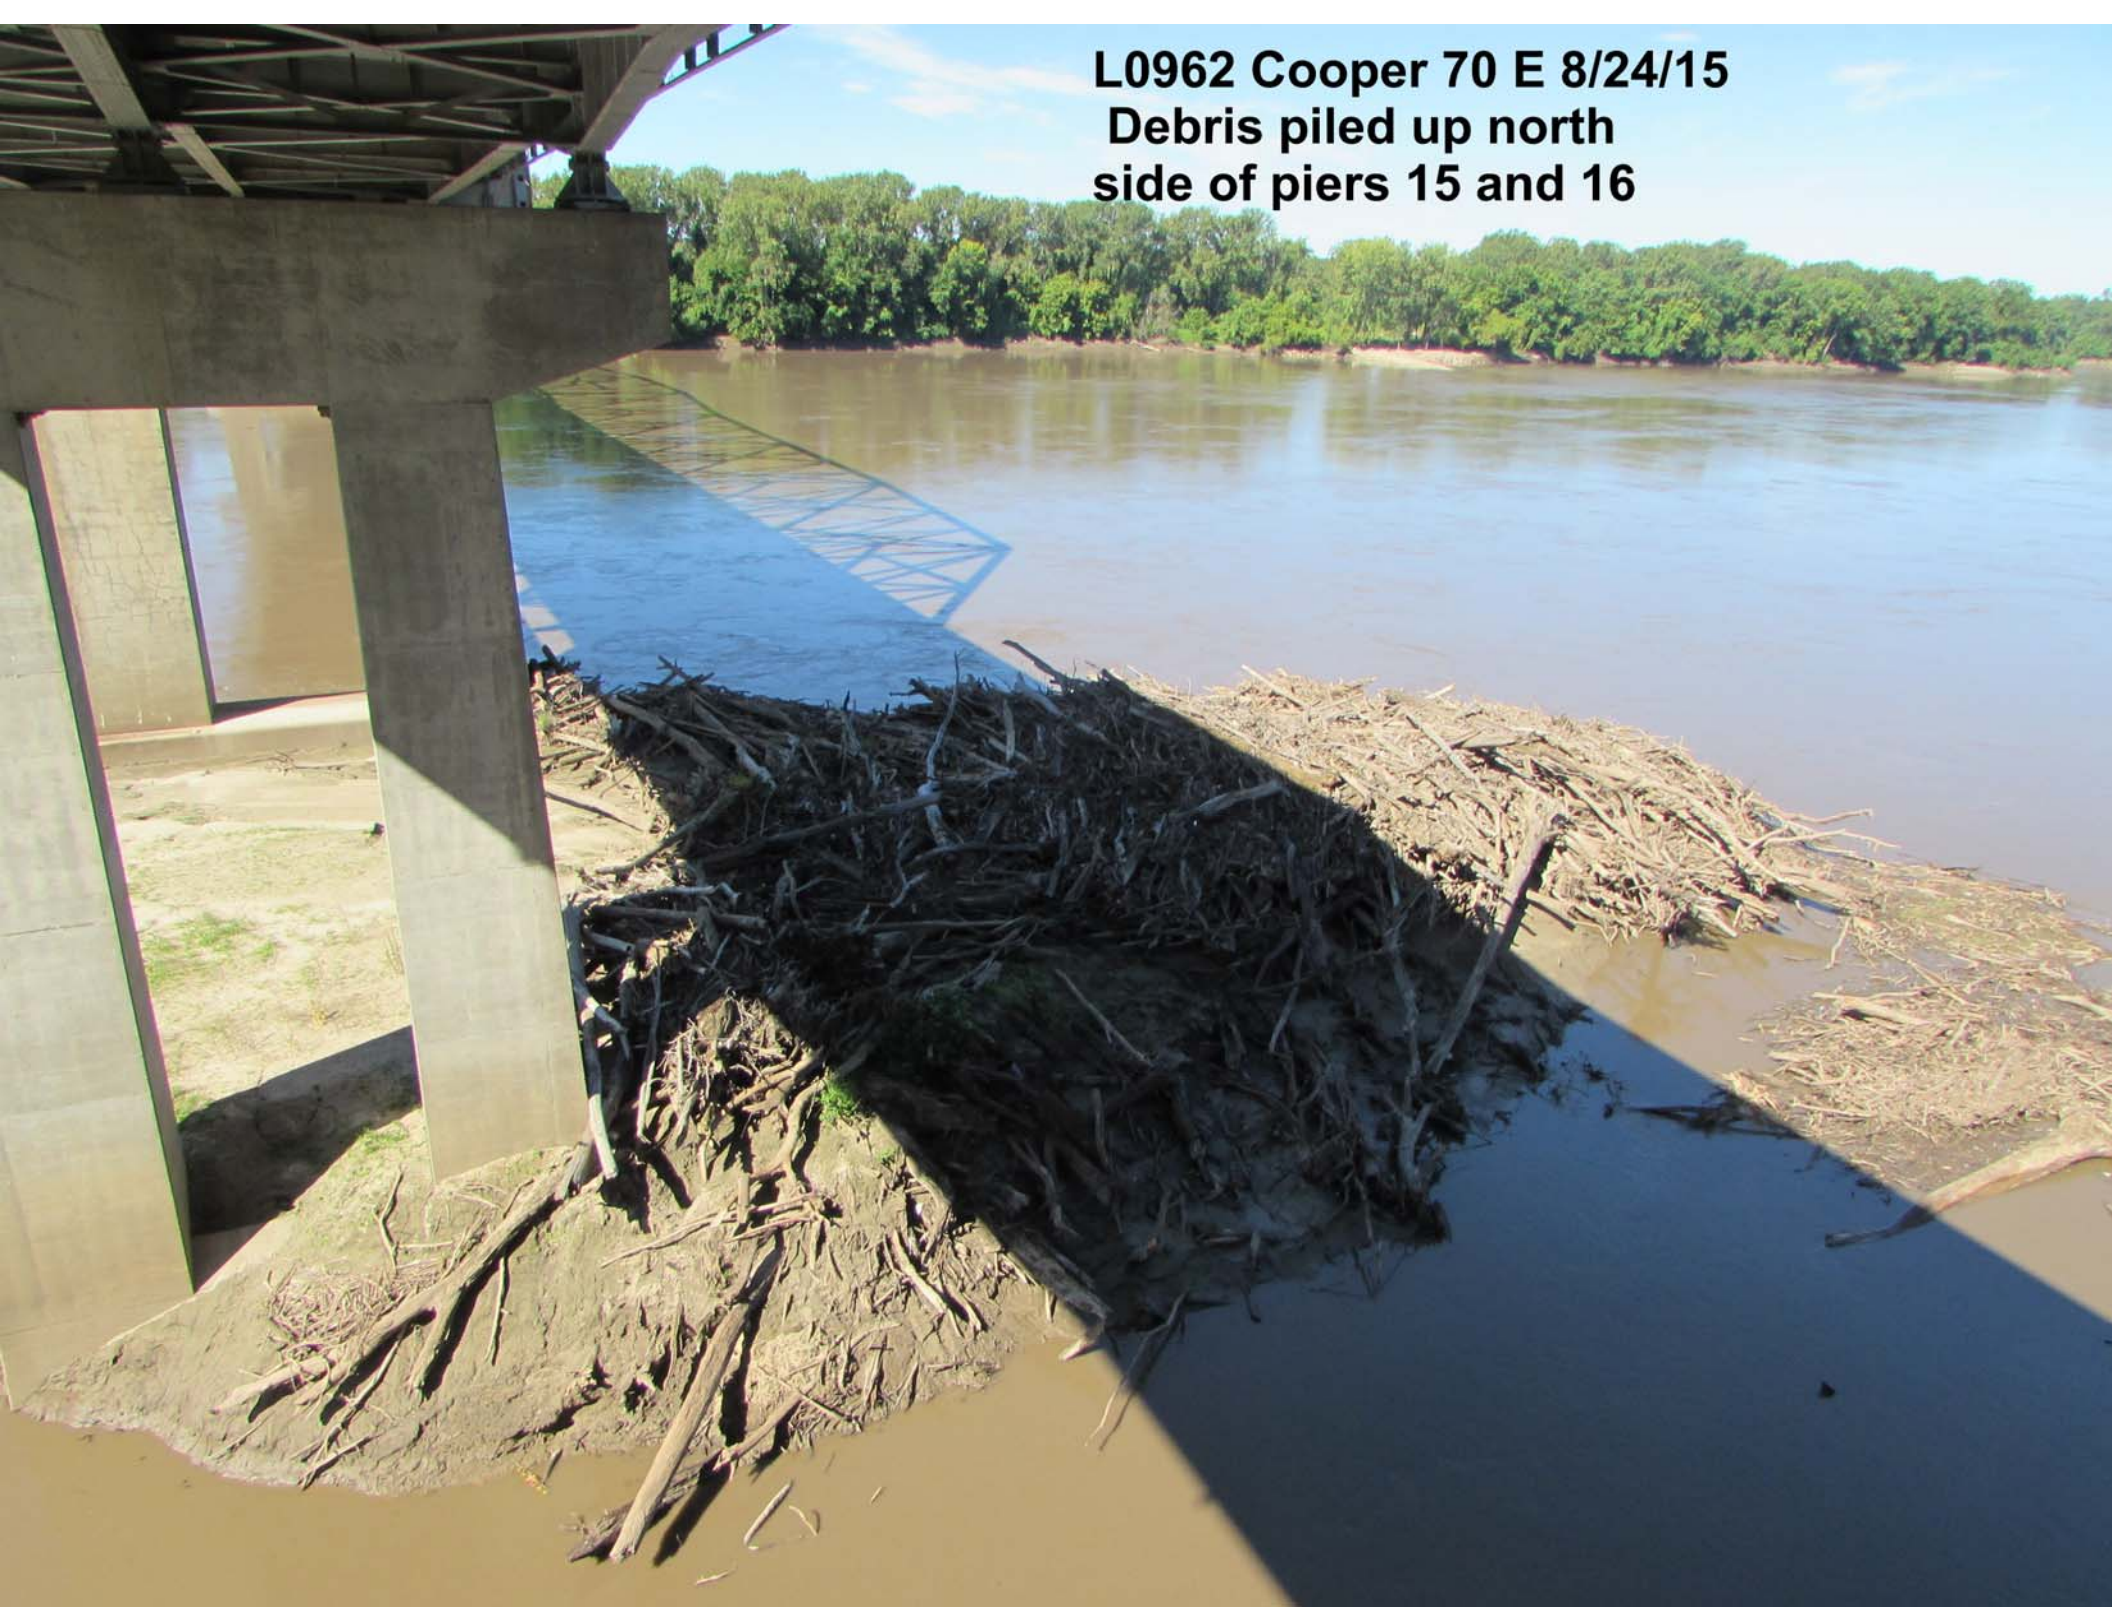
**L0962 Cooper 70 E 8/24/15**  
**Girder 1 over bent 16 with**  
**moderate section loss in**  
**between bottom plates**

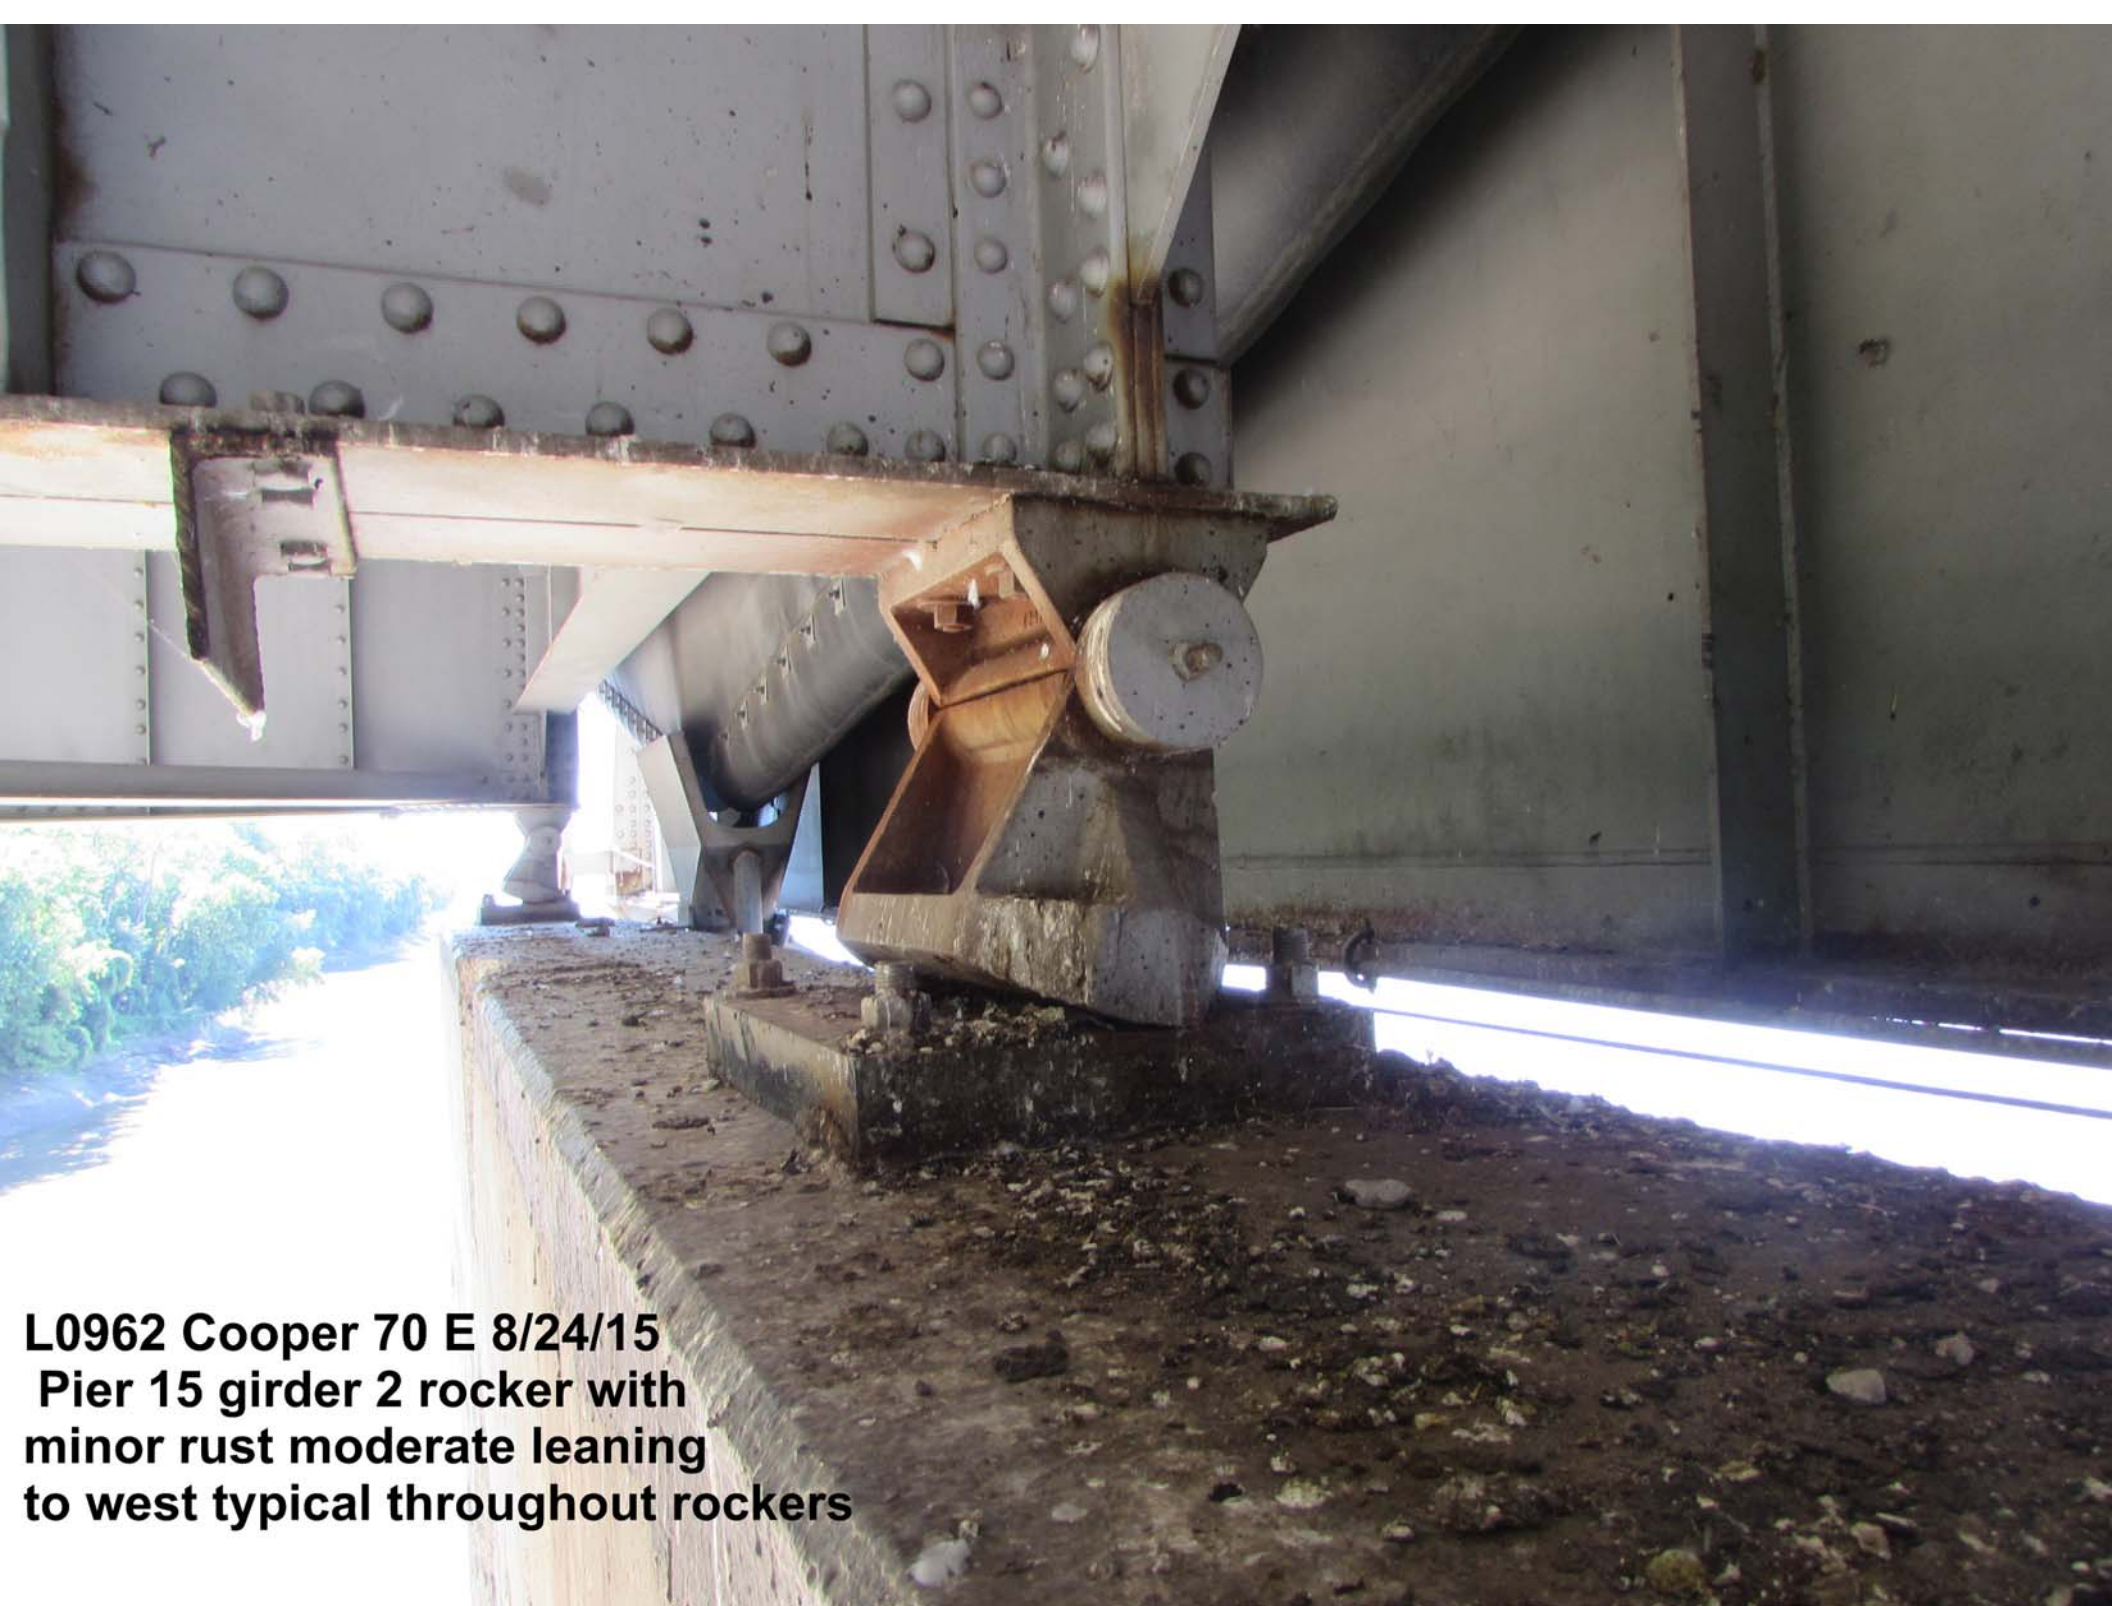
**L0962 Cooper 70 E 8/24/15  
Pier 15 east side with large  
spalls with rebar exposed and large  
map cracking throughout  
caps and columns**

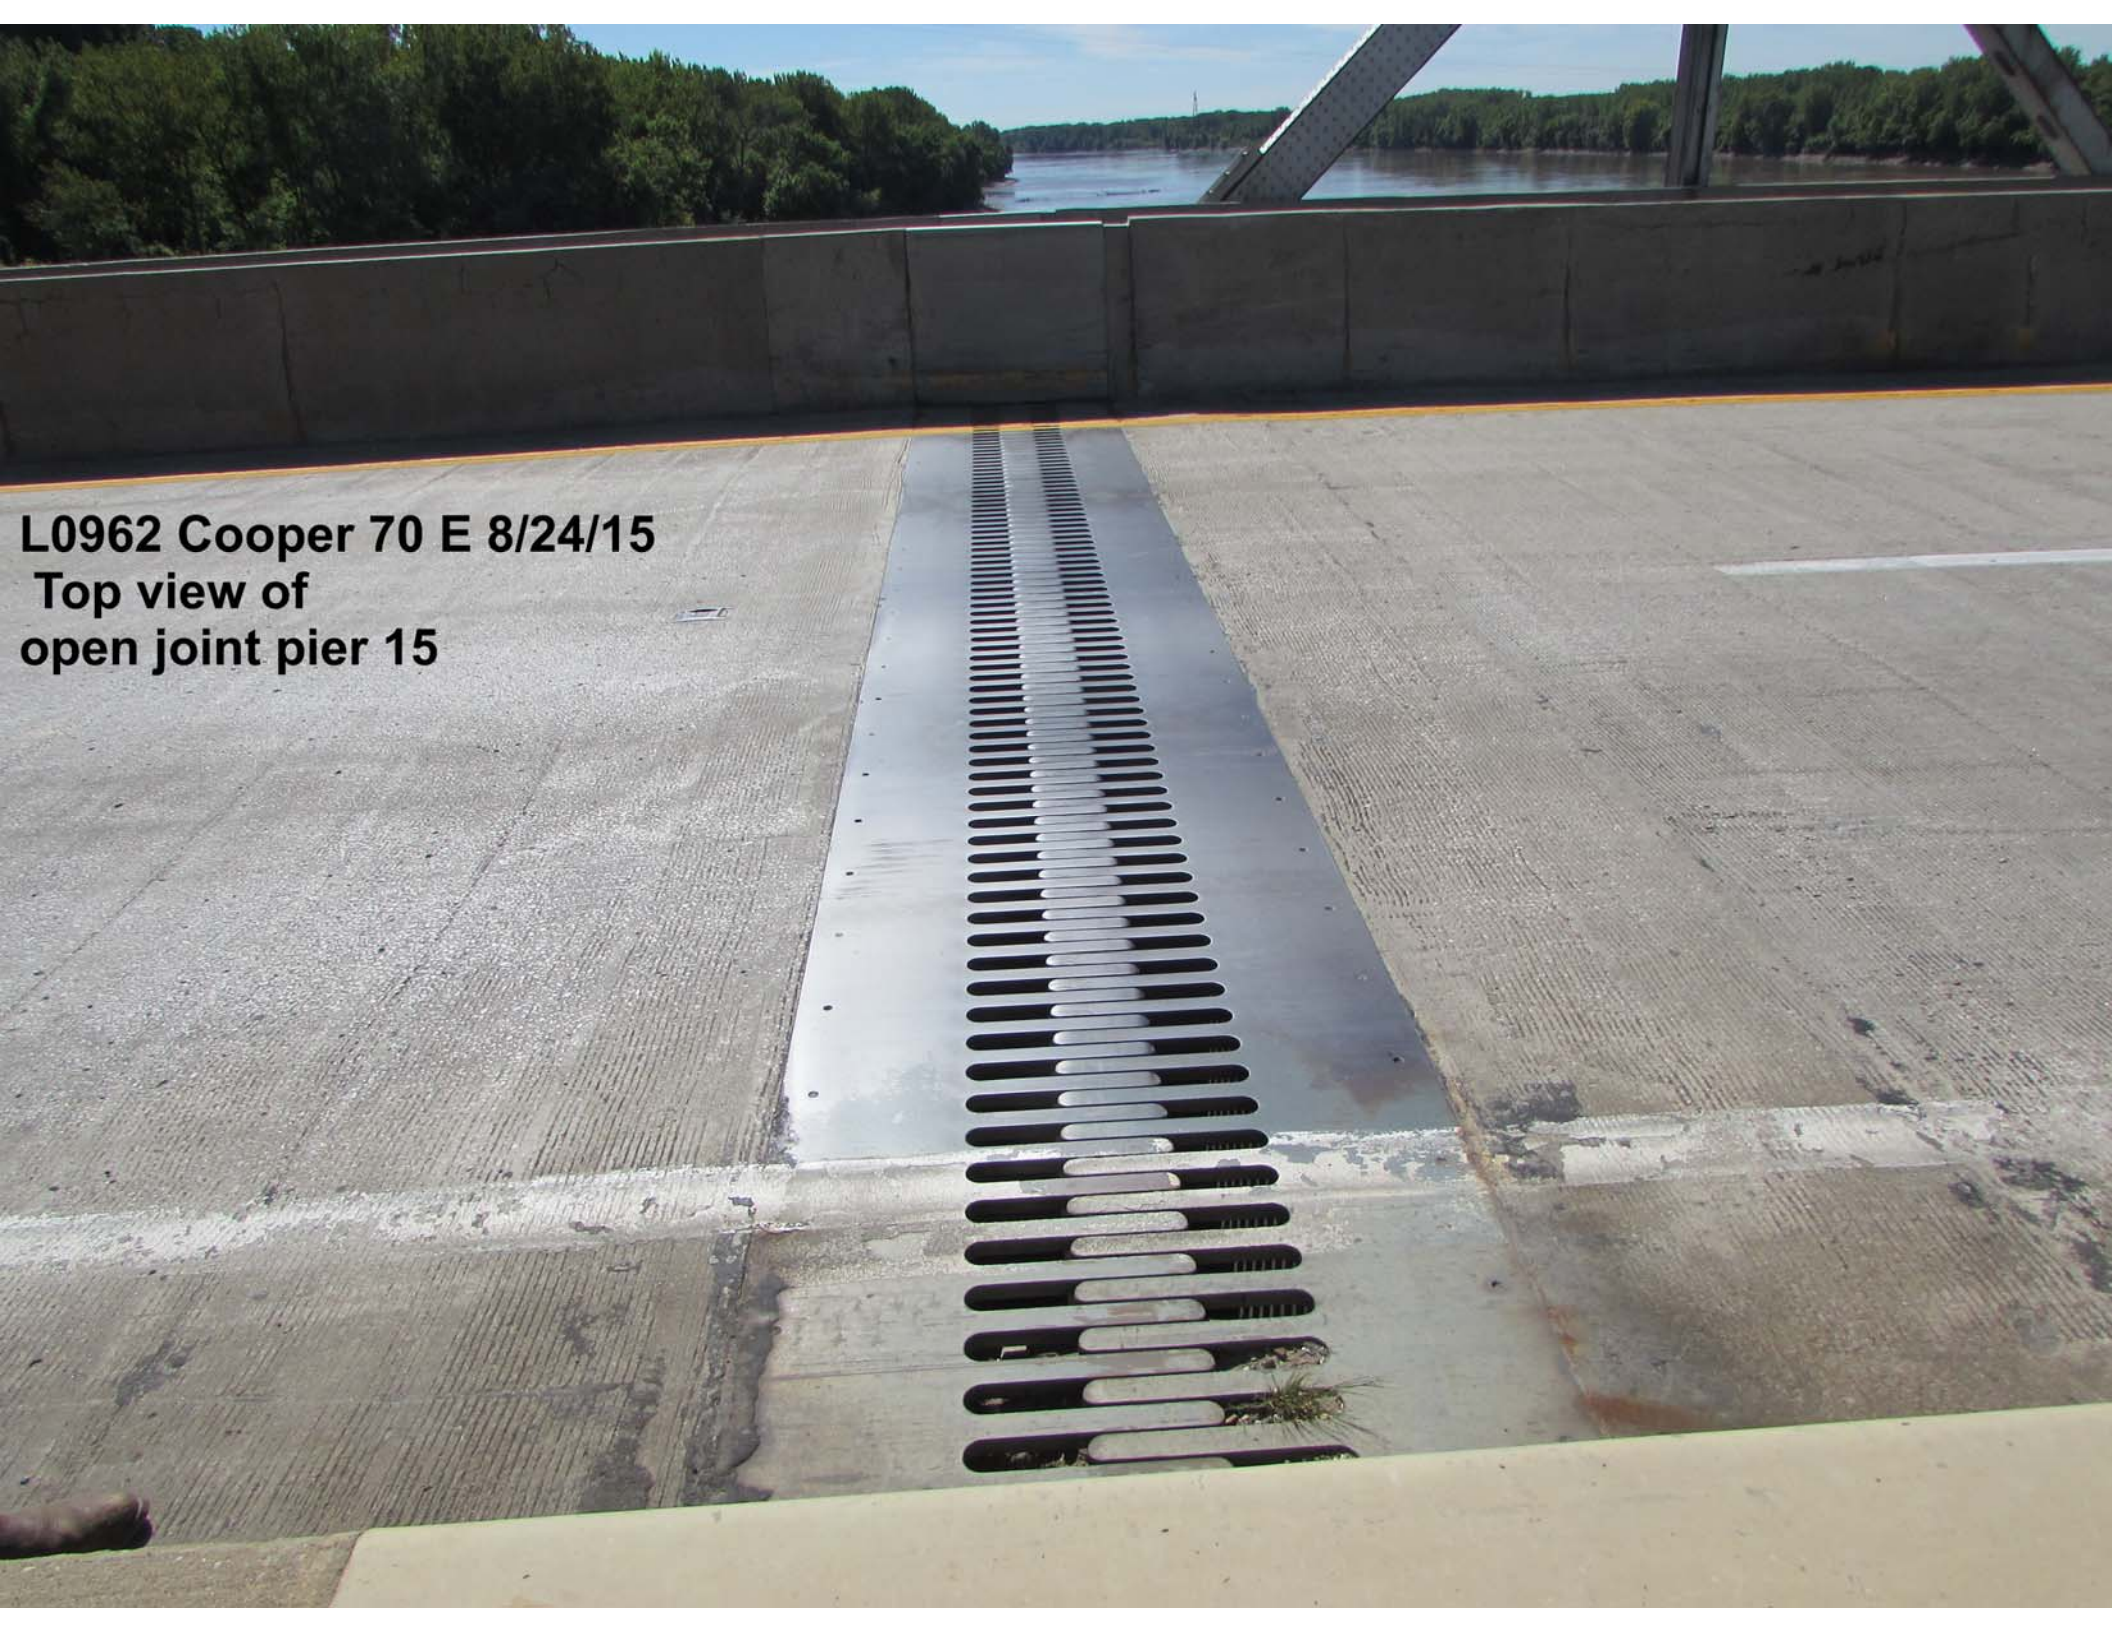
**L0962 Cooper 70 E 8/24/15**  
**Top view of**  
**open joint pier 15**

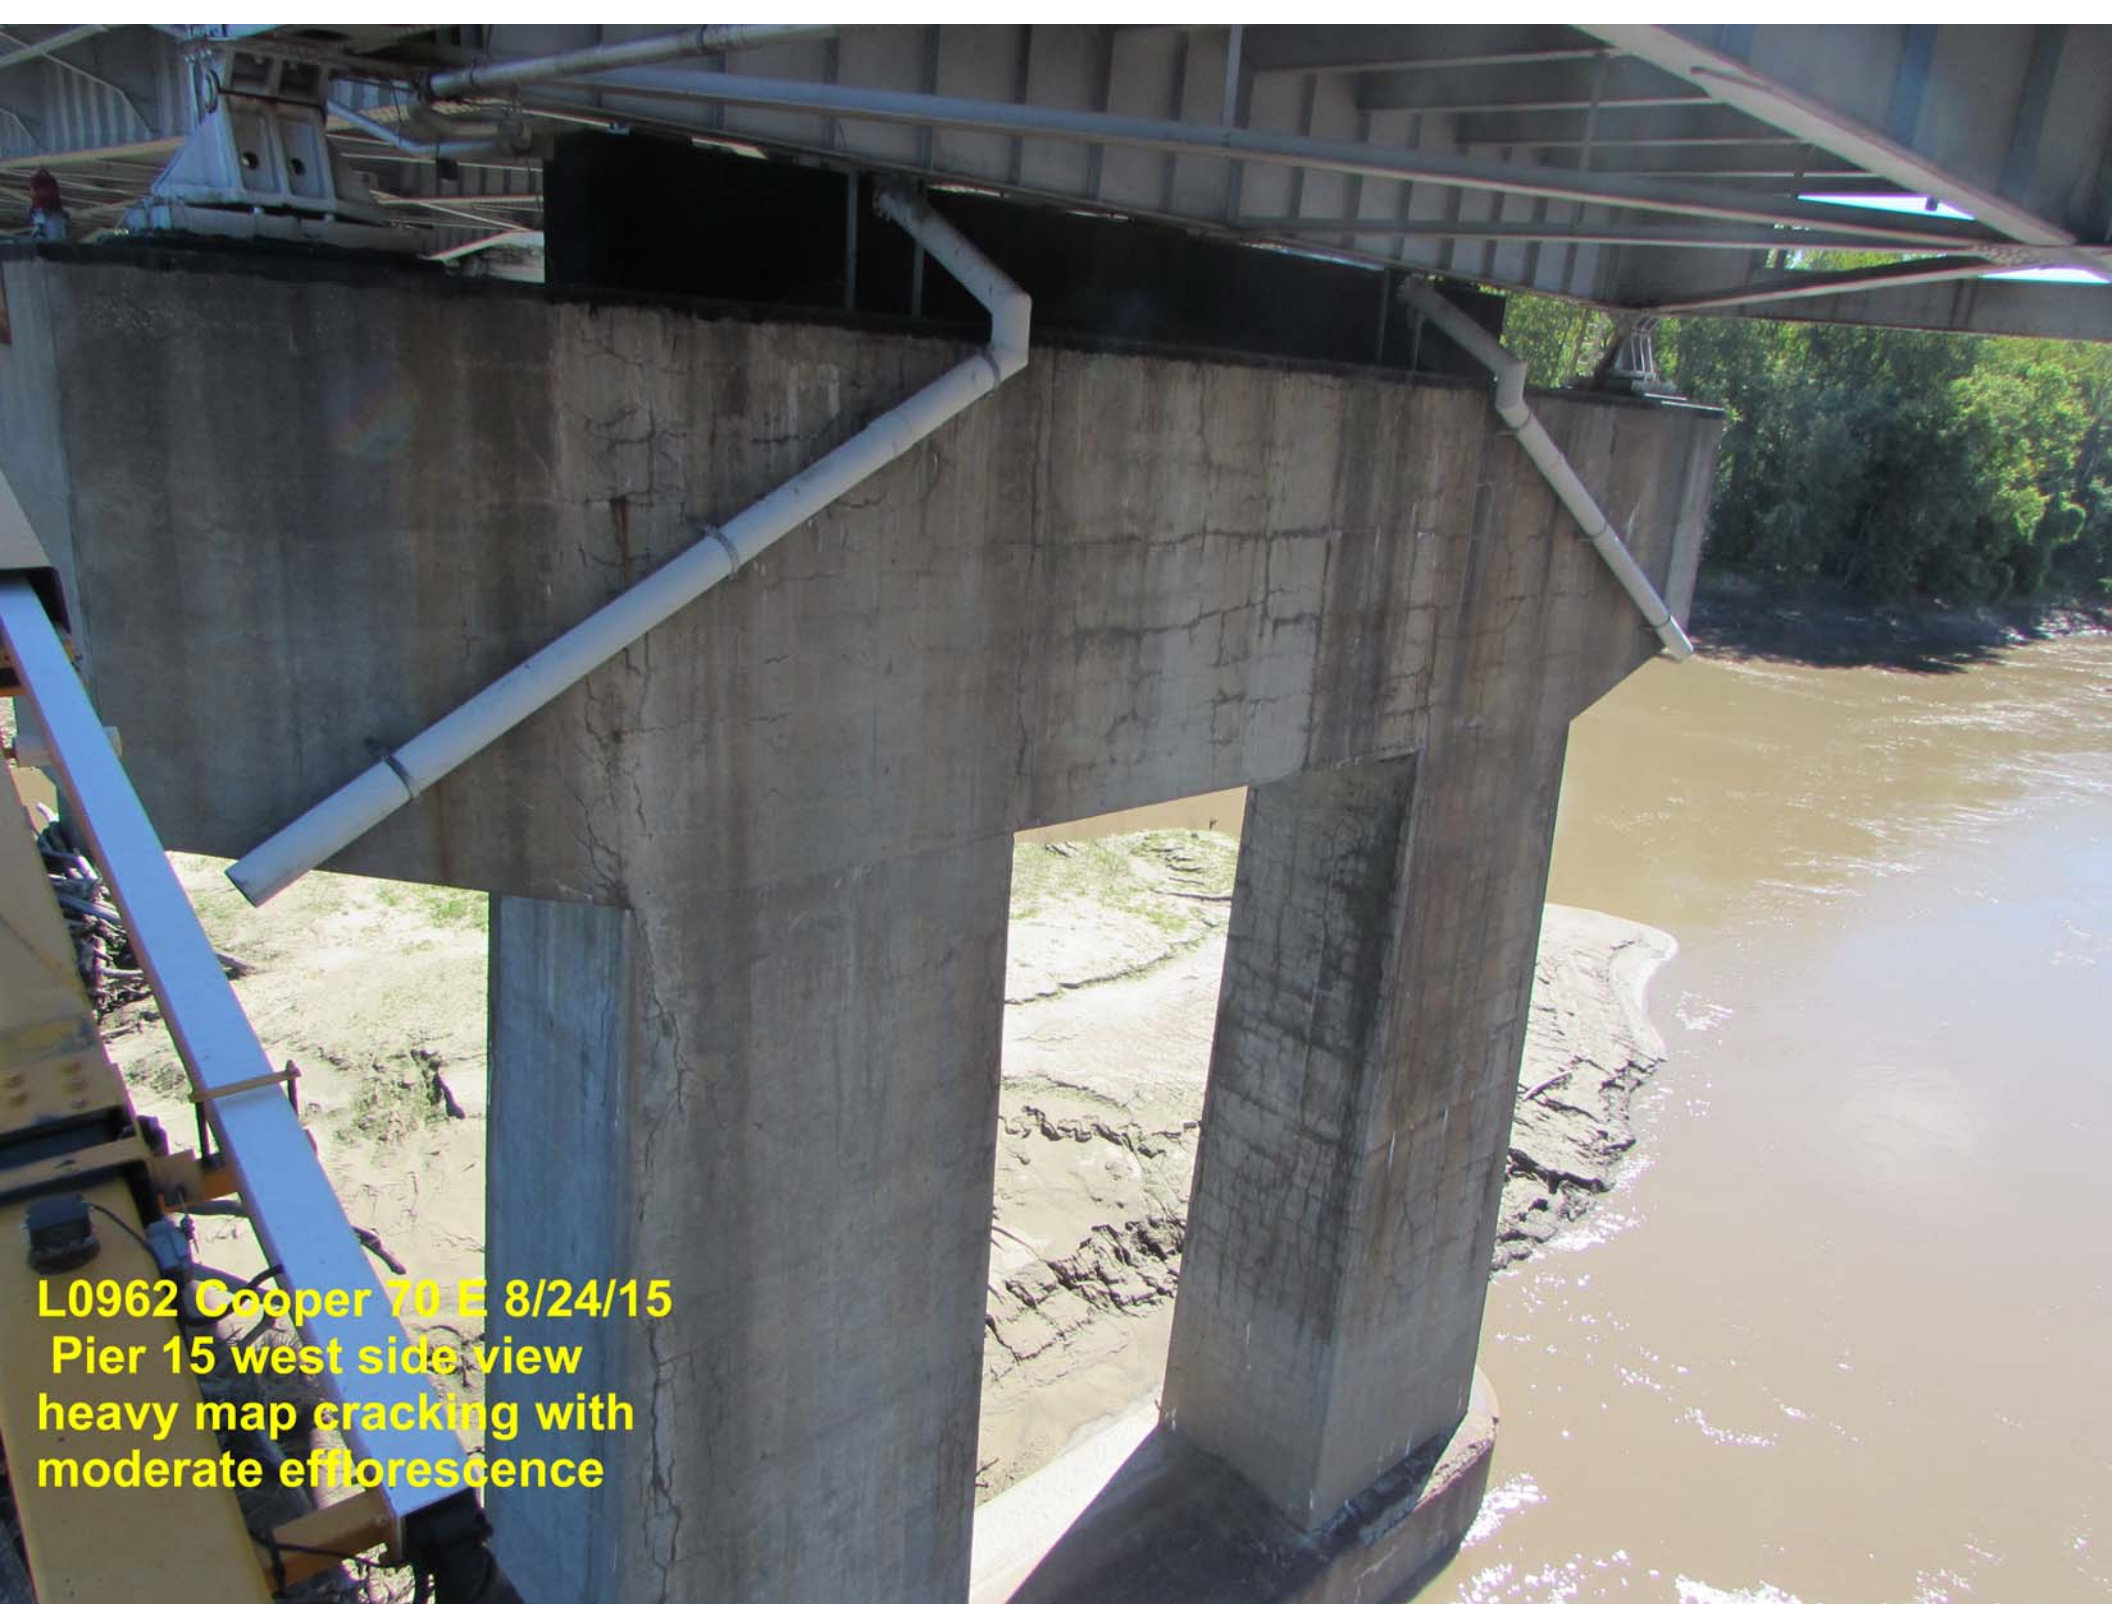
L0962 Cooper 70 E 8/24/15  
Pier 15 west side view  
heavy map cracking with  
moderate efflorescence

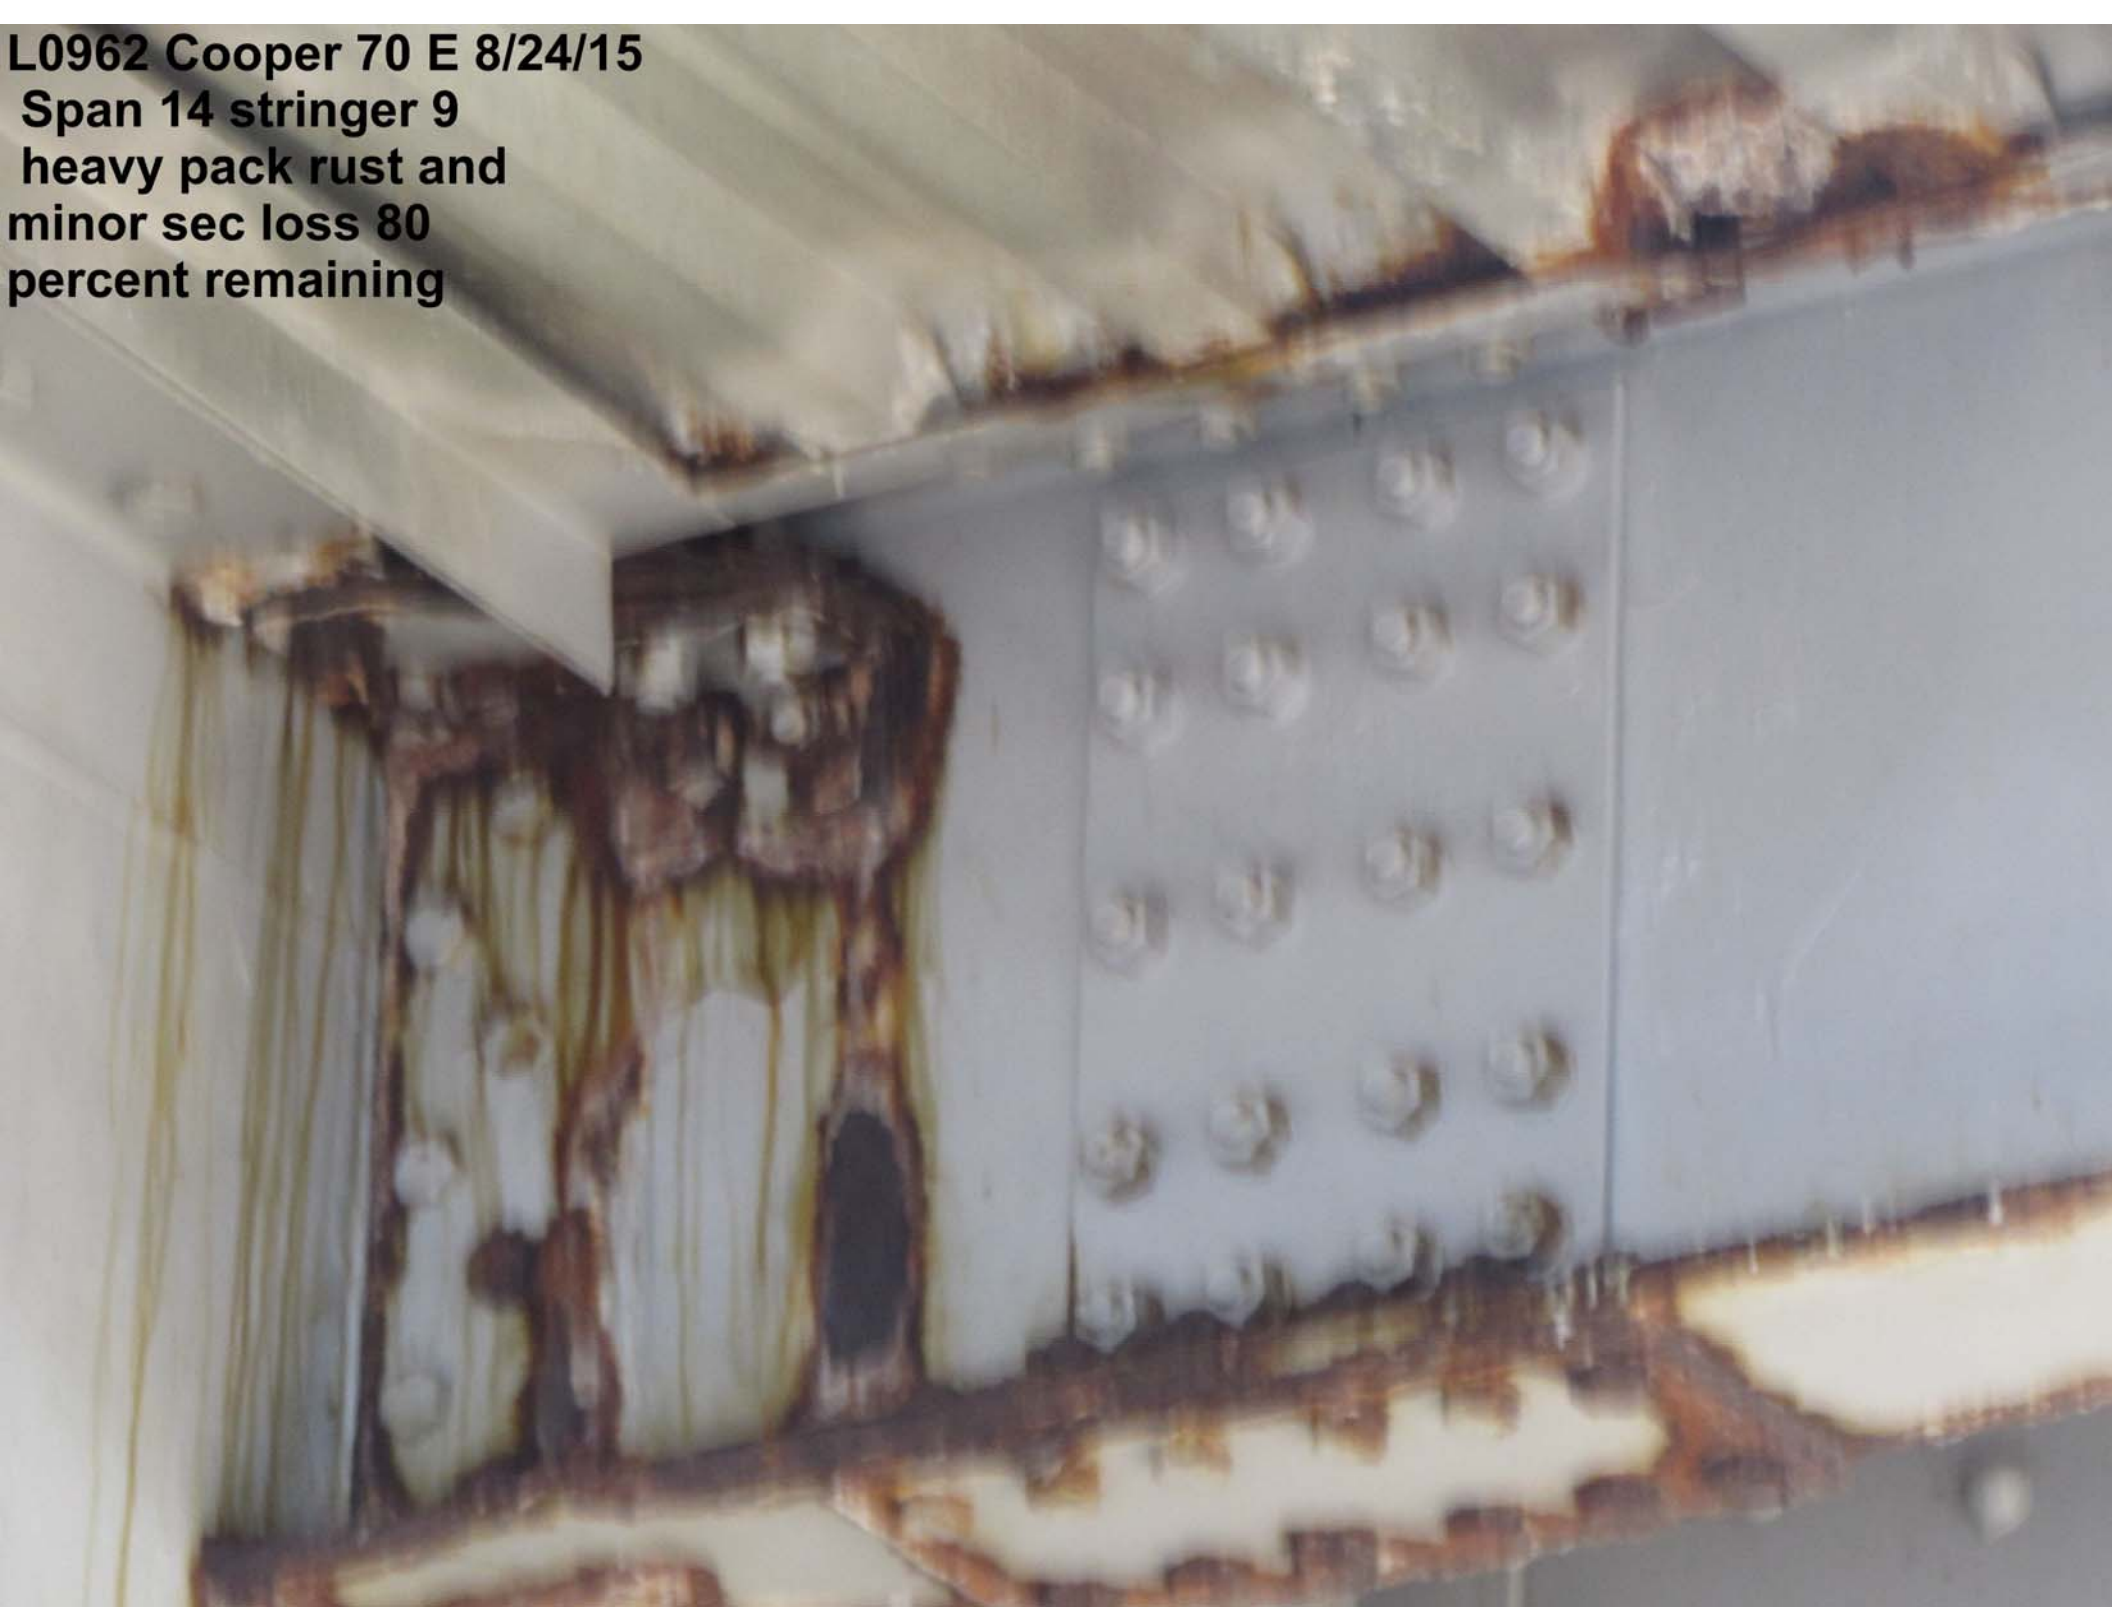
**L0962 Cooper 70 E 8/24/15**  
**Span 14 stringer 9**  
**heavy pack rust and**  
**minor sec loss 80**  
**percent remaining**

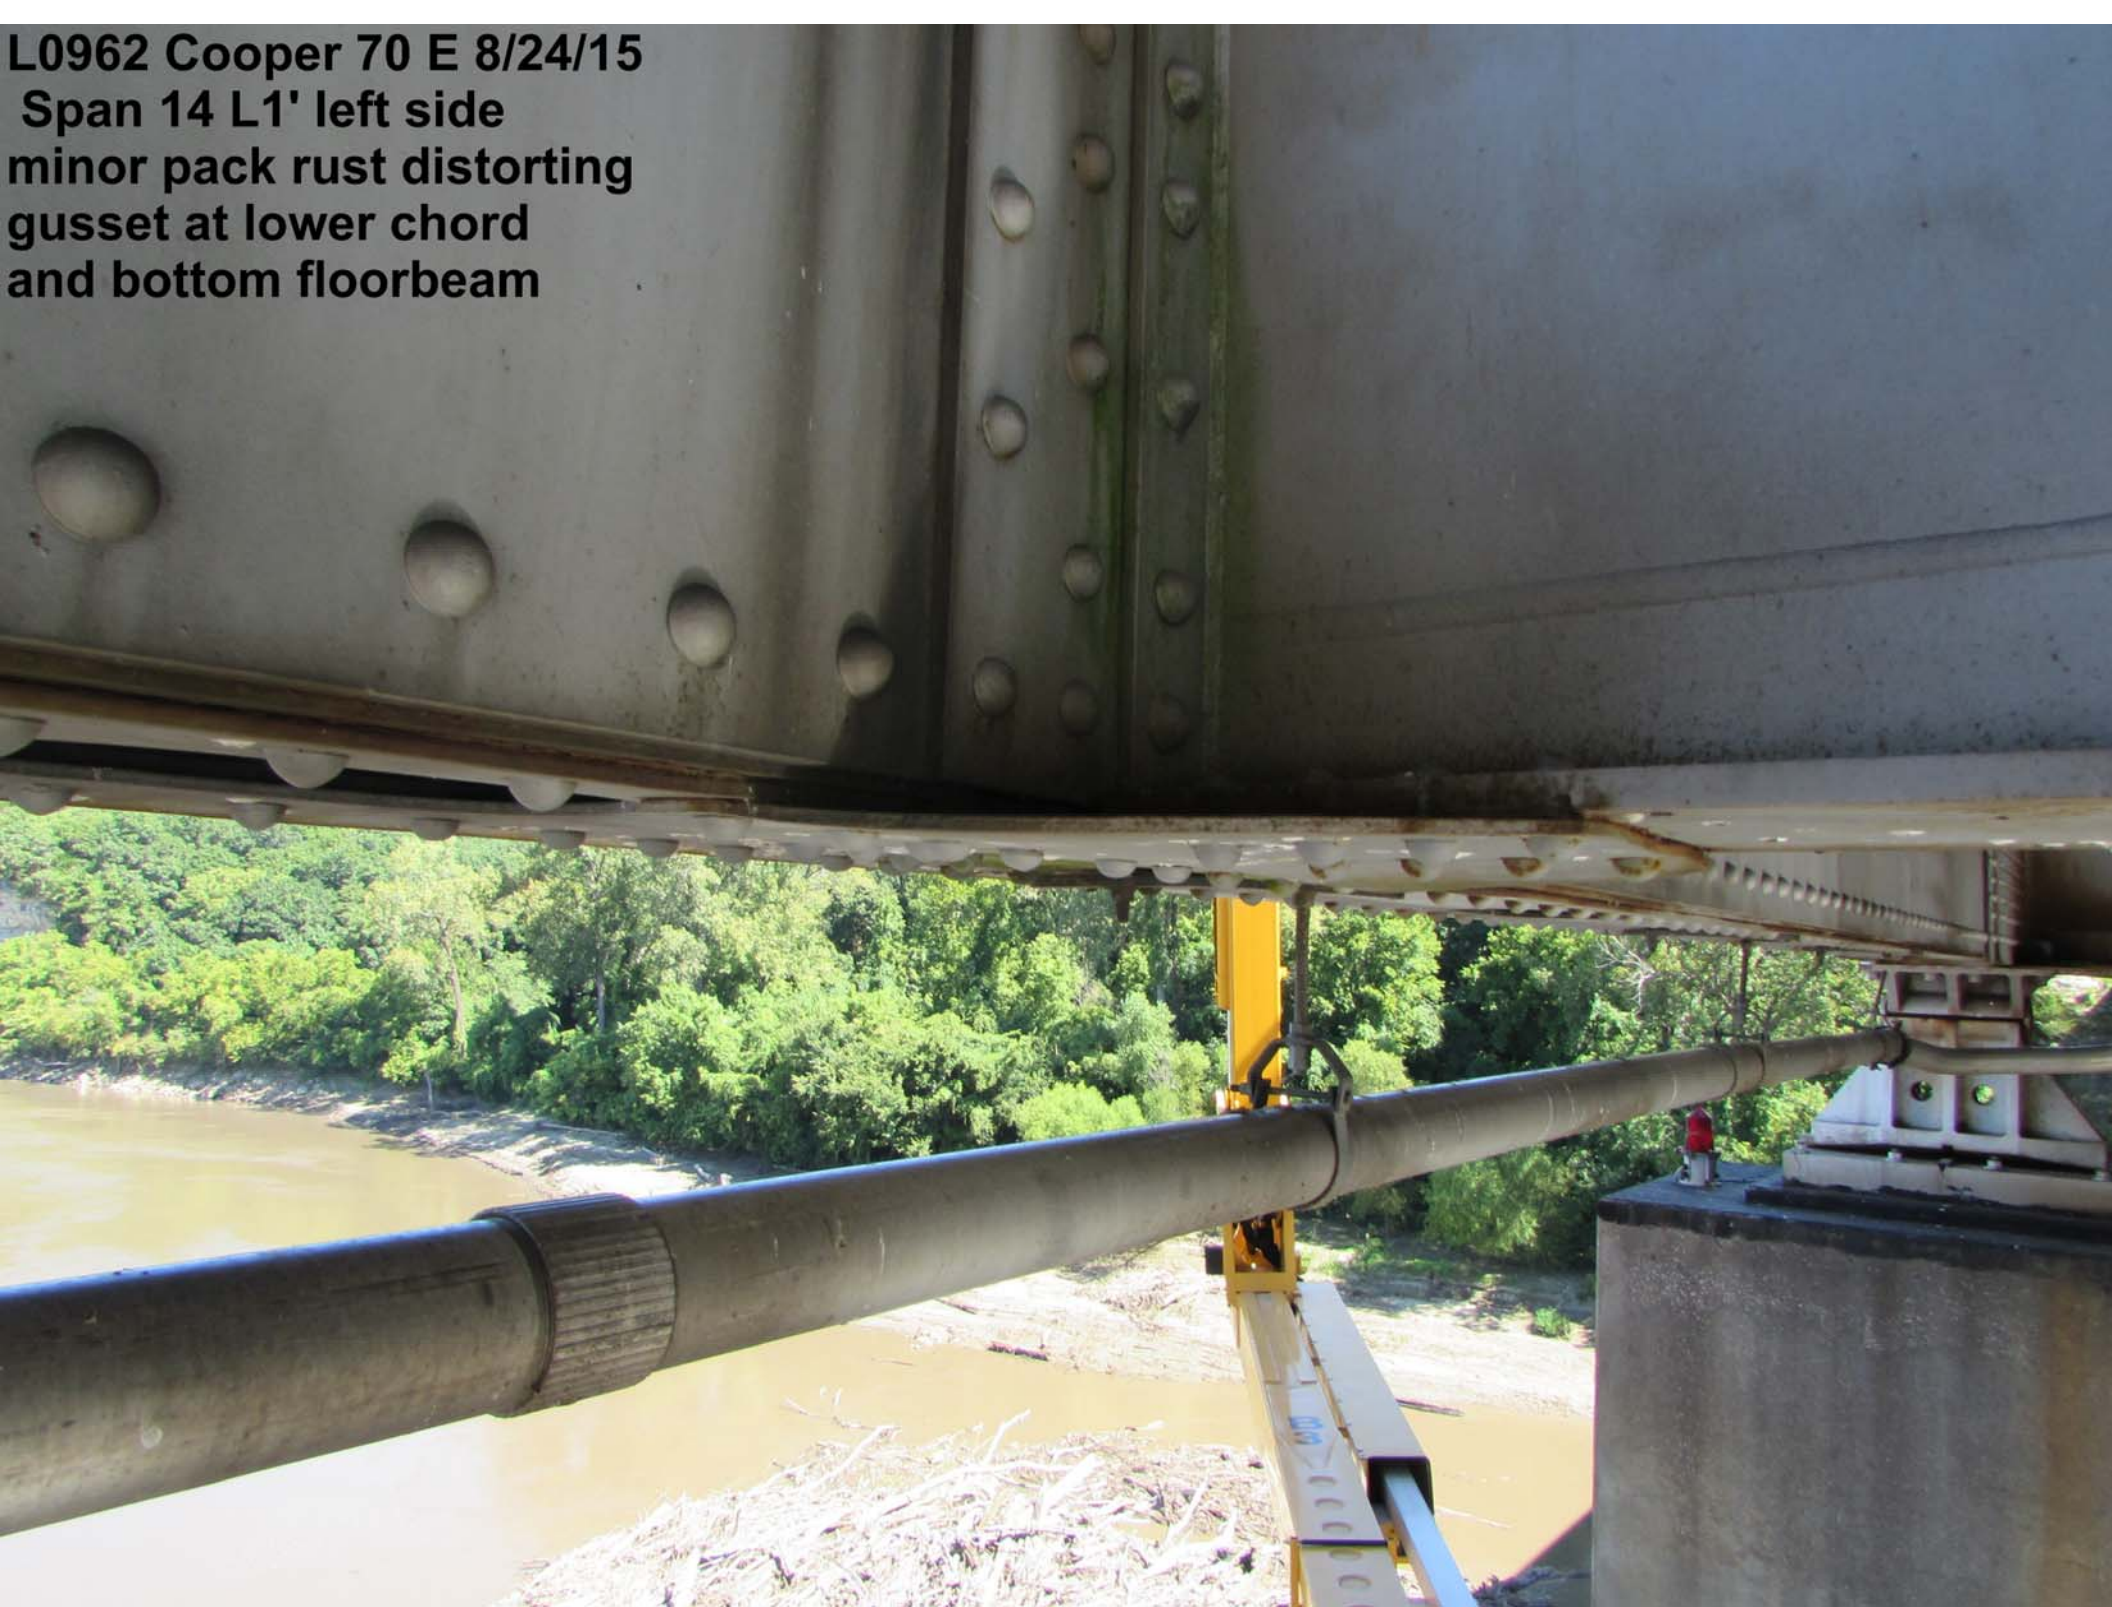
**L0962 Cooper 70 E 8/24/15**  
**Span 14 L1' left side**  
**minor pack rust distorting**  
**gusset at lower chord**  
**and bottom floorbeam**
