L0962 I 70 Cooper Co.  
Joint at L8, span 13  
Eastbound lane failing  
9-24-13

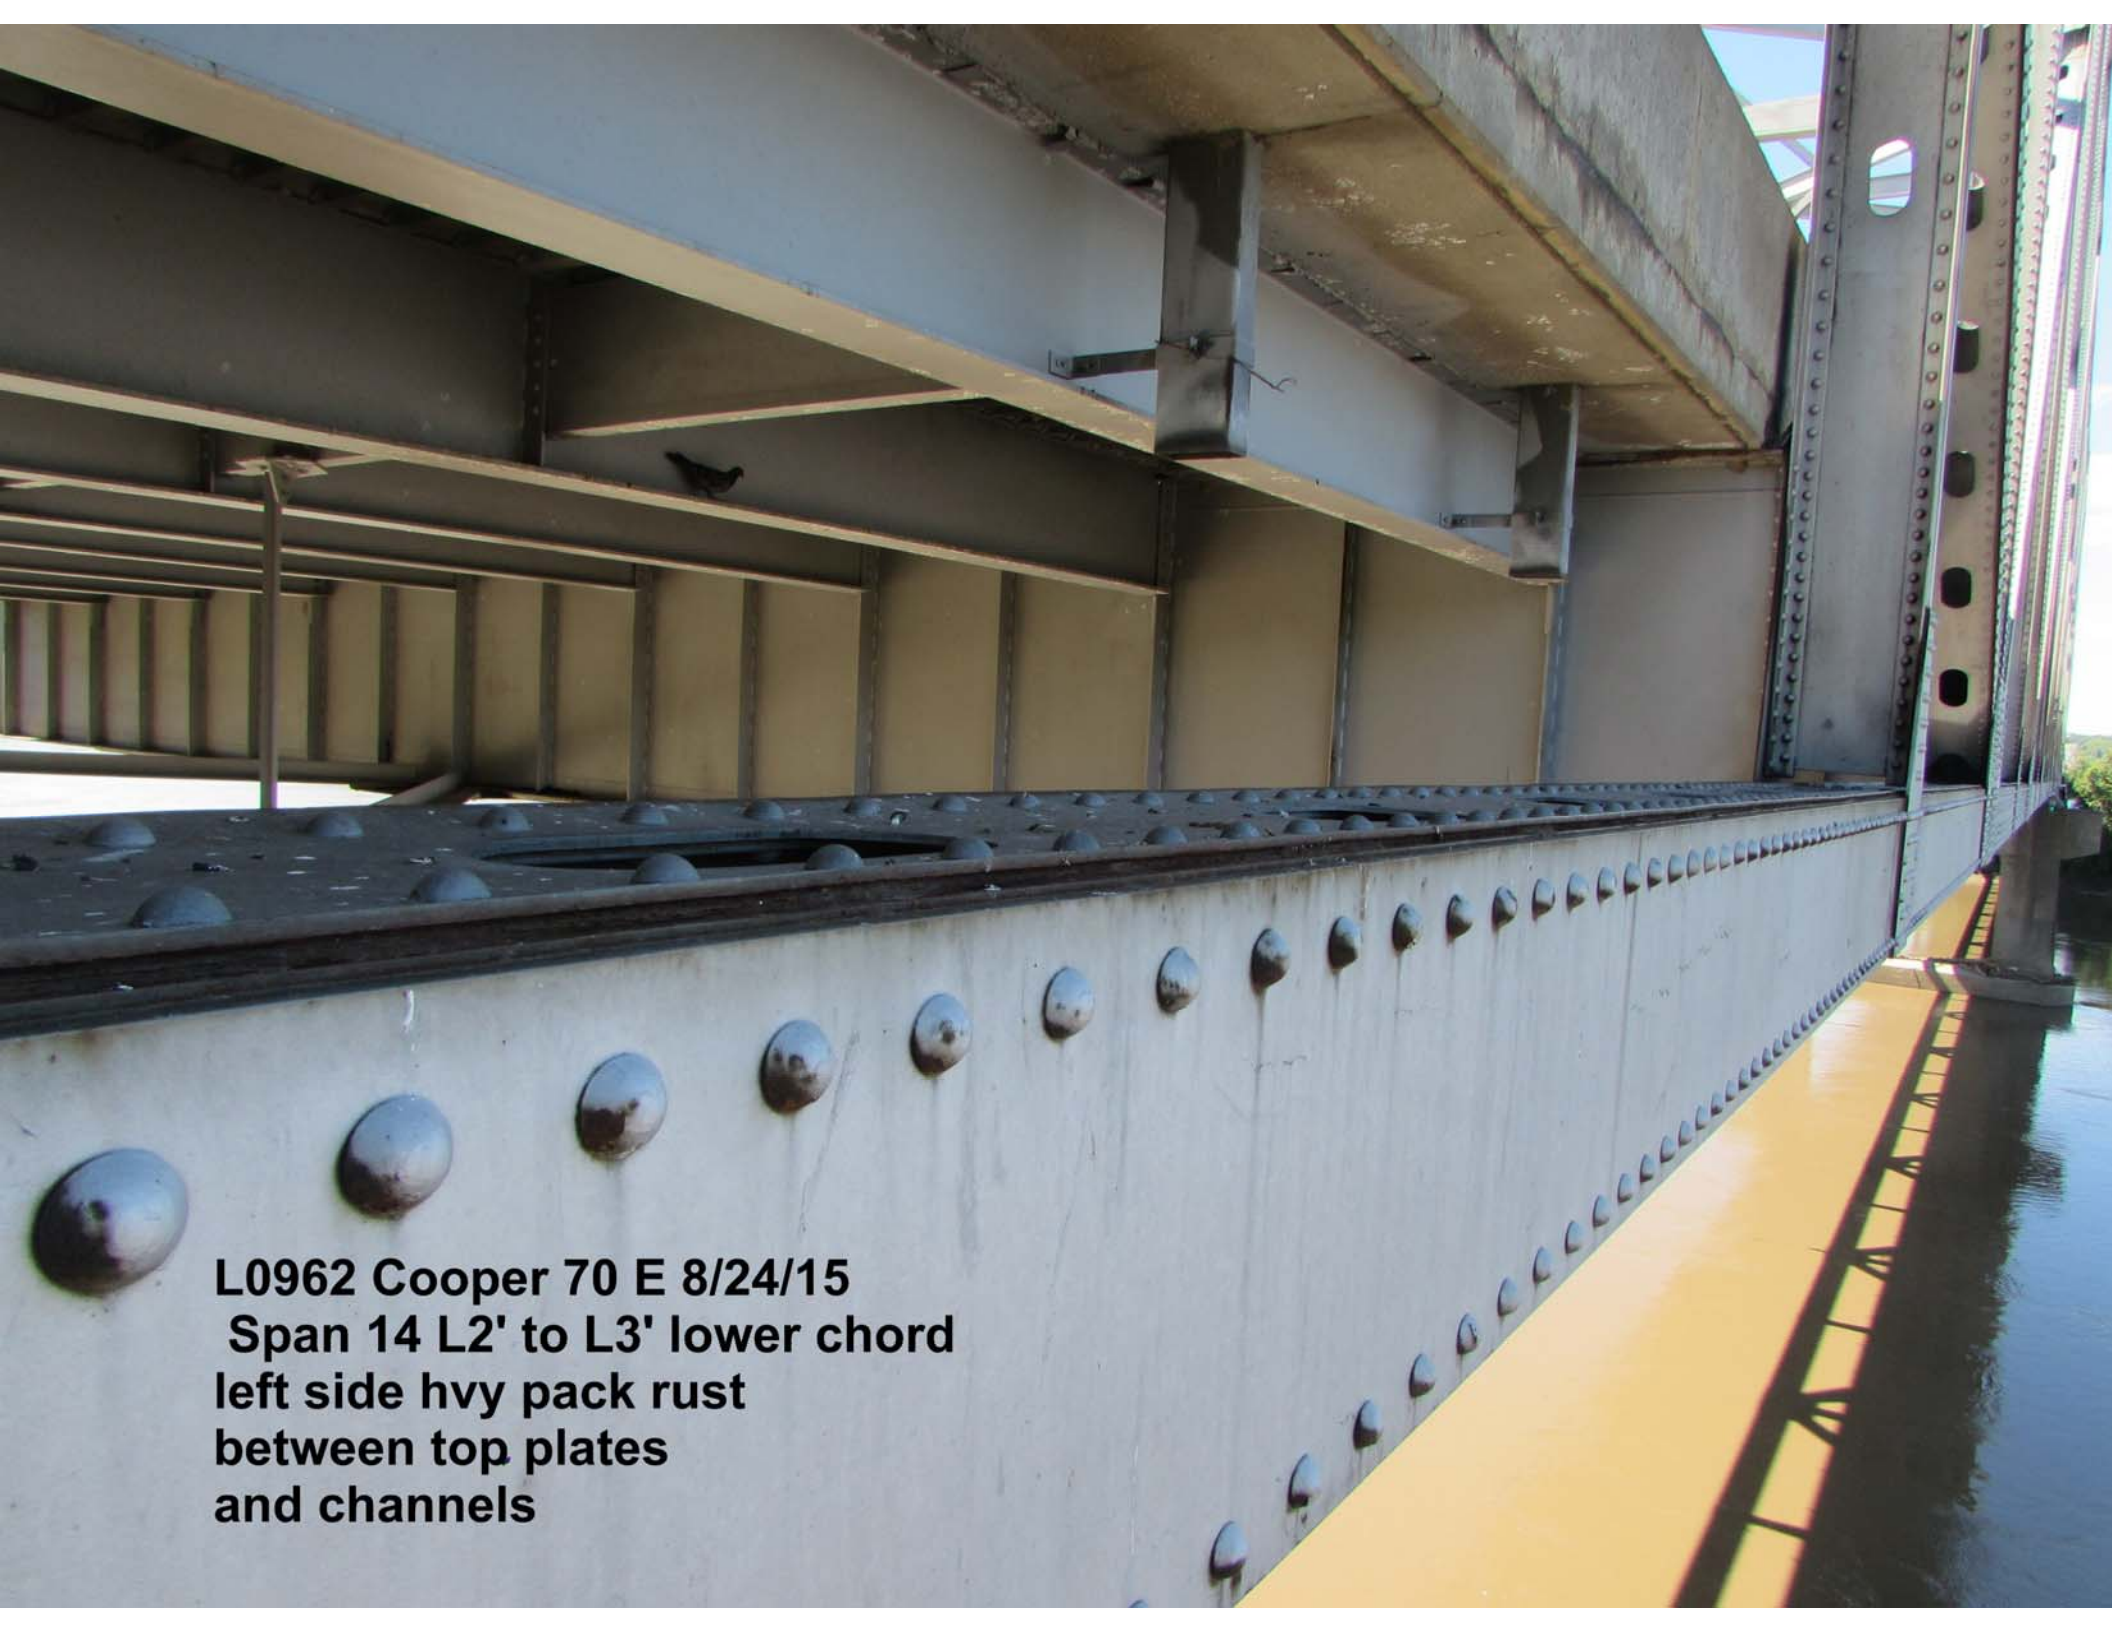
**L0962 Cooper 70 E 8/24/15**  
**Span 14 L2' to L3' lower chord**  
**left side hvy pack rust**  
**between top plates**  
**and channels**

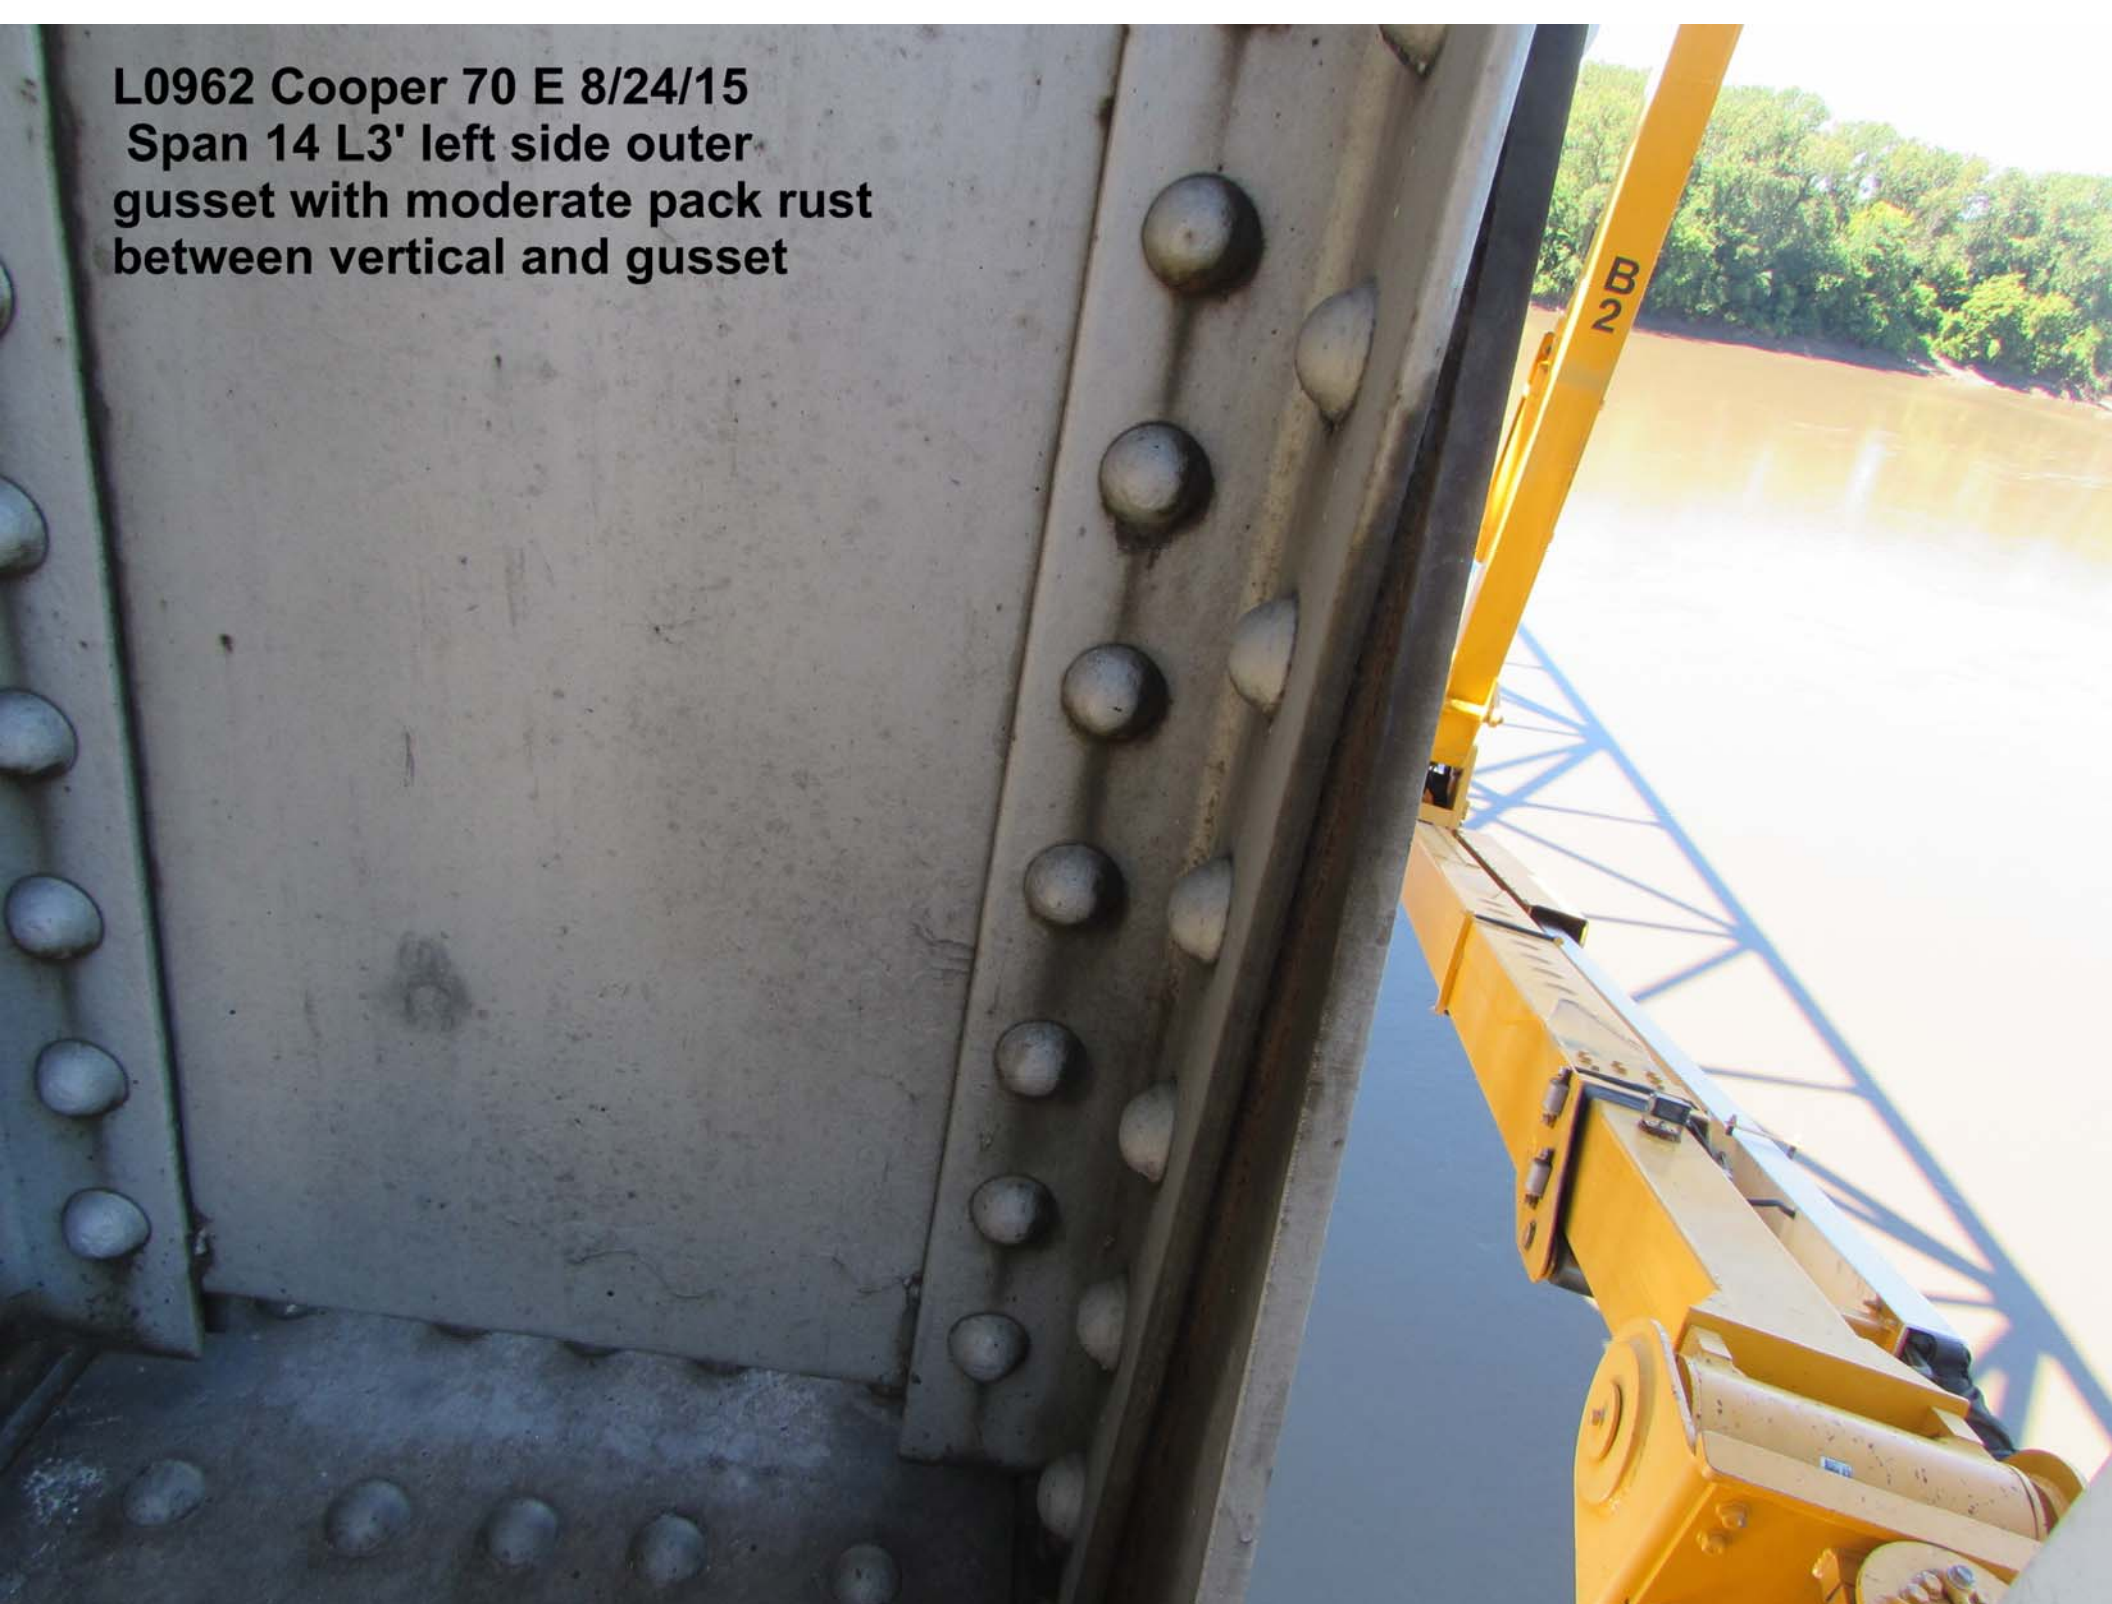
**L0962 Cooper 70 E 8/24/15**  
**Span 14 L3' left side outer**  
**gusset with moderate pack rust**  
**between vertical and gusset**

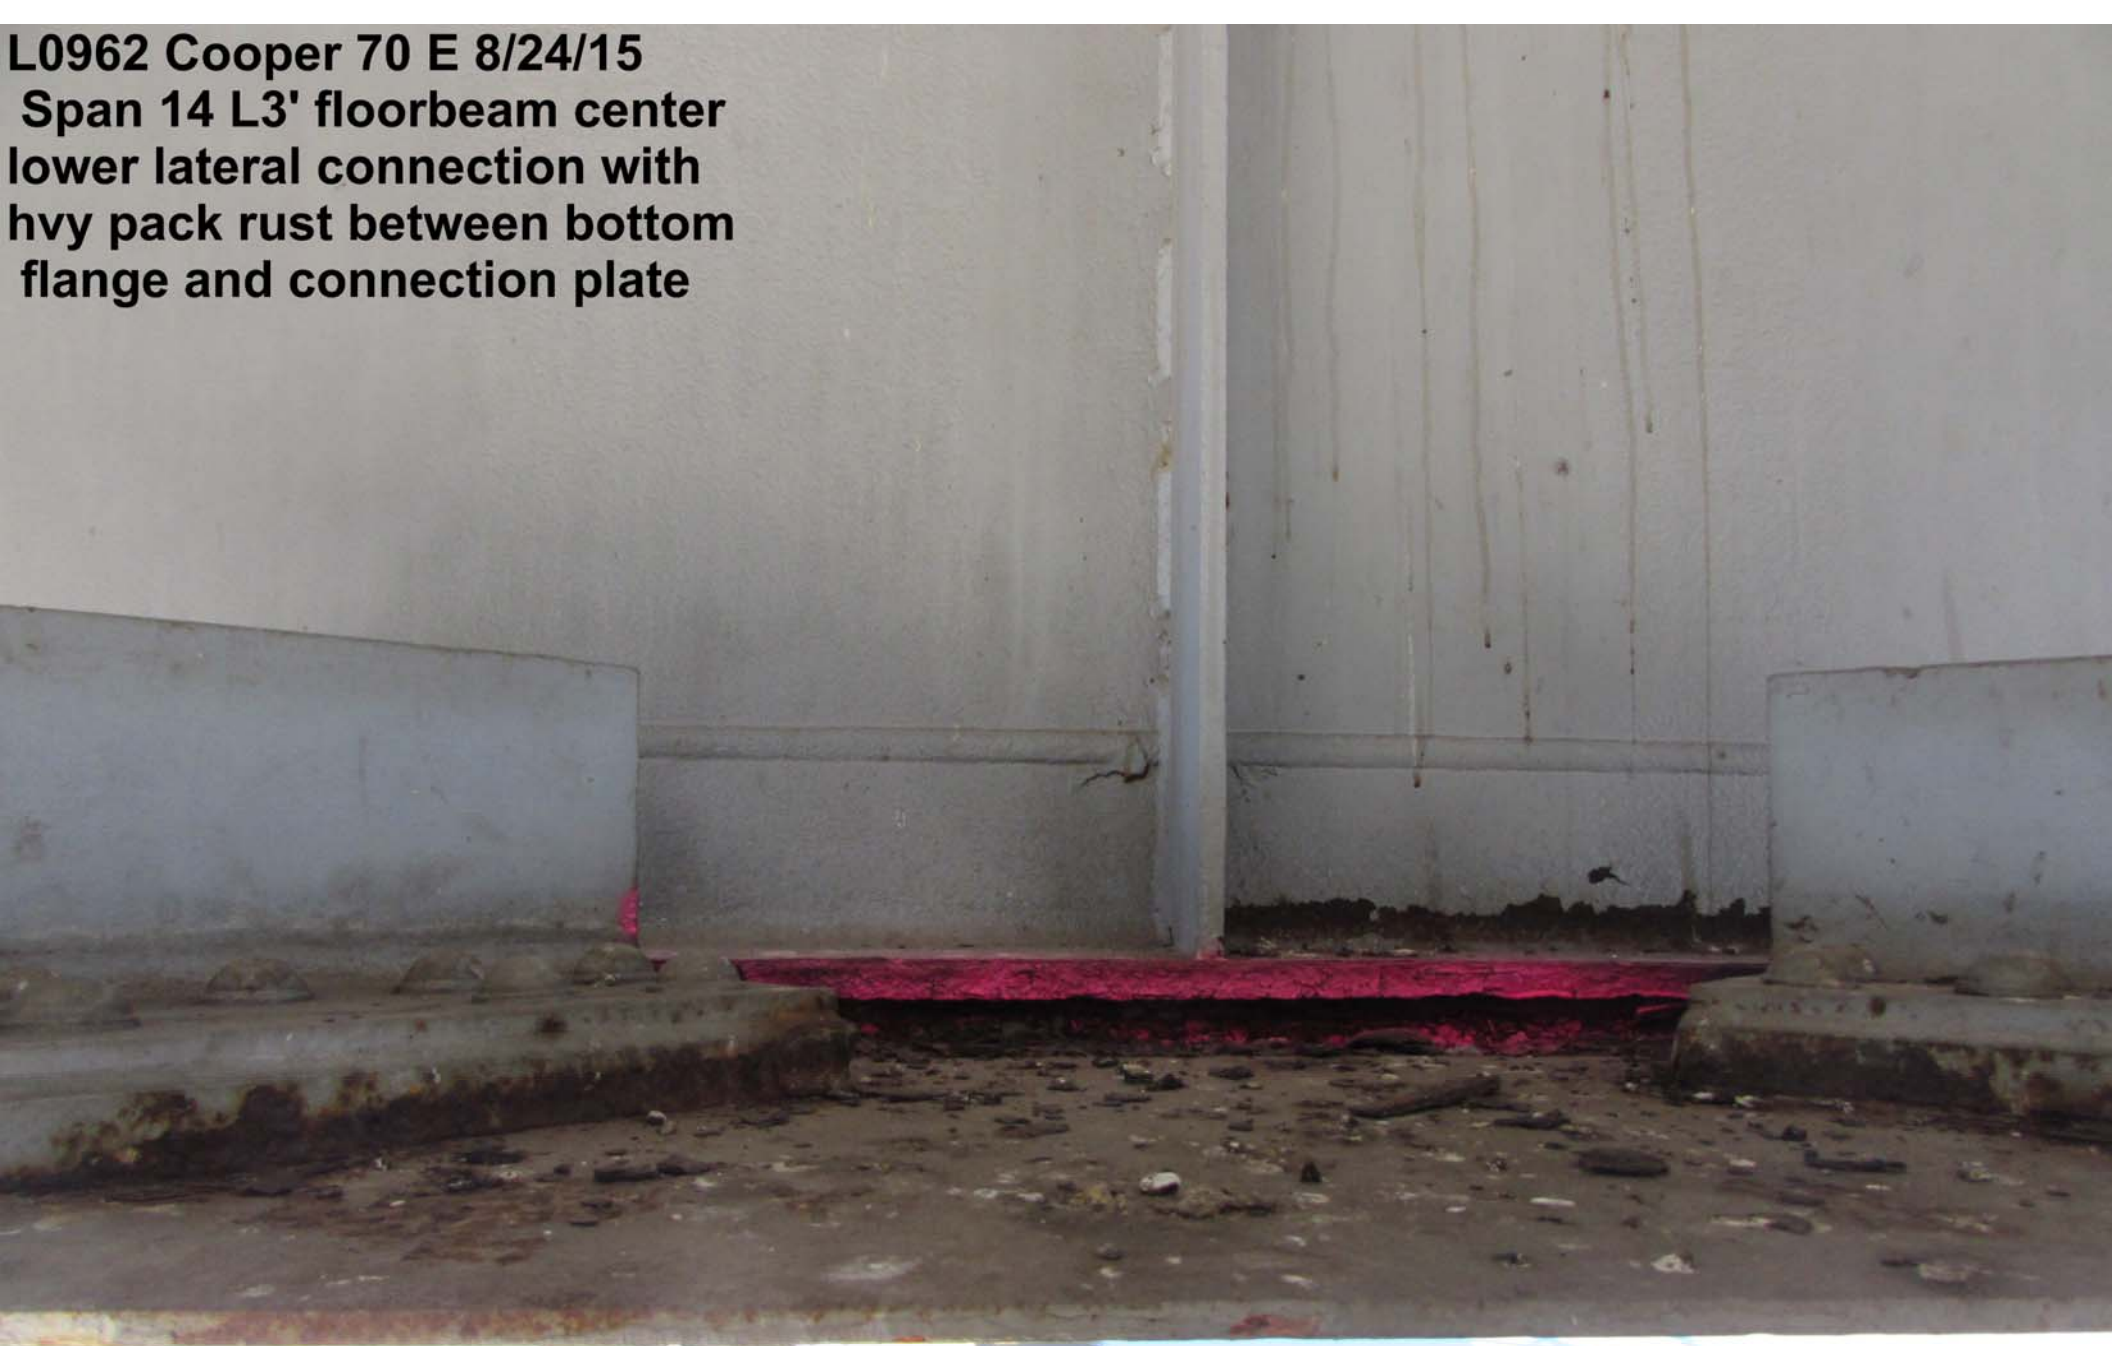
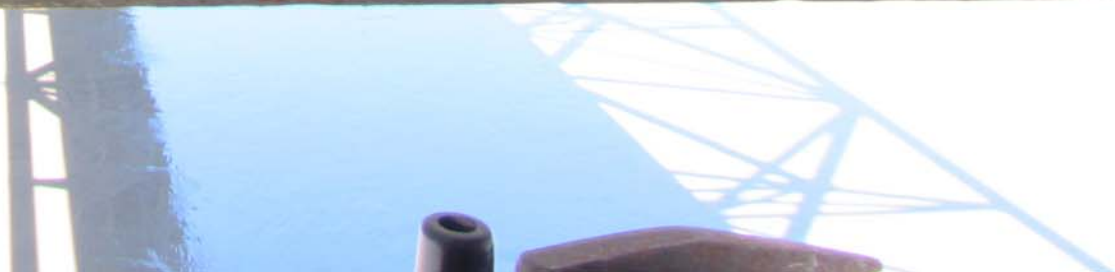
**L0962 Cooper 70 E 8/24/15**  
**Span 14 L3' floorbeam center**  
**lower lateral connection with**  
**hvy pack rust between bottom**  
**flange and connection plate**

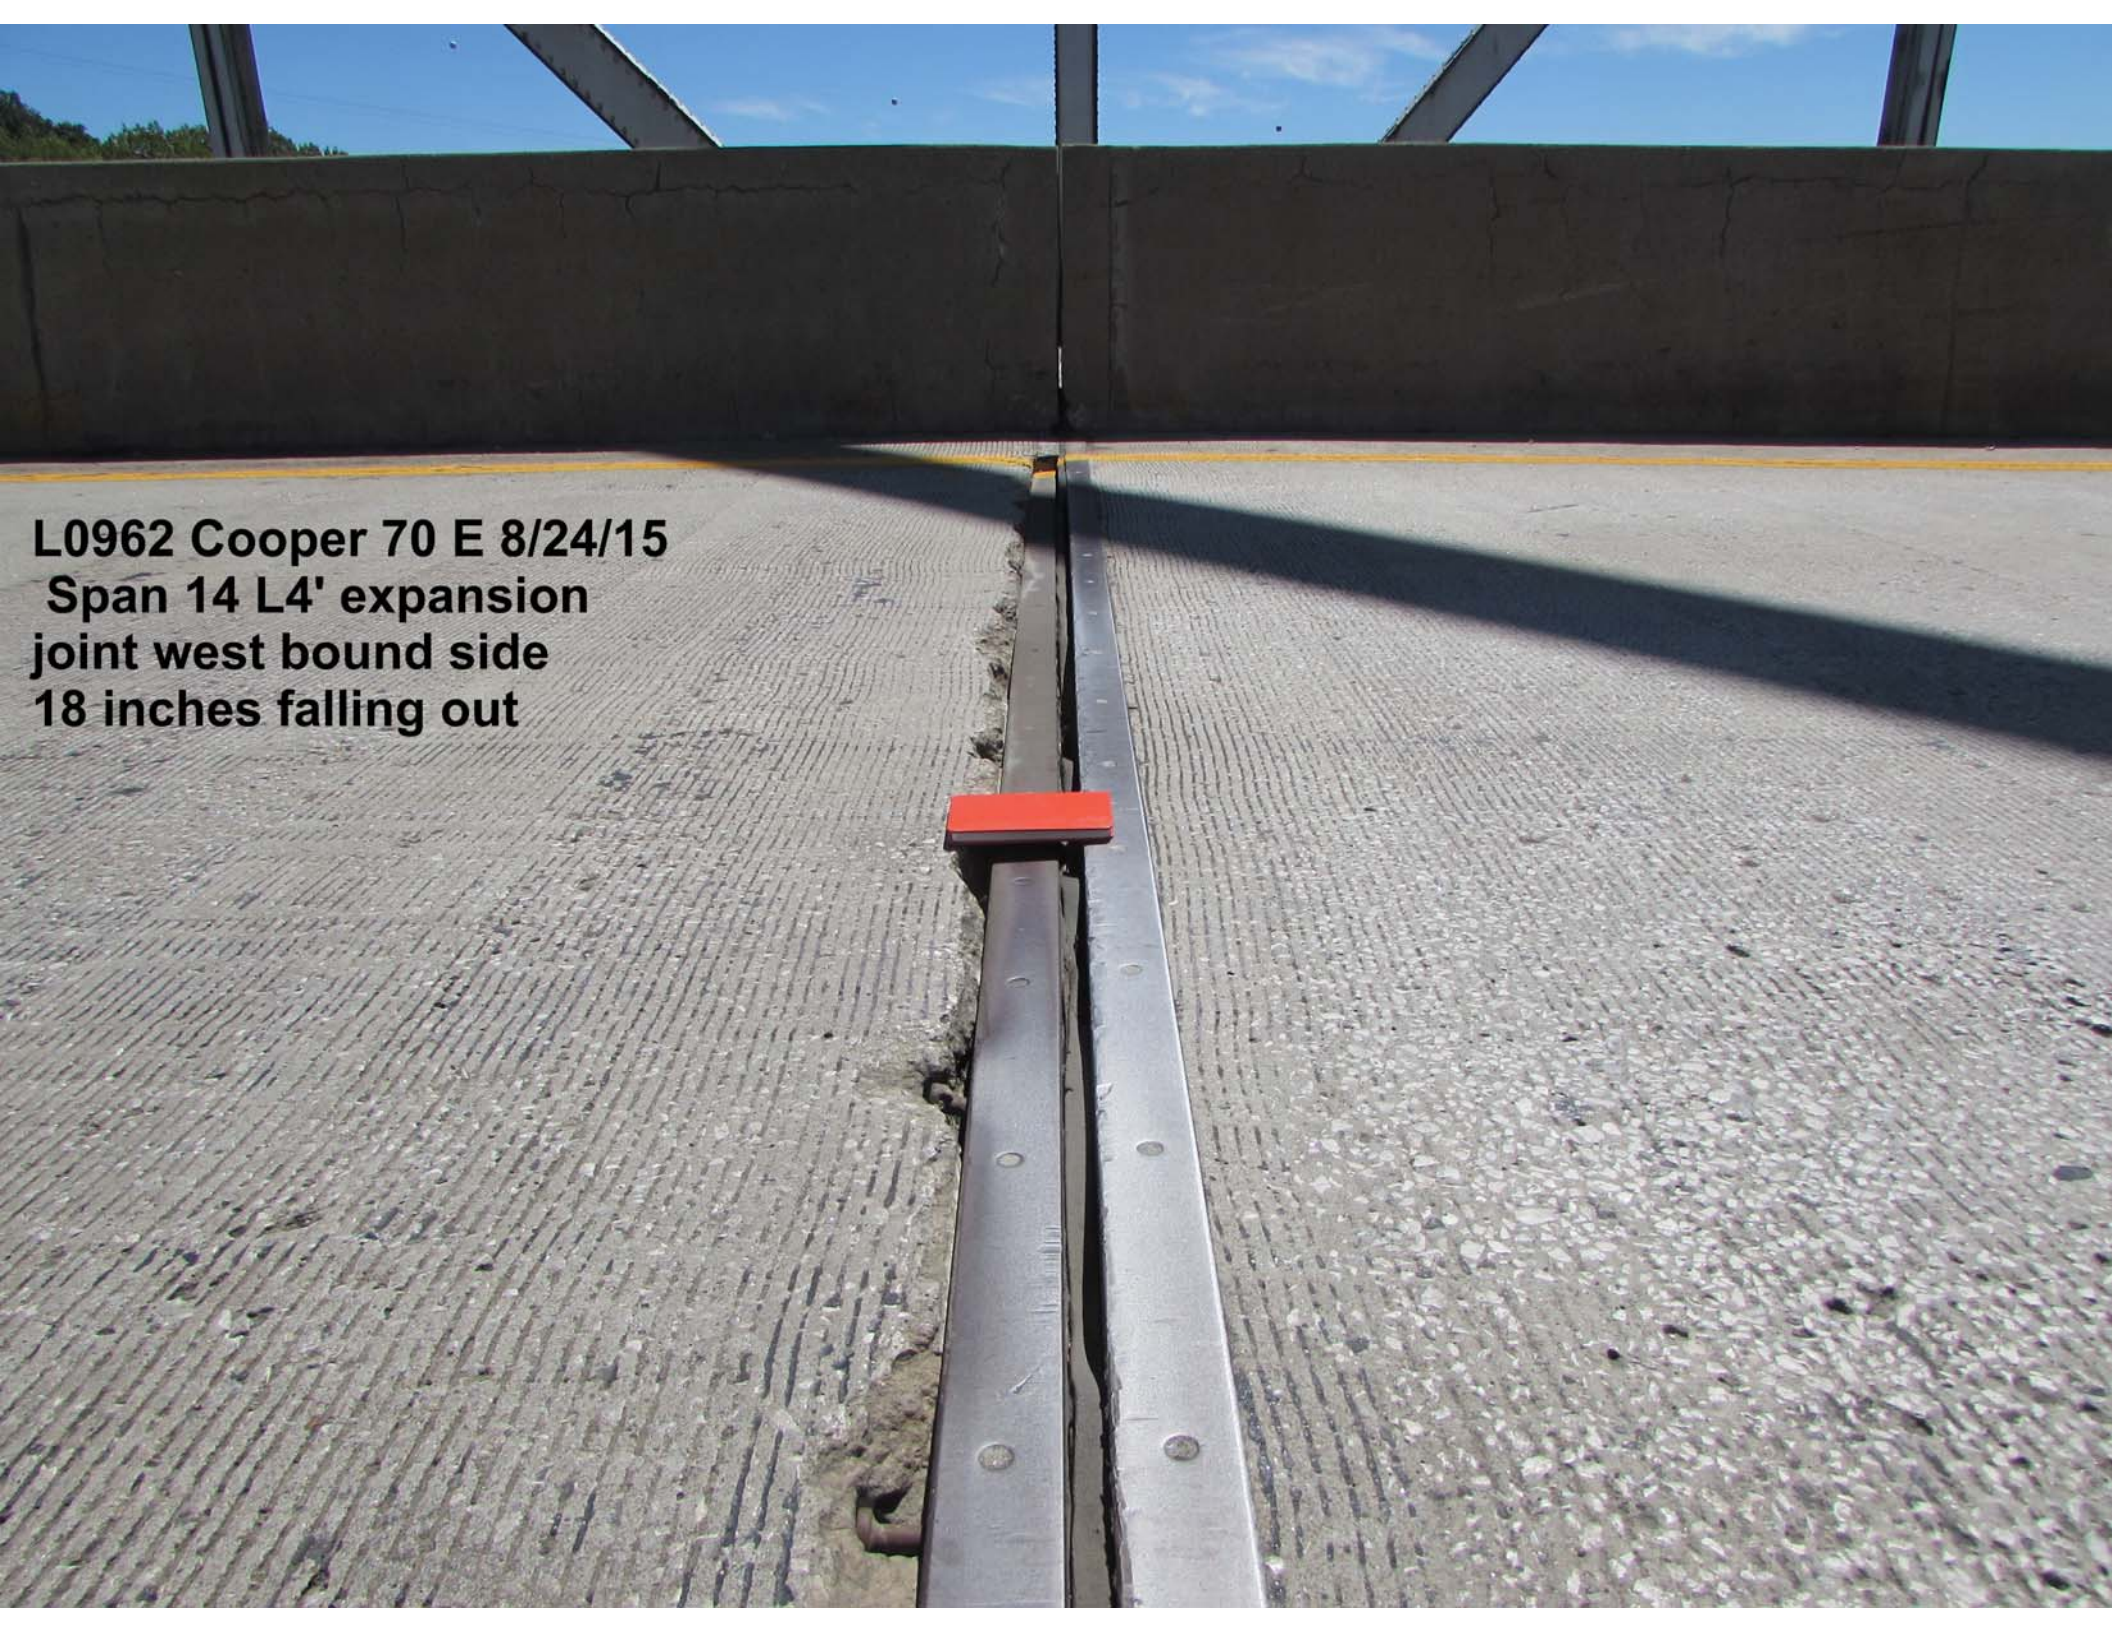
**L0962 Cooper 70 E 8/24/15**  
**Span 14 L4' expansion**  
**joint west bound side**  
**18 inches falling out**

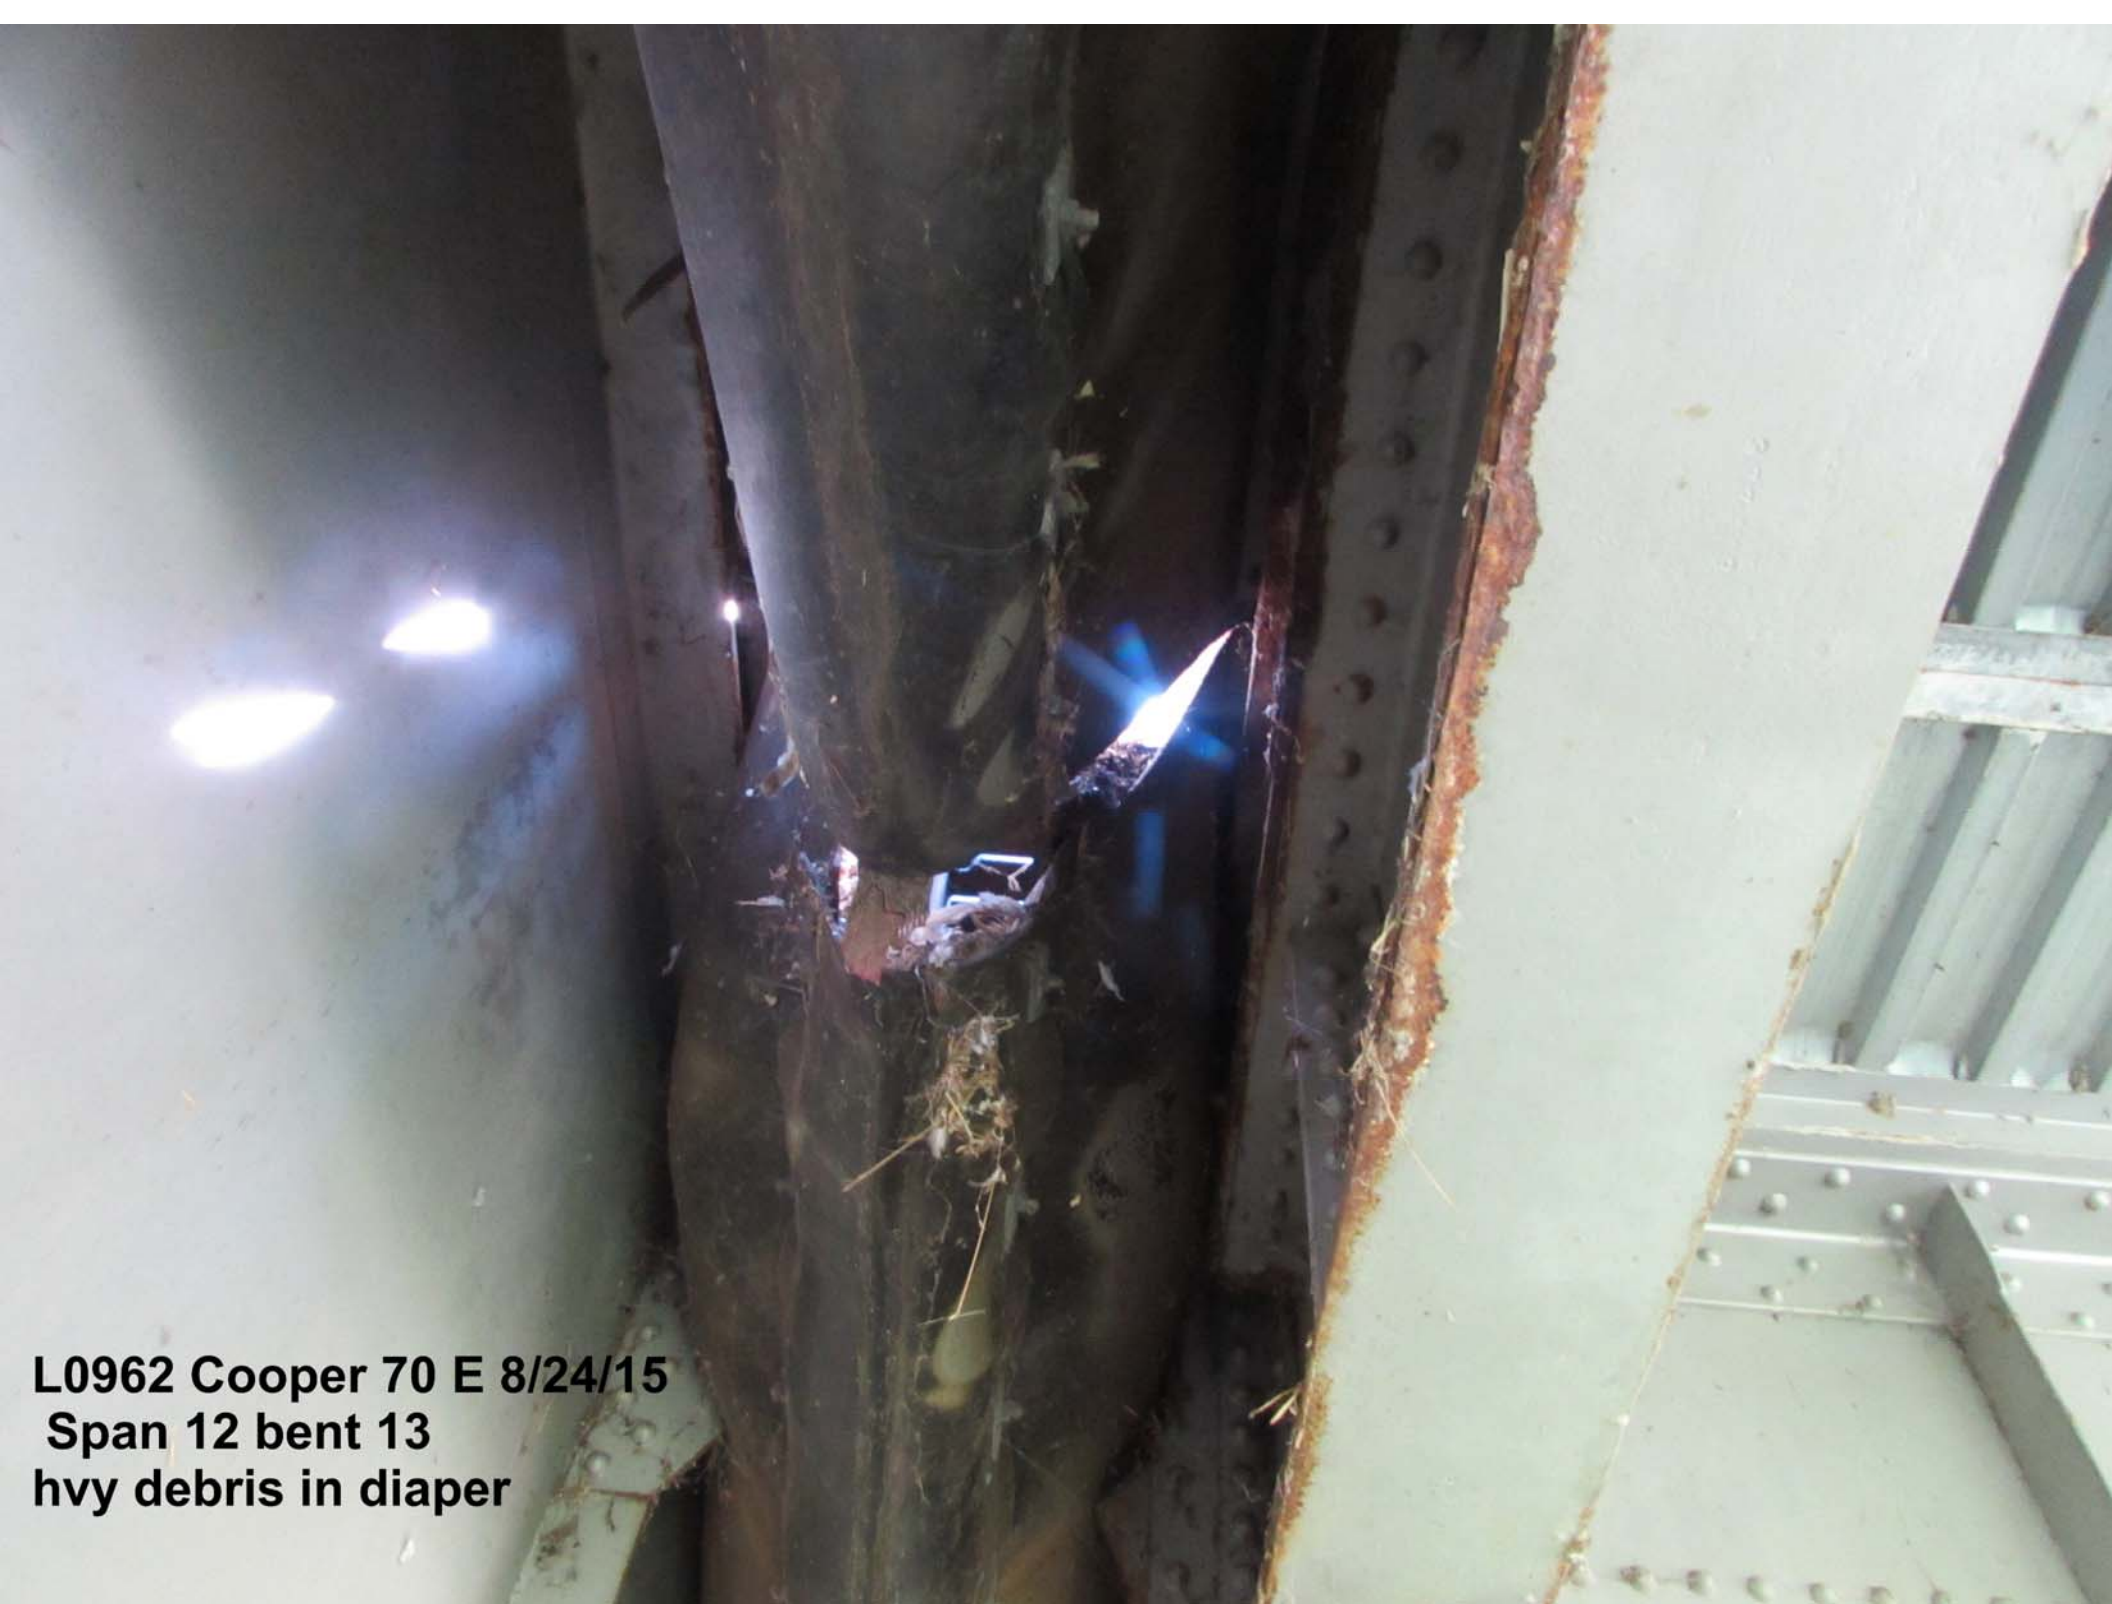
**L0962 Cooper 70 E 8/24/15**  
**Span 12 bent 13**  
**hvy debris in diaper**

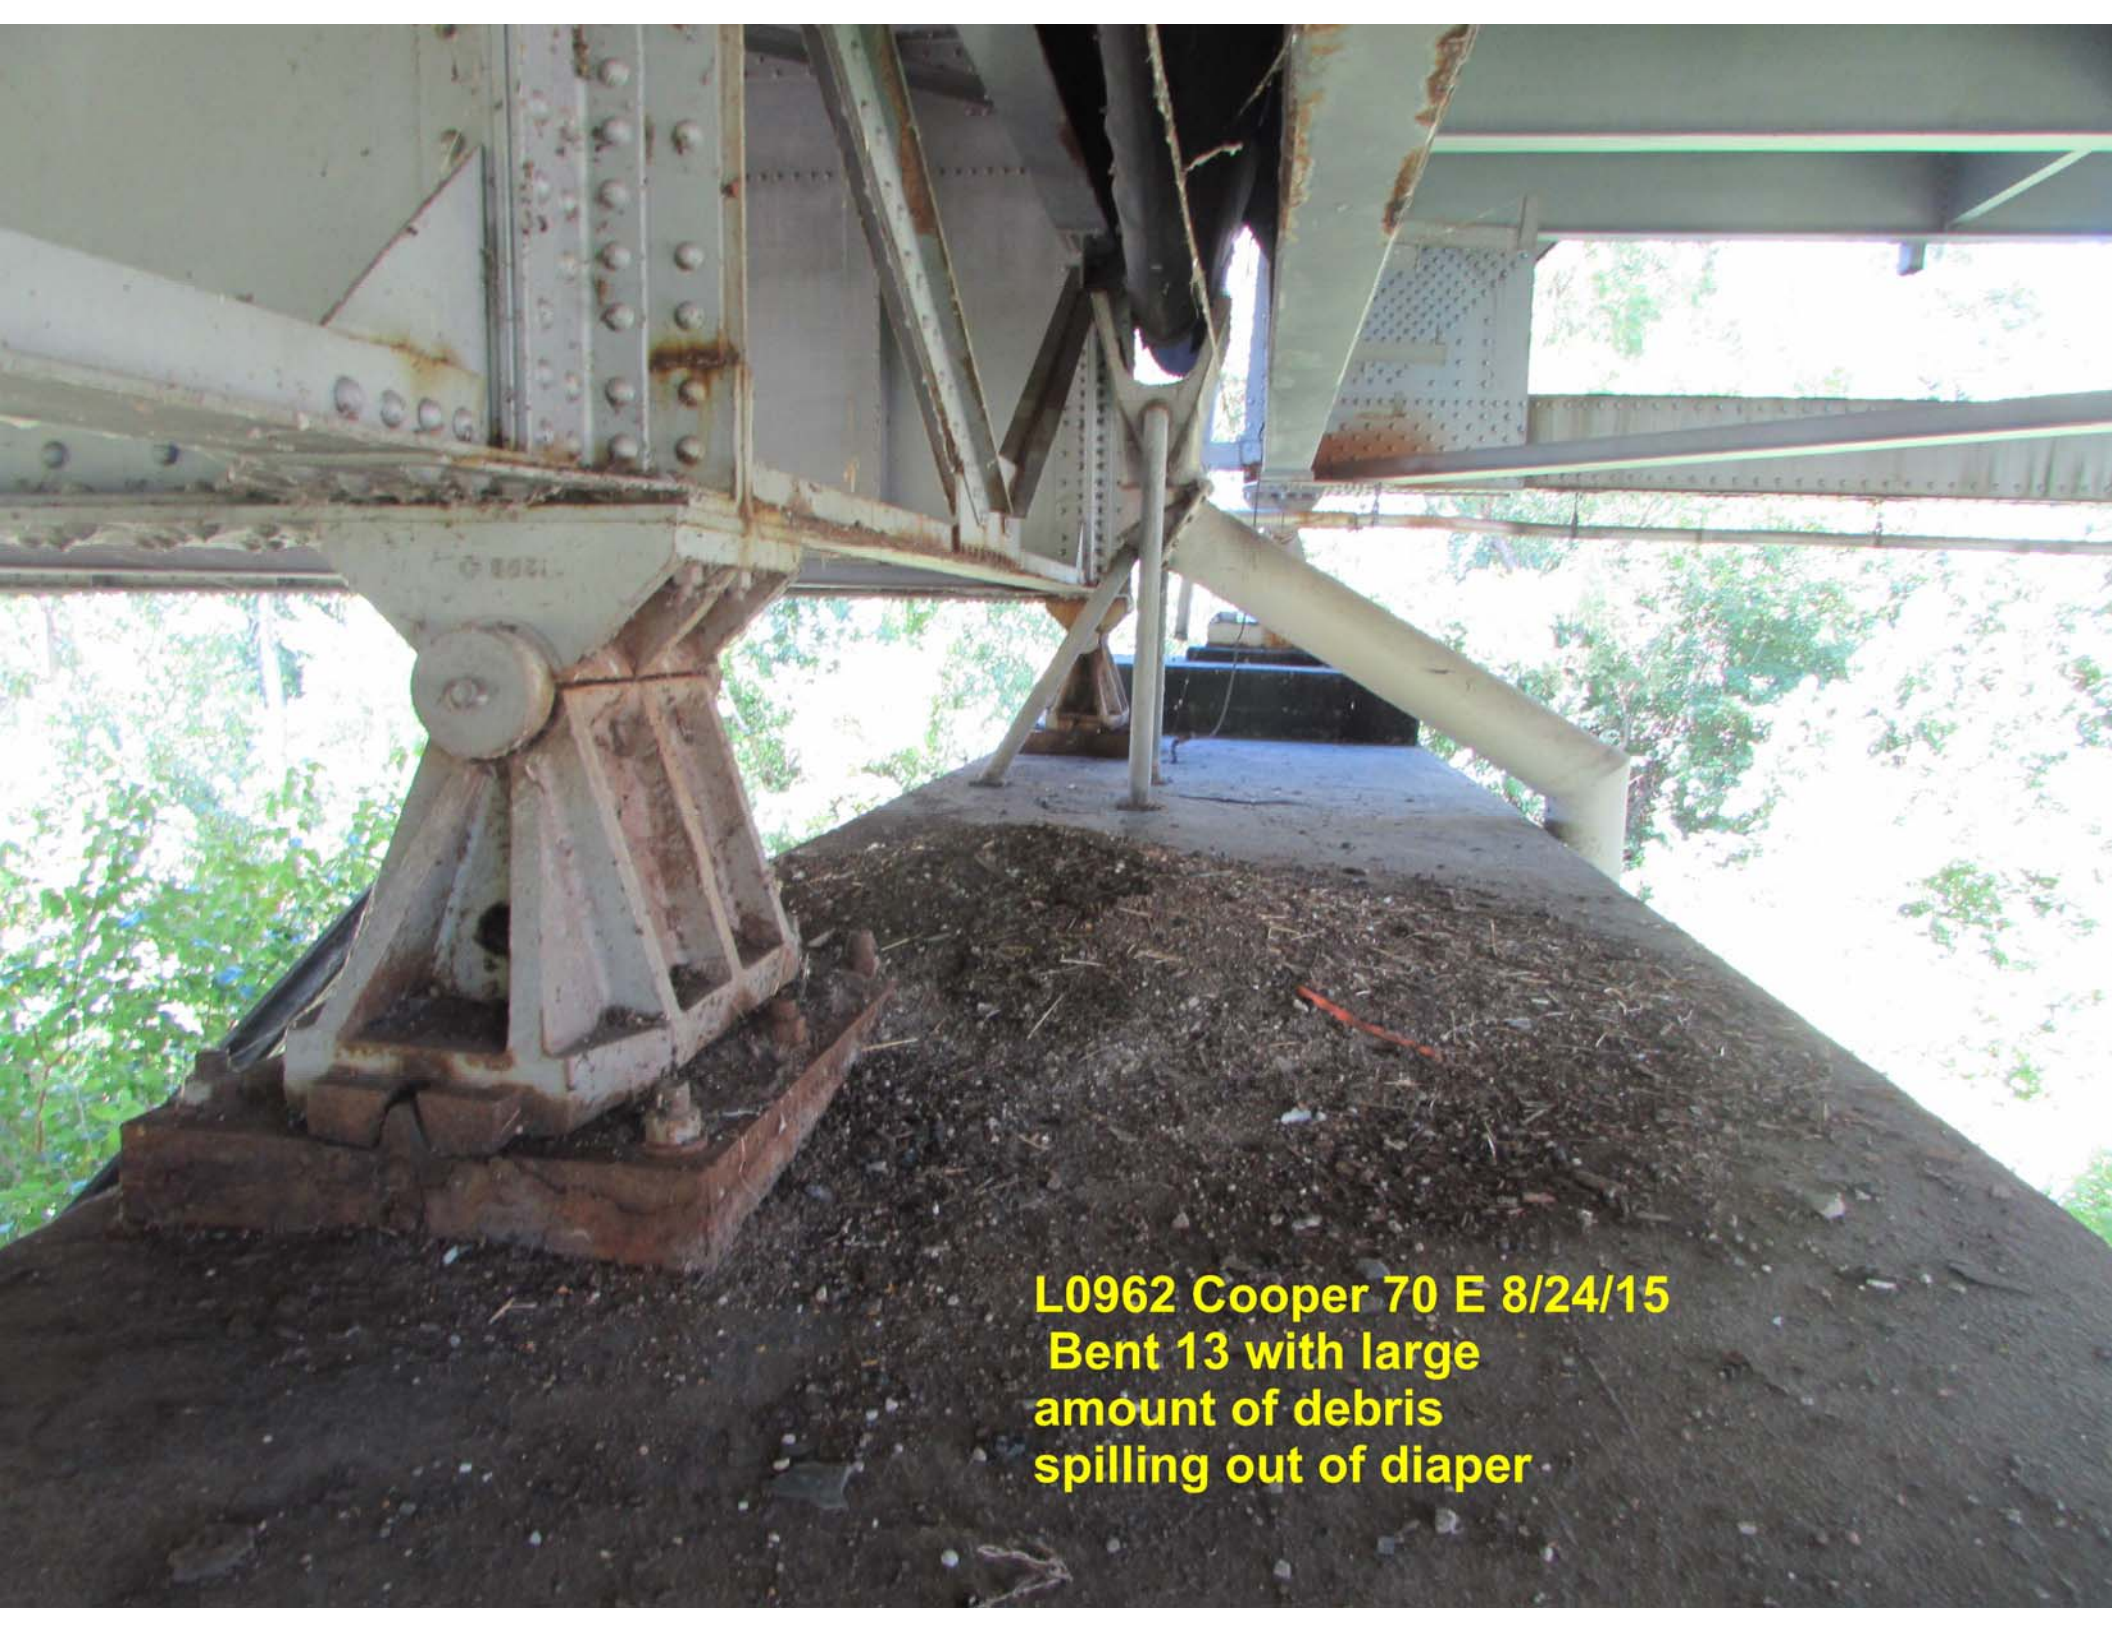
**L0962 Cooper 70 E 8/24/15  
Bent 13 with large  
amount of debris  
spilling out of diaper**
