L0962 I 70 Cooper Co.  
Joint at L8, span 13  
Eastbound lane failing  
9-24-13

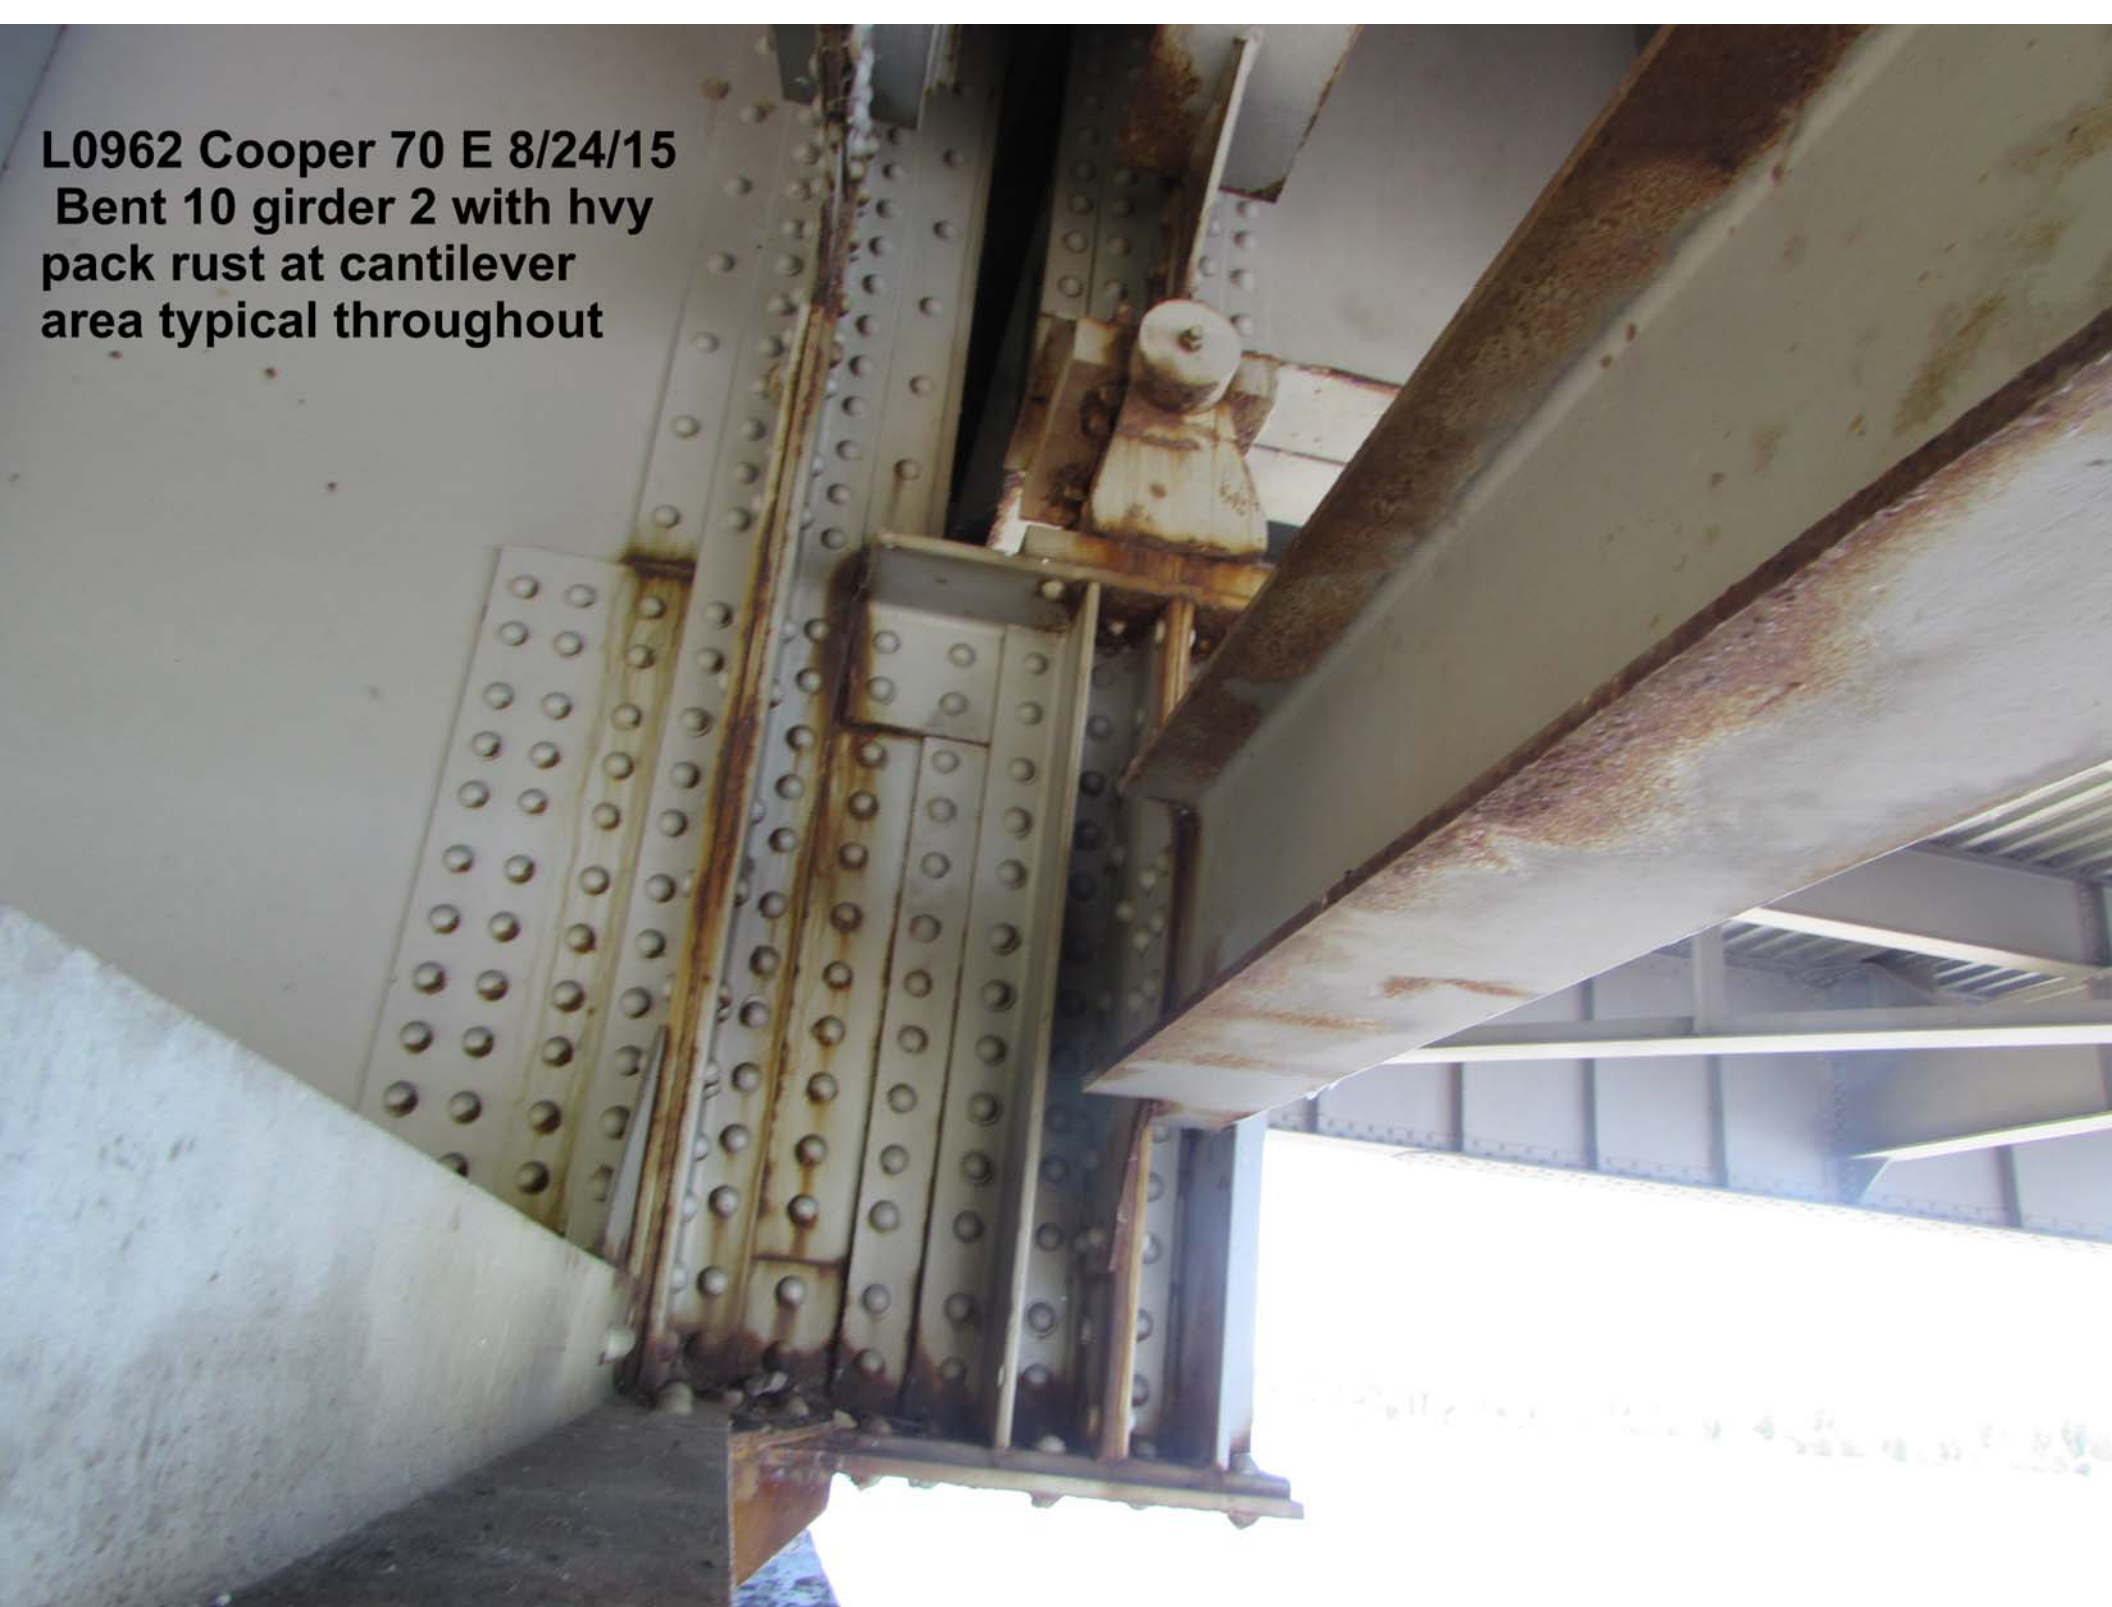
**L0962 Cooper 70 E 8/24/15**  
**Bent 10 girder 2 with hvy**  
**pack rust at cantilever**  
**area typical throughout**

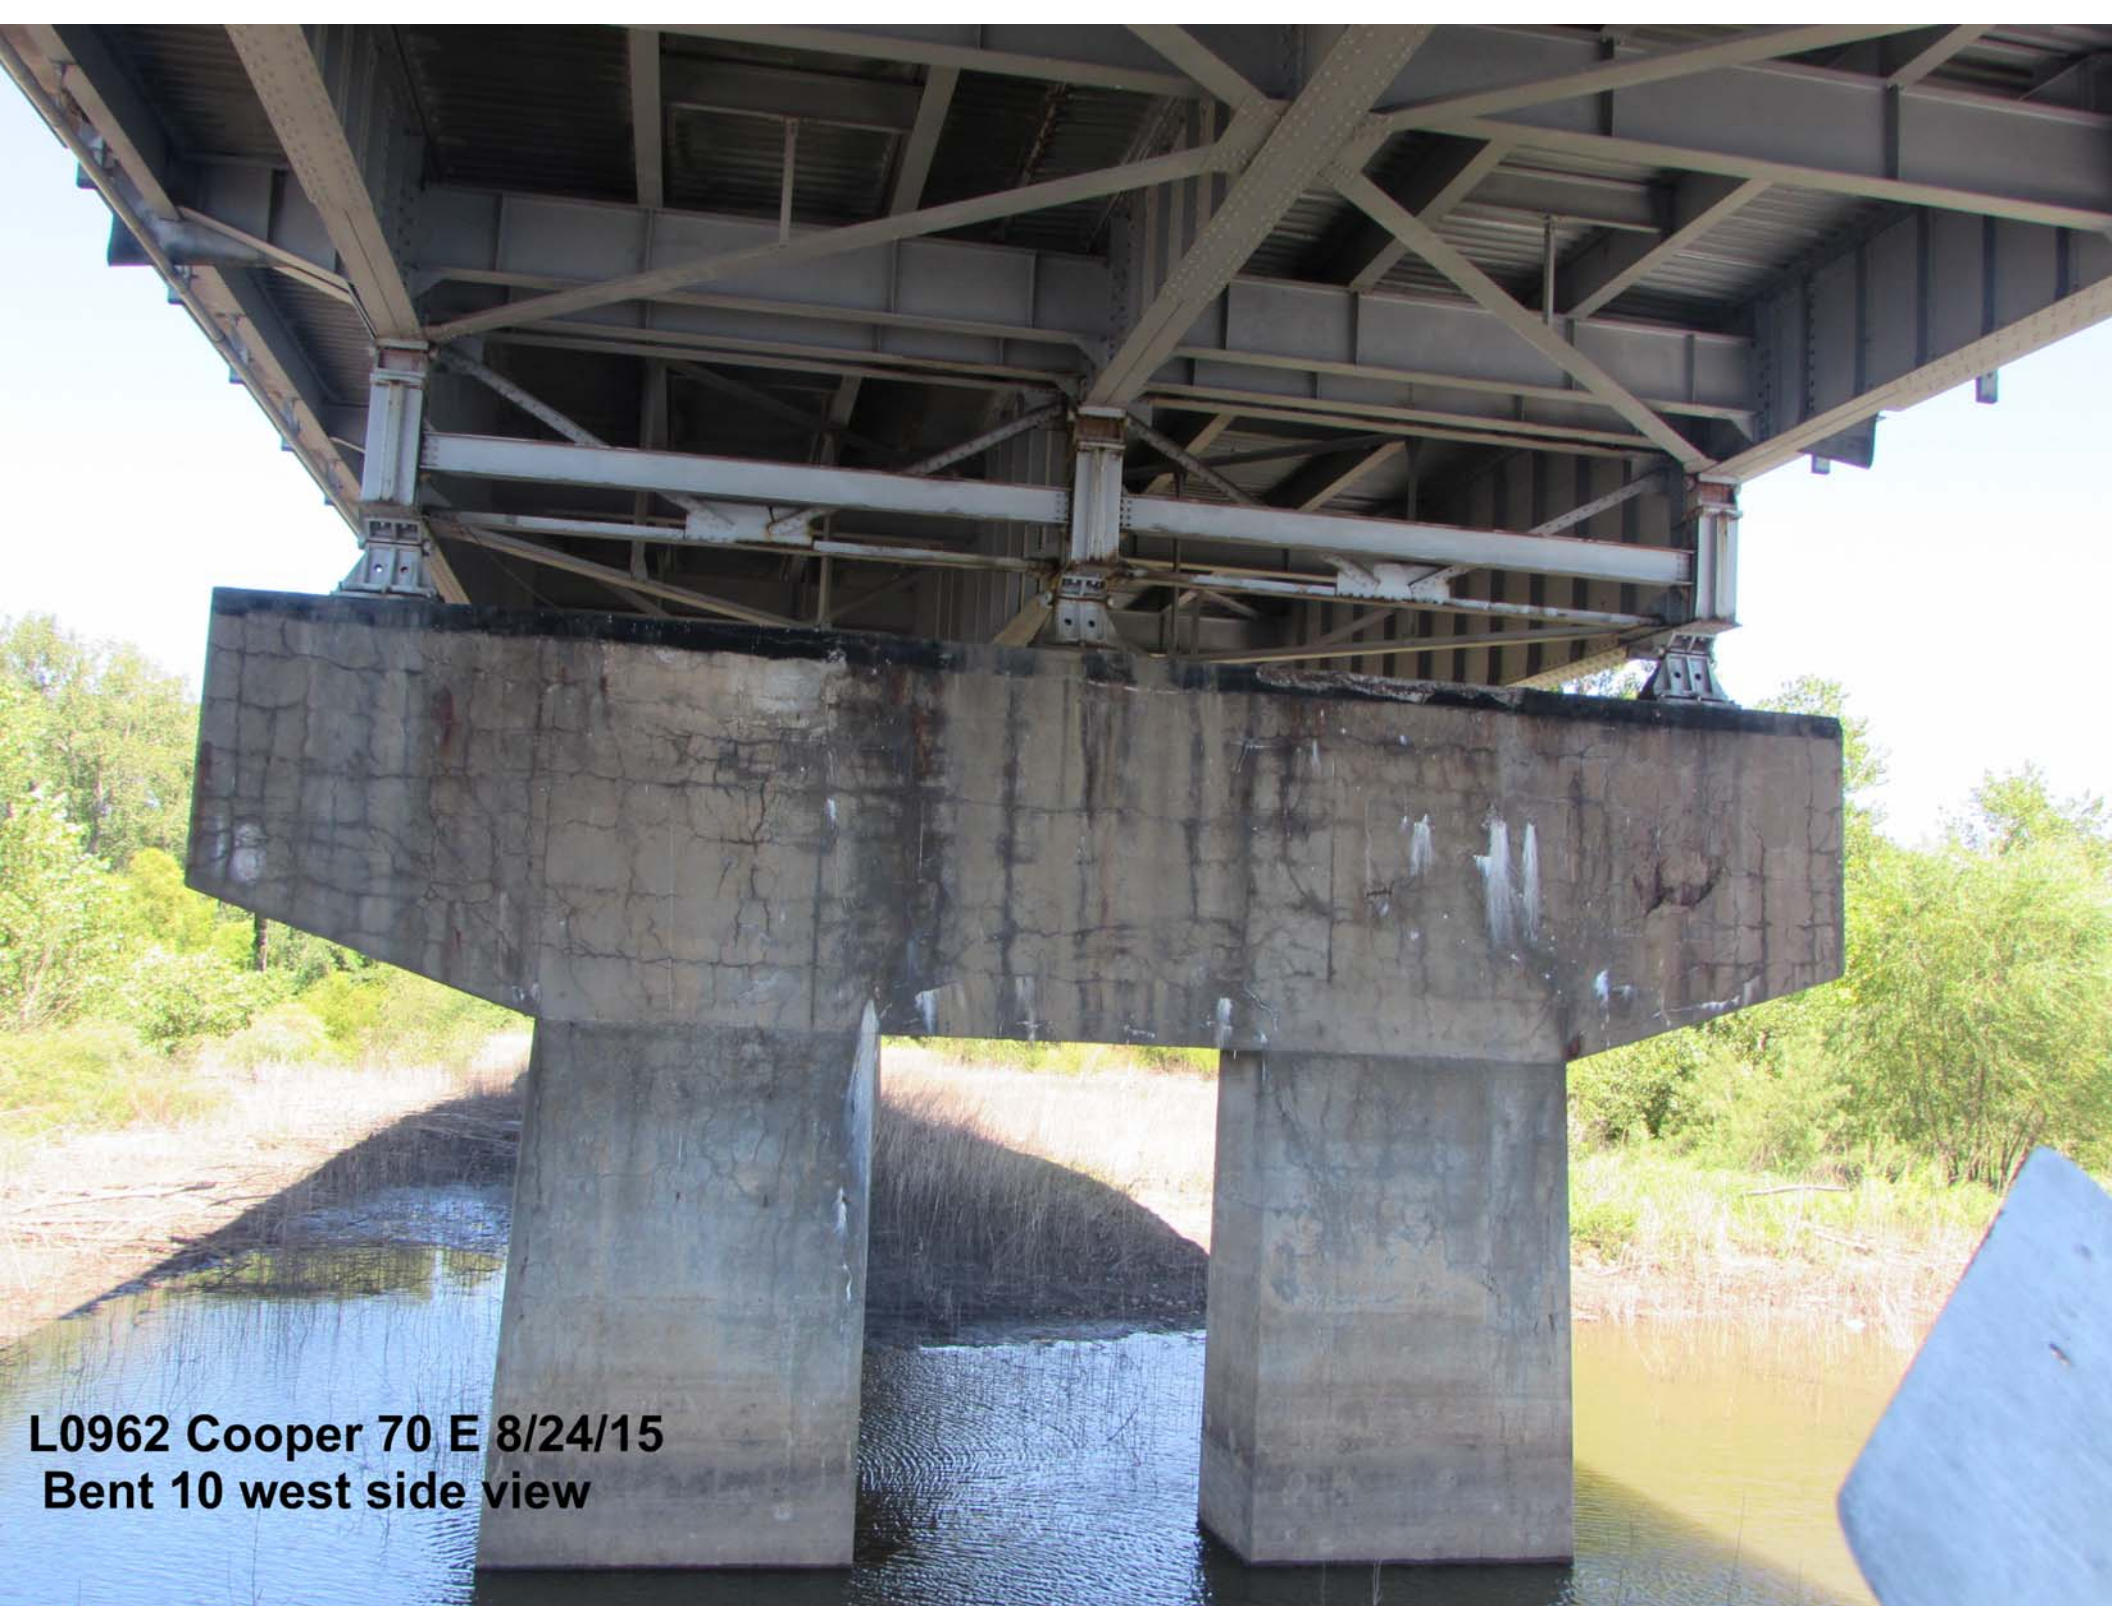
**L0962 Cooper 70 E 8/24/15**  
**Bent 10 west side view**

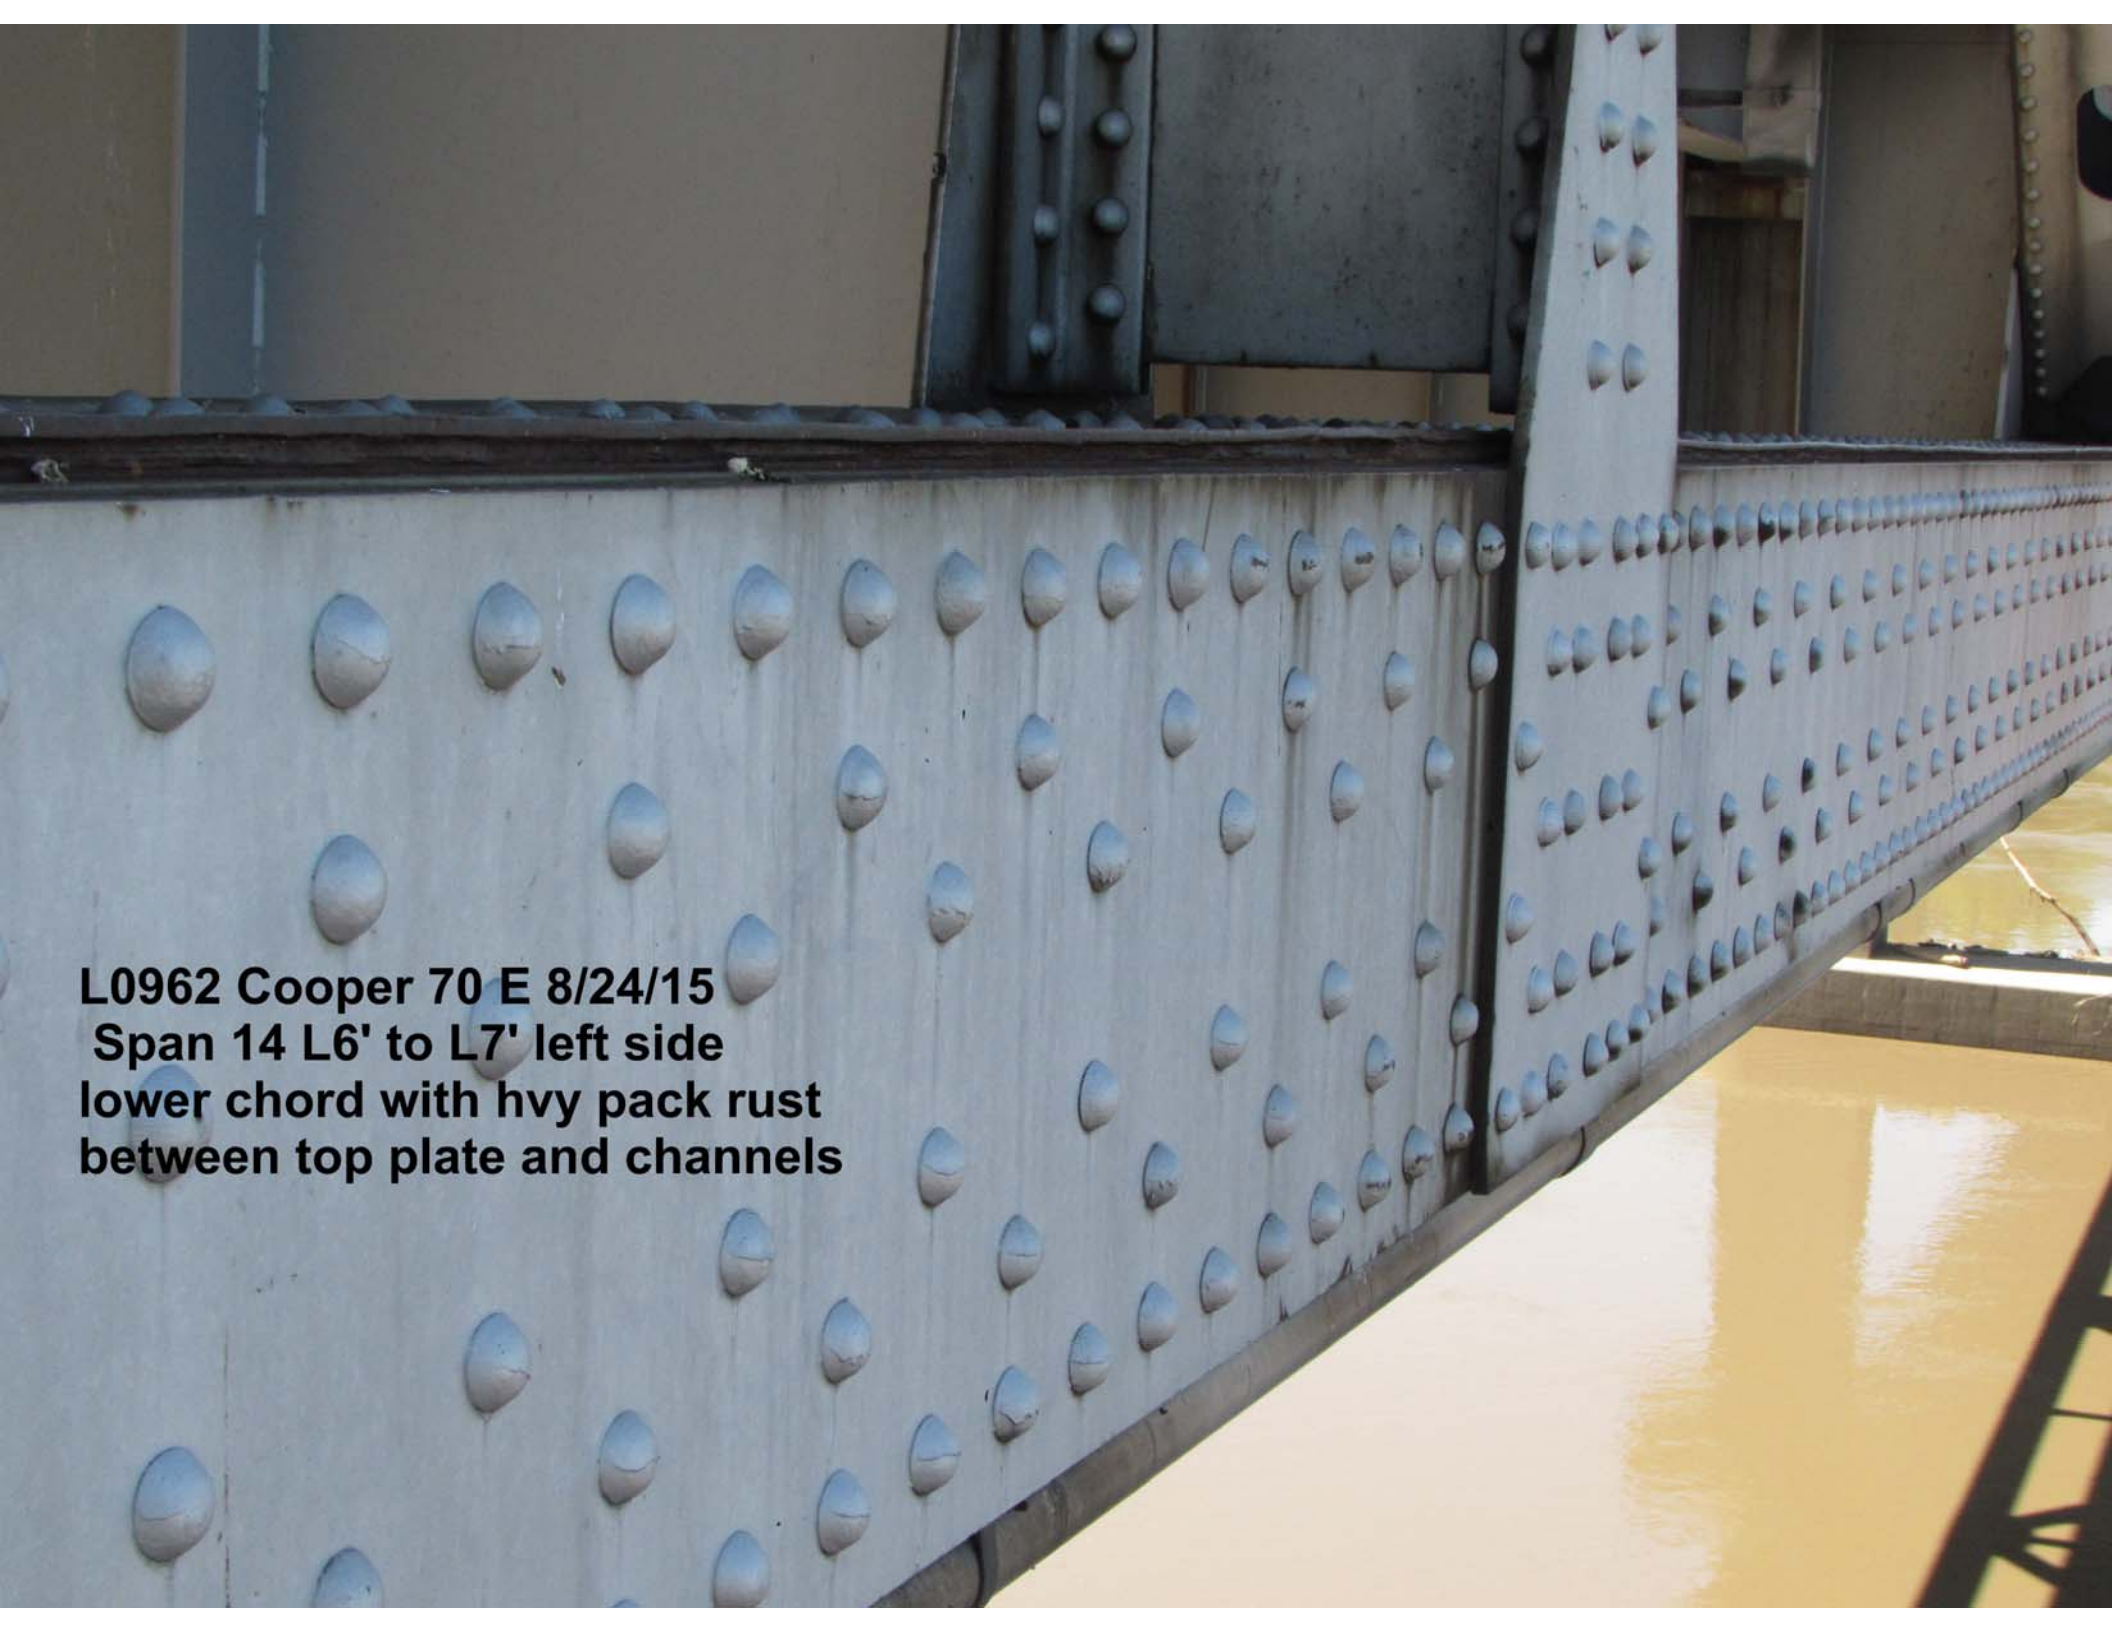
**L0962 Cooper 70 E 8/24/15**  
**Span 14 L6' to L7' left side**  
**lower chord with hvy pack rust**  
**between top plate and channels**

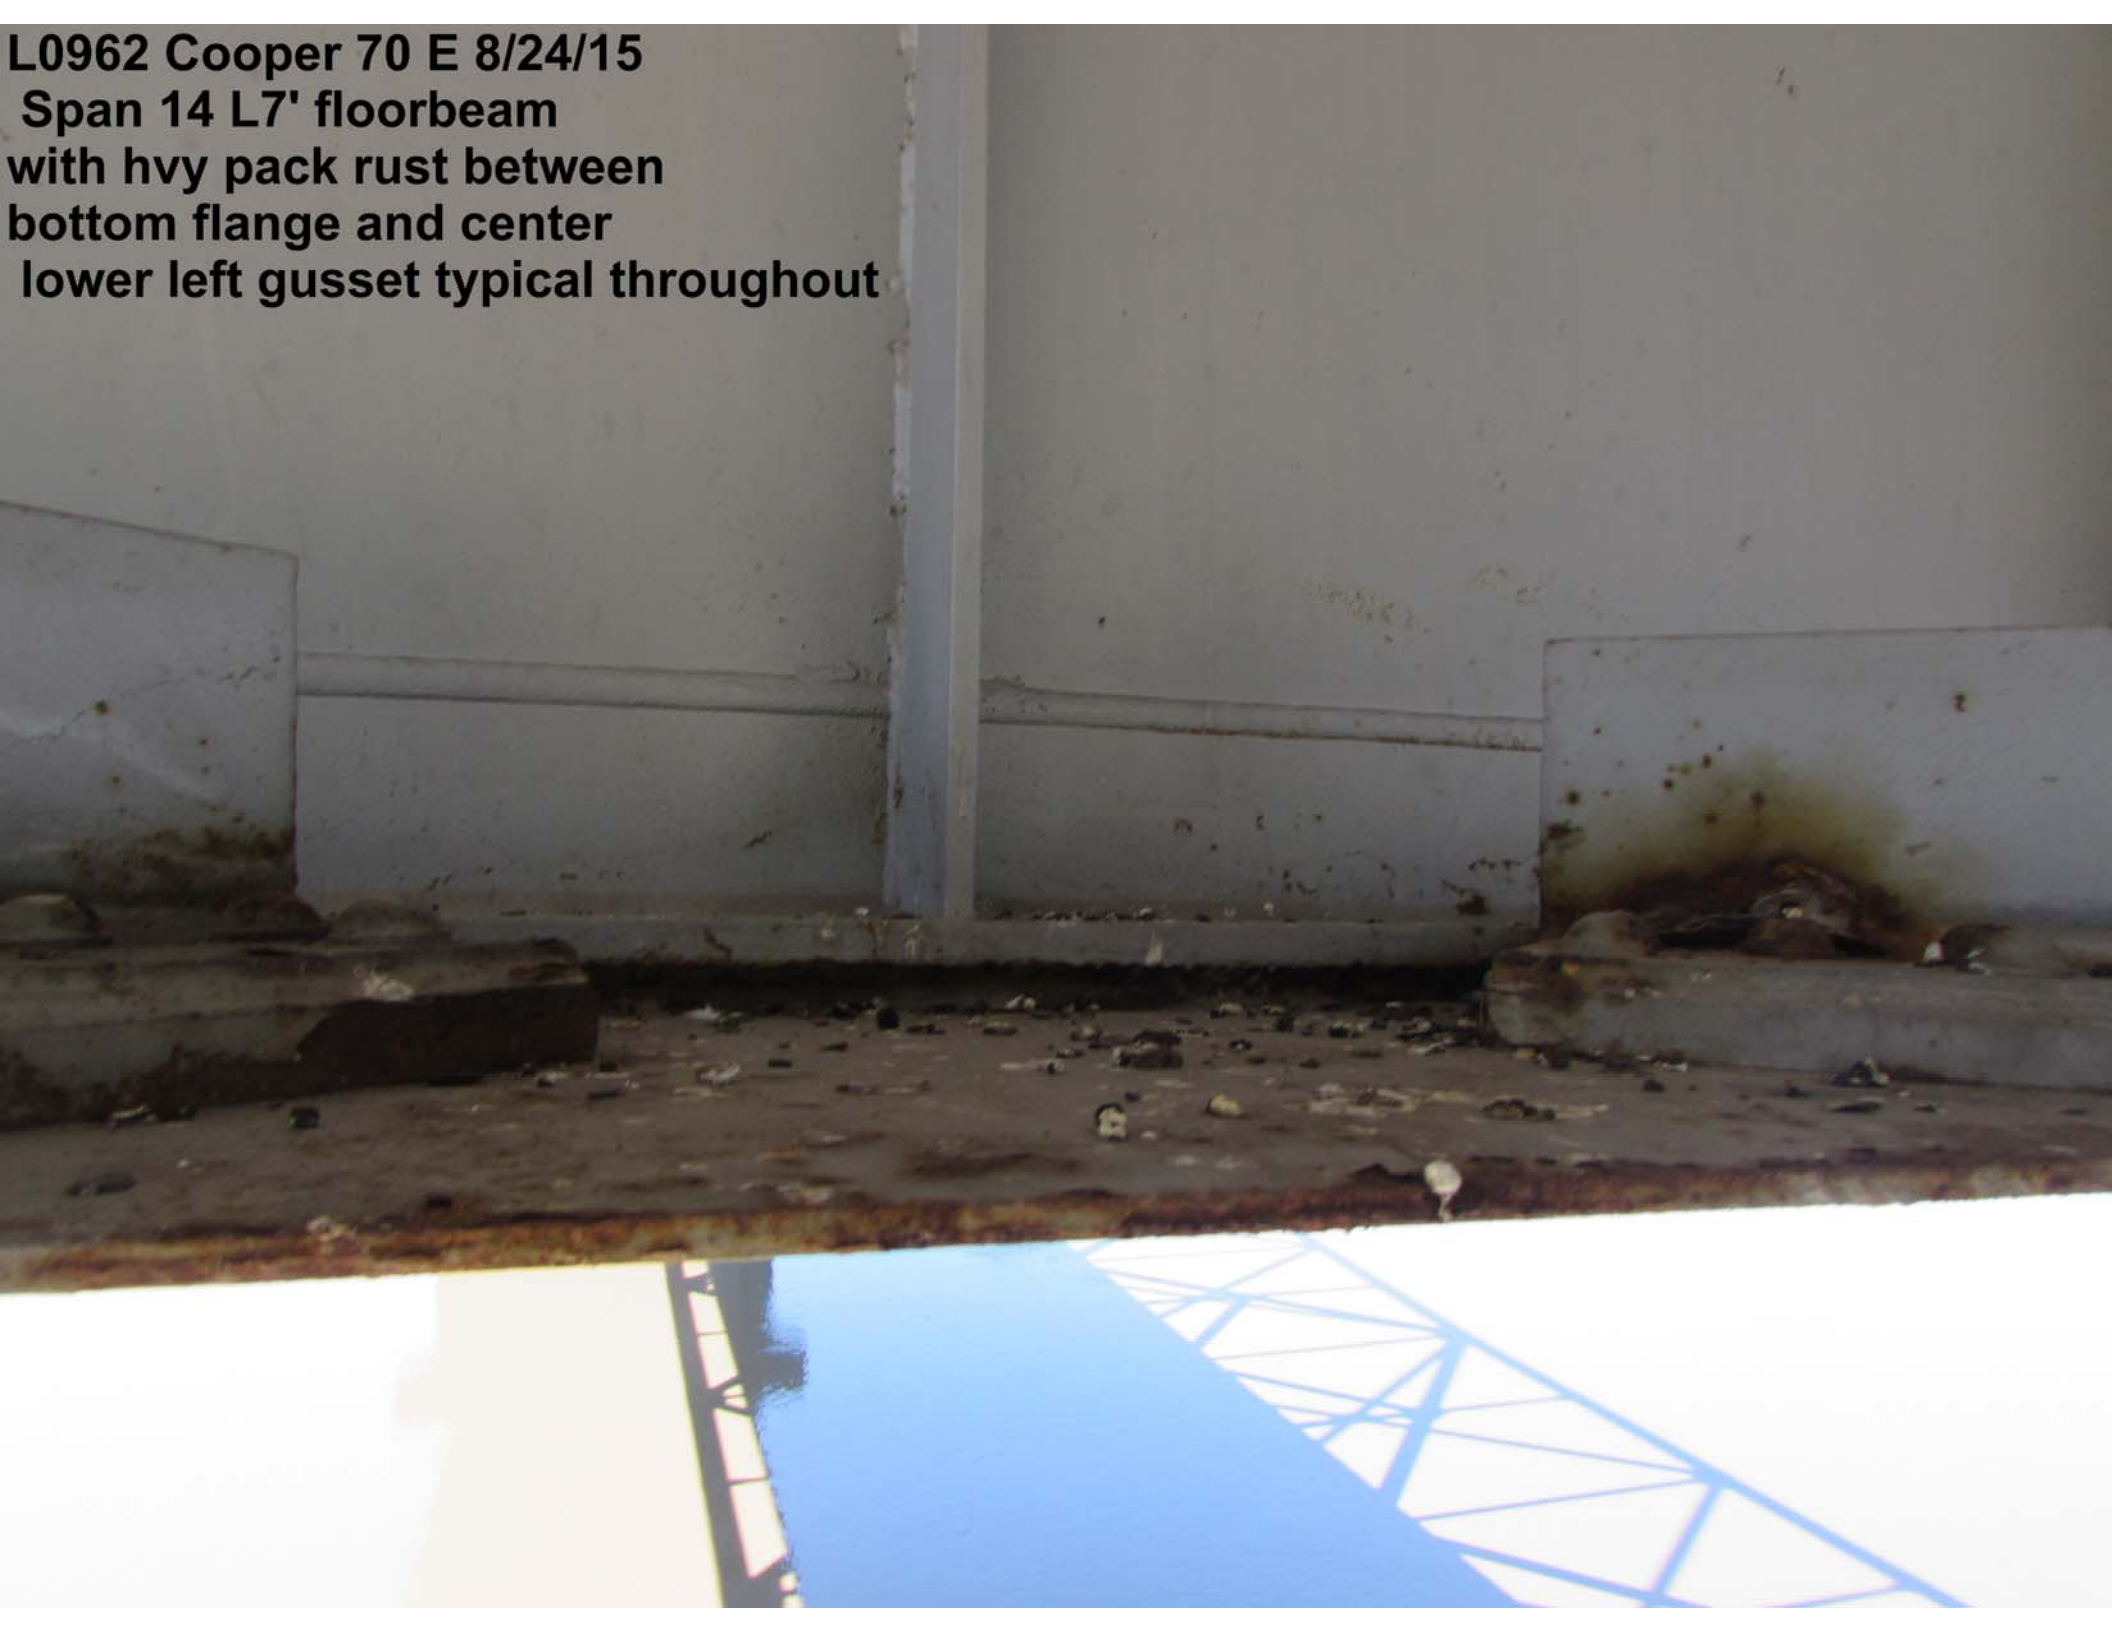
**L0962 Cooper 70 E 8/24/15**  
**Span 14 L7' floorbeam**  
**with hvy pack rust between**  
**bottom flange and center**  
**lower left gusset typical throughout**

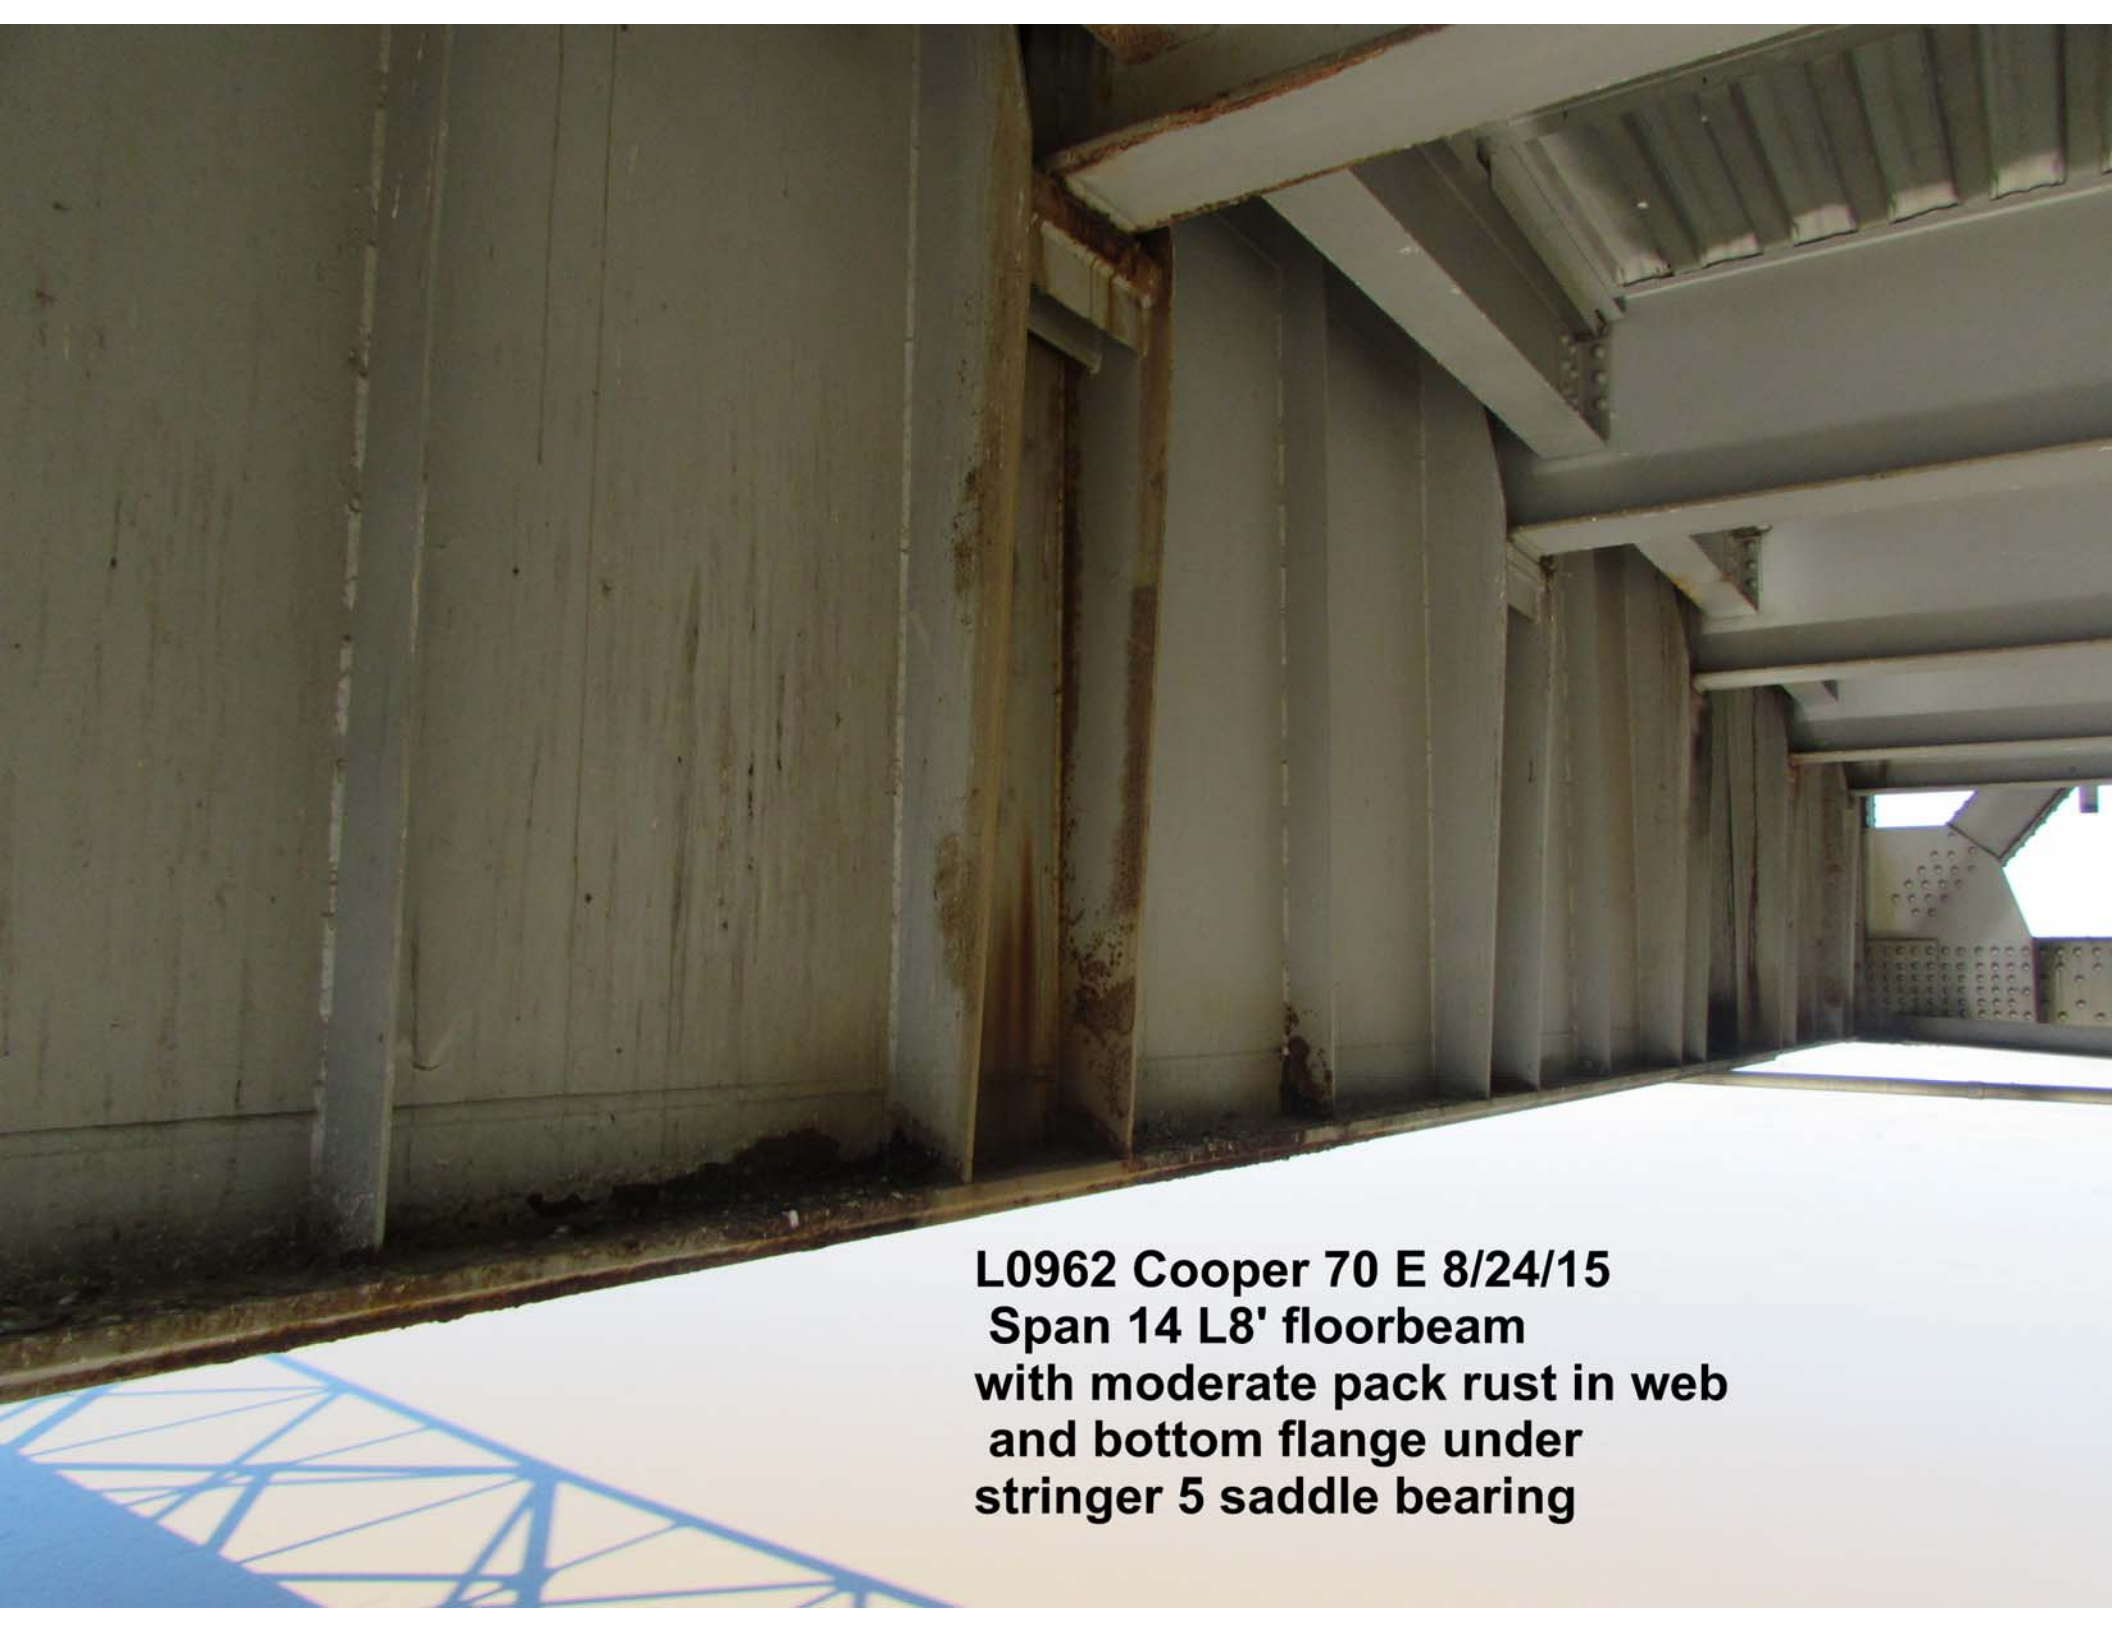
**L0962 Cooper 70 E 8/24/15  
Span 14 L8' floorbeam  
with moderate pack rust in web  
and bottom flange under  
stringer 5 saddle bearing**

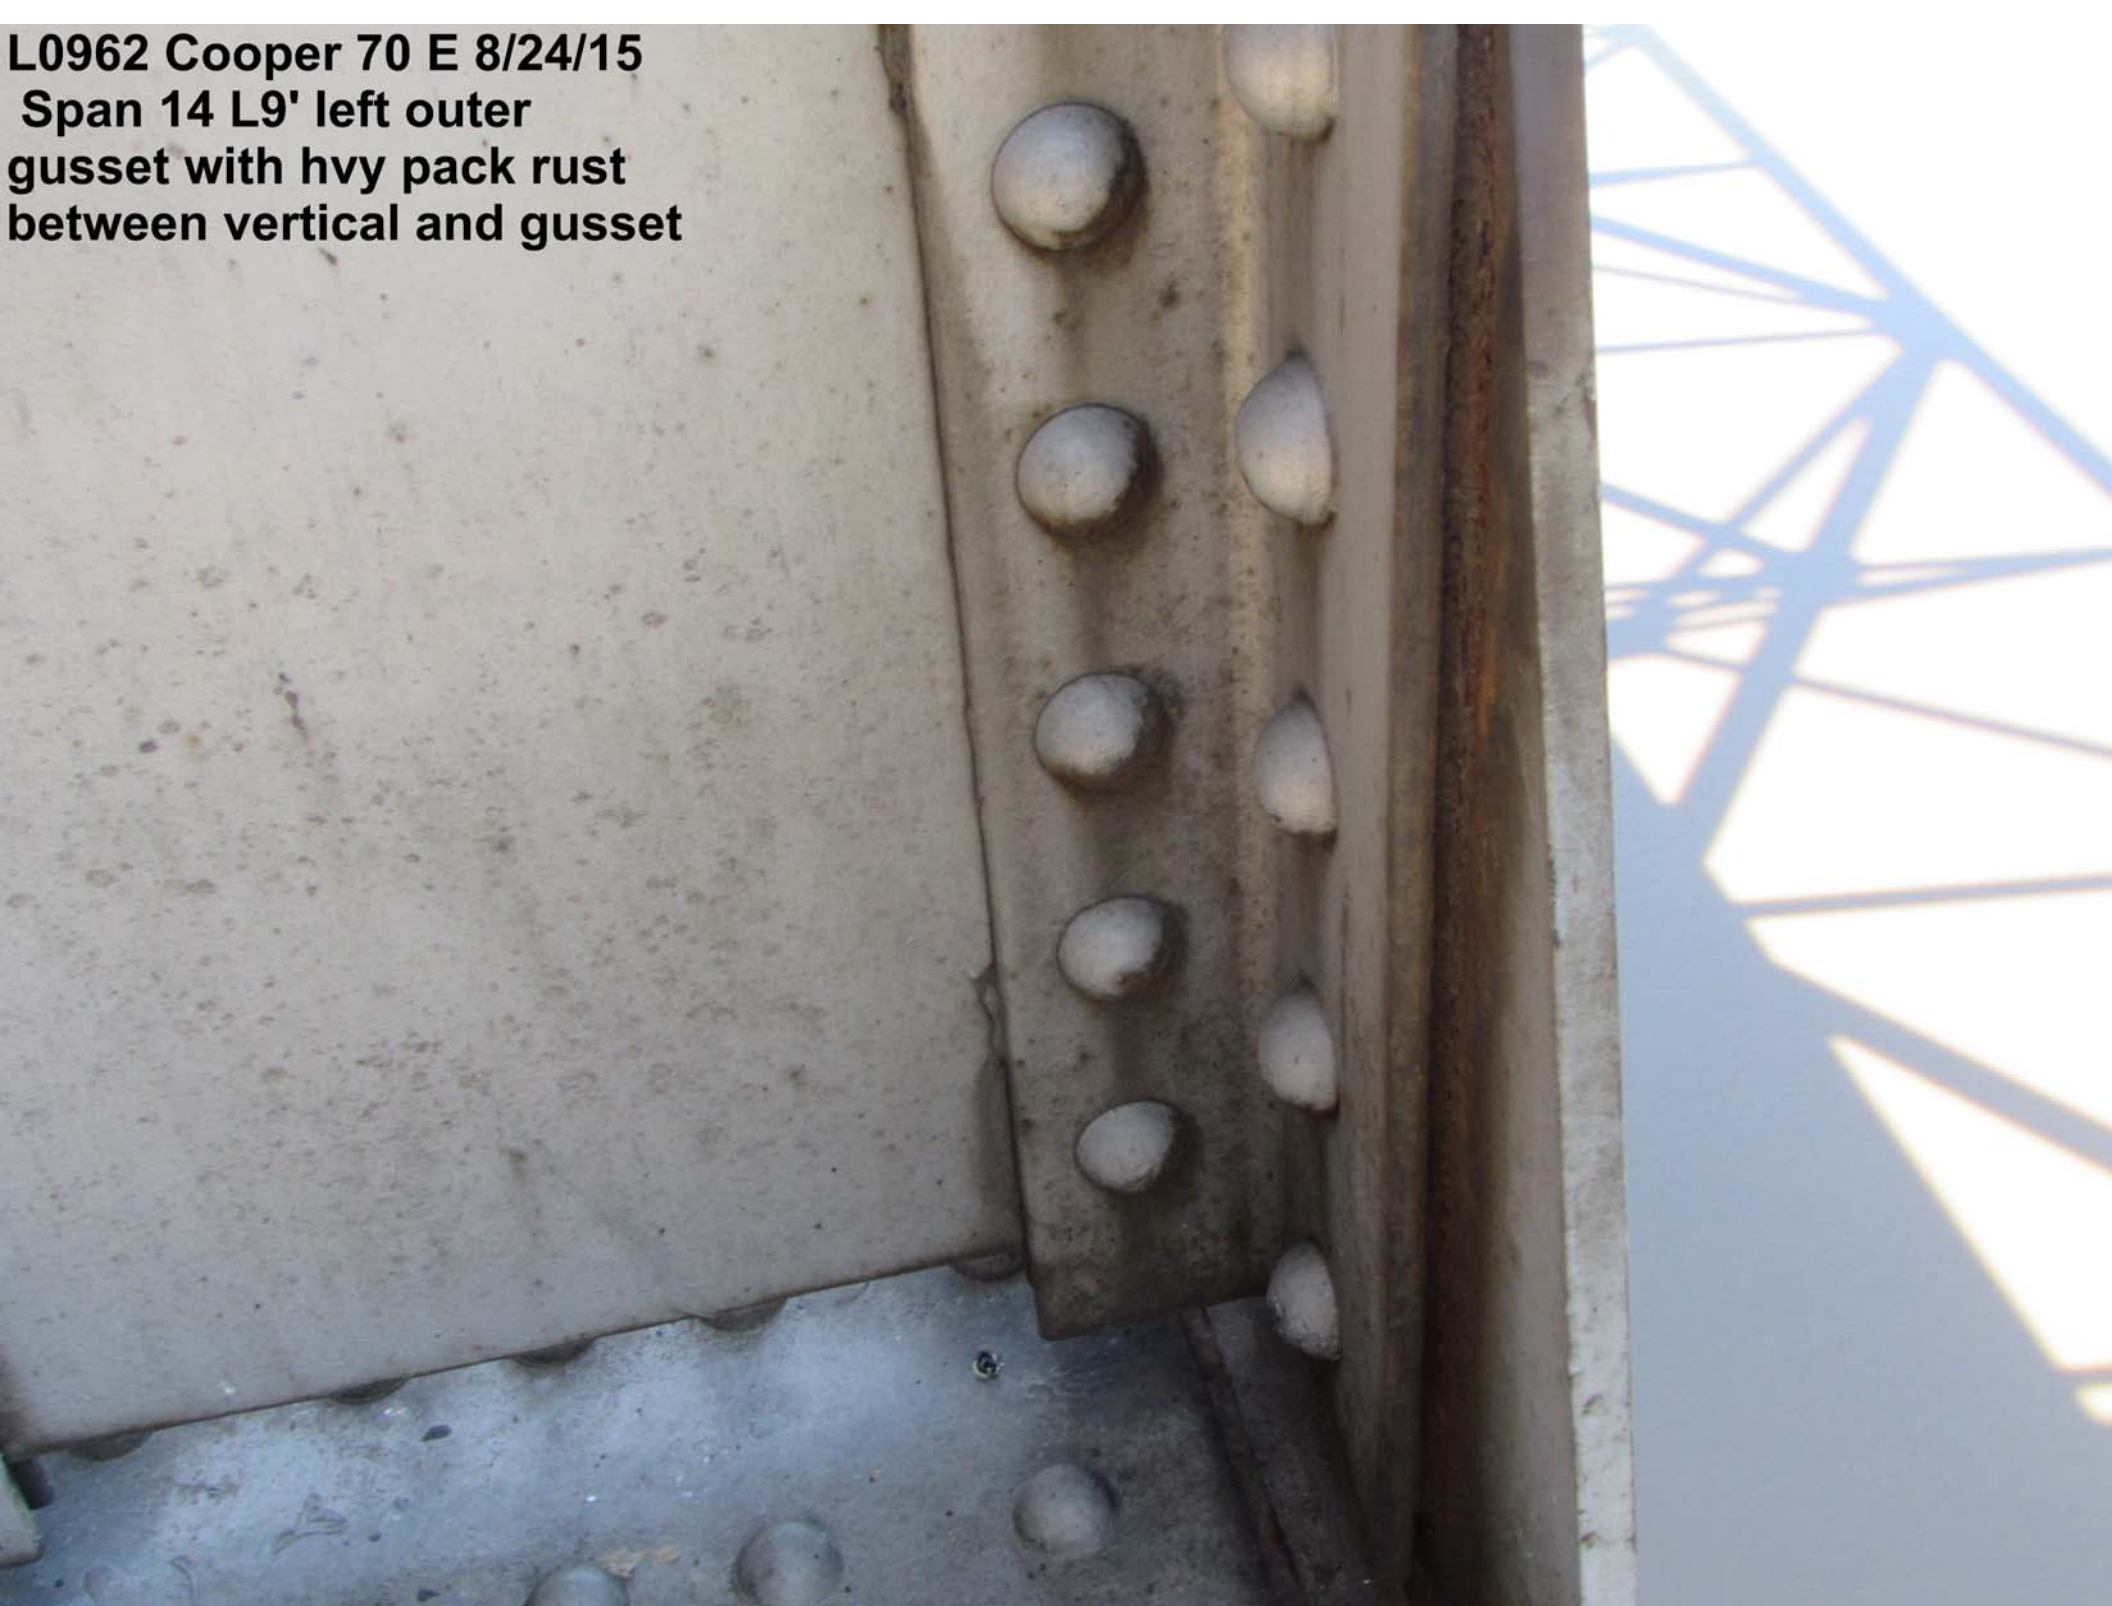
**L0962 Cooper 70 E 8/24/15**  
**Span 13 L18 floorbeam**  
**east side with minor rust**  
**on web and bottom flange**
