L0962 I 70 Cooper Co.  
Joint at L8, span 13  
Eastbound lane failing  
9-24-13

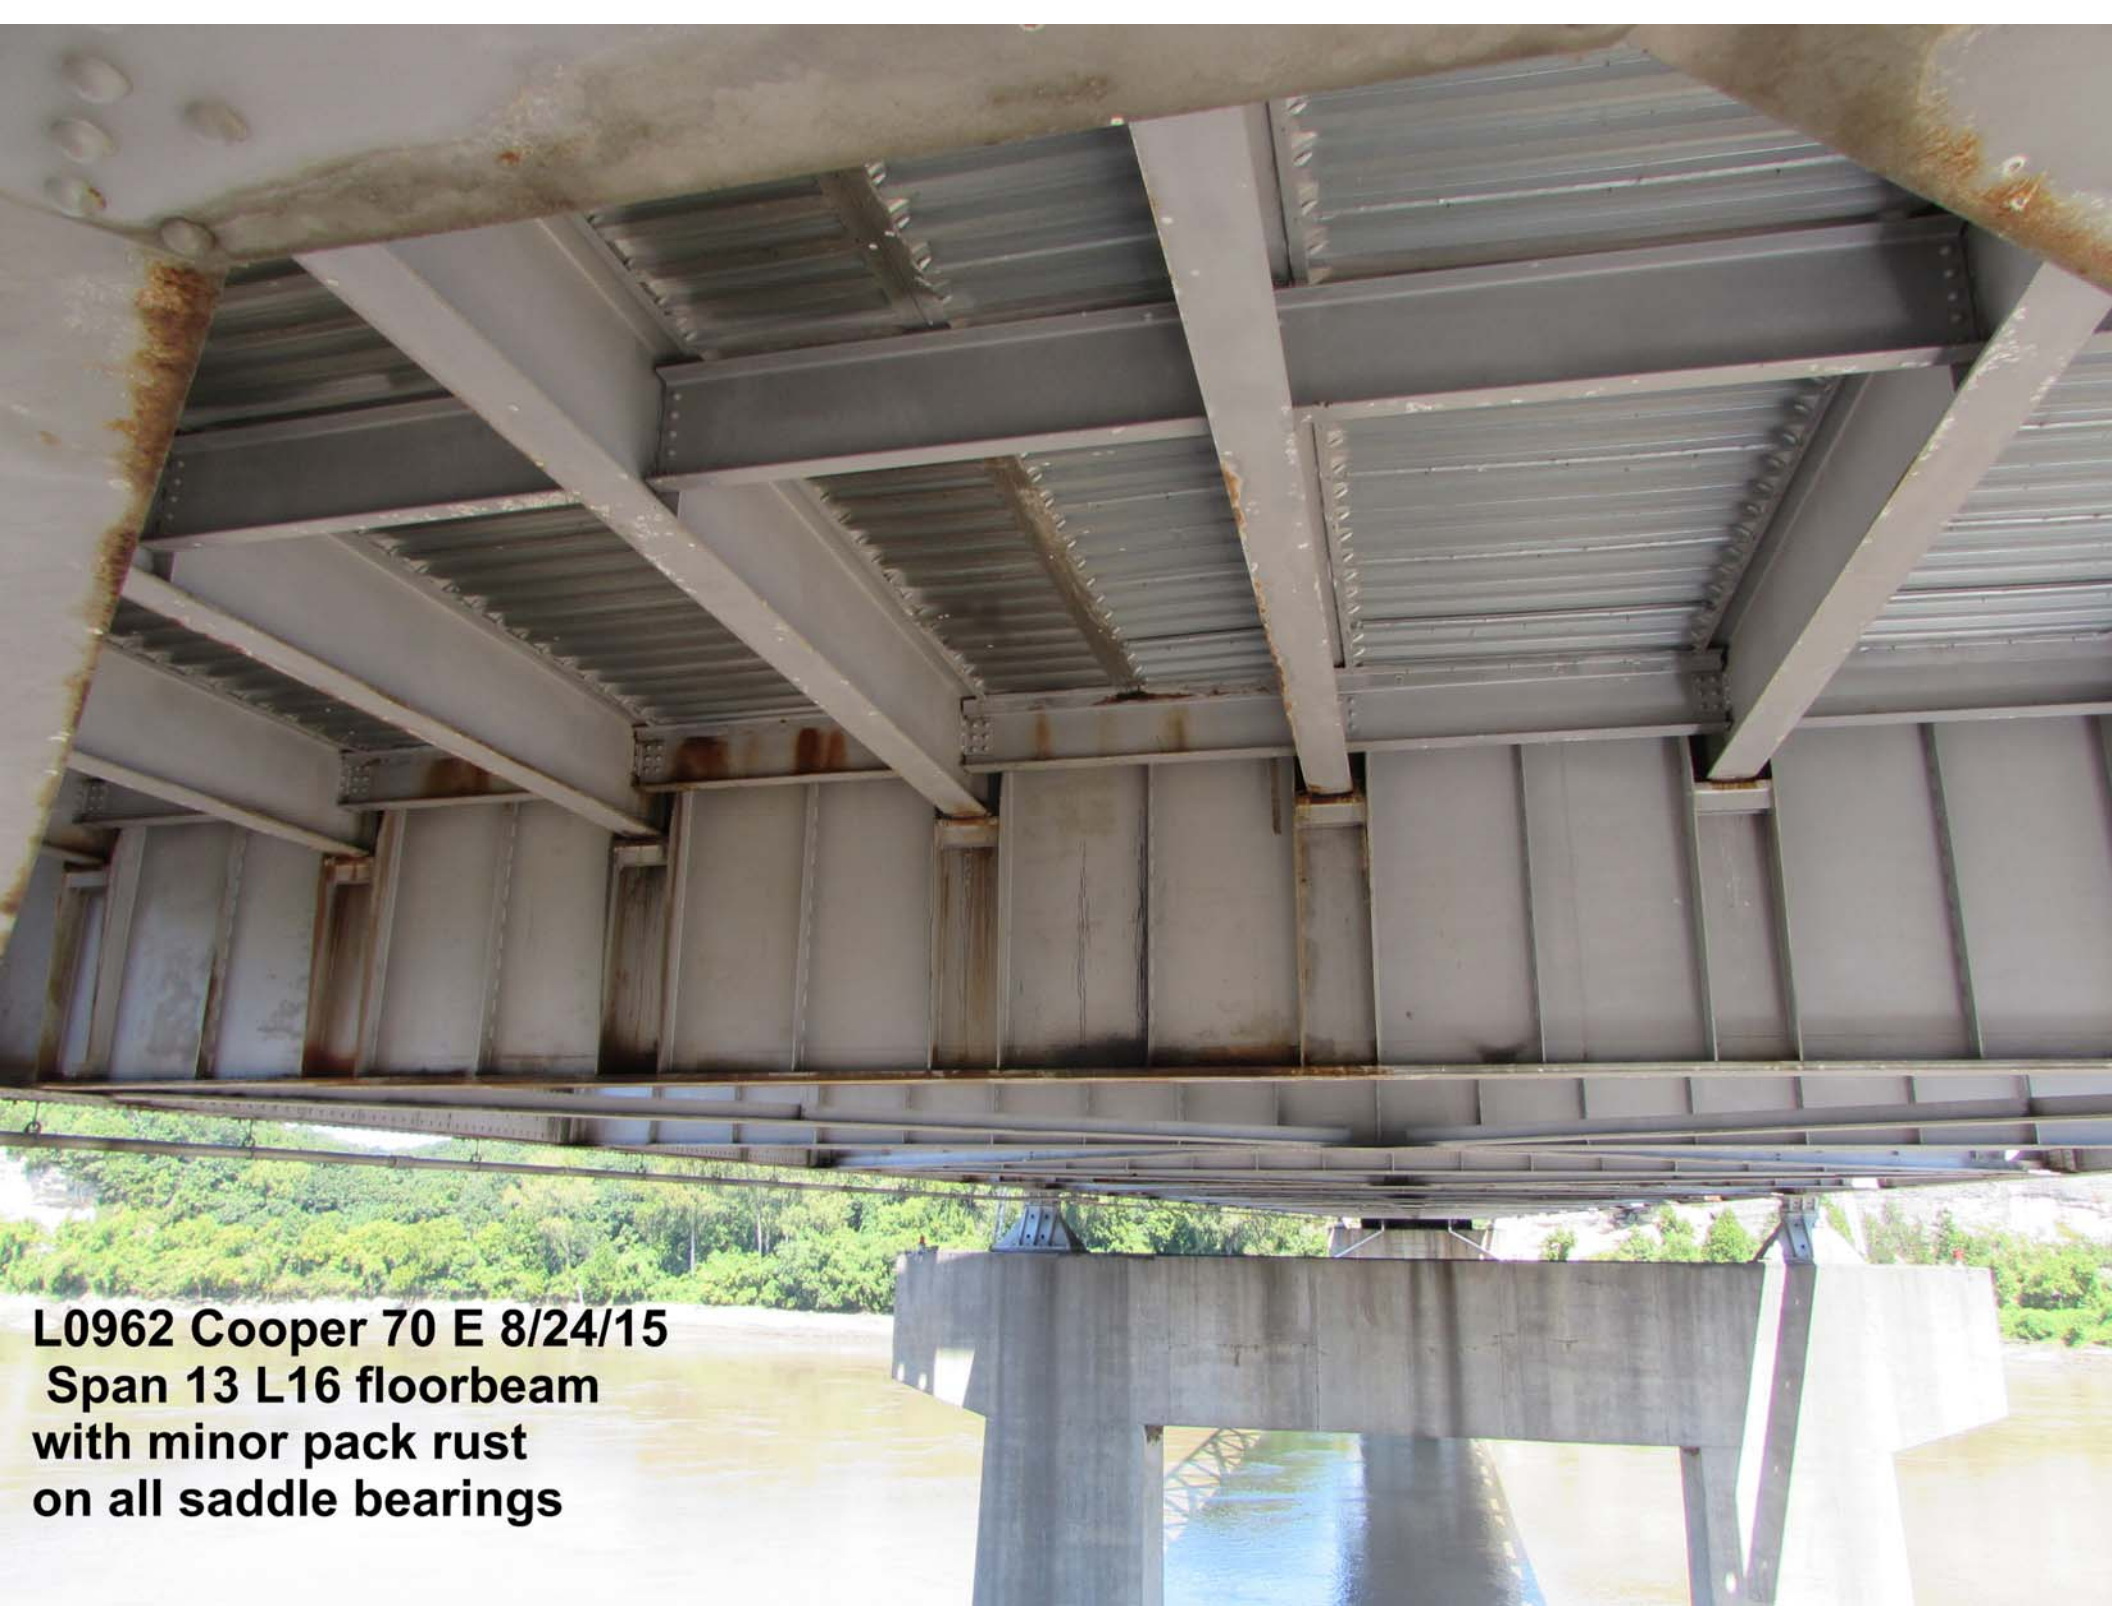
**L0962 Cooper 70 E 8/24/15**  
**Span 13 L16 floorbeam**  
**with minor pack rust**  
**on all saddle bearings**

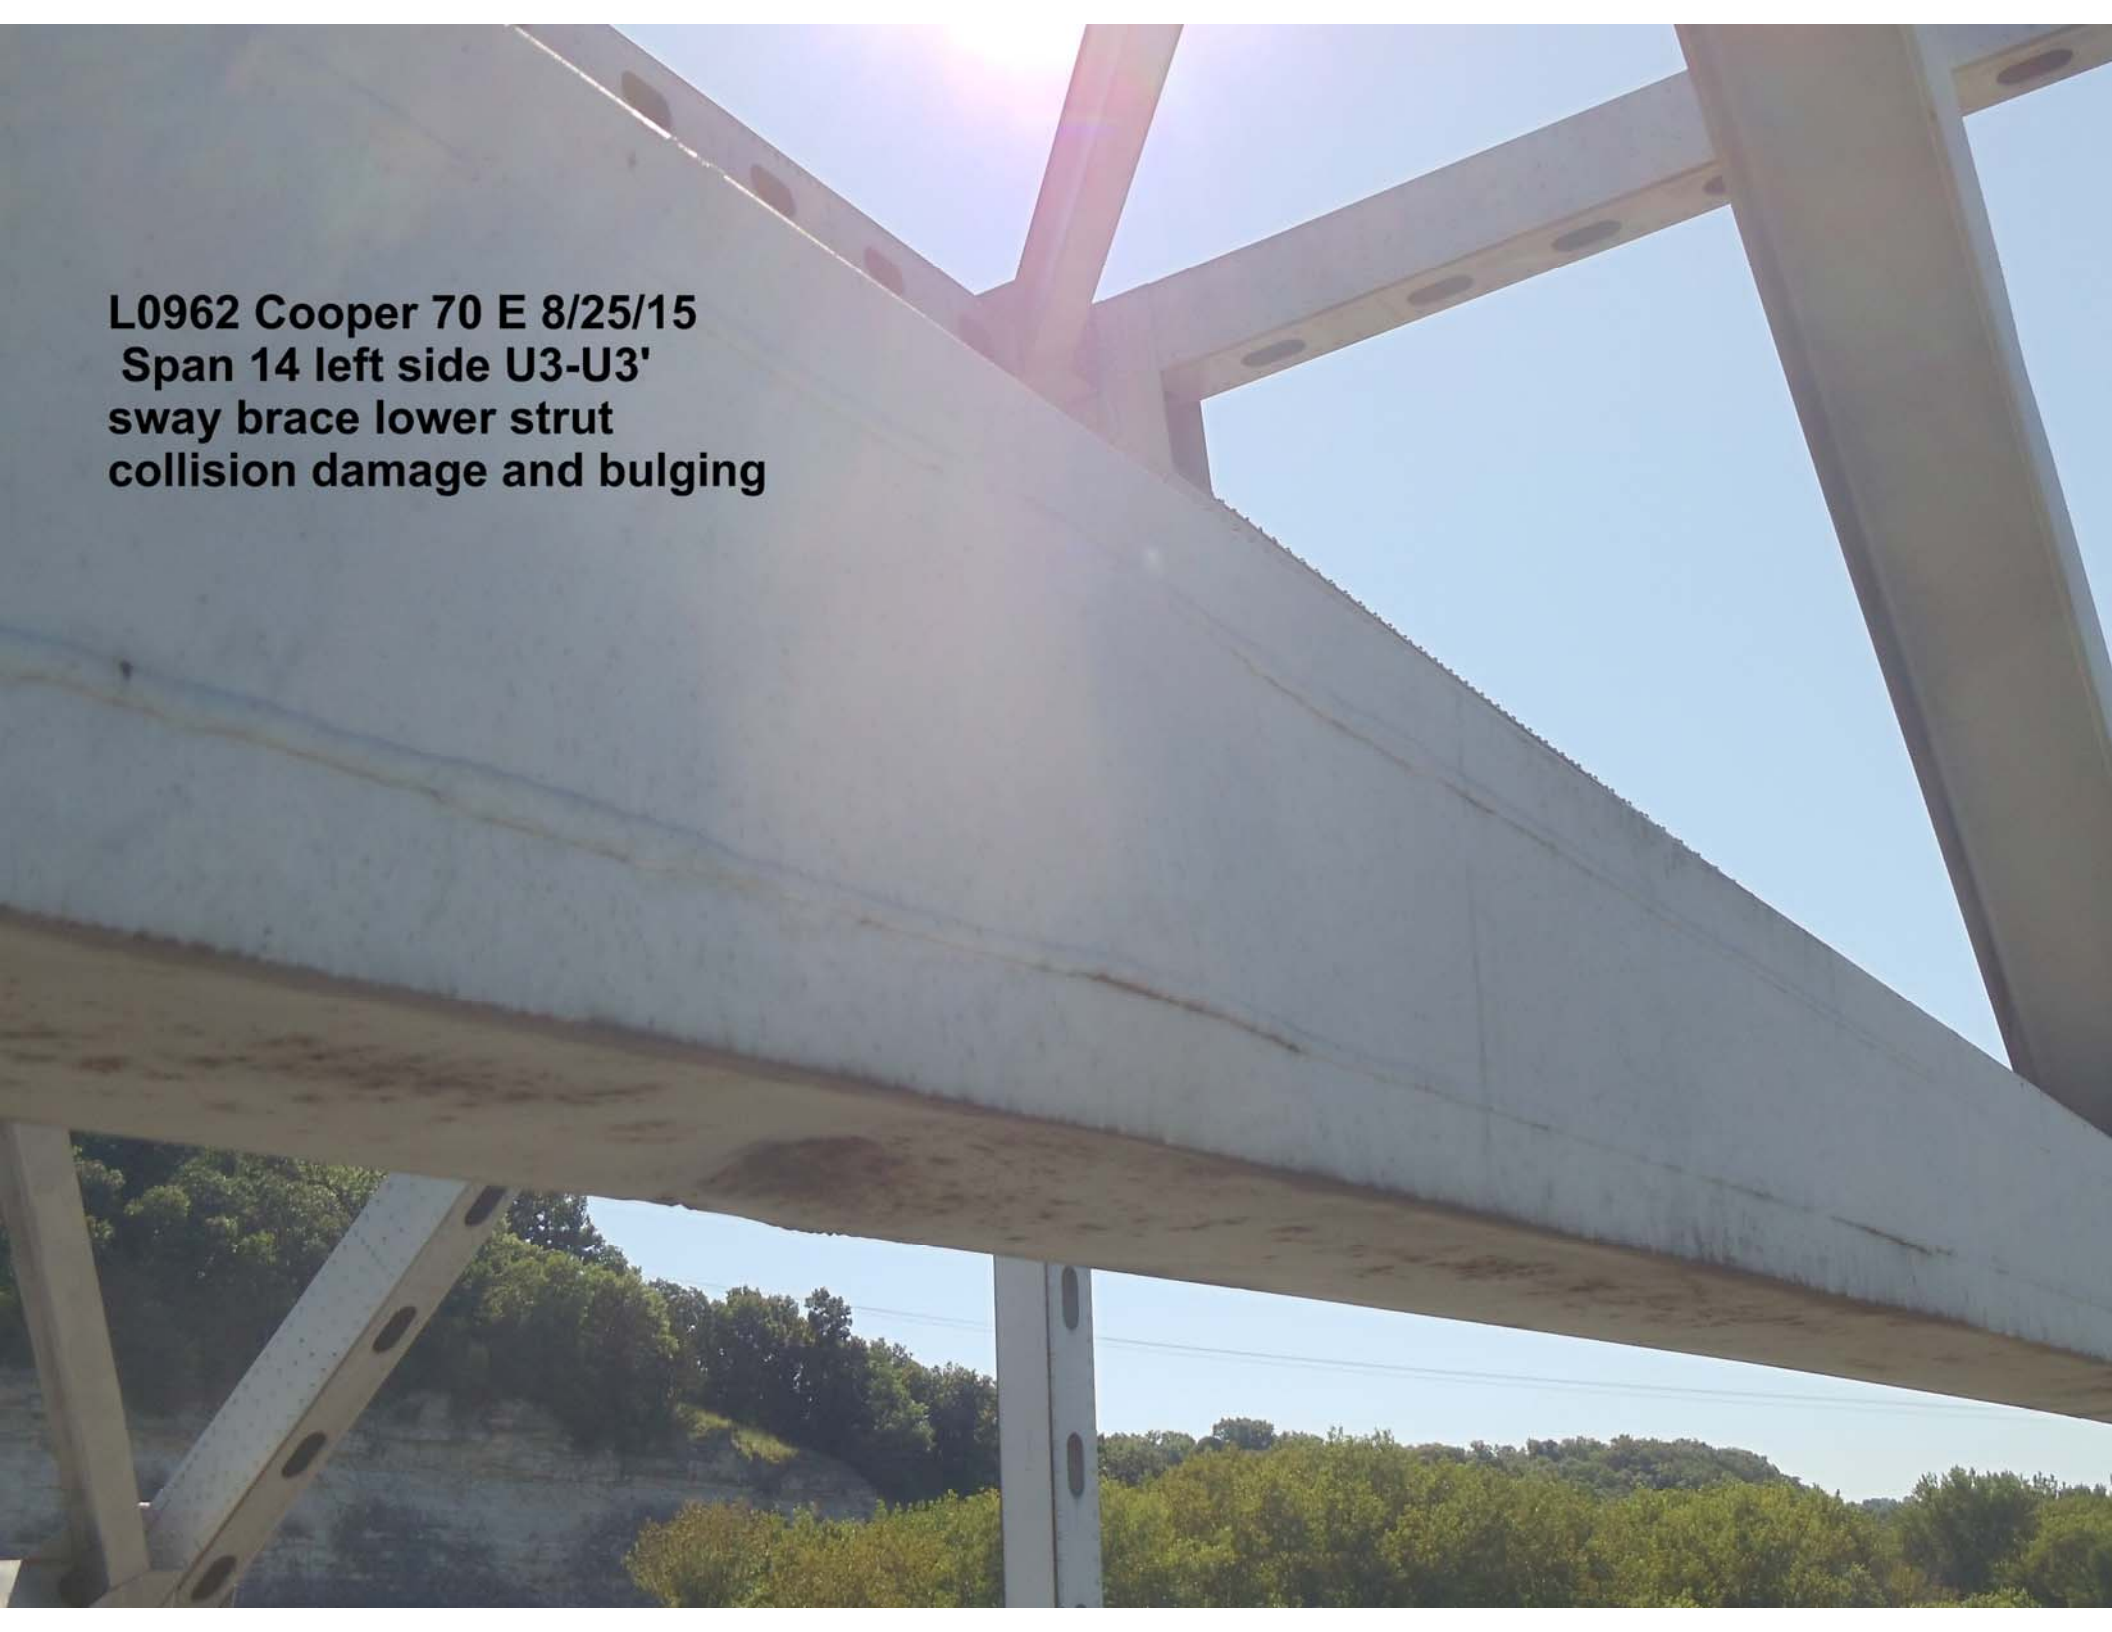
**L0962 Cooper 70 E 8/25/15**  
**Span 14 left side U3-U3' sway**  
**brace lower strut collision**  
**damage and bulging**

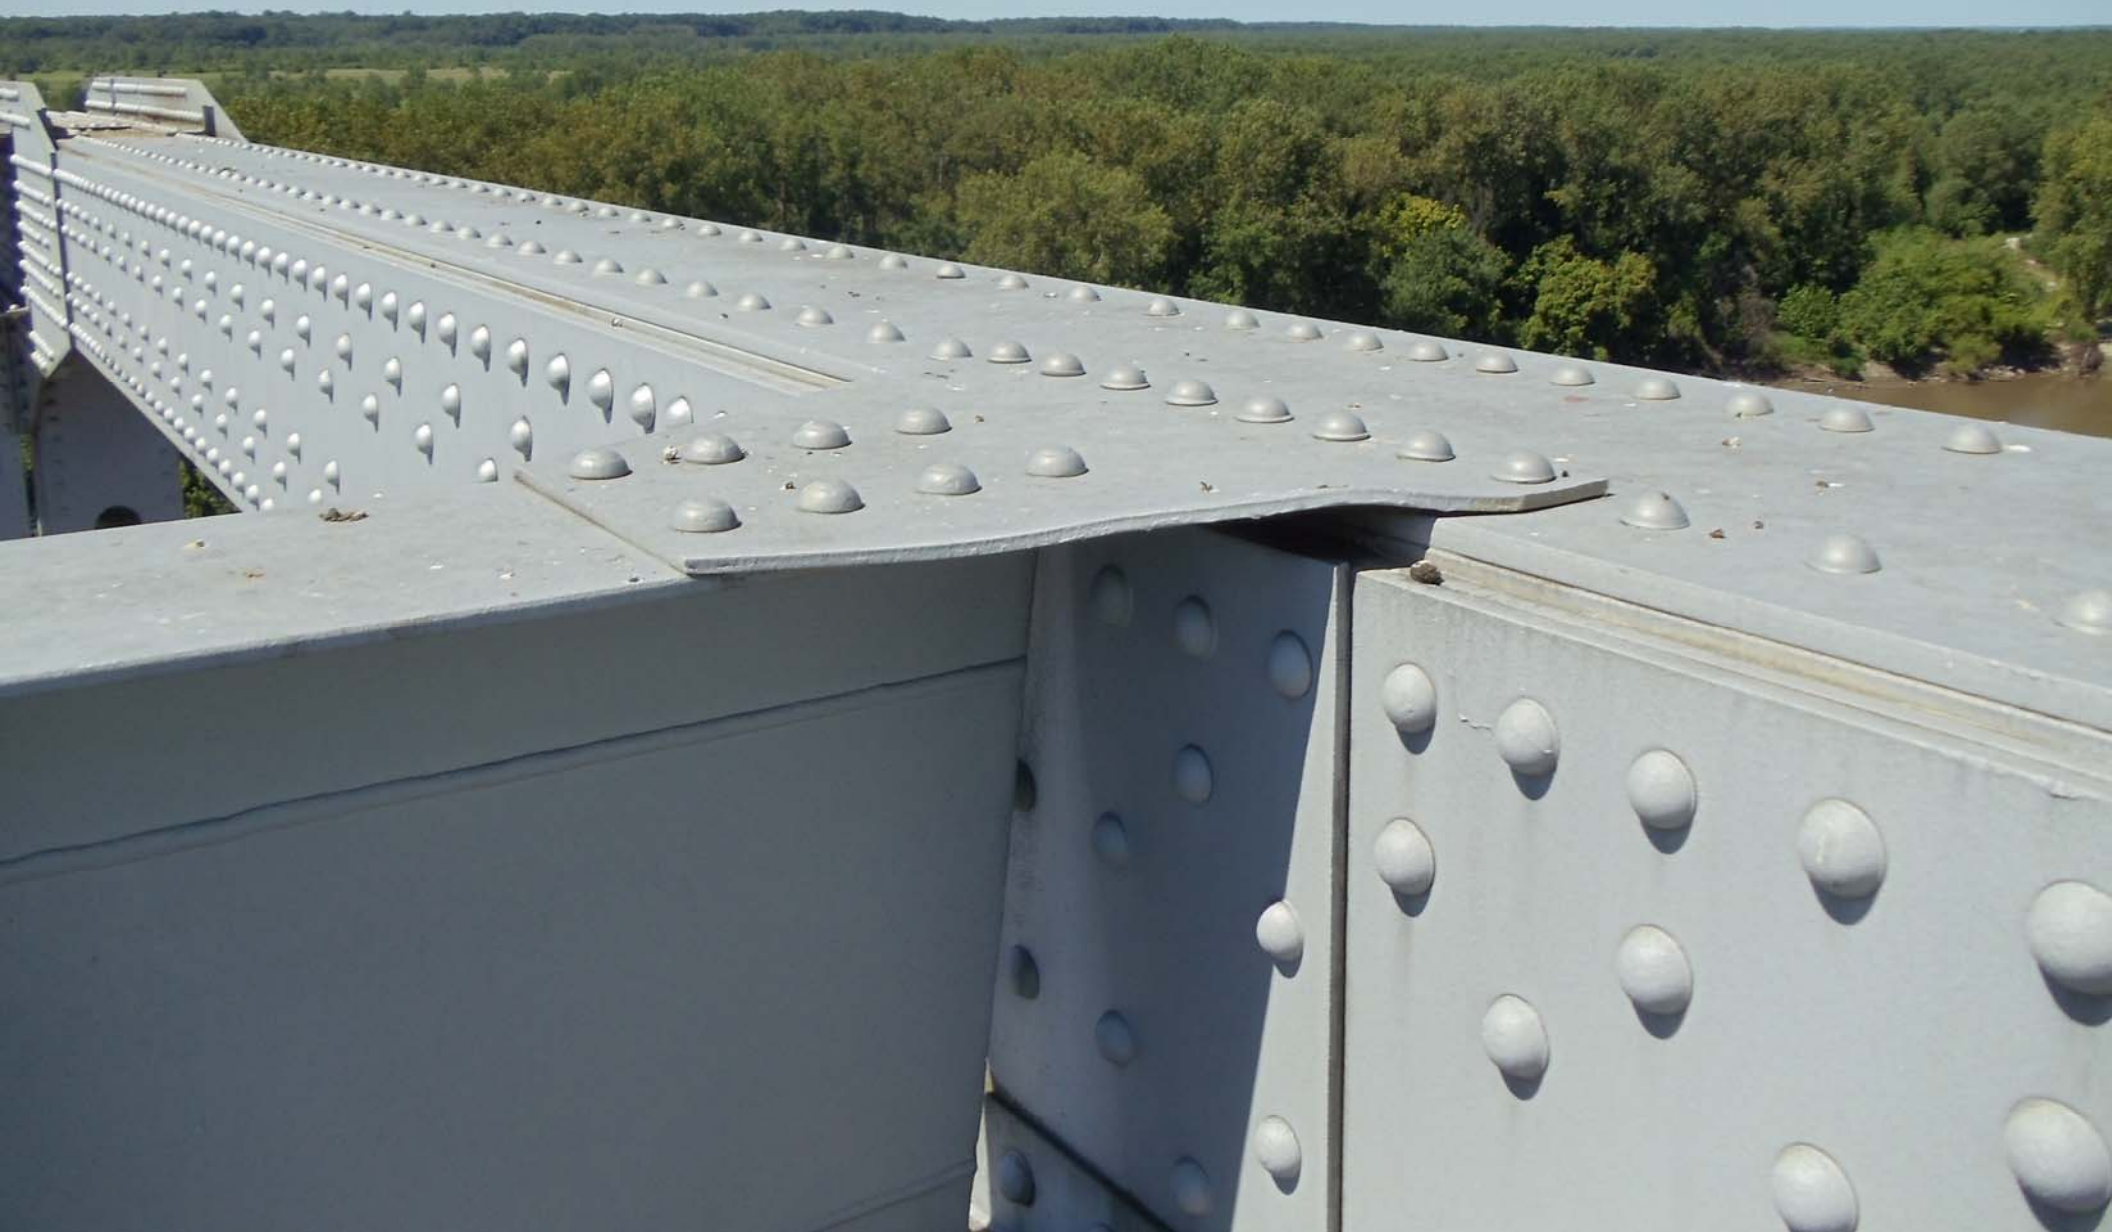
**L0962 Cooper 70 E 8/25/15**  
**Span 14 U19' left side top**  
**gusset with minor distortion**

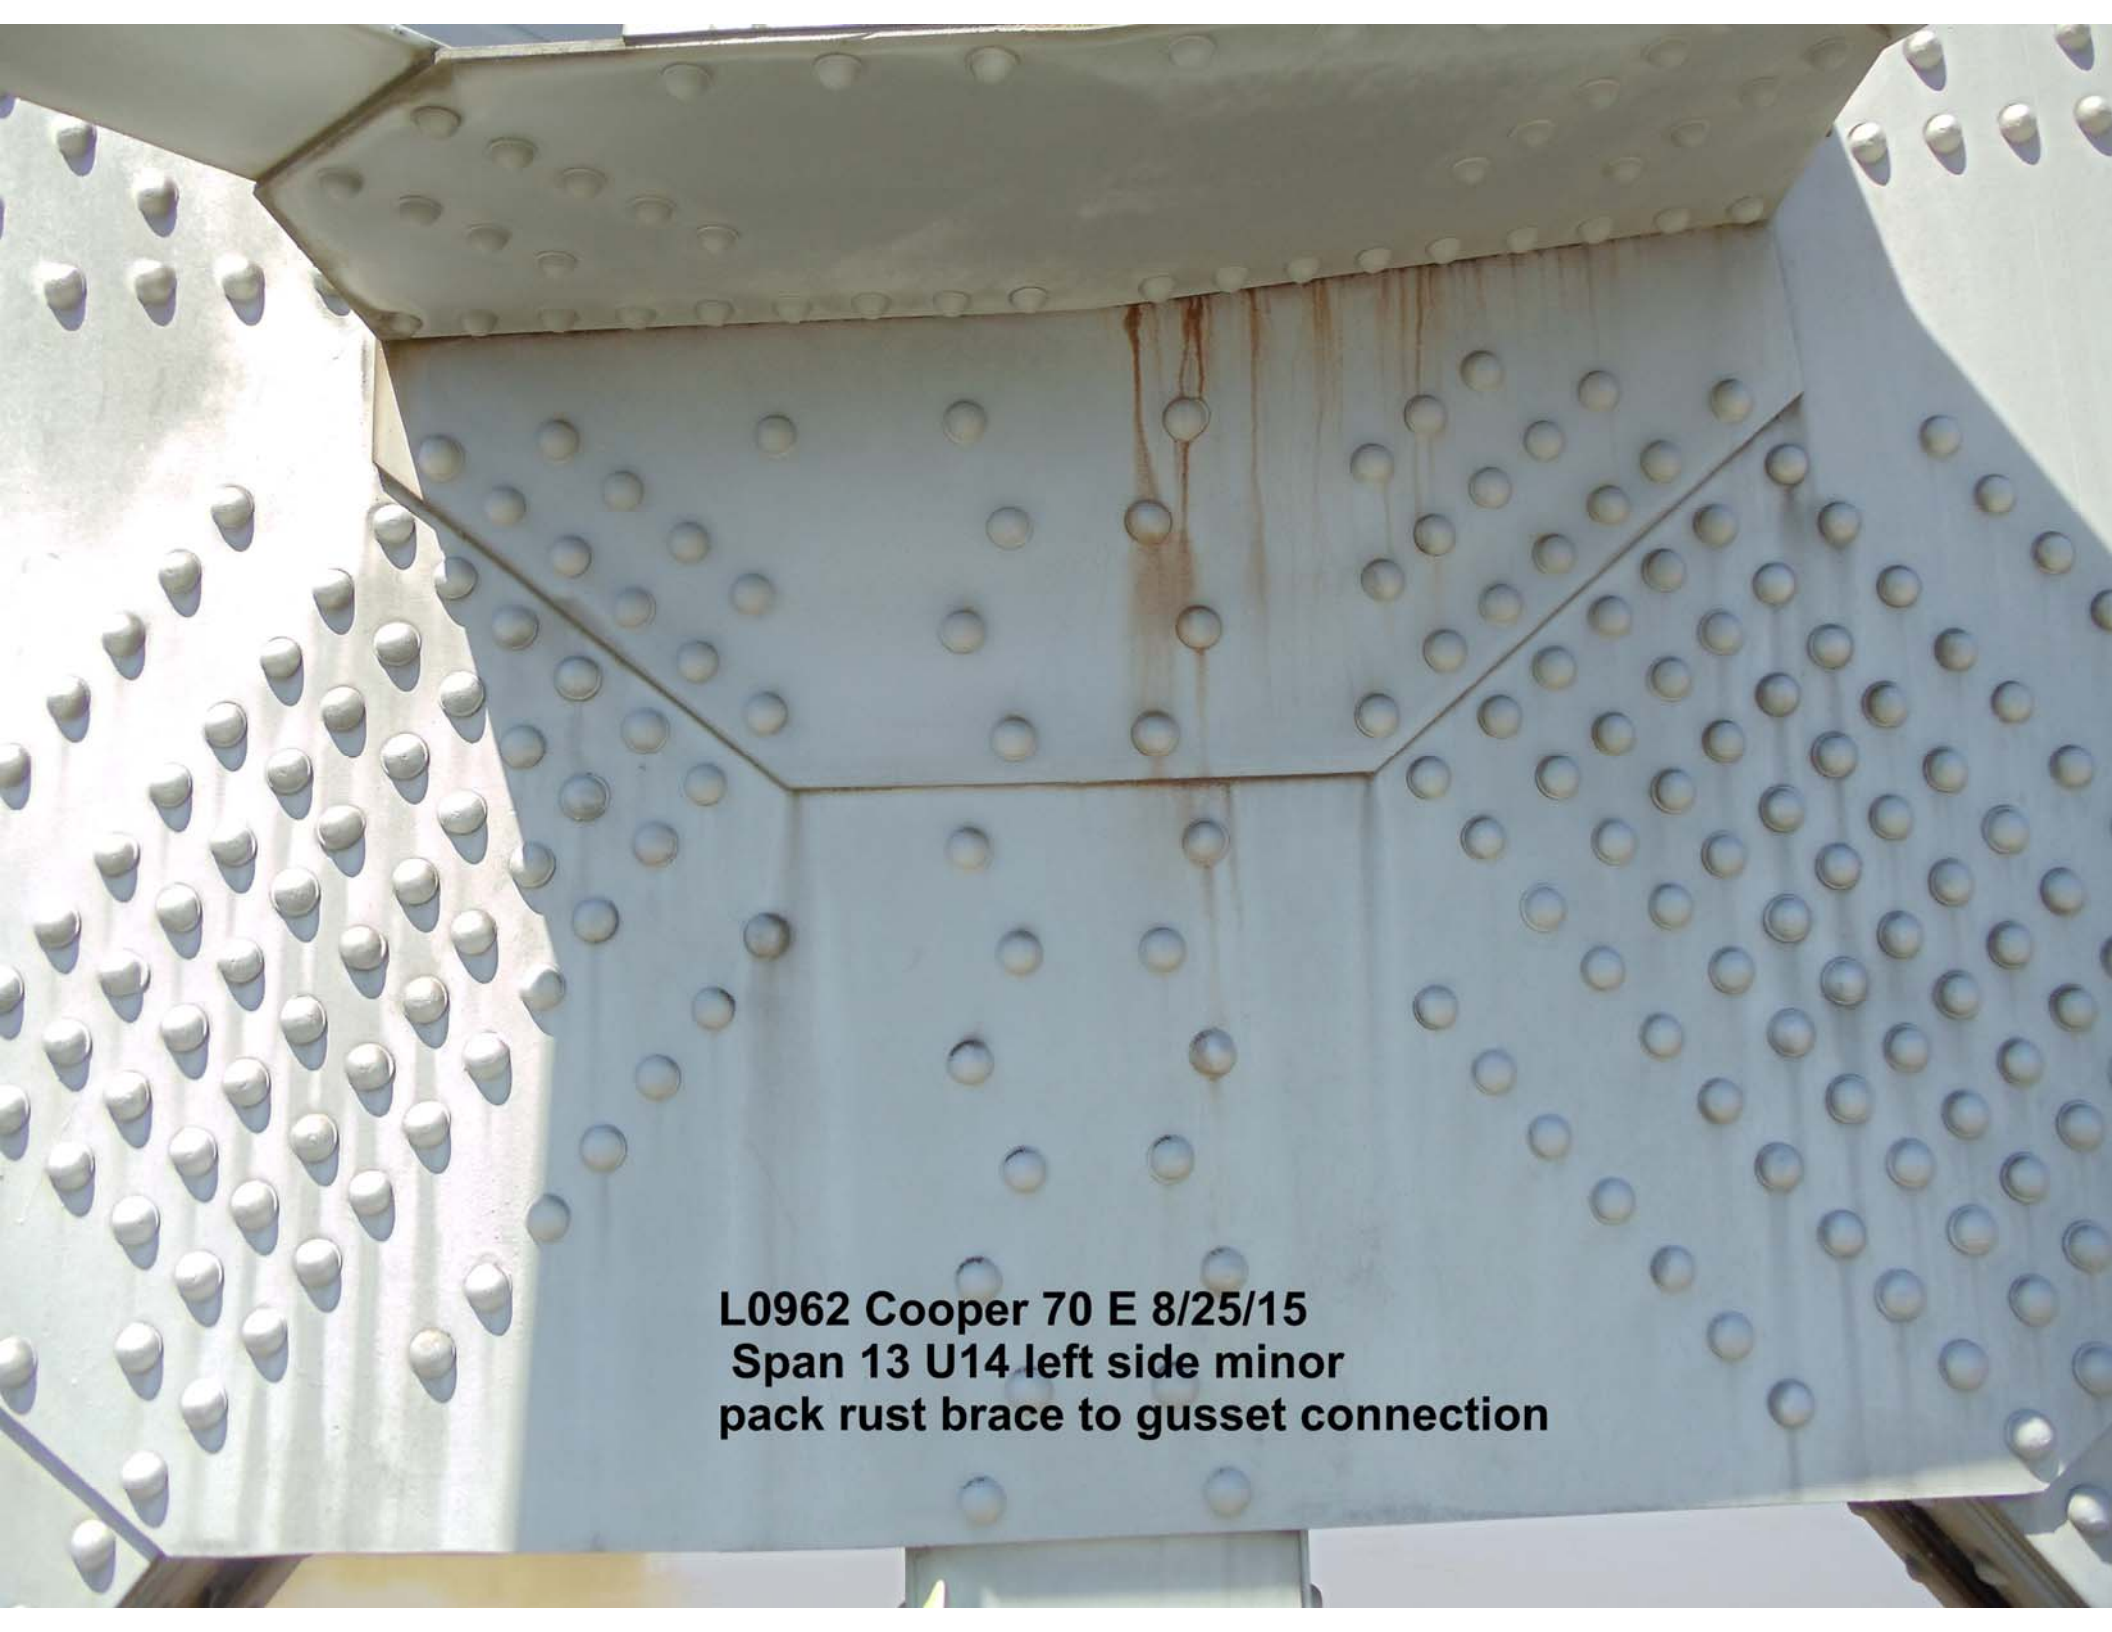
**L0962 Cooper 70 E 8/25/15  
Span 13 U14 left side minor  
pack rust brace to gusset connection**

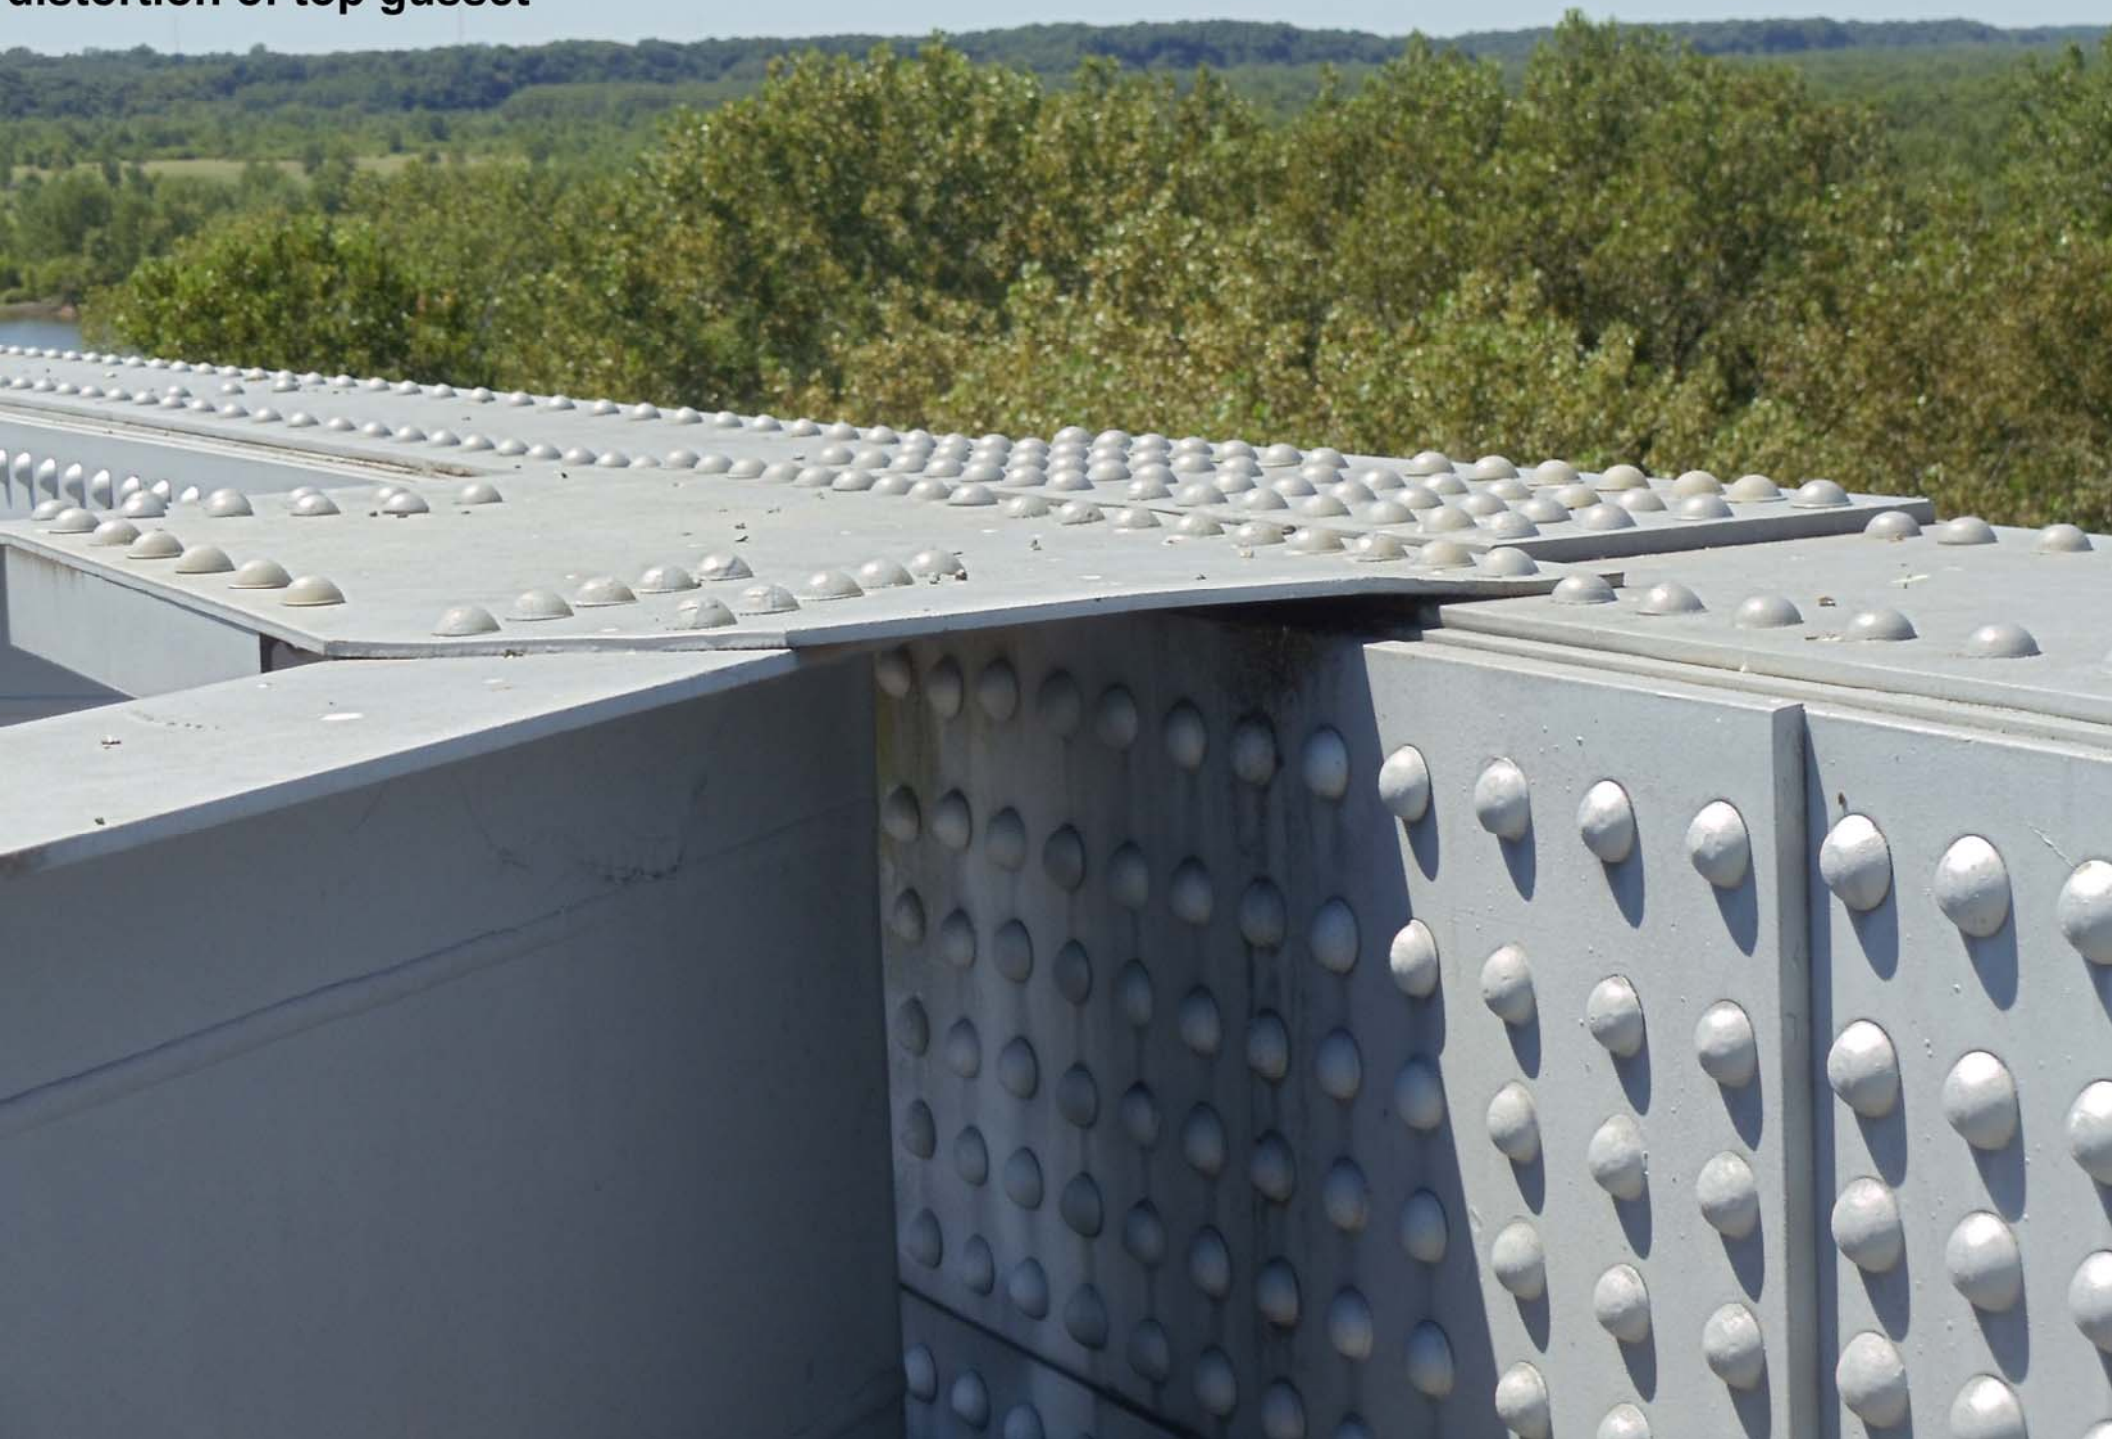
**L0962 Cooper 70 E 8/25/15**  
**Span 13 U10 left side minor**  
**distortion of top gusset**

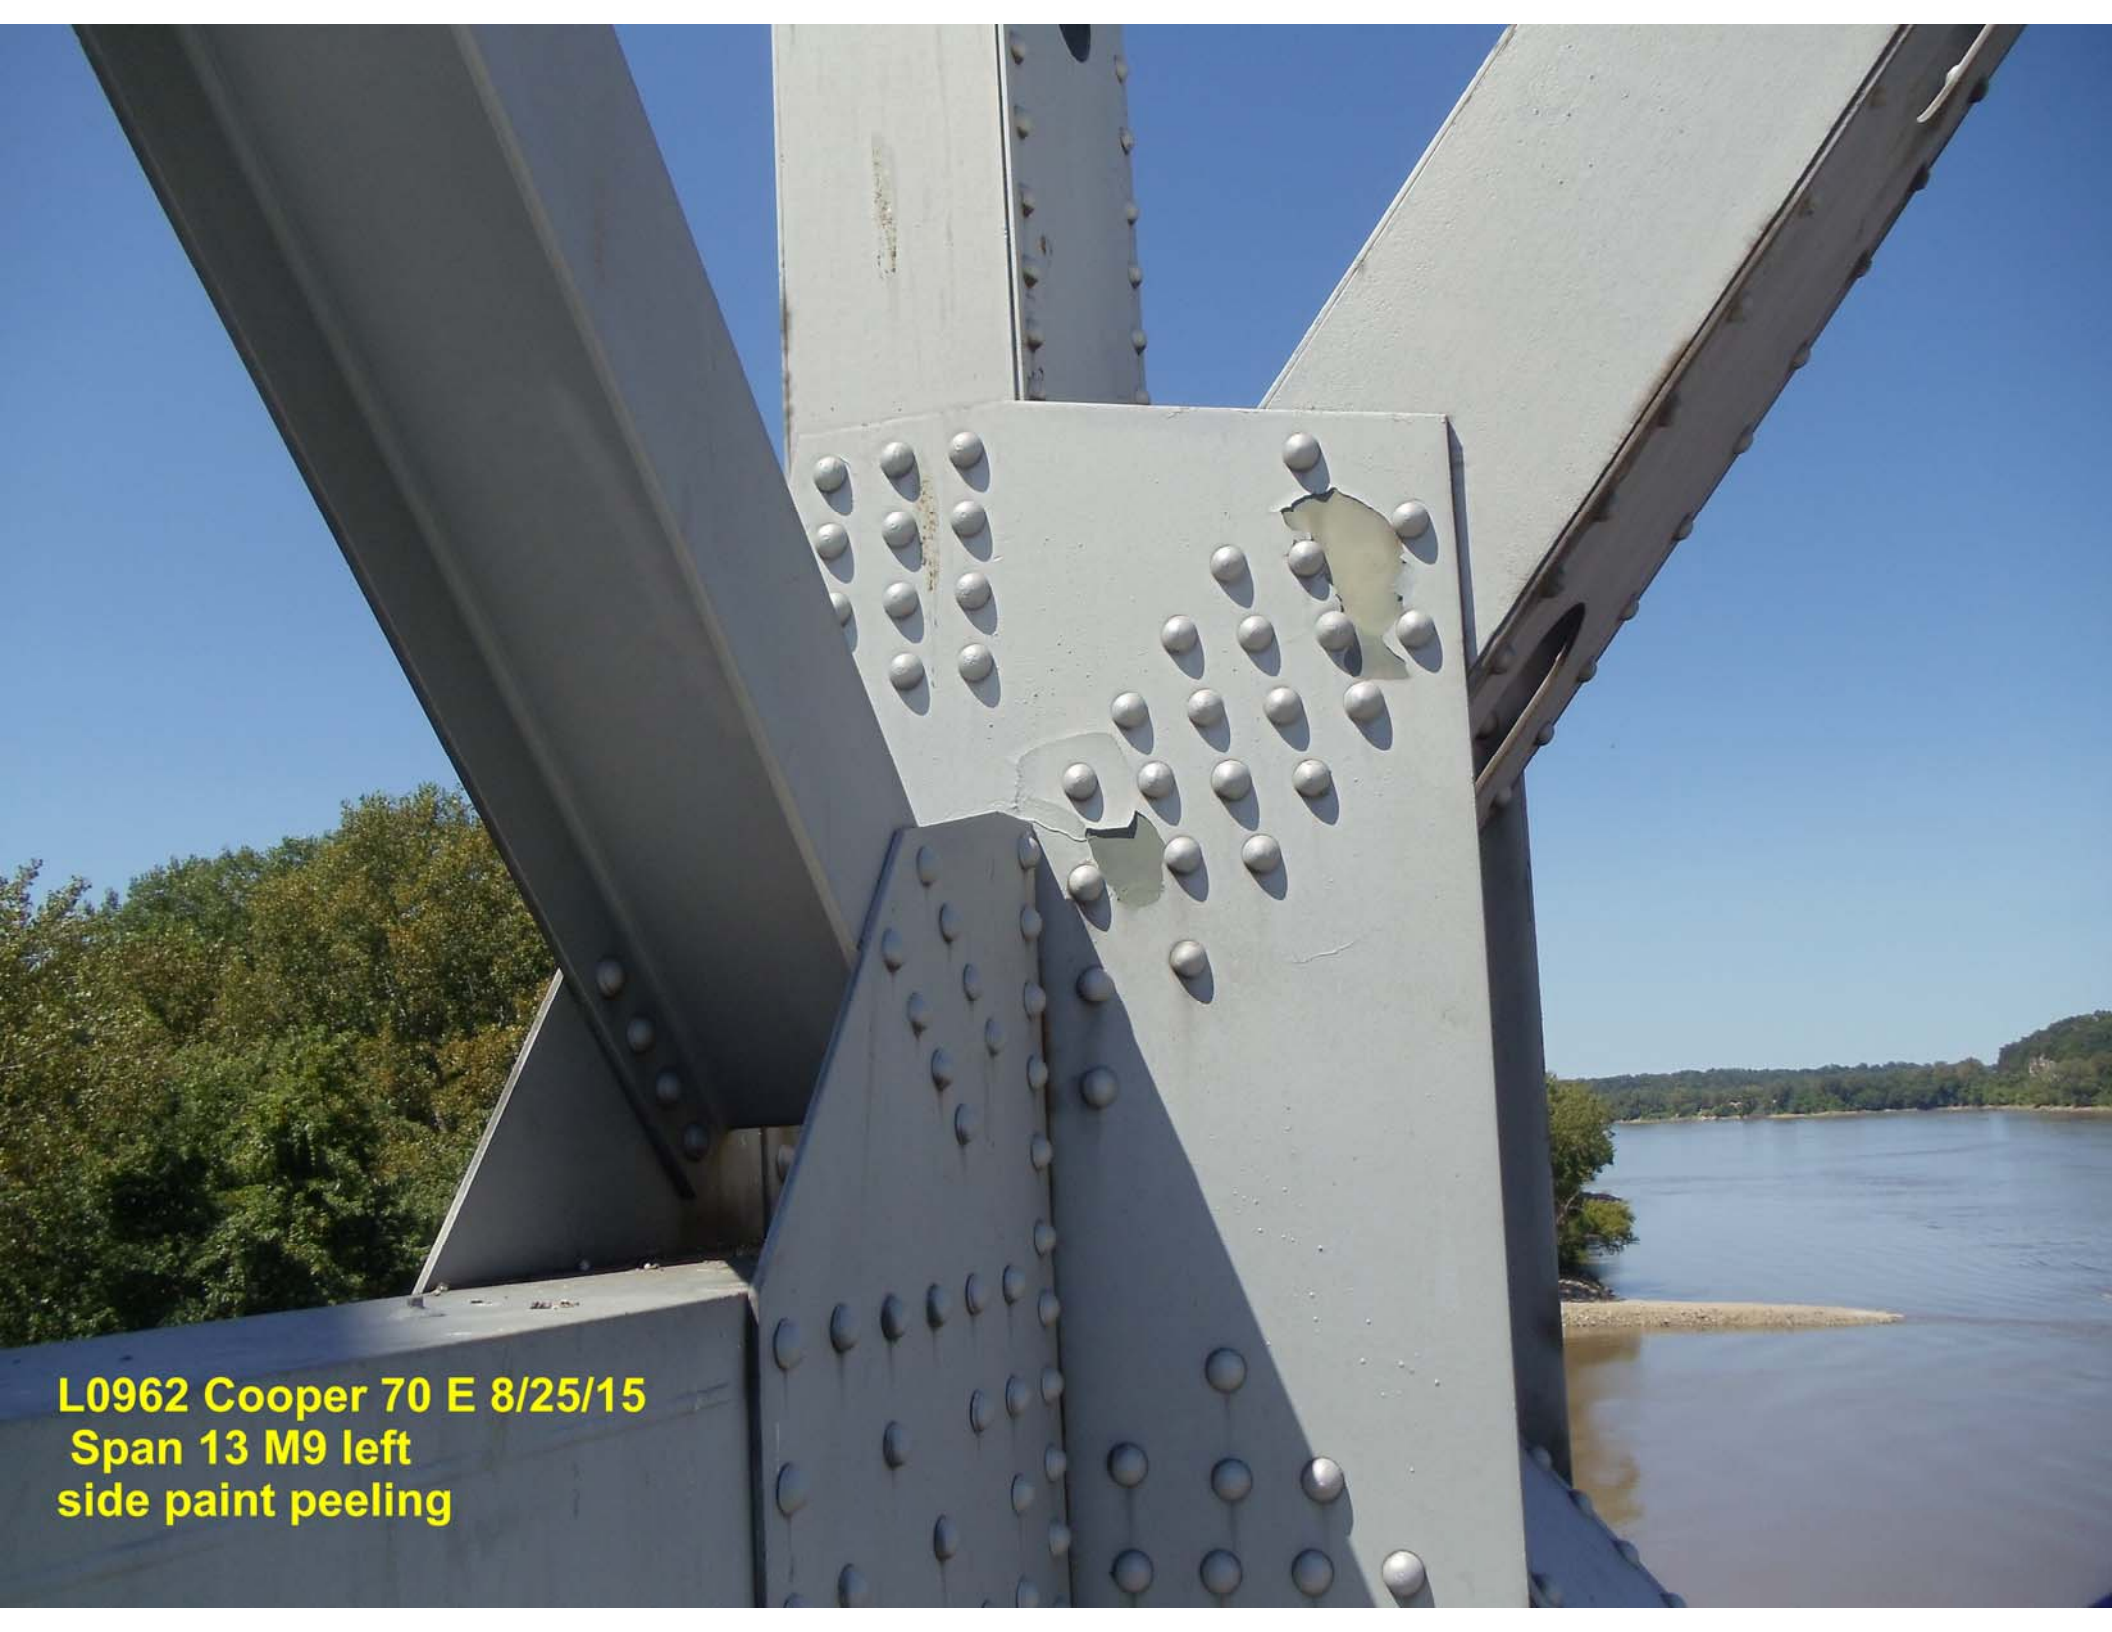
**L0962 Cooper 70 E 8/25/15**  
**Span 13 M9 left**  
**side paint peeling**

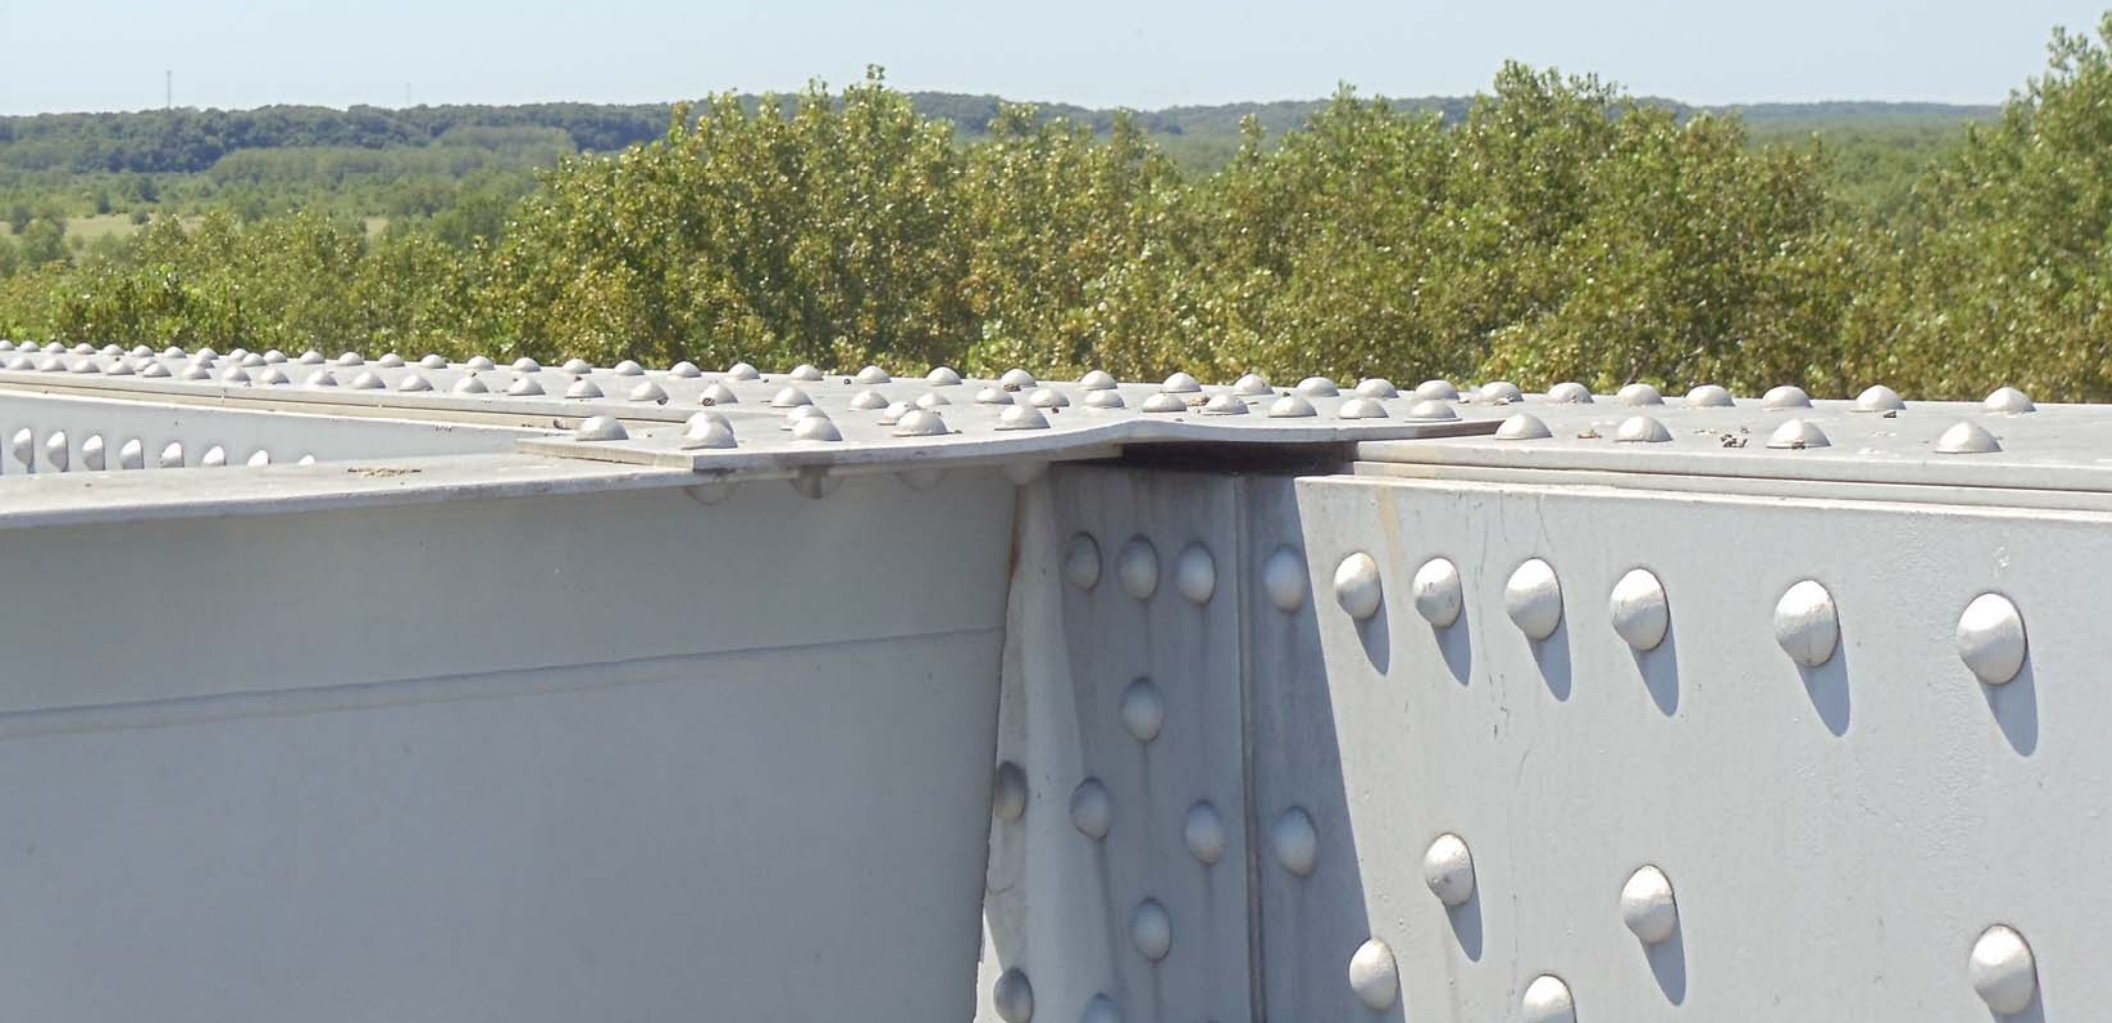
L0962 Cooper 70 E 8/25/15  
Span 13 M3-L4 left  
side diagonal minor pack  
rust at riveted connection
