L0962 I 70 Cooper Co.  
Joint at L8, span 13  
Eastbound lane failing  
9-24-13

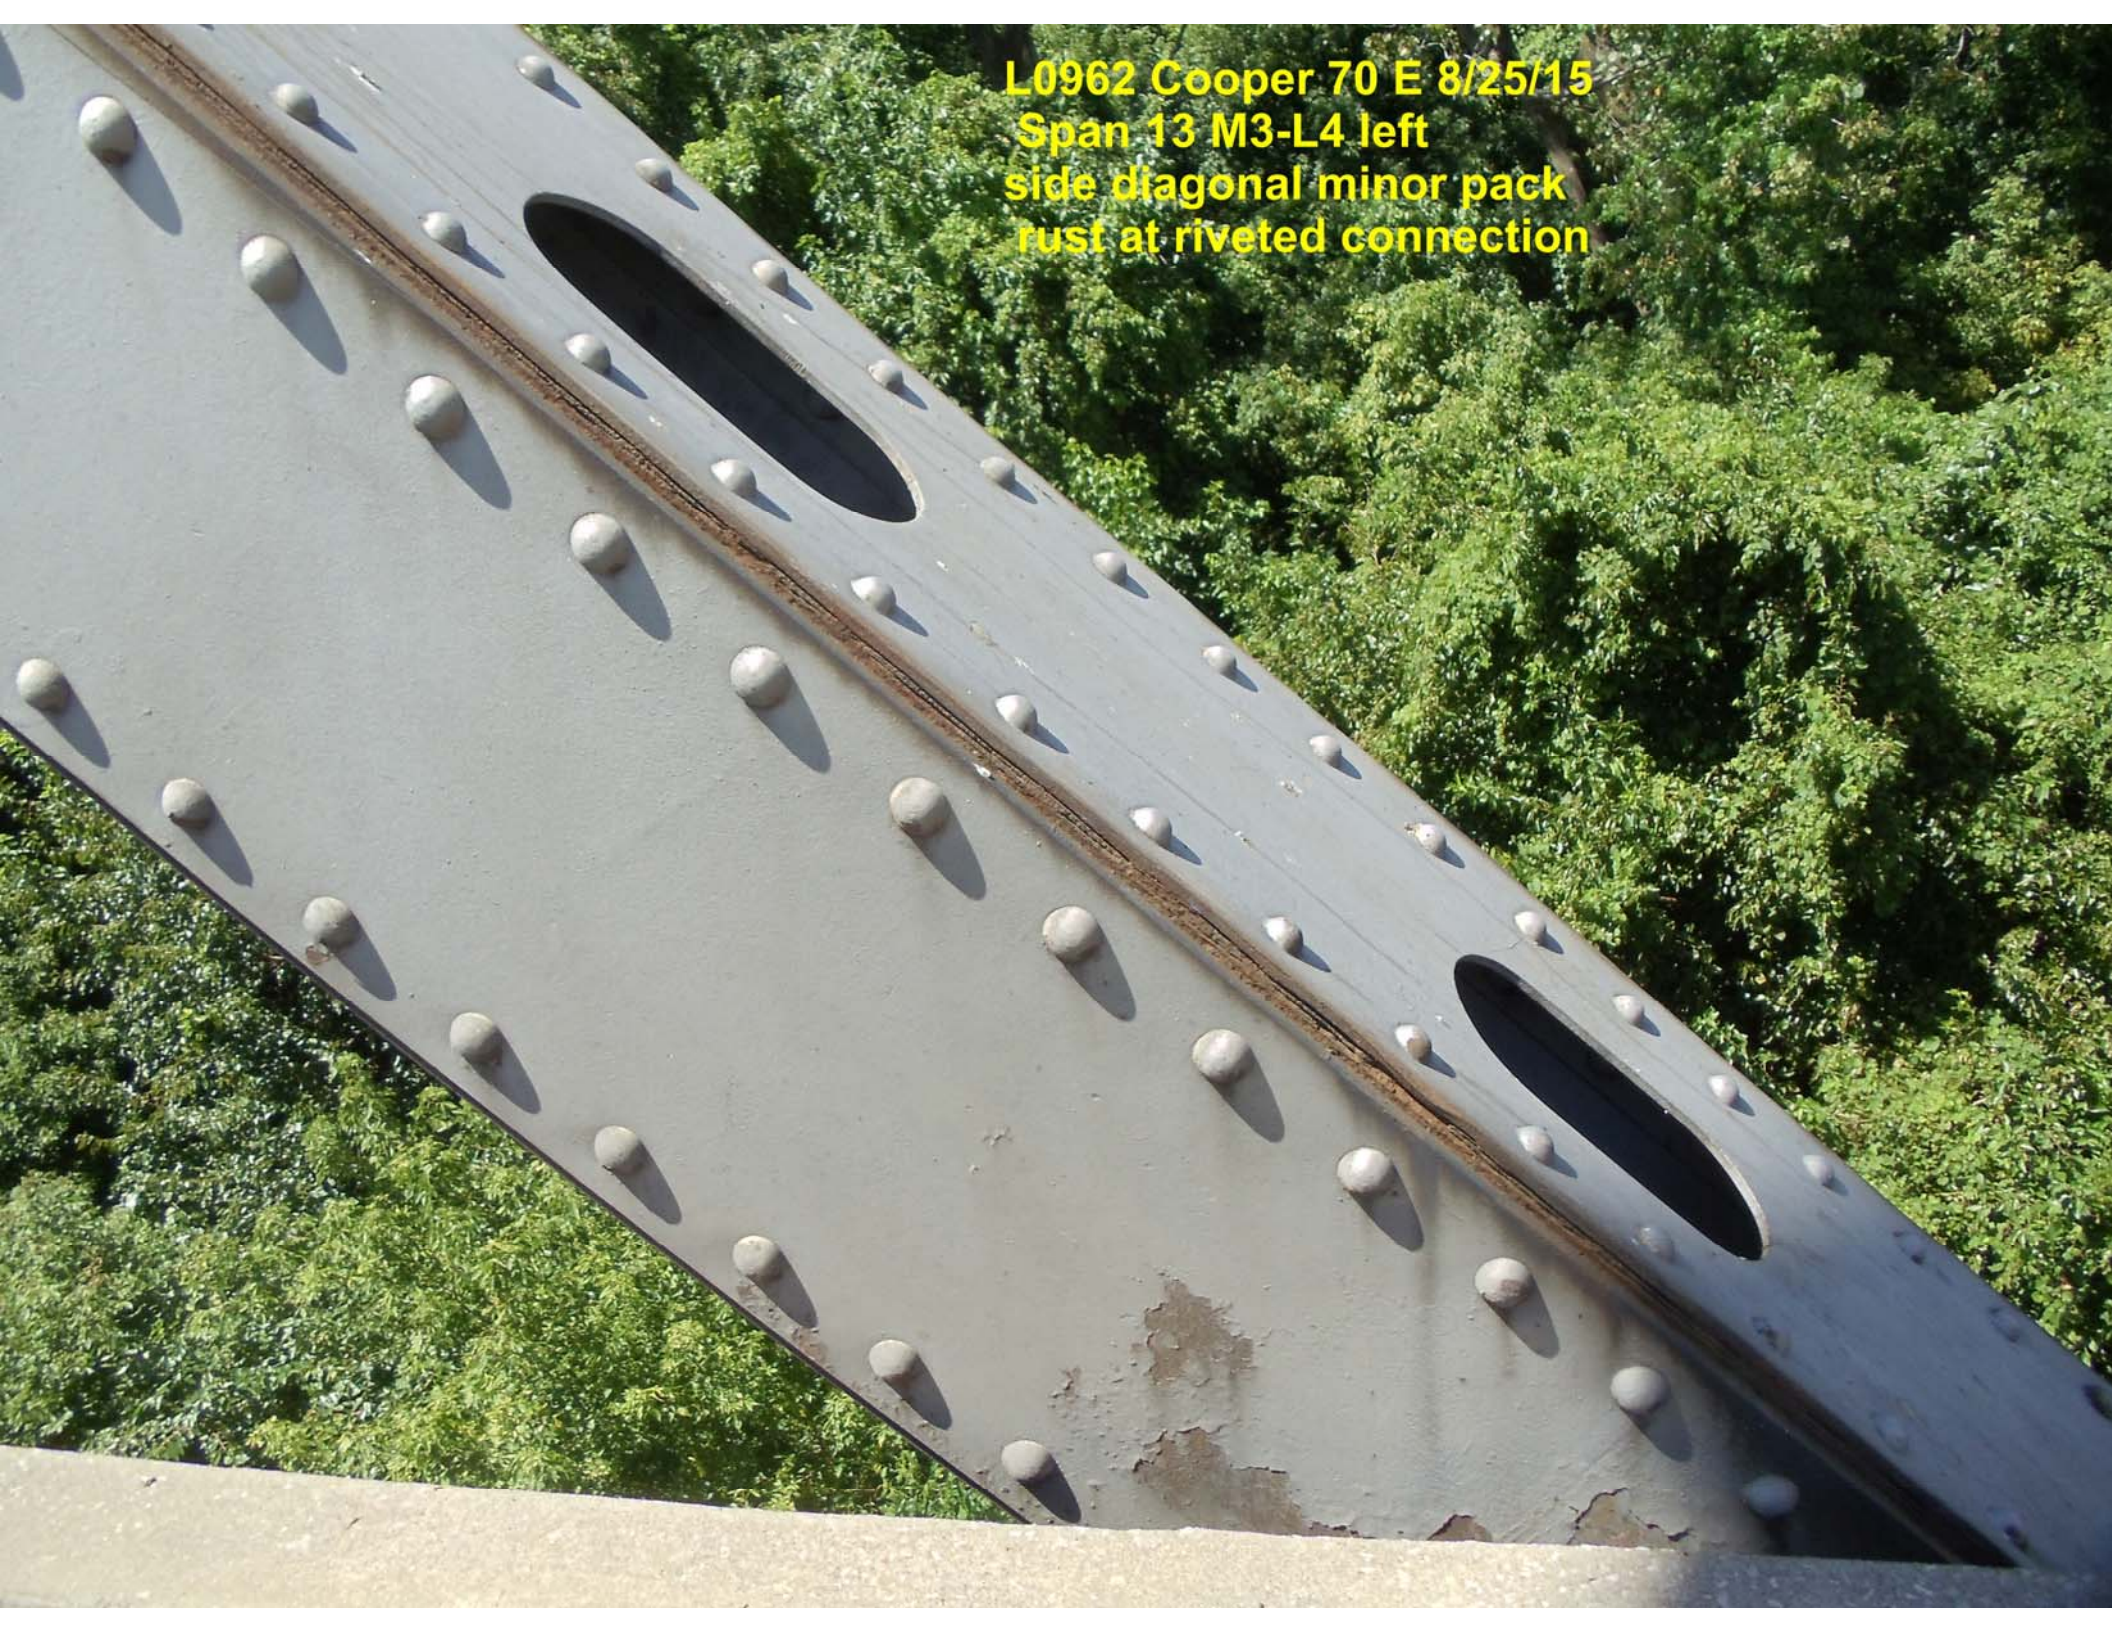
**L0962 Cooper 70 E 8/25/15**  
**Span 13 M3-L4 left side**  
**diagonal minor pack rust**  
**at riveted connection**

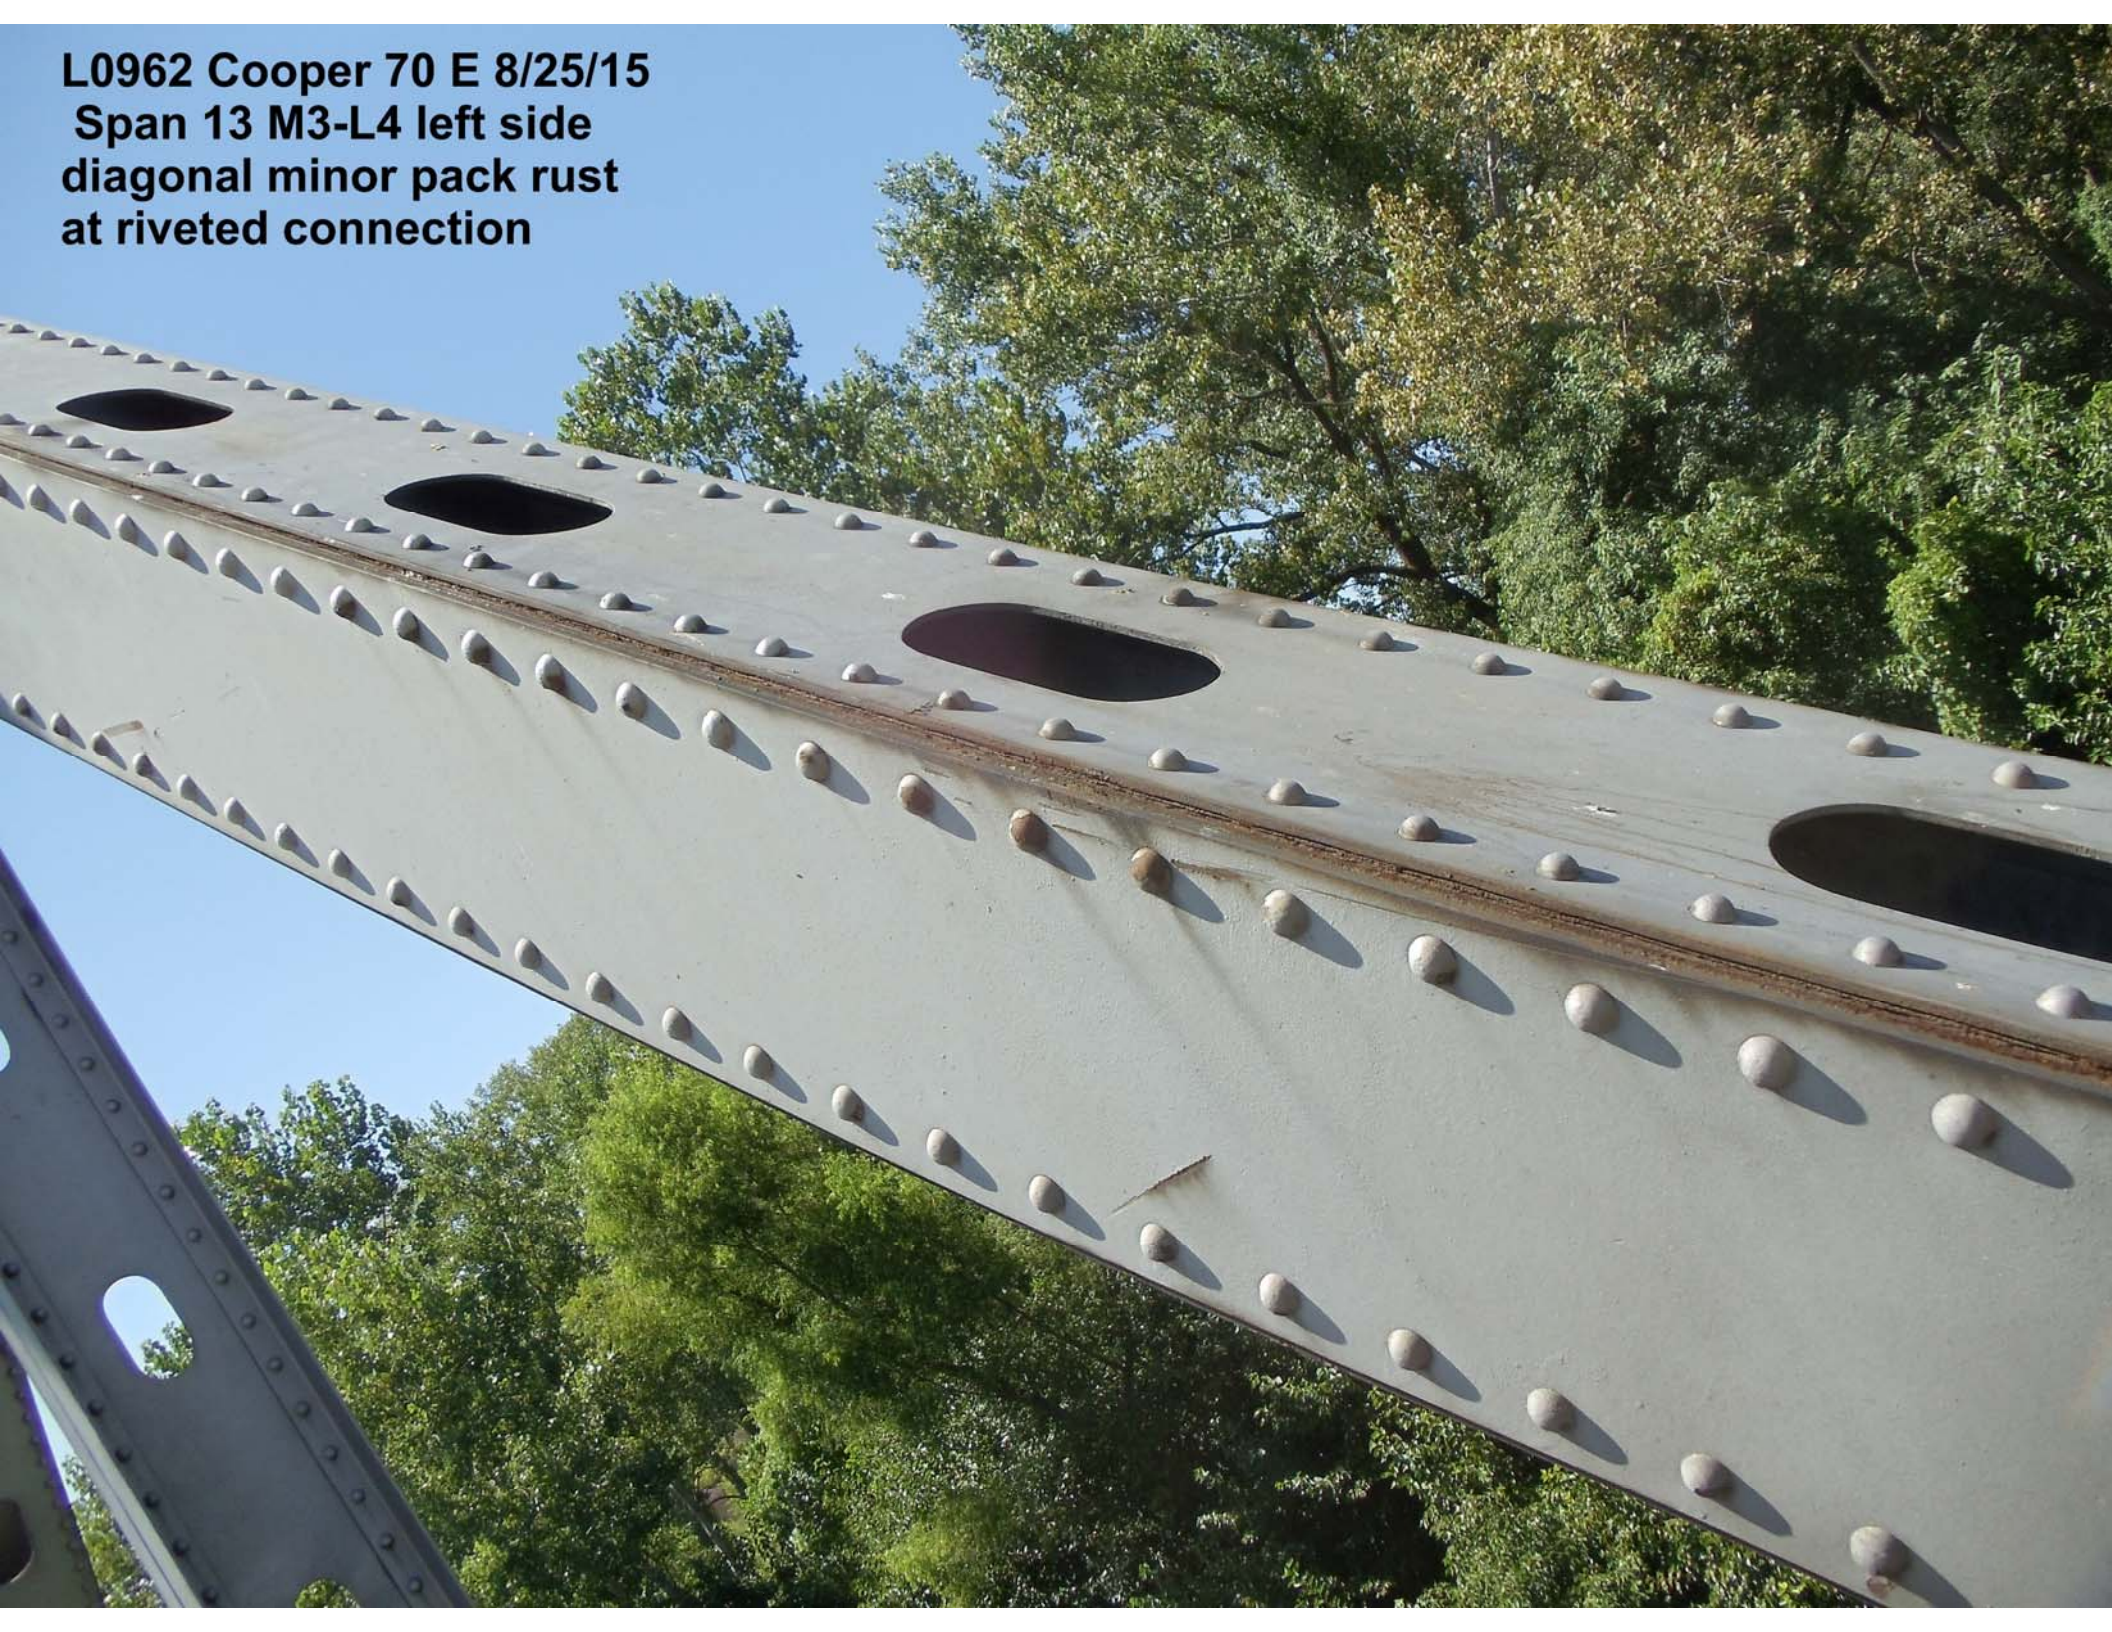
**L0962 Cooper 70 E 8/24/15**  
**Span 13 L11 left lower**  
**gusset hvy pack rust**  
**distorting gusset**

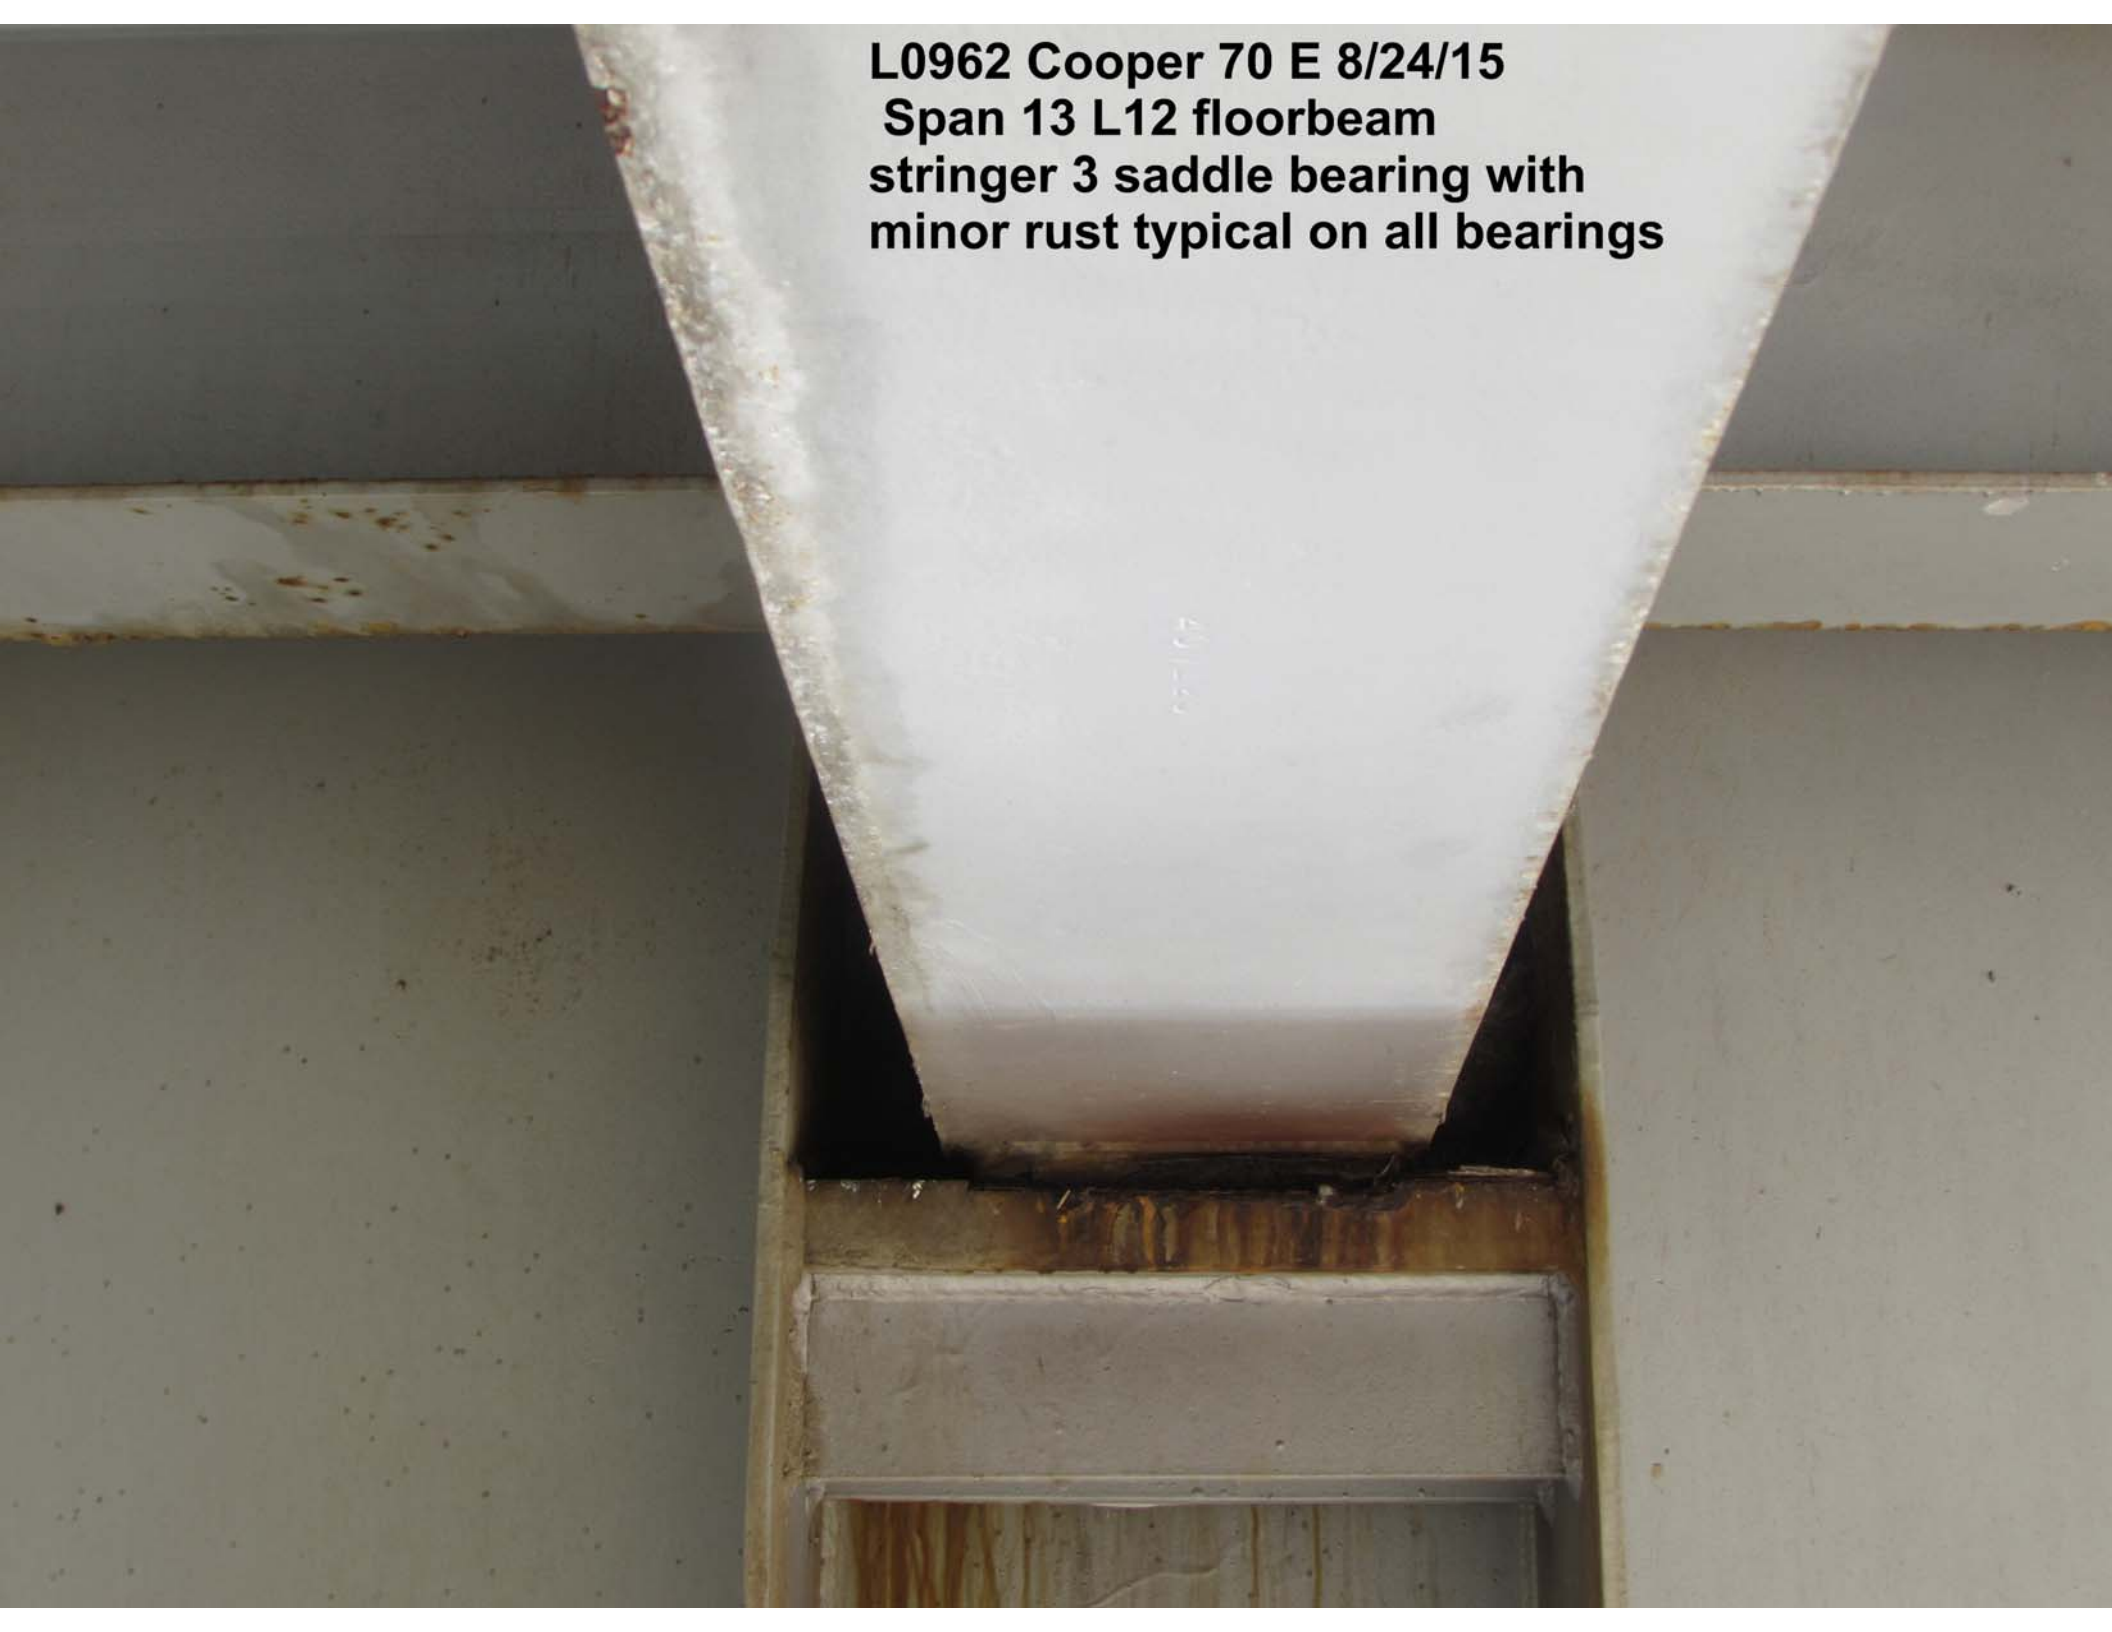
**L0962 Cooper 70 E 8/24/15**  
**Span 13 L11 to L12 left**  
**side lower chord with 3 inch by**  
**10 inch area of adv sec loss**  
**bottom of chord at L12 lower gusset**

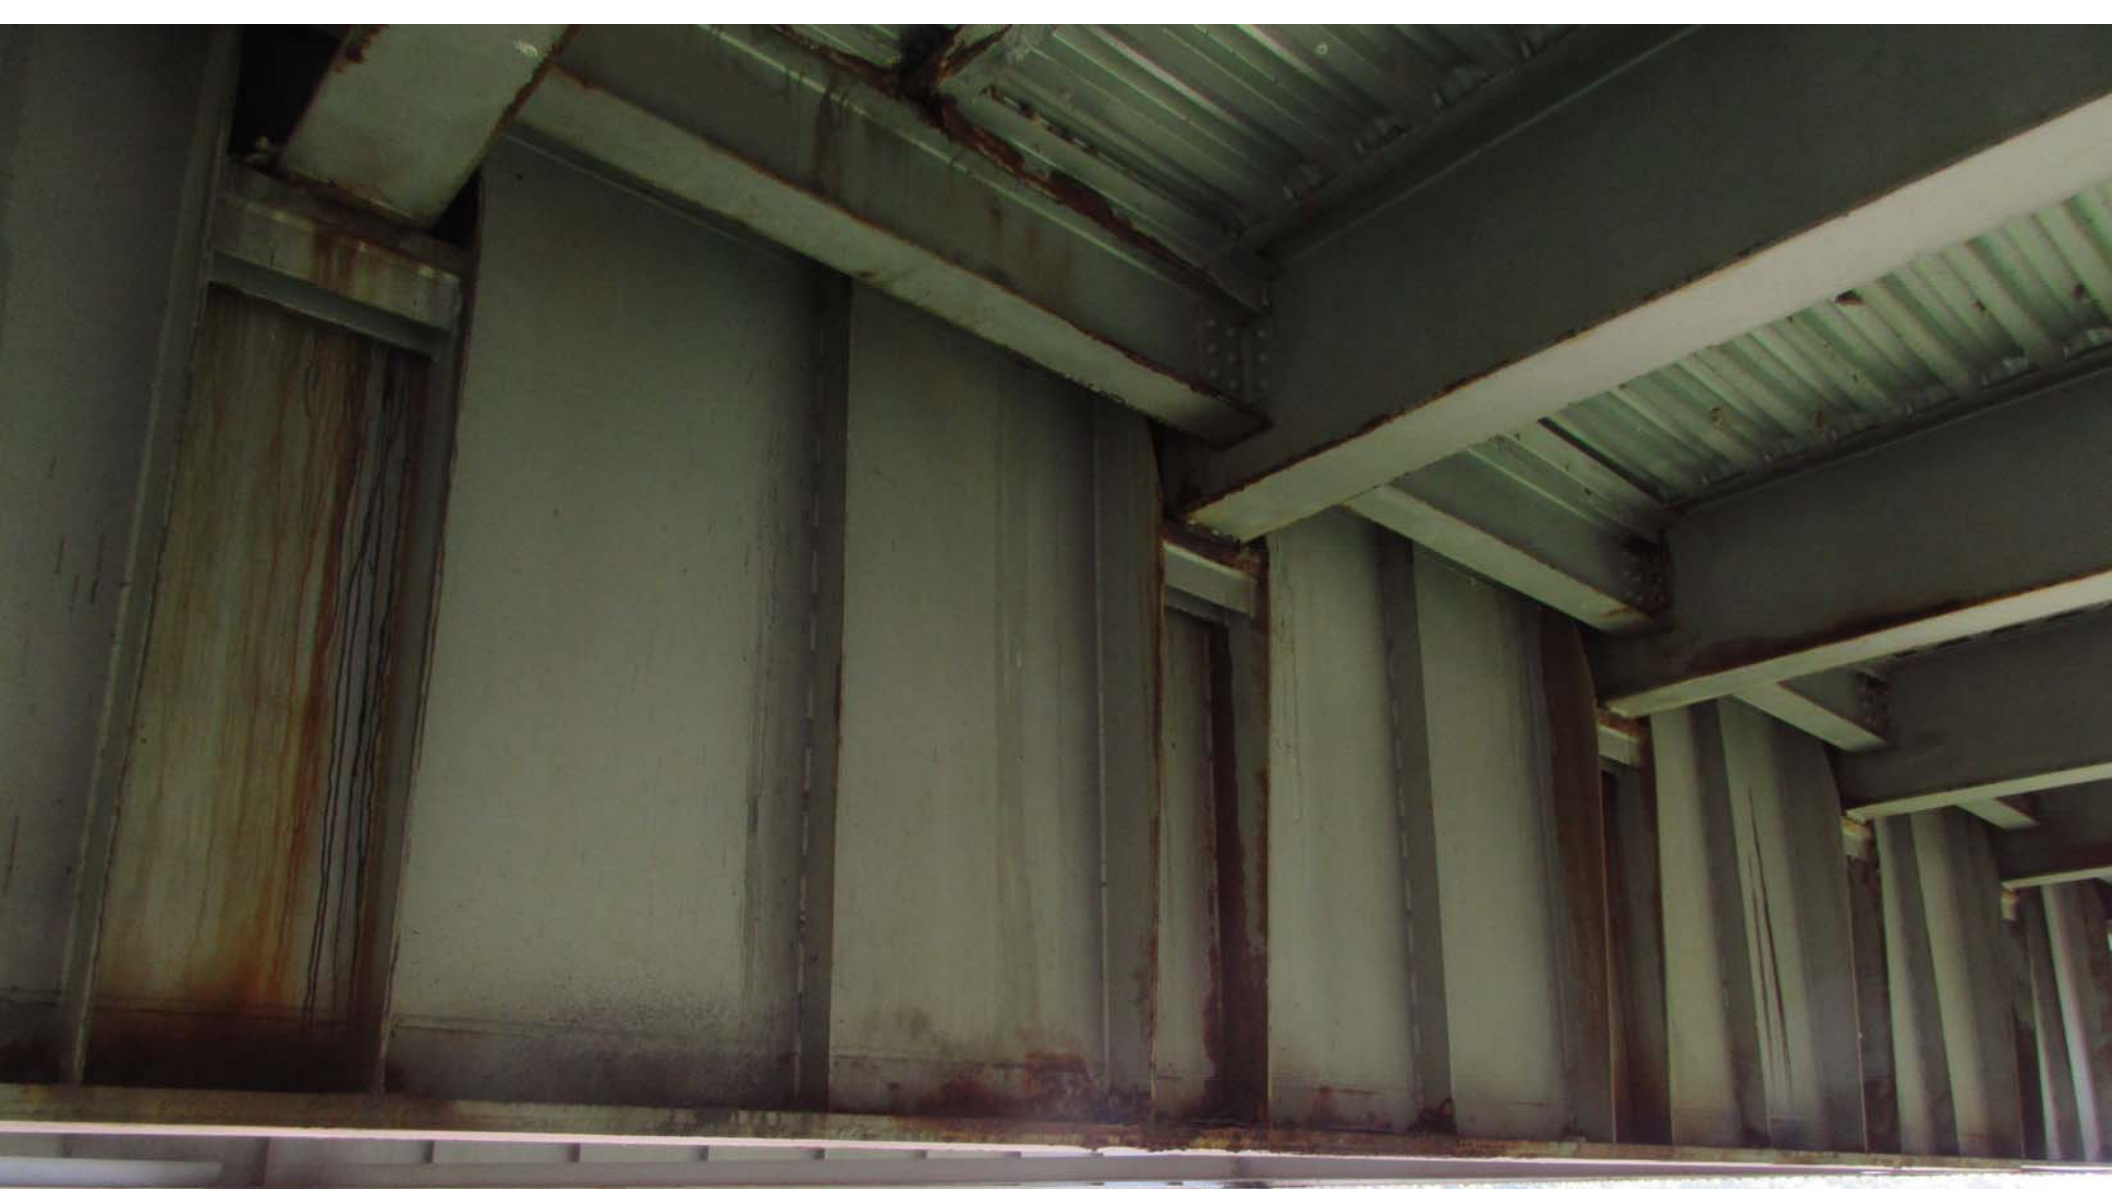
**L0962 Cooper 70 E 8/24/15  
Span 13 L4 floorbeam west  
side with moderate pack rust in  
web and bottom flange under  
stringer 5 saddle bearing**

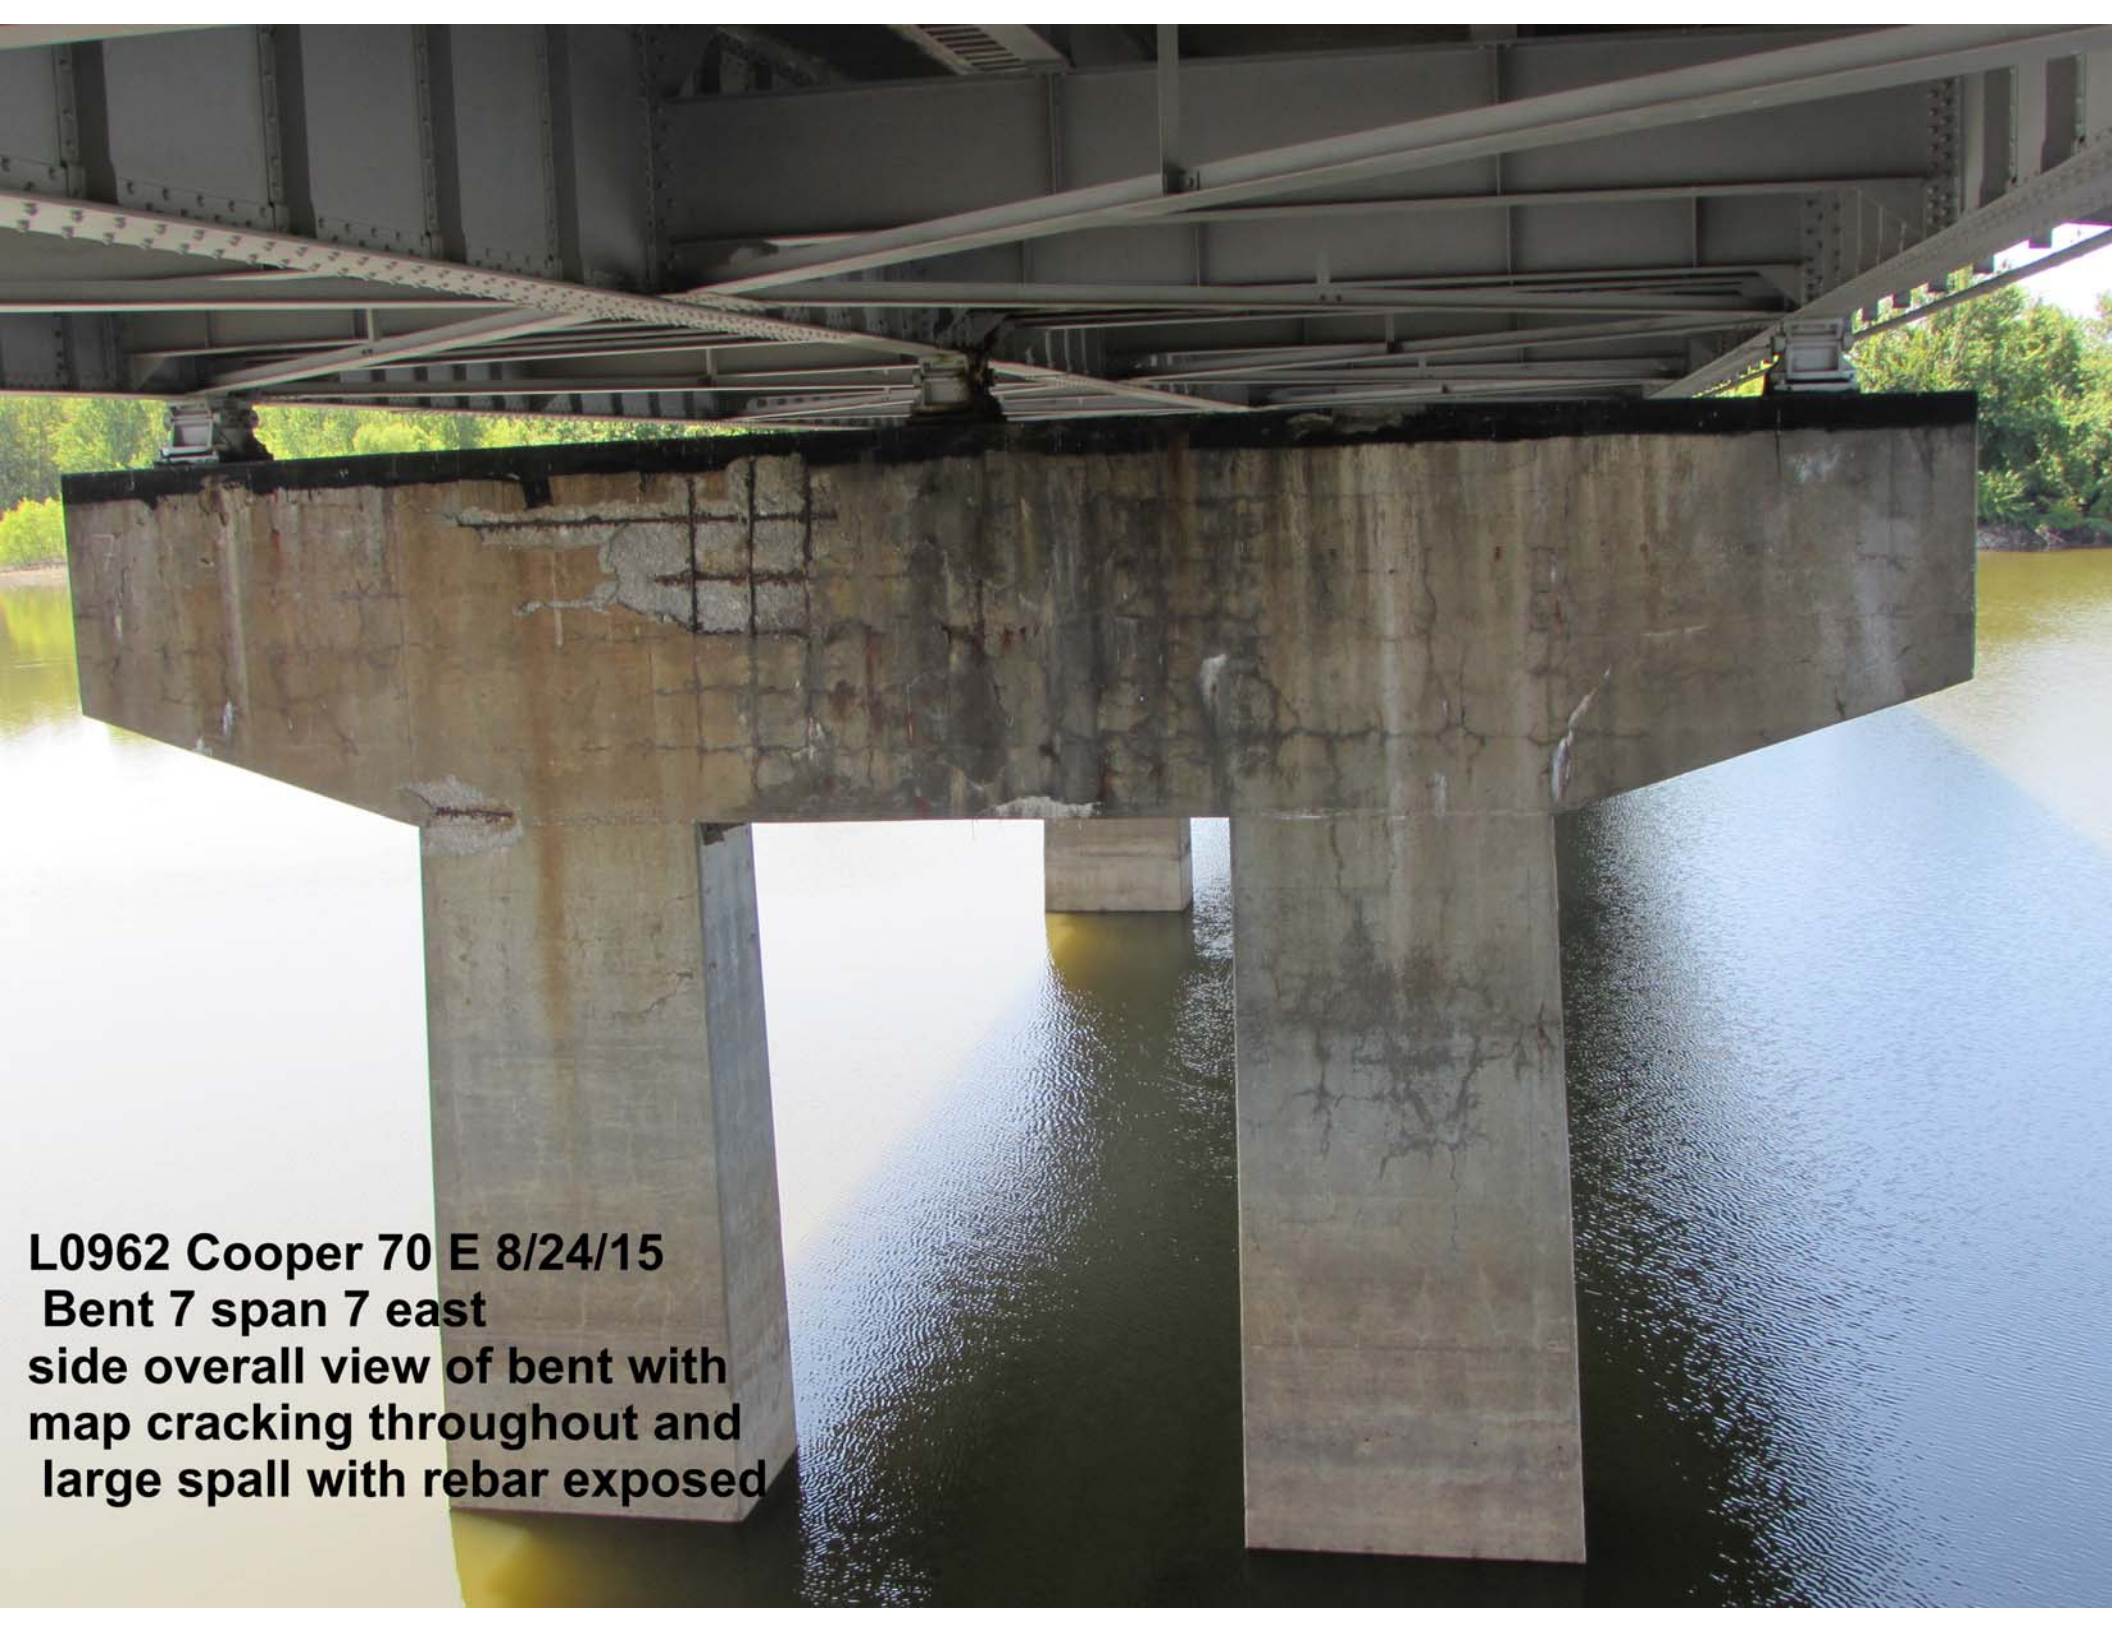
**L0962 Cooper 70 E 8/24/15**  
**Bent 7 span 7 east**  
**side overall view of bent with**  
**map cracking throughout and**  
**large spall with rebar exposed**

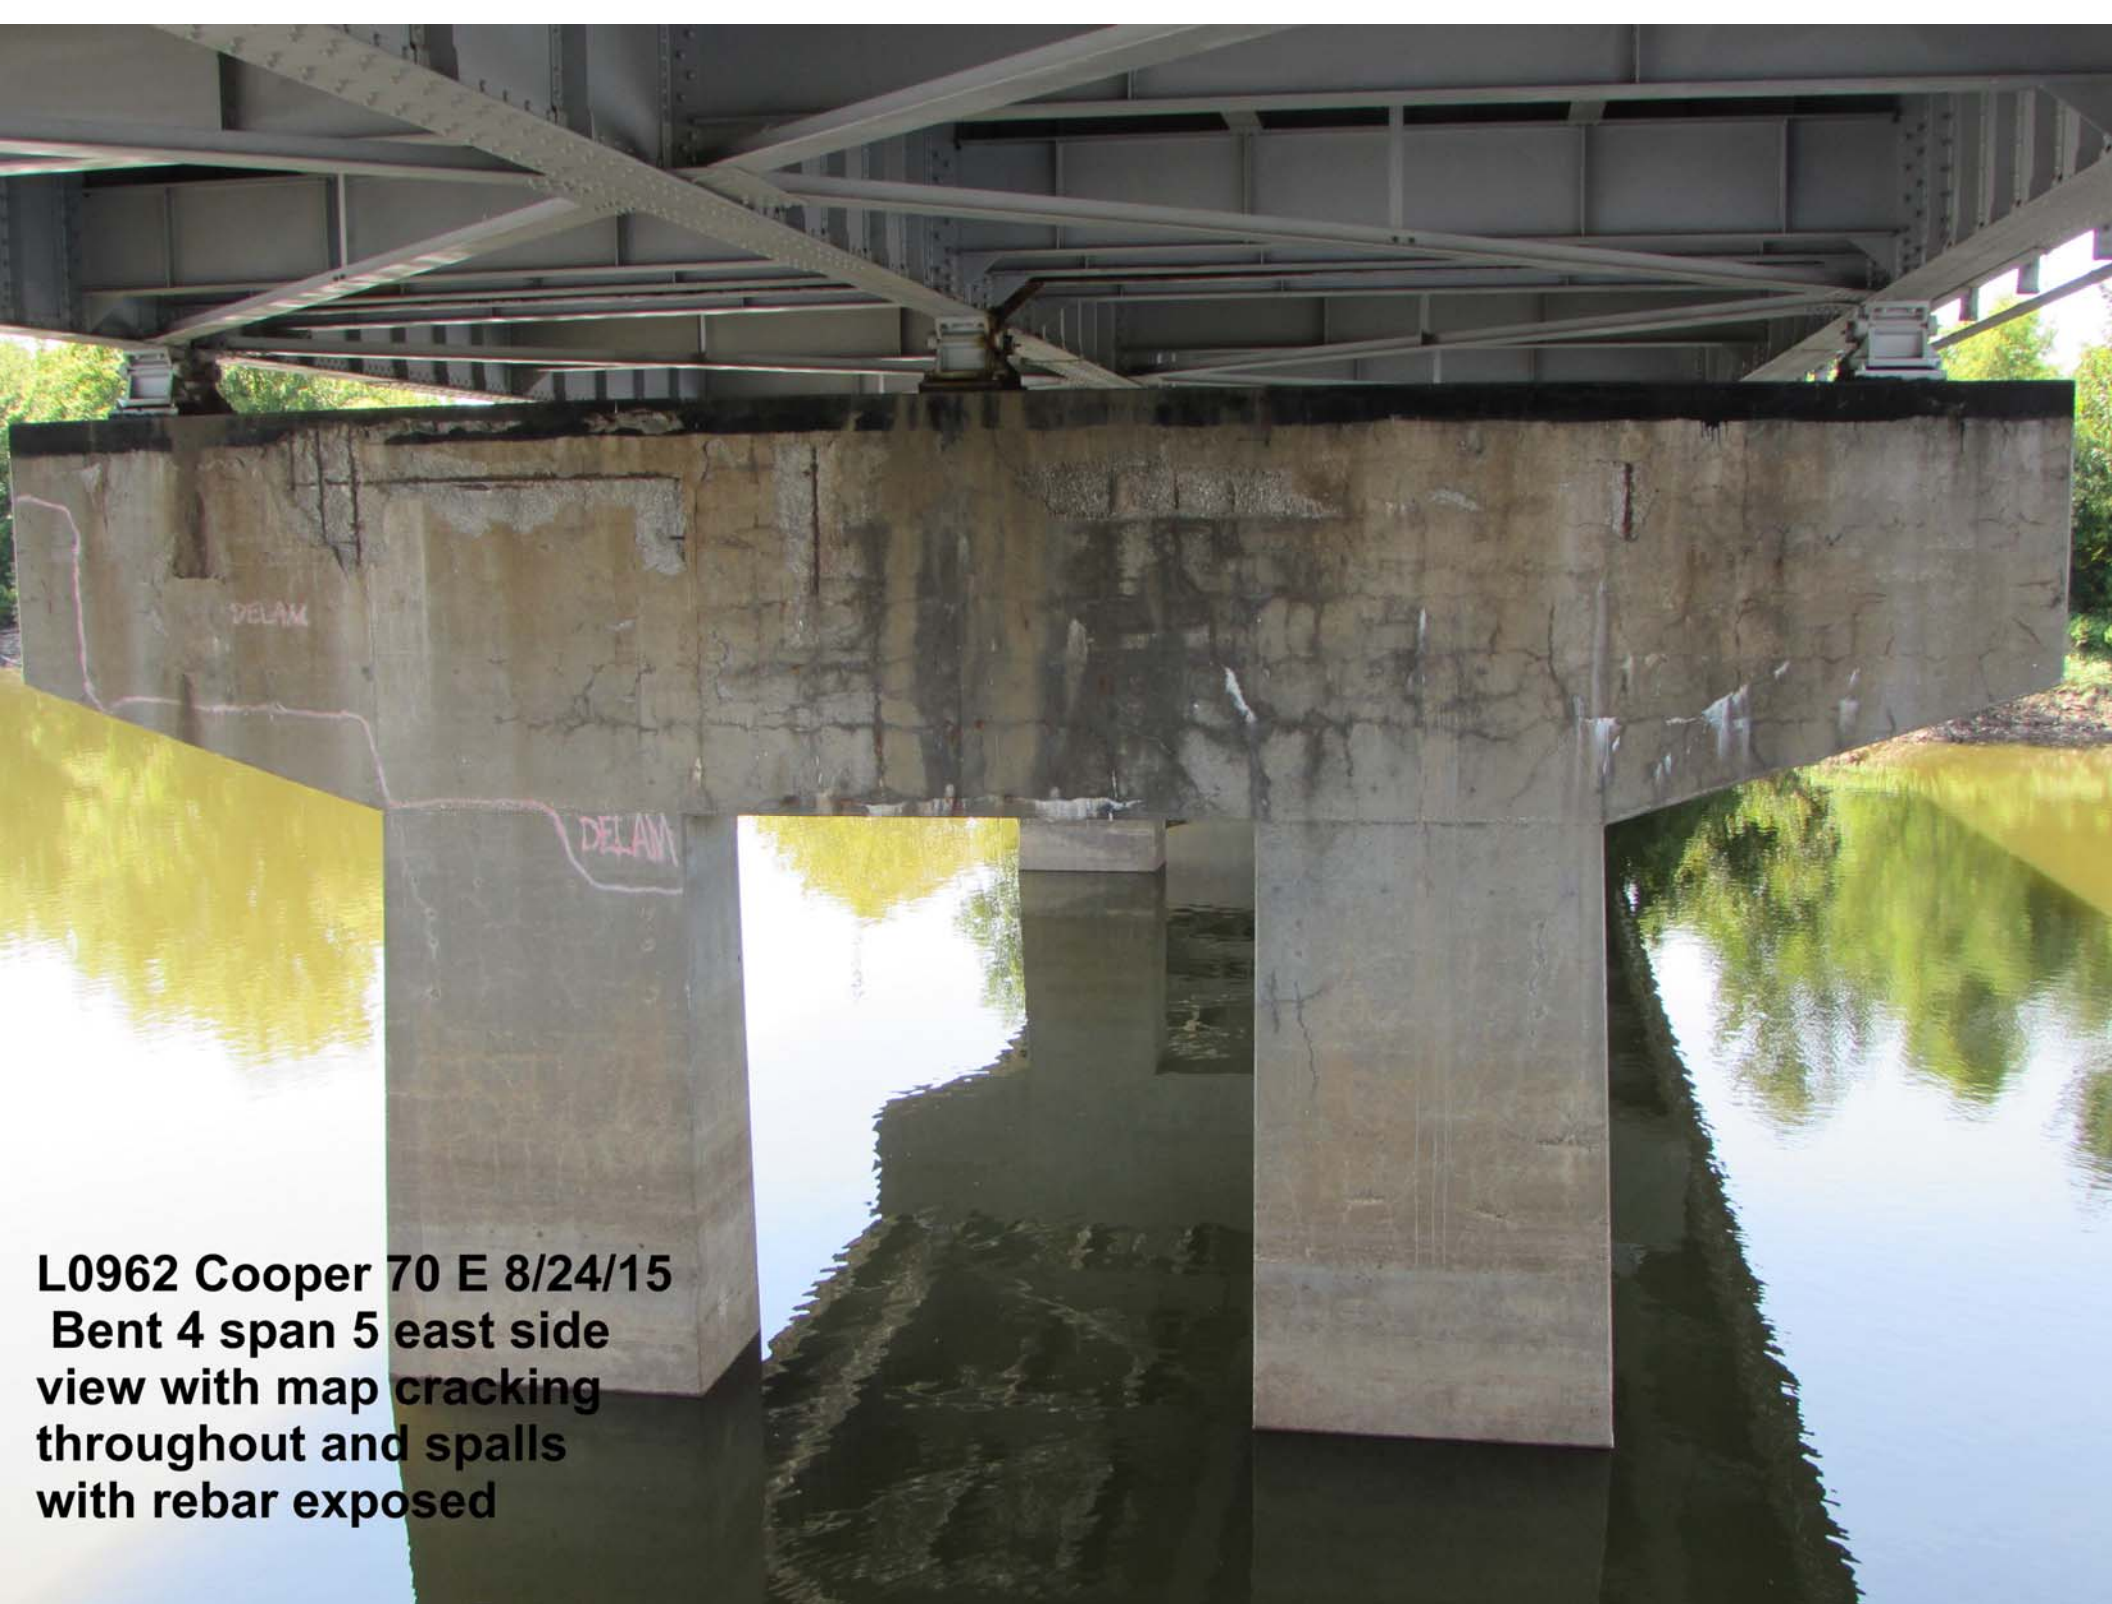
**L0962 Cooper 70 E 8/24/15  
Bent 4 span 5 east side  
view with map cracking  
throughout and spalls  
with rebar exposed**

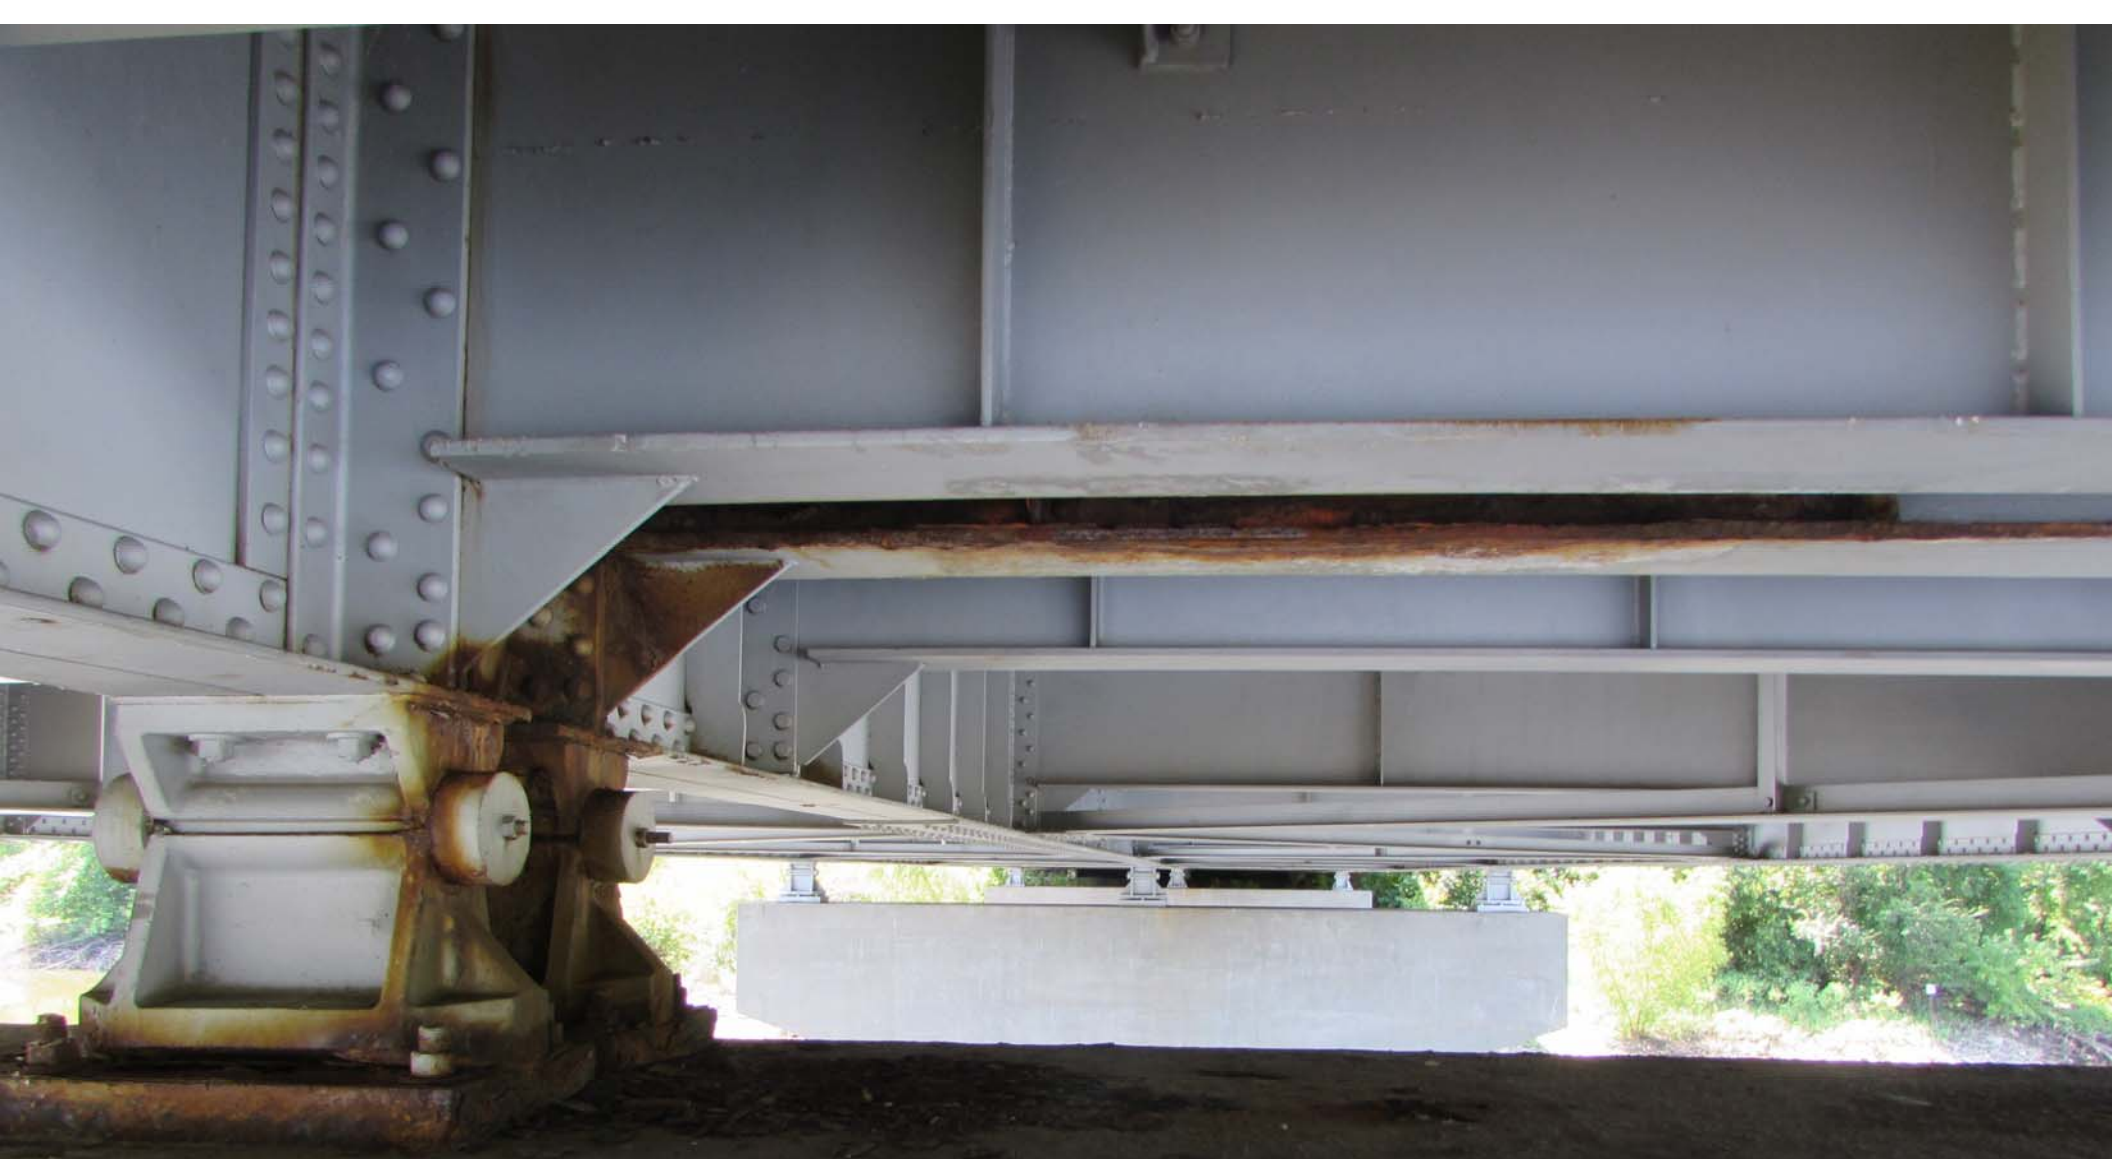
**L0962 Cooper 70 E 8/24/15**  
**Bent 4 rockers and floorbeam**  
**with hvy pack rust and**  
**sec loss with 50 percent**  
**remaining**
