L0962 I 70 Cooper Co.  
Joint at L8, span 13  
Eastbound lane failing  
9-24-13

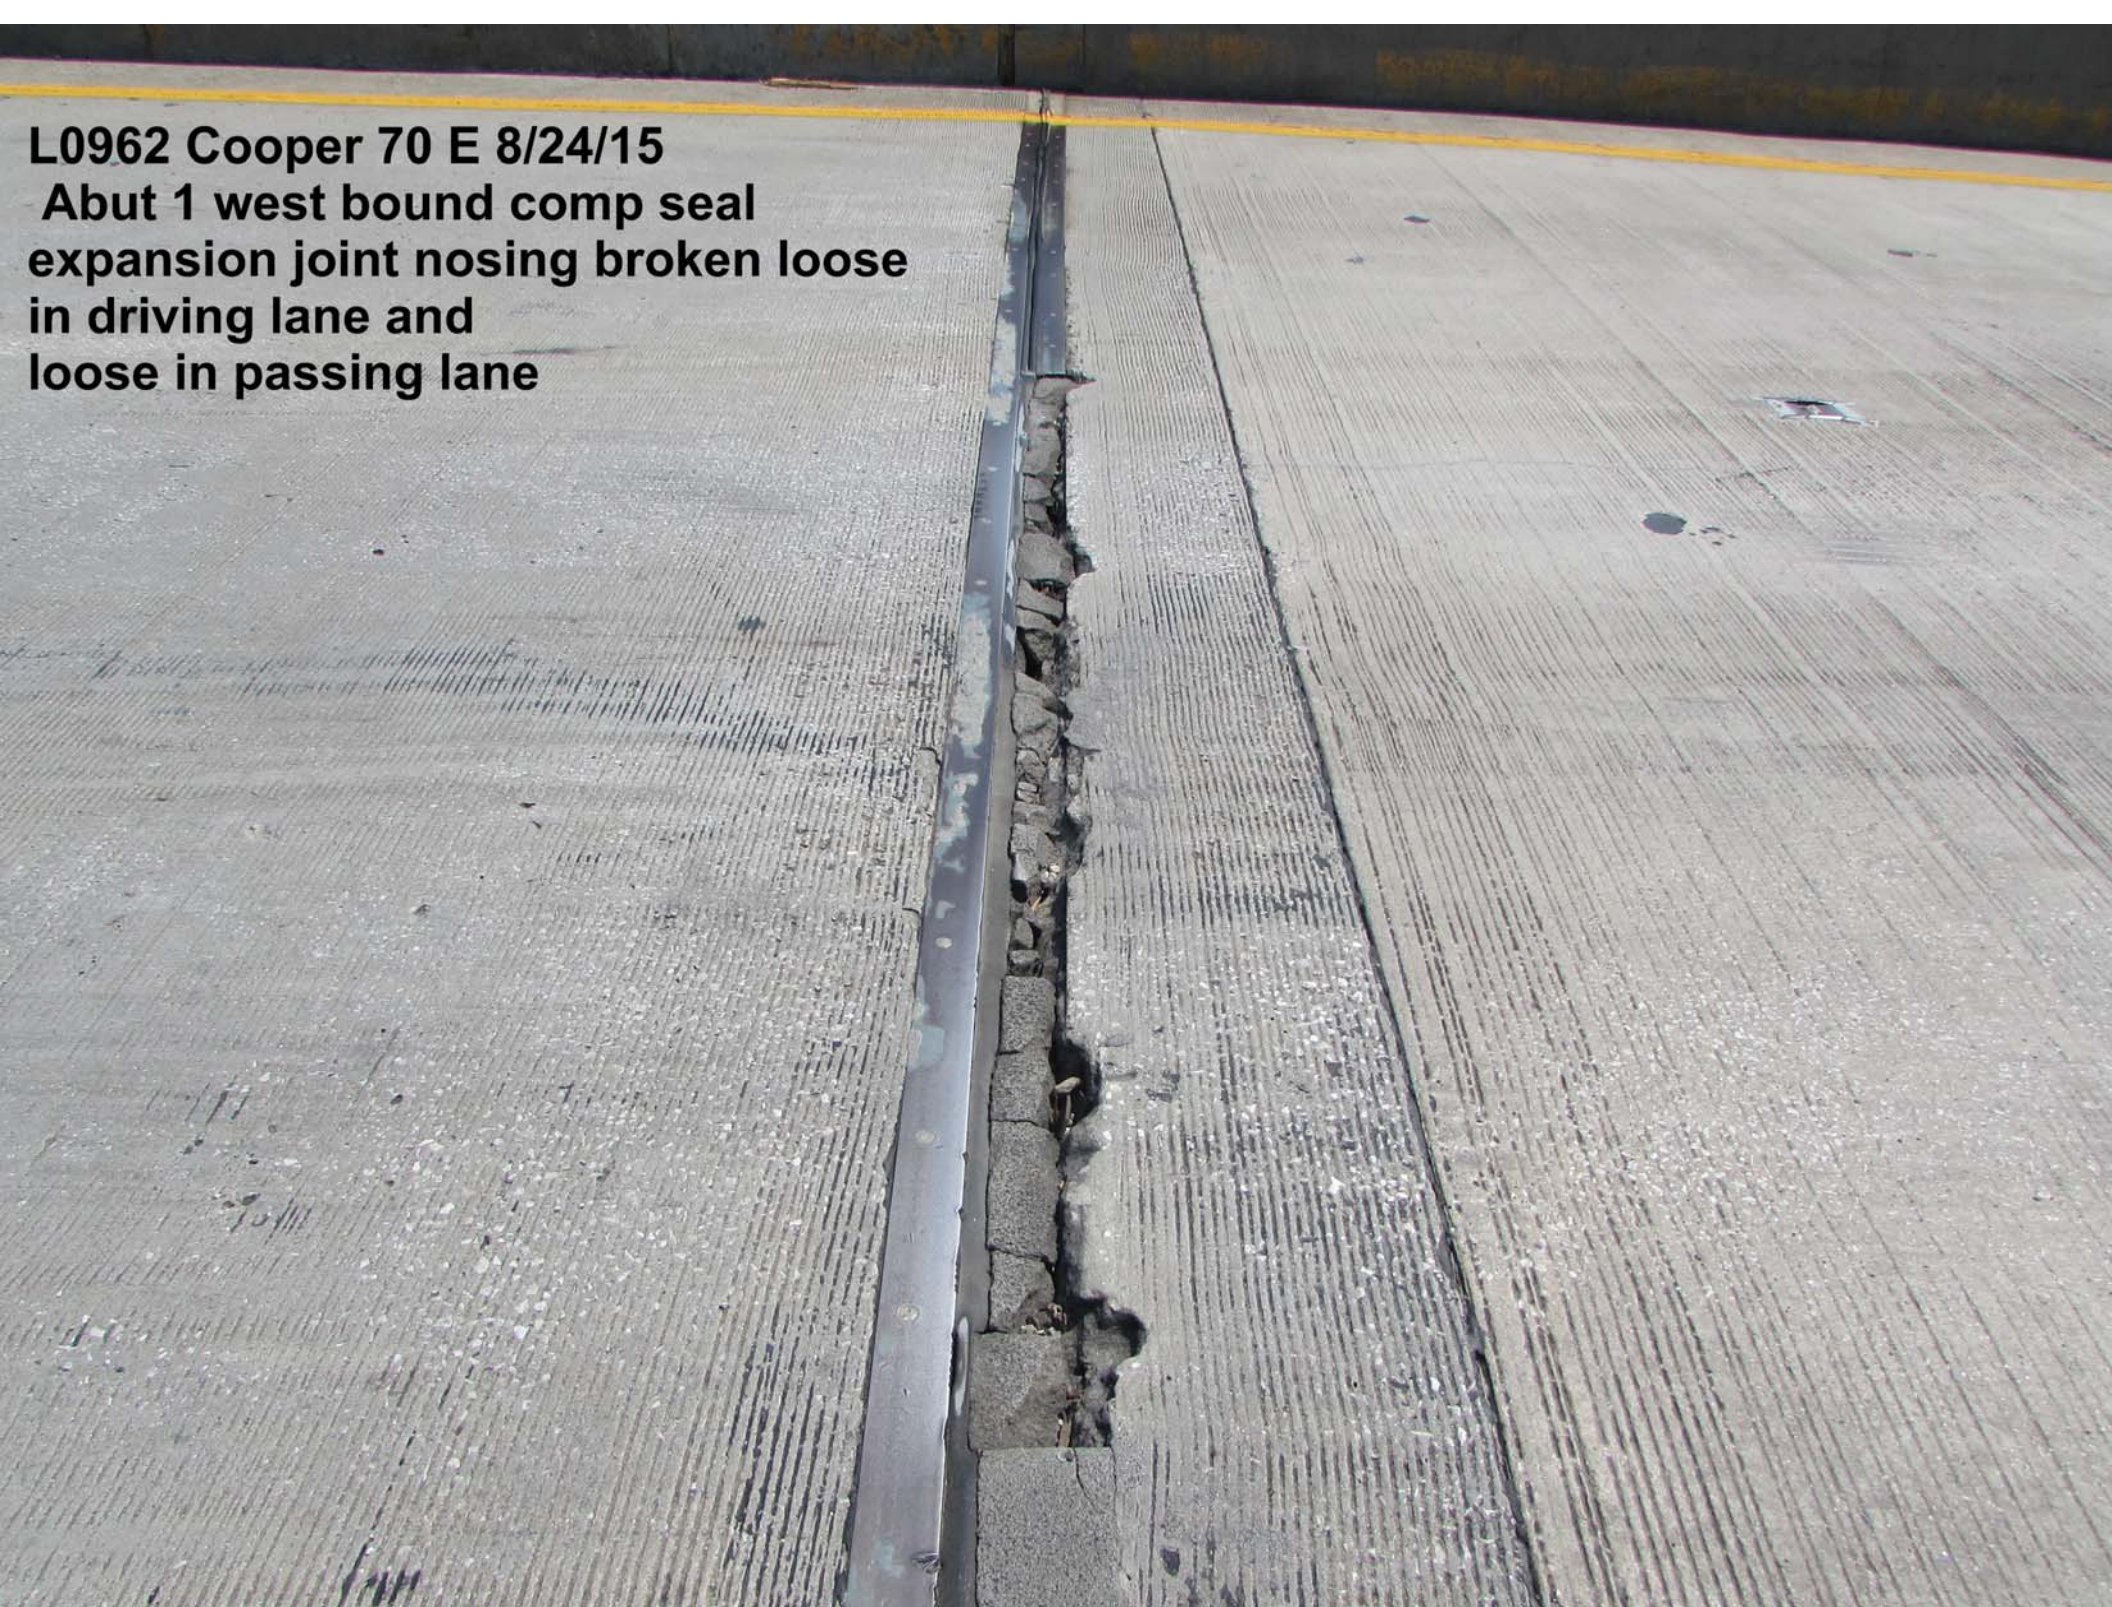
**L0962 Cooper 70 E 8/24/15**  
**Bent 4 west bound finger plate**  
**expansion joint uneven**  
**1/4 inch throughout west**  
**bound lanes**

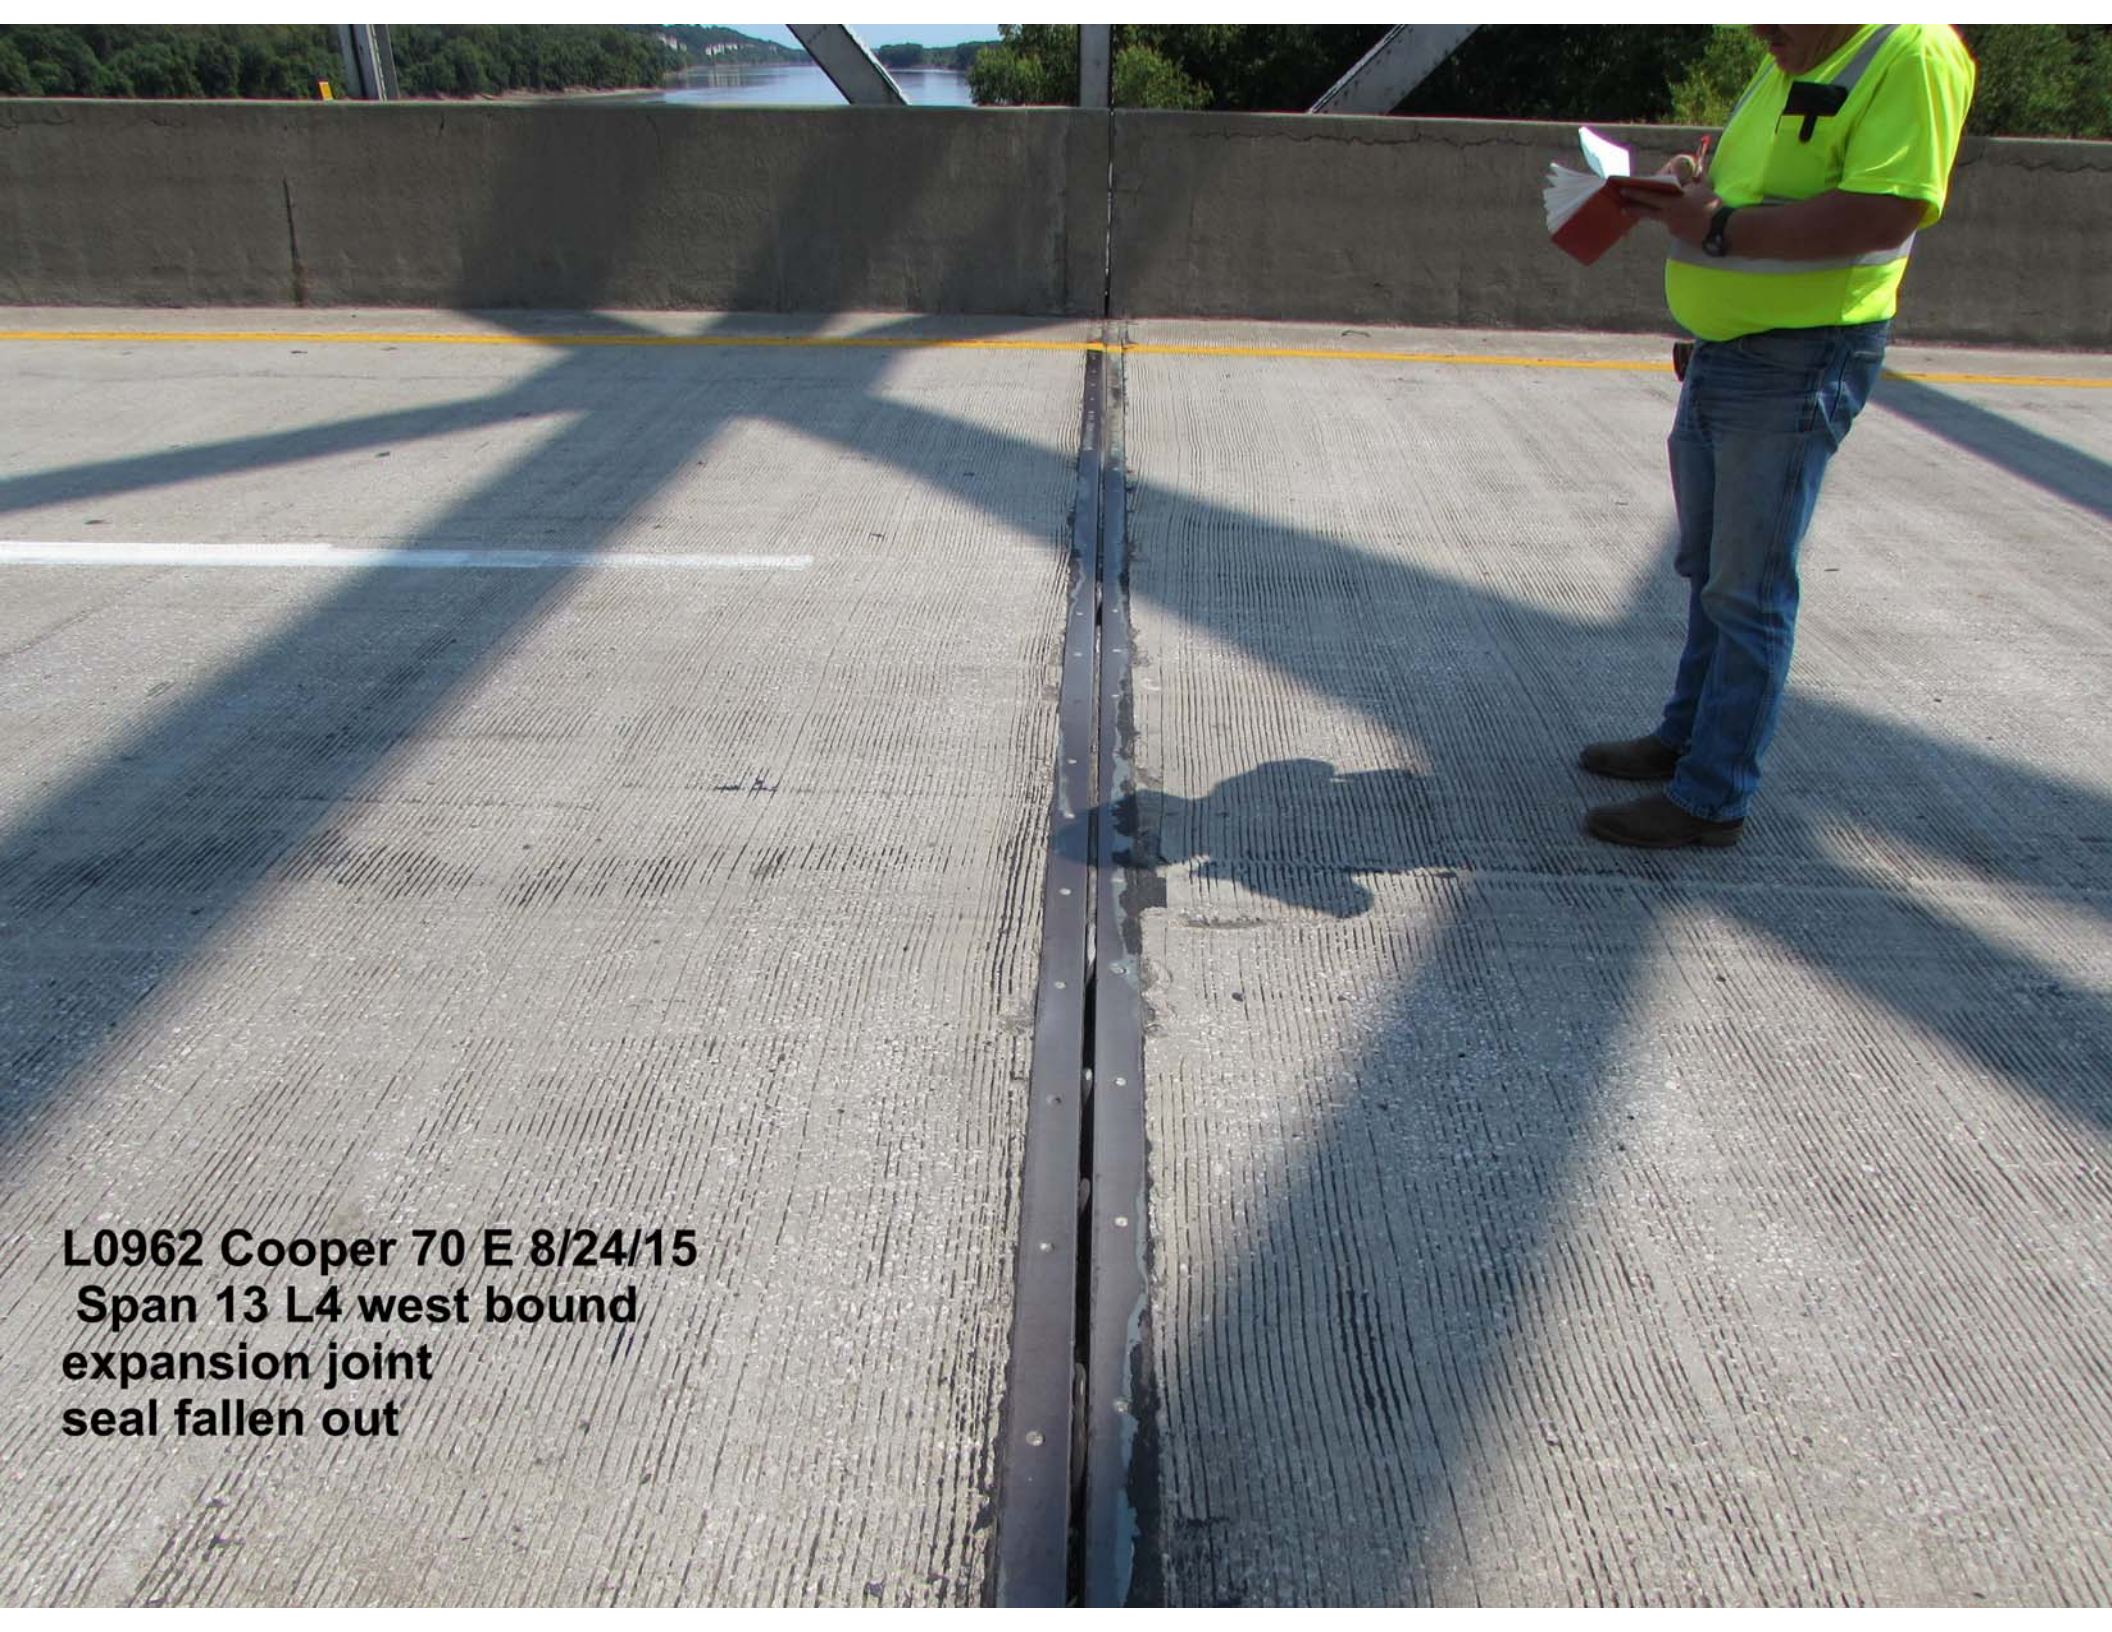
**L0962 Cooper 70 E 8/24/15**  
**Span 13 L4 west bound**  
**expansion joint**  
**seal fallen out**

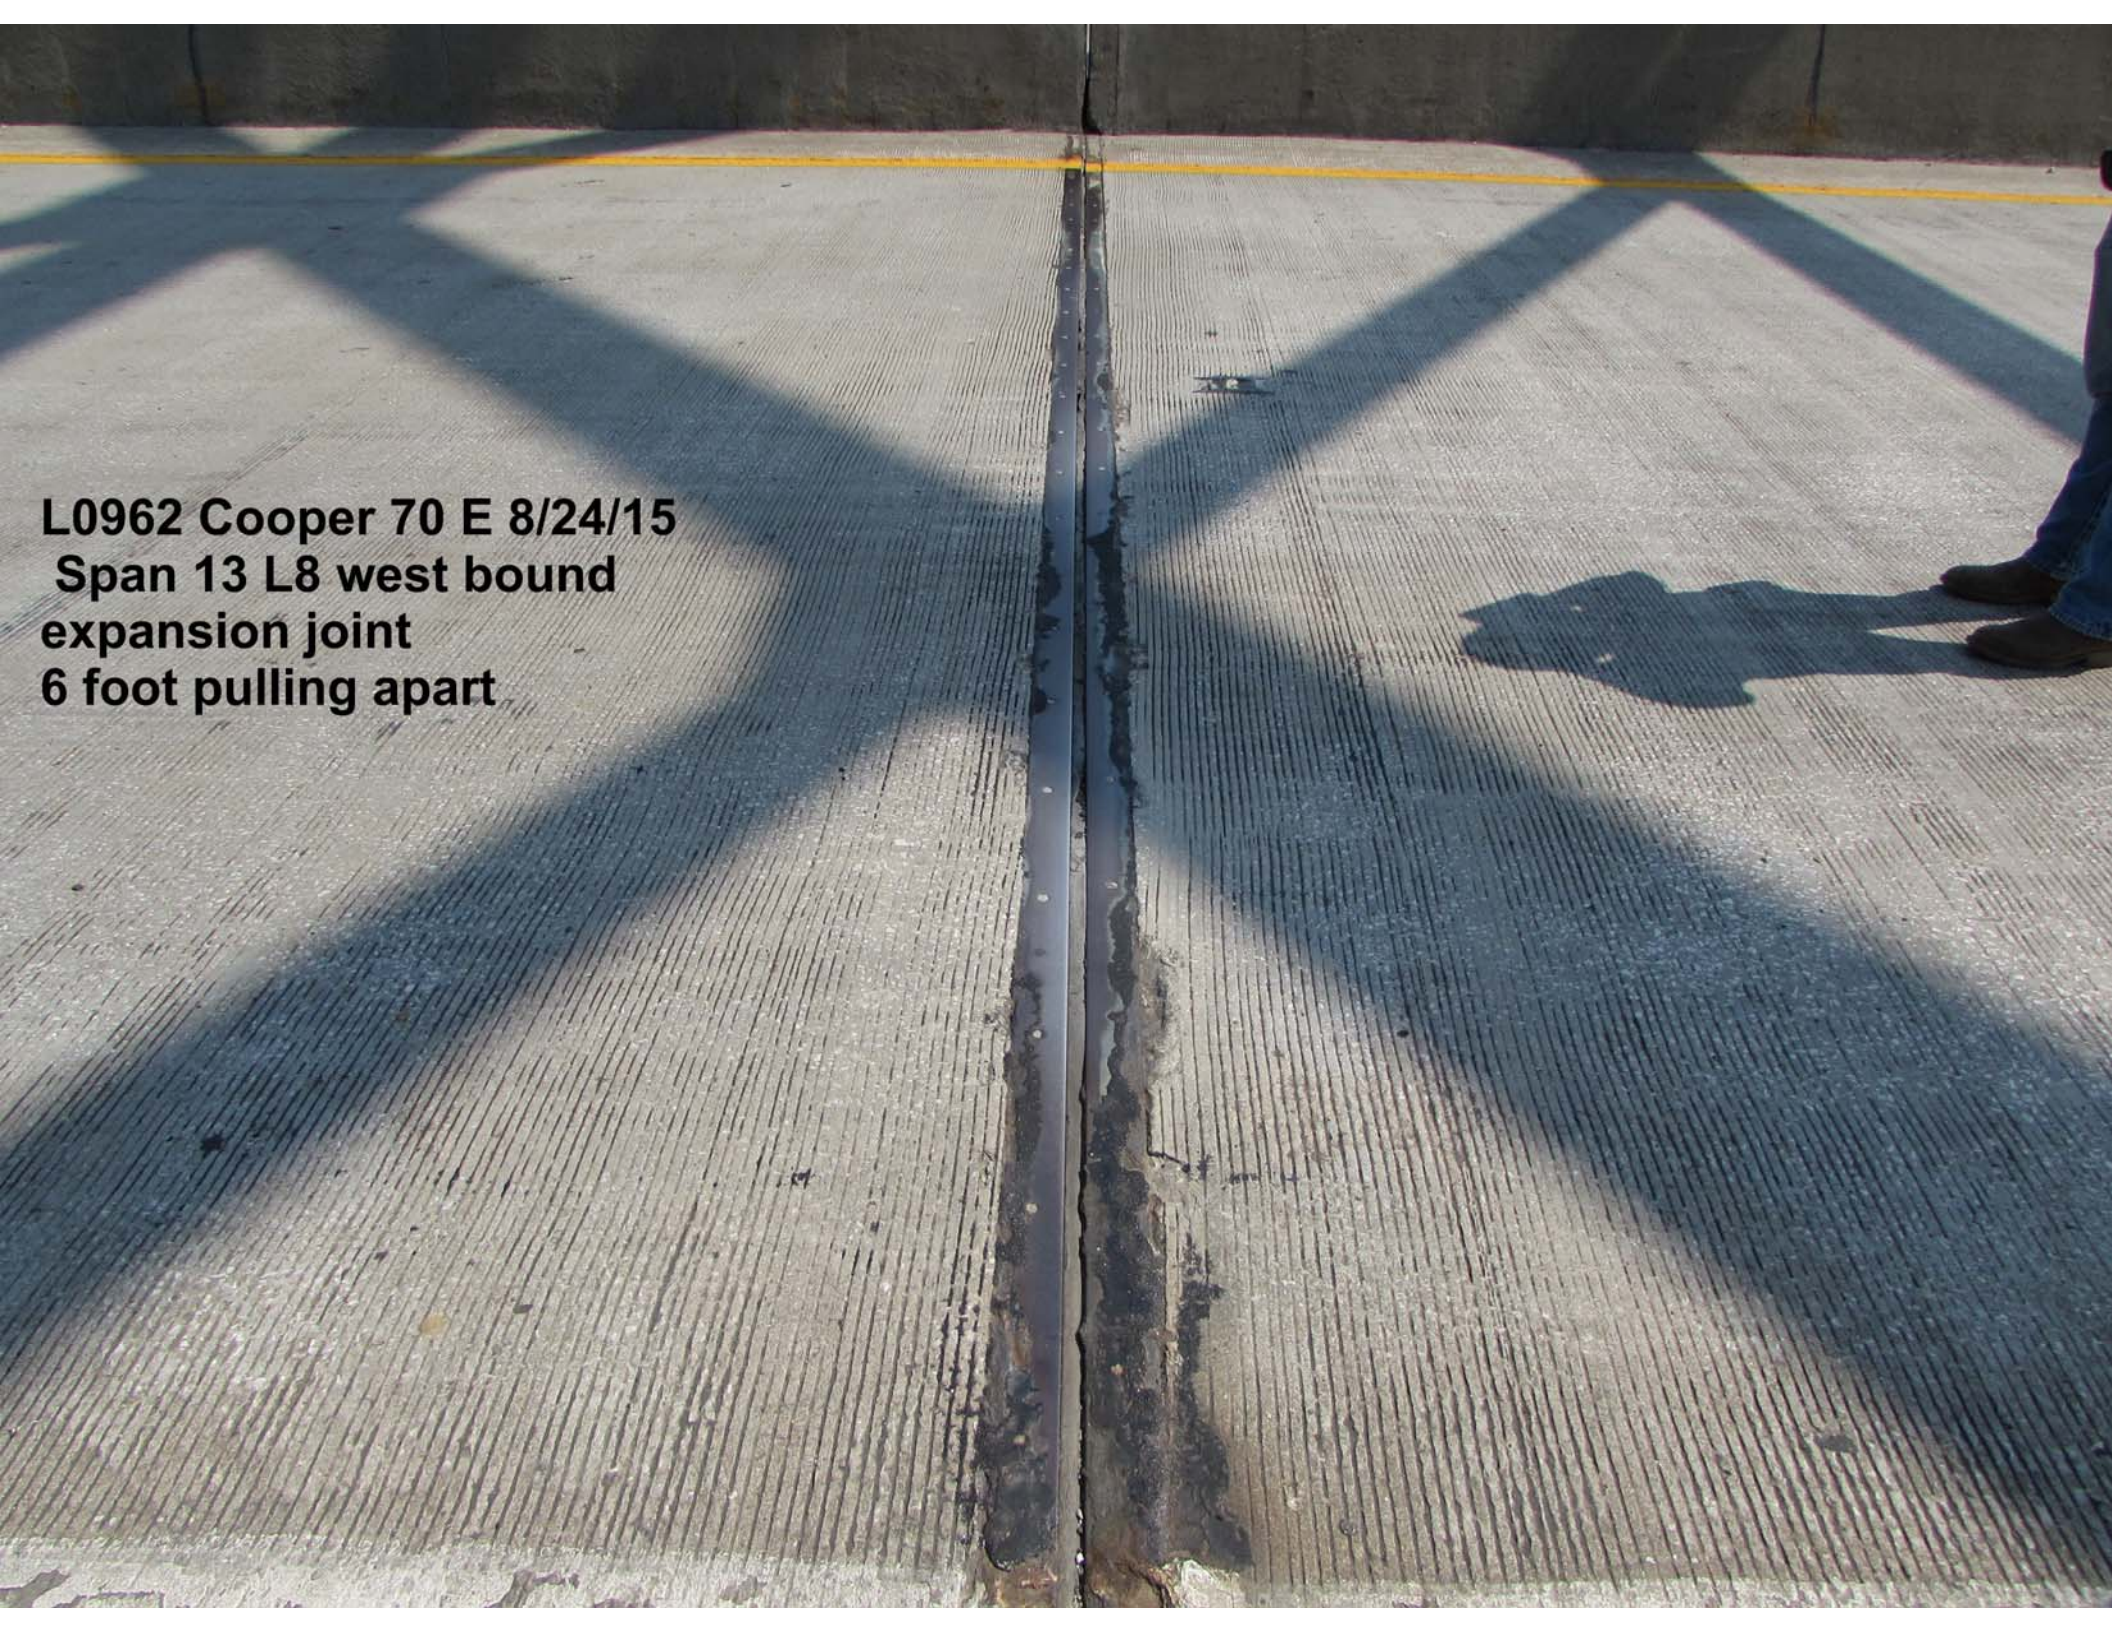
**L0962 Cooper 70 E 8/24/15**  
**Span 13 L8 west bound**  
**expansion joint**  
**6 foot pulling apart**

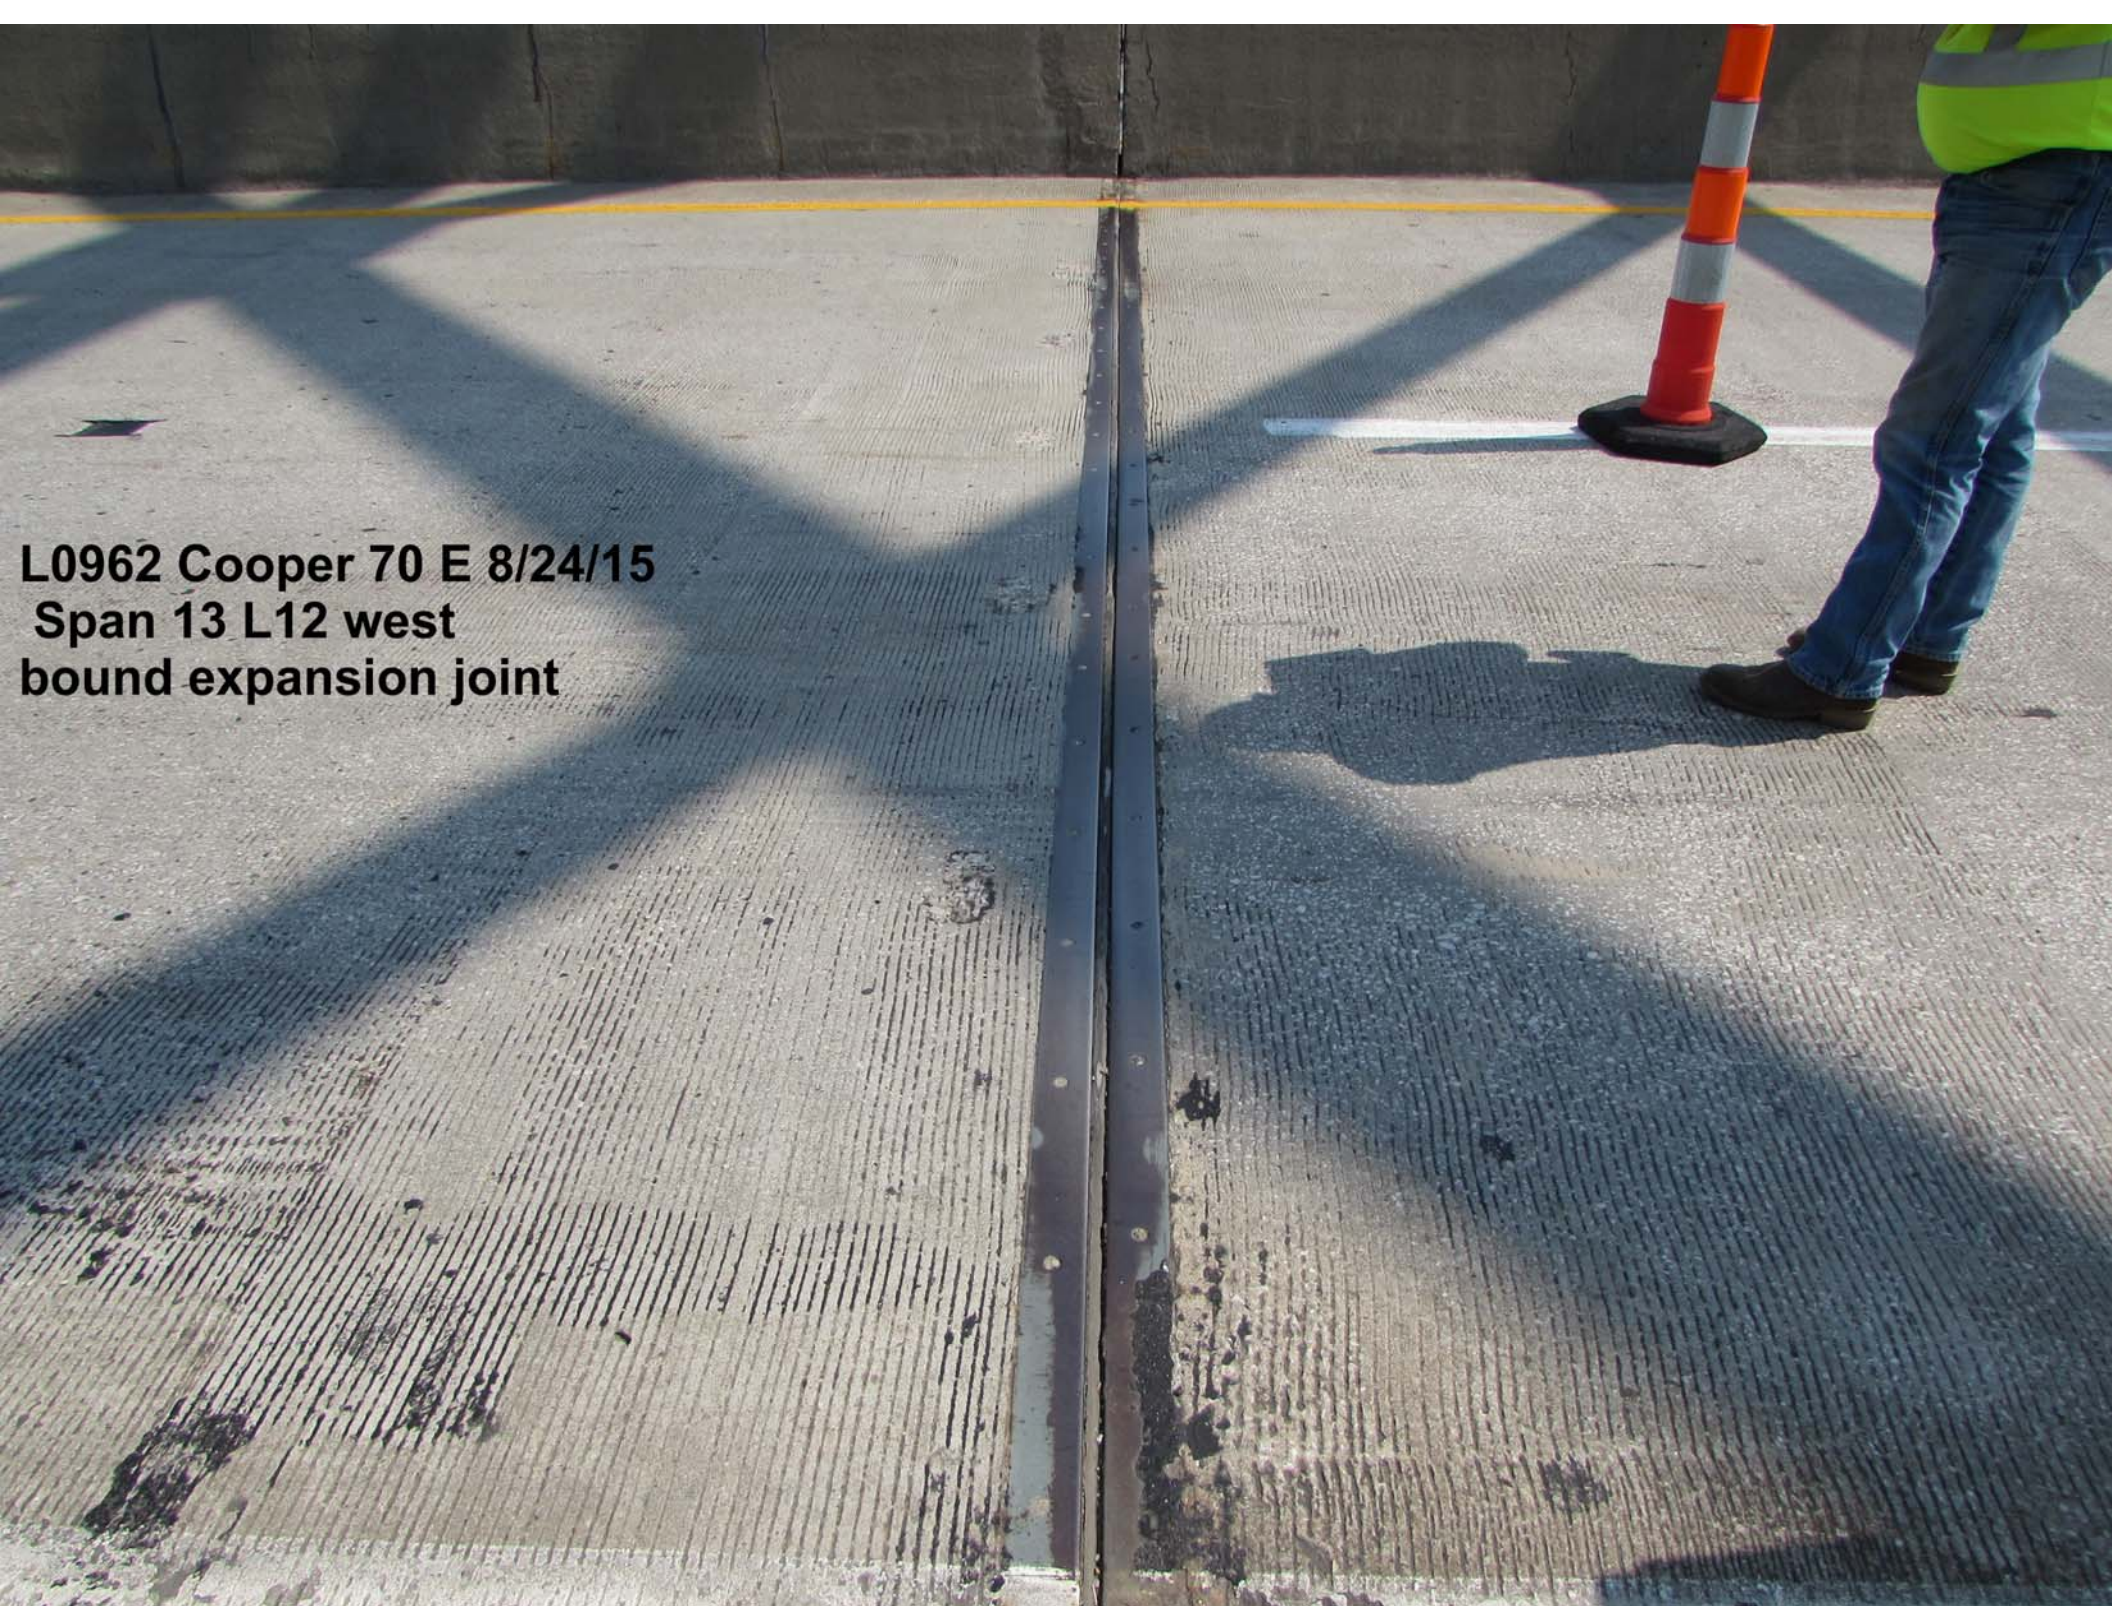
**L0962 Cooper 70 E 8/24/15**  
**Span 13 L16 west bound**  
**expansion joint 3 foot**  
**of seal falling out**

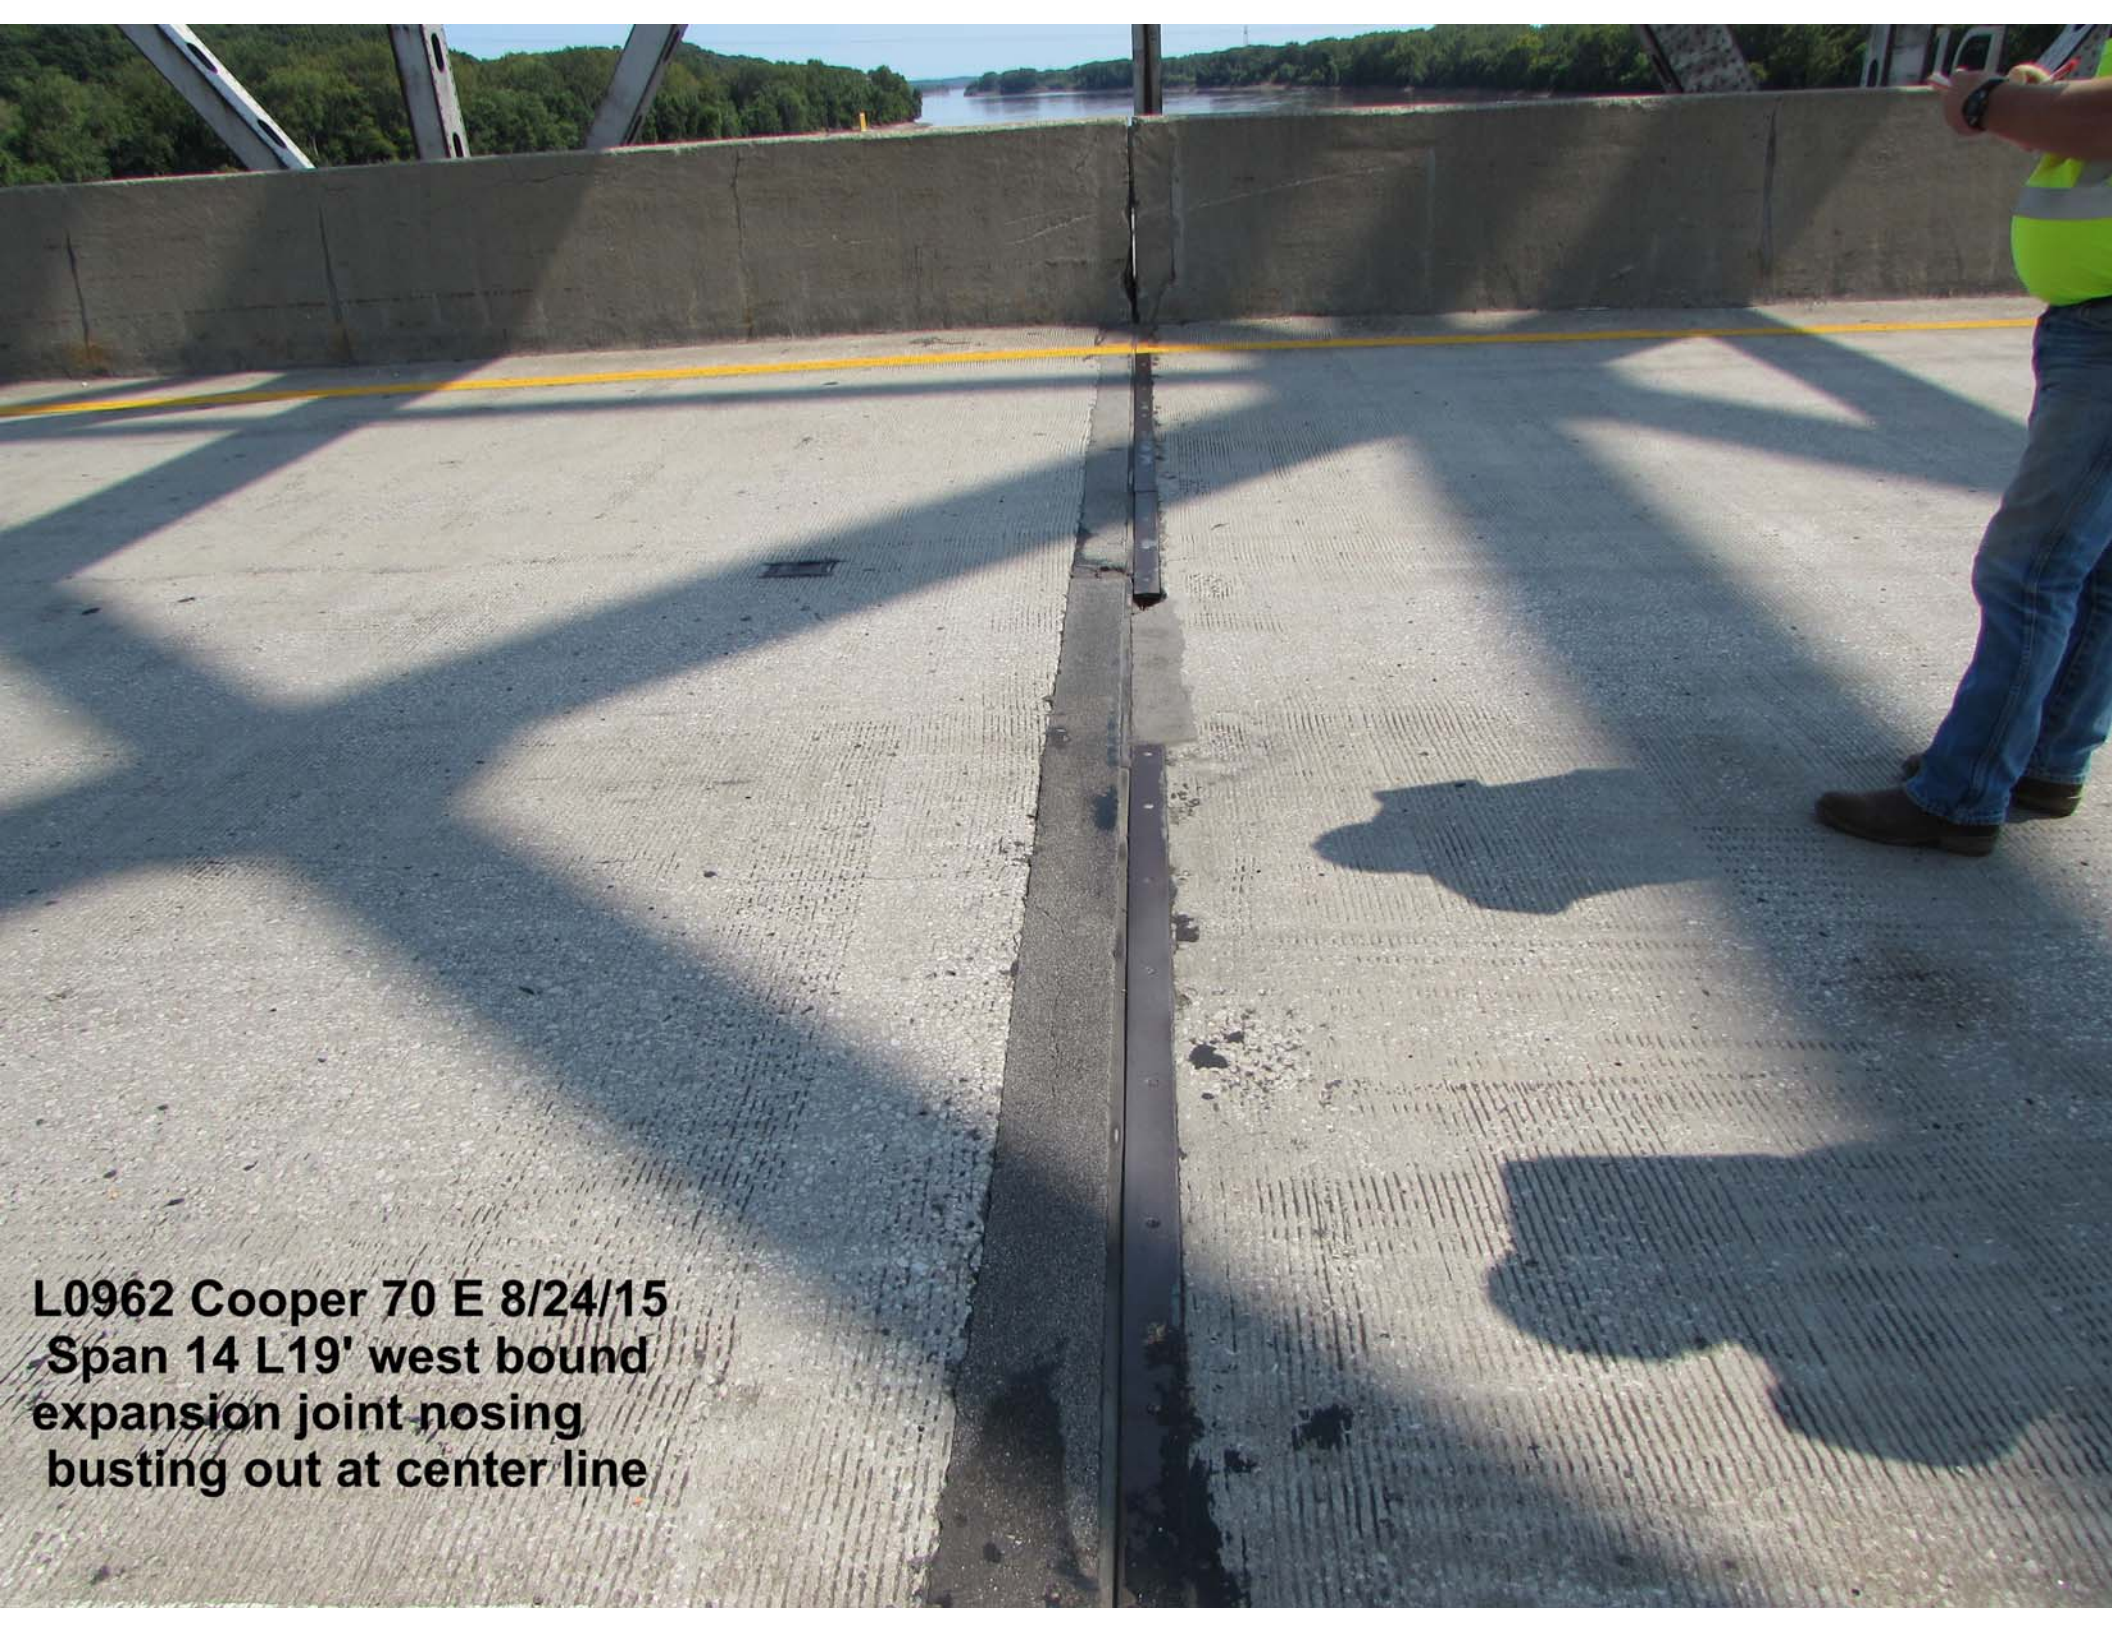
**L0962 Cooper 70 E 8/24/15**  
**Span 14 L19' west bound**  
**expansion joint nosing**  
**busting out at center line**

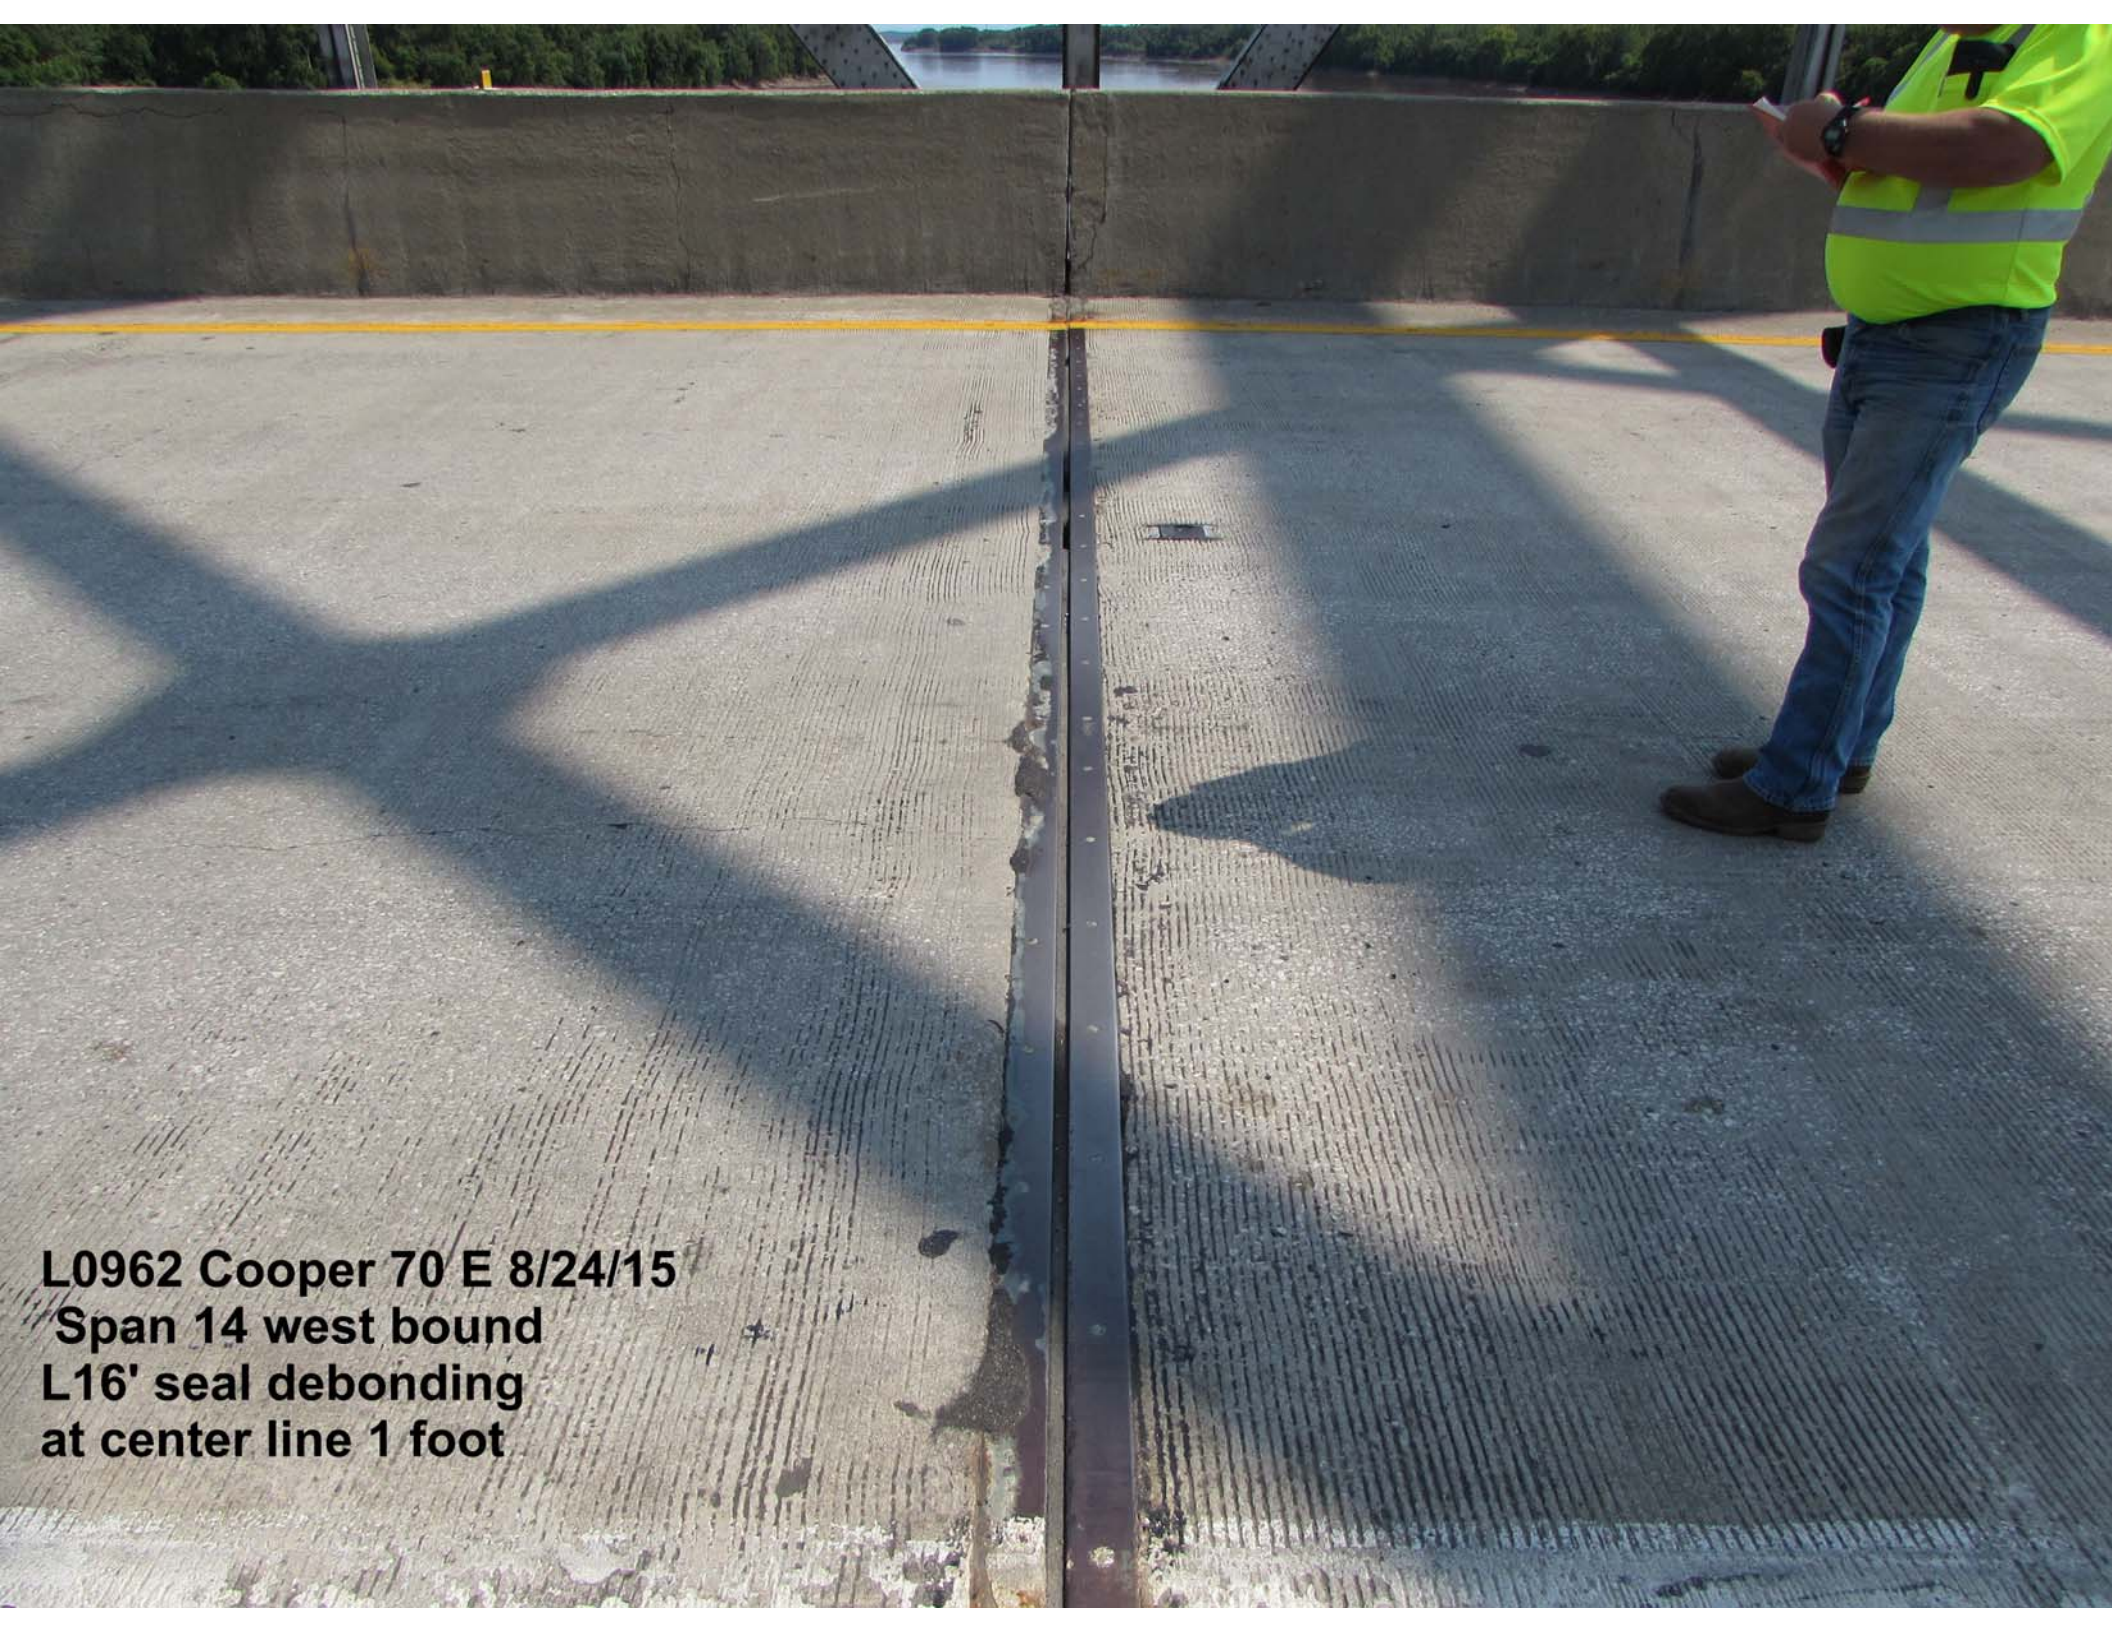
**L0962 Cooper 70 E 8/24/15**  
**Span 14 west bound**  
**L16' seal debonding**  
**at center line 1 foot**
