L0962 I 70 Cooper Co.  
Joint at L8, span 13  
Eastbound lane failing  
9-24-13

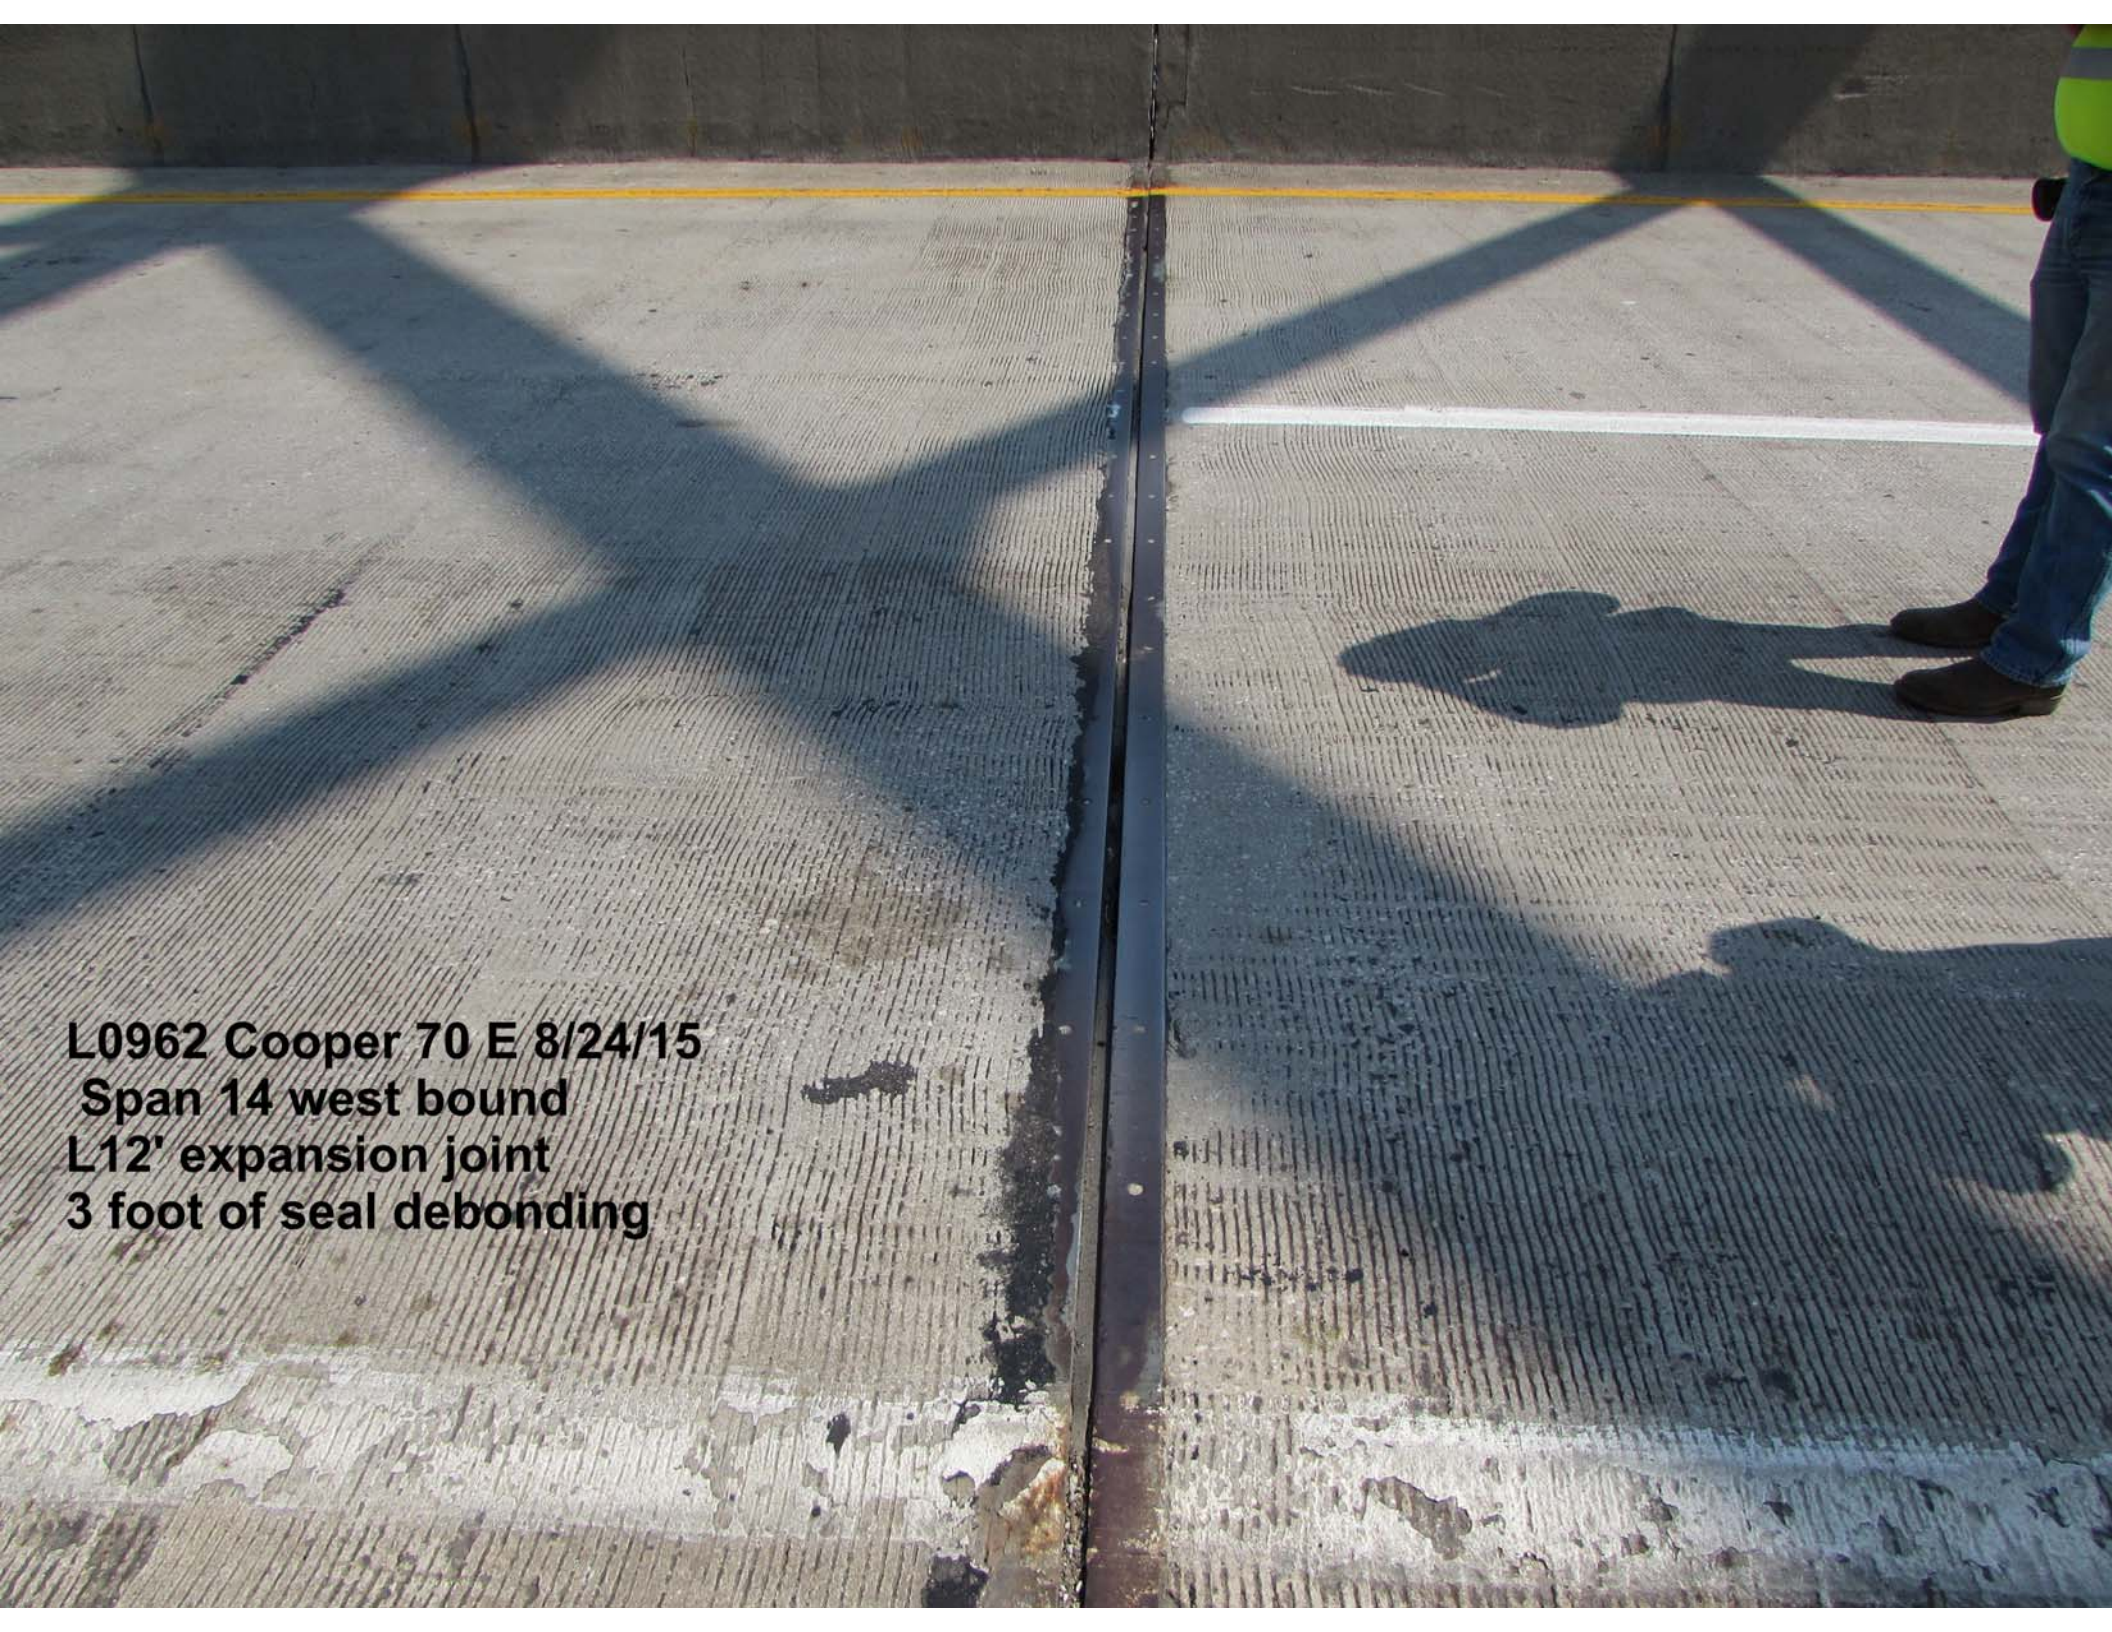
L0962 Cooper 70 E 8/24/15  
Span 14 west bound  
L12' expansion joint  
3 foot of seal debonding

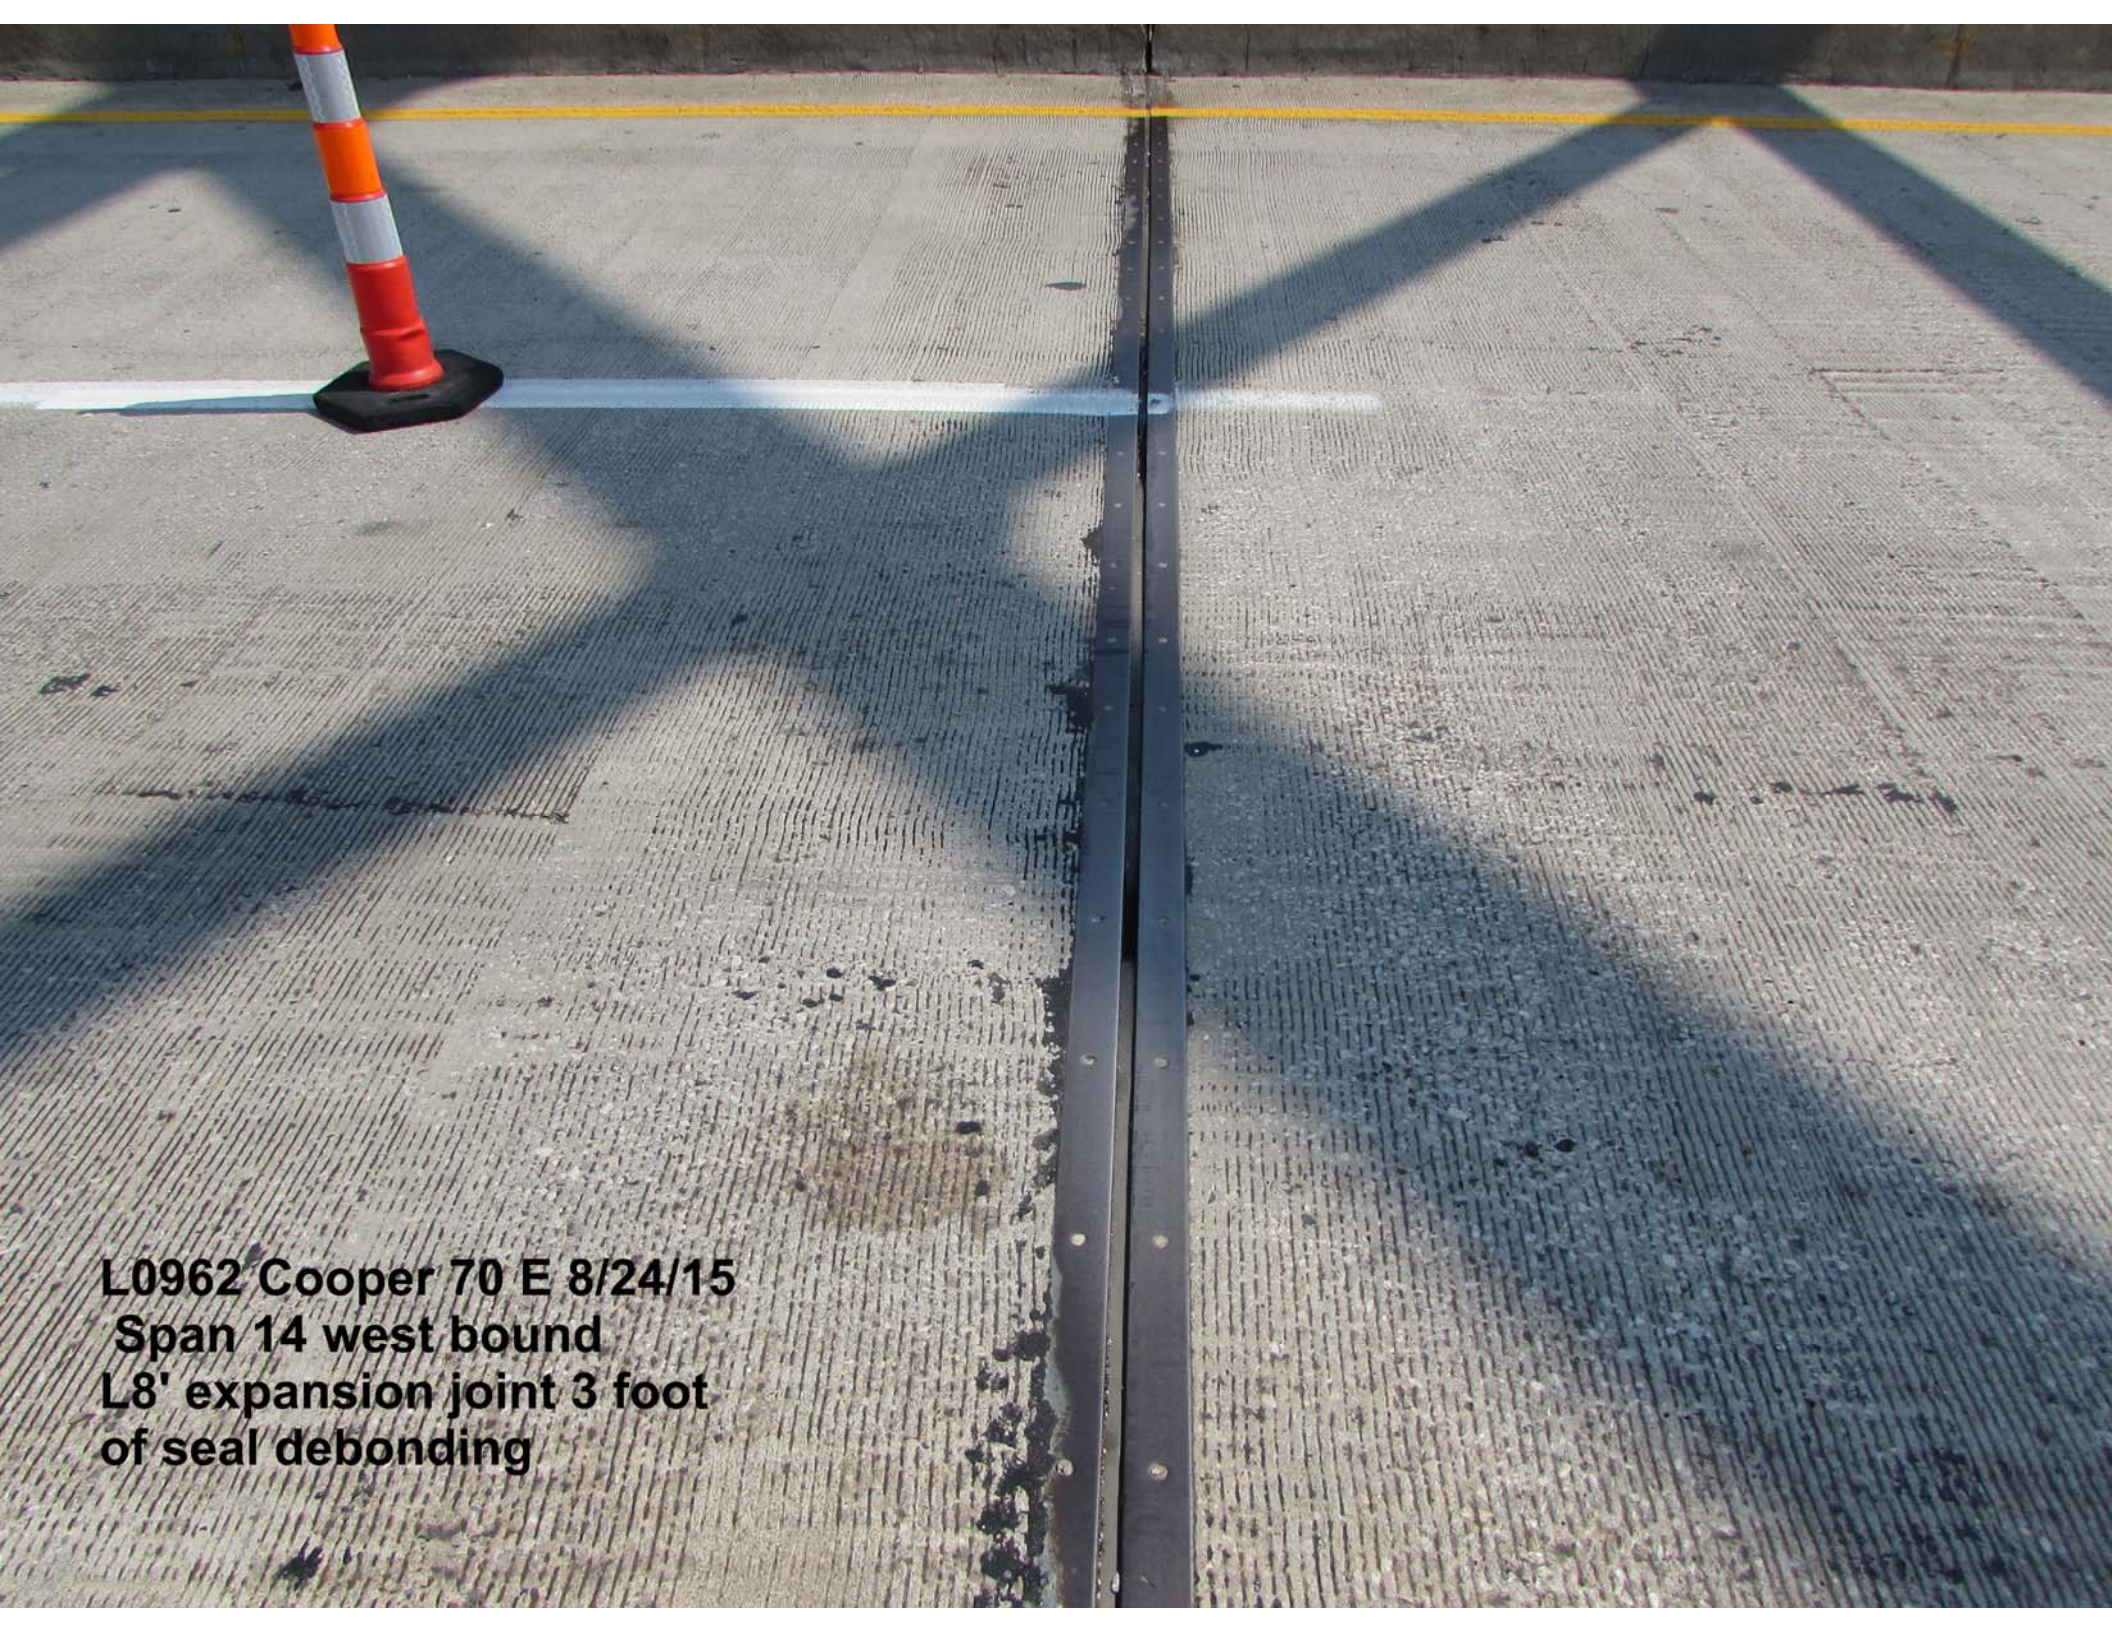
L0962 Cooper 70 E 8/24/15  
Span 14 west bound  
L8' expansion joint 3 foot  
of seal debonding

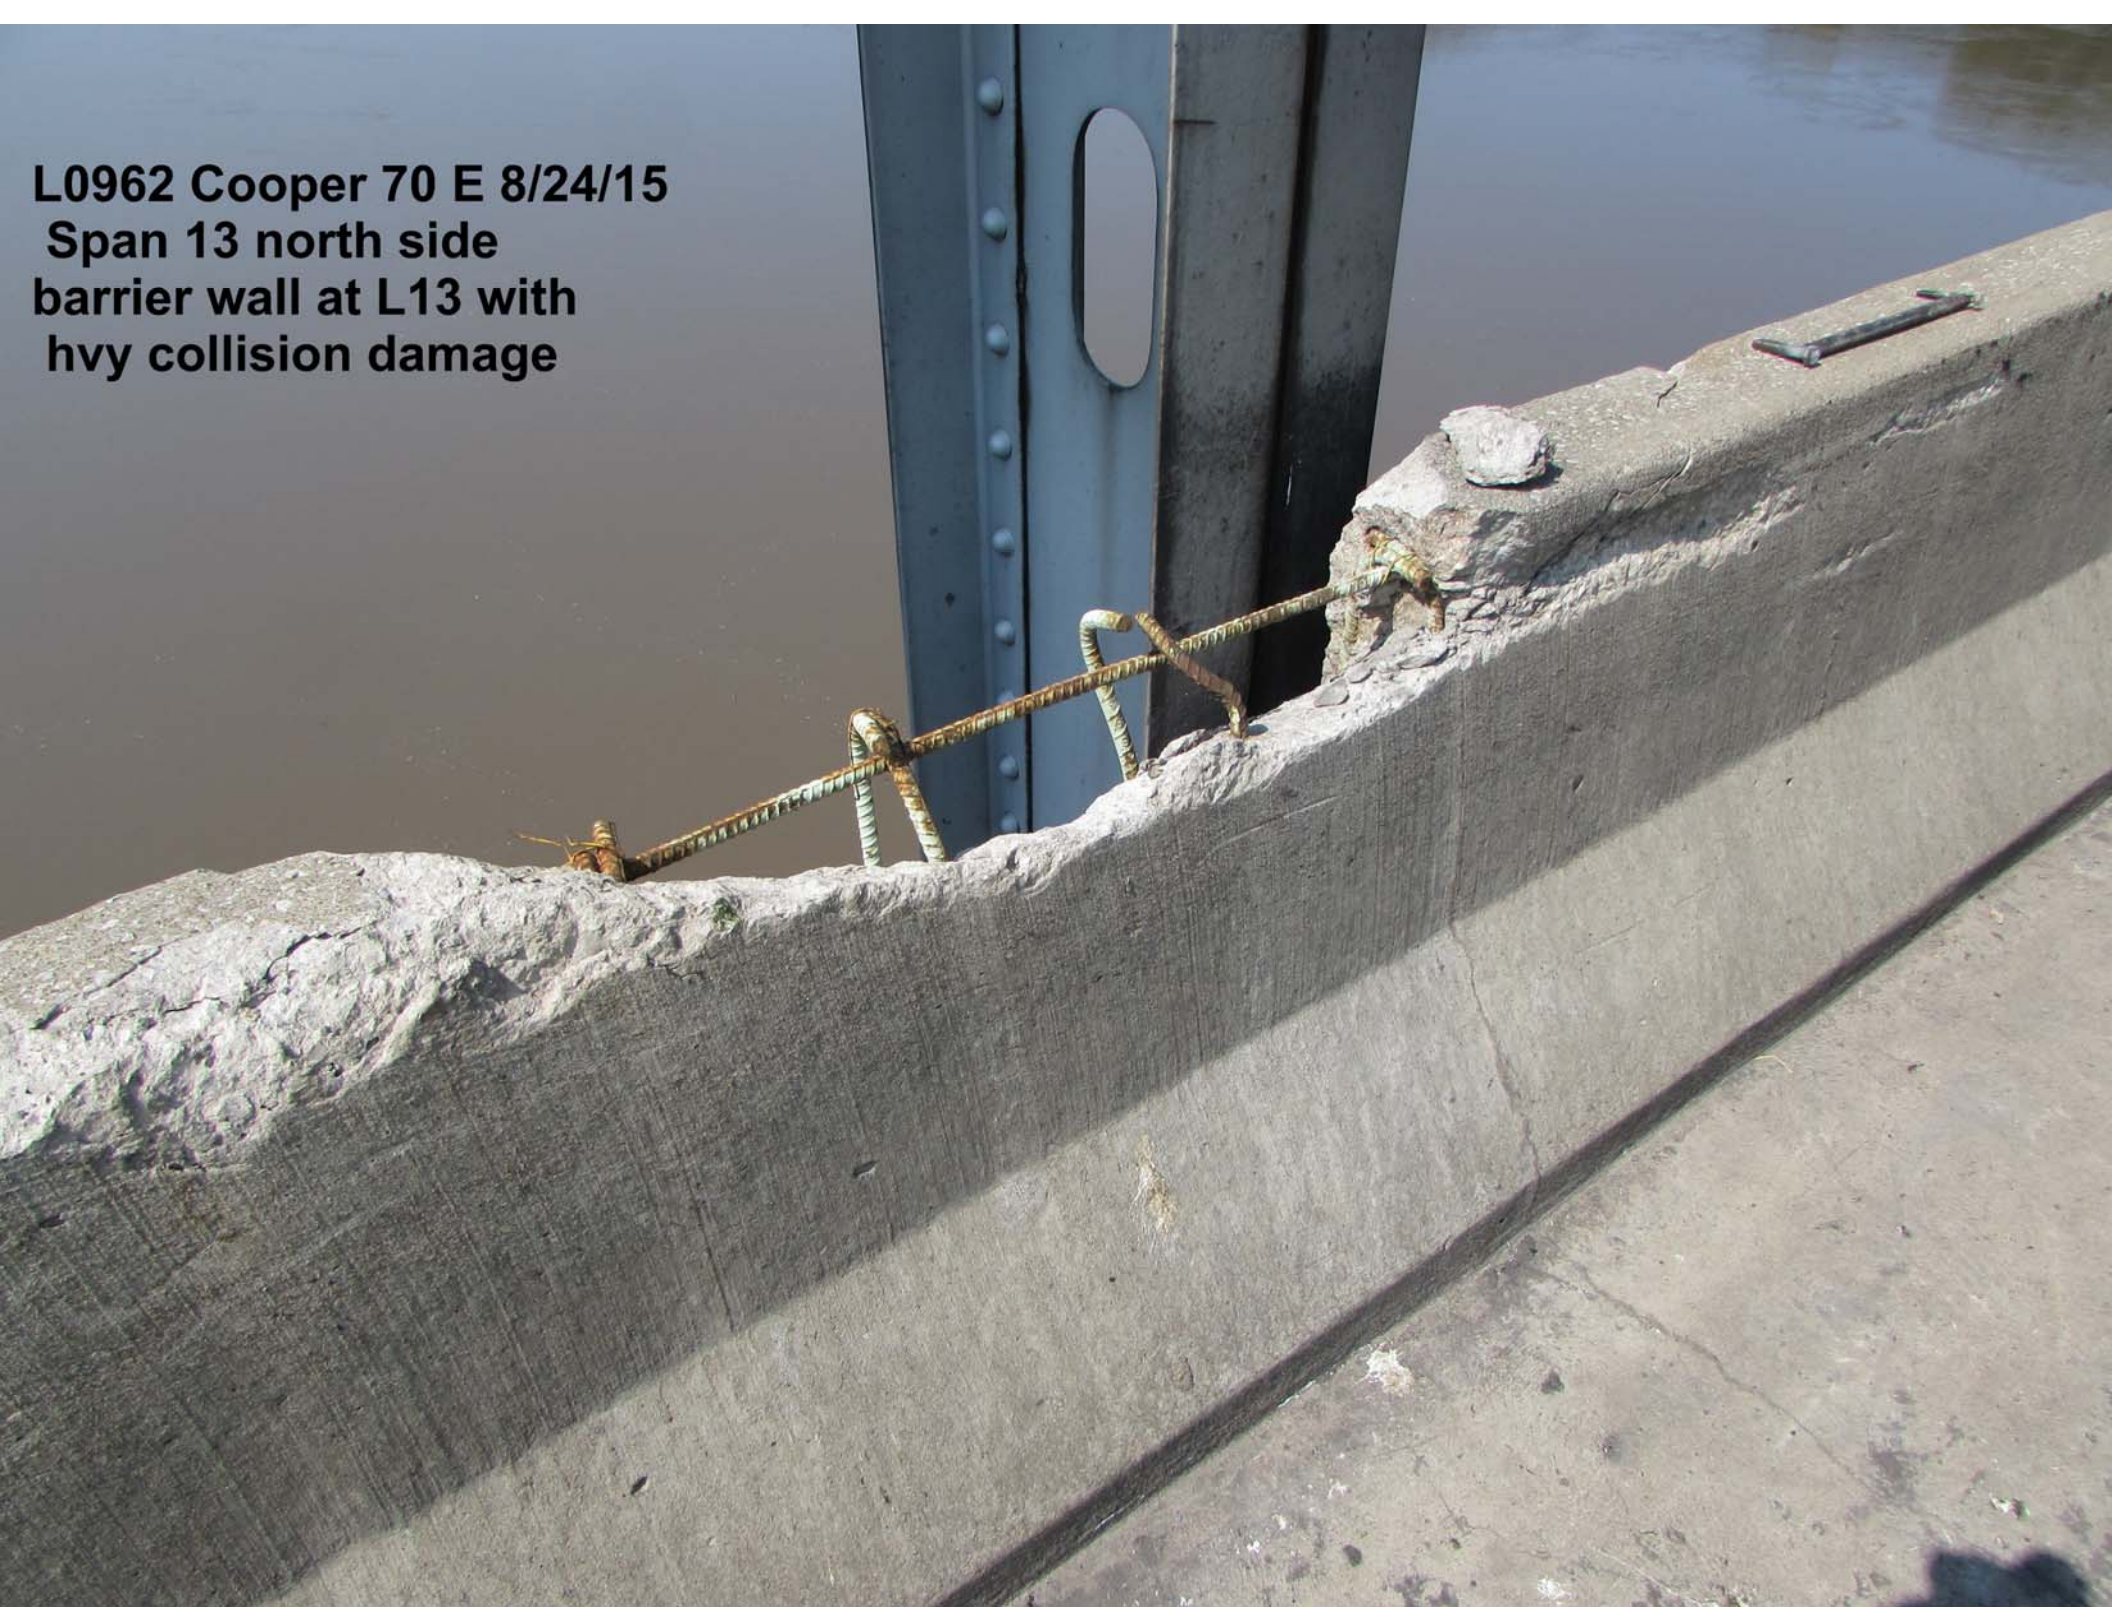
**L0962 Cooper 70 9/9/15**  
**Span 13 minor distortion**  
**to top gusset plate VT**  
**right side east side**

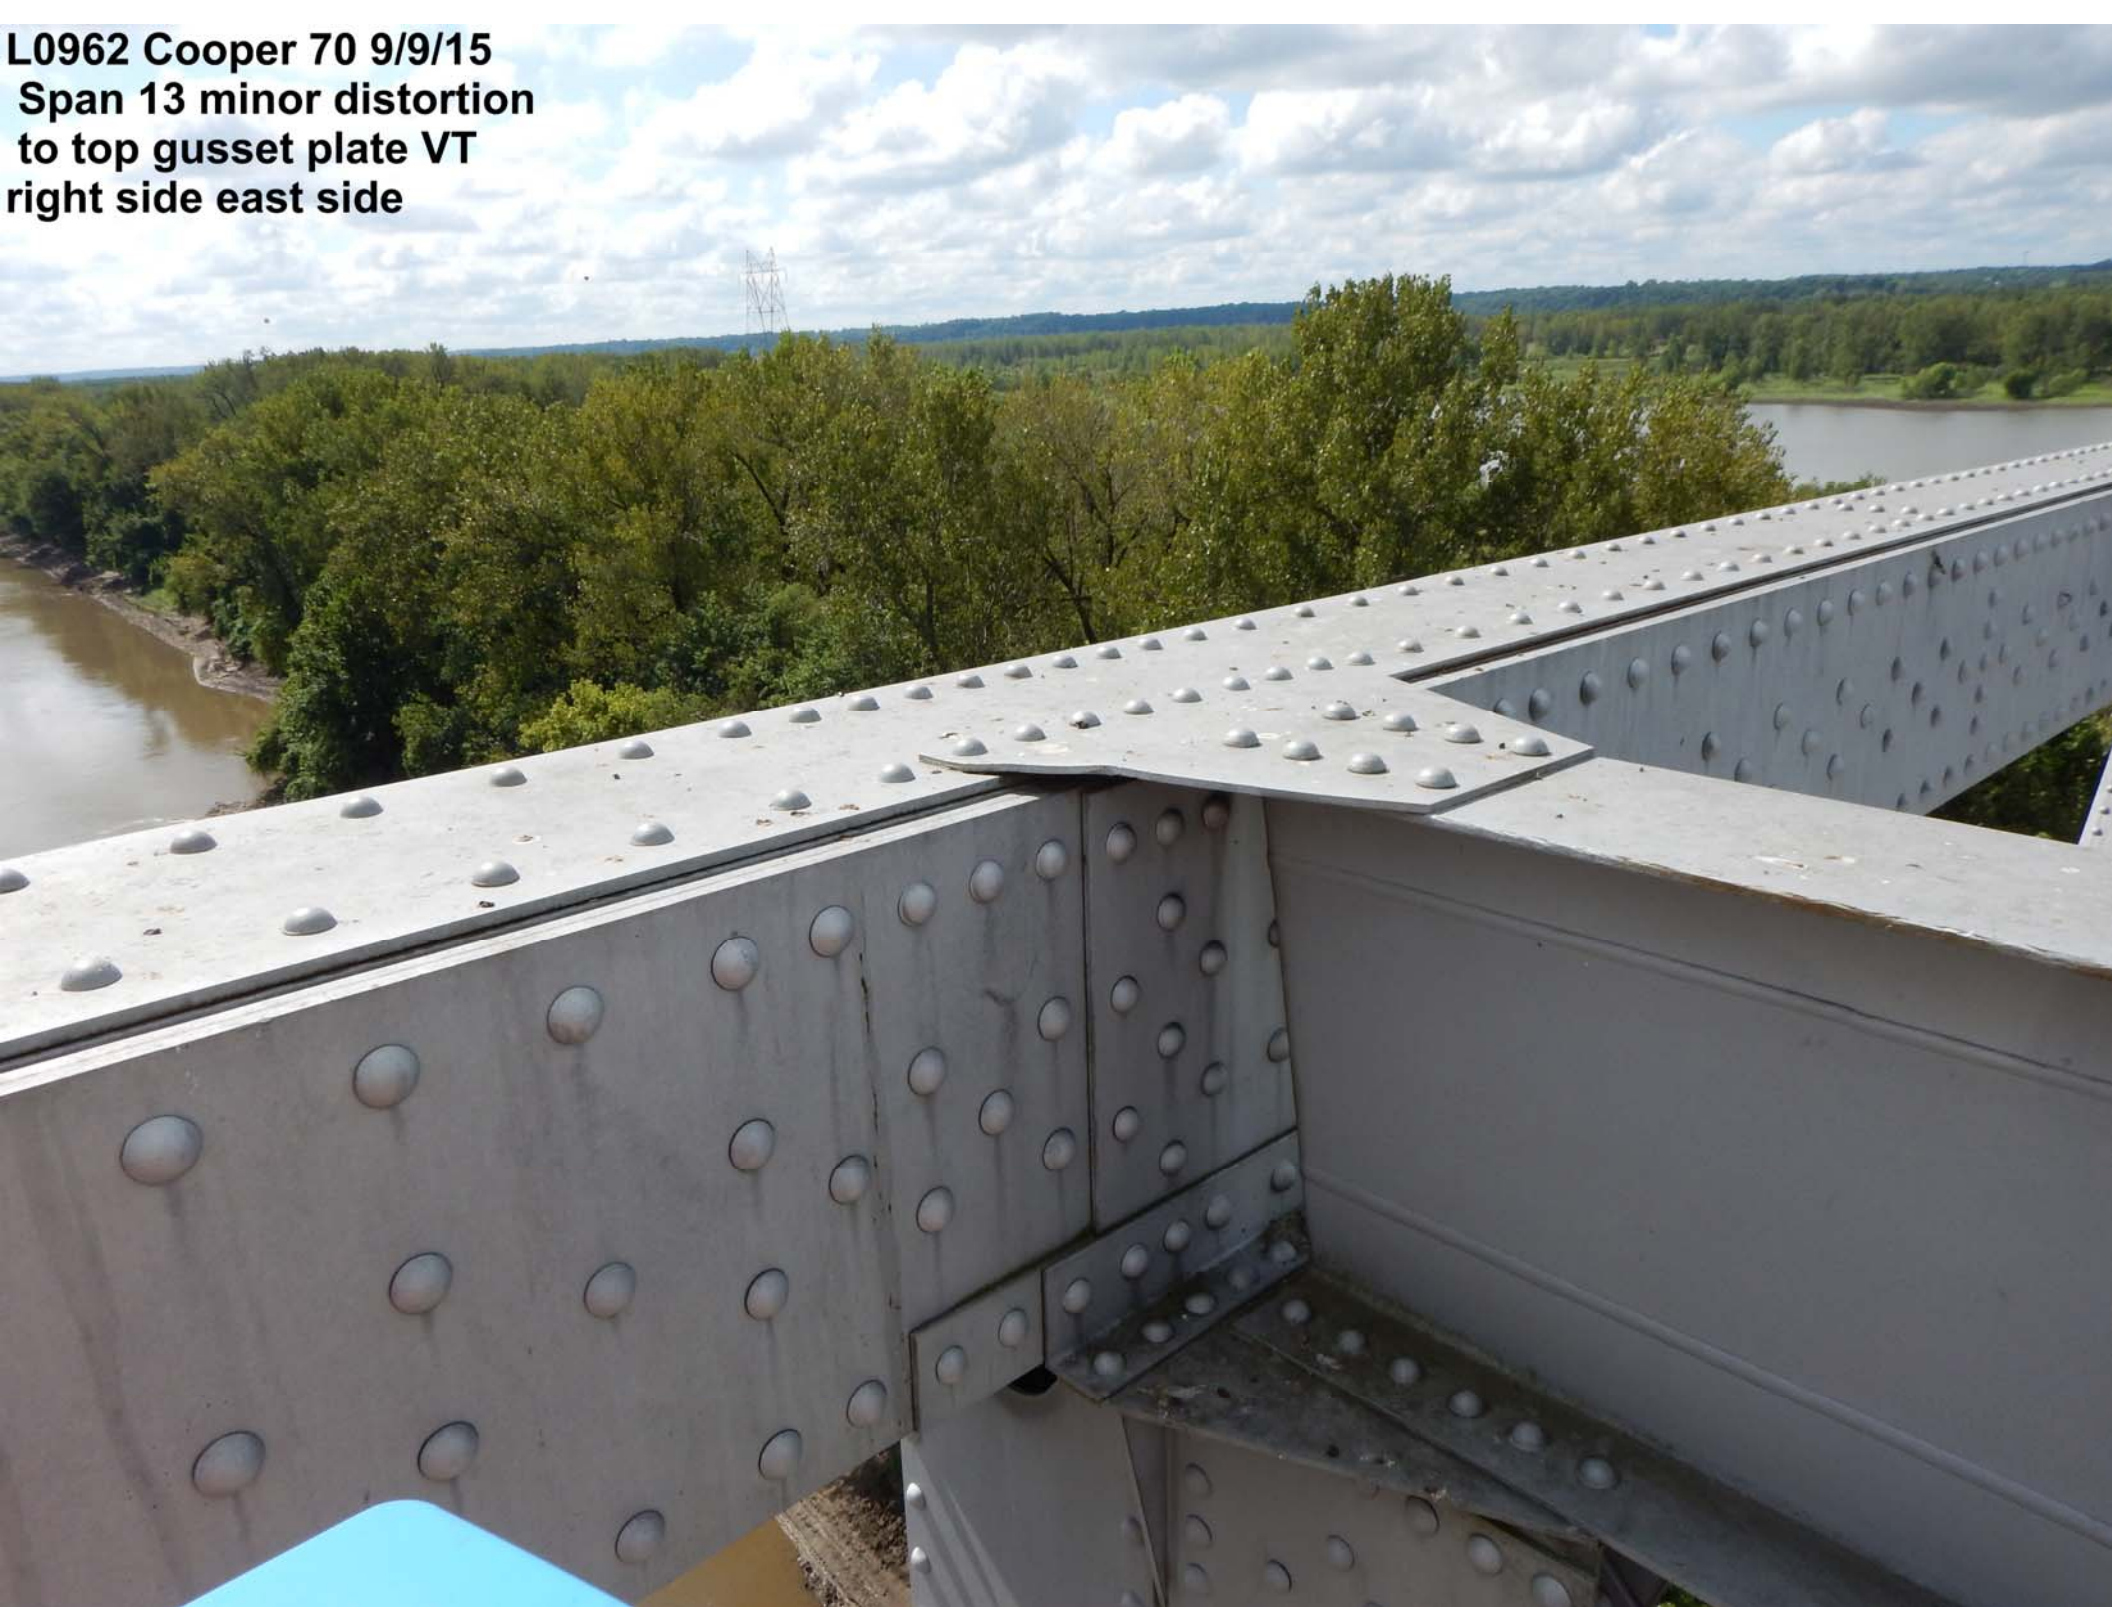
L0962 Cooper 70 9/9/15  
Span 13 paint fading  
at L10M9R on box  
beam above curb line

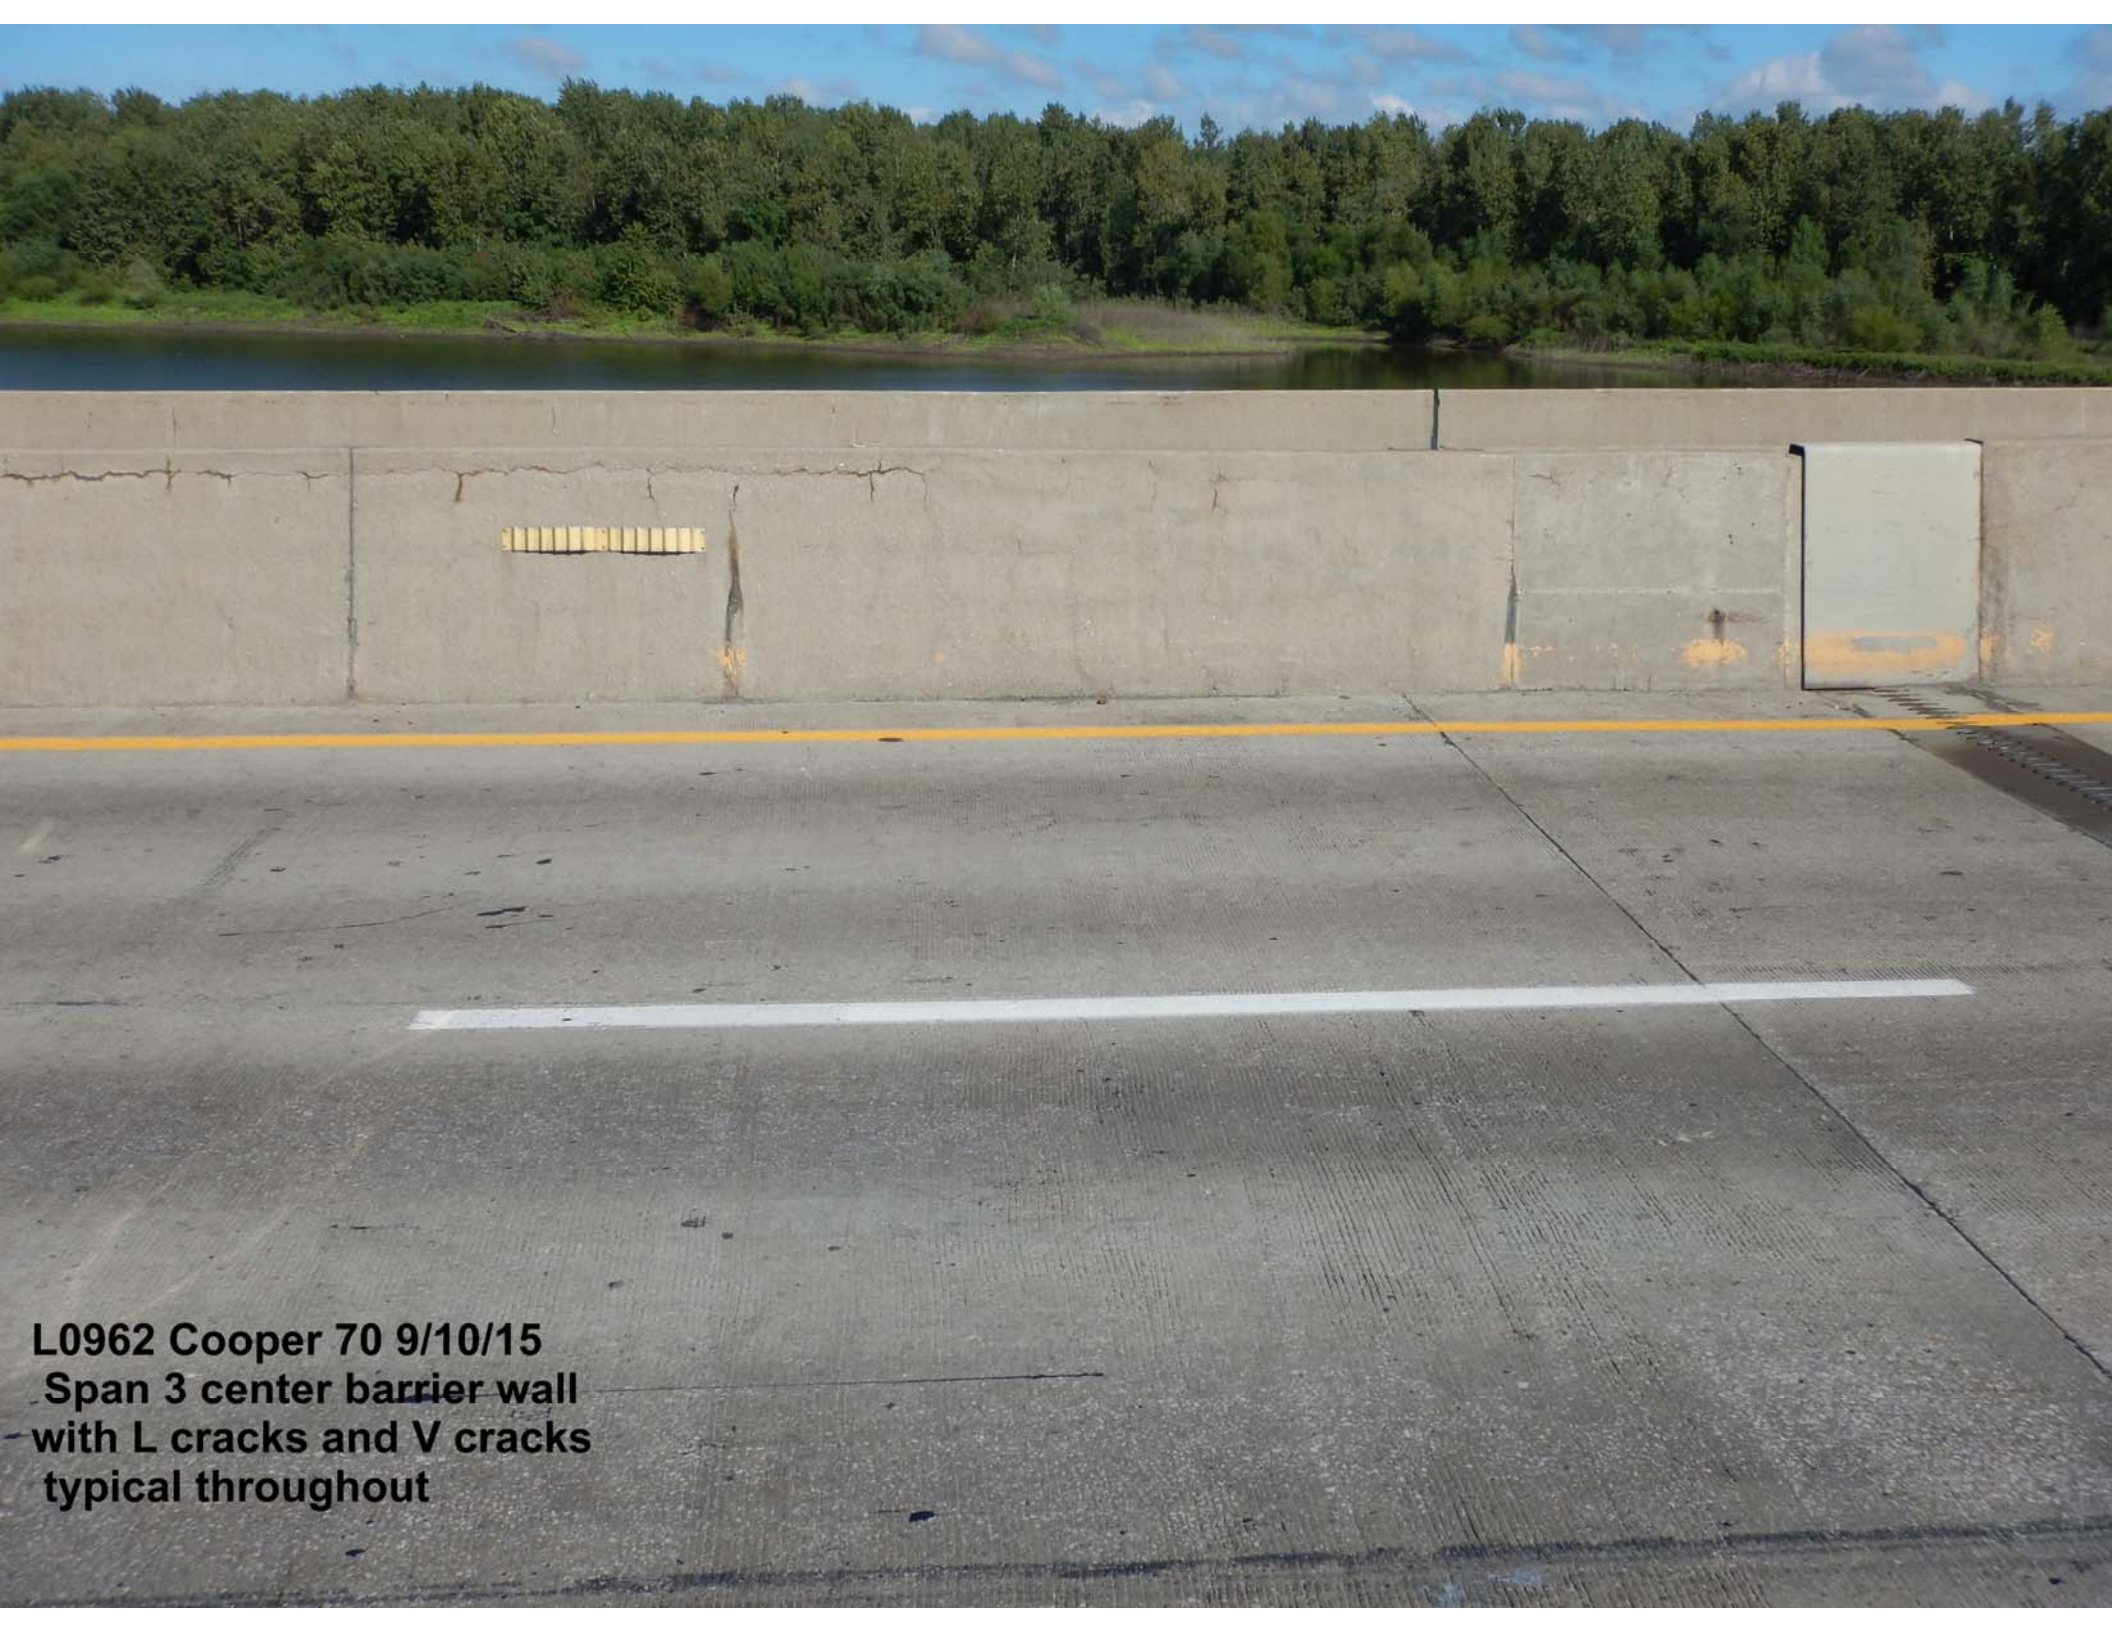
**L0962 Cooper 70 9/10/15**  
**Span 3 center barrier wall**  
**with L cracks and V cracks**  
**typical throughout**

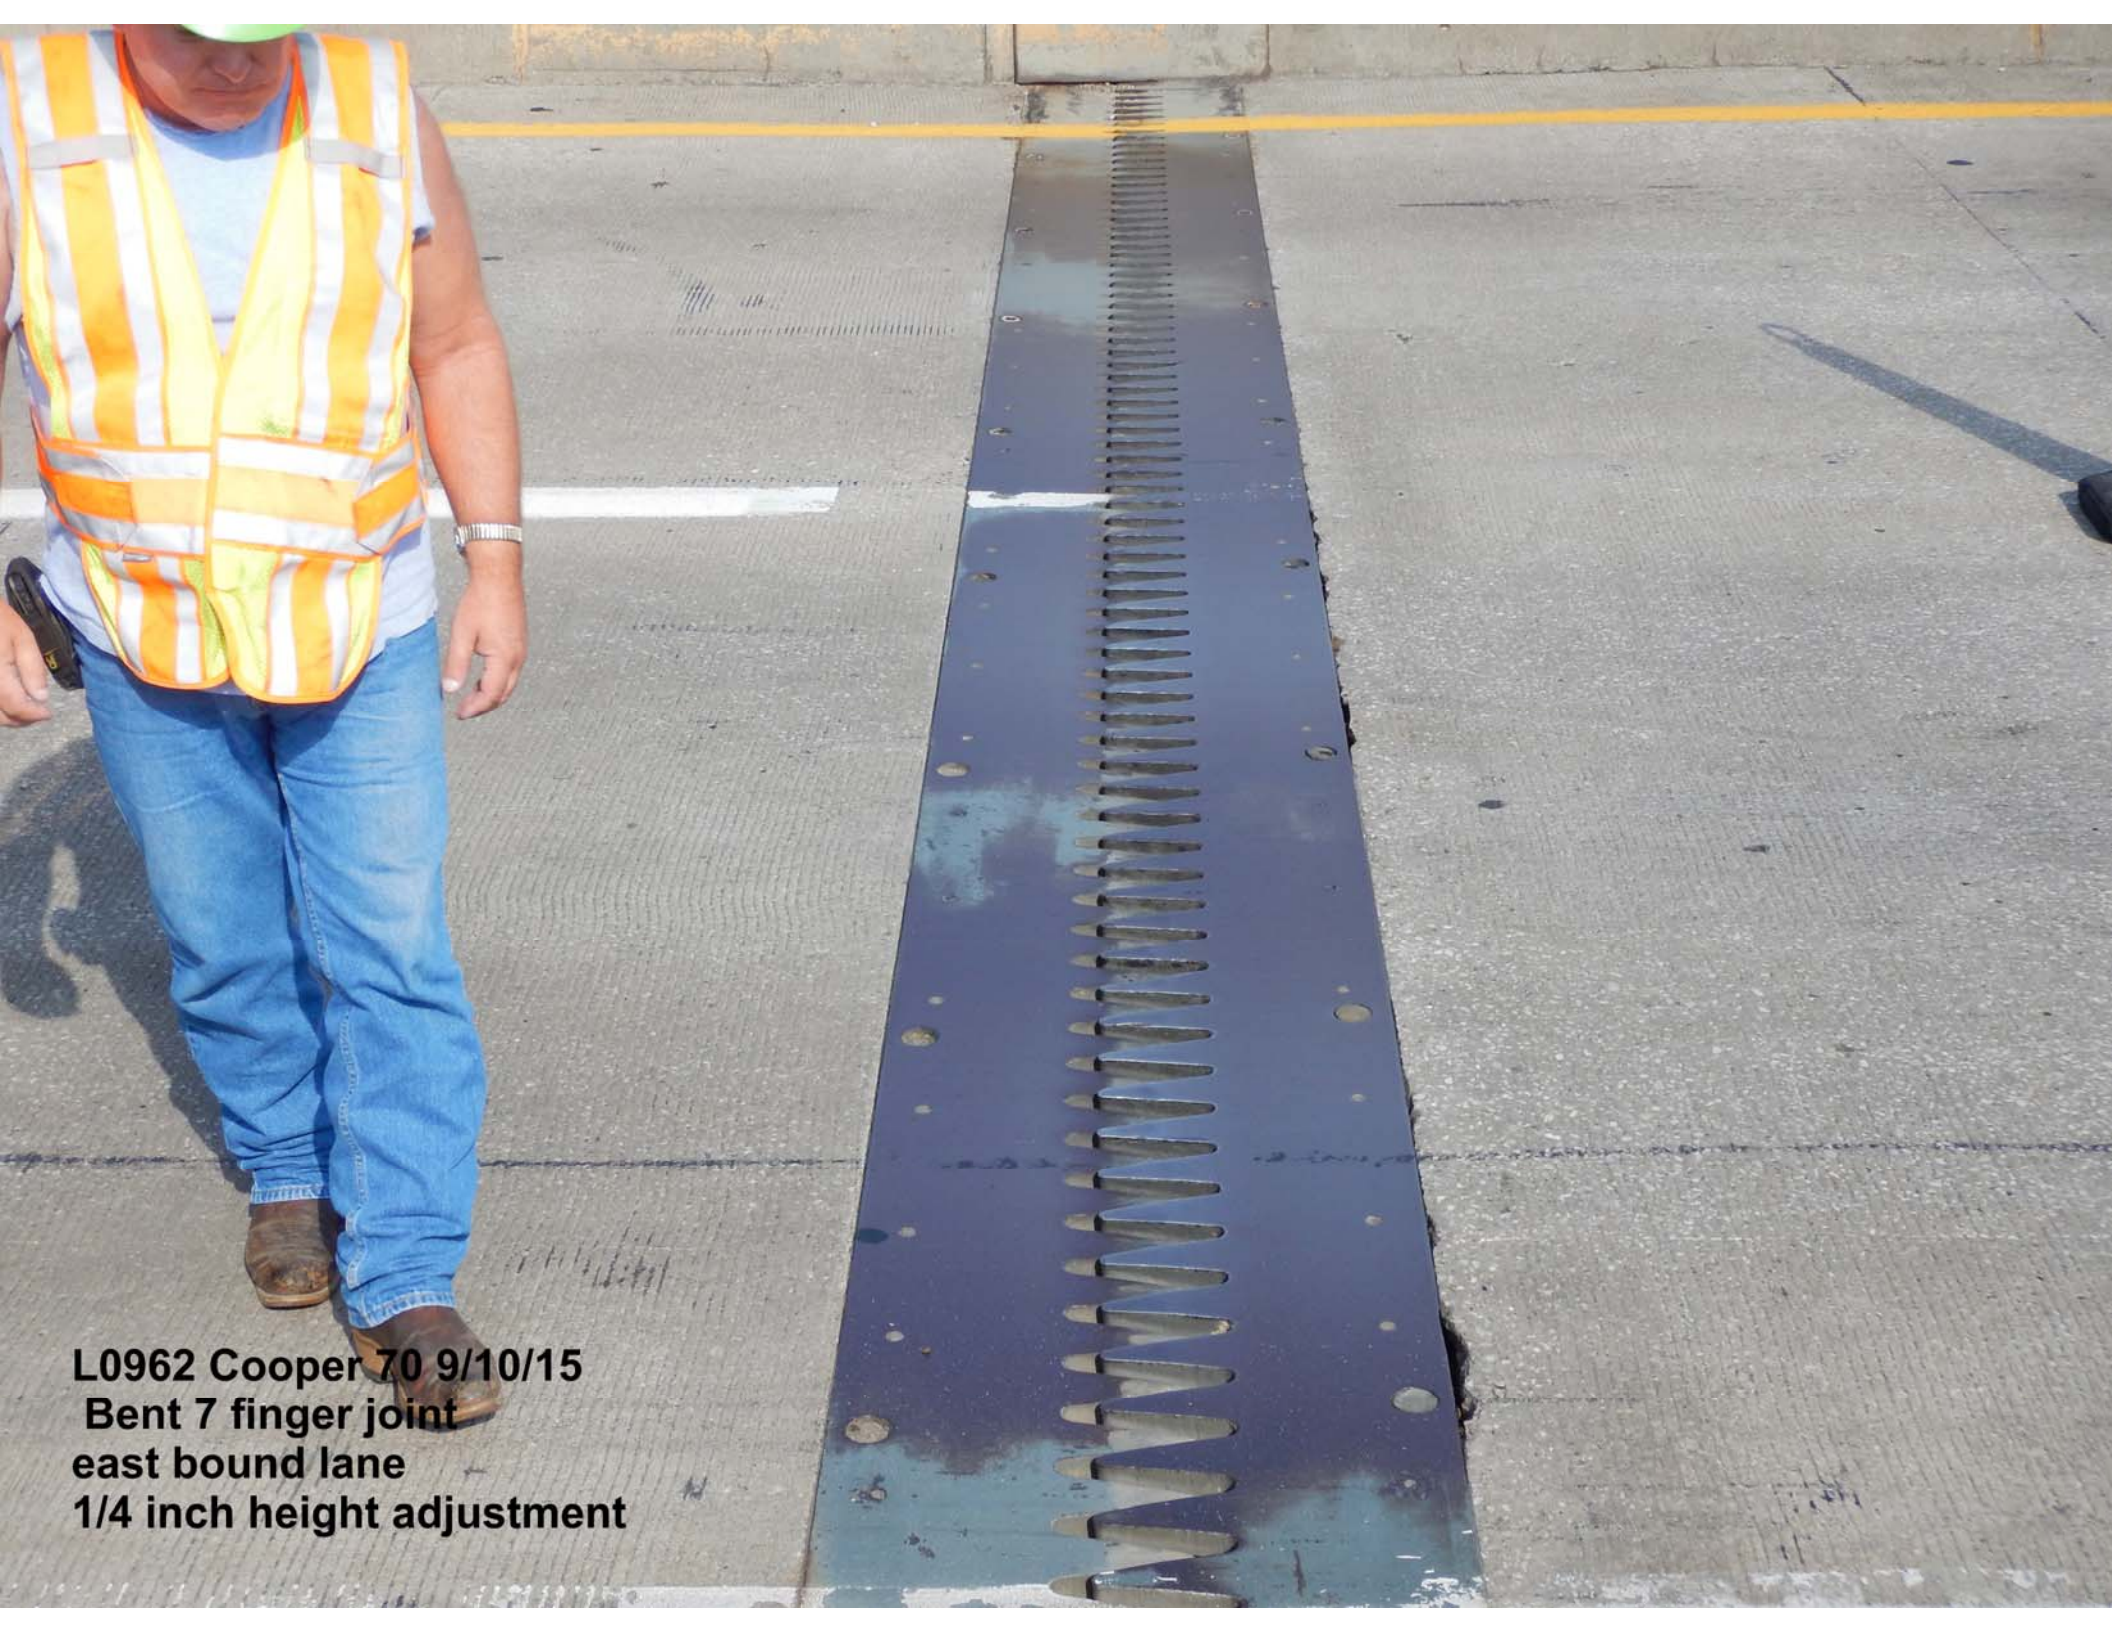
**L0962 Cooper 70 9/10/15**  
**Bent 7 finger joint**  
**east bound lane**  
**1/4 inch height adjustment**
