L0962 I 70 Cooper Co.  
Joint at L8, span 13  
Eastbound lane failing  
9-24-13

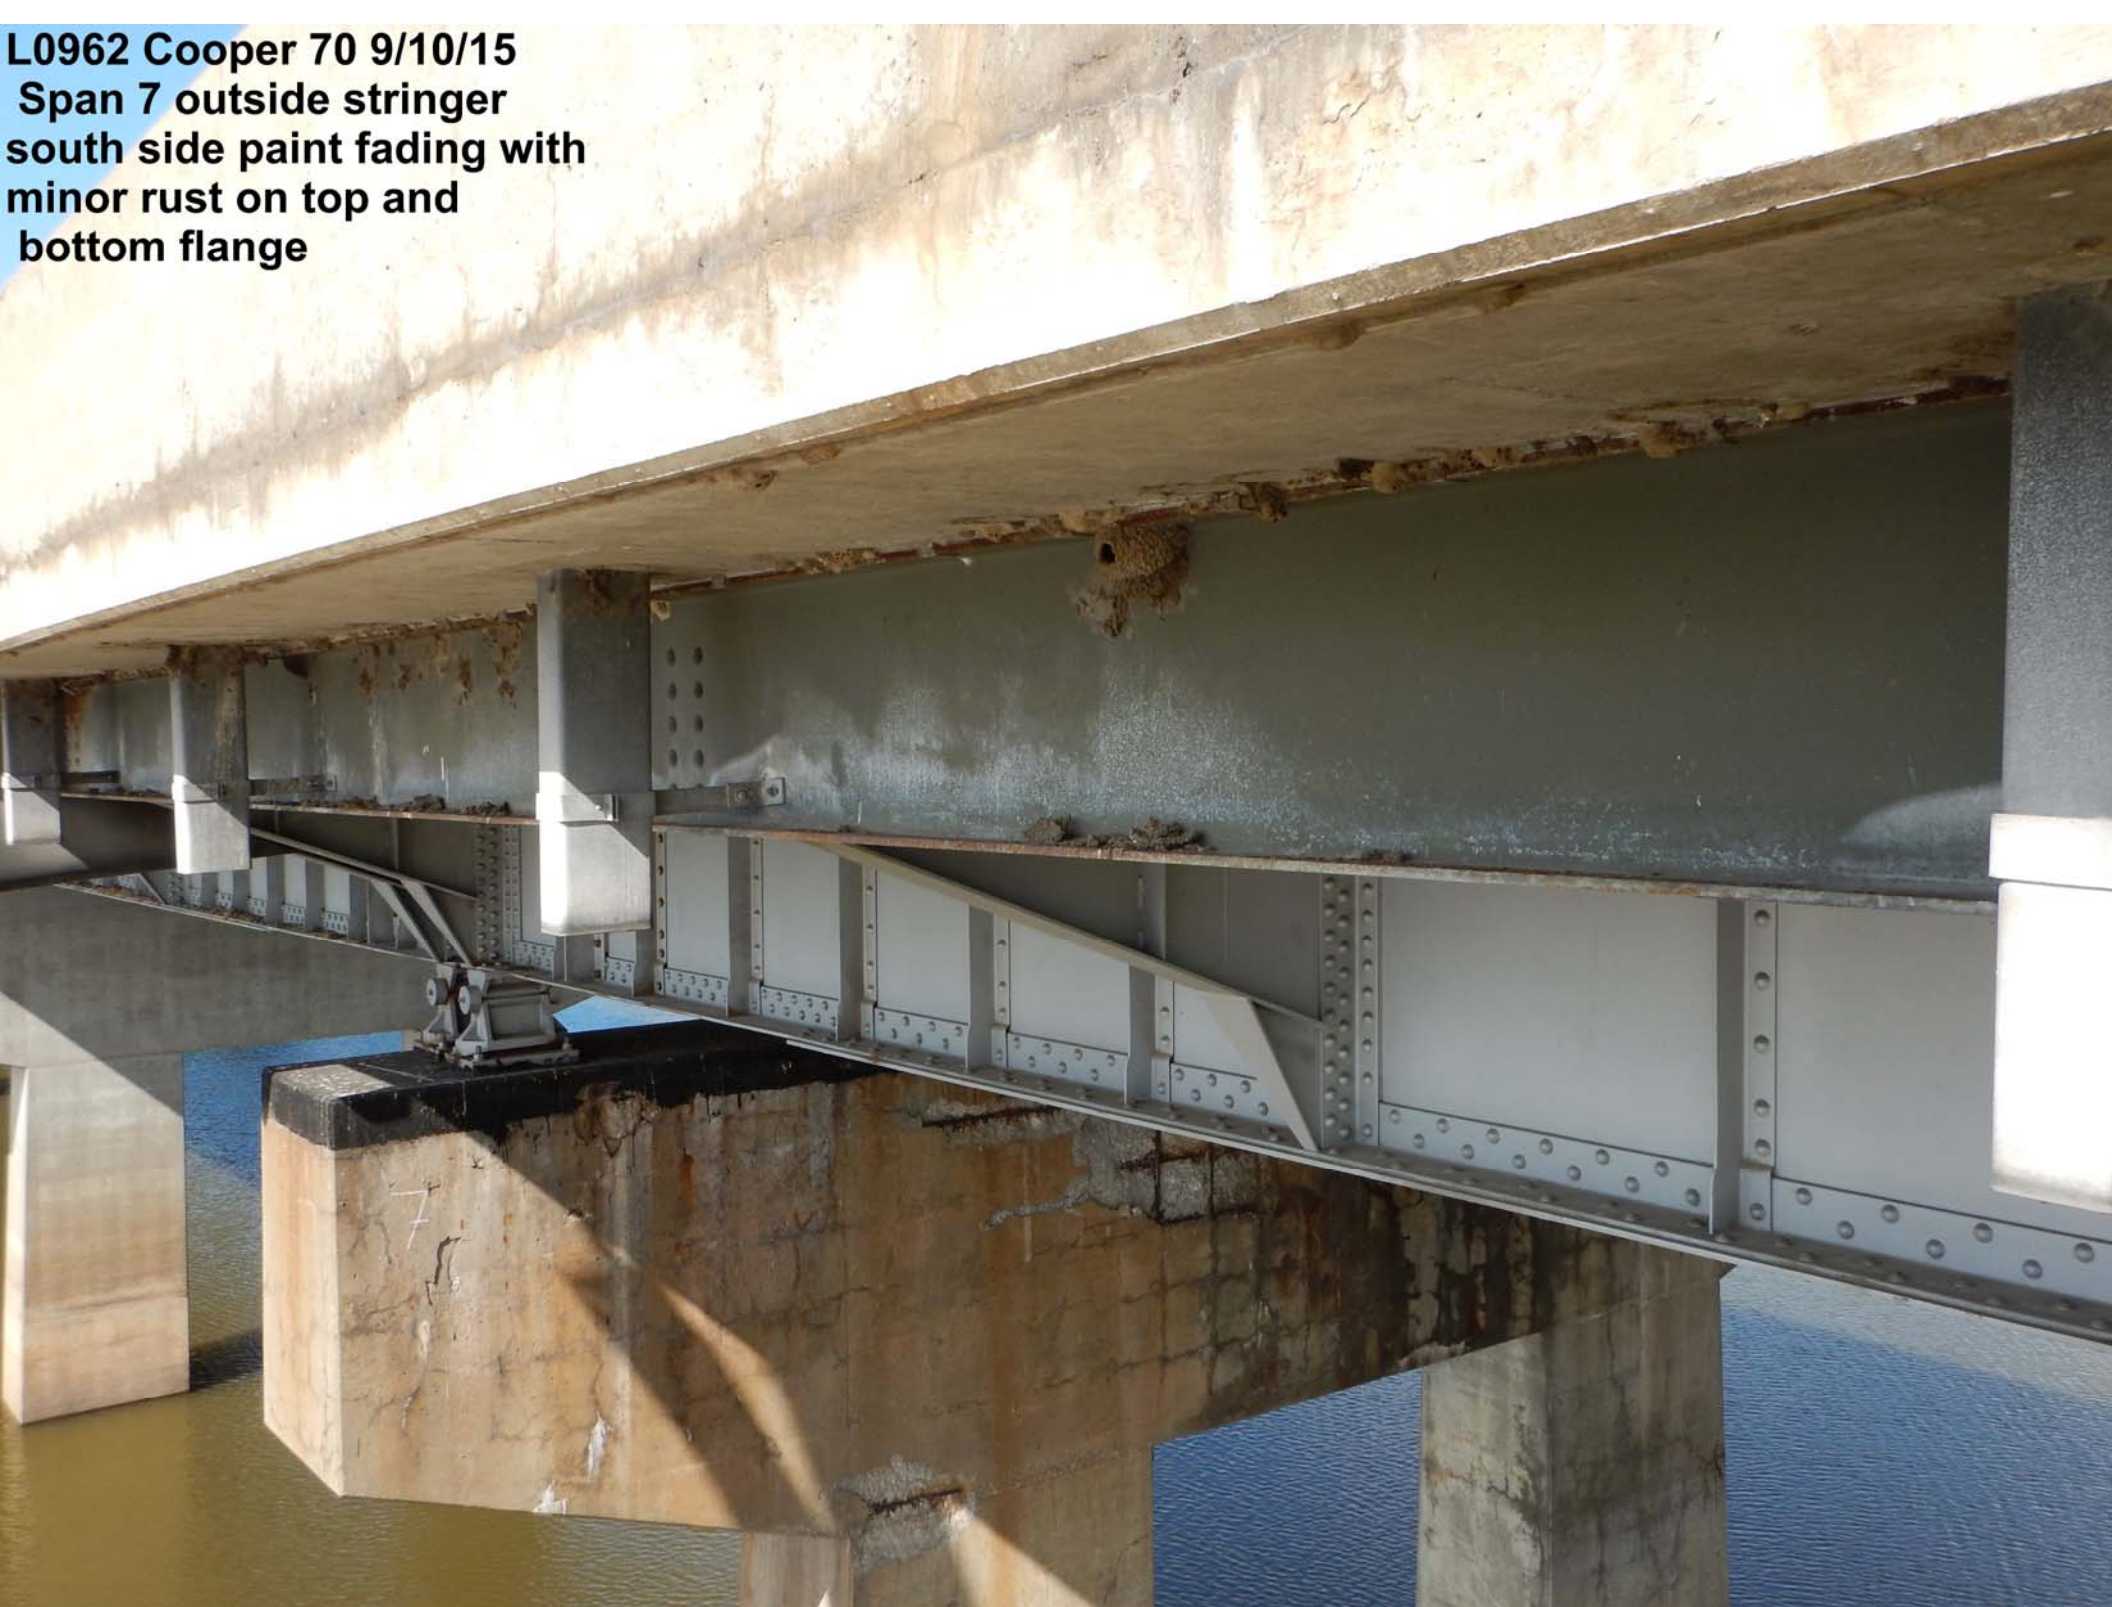
L0962 Cooper 70 9/10/15  
Span 6 floorbeam at  
bent 7 with moderate sec loss  
in bottom web 60 percent remain

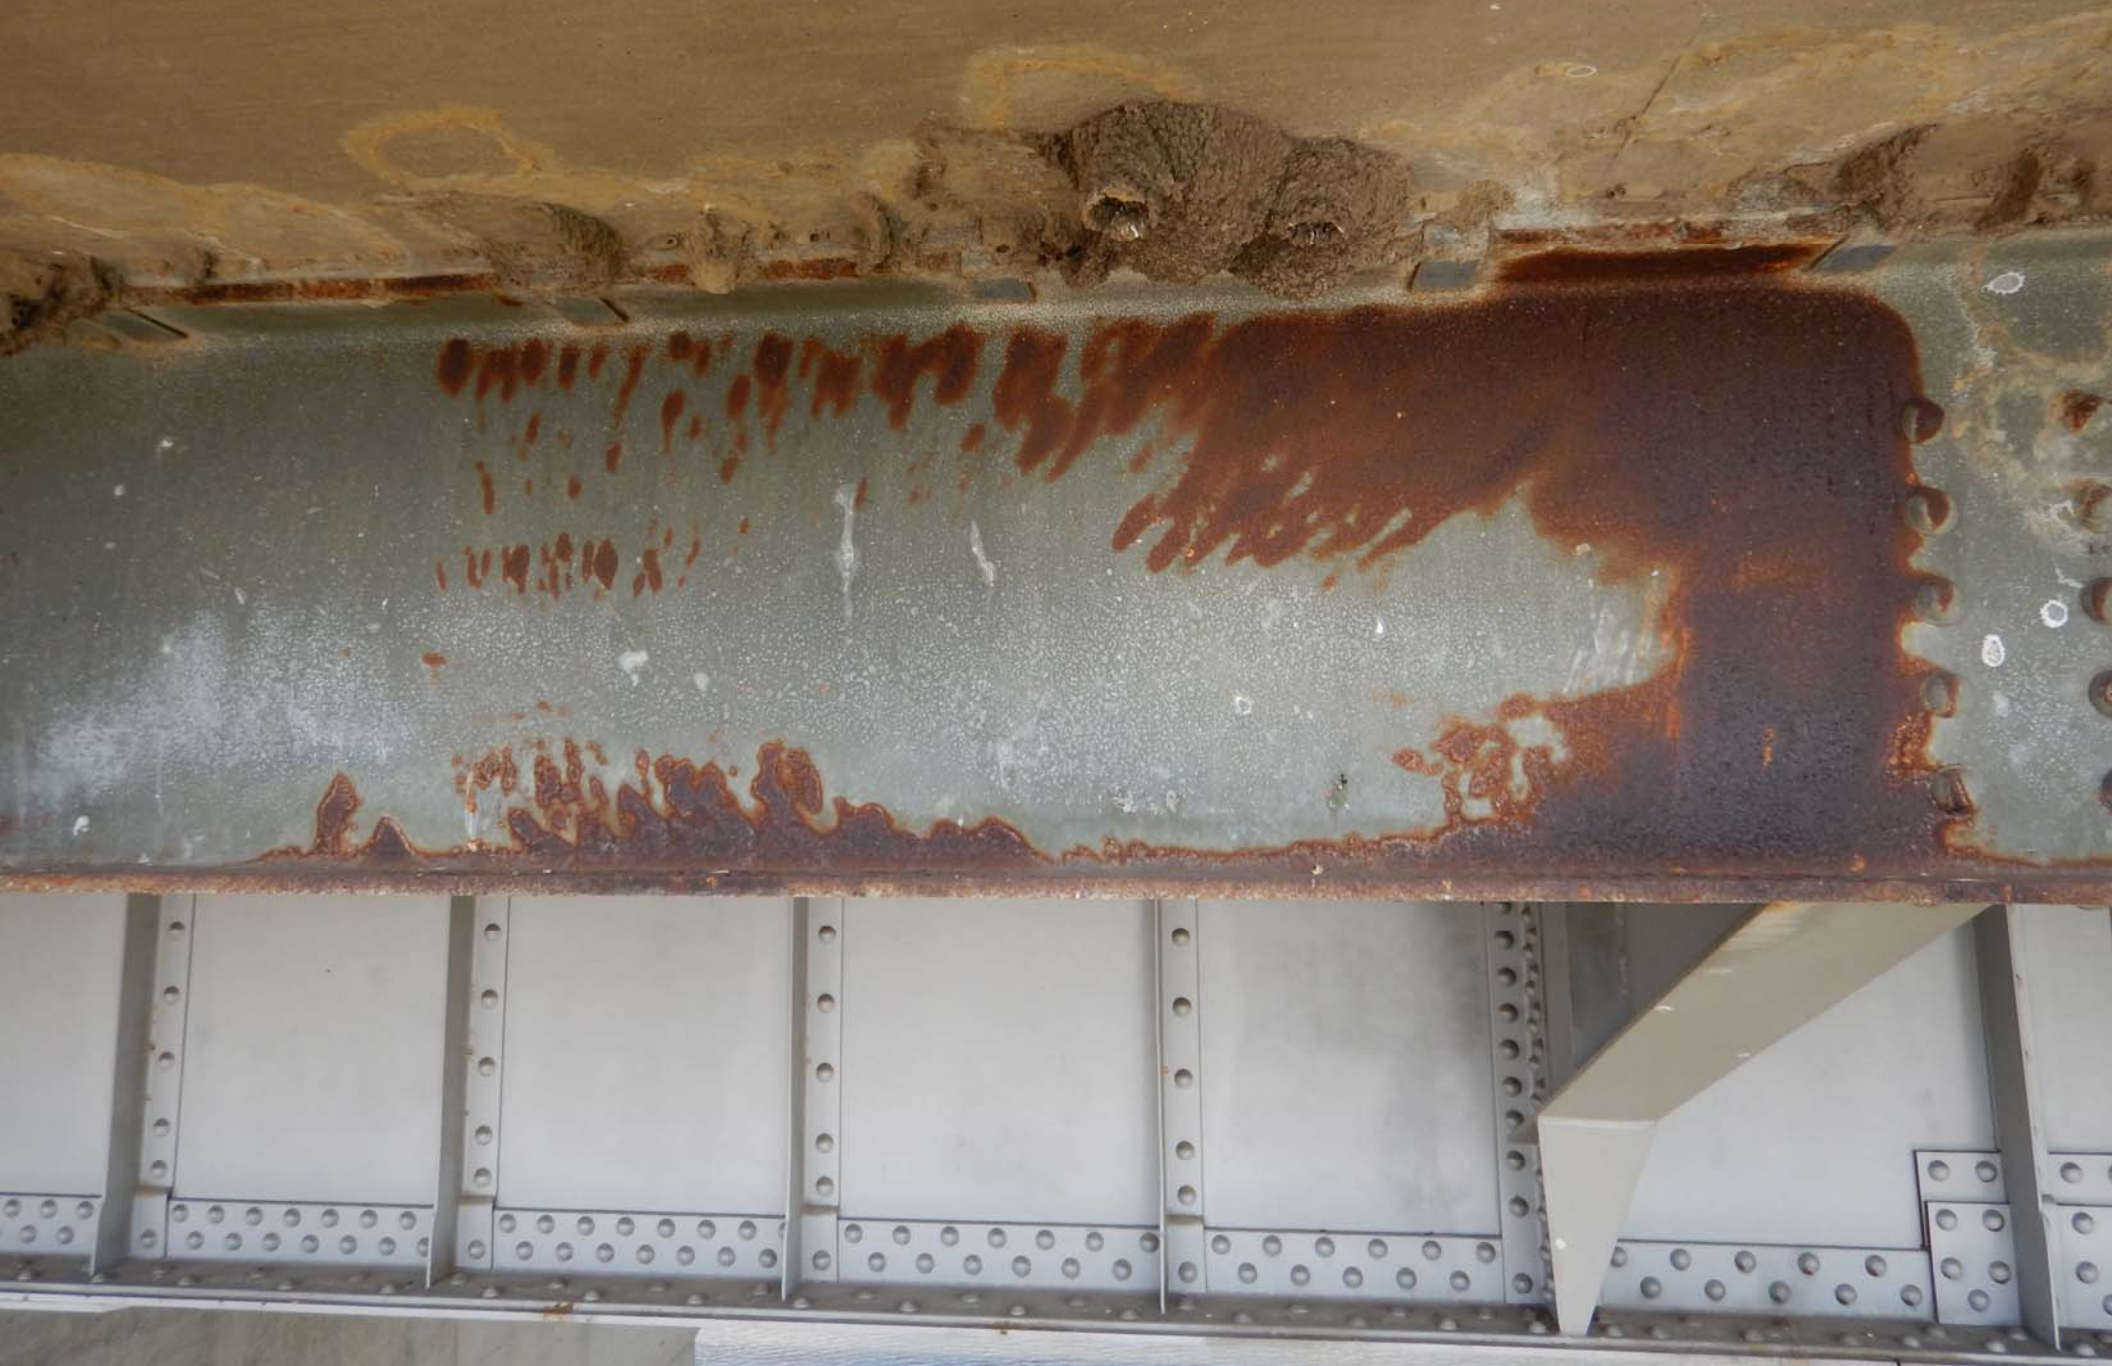
**L0962 Cooper 70 9/10/15**  
**Span 8 outside stringer**  
**south side with minor rusting**

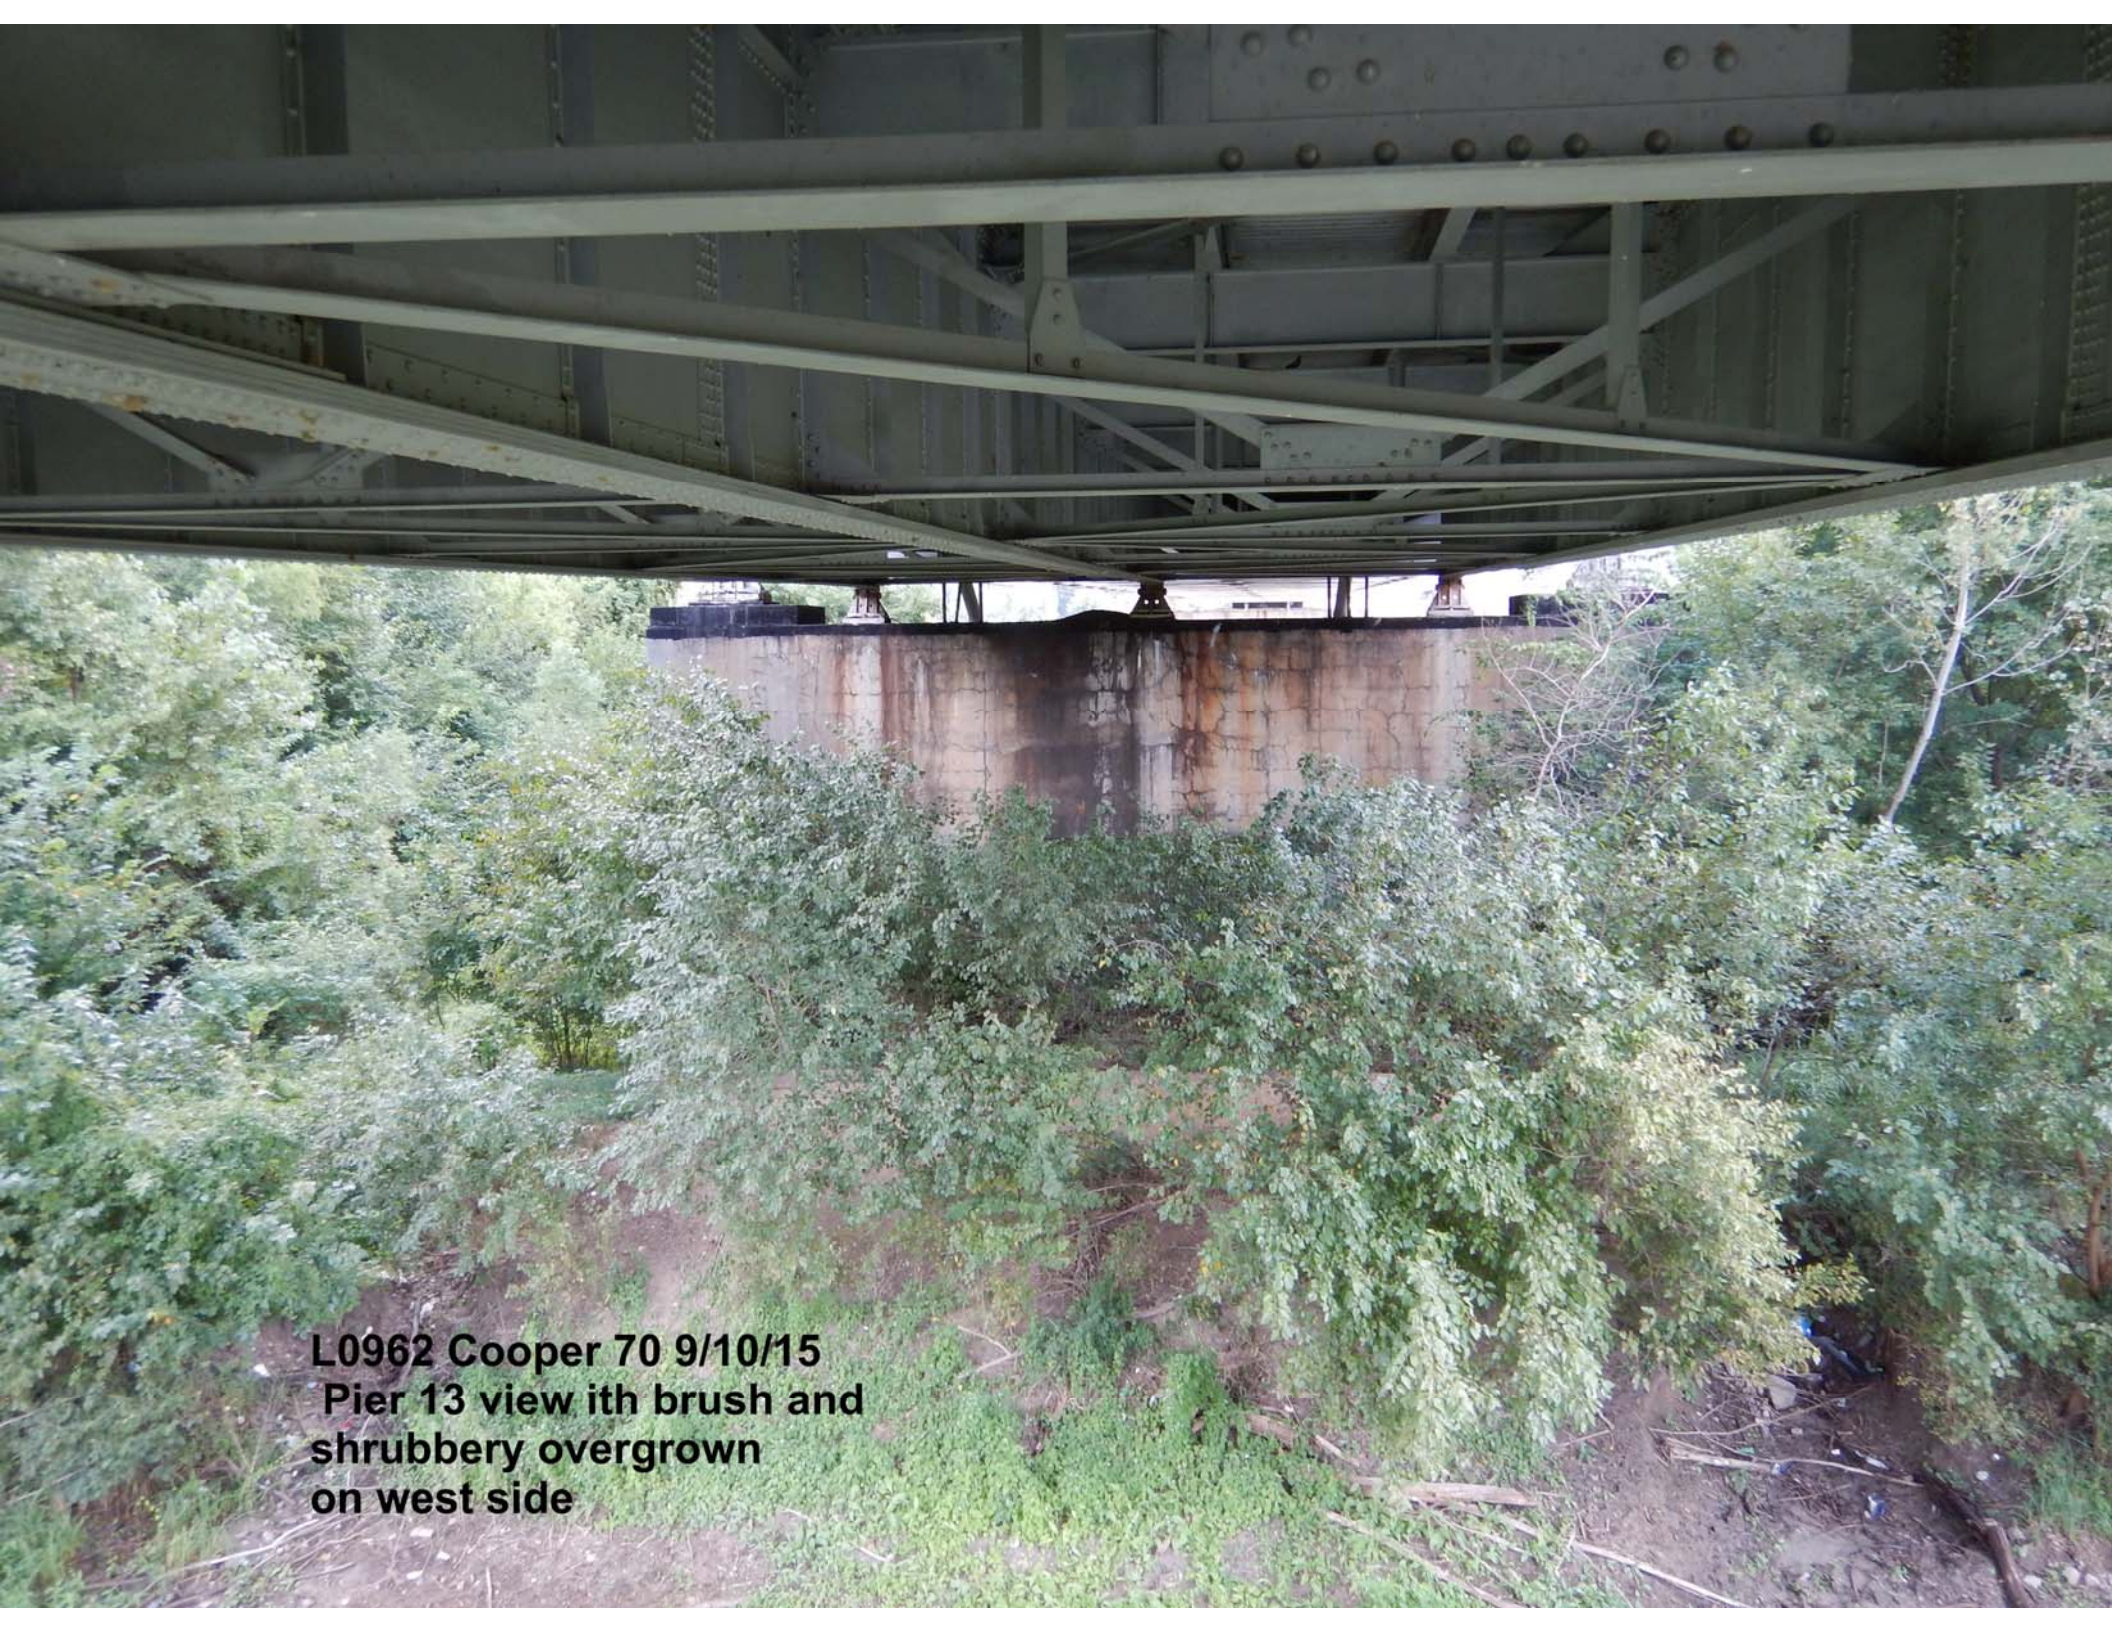
**L0962 Cooper 70 9/10/15**  
**Pier 13 finger joint**  
**east bound lane 1/4 inch**  
**high on east side**

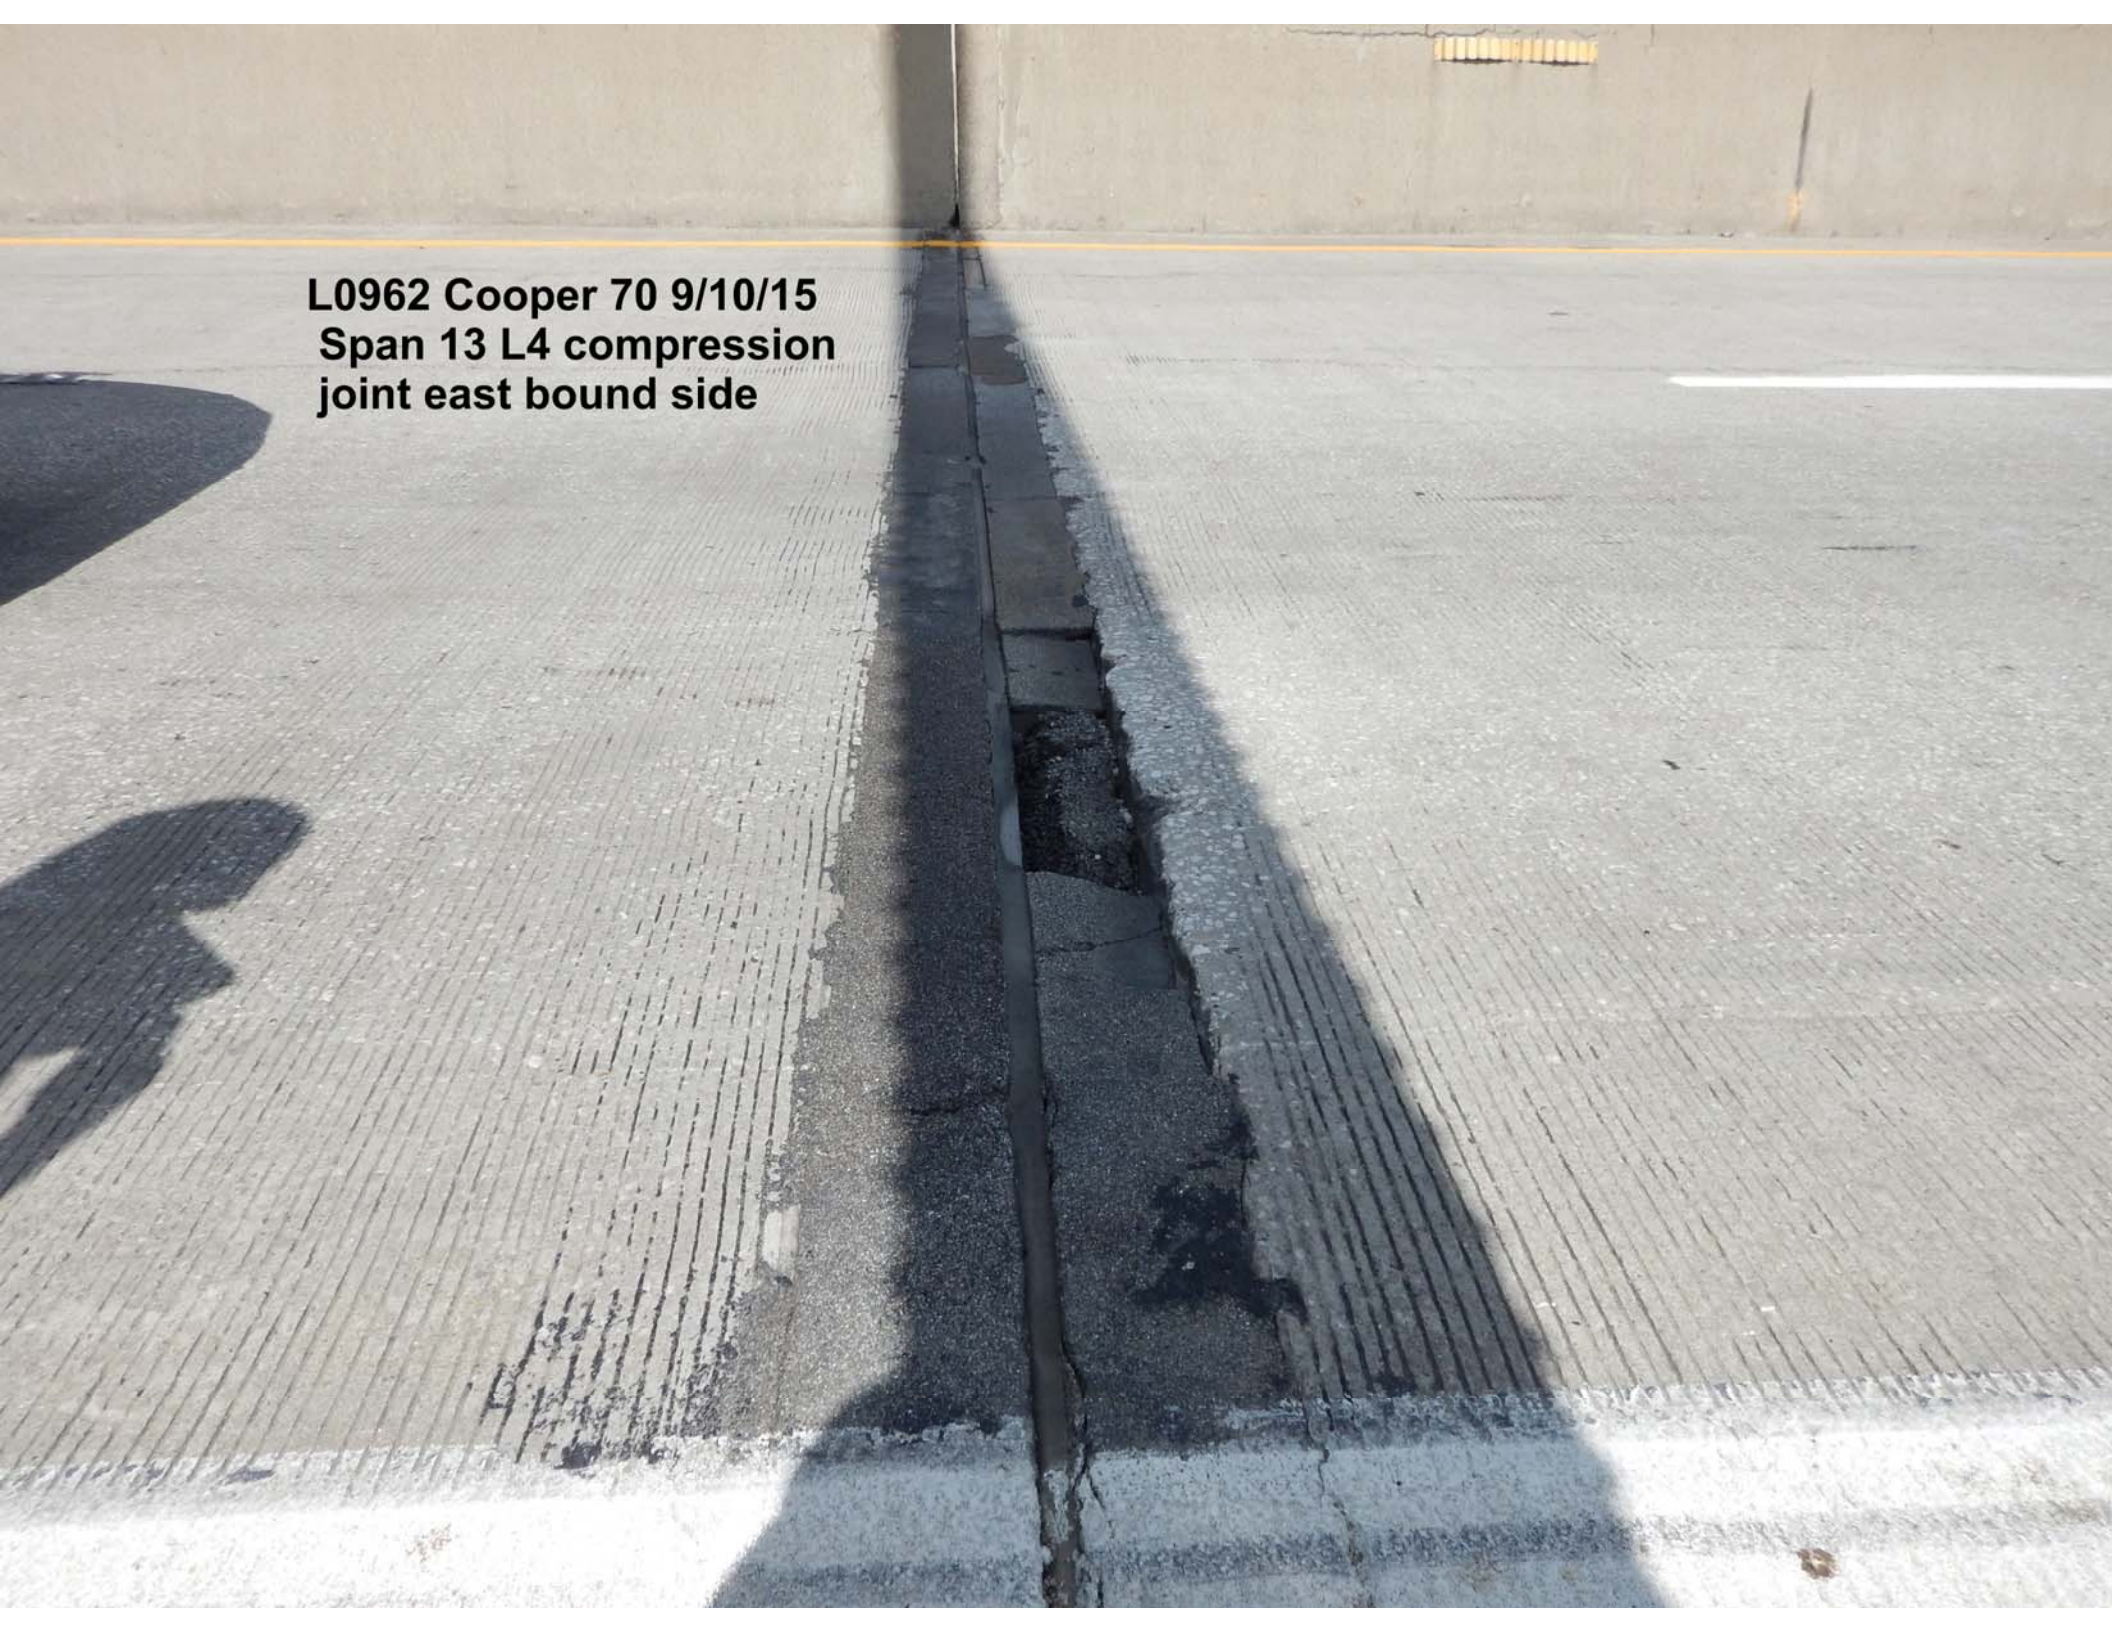
**L0962 Cooper 70 9/10/15  
Span 13 L3 to L4 right lower  
chord with hvy pack rust  
distorting top plate**

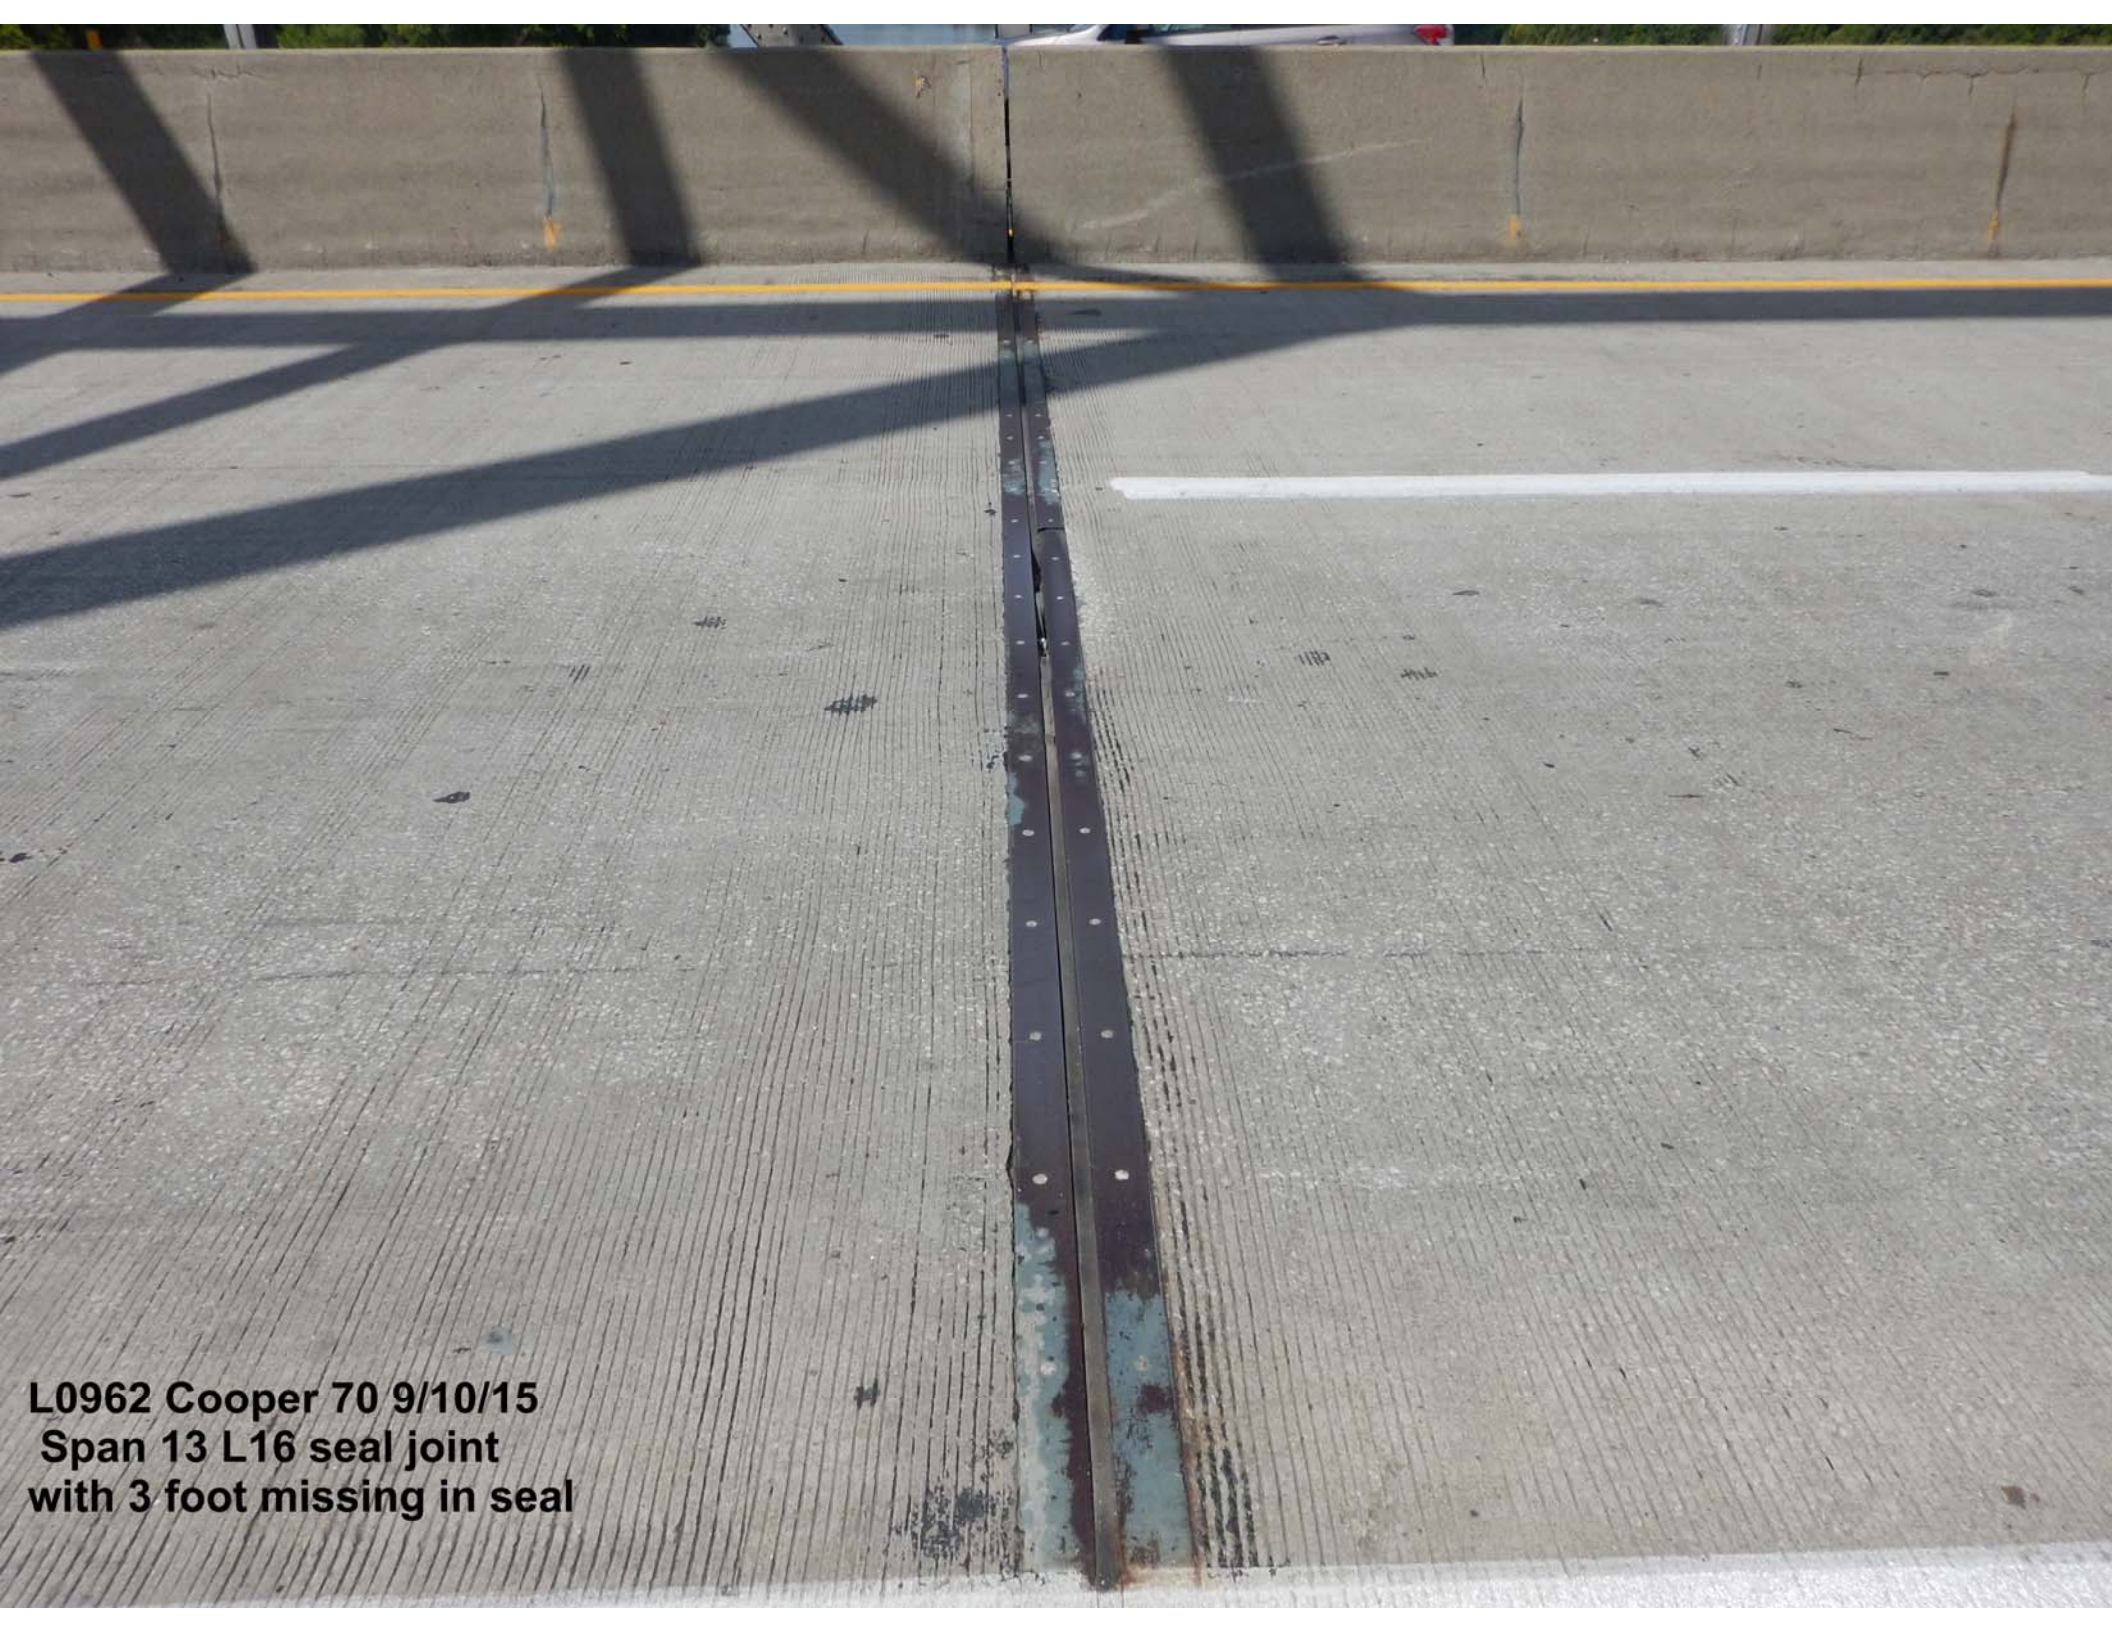
**L0962 Cooper 70 9/10/15  
Span 13 L16 seal joint  
with 3 foot missing in seal**

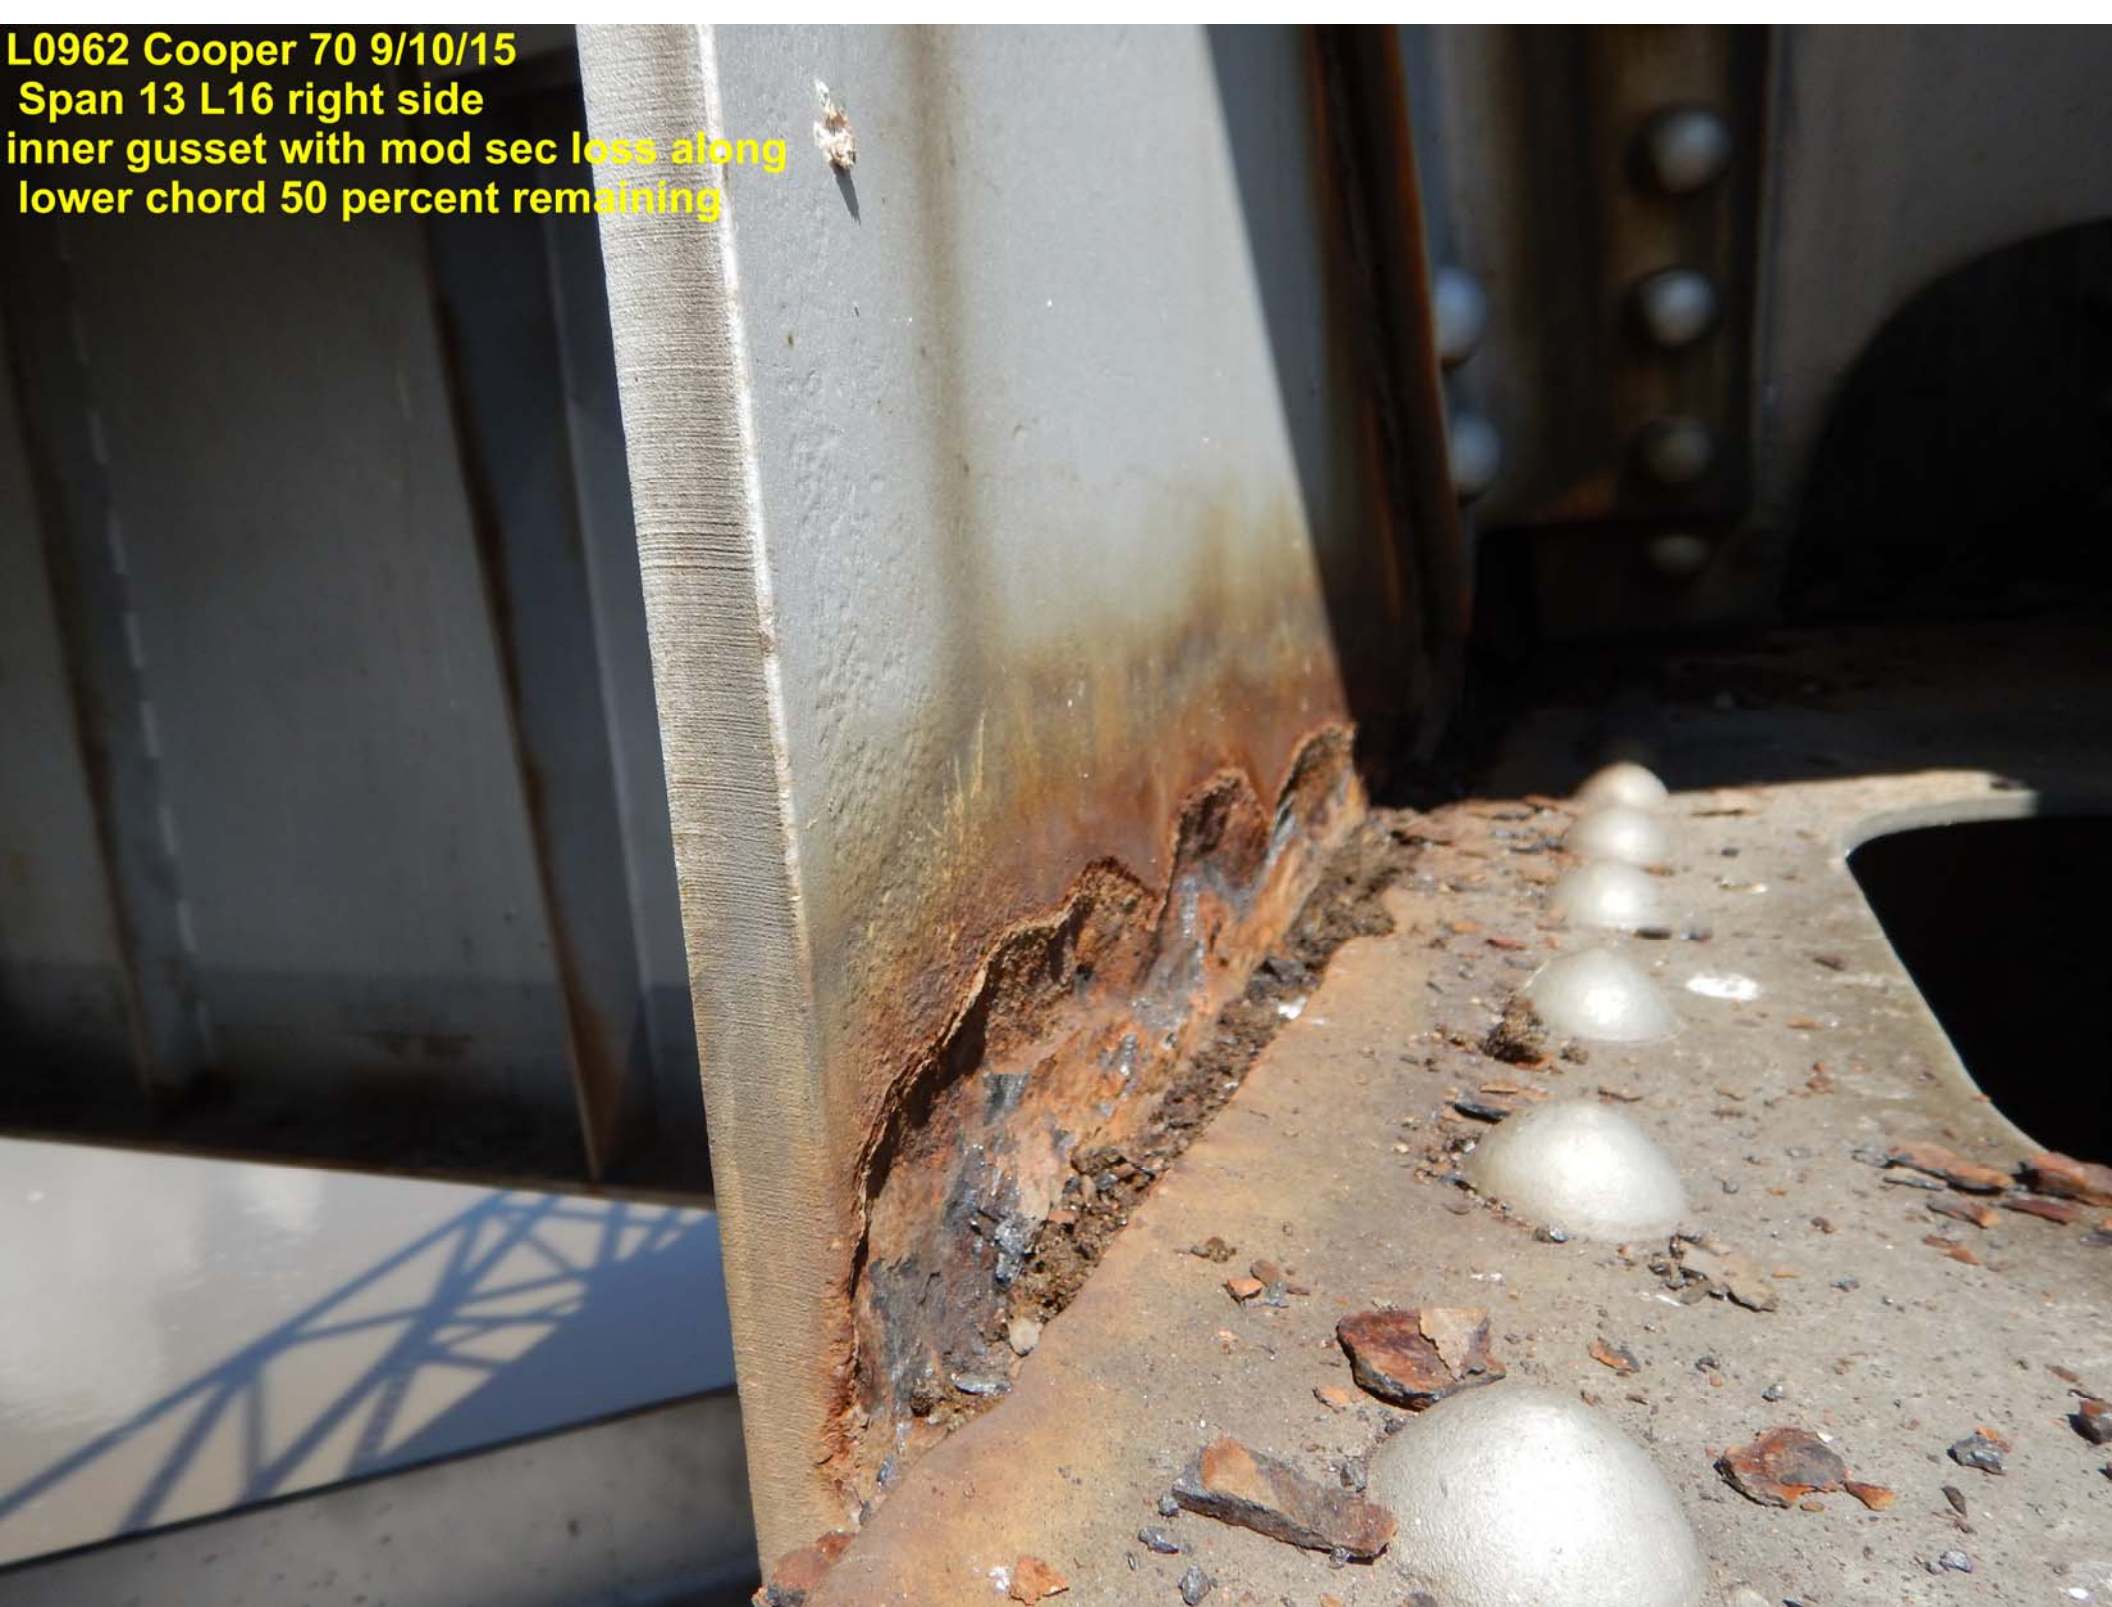
L0962 Cooper 70 9/10/15  
Span 13 L16 right side  
inner gusset with mod sec loss along  
lower chord 50 percent remaining
