L0962 I 70 Cooper Co.  
Joint at L8, span 13  
Eastbound lane failing  
9-24-13

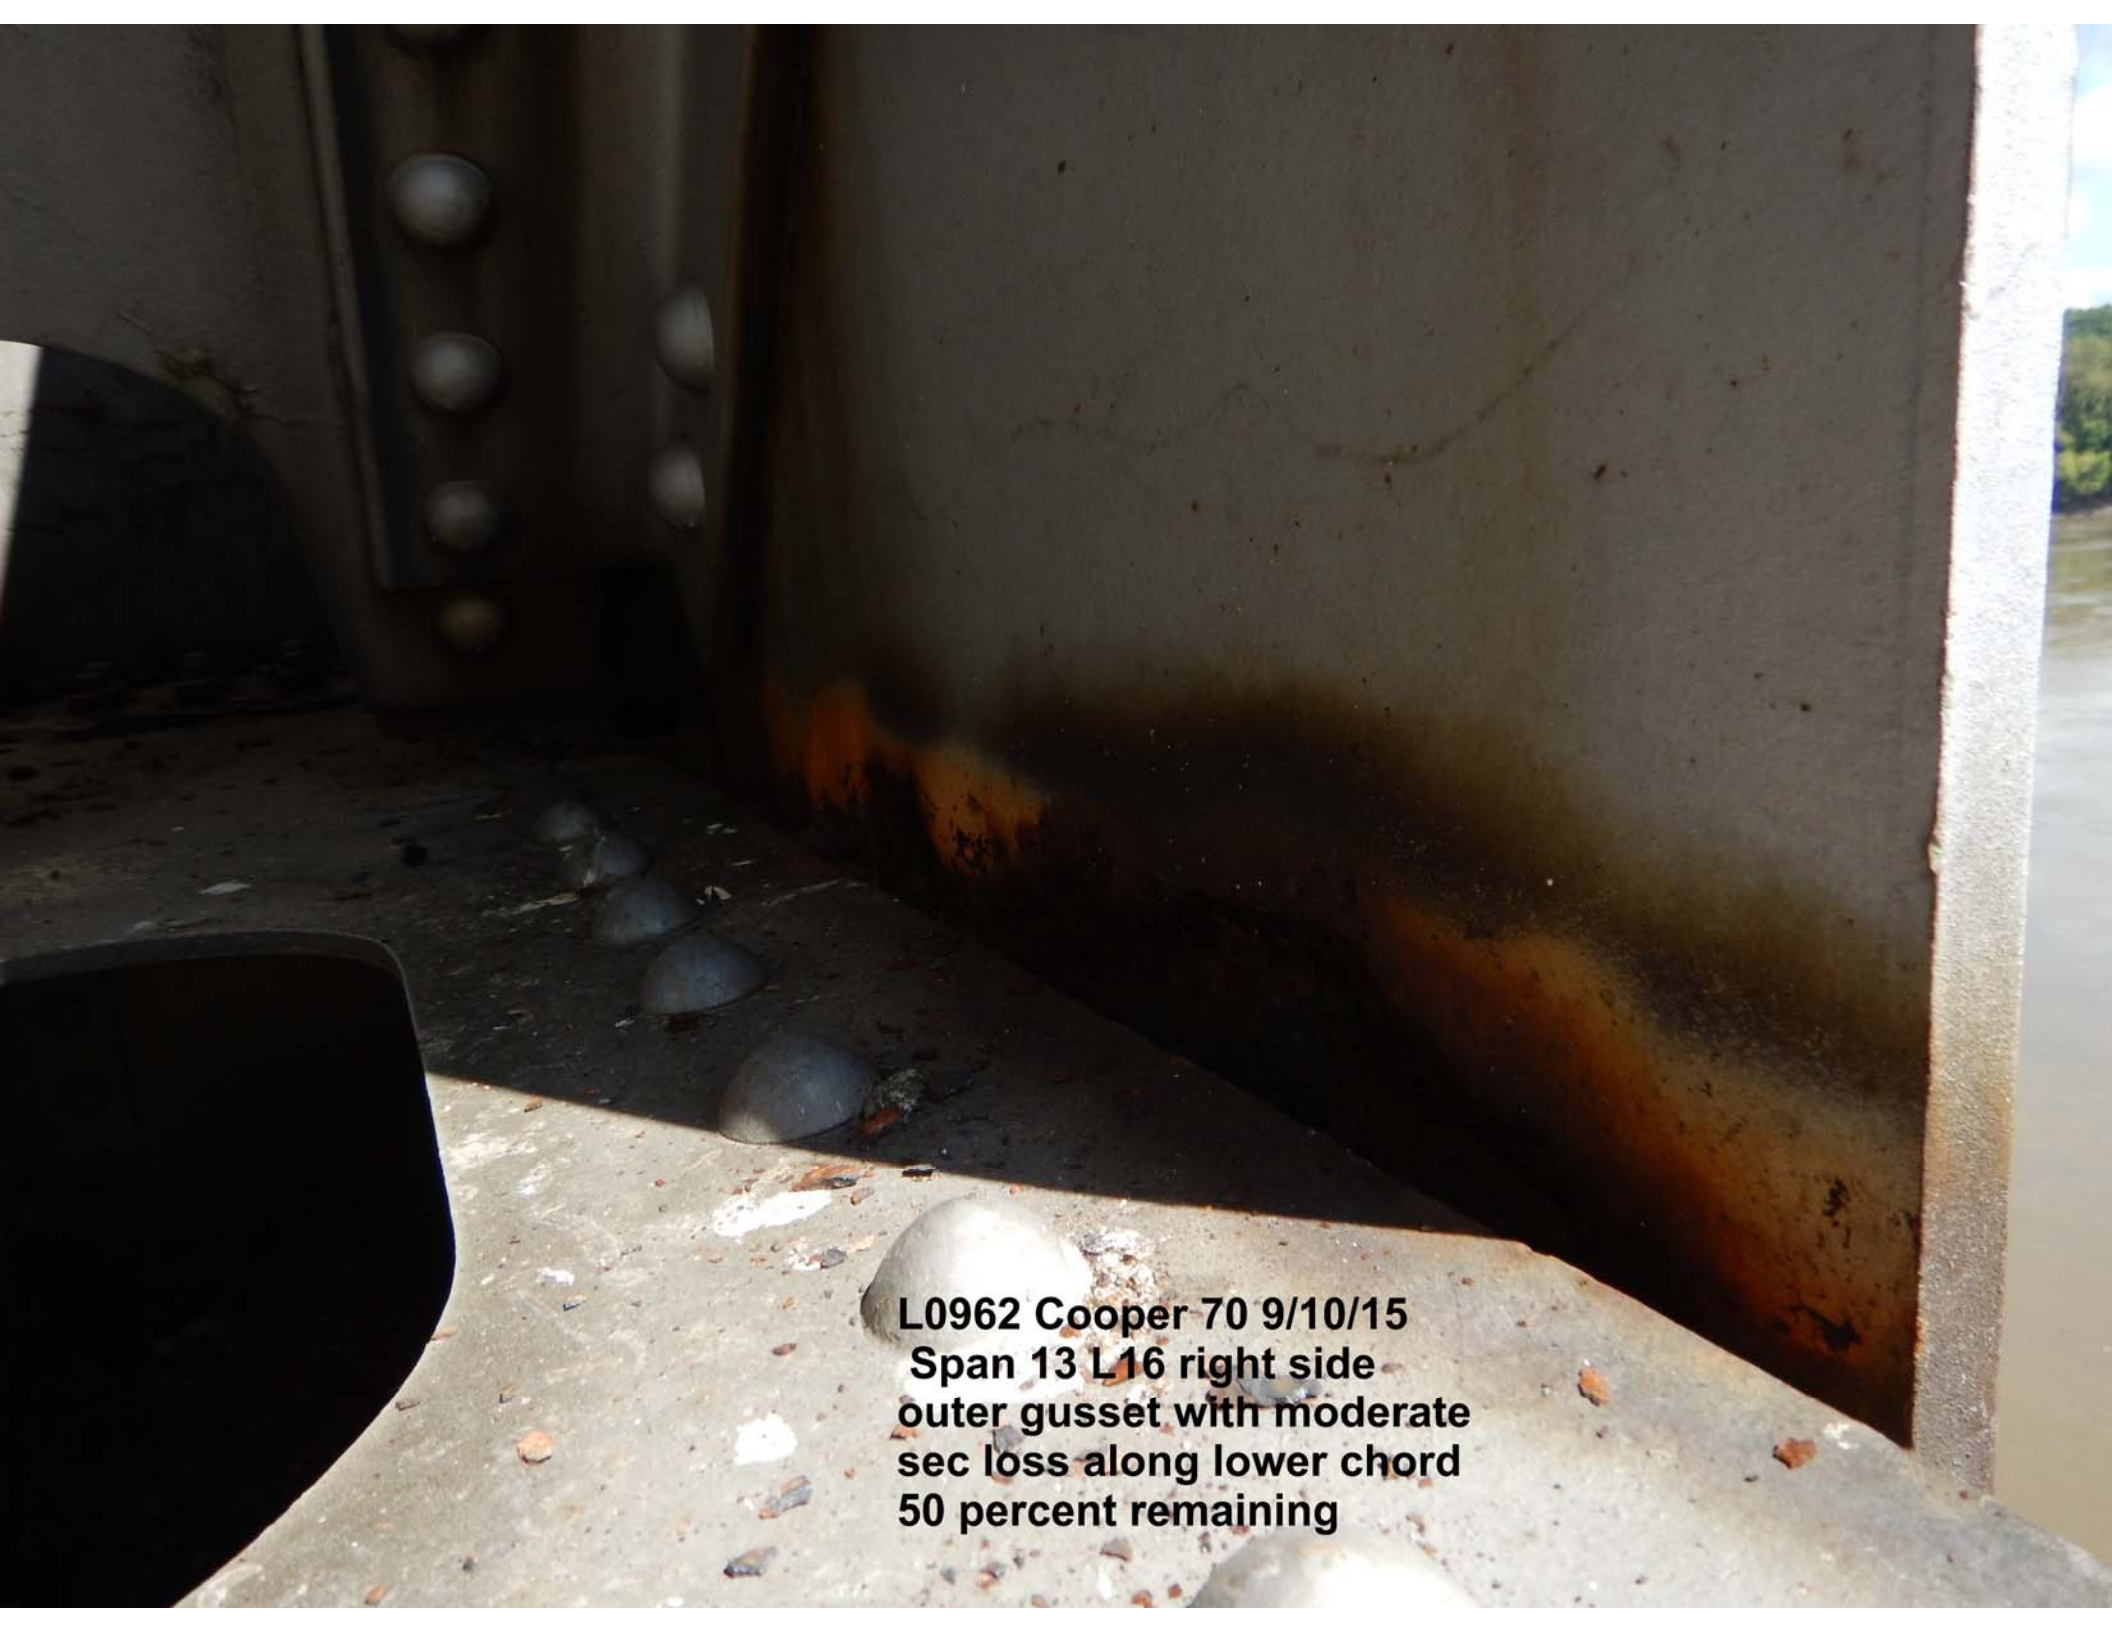
**L0962 Cooper 70 9/10/15  
Span 13 L16 right side  
outer gusset with moderate  
sec loss along lower chord  
50 percent remaining**

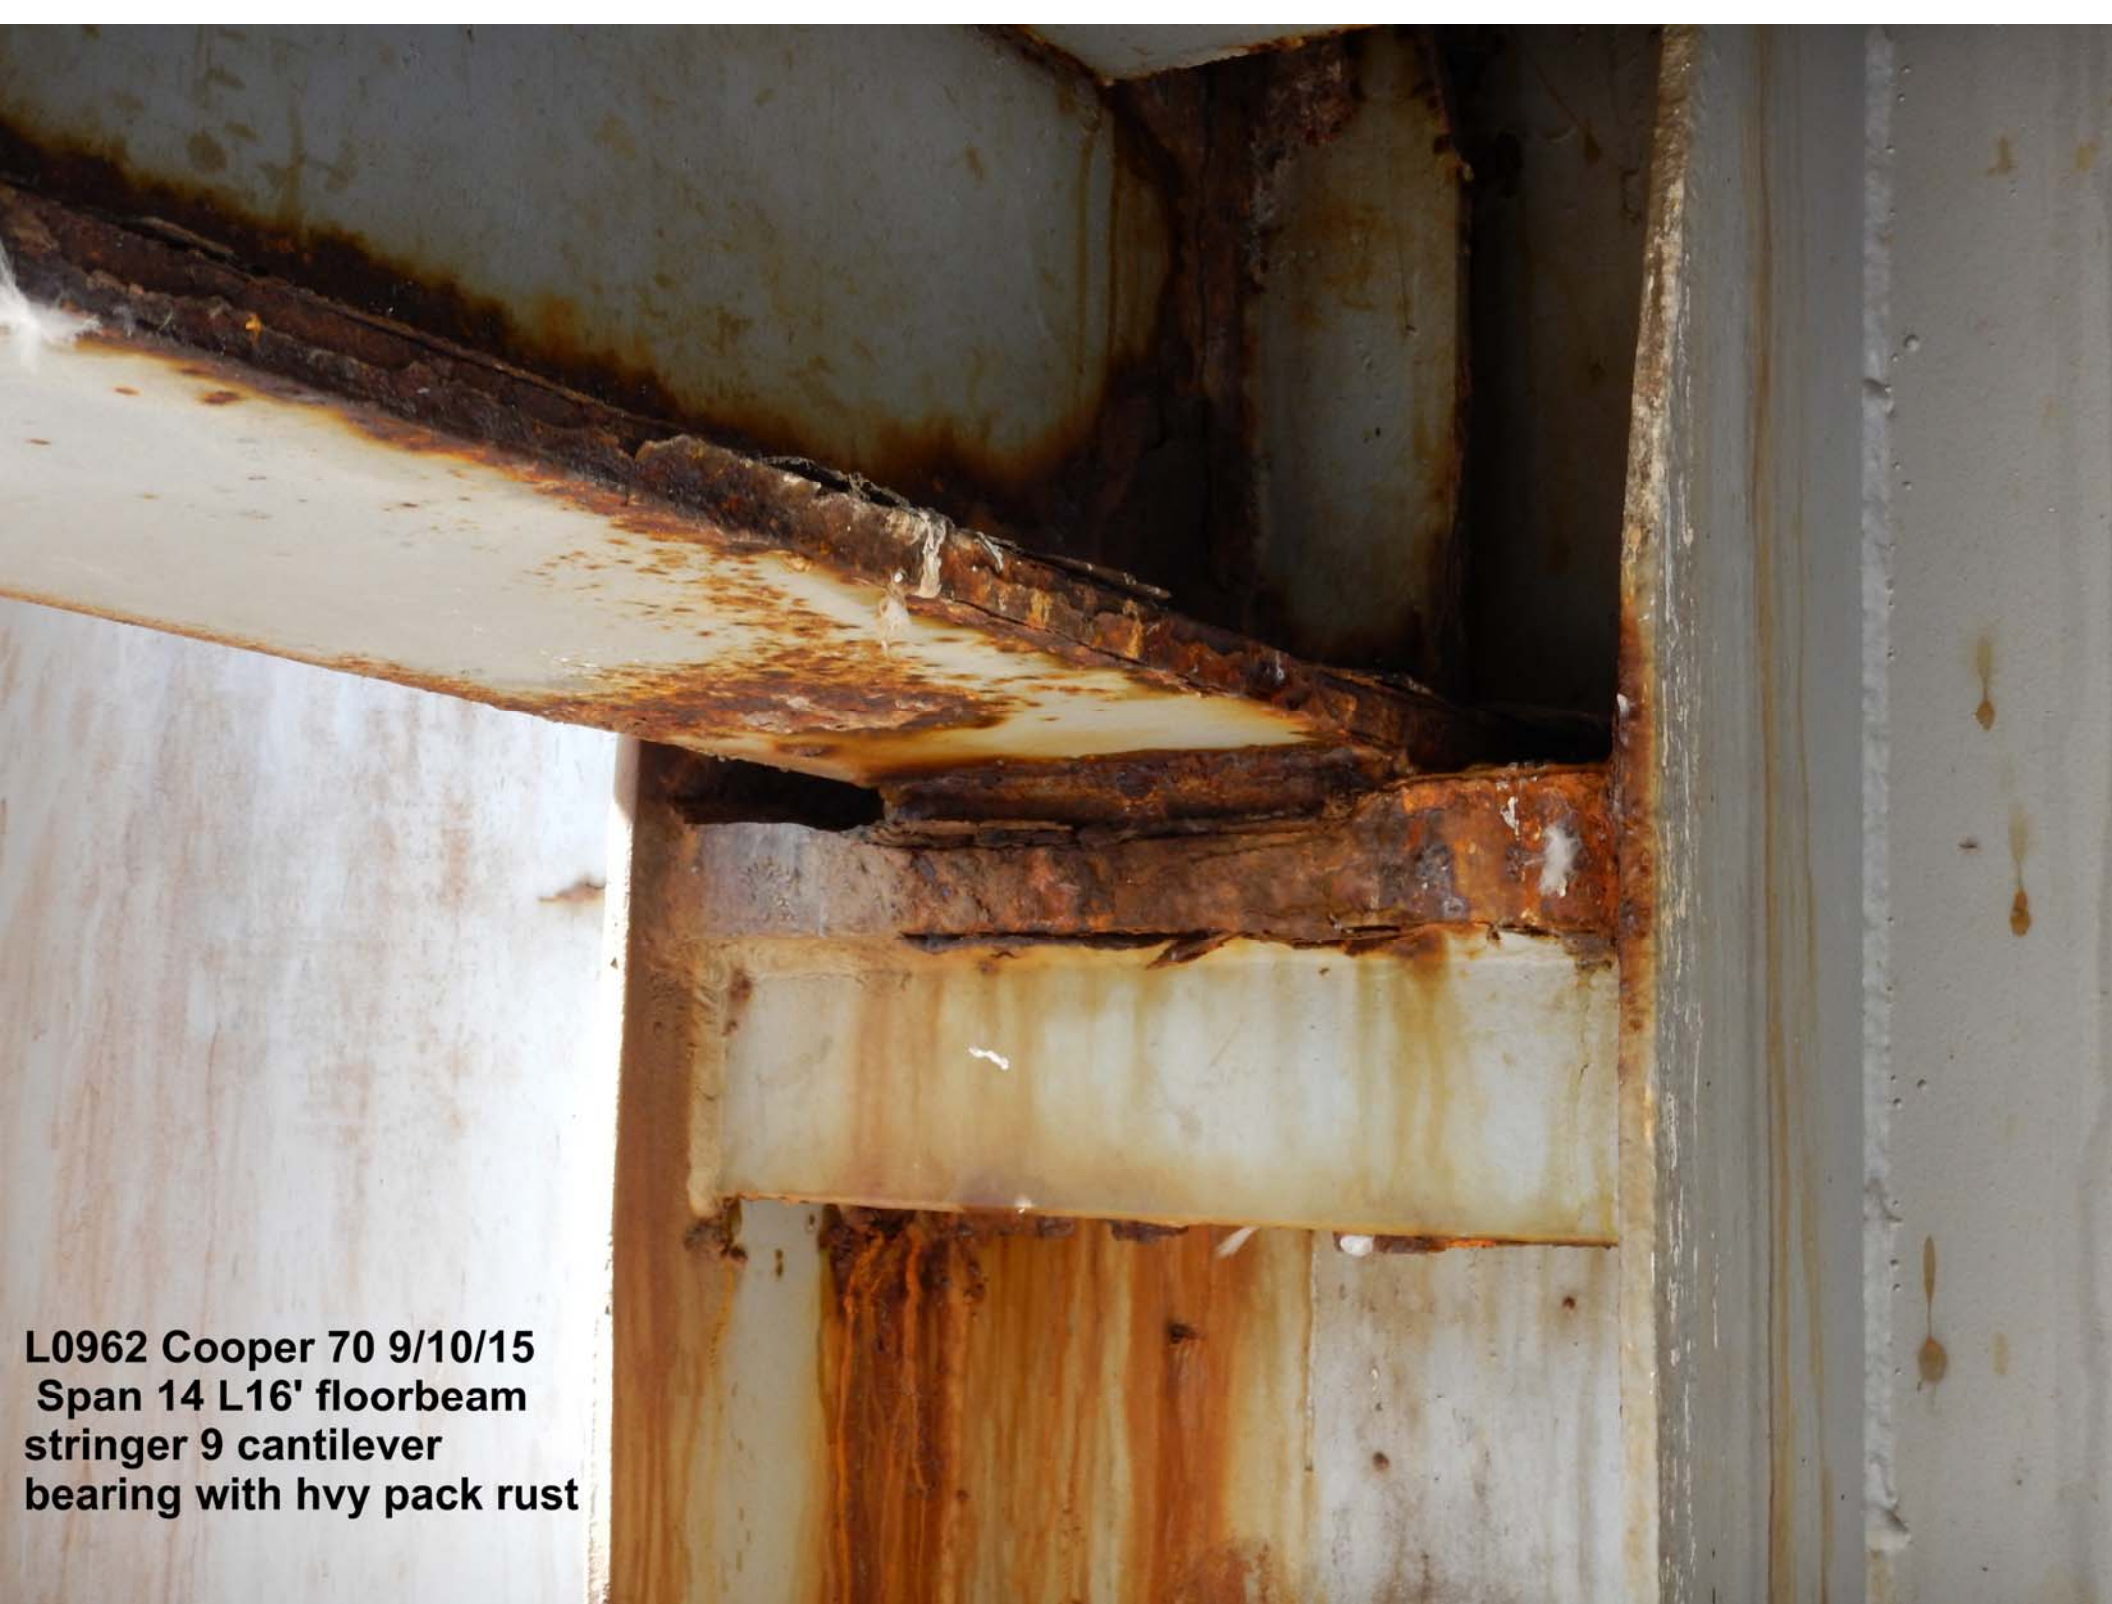
**L0962 Cooper 70 9/10/15**  
**Span 14 L16' floorbeam**  
**stringer 9 cantilever**  
**bearing with hvy pack rust**

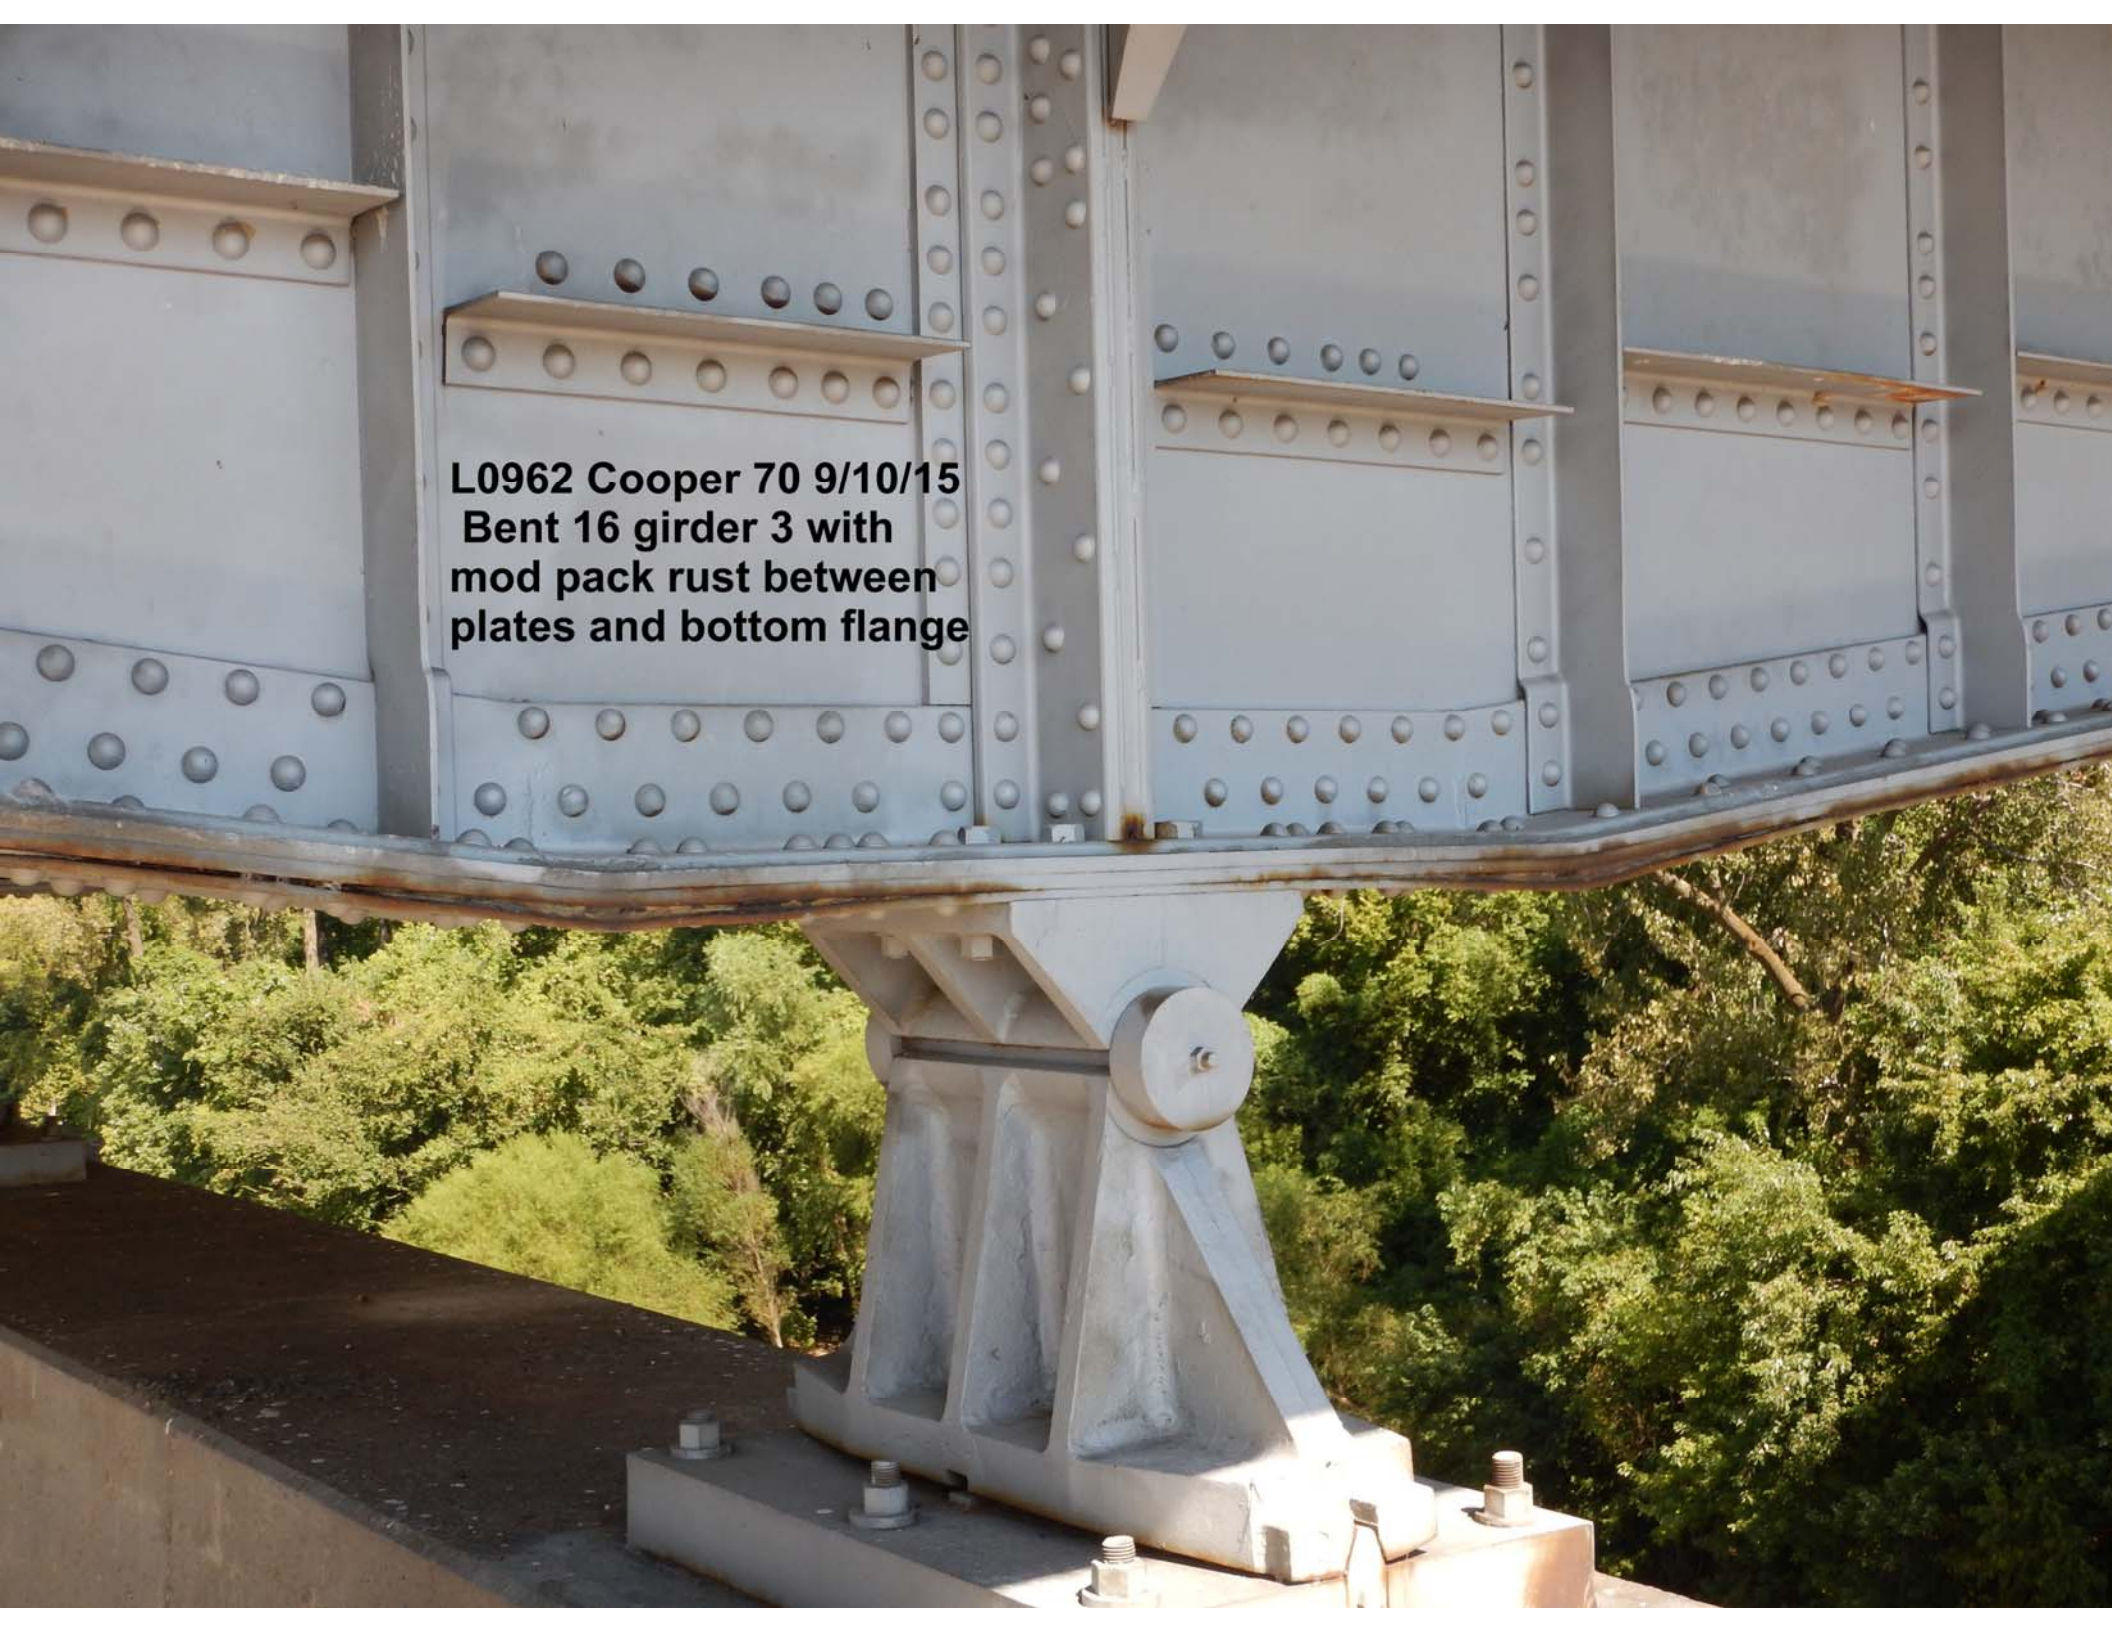
**L0962 Cooper 70 9/10/15  
Bent 16 girder 3 with  
mod pack rust between  
plates and bottom flange**

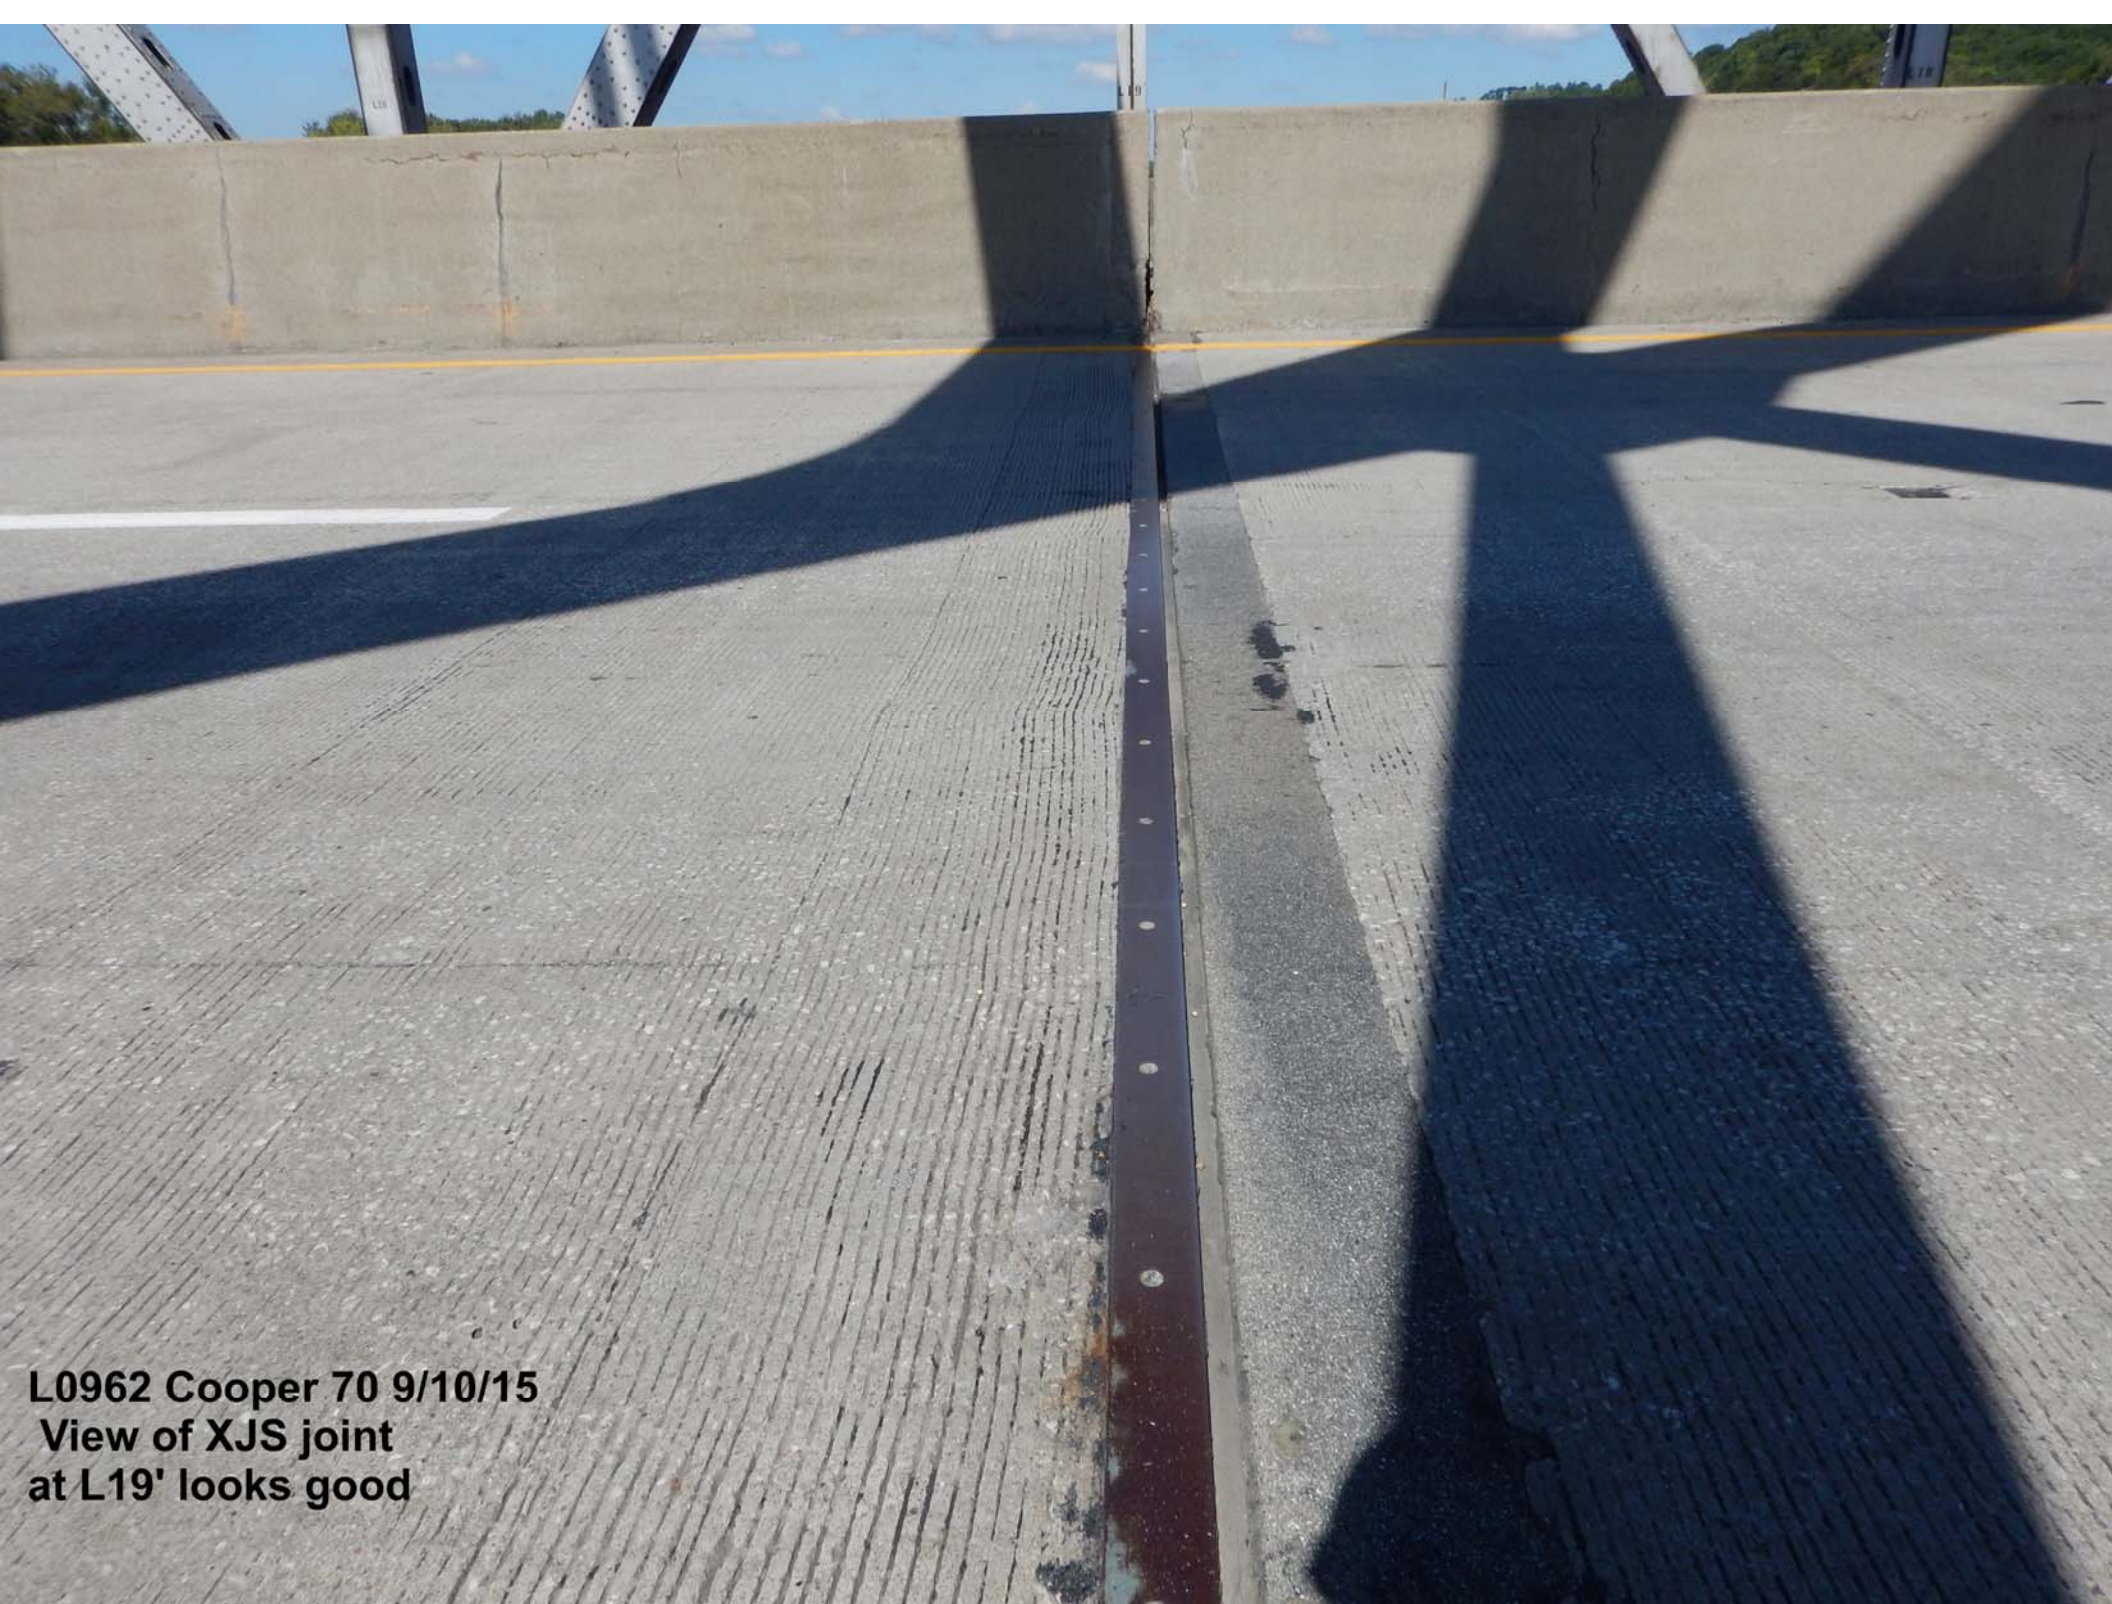
**L0962 Cooper 70 9/10/15**  
**View of XJS joint at**  
**L16' starting to fail**

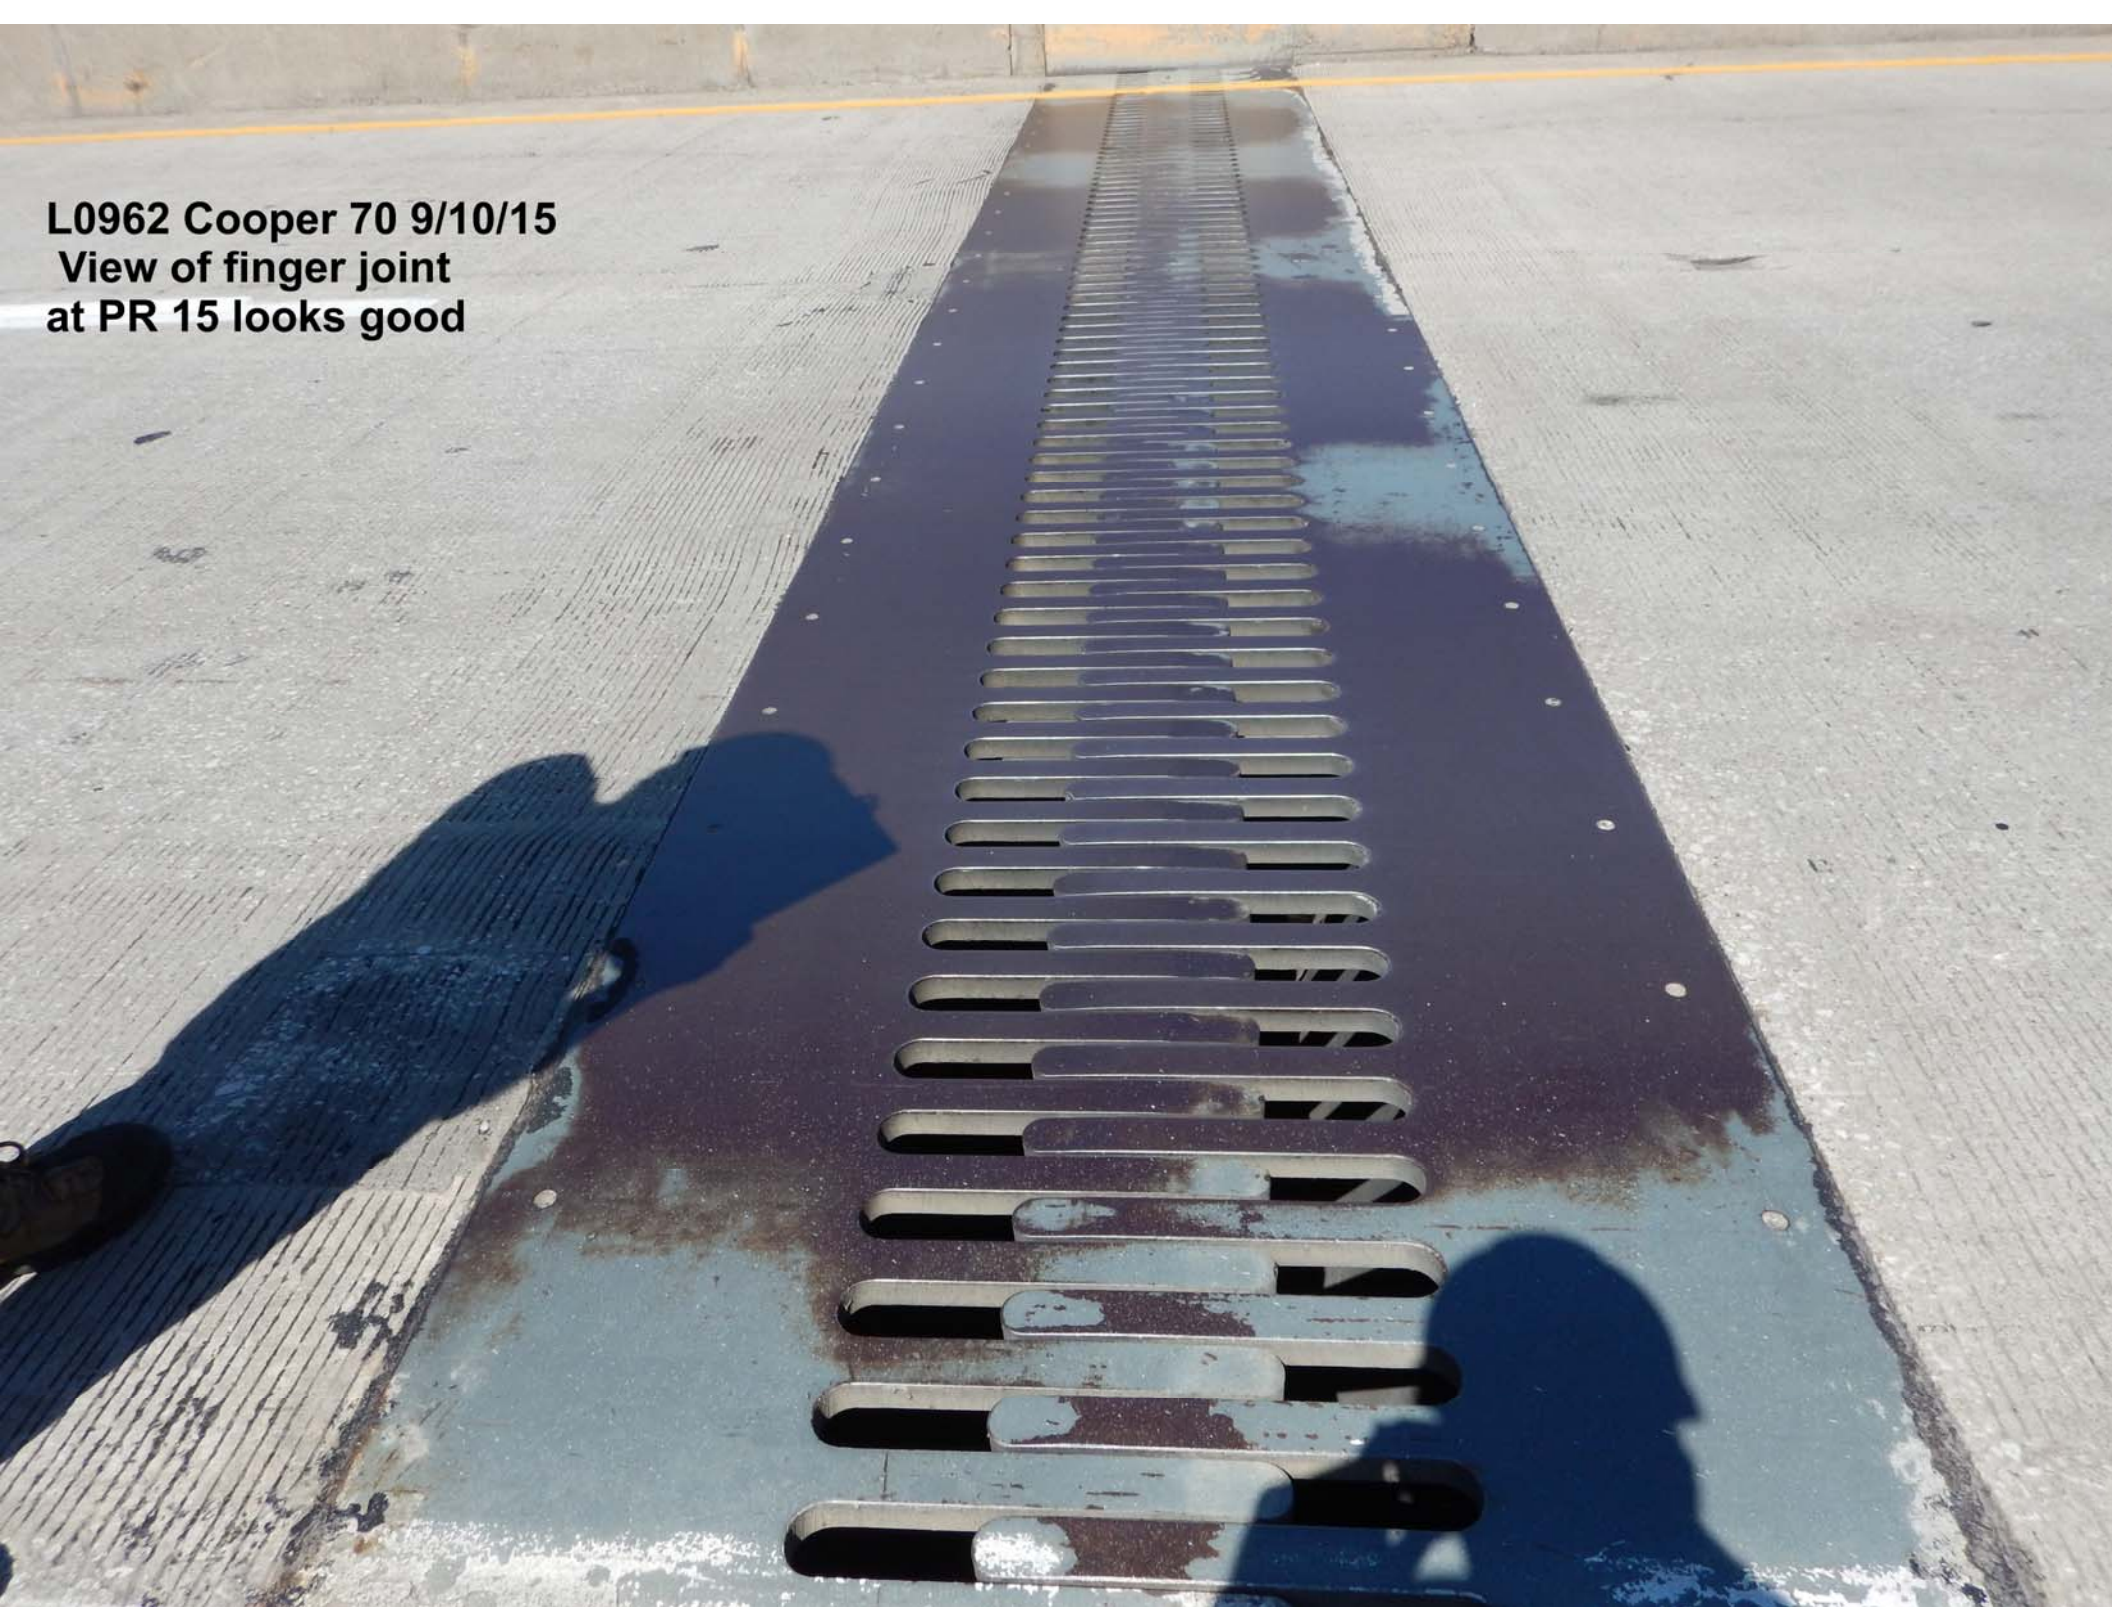
L0962 Cooper 70 9/10/15  
View of finger joint  
at PR 15 looks good
