L0962 Cooper 70 8/28/17
P13 east side lrg area of map
cracks with saturation and eff

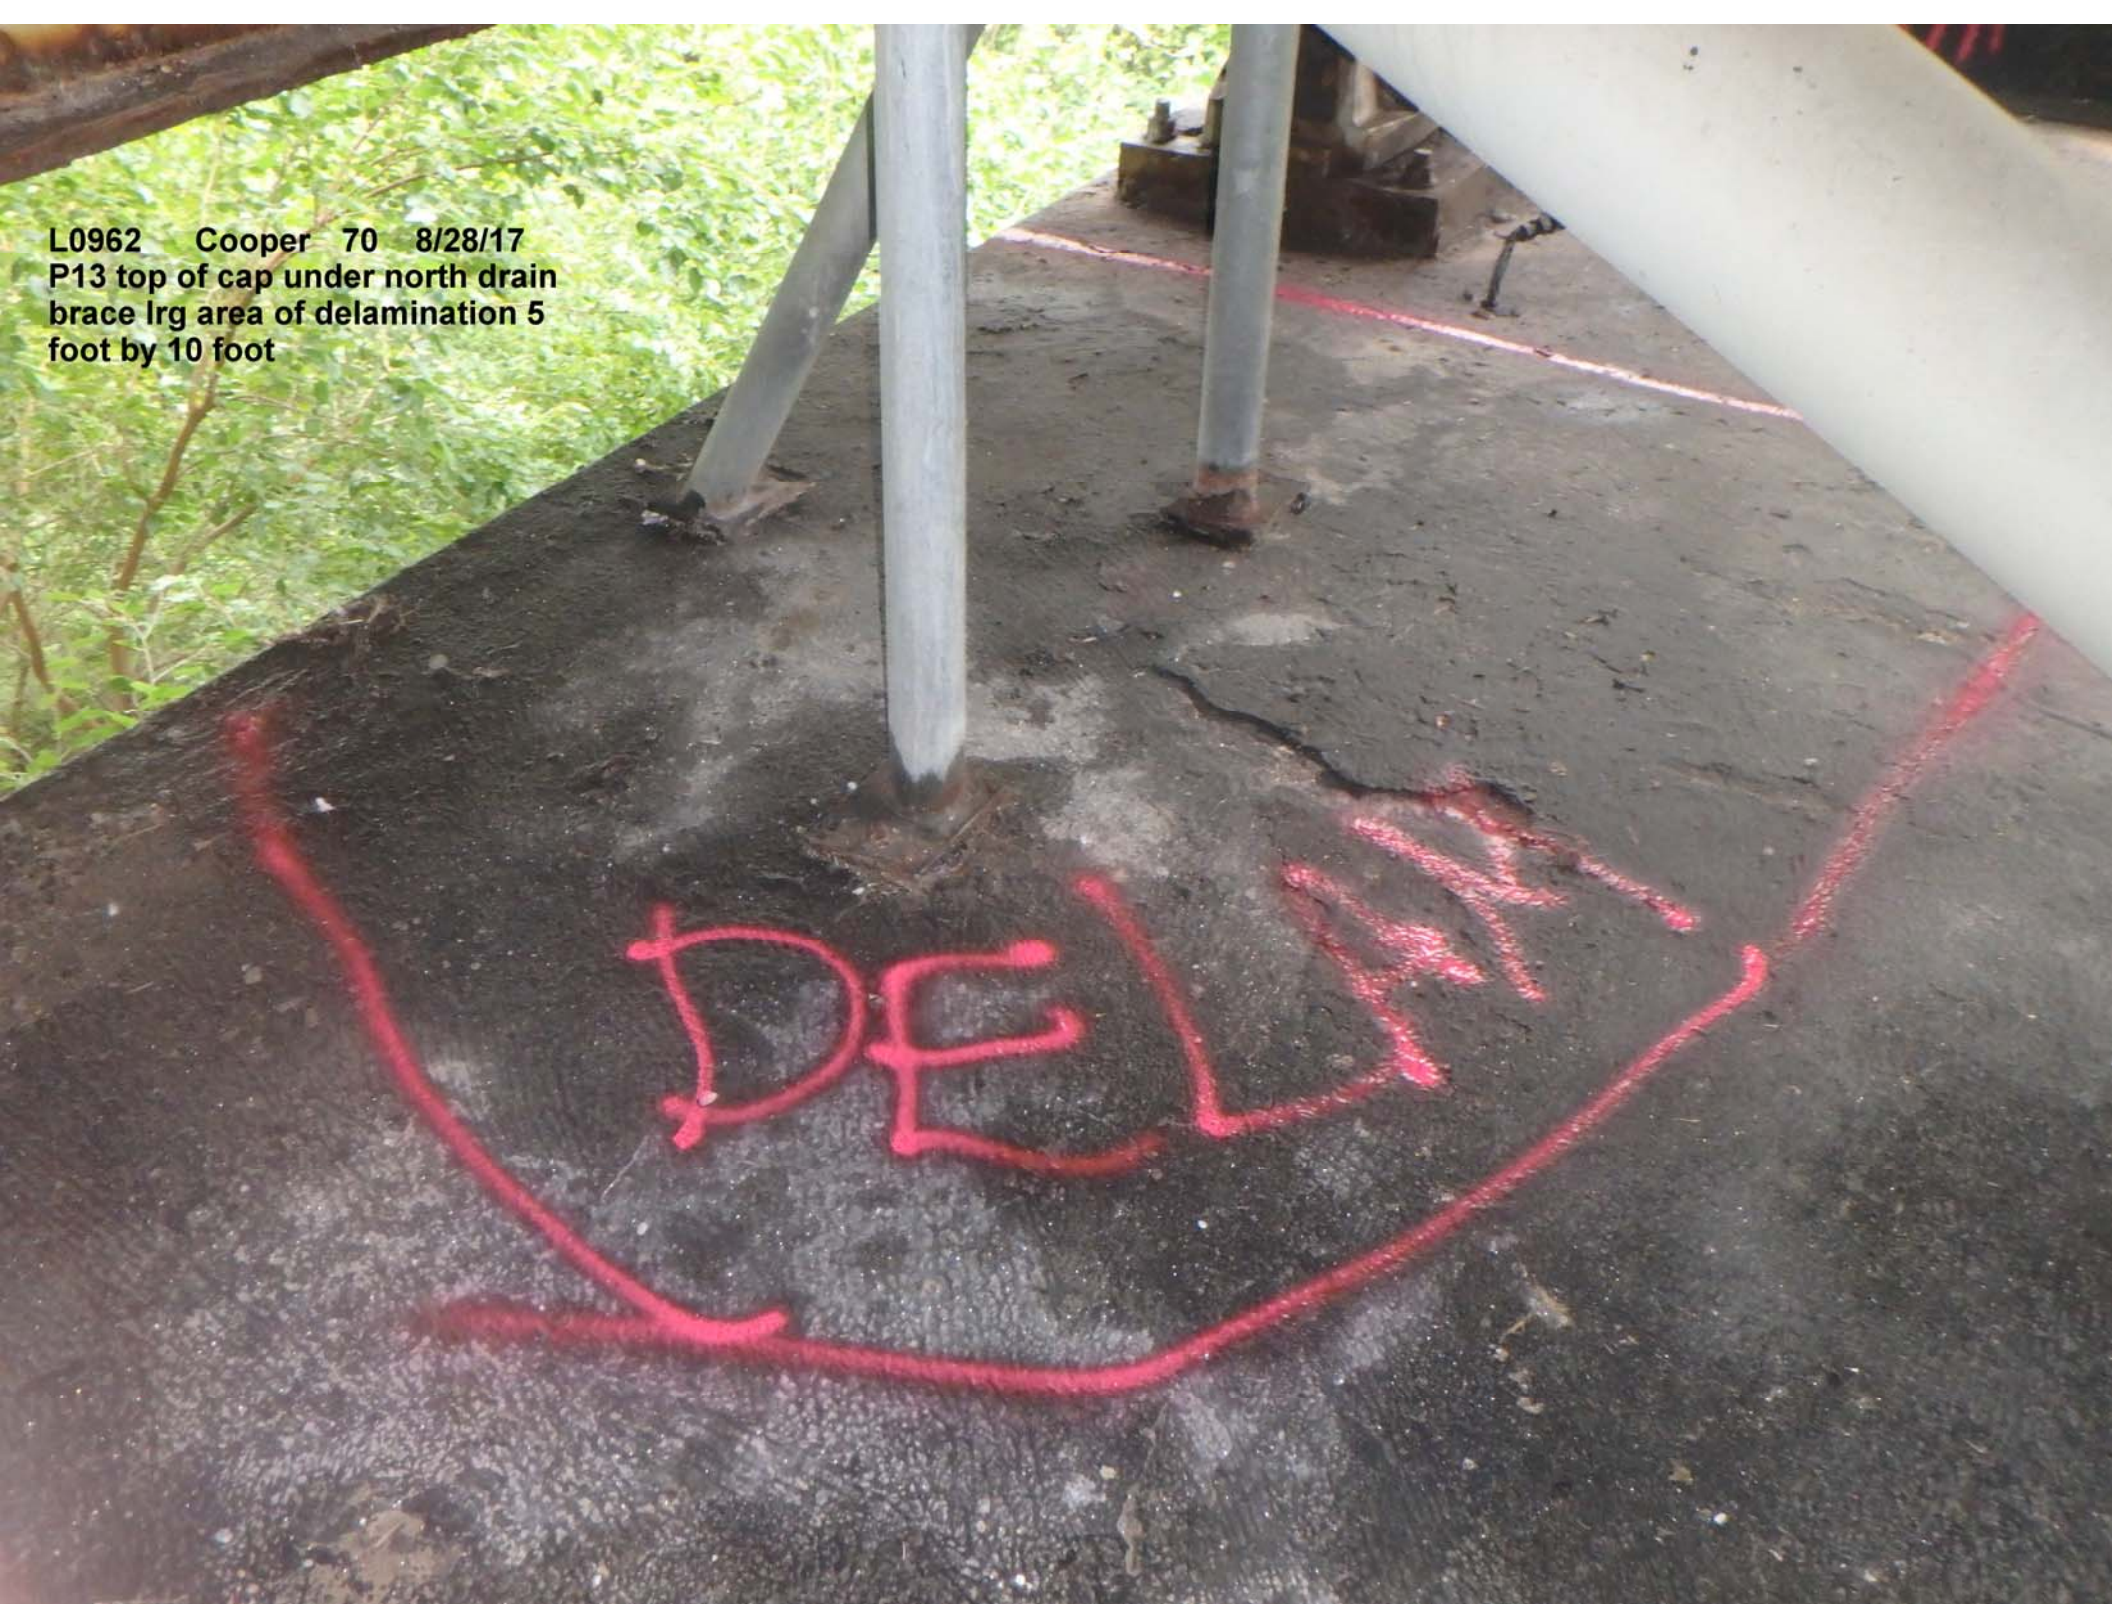
L0962 Cooper 70 8/28/17
P13 top of cap under north drain
brace lrg area of delamination 5
foot by 10 foot

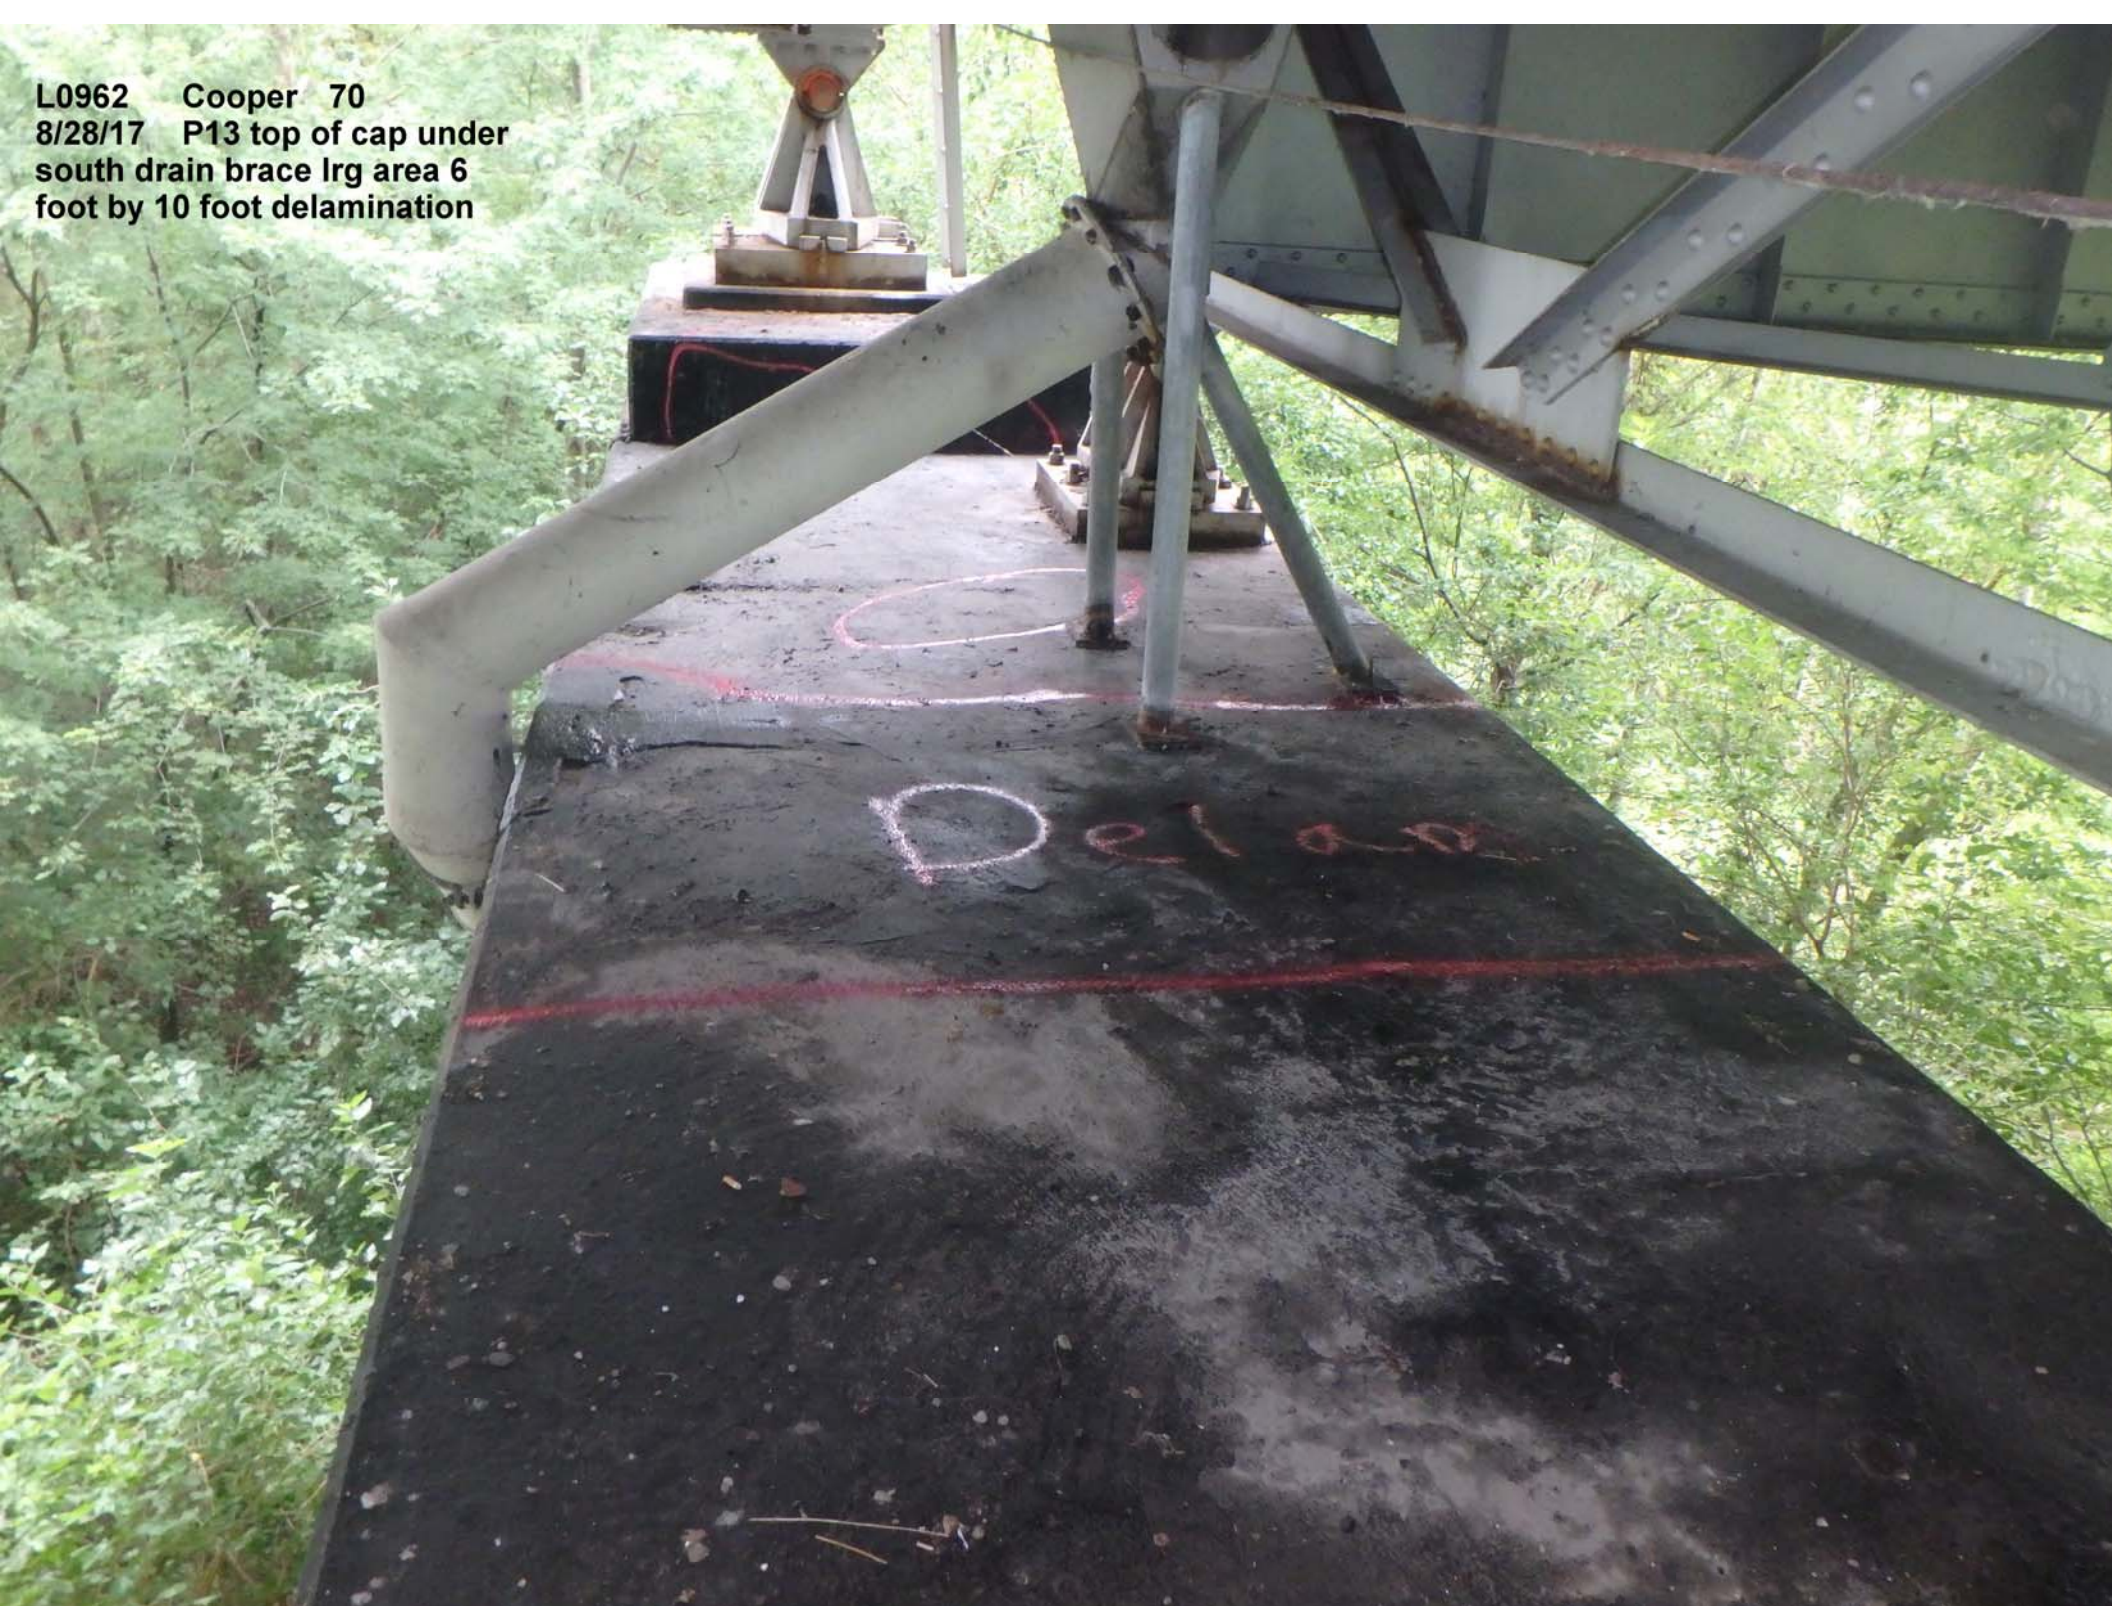
L0962 Cooper 70
8/28/17 P13 top of cap under
south drain brace lrg area 6
foot by 10 foot delamination

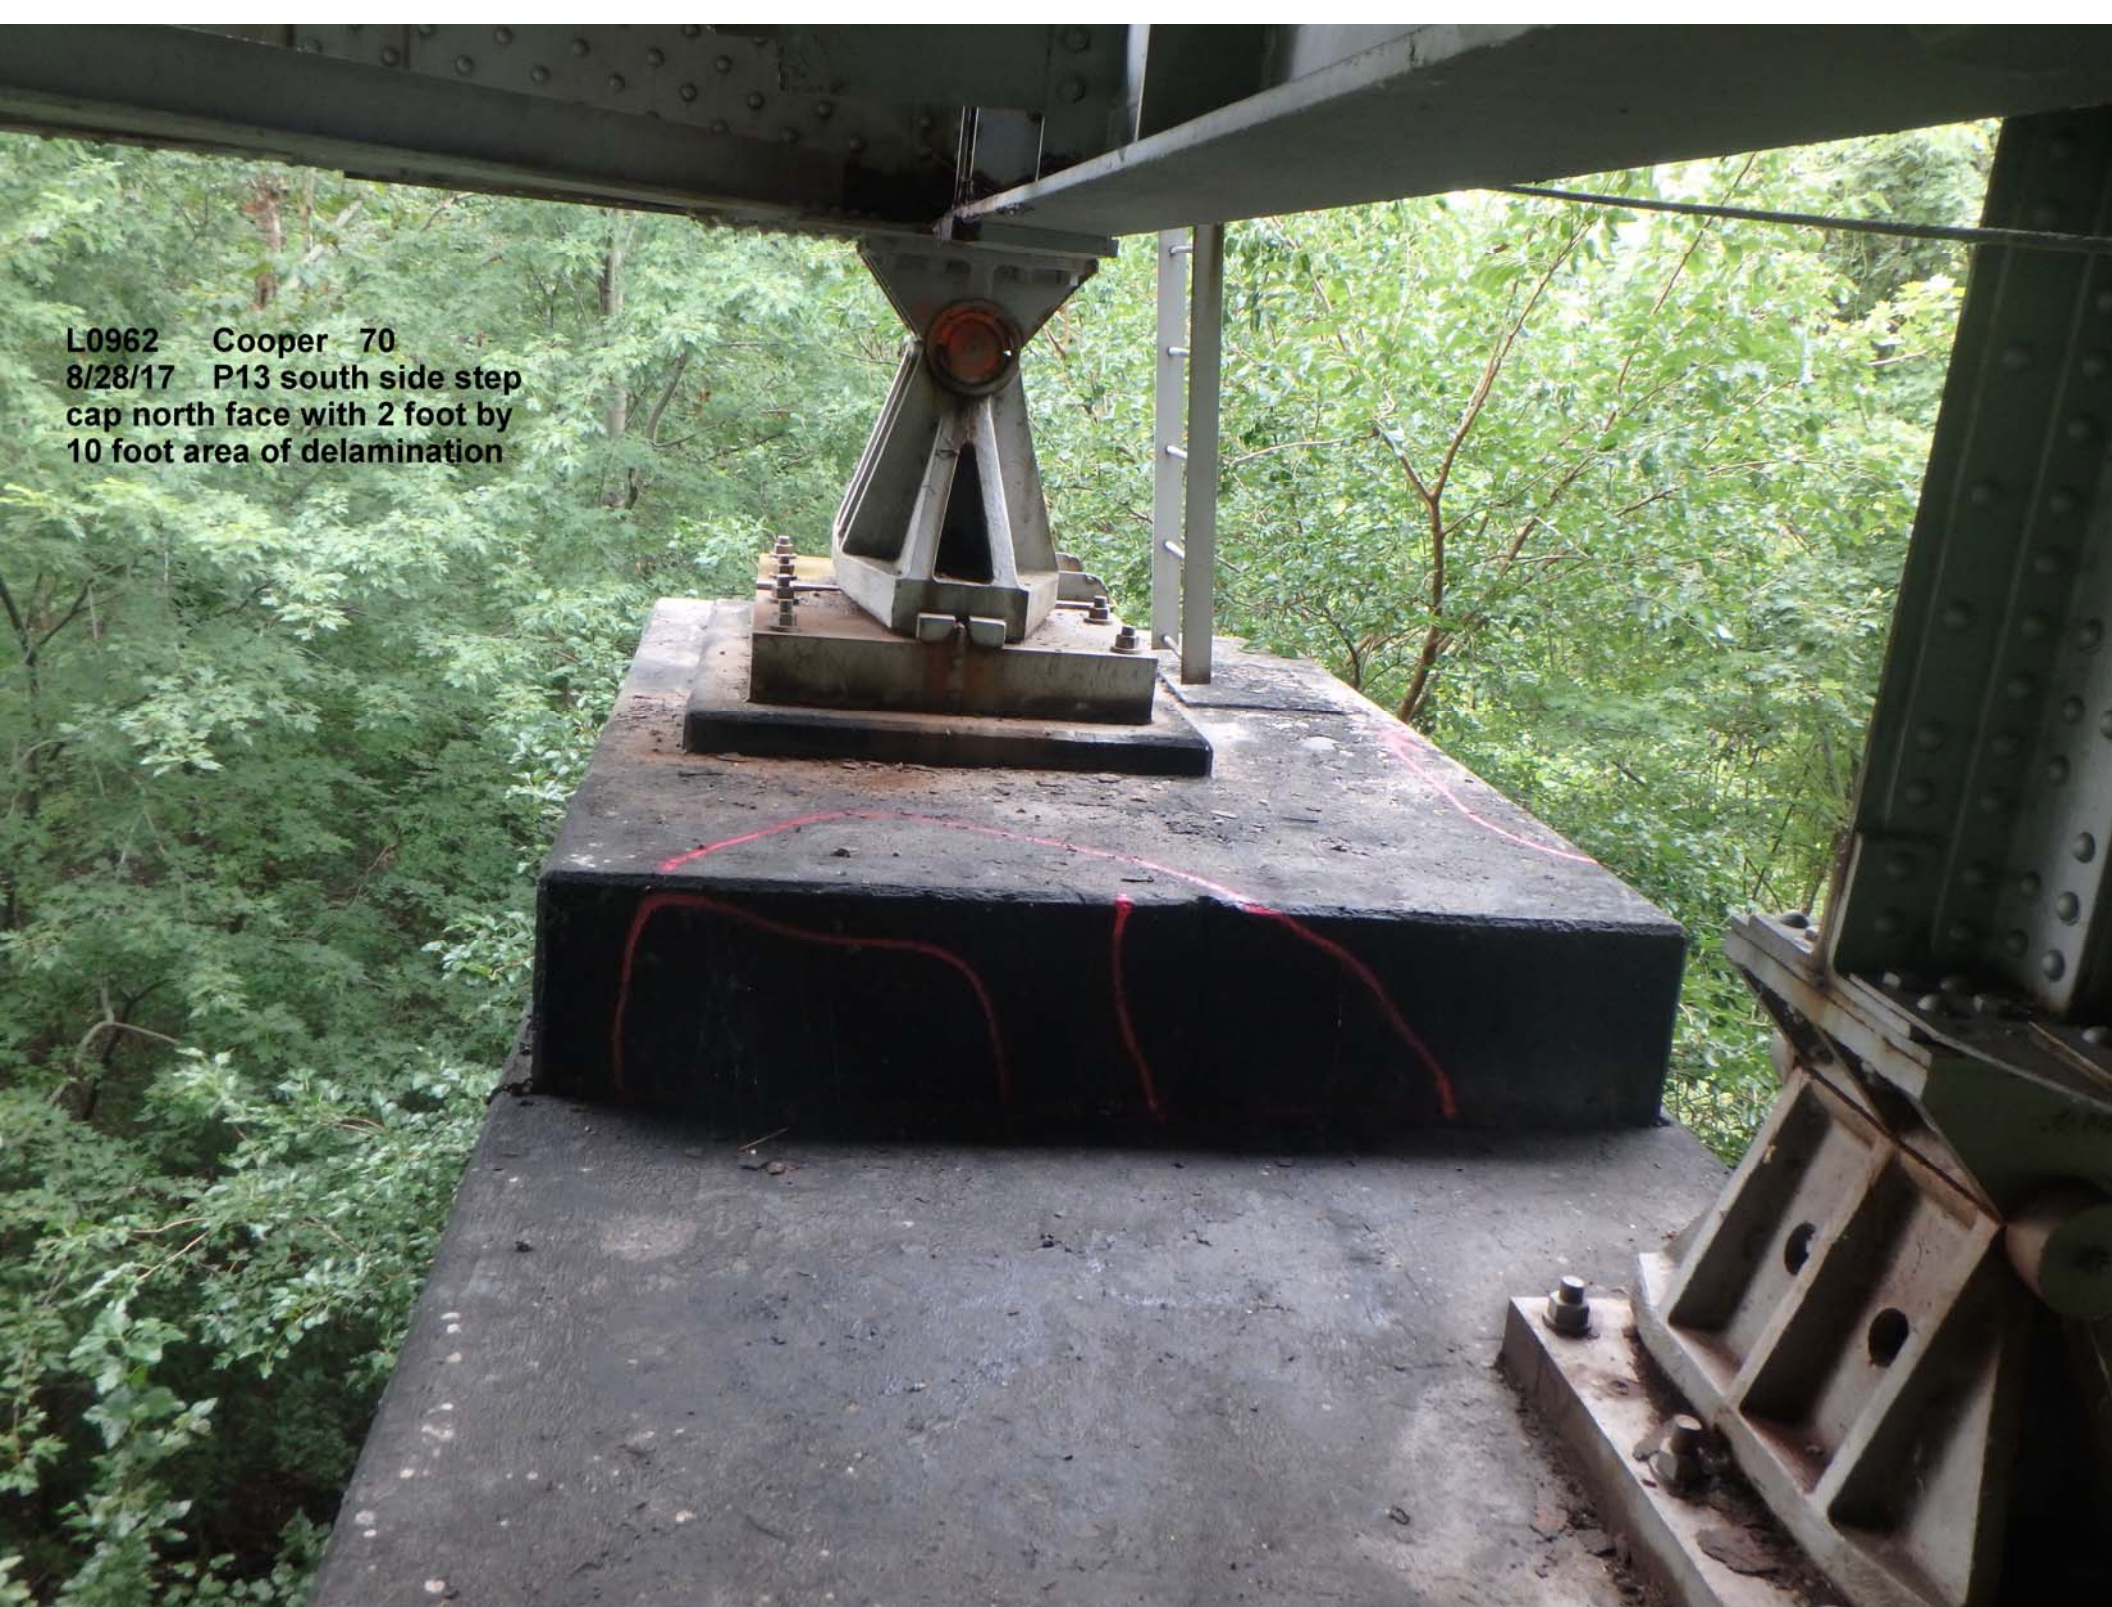
L0962 Cooper 70
8/28/17 P13 south side step
cap north face with 2 foot by
10 foot area of delamination

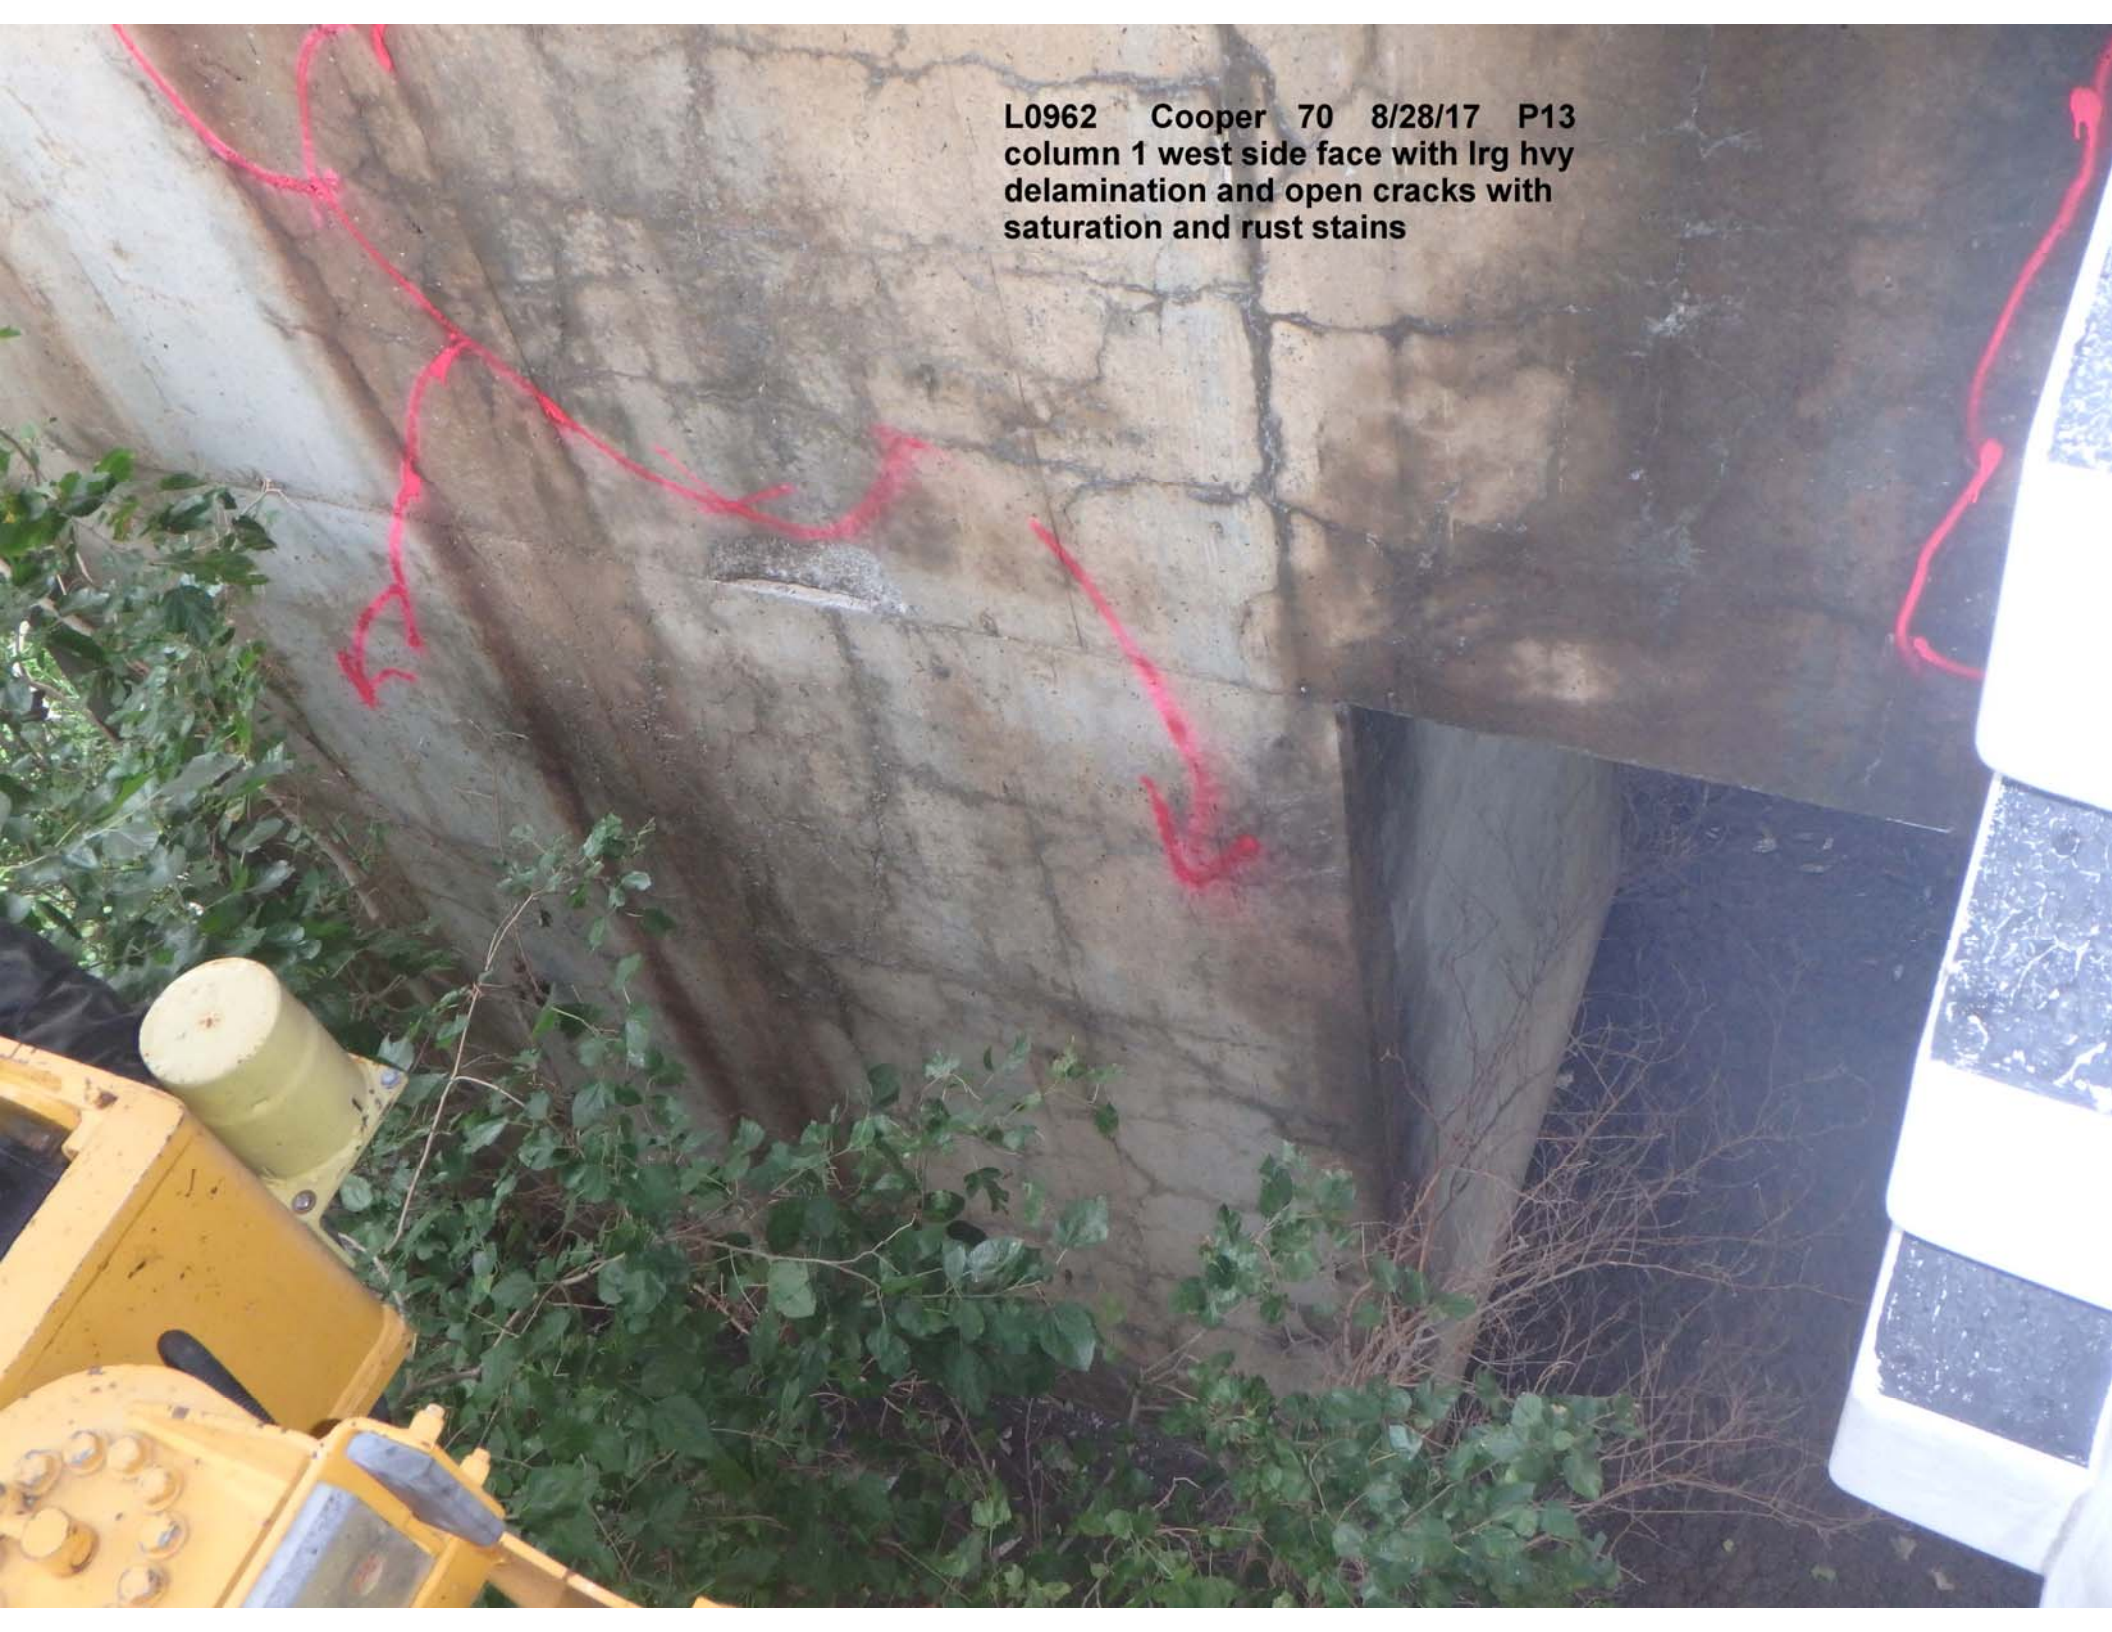
L0962 Cooper 70 8/28/17 P13
column 1 west side face with lrg hvy
delamination and open cracks with
saturation and rust stains

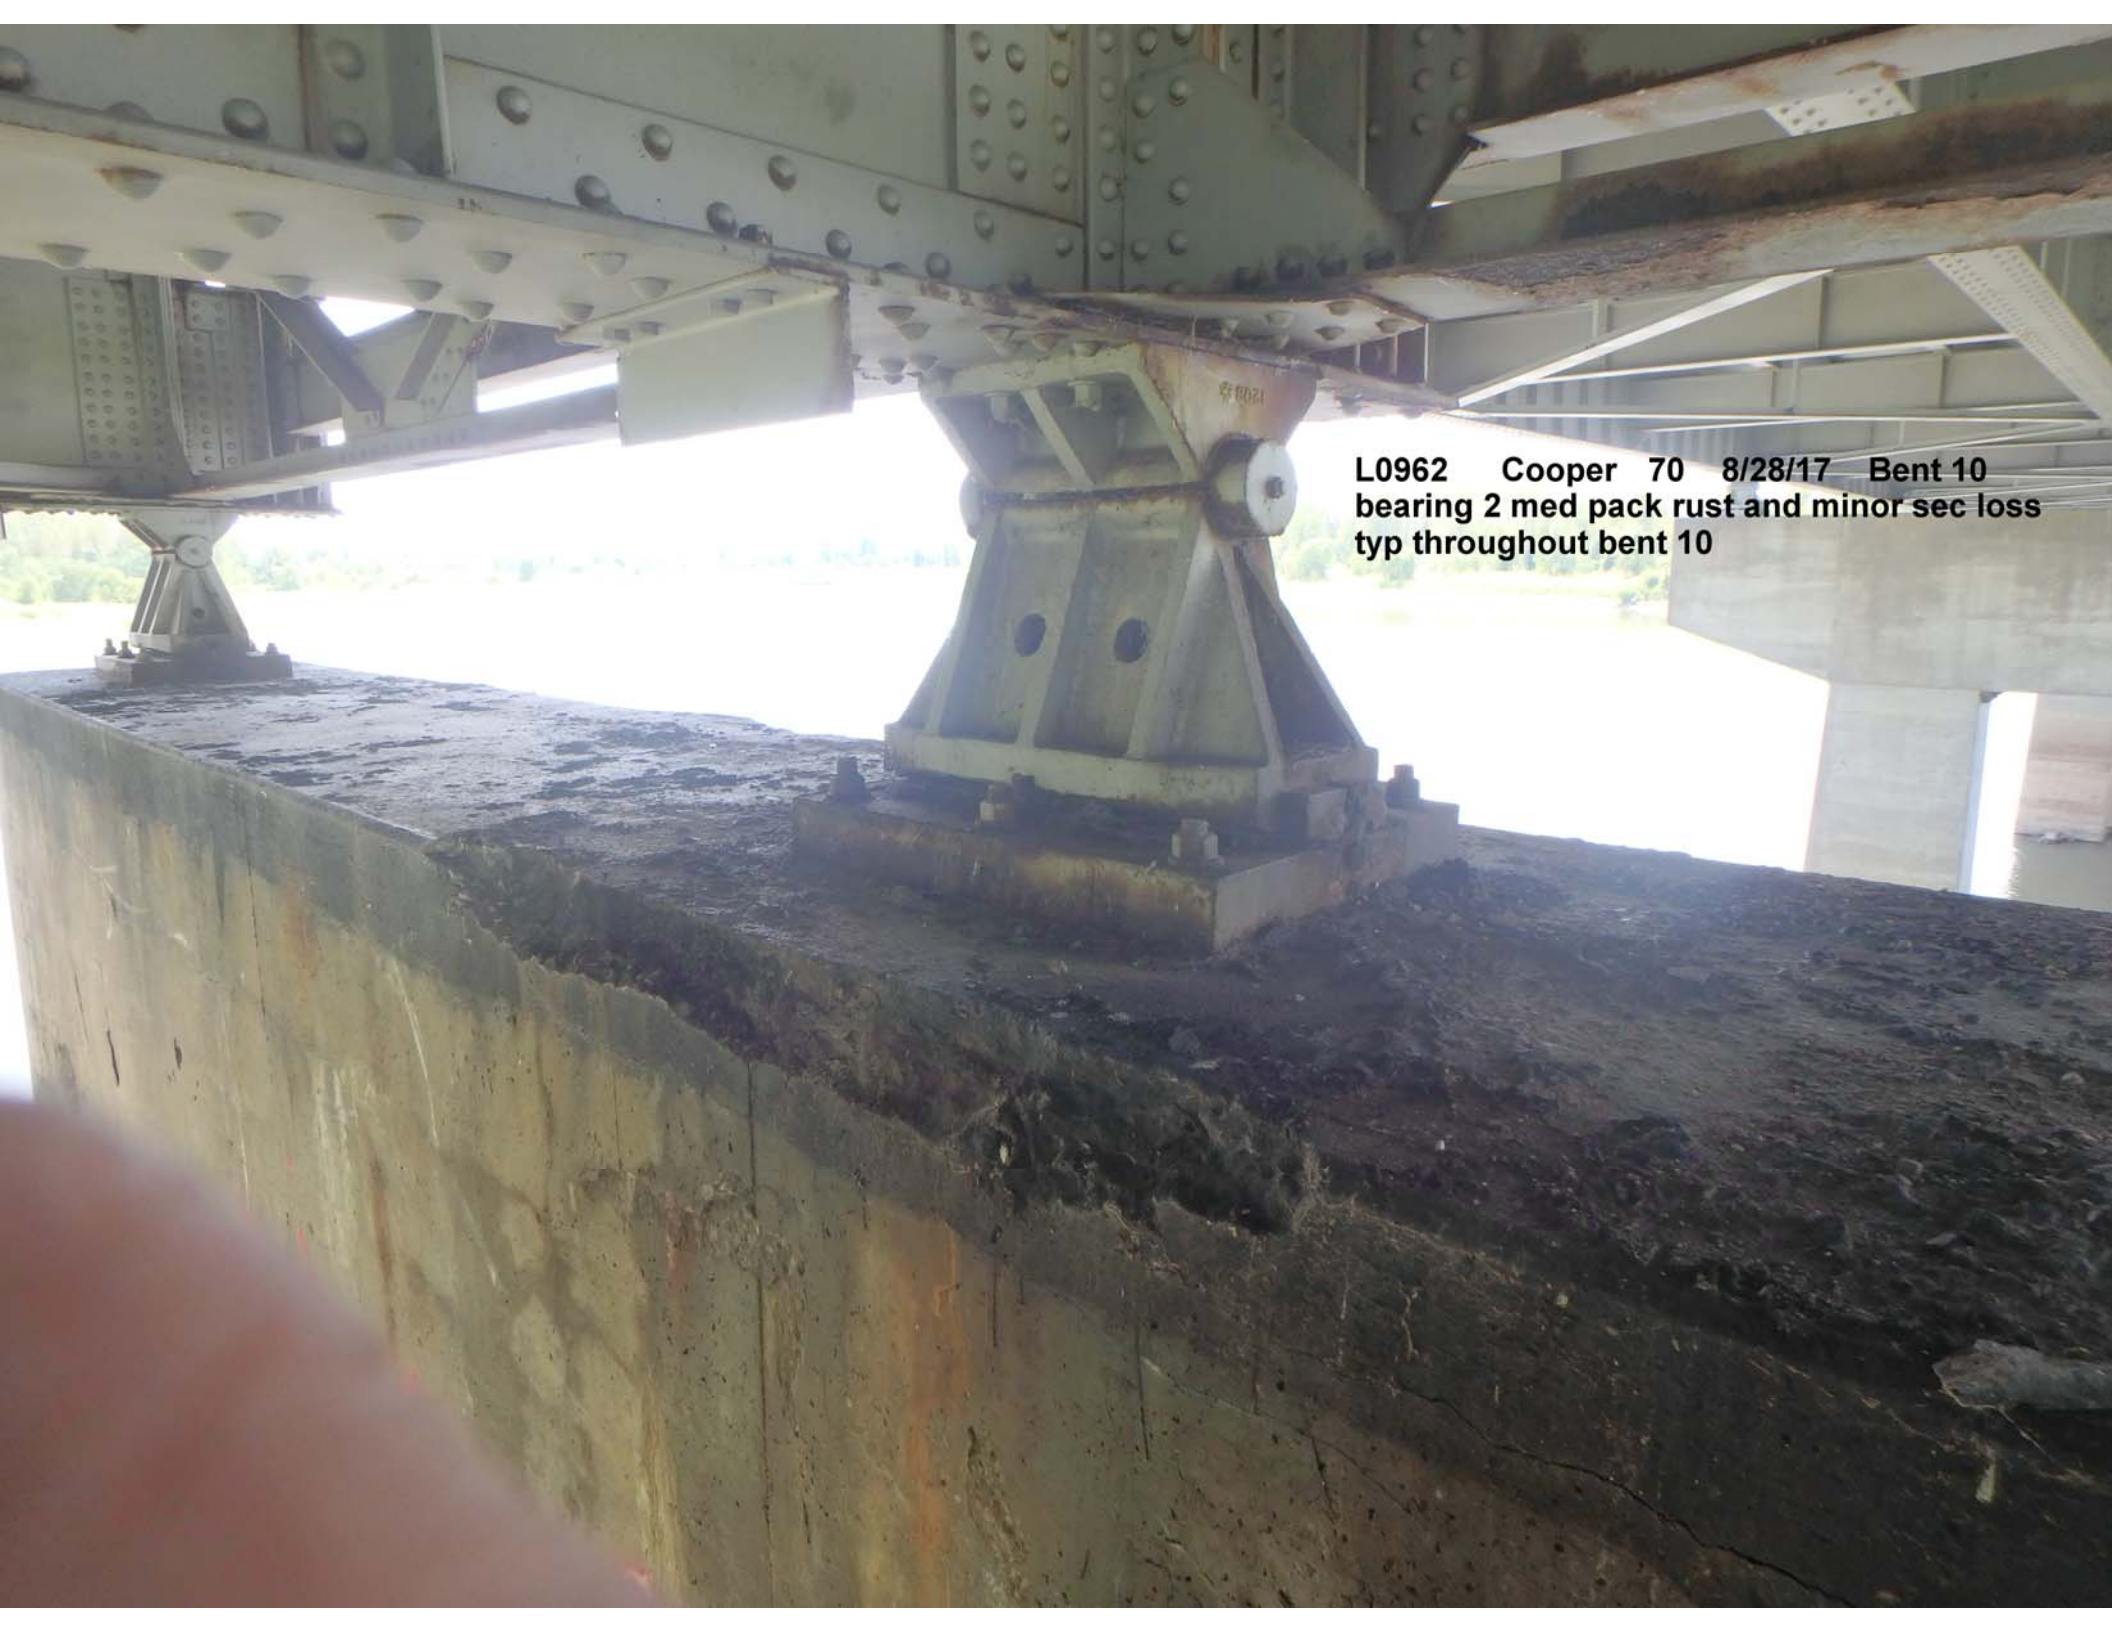
L0962 Cooper 70 8/28/17 Bent 10
column 1 east side face entire face with
deep delaminations open cracks rust stains
eff and saturation

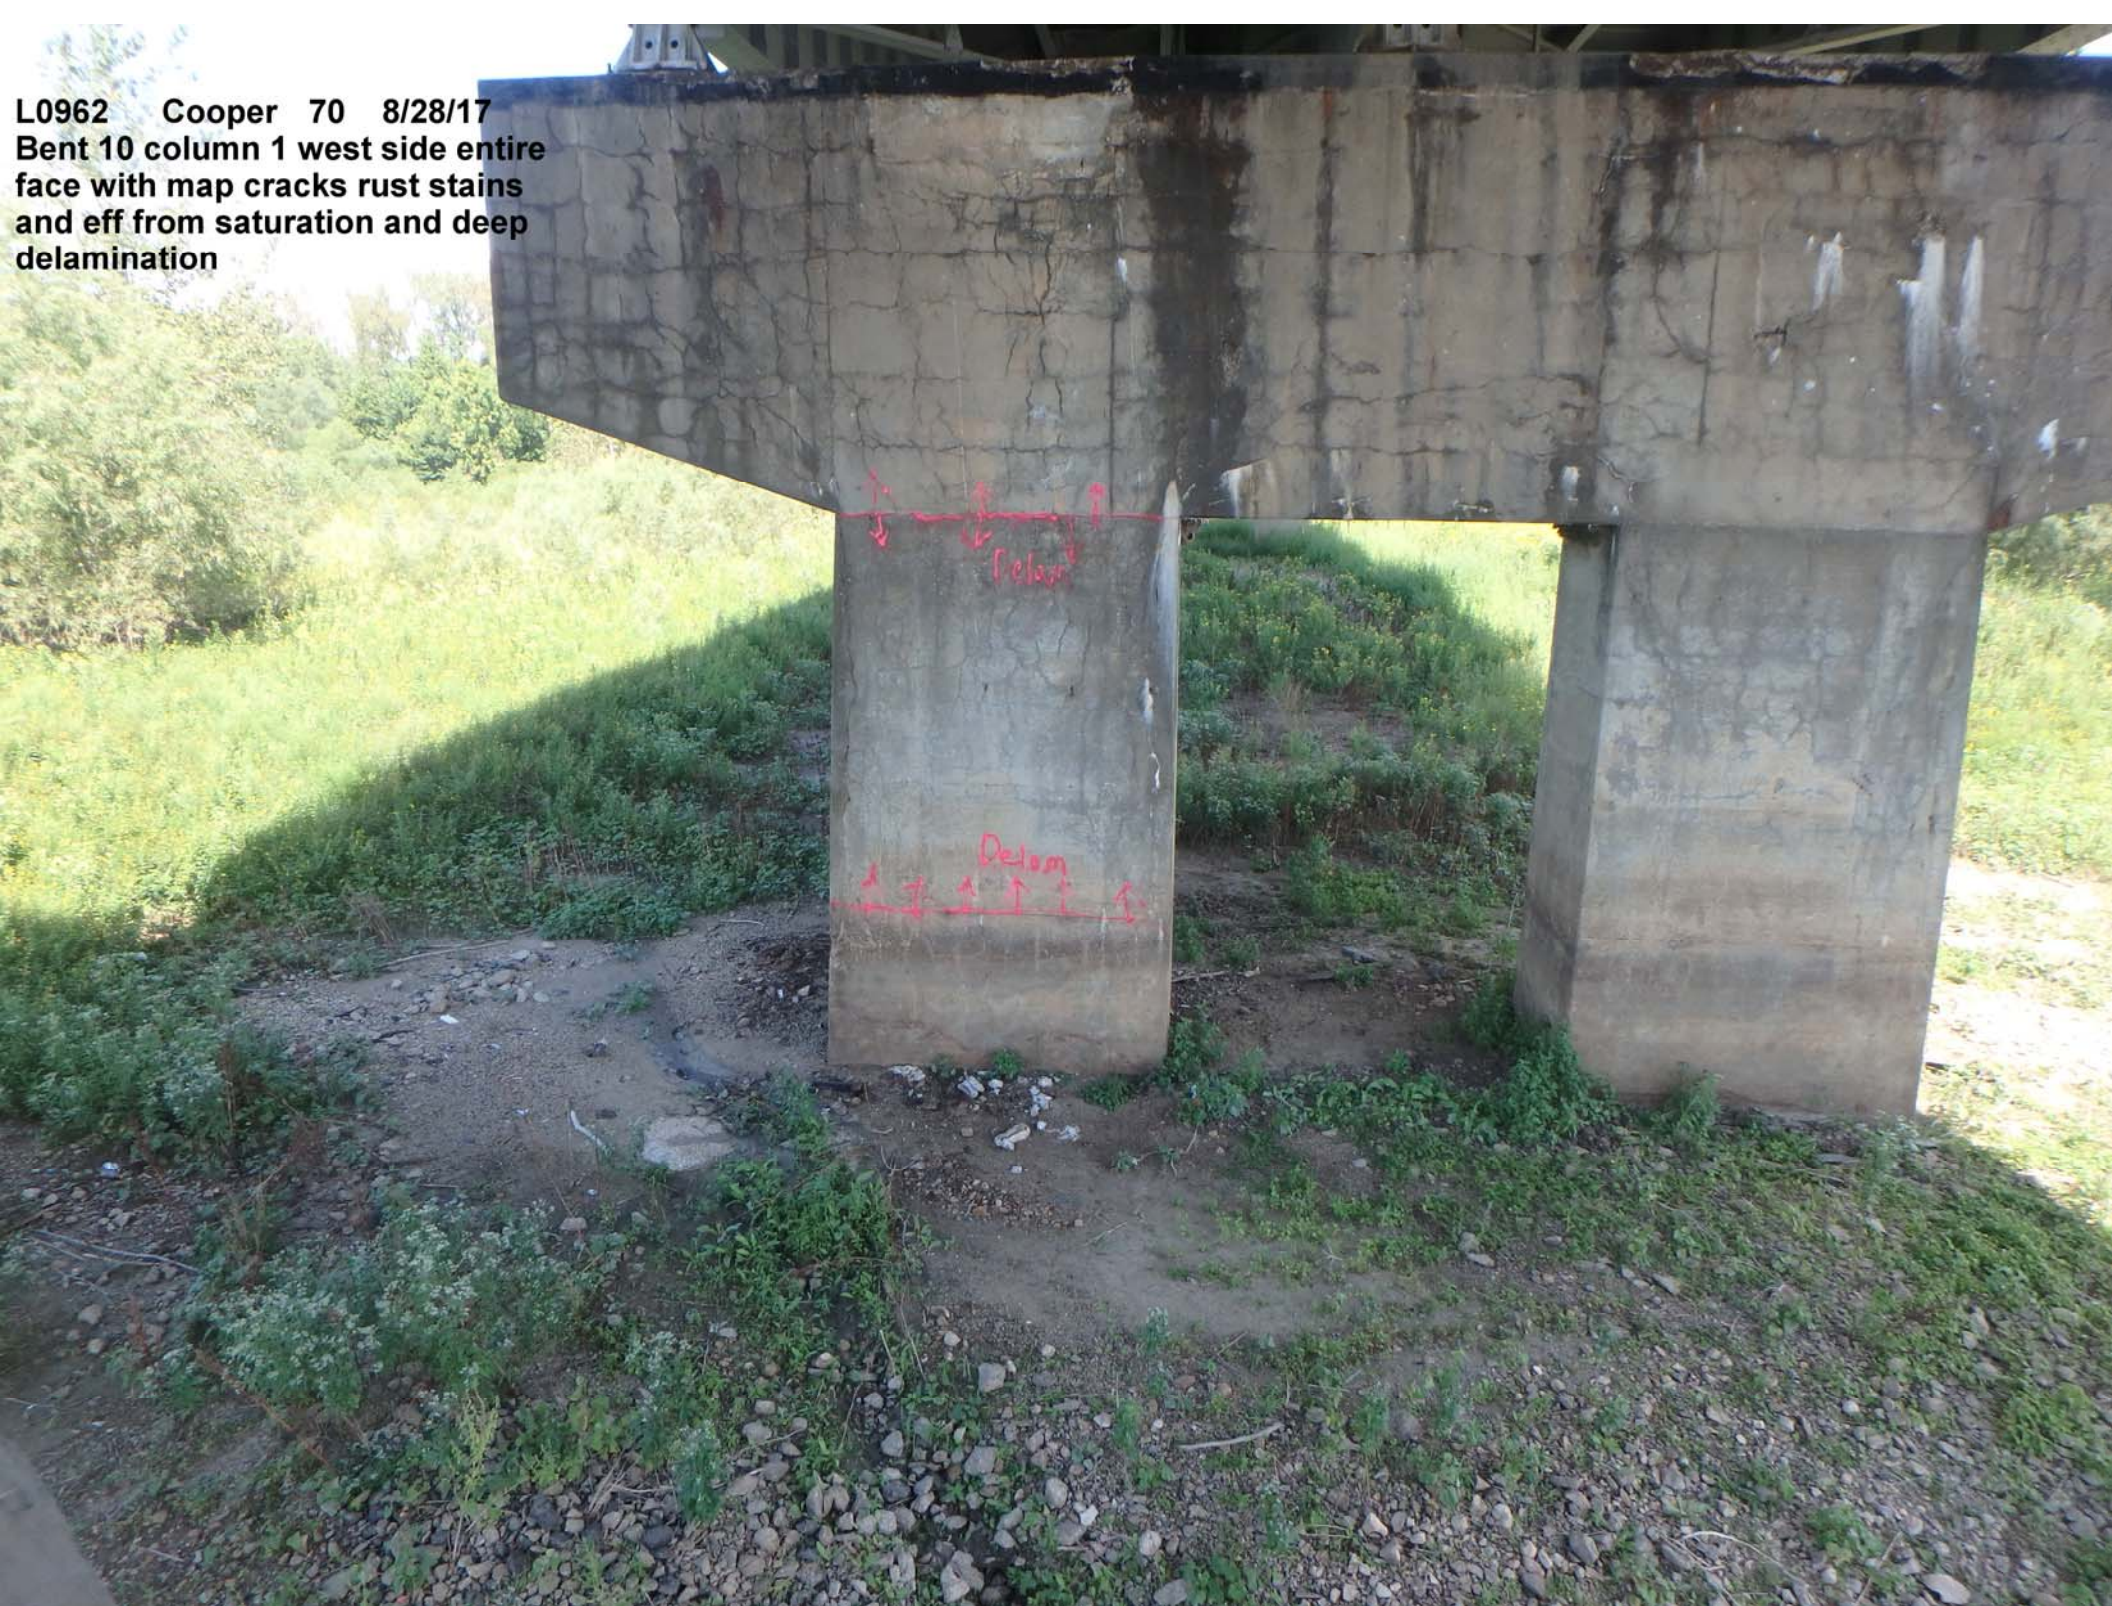
L0962 Cooper 70 8/28/17
Bent 10 column 1 west side entire
face with map cracks rust stains
and eff from saturation and deep
delamination
