L0962 Cooper 70 8/28/17
P13 east side lrg area of map
cracks with saturation and eff

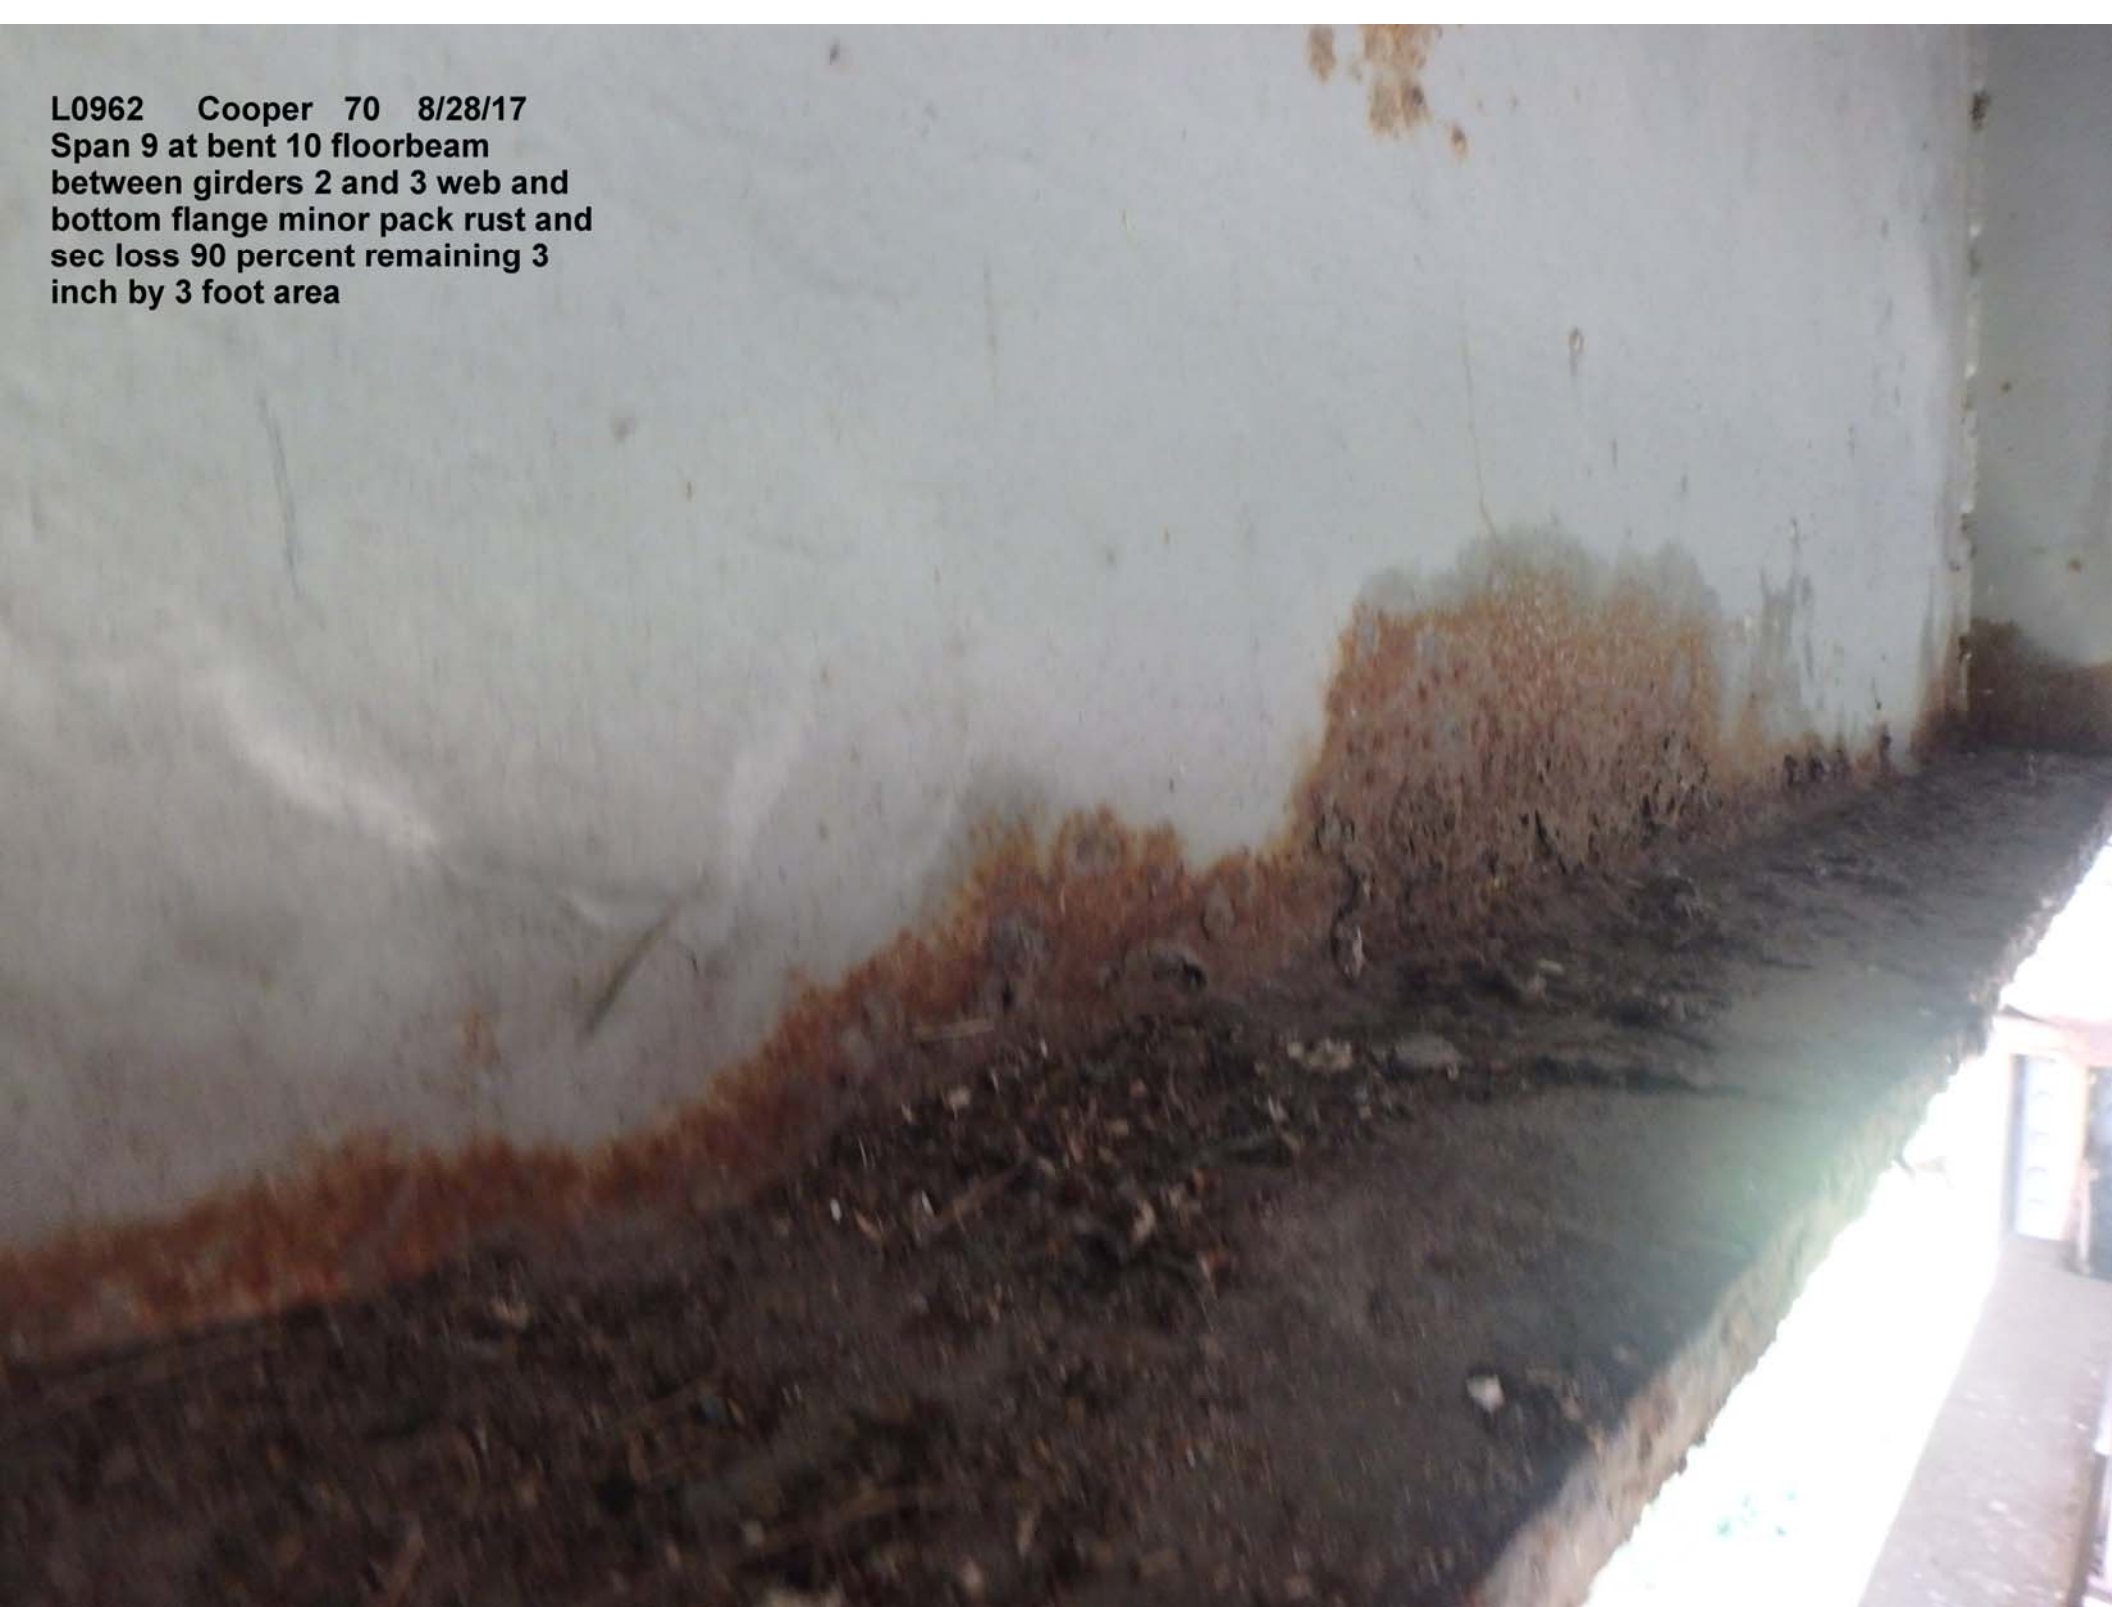
L0962 Cooper 70 8/28/17
Span 9 at bent 10 floorbeam
between girders 2 and 3 web and
bottom flange minor pack rust and
sec loss 90 percent remaining 3
inch by 3 foot area

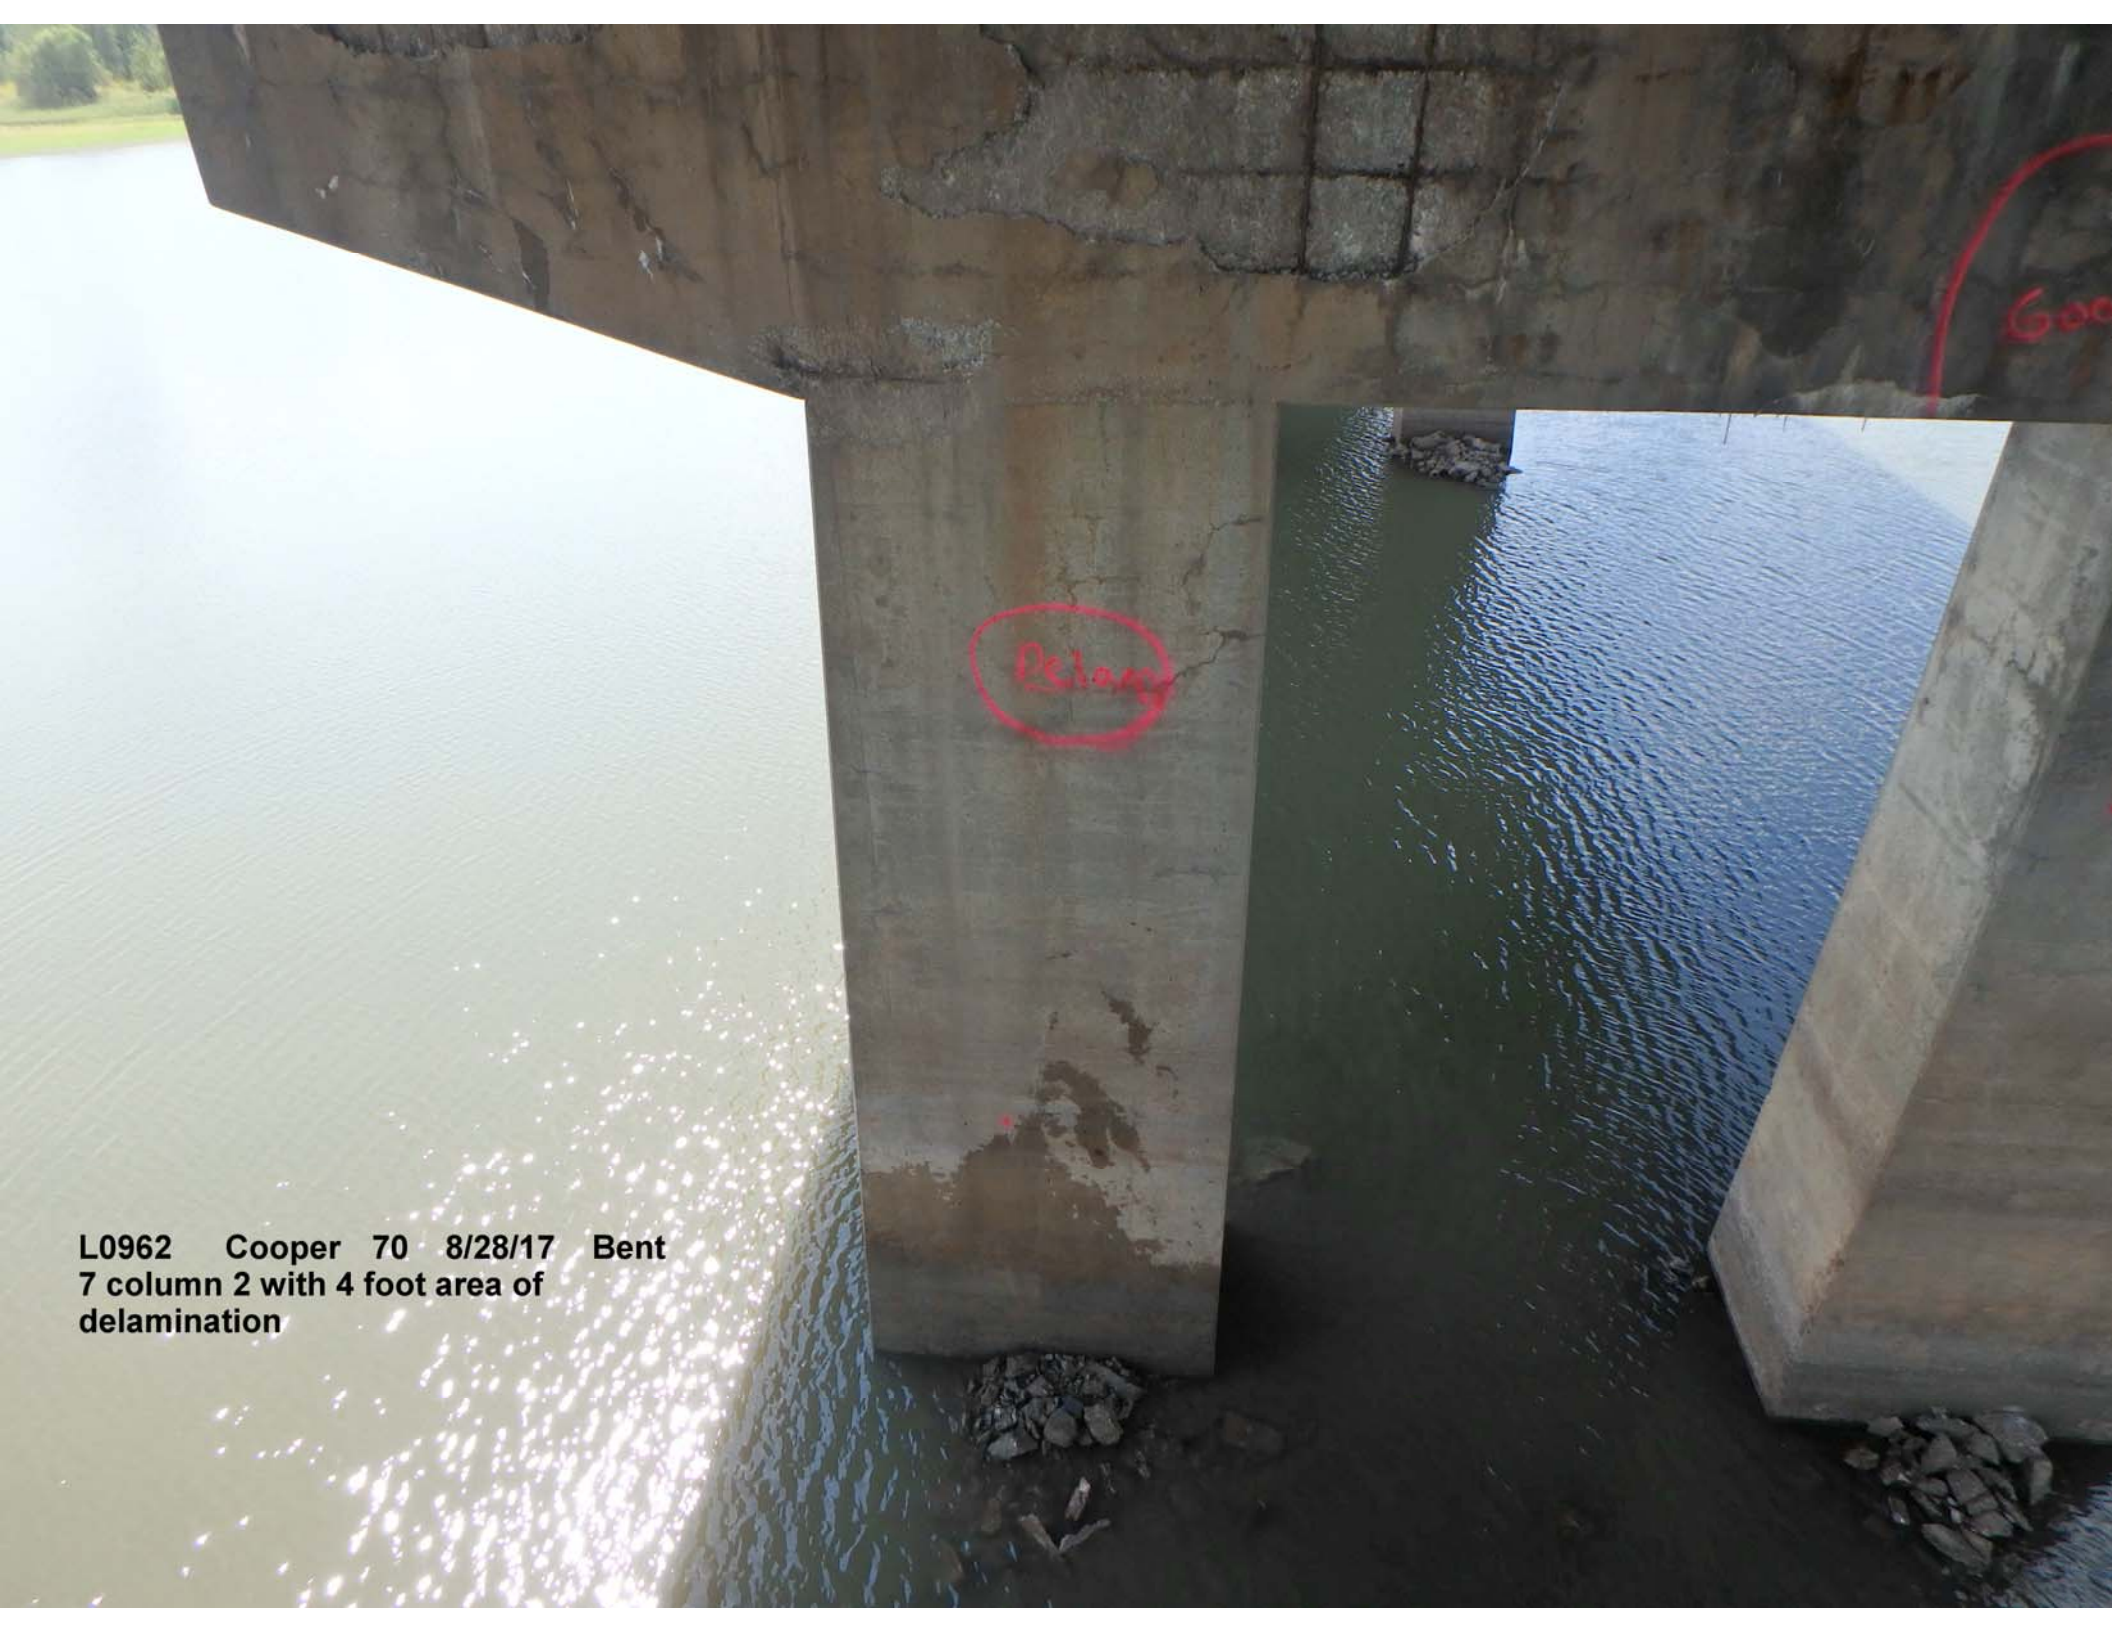
L0962 Cooper 70 8/28/17 Bent
7 column 2 with 4 foot area of
delamination

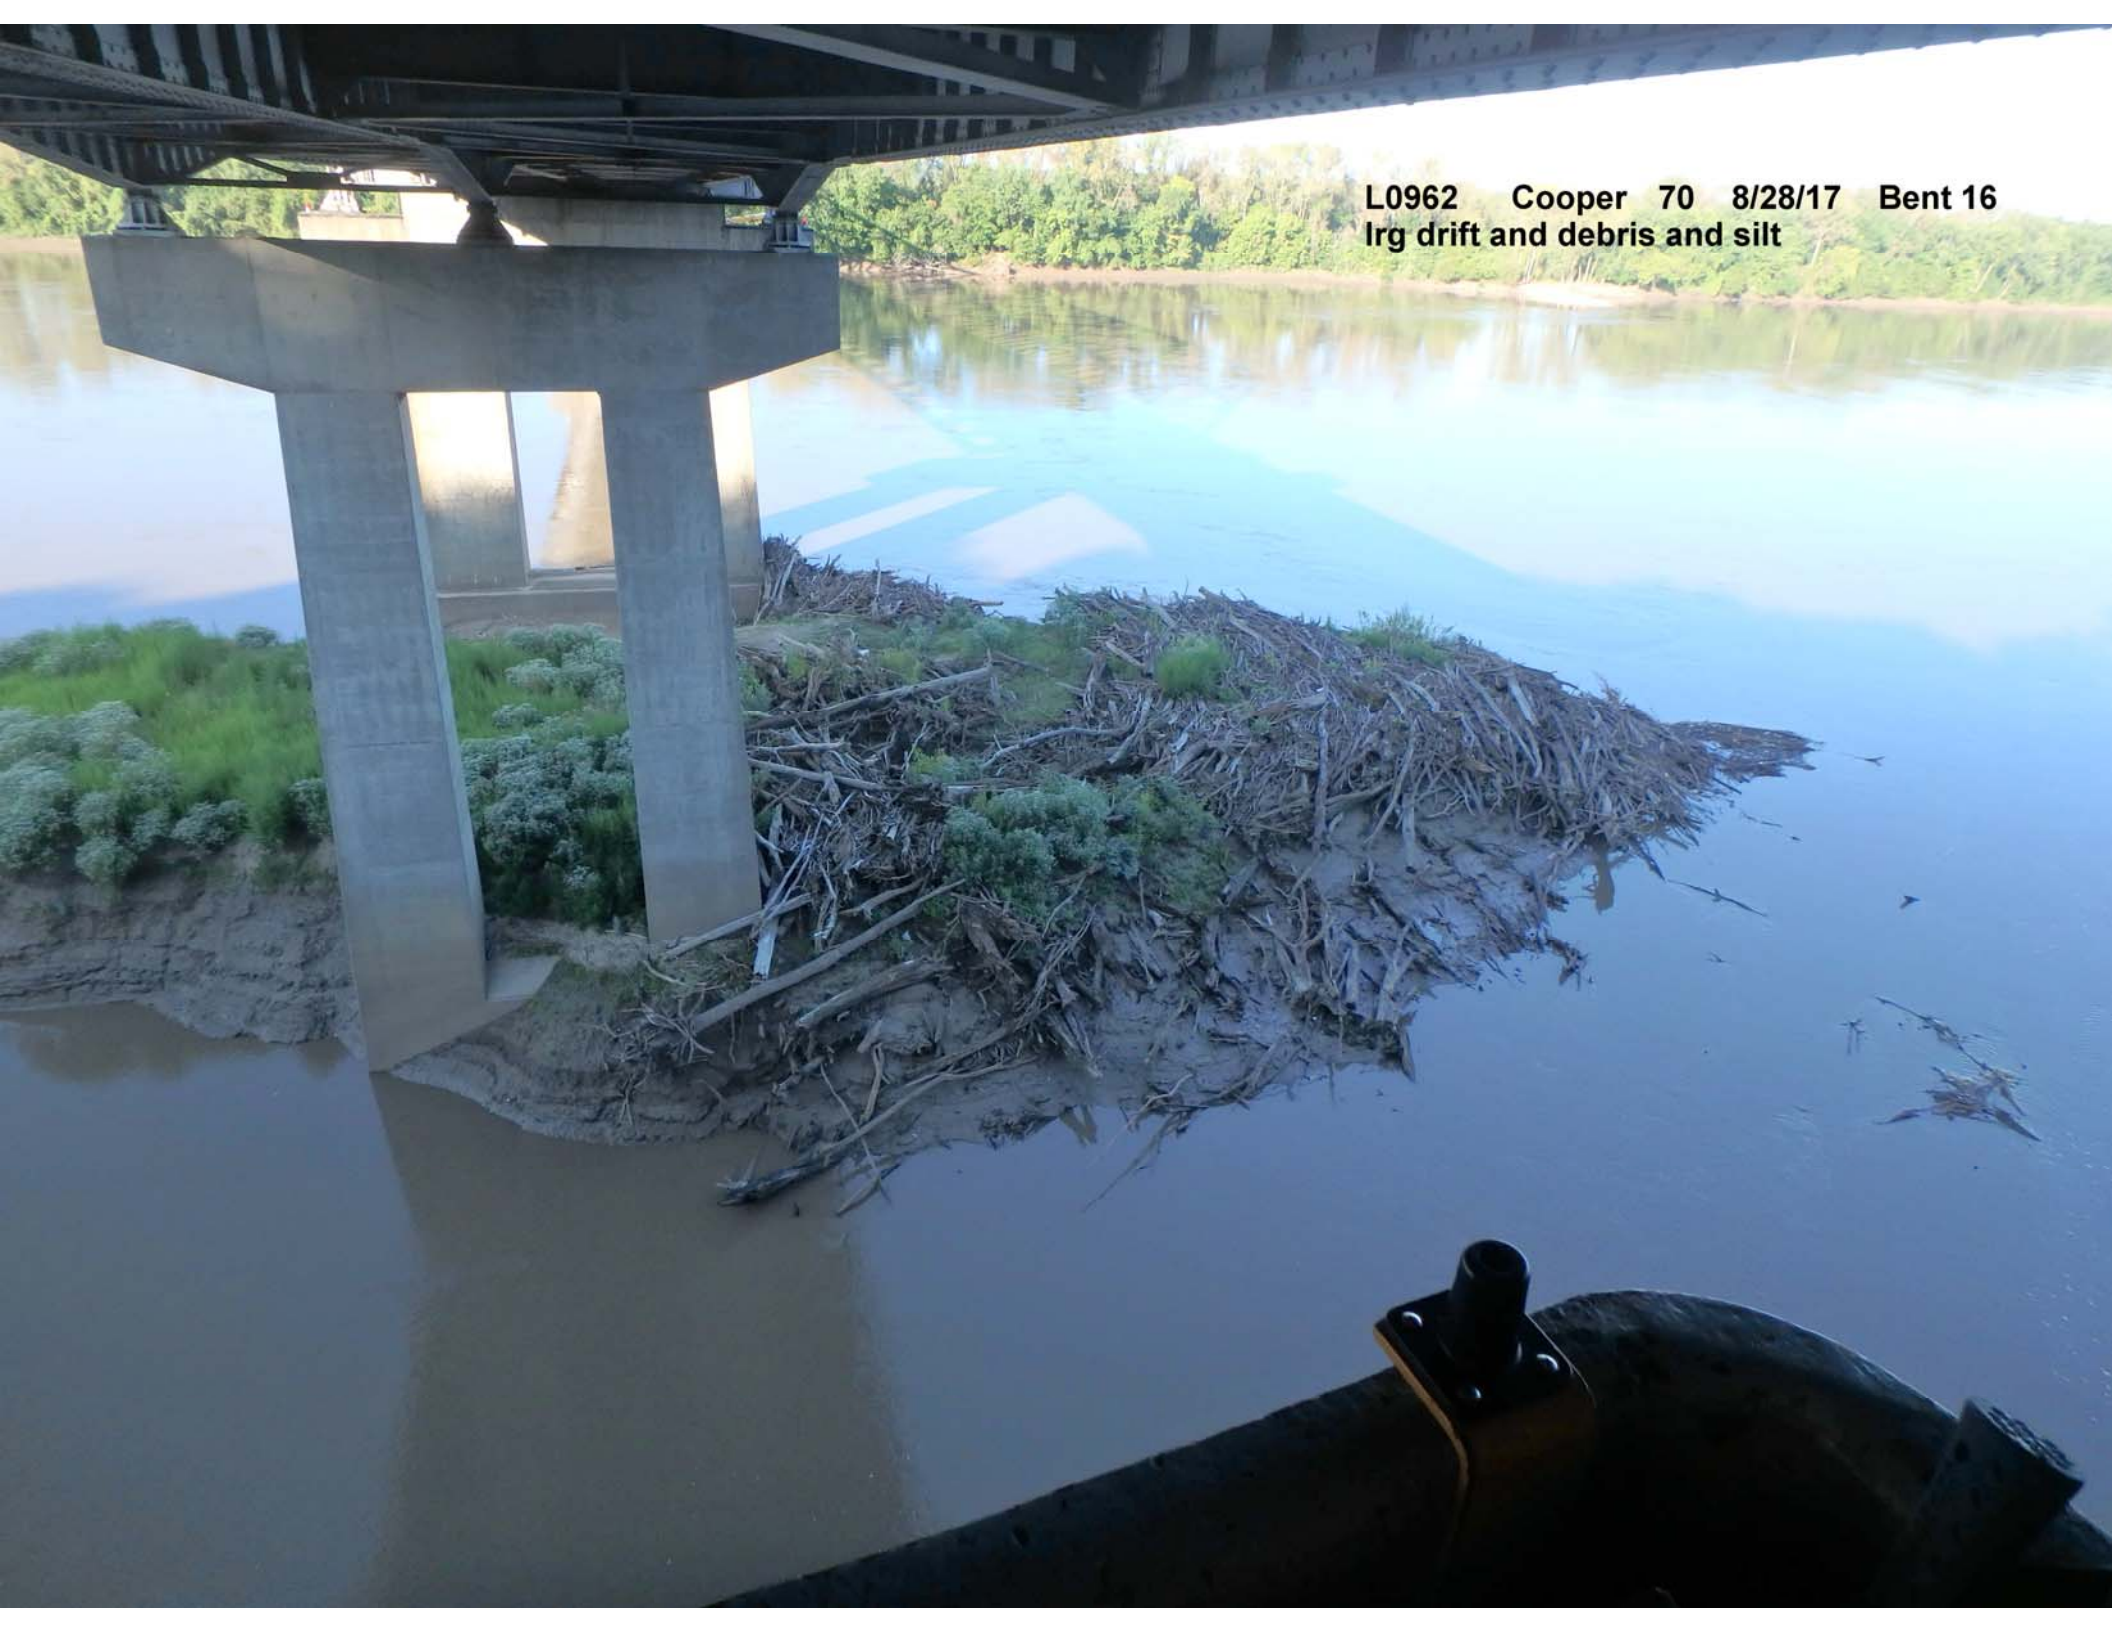
L0962 Cooper 70 8/28/17 Bent 16
lrg drift and debris and silt

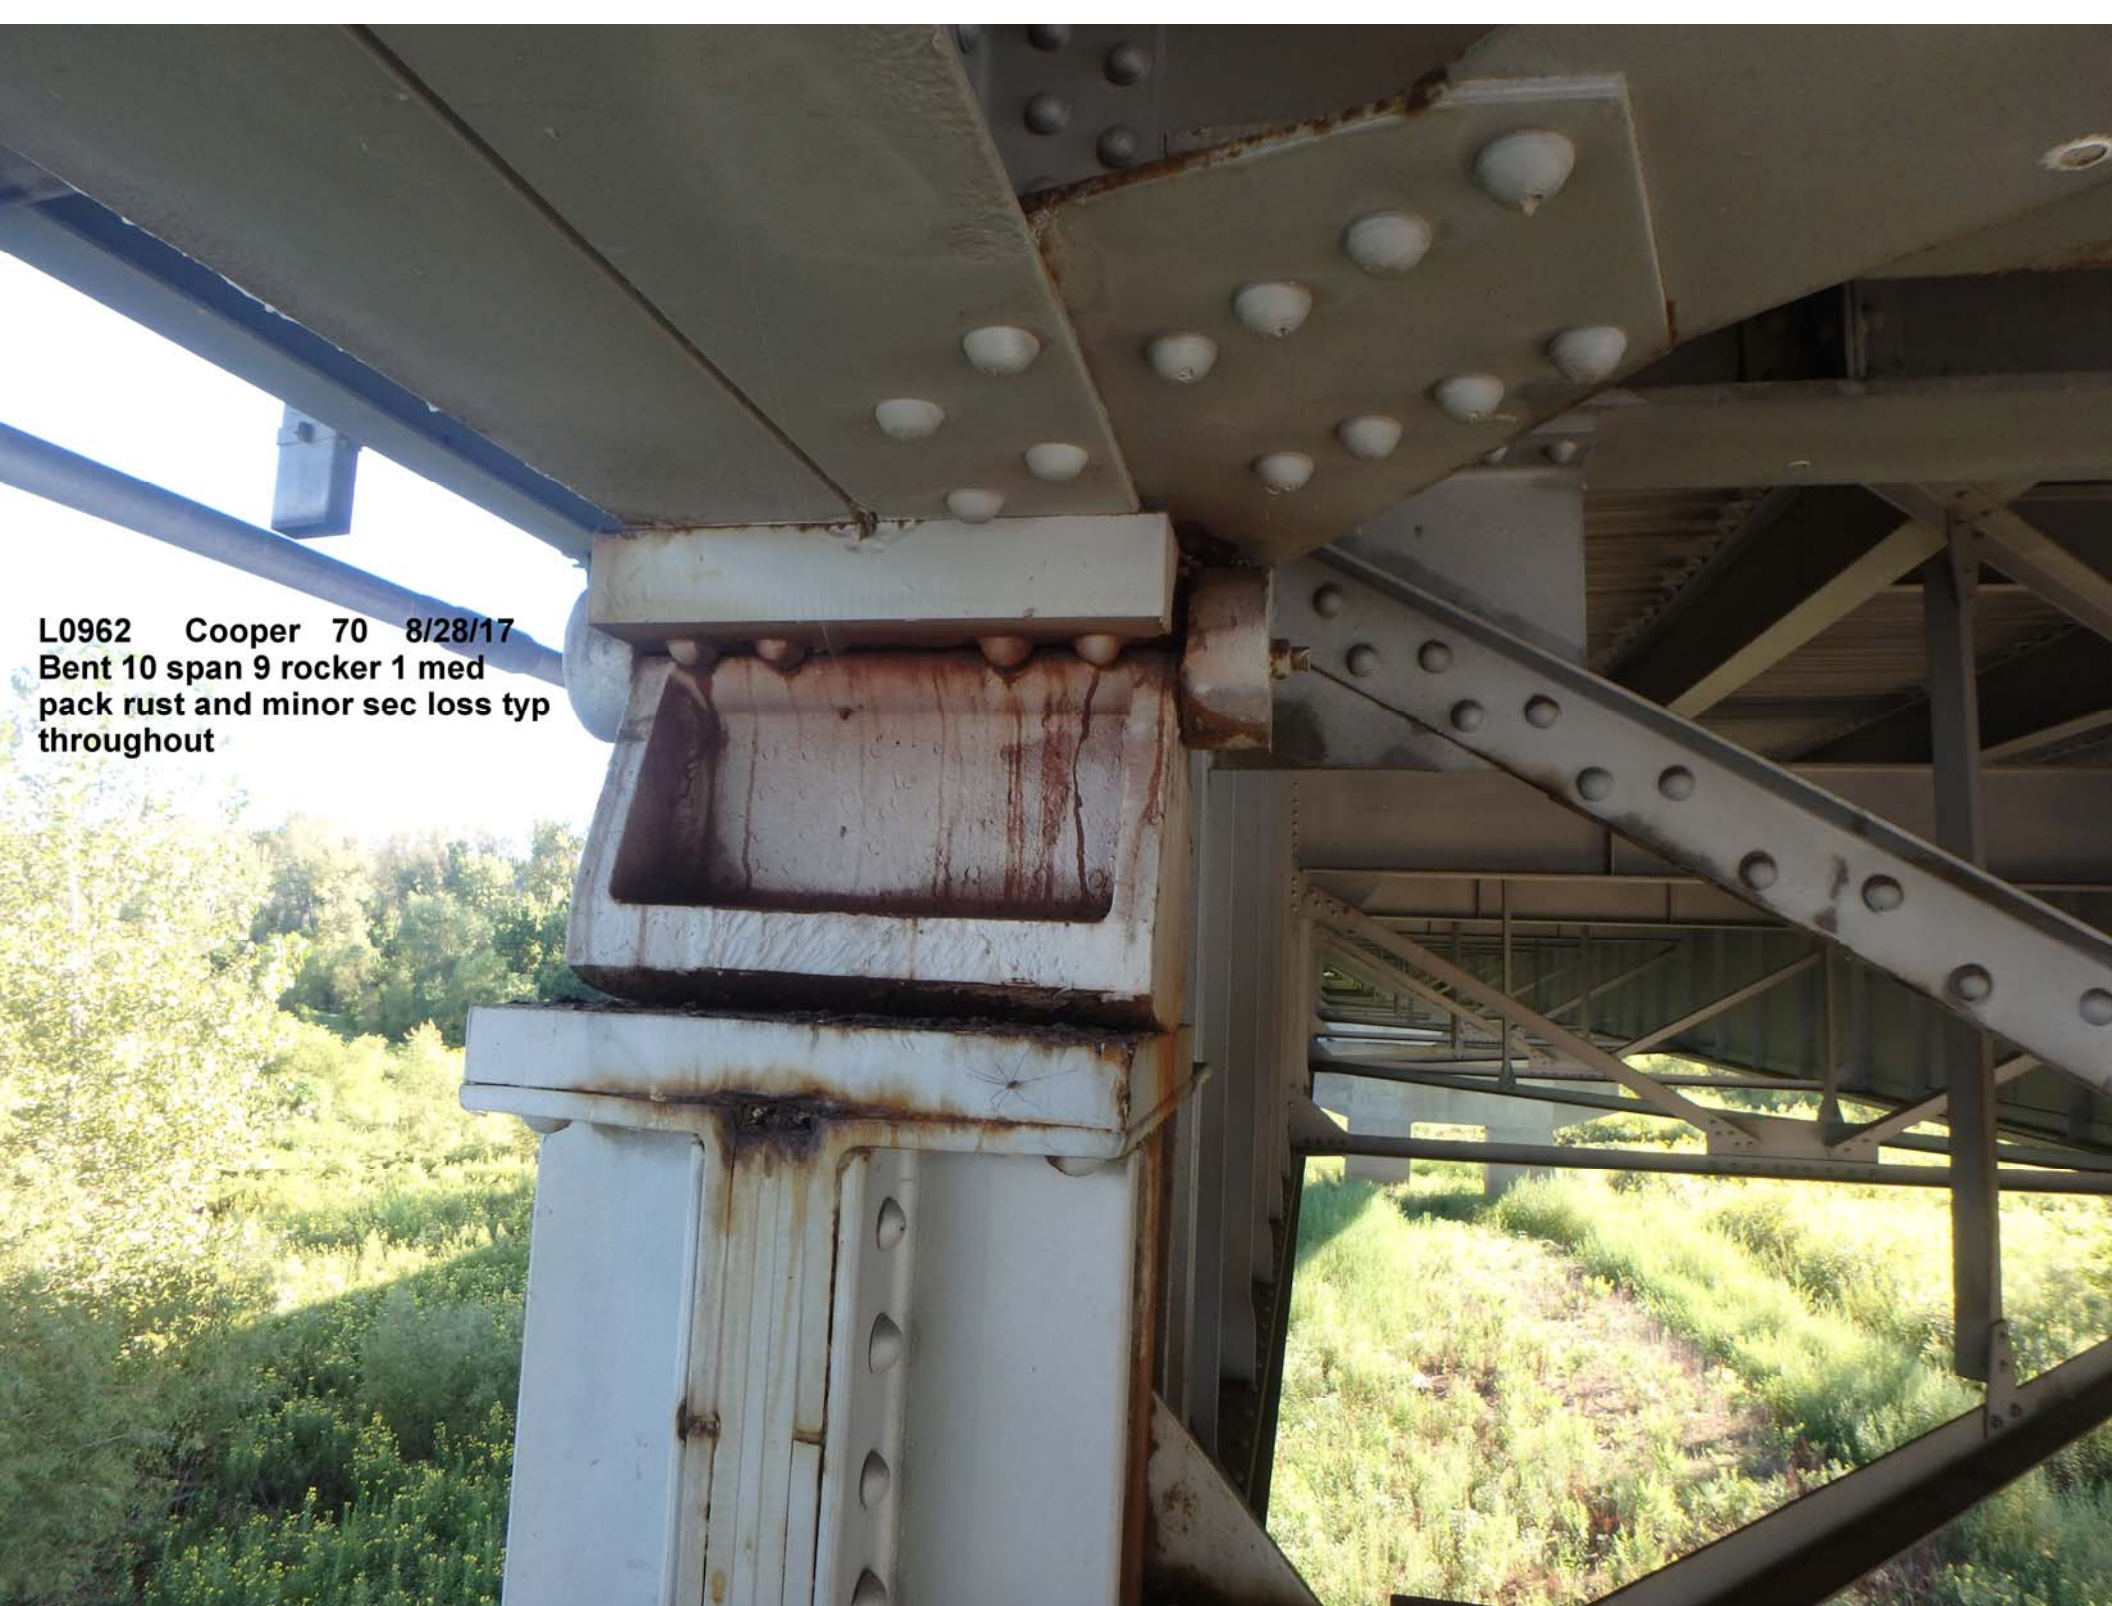
L0962 Cooper 70 8/28/17
Bent 10 span 9 rocker 1 med
pack rust and minor sec loss typ
throughout

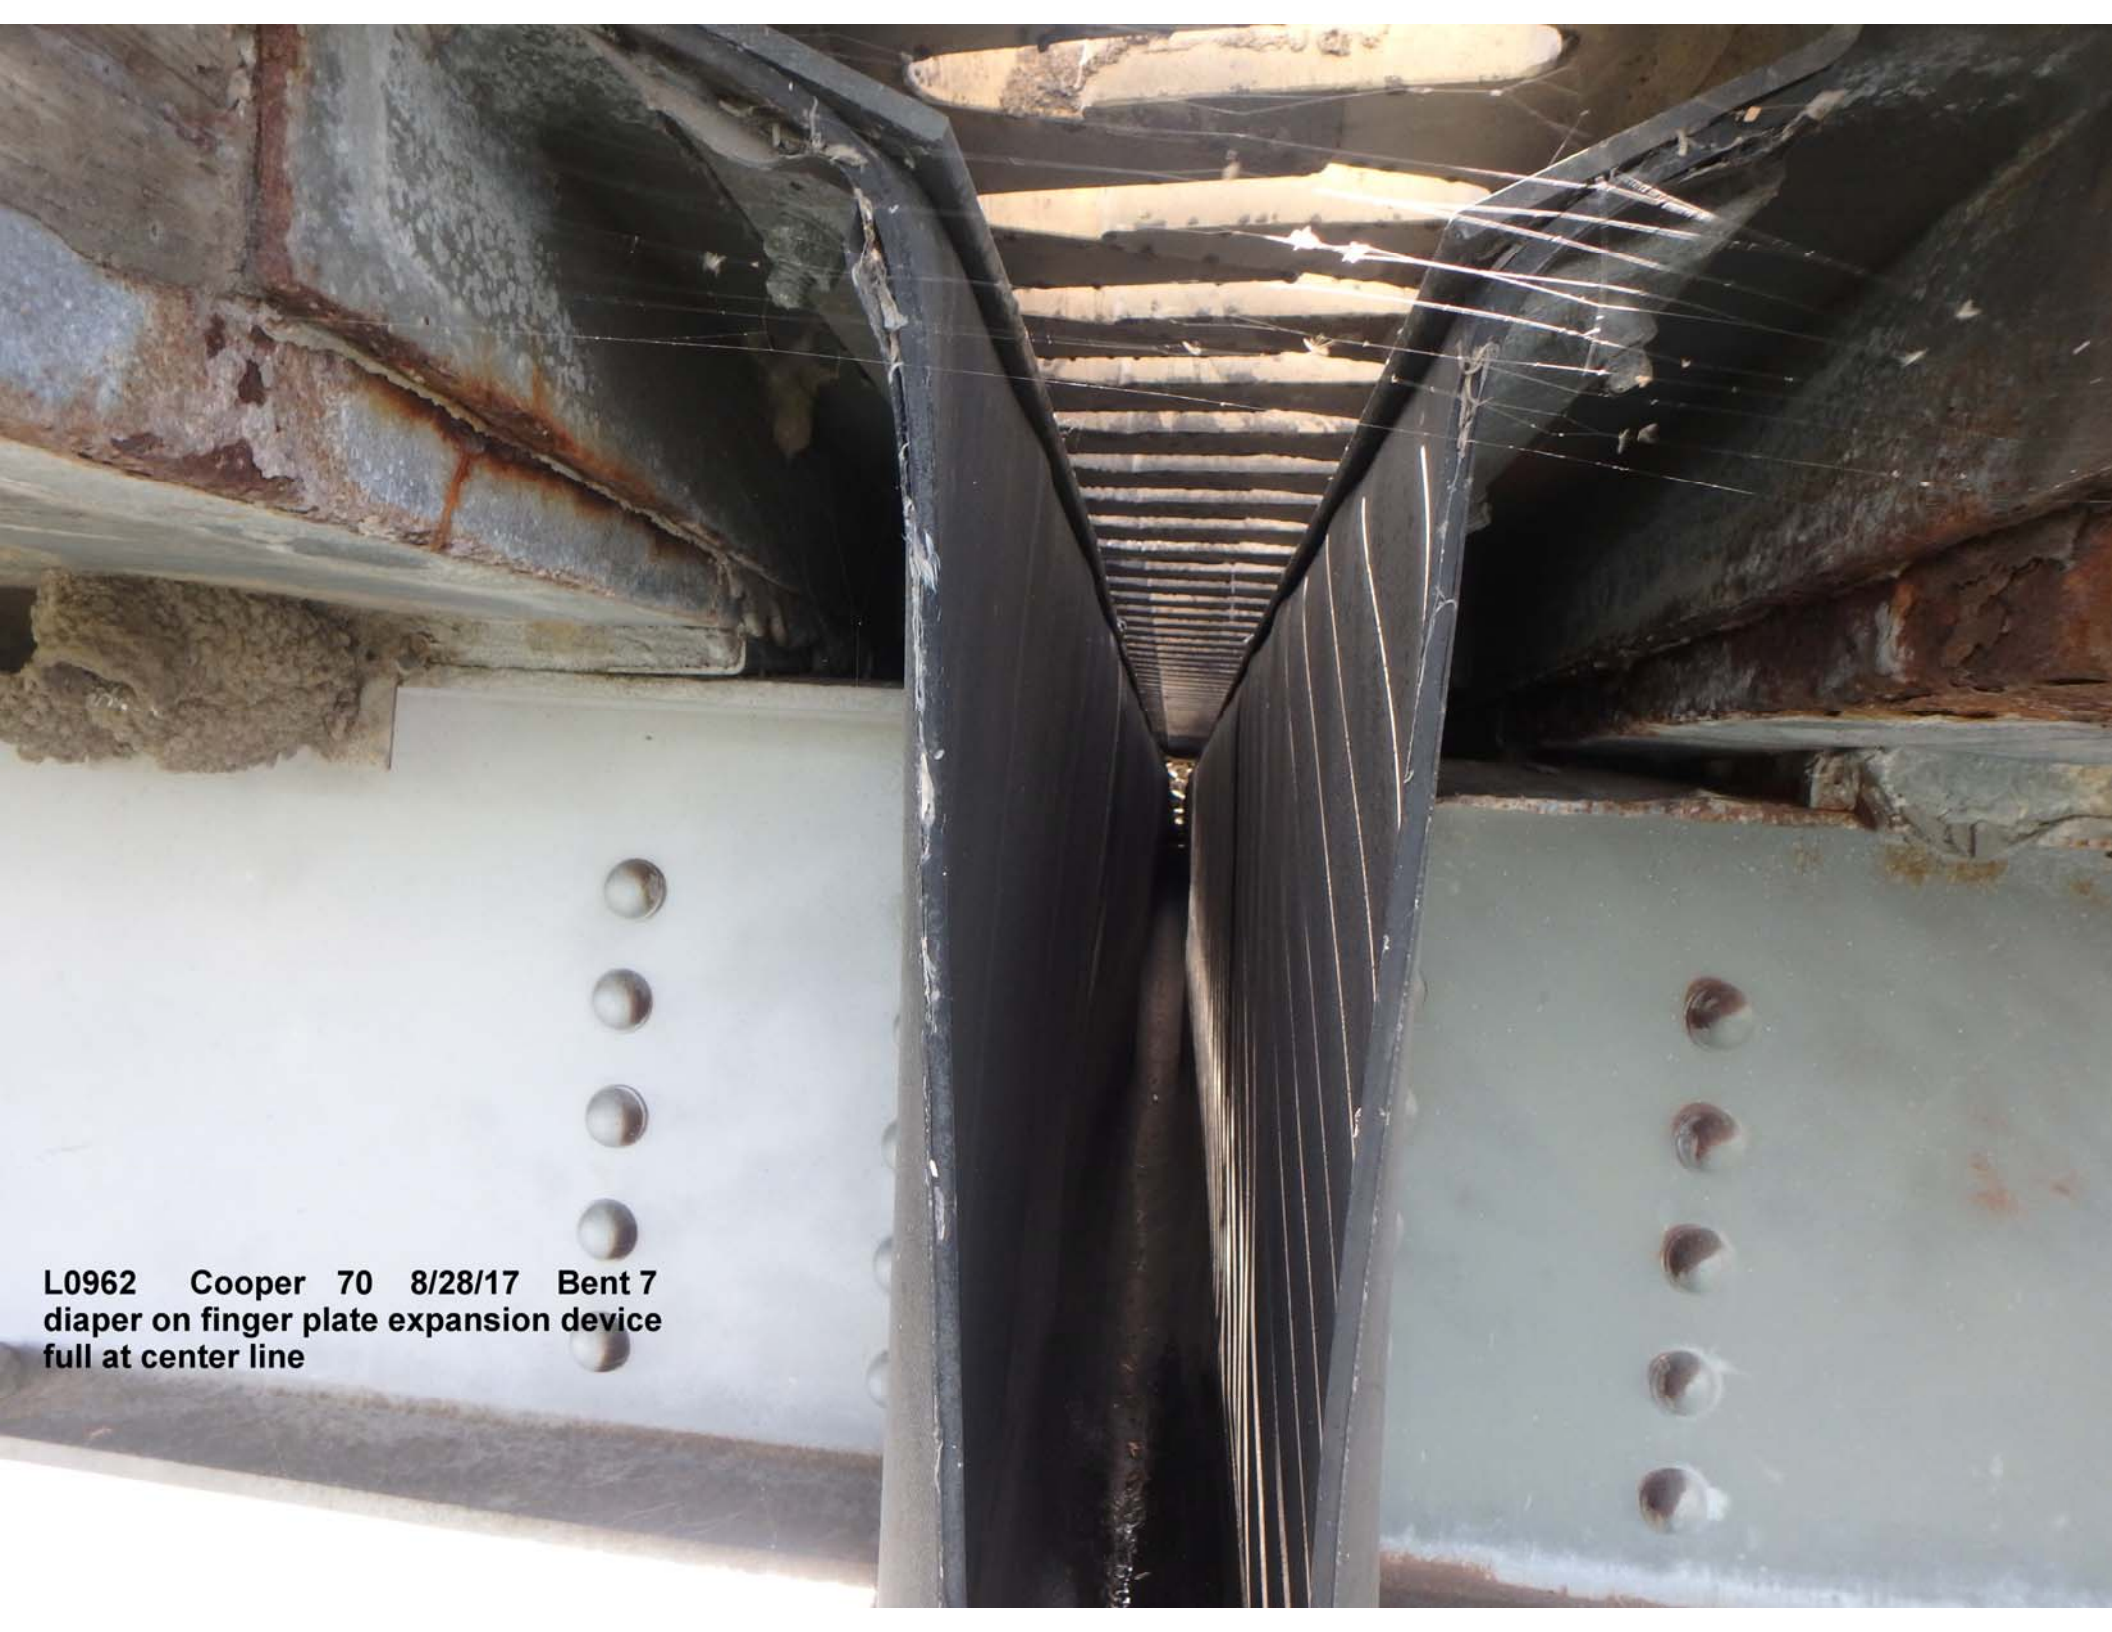
L0962 Cooper 70 8/28/17 Bent 7
bearing 2 with hvy pack rust and minor sec
loss on rocker and masonry plate

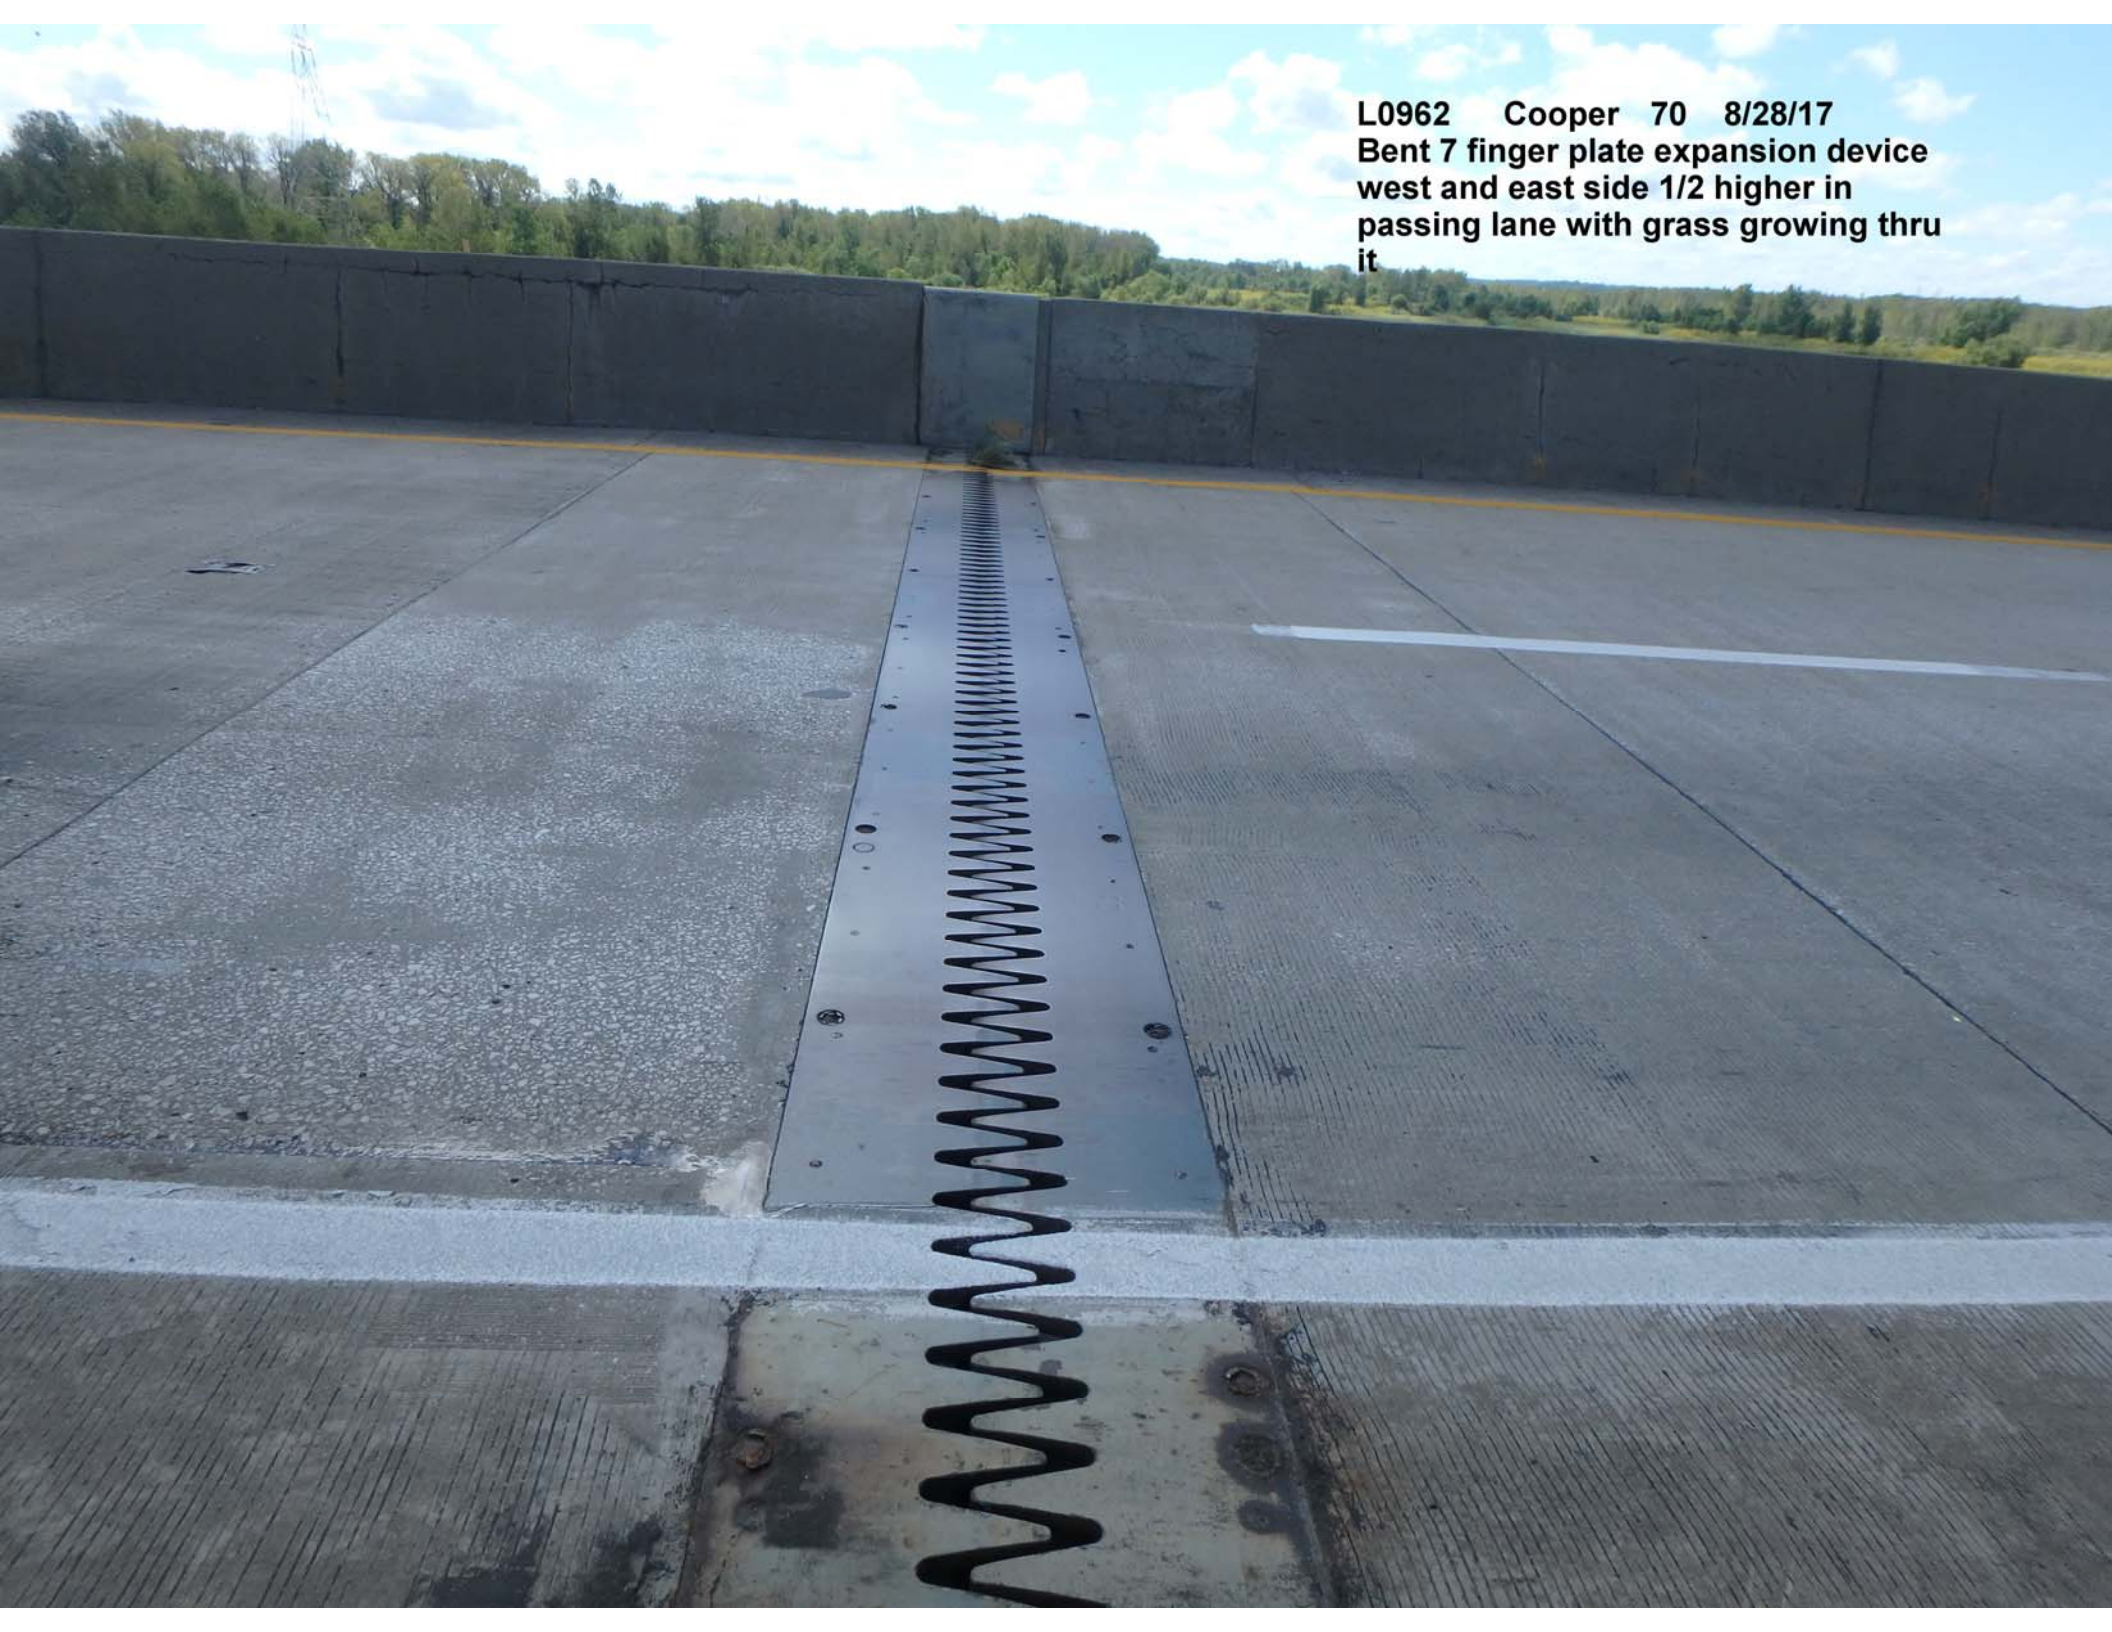
L0962 Cooper 70 8/28/17
Bent 7 finger plate expansion device
west and east side 1/2 higher in
passing lane with grass growing thru
it
