L0962 Cooper 70 8/28/17
P13 east side lrg area of map
cracks with saturation and eff

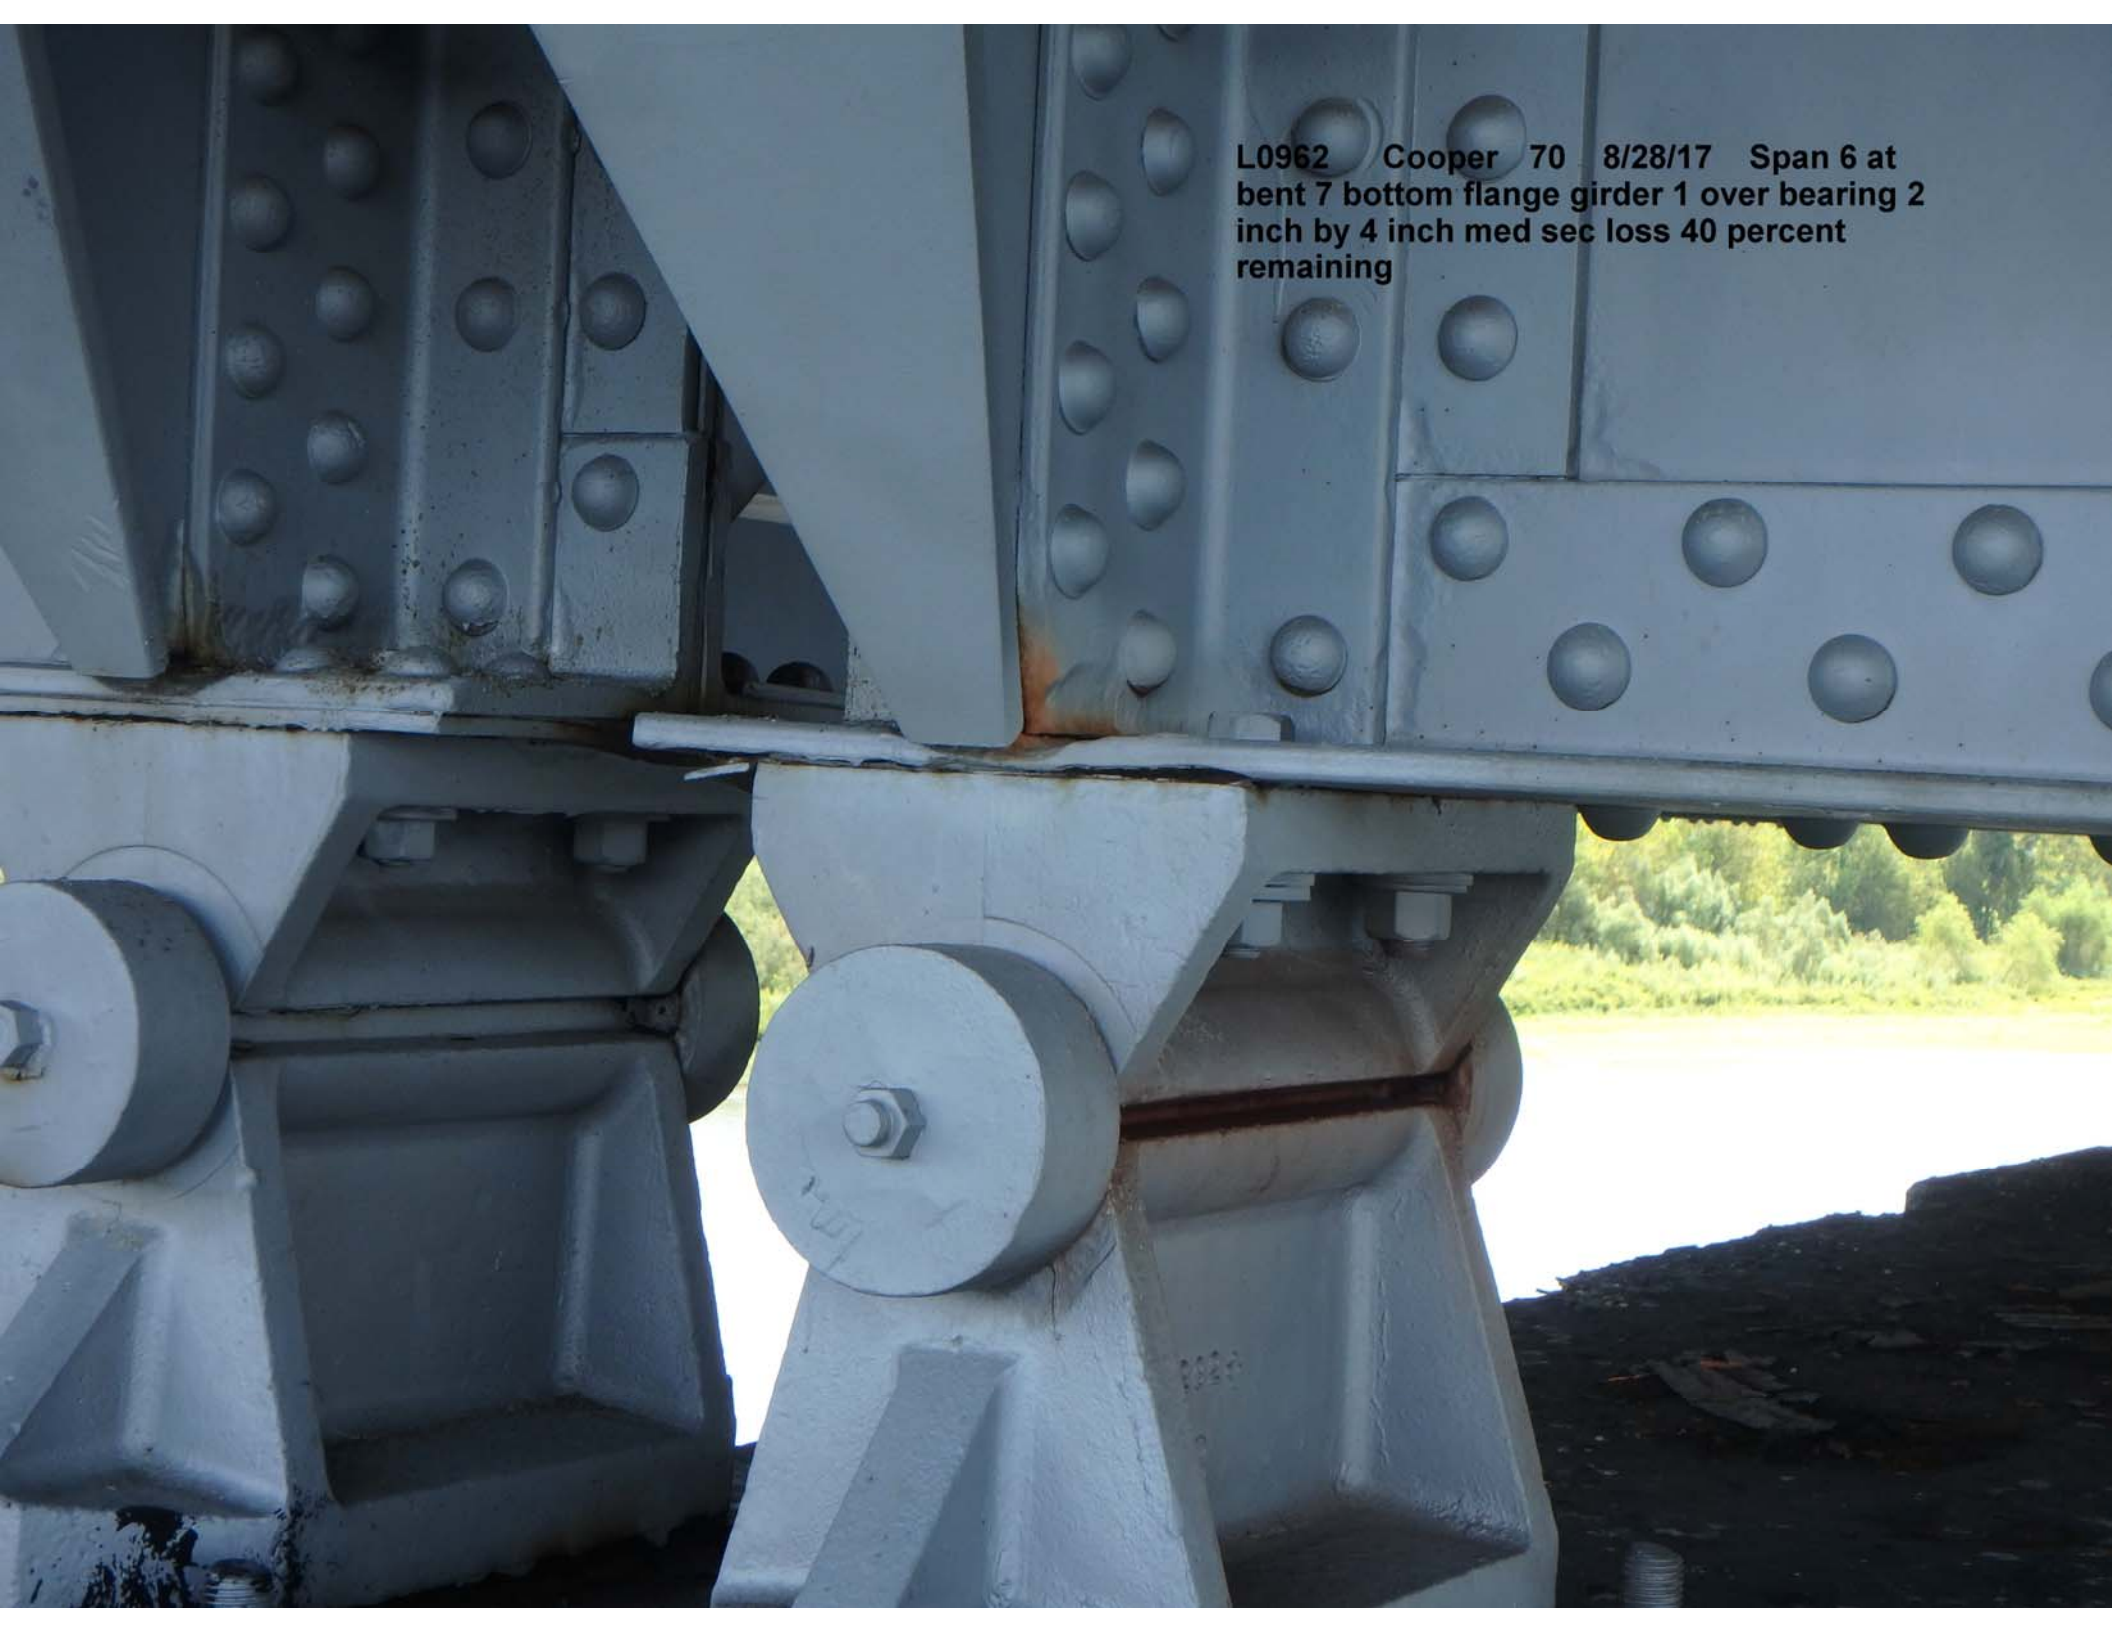
L0962 Cooper 70 8/28/17 Span 6 at
bent 7 bottom flange girder 1 over bearing 2
inch by 4 inch med sec loss 40 percent
remaining

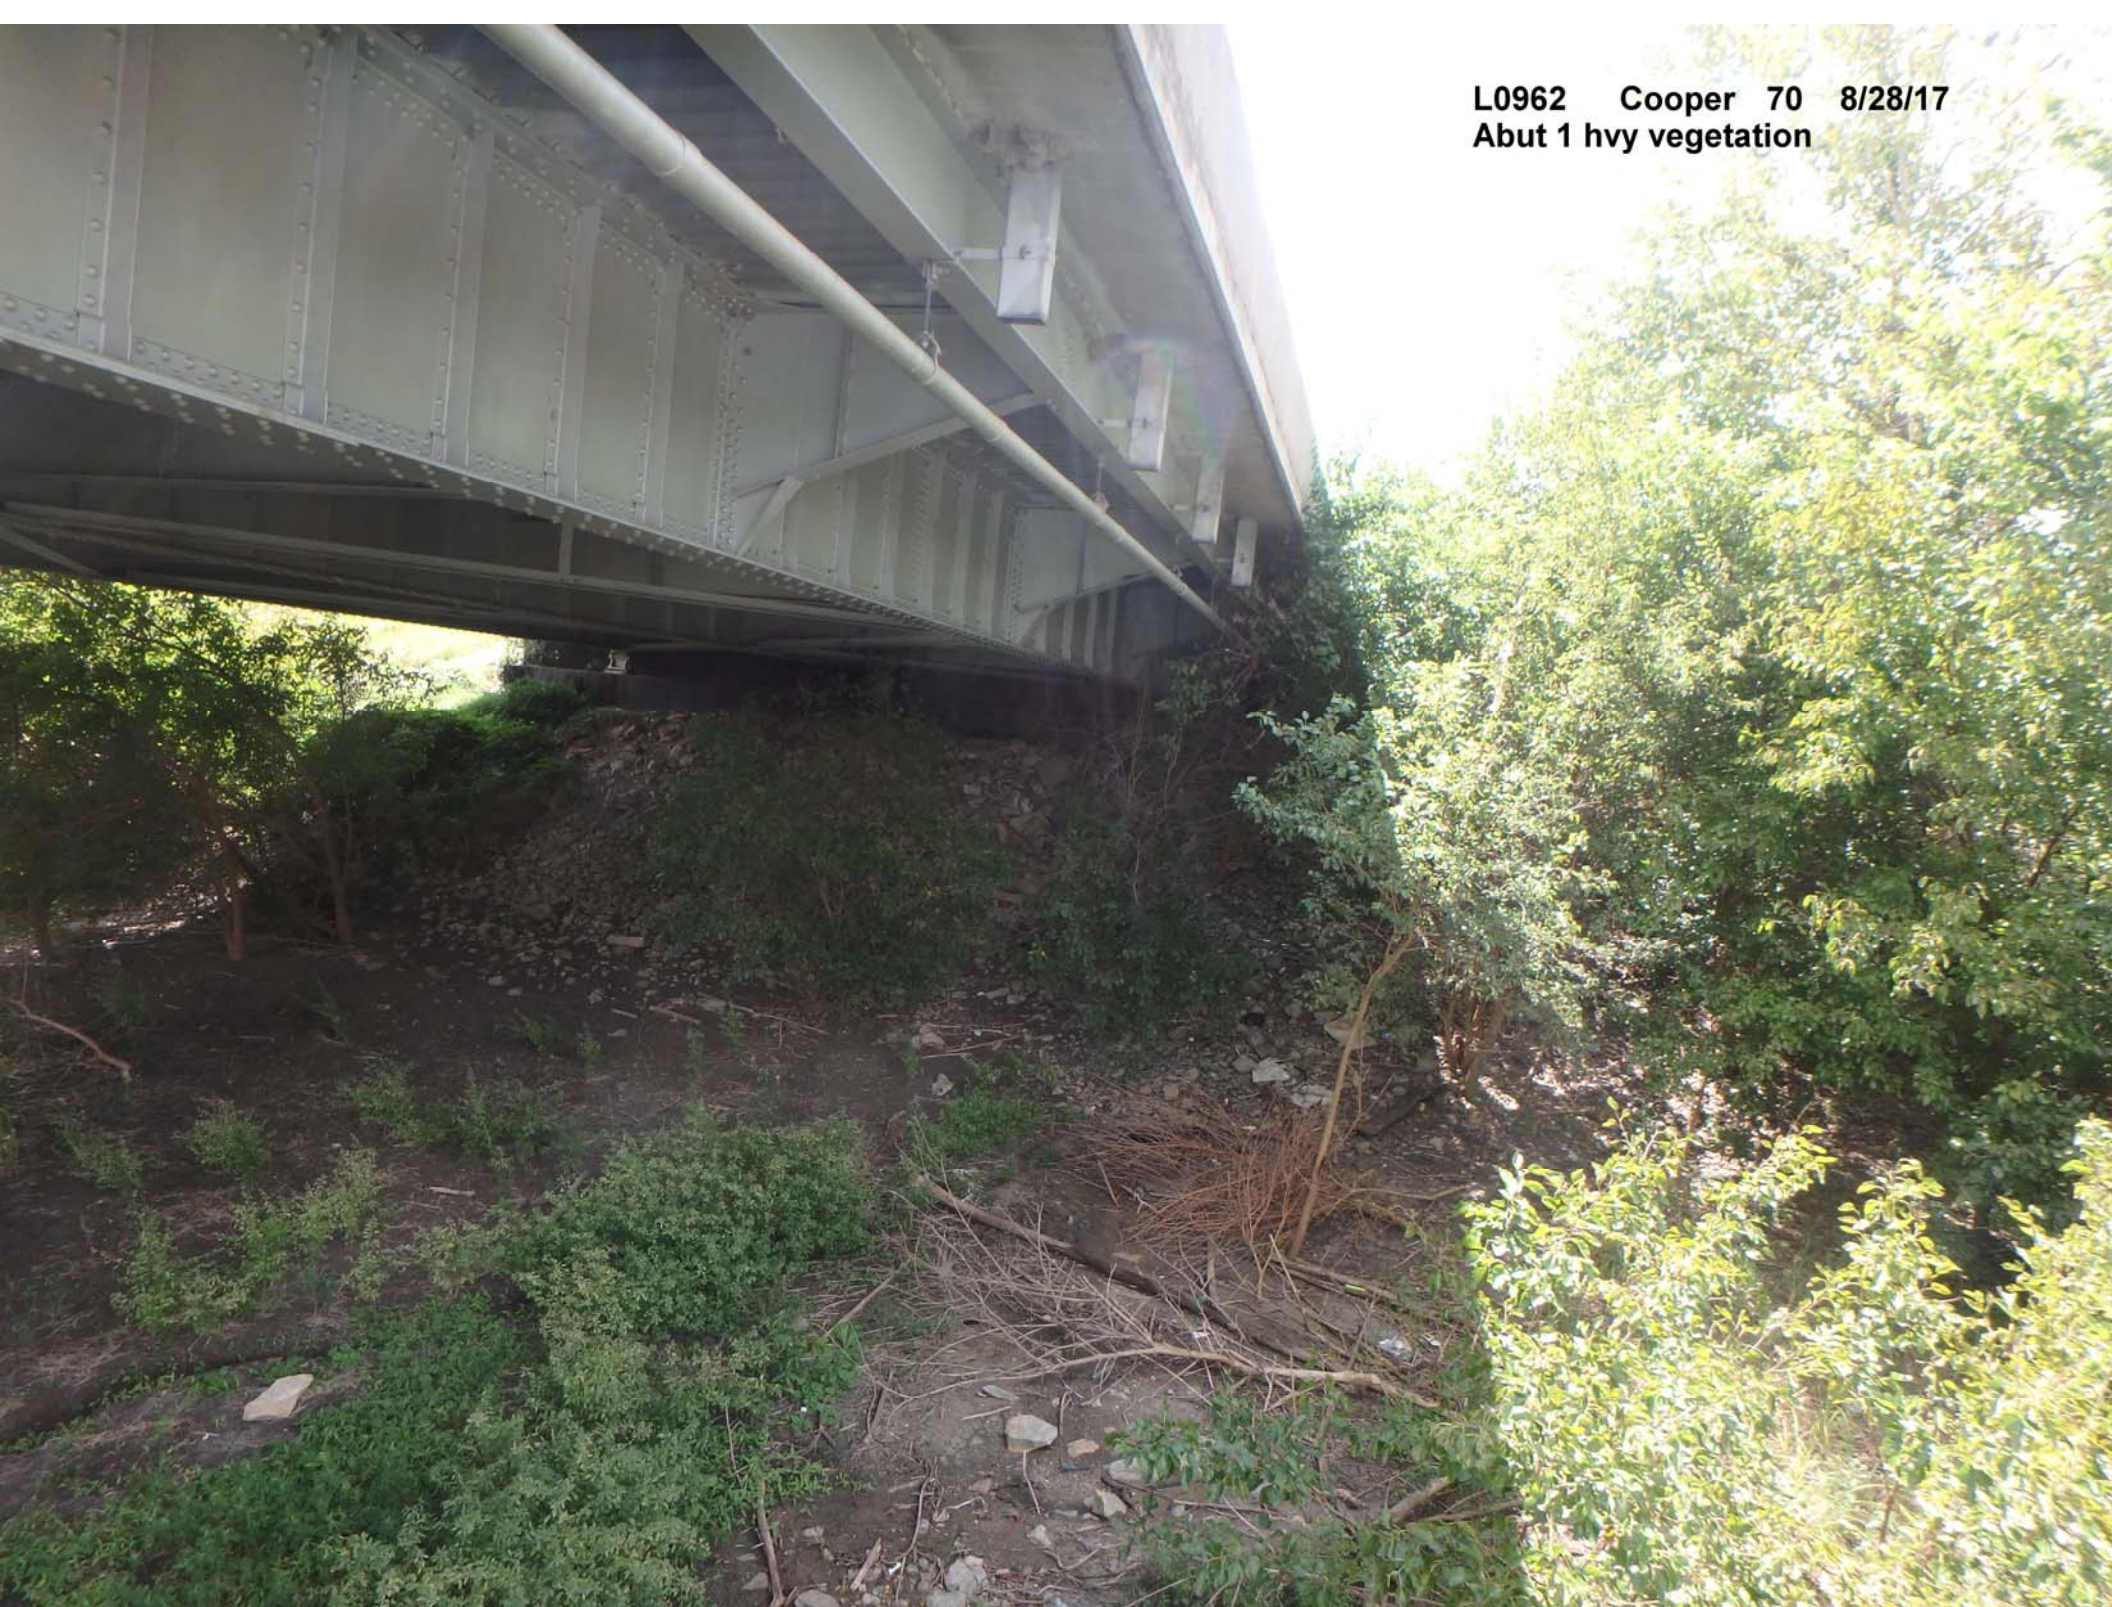
L0962 Cooper 70 8/28/17
Abut 1 hvy vegetation
