L0962 Cooper Co.
08/28/2017
Looking West

L0962 I-70 Cooper
Pier 15 Open Expansion Joint WBL
8-28-17

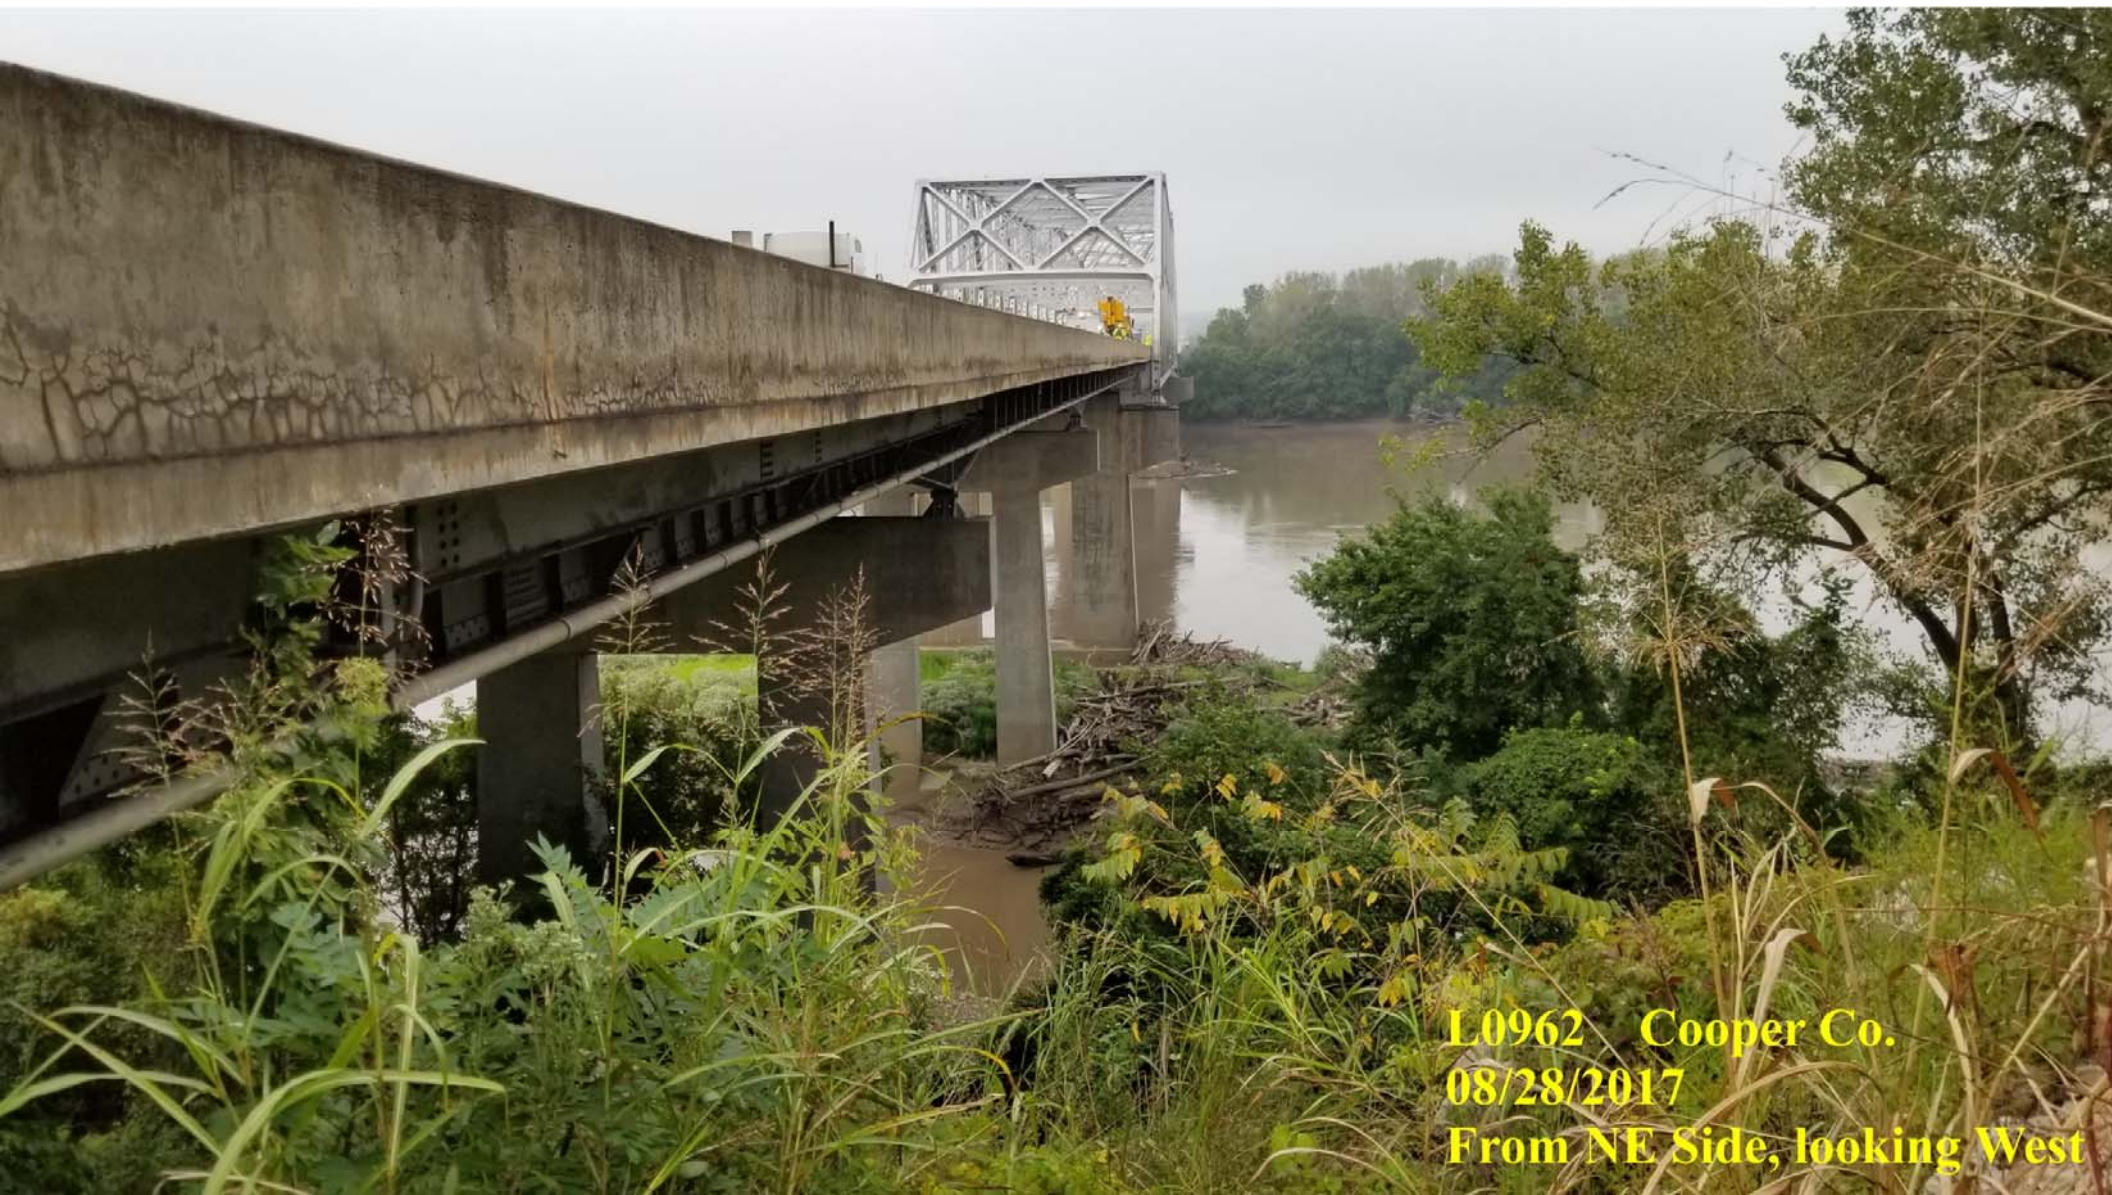
L0962 Cooper Co.
08/28/2017
Abut. 18, NE Side, Looking South

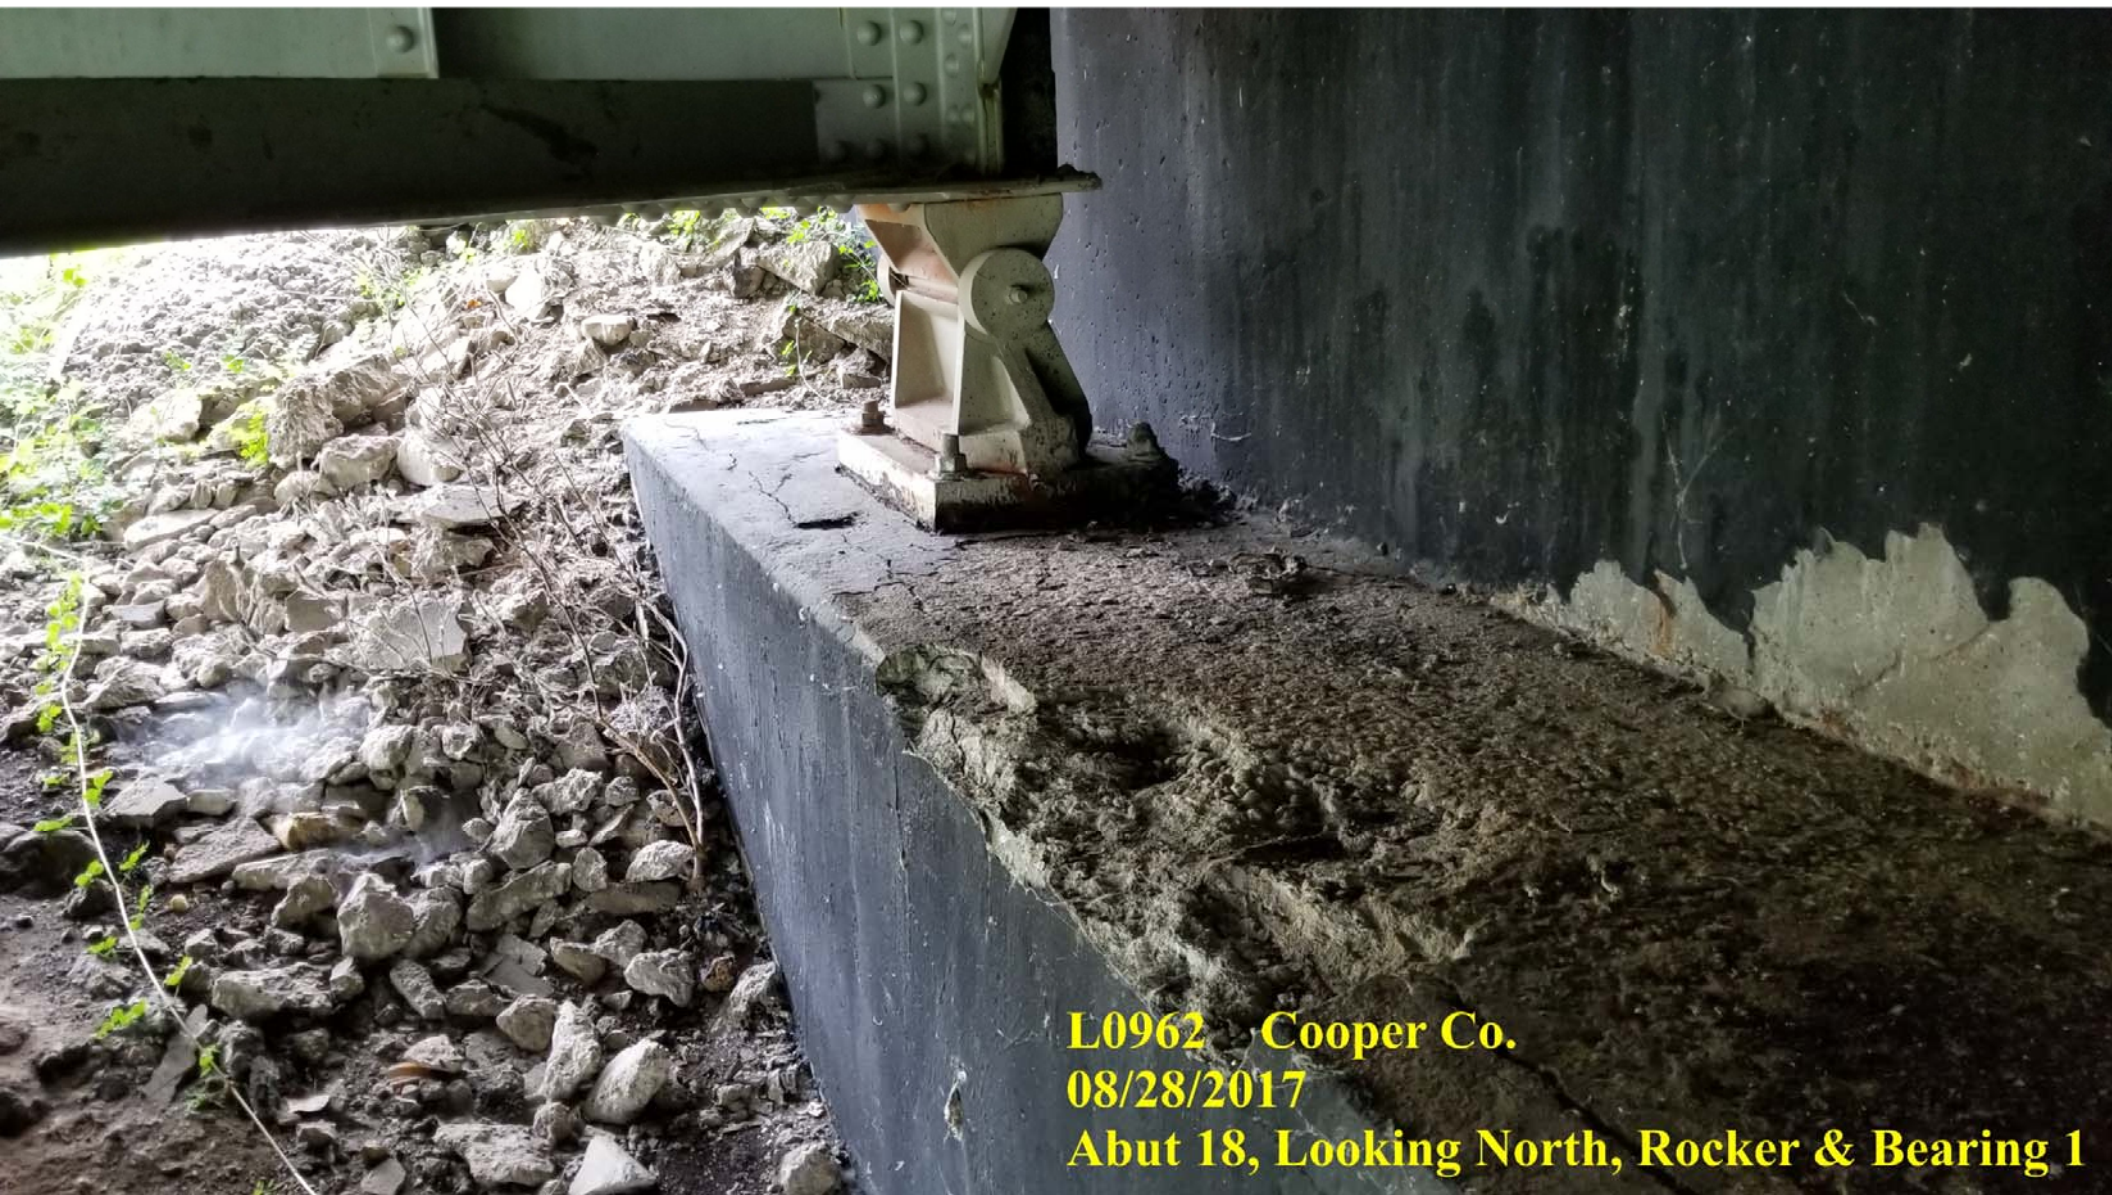
L0962 Cooper Co.
08/28/2017
Abut. 18, Looking South, Rocker & Bearing 1

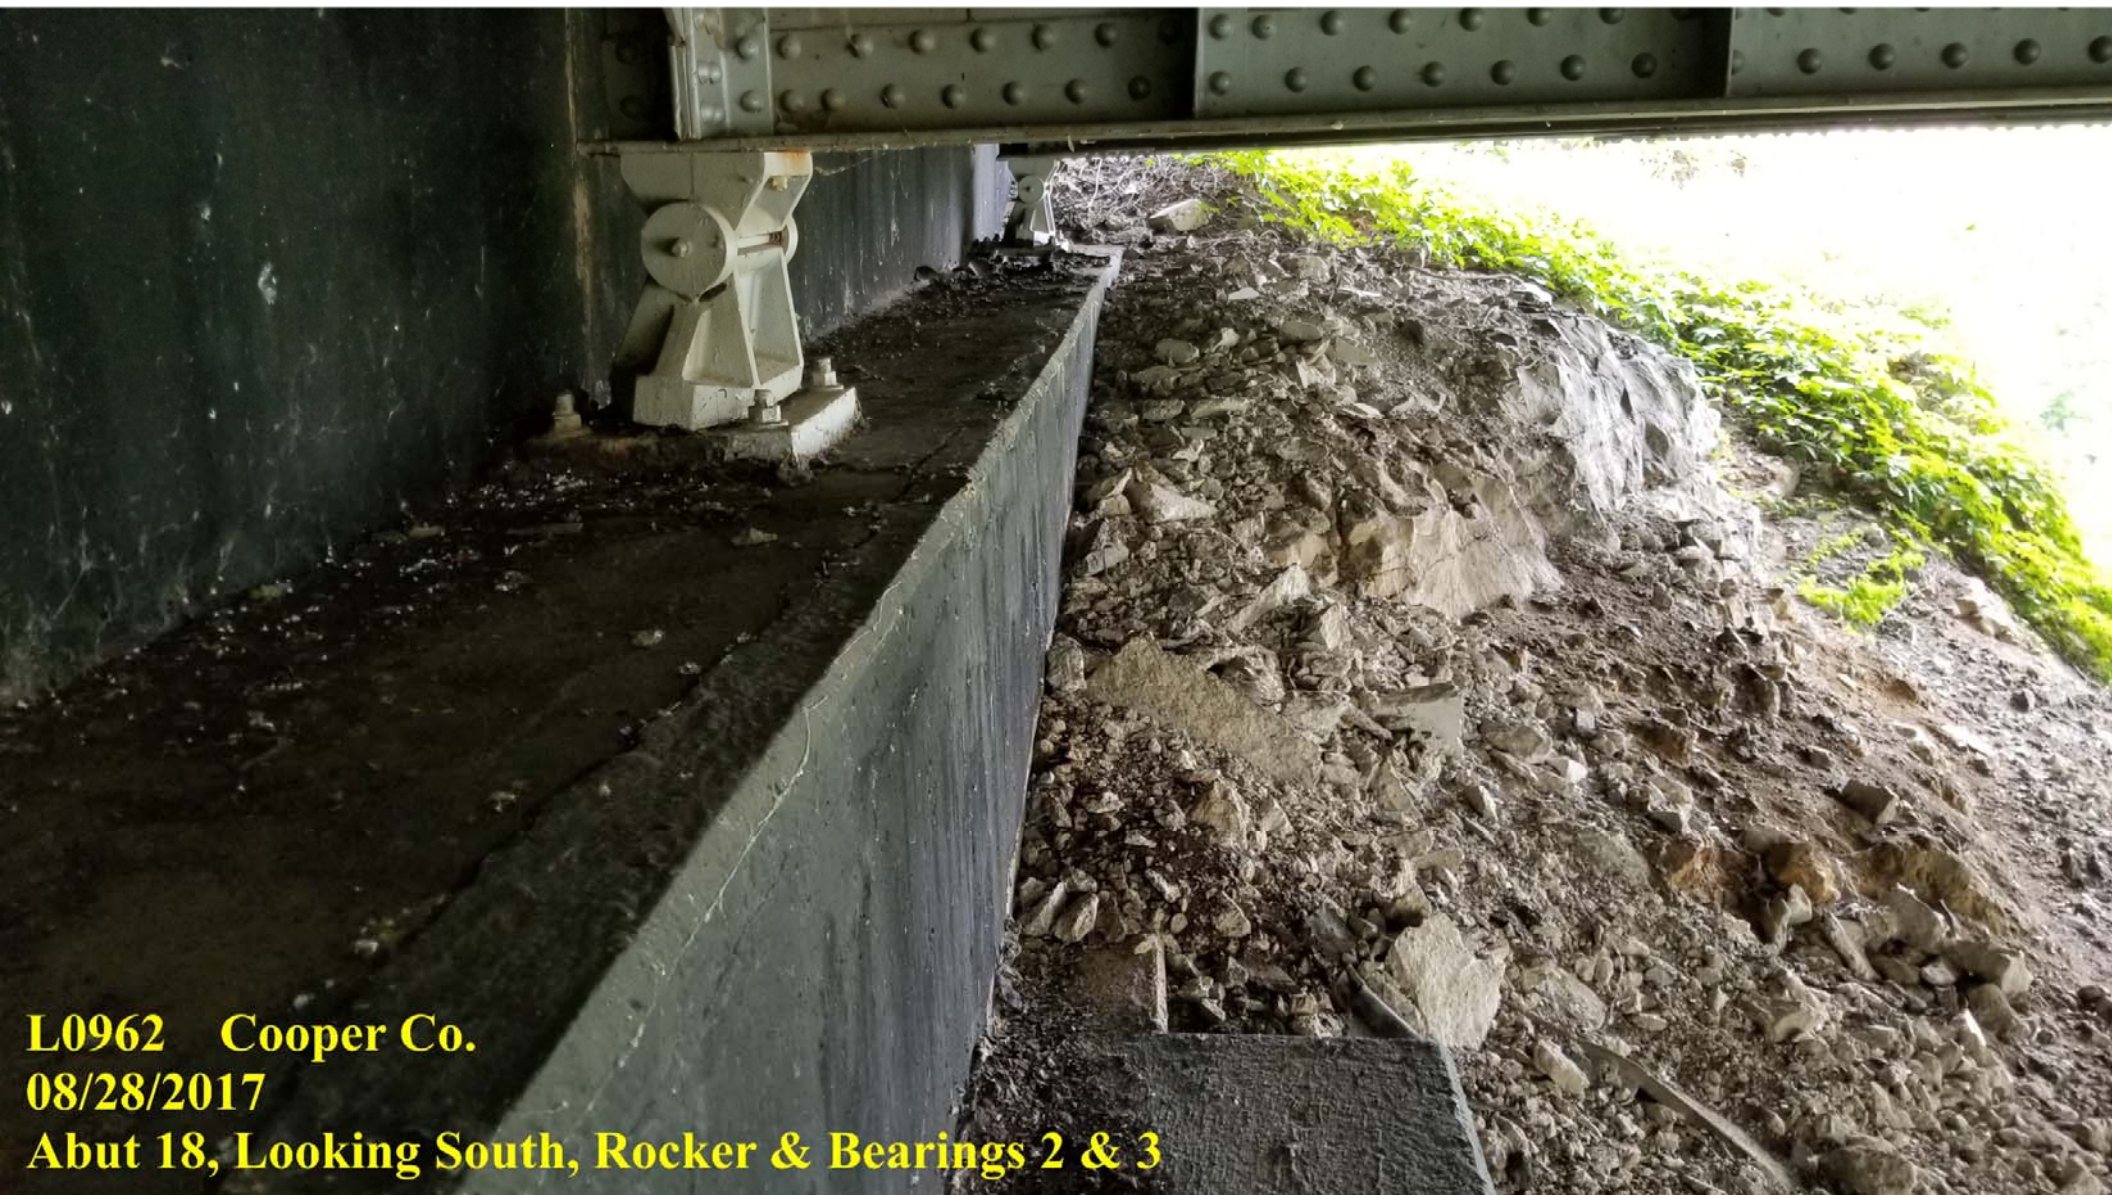
Abut 18, Looking North, Rocker & Bearing 1

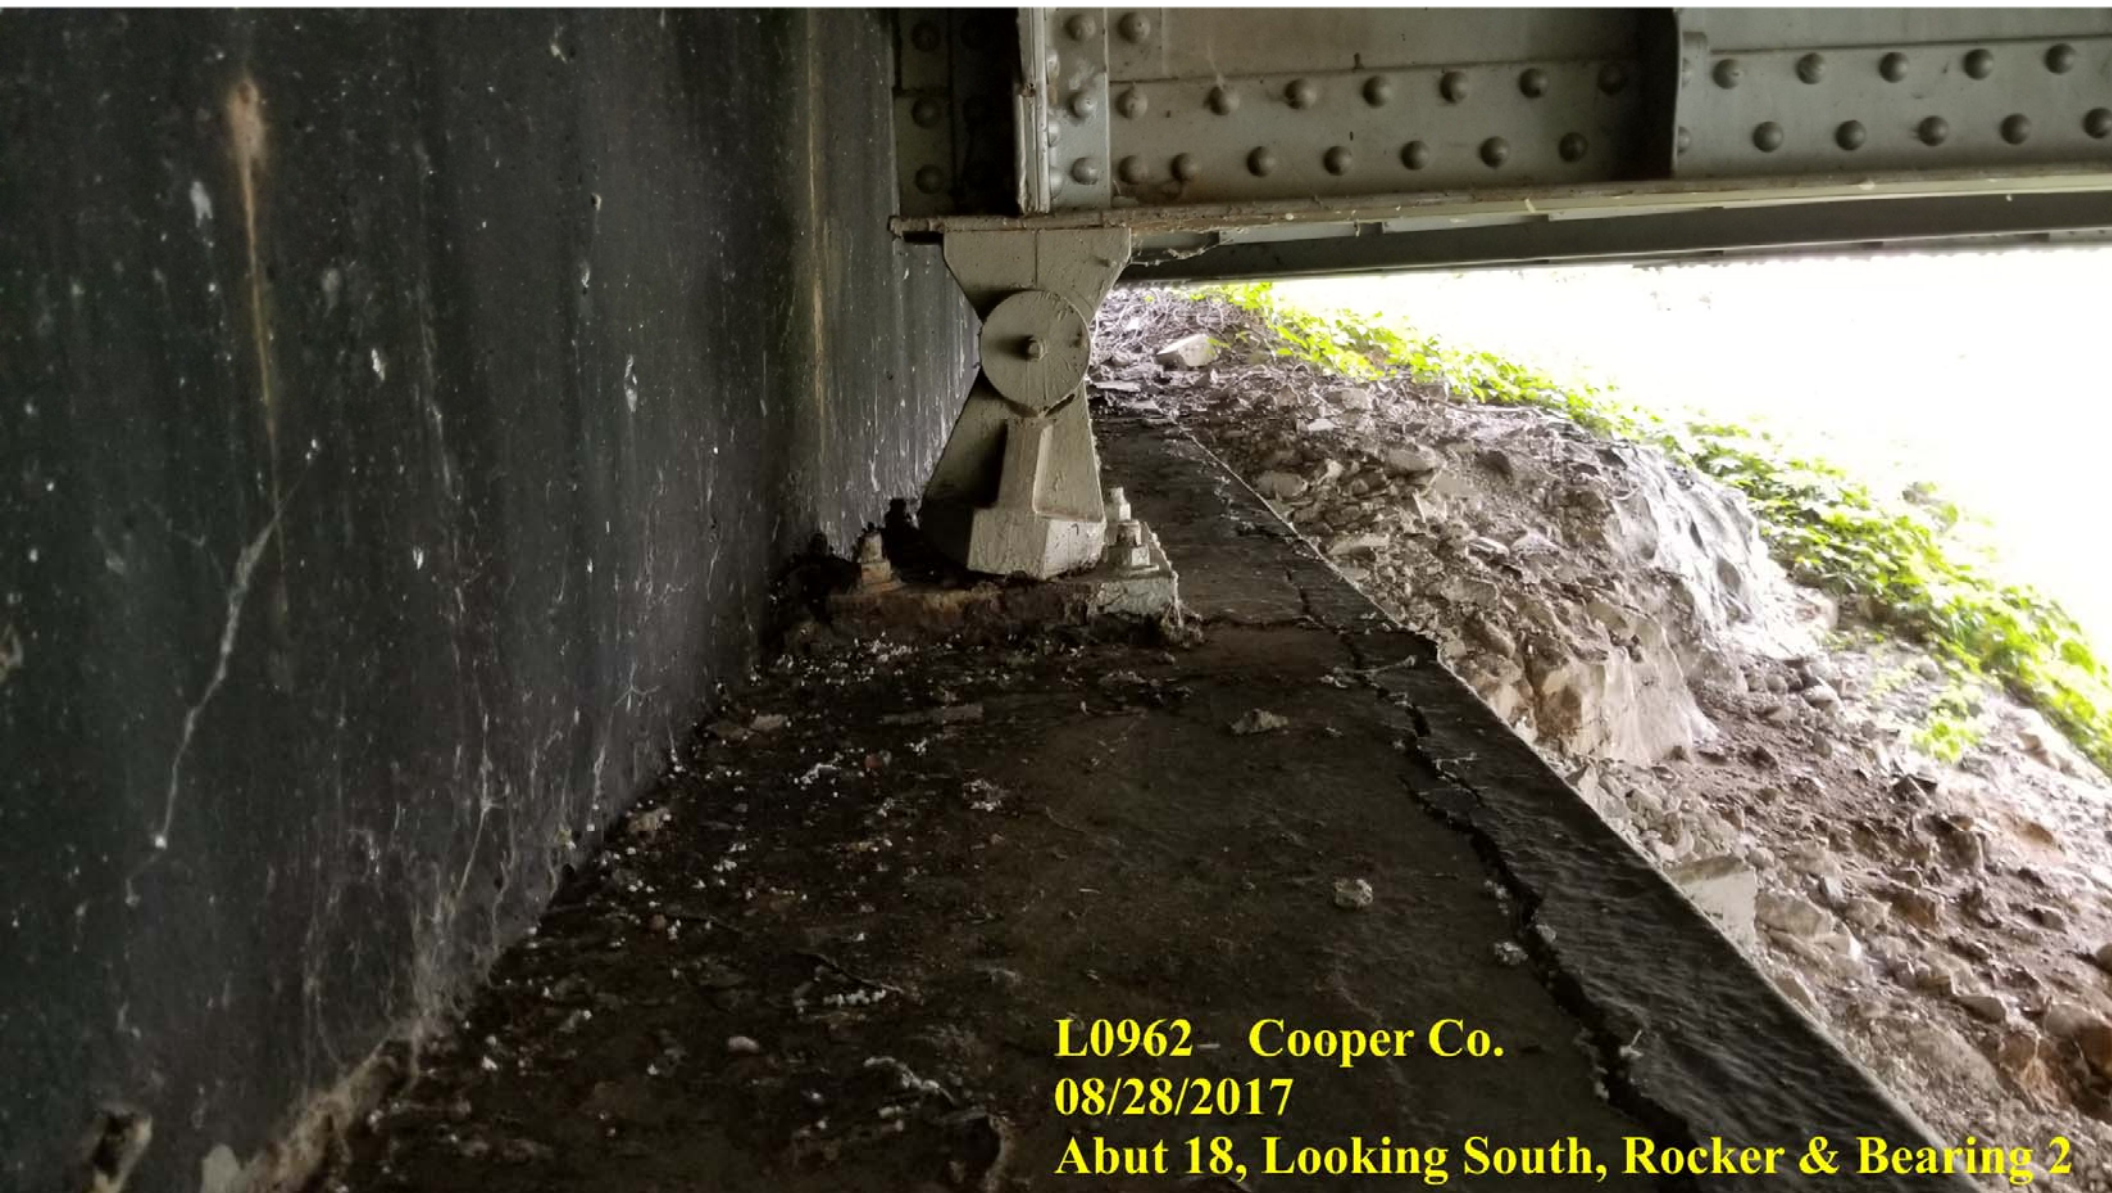
L0962 Cooper Co.
08/28/2017
Abut 18, Looking South, Rocker & Bearings 2 & 3

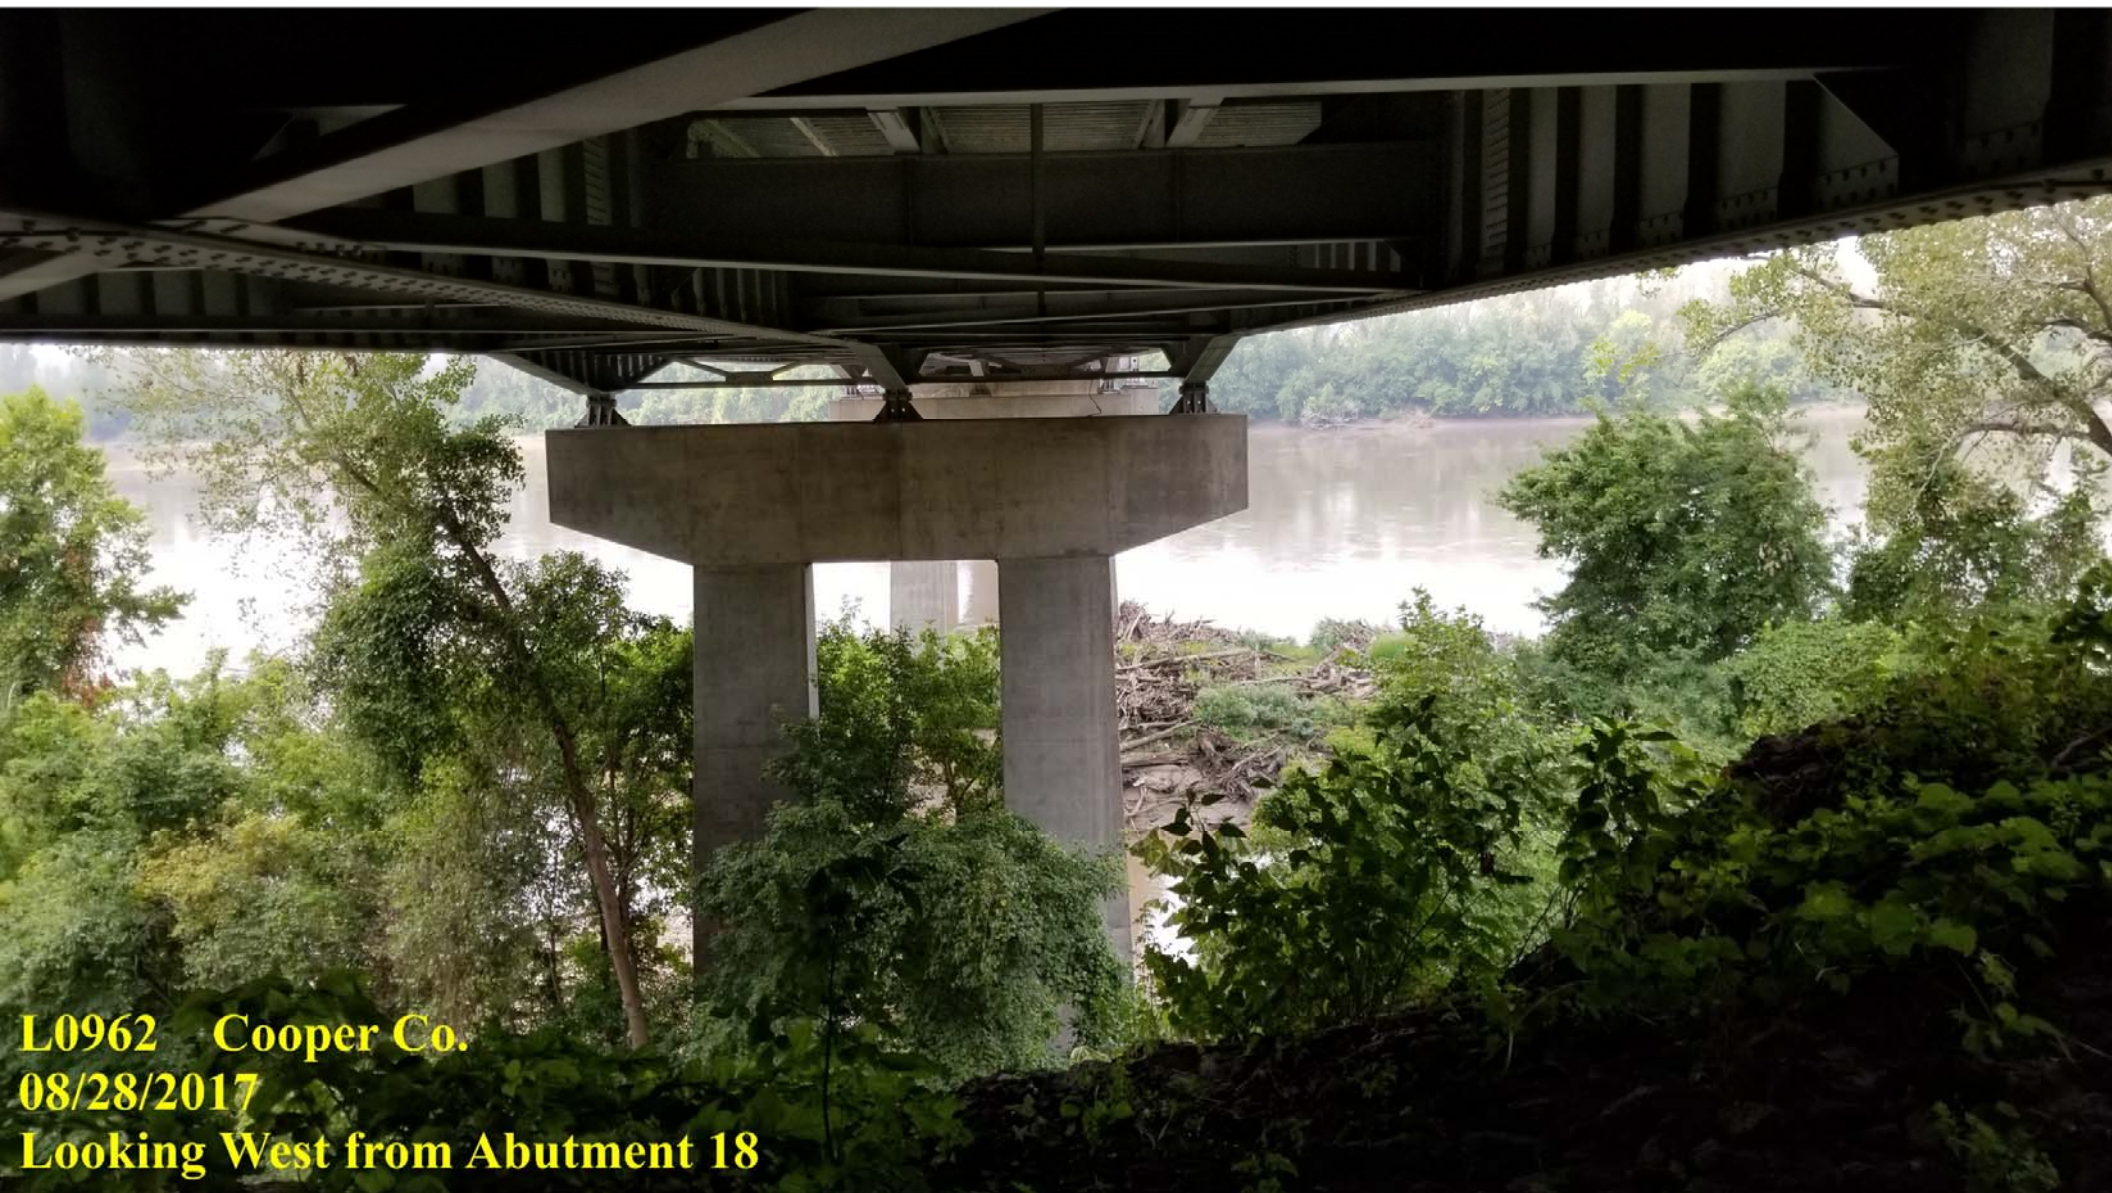
Abut 18, Looking South, Rocker & Bearing 2

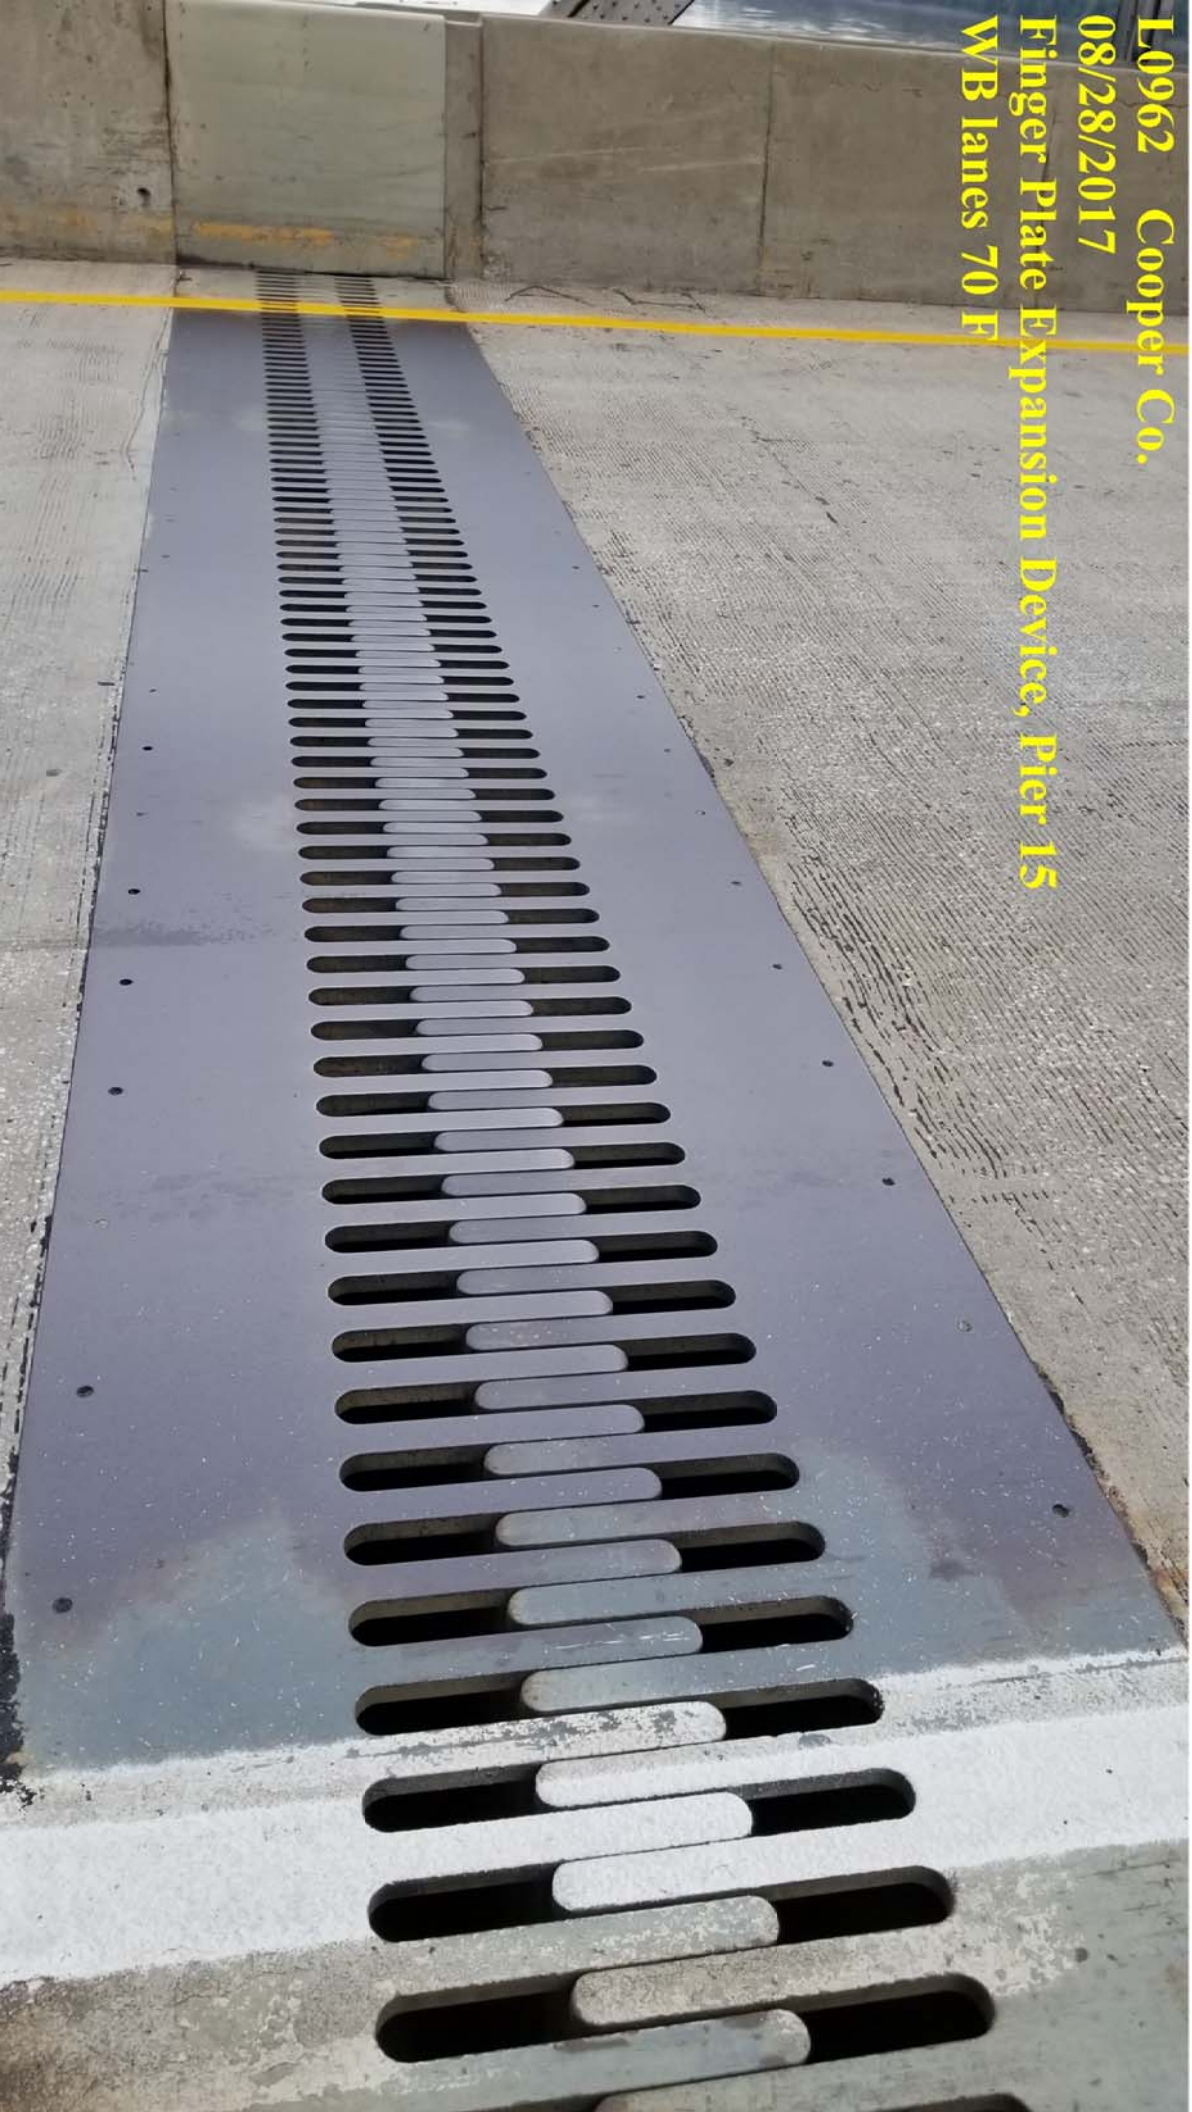
Finger Plate Expansion Device, Pier 15

WB lanes 70 F

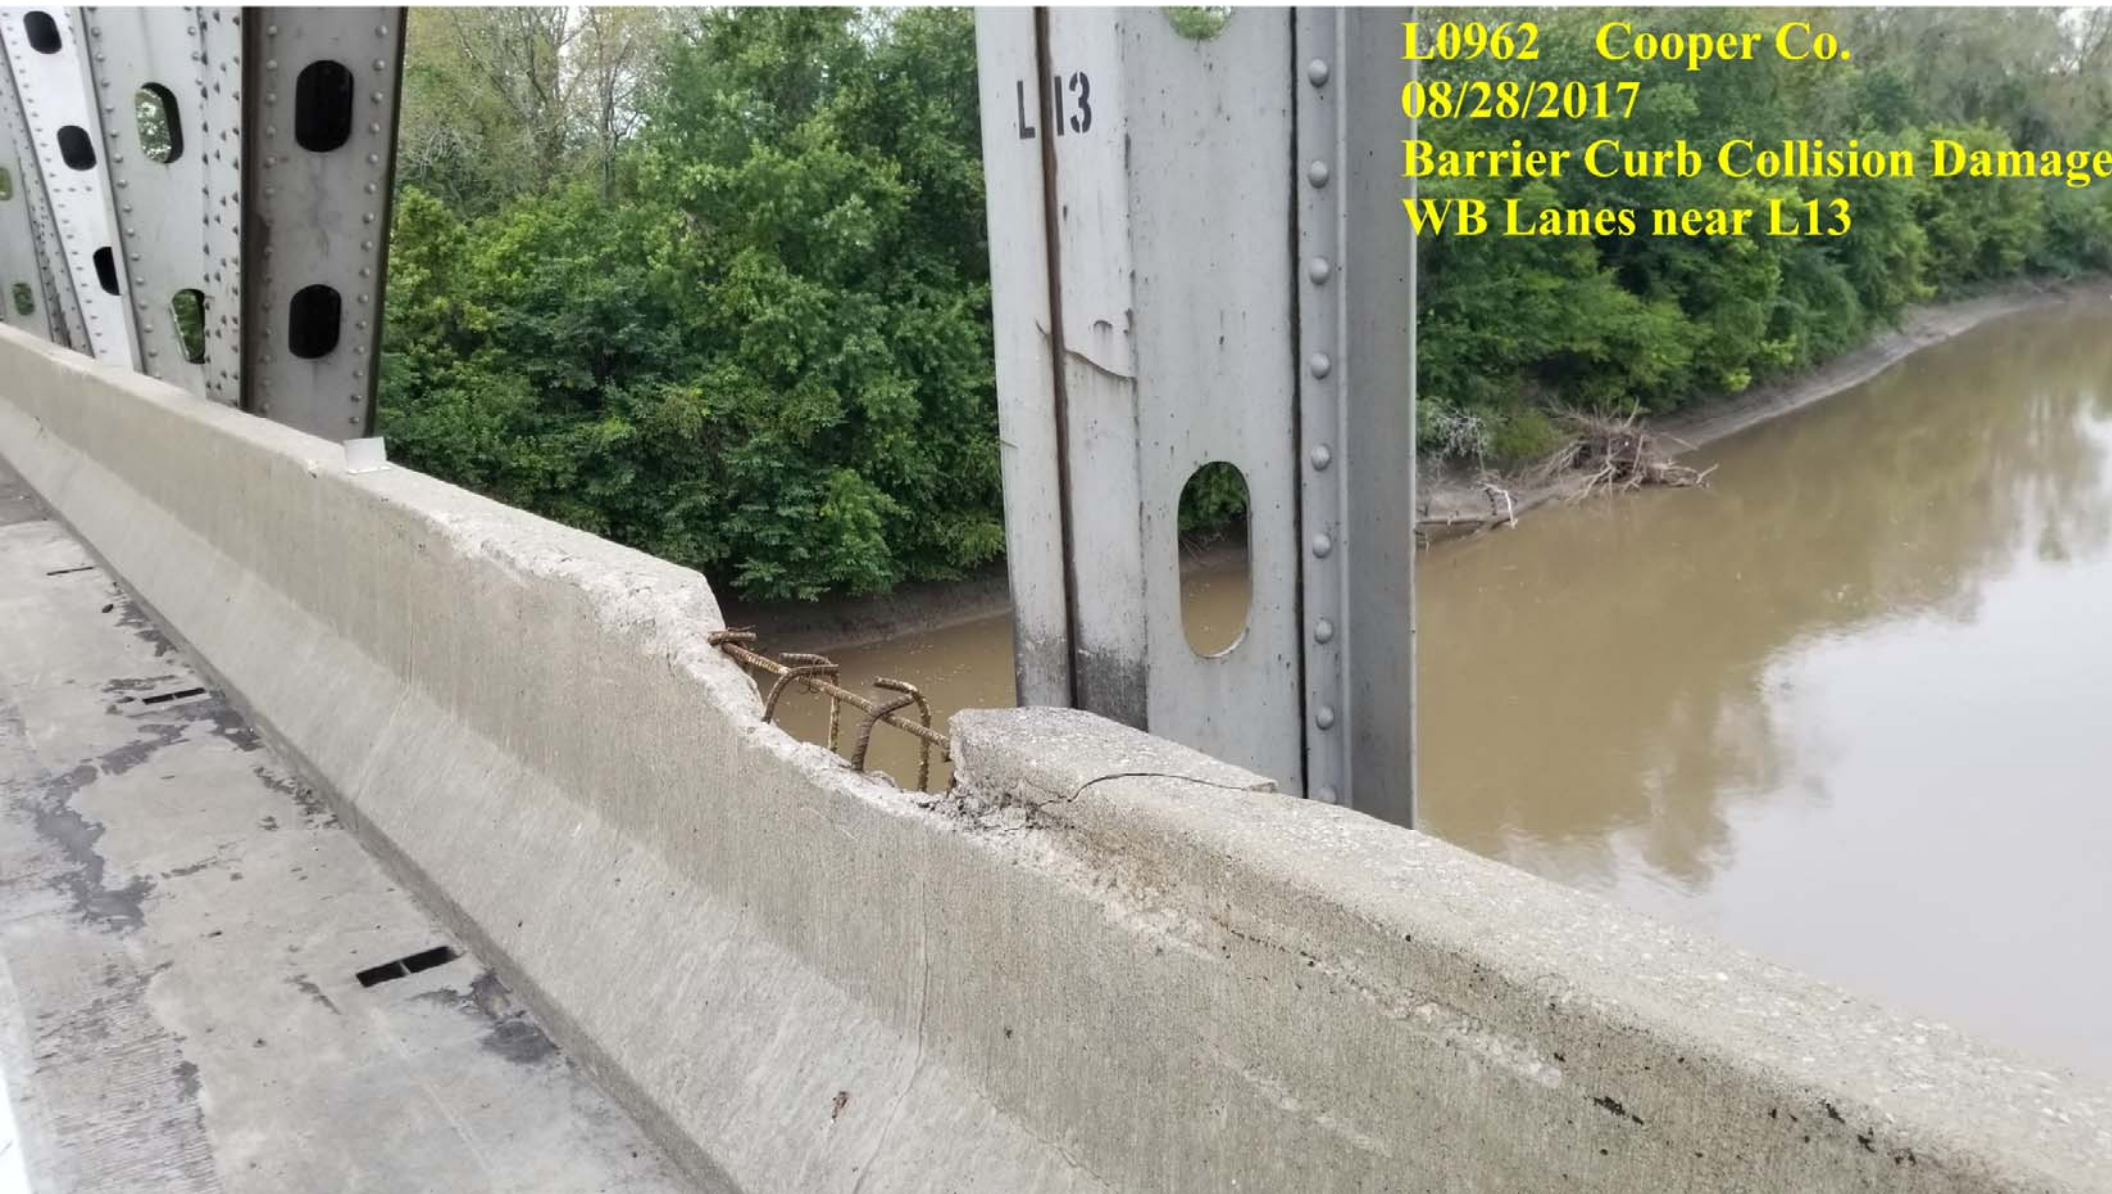
Barrier Curb Collision Damage

WB Lanes near L13

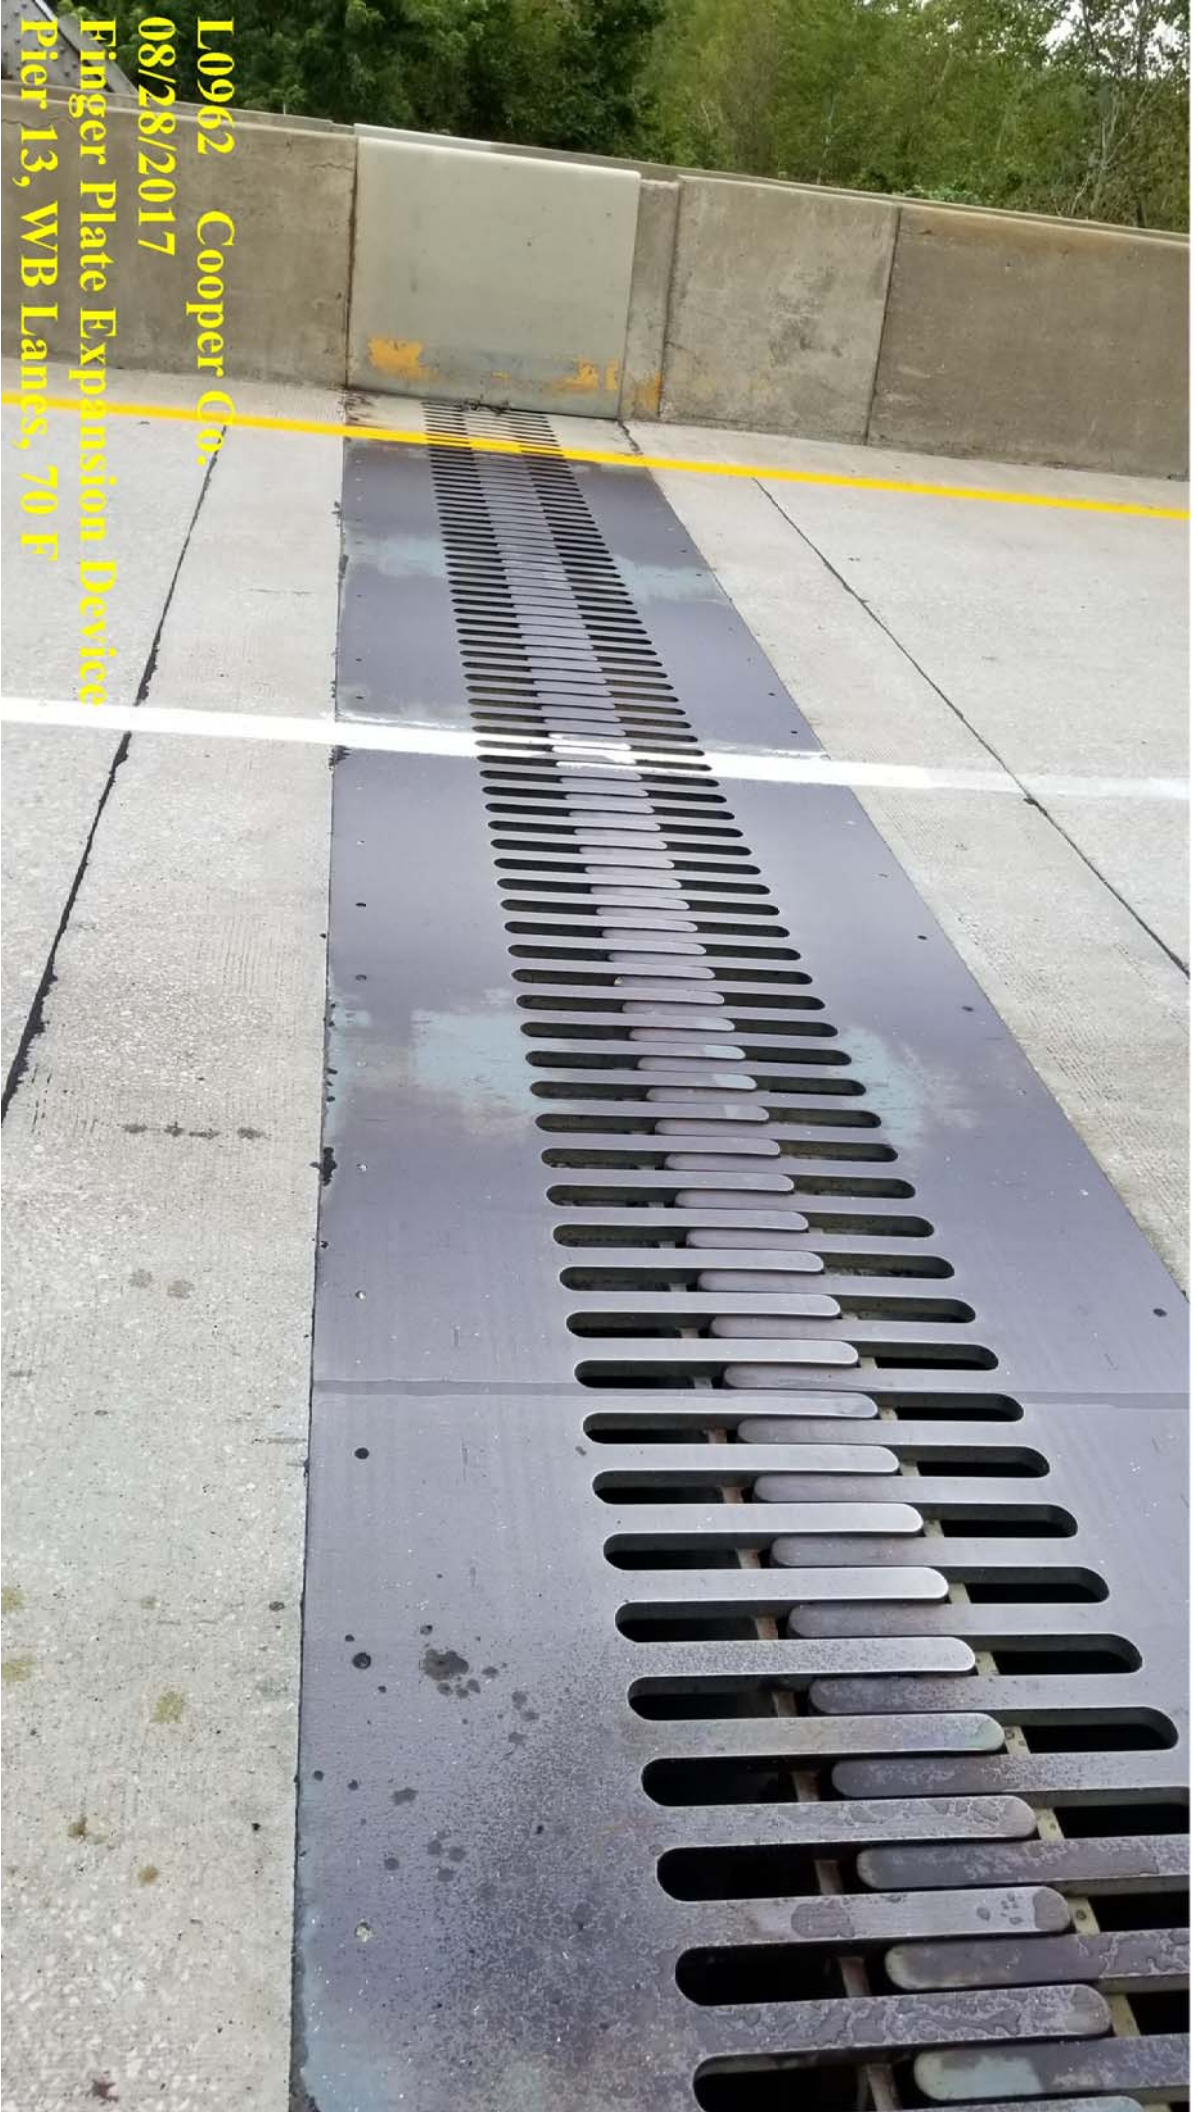
L0962 Cooper Co.
08/28/2017
Finger Plate Expansion Device
Pier 13, WB Lanes, 70 F

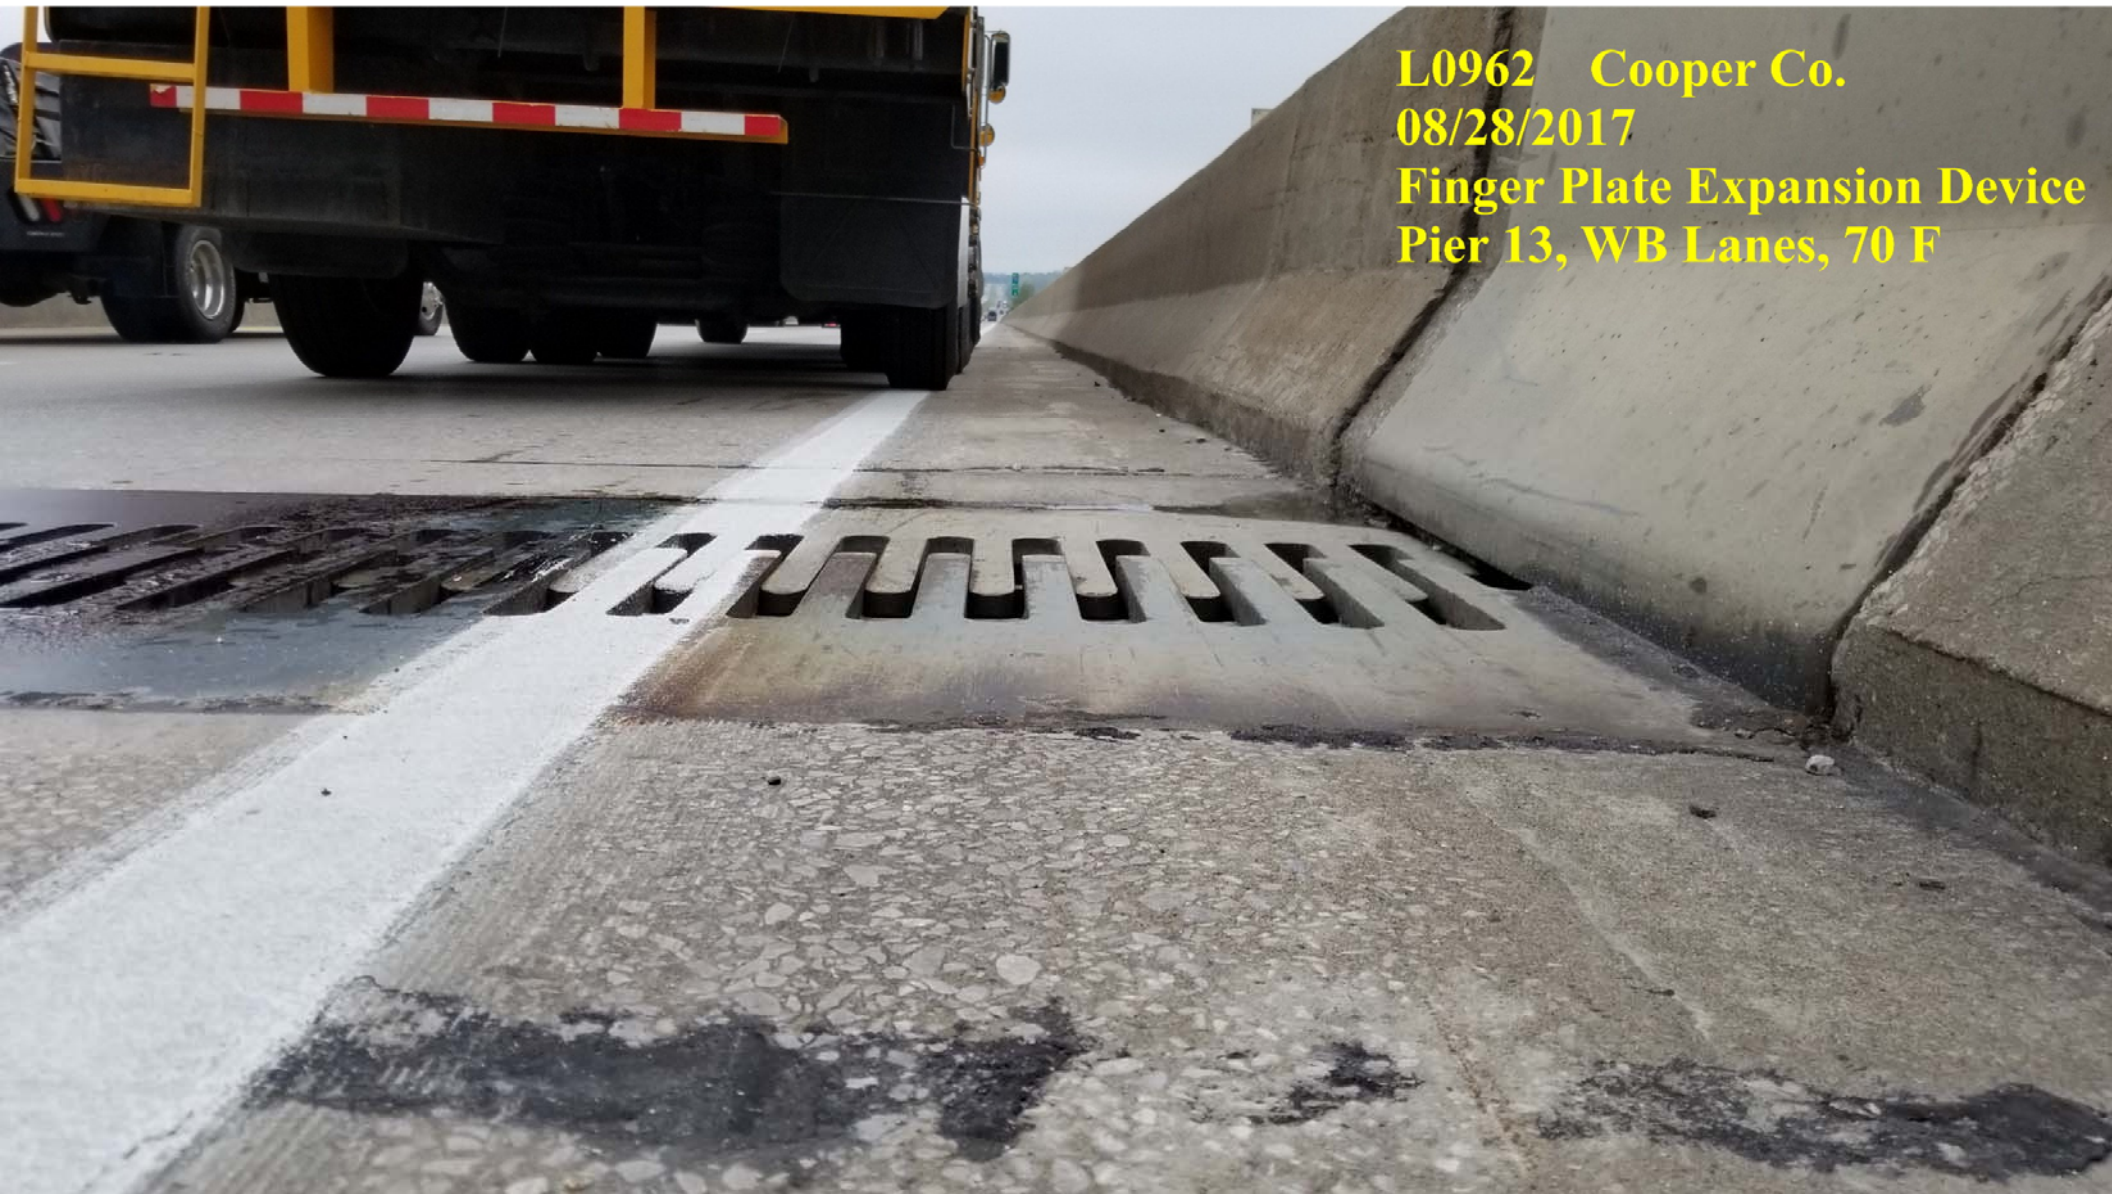
L0962 Cooper Co.
08/28/2017
Finger Plate Expansion Device
Pier 13, WB Lanes, 70 F
