L0962 Cooper Co.
08/28/2017
Looking West

L0962 I-70 Cooper
Pier 15 Open Expansion Joint WBL
8-28-17

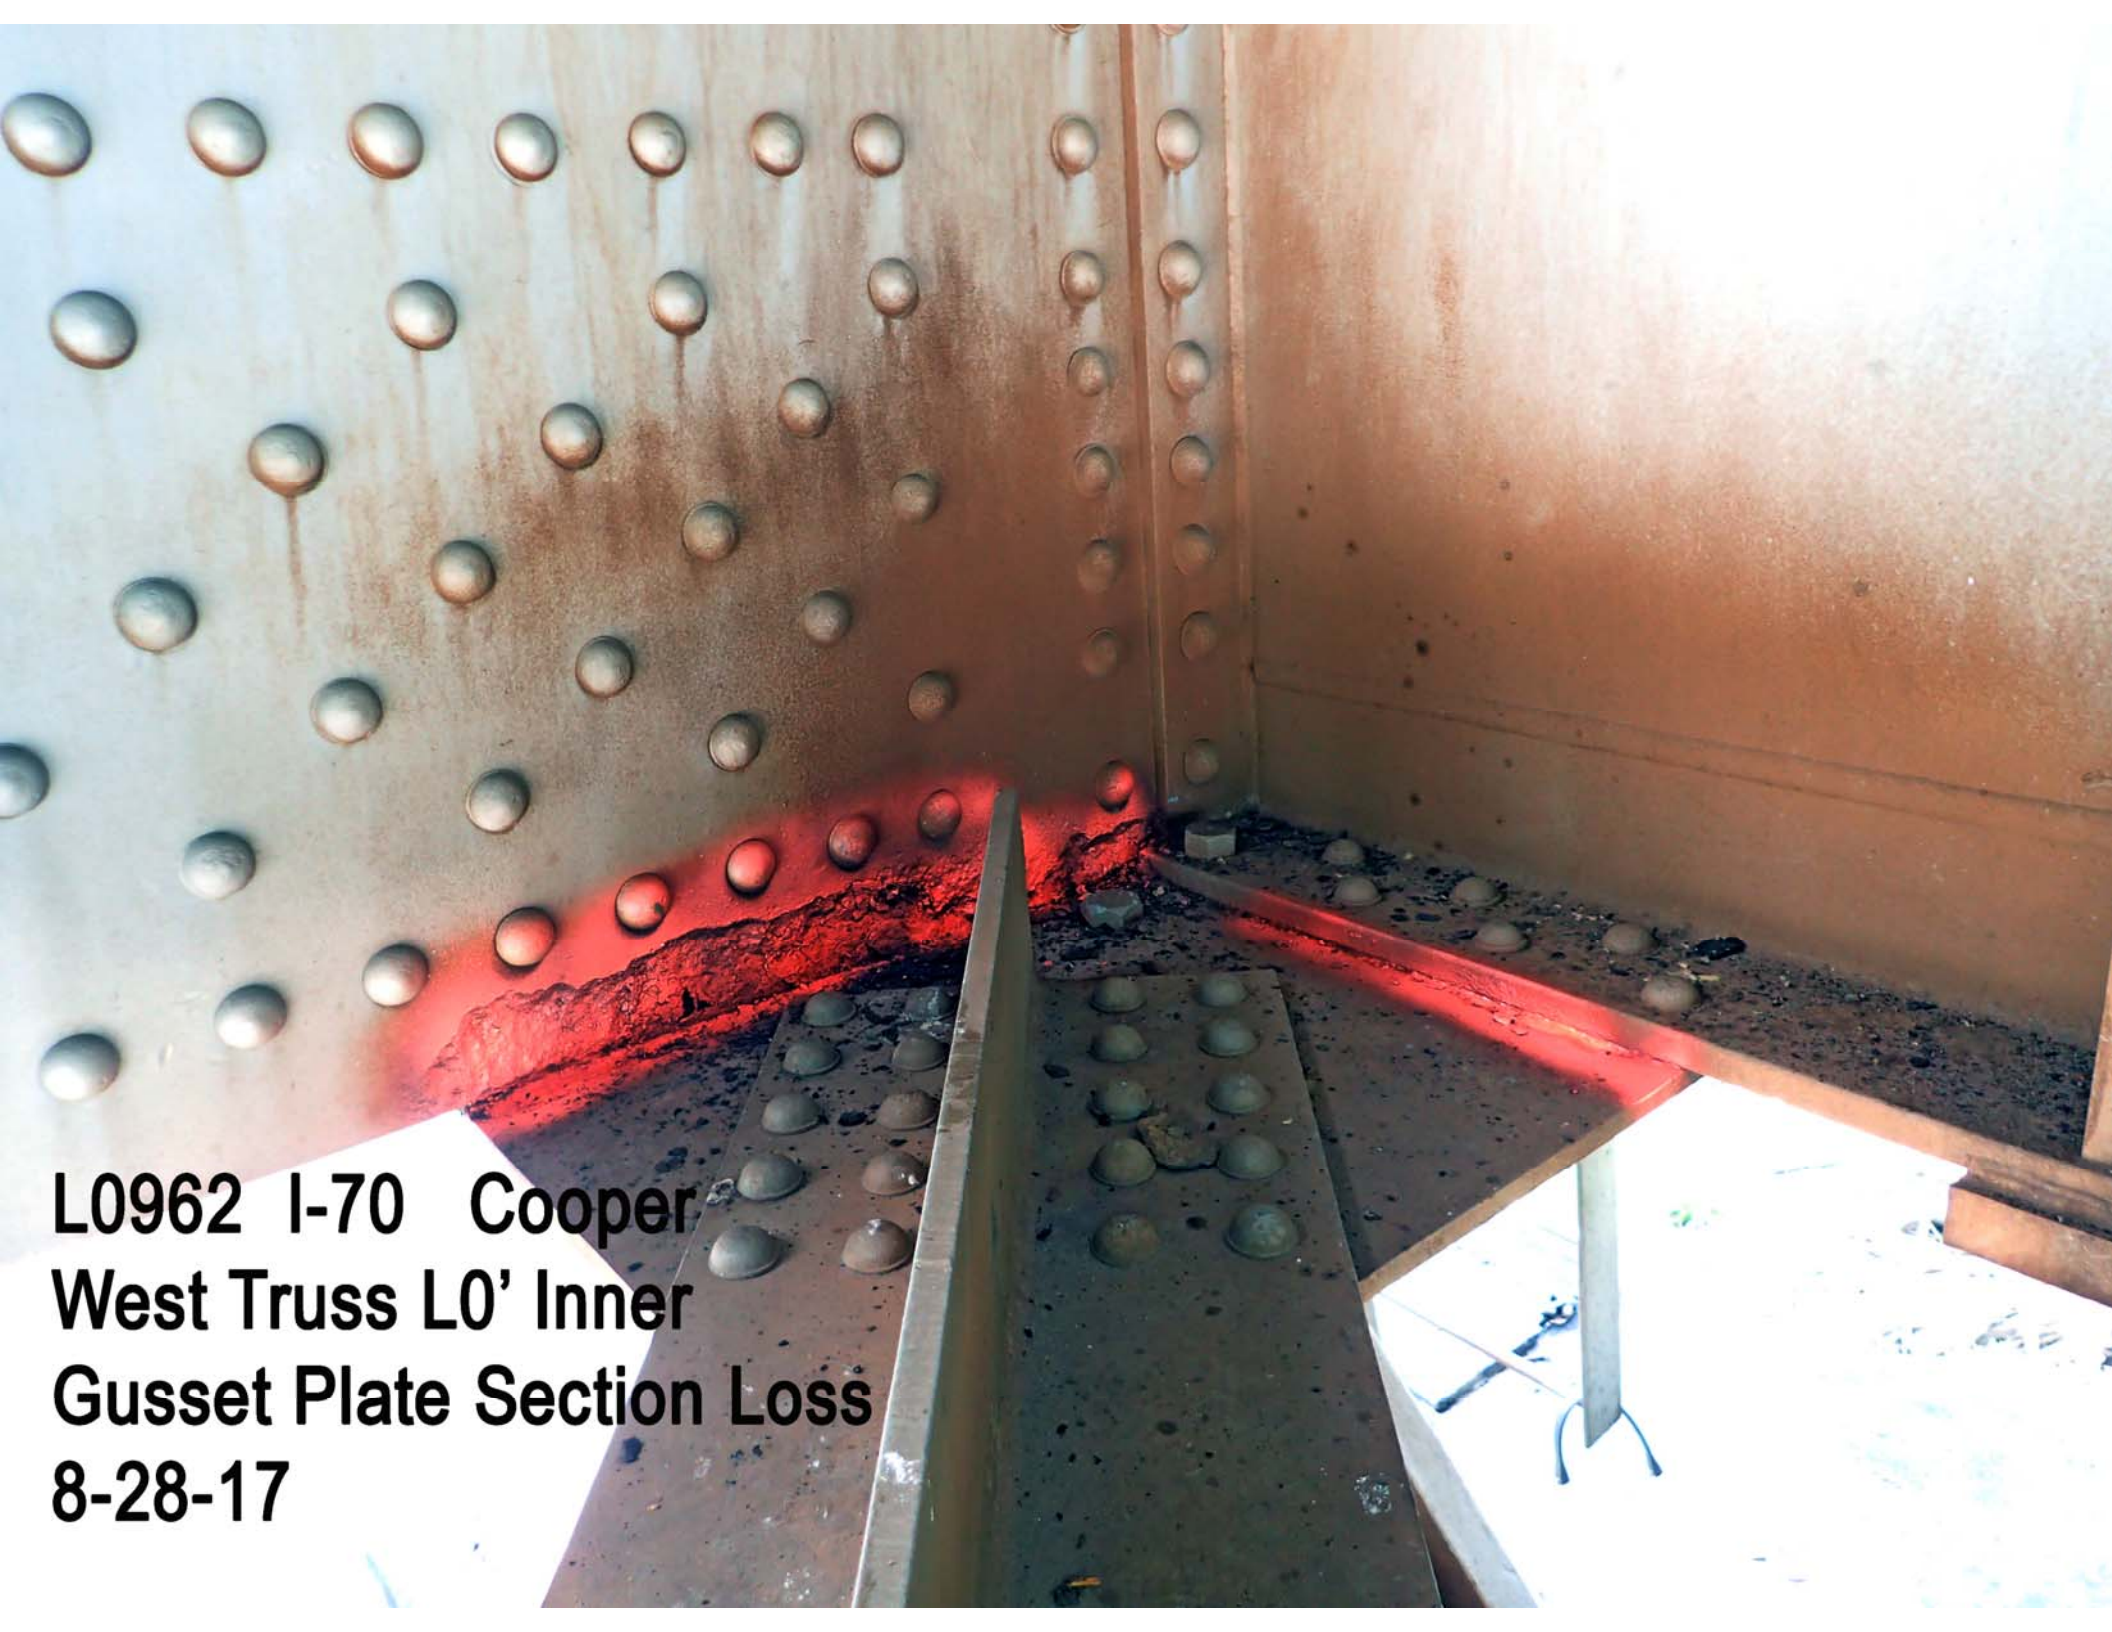
**L0962 I-70 Cooper
West End Floorbeam L0'L0'
at Stringer 1 Top Flange Section Loss
8-28-17**

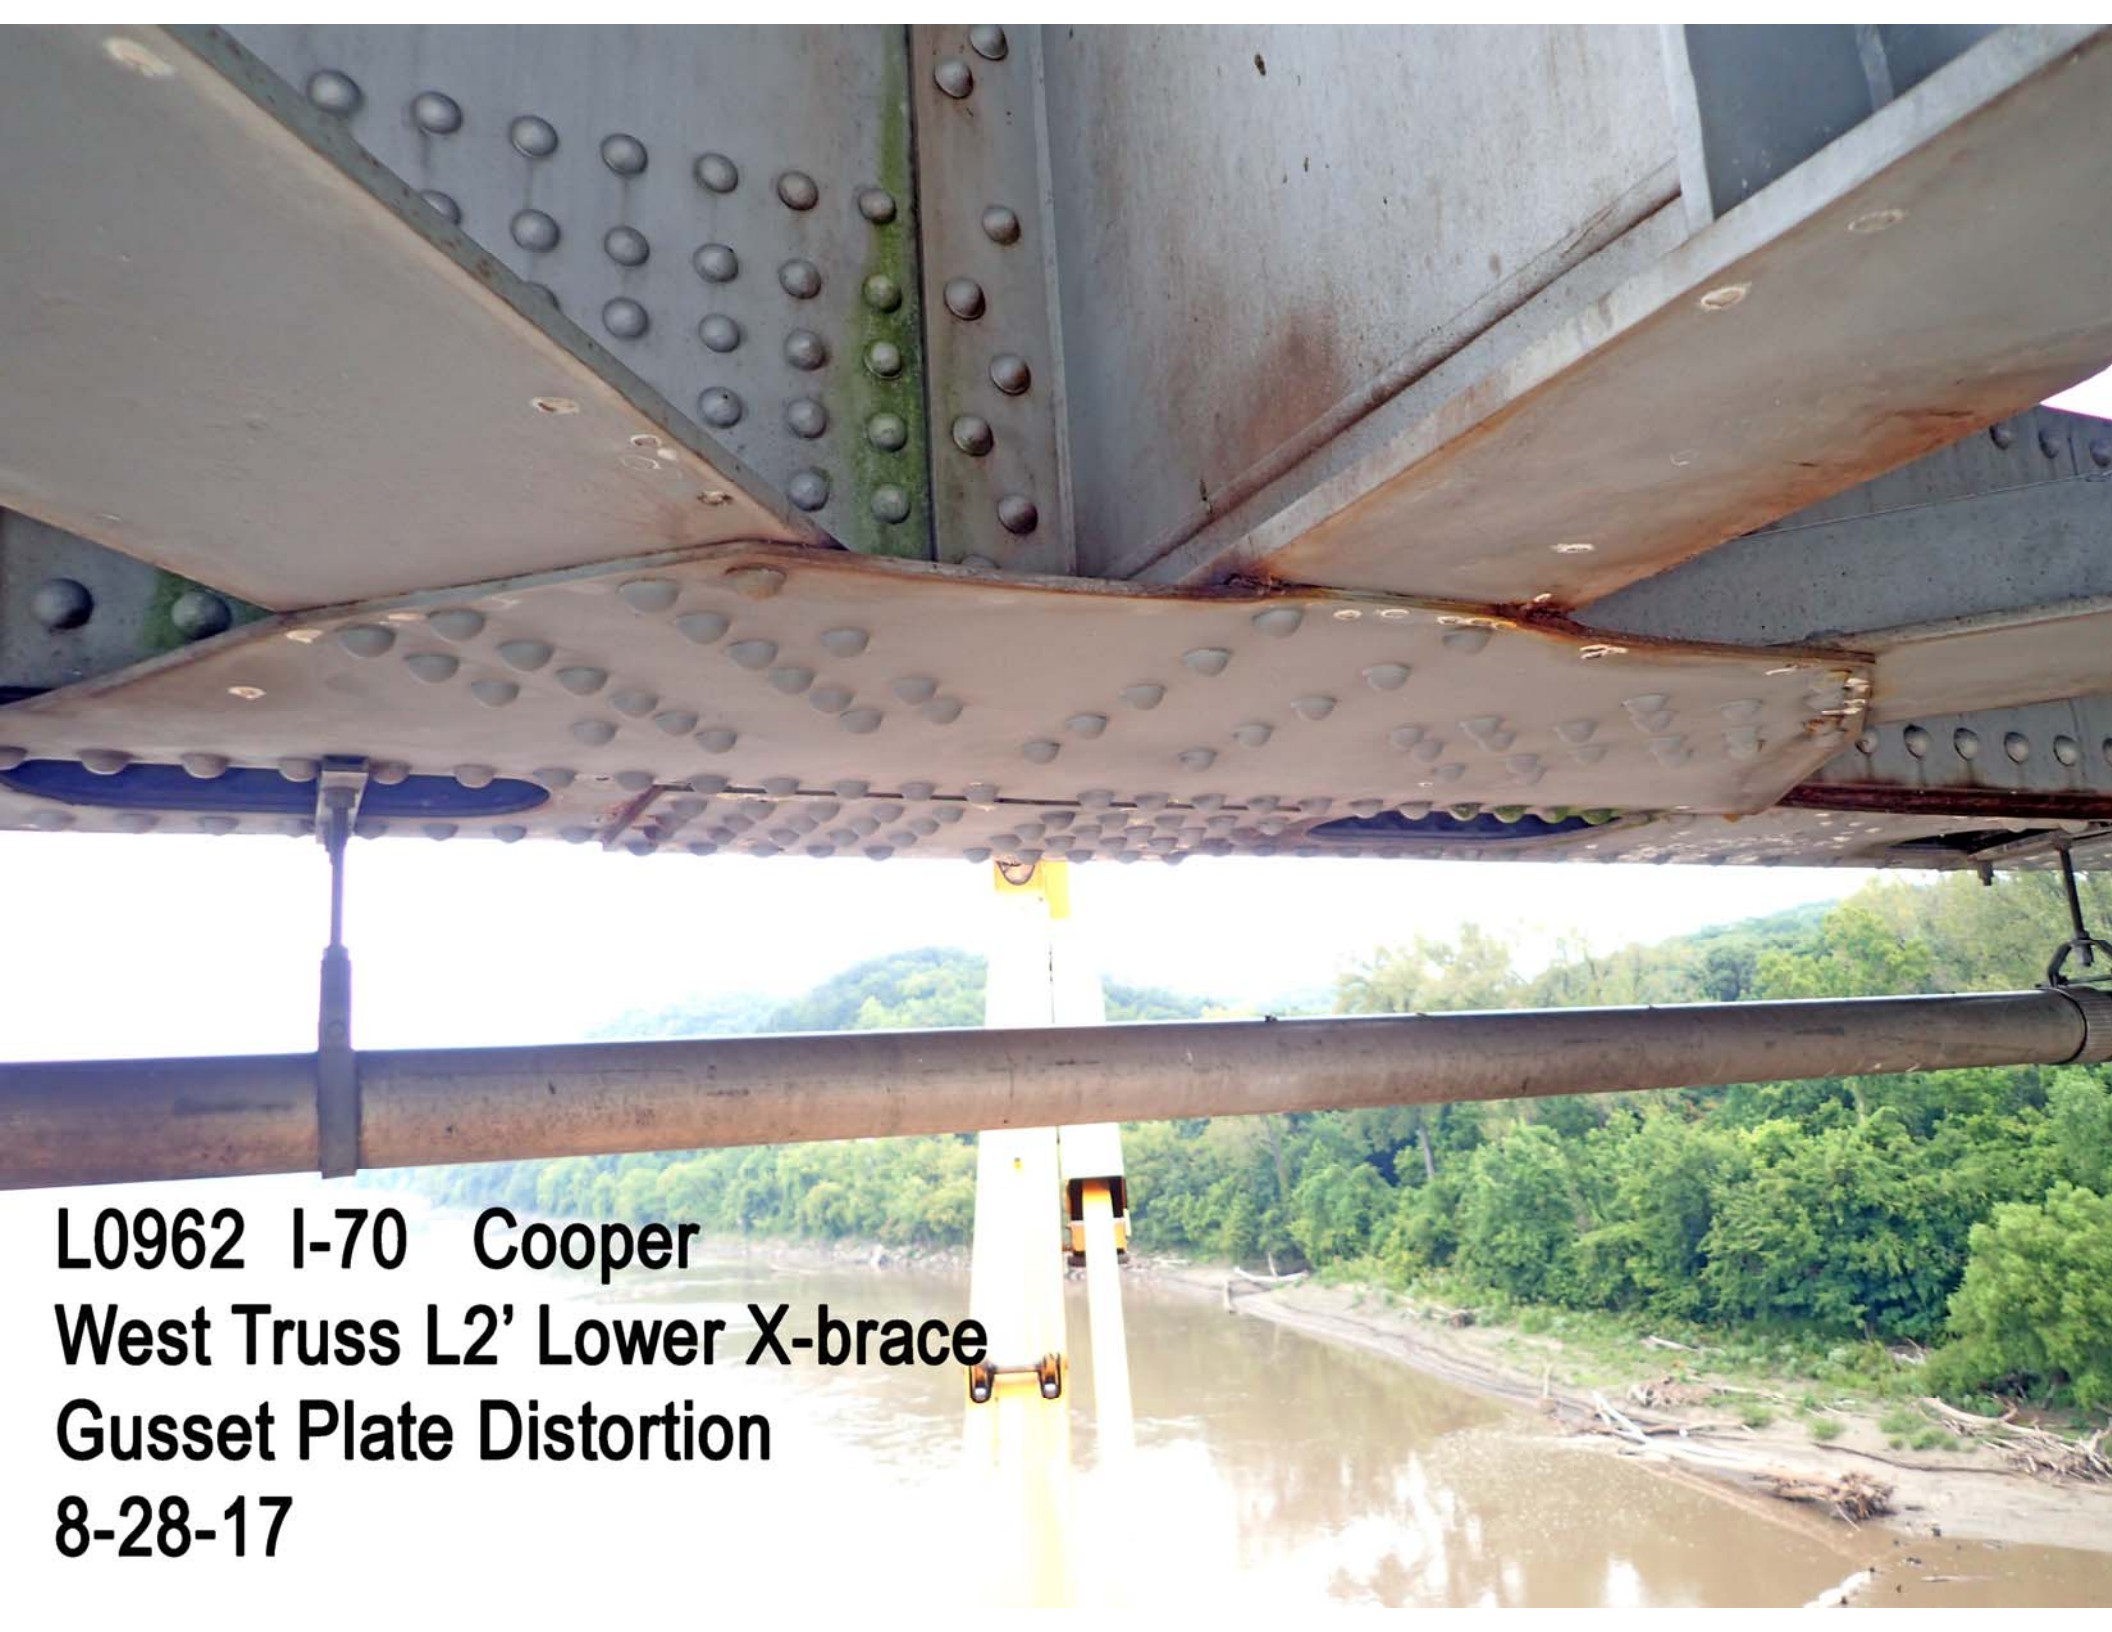
**L0962 I-70 Cooper
West Truss L2' Lower X-brace
Gusset Plate Distortion
8-28-17**

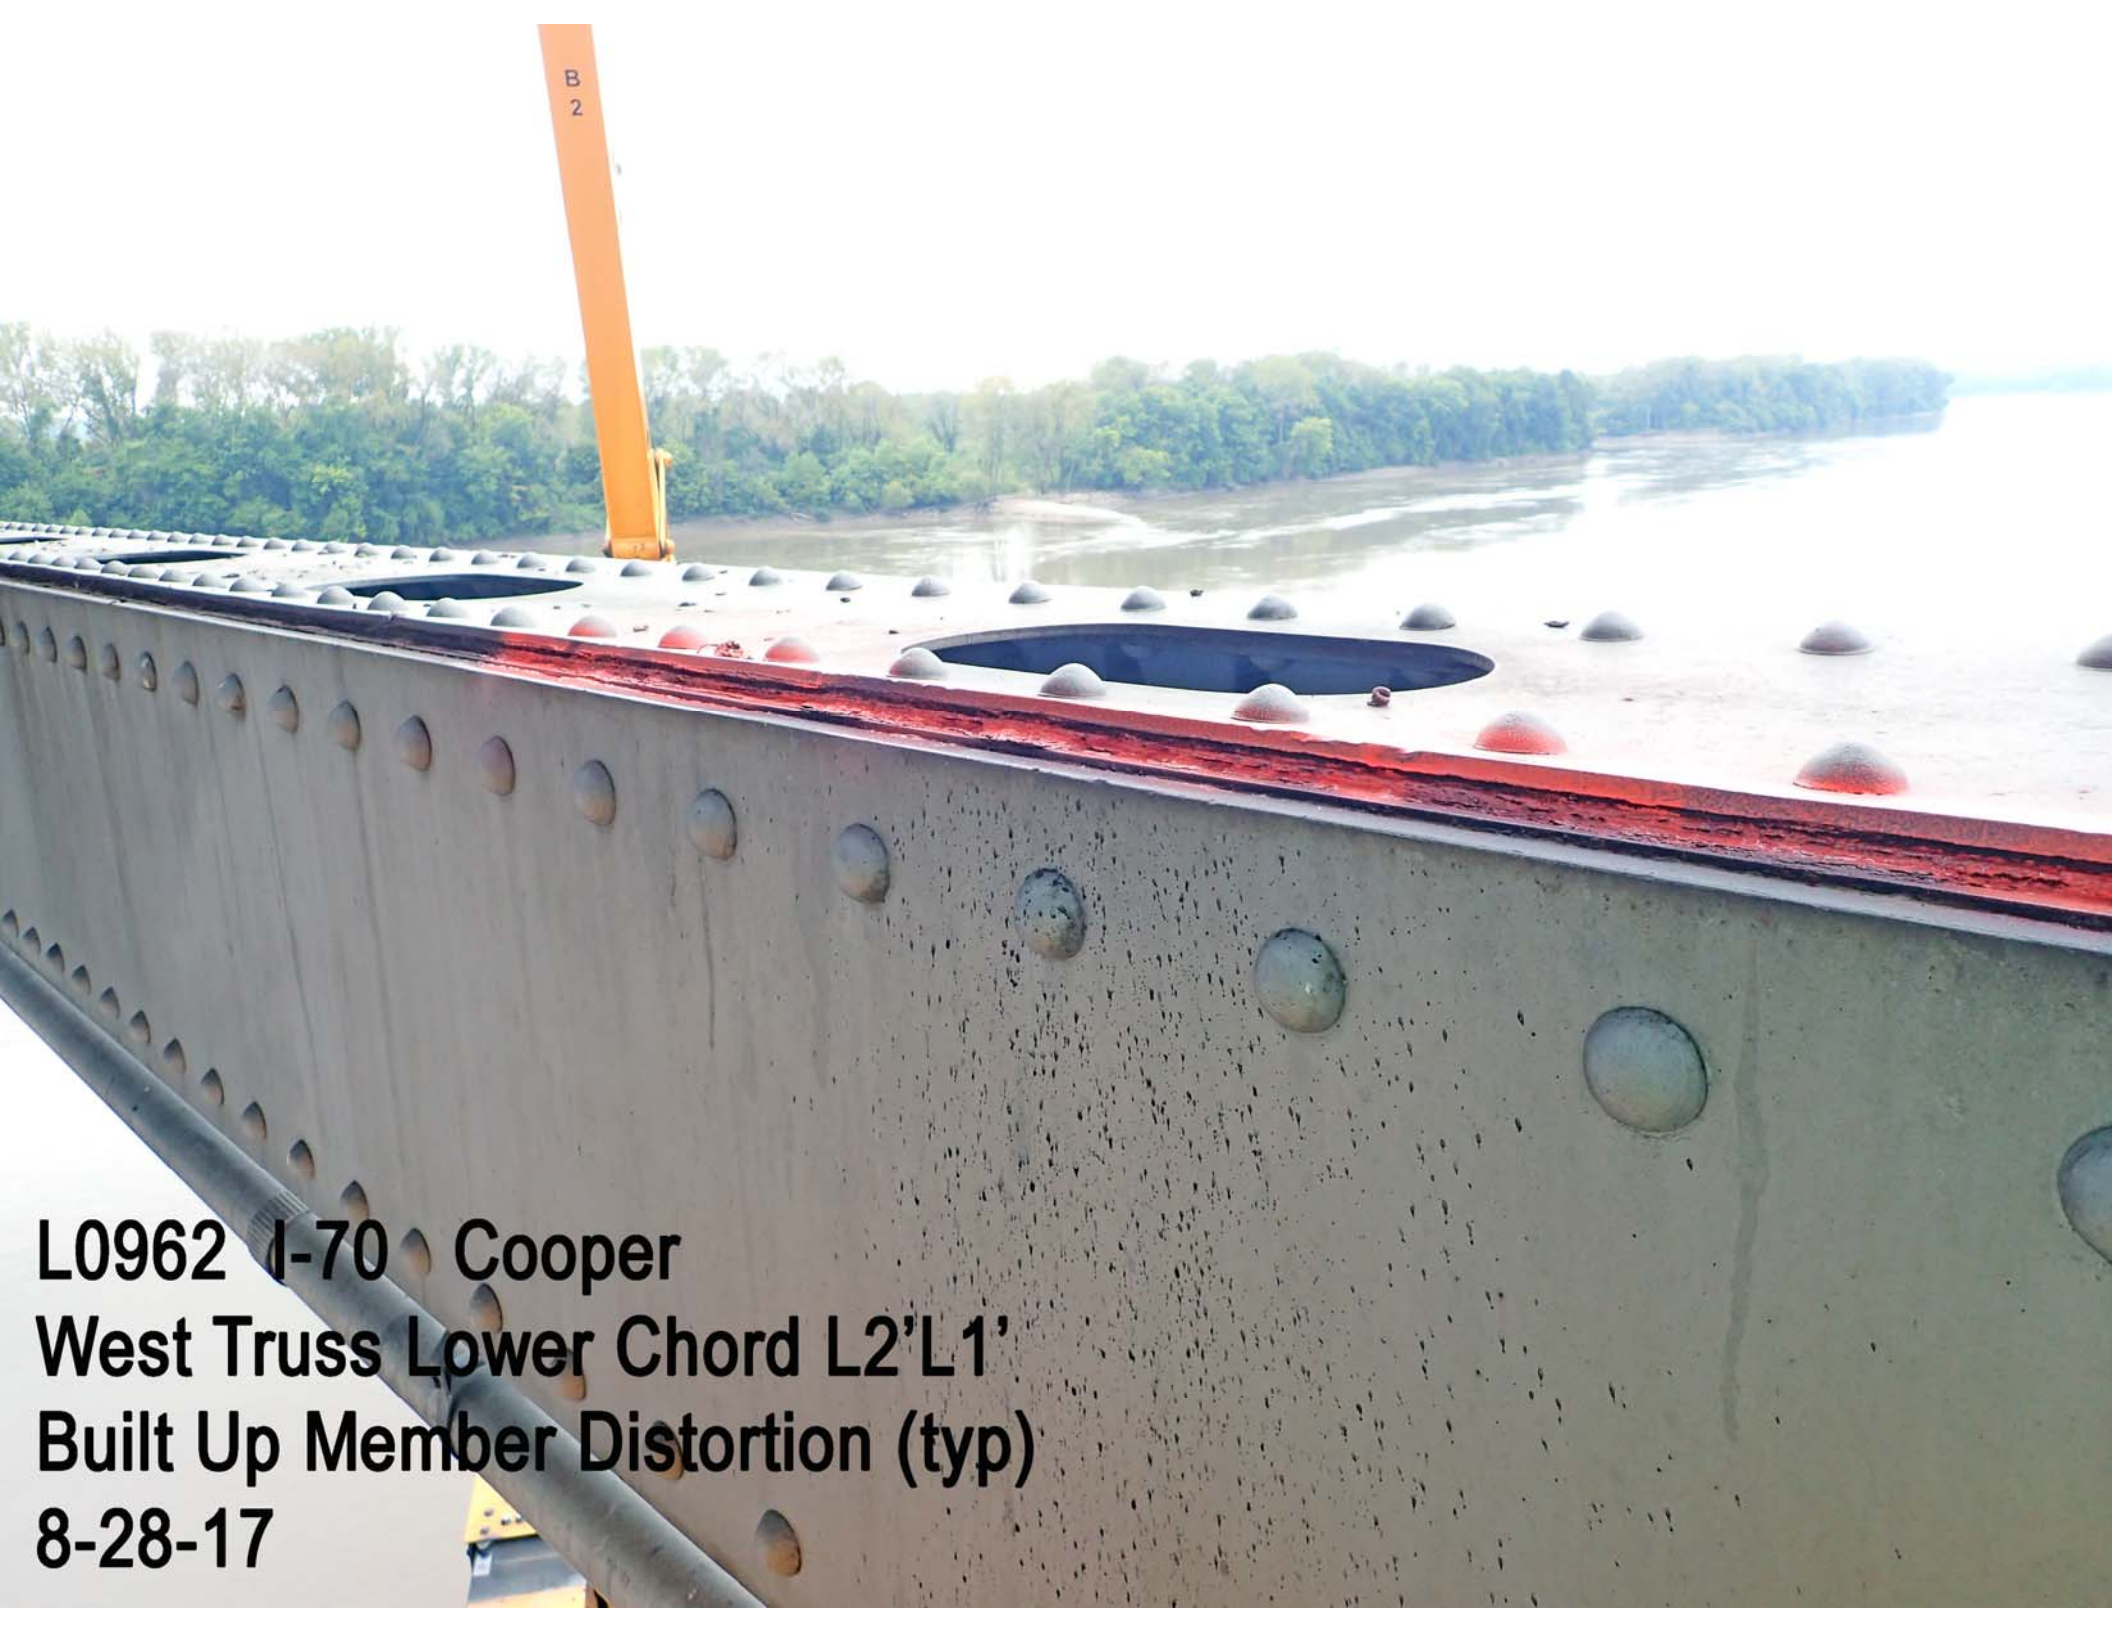
**L0962 I-70 Cooper
West Truss Lower Chord L2'L1'
Built Up Member Distortion (typ)
8-28-17**

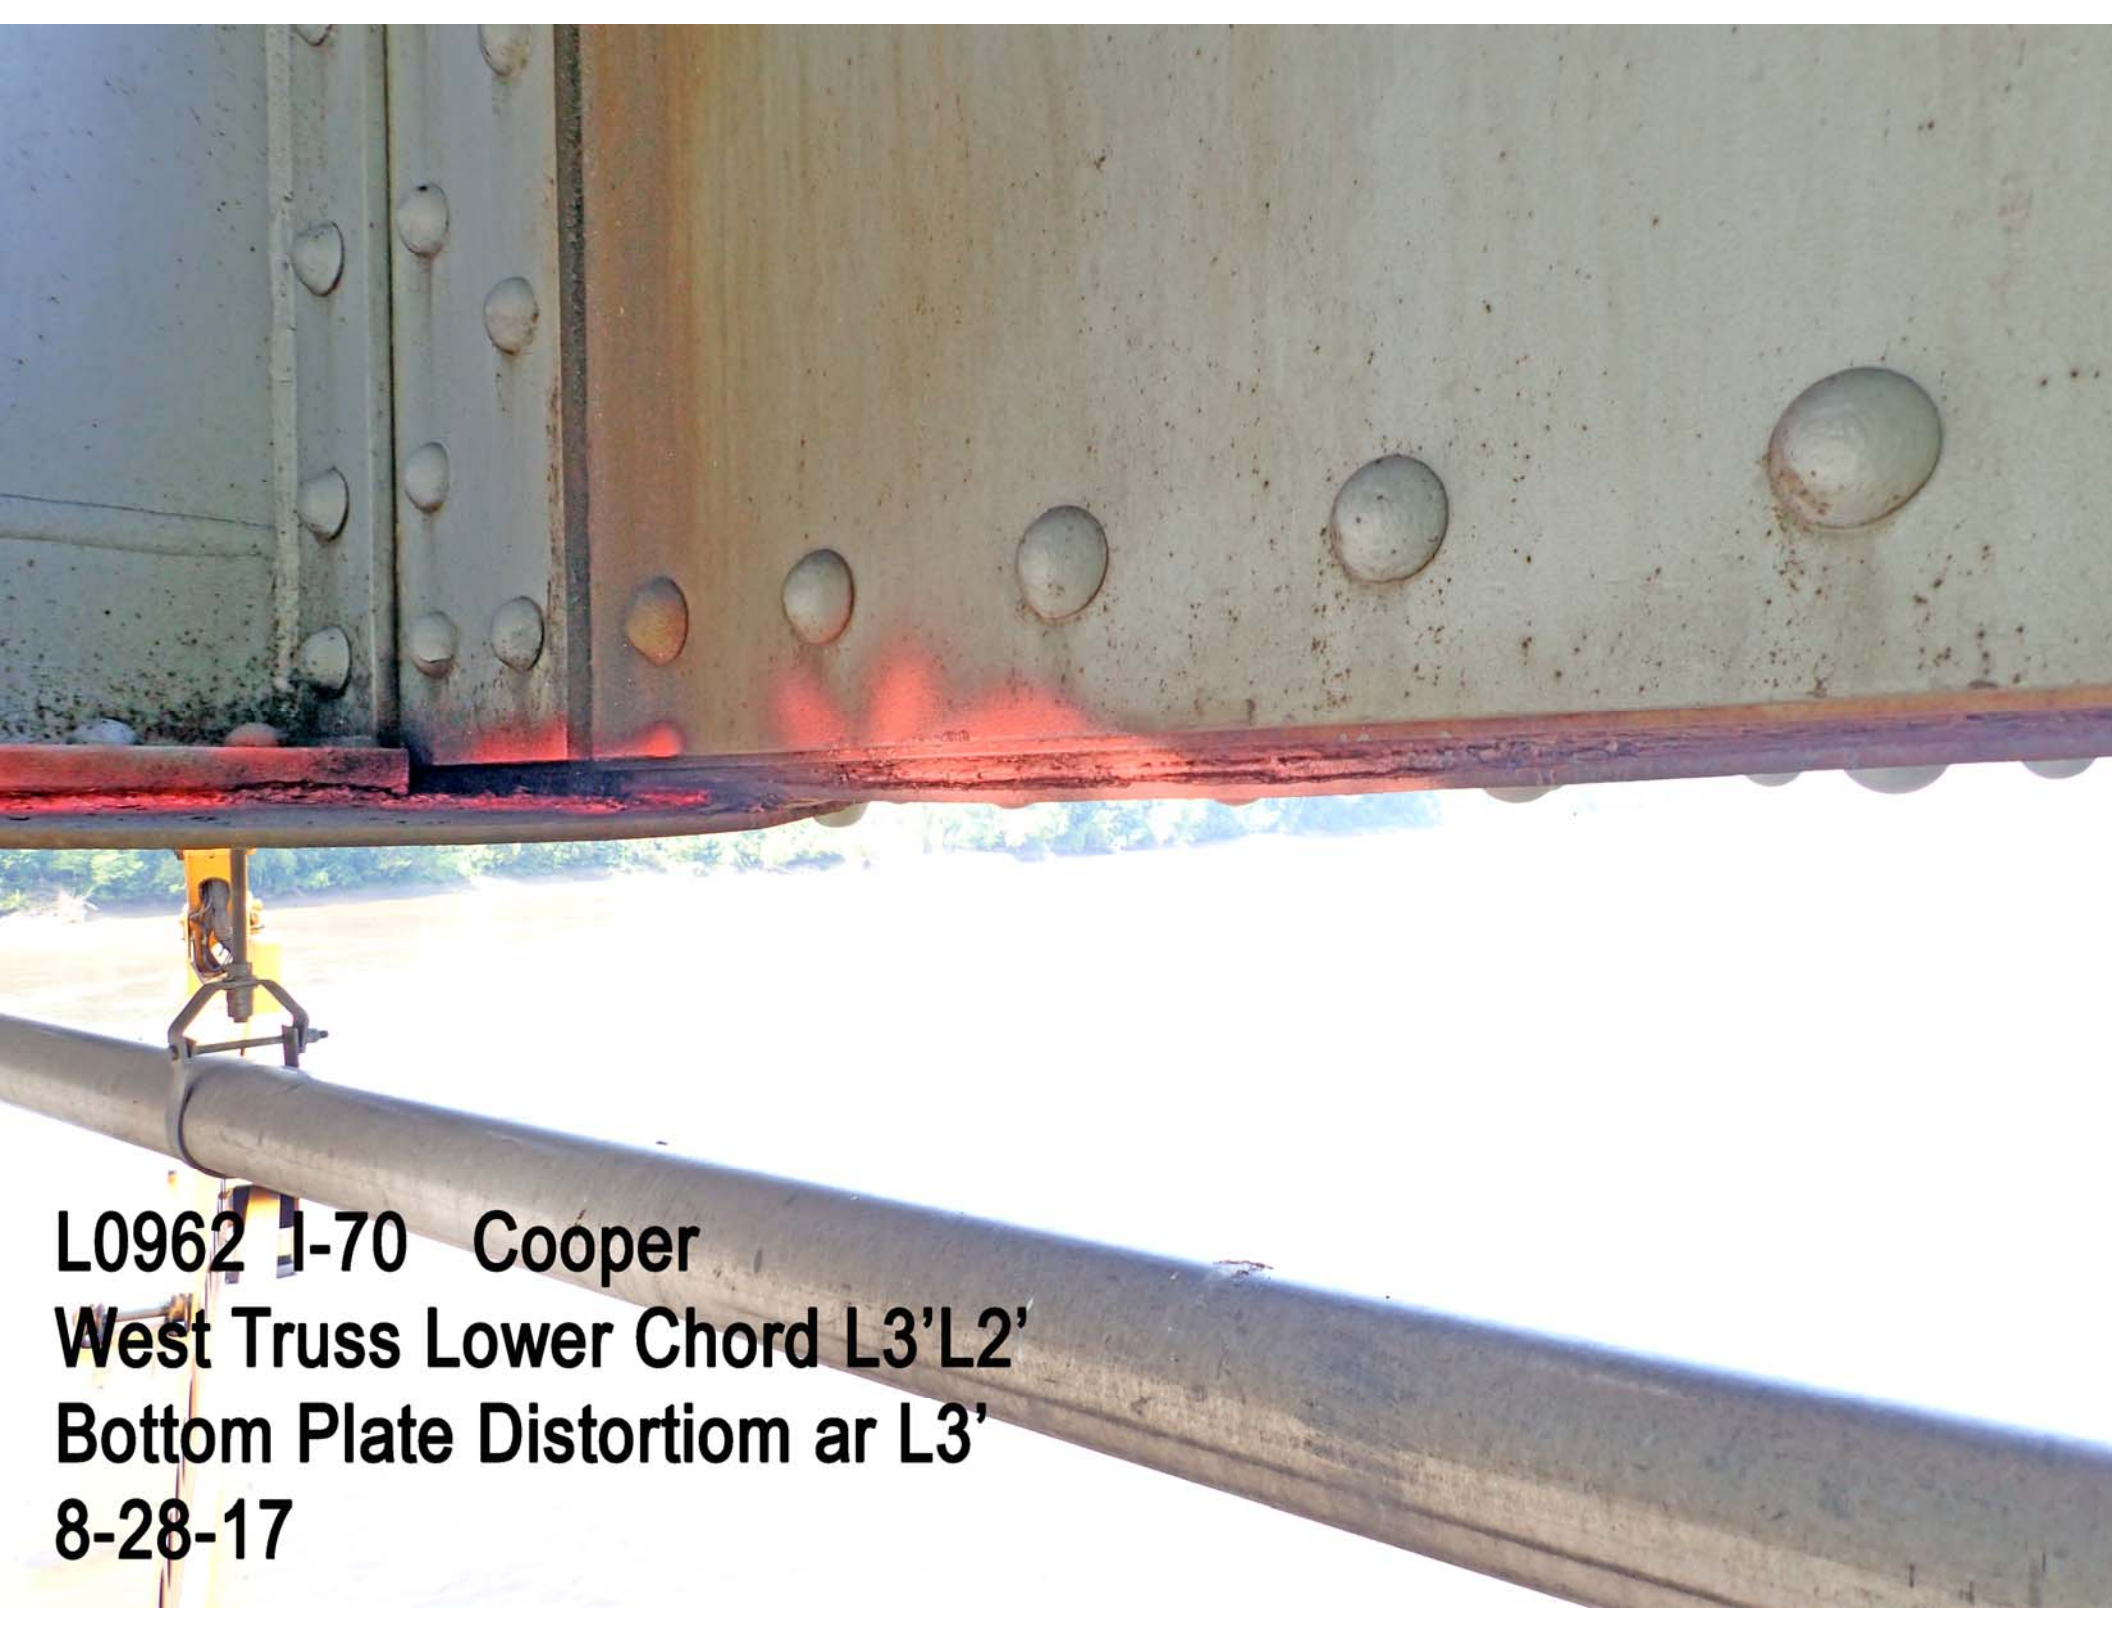
L0962 1-70 Cooper
West Truss Lower Chord L3'L2'
Bottom Plate Distortion at L3'
8-28-17

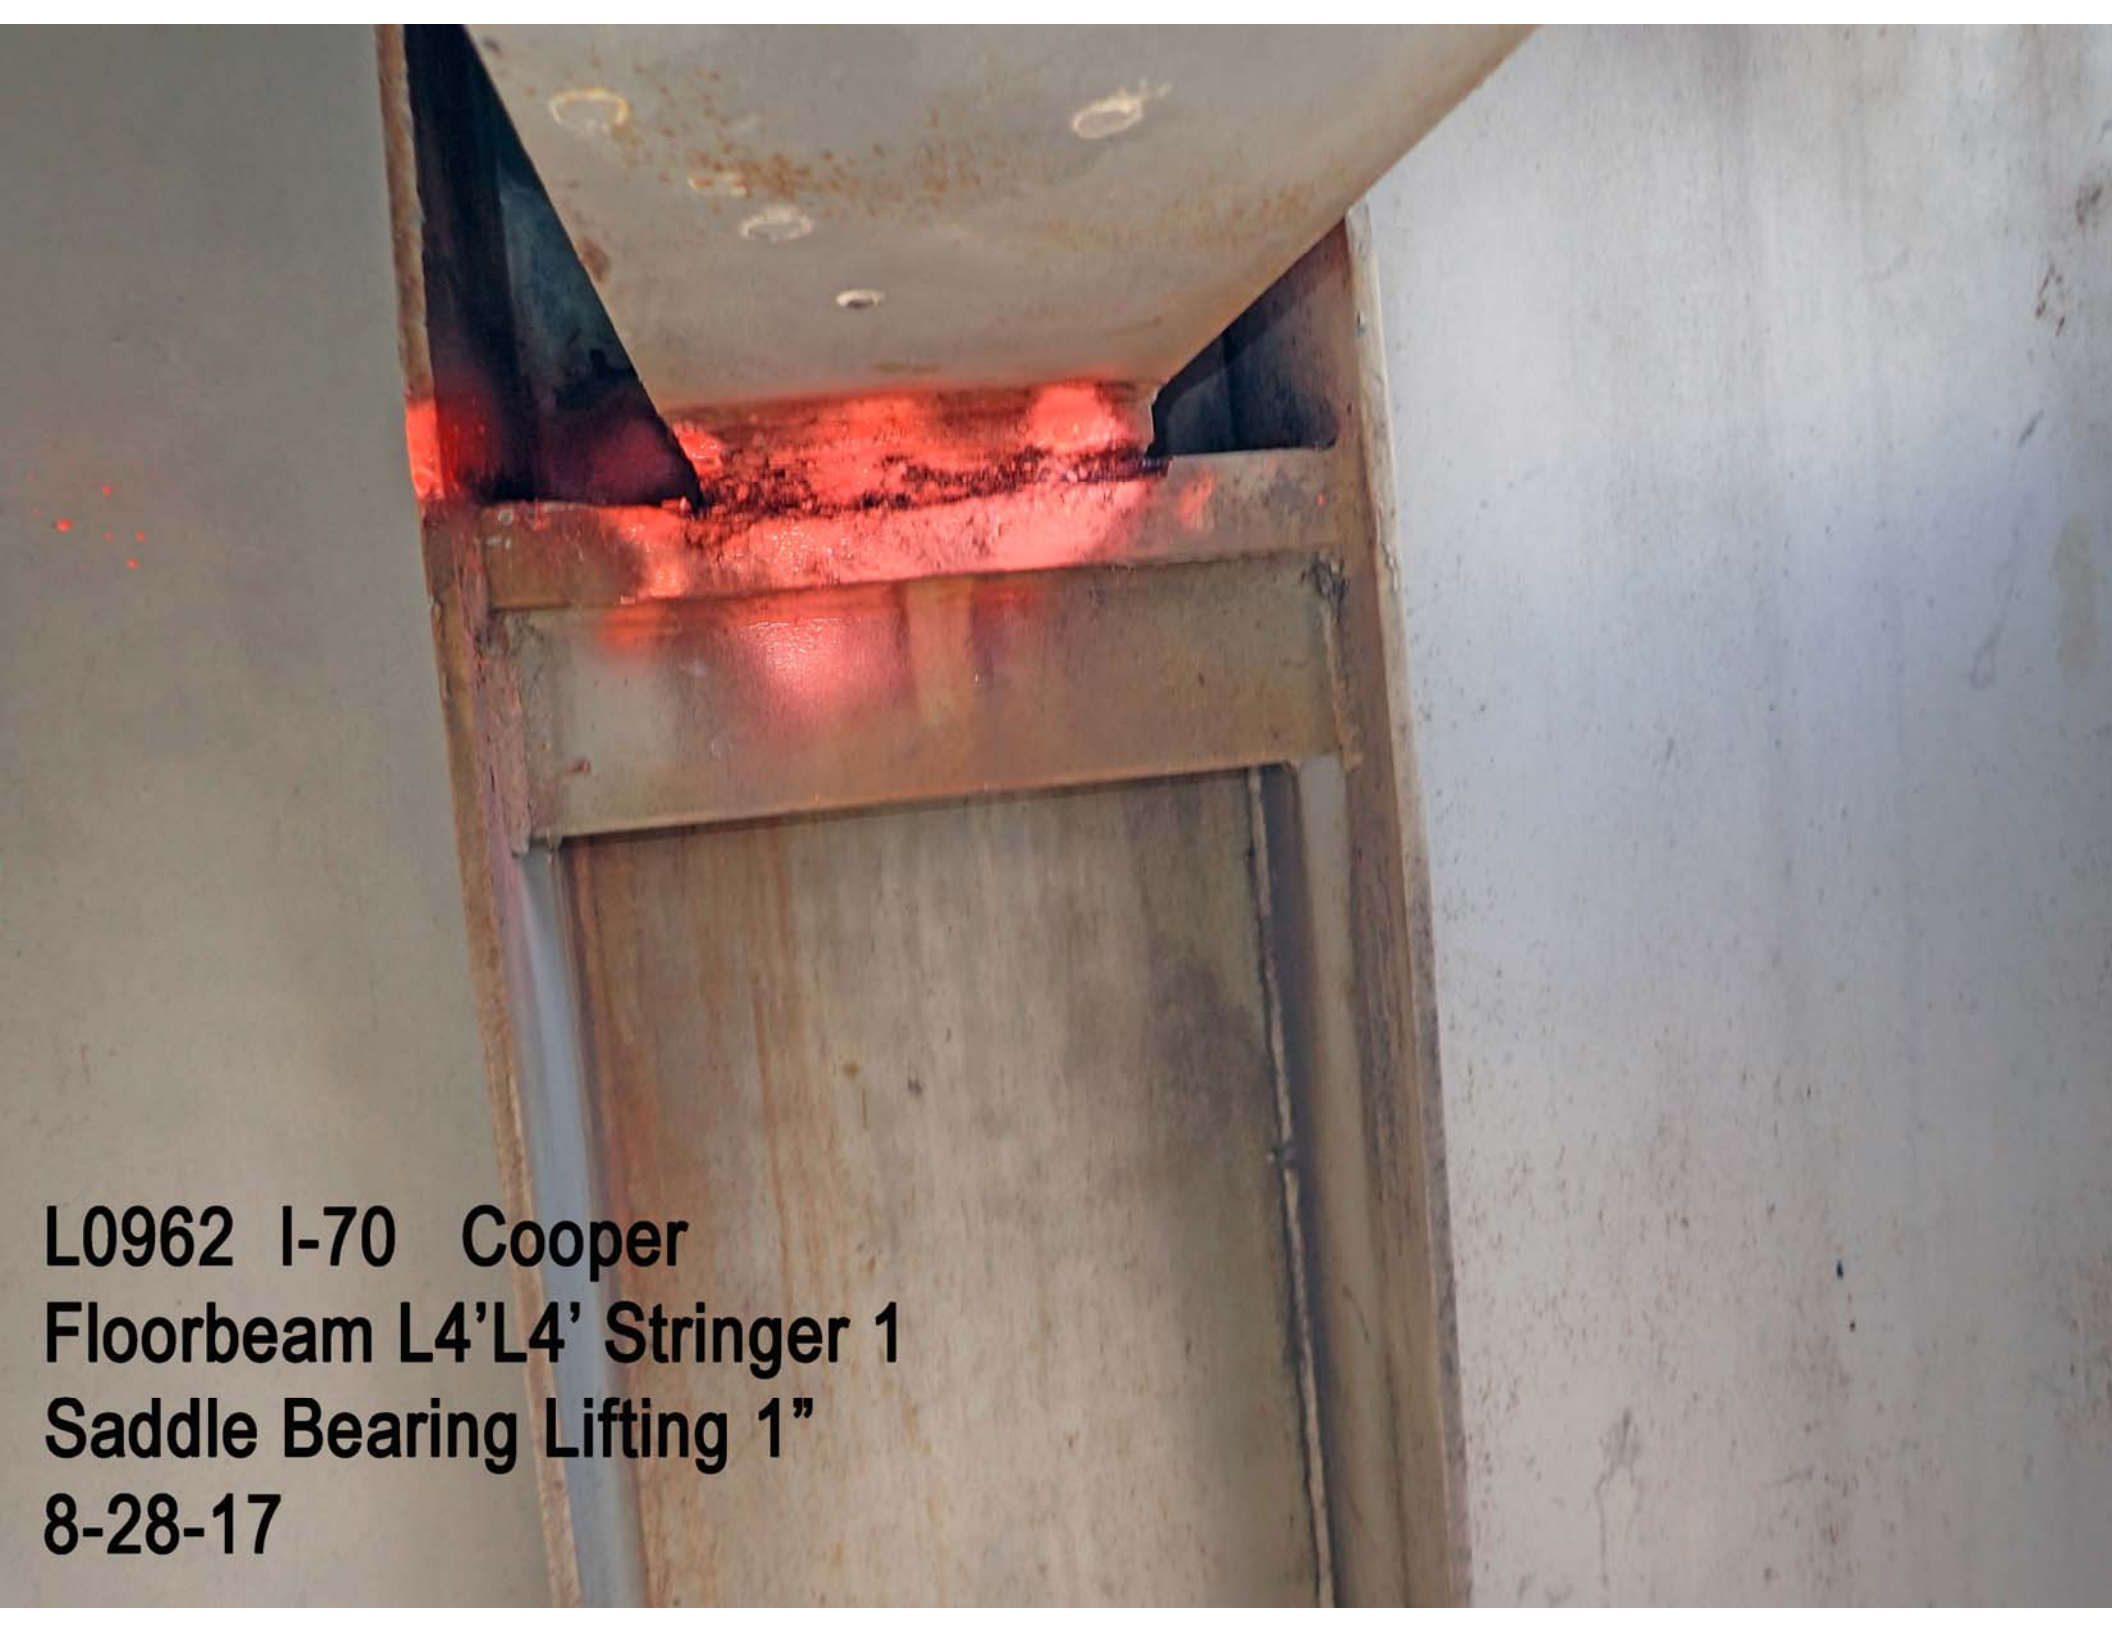
**L0962 I-70 Cooper
Floorbeam L4'L4' Stringer 1
Saddle Bearing Lifting 1"
8-28-17**

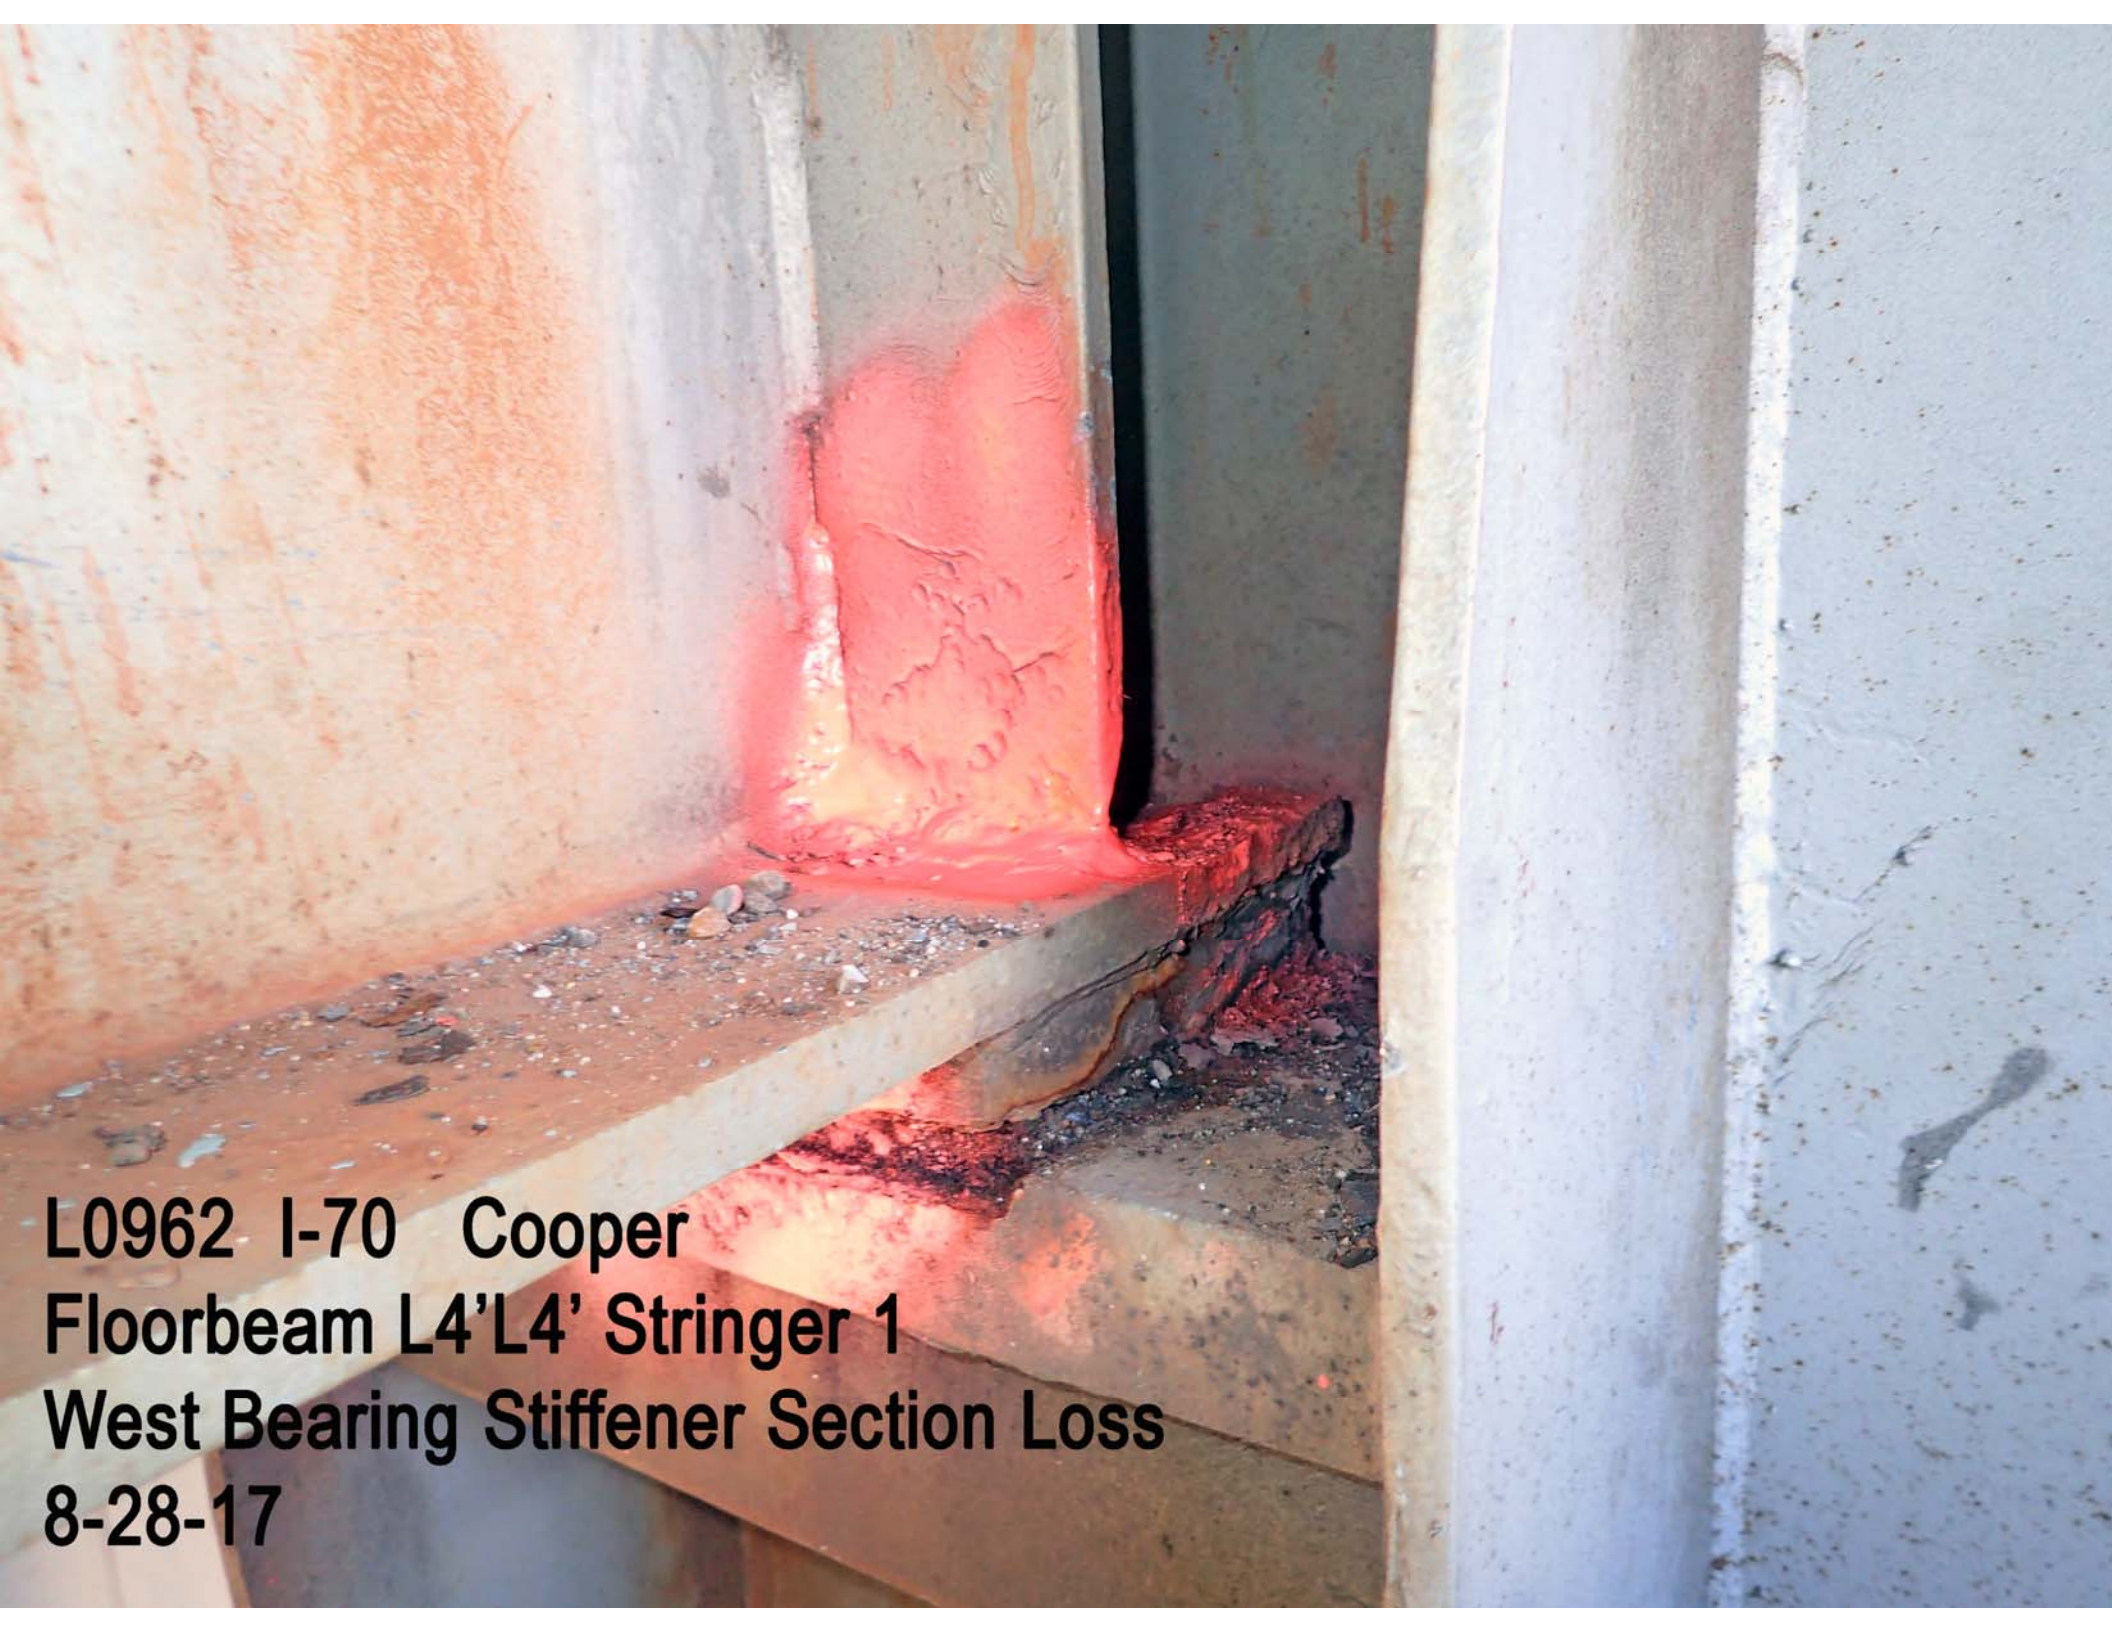
**L0962 I-70 Cooper
Floorbeam L4'L4' Stringer 1
West Bearing Stiffener Section Loss
8-28-17**
