L0962 Cooper Co.
08/28/2017
Looking West

L0962 I-70 Cooper
Pier 15 Open Expansion Joint WBL
8-28-17

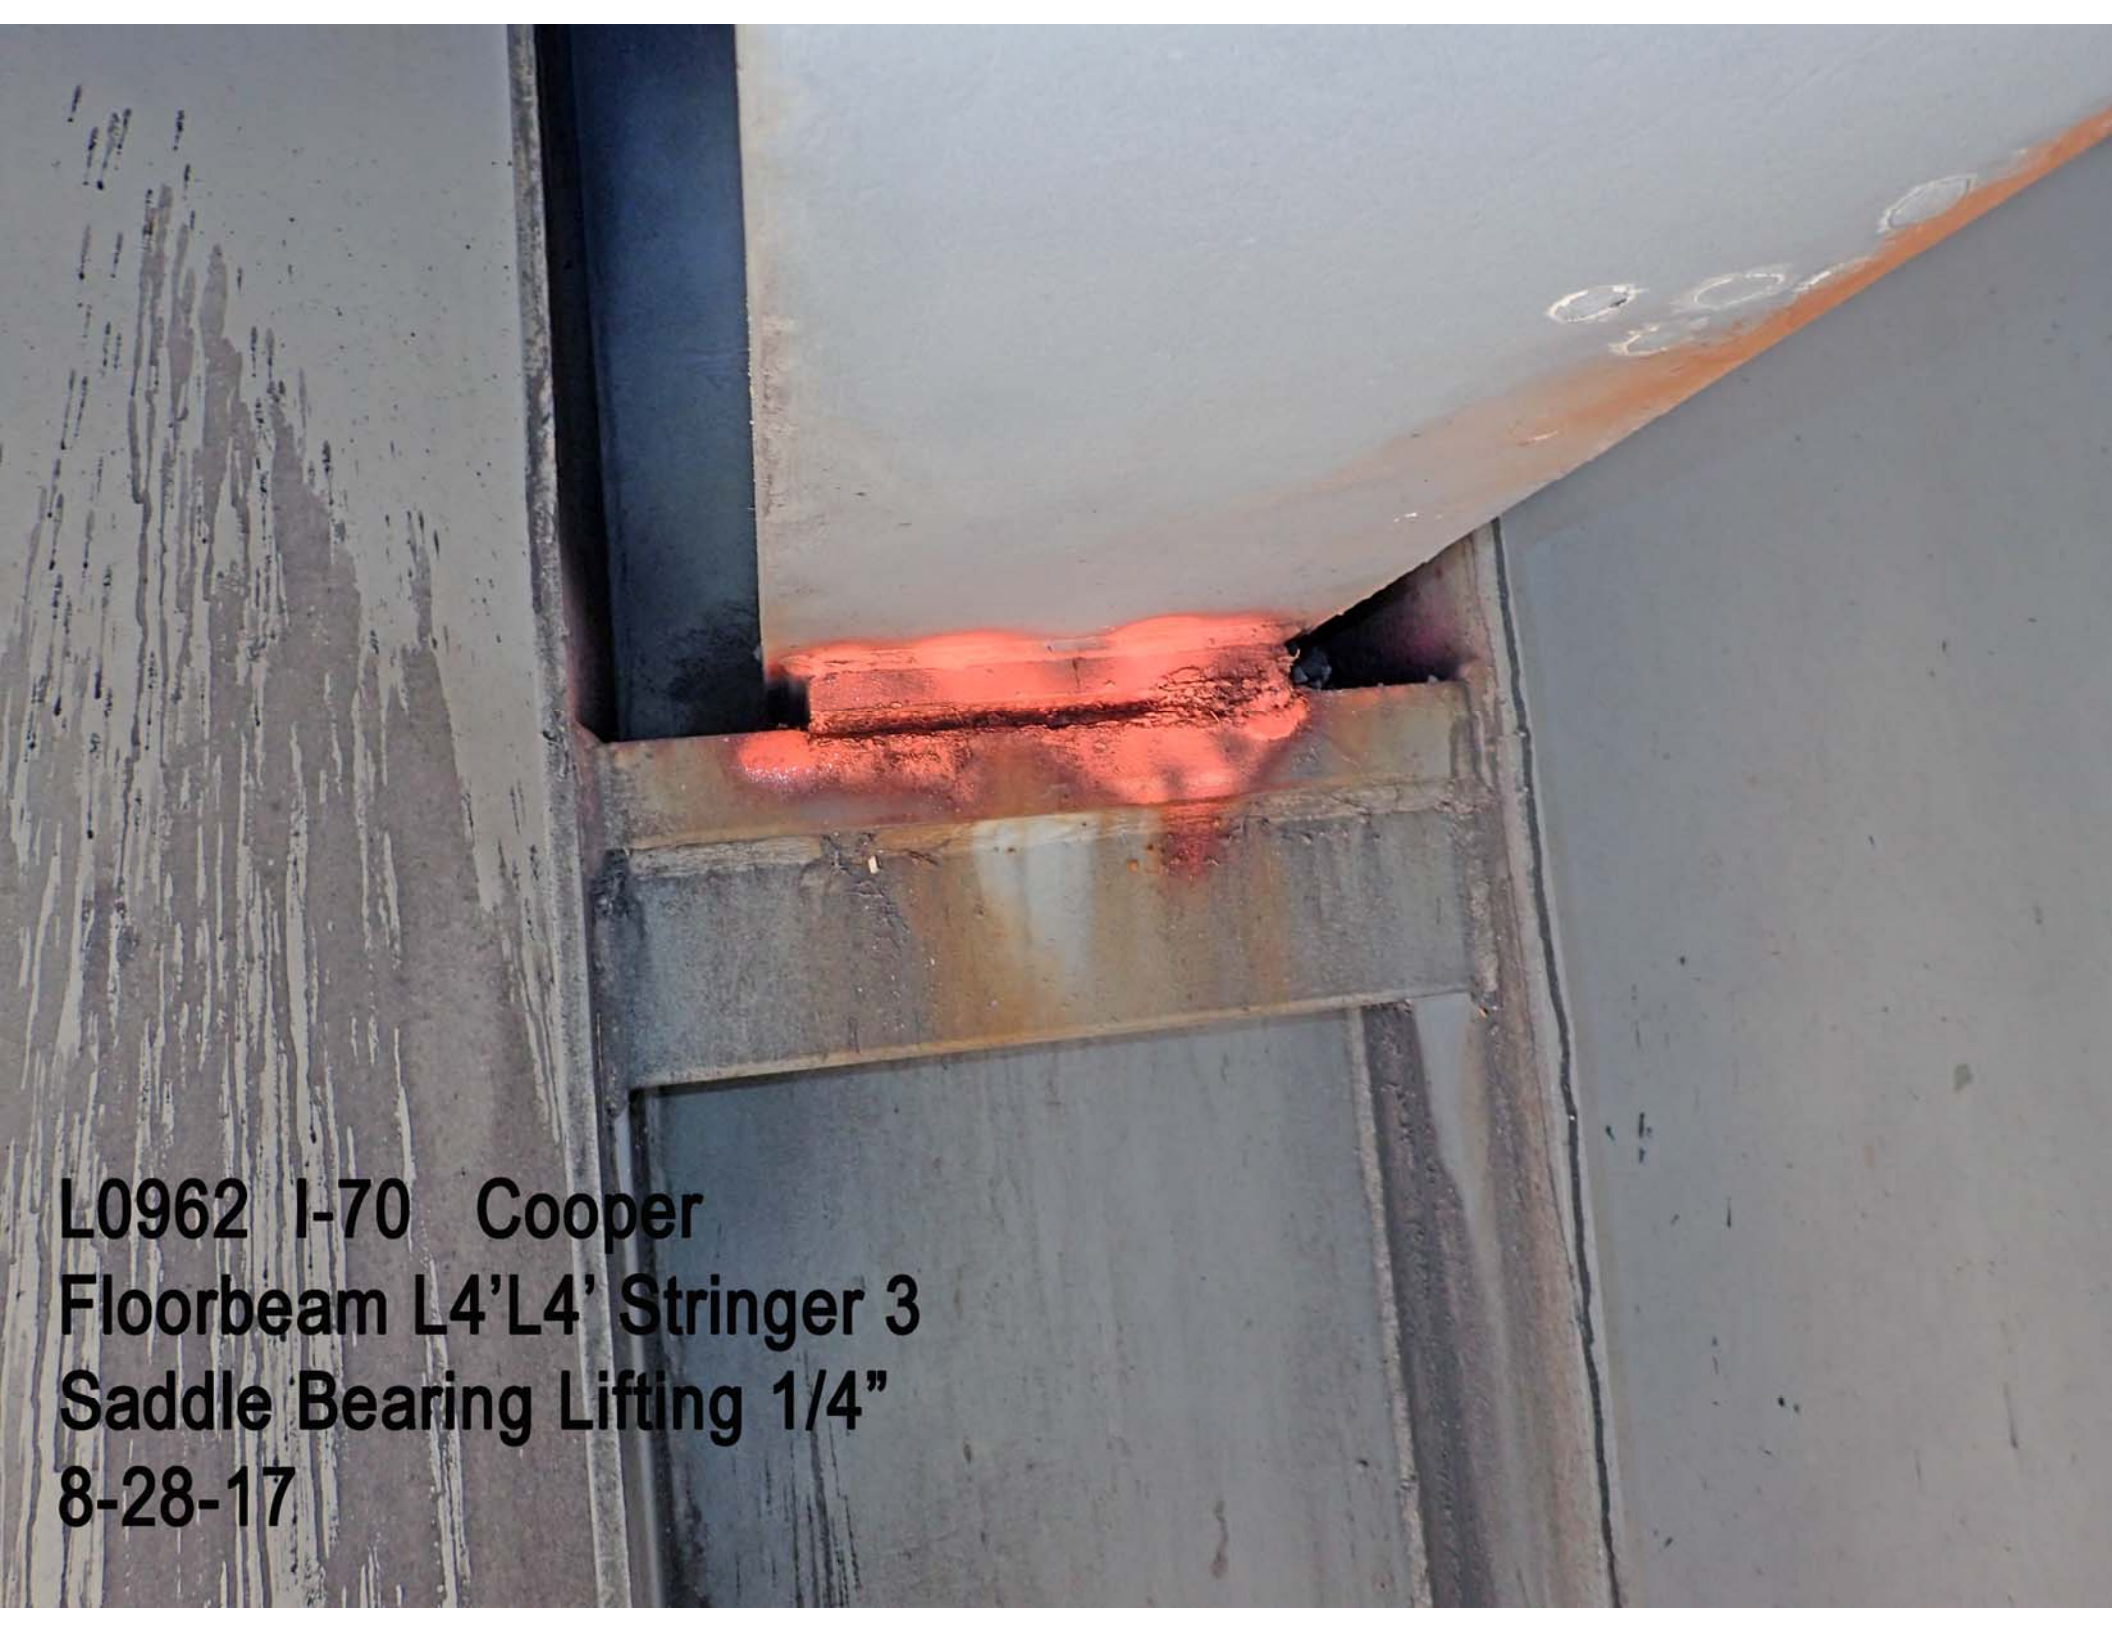
L0962 I-70 Cooper
Floorbeam L4'L4' Stringer 3
Saddle Bearing Lifting 1/4"
8-28-17

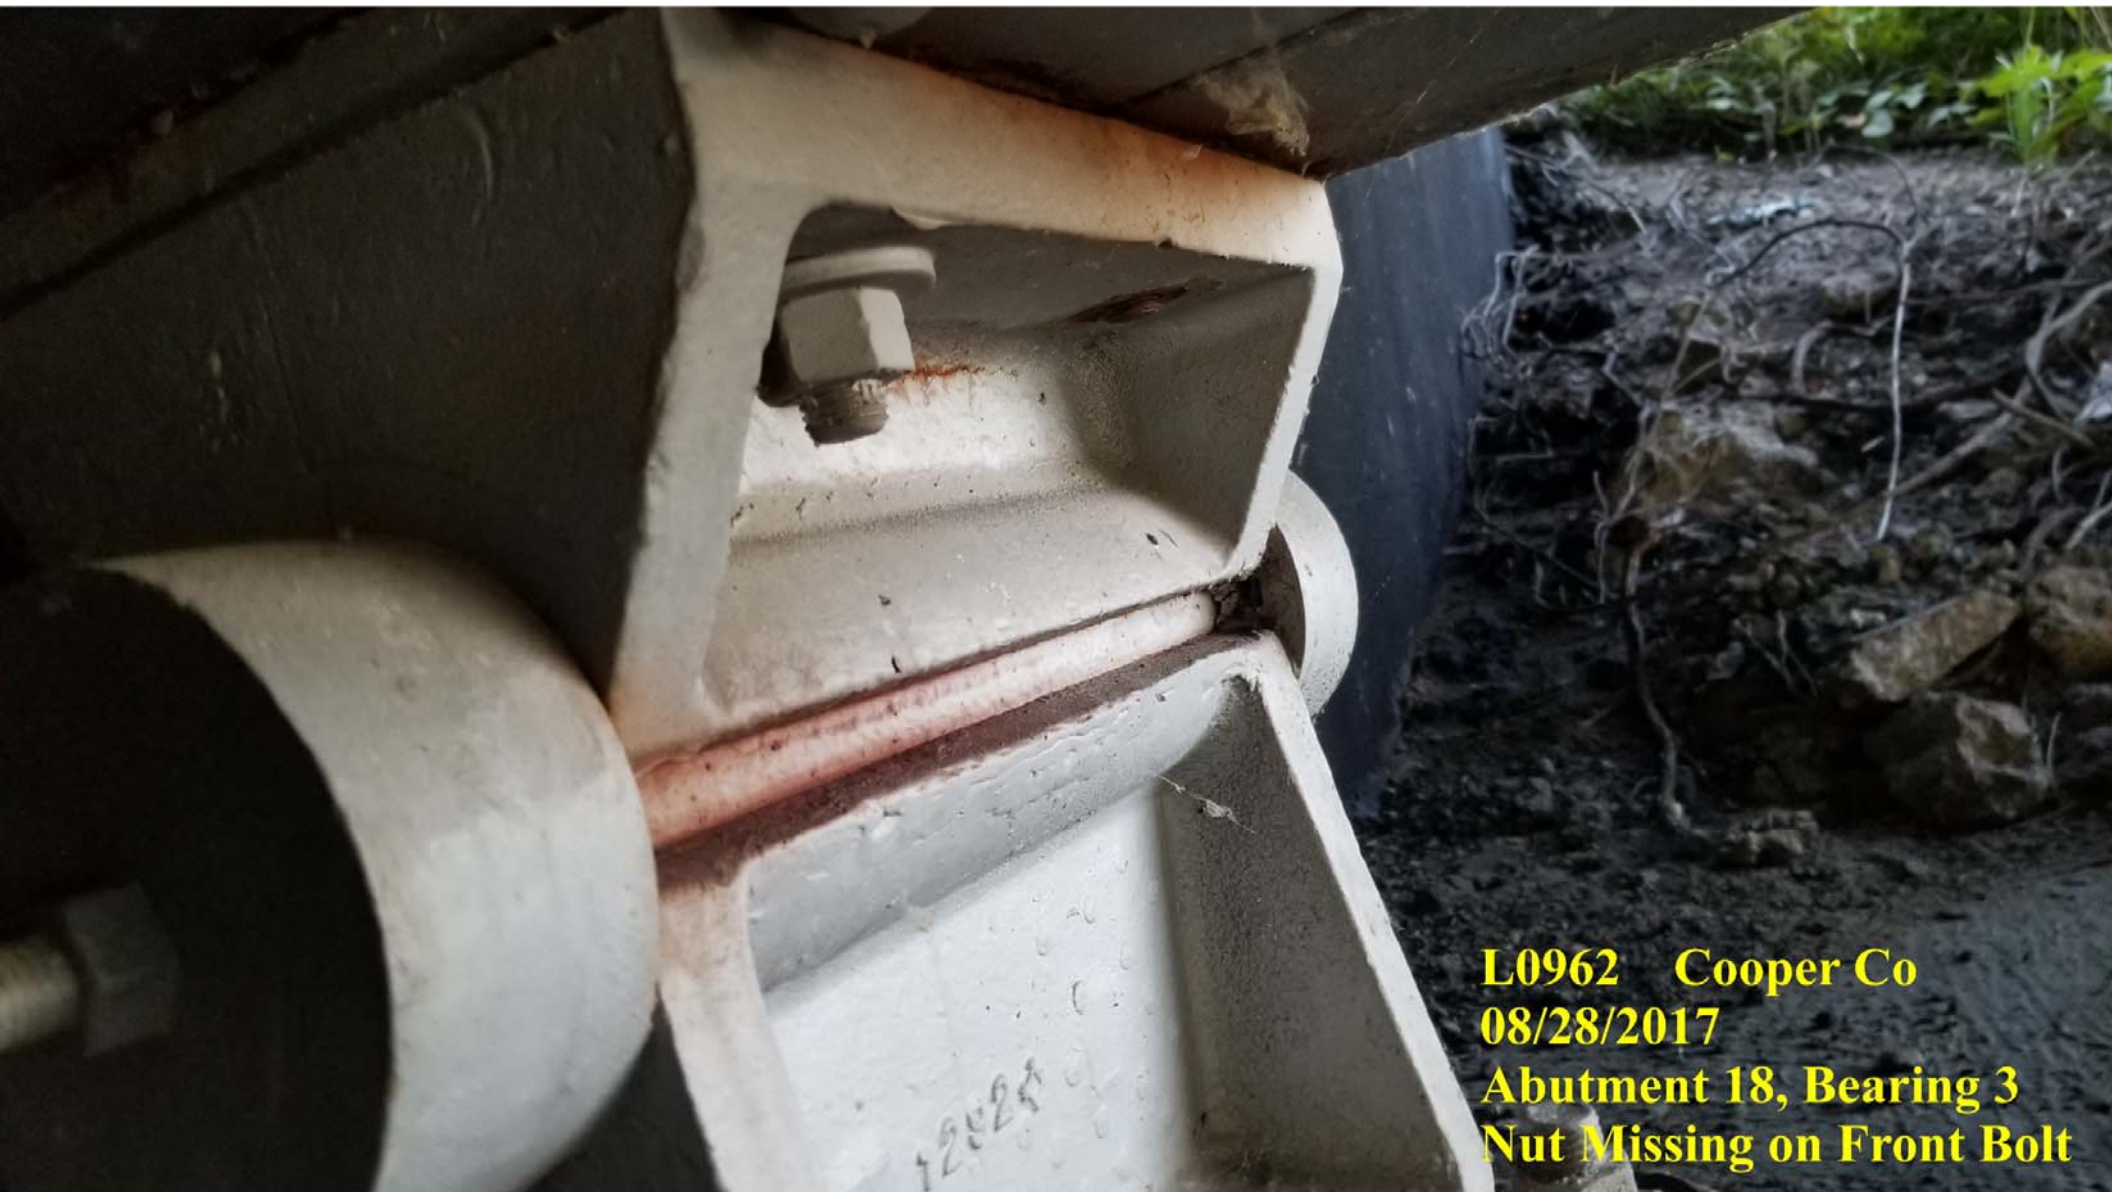
L0962 Cooper Co
08/28/2017
Abutment 18, Bearing 3
Nut Missing on Front Bolt

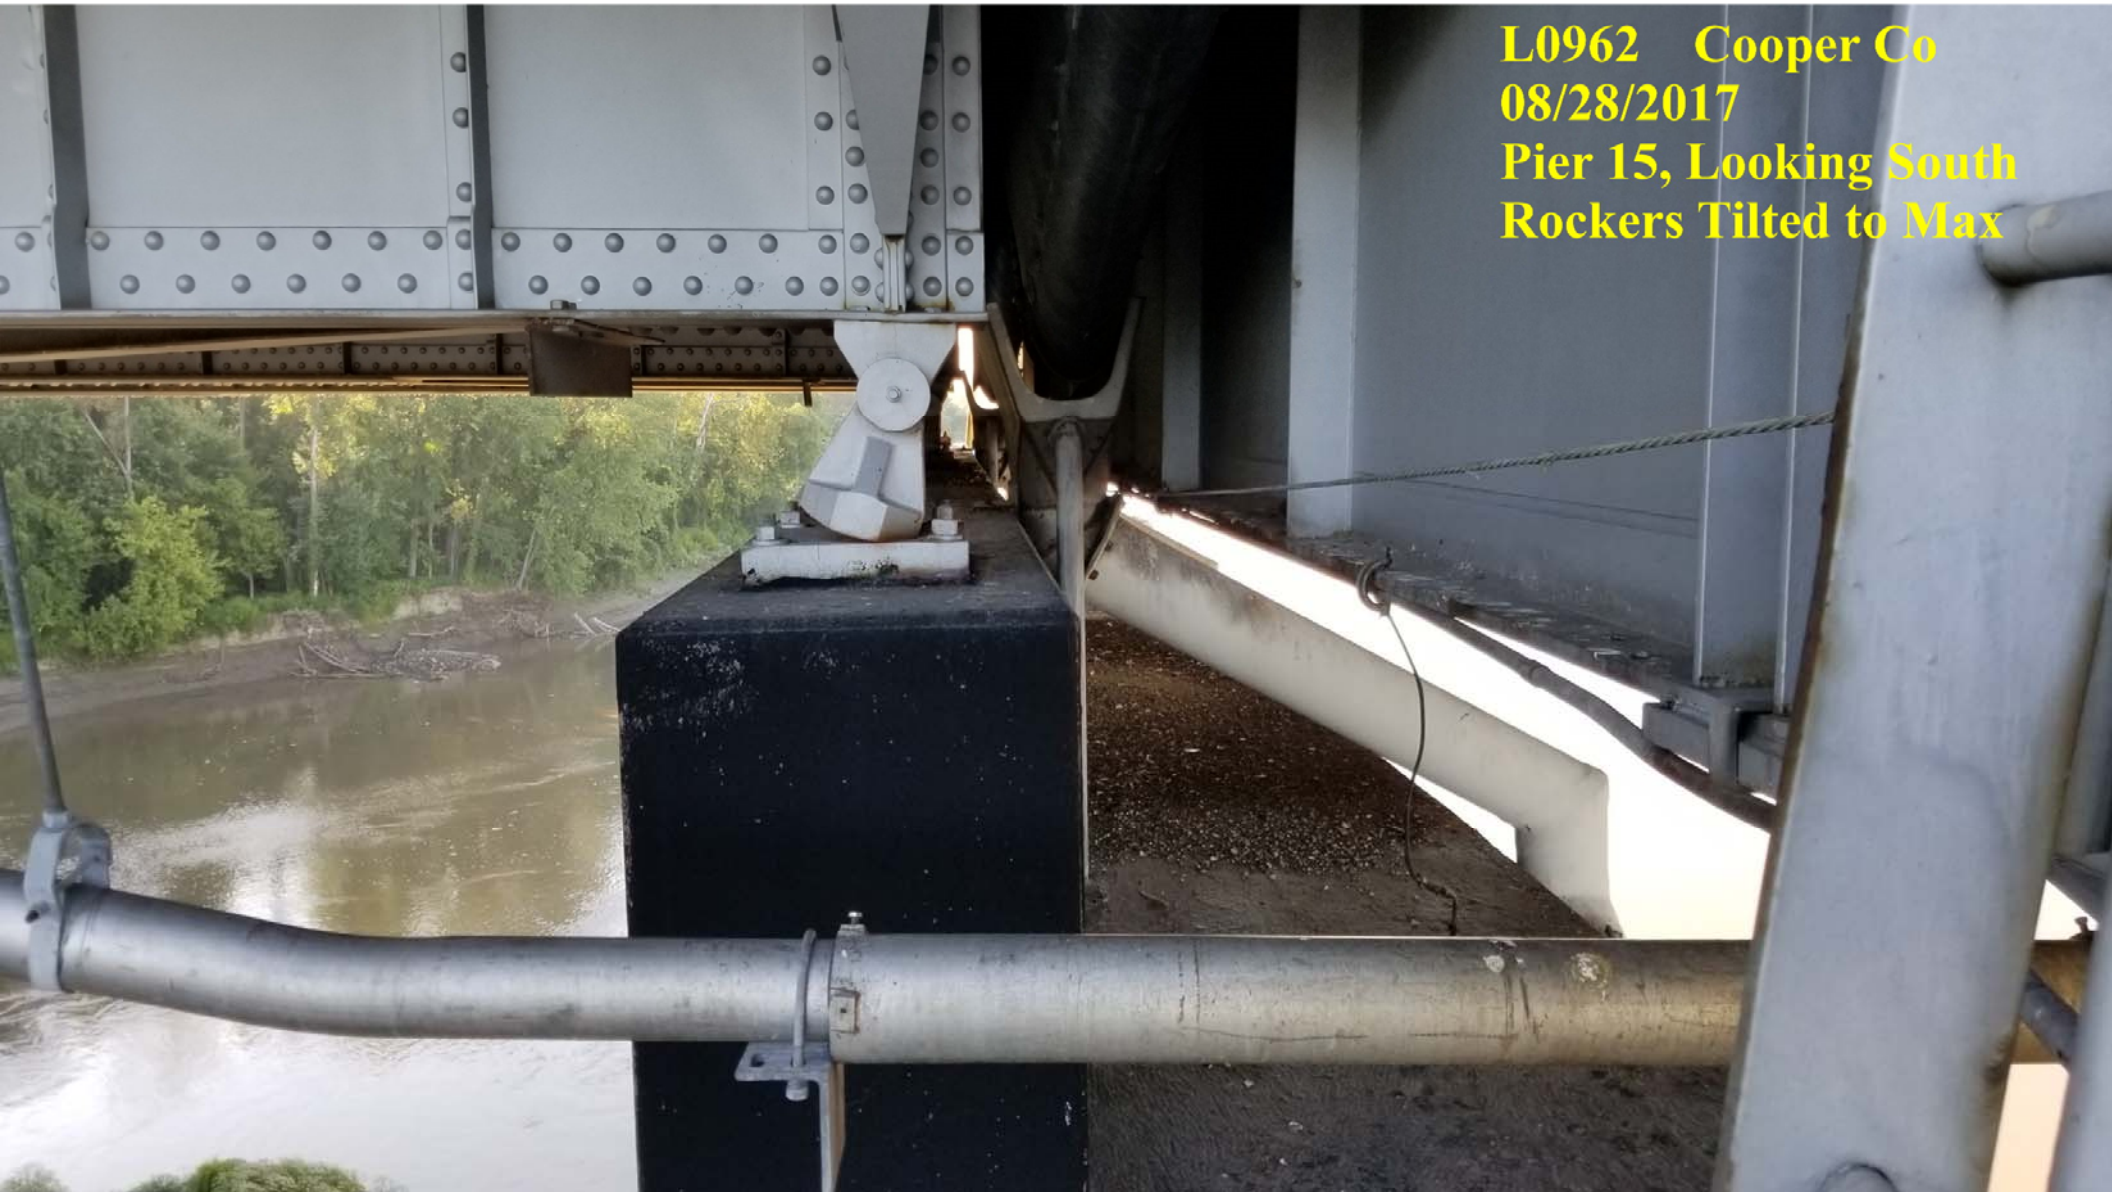
L0962 Cooper Co
08/28/2017
Pier 15, Looking South
Rockers Tilted to Max

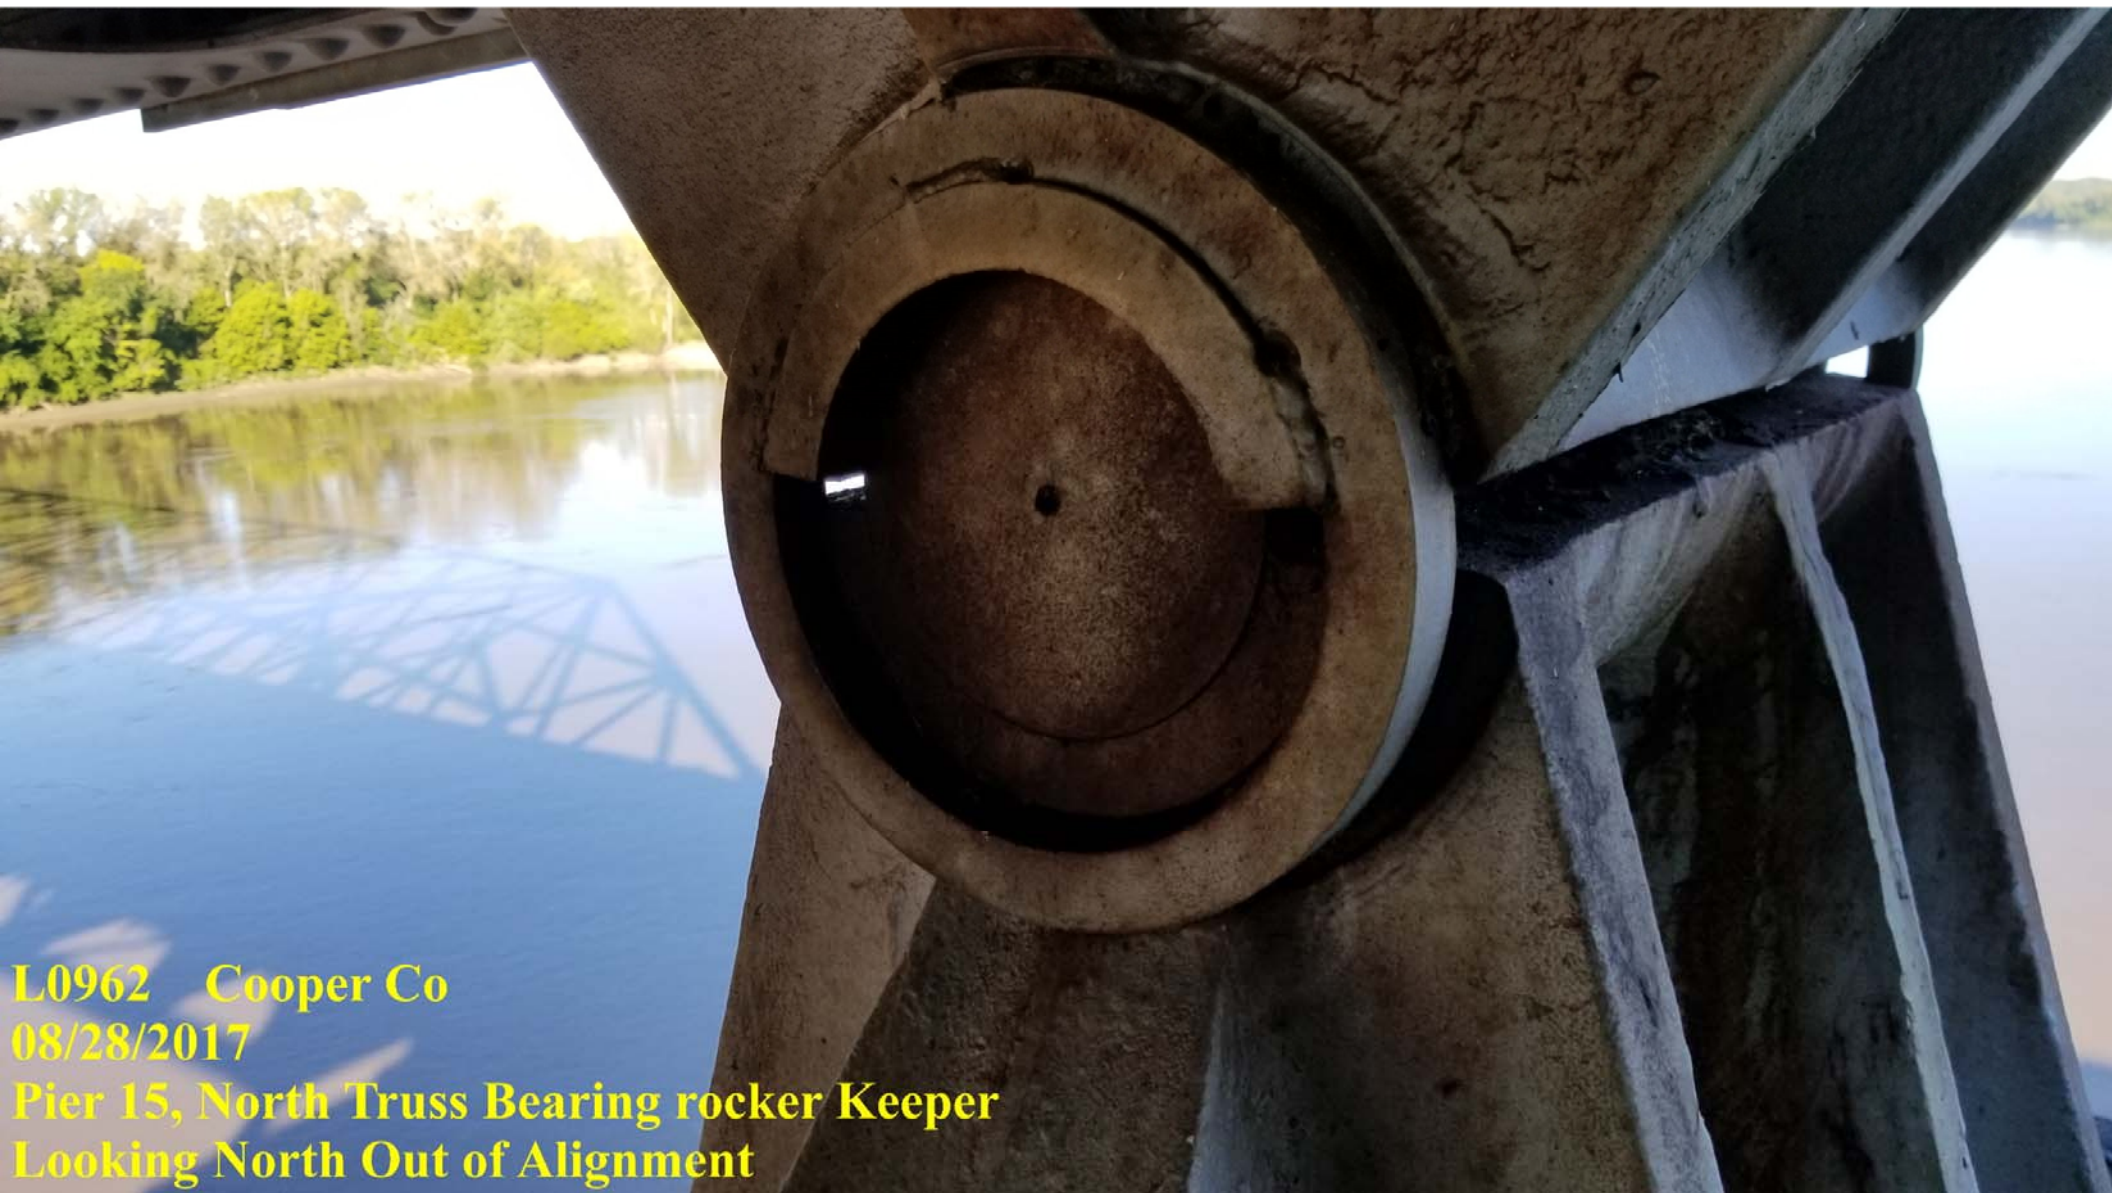
**L0962 Cooper Co
08/28/2017
Pier 15, North Truss Bearing rocker Keeper
Looking South Out of Alignment**

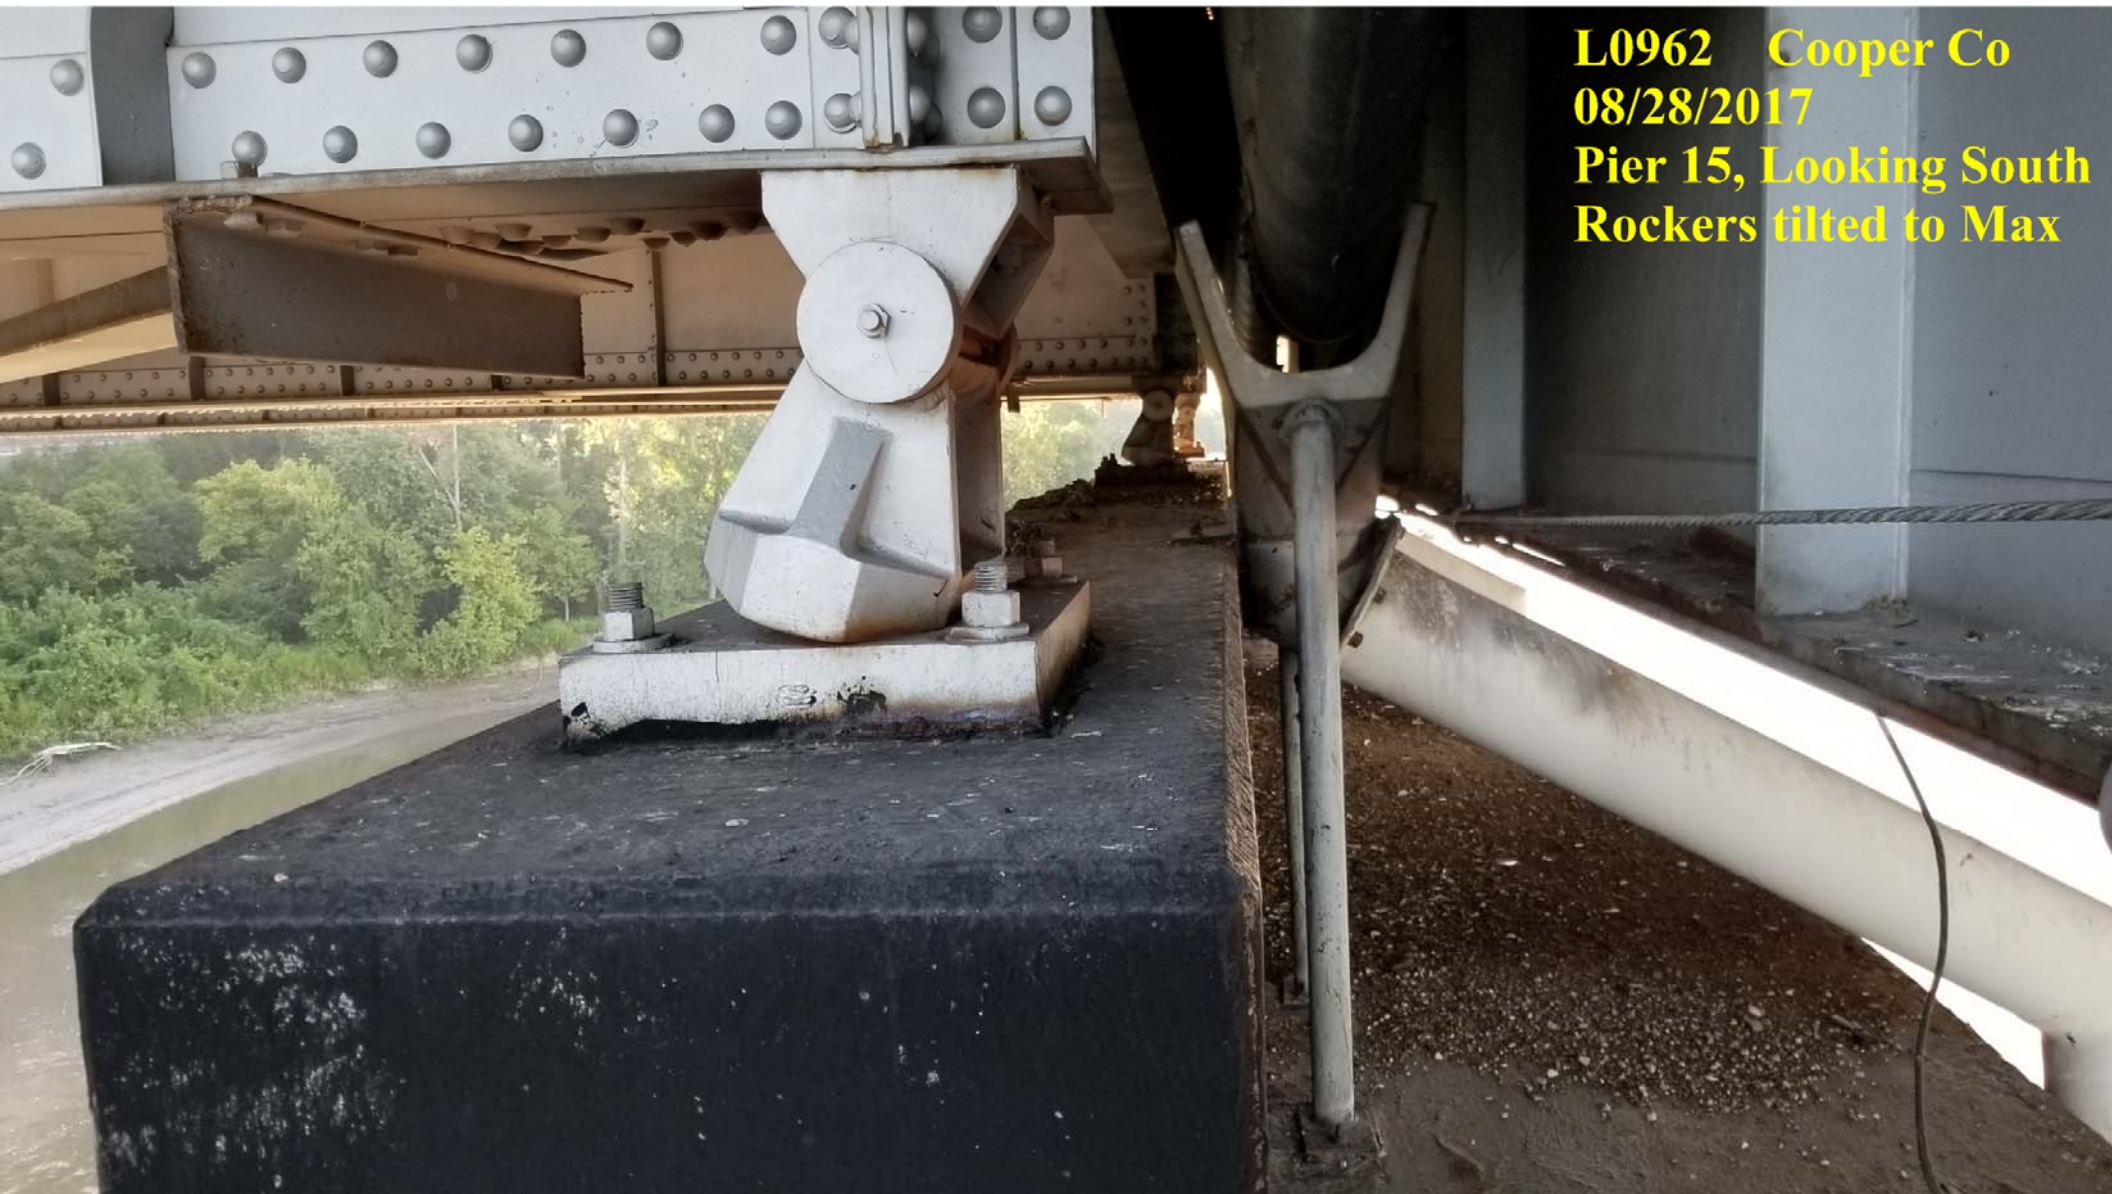
Pier 15, North Truss Bearing rocker Keeper

Looking North Out of Alignment

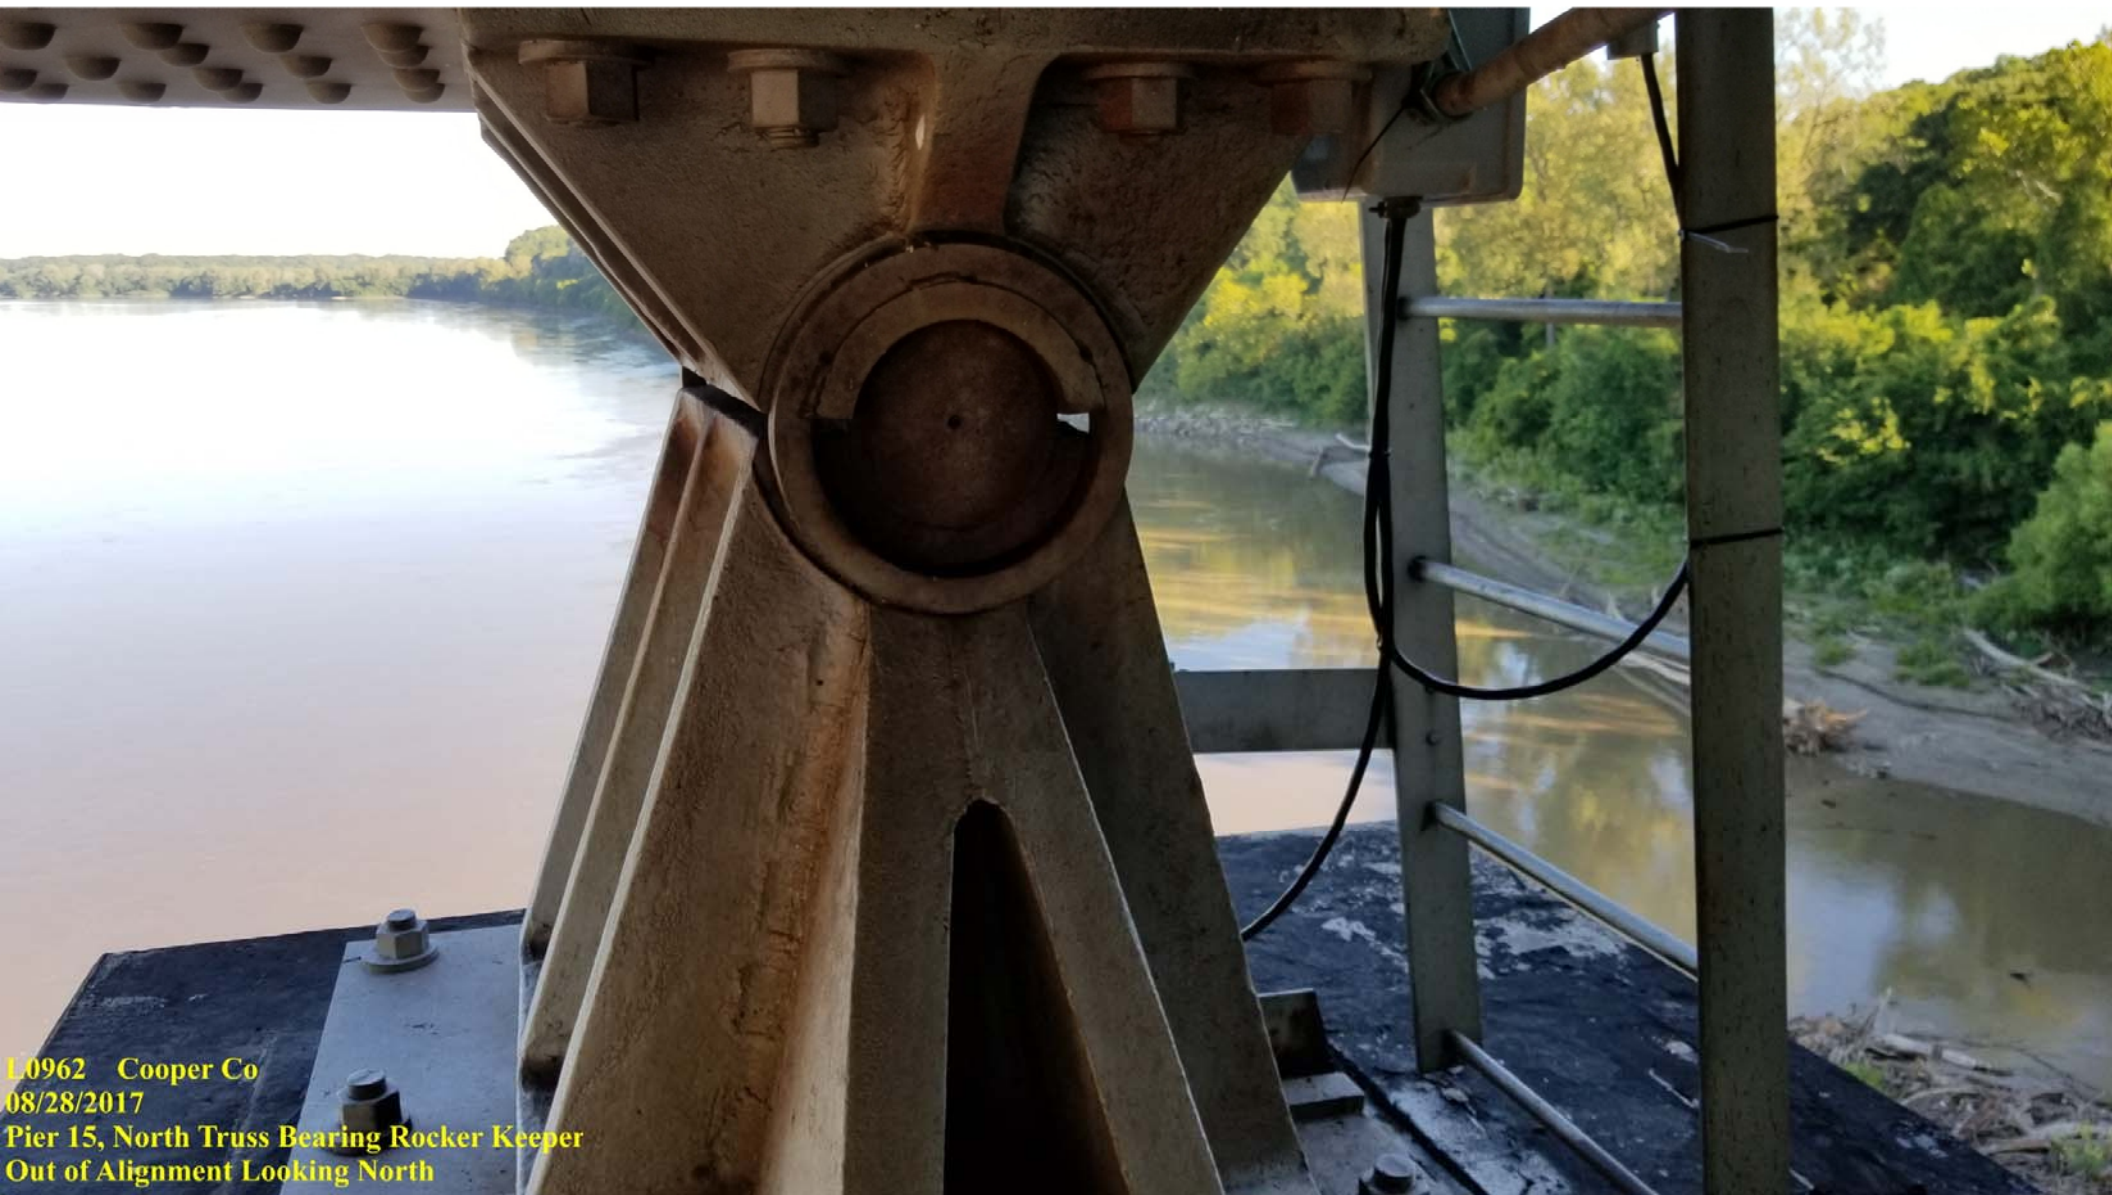
L0962 Cooper Co
08/28/2017
Pier 15, Looking South
Rockers tilted to Max

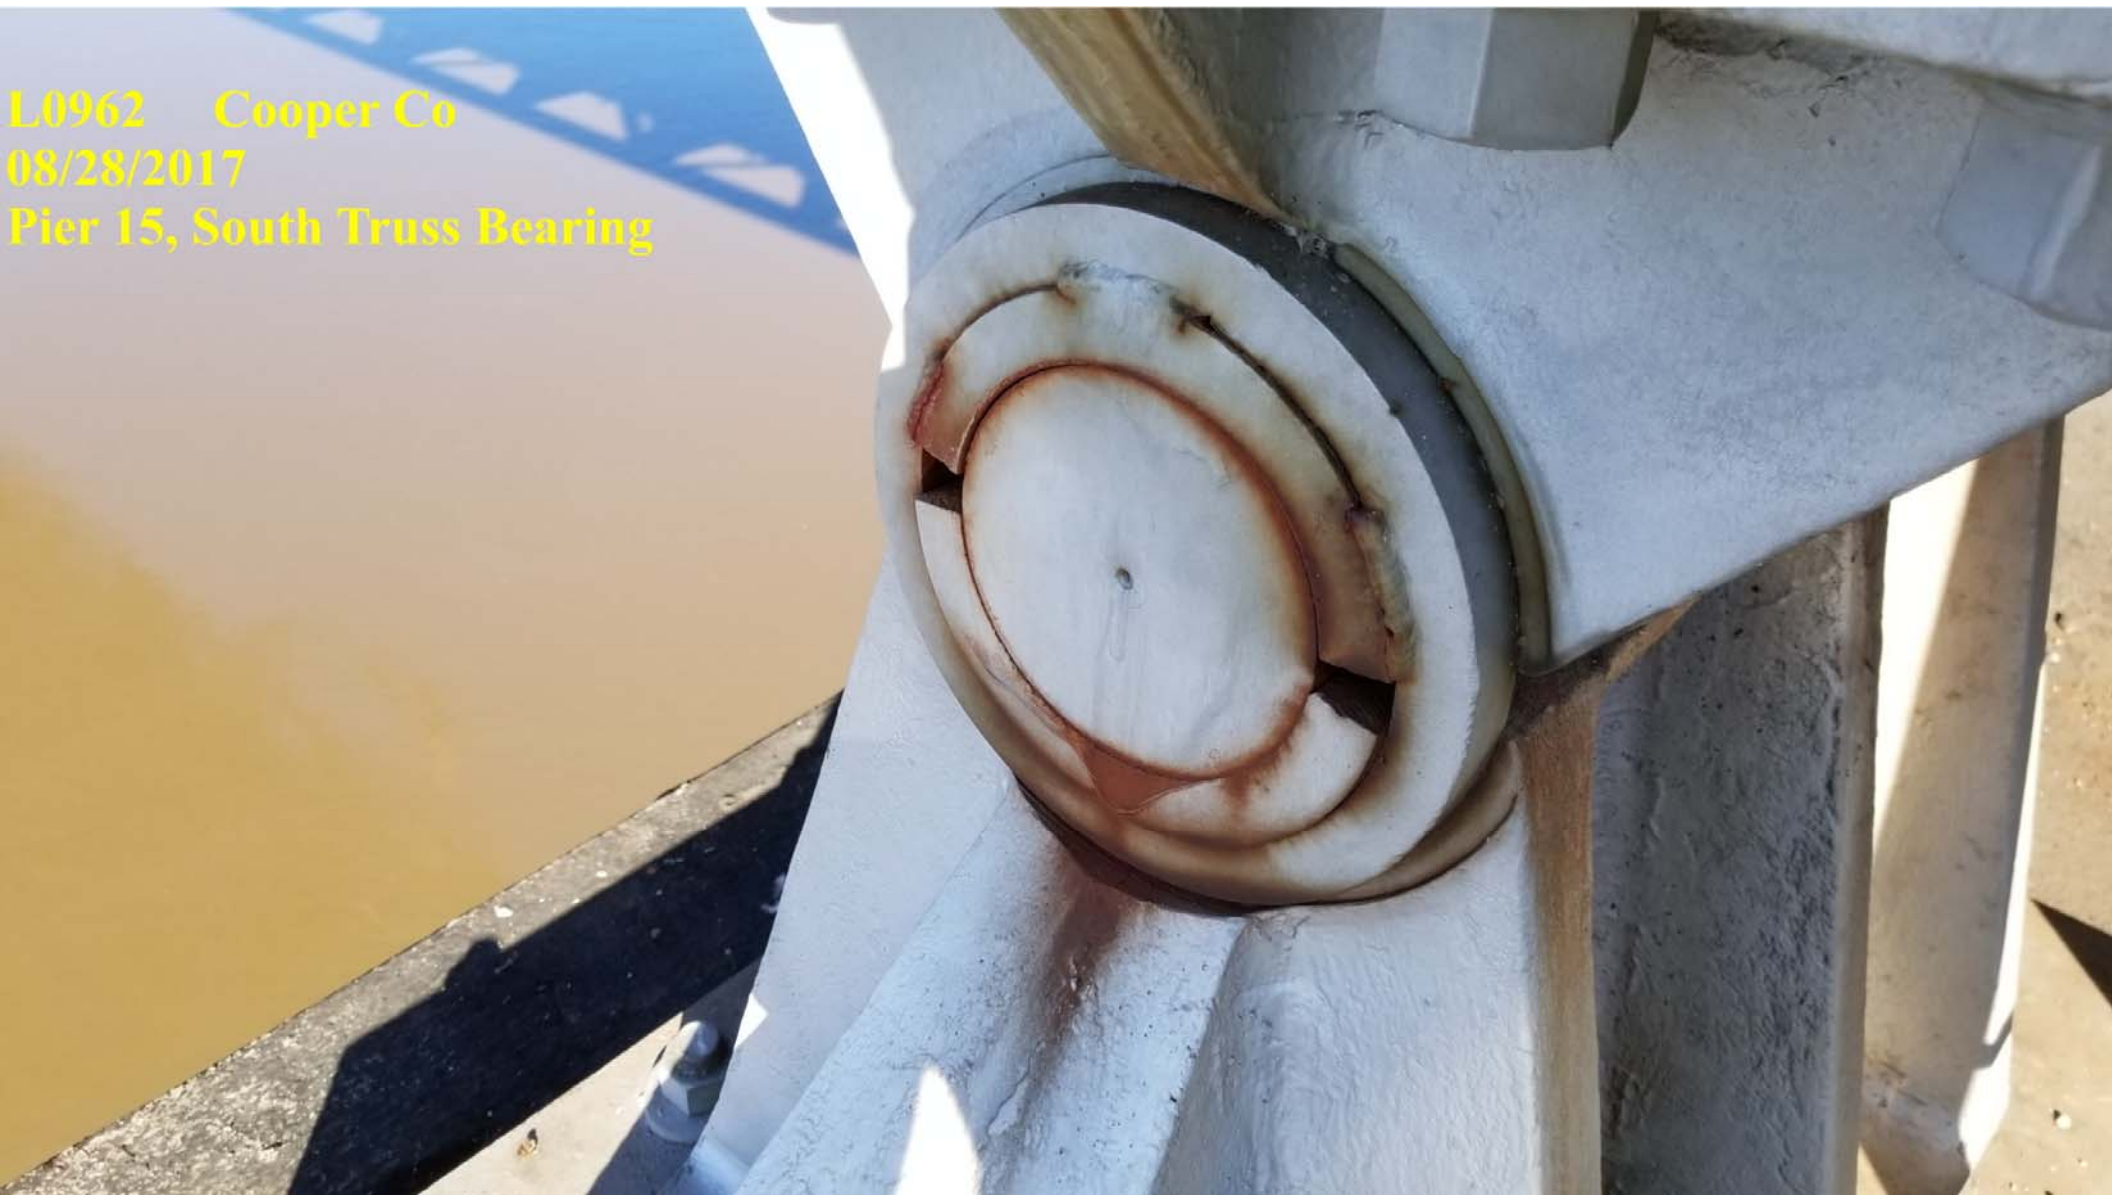
L0962 Cooper Co
08/28/2017
Pier 15, South Truss Bearing

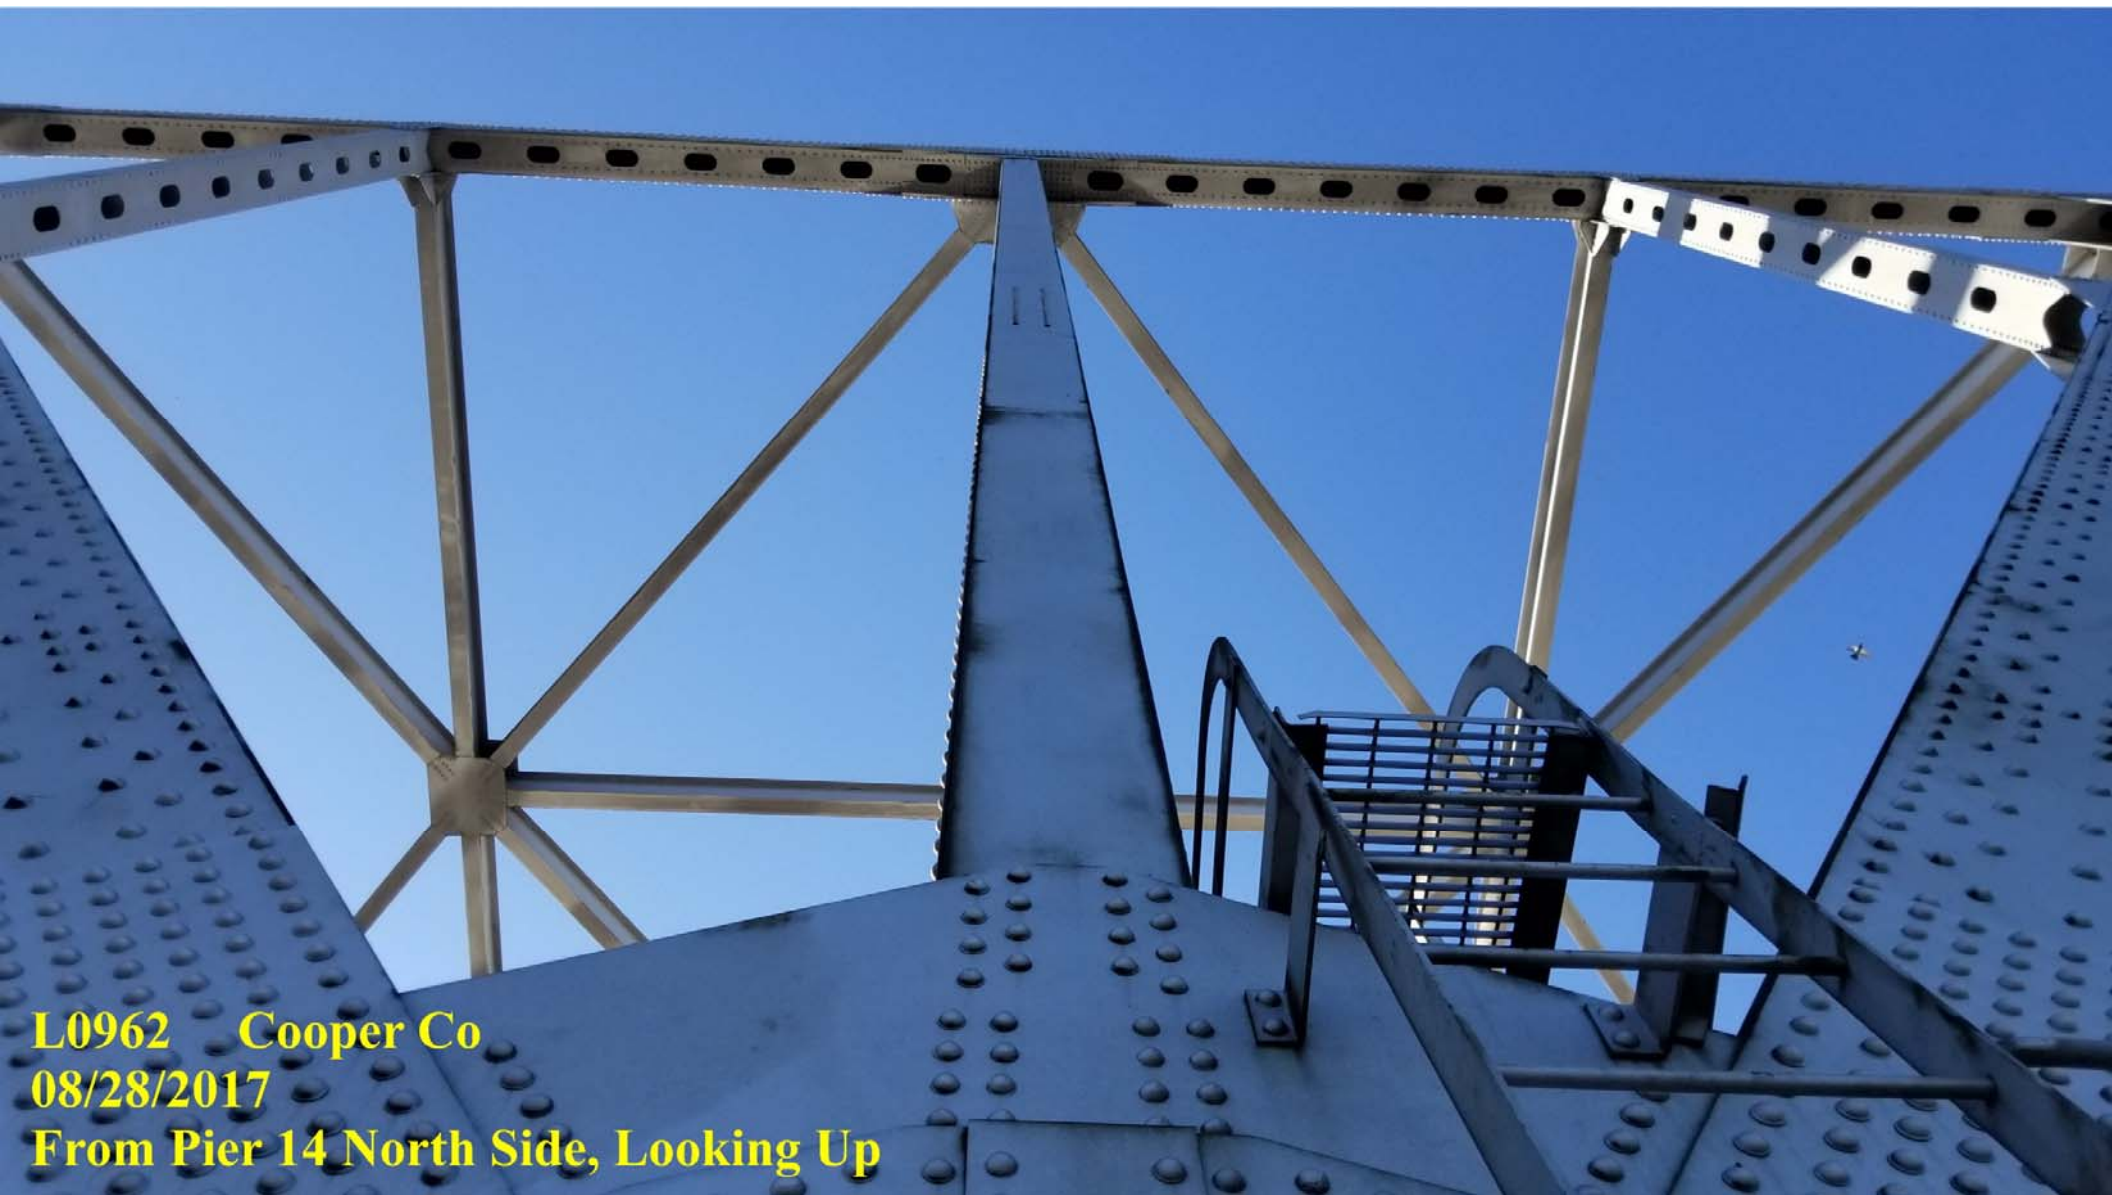
L0962 Cooper Co
08/28/2017
Pier 14, North Truss Bearing
and Gusset Plates
