L0962 Cooper Co.
08/28/2017
Looking West

L0962 I-70 Cooper
Pier 15 Open Expansion Joint WBL
8-28-17

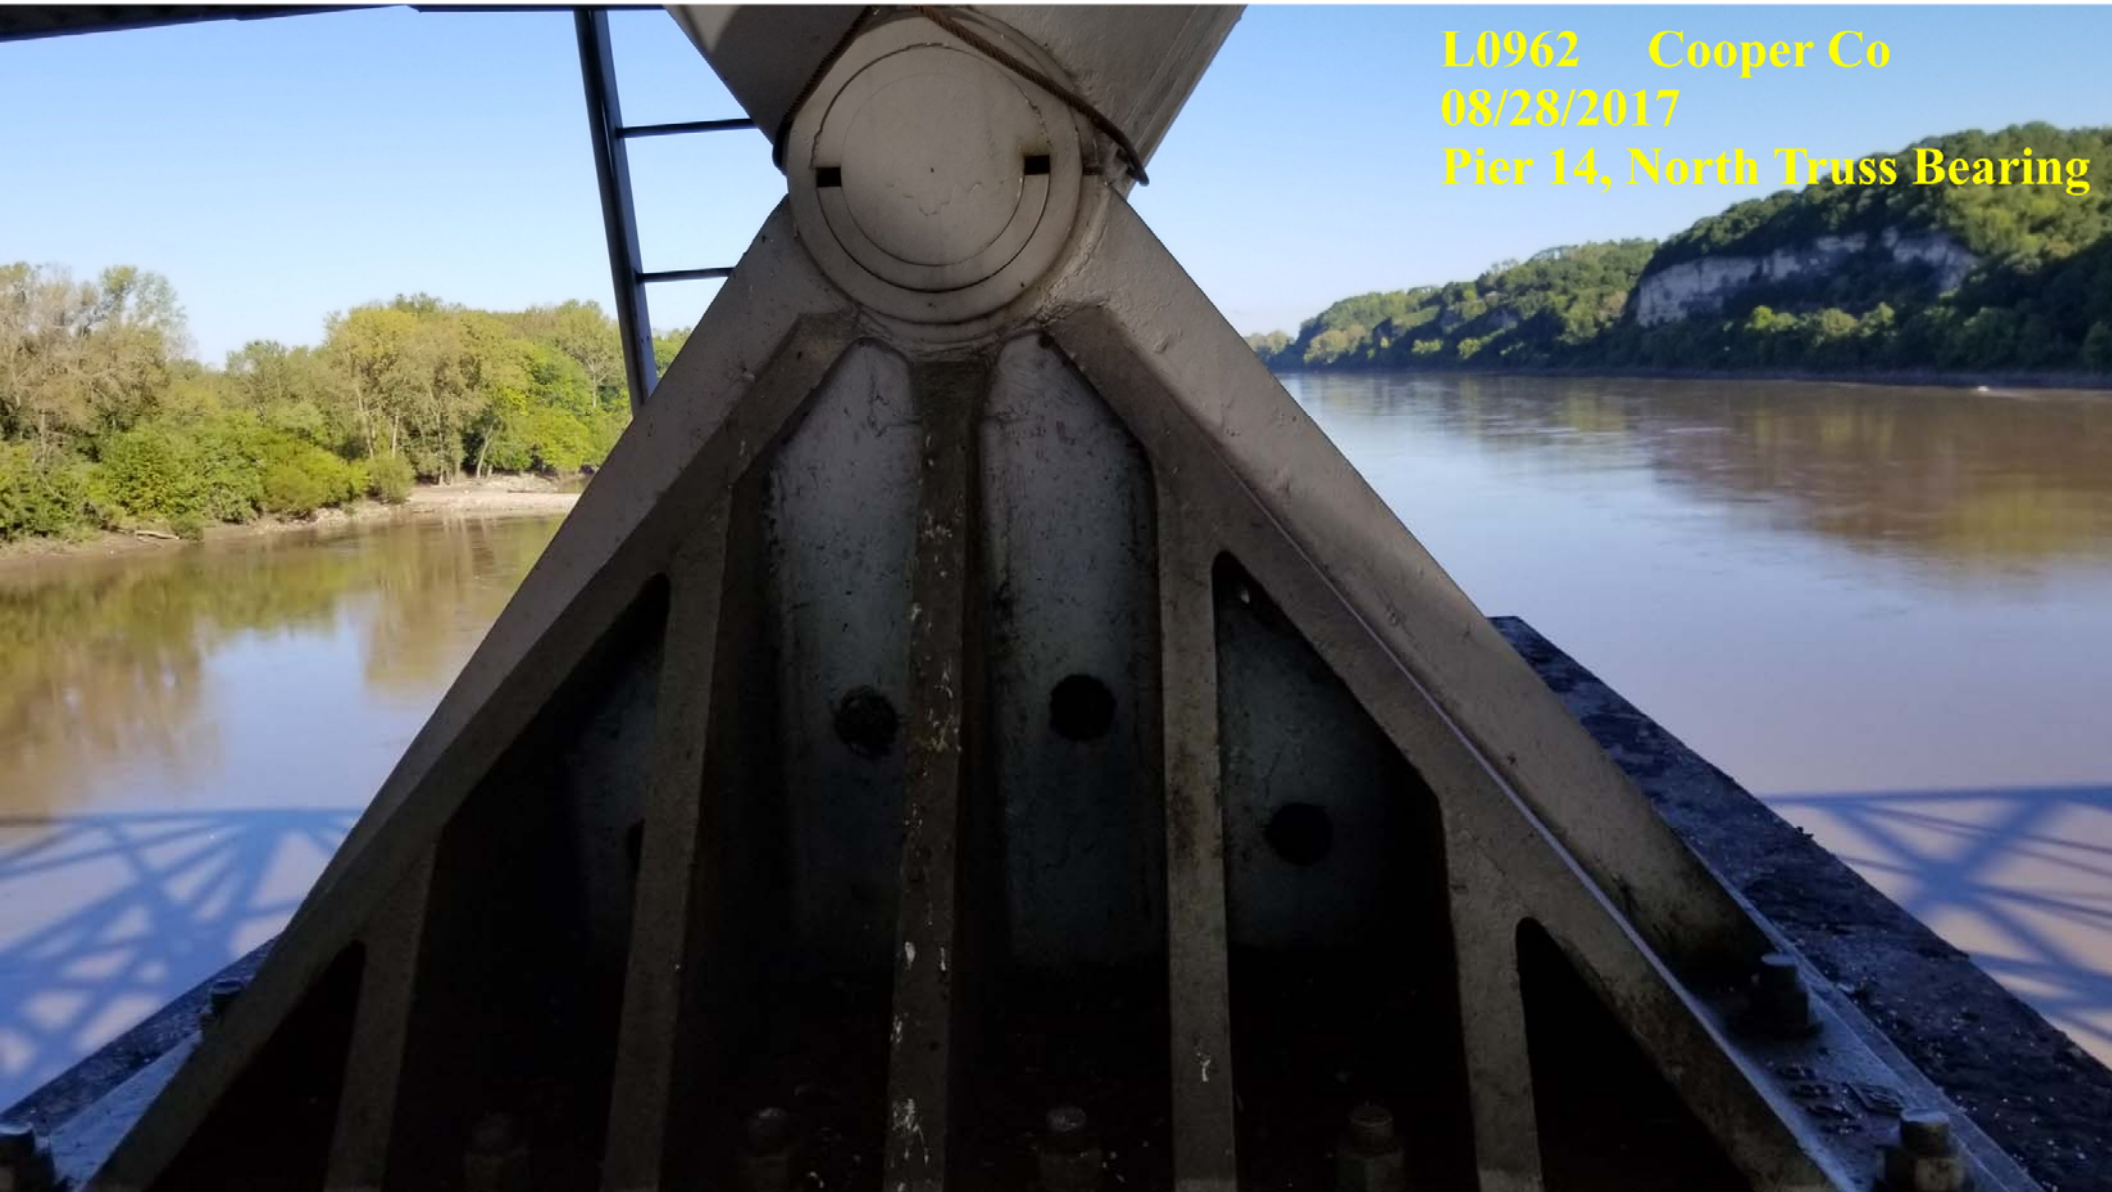
L0962 Cooper Co
08/28/2017
Pier 14, North Truss Bearing

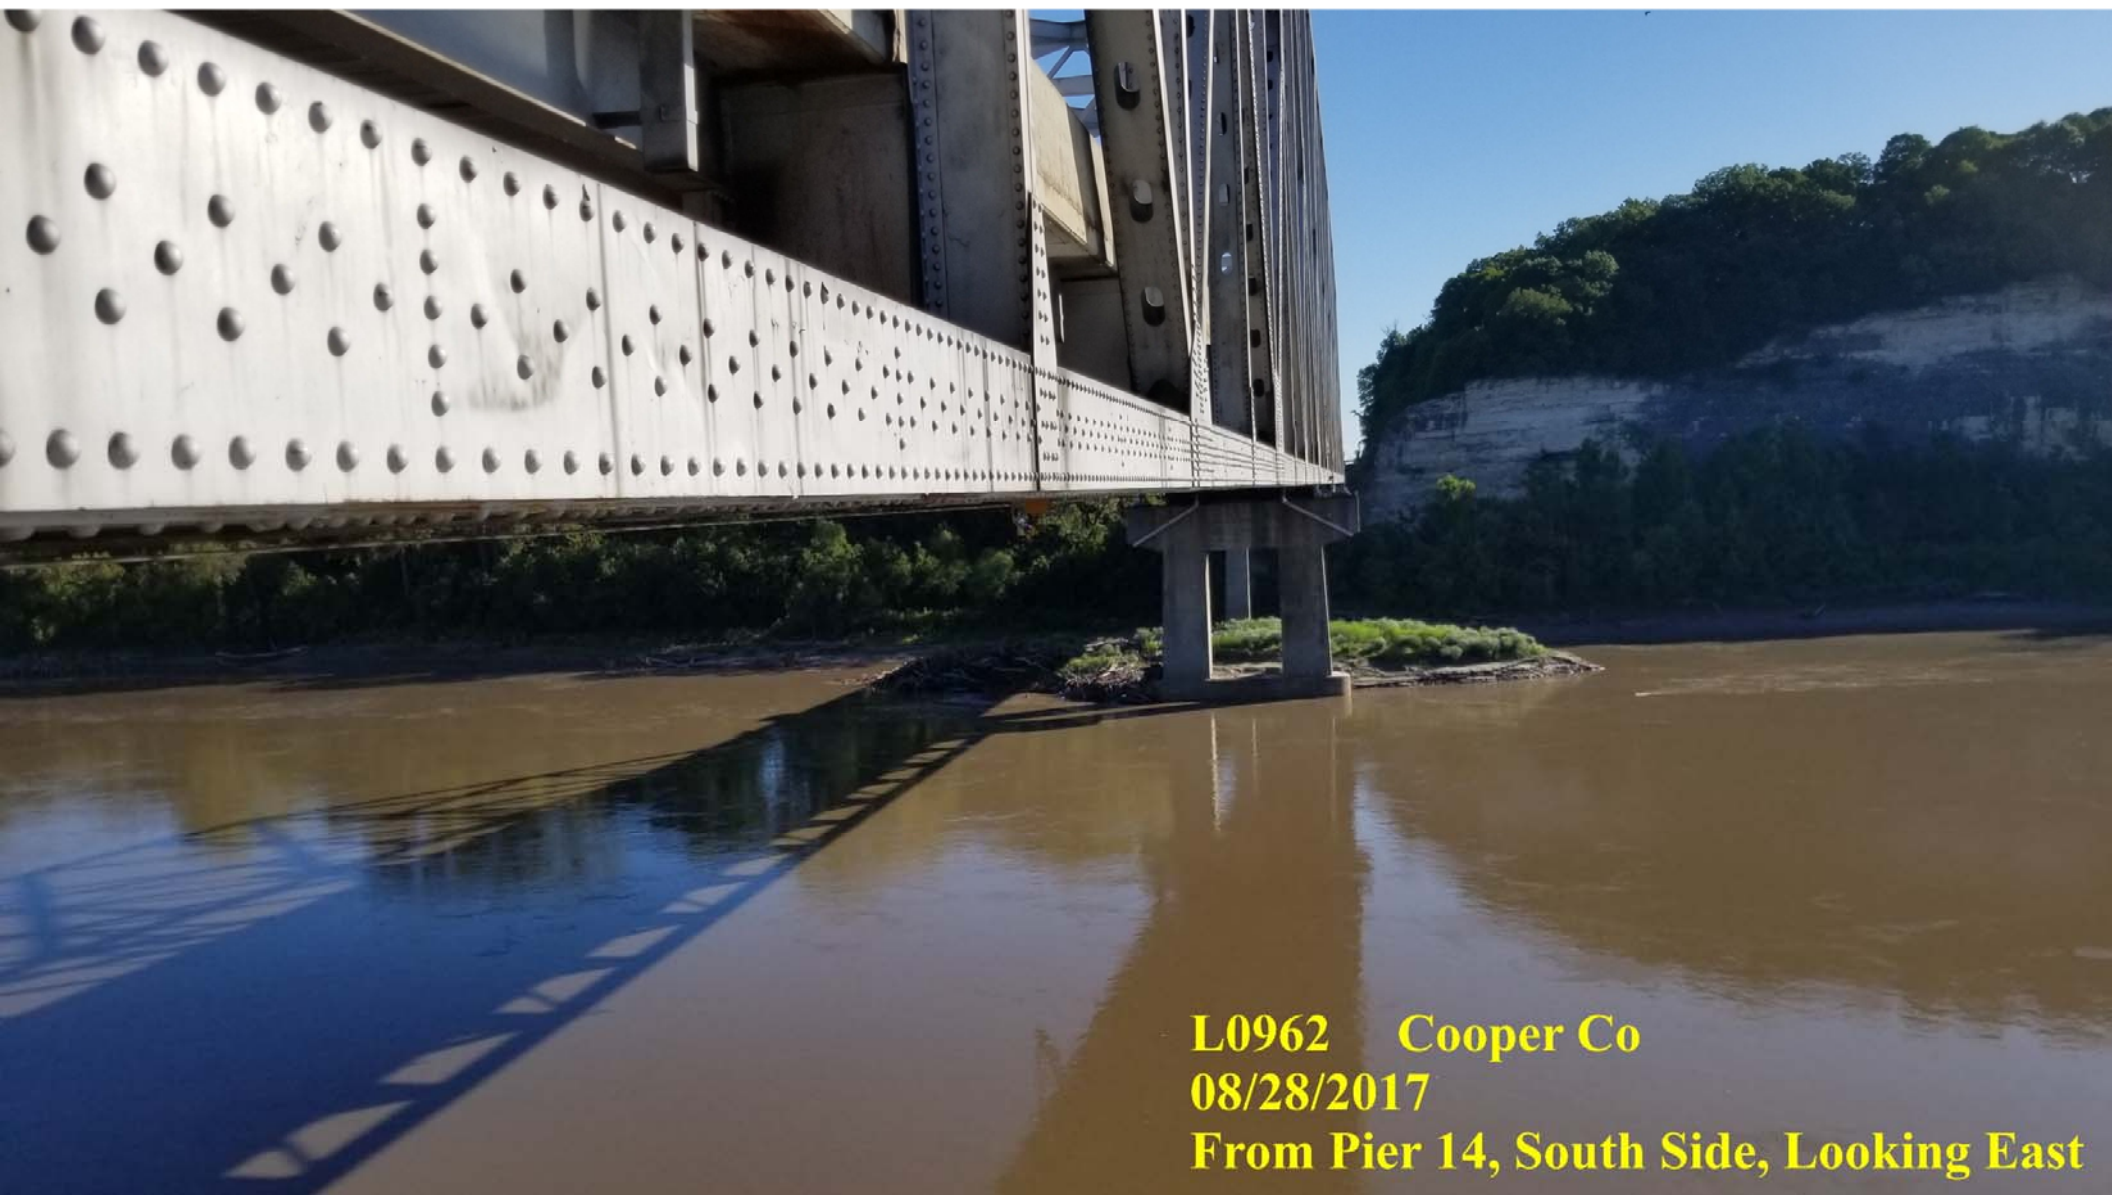
Lower Truss Chord

Pack Rust between Vertical & Horizontal Plates

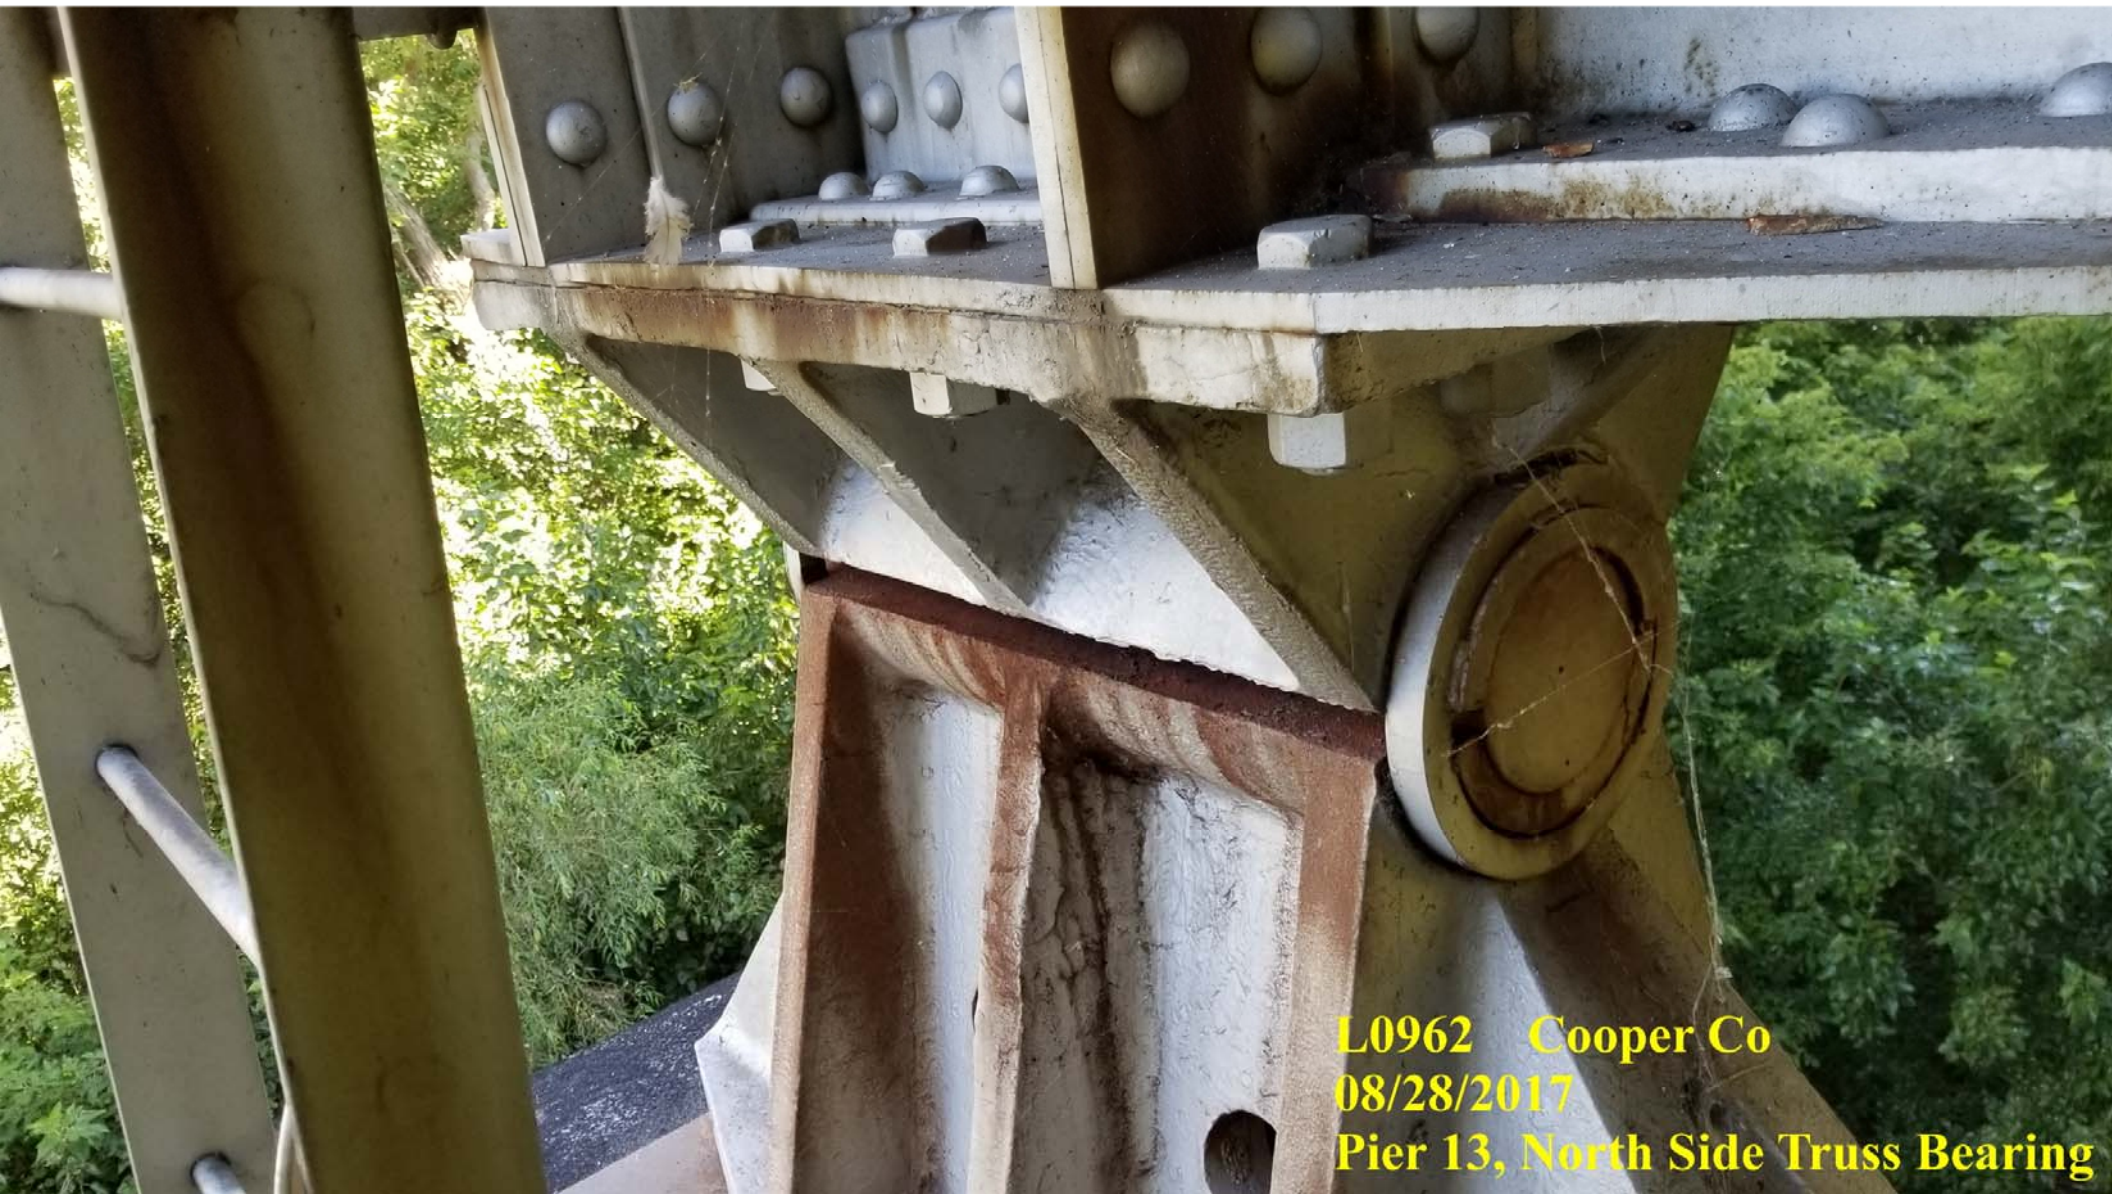
L0962 Cooper Co
08/28/2017
Pier 13, North Side Truss Bearing

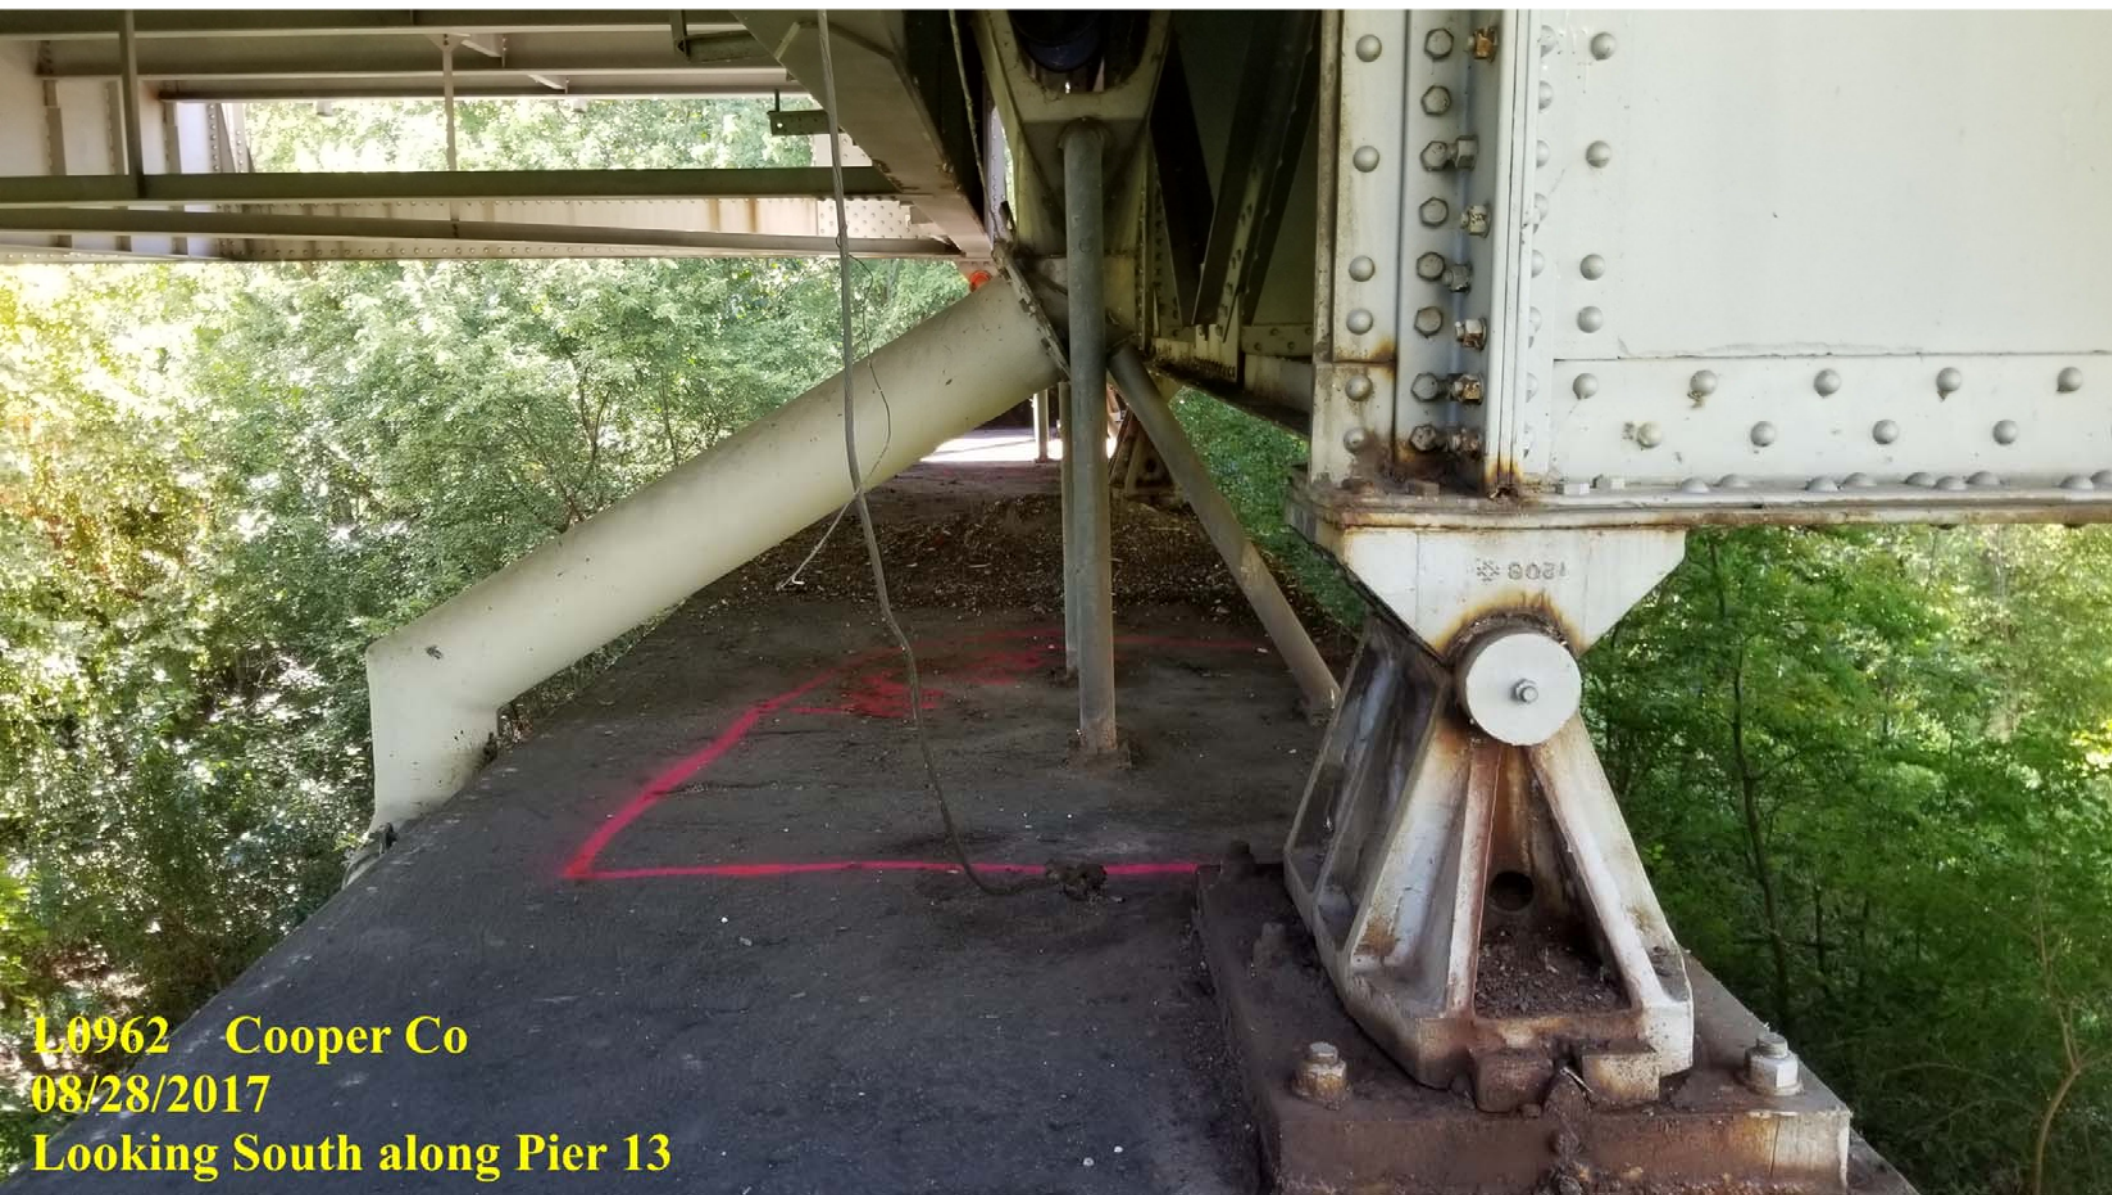
L0962 Cooper Co
08/28/2017
Pier 13, North Side Truss Bearing

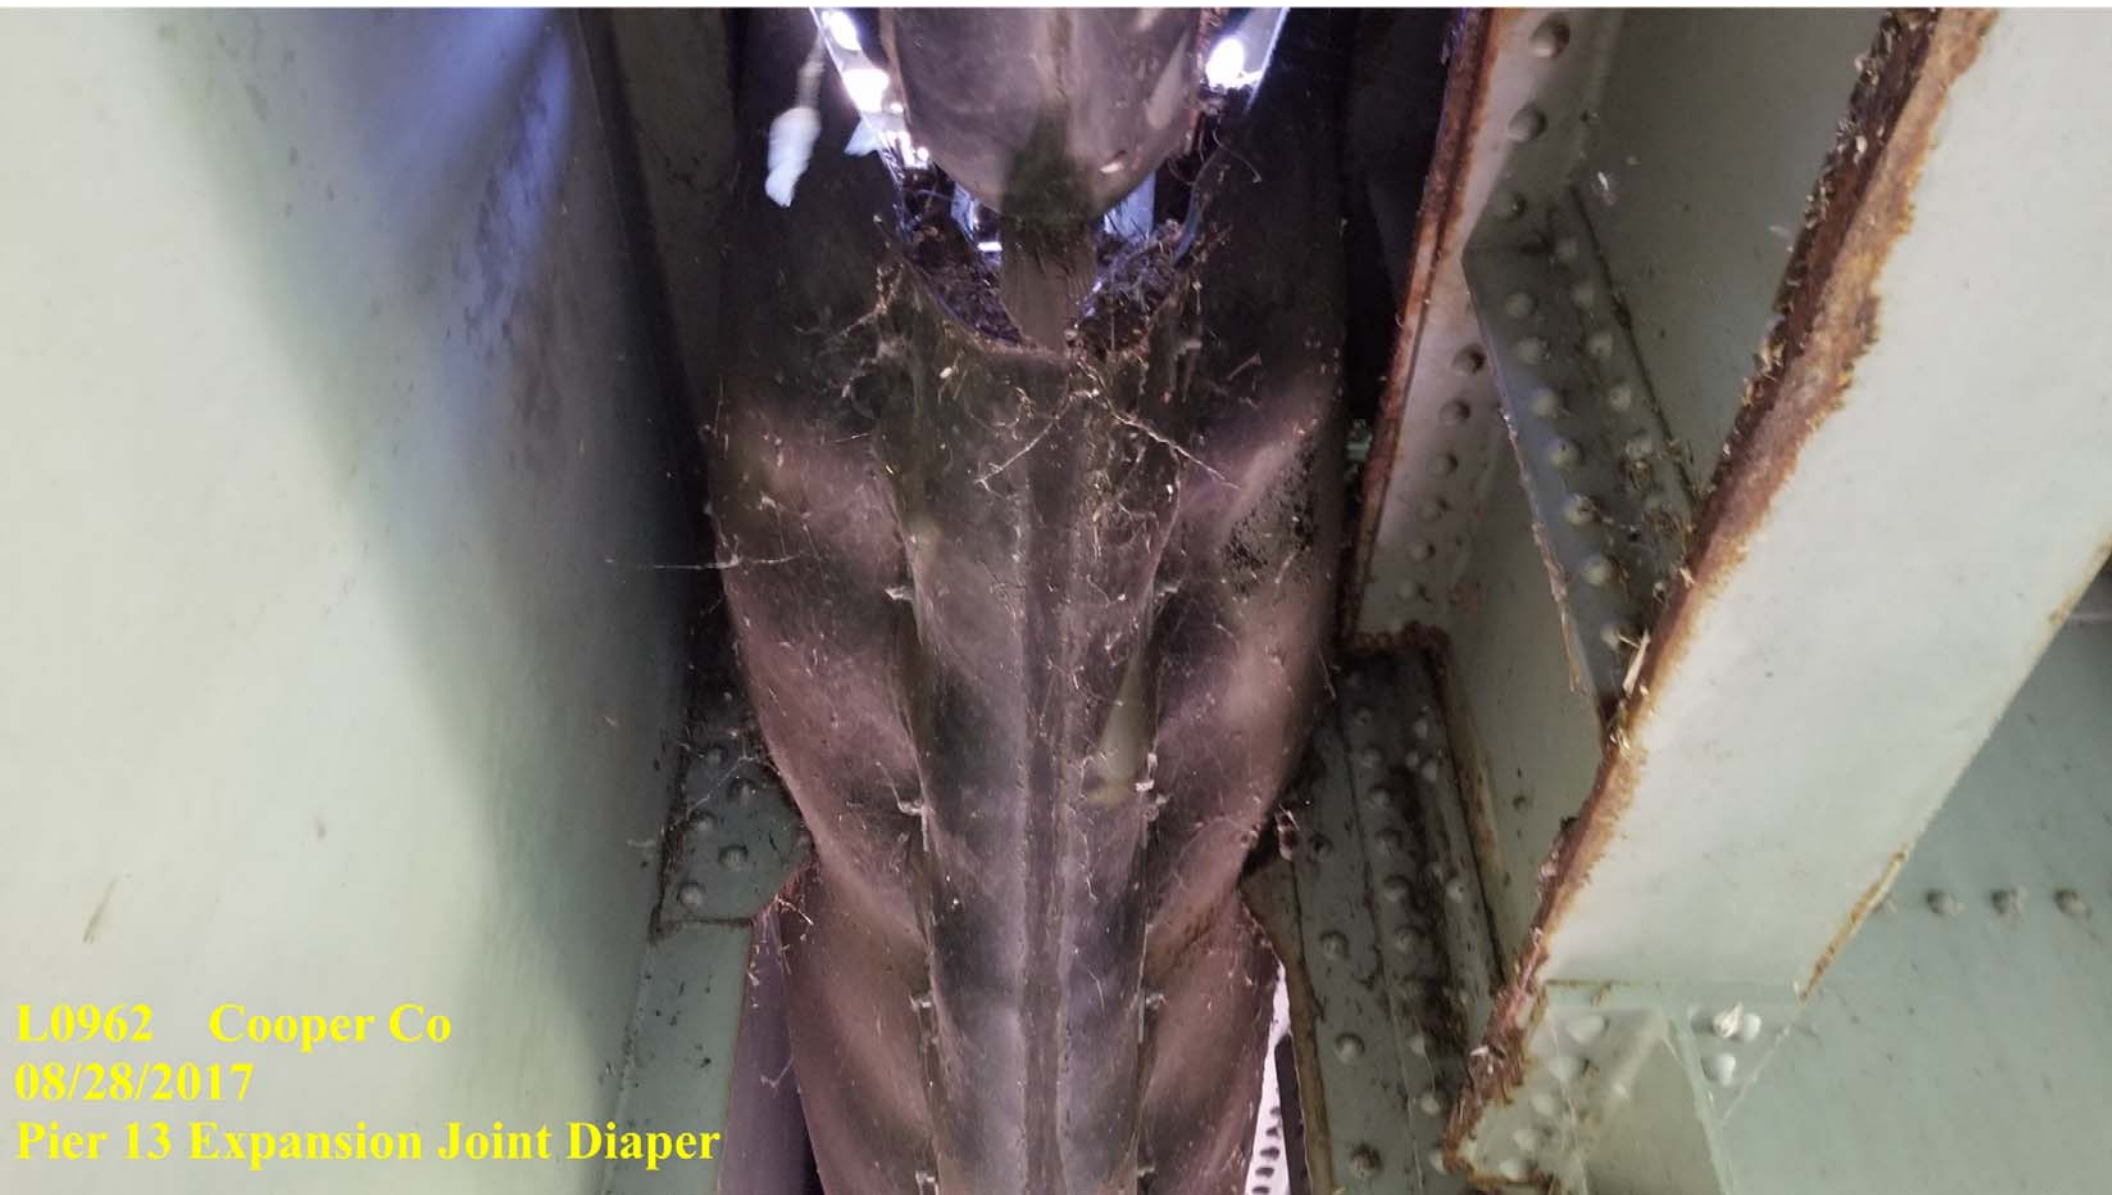
L0962 Cooper Co
08/28/2017
Pier 13 Expansion Joint Diaper

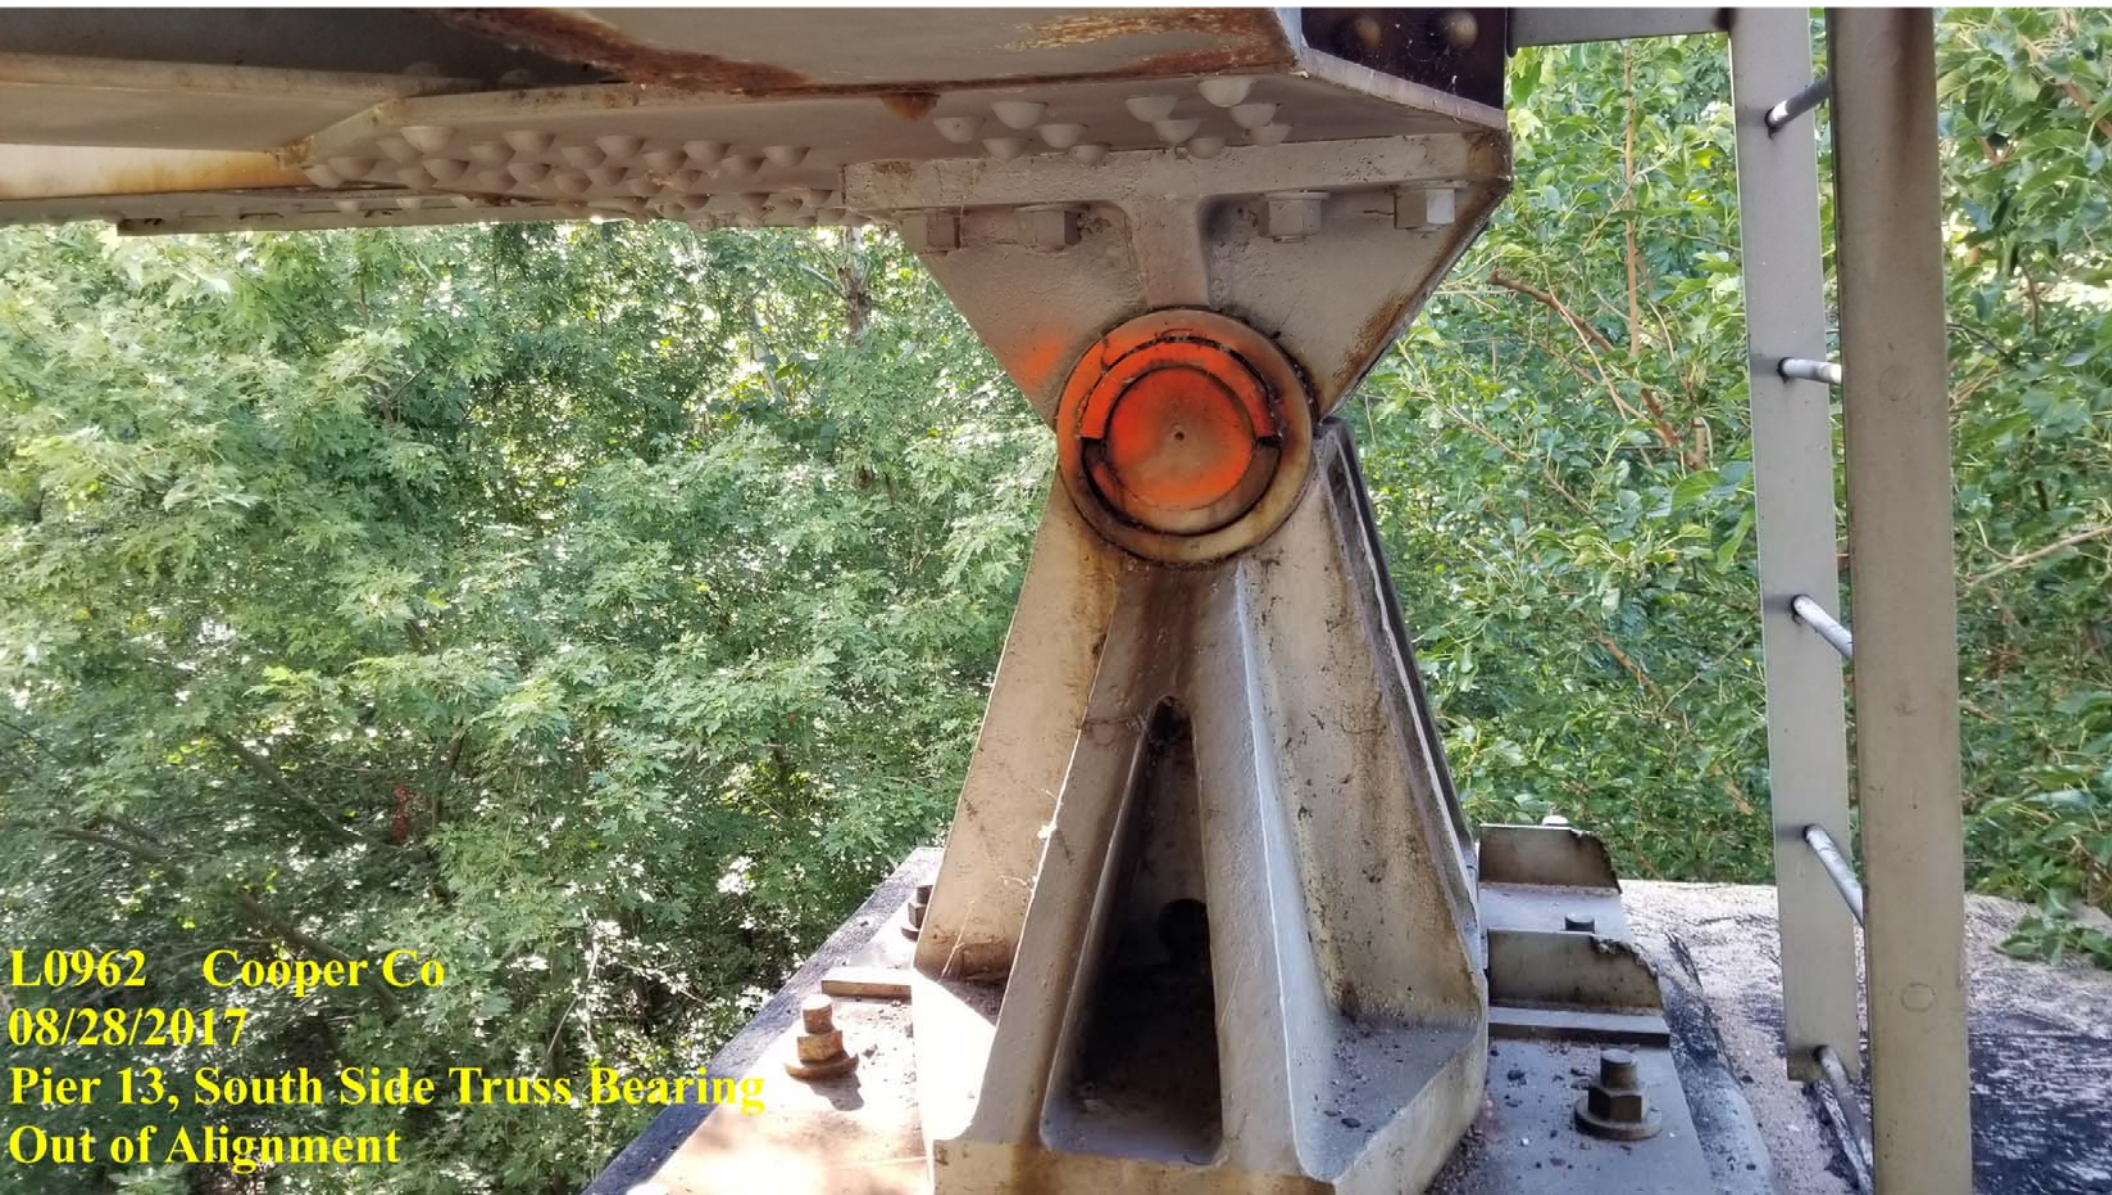
L0962 Cooper Co
08/28/2017
Pier 13, South Side Truss Bearing
Out of Alignment

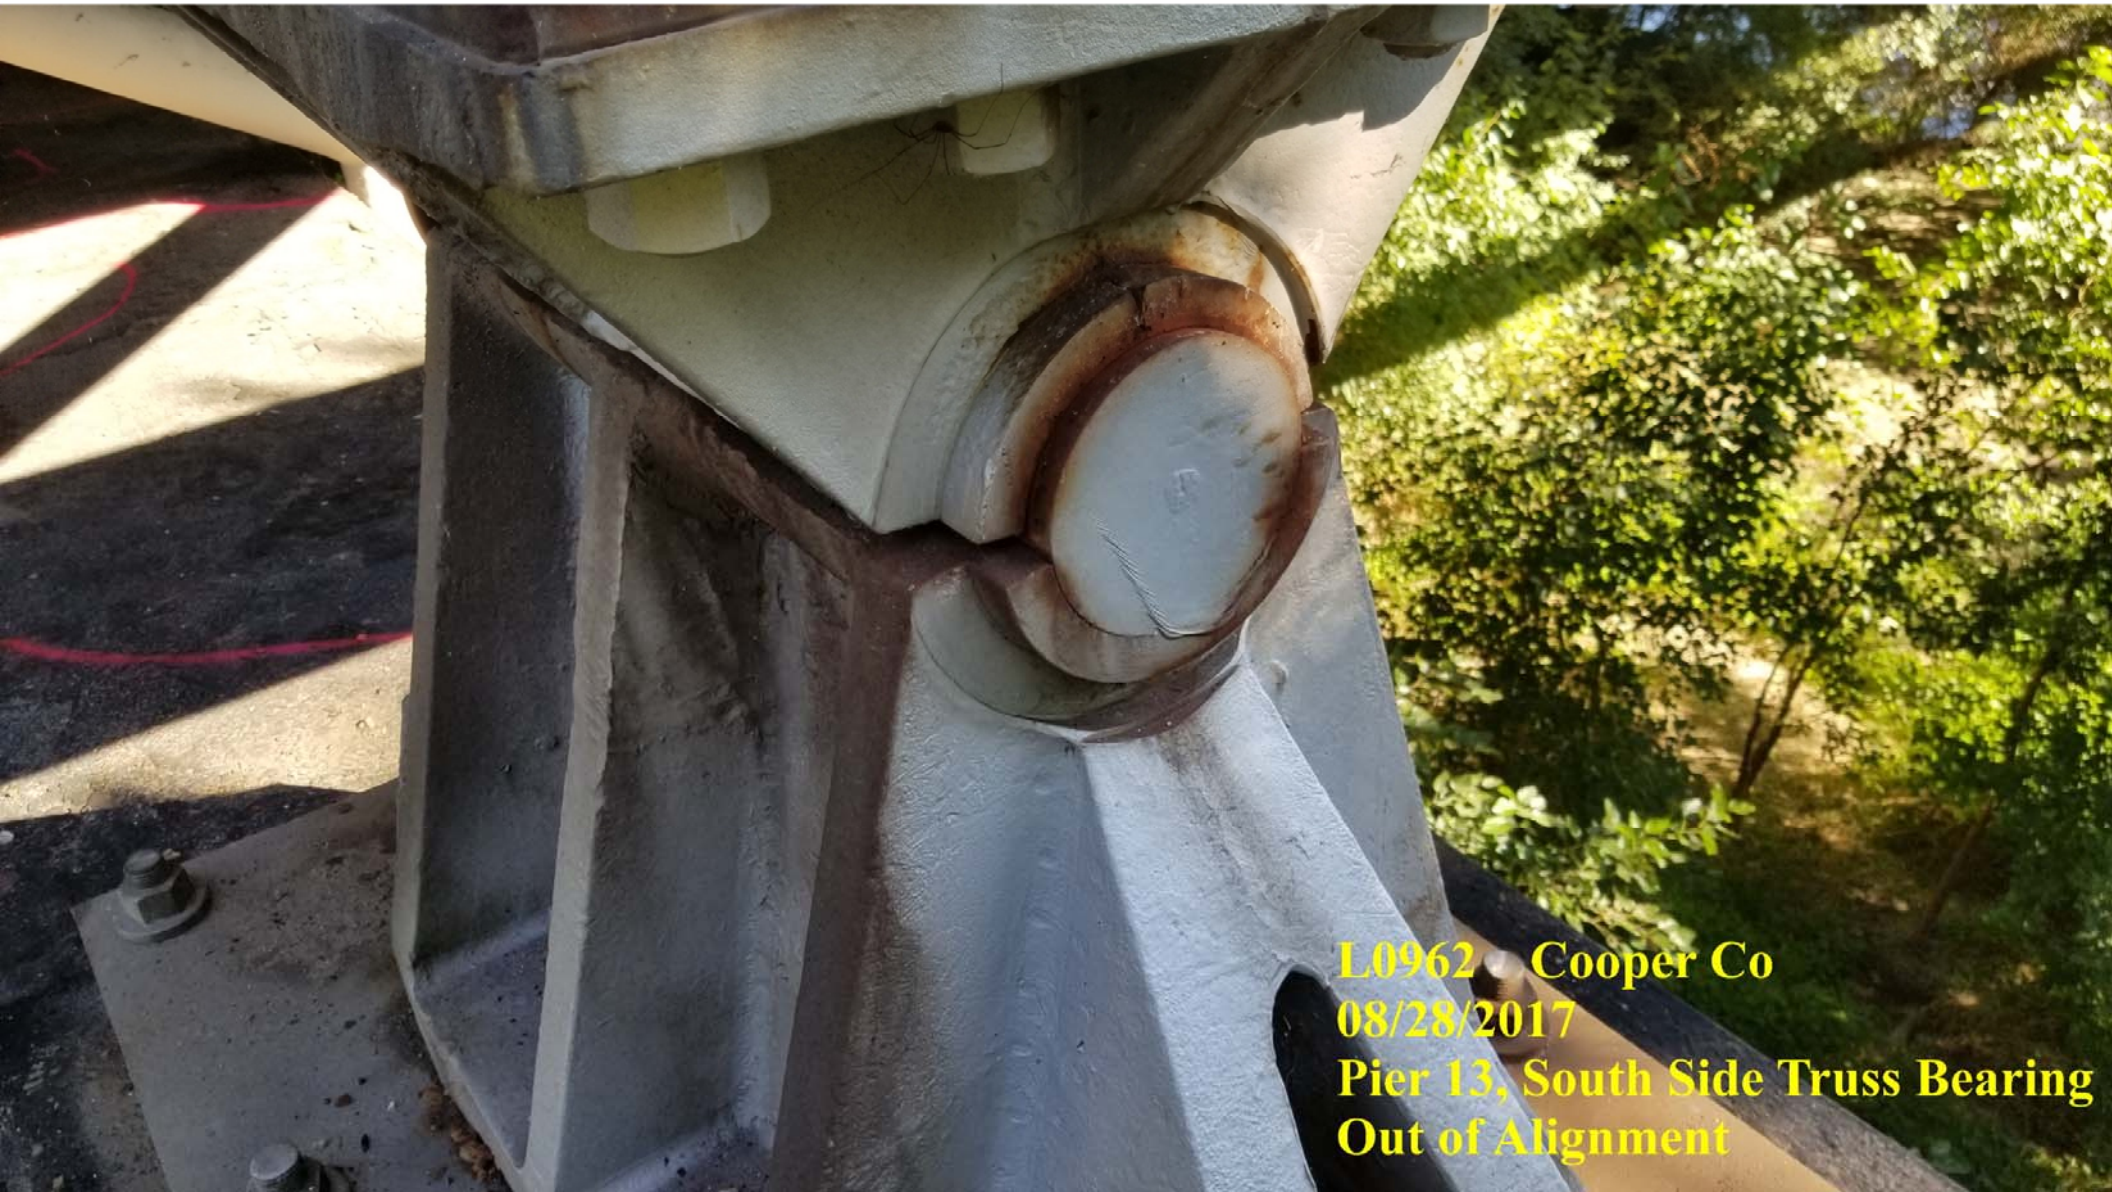
L0962 • Cooper Co
08/28/2017
Pier 13, South Side Truss Bearing
Out of Alignment

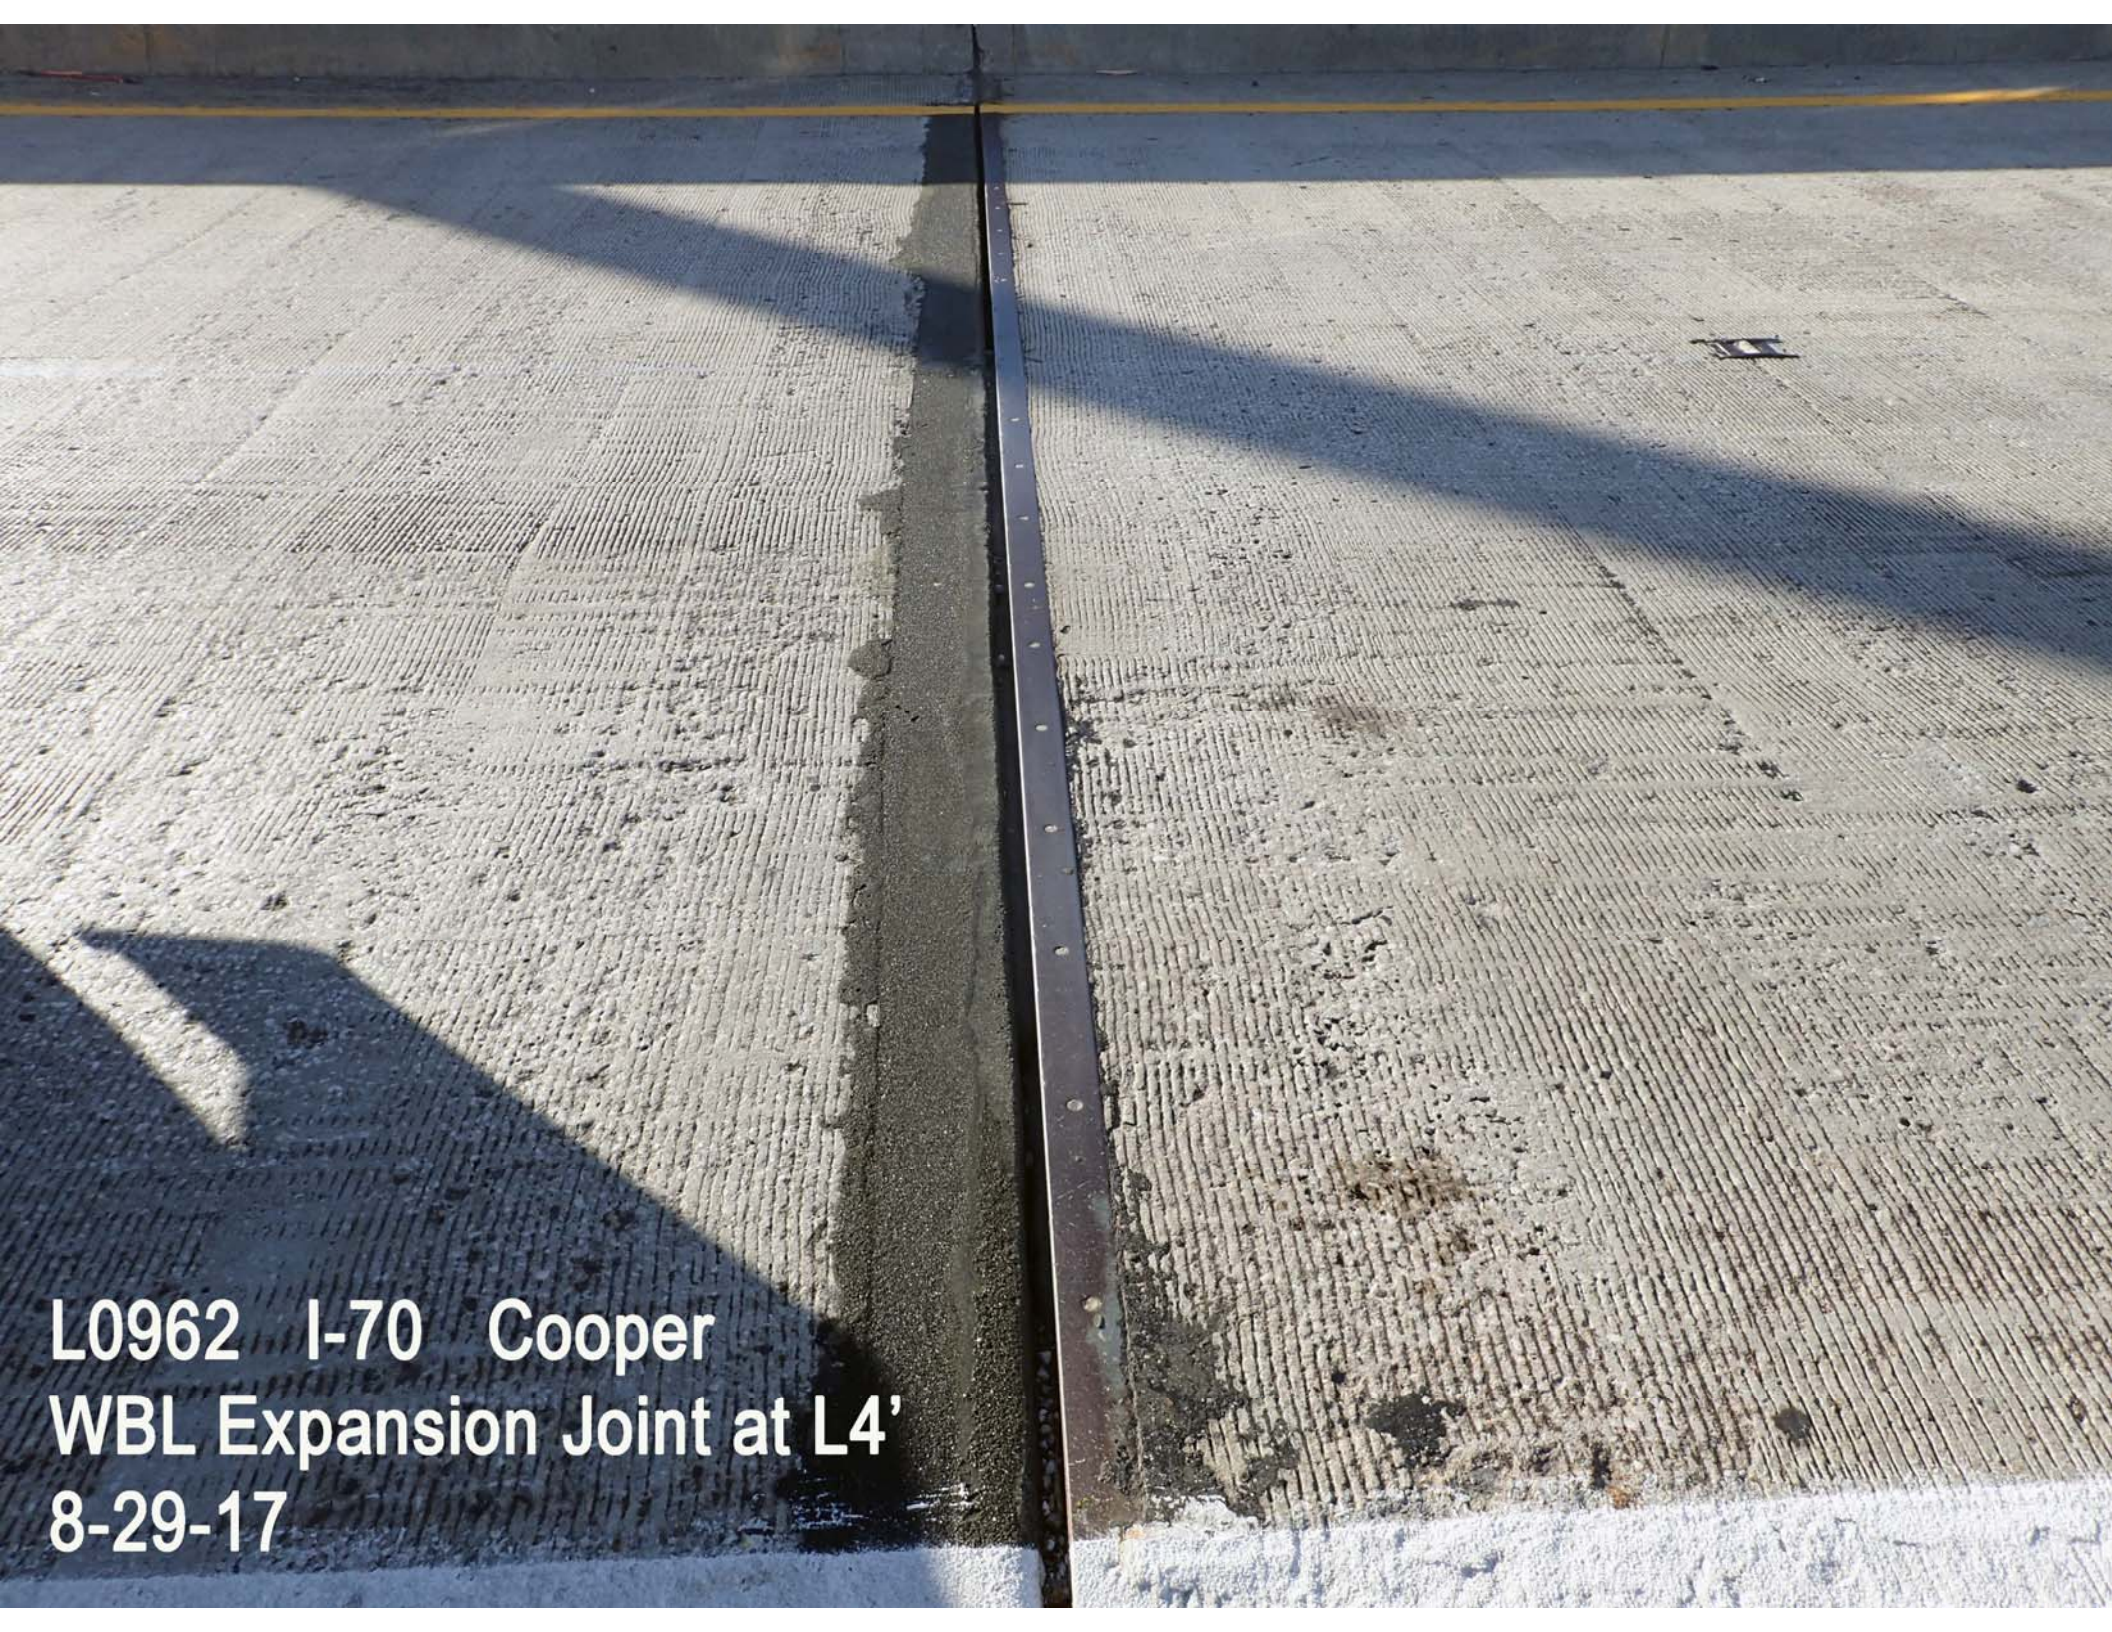
L0962 I-70 Cooper
WBL Expansion Joint at L4'
8-29-17
