L0962 Cooper Co.
08/28/2017
Looking West

L0962 I-70 Cooper
Pier 15 Open Expansion Joint WBL
8-28-17

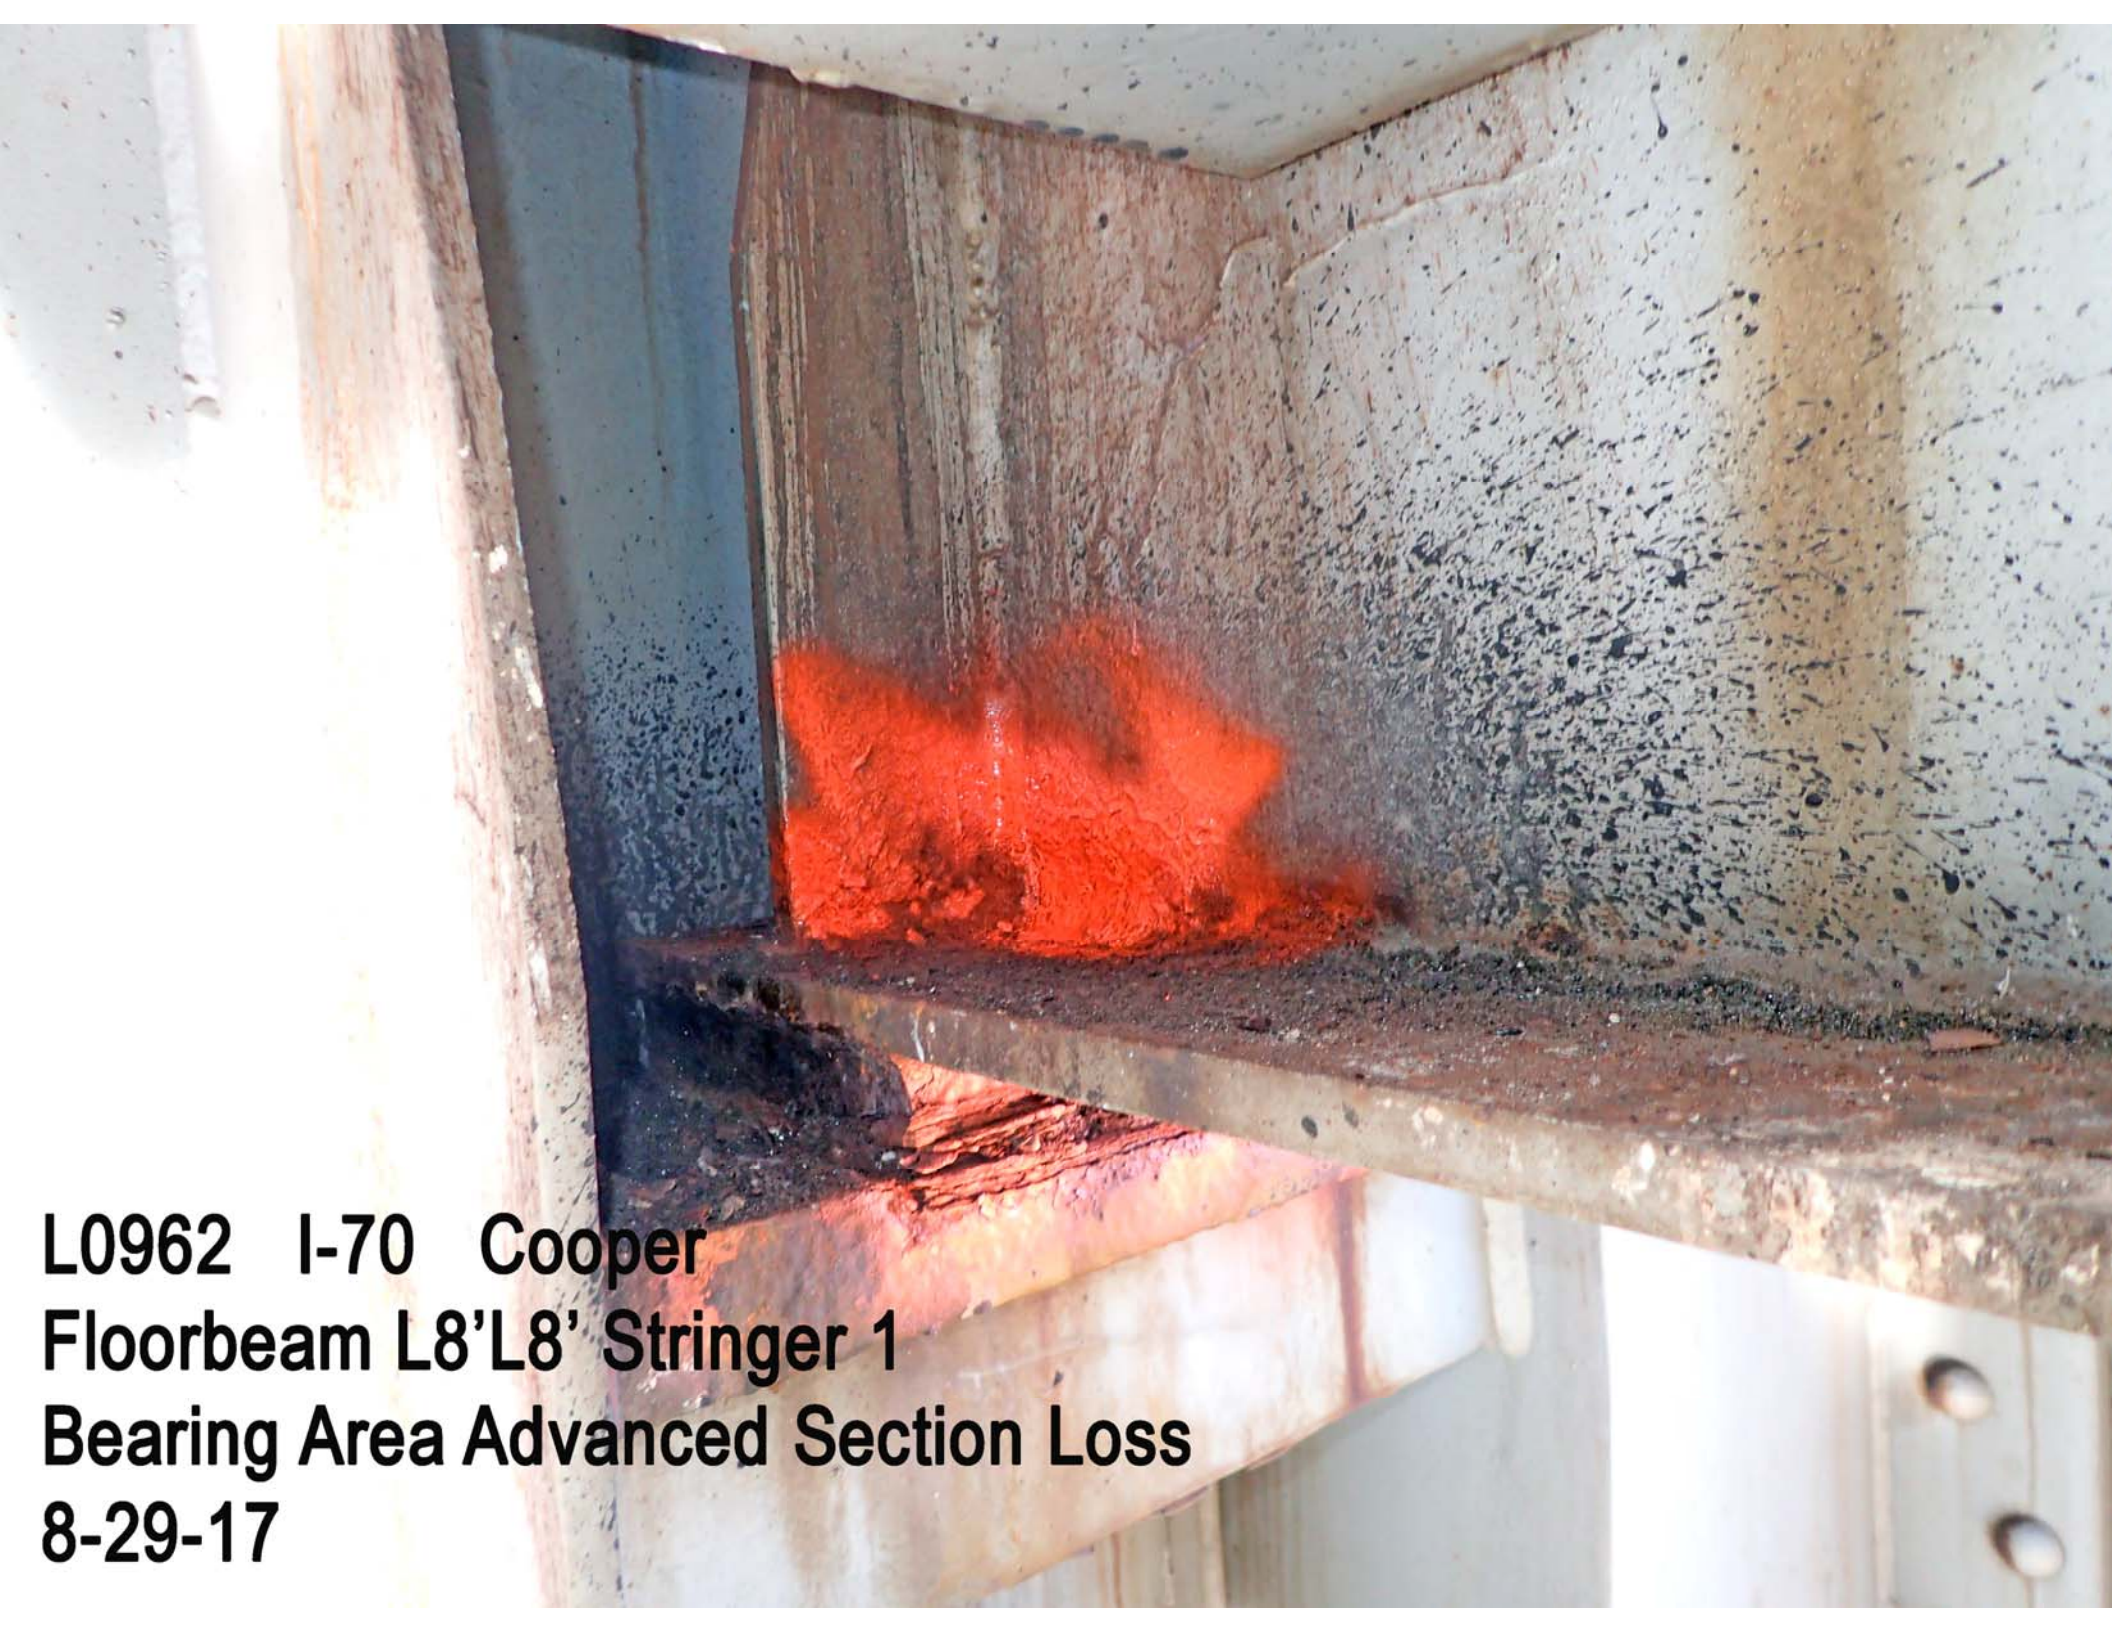
**L0962 I-70 Cooper
Floorbeam L8'L8' Stringer 1
Bearing Area Advanced Section Loss
8-29-17**

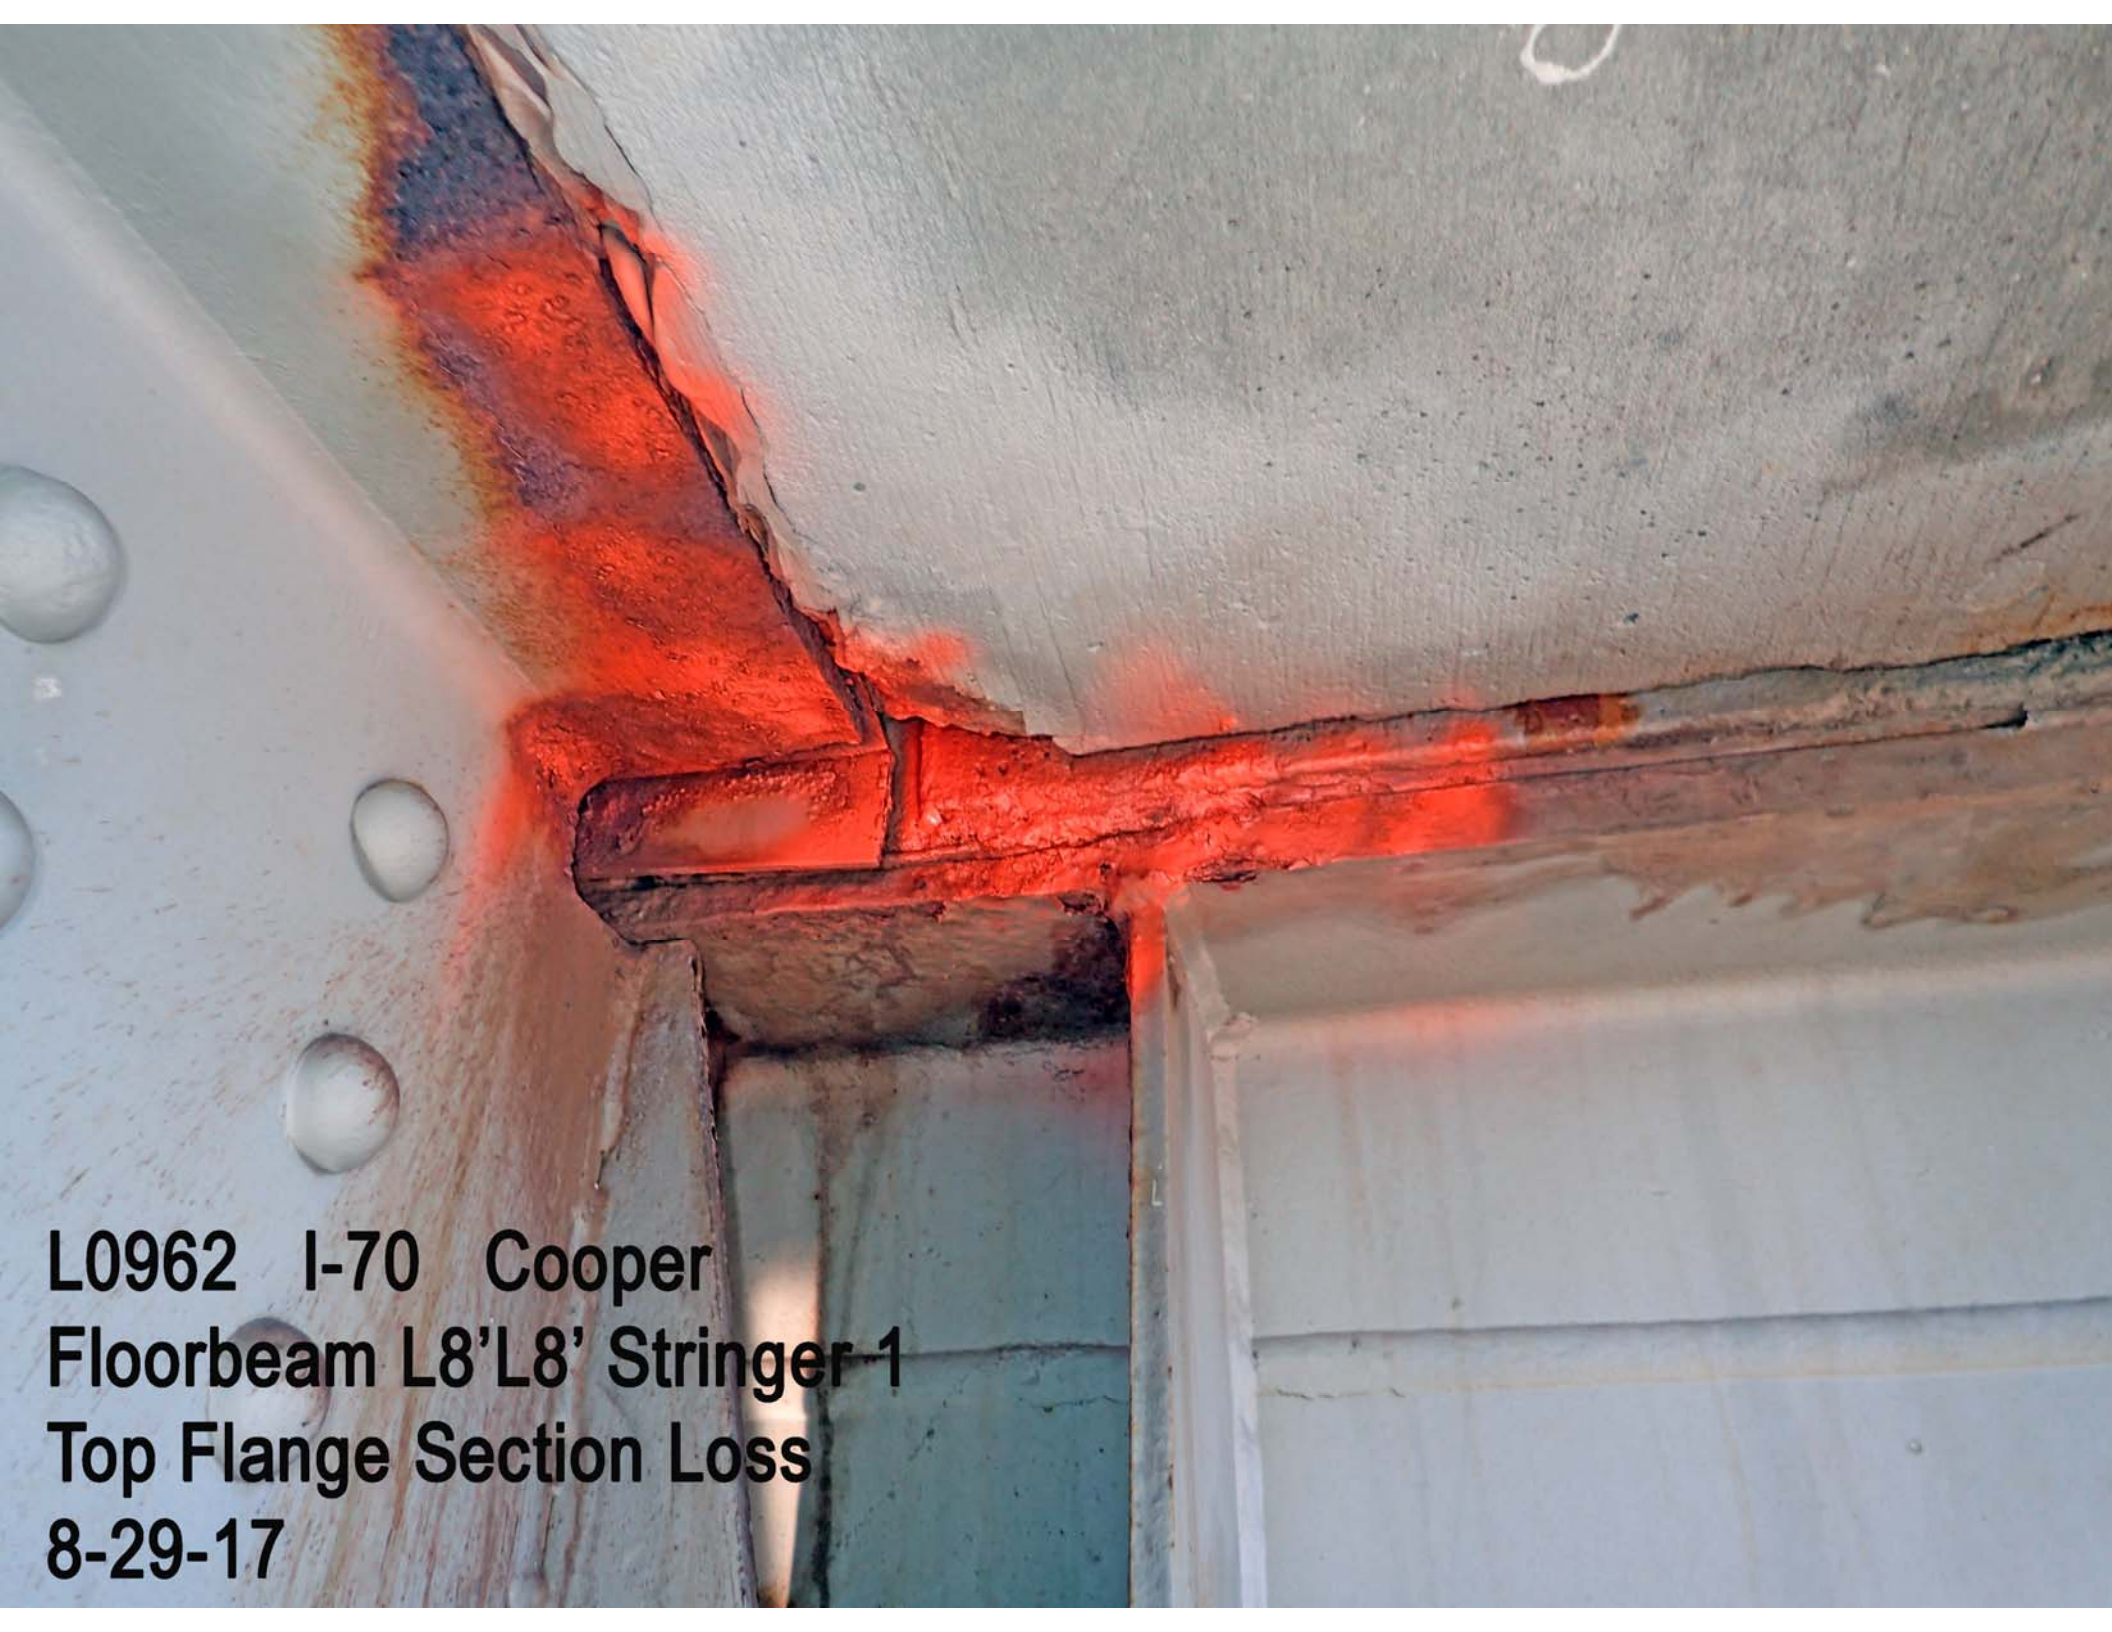
**L0962 I-70 Cooper
Floorbeam L8'L8' Stringer 1
Top Flange Section Loss
8-29-17**

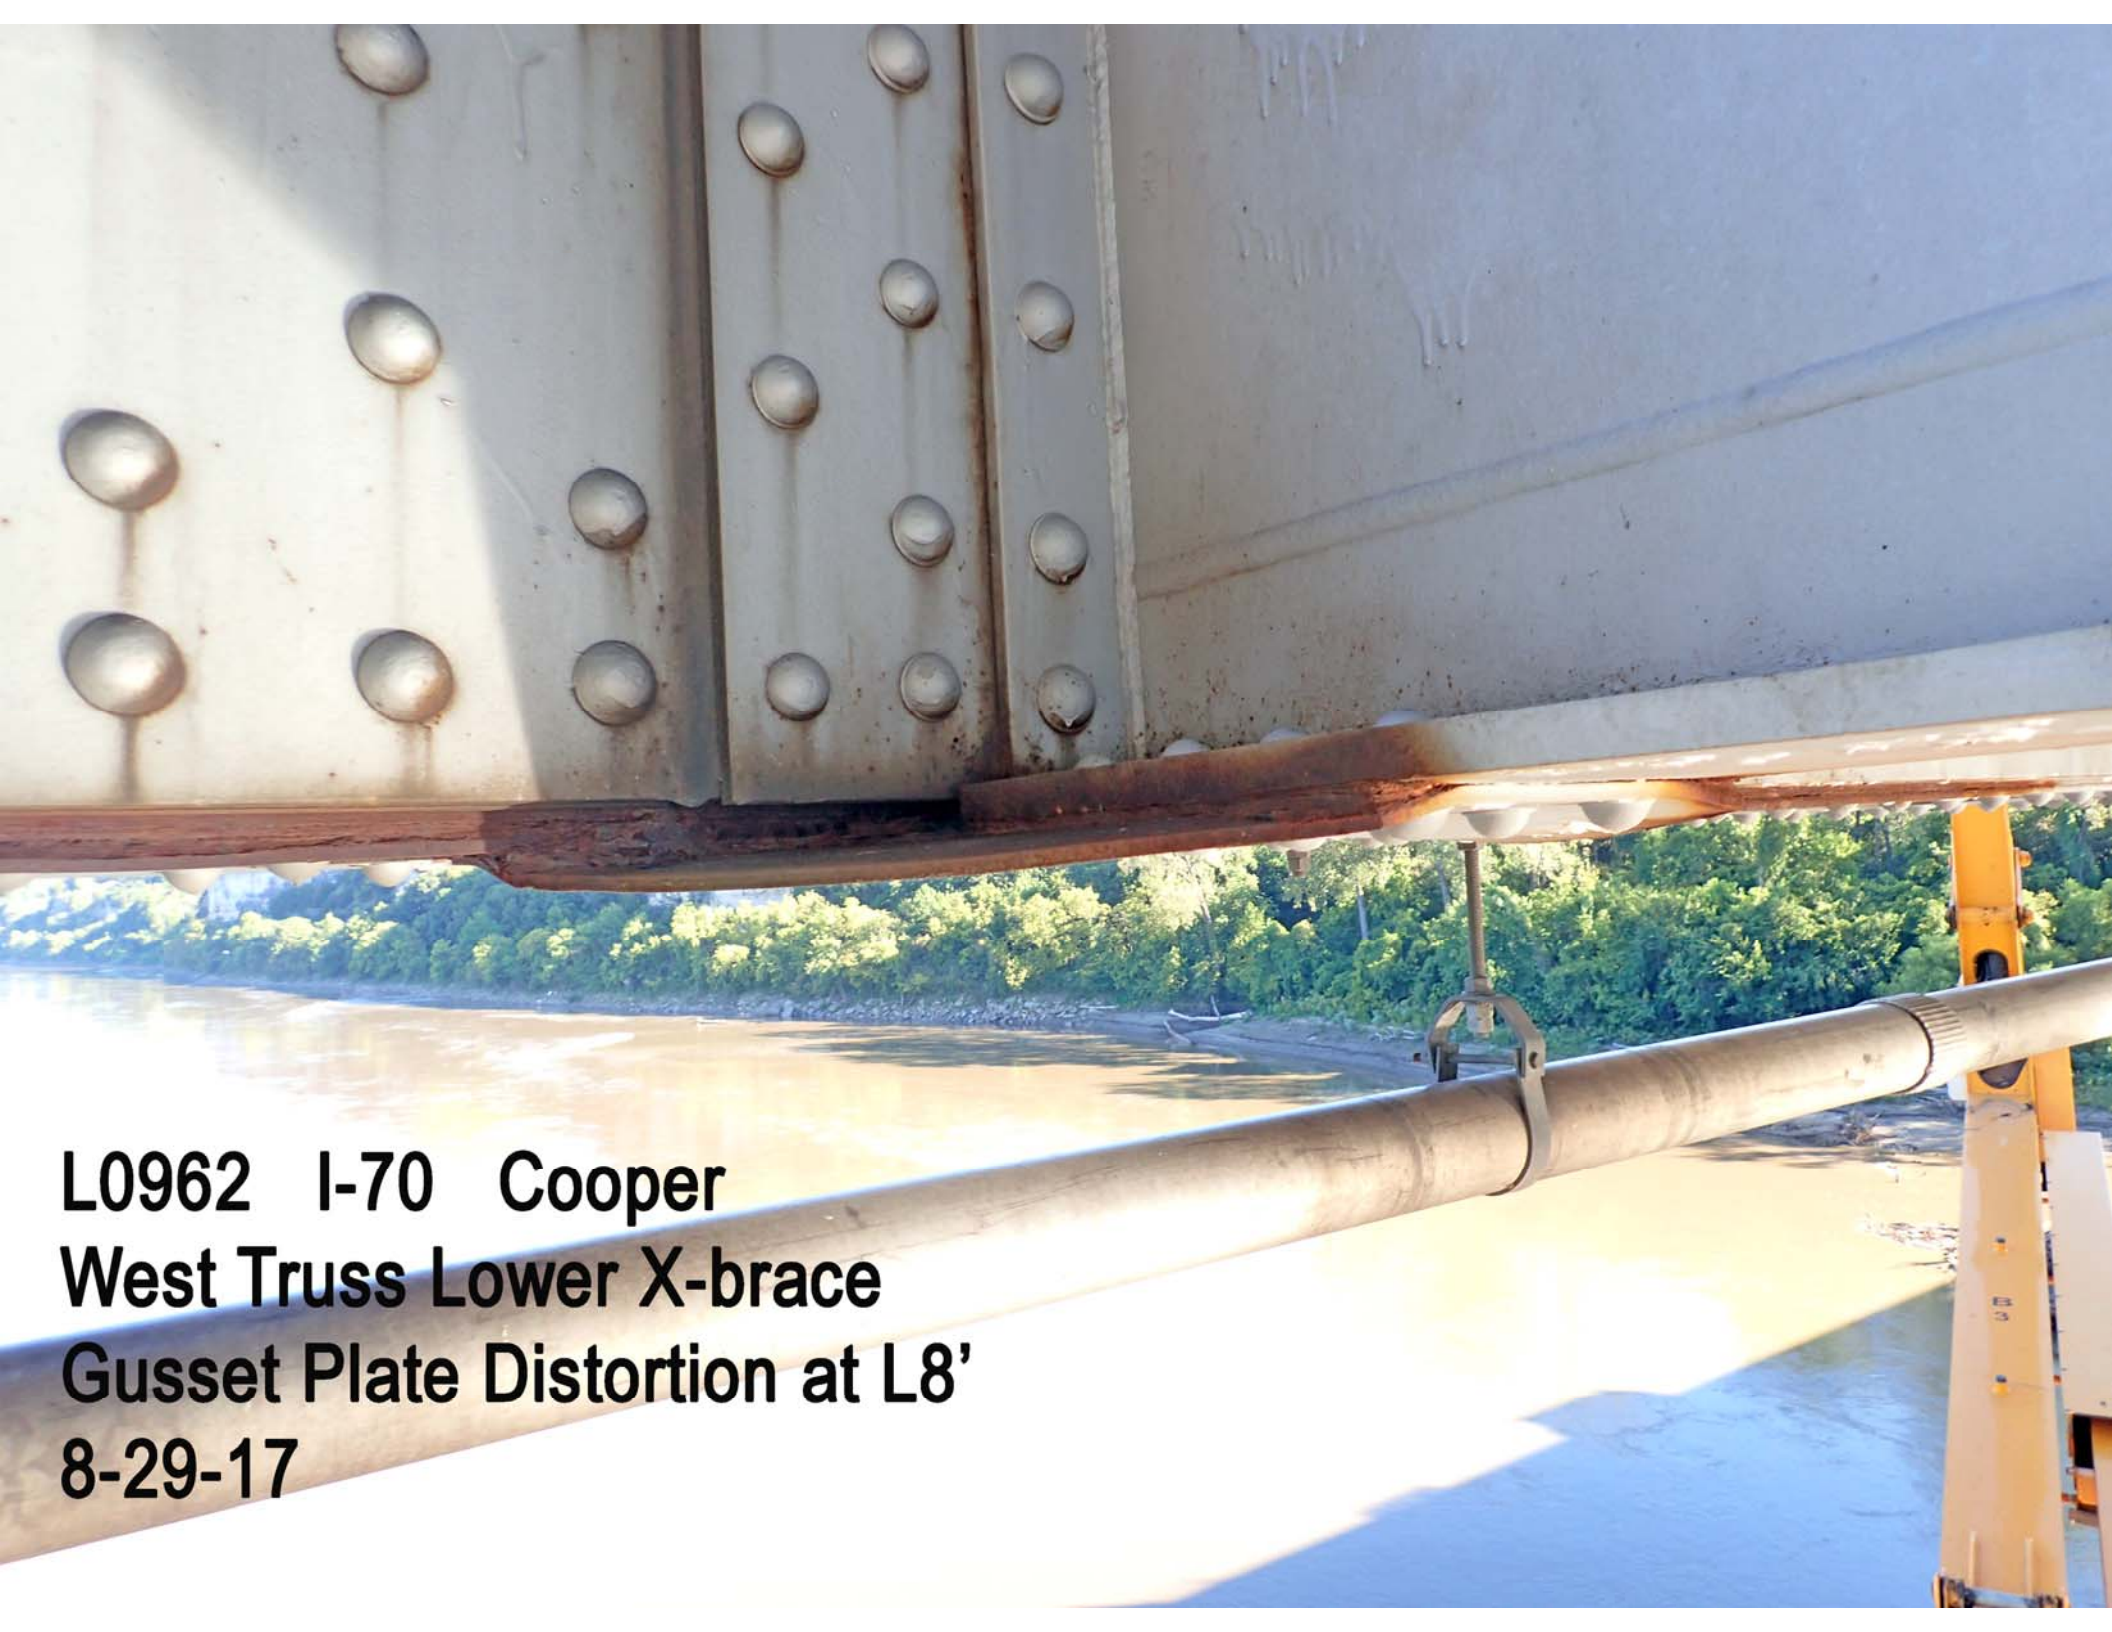
L0962 I-70 Cooper
West Truss Lower X-brace
Gusset Plate Distortion at L8'
8-29-17

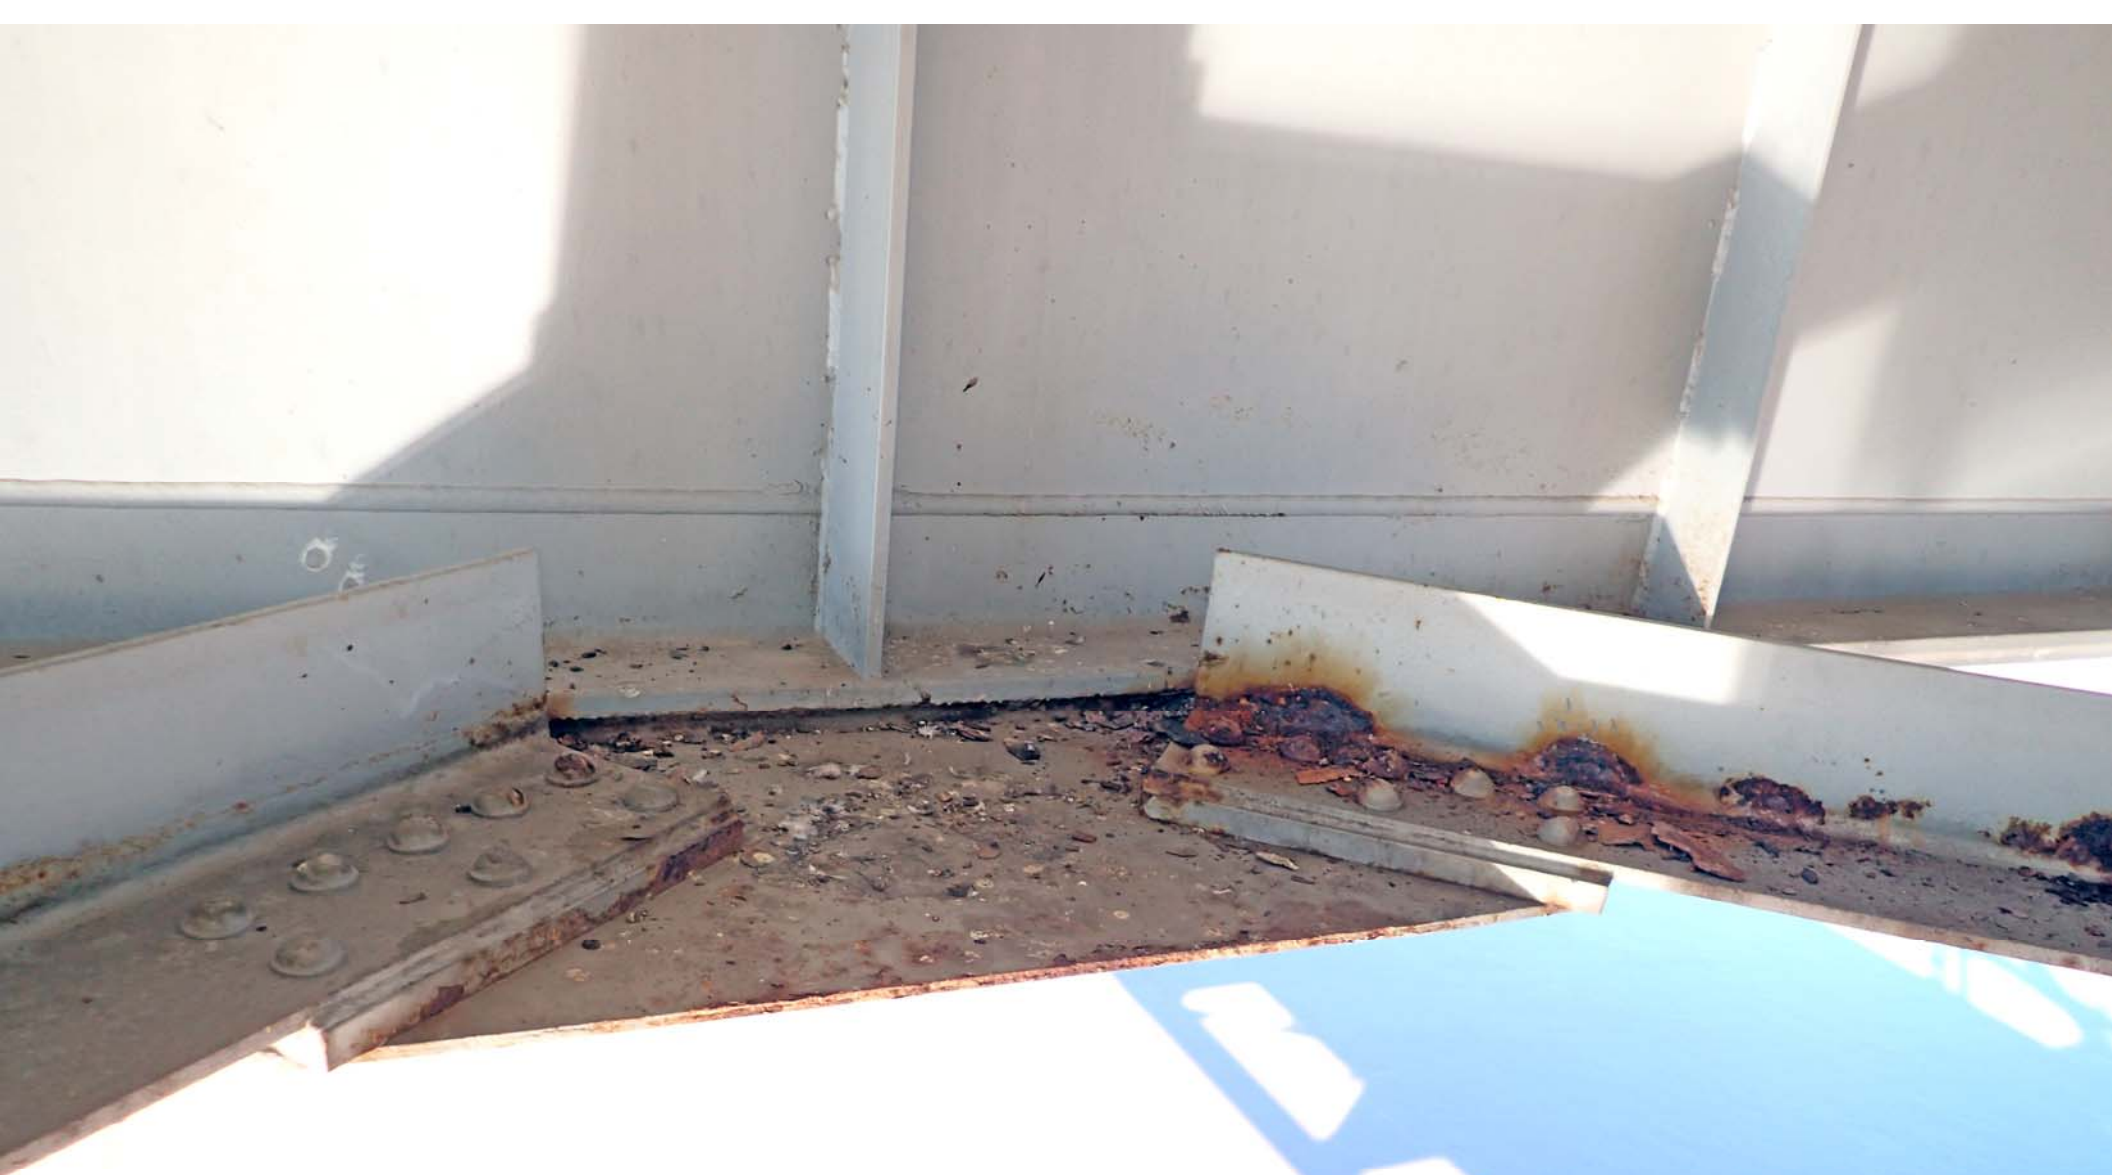
**L0962 I-70 Cooper
Floorbeam L7'L7' Middle X-brace
Gusset Plate and Member Section Loss
8-29-17**

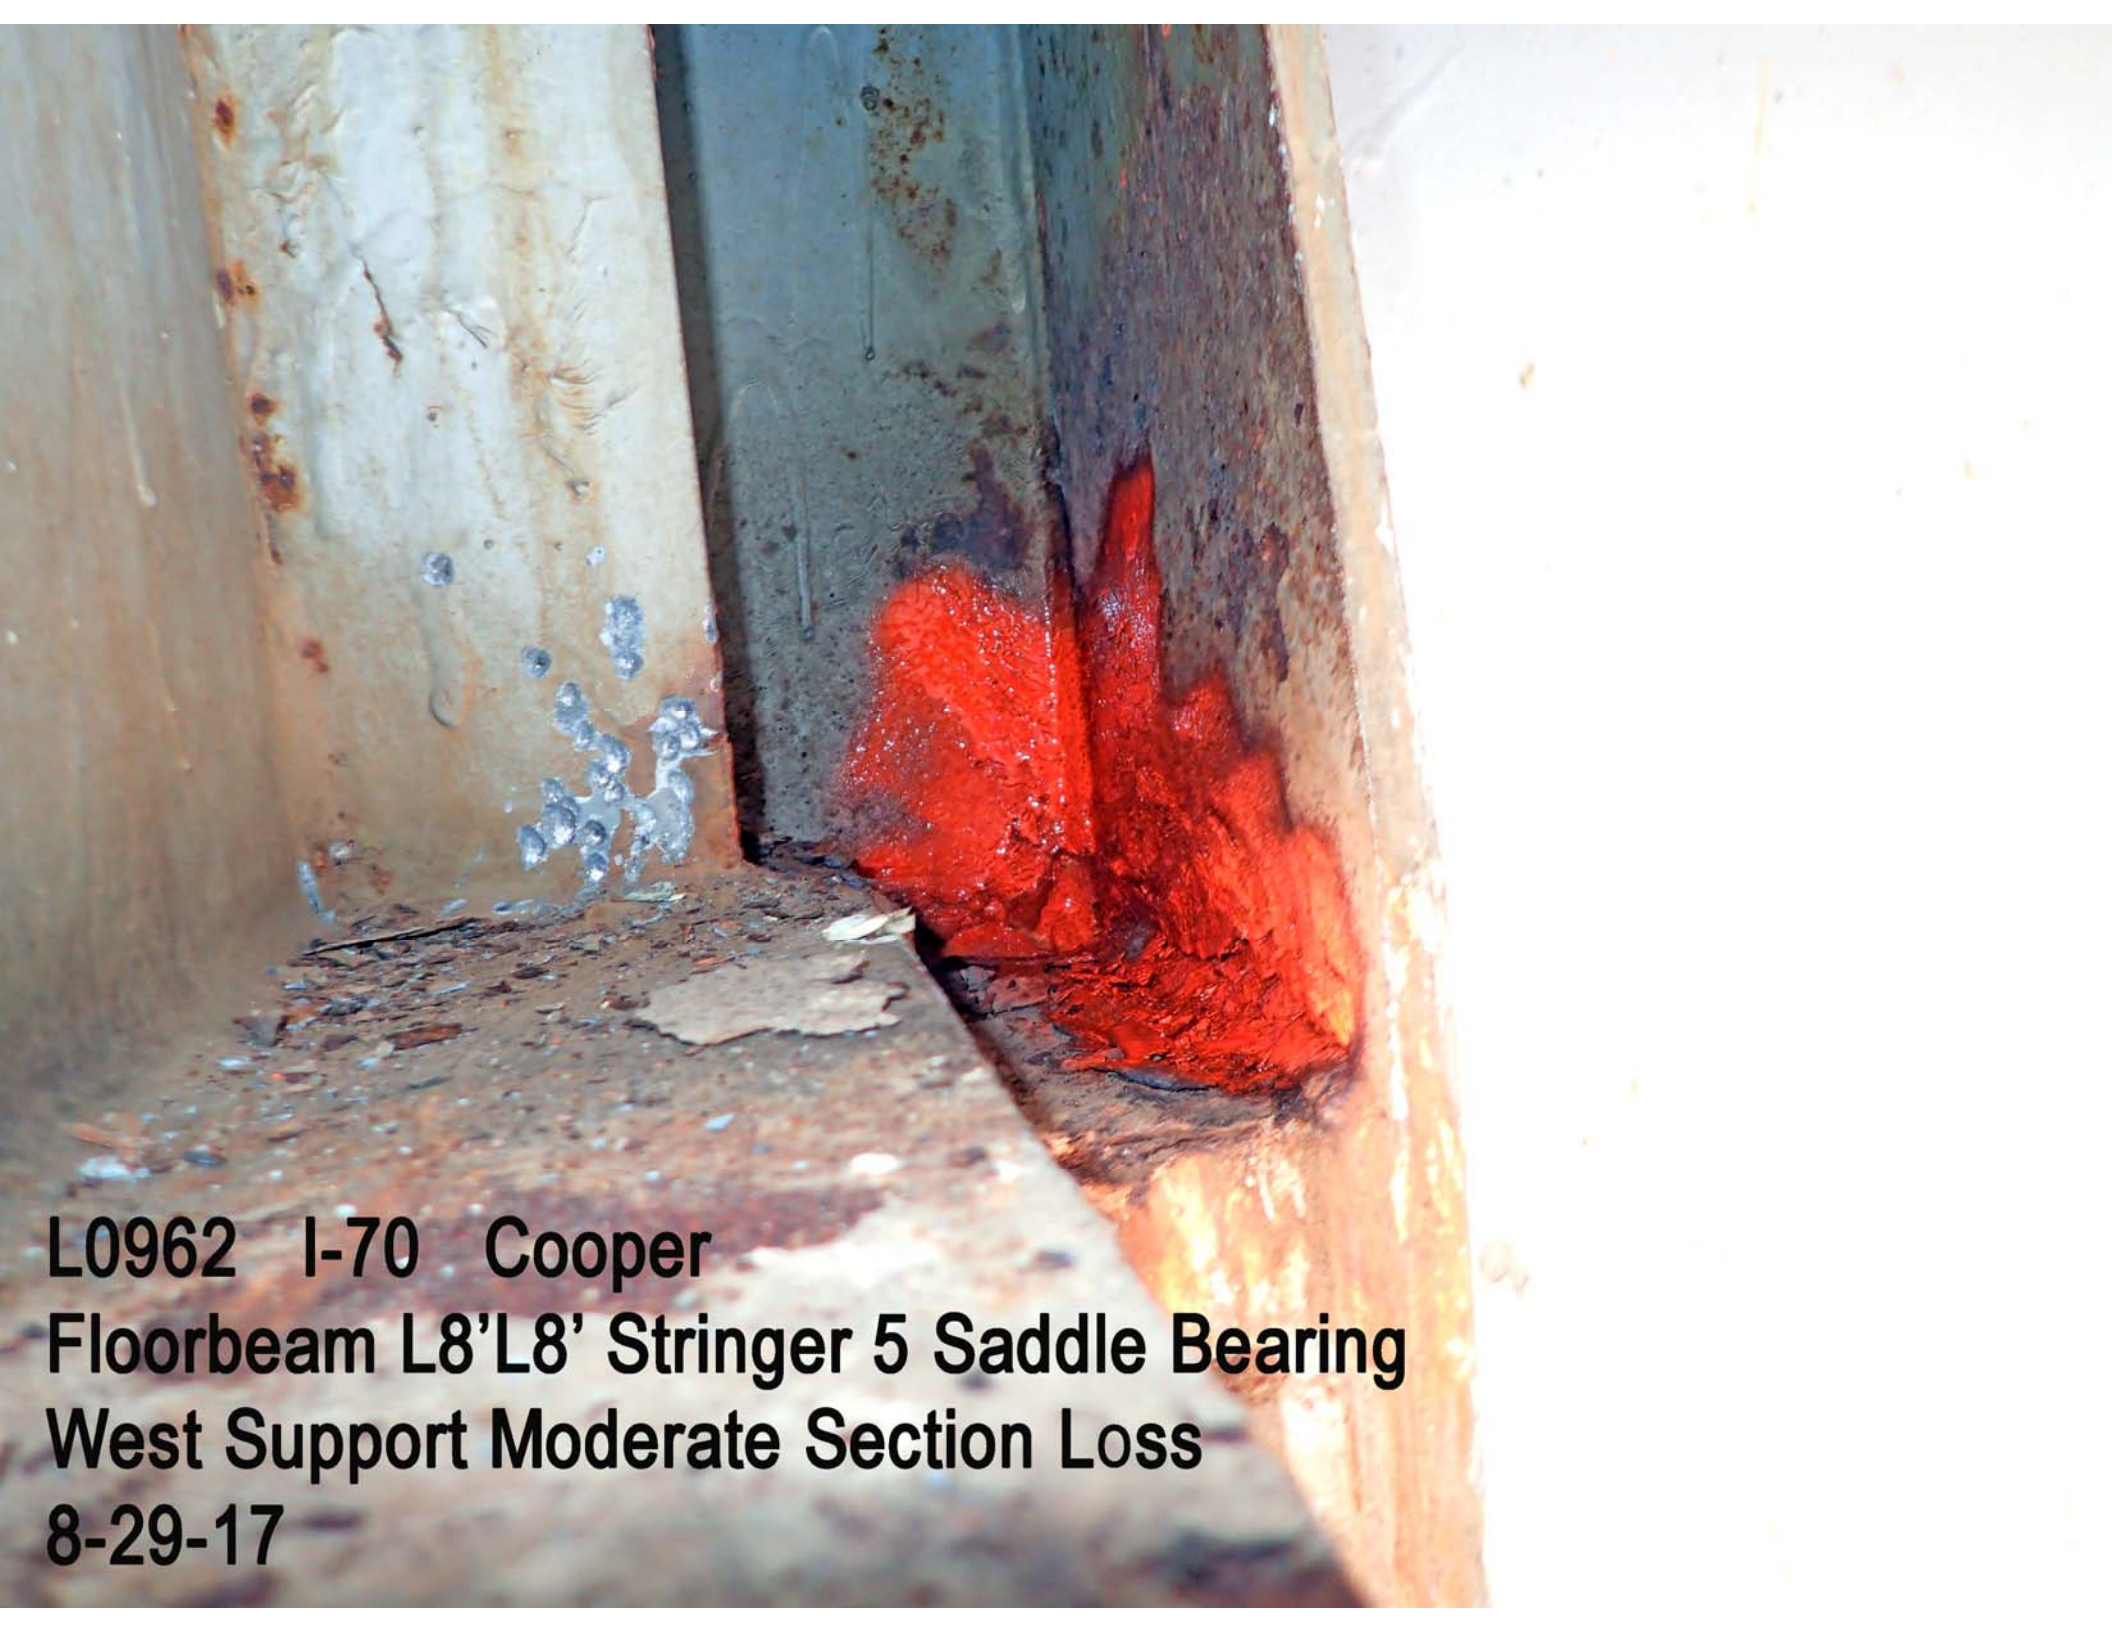
**L0962 I-70 Cooper
Floorbeam L8'L8' Stringer 5
Saddle Bearing Lifting 3/4"
8-29-17**

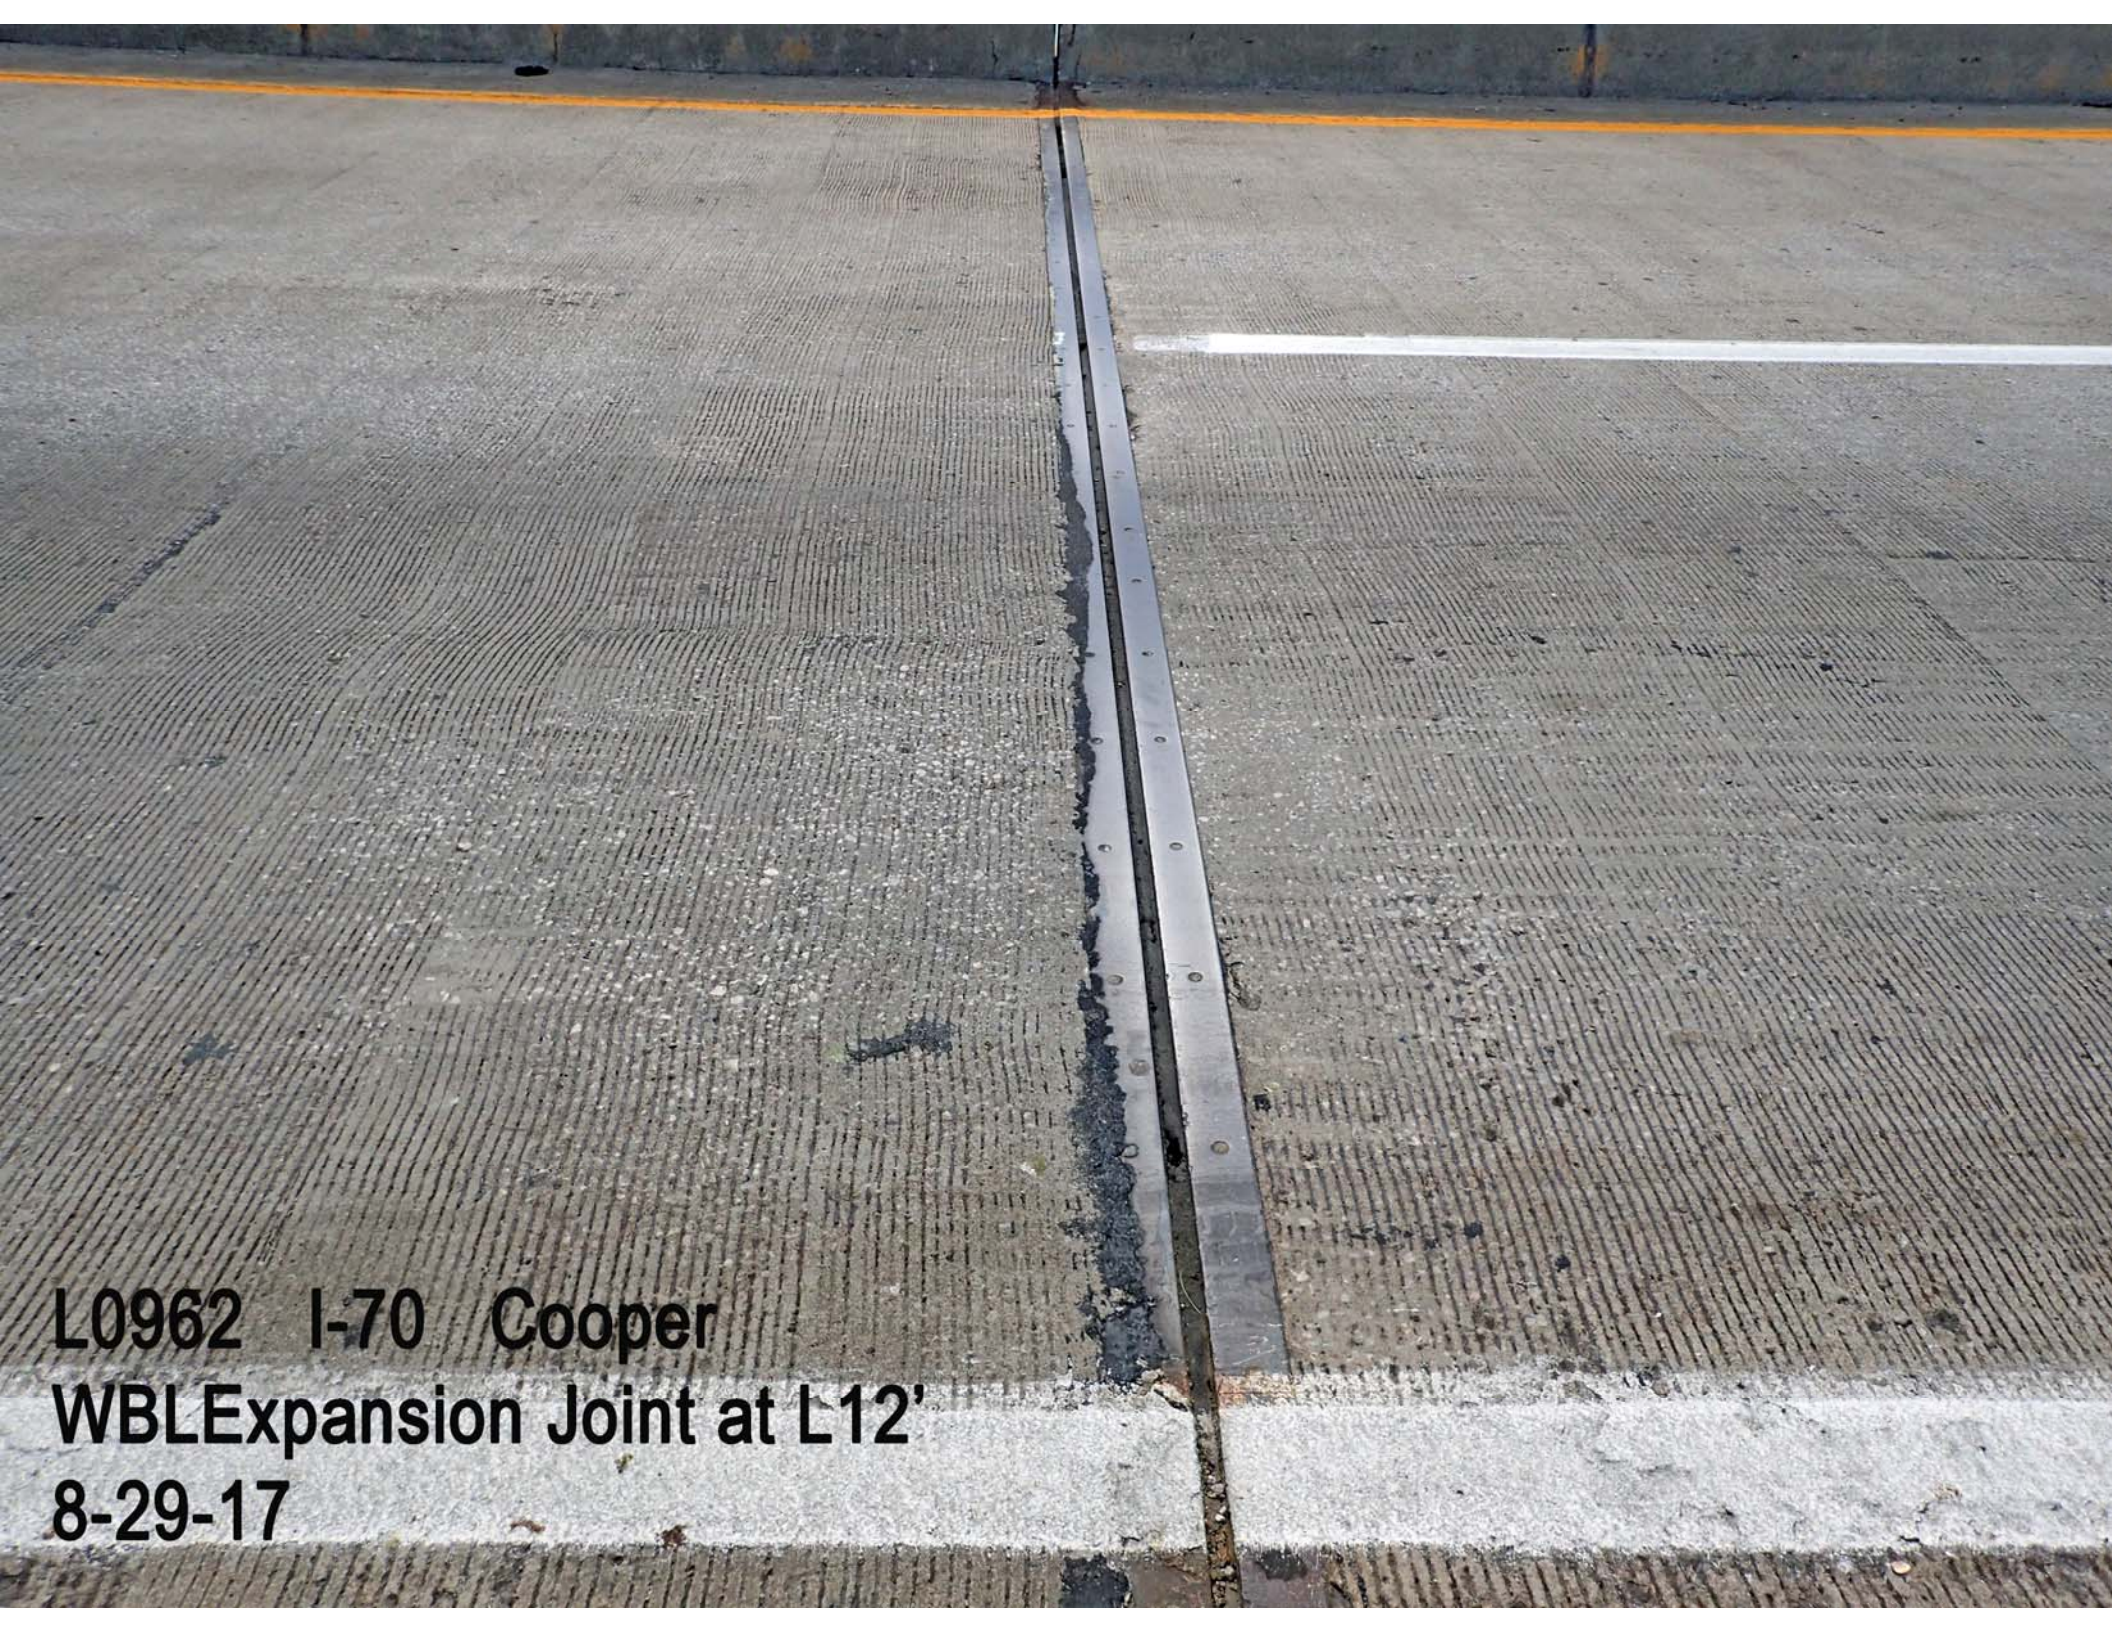
L0962 I-70 Cooper
West Truss L8'M9' Diagonal
Distortion at Built-Up Member Joints (typ)
8-29-17

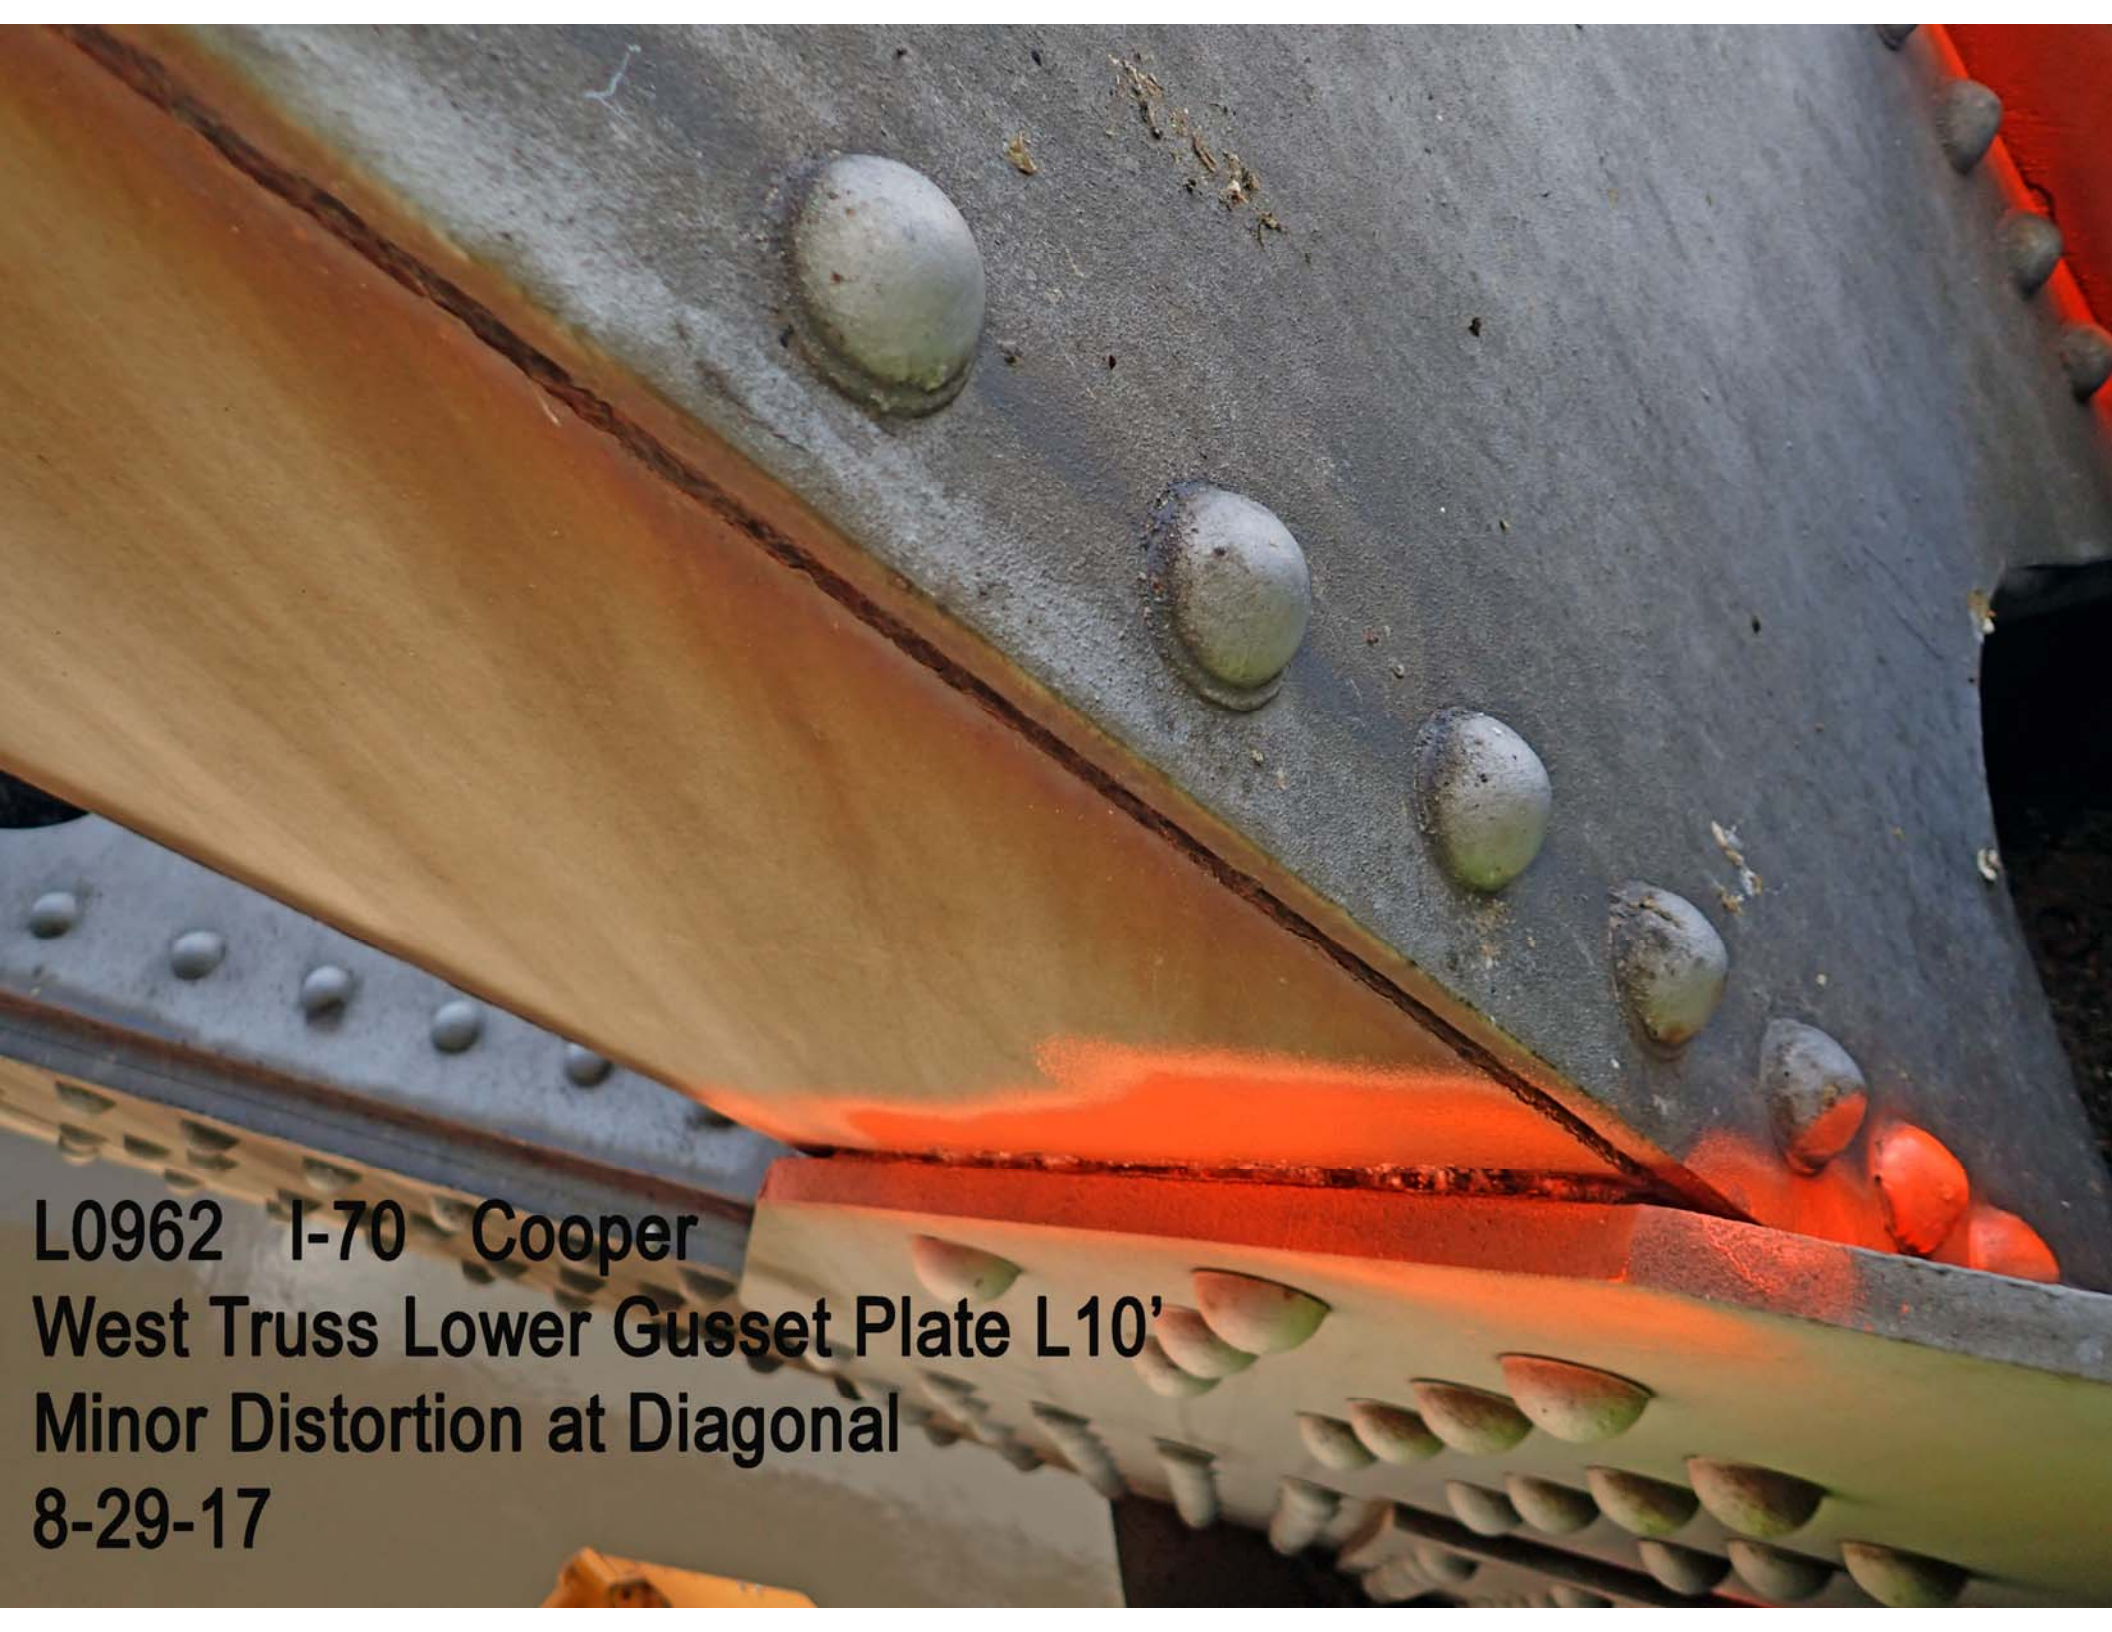
**L0962 I-70 Cooper
West Truss Lower Gusset Plate L10'
Minor Distortion at Diagonal
8-29-17**
