L0962 Cooper Co.
08/28/2017
Looking West

L0962 I-70 Cooper
Pier 15 Open Expansion Joint WBL
8-28-17

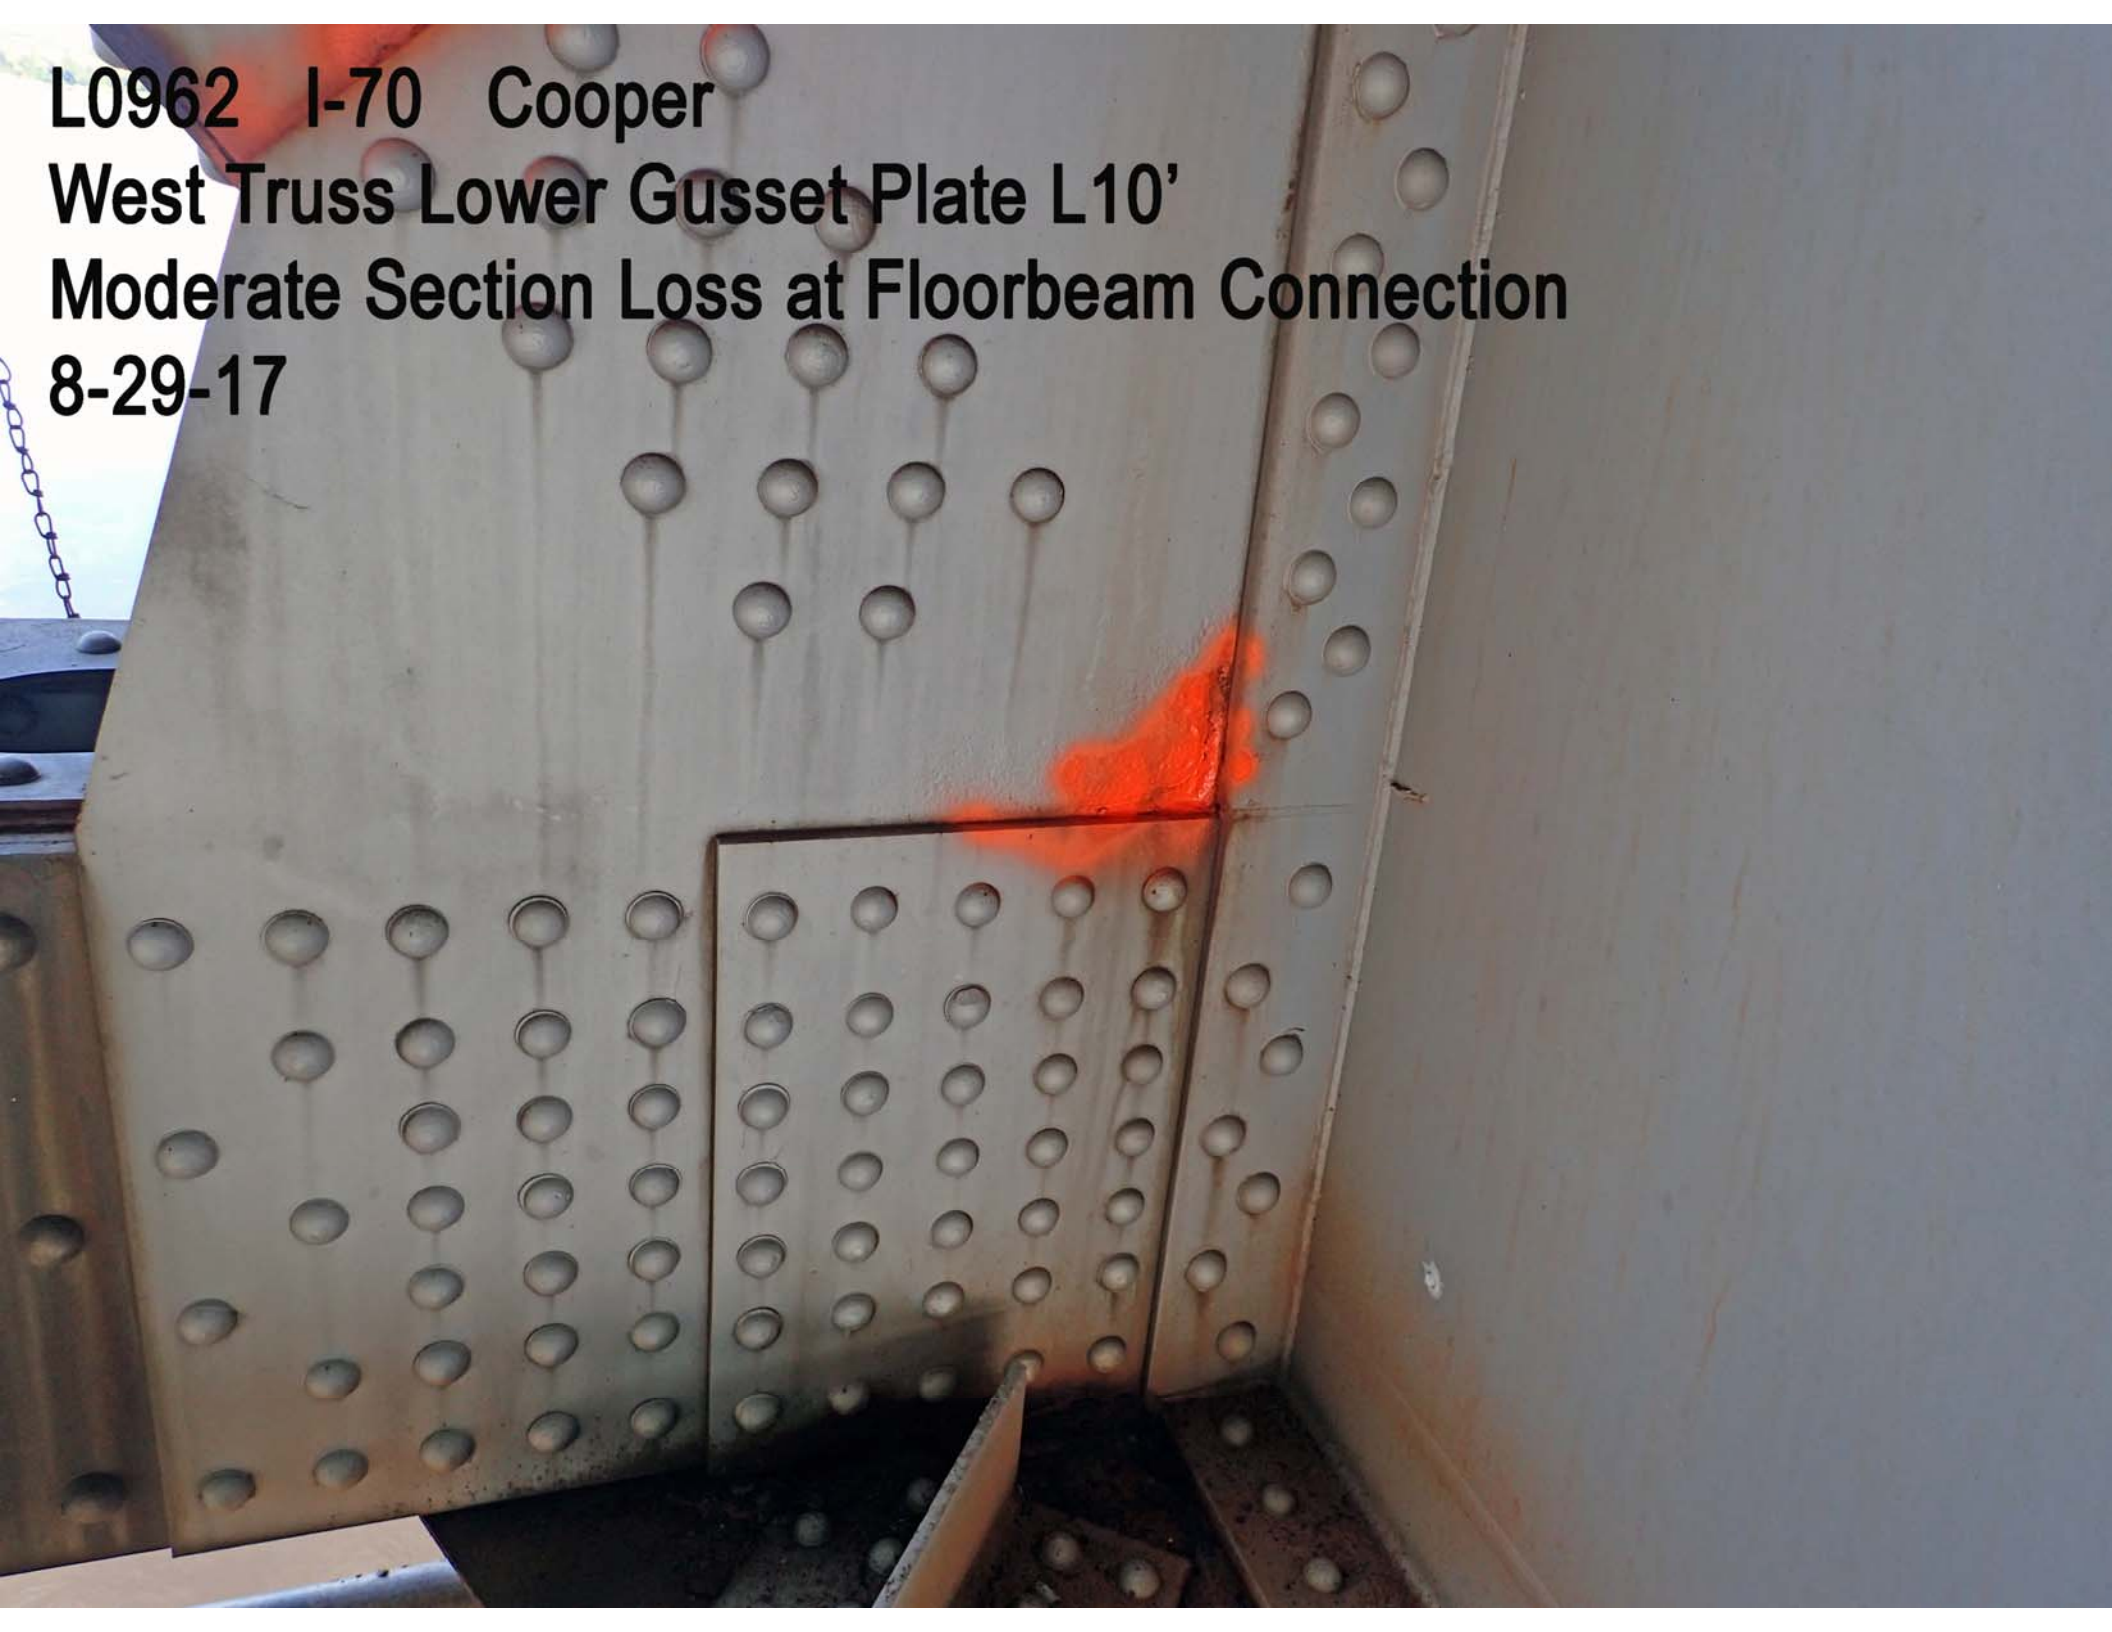
Moderate Section Loss at Floorbeam Connection

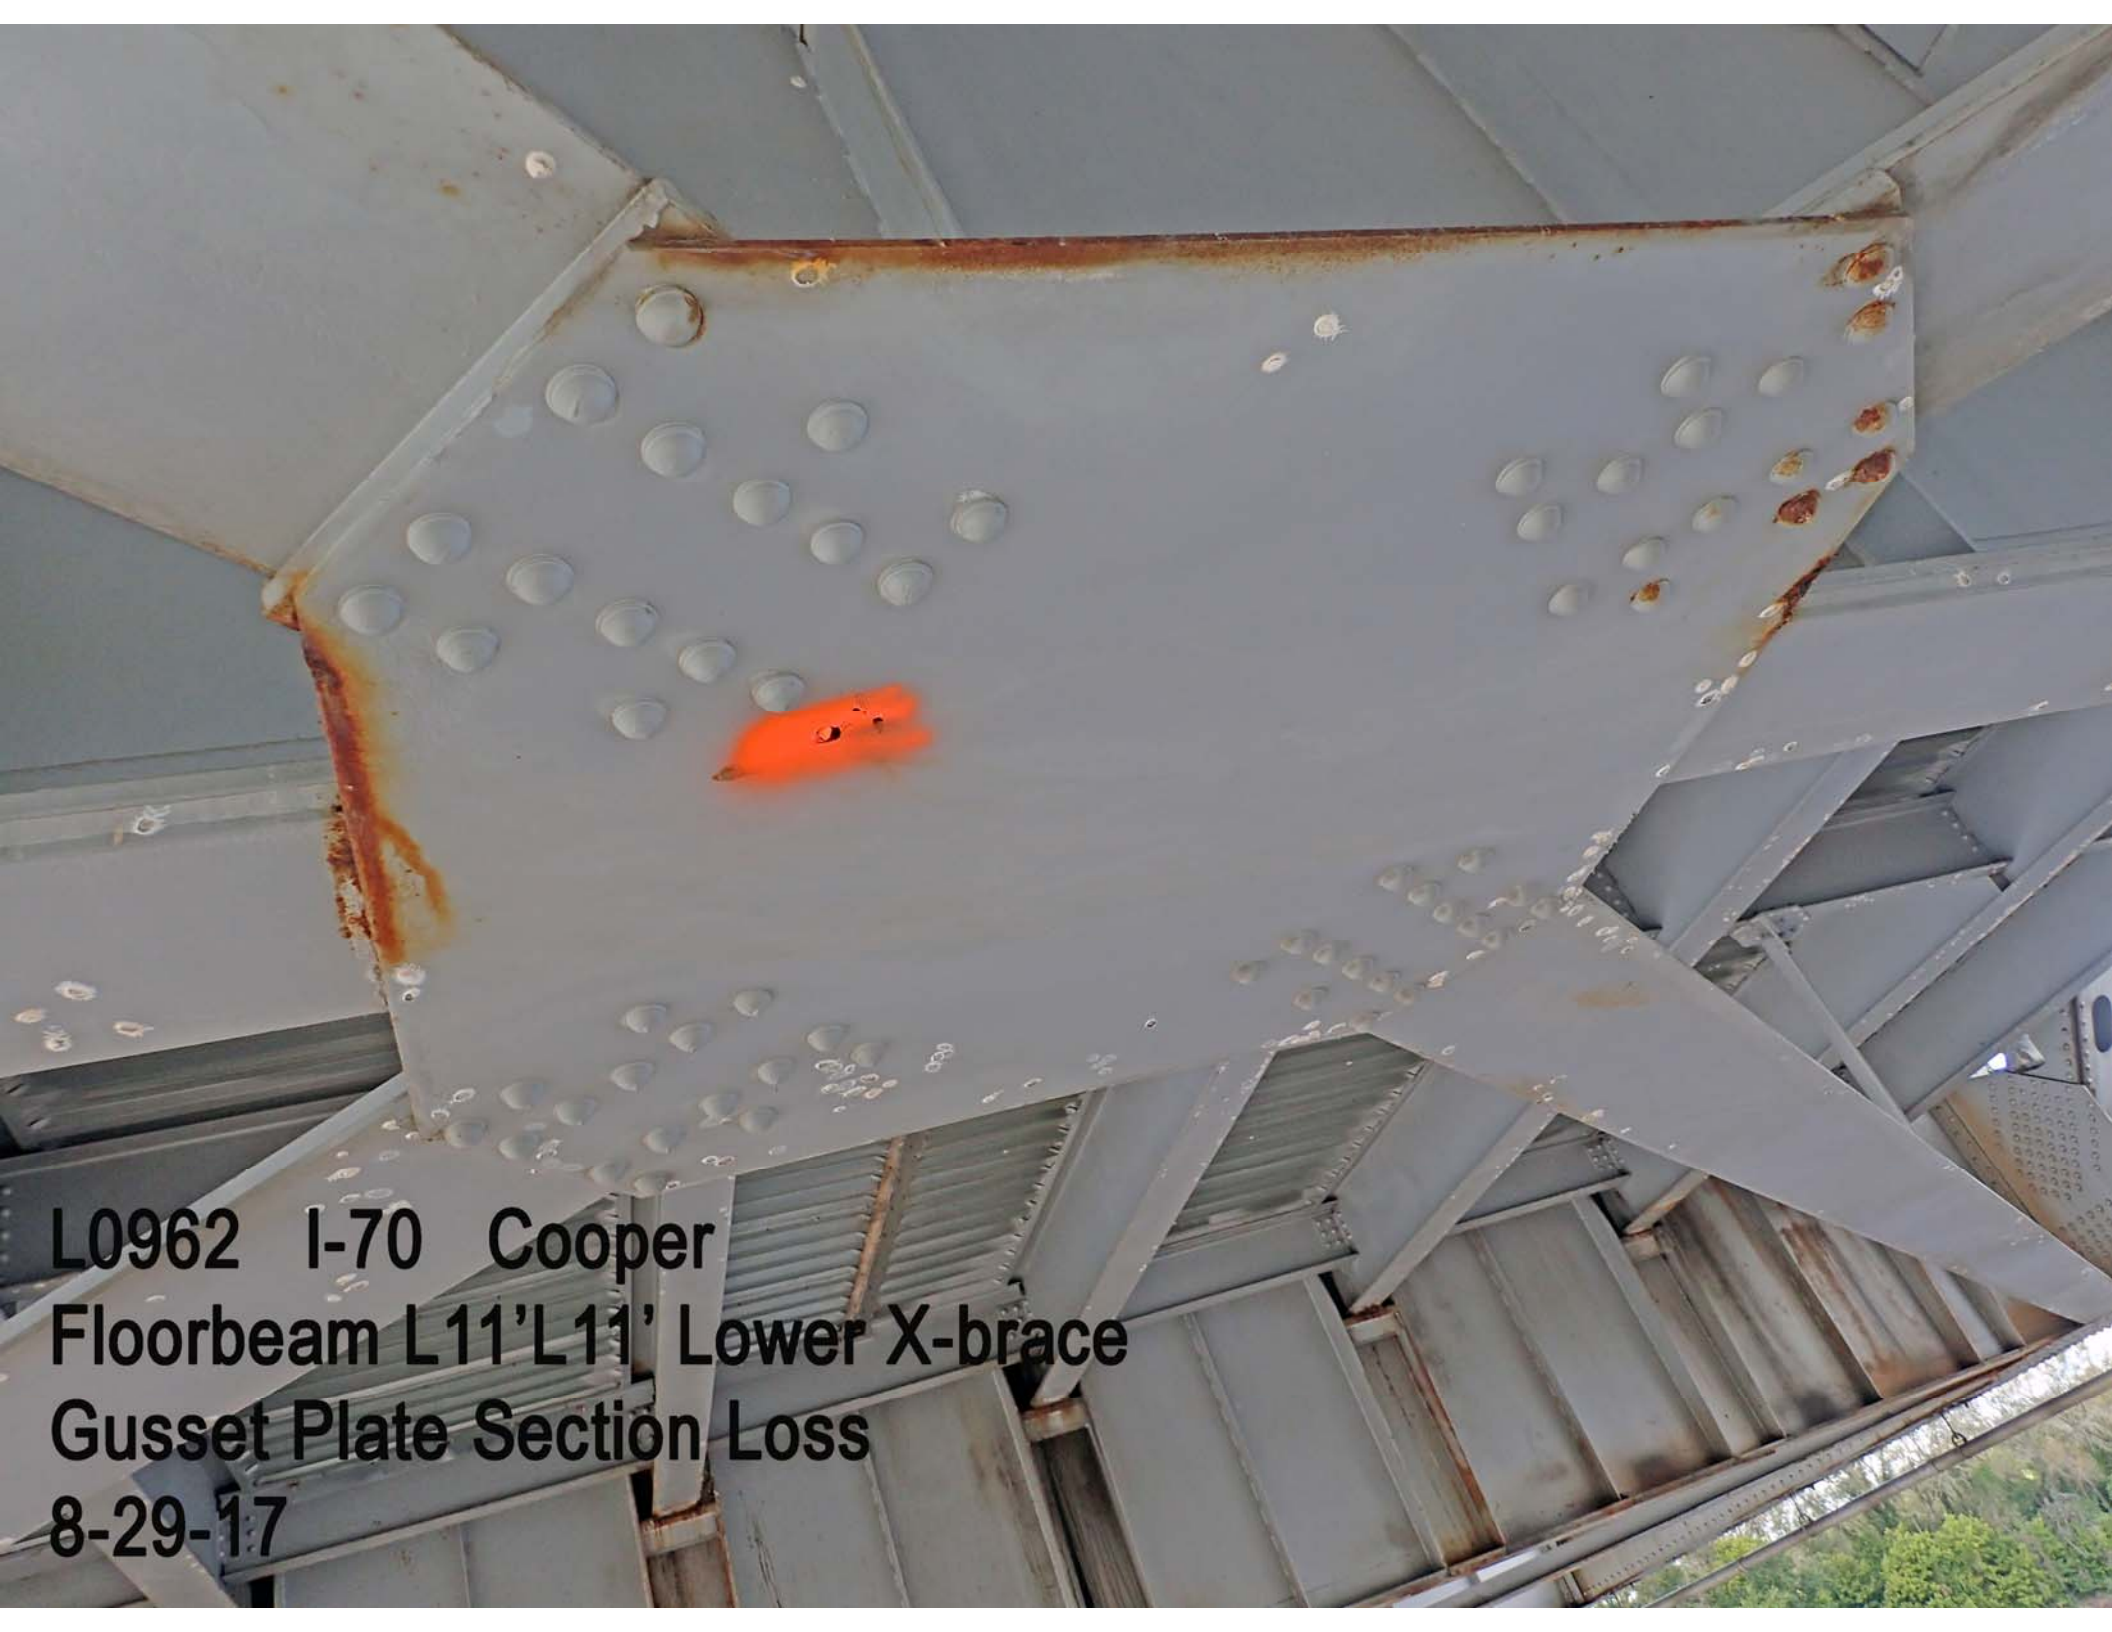
L0962 I-70 Cooper
Floorbeam L11'L11' Lower X-brace
Gusset Plate Section Loss
8-29-17

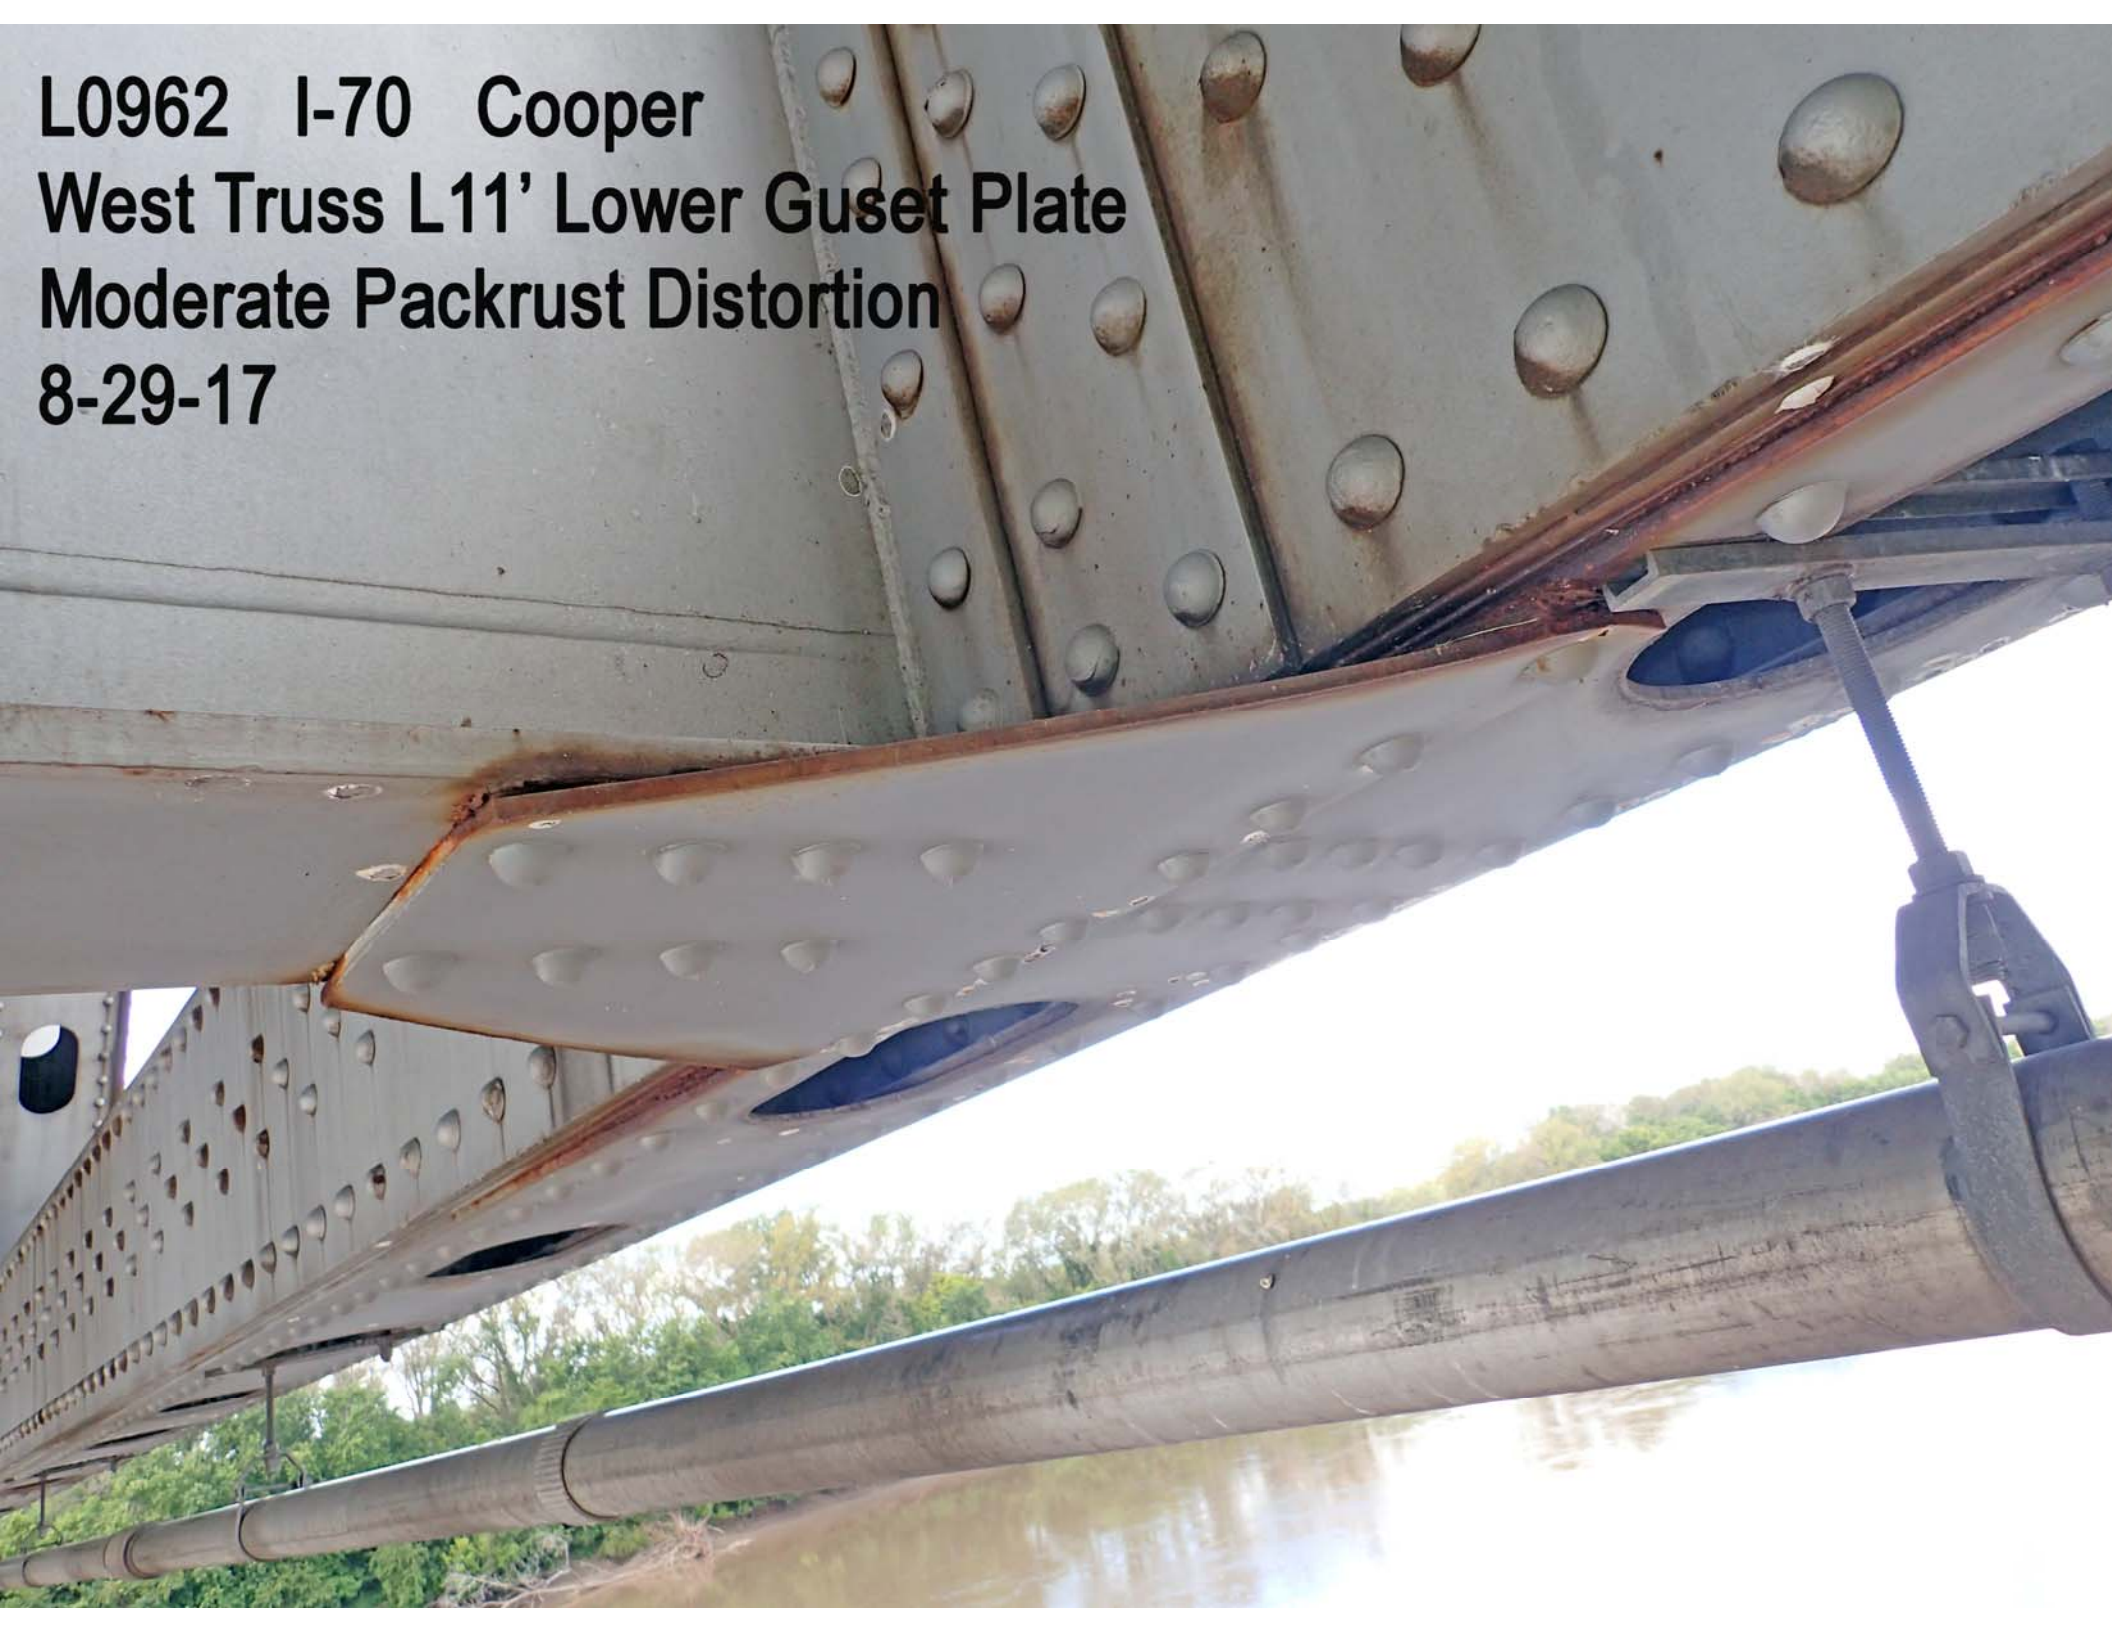
L0962 I-70 Cooper
West Truss L11' Lower Guset Plate
Moderate Packrust Distortion
8-29-17

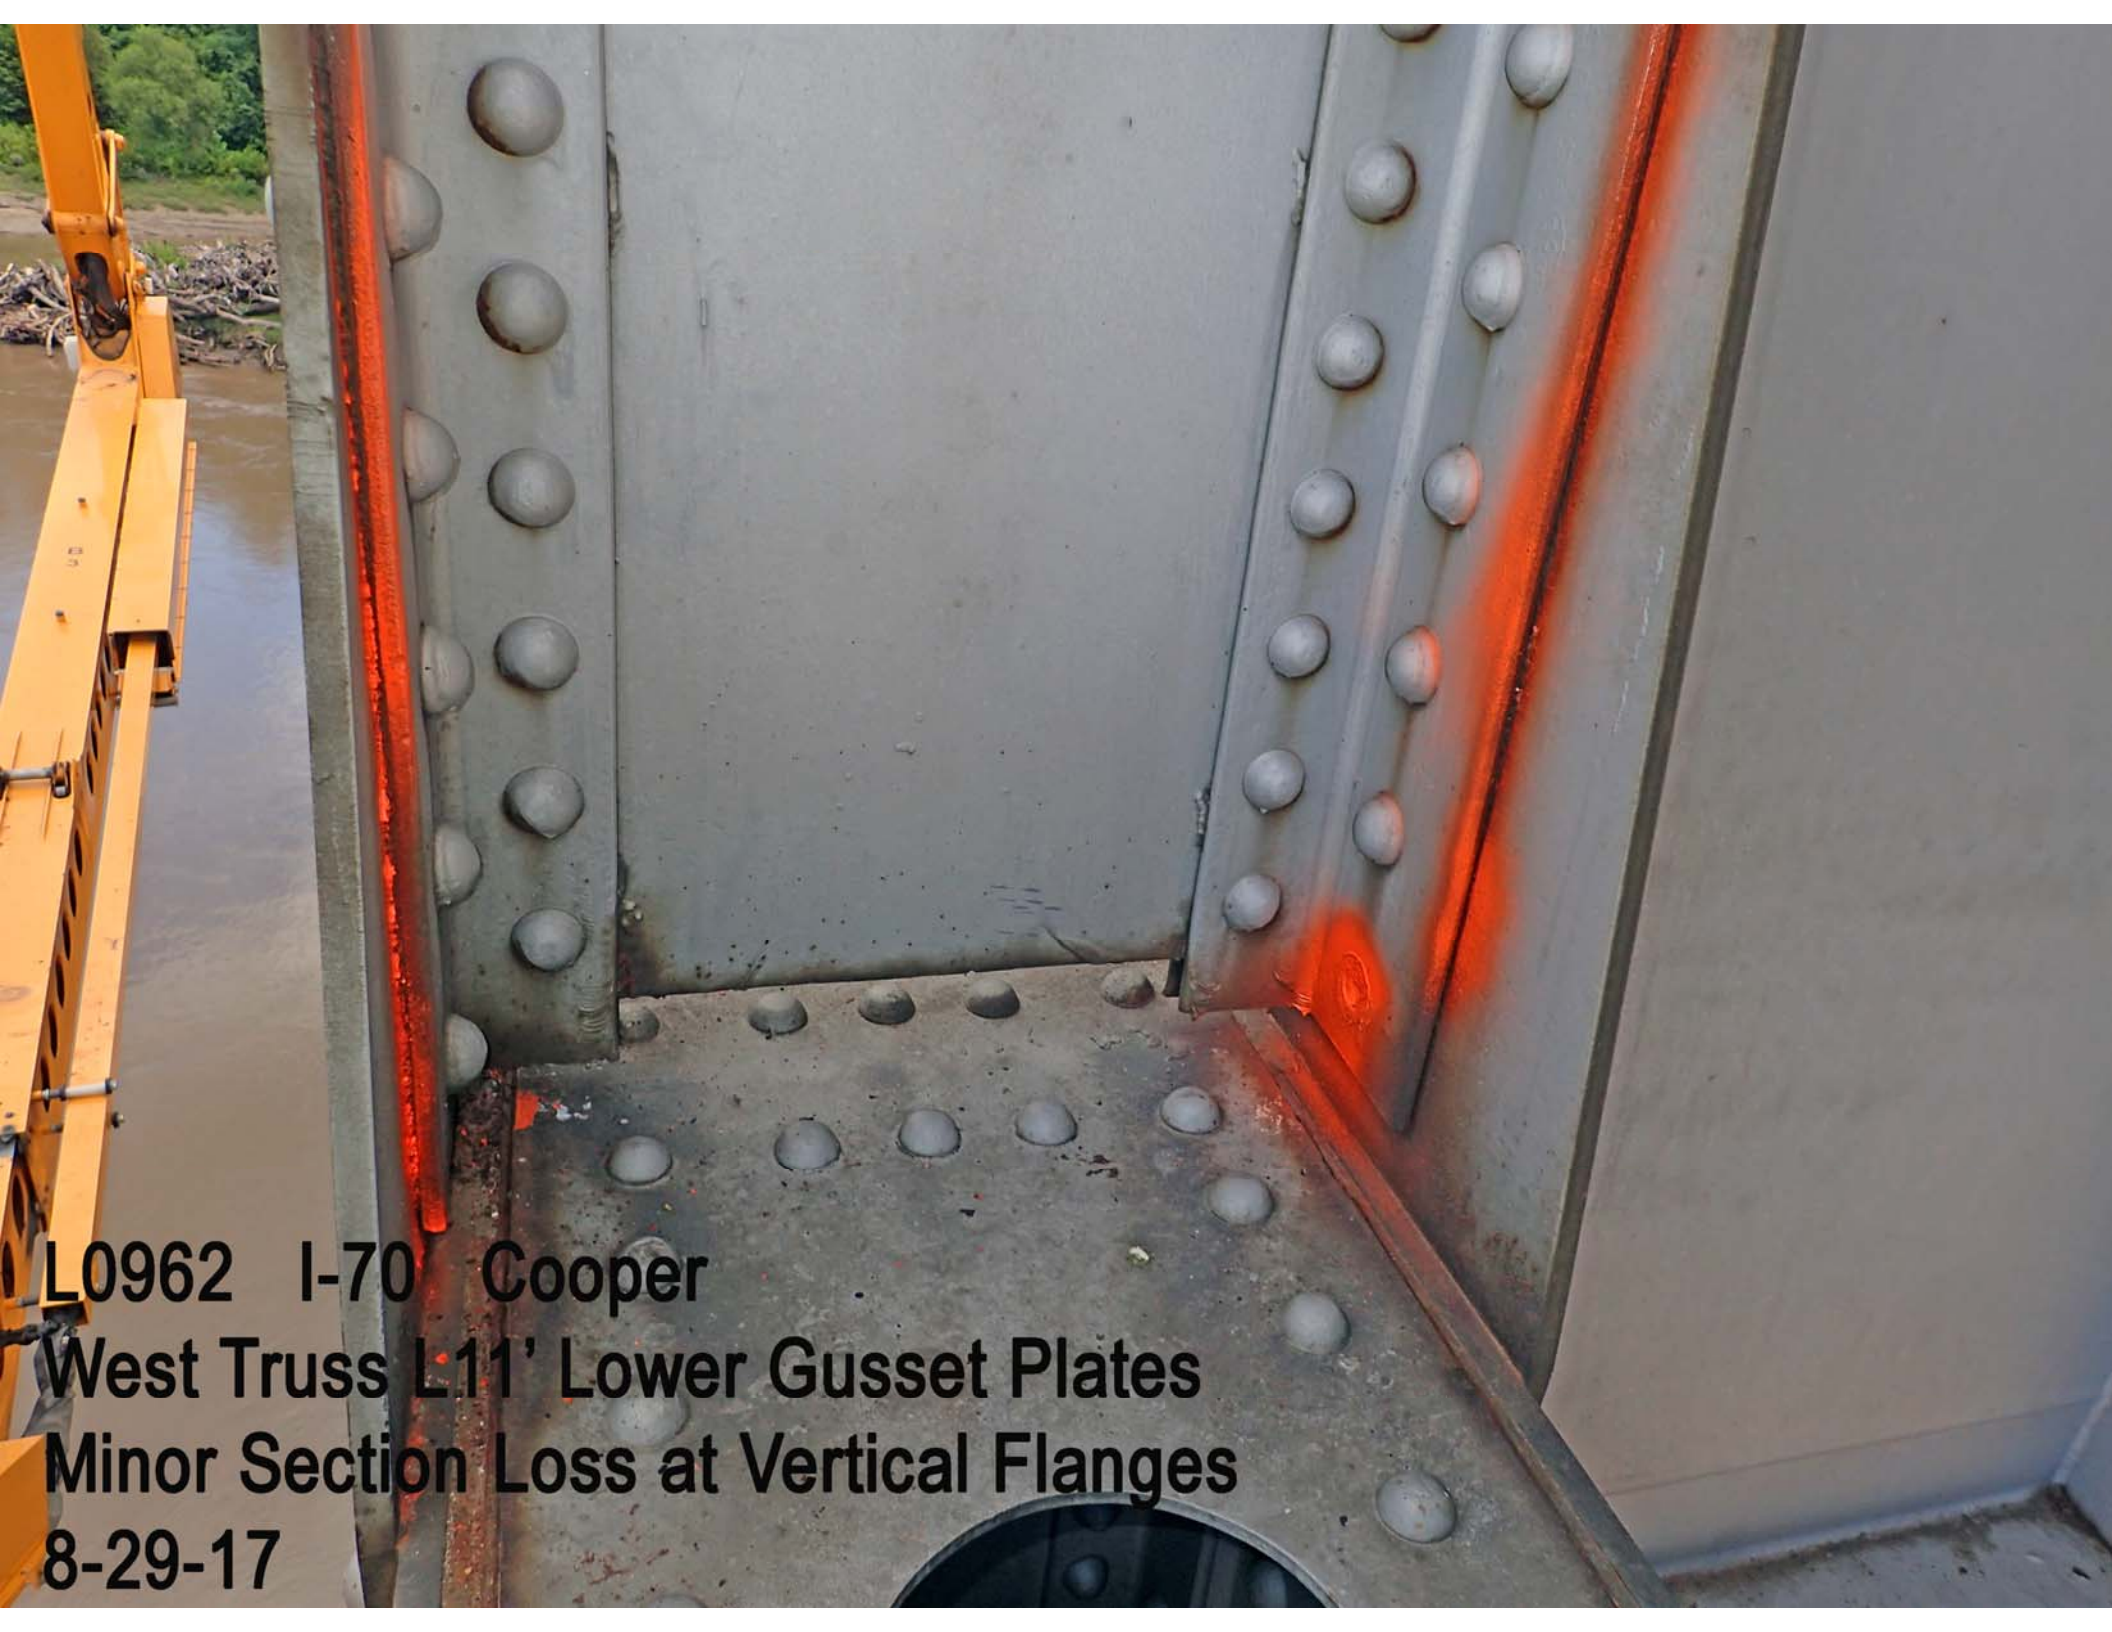
L0962 I-70 Cooper
West Truss L11' Lower Gusset Plates
Minor Section Loss at Vertical Flanges
8-29-17

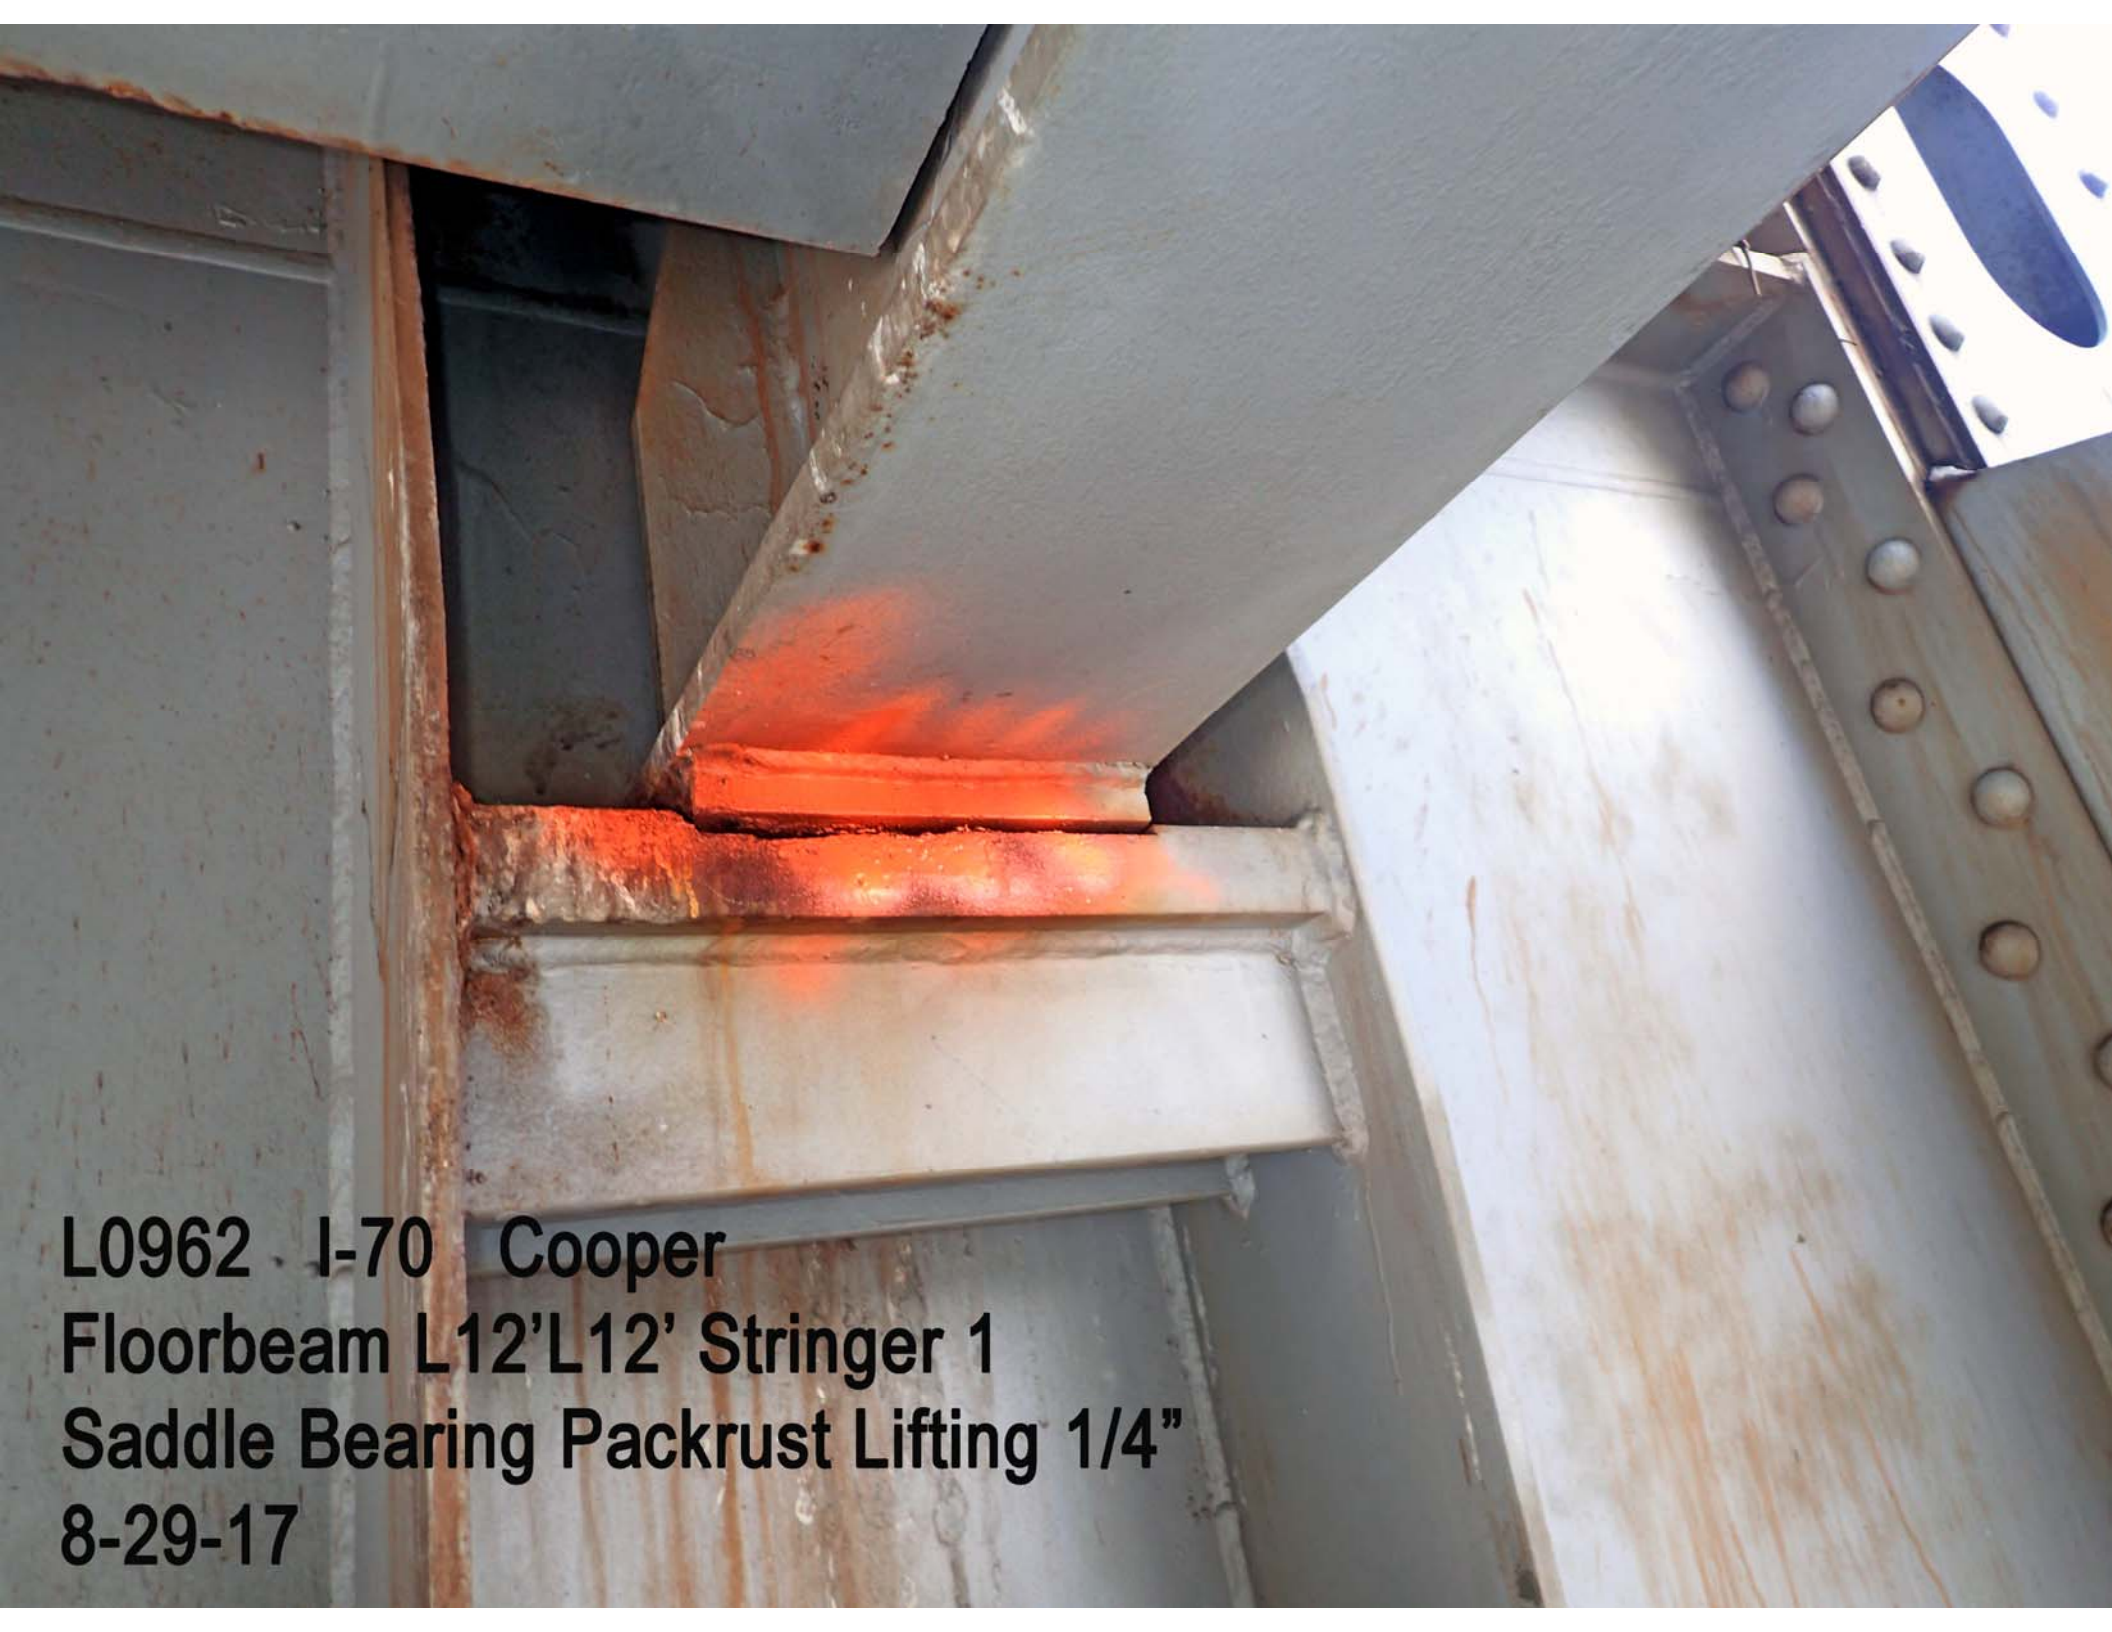
L0962 I-70 Cooper
Floorbeam L12'L12' Stringer 1
Saddle Bearing Packrust Lifting 1/4"
8-29-17

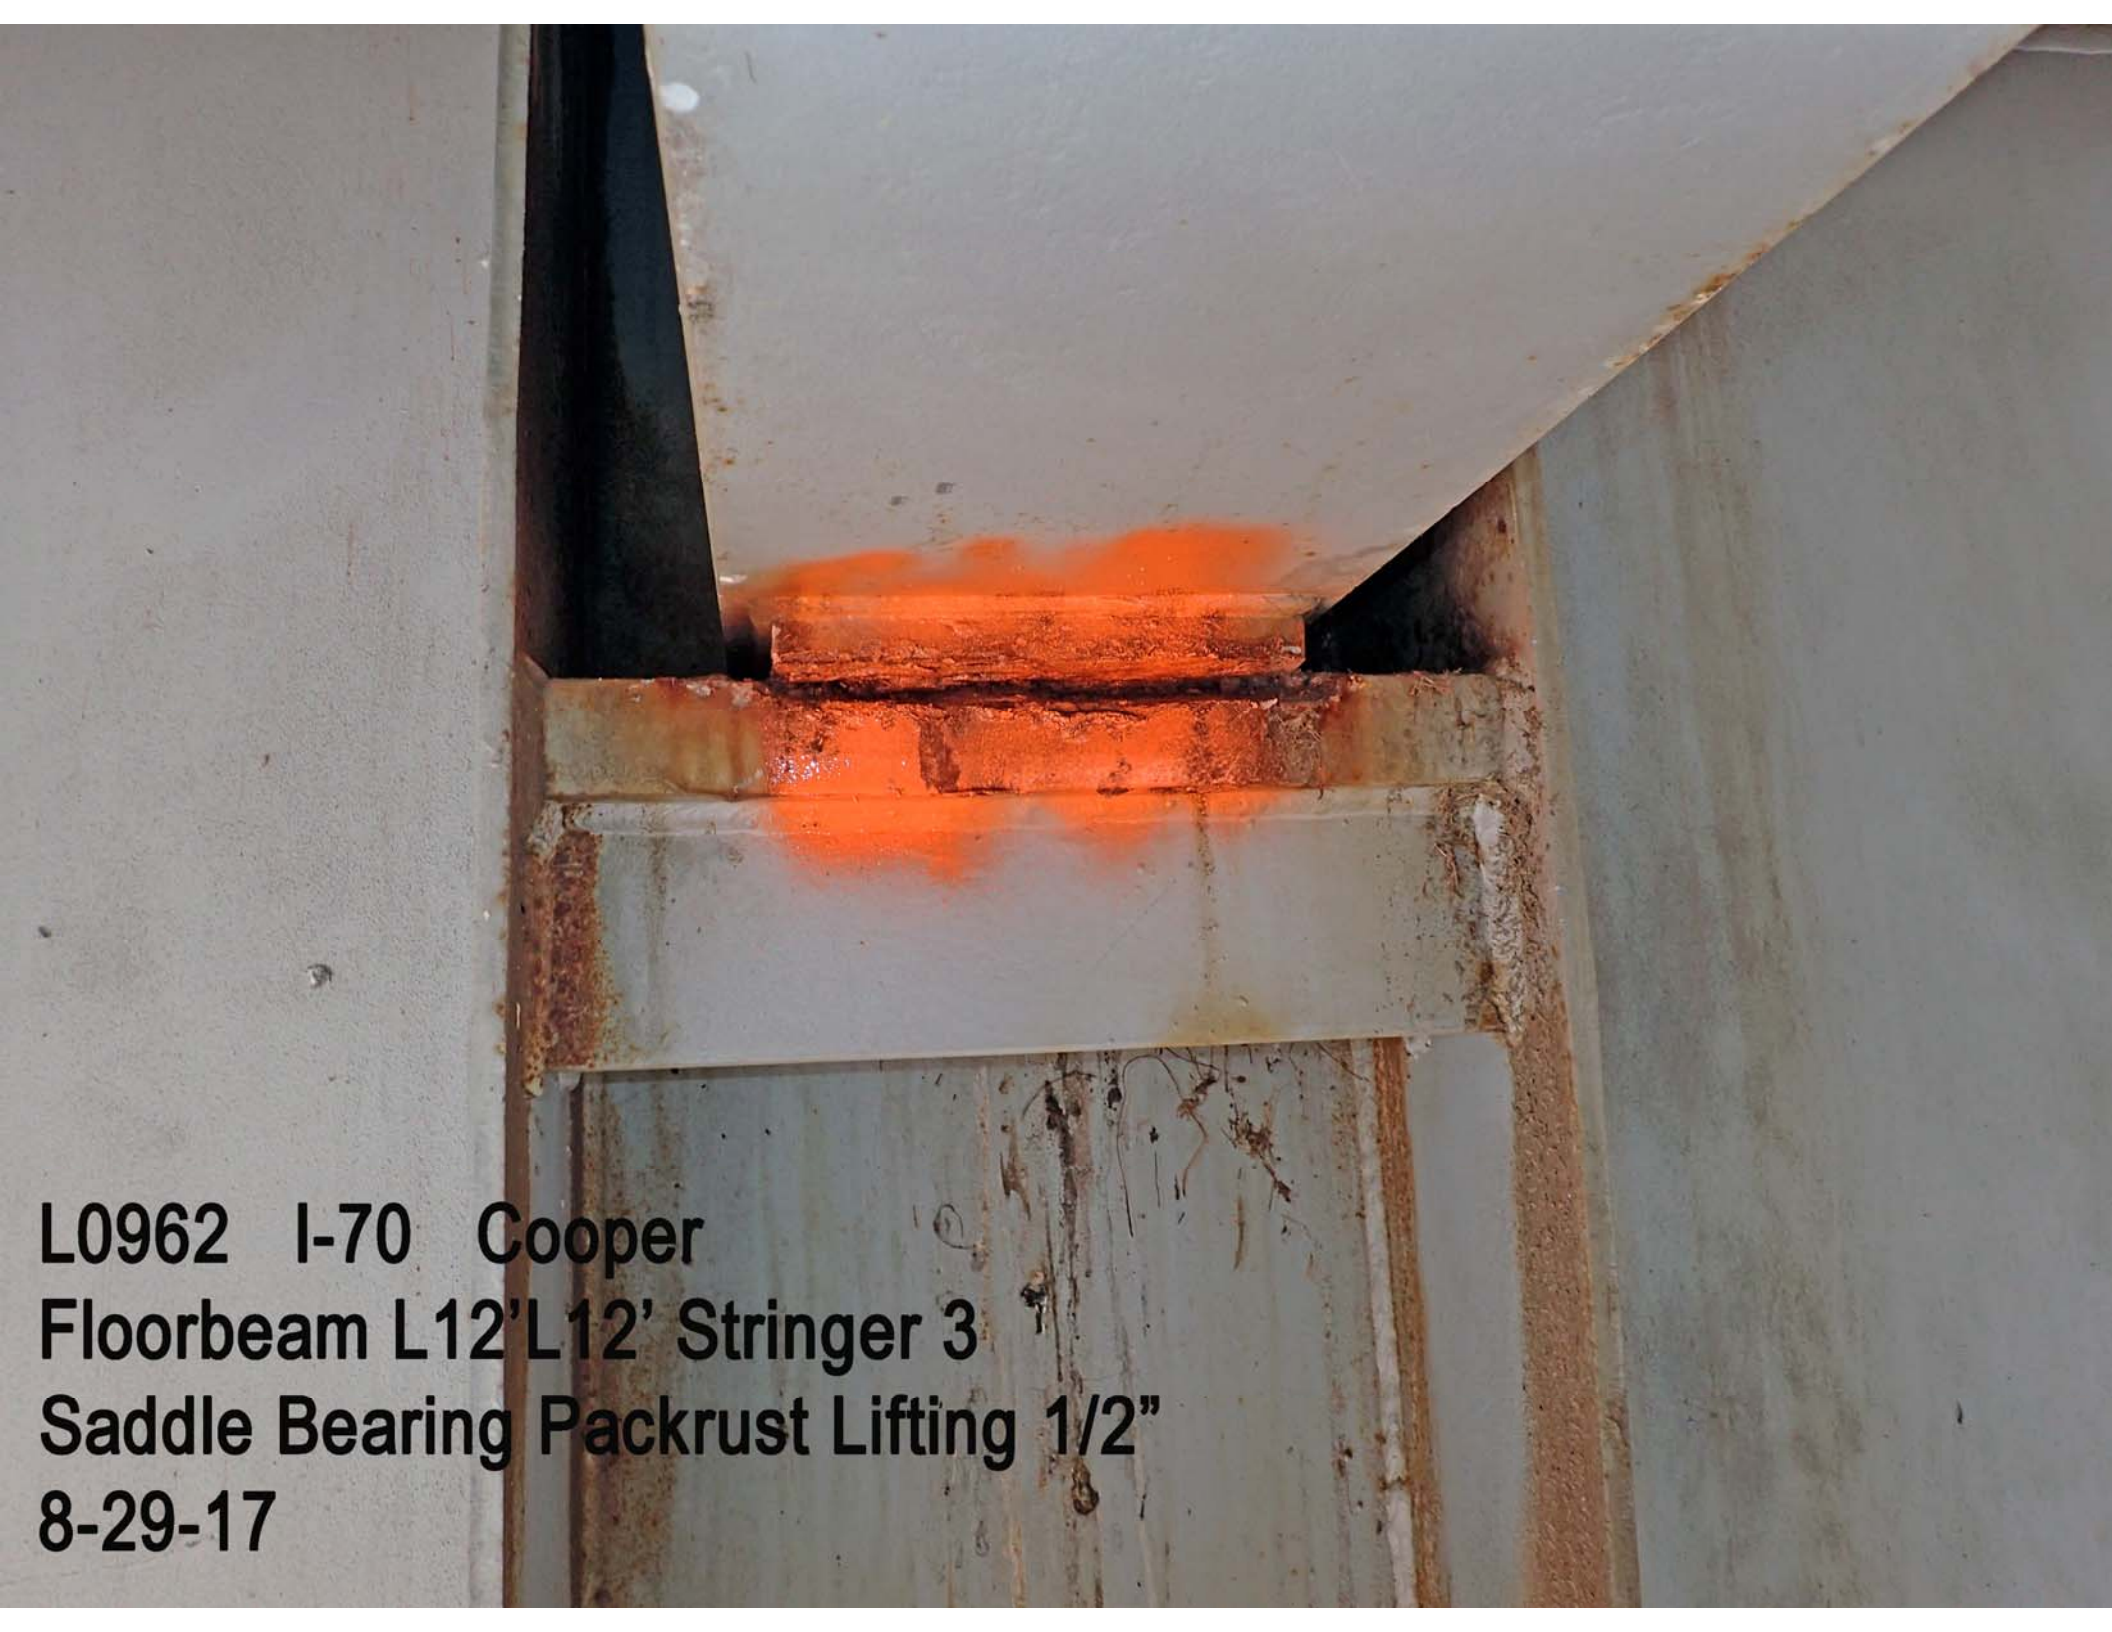
L0962 I-70 Cooper
Floorbeam L12'L12' Stringer 3
Saddle Bearing Packrust Lifting 1/2"
8-29-17

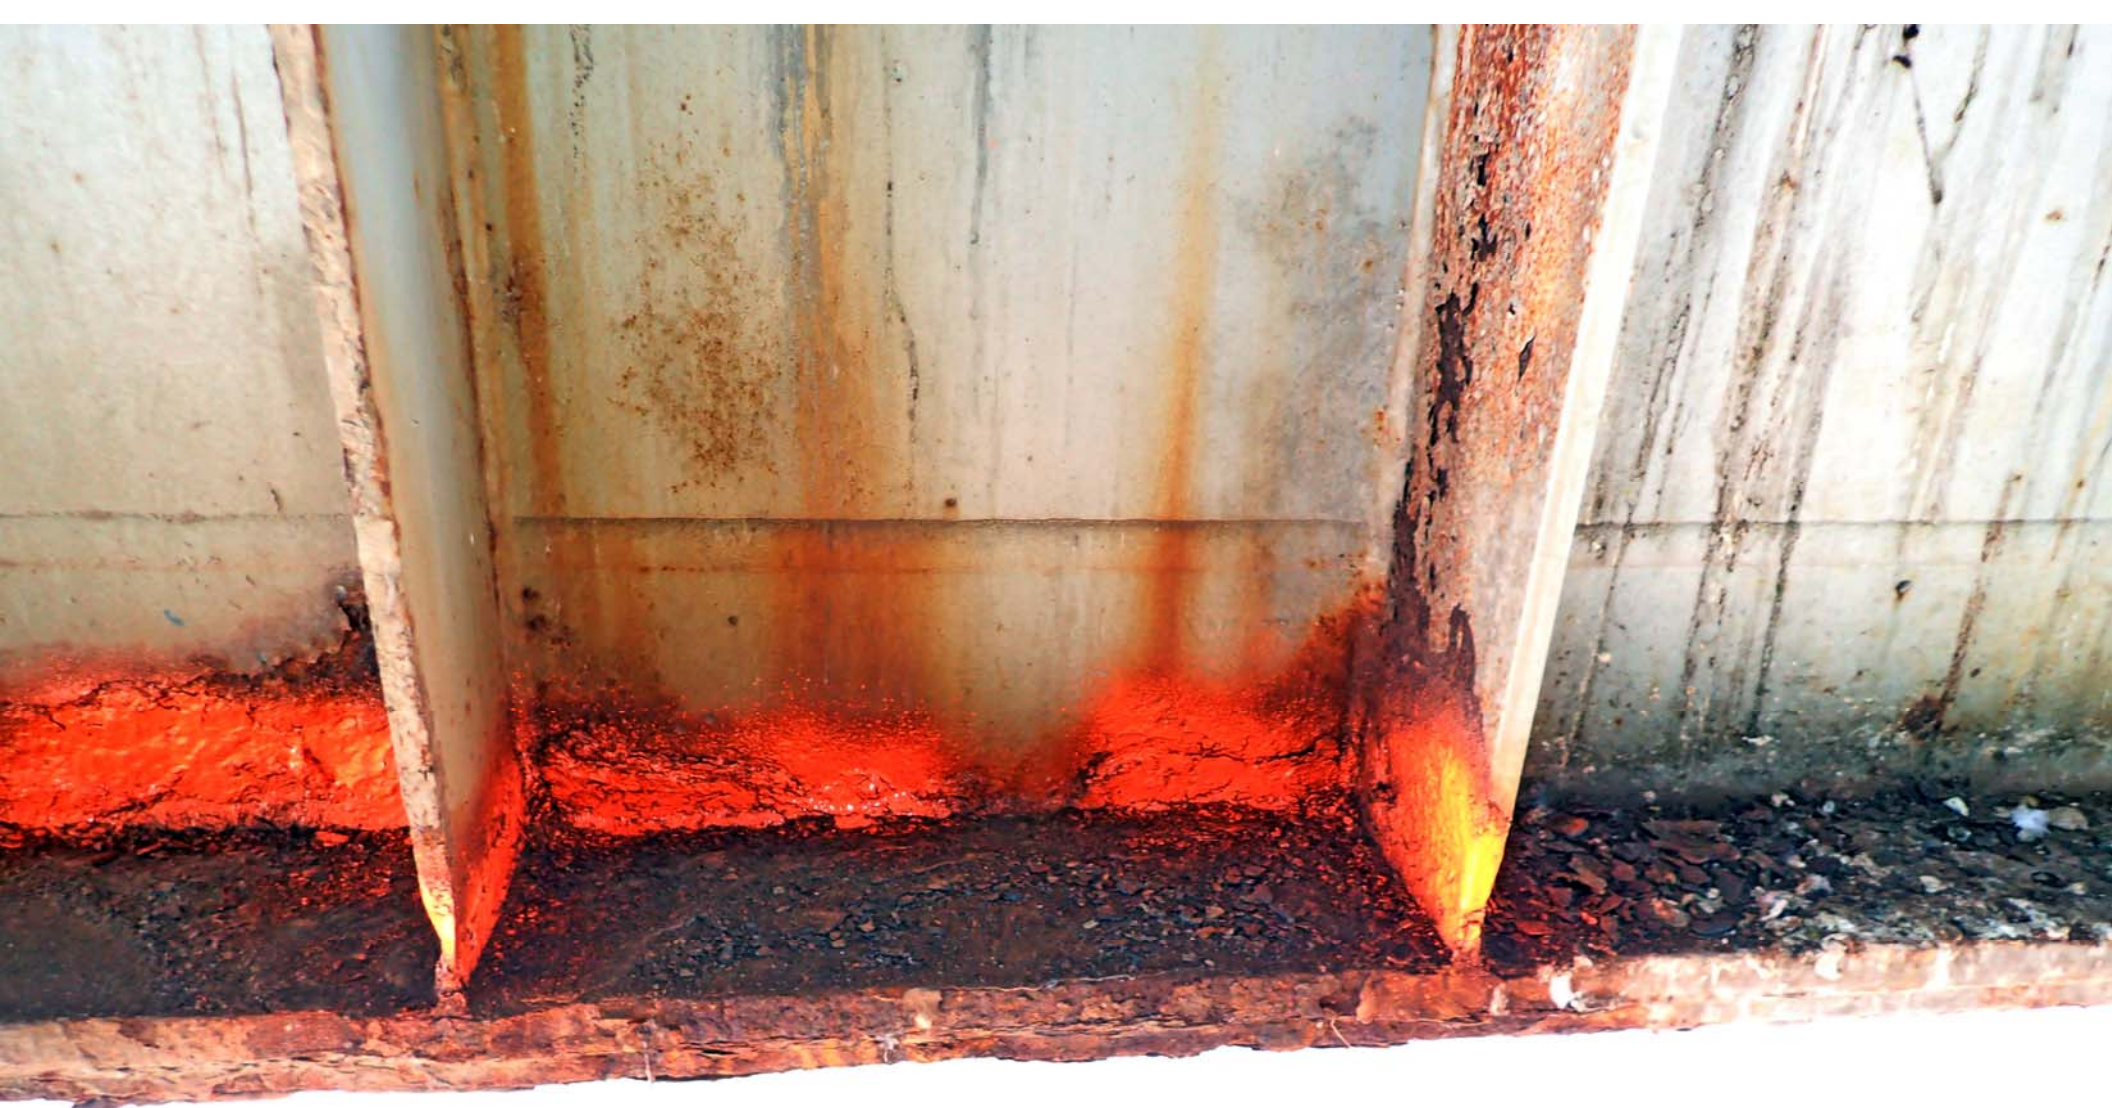
**L0962 I-70 Cooper
Floorbeam L12'L12' North Web Stiffener
Between Stringers 4 & 5 Minor Section Loss
8-29-17**
