L0962 Cooper Co.
08/28/2017
Looking West

L0962 I-70 Cooper
Pier 15 Open Expansion Joint WBL
8-28-17

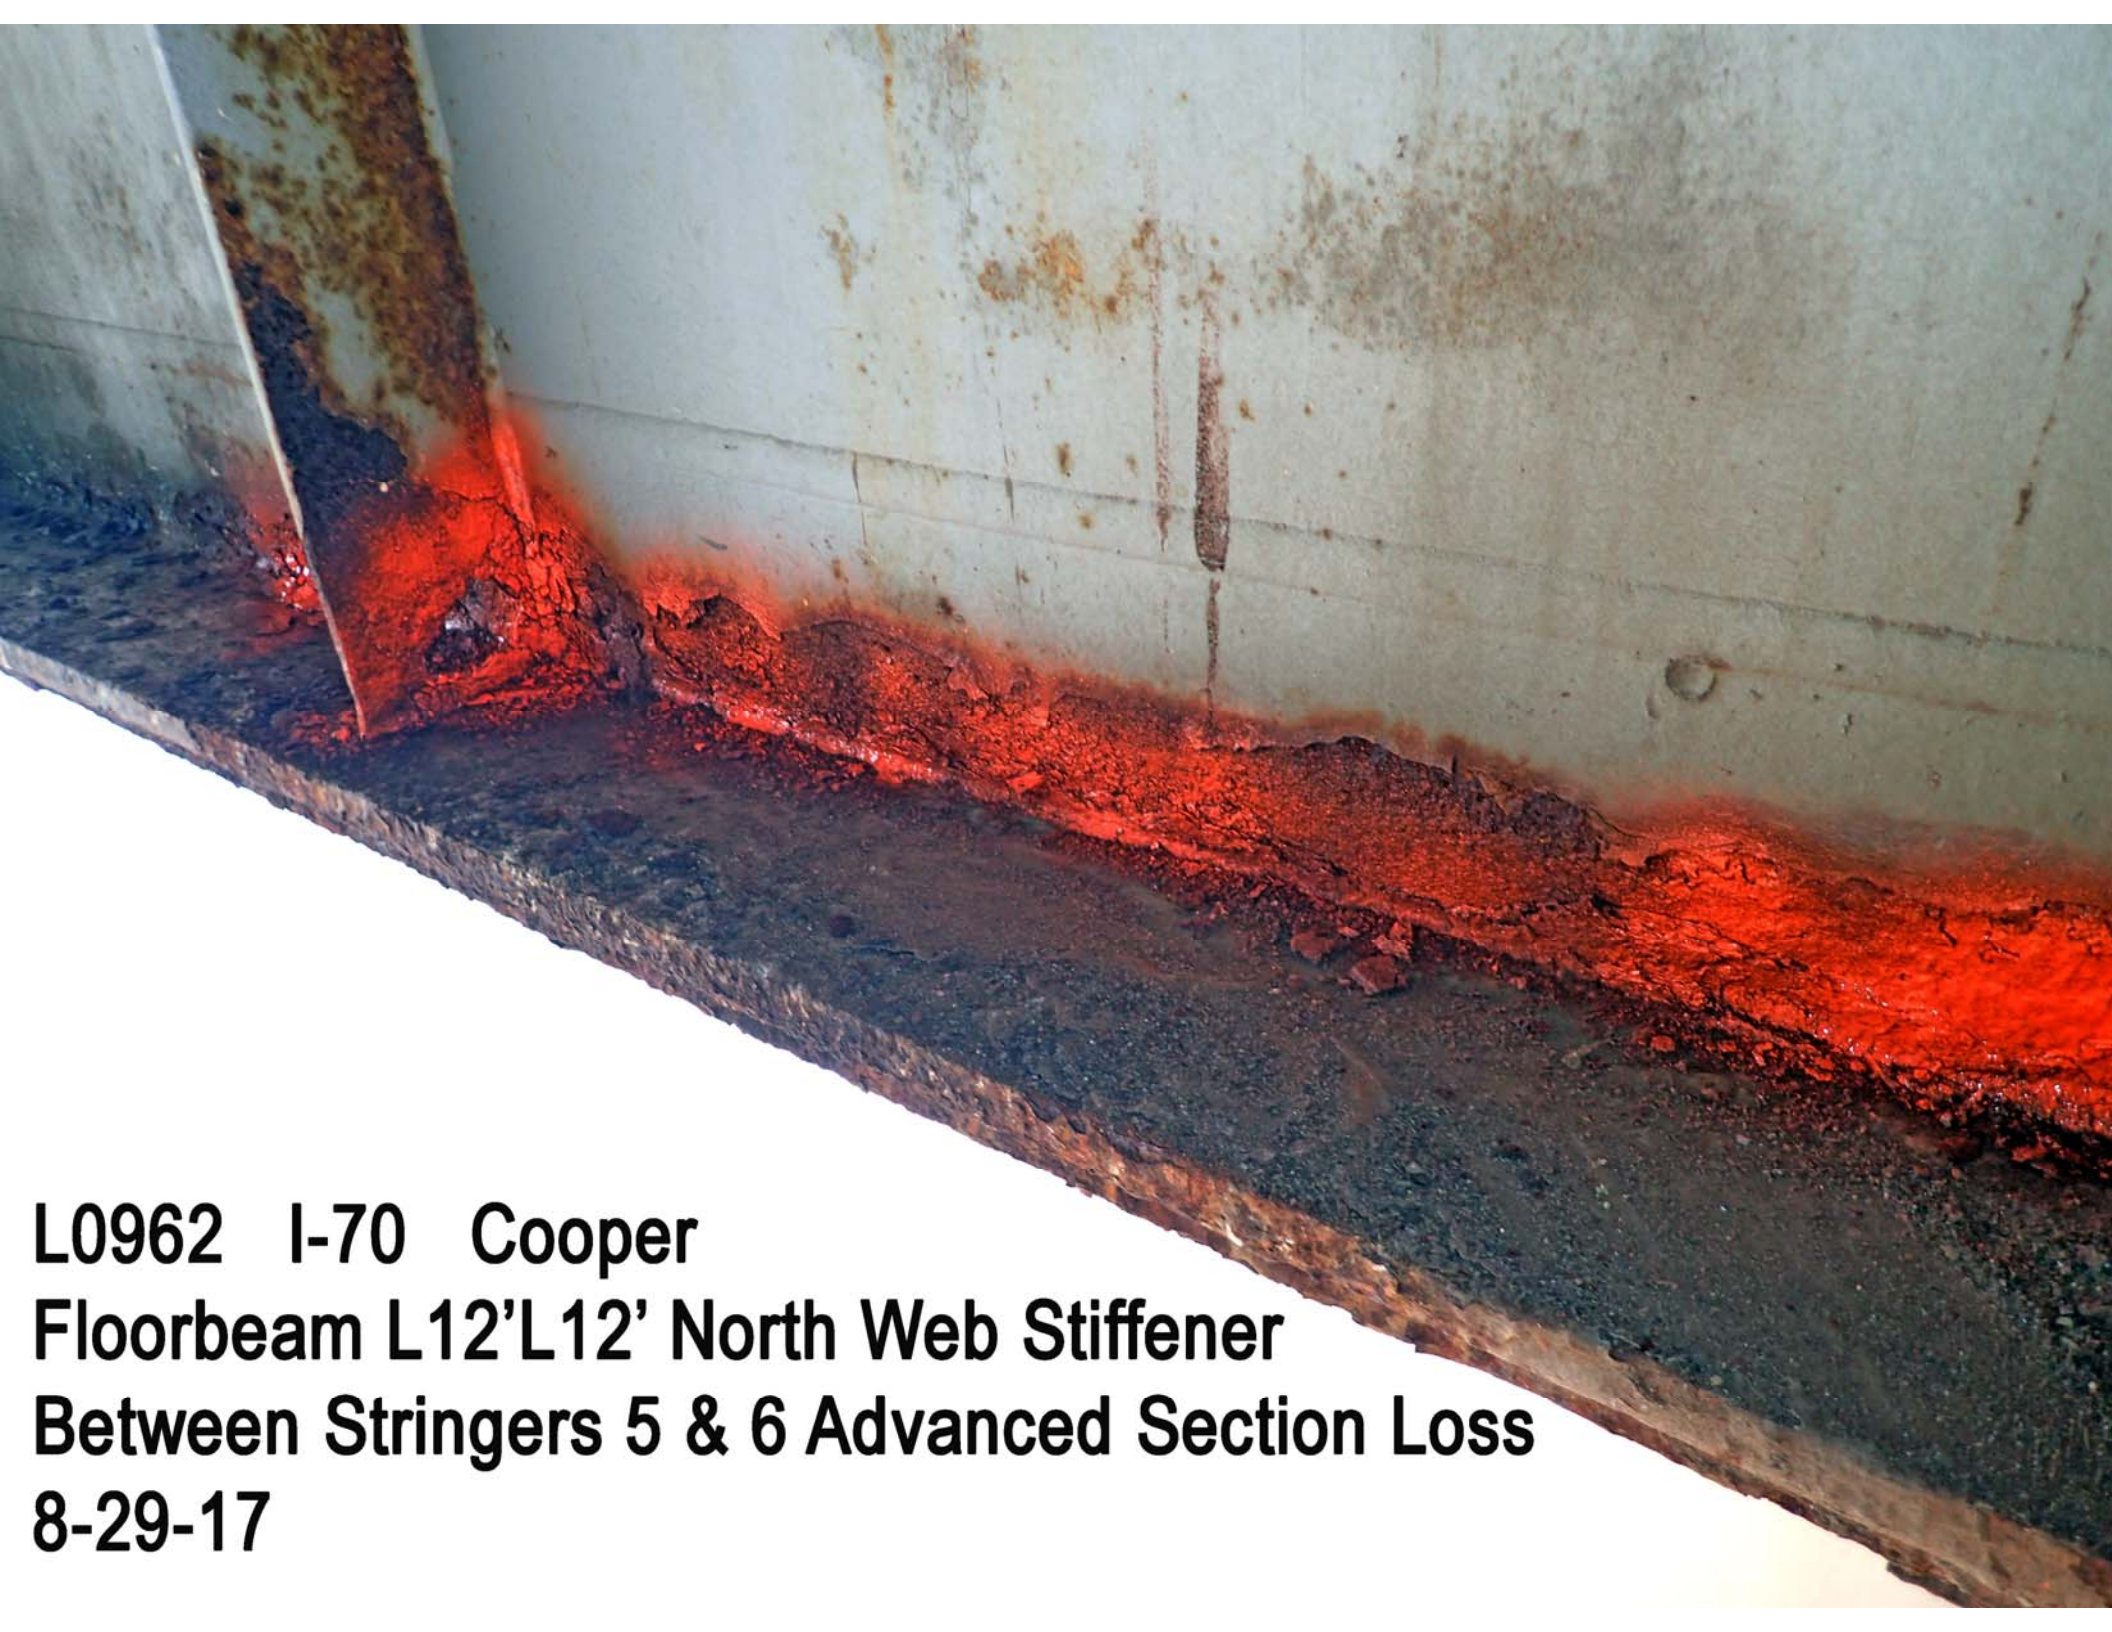
**L0962 I-70 Cooper
Floorbeam L12'L12' Stringer 5
Saddle Bearing Support Moderate Section Loss
8-29-17**

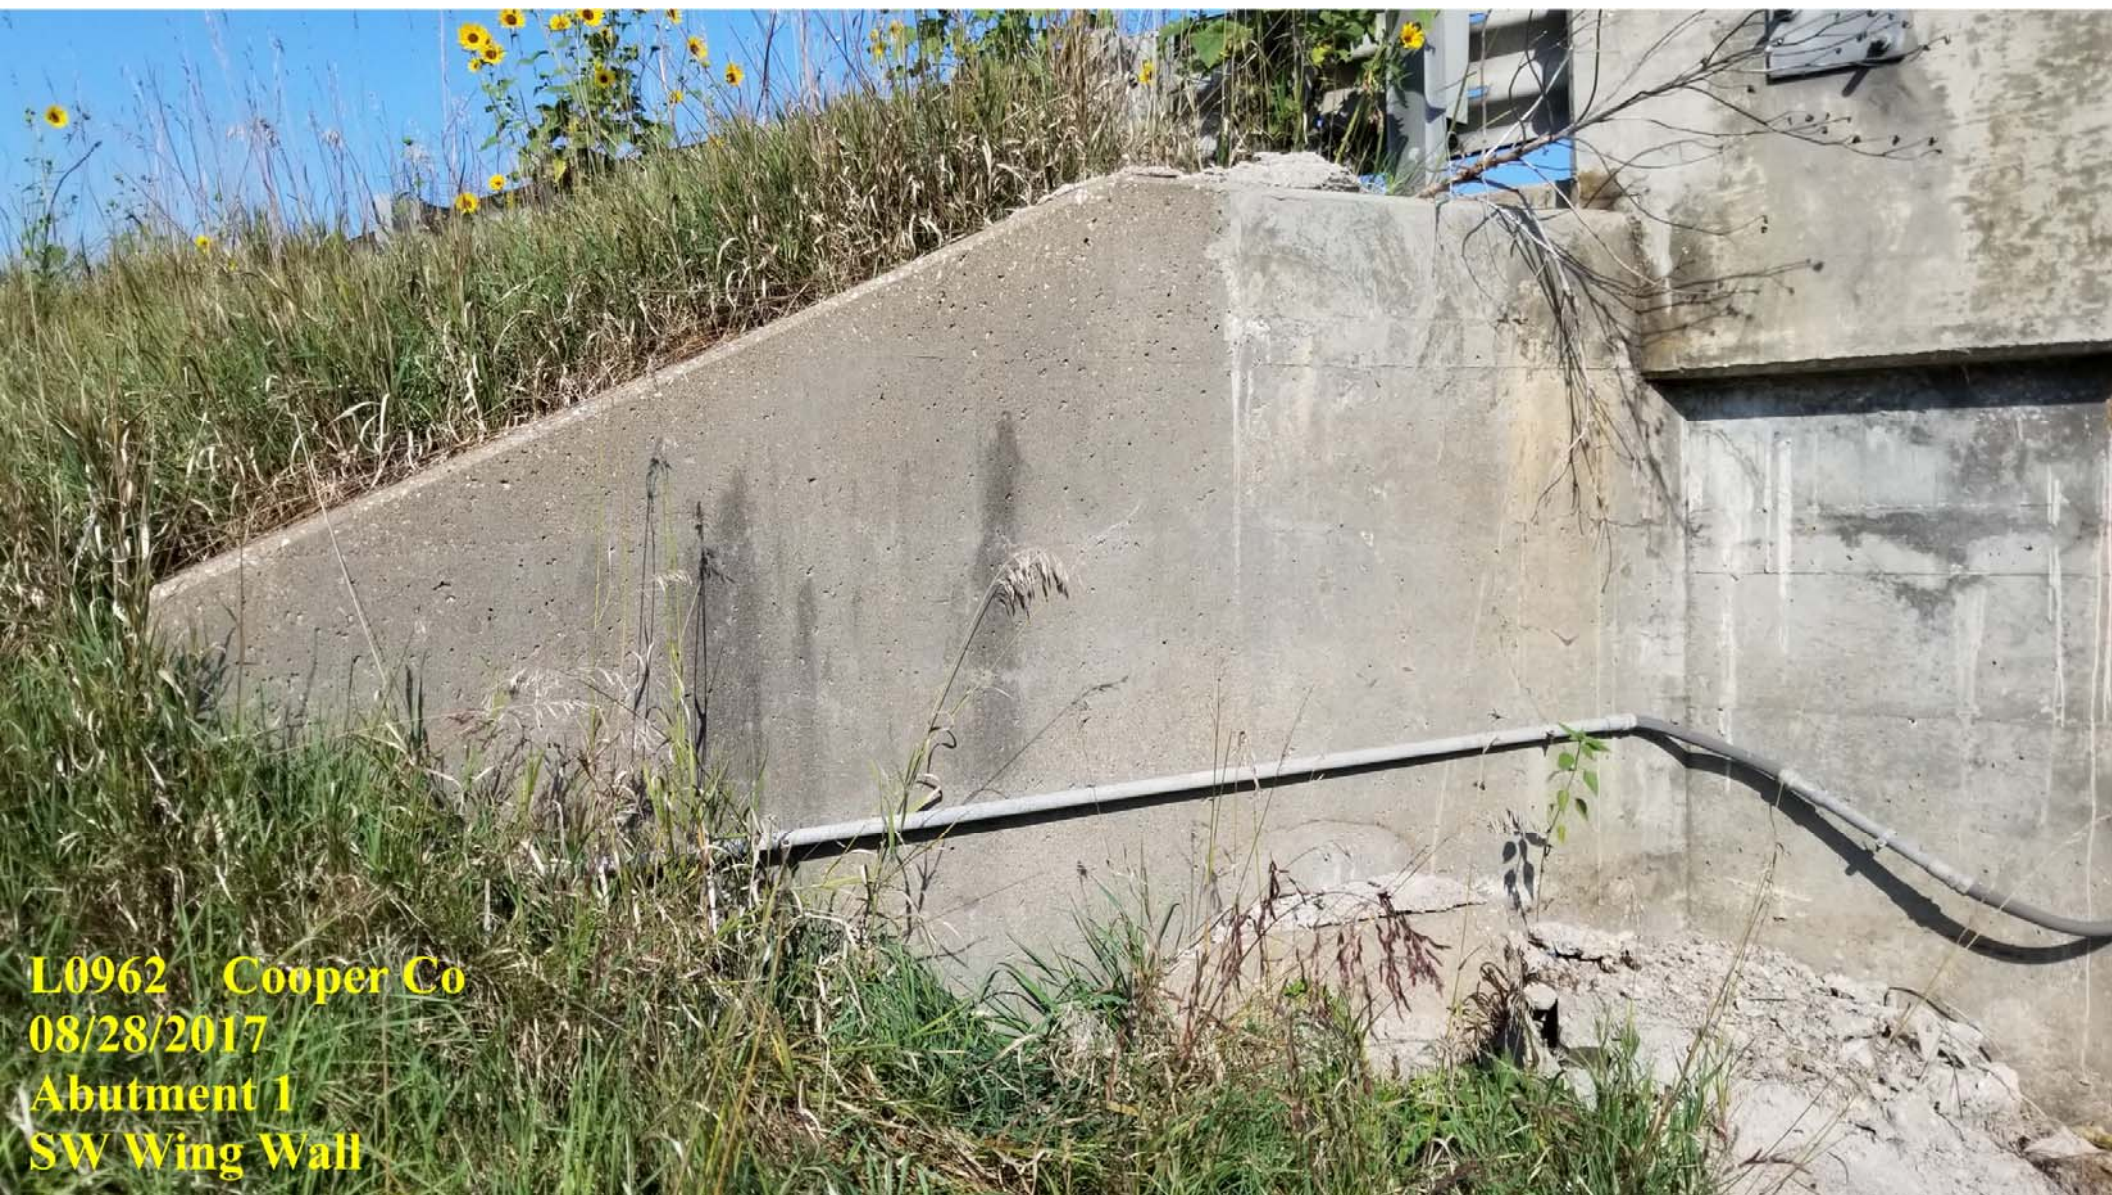
L0962 Cooper Co
08/28/2017
Abutment 1
SW Wing Wall

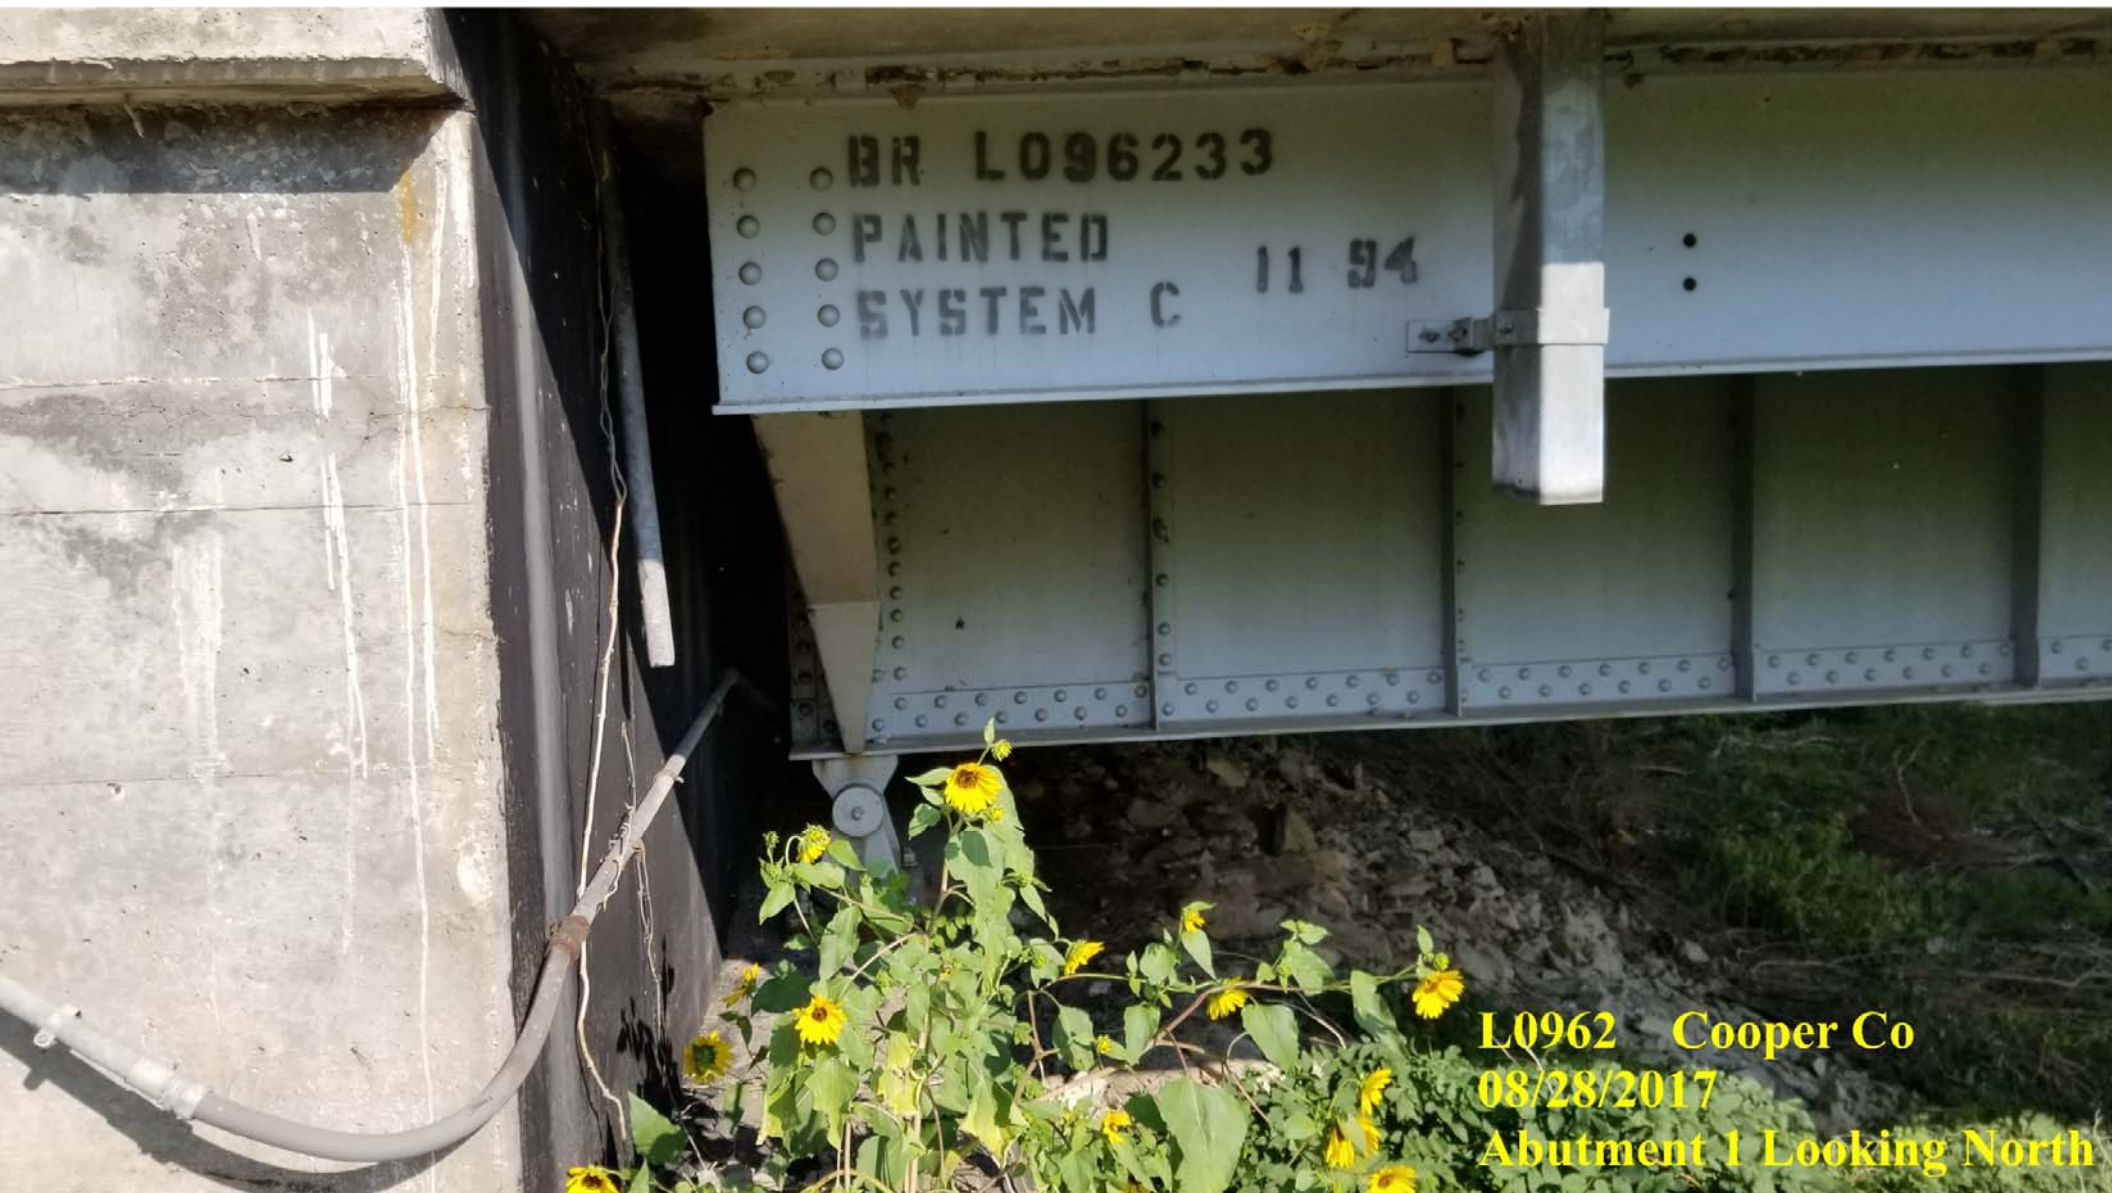
L0962 Cooper Co
08/28/2017
Abutment 1 Looking North

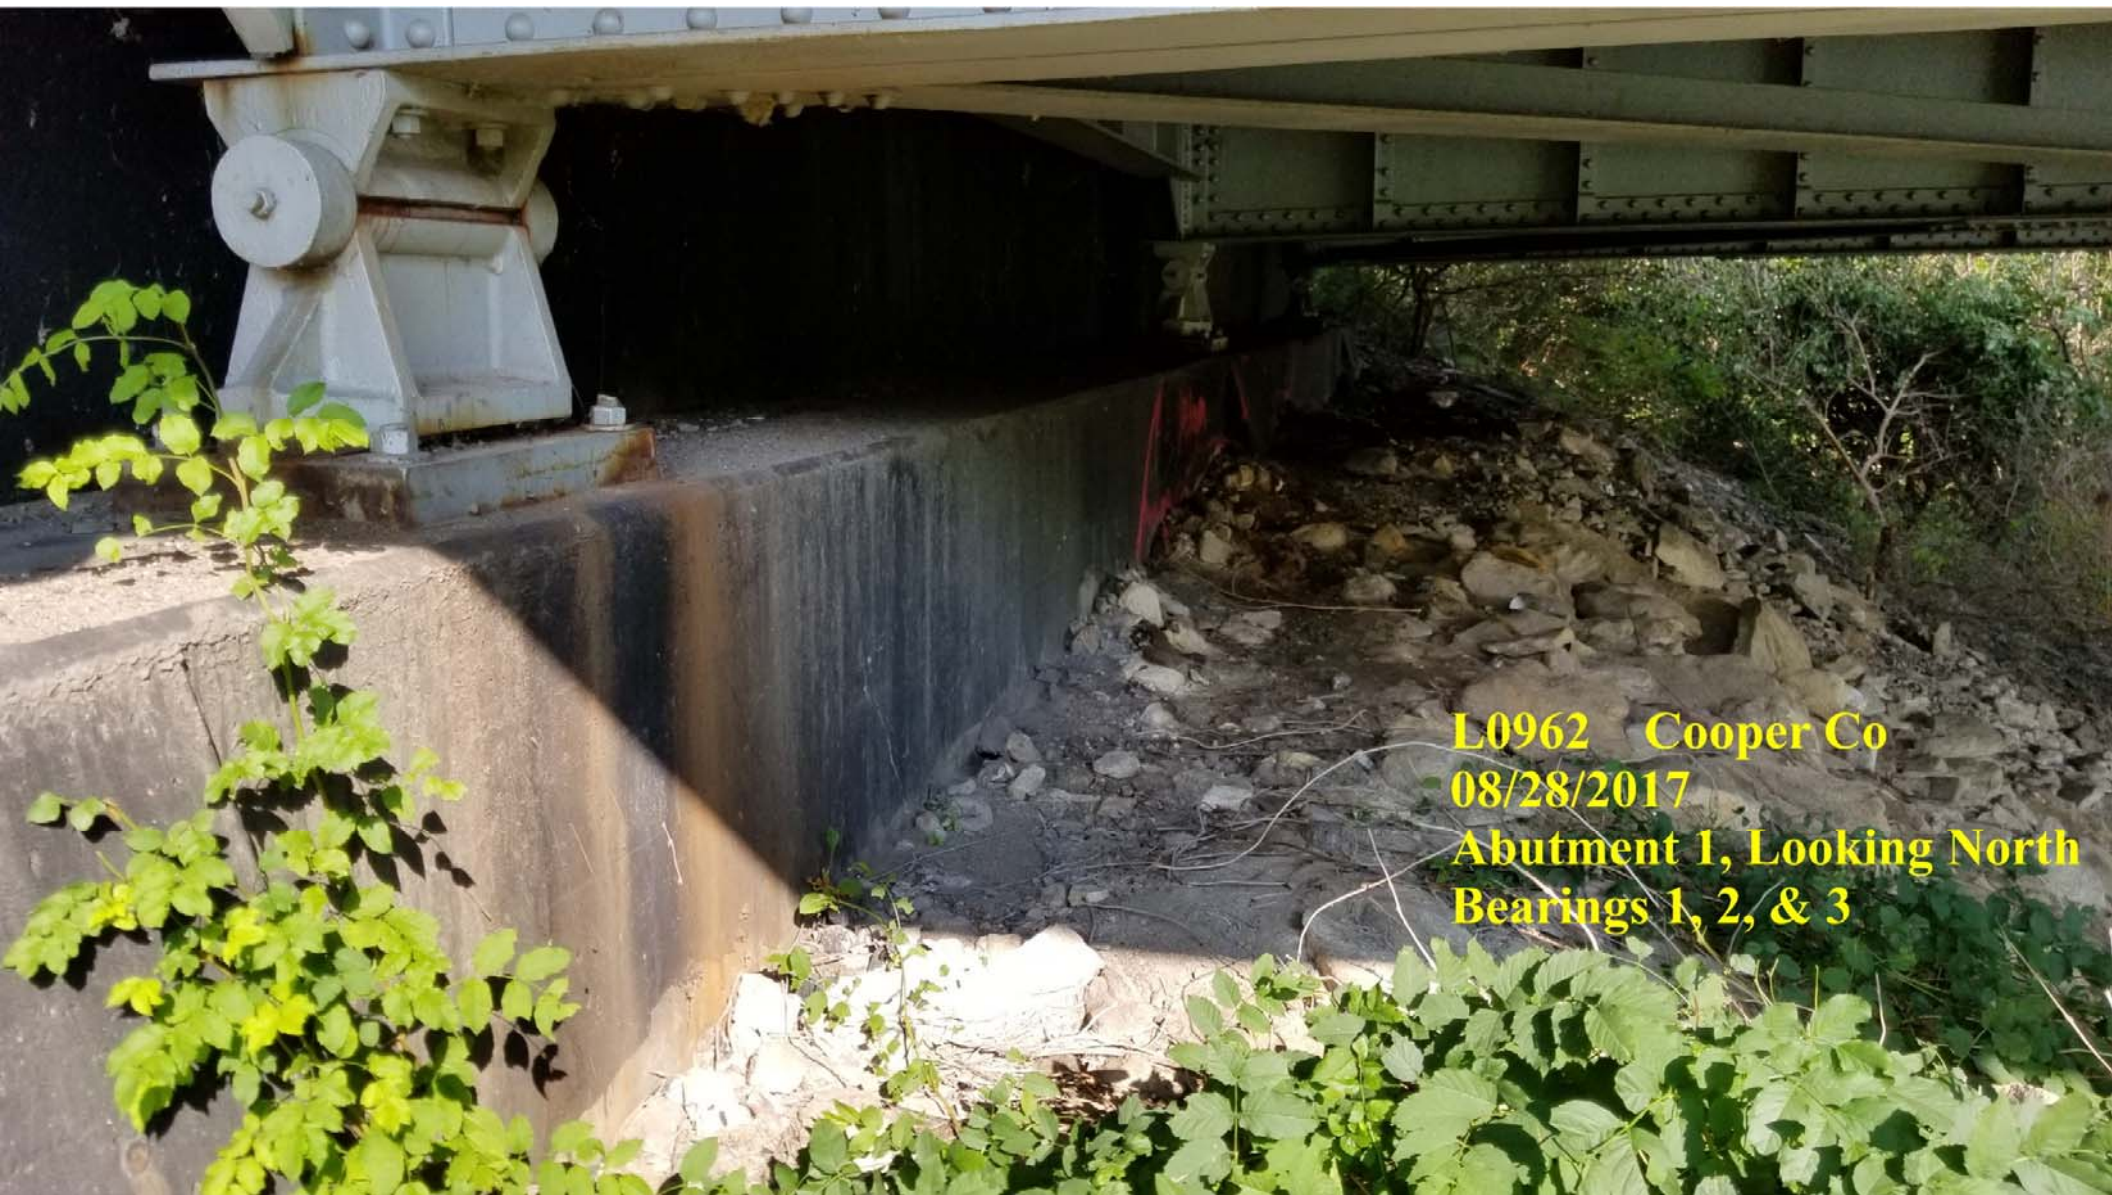
L0962 Cooper Co
08/28/2017
Abutment 1, Looking North
Bearings 1, 2, & 3

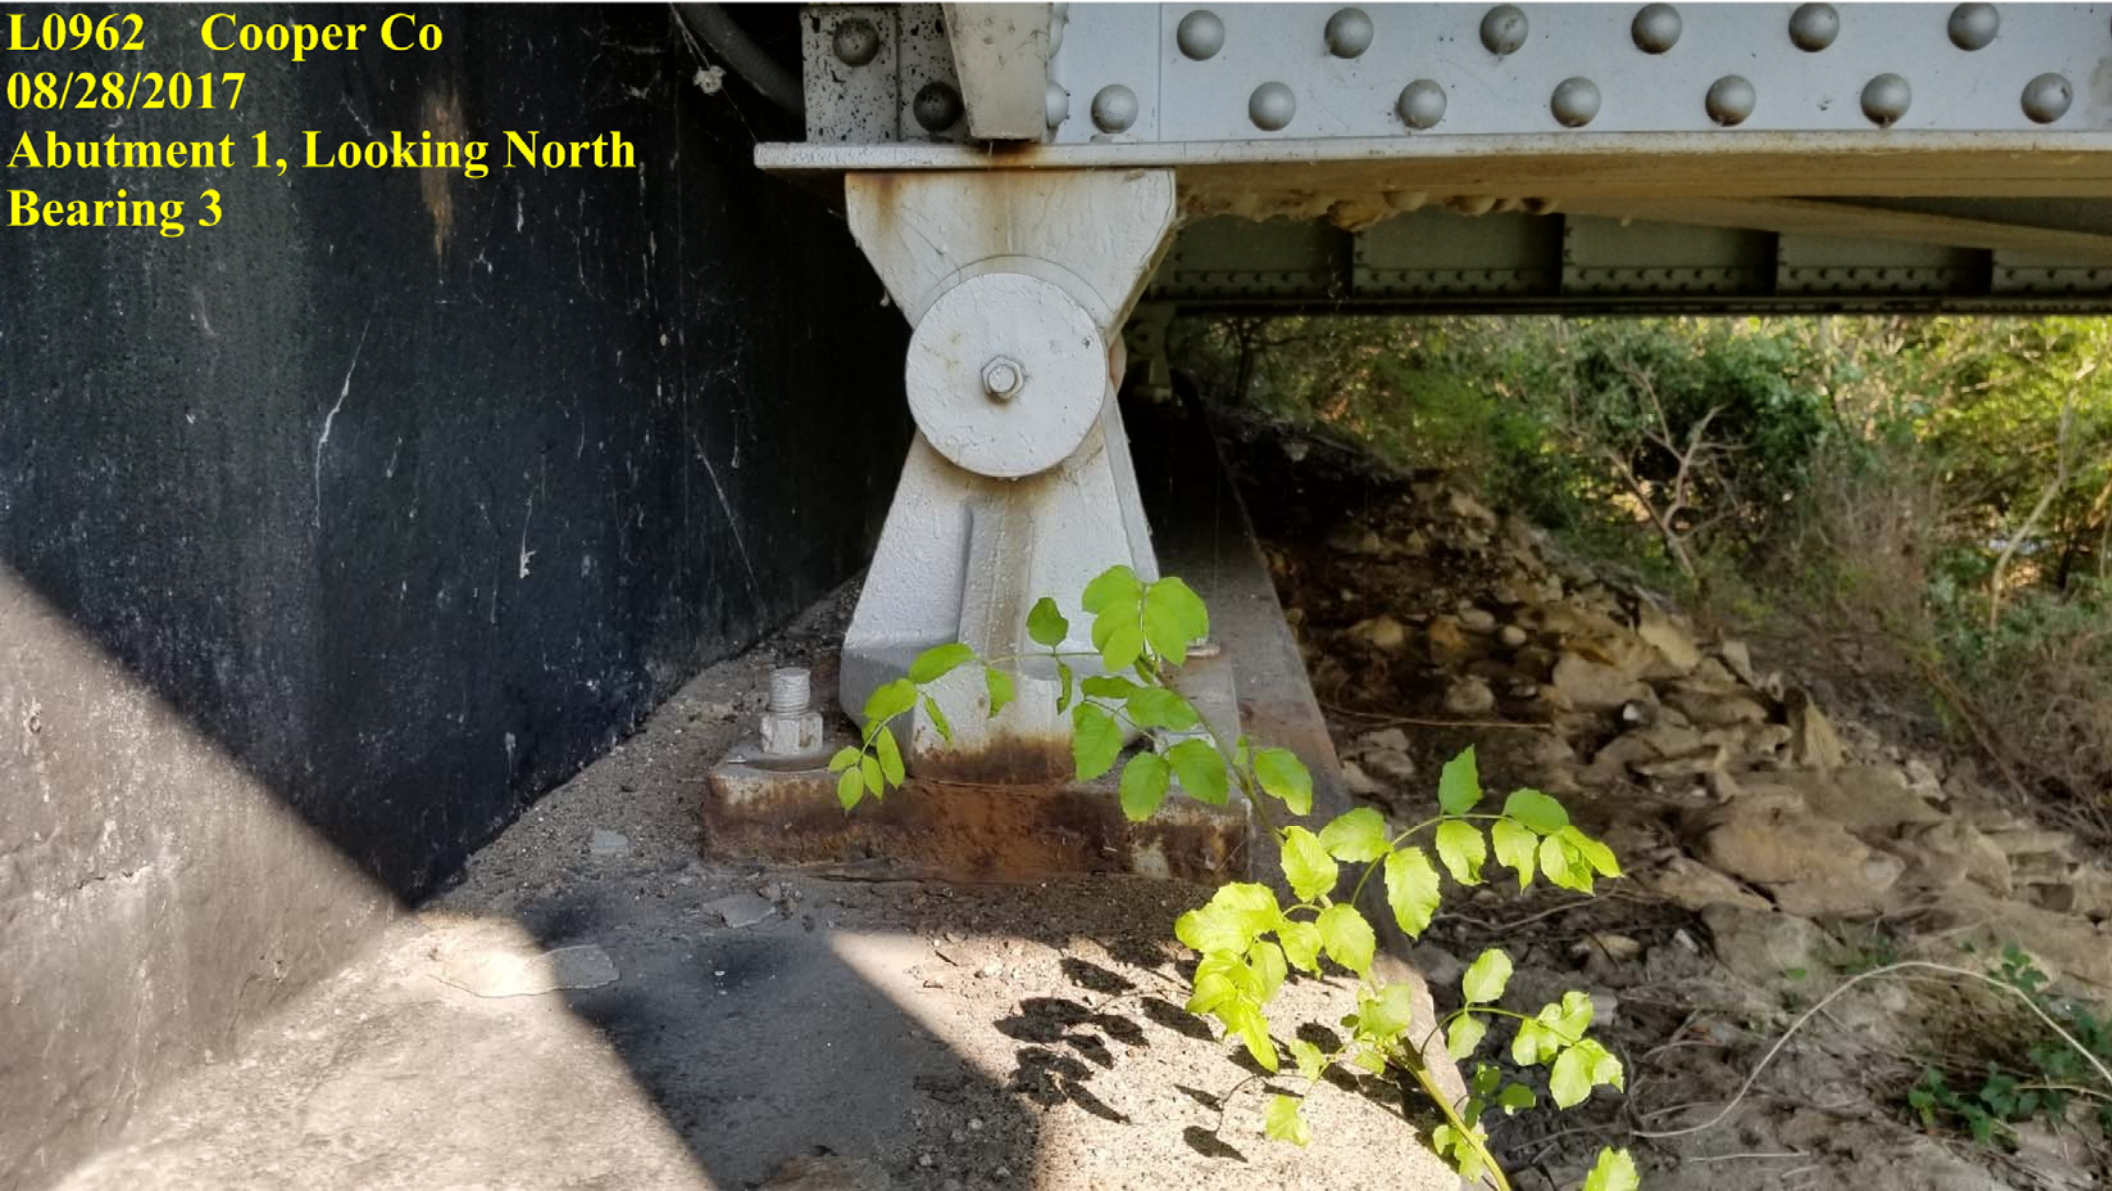
L0962 Cooper Co
08/28/2017
Abutment 1, Looking North
Bearing 3

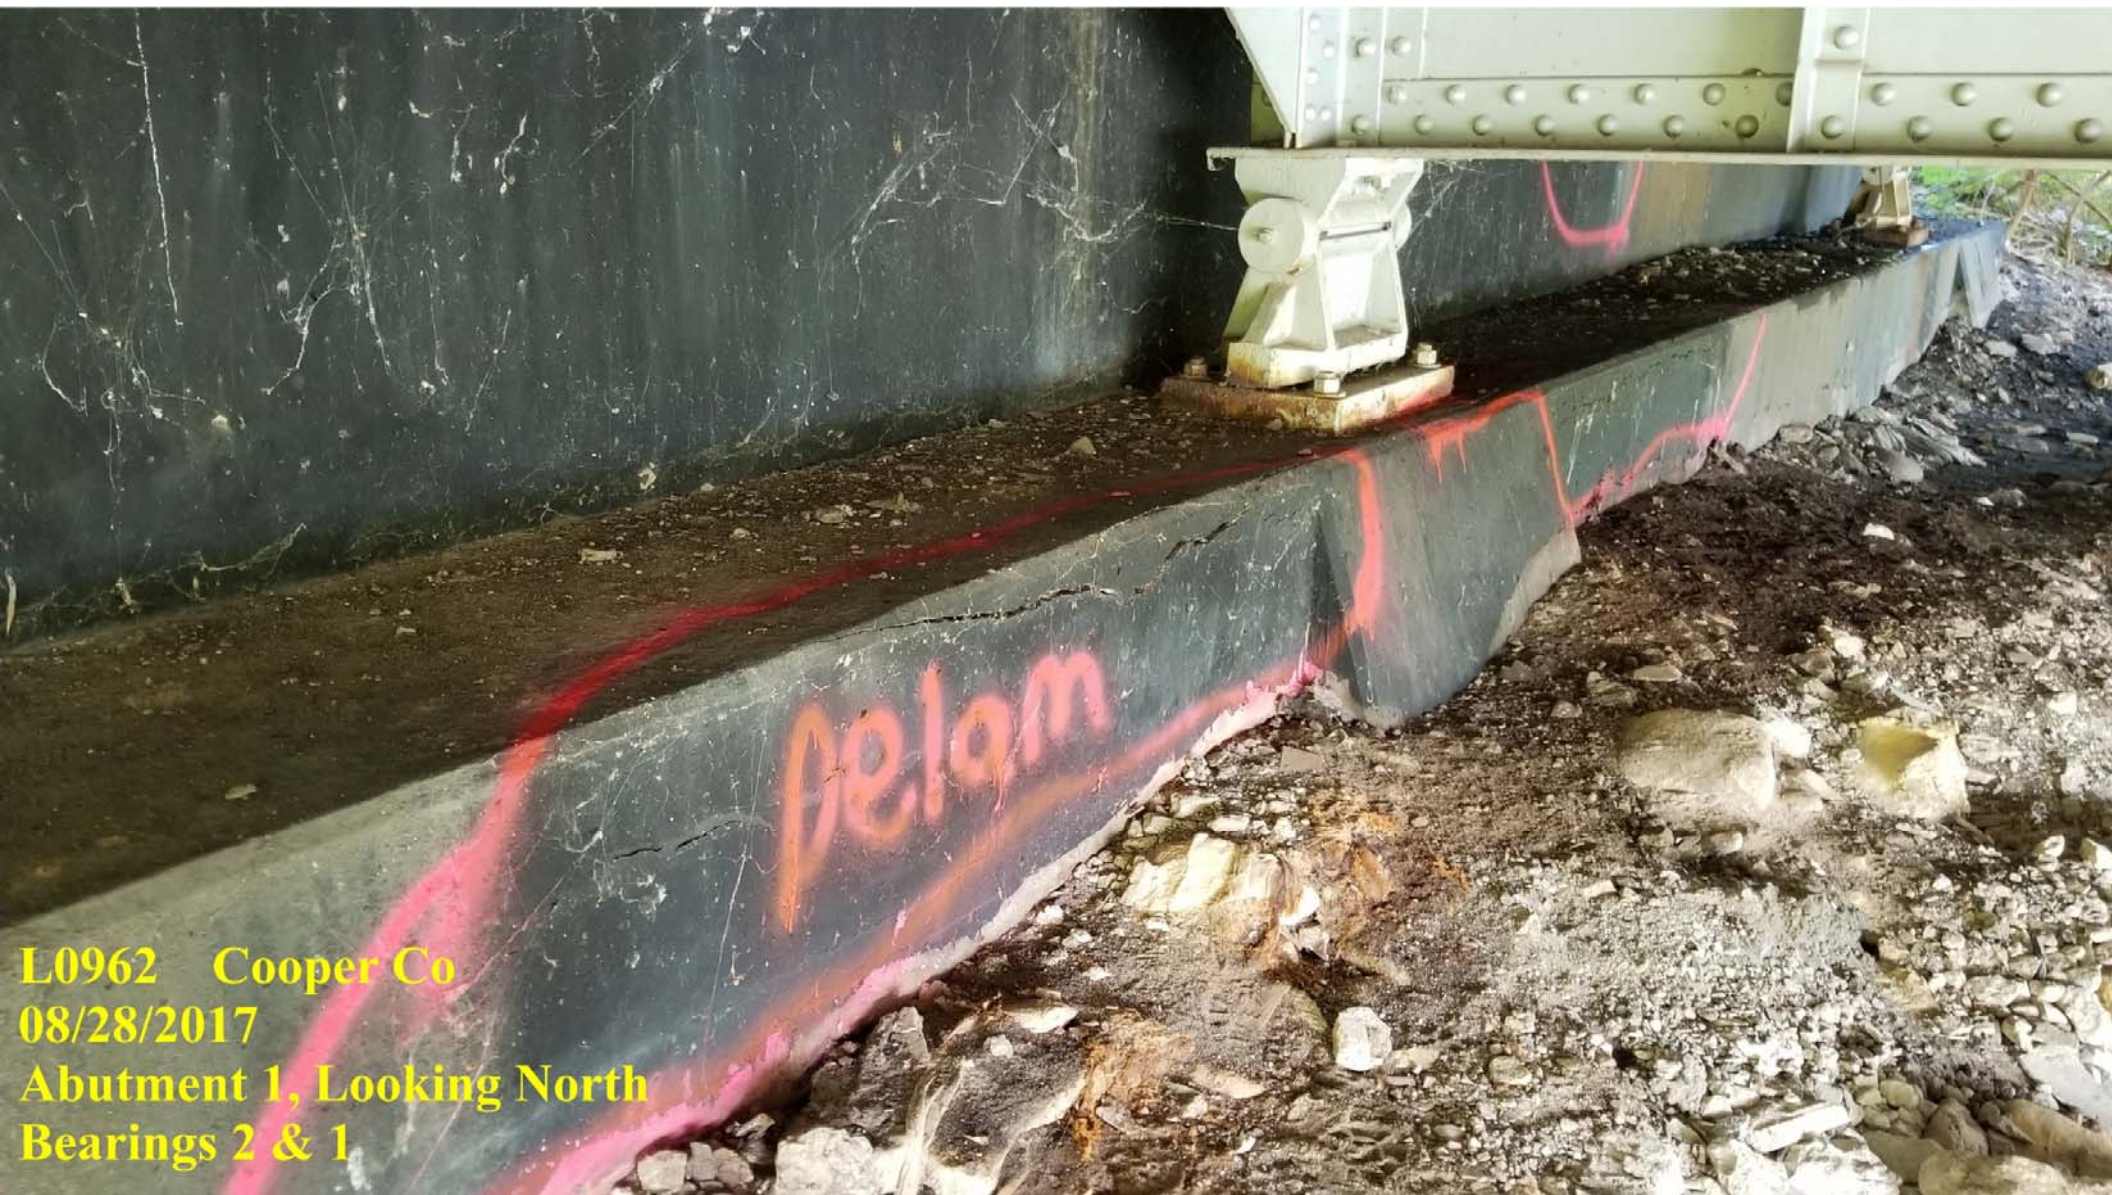
L0962 Cooper Co
08/28/2017
Abutment 1, Looking North
Bearings 2 & 1

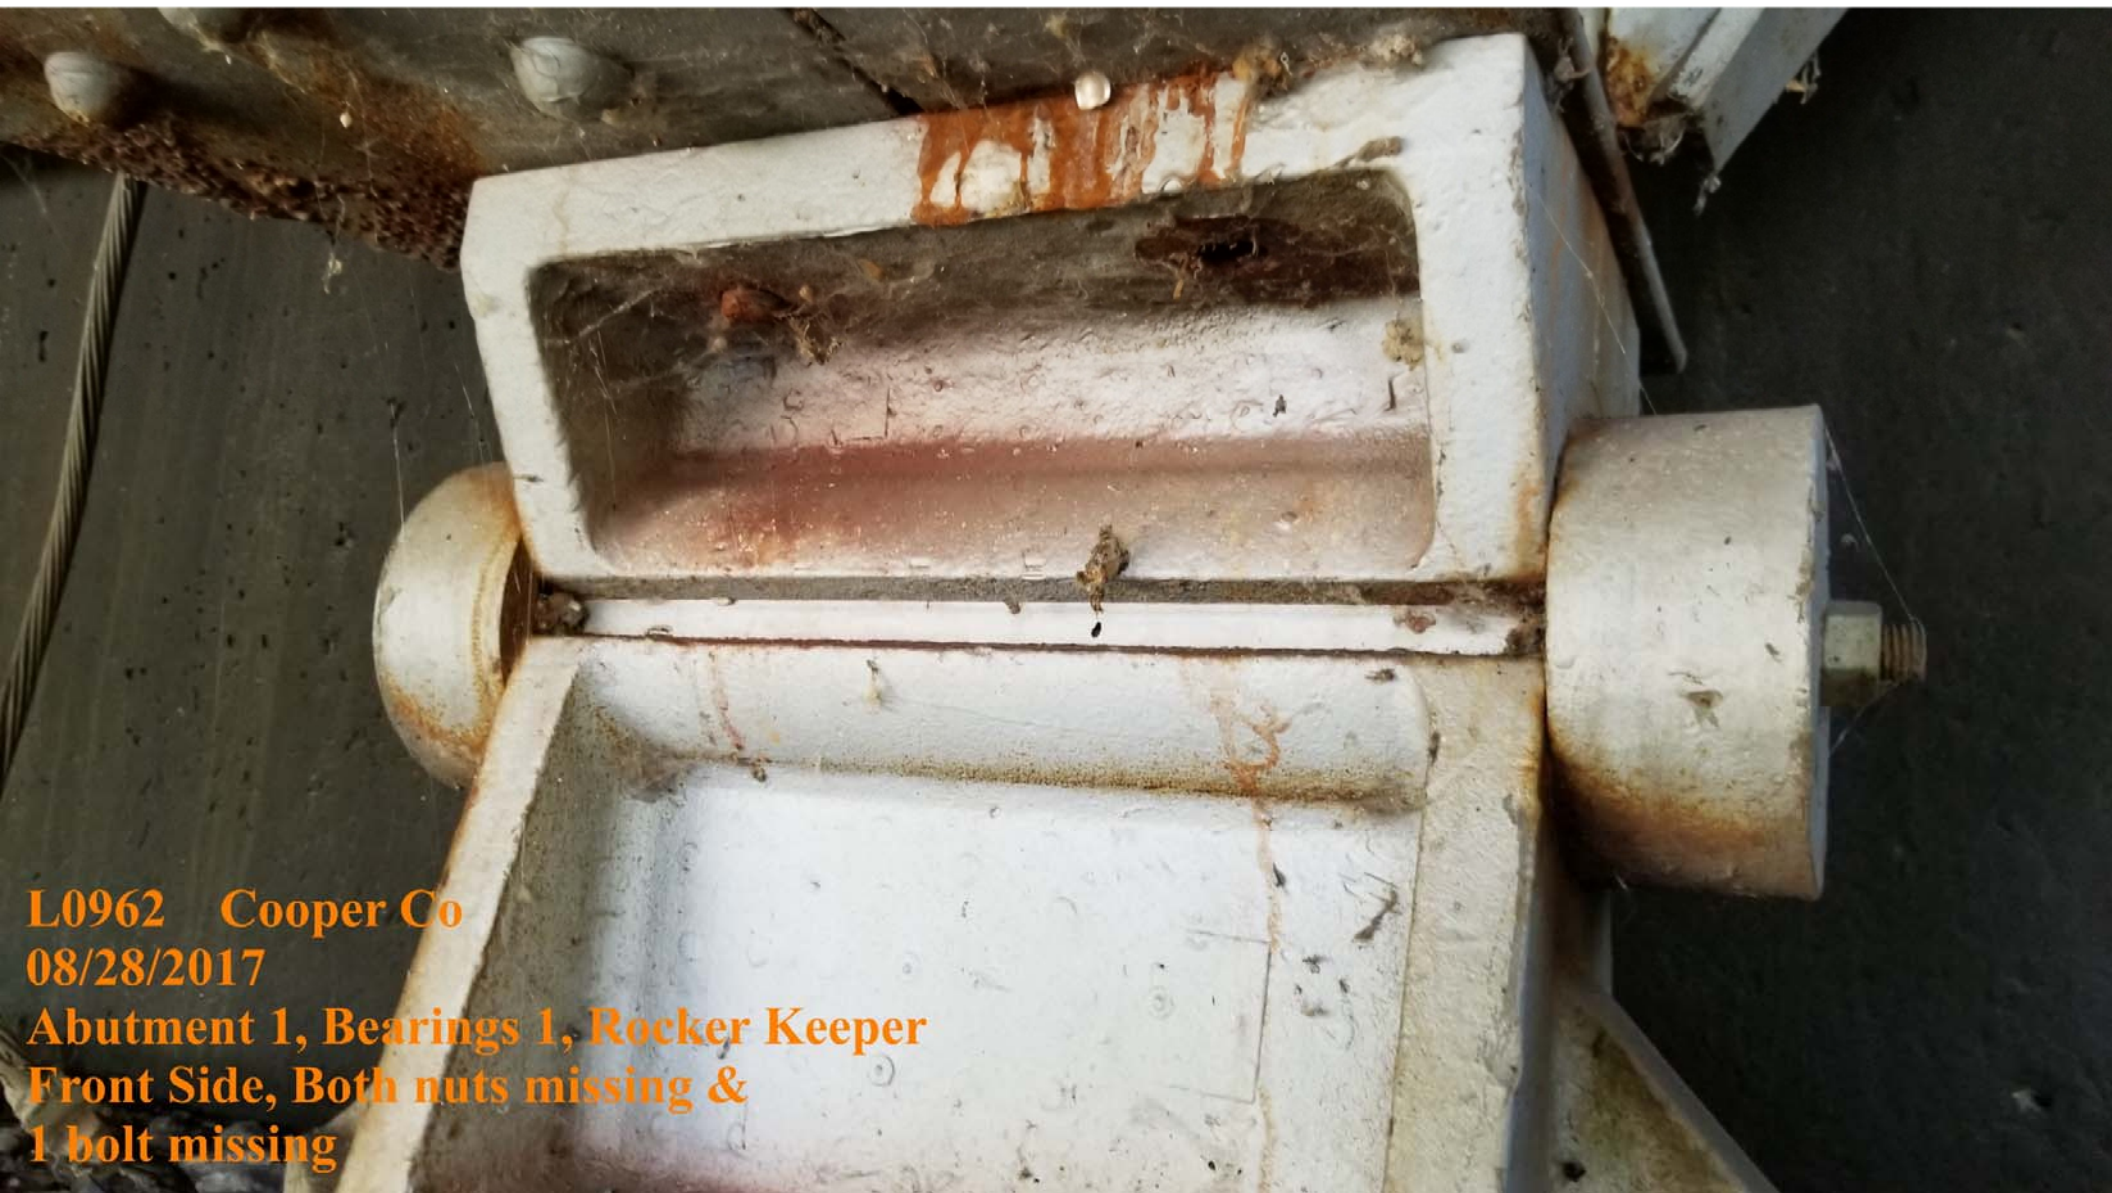
L0962 Cooper Co
08/28/2017
Abutment 1, Bearings 1, Rocker Keeper
Front Side, Both nuts missing &
1 bolt missing

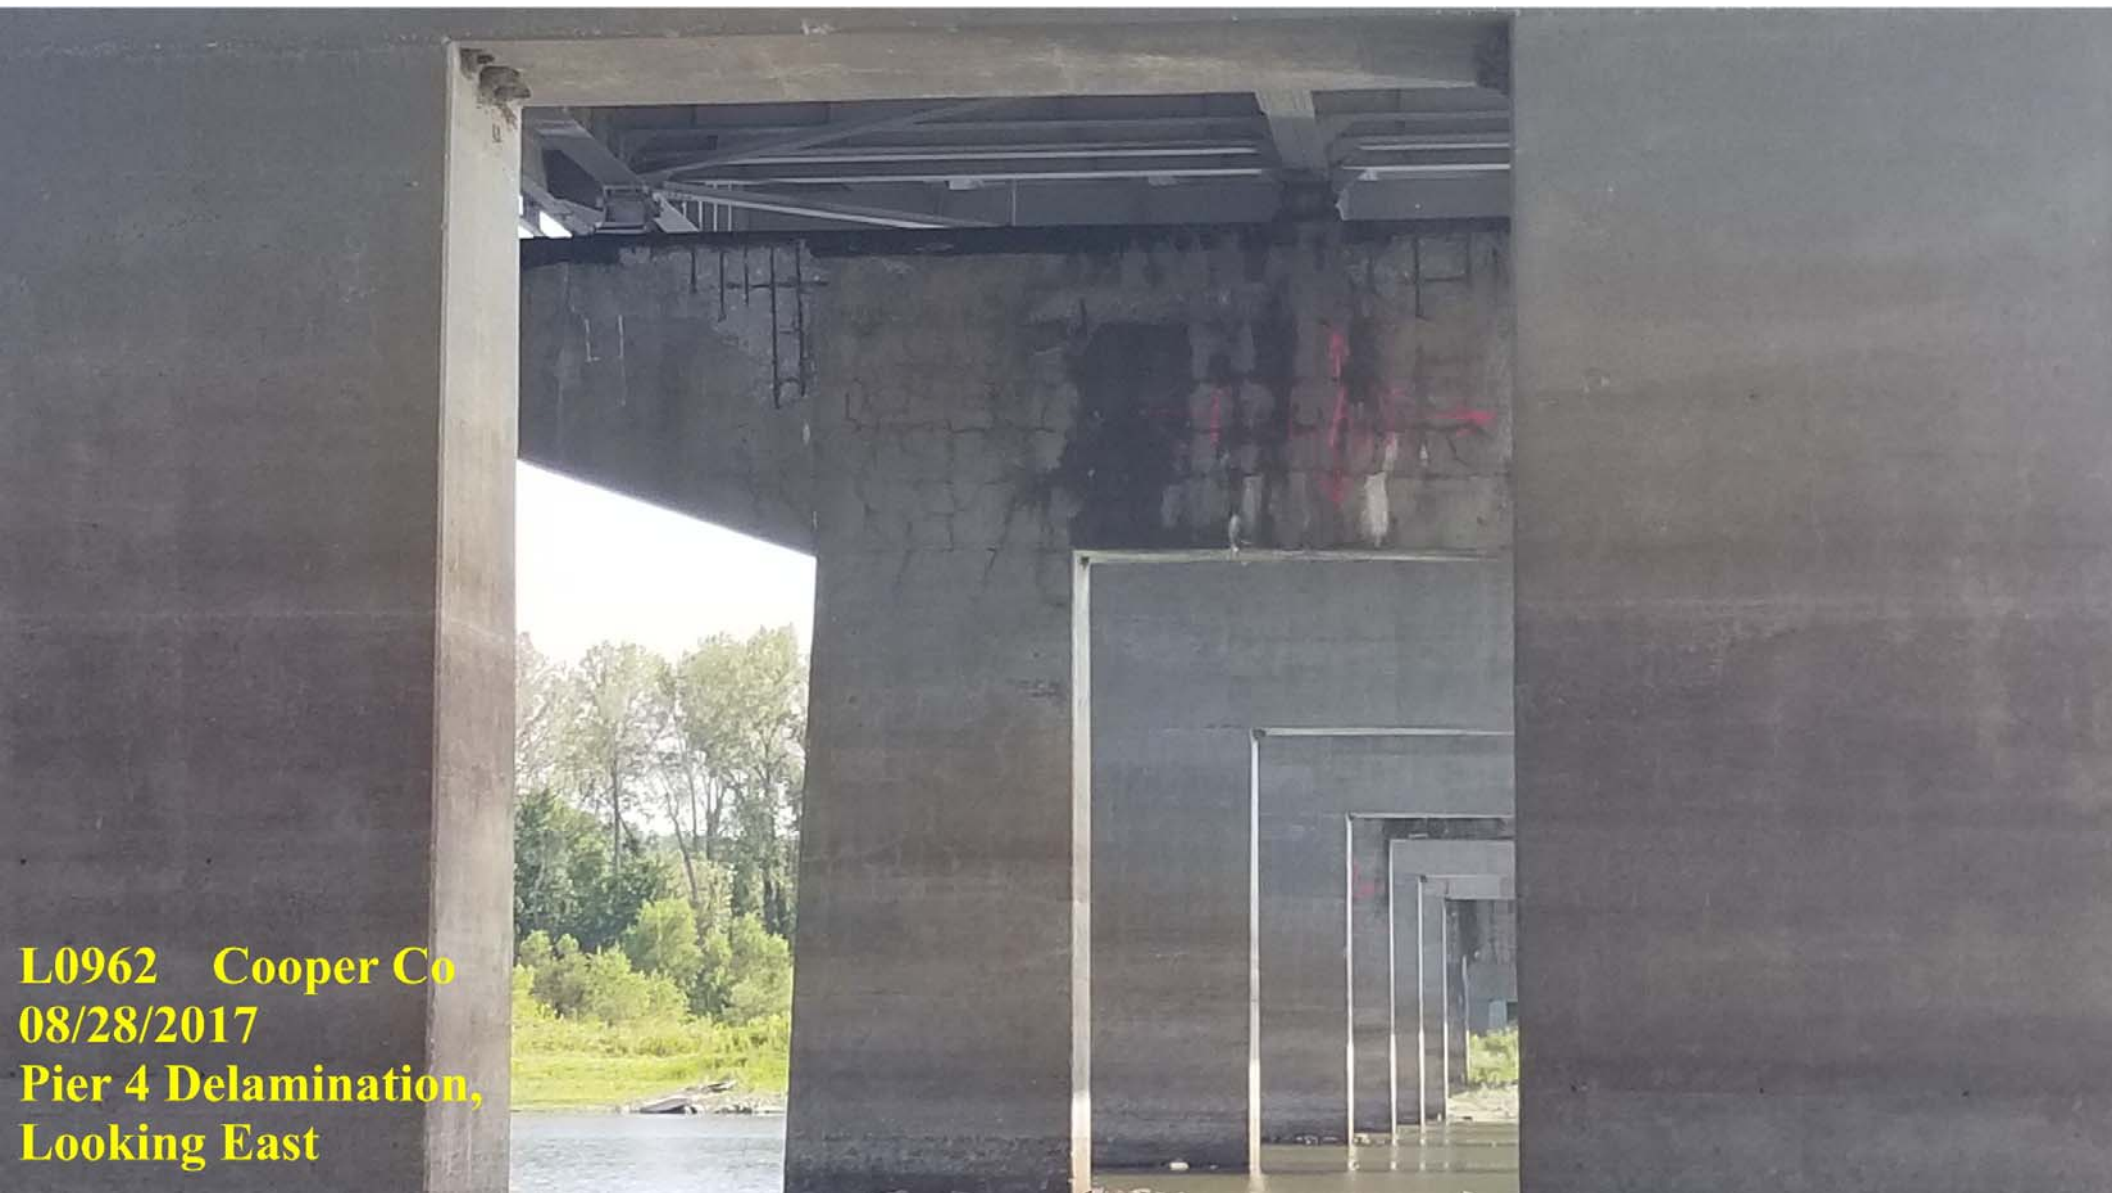
L0962 Cooper Co
08/28/2017
Pier 4 Delamination,
Looking East
