L0962 Cooper Co.
08/28/2017
Looking West

L0962 I-70 Cooper
Pier 15 Open Expansion Joint WBL
8-28-17

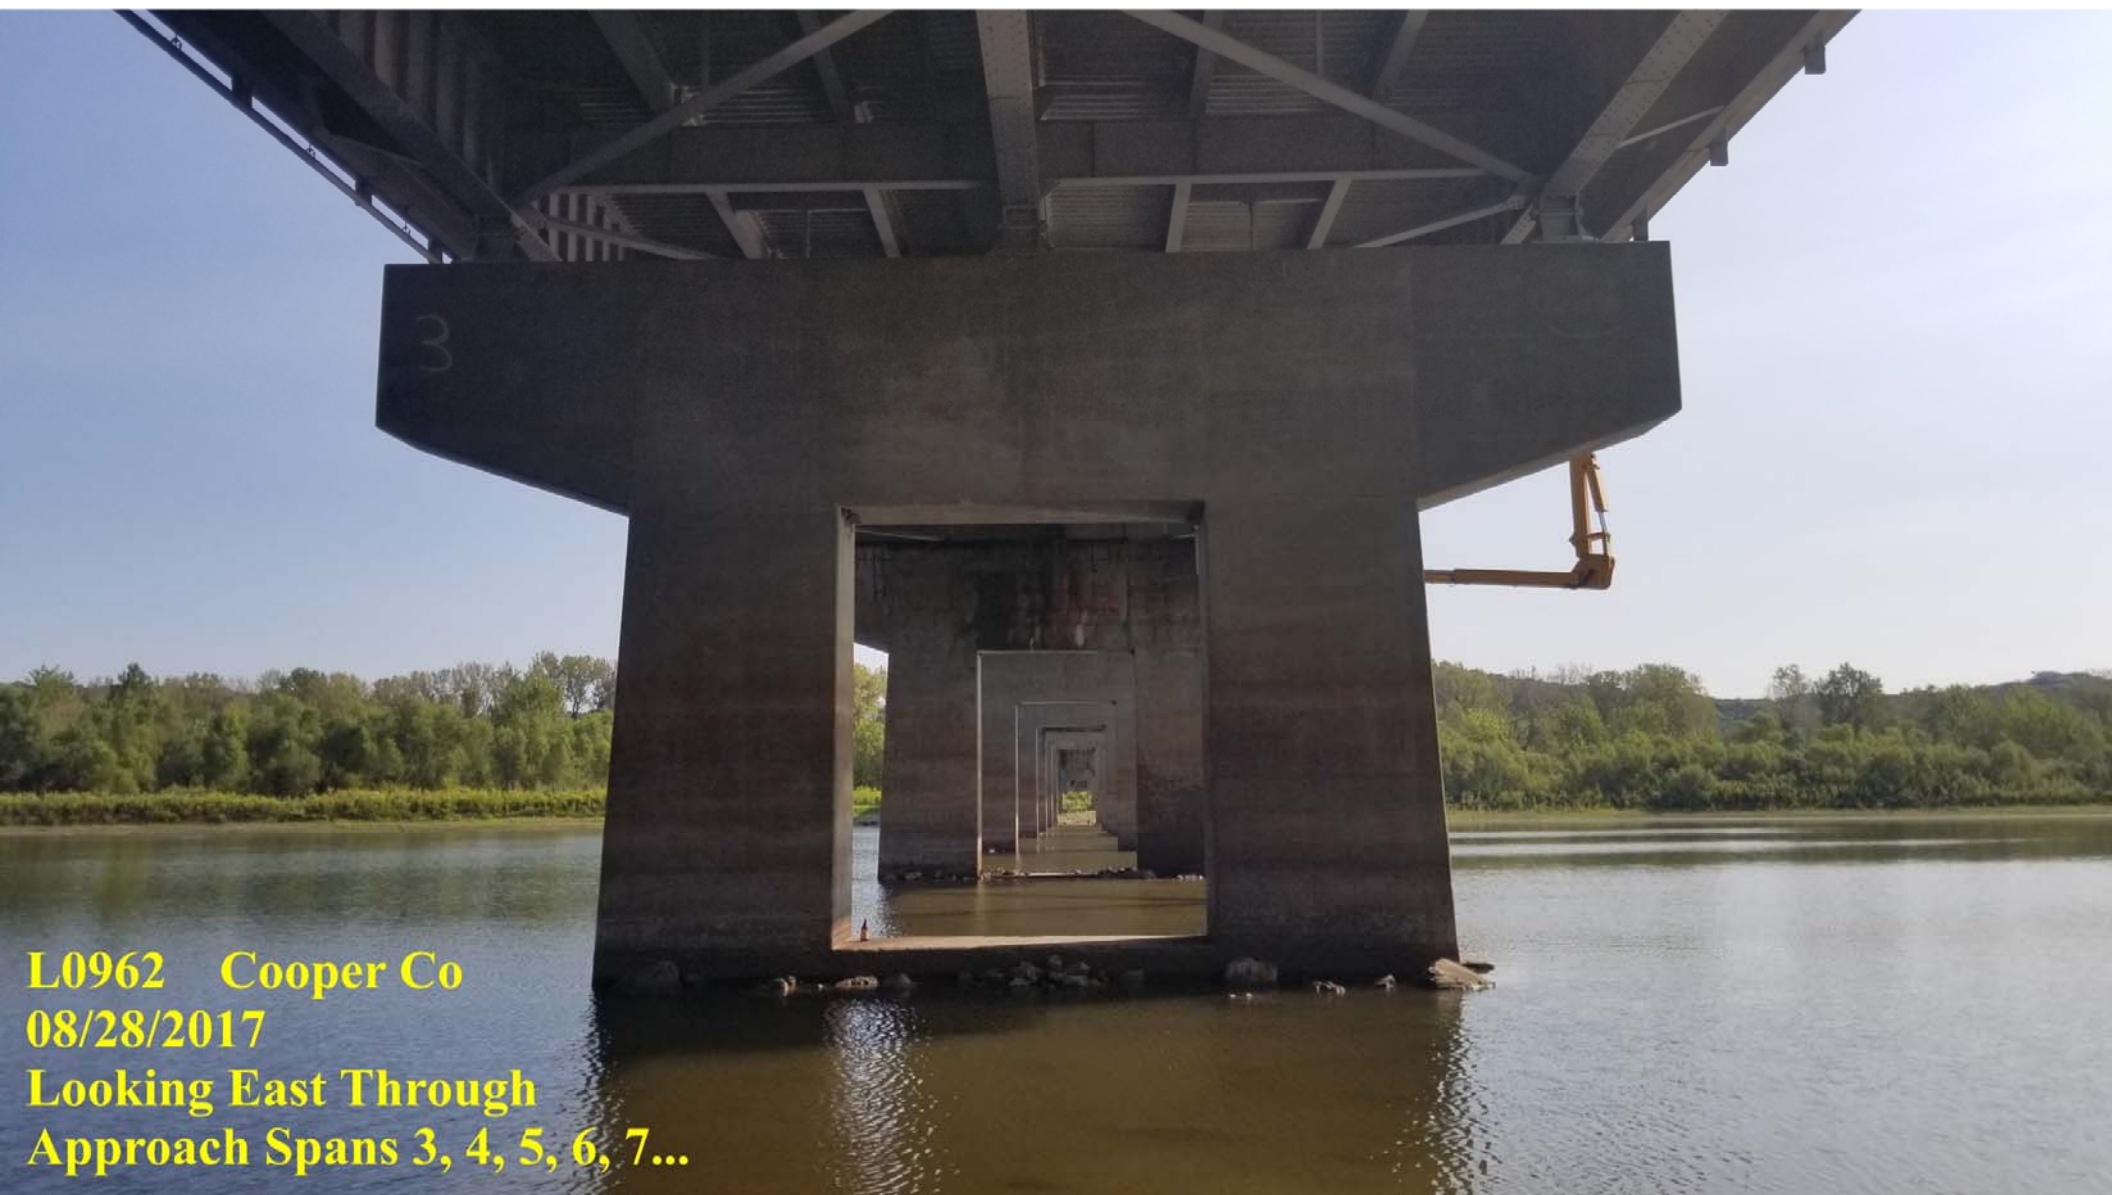
L0962 Cooper Co
08/28/2017
Looking East Through
Approach Spans 3, 4, 5, 6, 7...

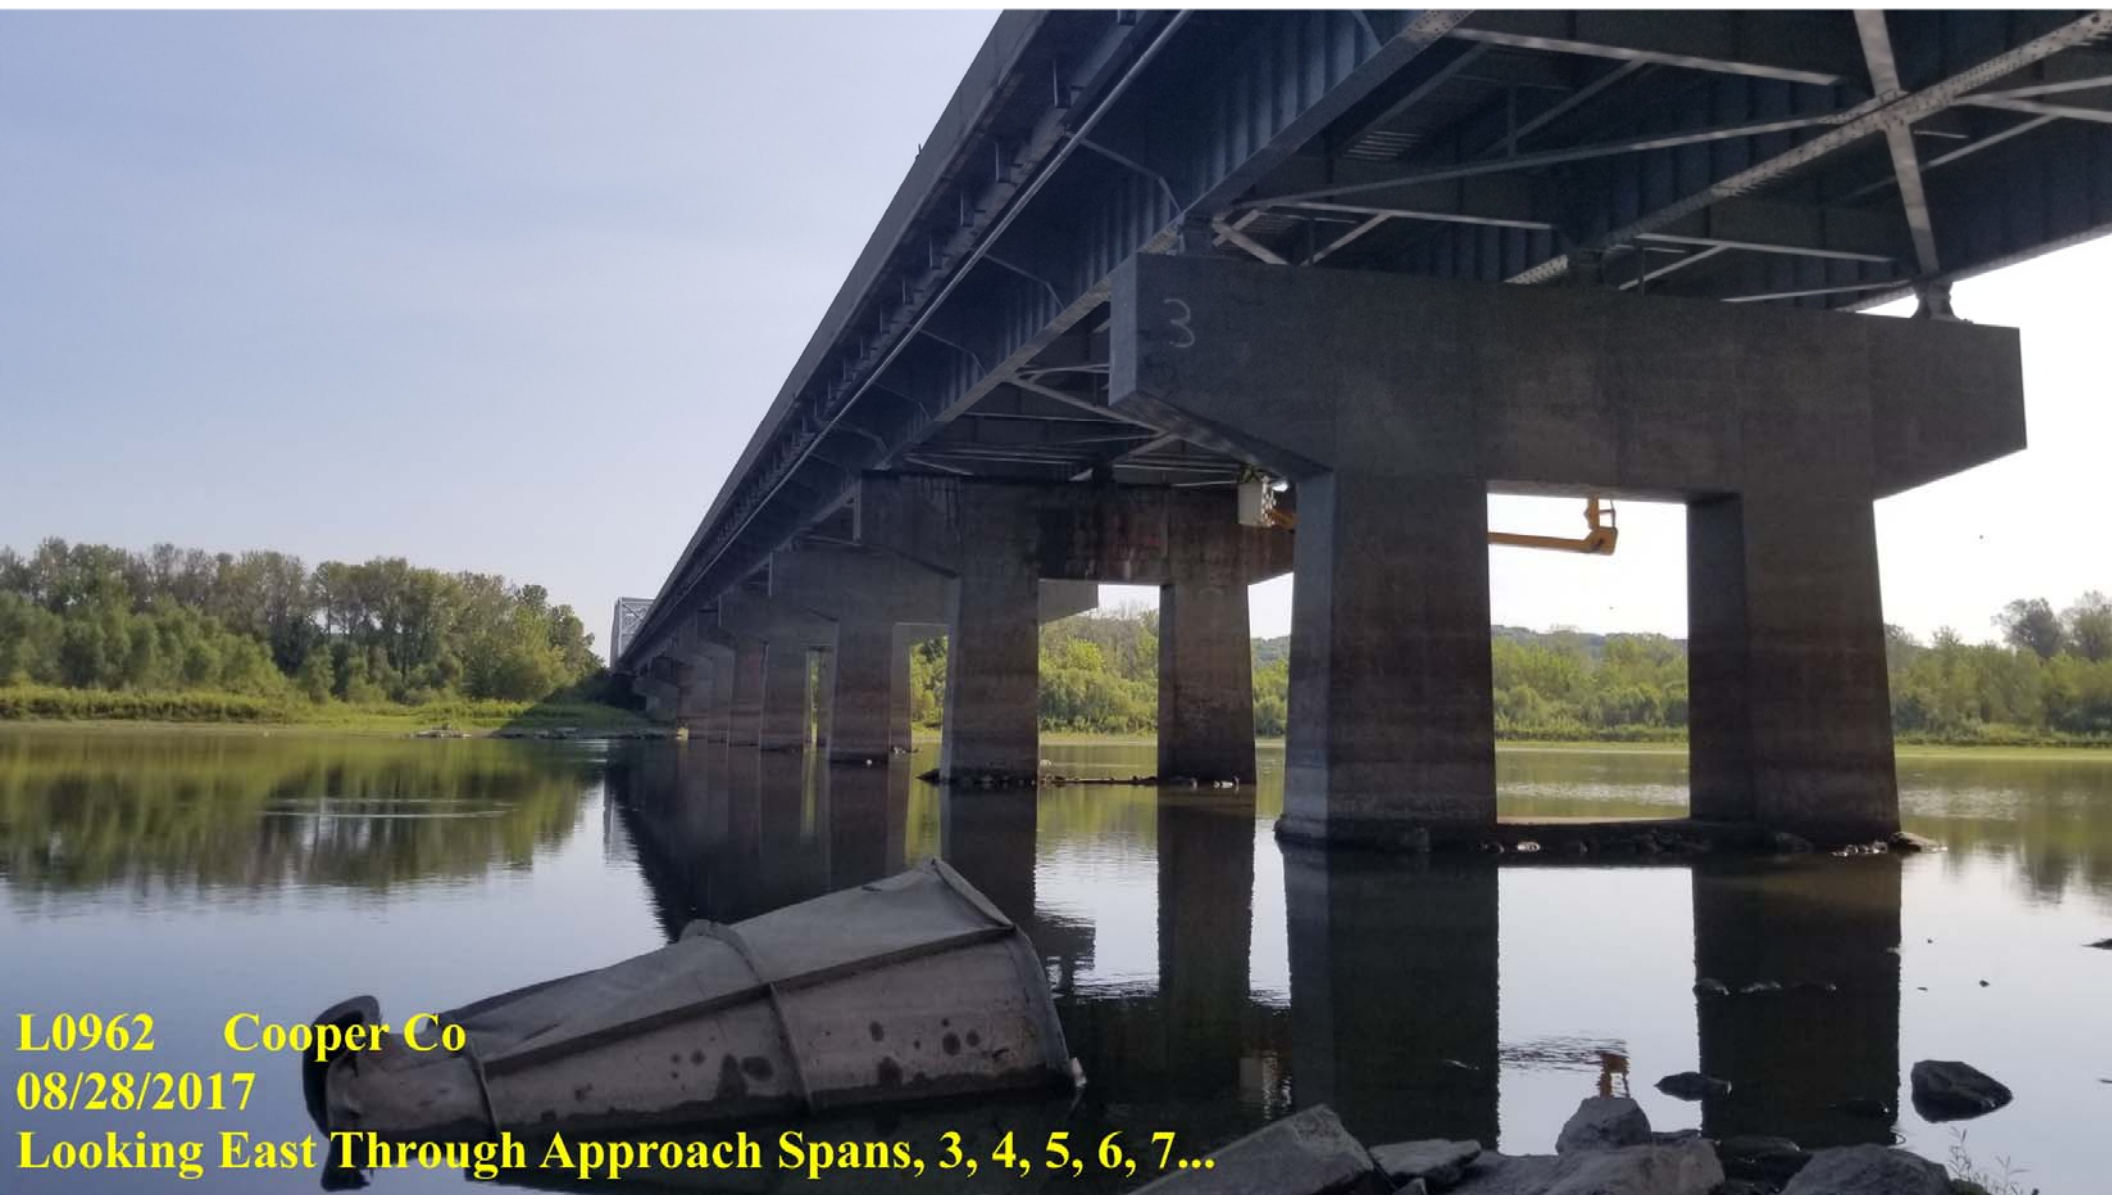
L0962 Cooper Co
08/28/2017
Looking East Through Approach Spans, 3, 4, 5, 6, 7...

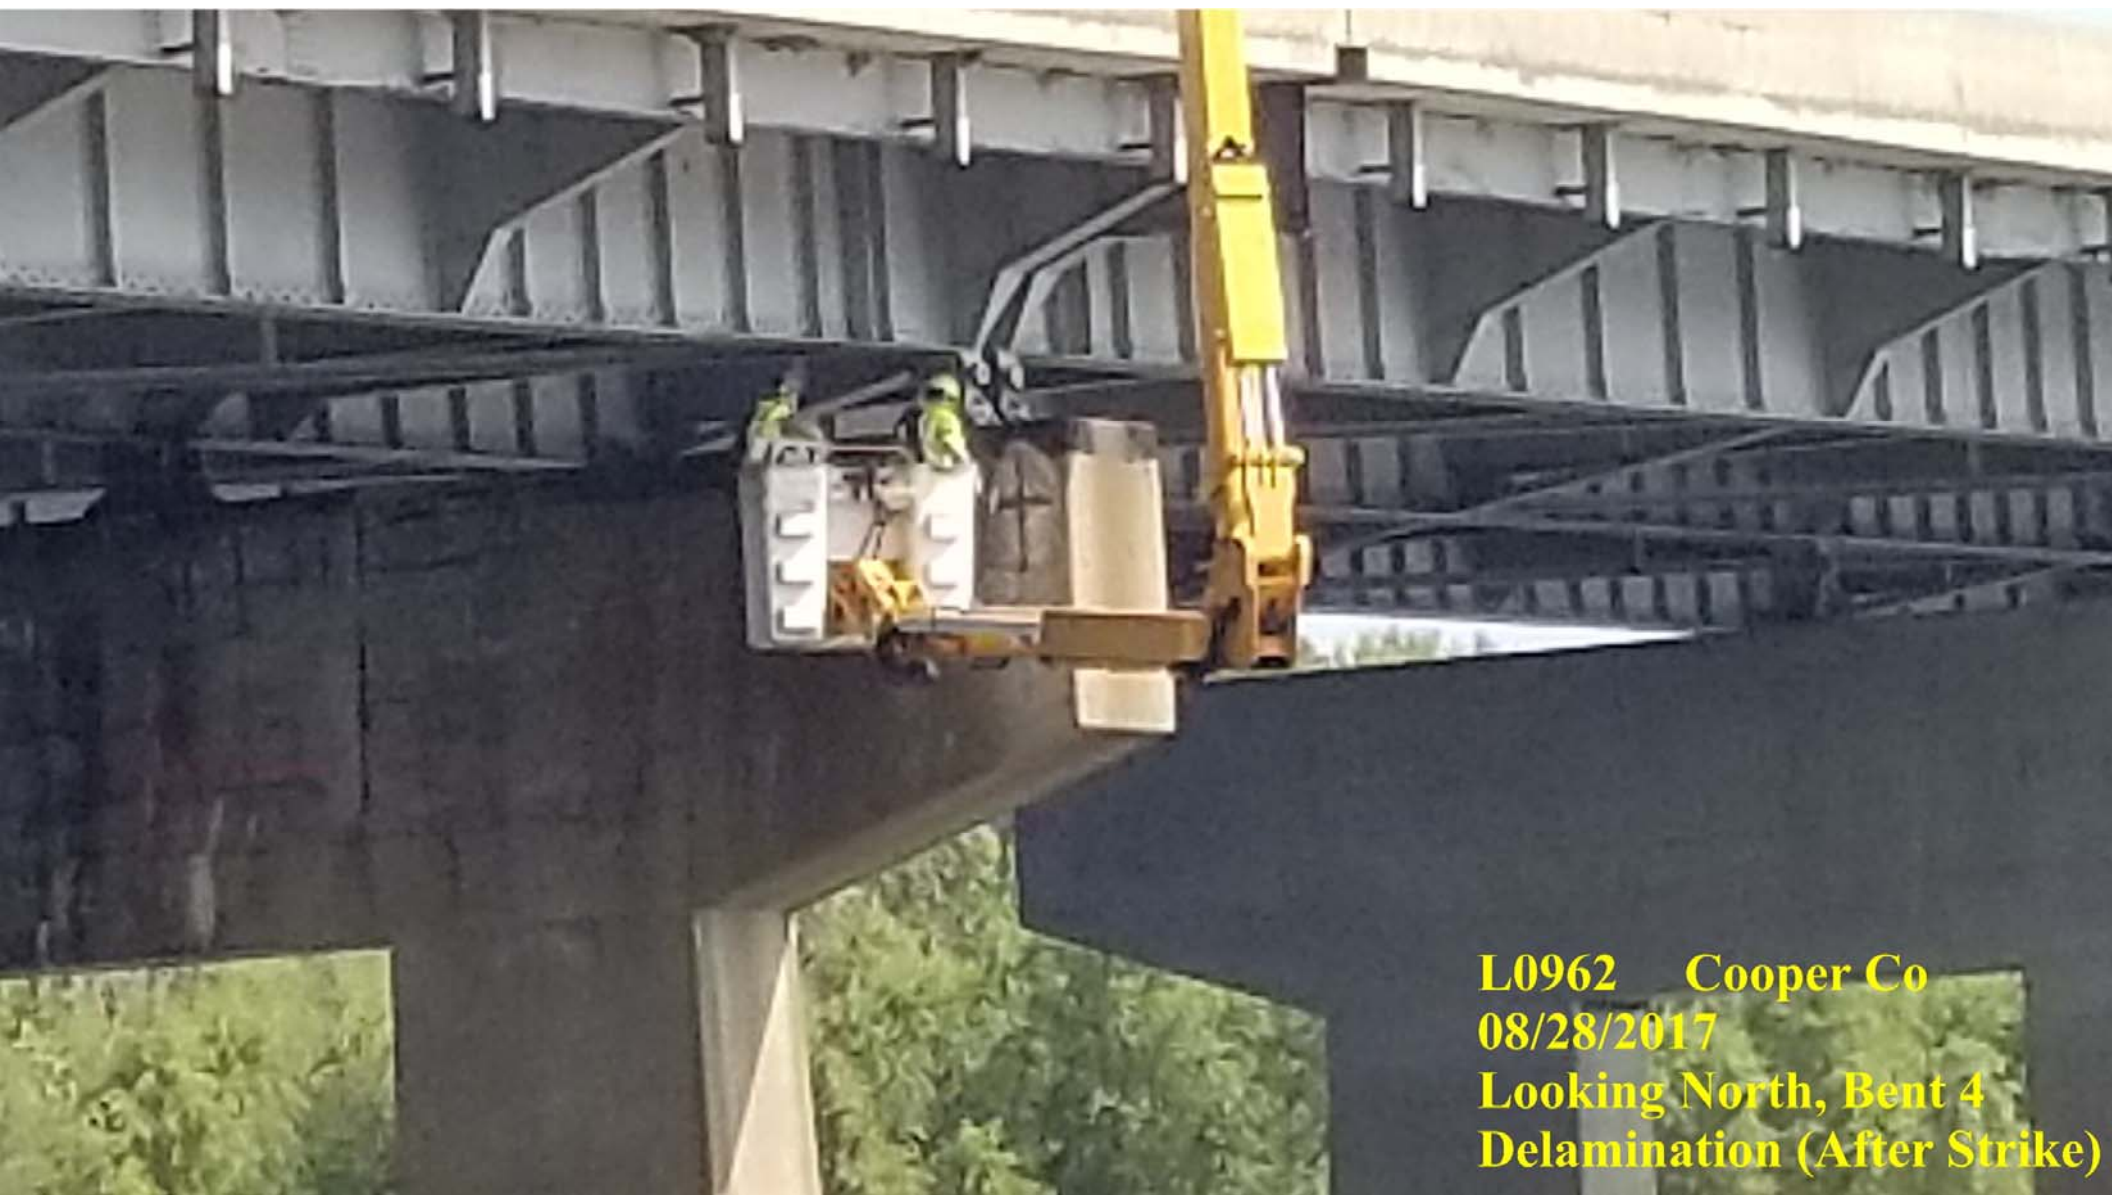
L0962 Cooper Co
08/28/2017
Looking North, Bent 4
Delamination (After Strike)

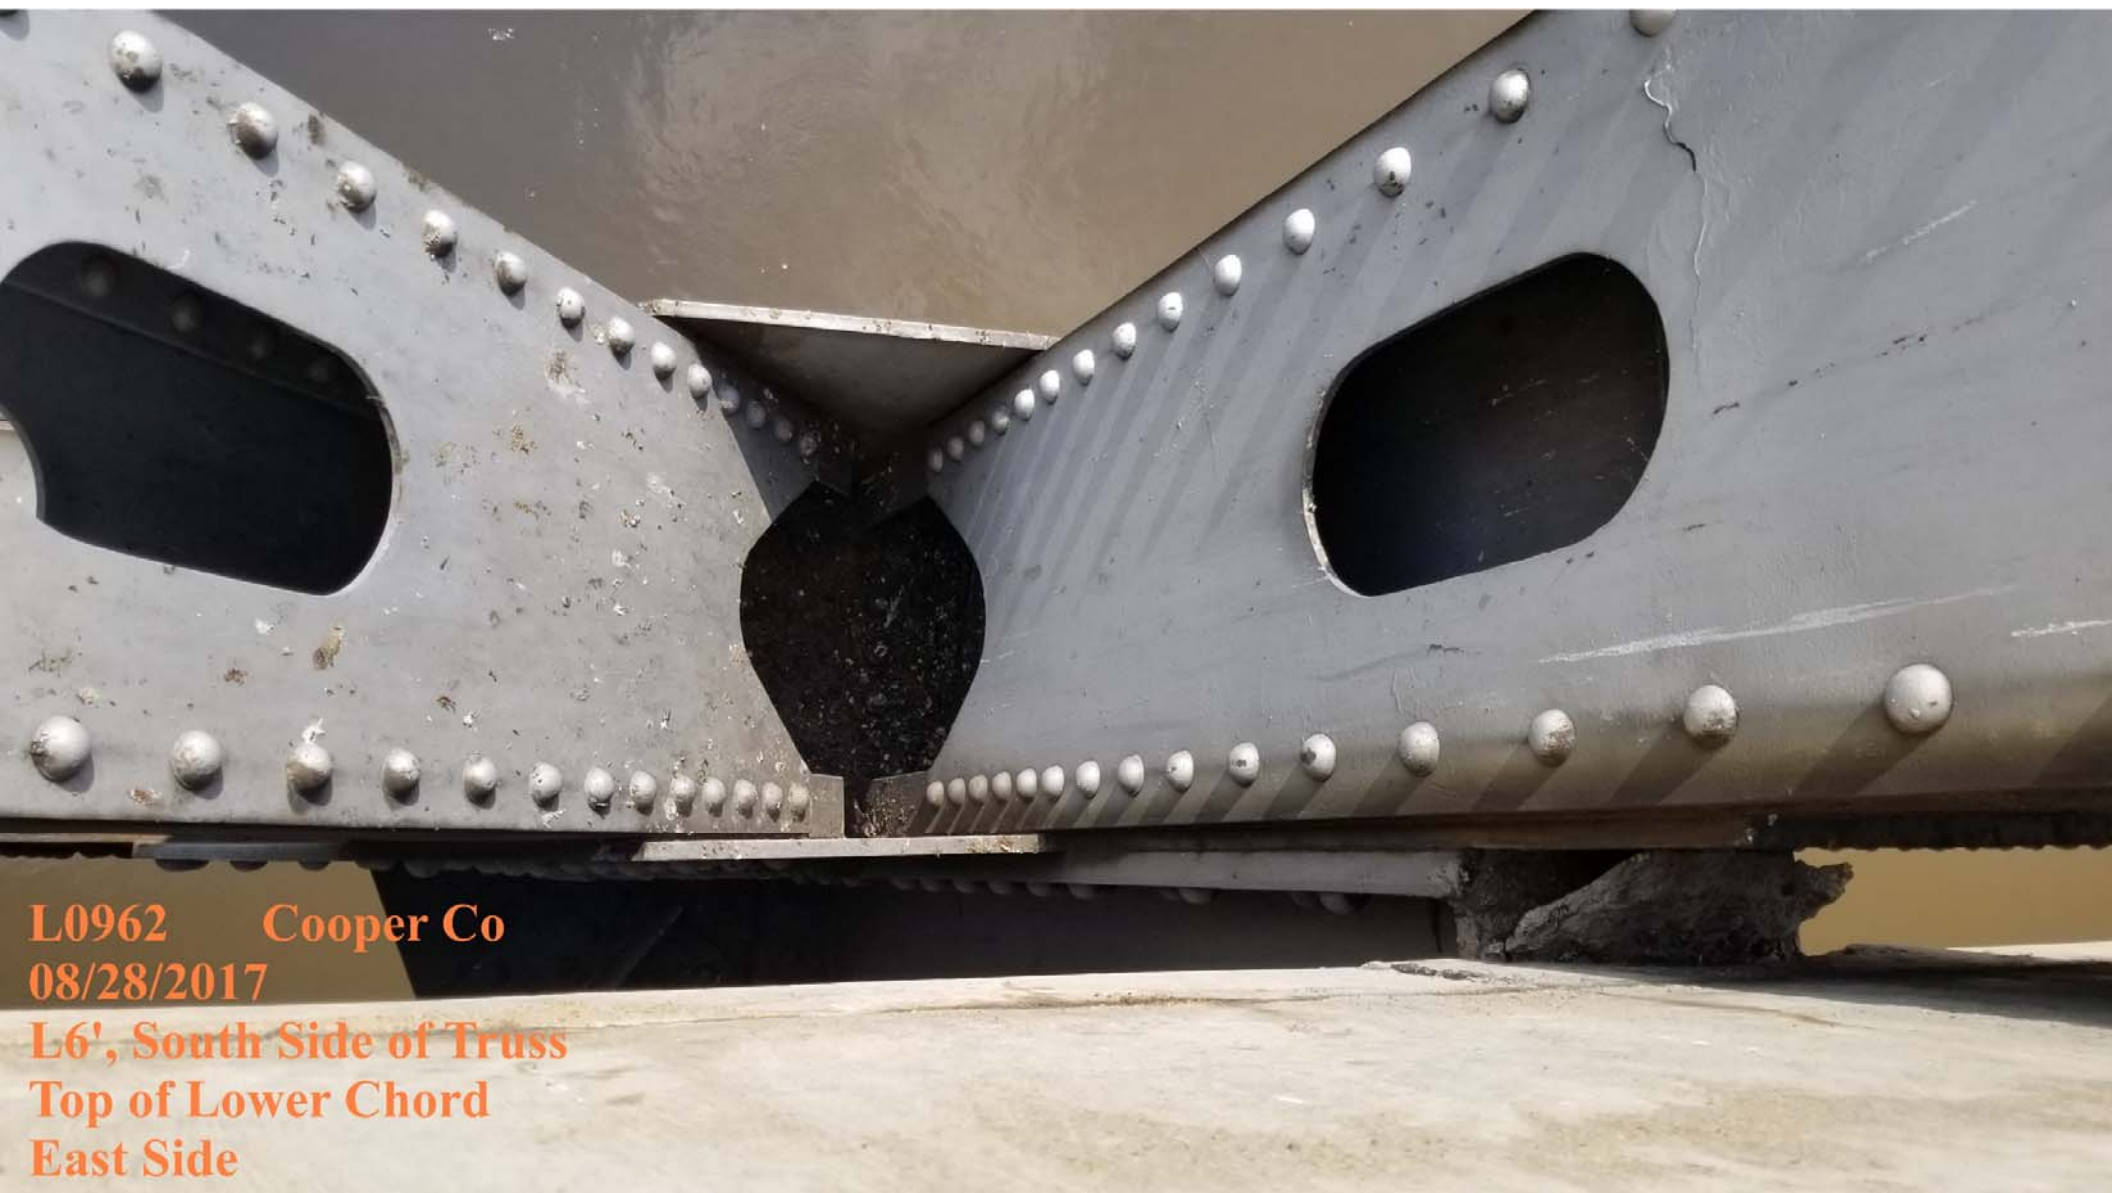
L0962 Cooper Co
08/28/2017
L6' South Side of Truss
Top Lower Chord, West Side

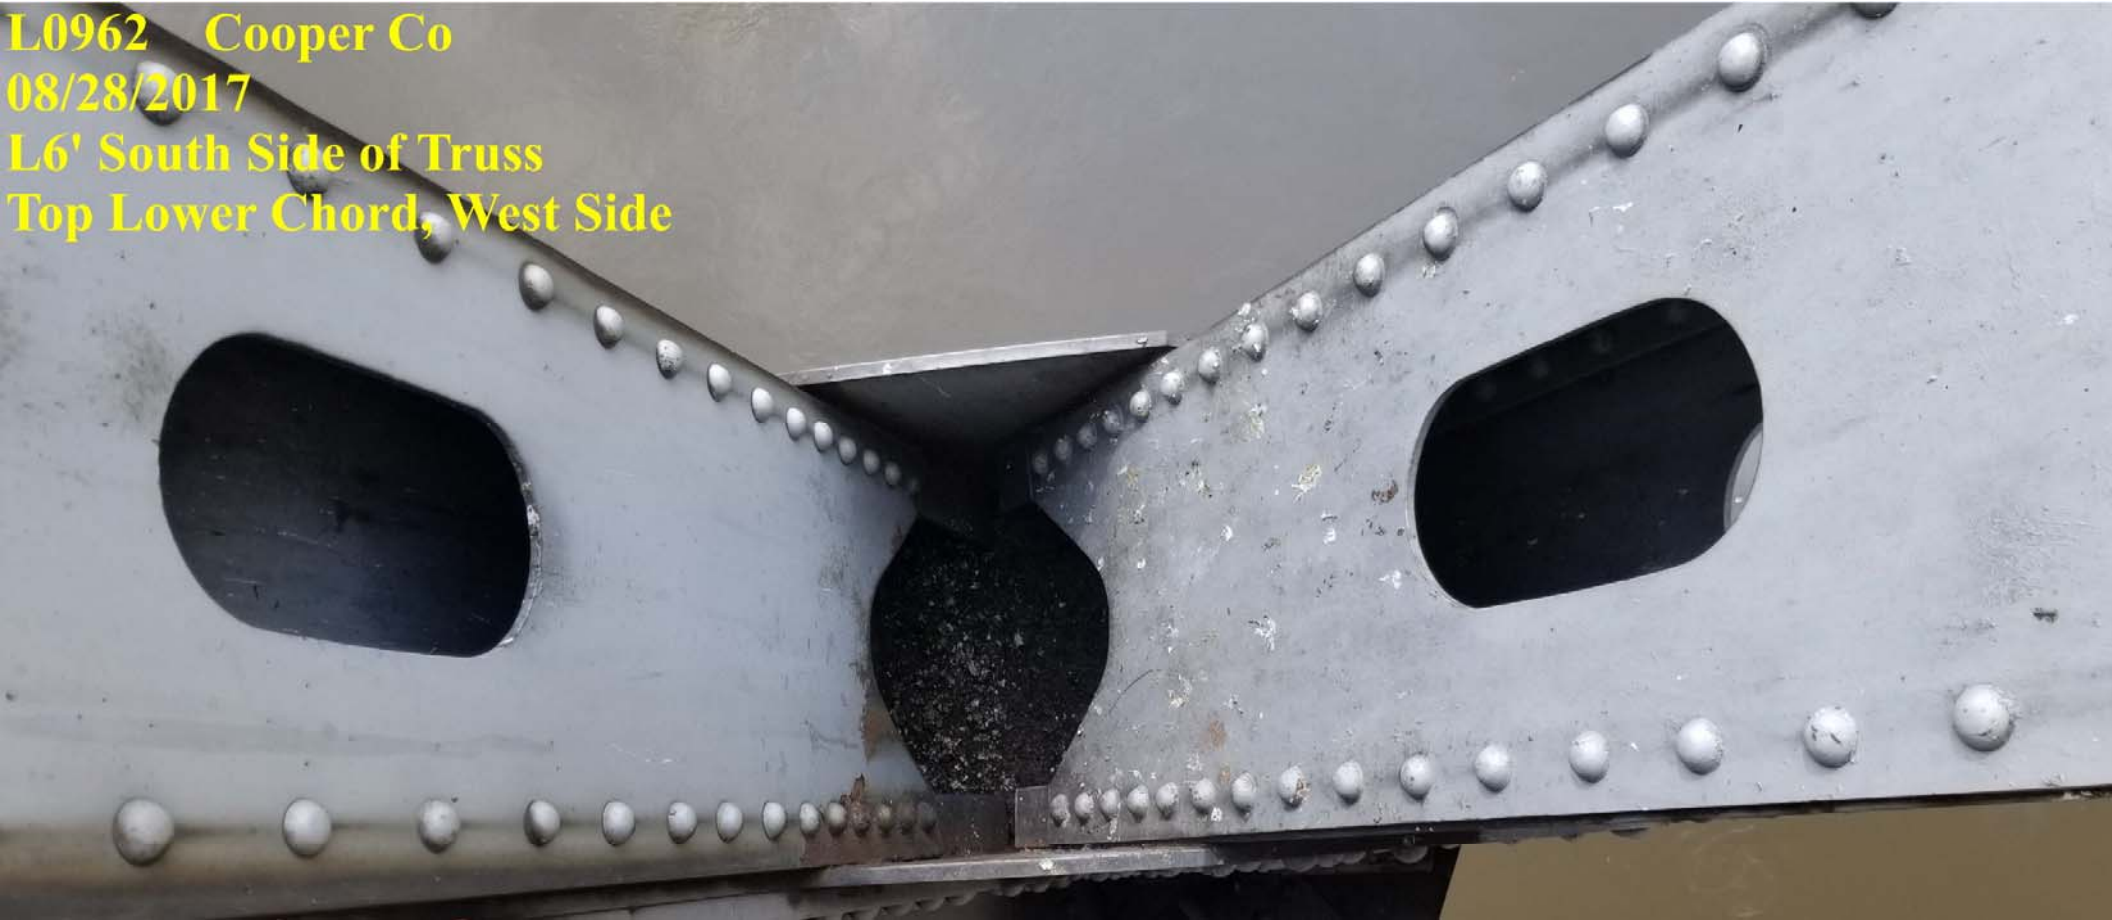
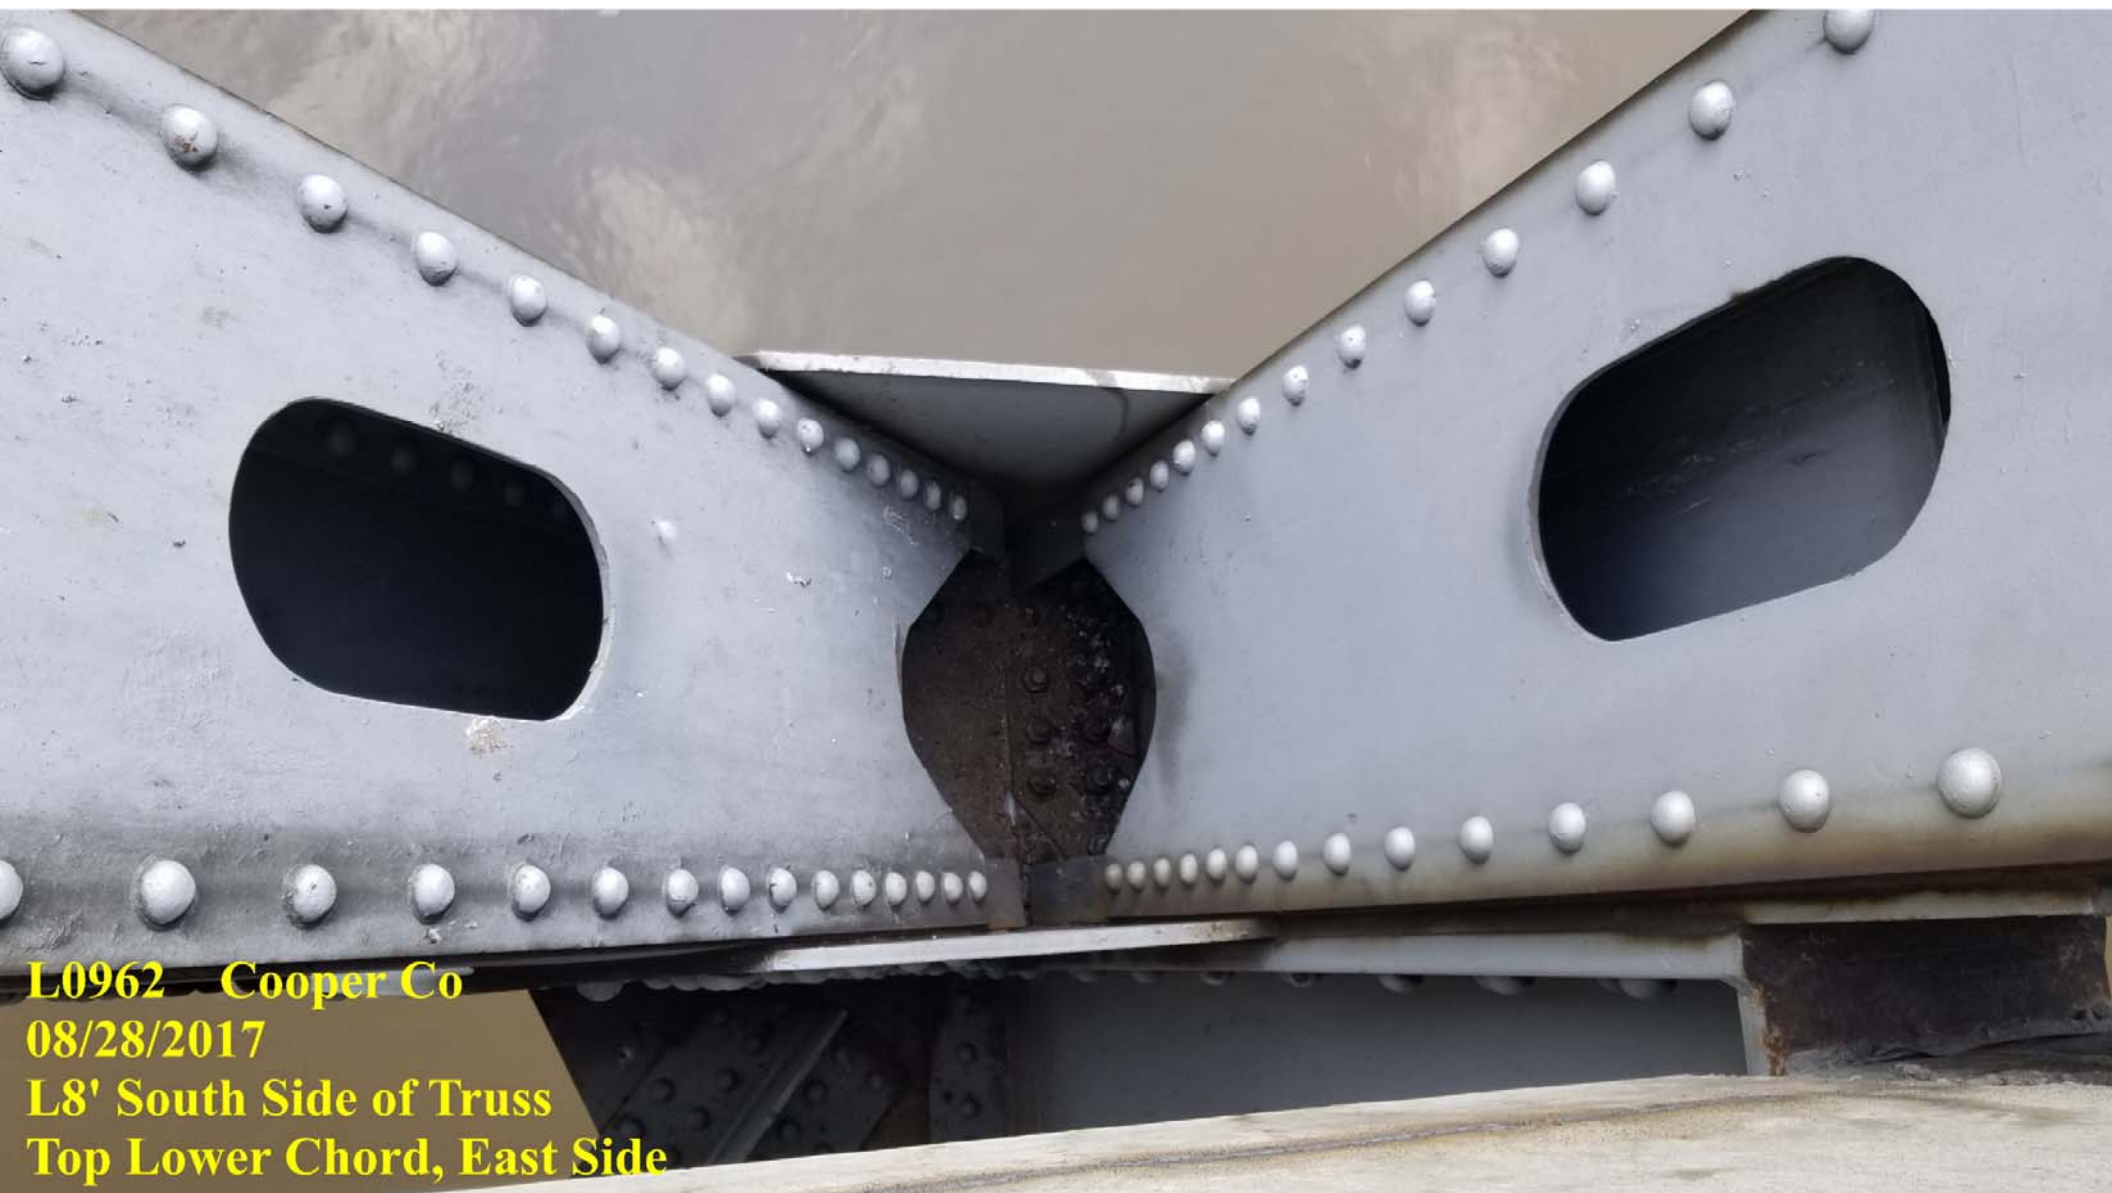
L0962 - Cooper Co
08/28/2017
L8' South Side of Truss
Top Lower Chord, East Side

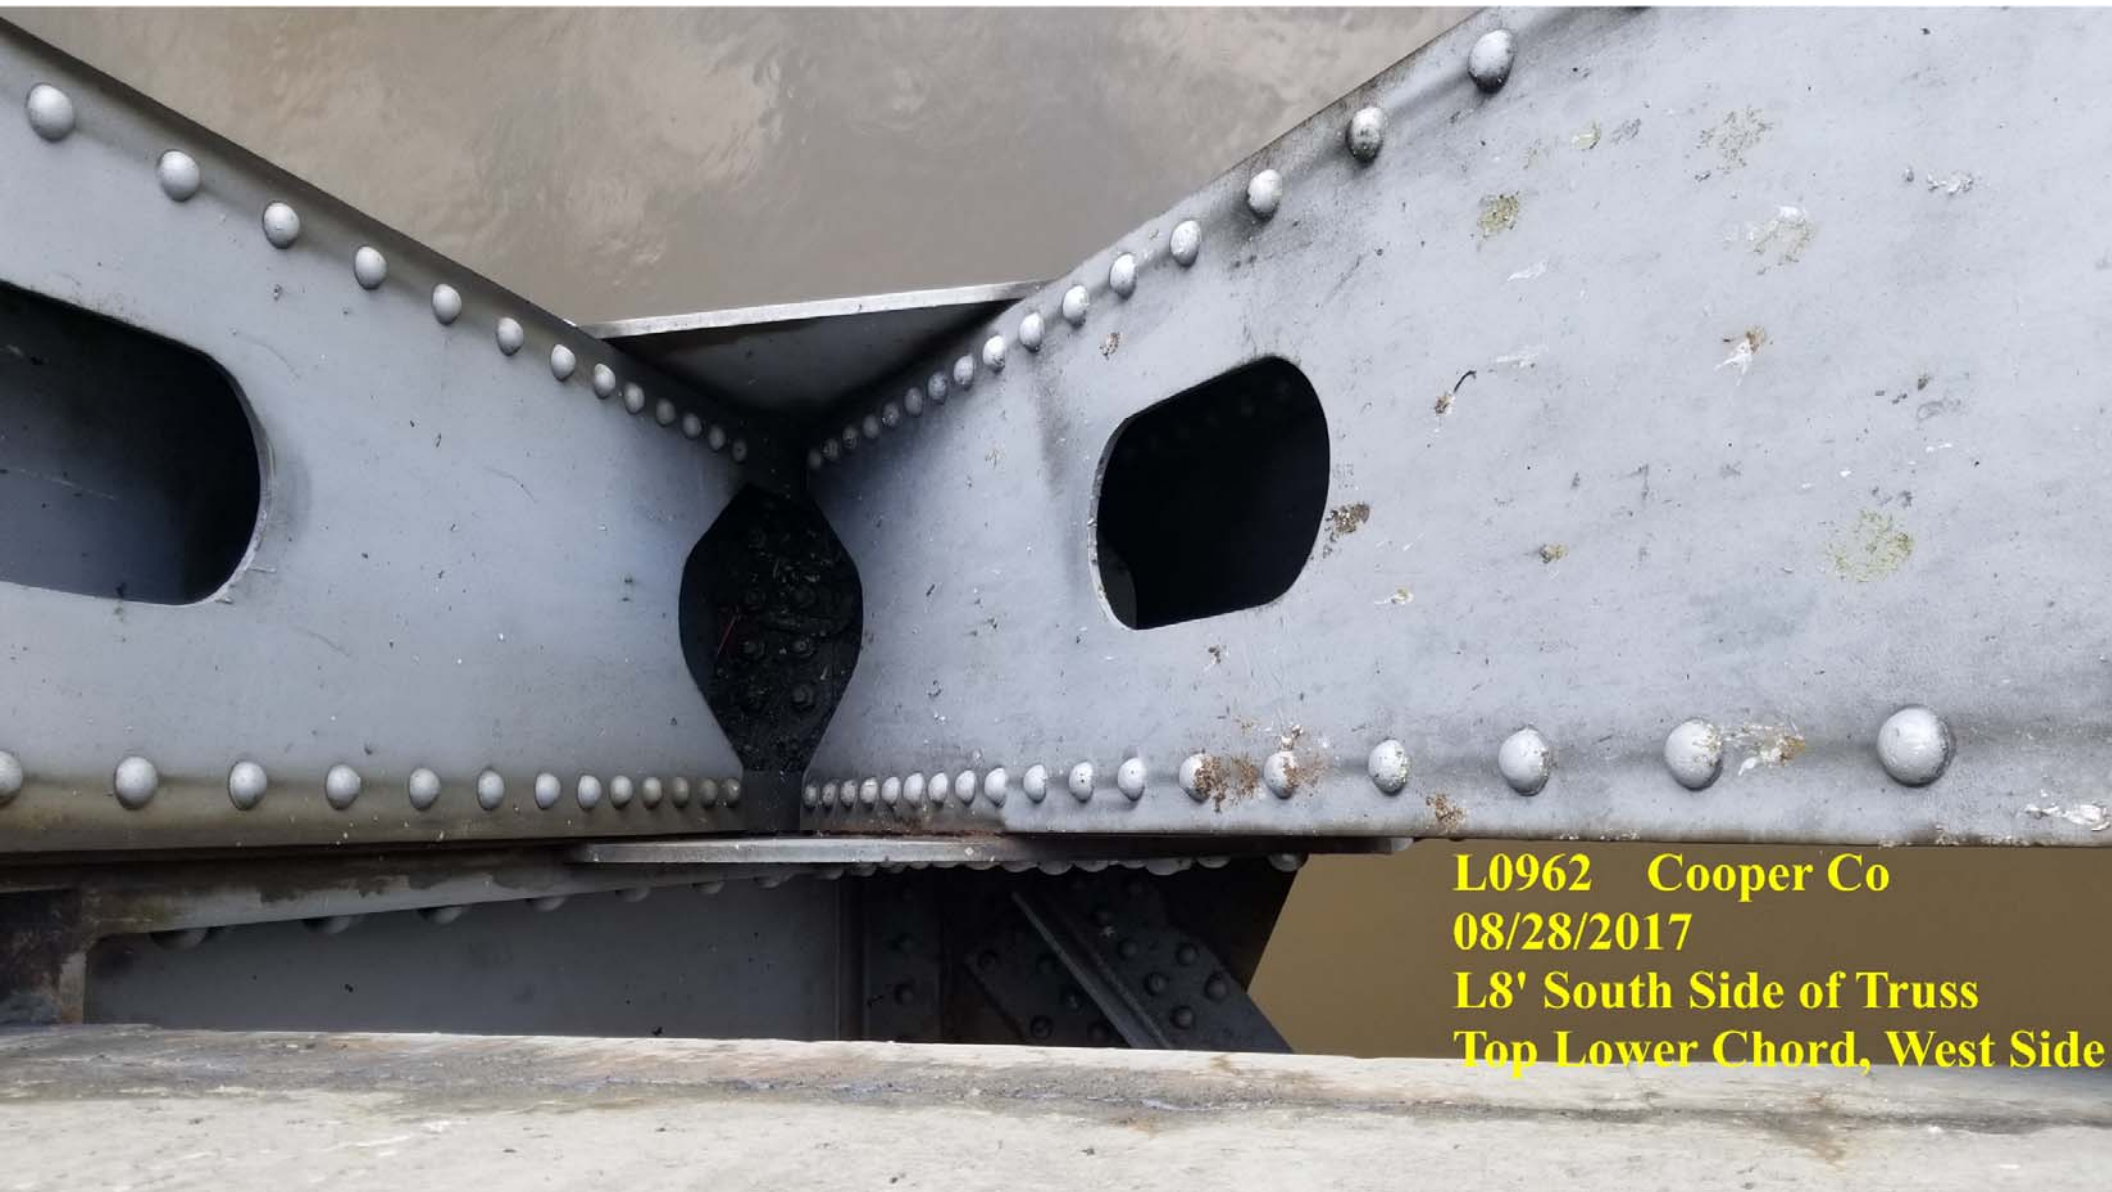
L0962 Cooper Co
08/28/2017
L8' South Side of Truss
Top Lower Chord, West Side

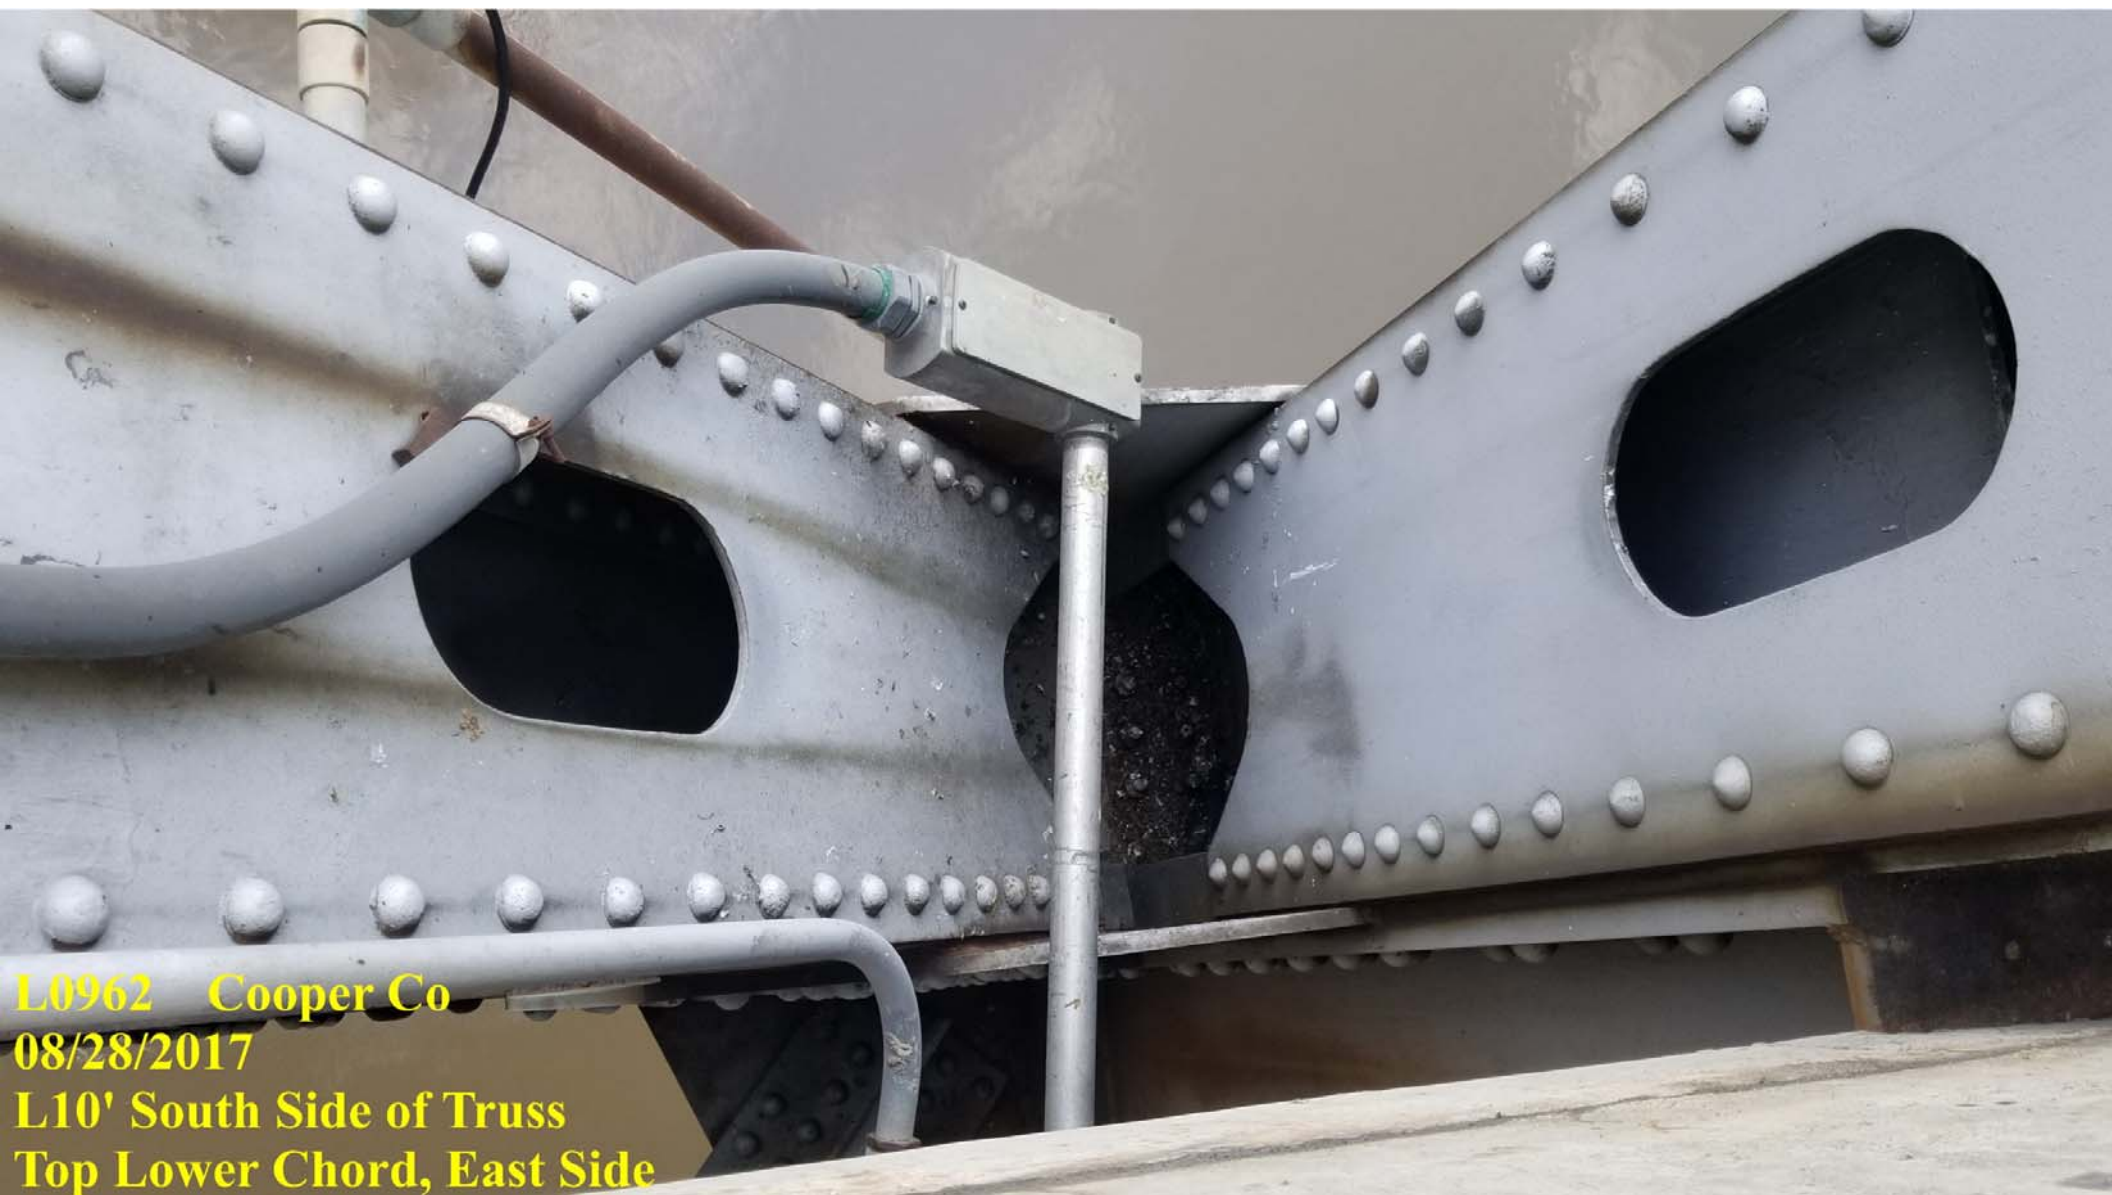
L0962 Cooper Co
08/28/2017
L10' South Side of Truss
Top Lower Chord, East Side

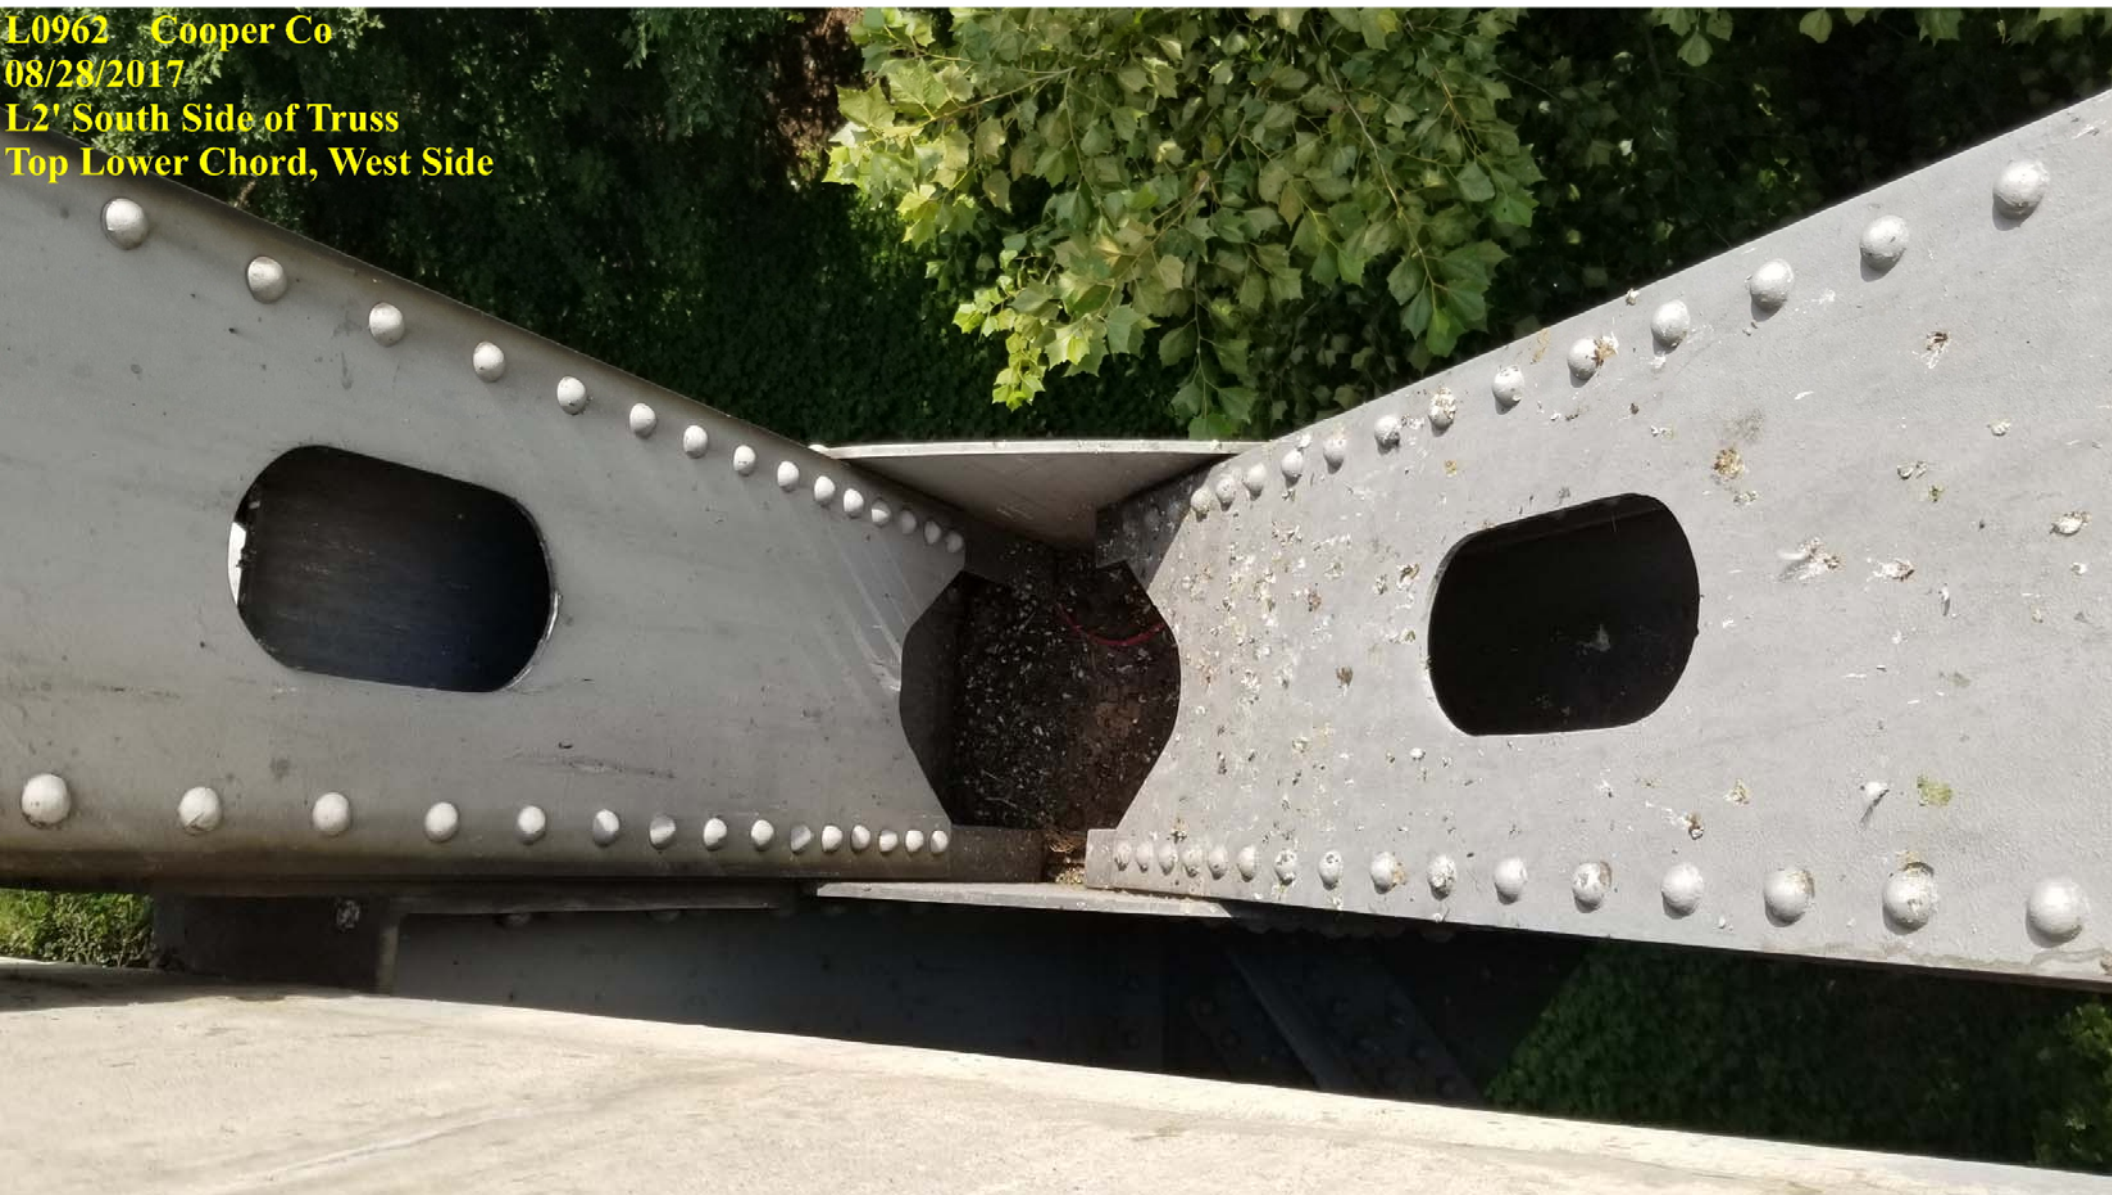
Approx 100' E. of Pier 10

EB Lanes, Barrier Curb Collision Damage
