L0962 Cooper Co.
08/28/2017
Looking West

L0962 I-70 Cooper
Pier 15 Open Expansion Joint WBL
8-28-17

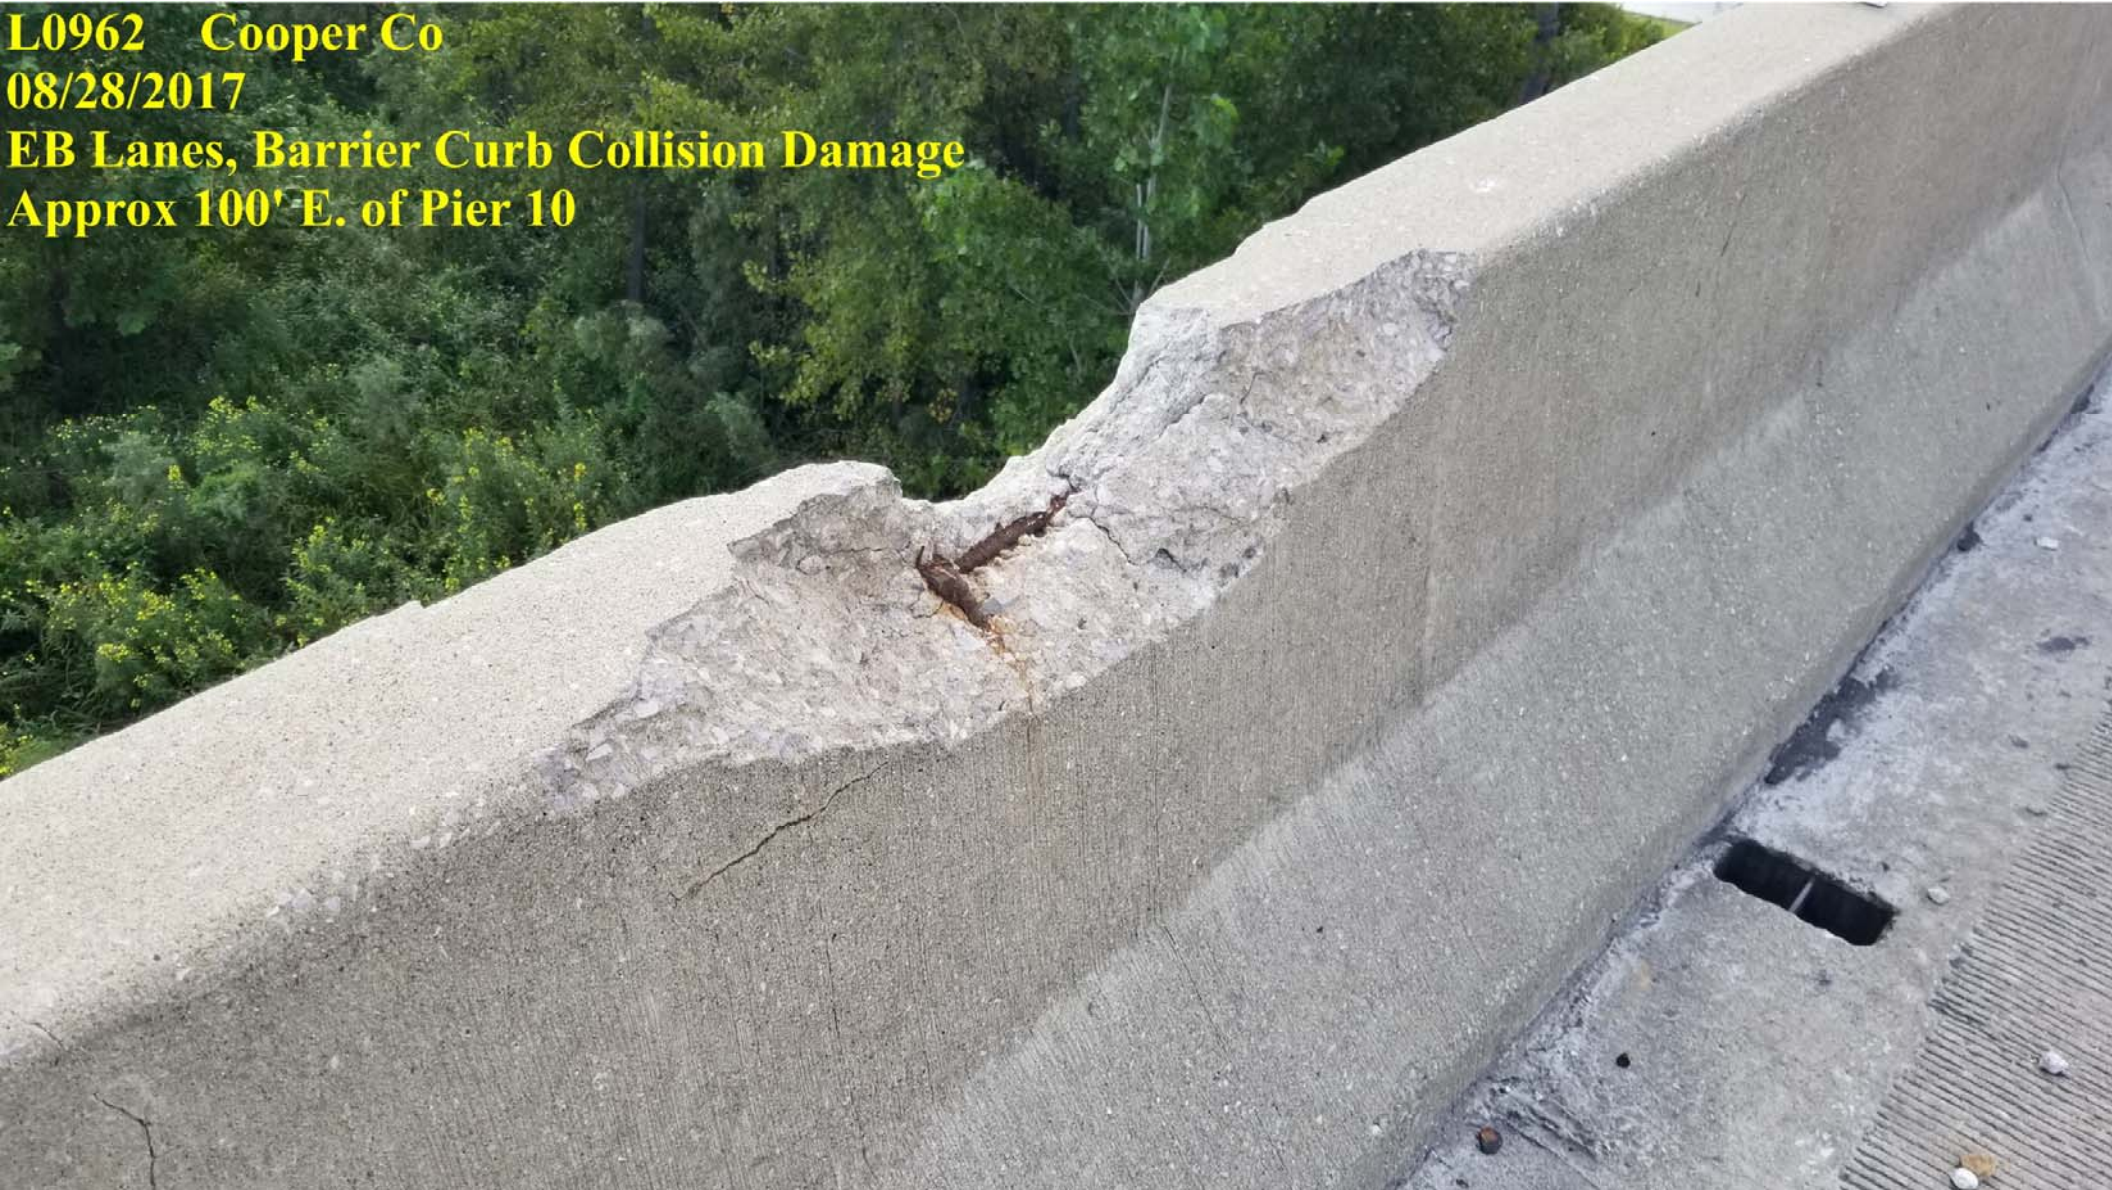
L0962 I-70 Cooper
EBL Expansion Joint at L0
8-30-17

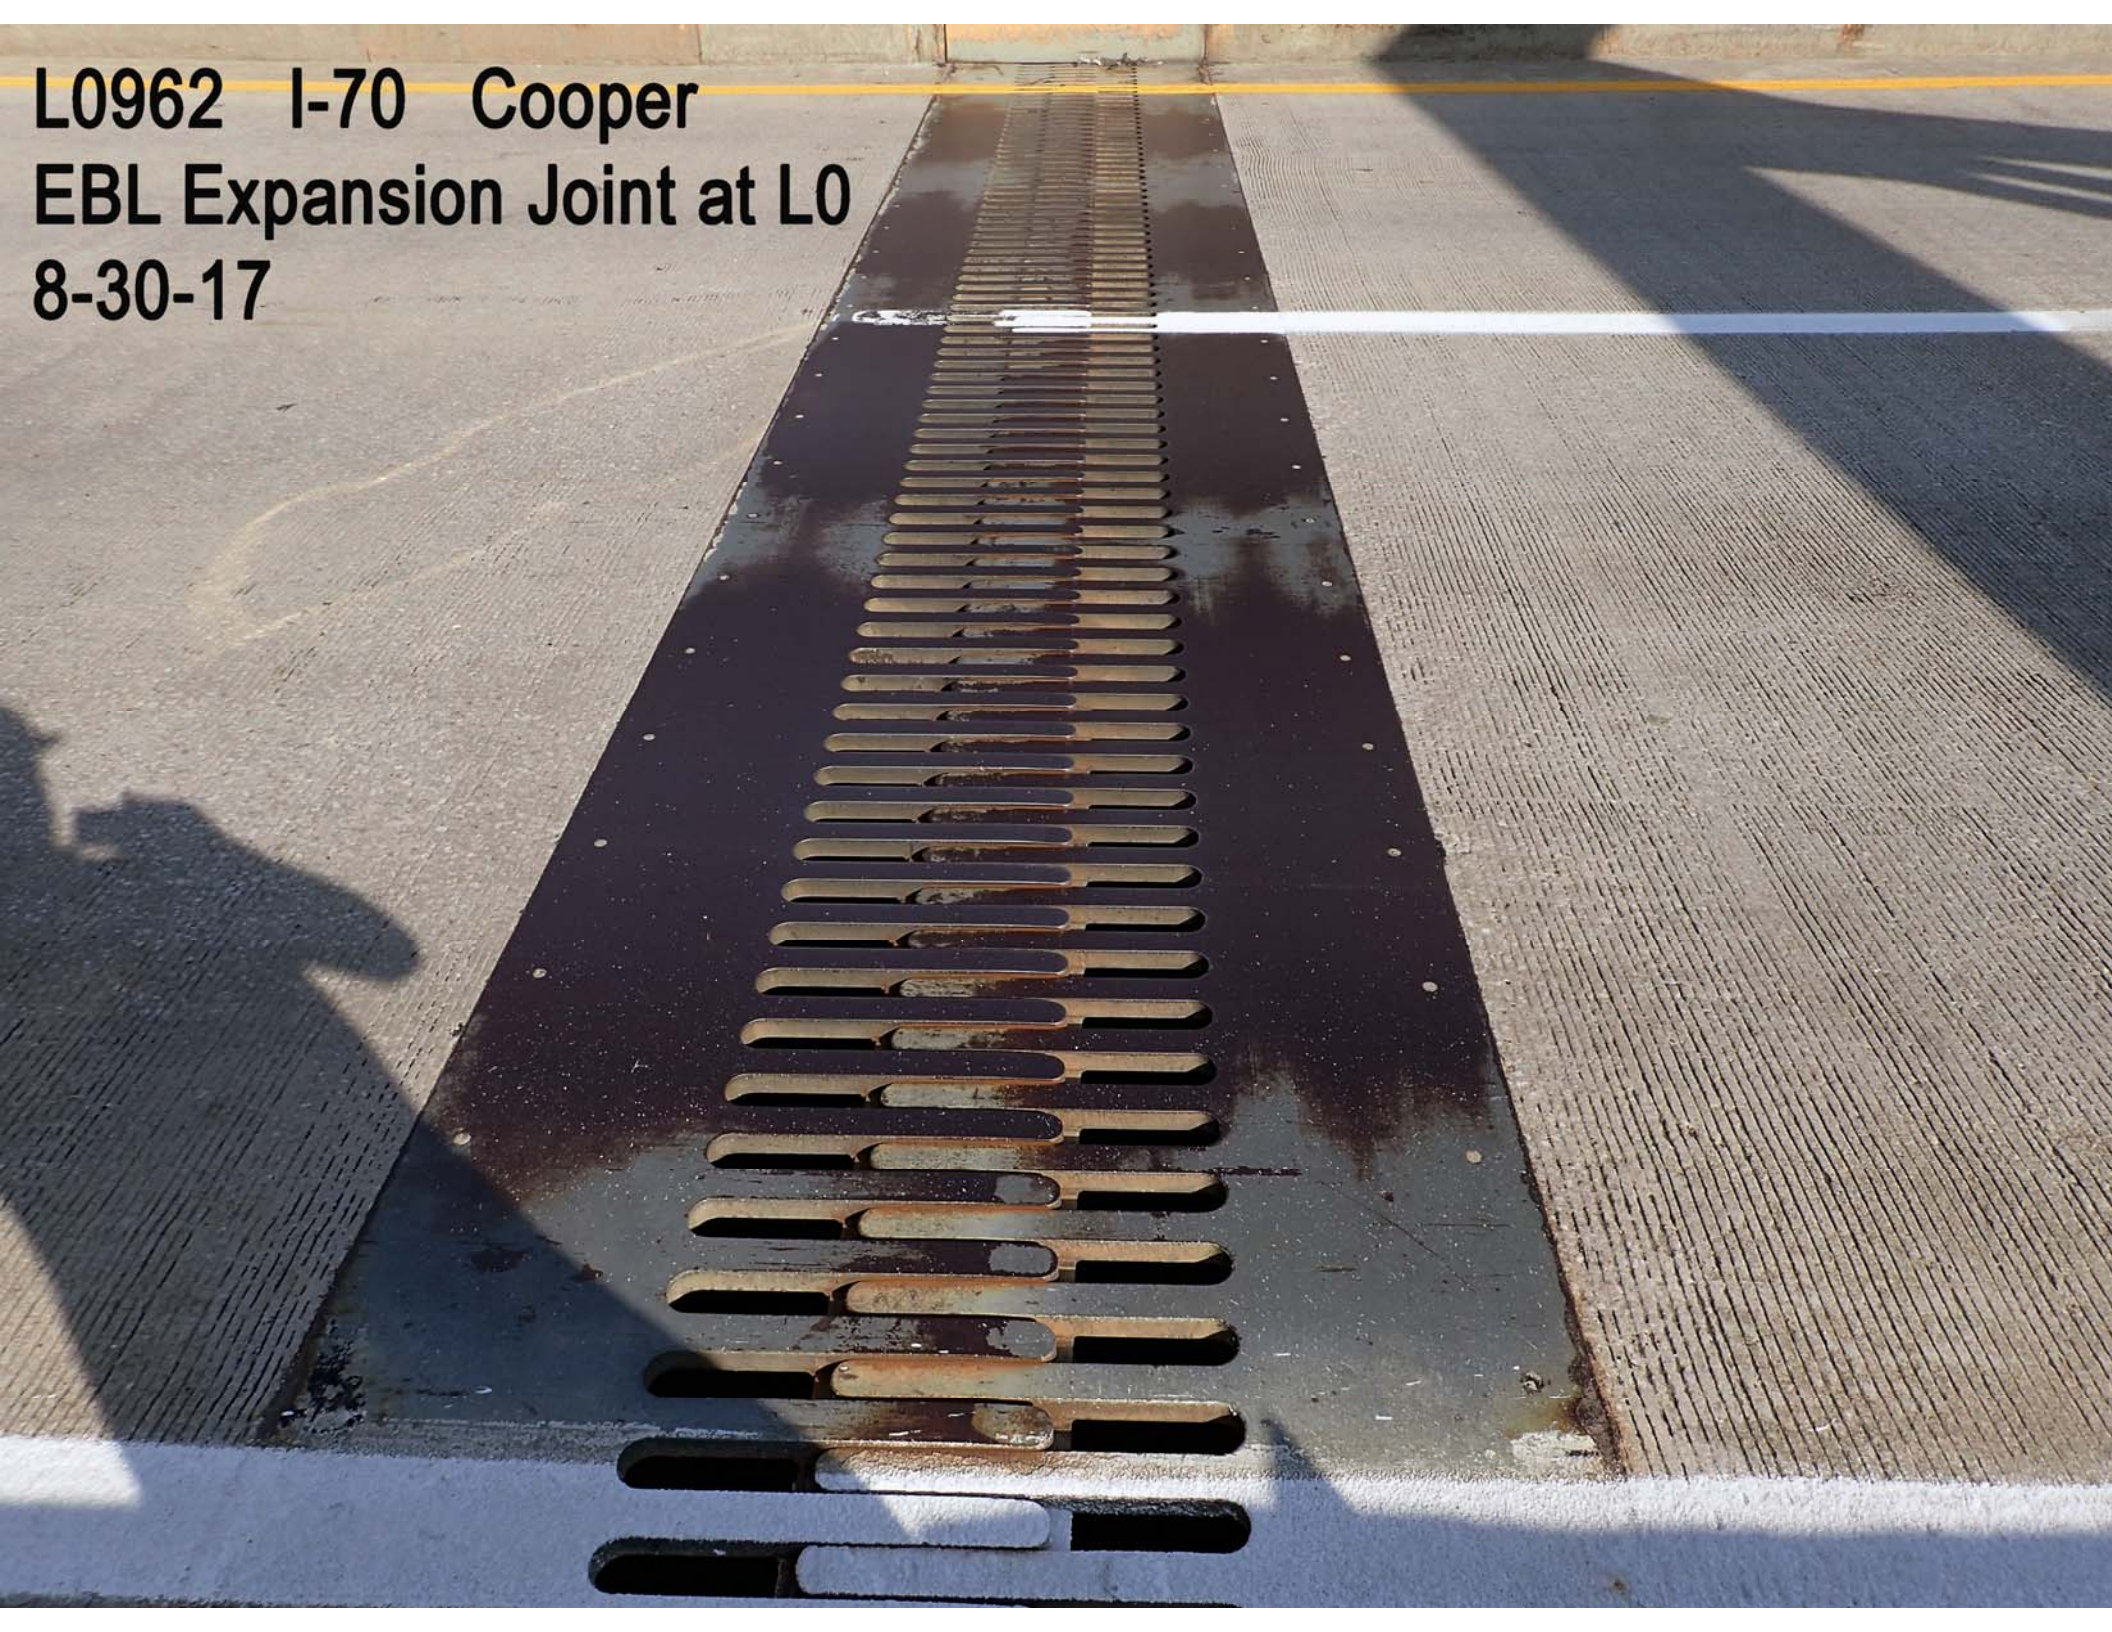
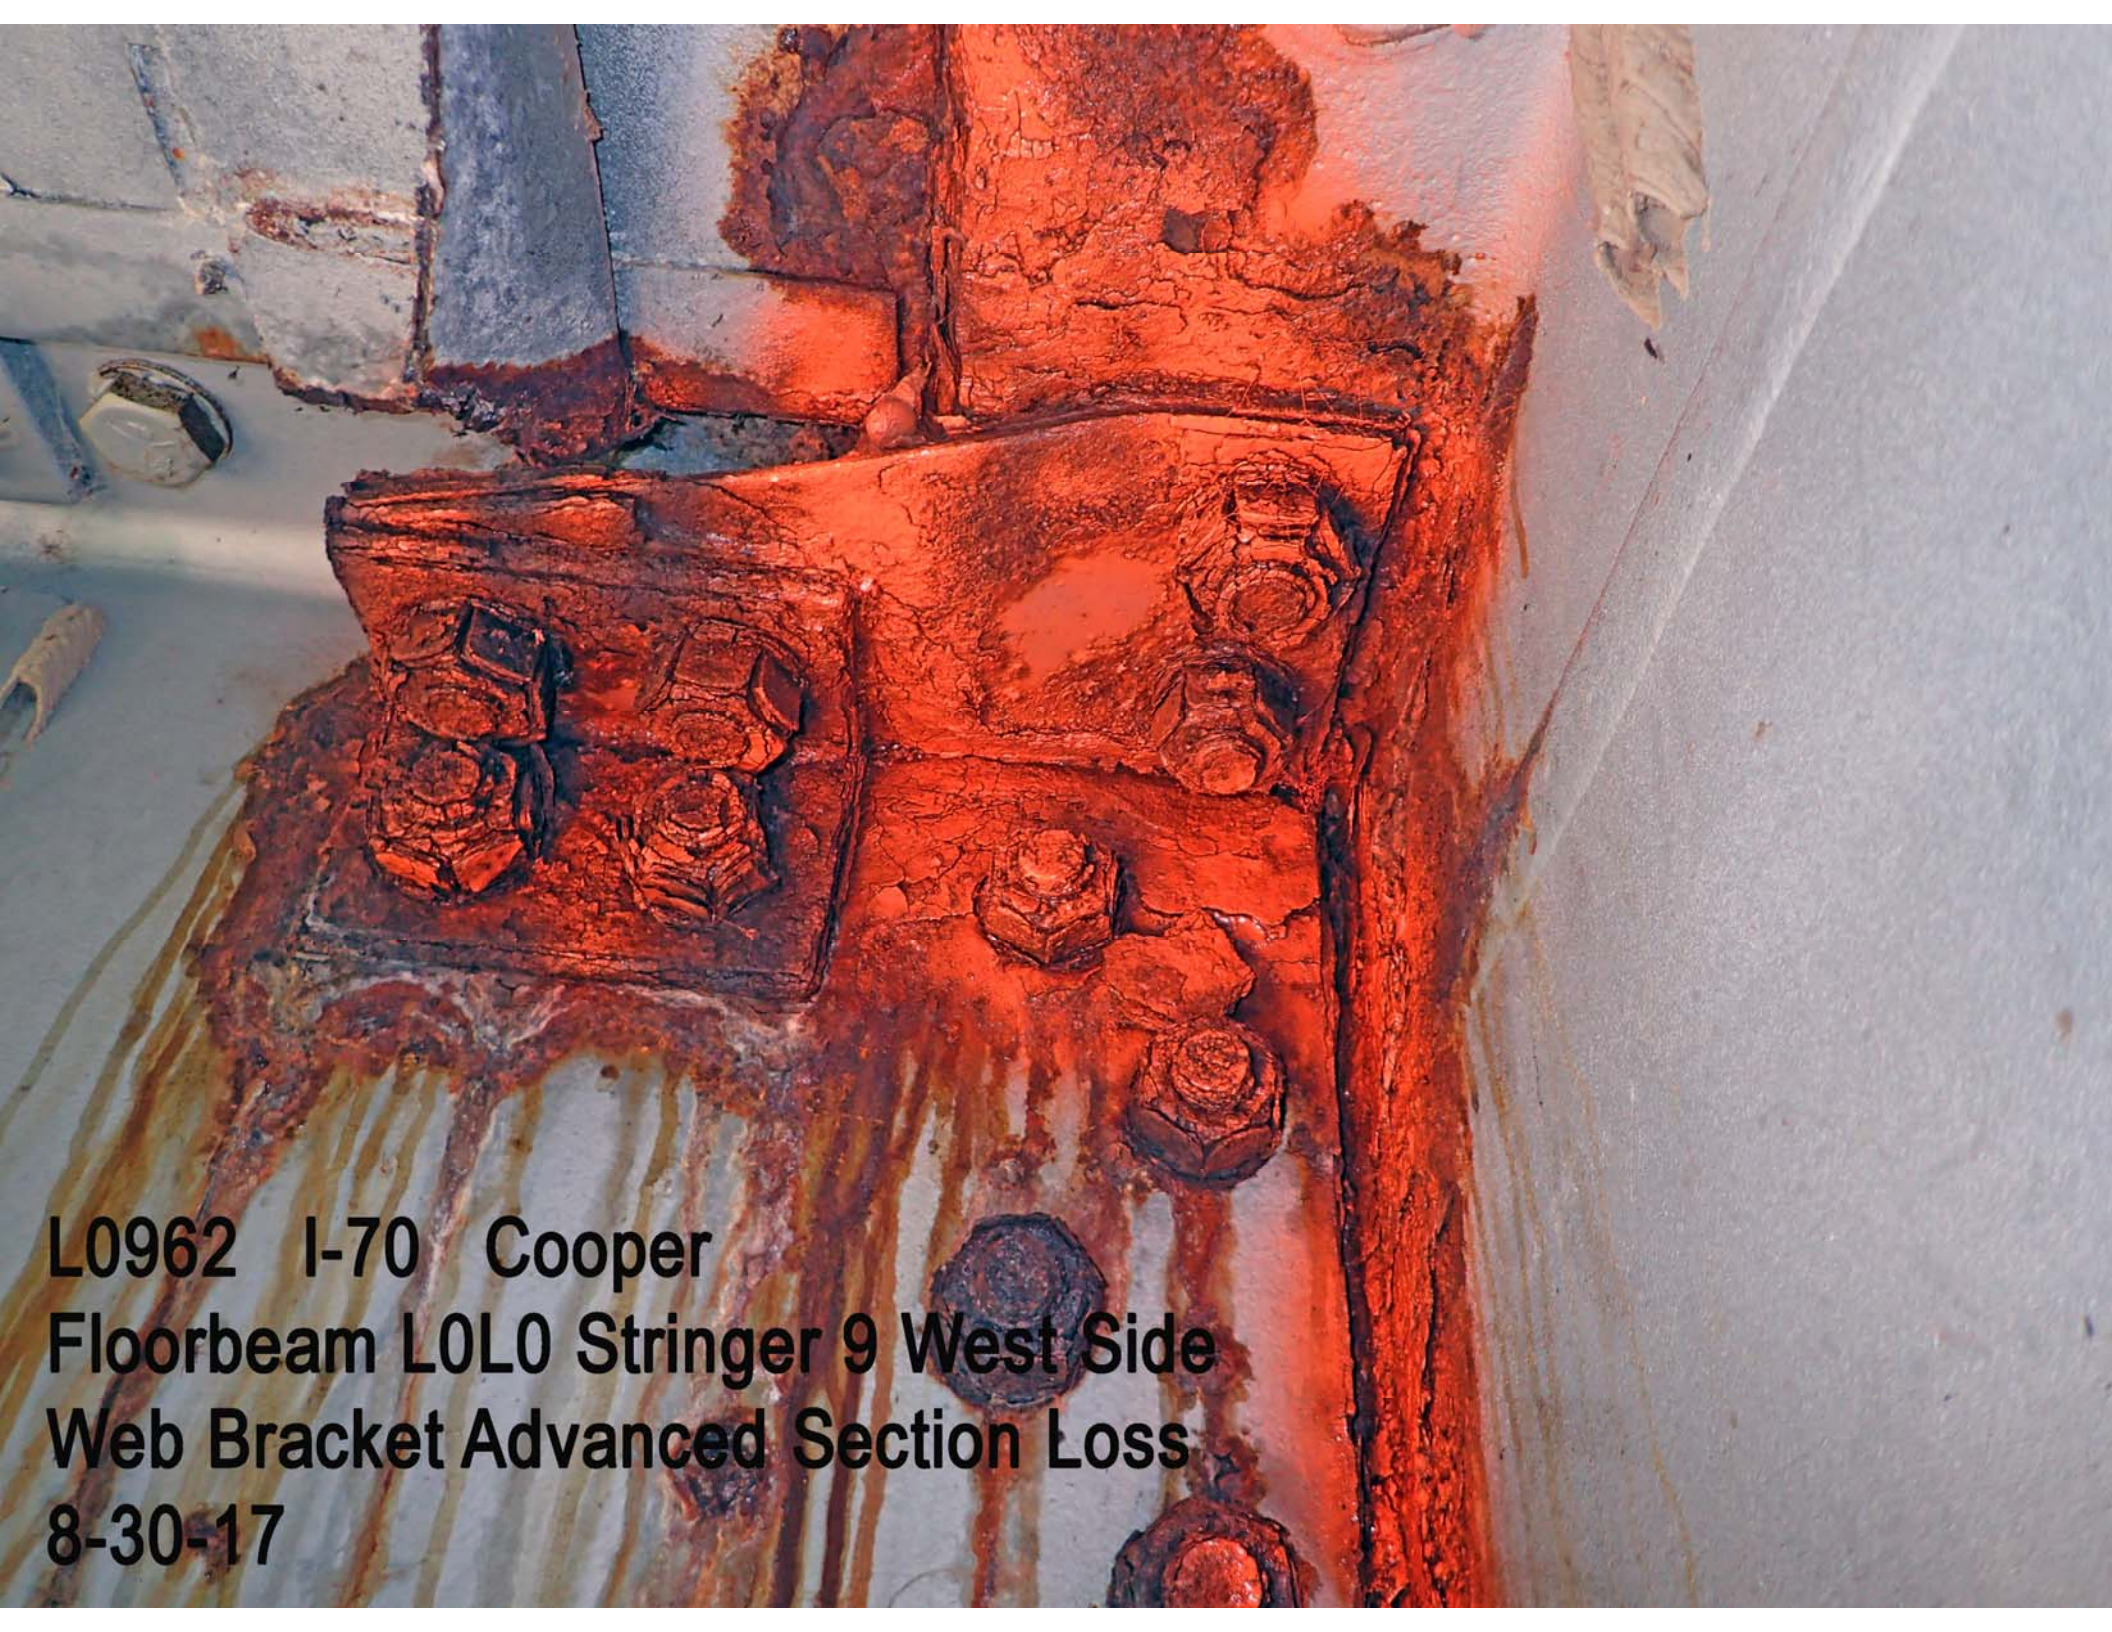
**L0962 I-70 Cooper
Floorbeam L0L0 Stringer 9 West Side
Web Bracket Advanced Section Loss
8-30-17**

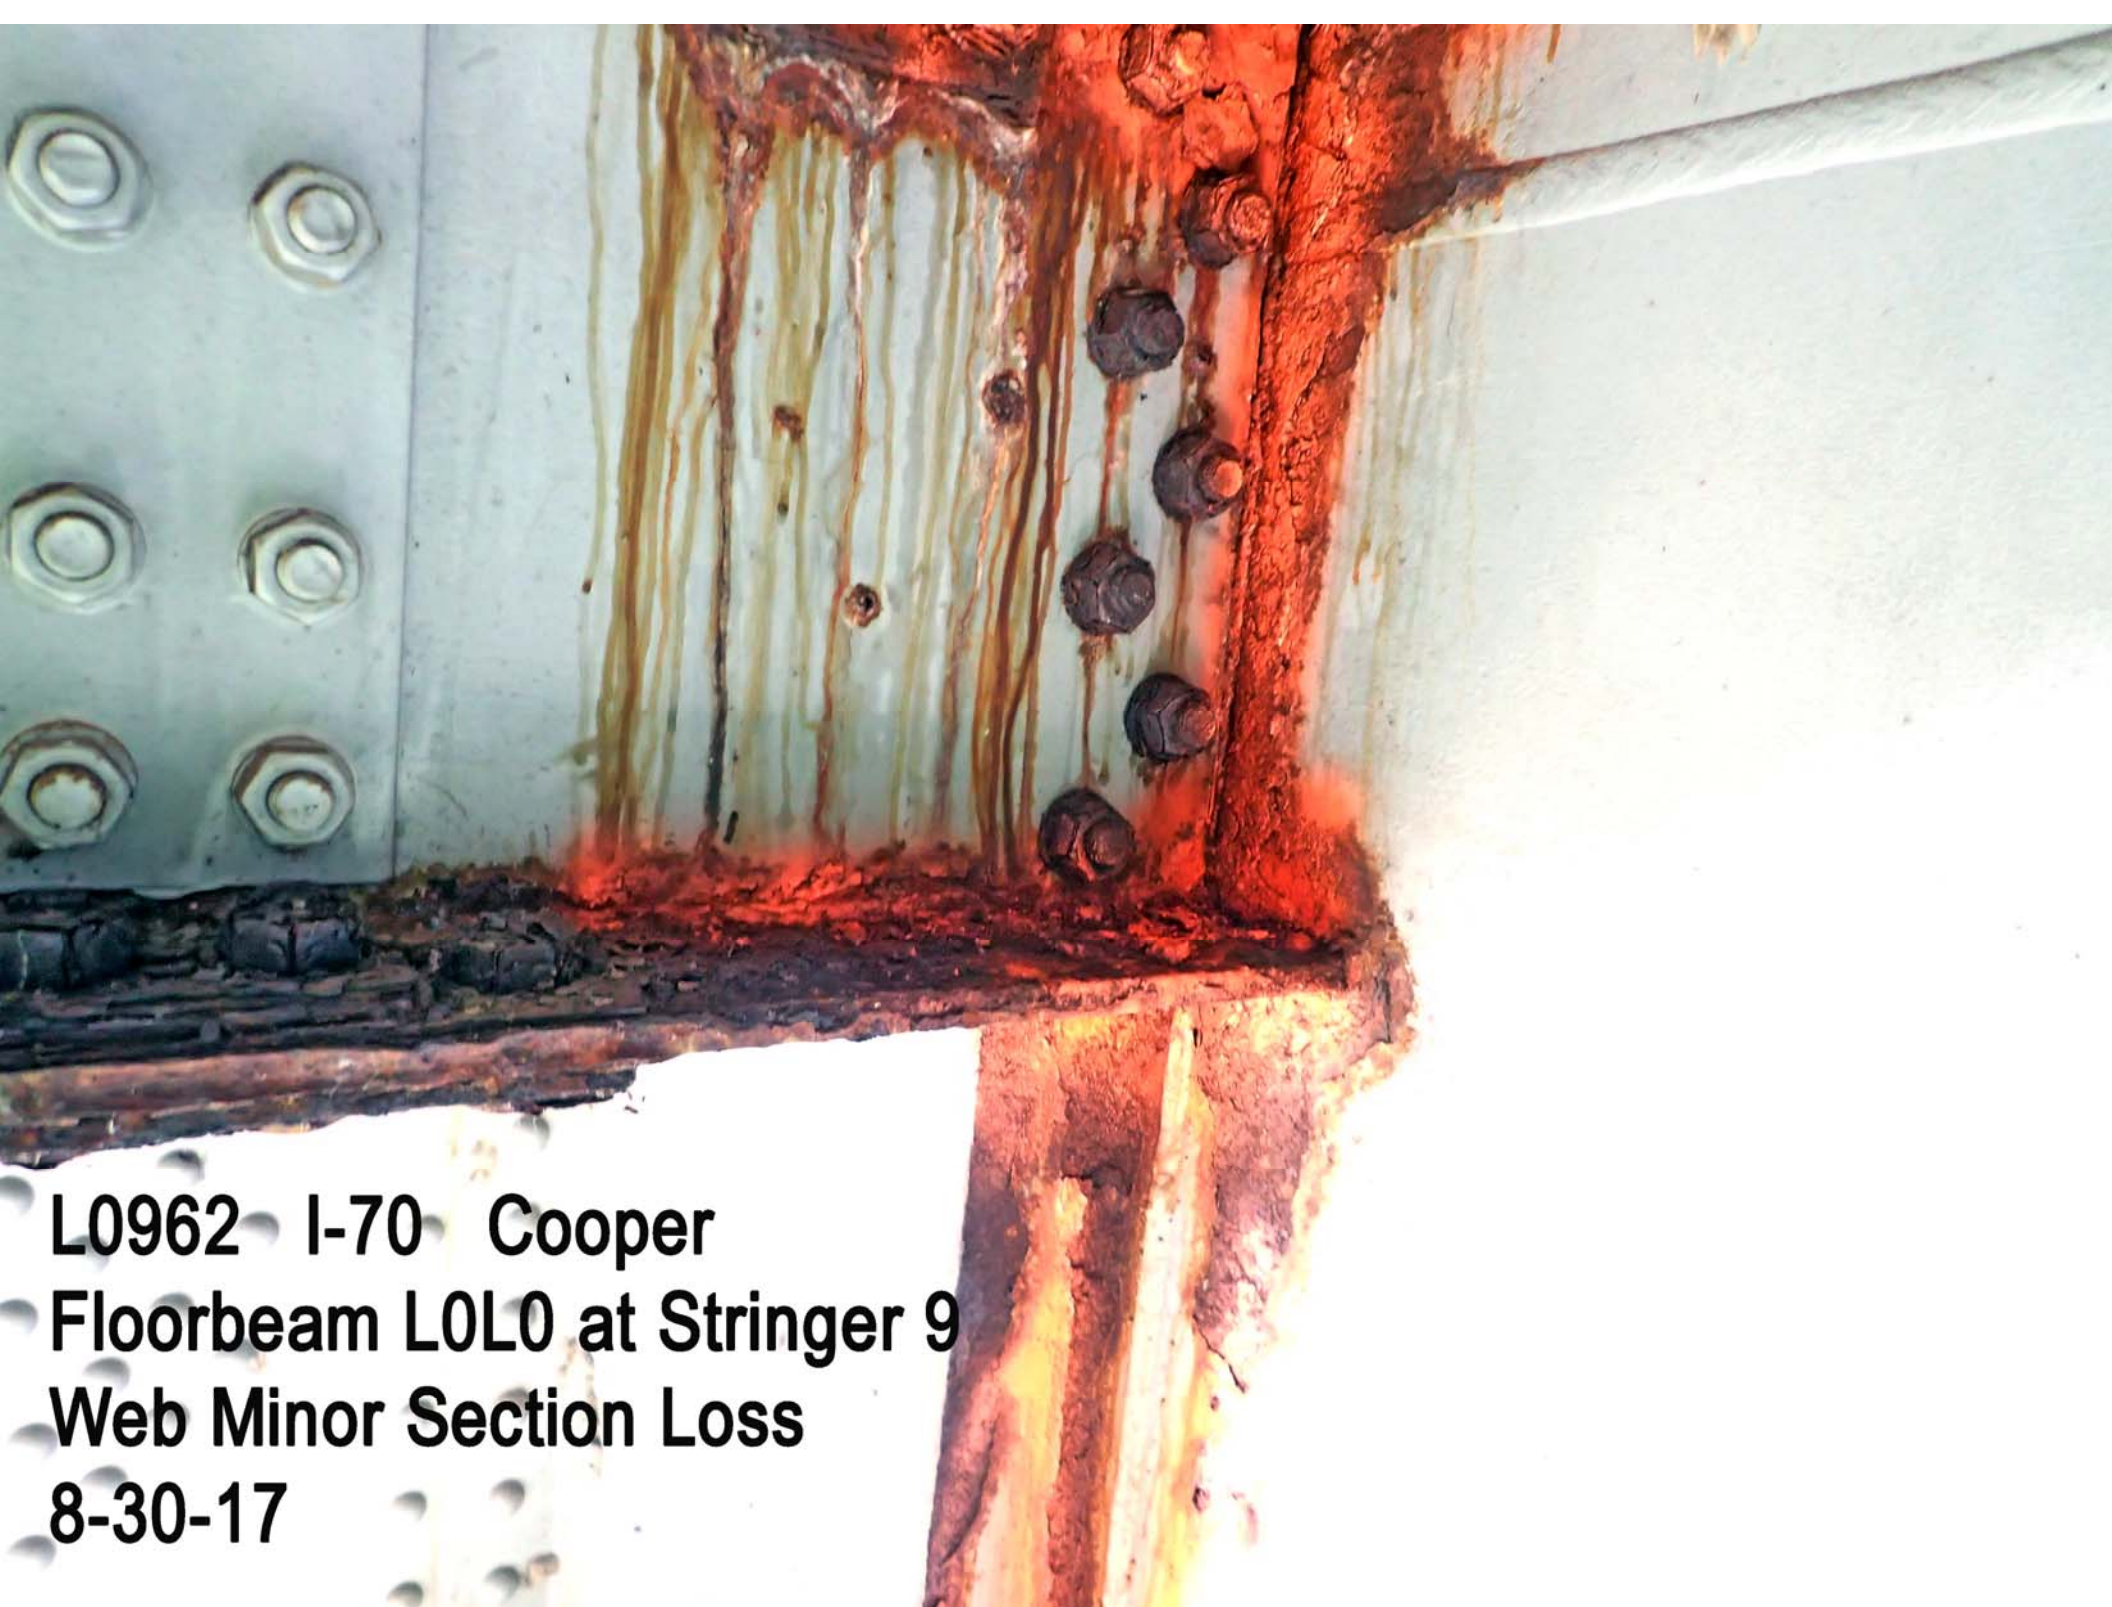
**L0962 I-70 Cooper
Floorbeam L0L0 at Stringer 9
Web Minor Section Loss
8-30-17**

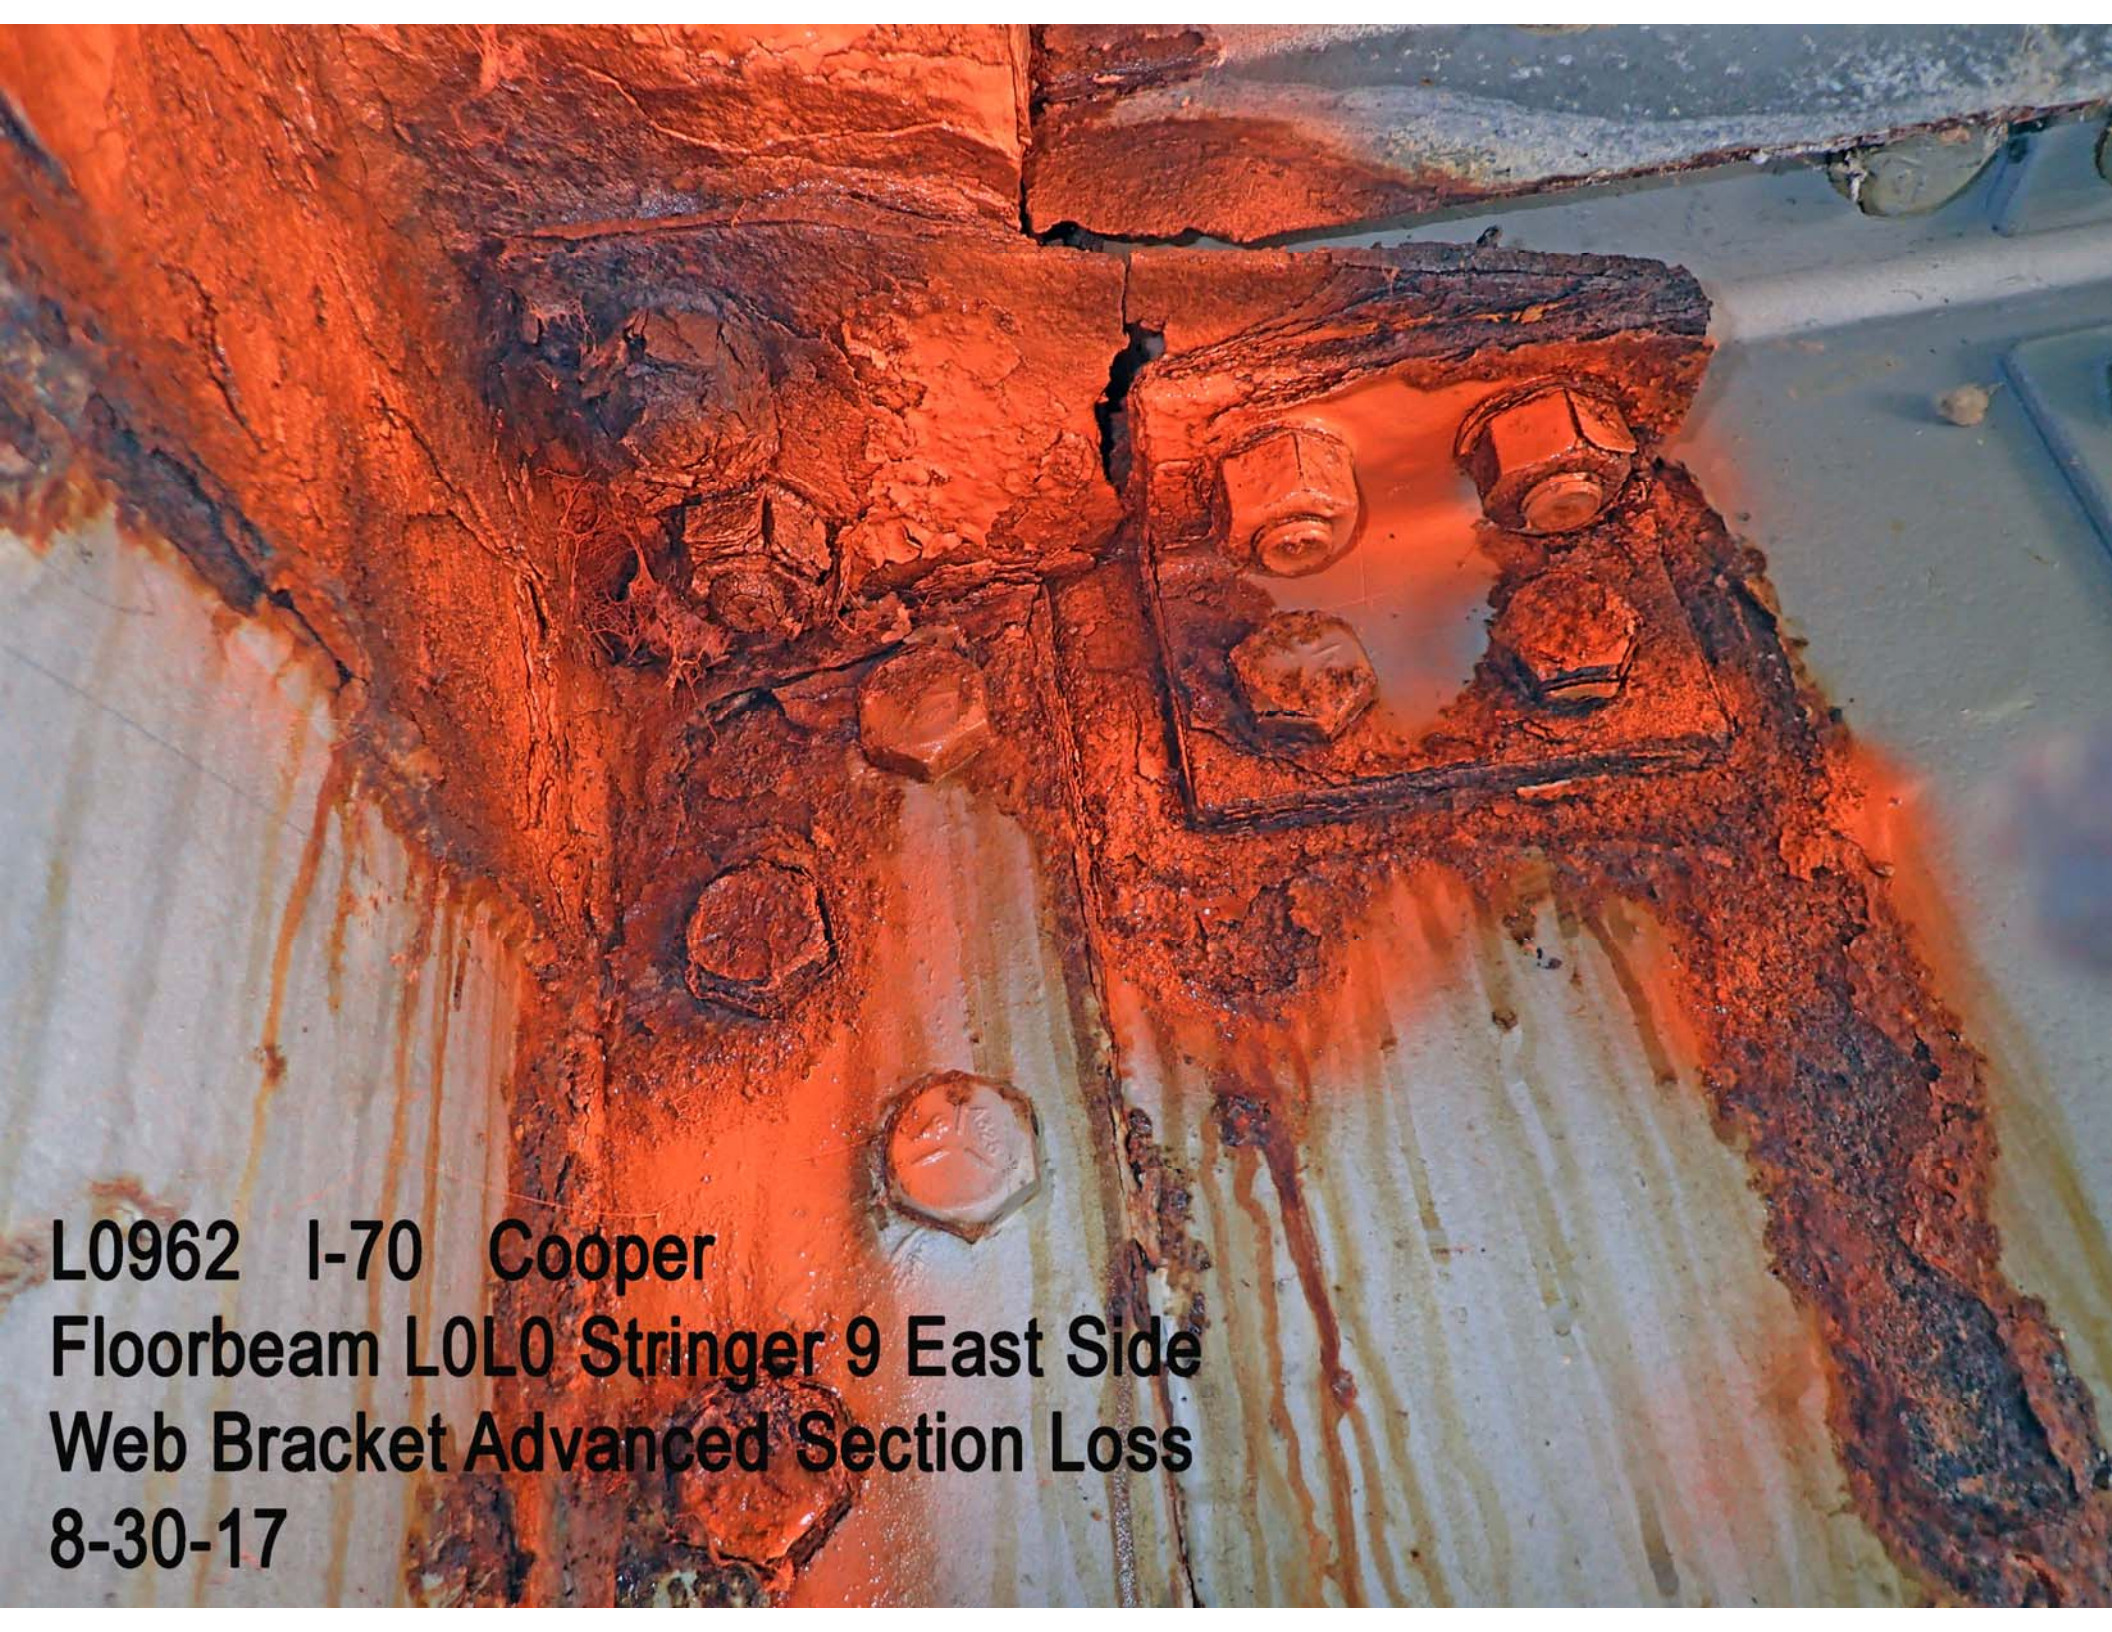
**L0962 I-70 Cooper
Floorbeam L0L0 Stringer 9 East Side
Web Bracket Advanced Section Loss
8-30-17**

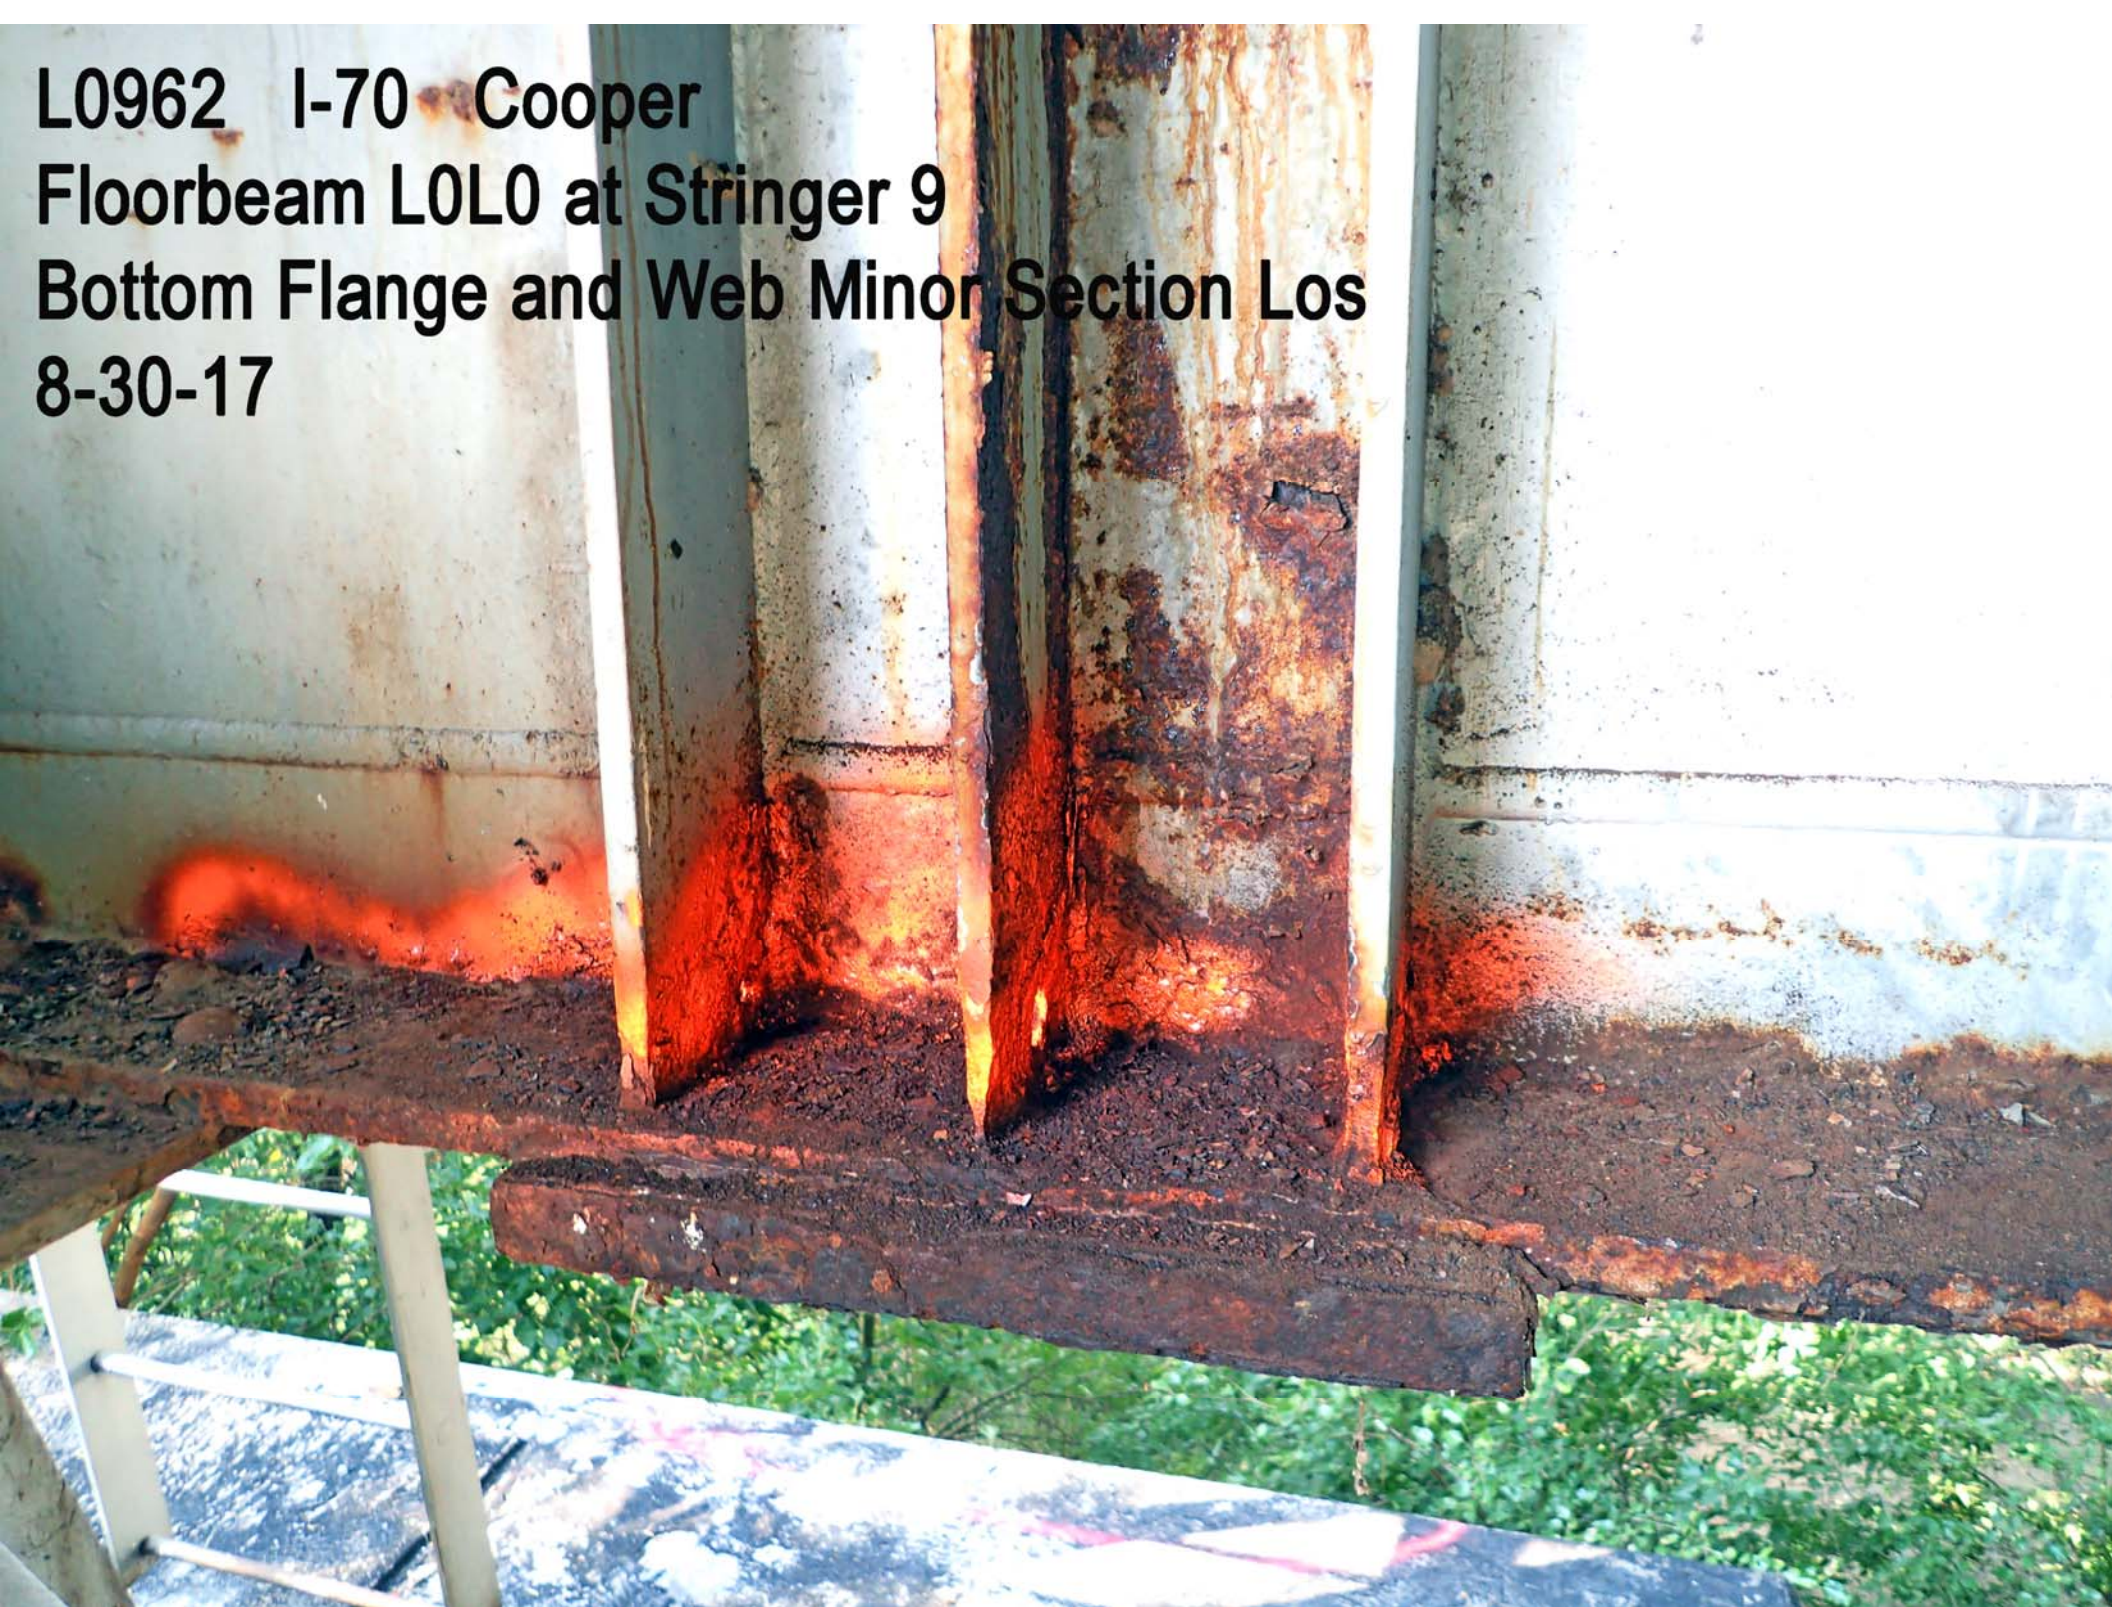
**L0962 I-70 Cooper
Floorbeam L0L0 at Stringer 9
Bottom Flange and Web Minor Section Los
8-30-17**

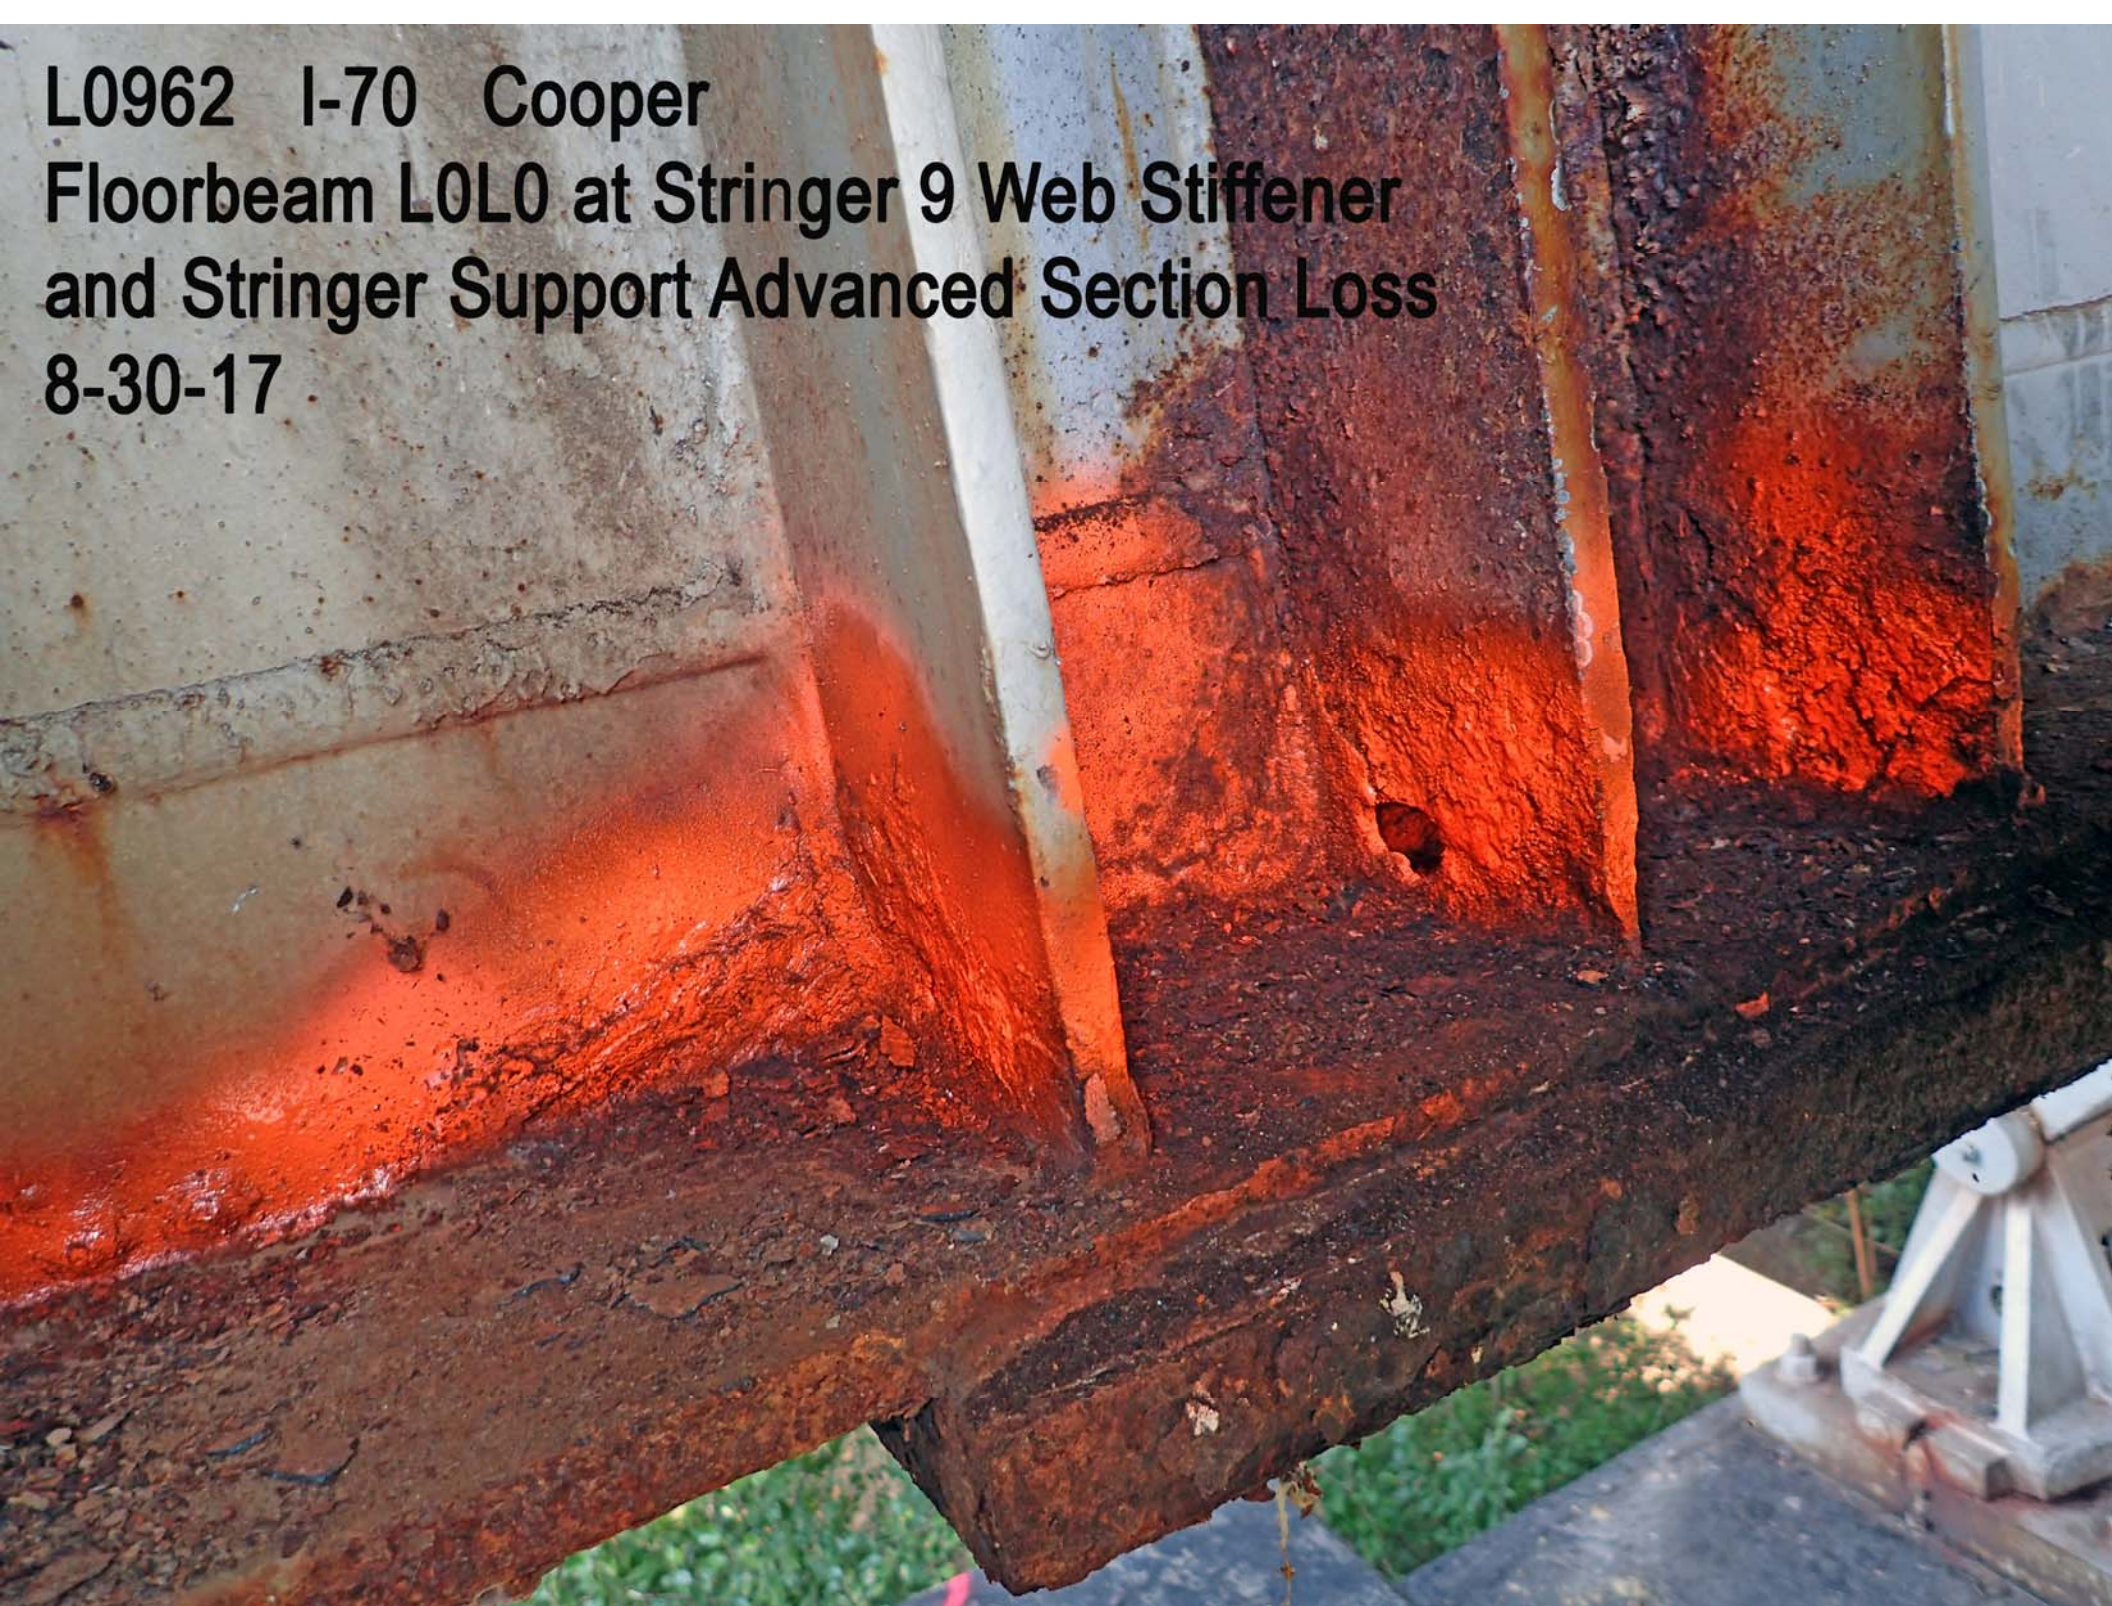
**L0962 I-70 Cooper
Floorbeam L0L0 at Stringer 9 Web Stiffener
and Stringer Support Advanced Section Loss
8-30-17**
