L0962 Cooper Co.
08/28/2017
Looking West

L0962 I-70 Cooper
Pier 15 Open Expansion Joint WBL
8-28-17

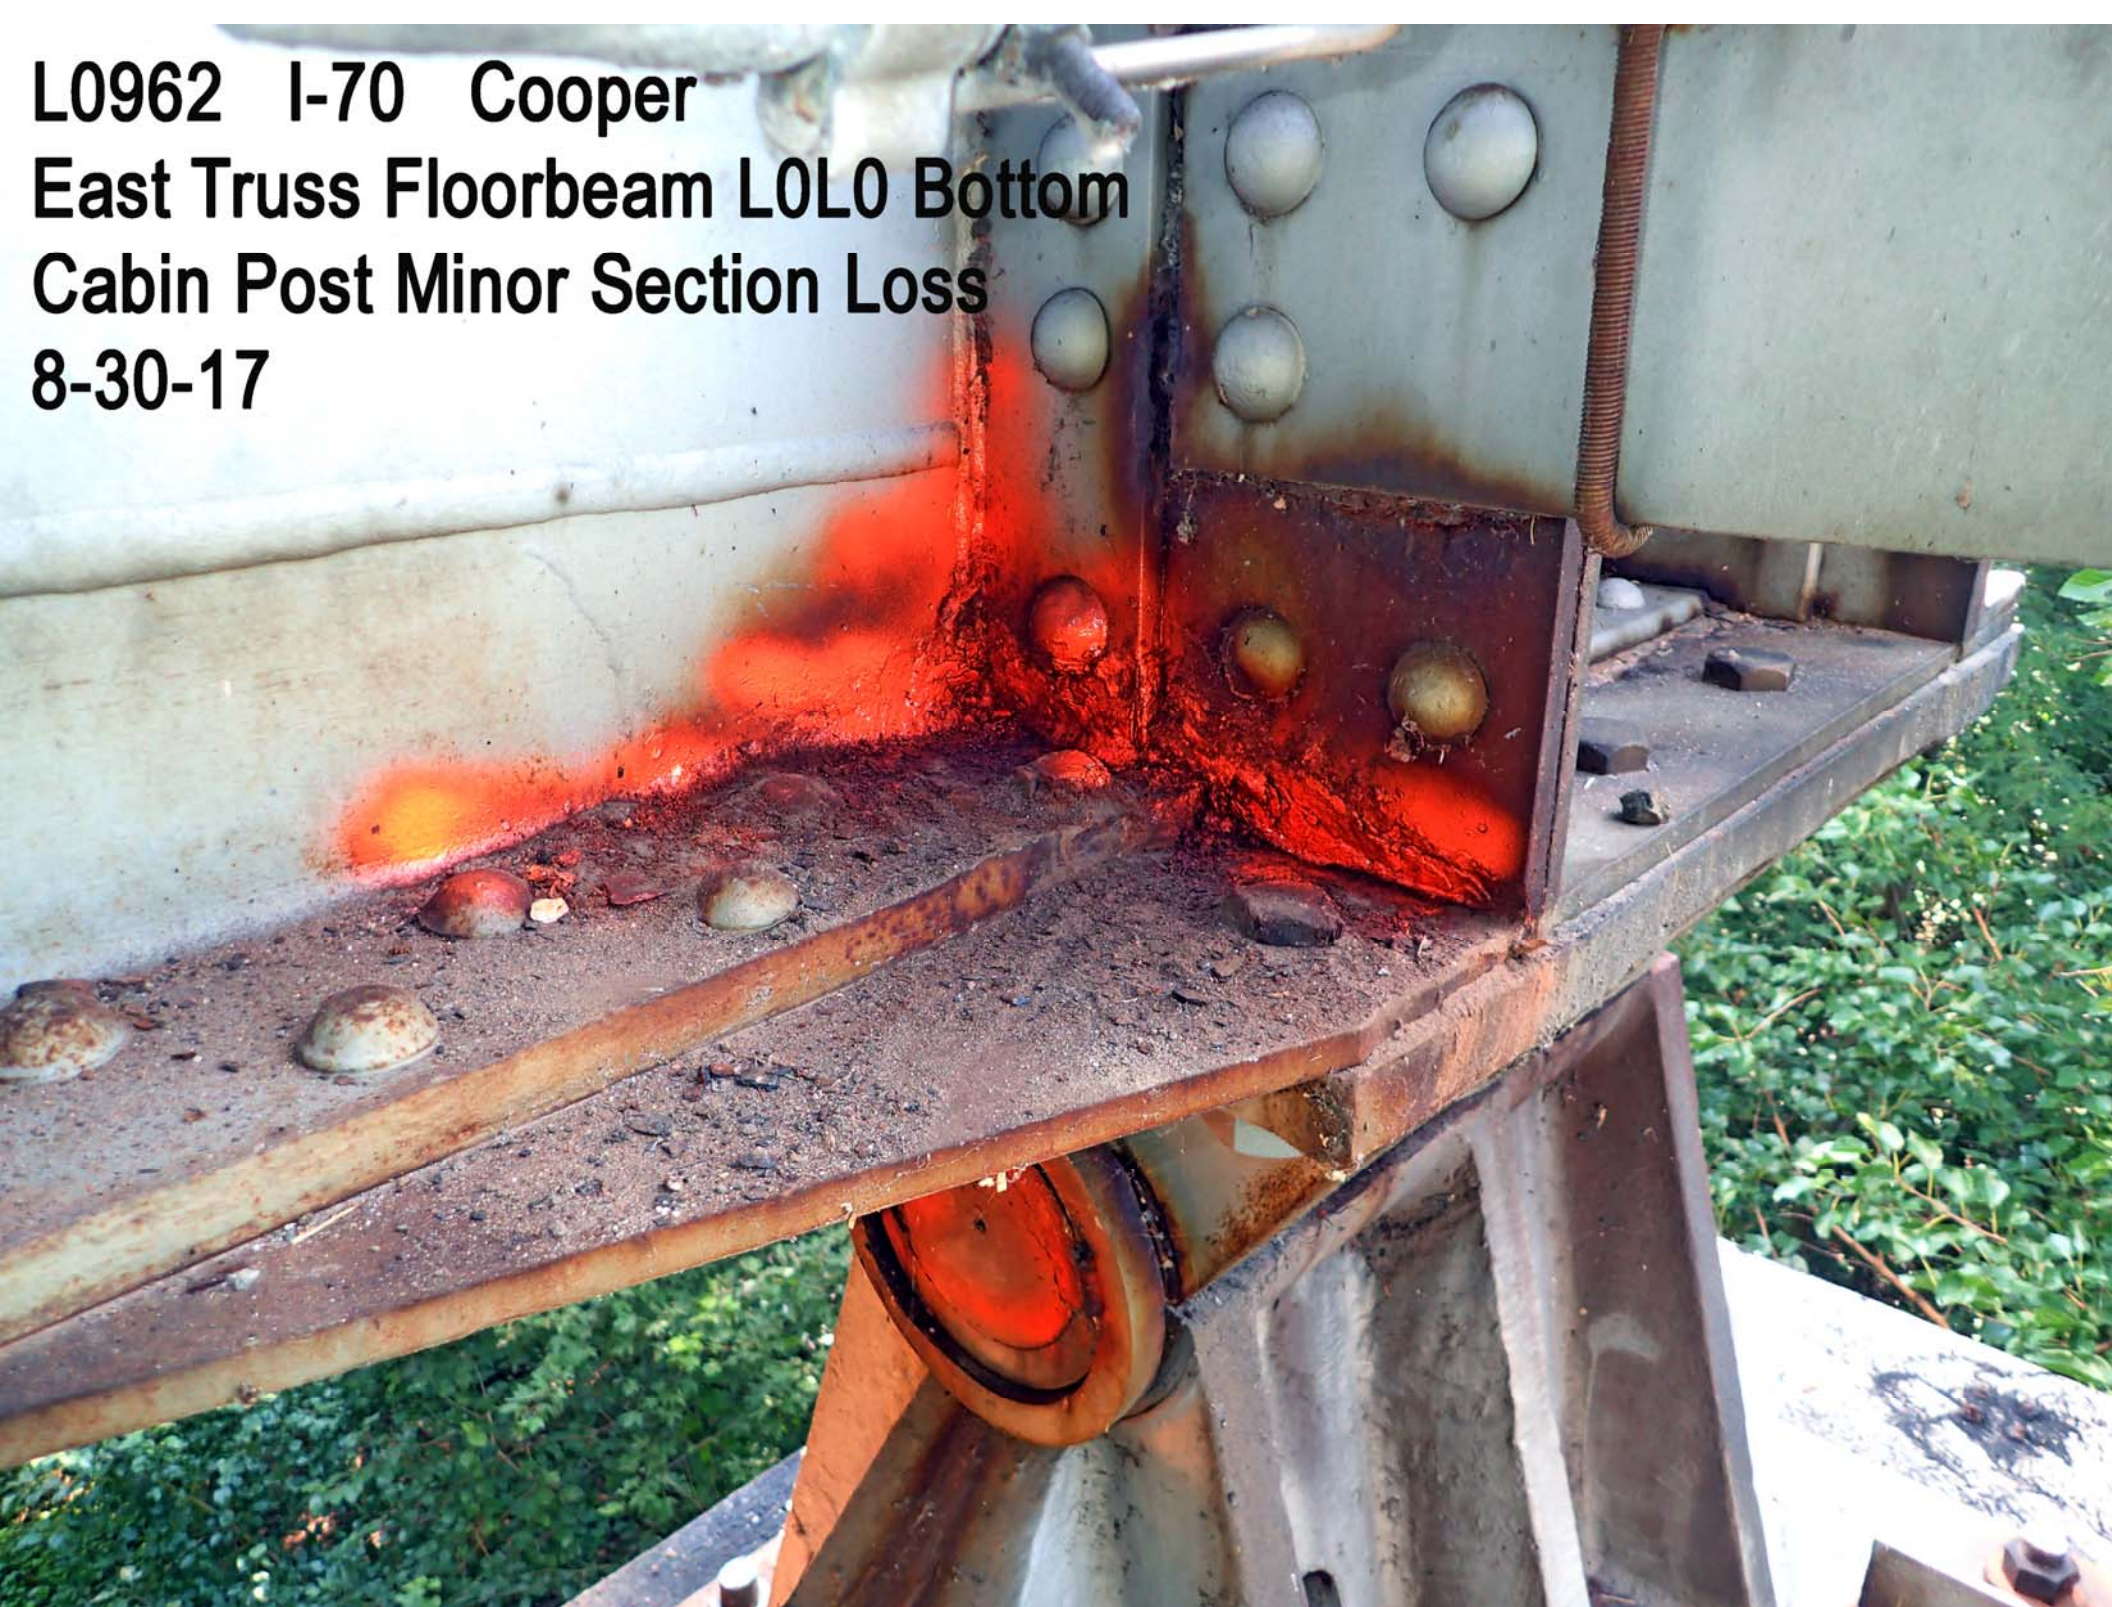
L0962 I-70 Cooper
East Truss Floorbeam L0L0 Bottom
Cabin Post Minor Section Loss
8-30-17

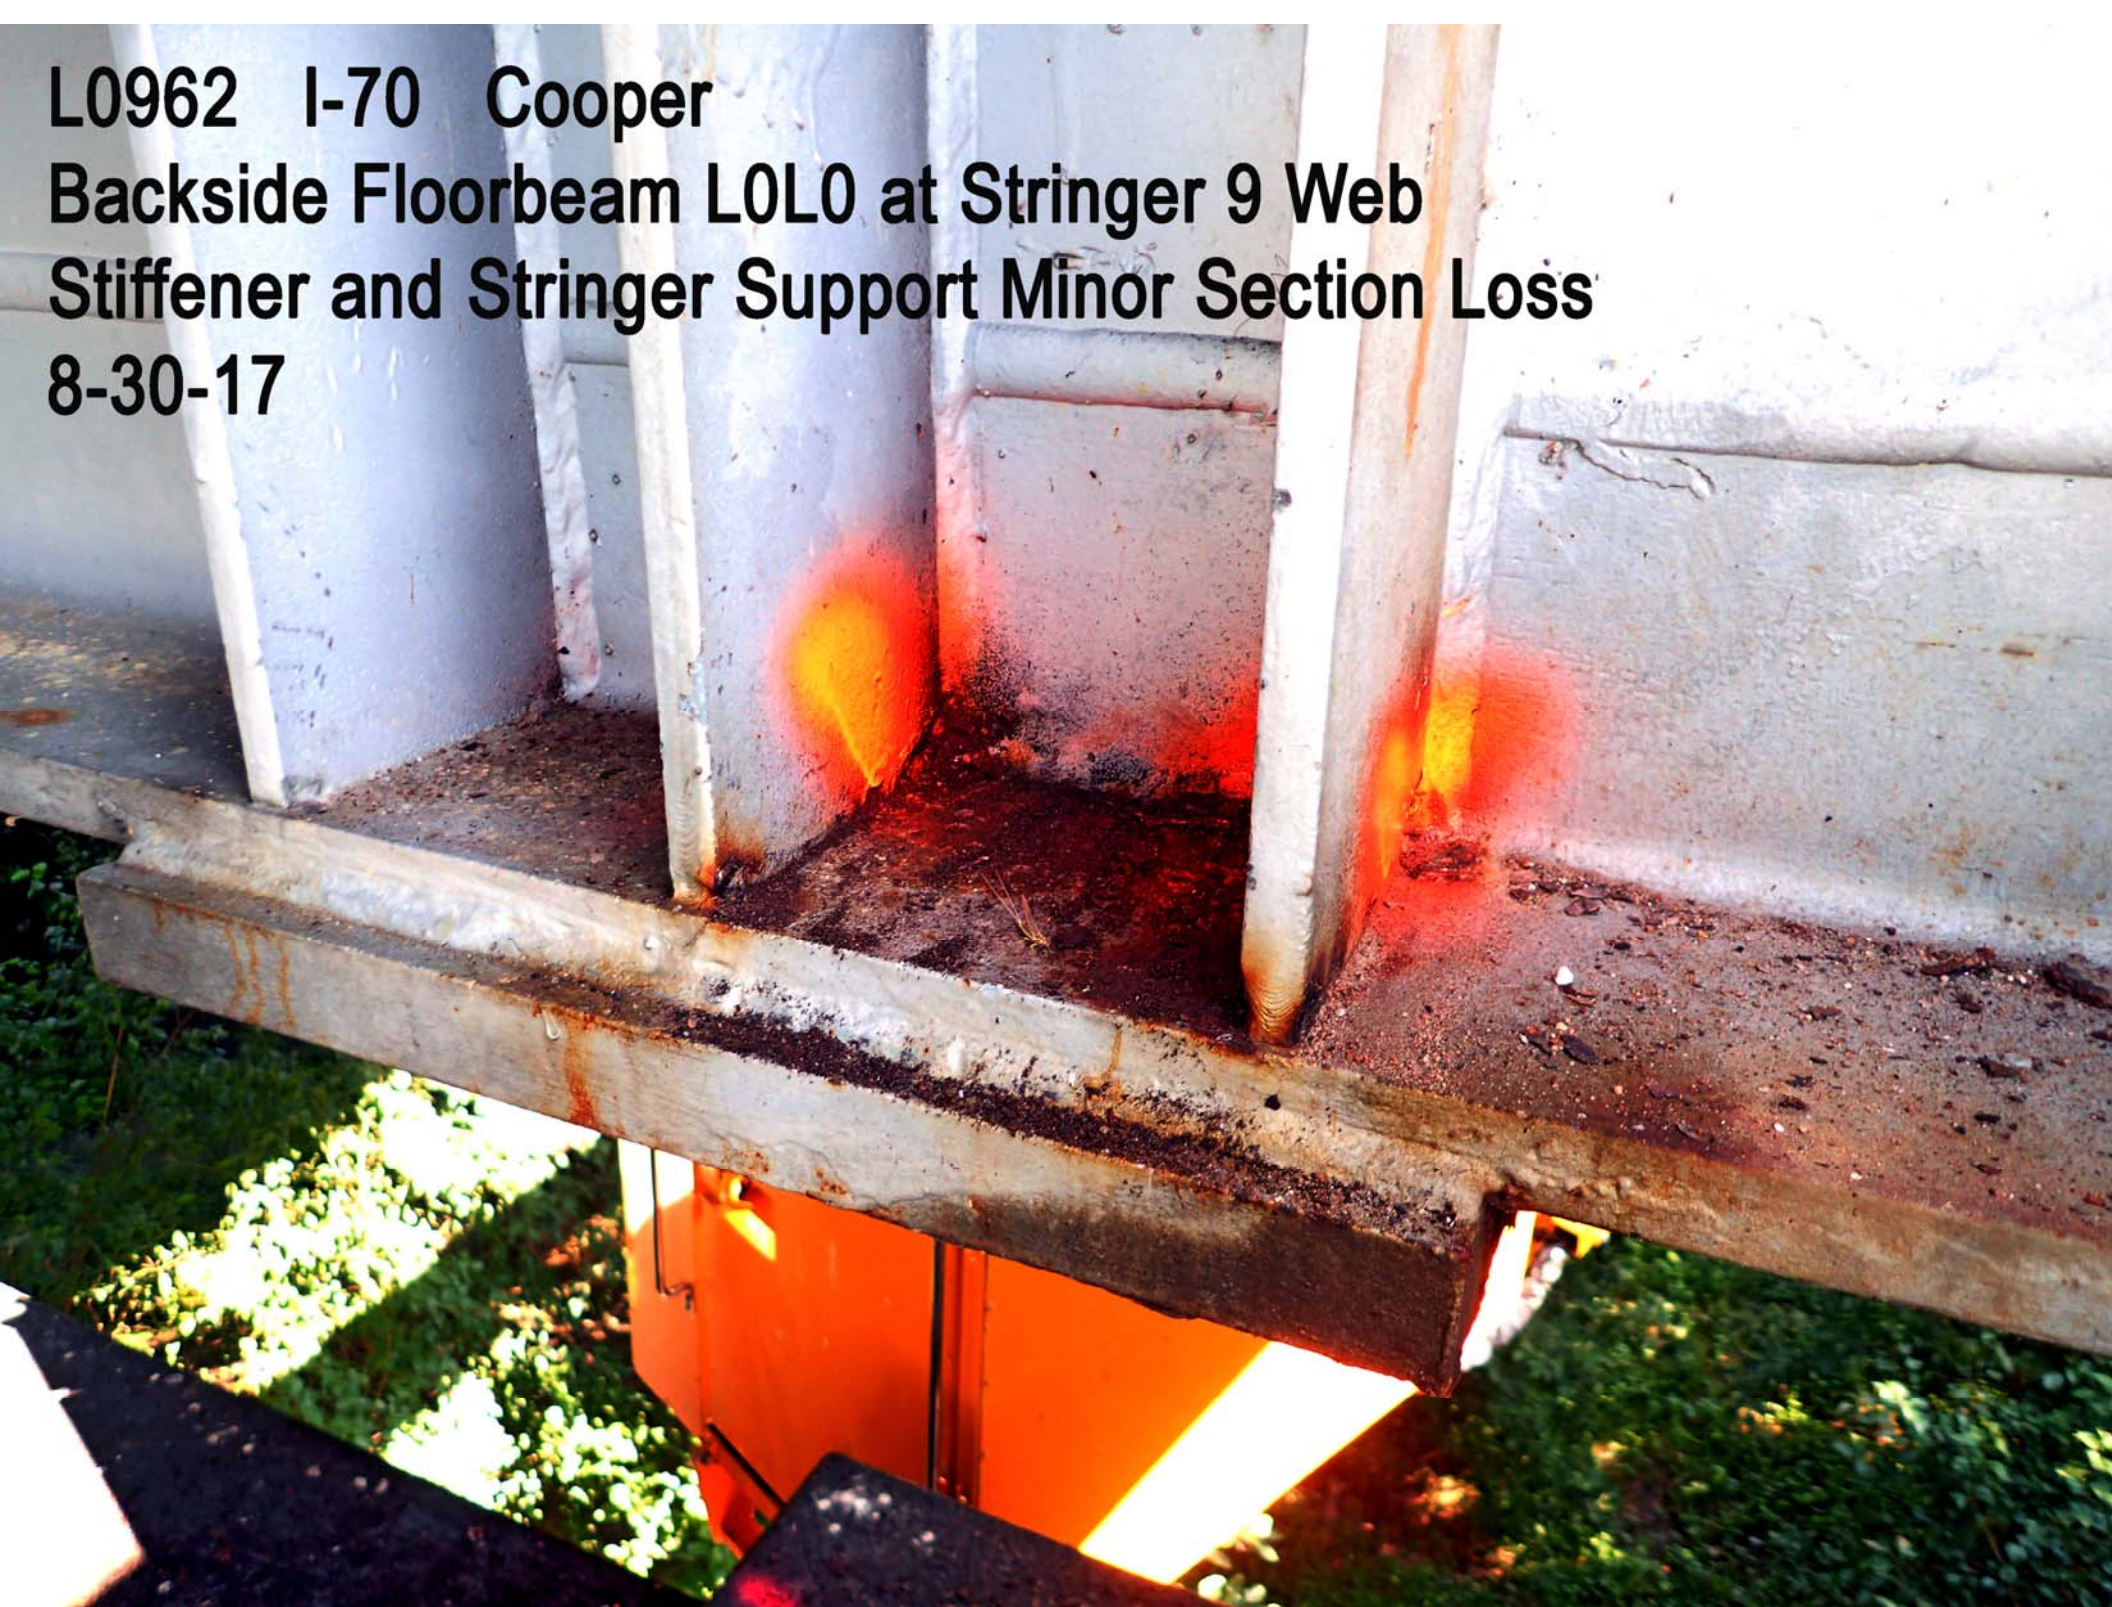
L0962 I-70 Cooper
Backside Floorbeam L0L0 at Stringer 9 Web
Stiffener and Stringer Support Minor Section Loss
8-30-17

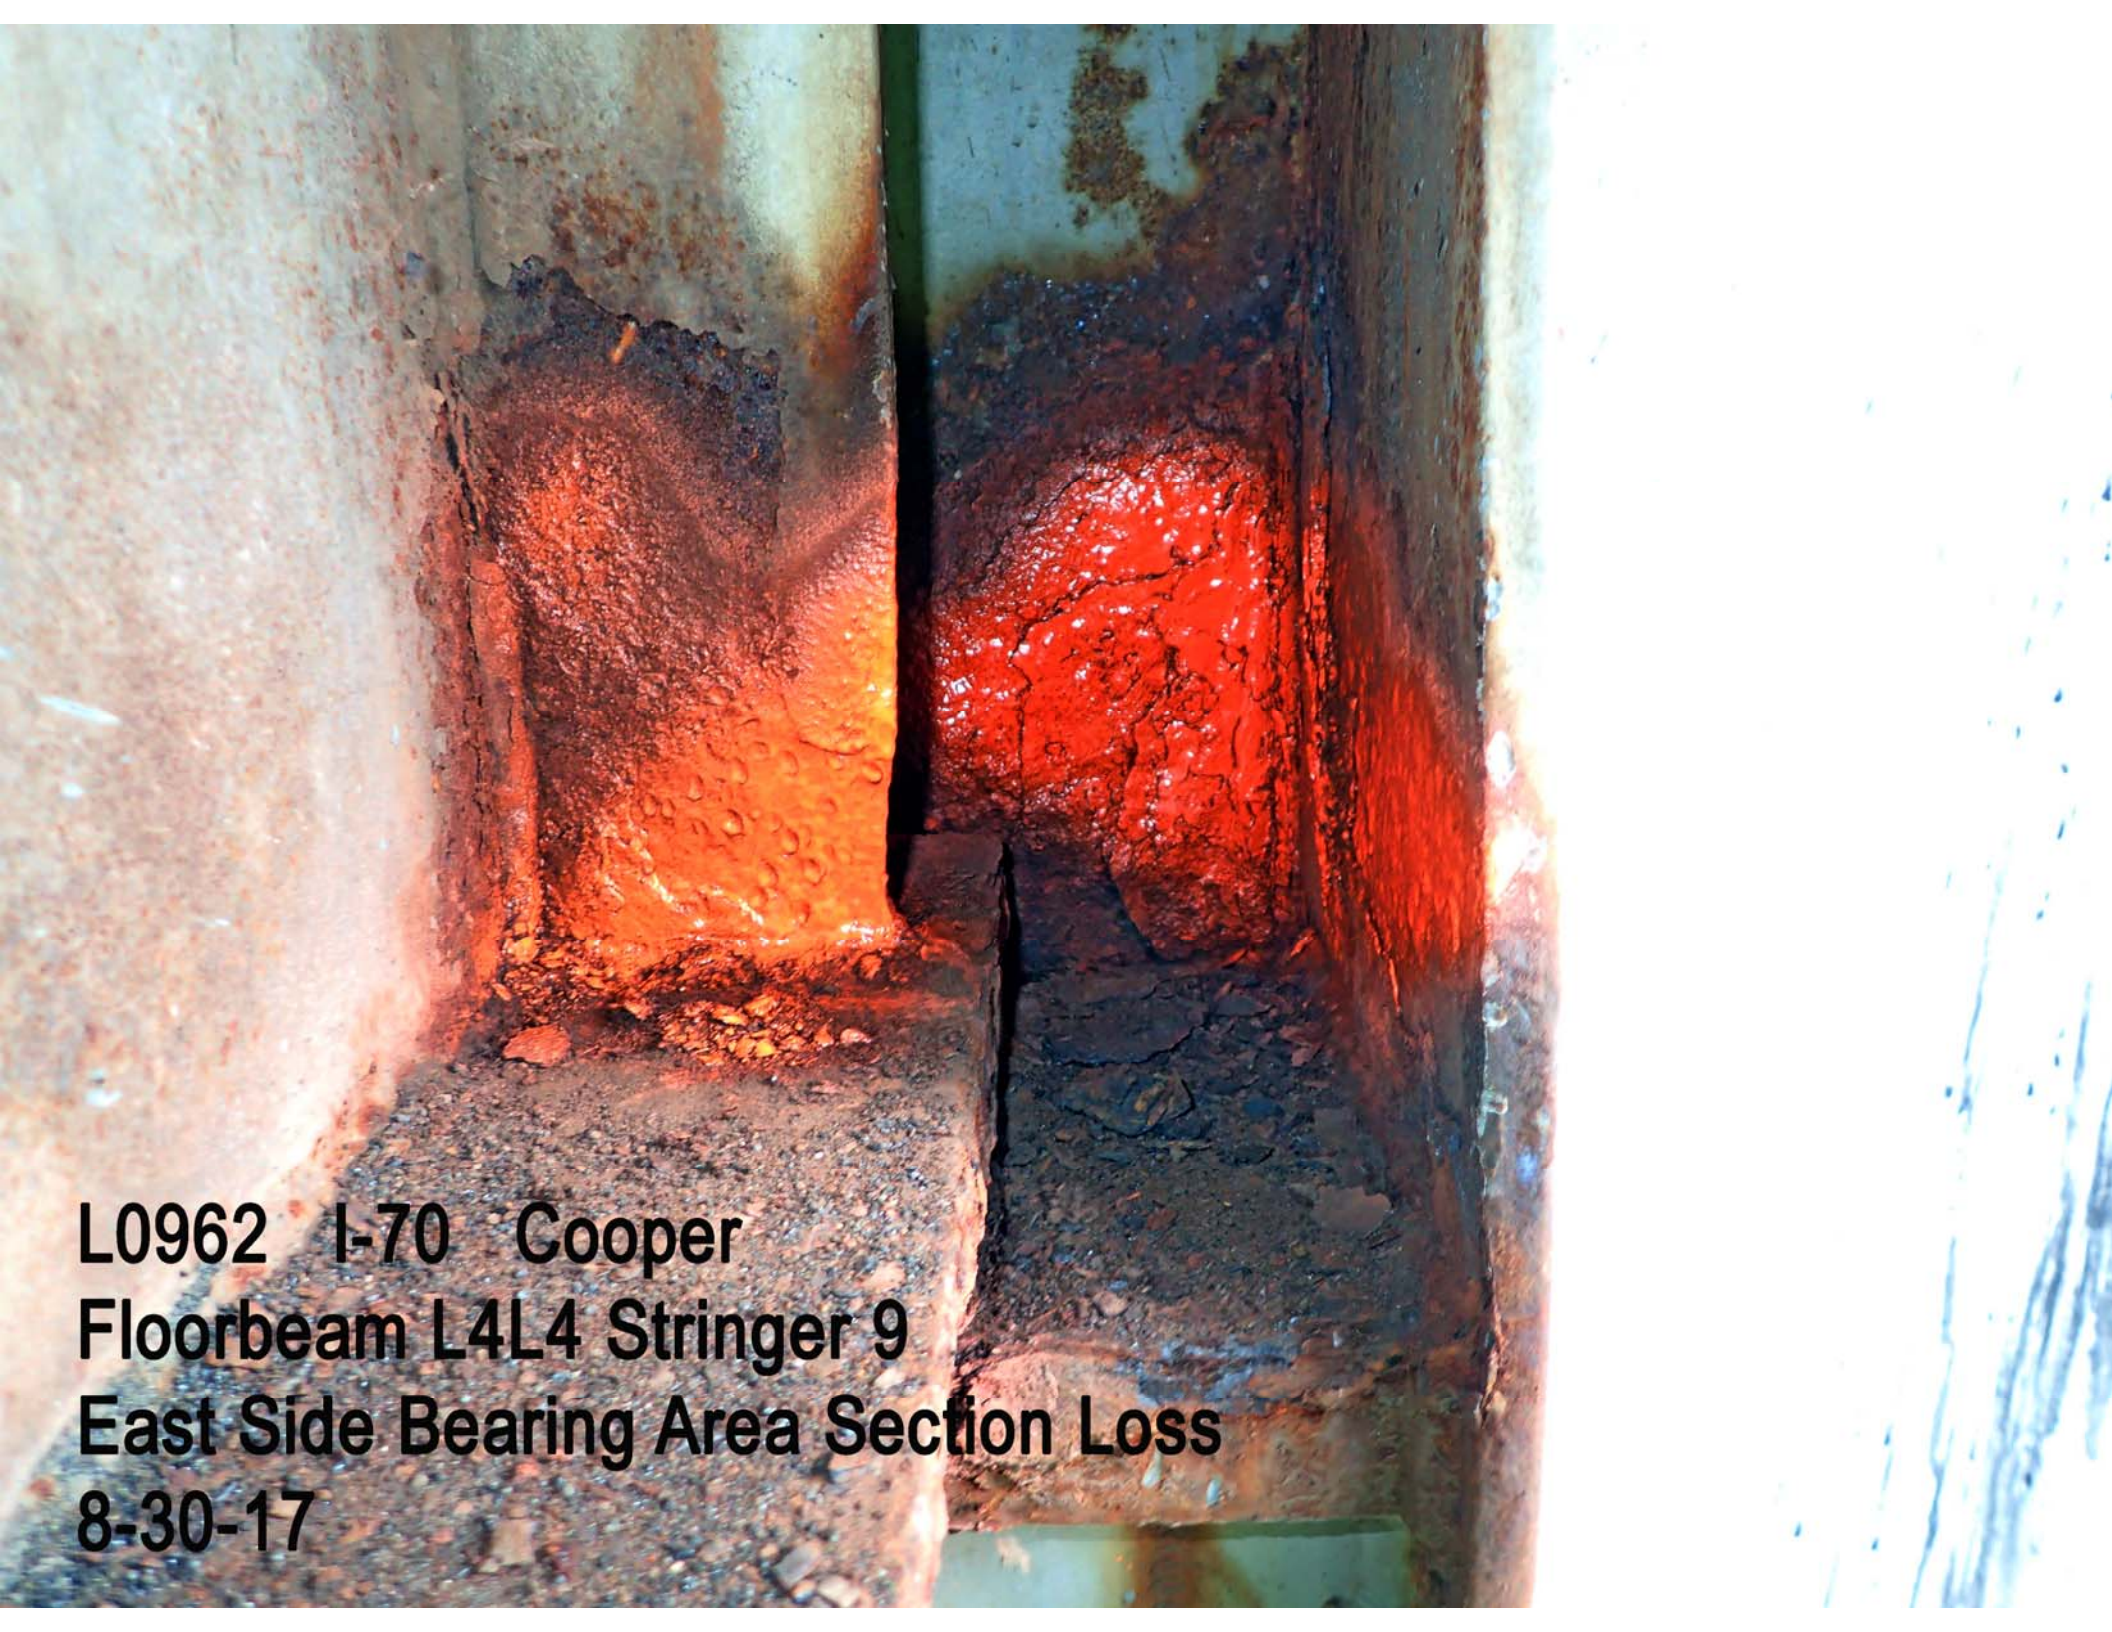
L0962 I-70 Cooper
Floorbeam L3L3 Center X-brace
Guset Plate Advanced Section Loss
8-30-17

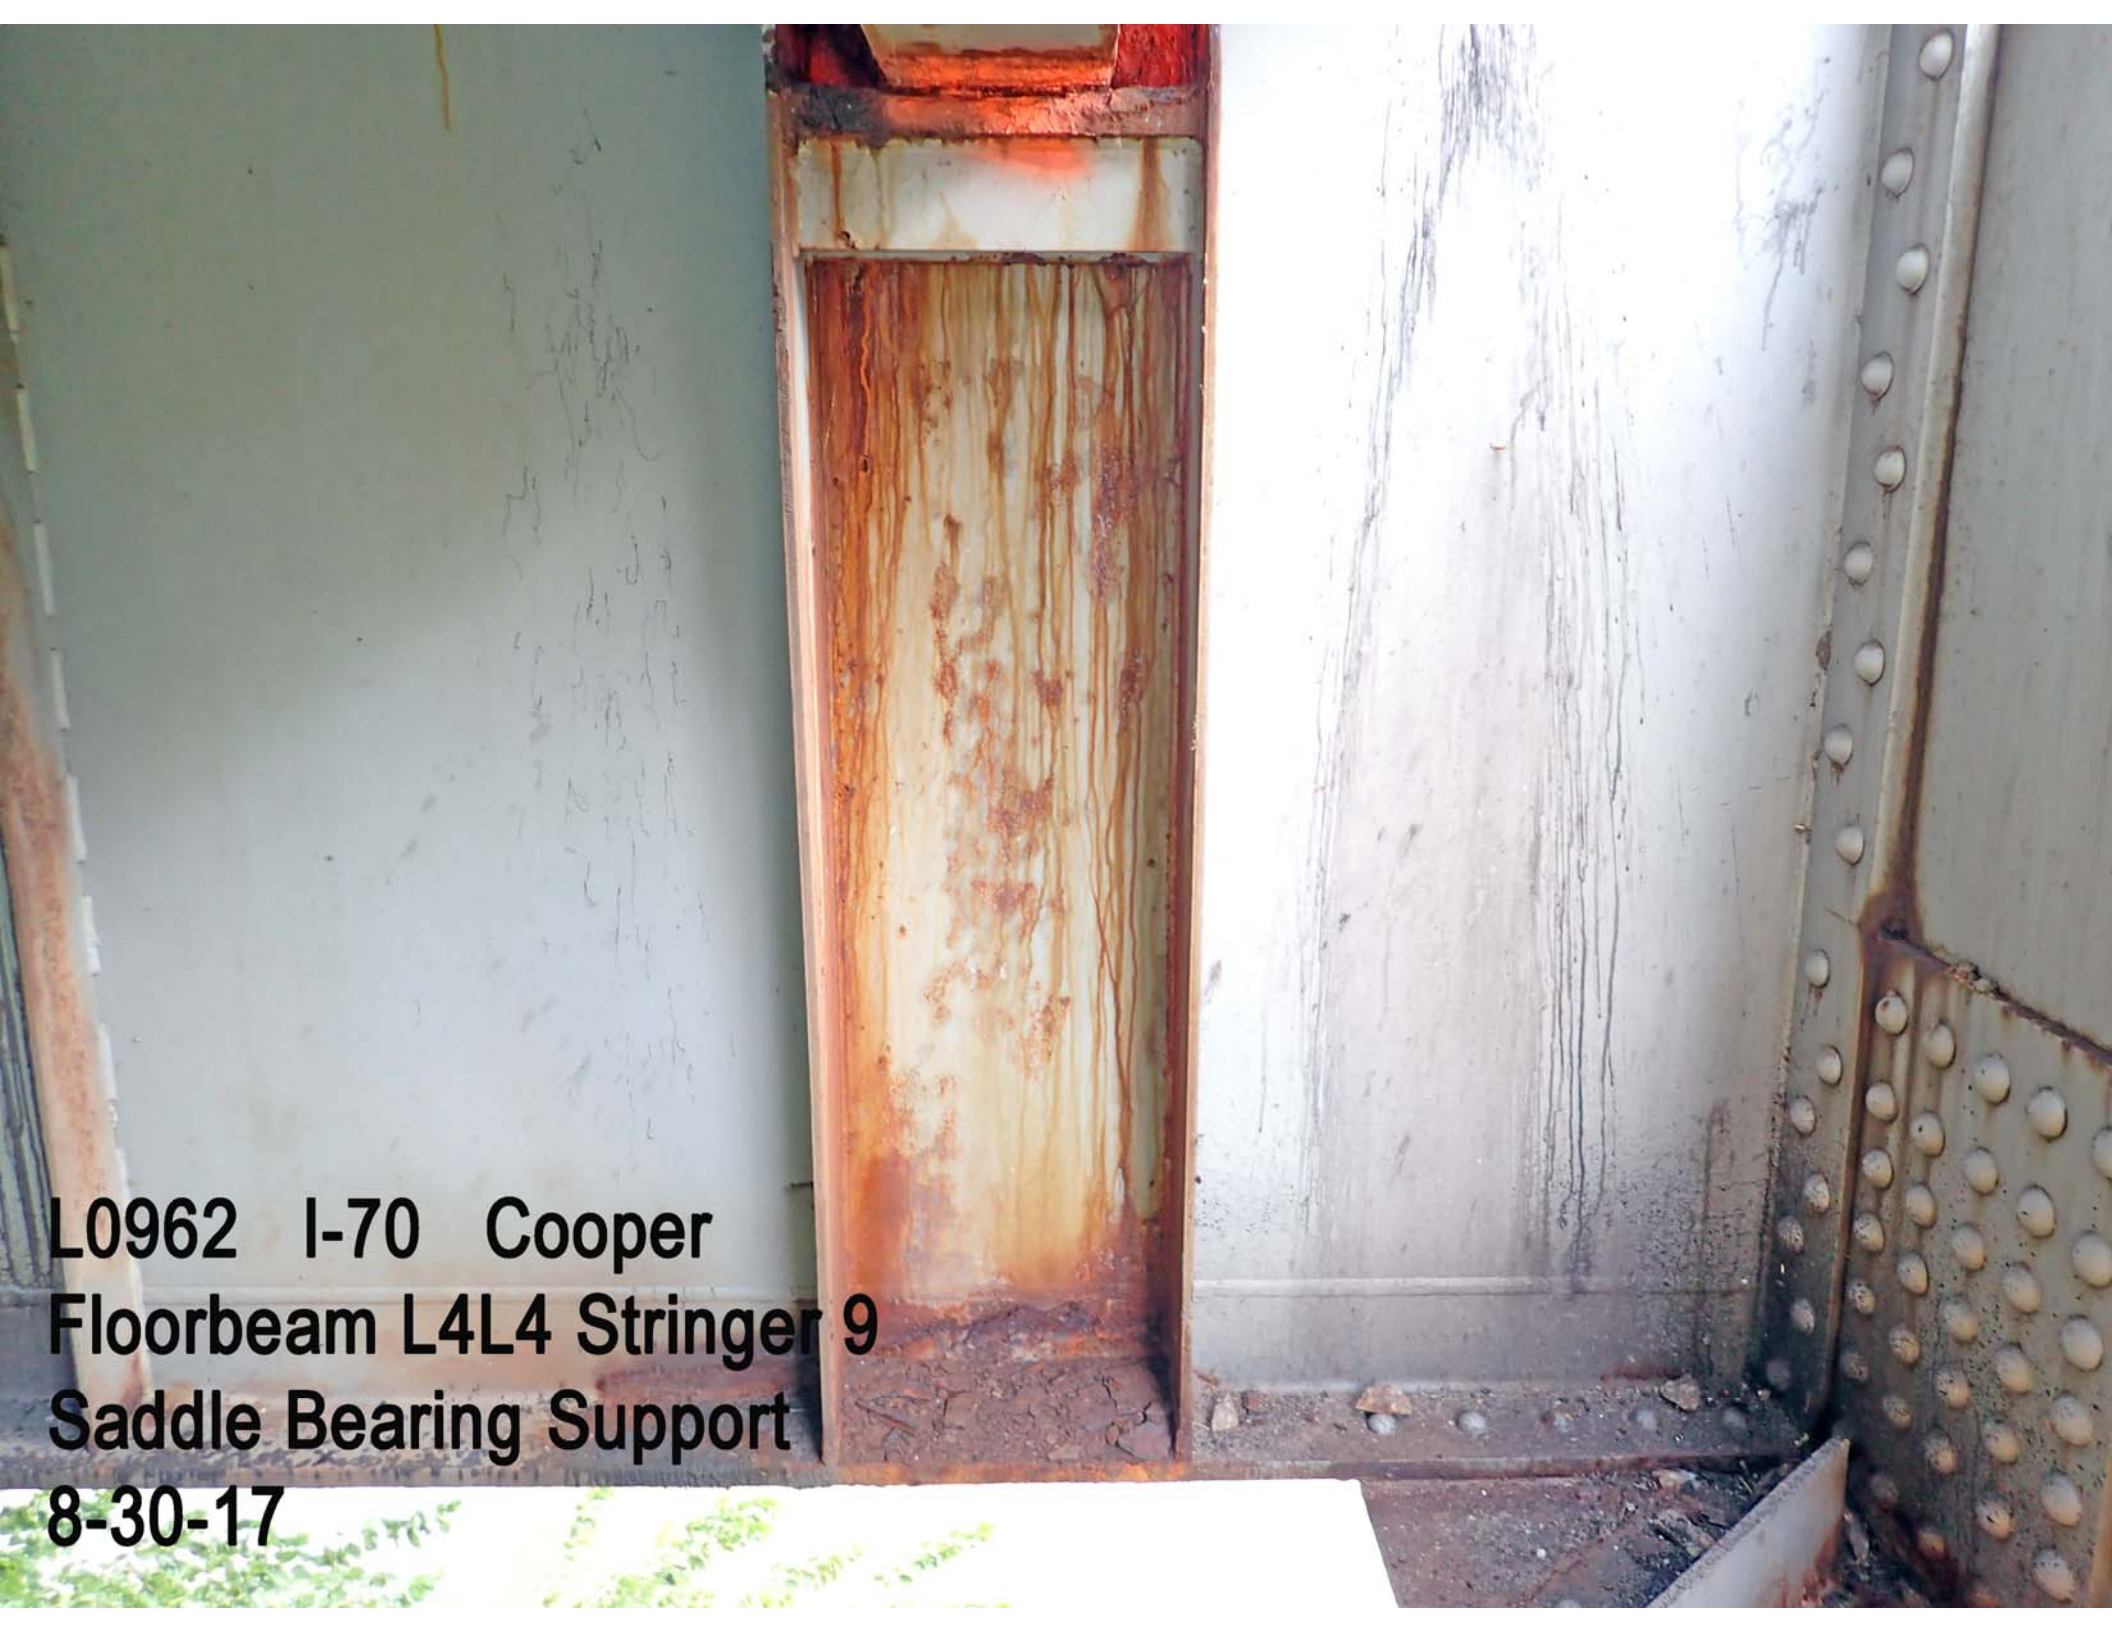
**L0962 I-70 Cooper
Floorbeam L4L4 Stringer 9 Saddle Bearing
Packrust Lifting 1/2"
8-30-17**

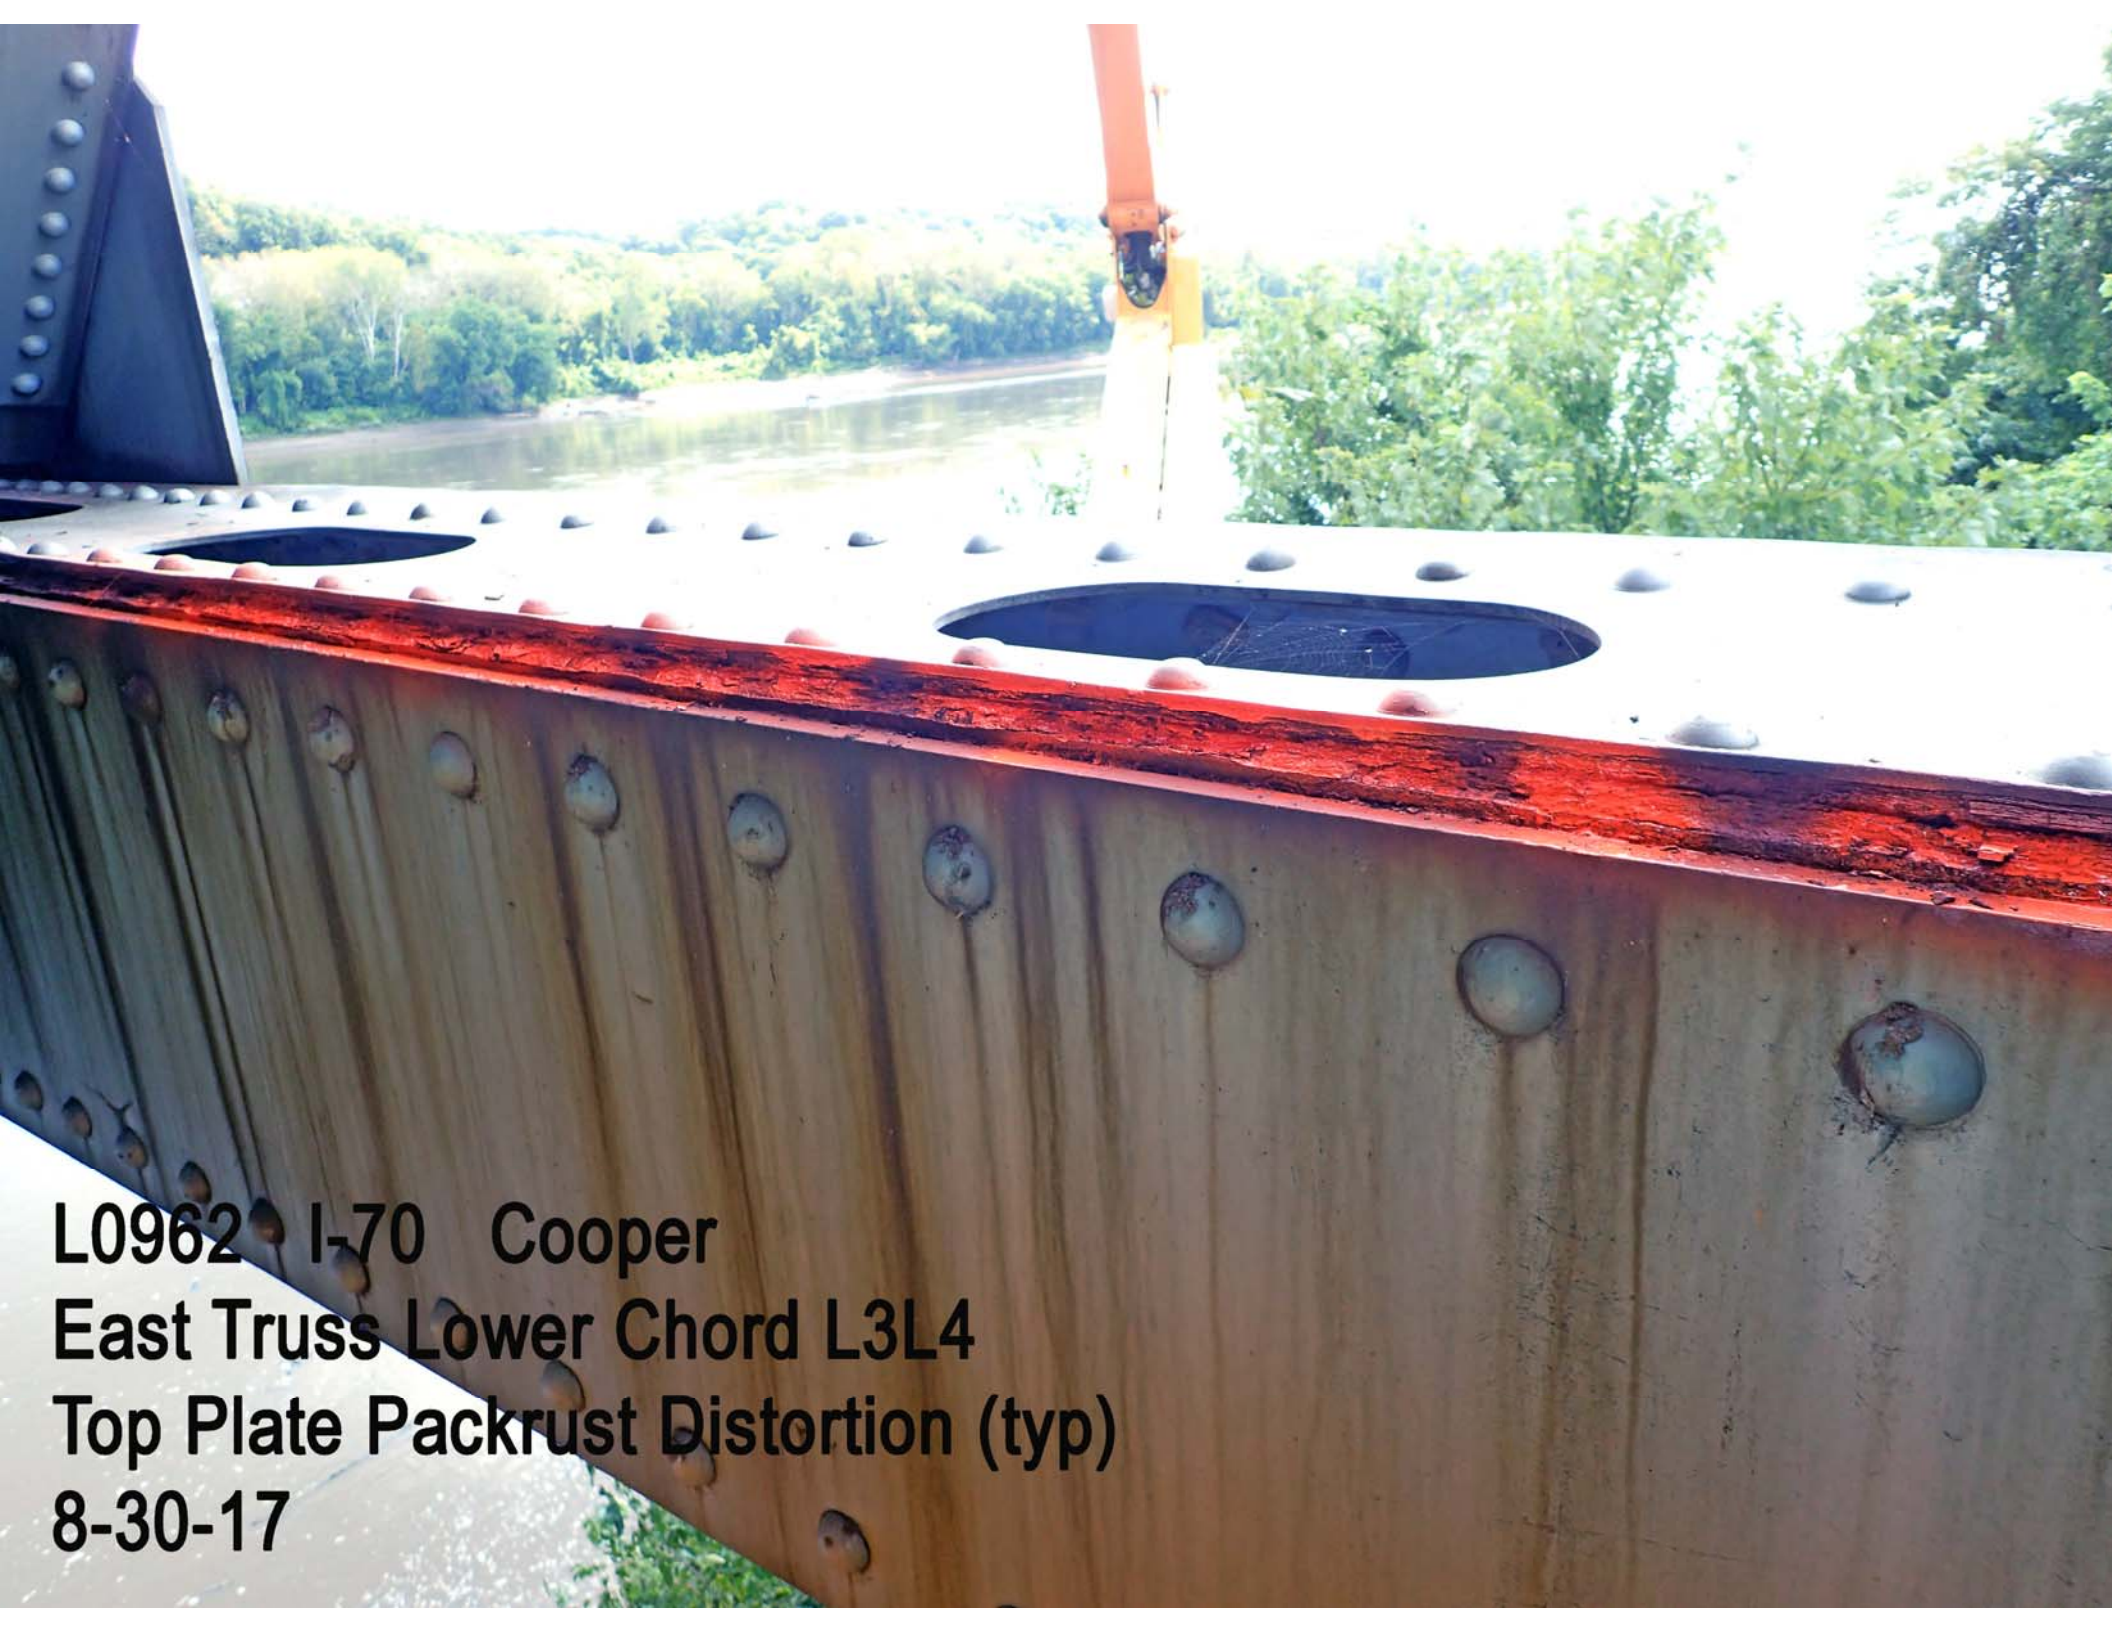
L0962 I-70 Cooper
East Truss Lower Chord L3L4
Top Plate Packrust Distortion (typ)
8-30-17

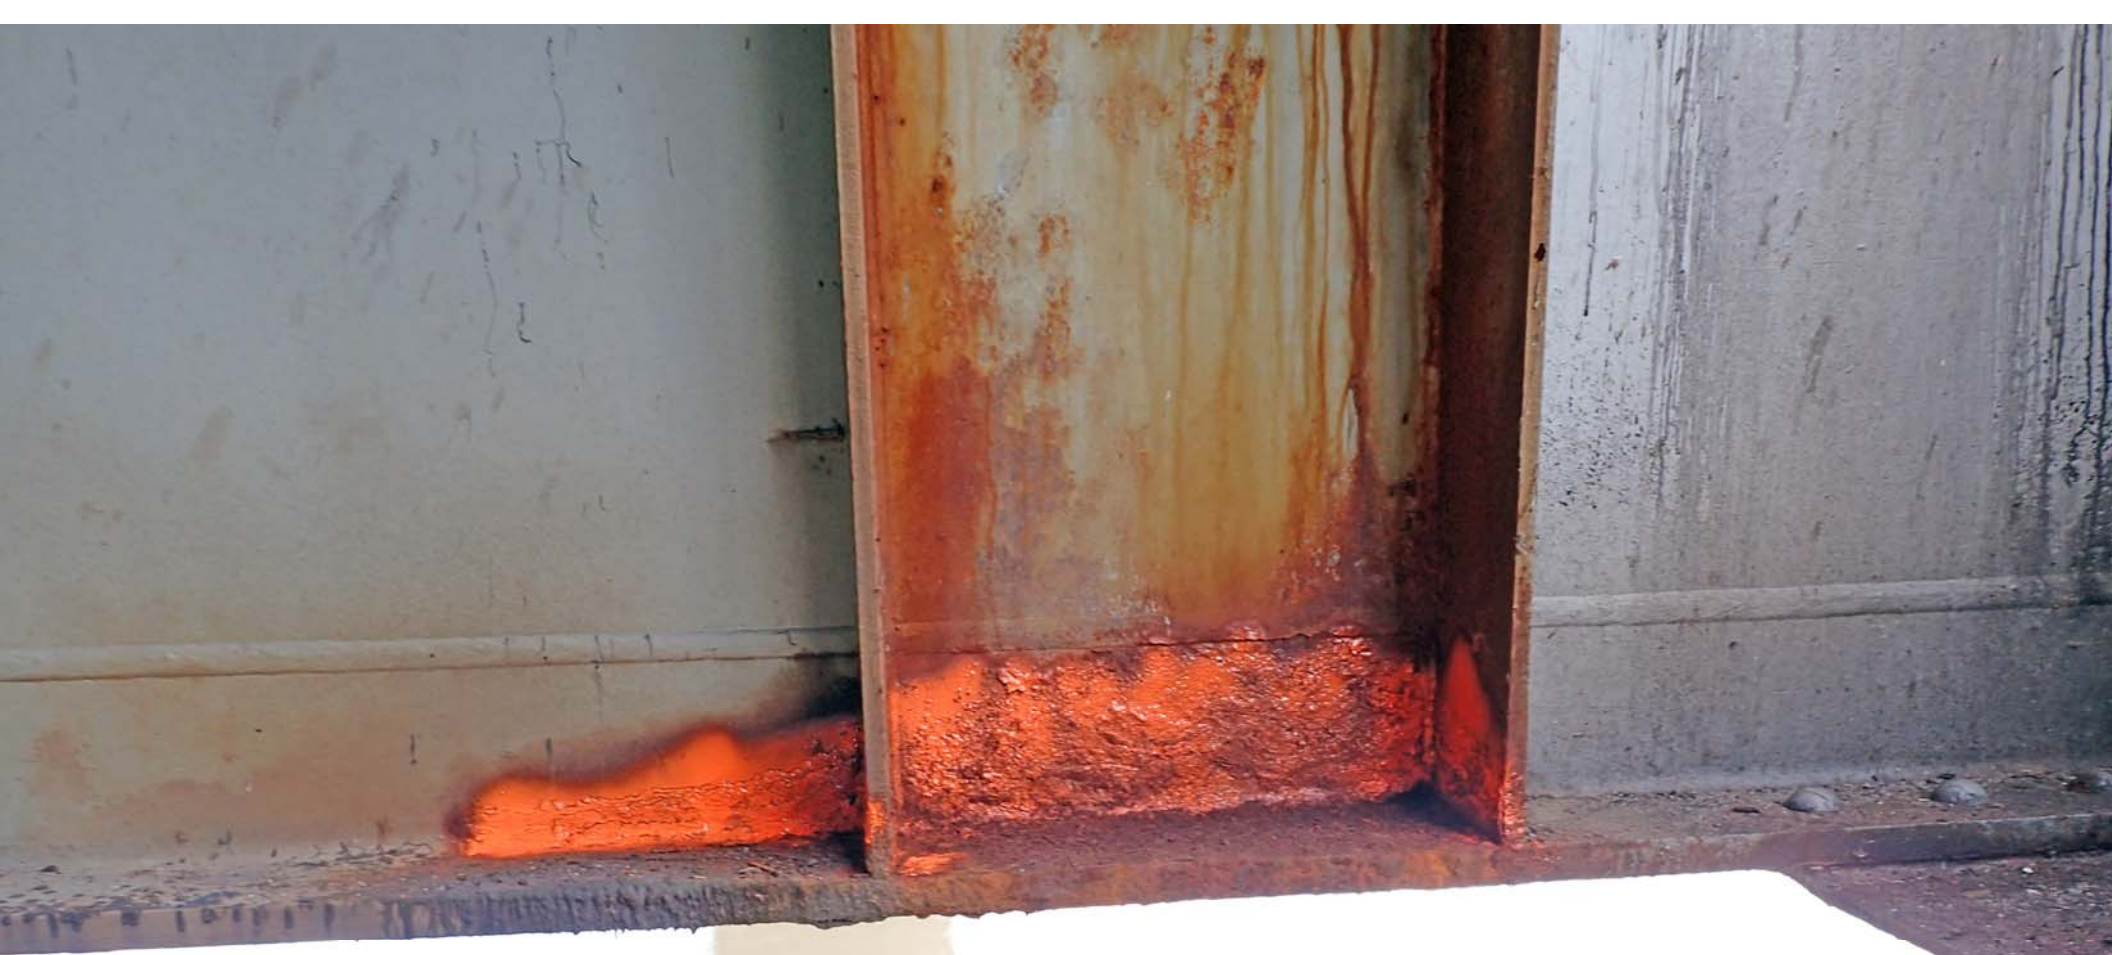
**L0962 I-70 Cooper
Floorbeam L4L4 at Stringer 9
Minor Section Loss
8-30-17**

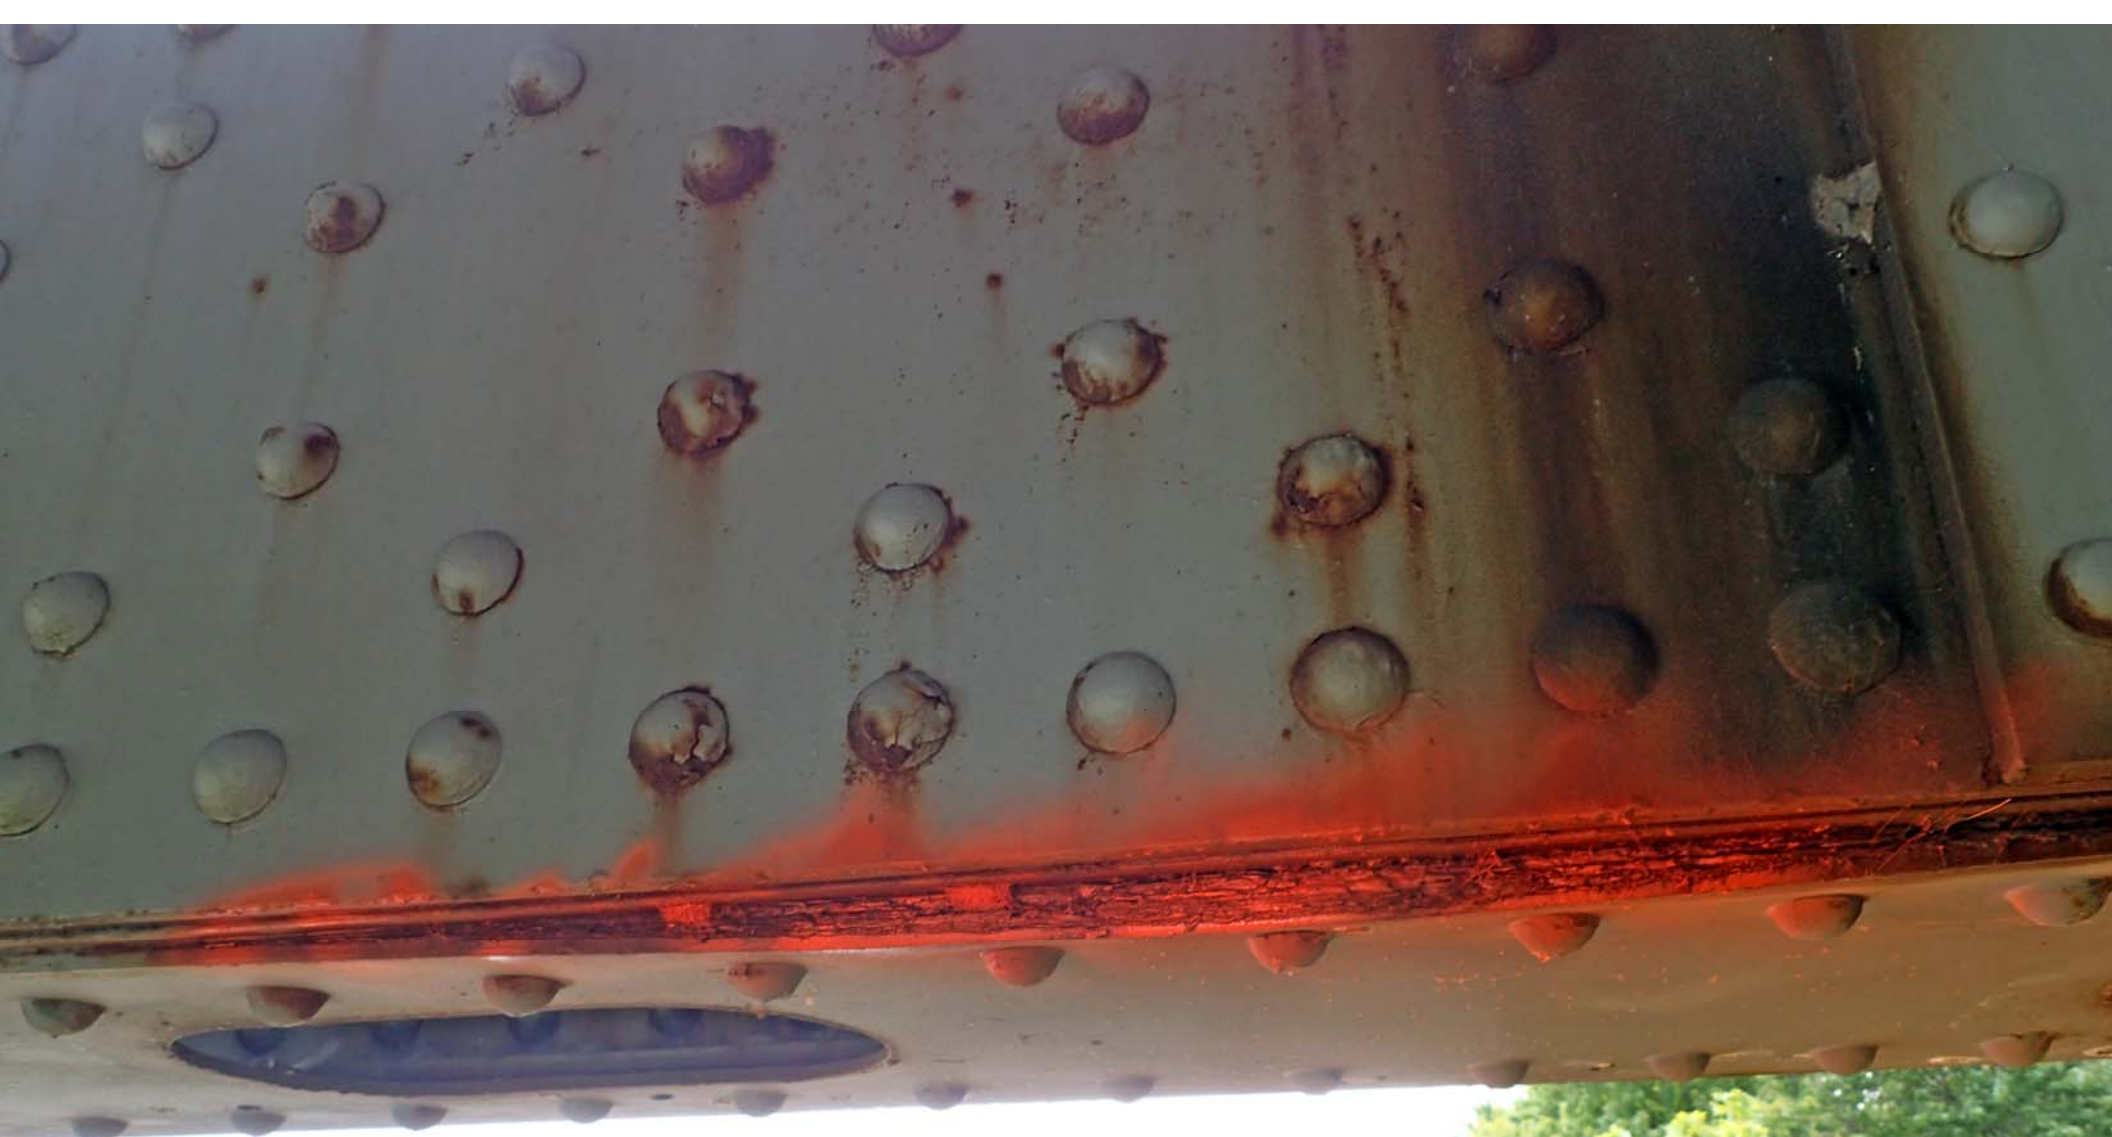
**L0962 I-70 Cooper
East Truss Lower Chord L4L5
Bottom Plate Packrust Distortion (typ)
8-30-17**
