L0962 Cooper Co.
08/28/2017
Looking West

L0962 I-70 Cooper
Pier 15 Open Expansion Joint WBL
8-28-17

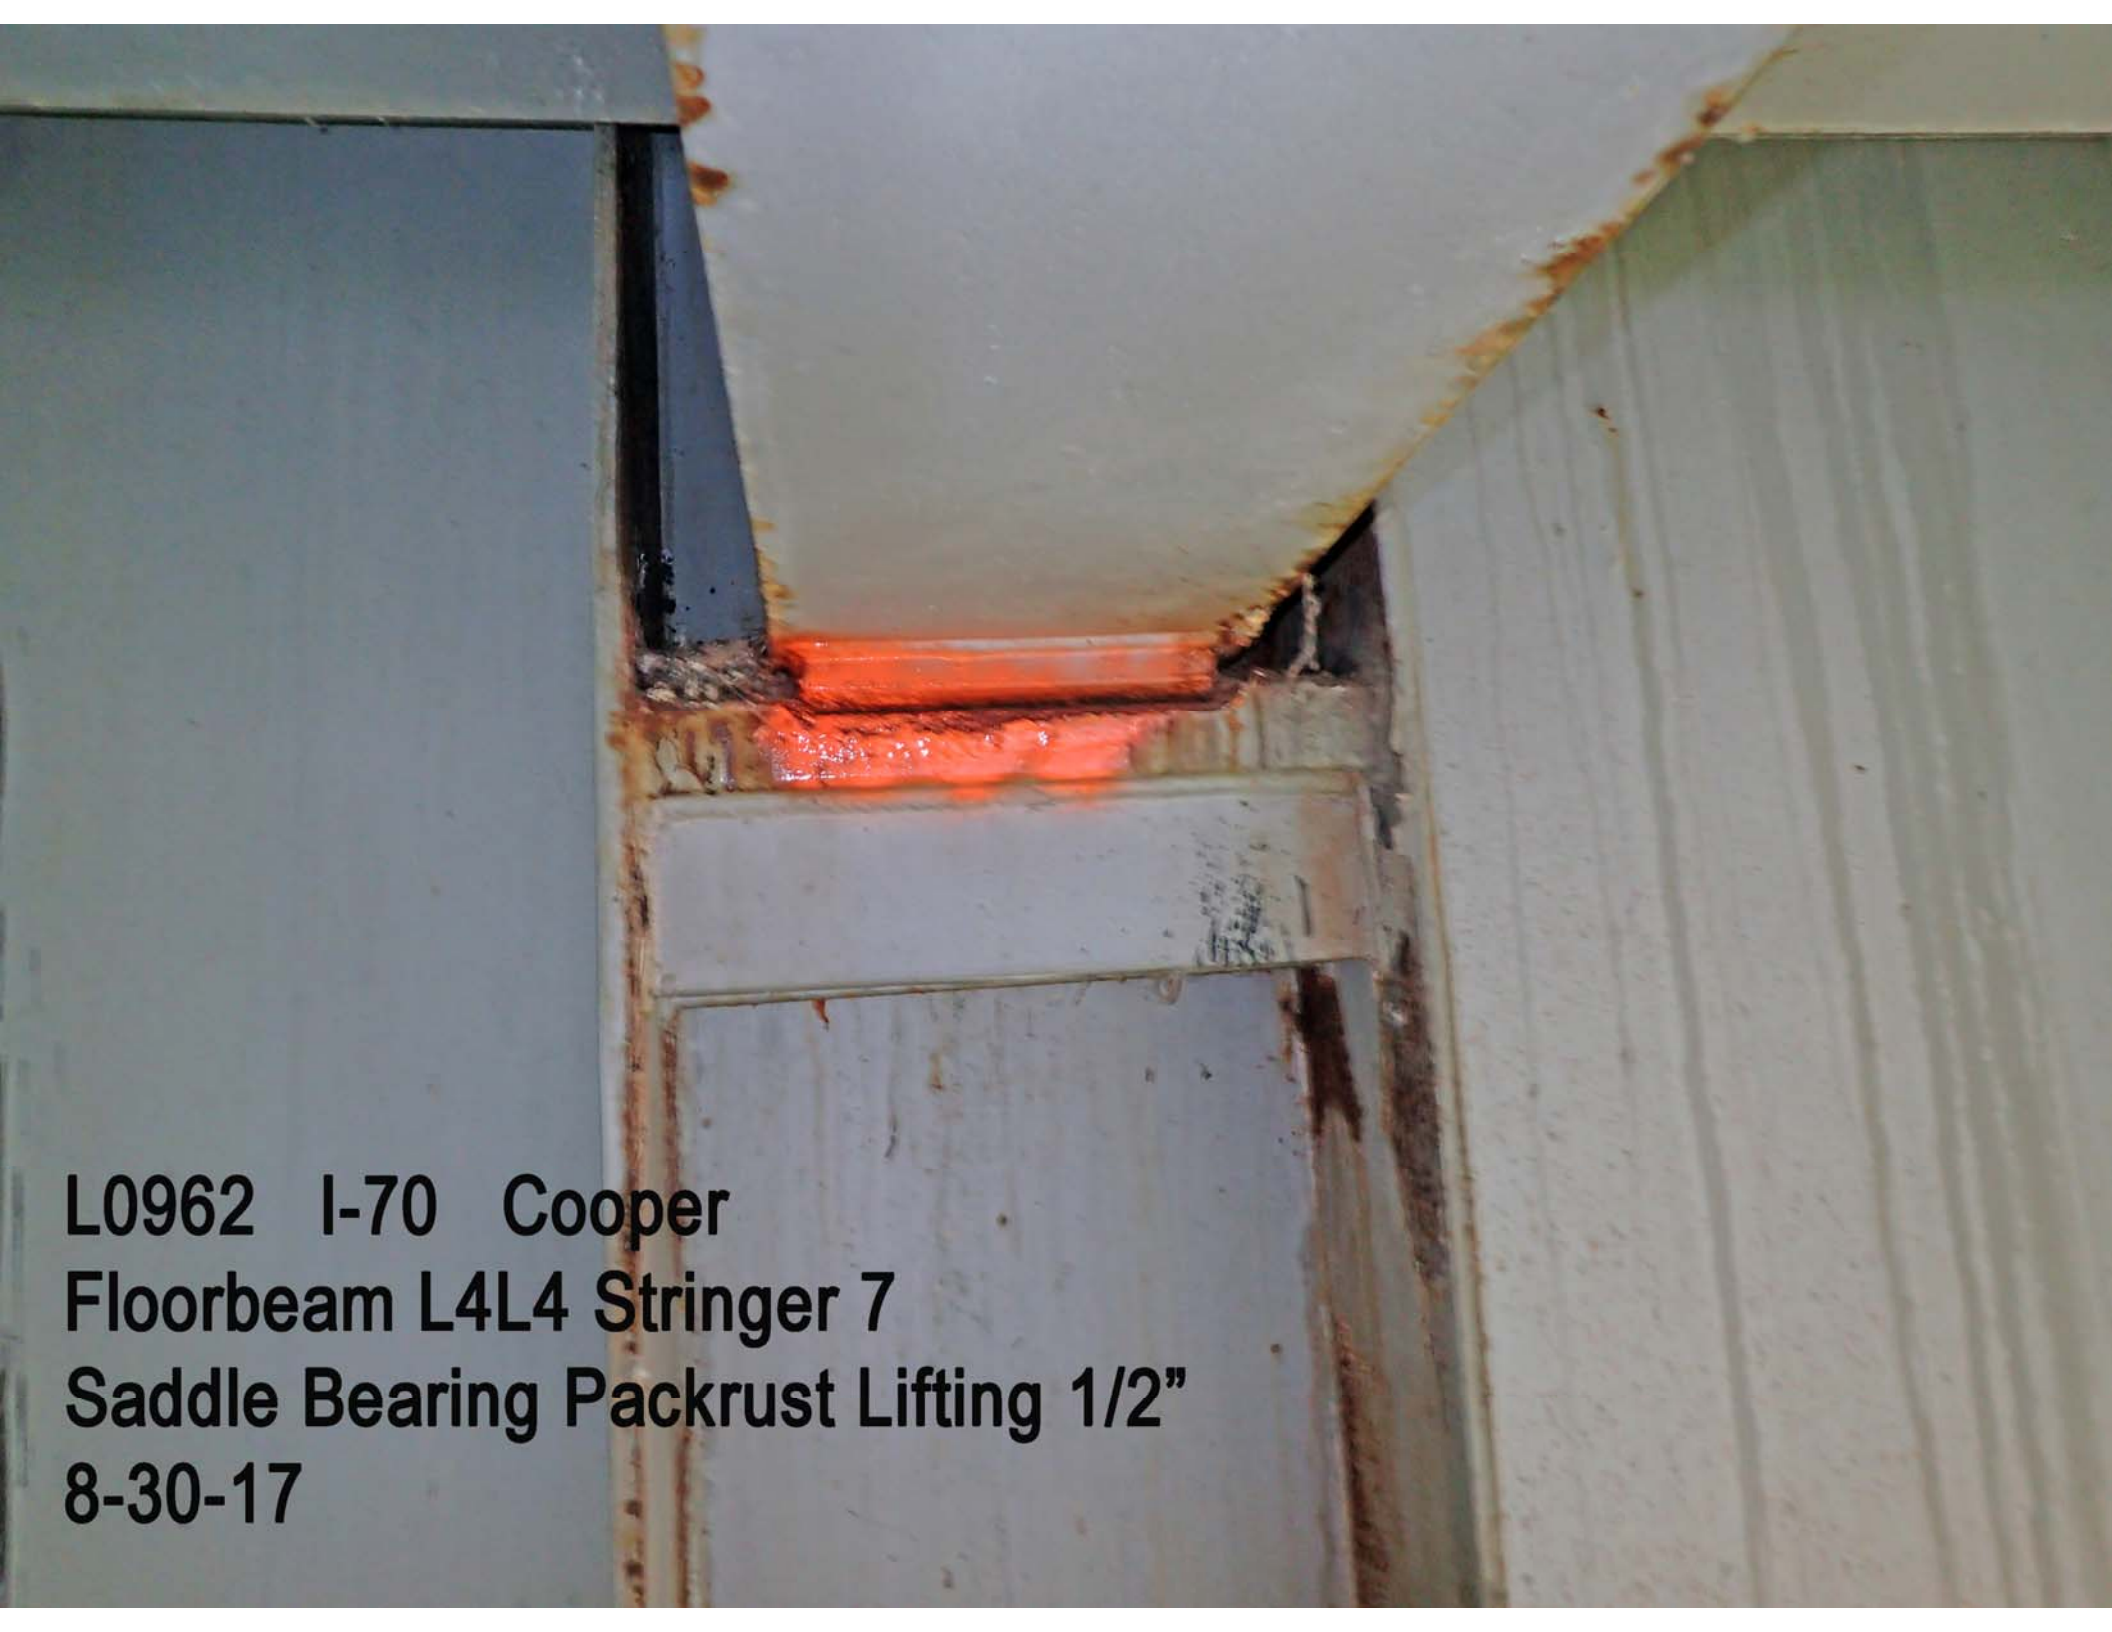
L0962 I-70 Cooper
Floorbeam L4L4 Stringer 7
Saddle Bearing Packrust Lifting 1/2"
8-30-17

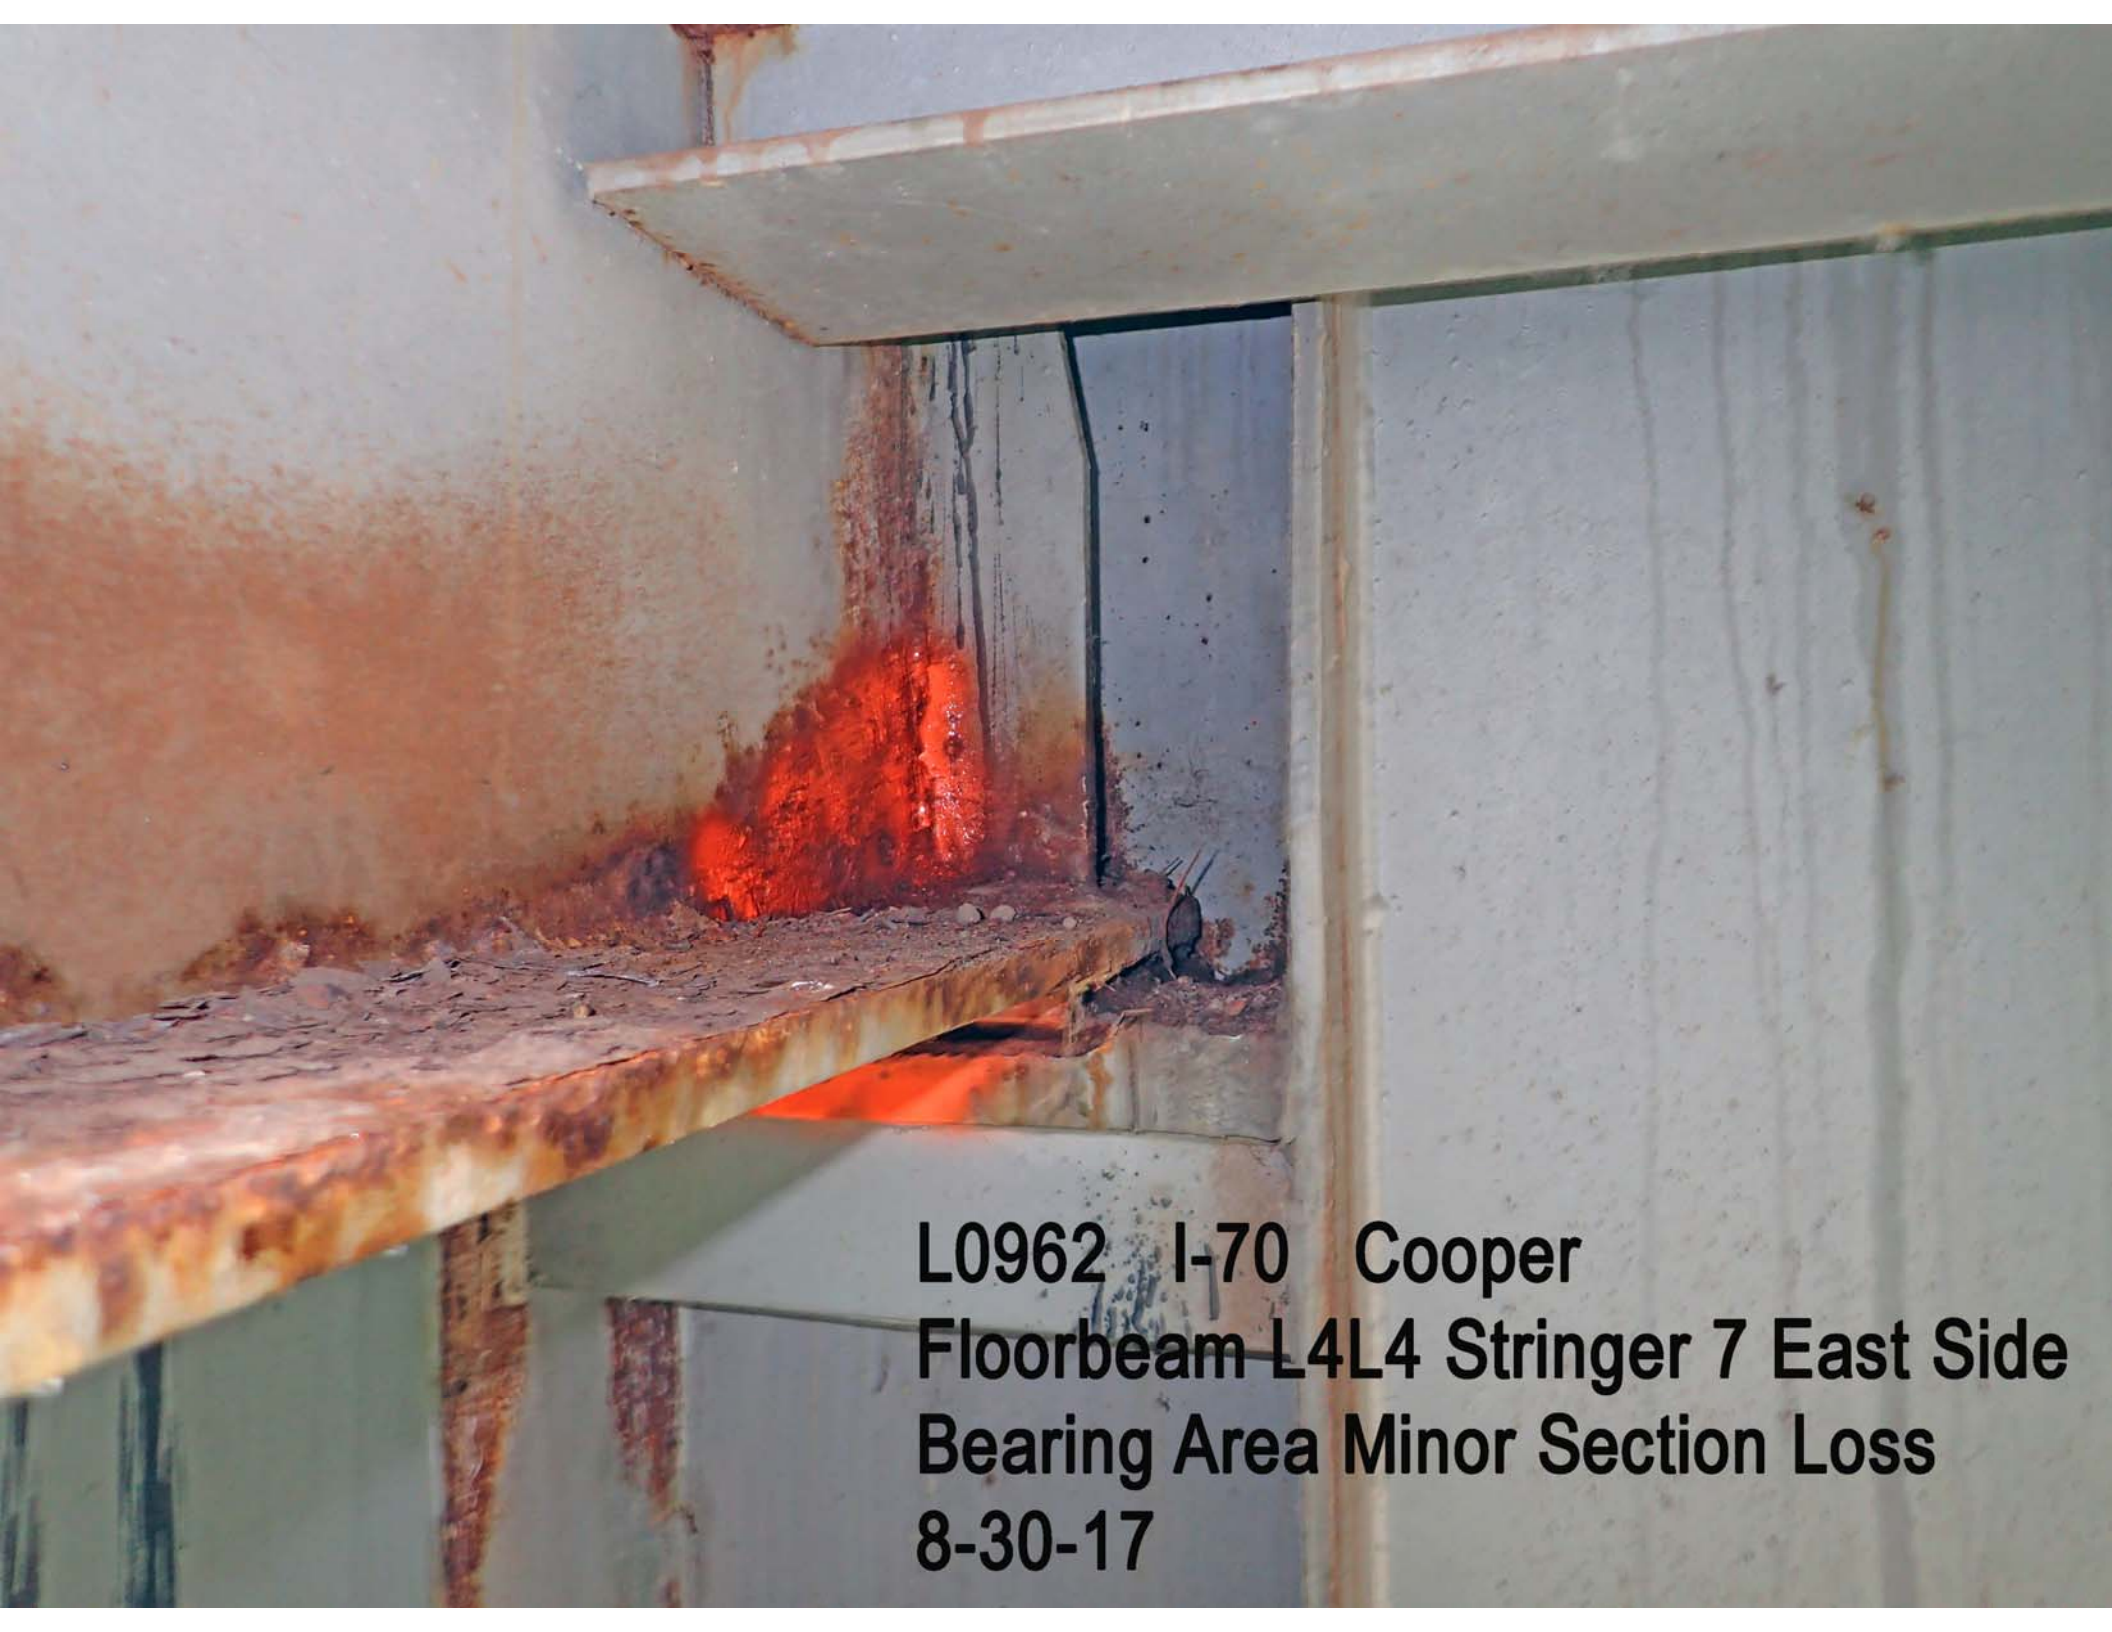
L0962 I-70 Cooper
Floorbeam L4L4 Stringer 7 East Side
Bearing Area Minor Section Loss
8-30-17

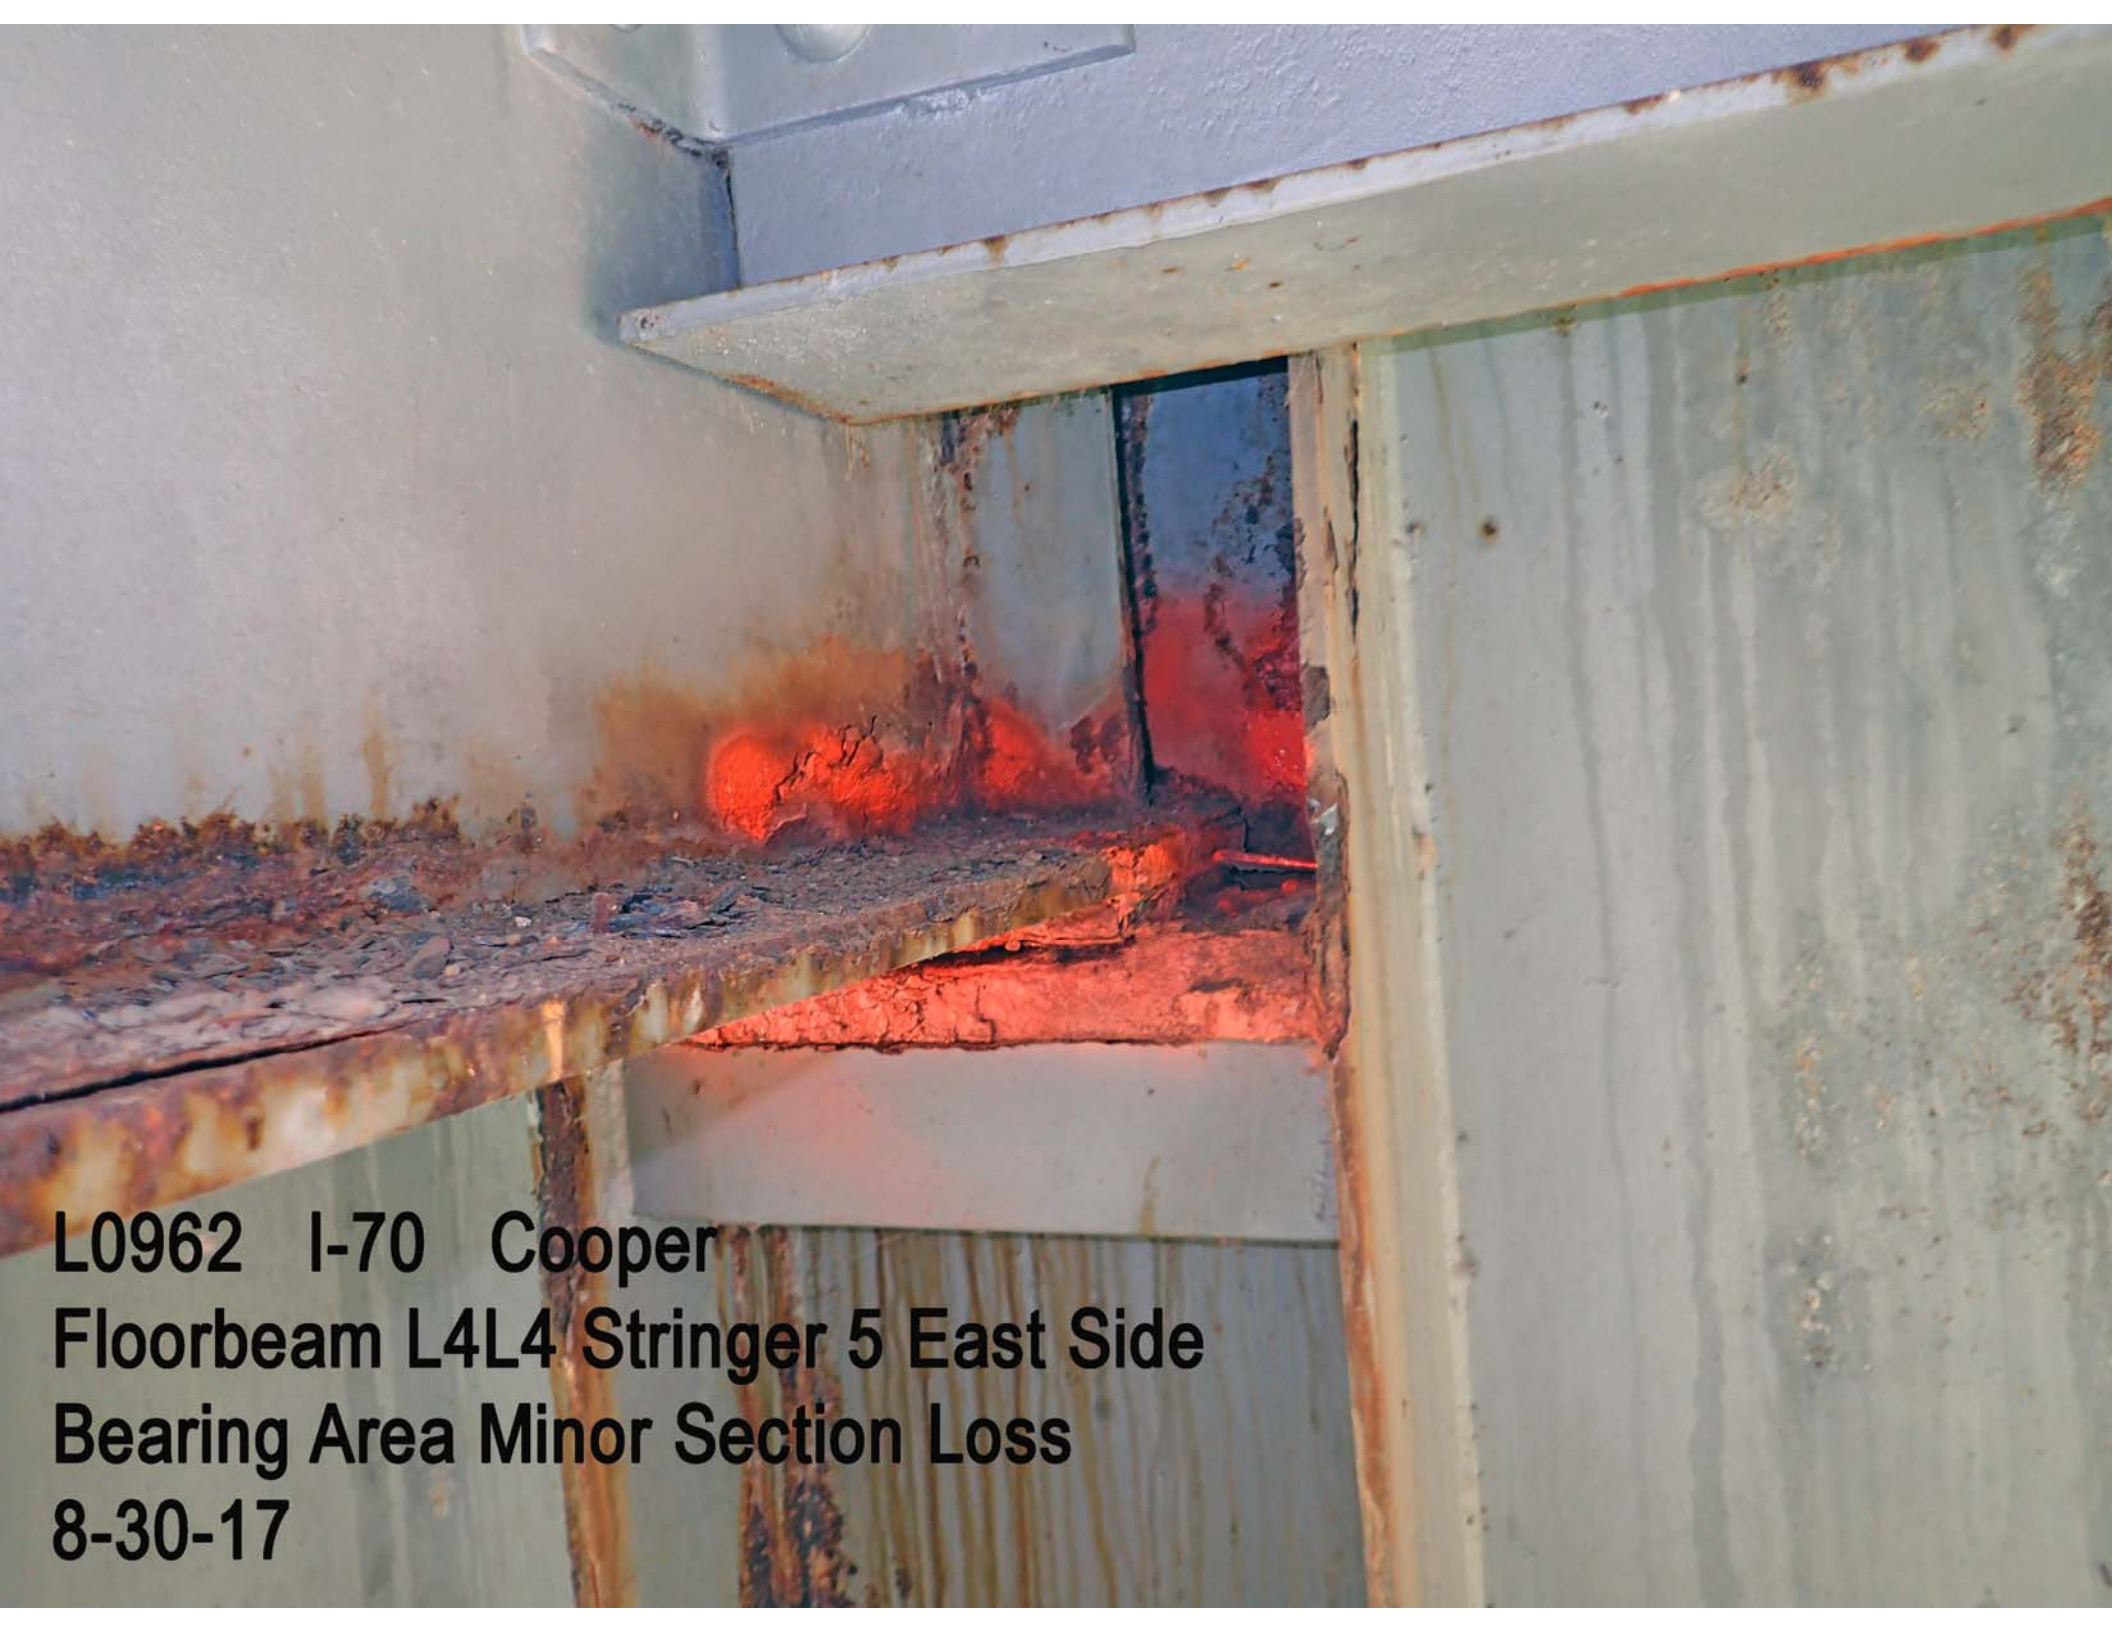
**L0962 I-70 Cooper
Floorbeam L4L4 Stringer 5 East Side
Bearing Area Minor Section Loss
8-30-17**

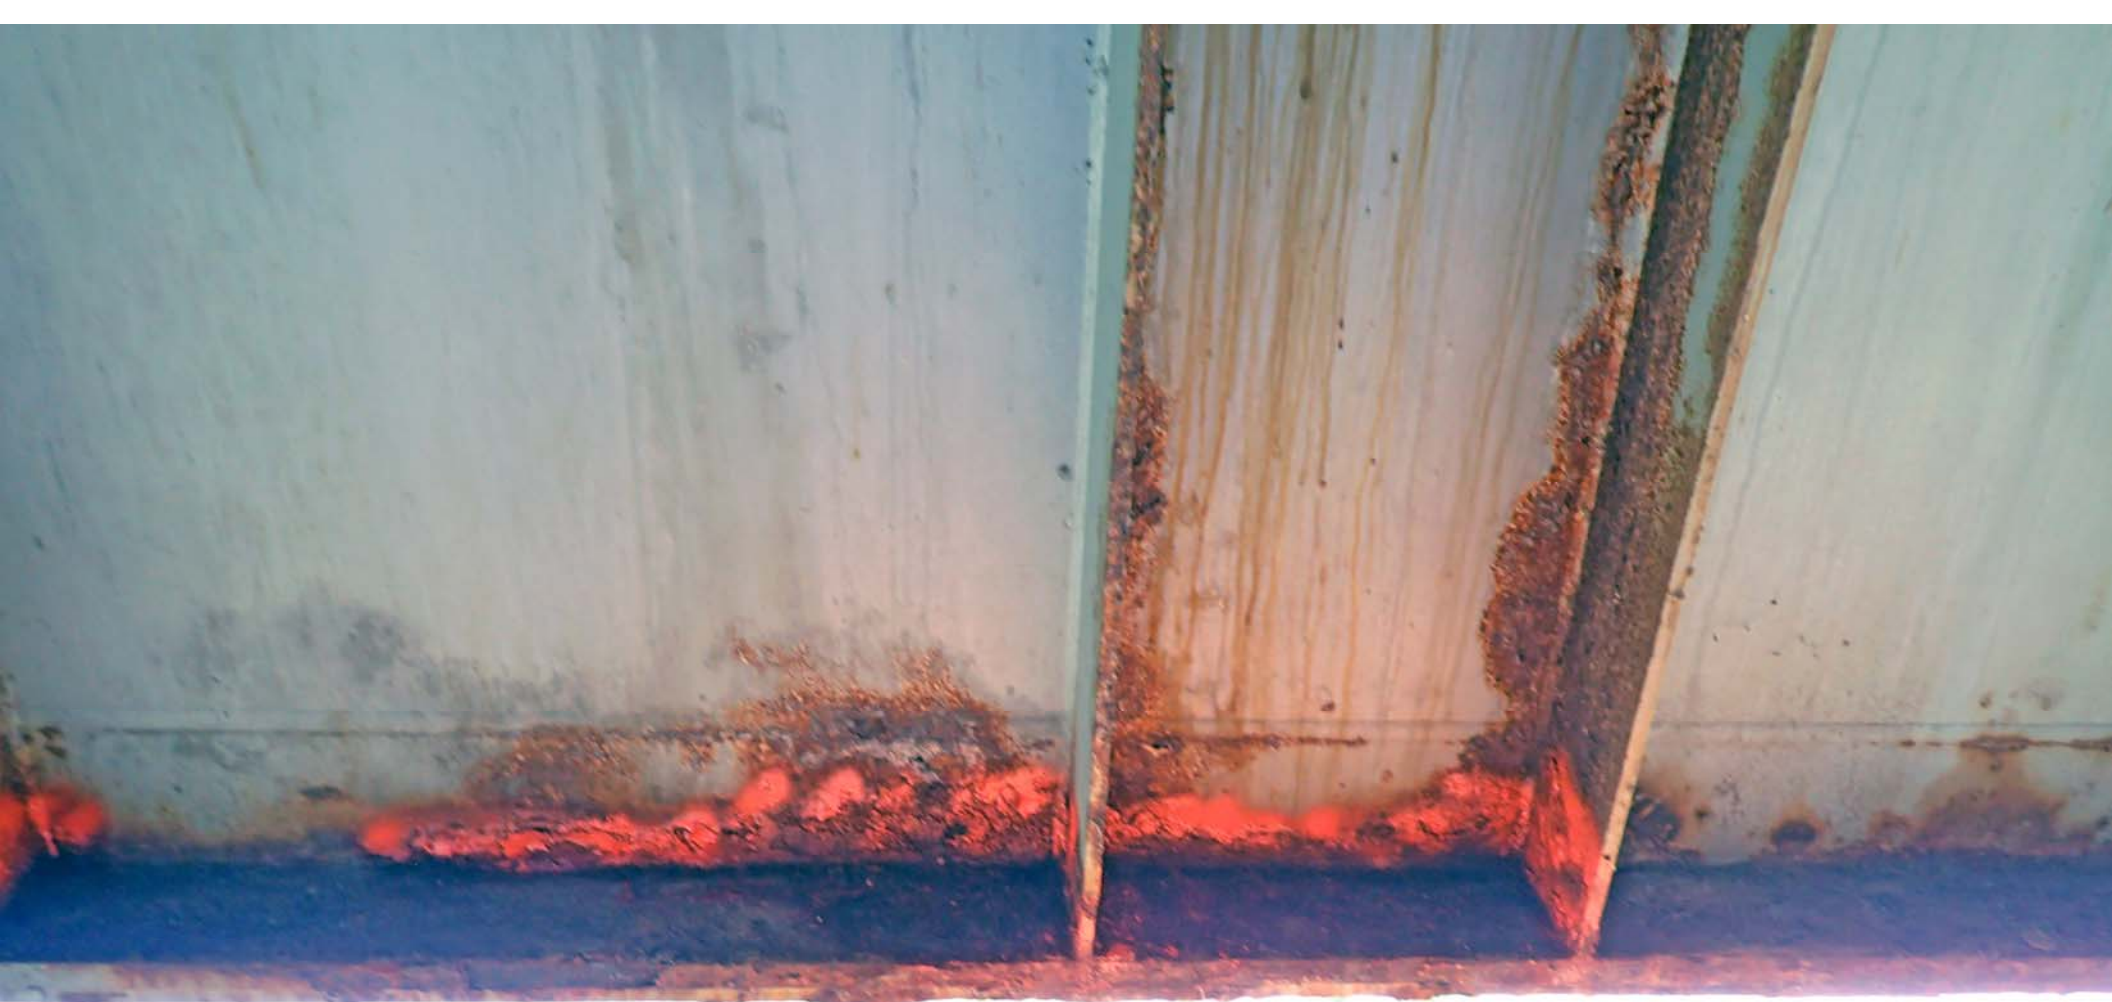
L0962 I-70 Cooper
Floorbeam L4L4 at Stringer 5
Minor Section Loss
8-30-17

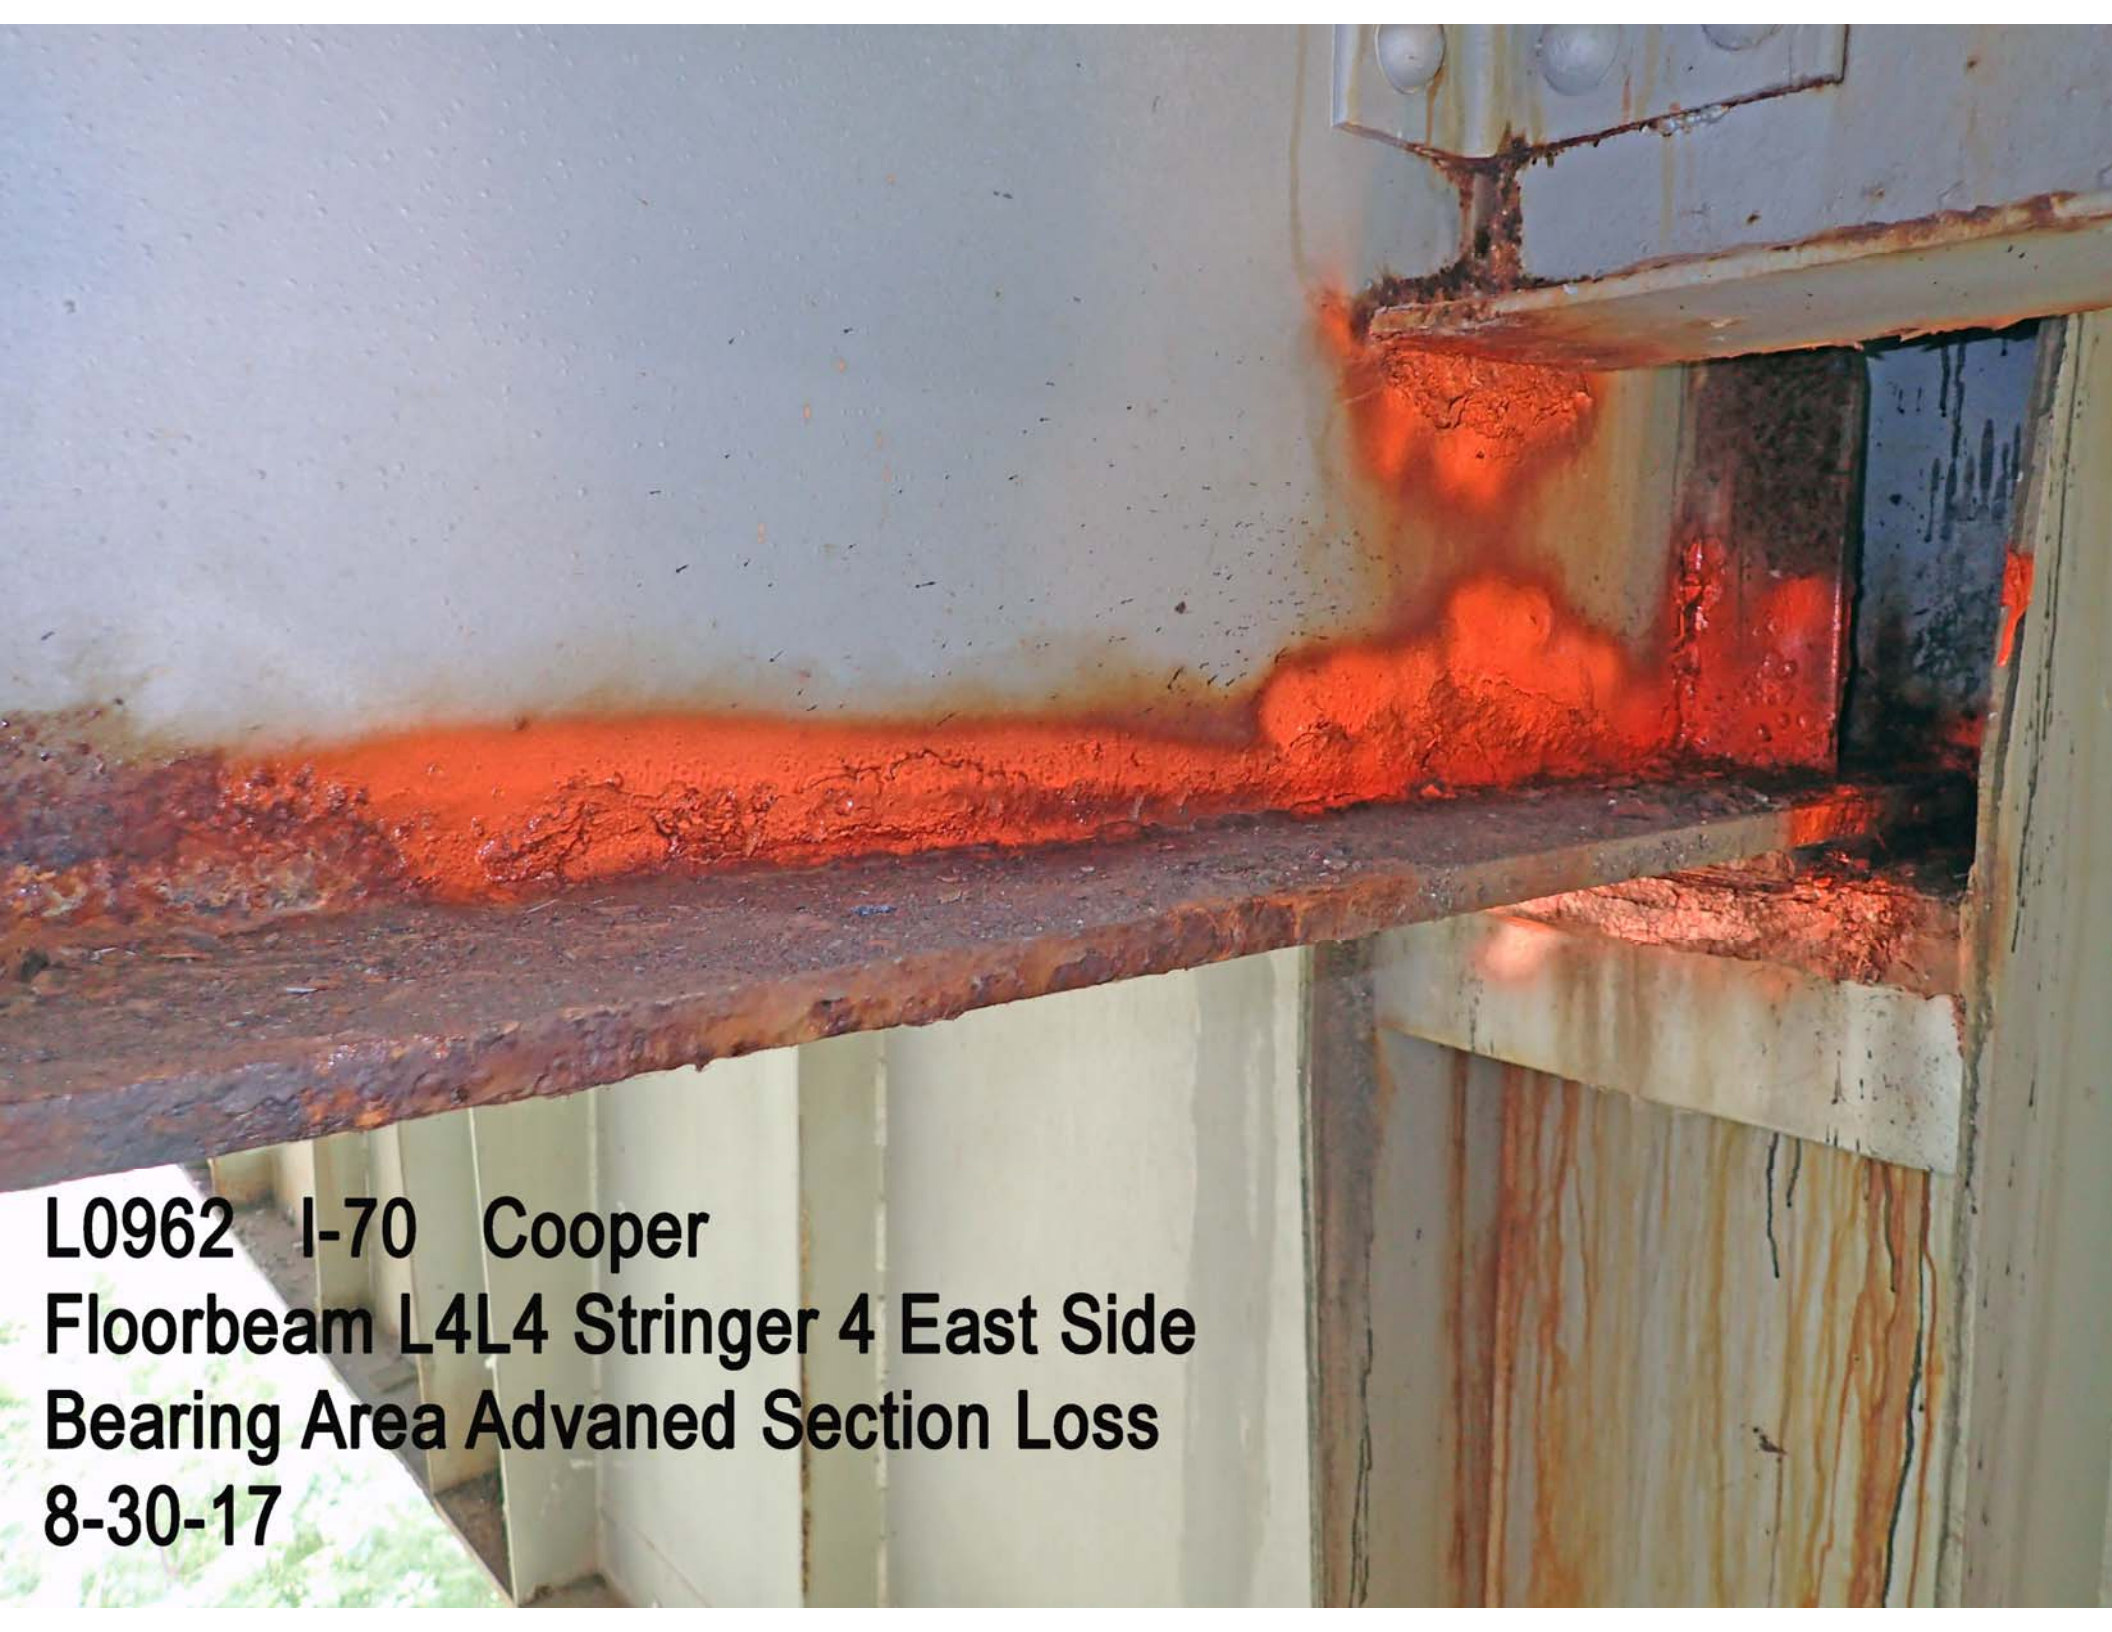
**L0962 I-70 Cooper
Floorbeam L4L4 Stringer 4 East Side
Bearing Area Advanced Section Loss
8-30-17**

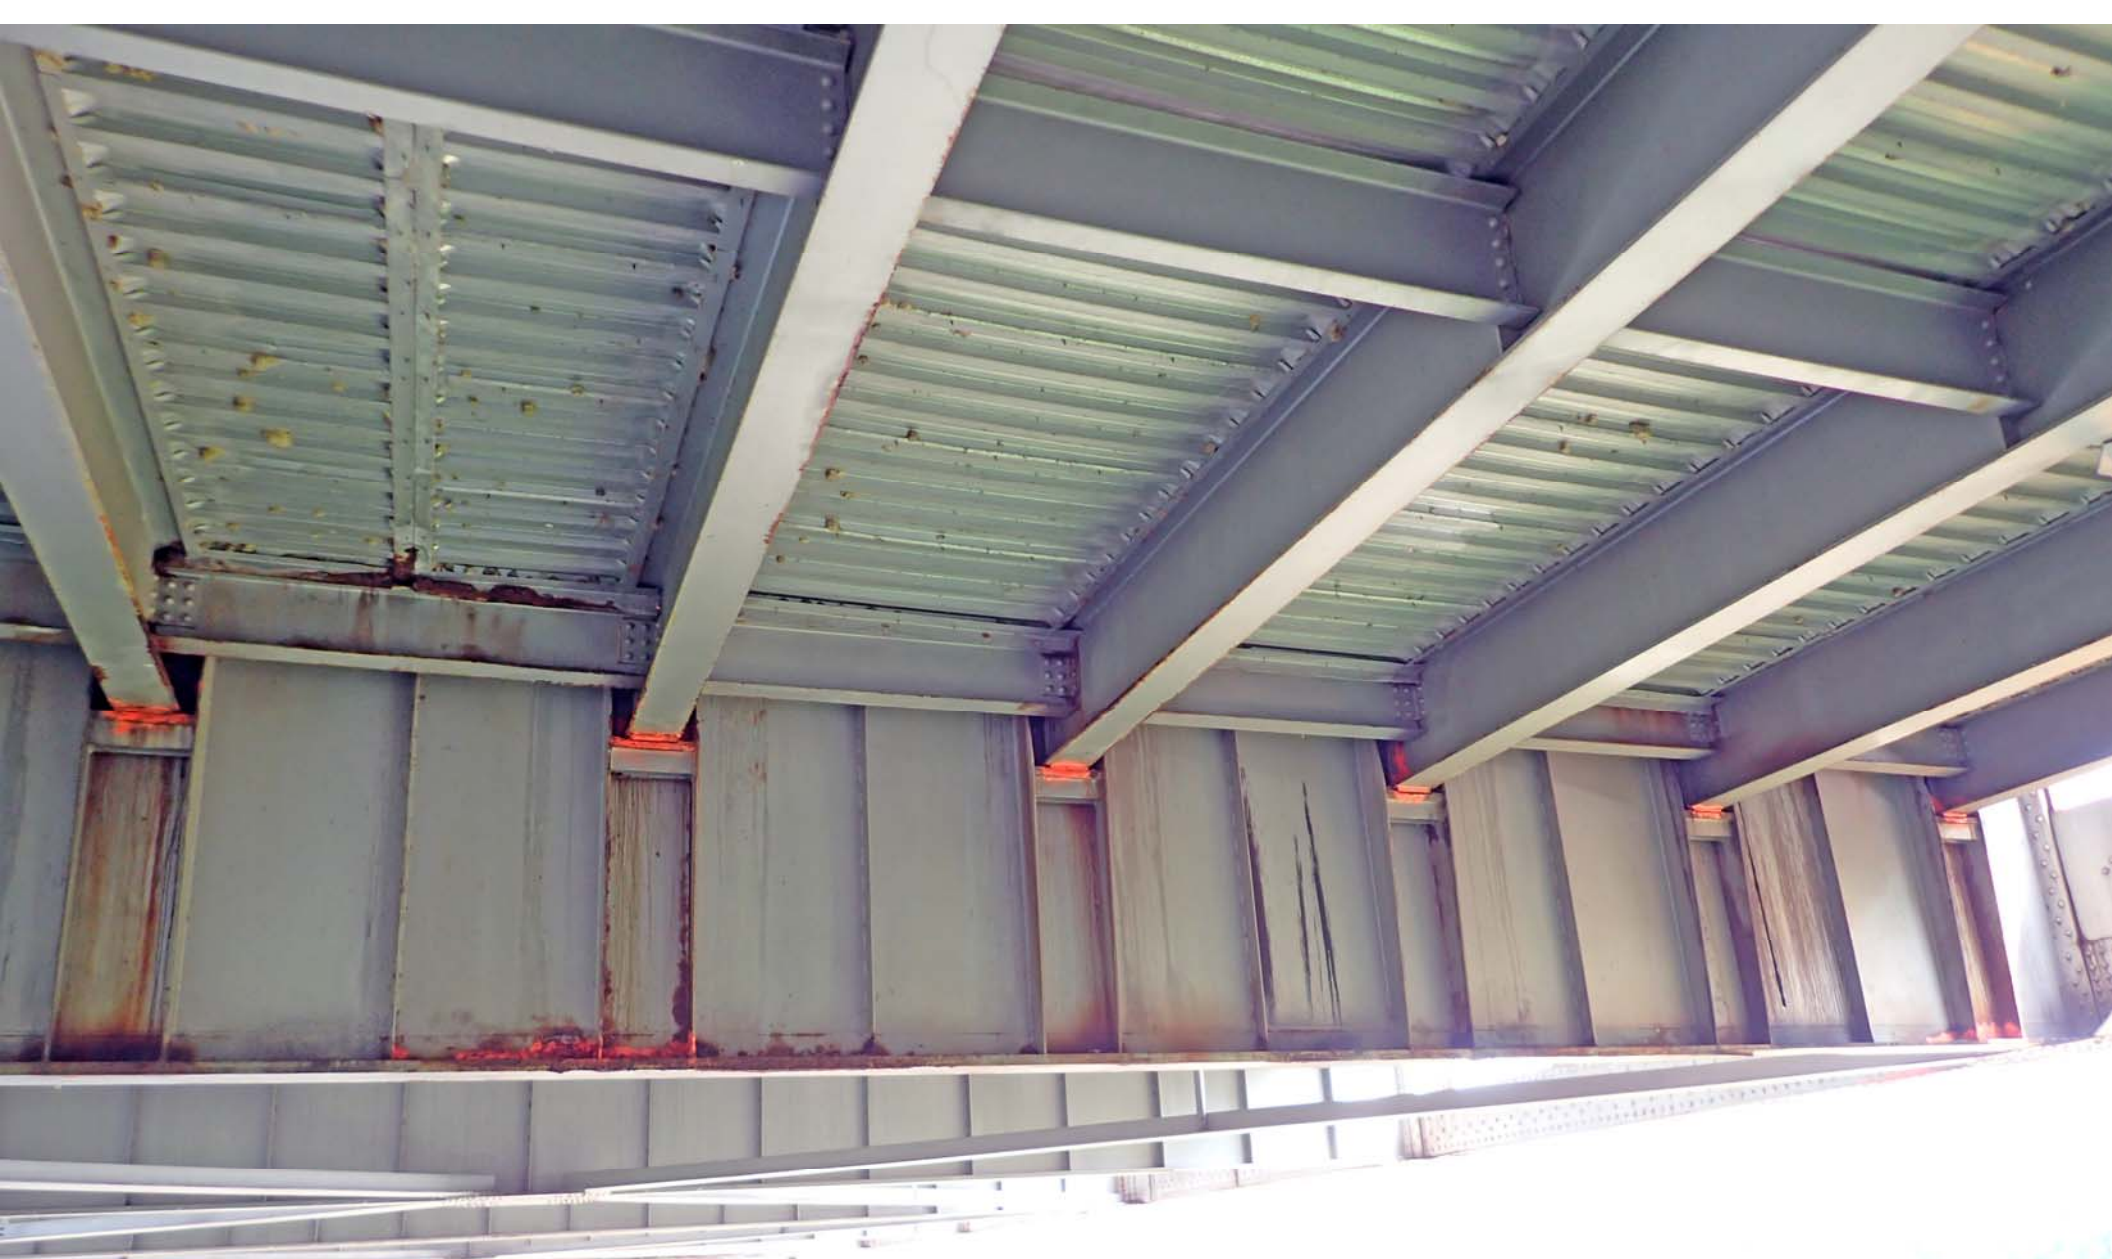
**L0962 I-70 Cooper
Floorbeam L4L4 Stringer 4
Saddle Bearing Packrust Lifting 1/4"
8-30-17**

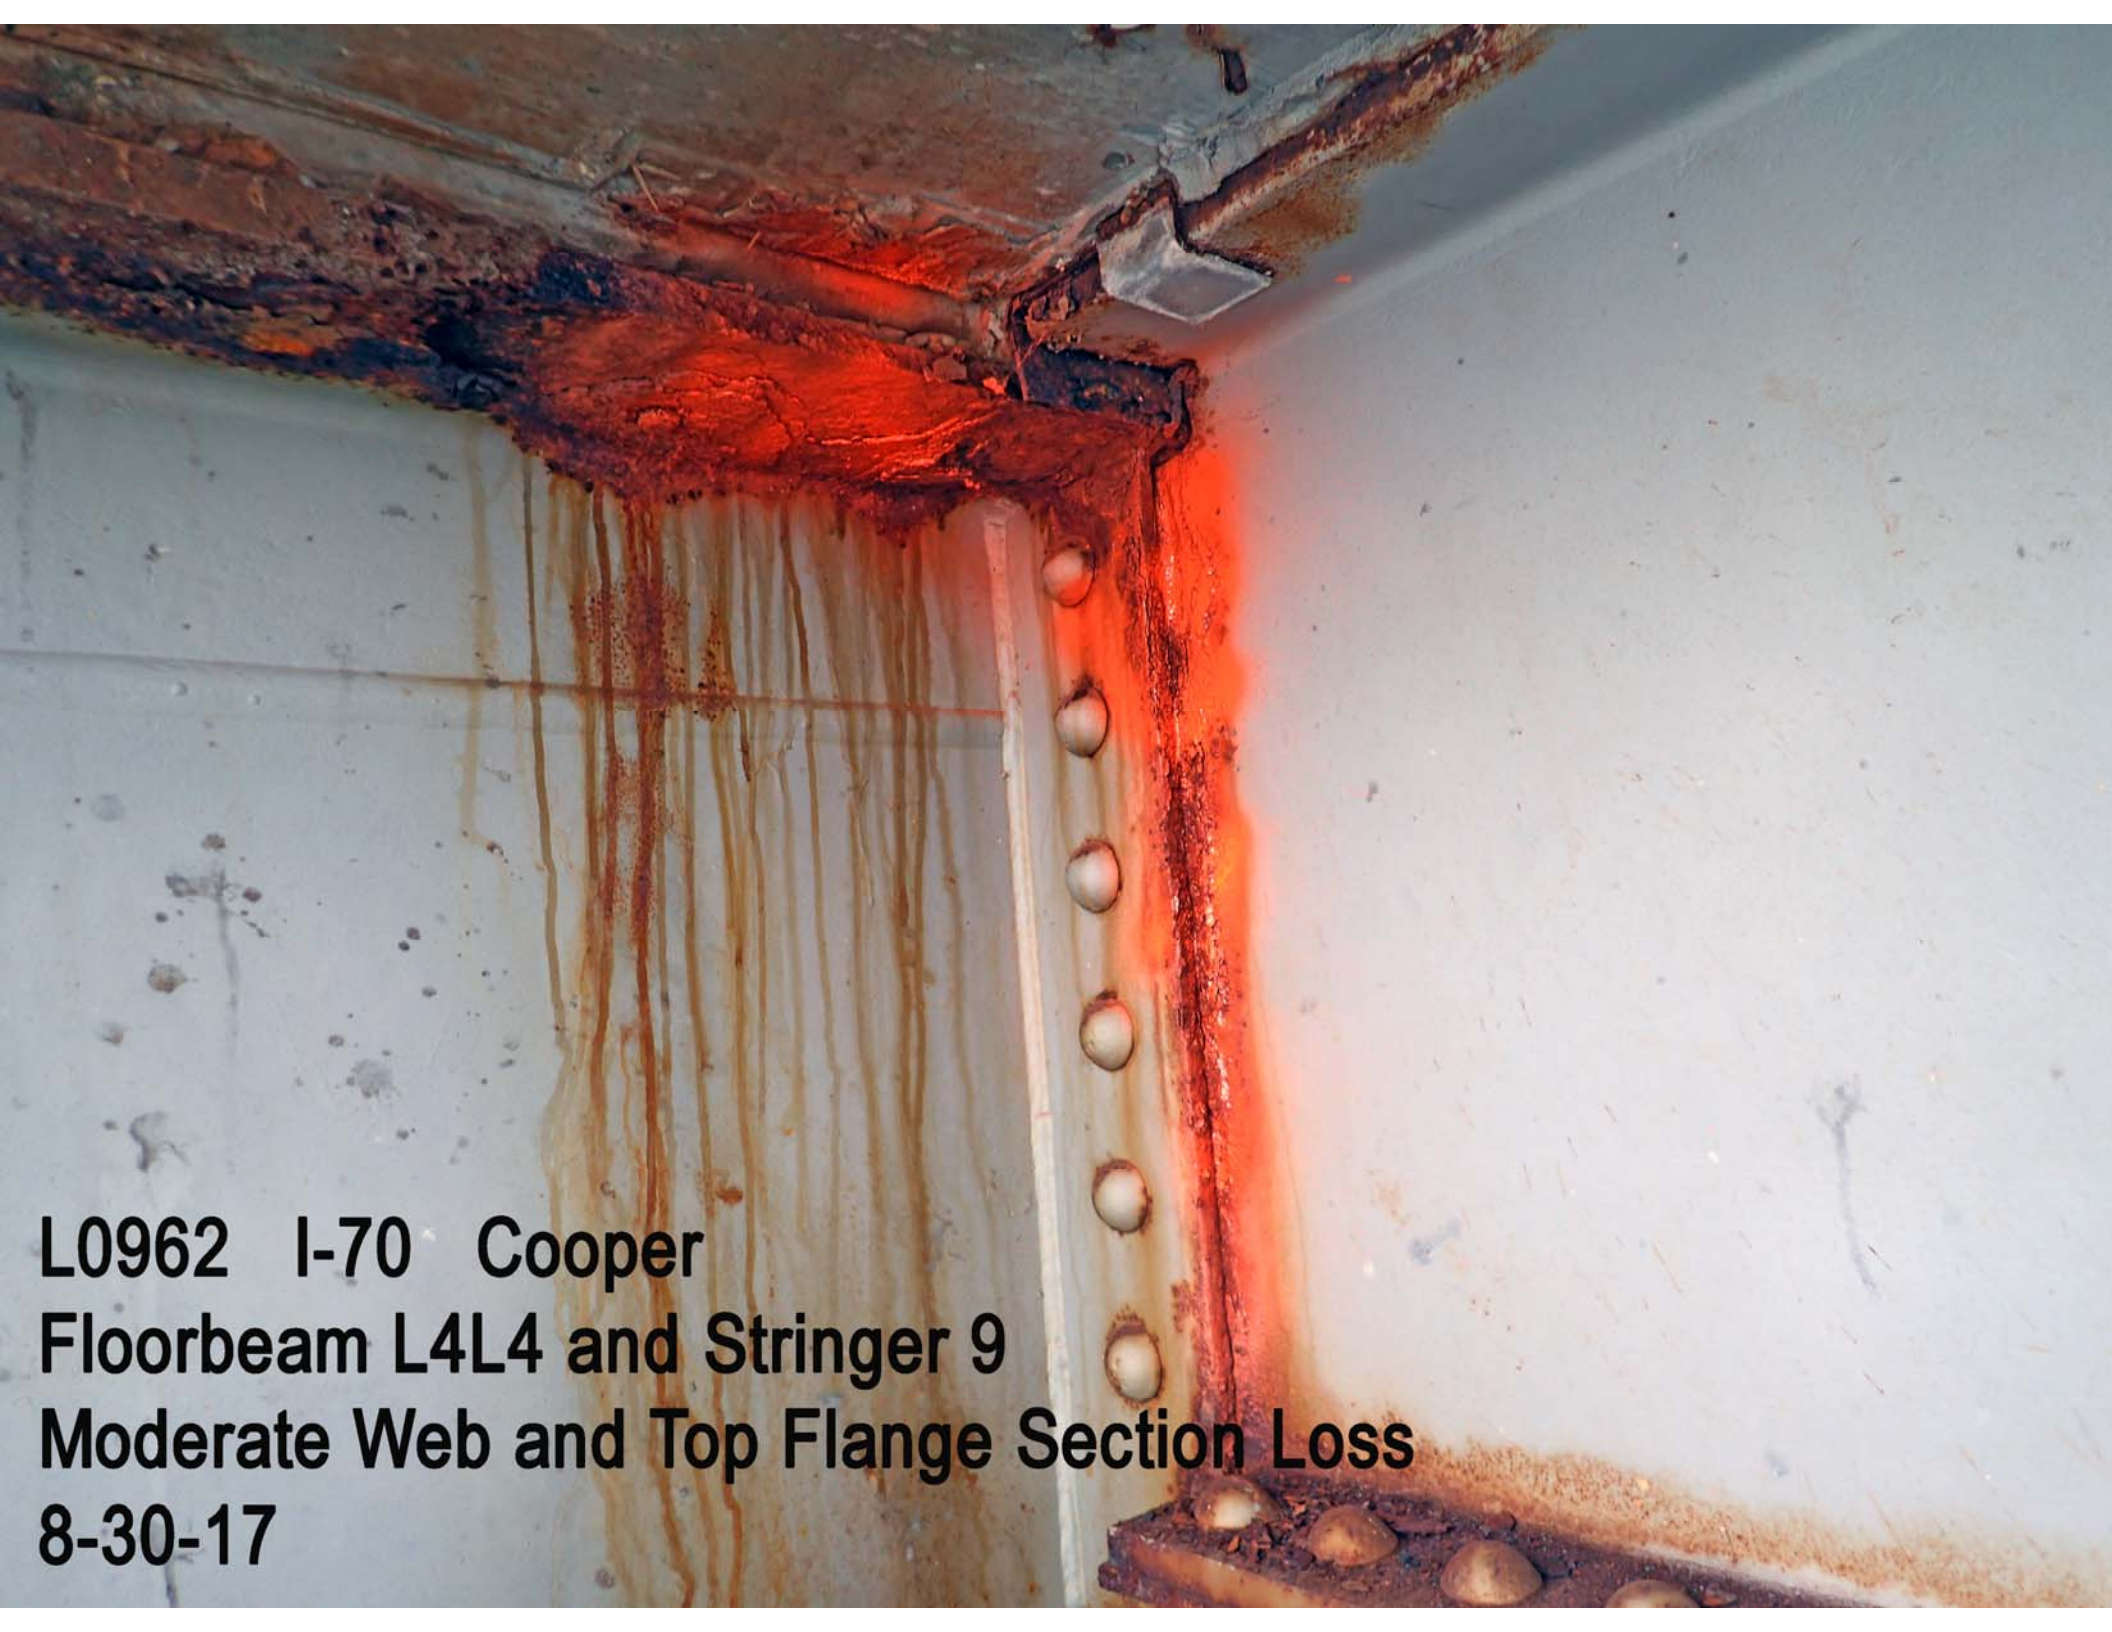
**L0962 I-70 Cooper
Floorbeam L4L4 and Stringer 9
Moderate Web and Top Flange Section Loss
8-30-17**
