L0962 Cooper Co.
08/28/2017
Looking West

L0962 I-70 Cooper
Pier 15 Open Expansion Joint WBL
8-28-17

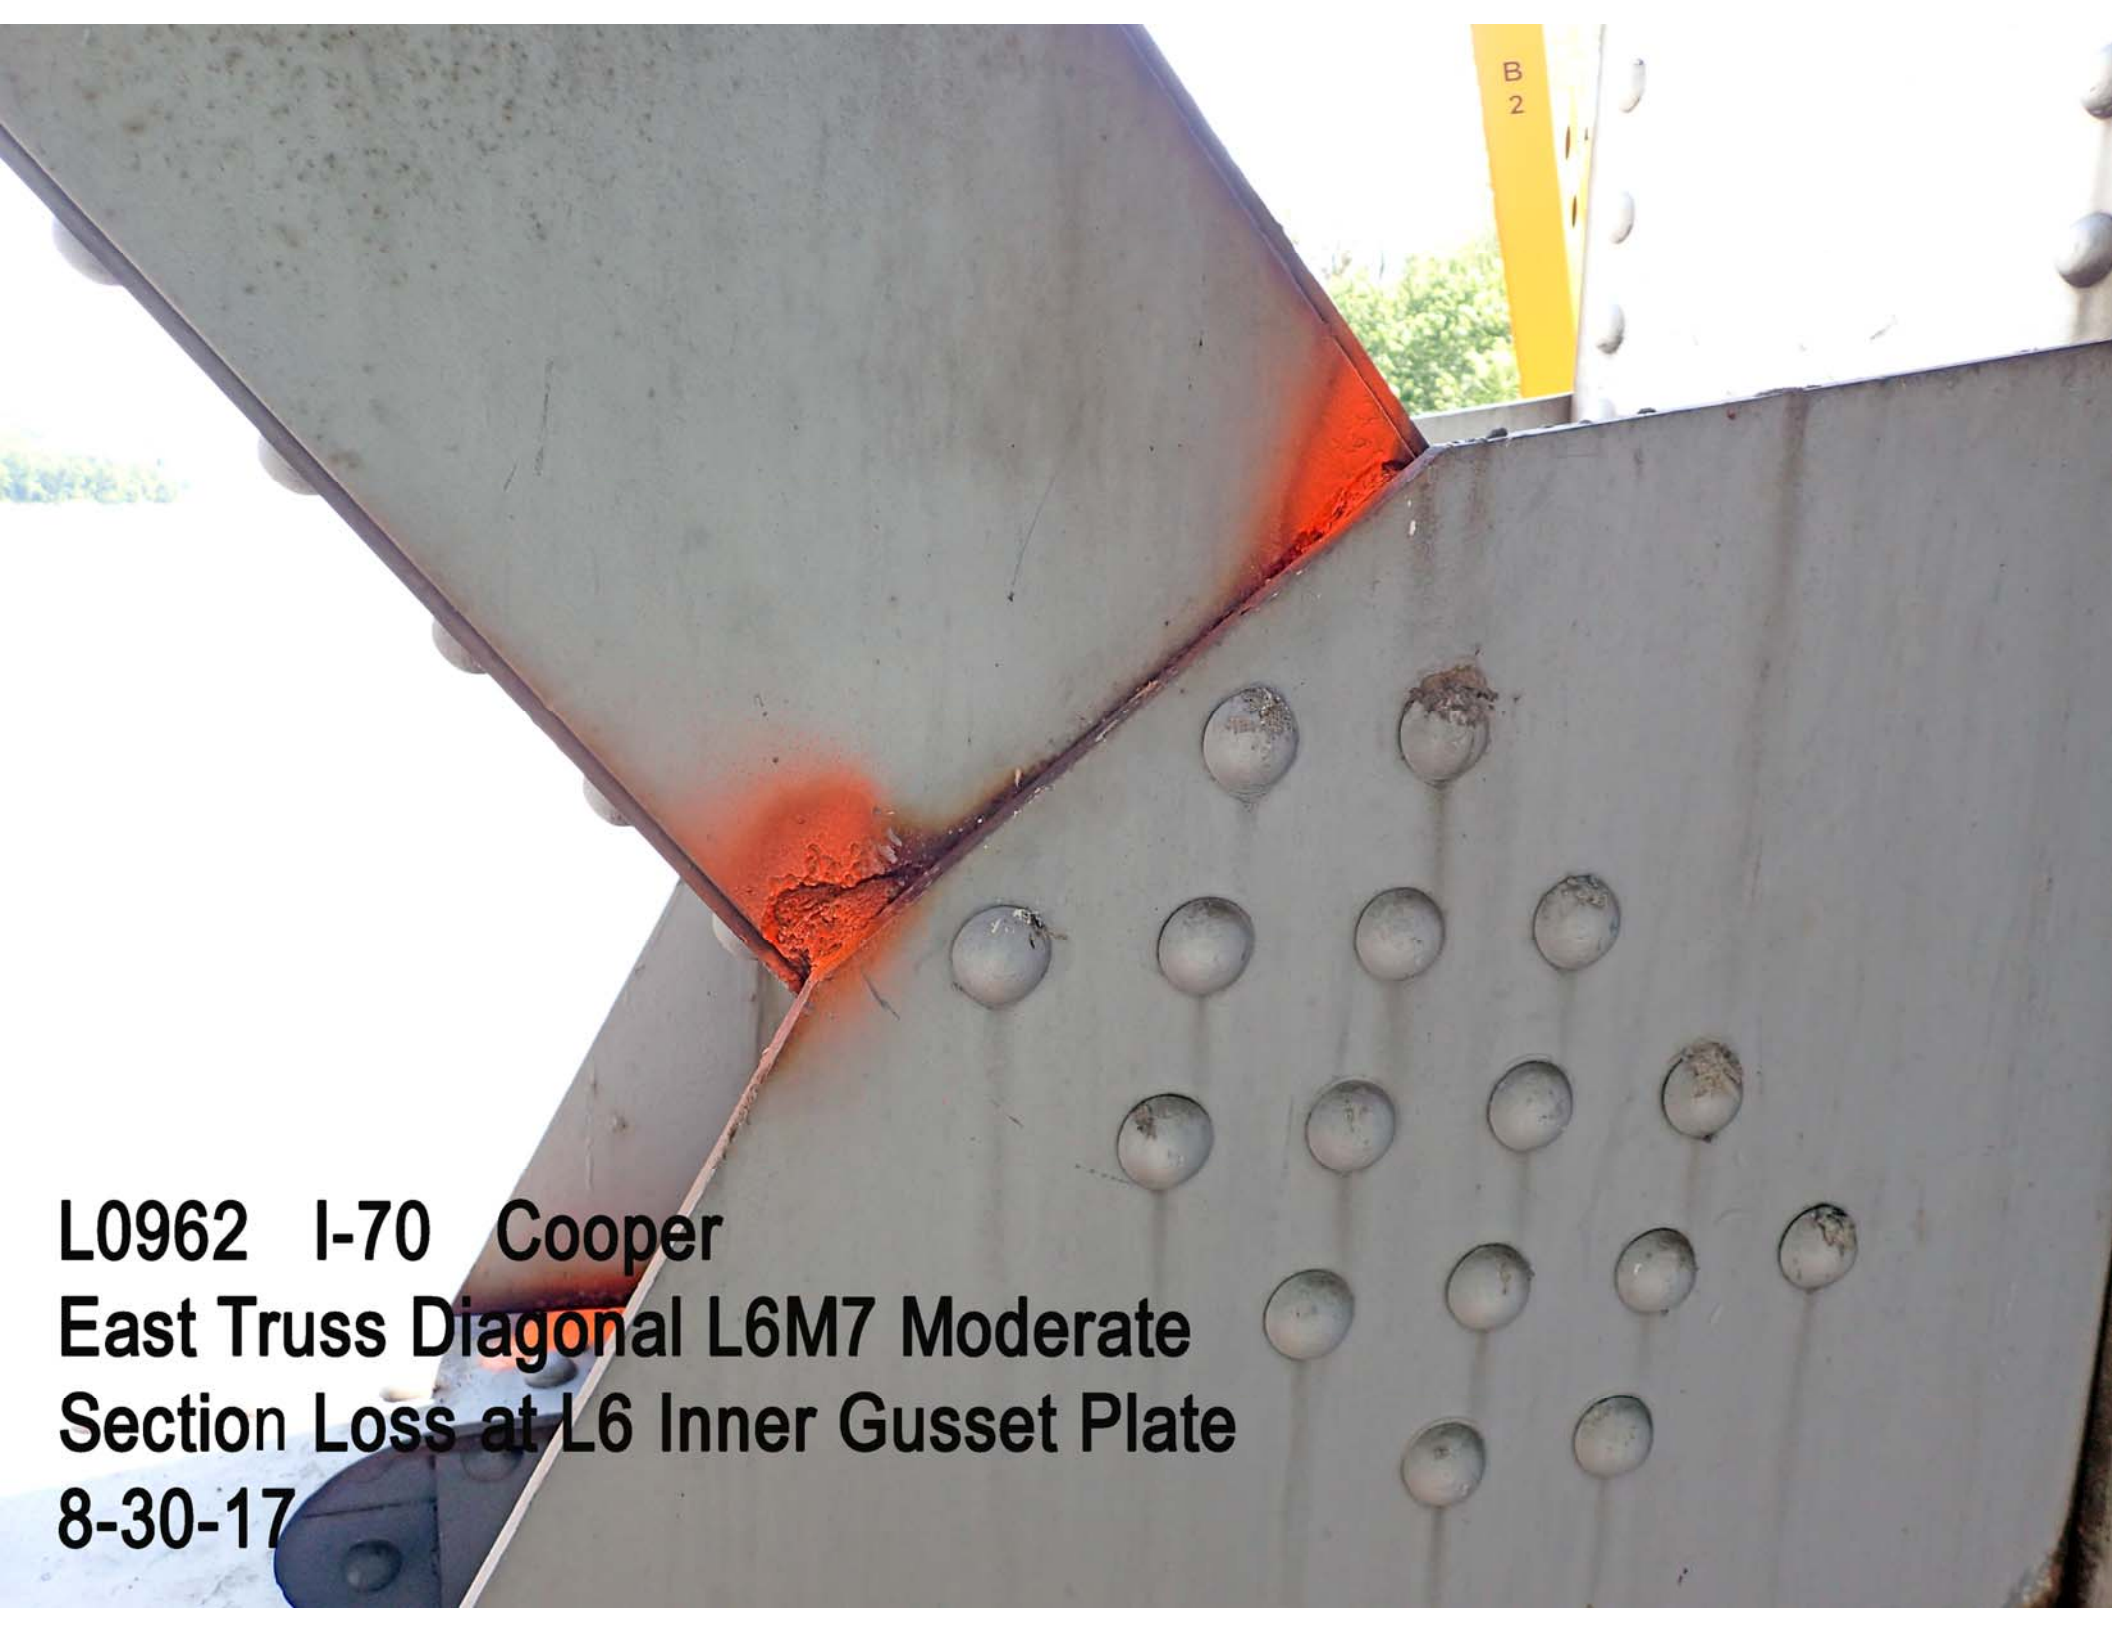
L0962 I-70 Cooper
East Truss Diagonal L6M7 Moderate
Section Loss at L6 Inner Gusset Plate
8-30-17

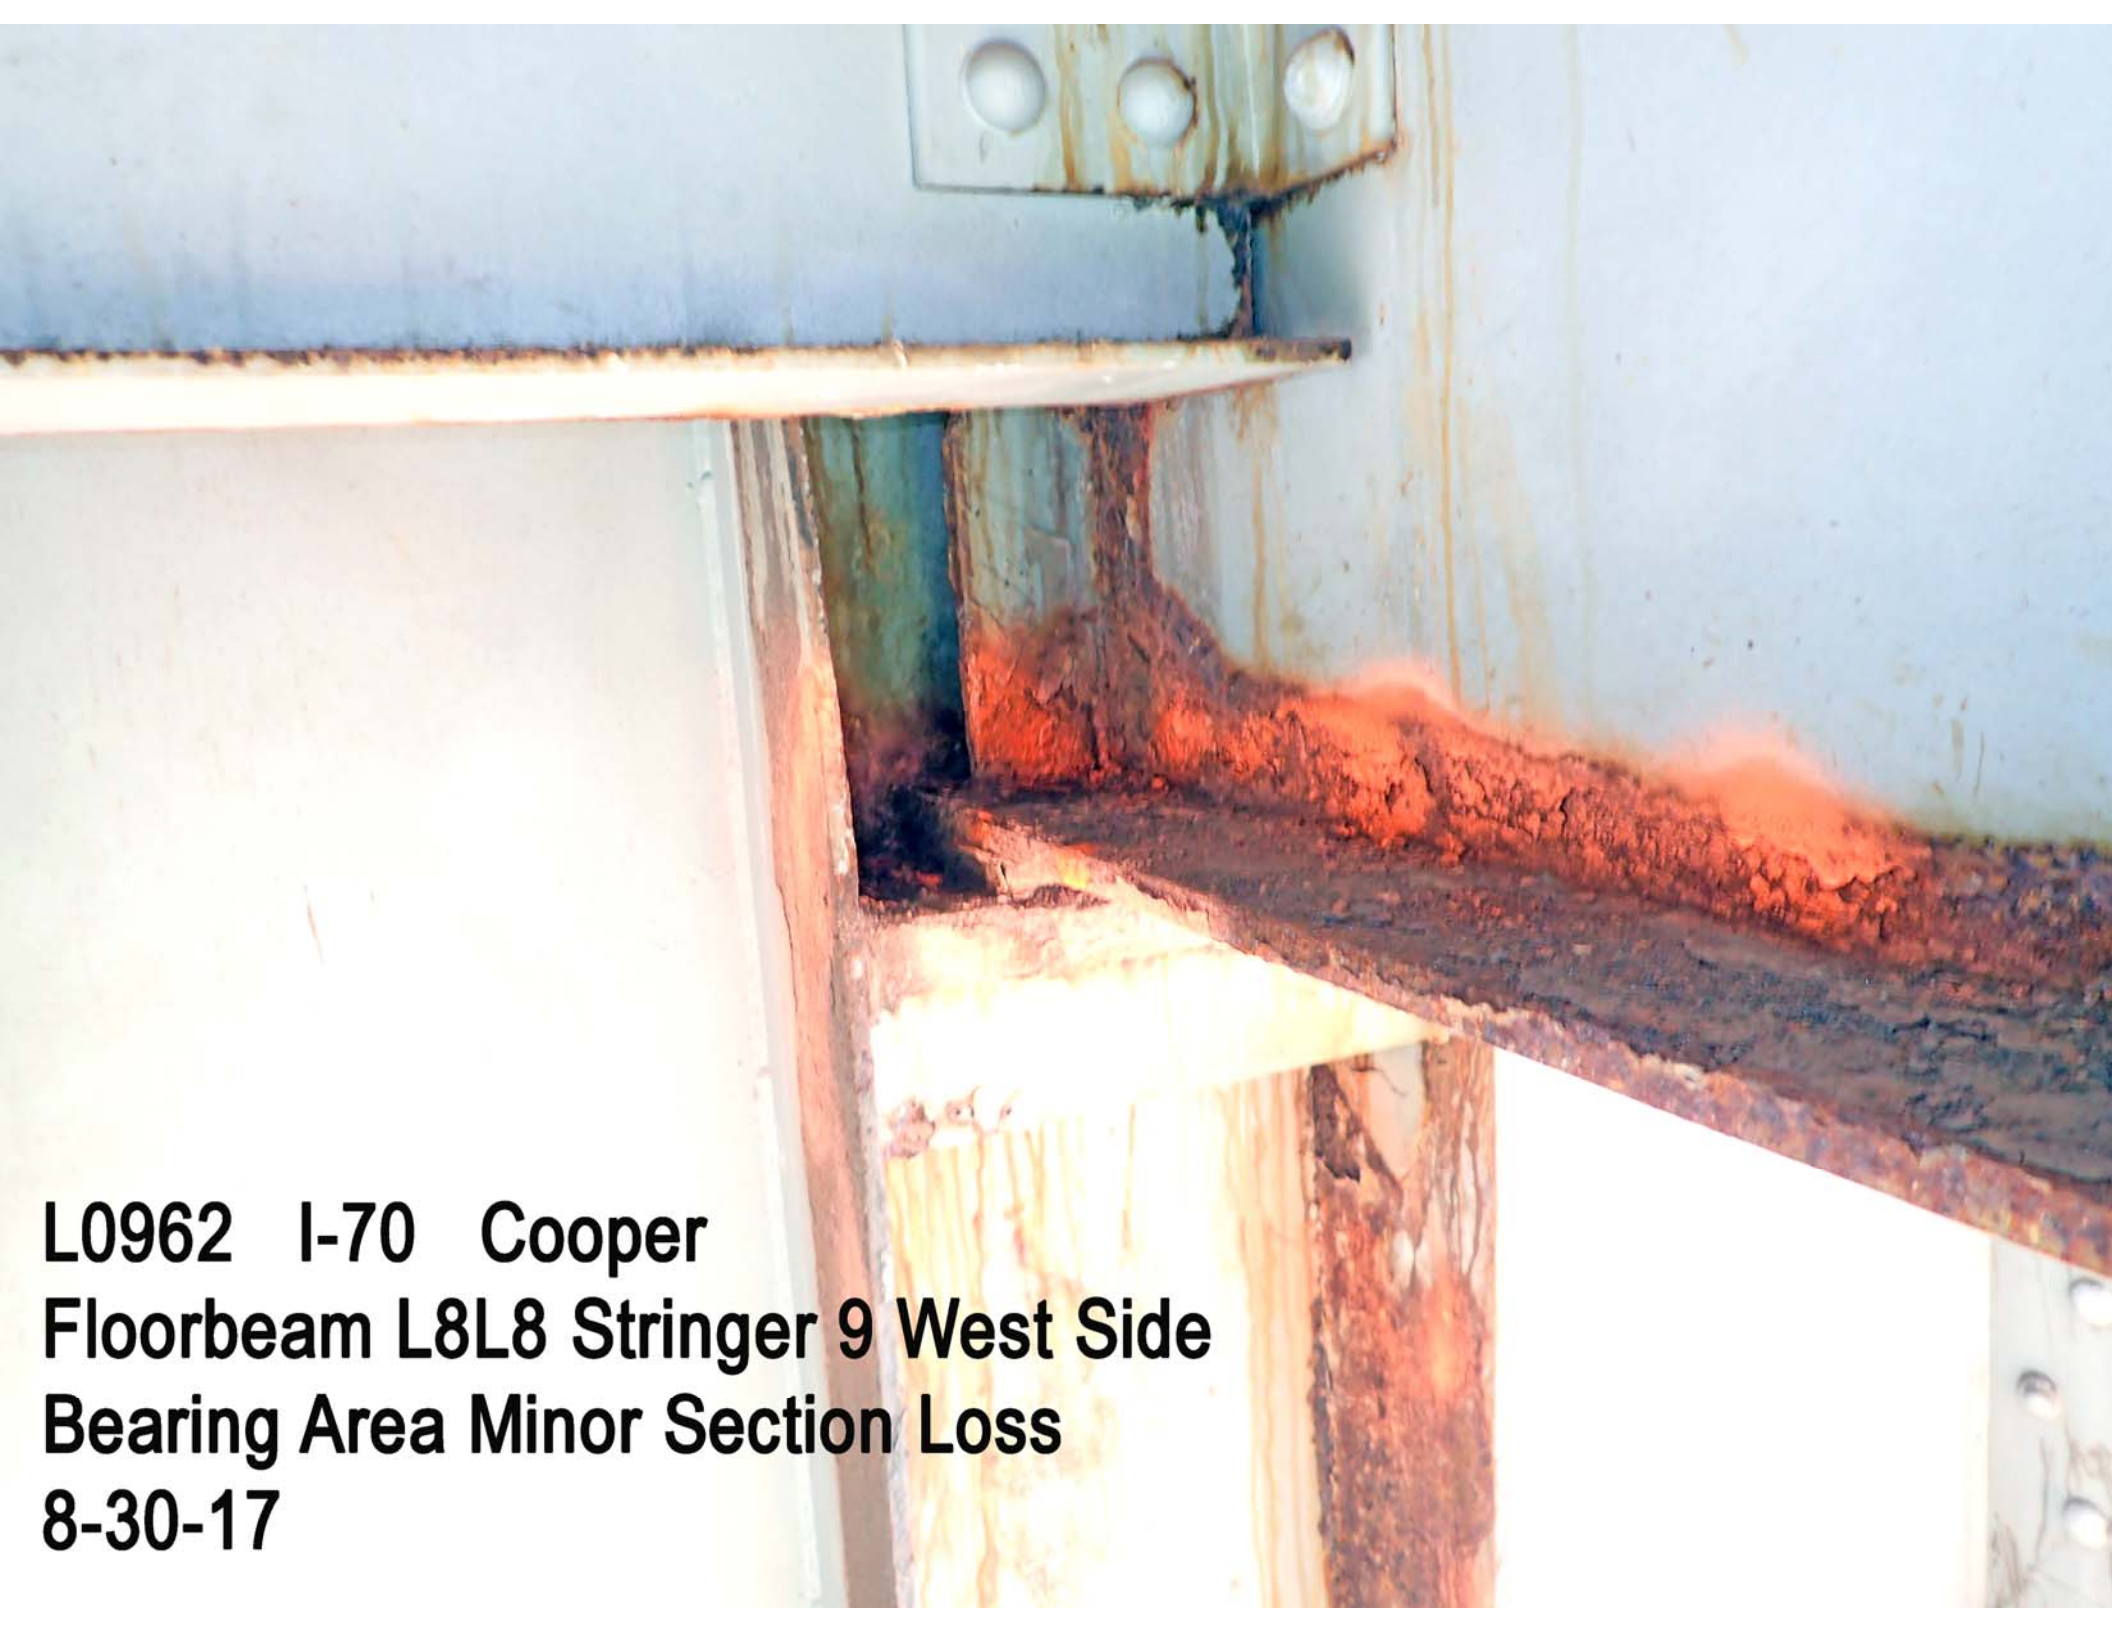
**L0962 I-70 Cooper
Floorbeam L8L8 Stringer 9 West Side
Bearing Area Minor Section Loss
8-30-17**

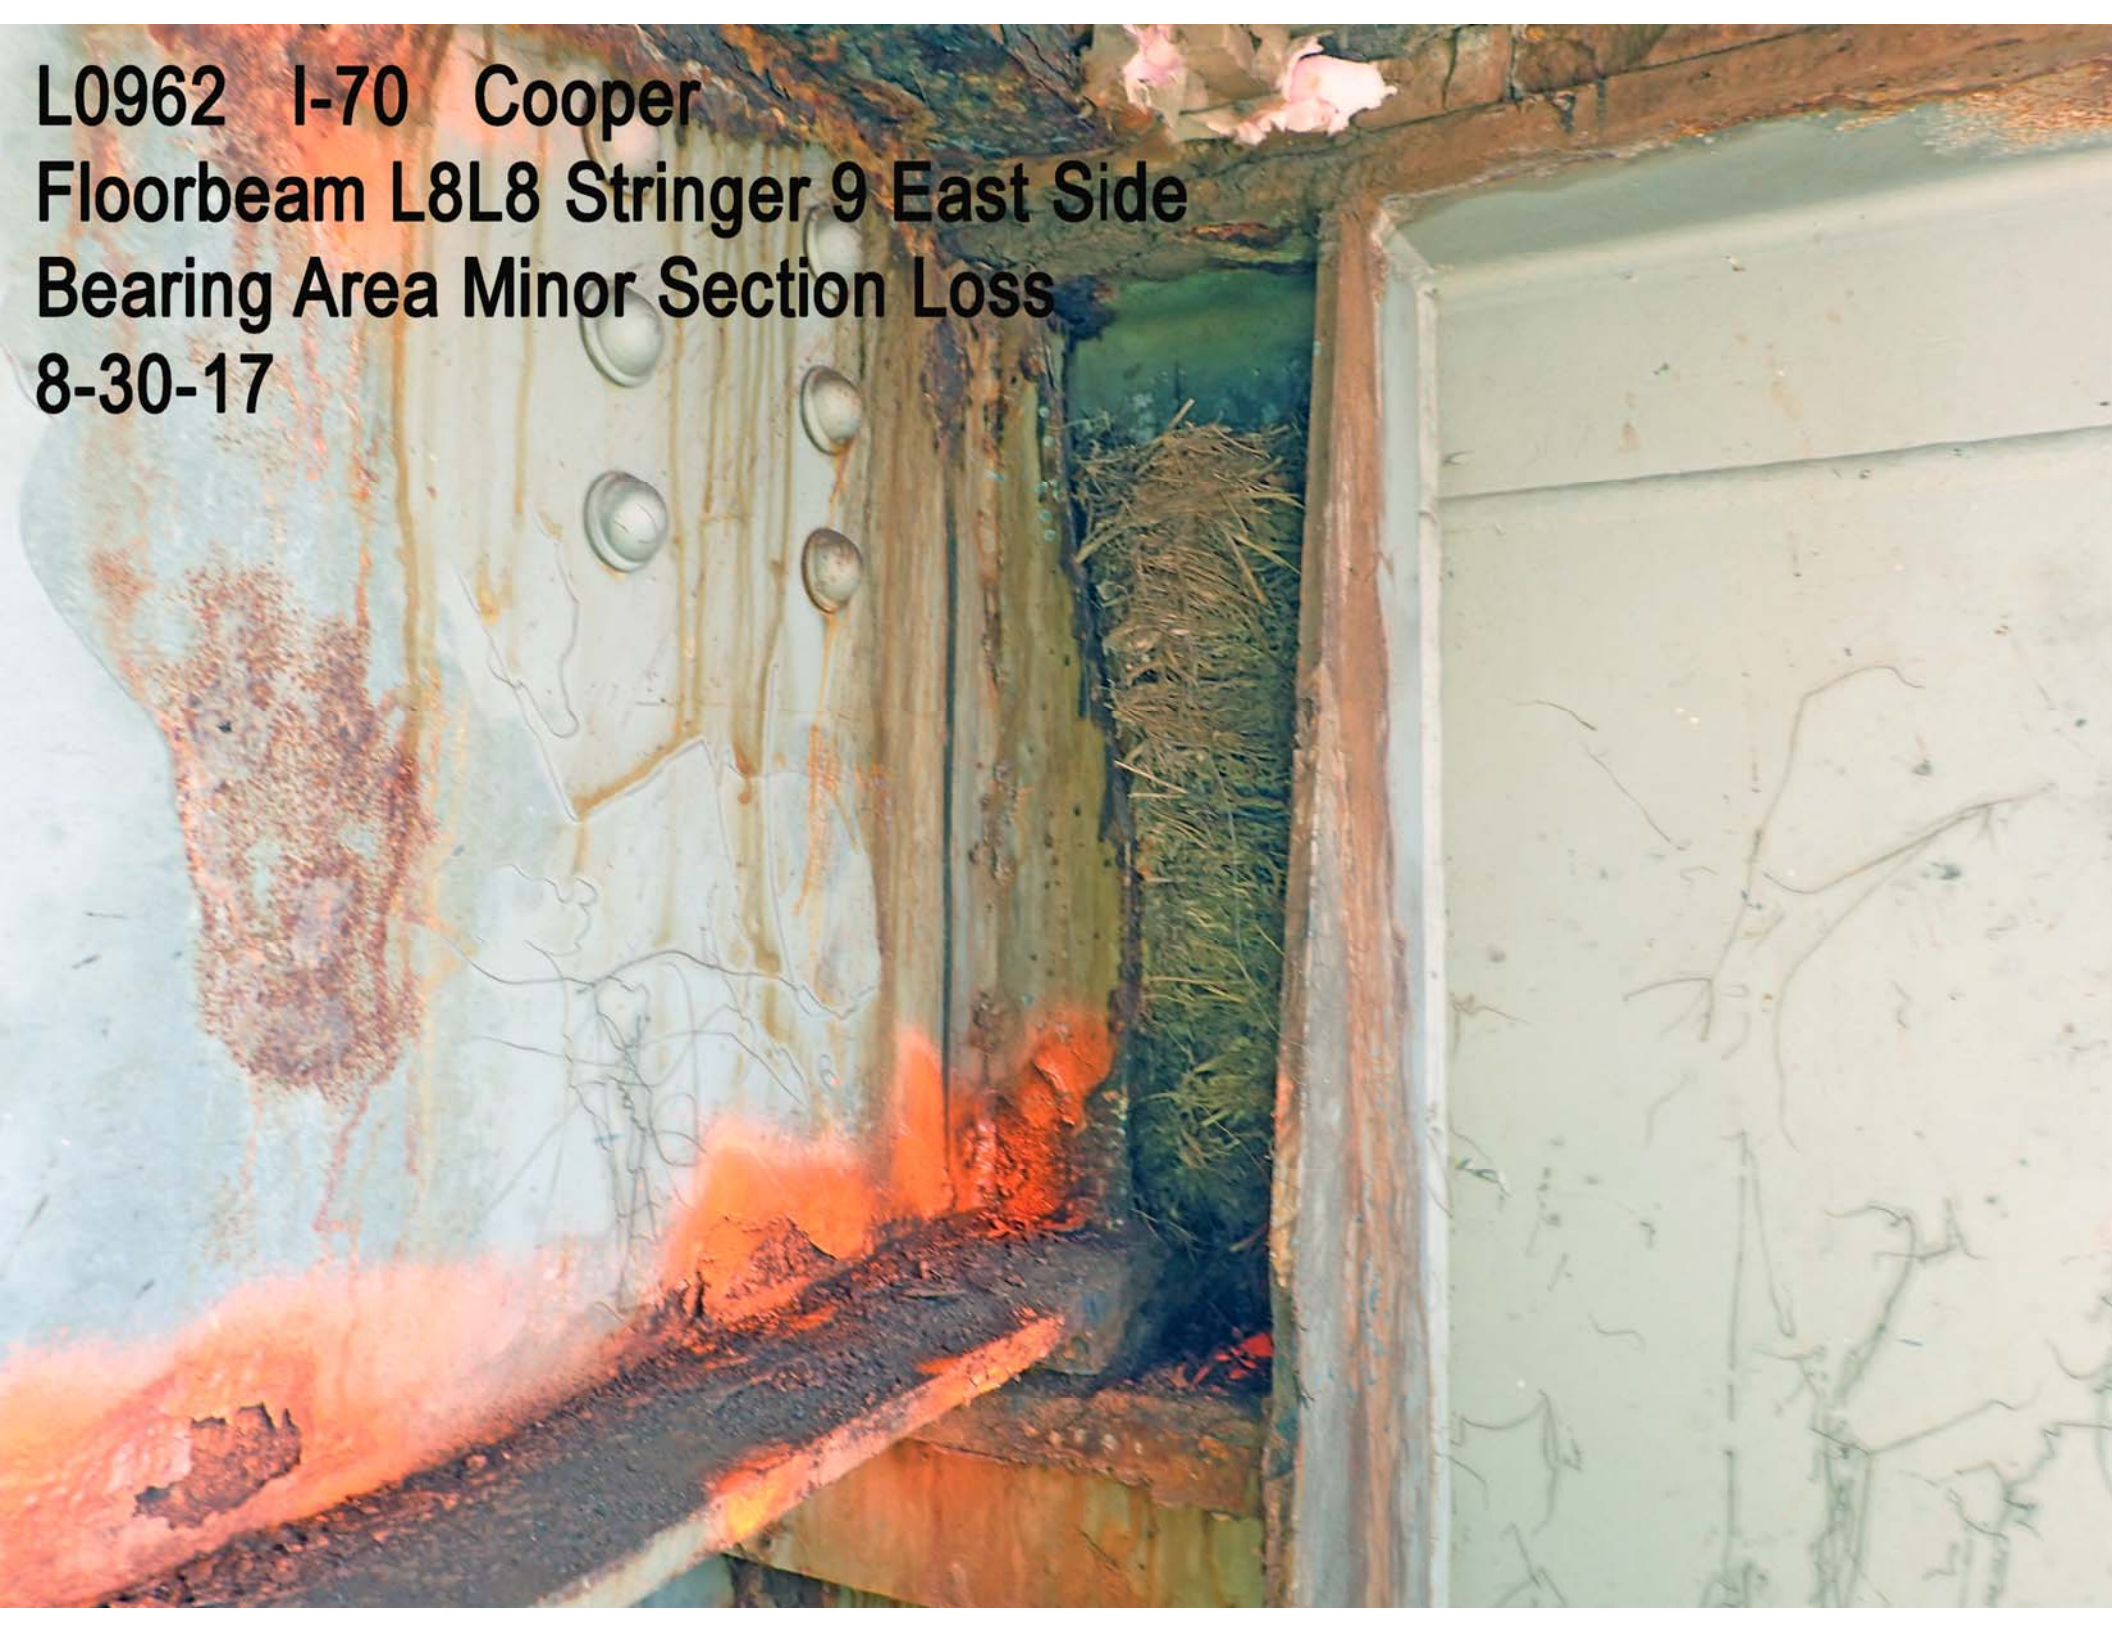
**L0962 I-70 Cooper
Floorbeam L8L8 Stringer 9 East Side
Bearing Area Minor Section Loss
8-30-17**

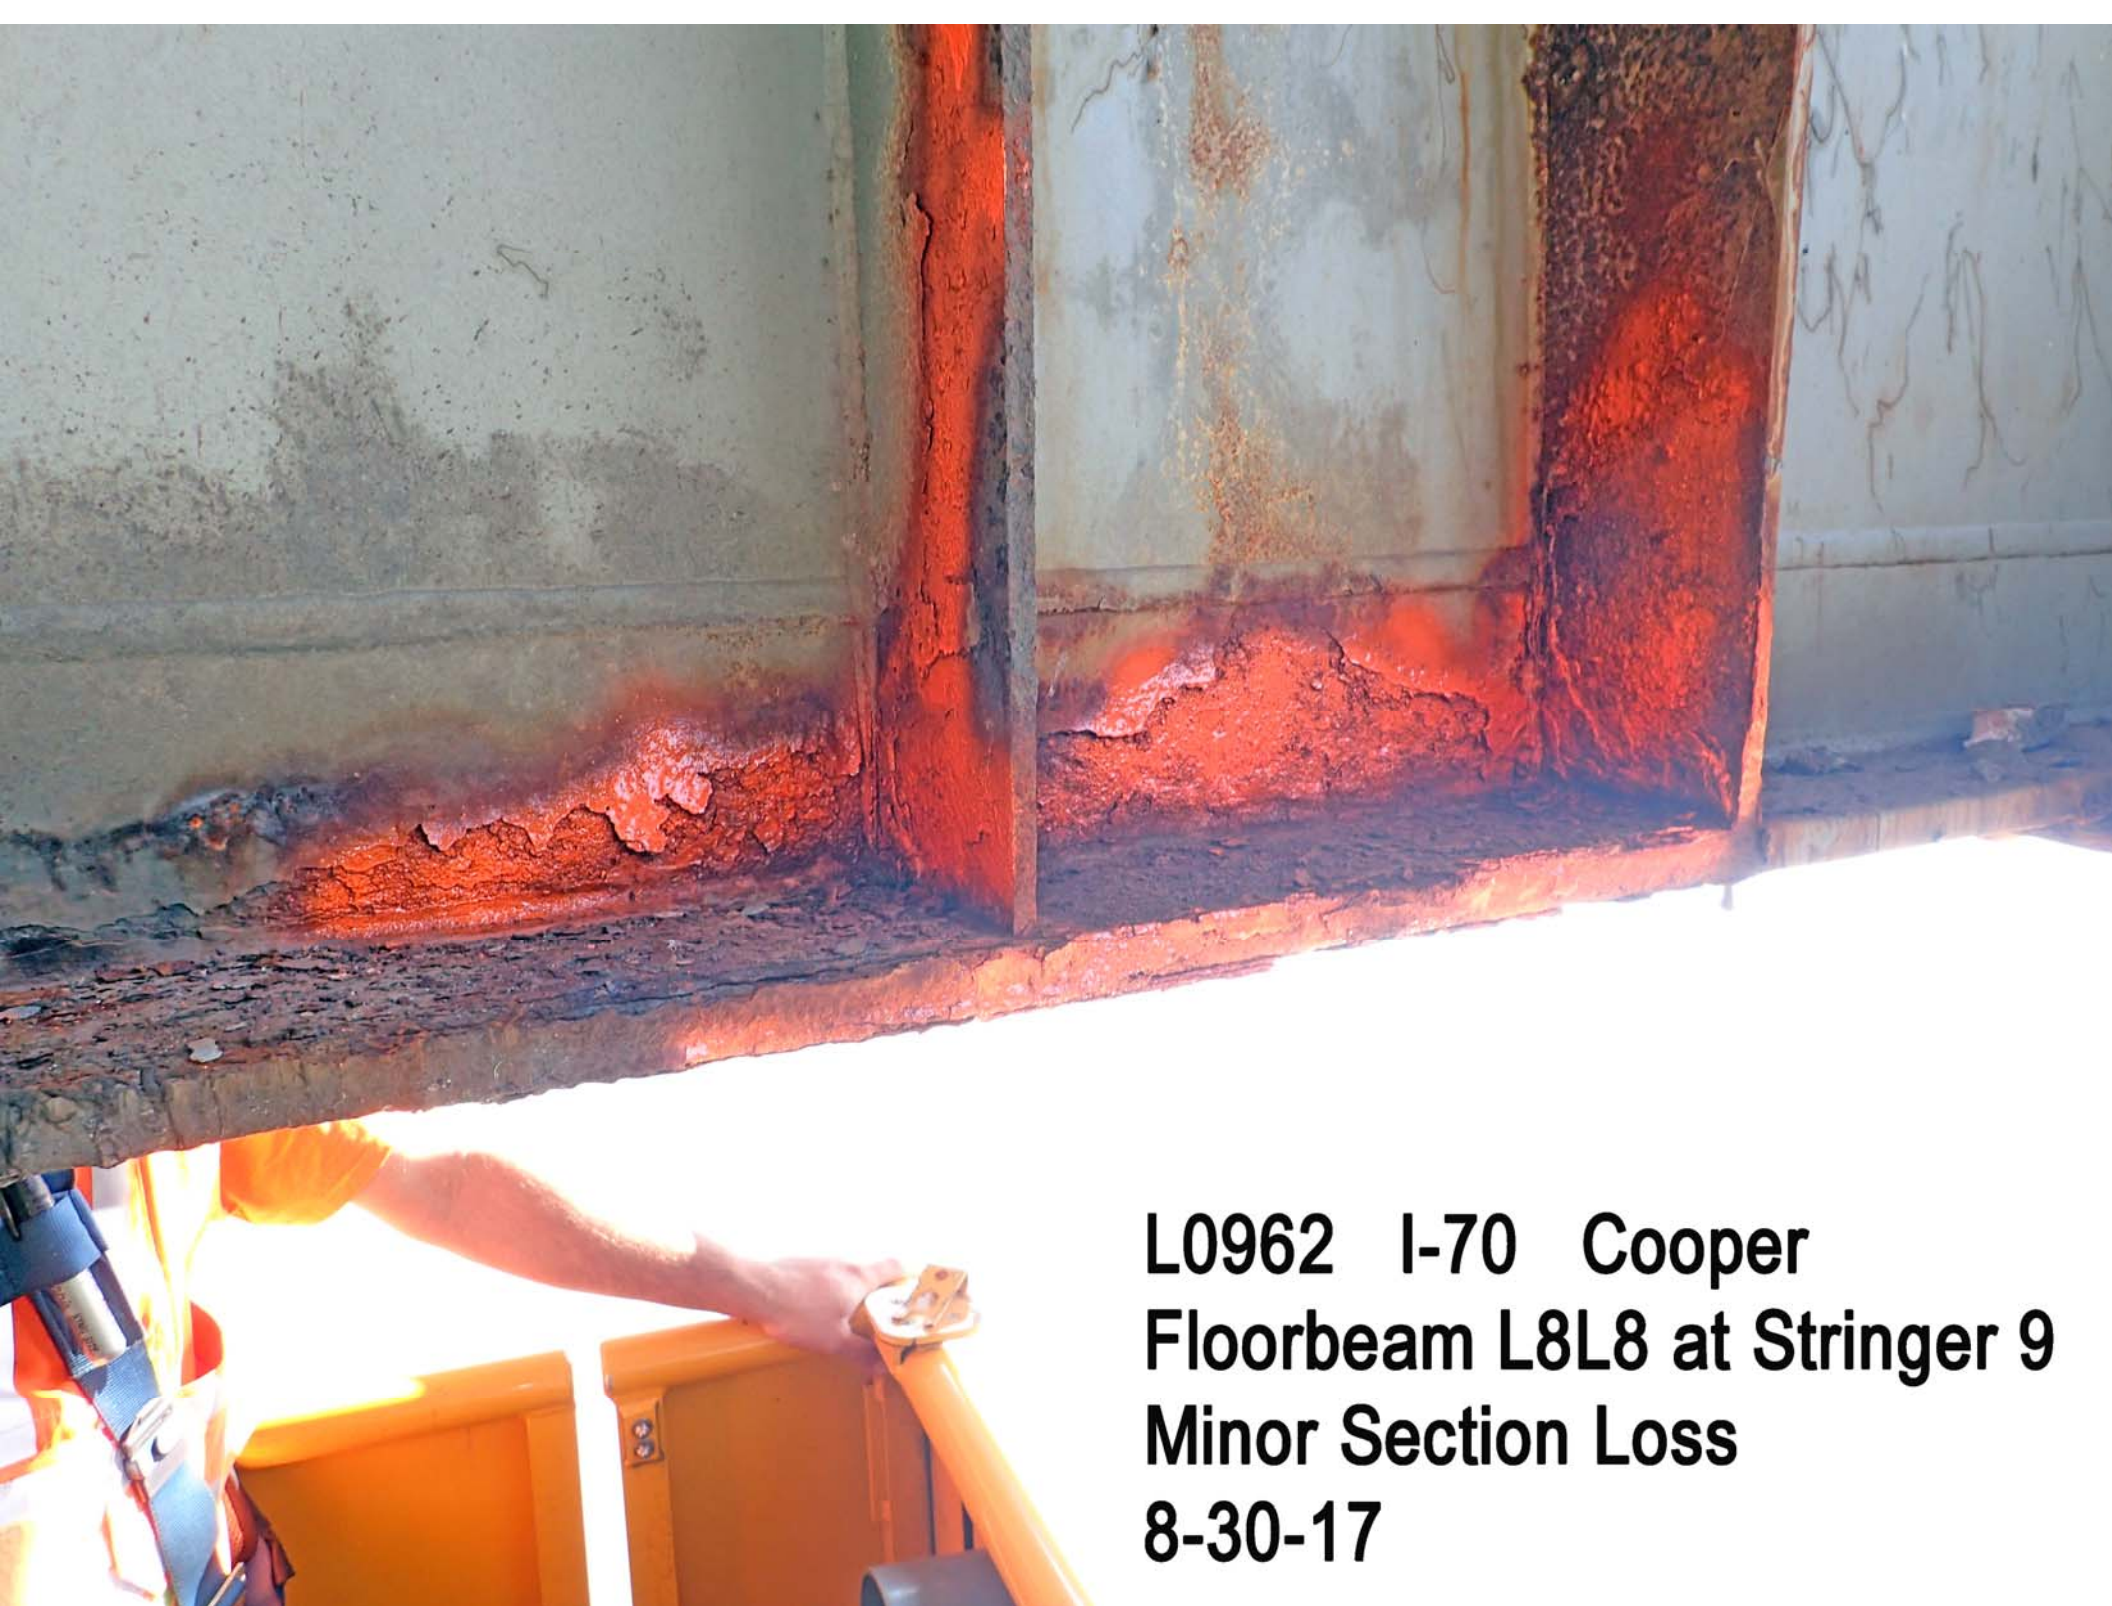
**L0962 I-70 Cooper
Floorbeam L8L8 at Stringer 9
Minor Section Loss
8-30-17**

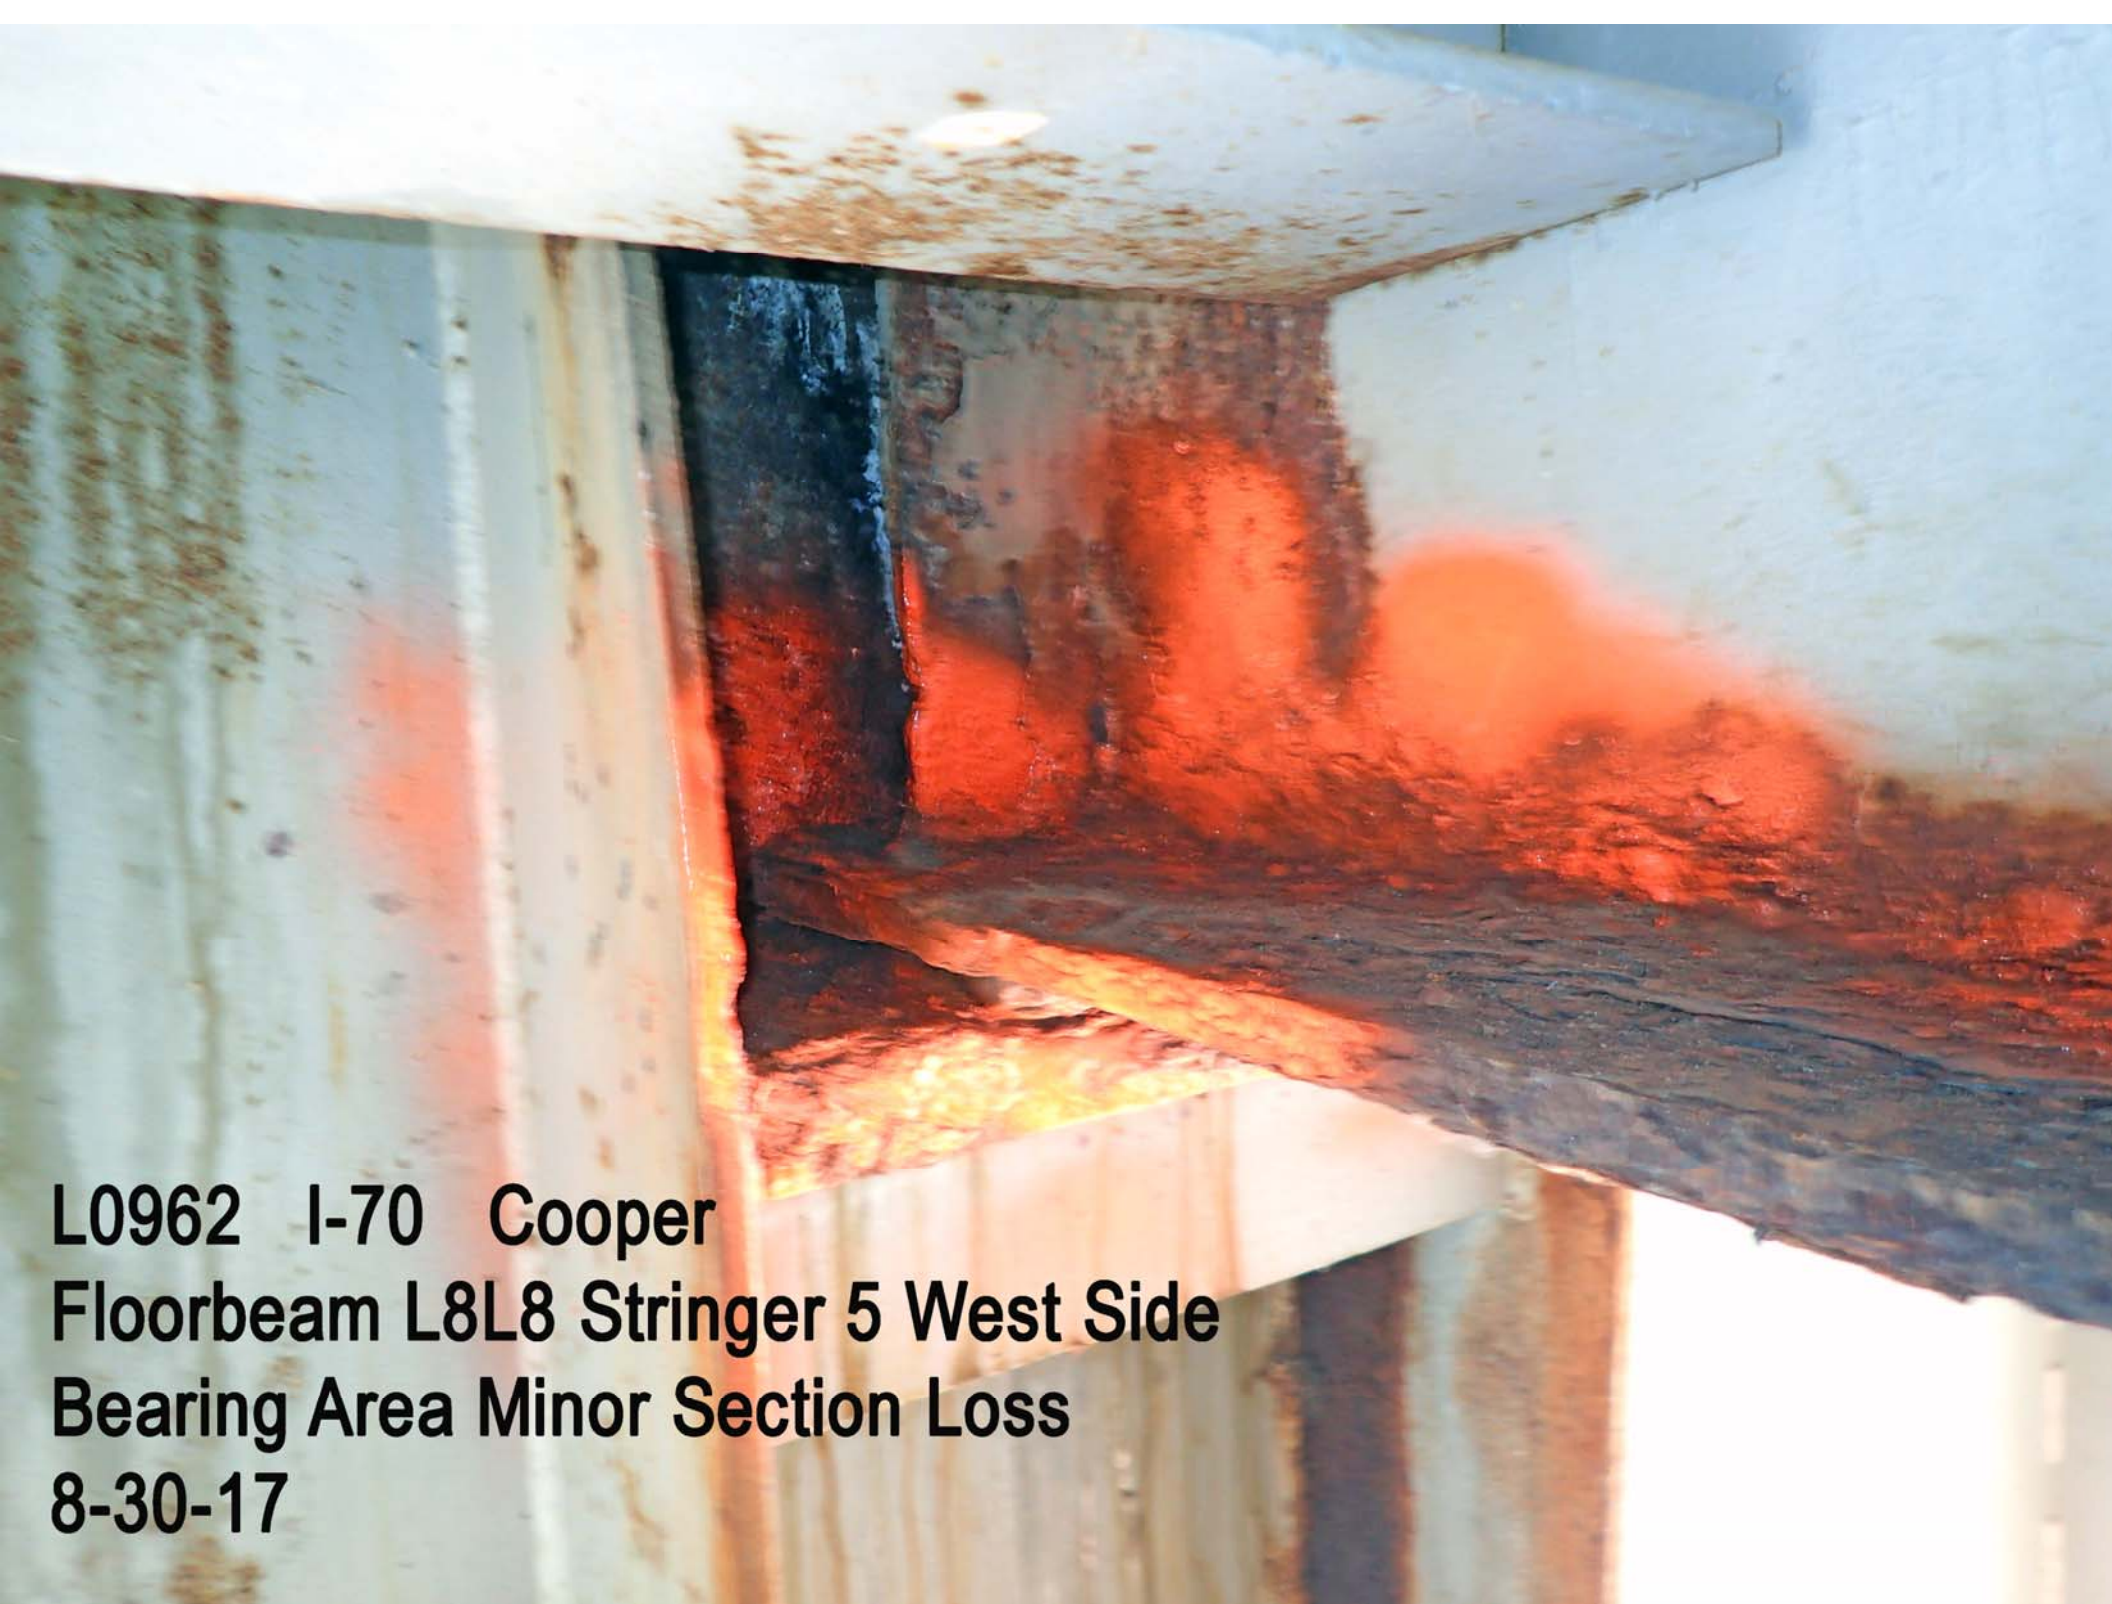
**L0962 I-70 Cooper
Floorbeam L8L8 Stringer 5 West Side
Bearing Area Minor Section Loss
8-30-17**

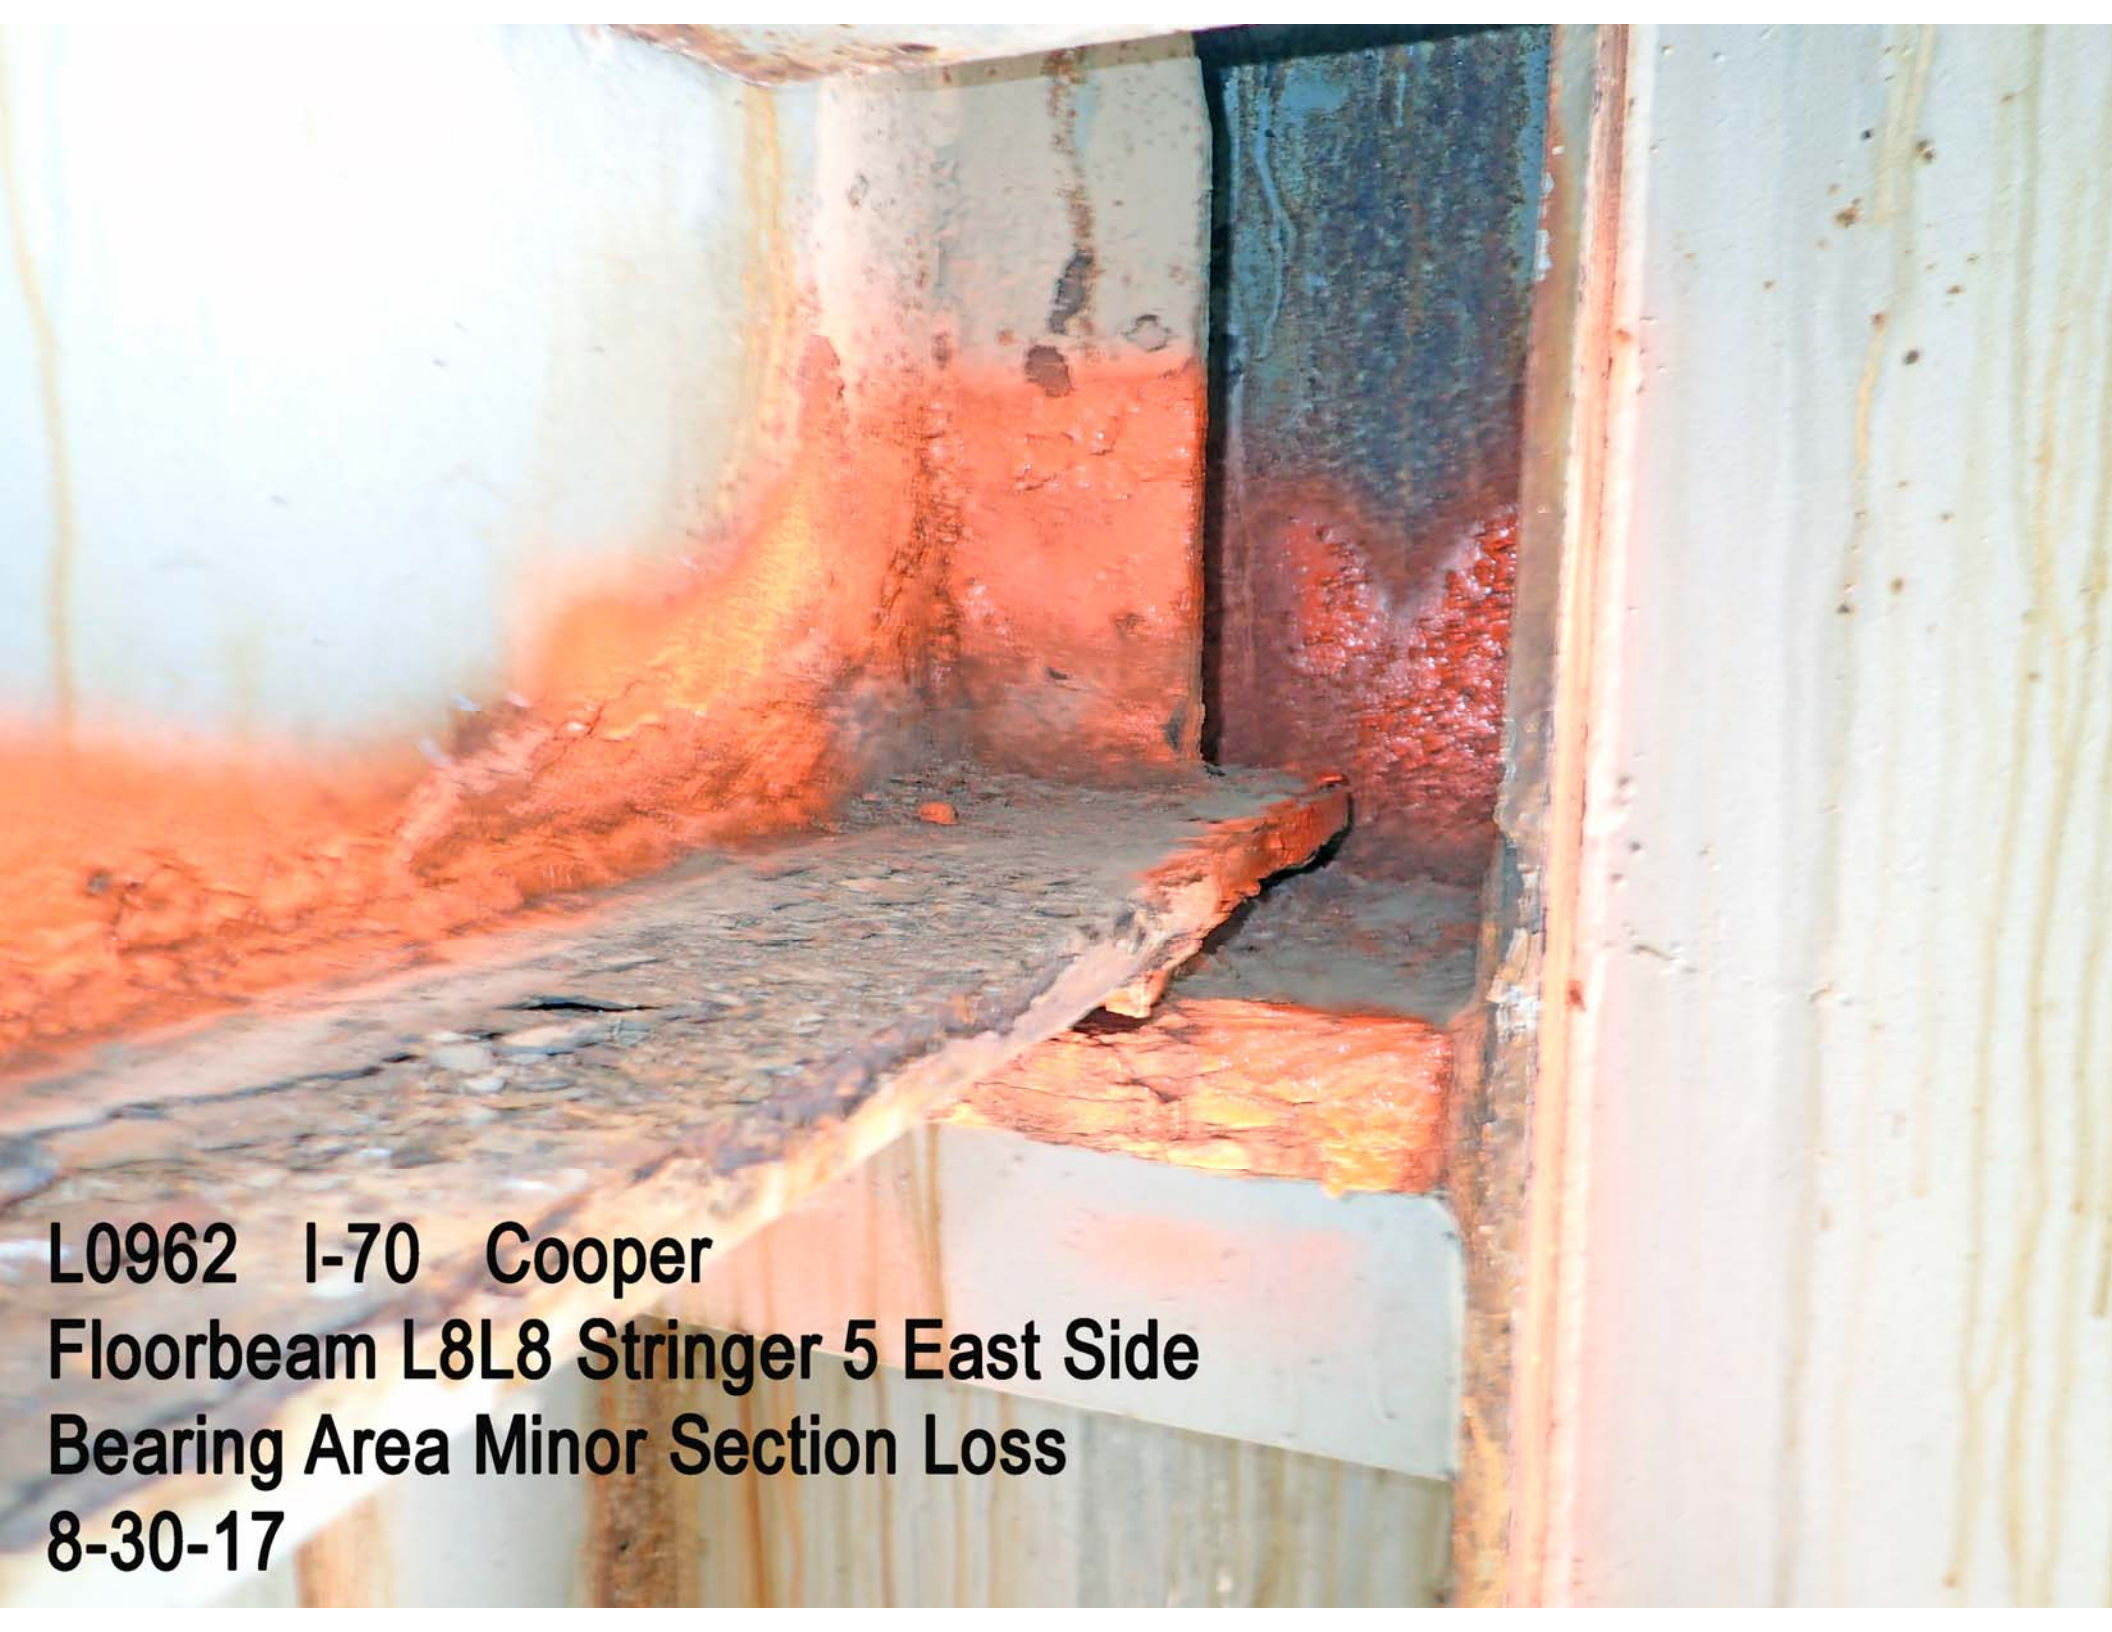
**L0962 I-70 Cooper
Floorbeam L8L8 Stringer 5 East Side
Bearing Area Minor Section Loss
8-30-17**

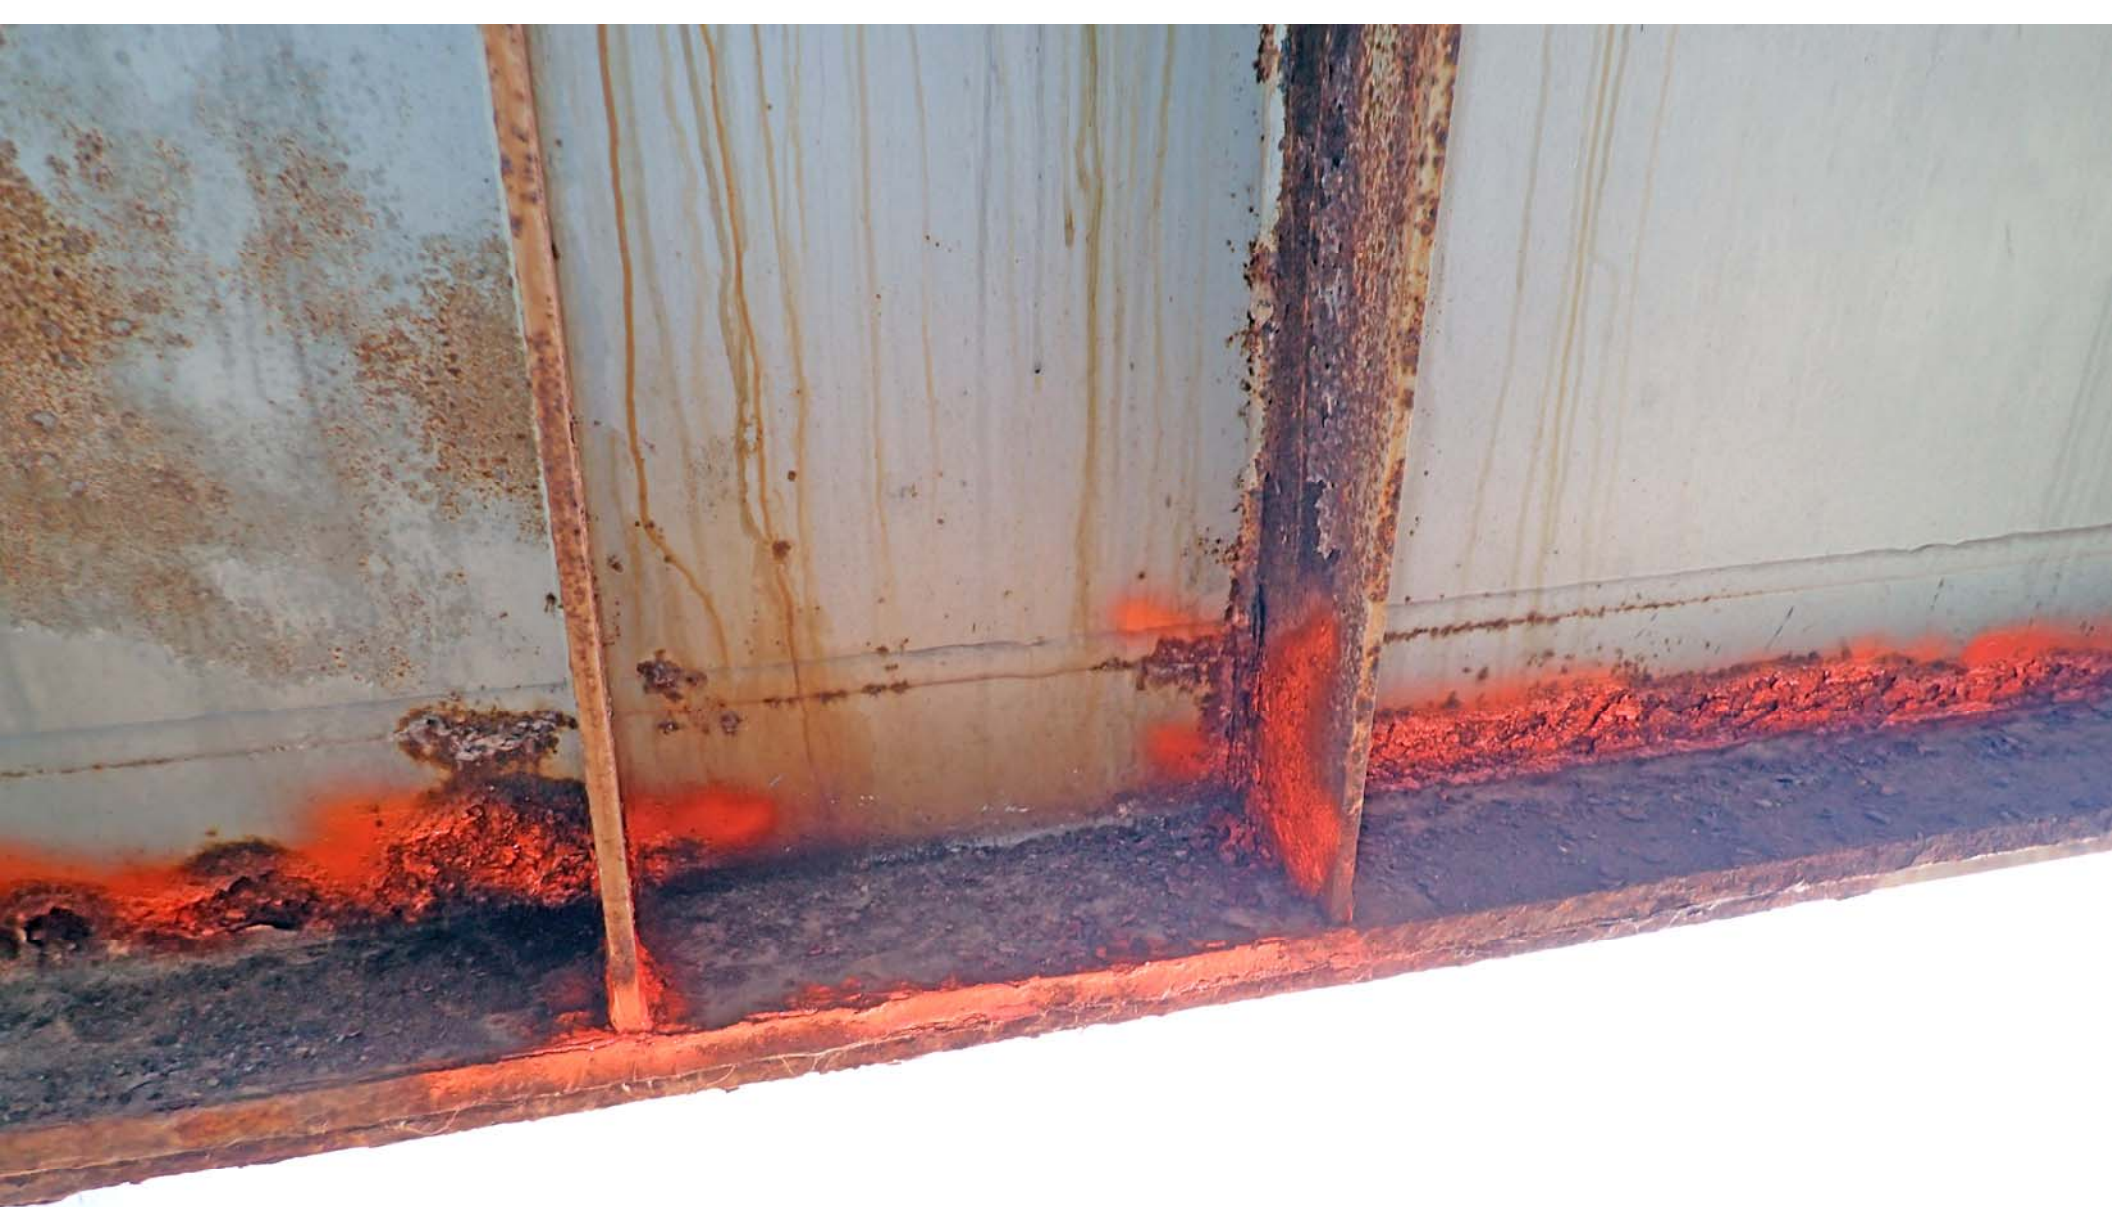
L0962 I-70 Cooper
Floorbeam L8L8 at Stringer 5
Minor Section Loss
8-30-17
