L0962 Cooper Co.
08/28/2017
Looking West

L0962 I-70 Cooper
Pier 15 Open Expansion Joint WBL
8-28-17

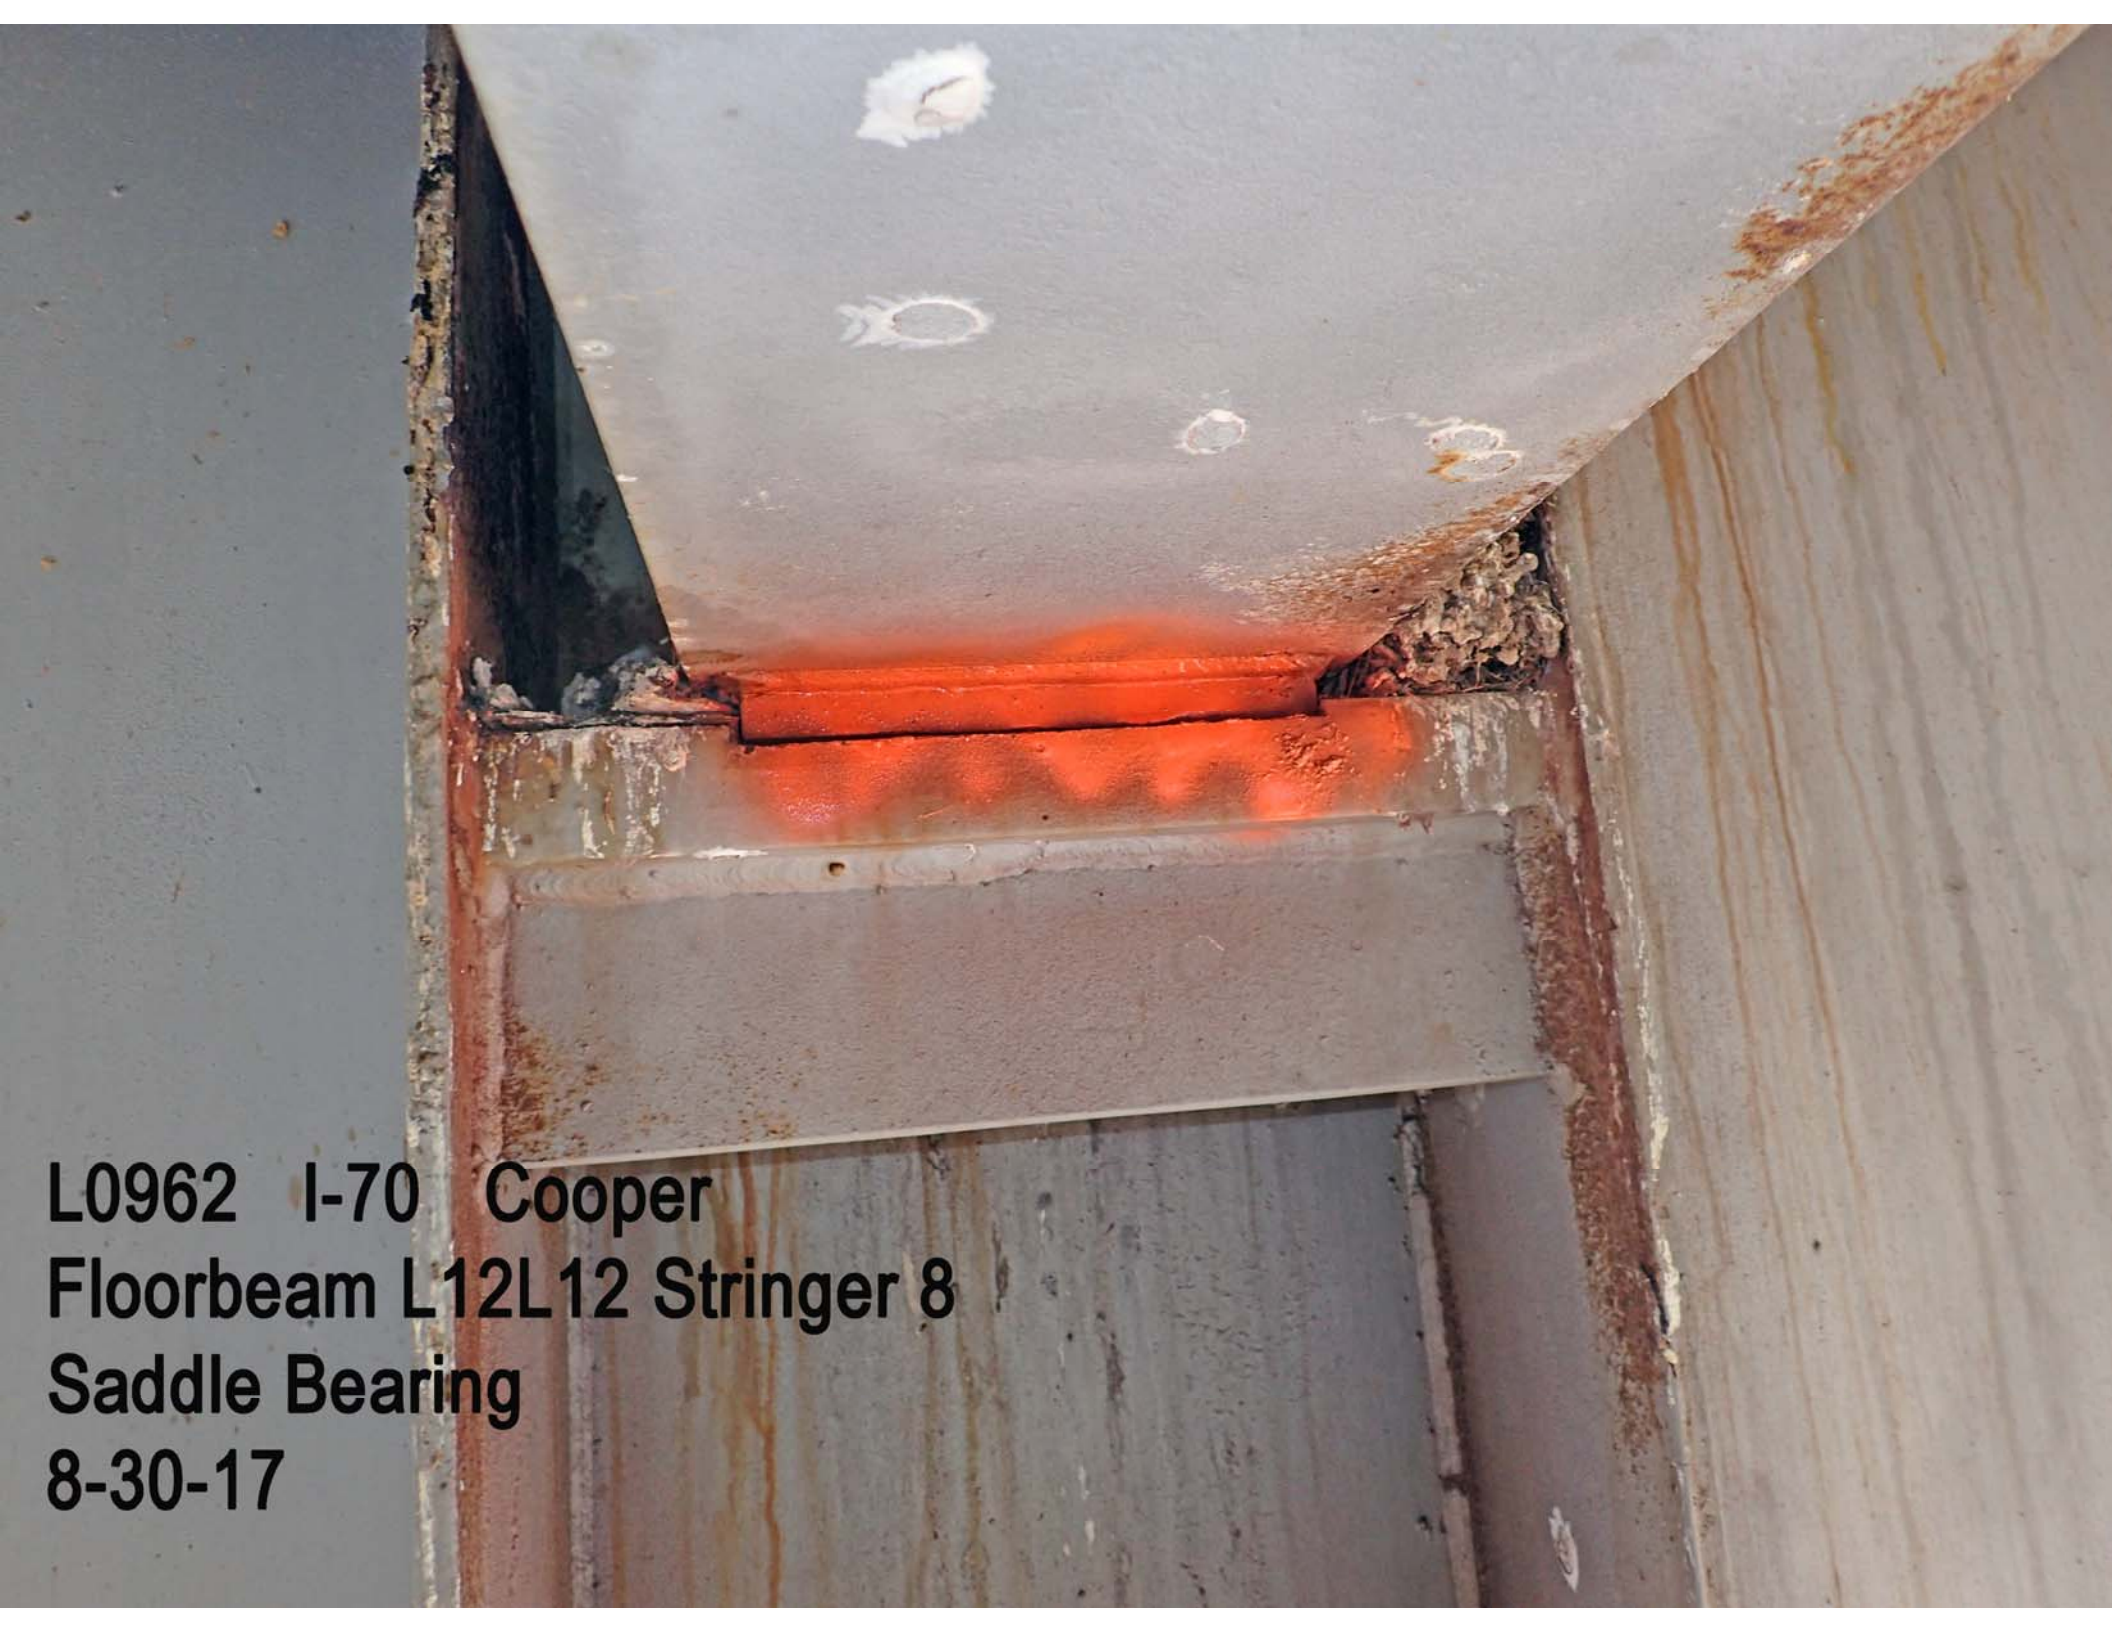
L0962 I-70 Cooper
Floorbeam L12L12 Stringer 9
Saddle Bearing Packrust Lifting 1/4"
8-30-17

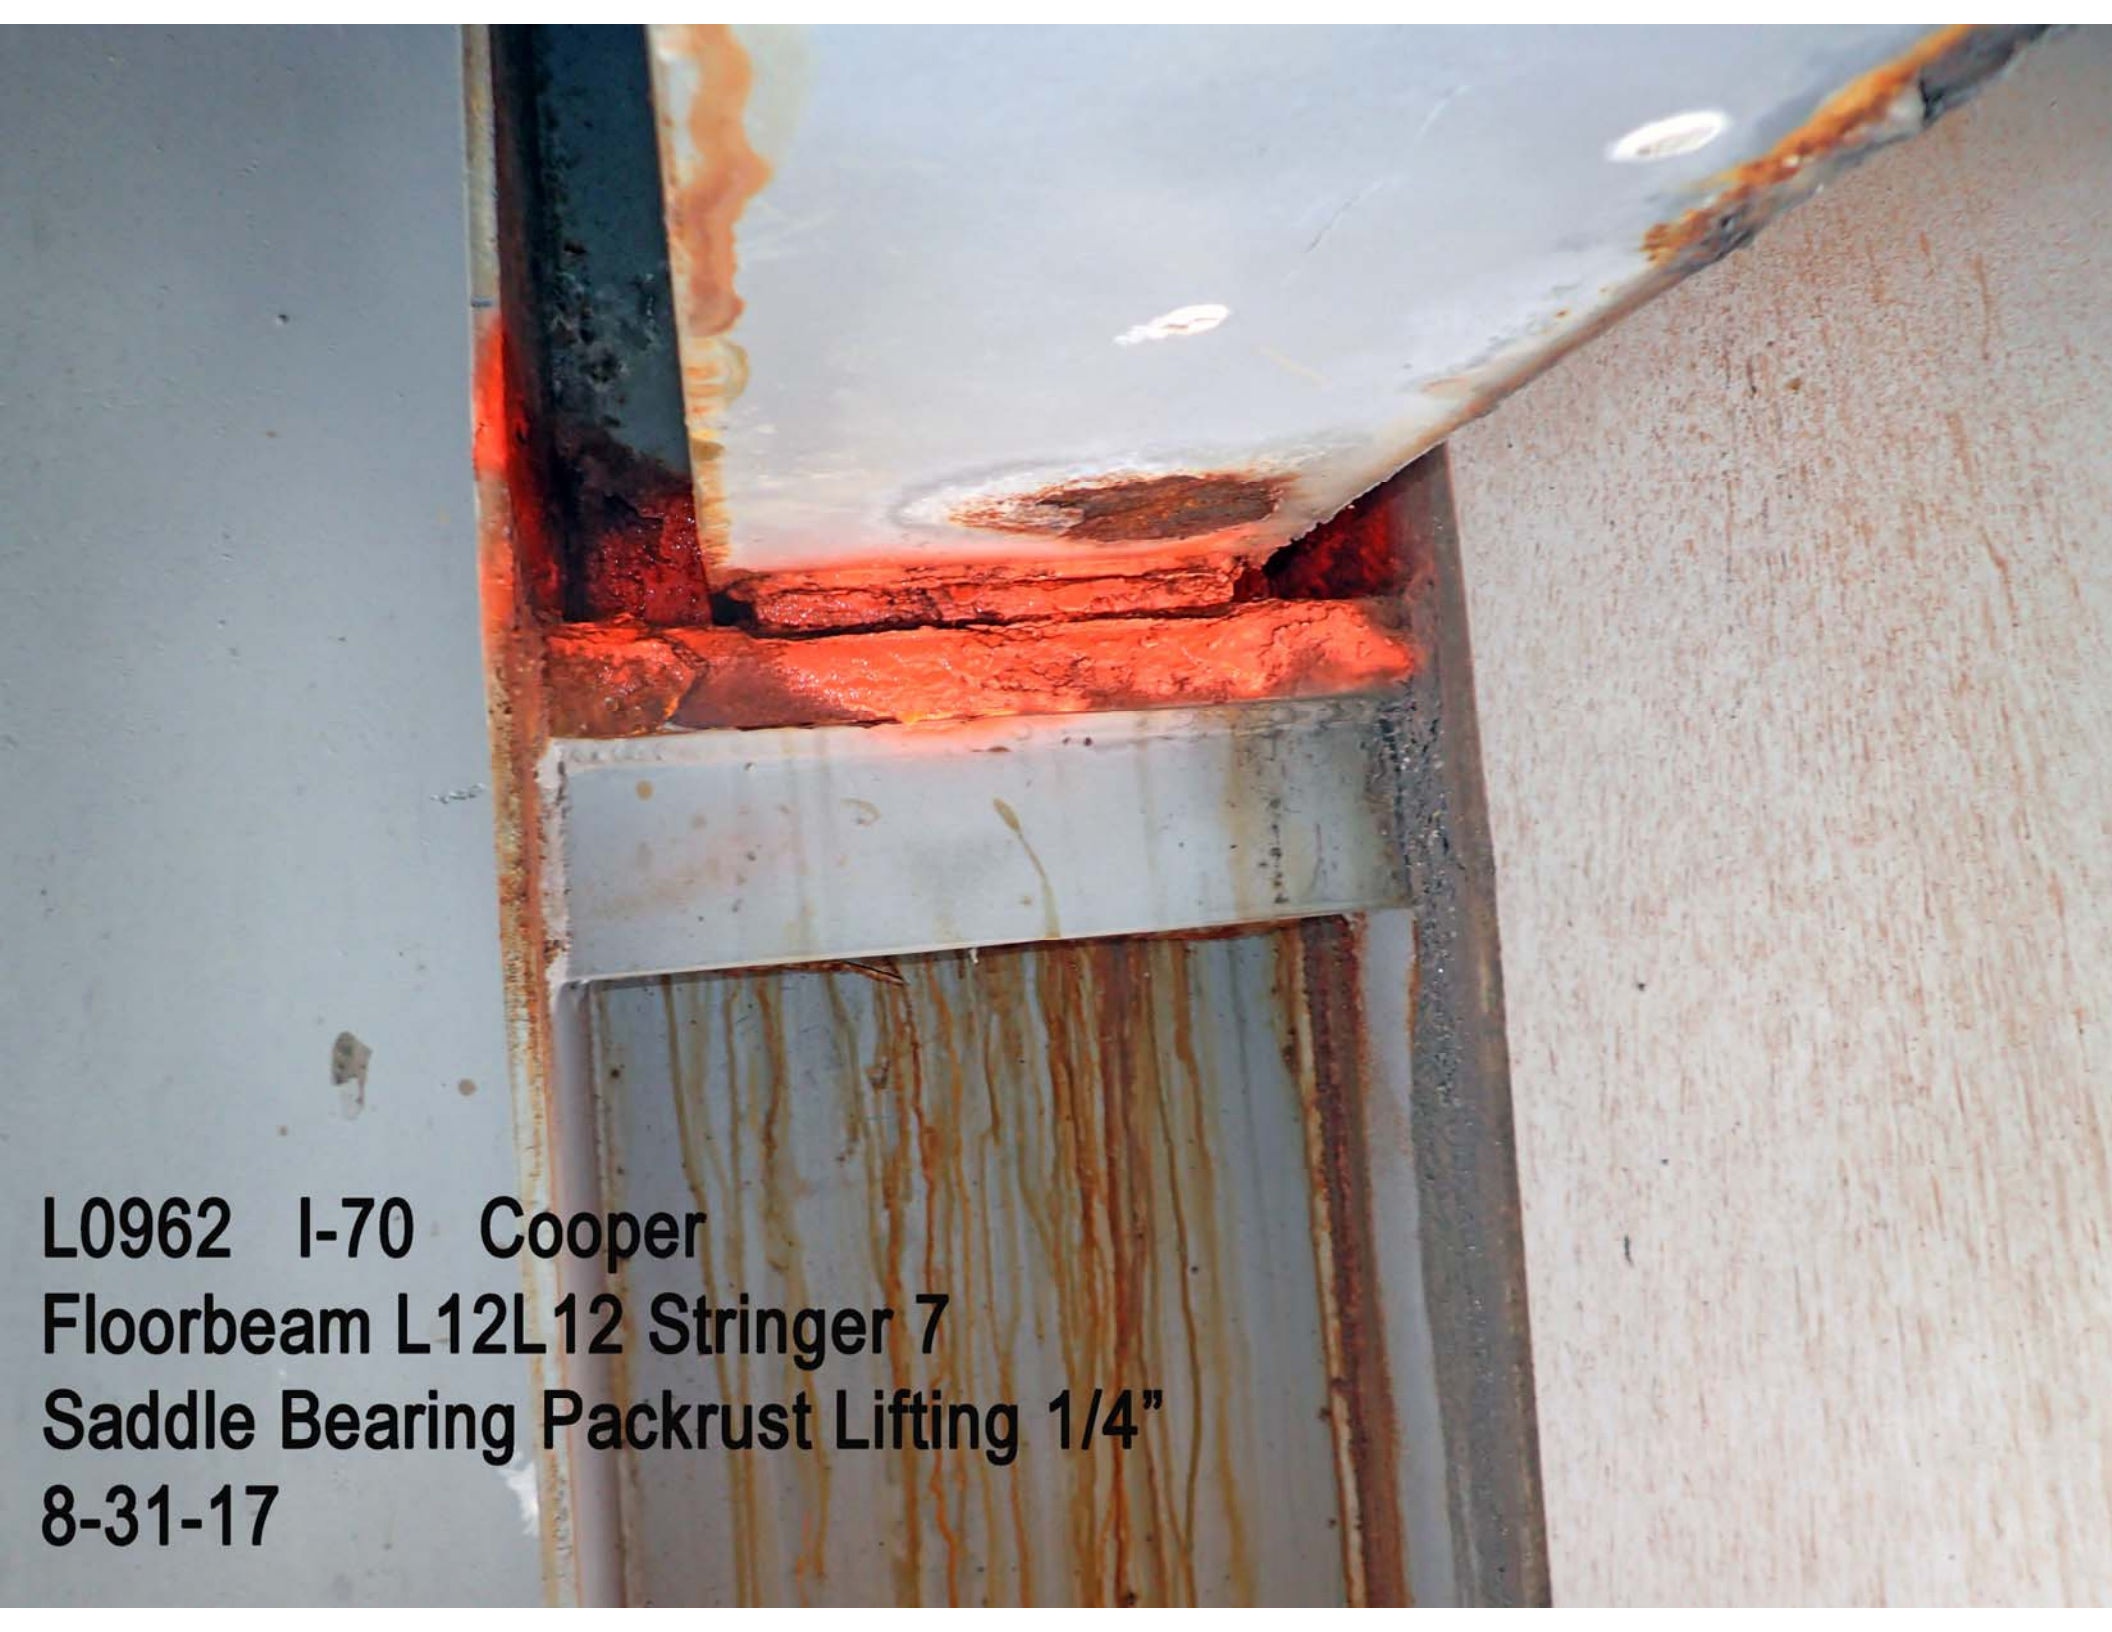
L0962 I-70 Cooper
Floorbeam L12L12 Stringer 7
Saddle Bearing Packrust Lifting 1/4"
8-31-17

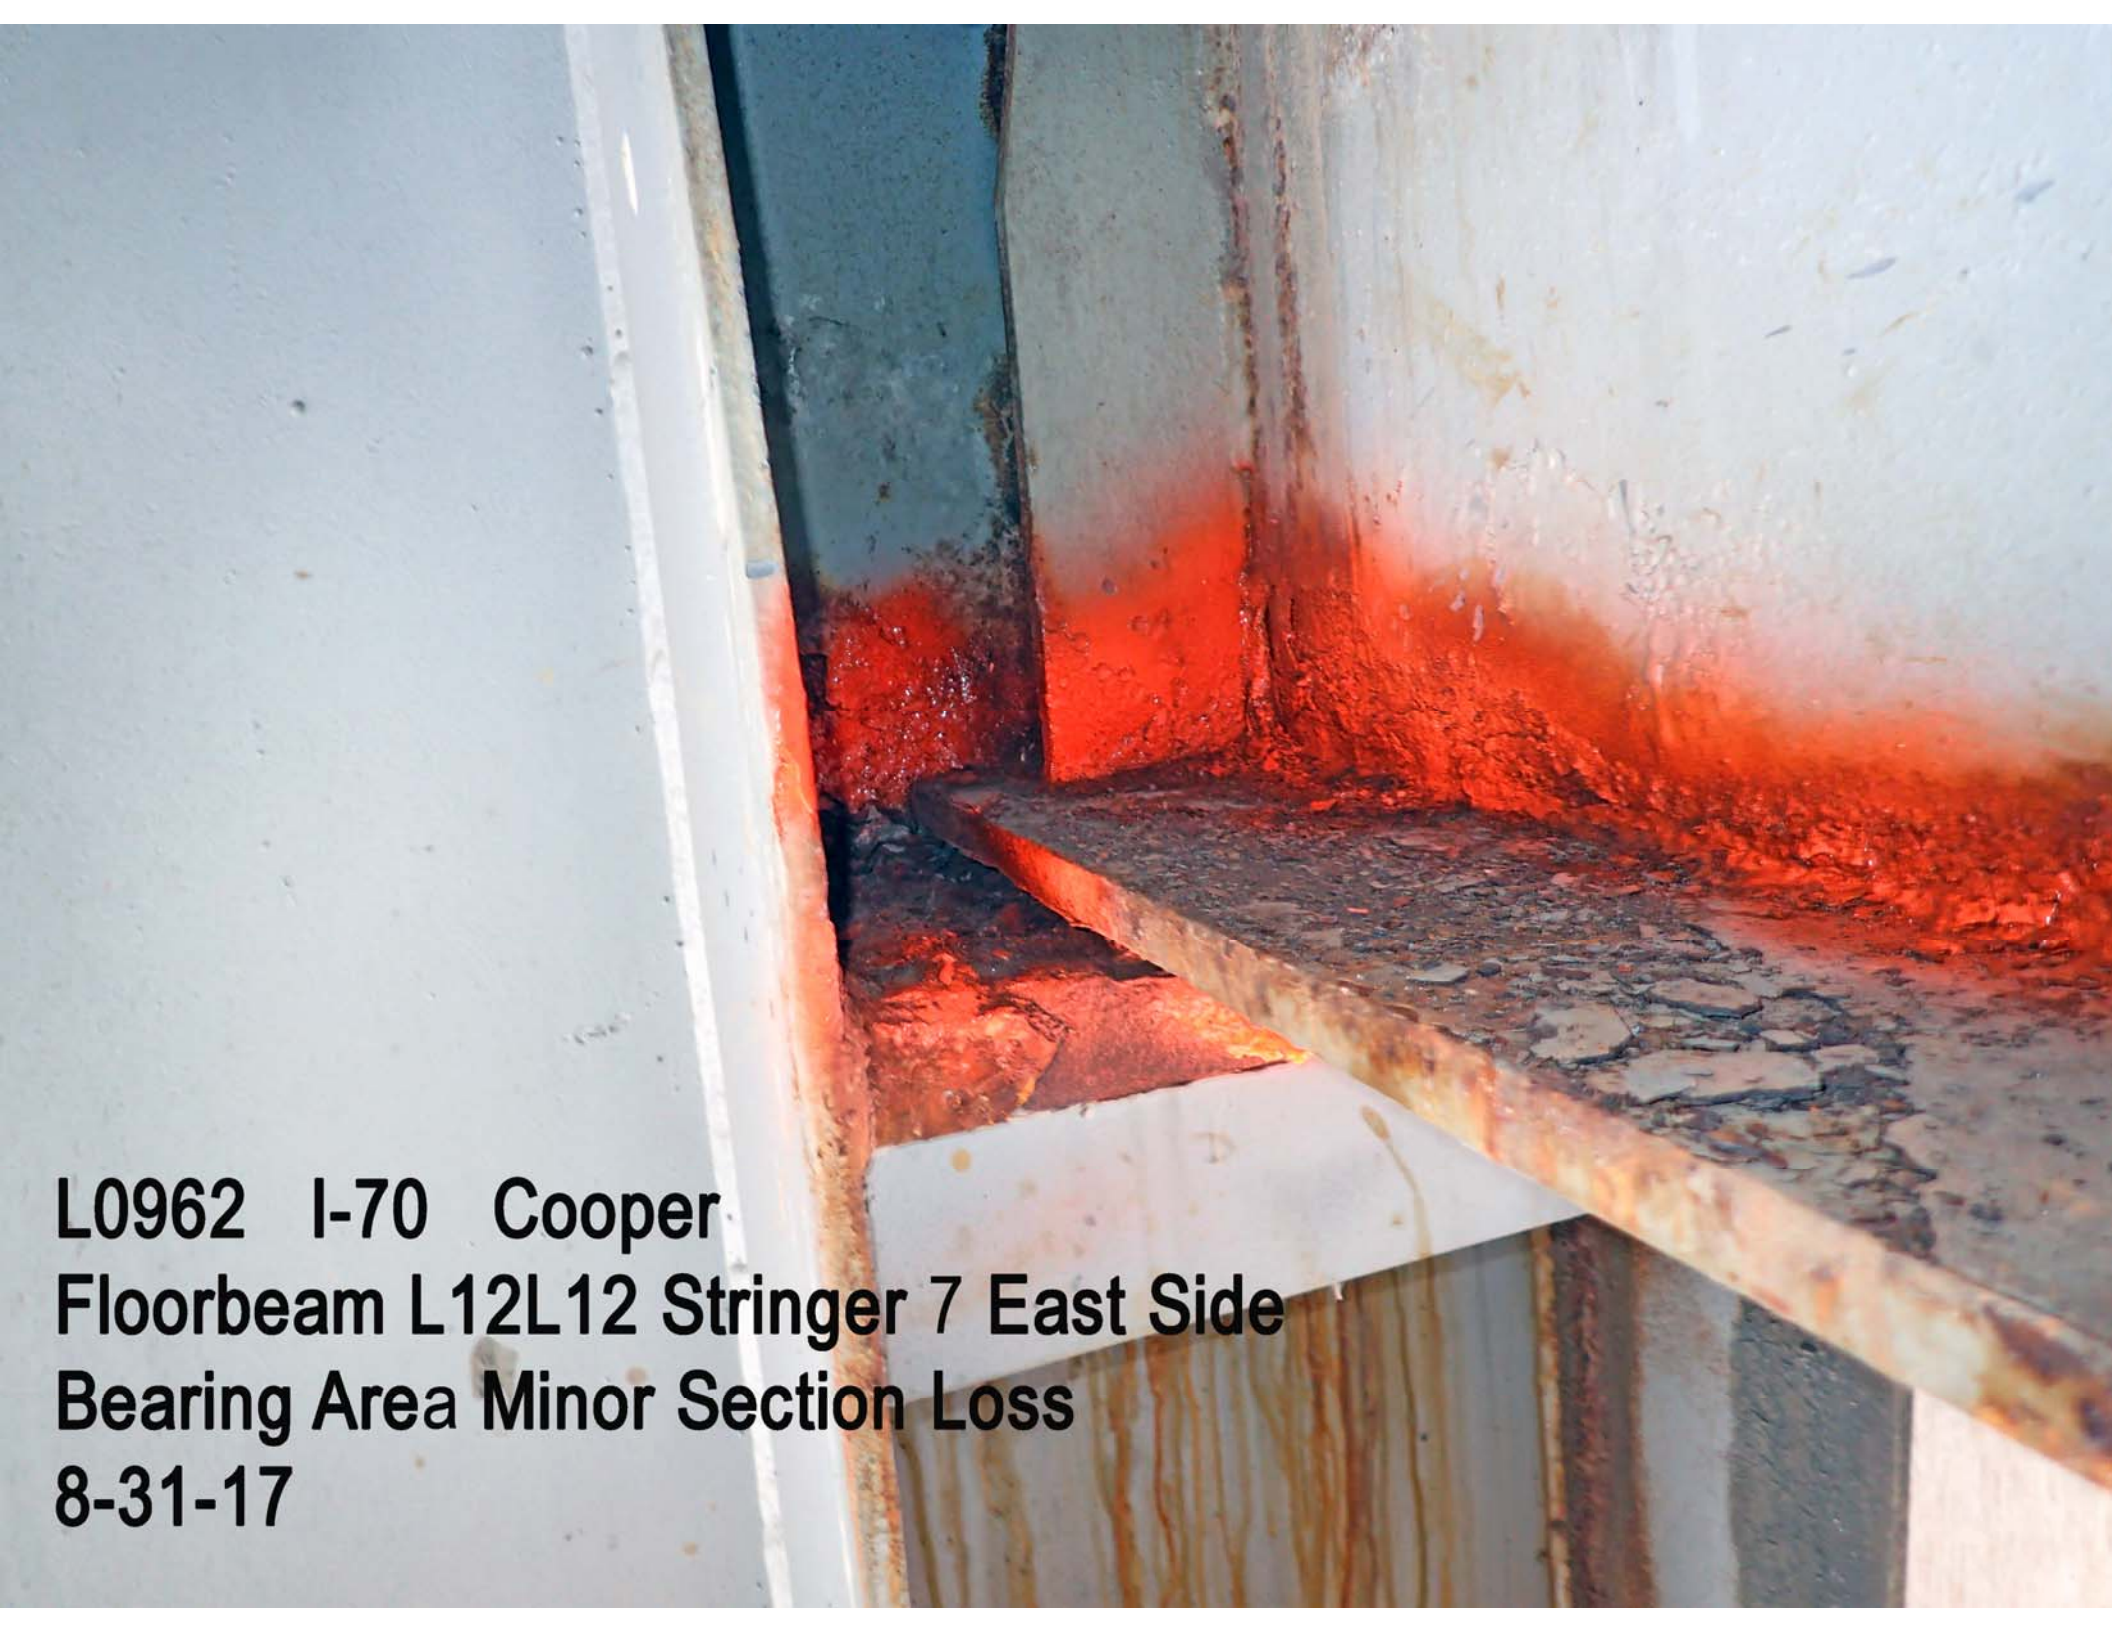
**L0962 I-70 Cooper
Floorbeam L12L12 Stringer 7 East Side
Bearing Area Minor Section Loss
8-31-17**

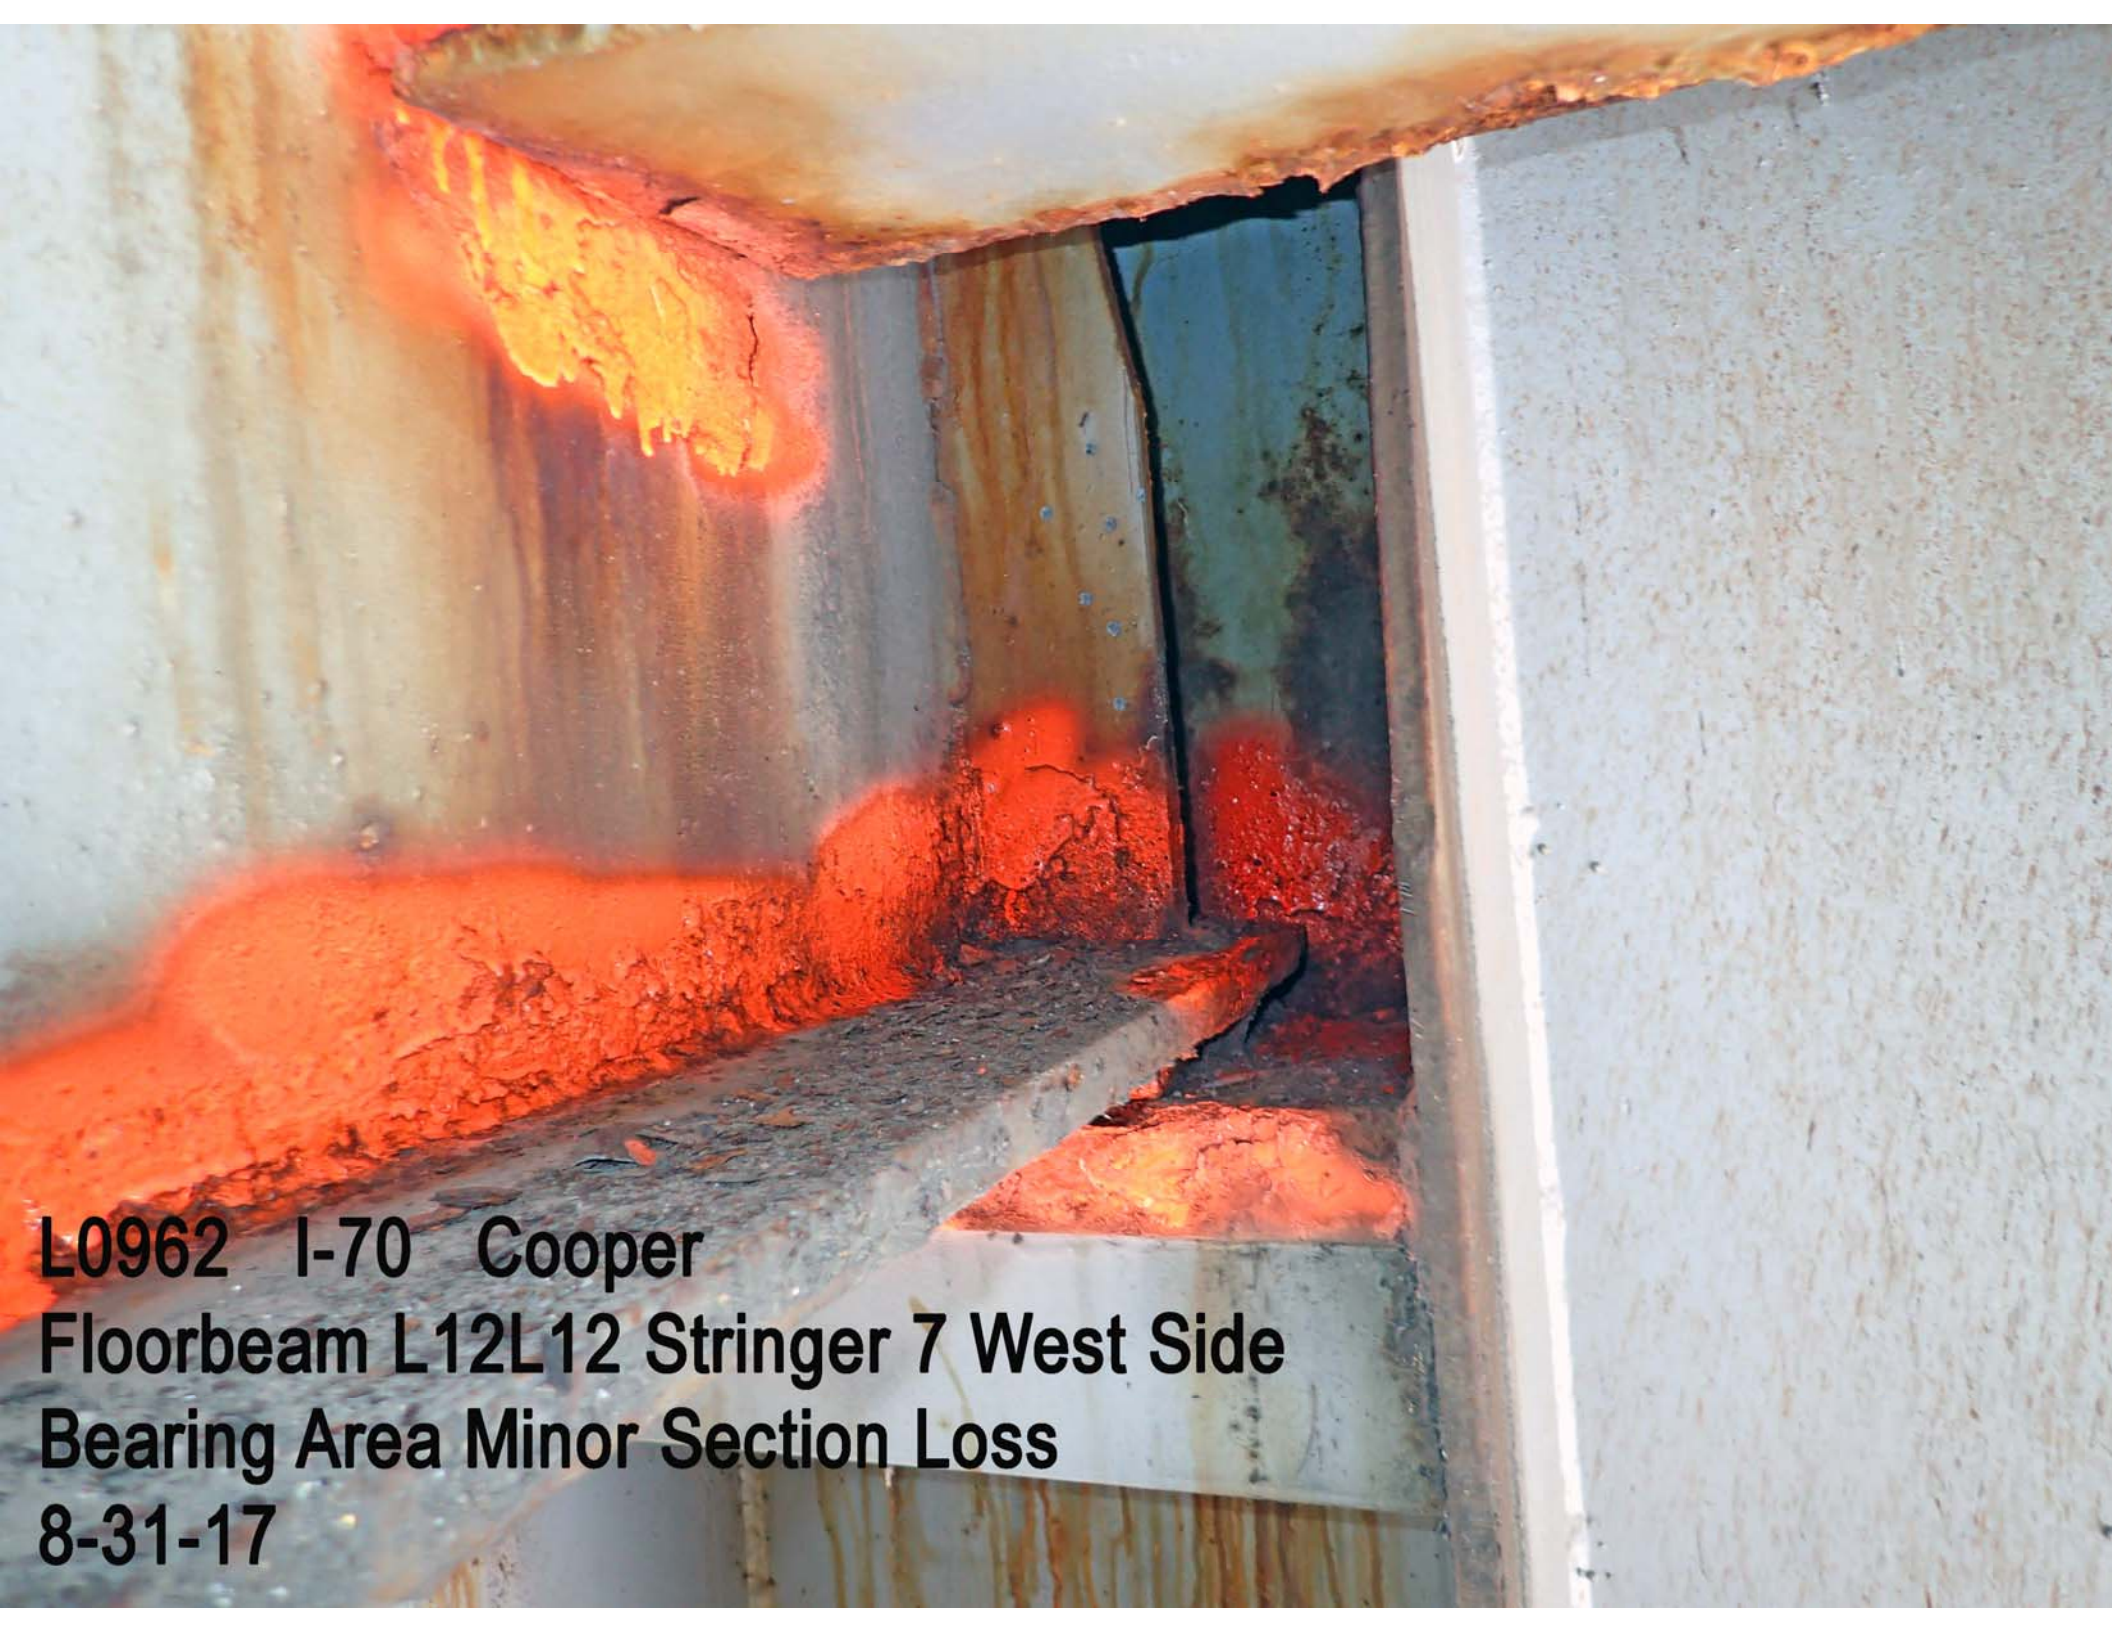
**L0962 I-70 Cooper
Floorbeam L12L12 Stringer 7 West Side
Bearing Area Minor Section Loss
8-31-17**

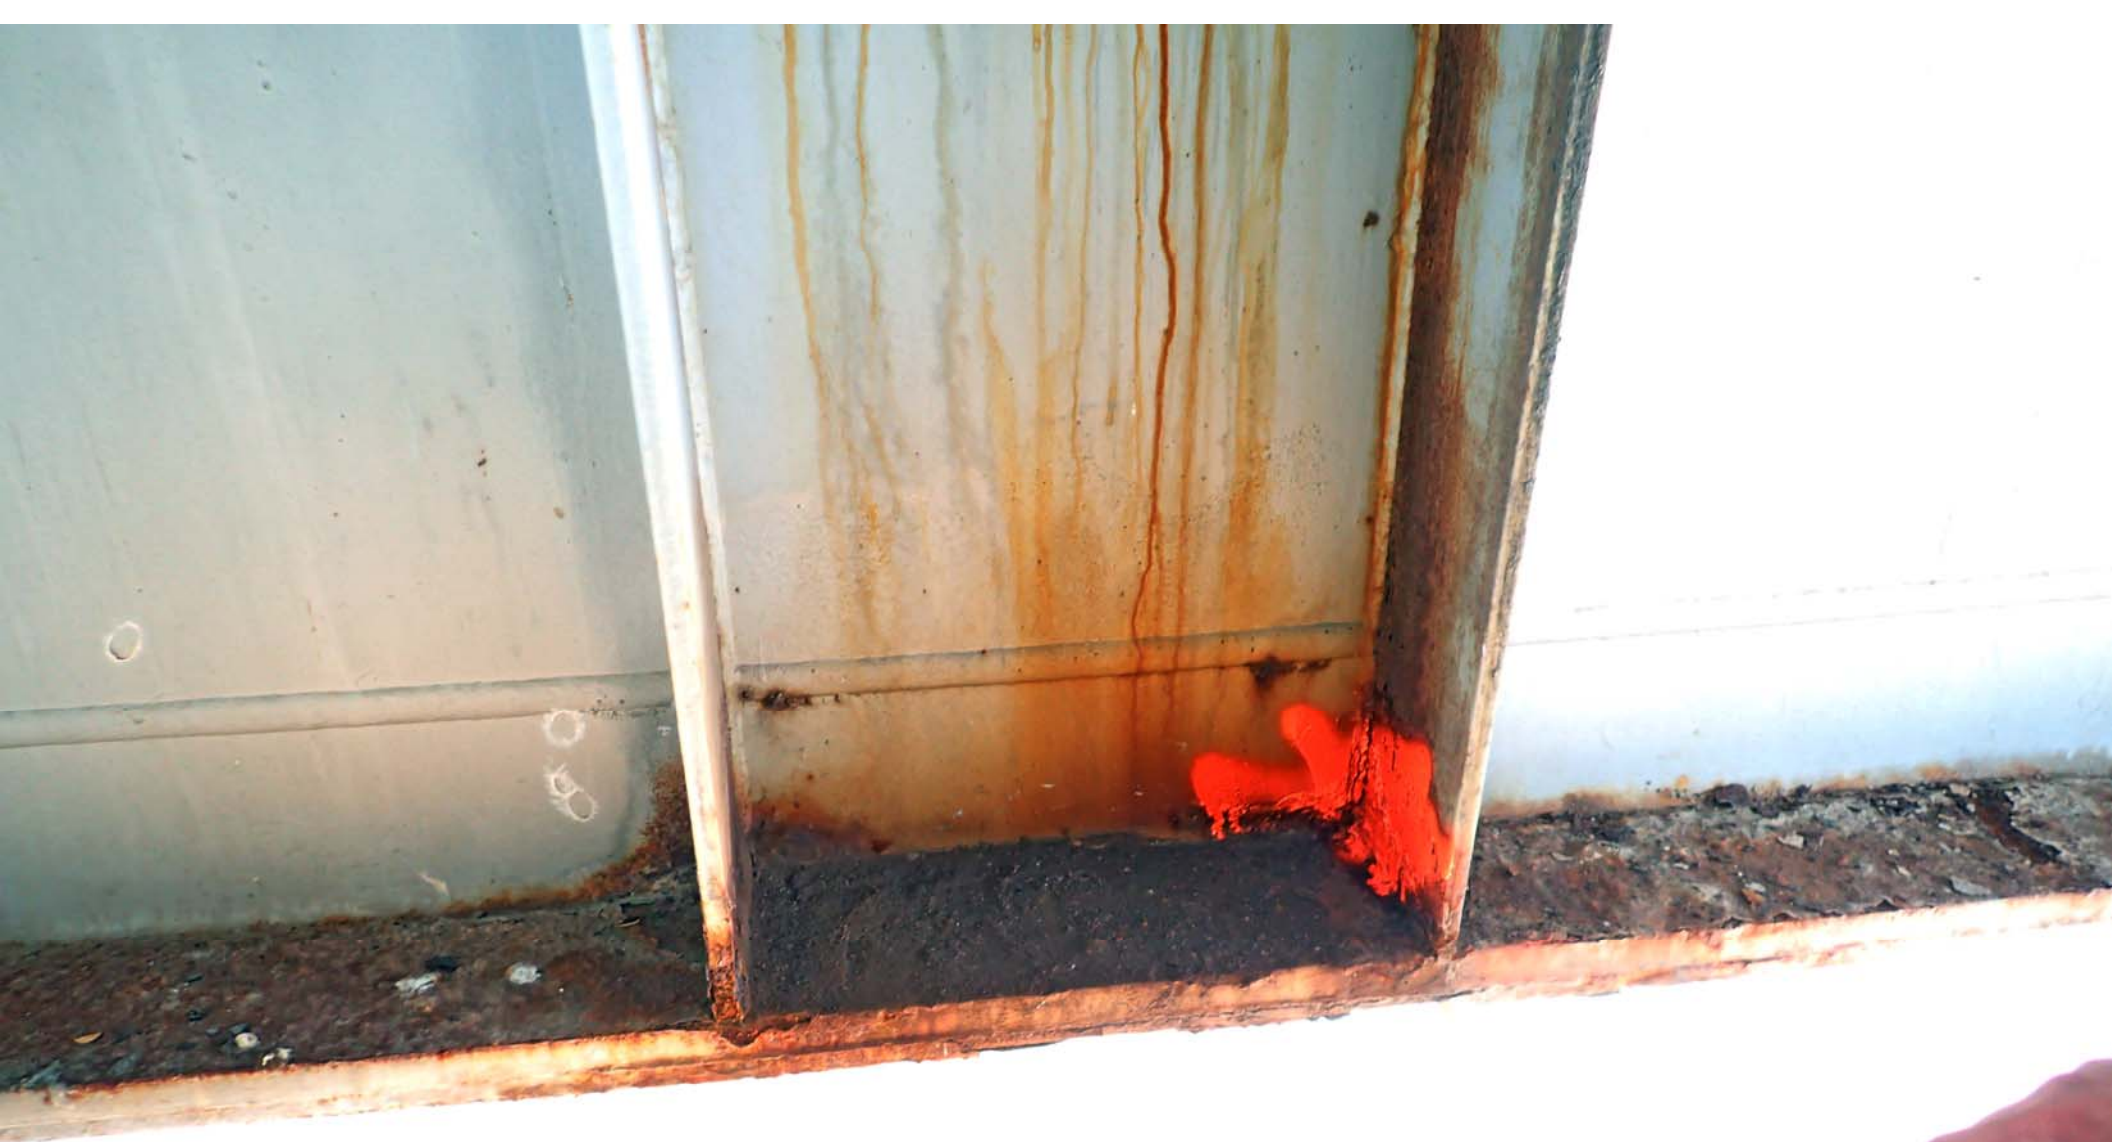
L0962 I-70 Cooper
Floorbeam L12L12 at Stringer 7
Minor Section Loss
8-31-17

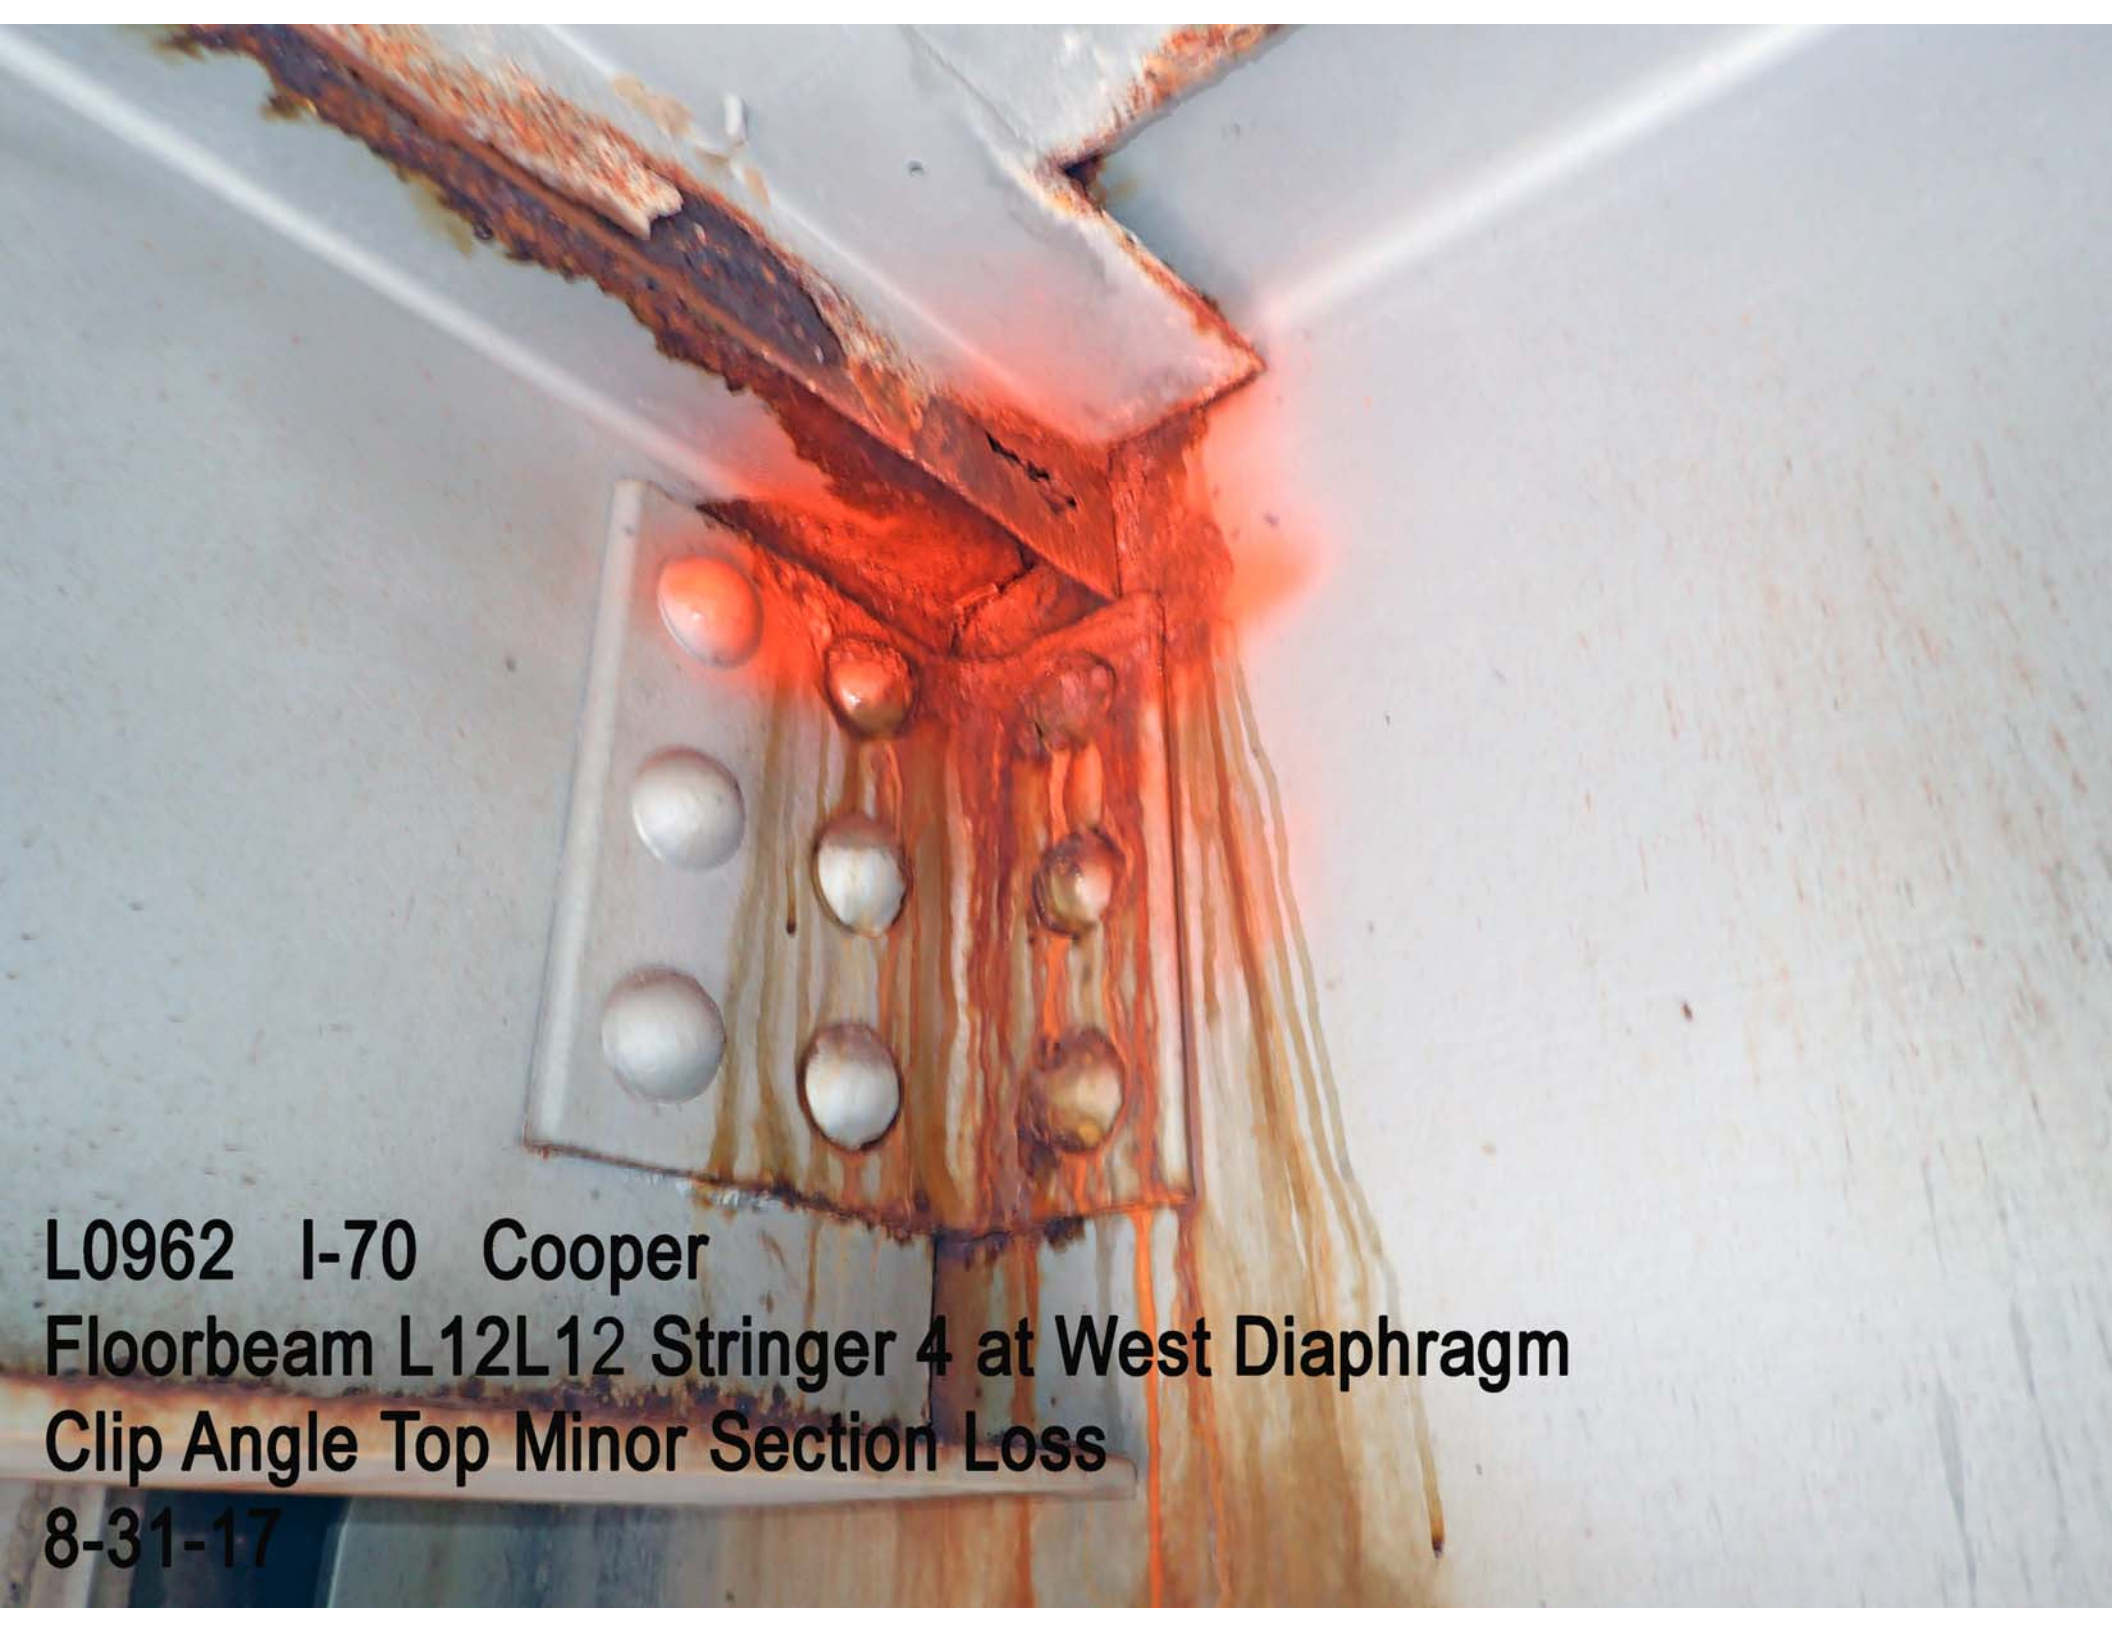
L0962 I-70 Cooper
Floorbeam L12L12 Stringer 4 at West Diaphragm
Clip Angle Top Minor Section Loss
8-31-17

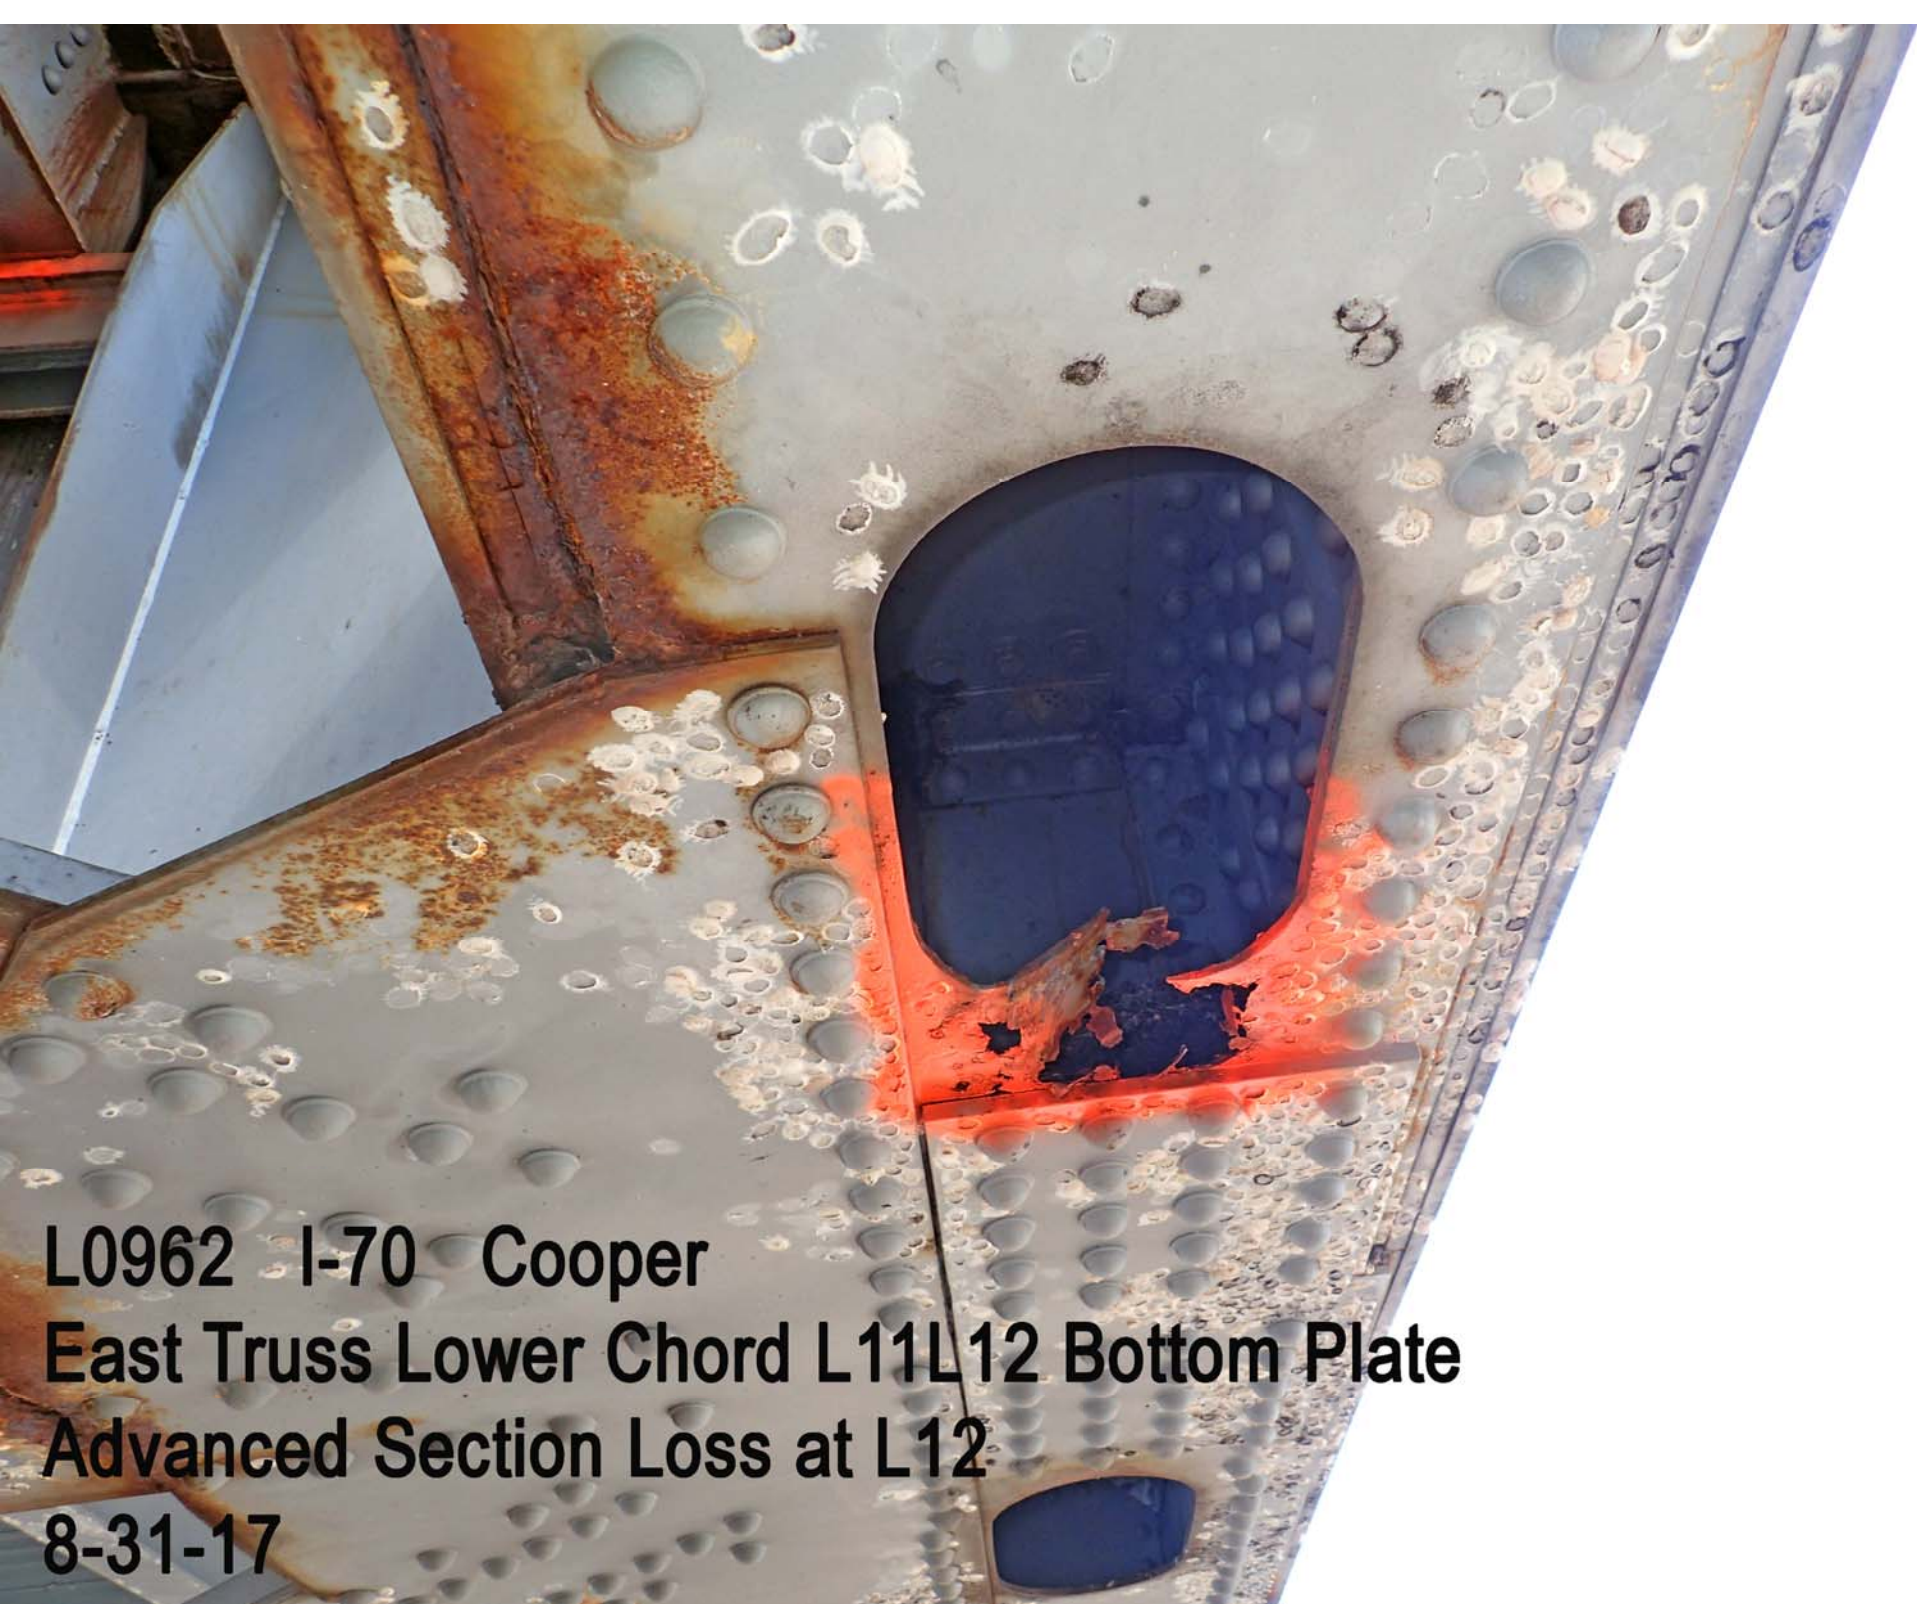
**L0962 I-70 Cooper
East Truss Lower Chord L11L12 Bottom Plate
Advanced Section Loss at L12
8-31-17**
