L0962 Cooper Co.
08/28/2017
Looking West

L0962 I-70 Cooper
Pier 15 Open Expansion Joint WBL
8-28-17

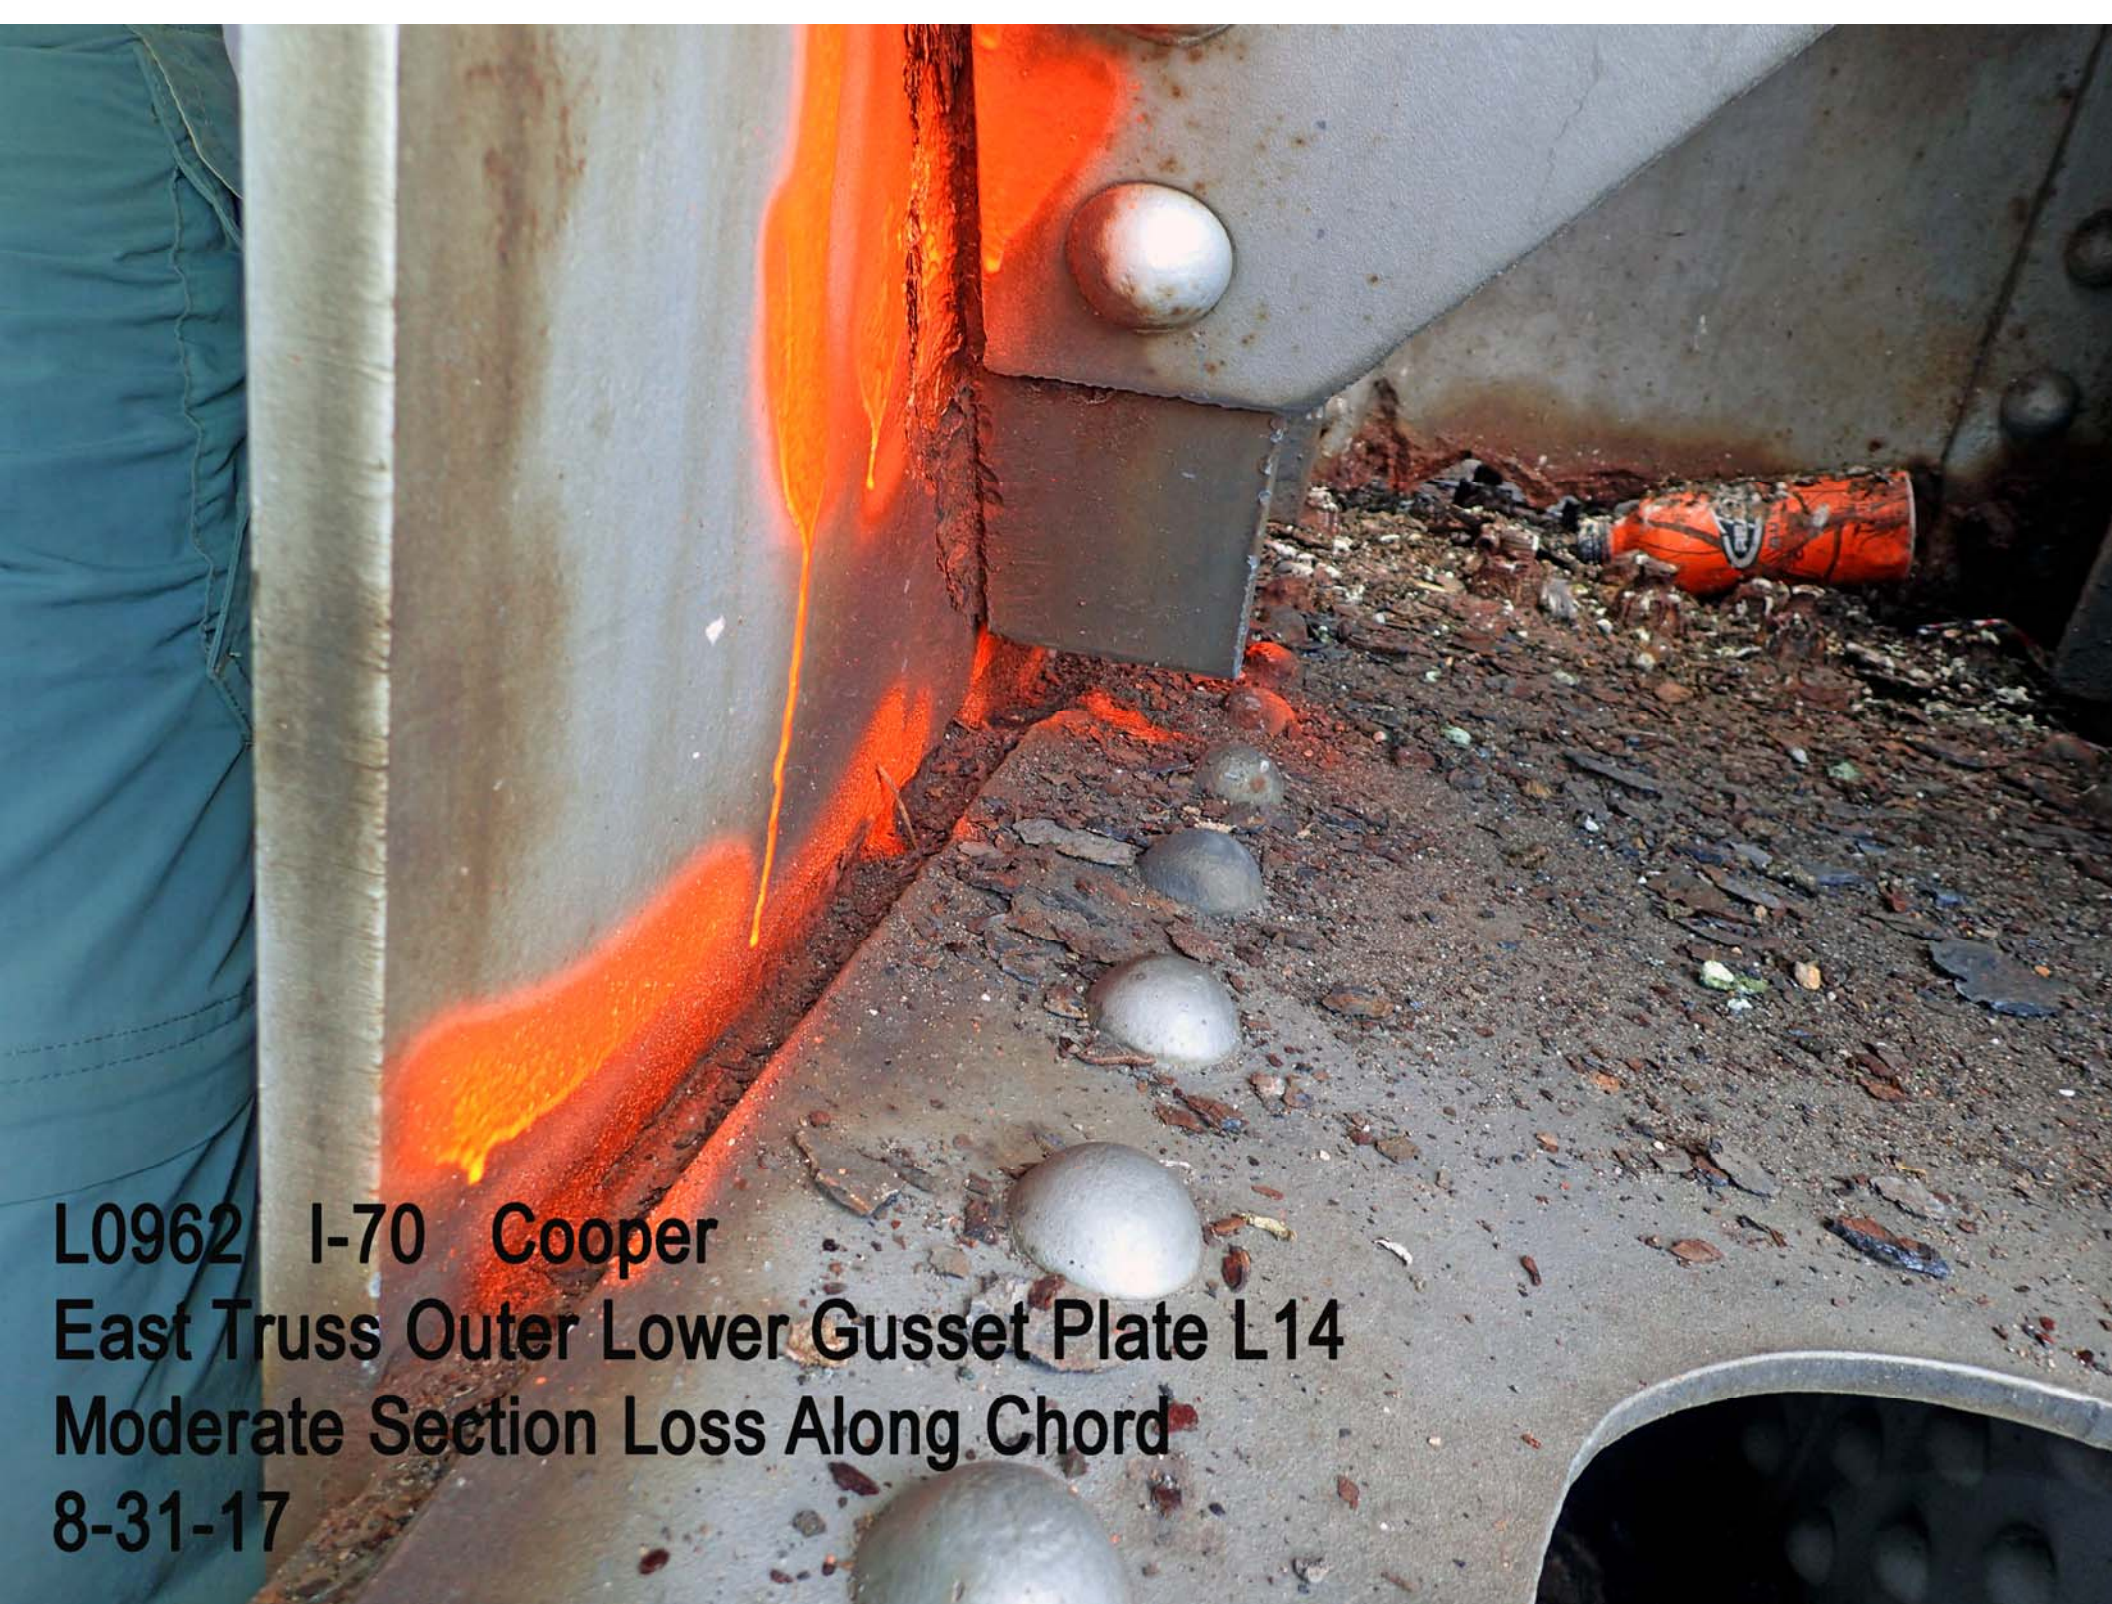
L0962 I-70 Cooper
East Truss Outer Lower Gusset Plate L14
Moderate Section Loss Along Chord
8-31-17

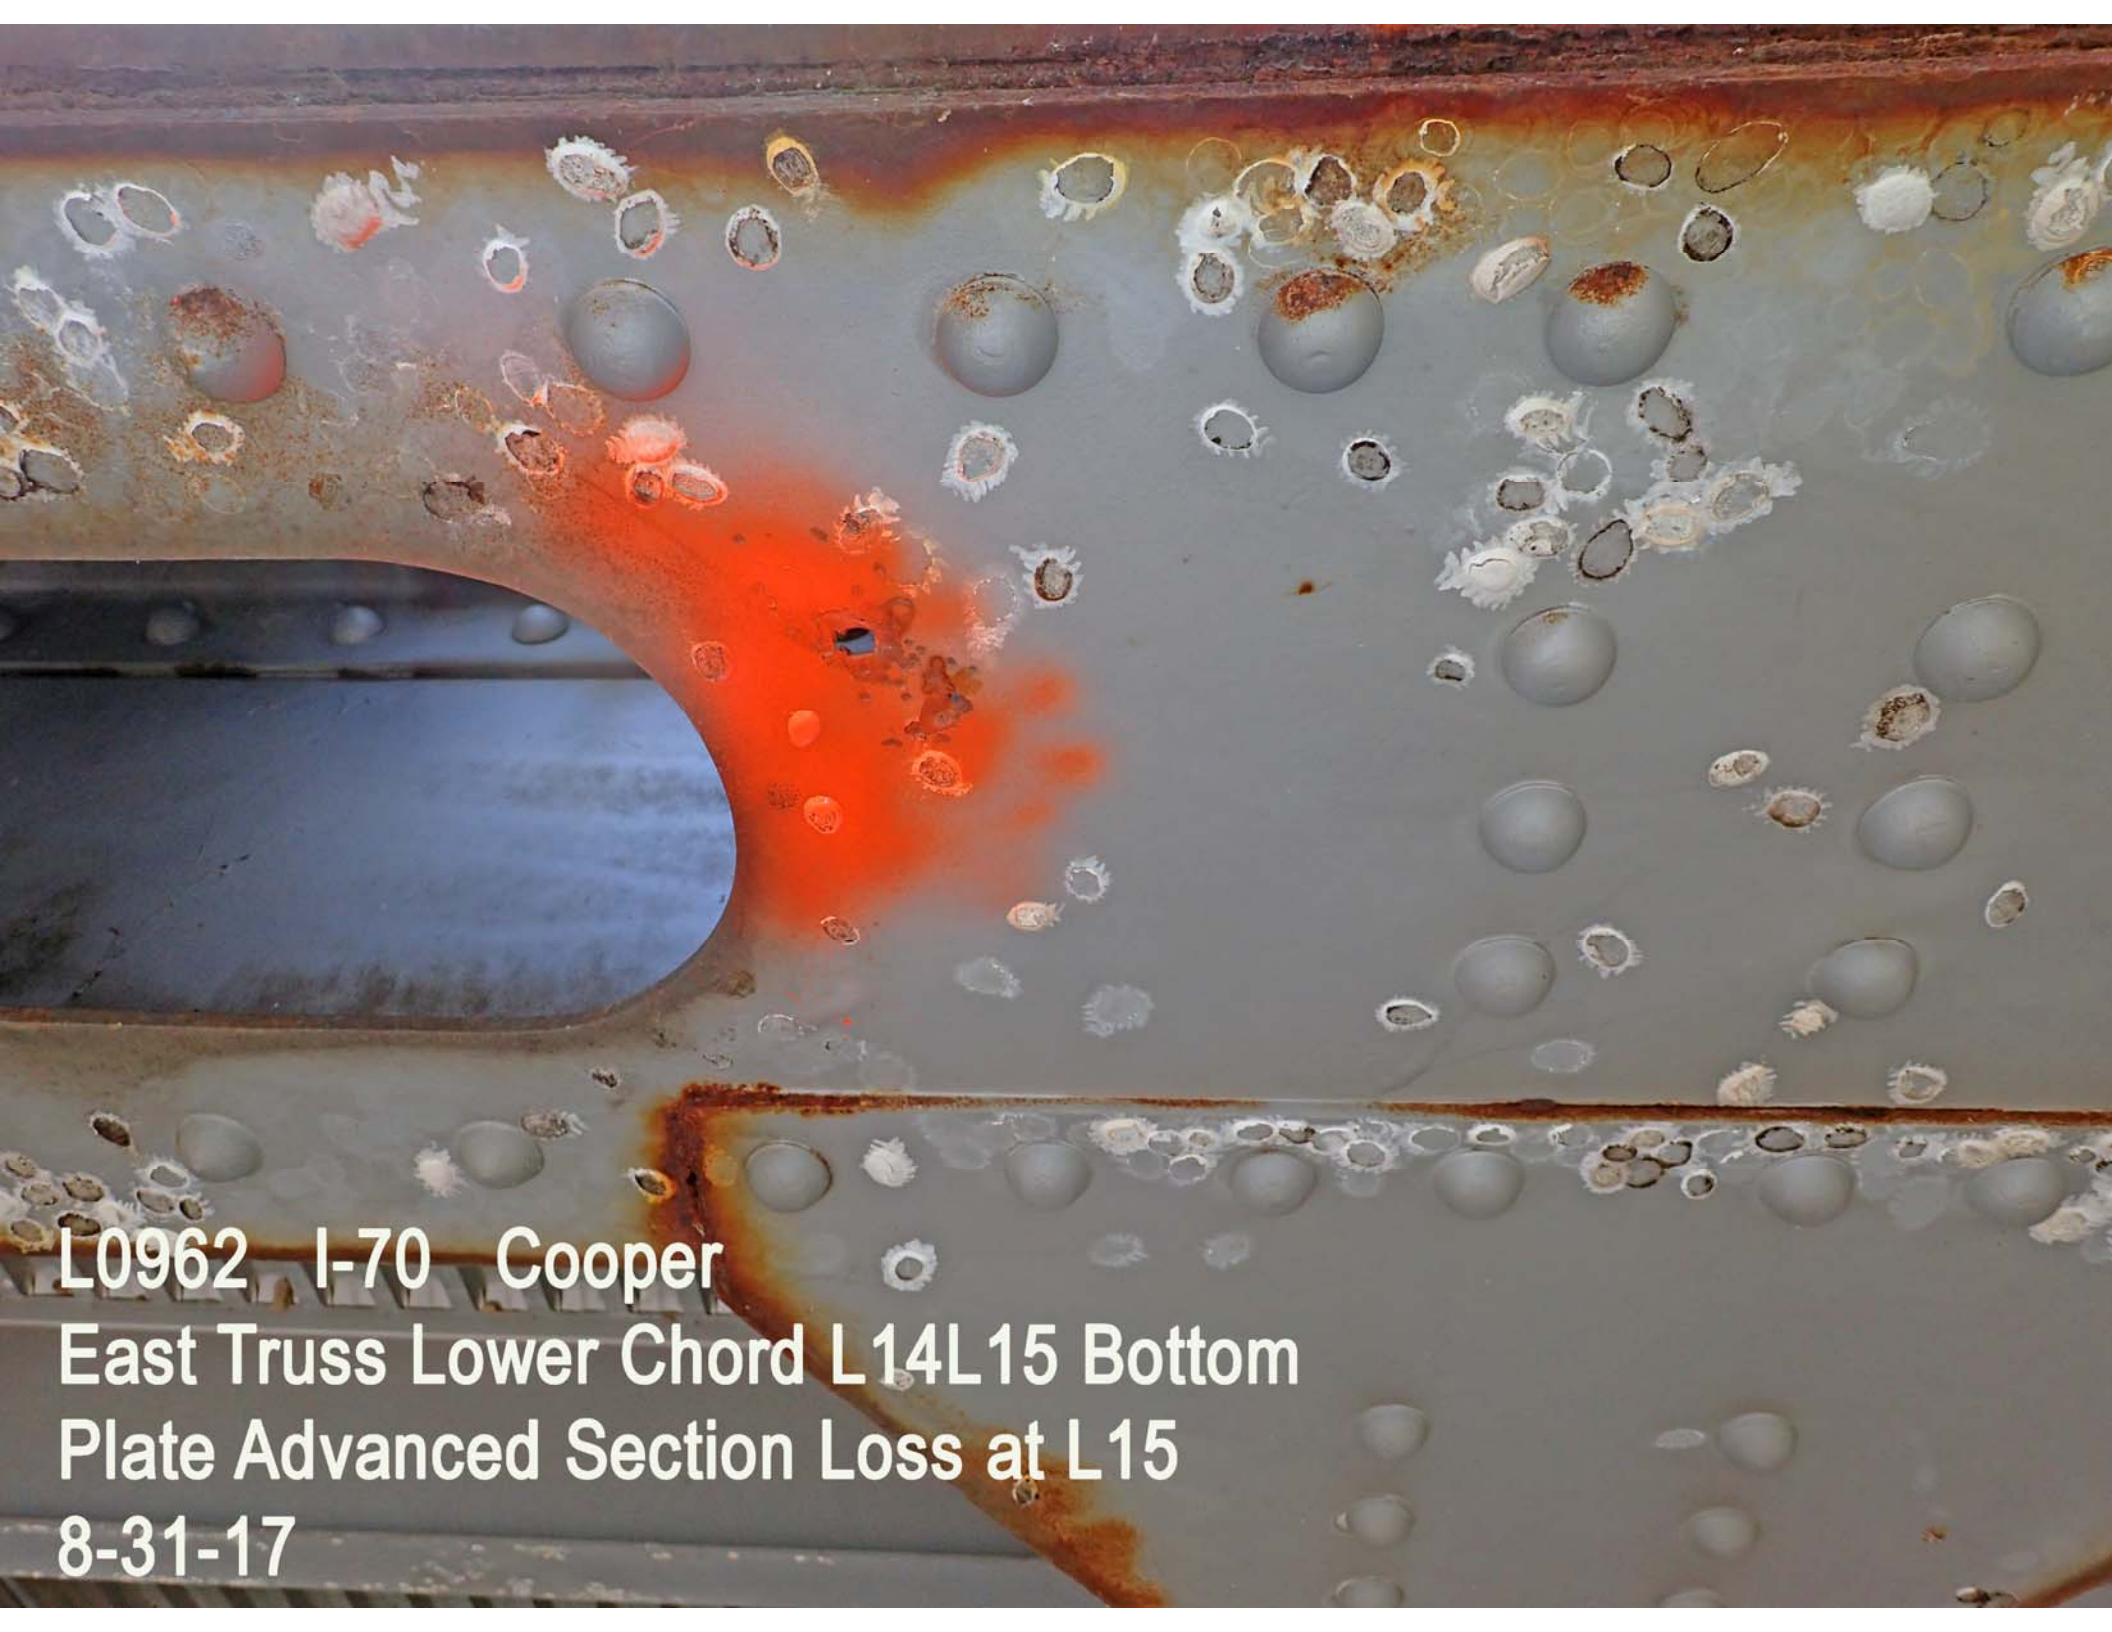
L0962 I-70 Cooper
East Truss Lower Chord L14L15 Bottom
Plate Advanced Section Loss at L15
8-31-17

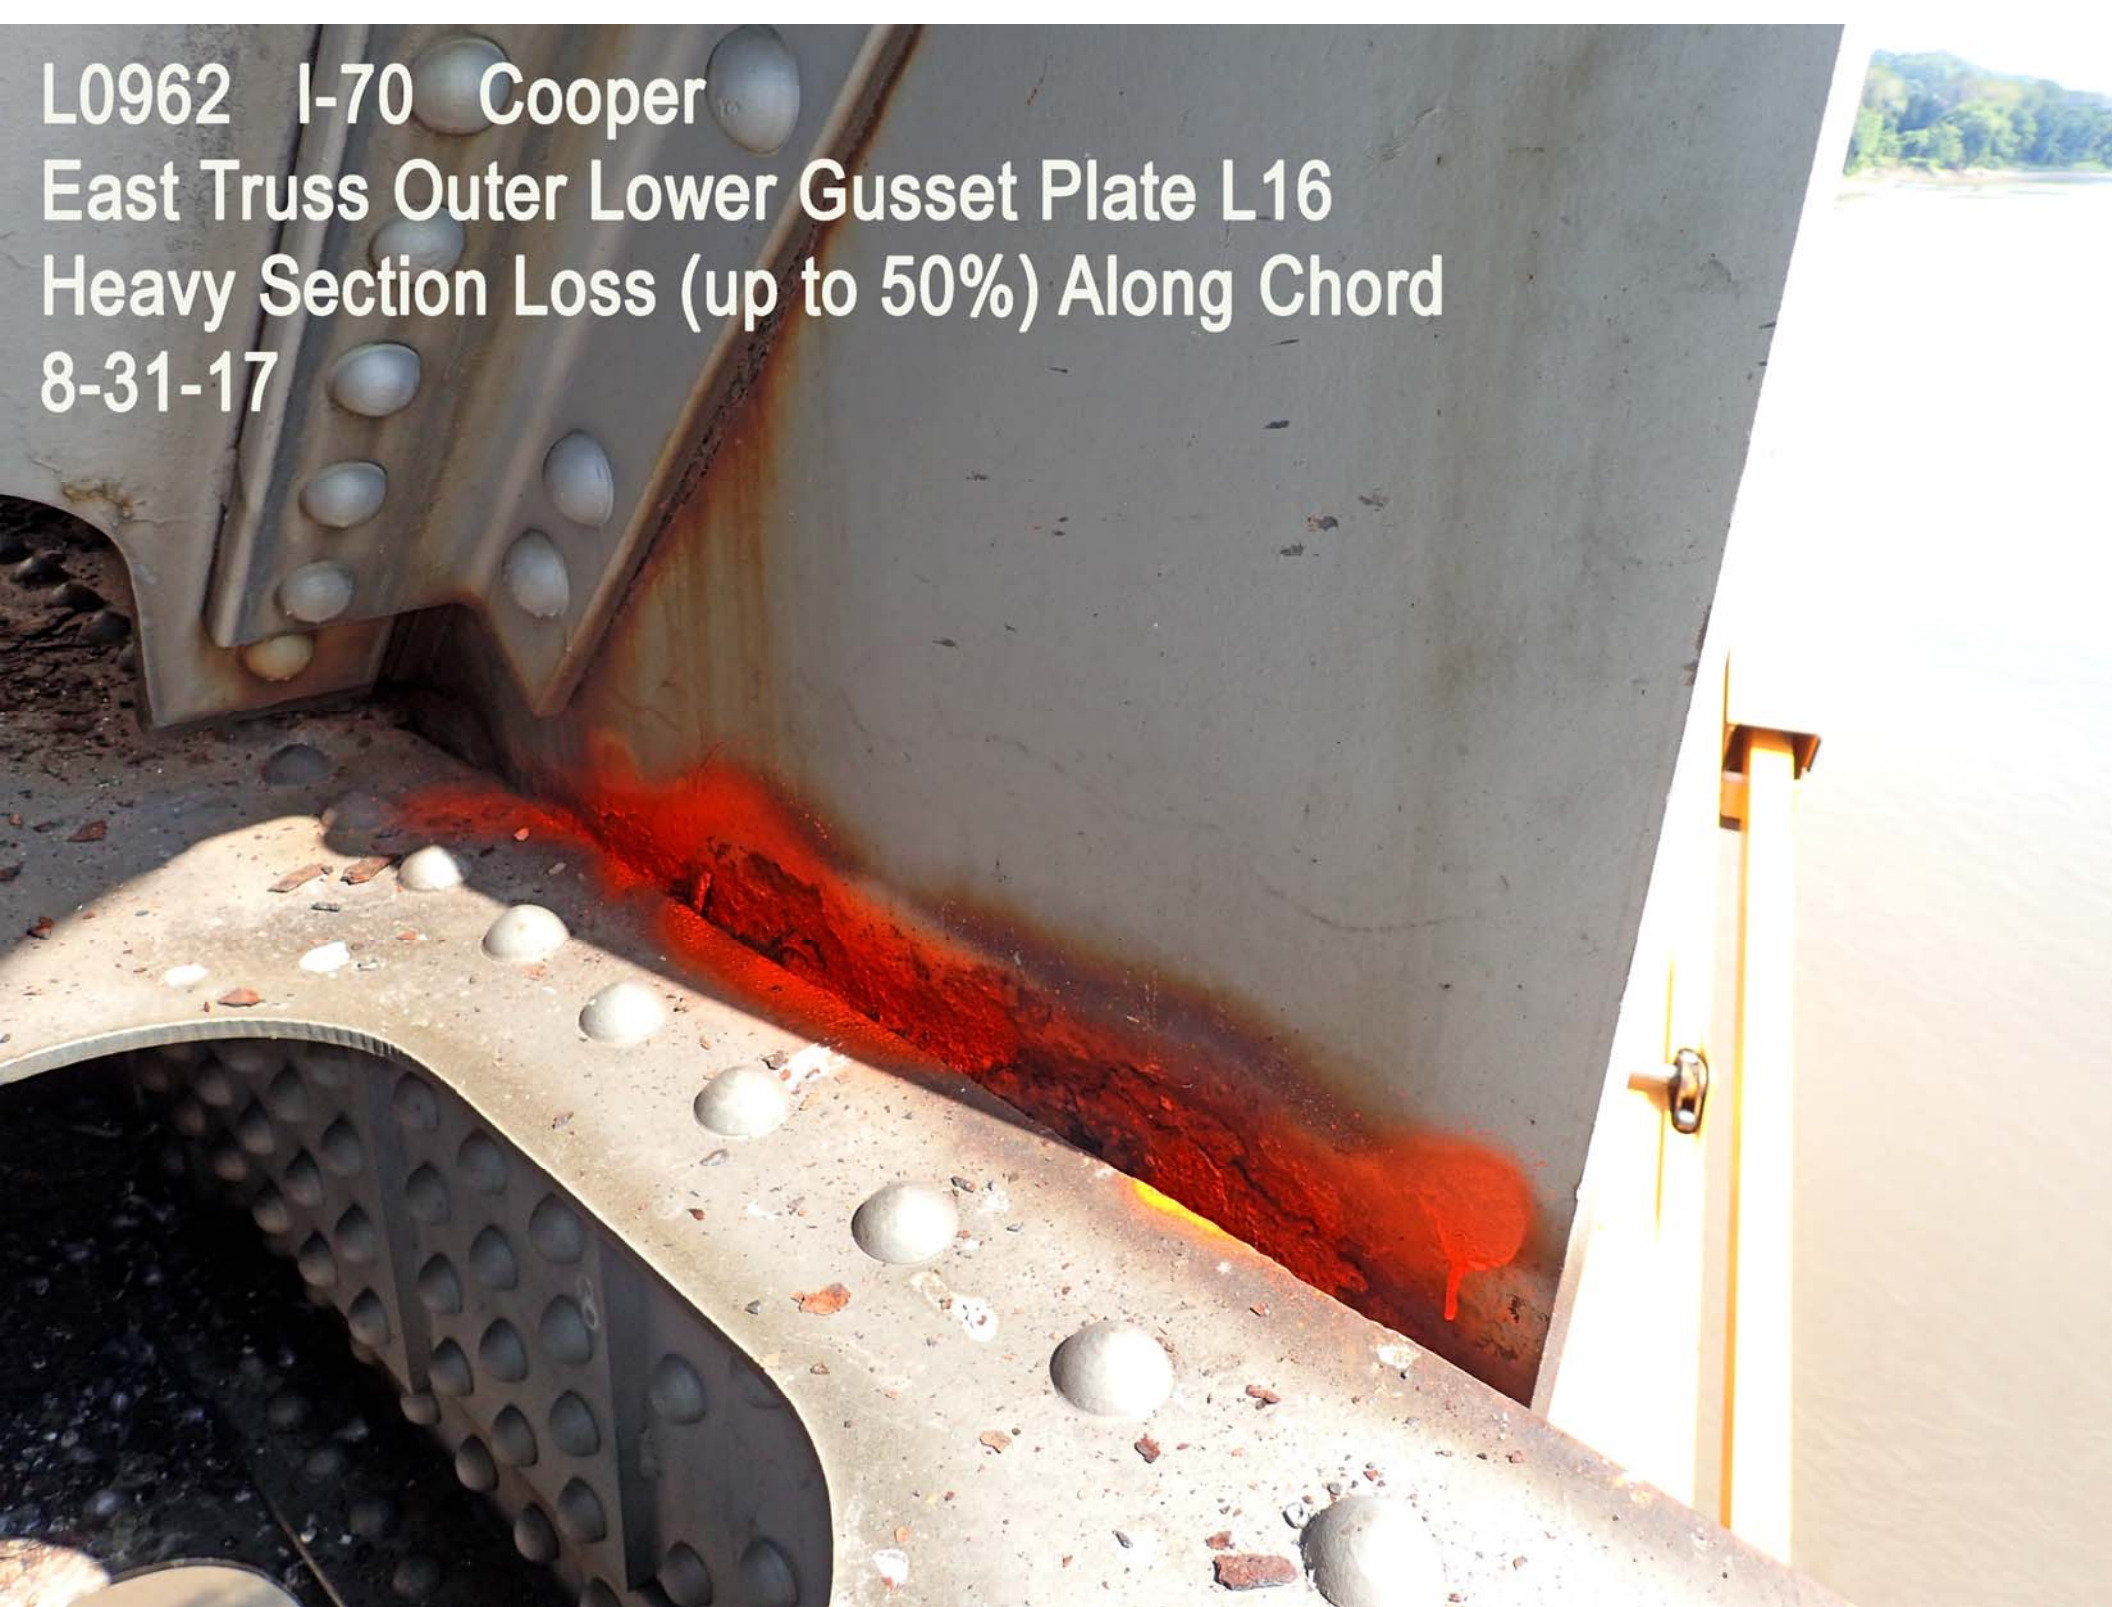
East Truss Inside Lower Gusset Plate L16

Heavy (up to 50%) Section Loss Along Chord

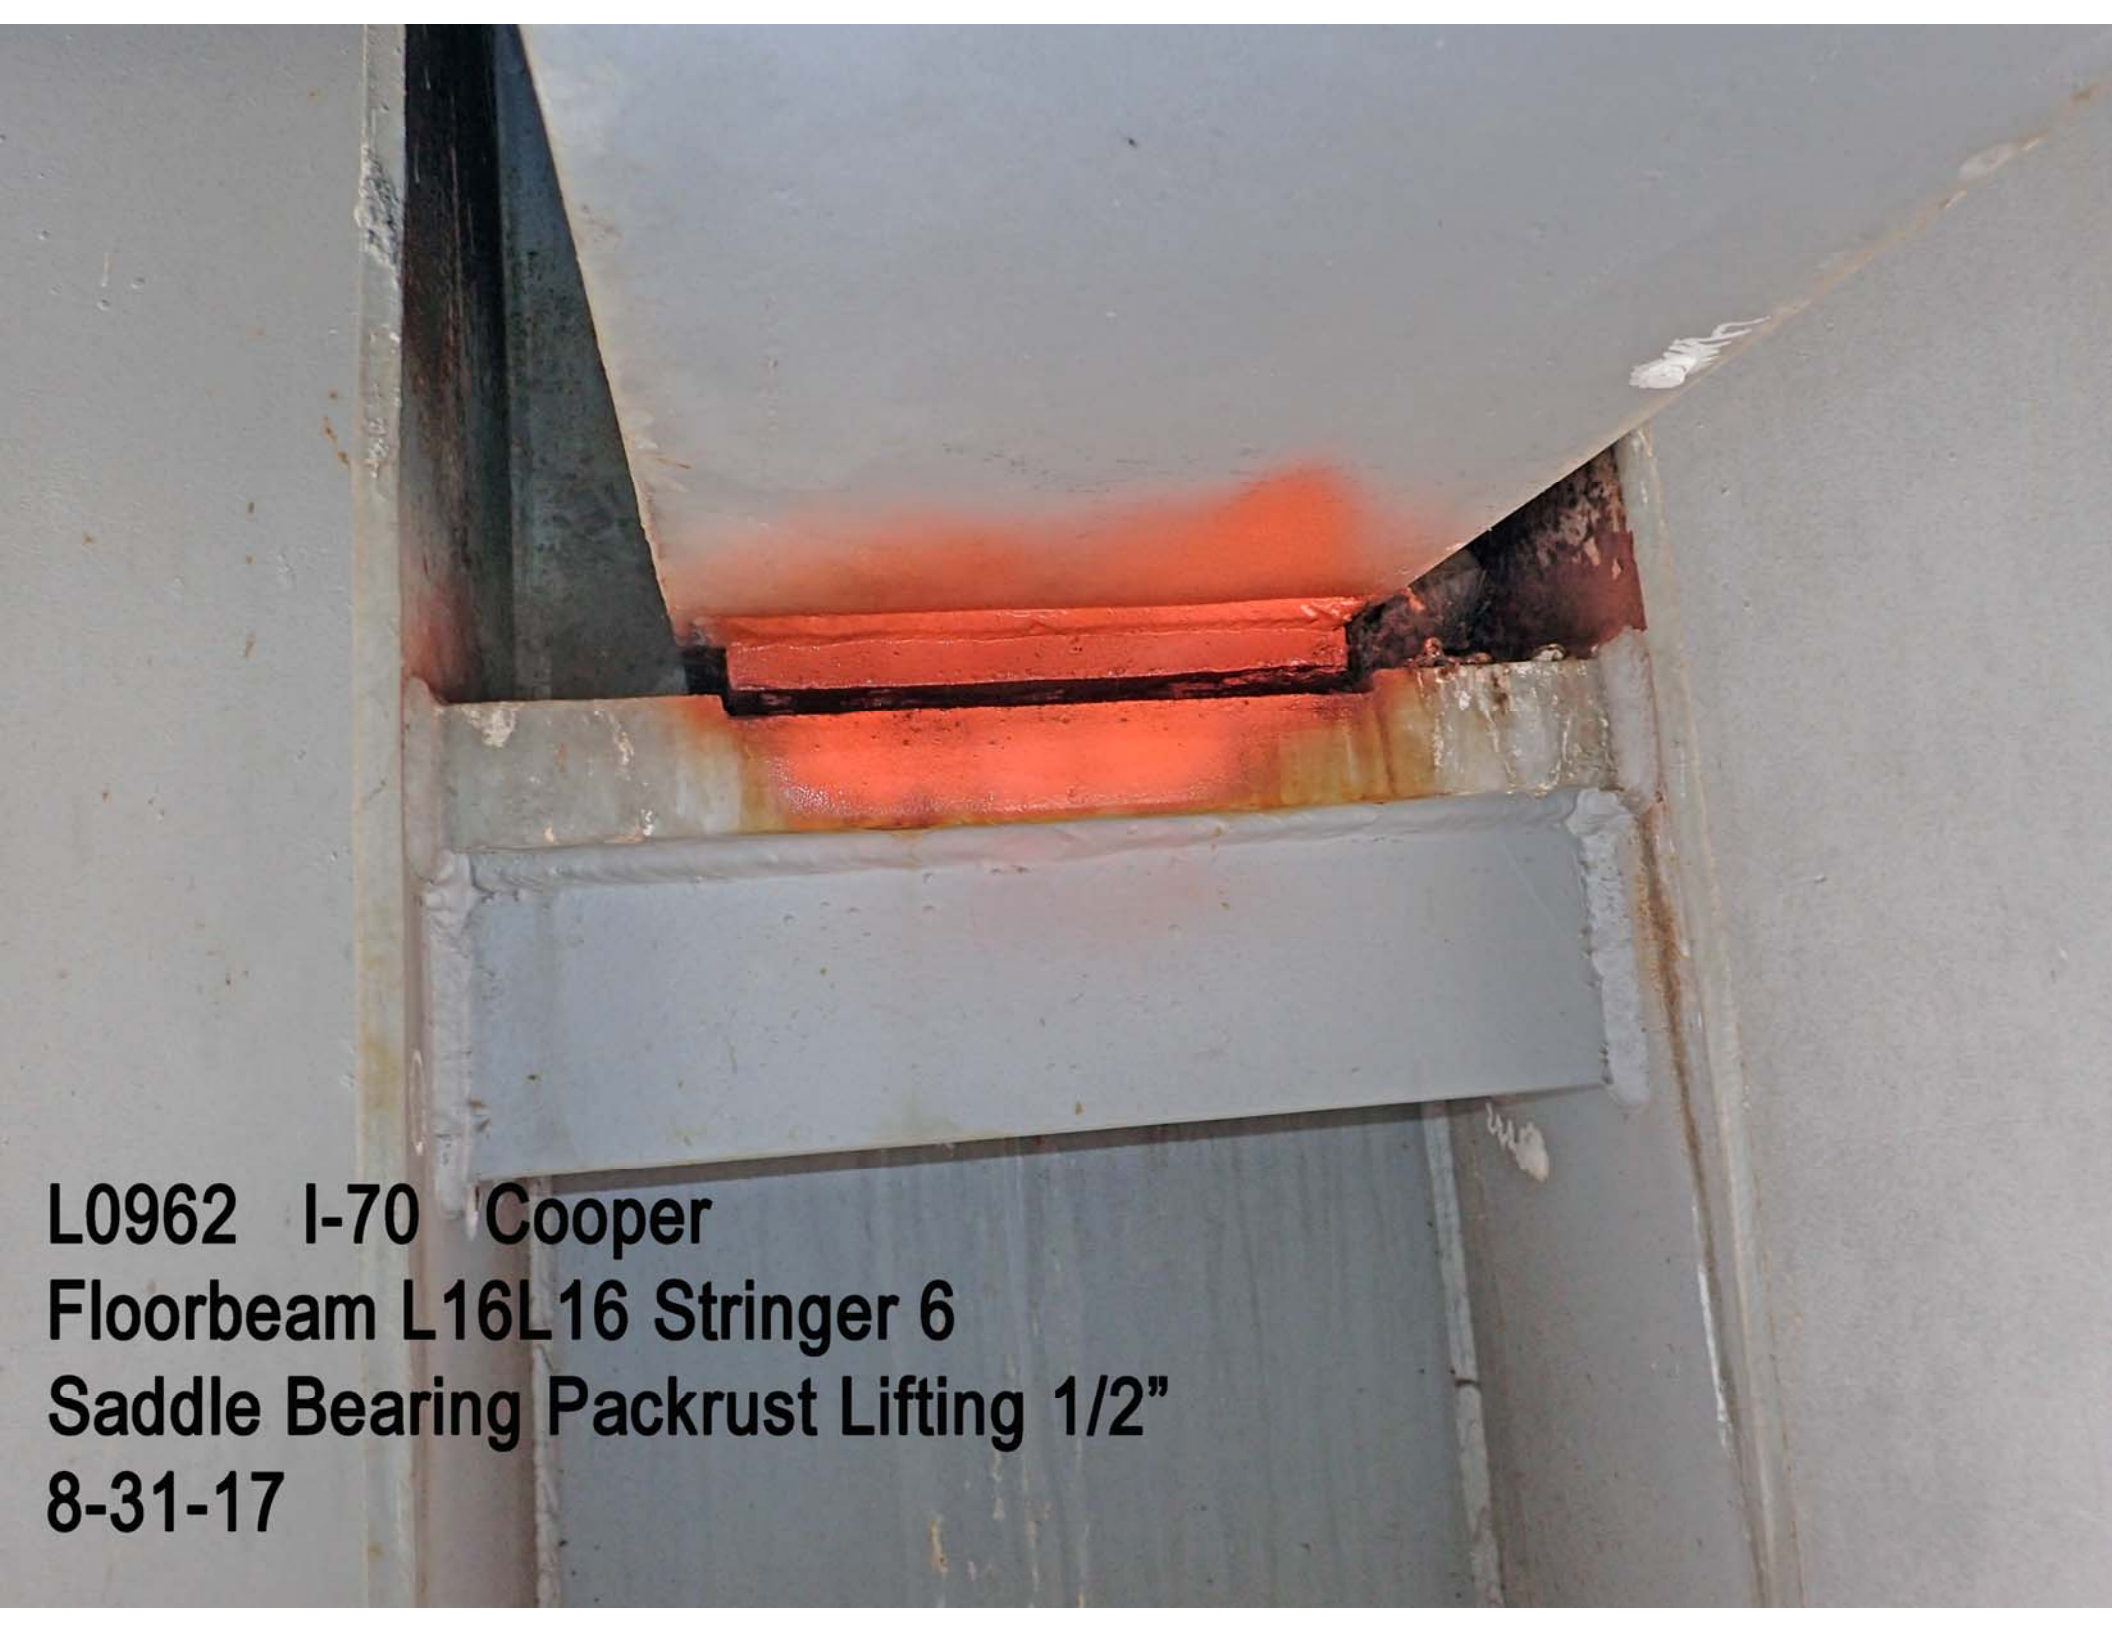
L0962 I-70 Cooper
Floorbeam L16L16 Stringer 6
Saddle Bearing Packrust Lifting 1/2"
8-31-17

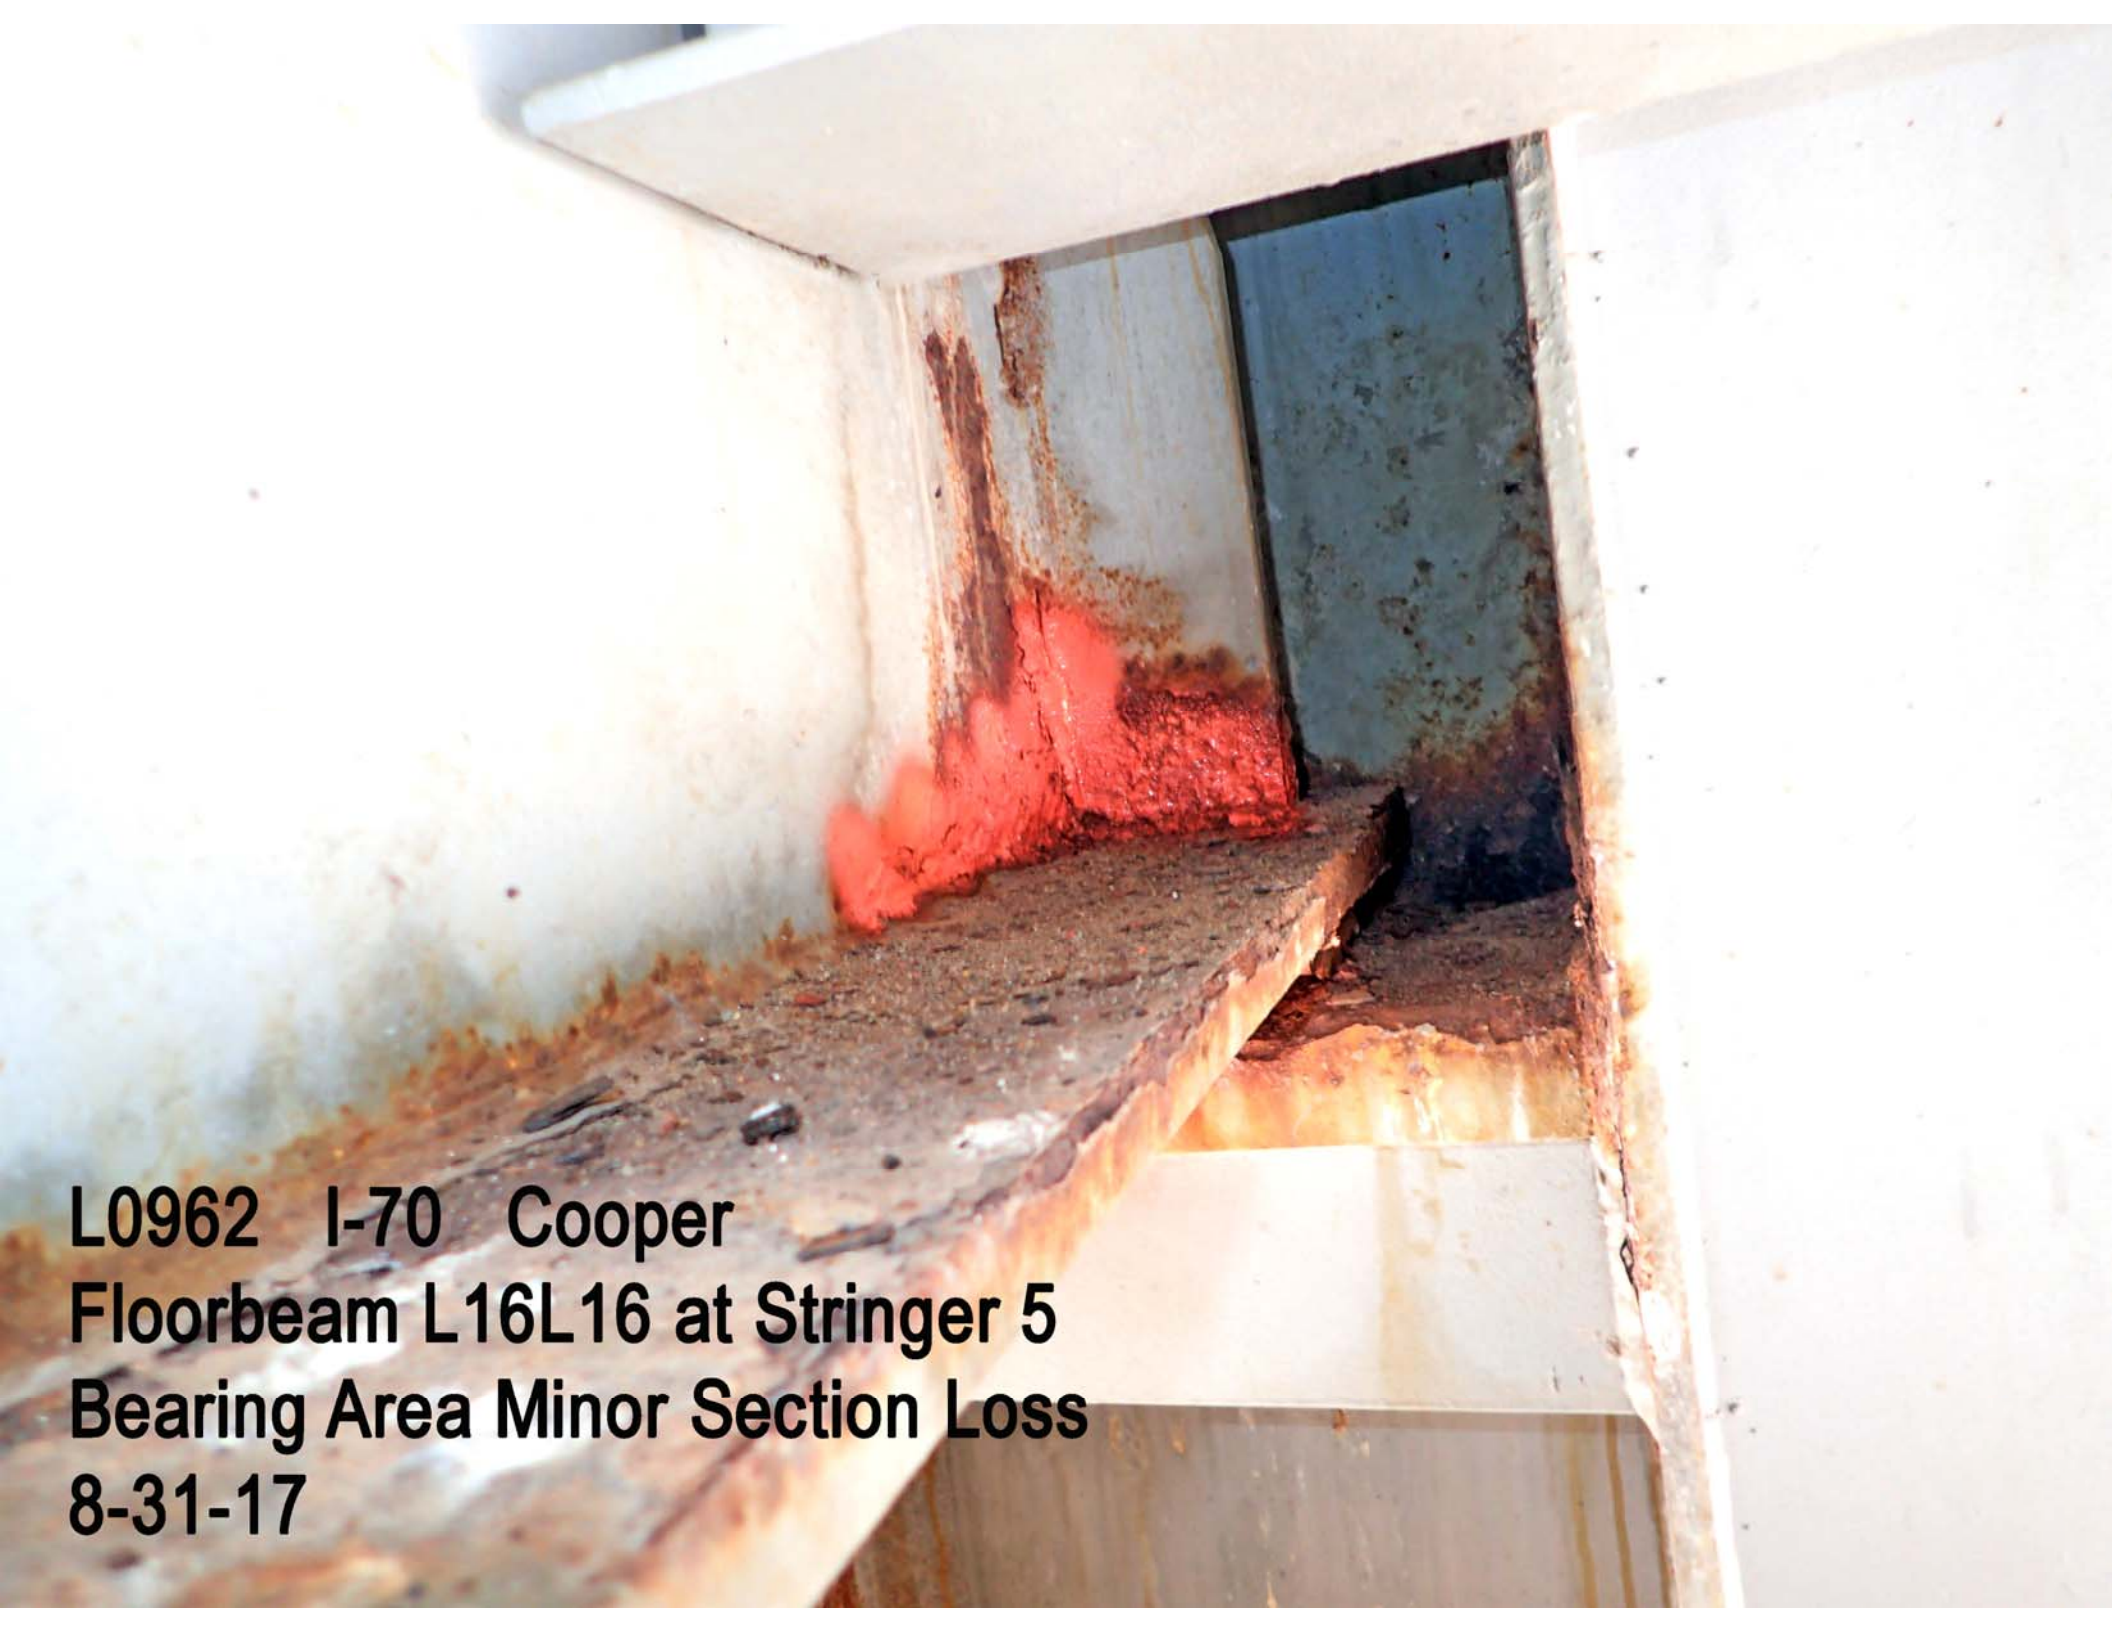
L0962 I-70 Cooper
Floorbeam L16L16 at Stringer 5
Bearing Area Minor Section Loss
8-31-17

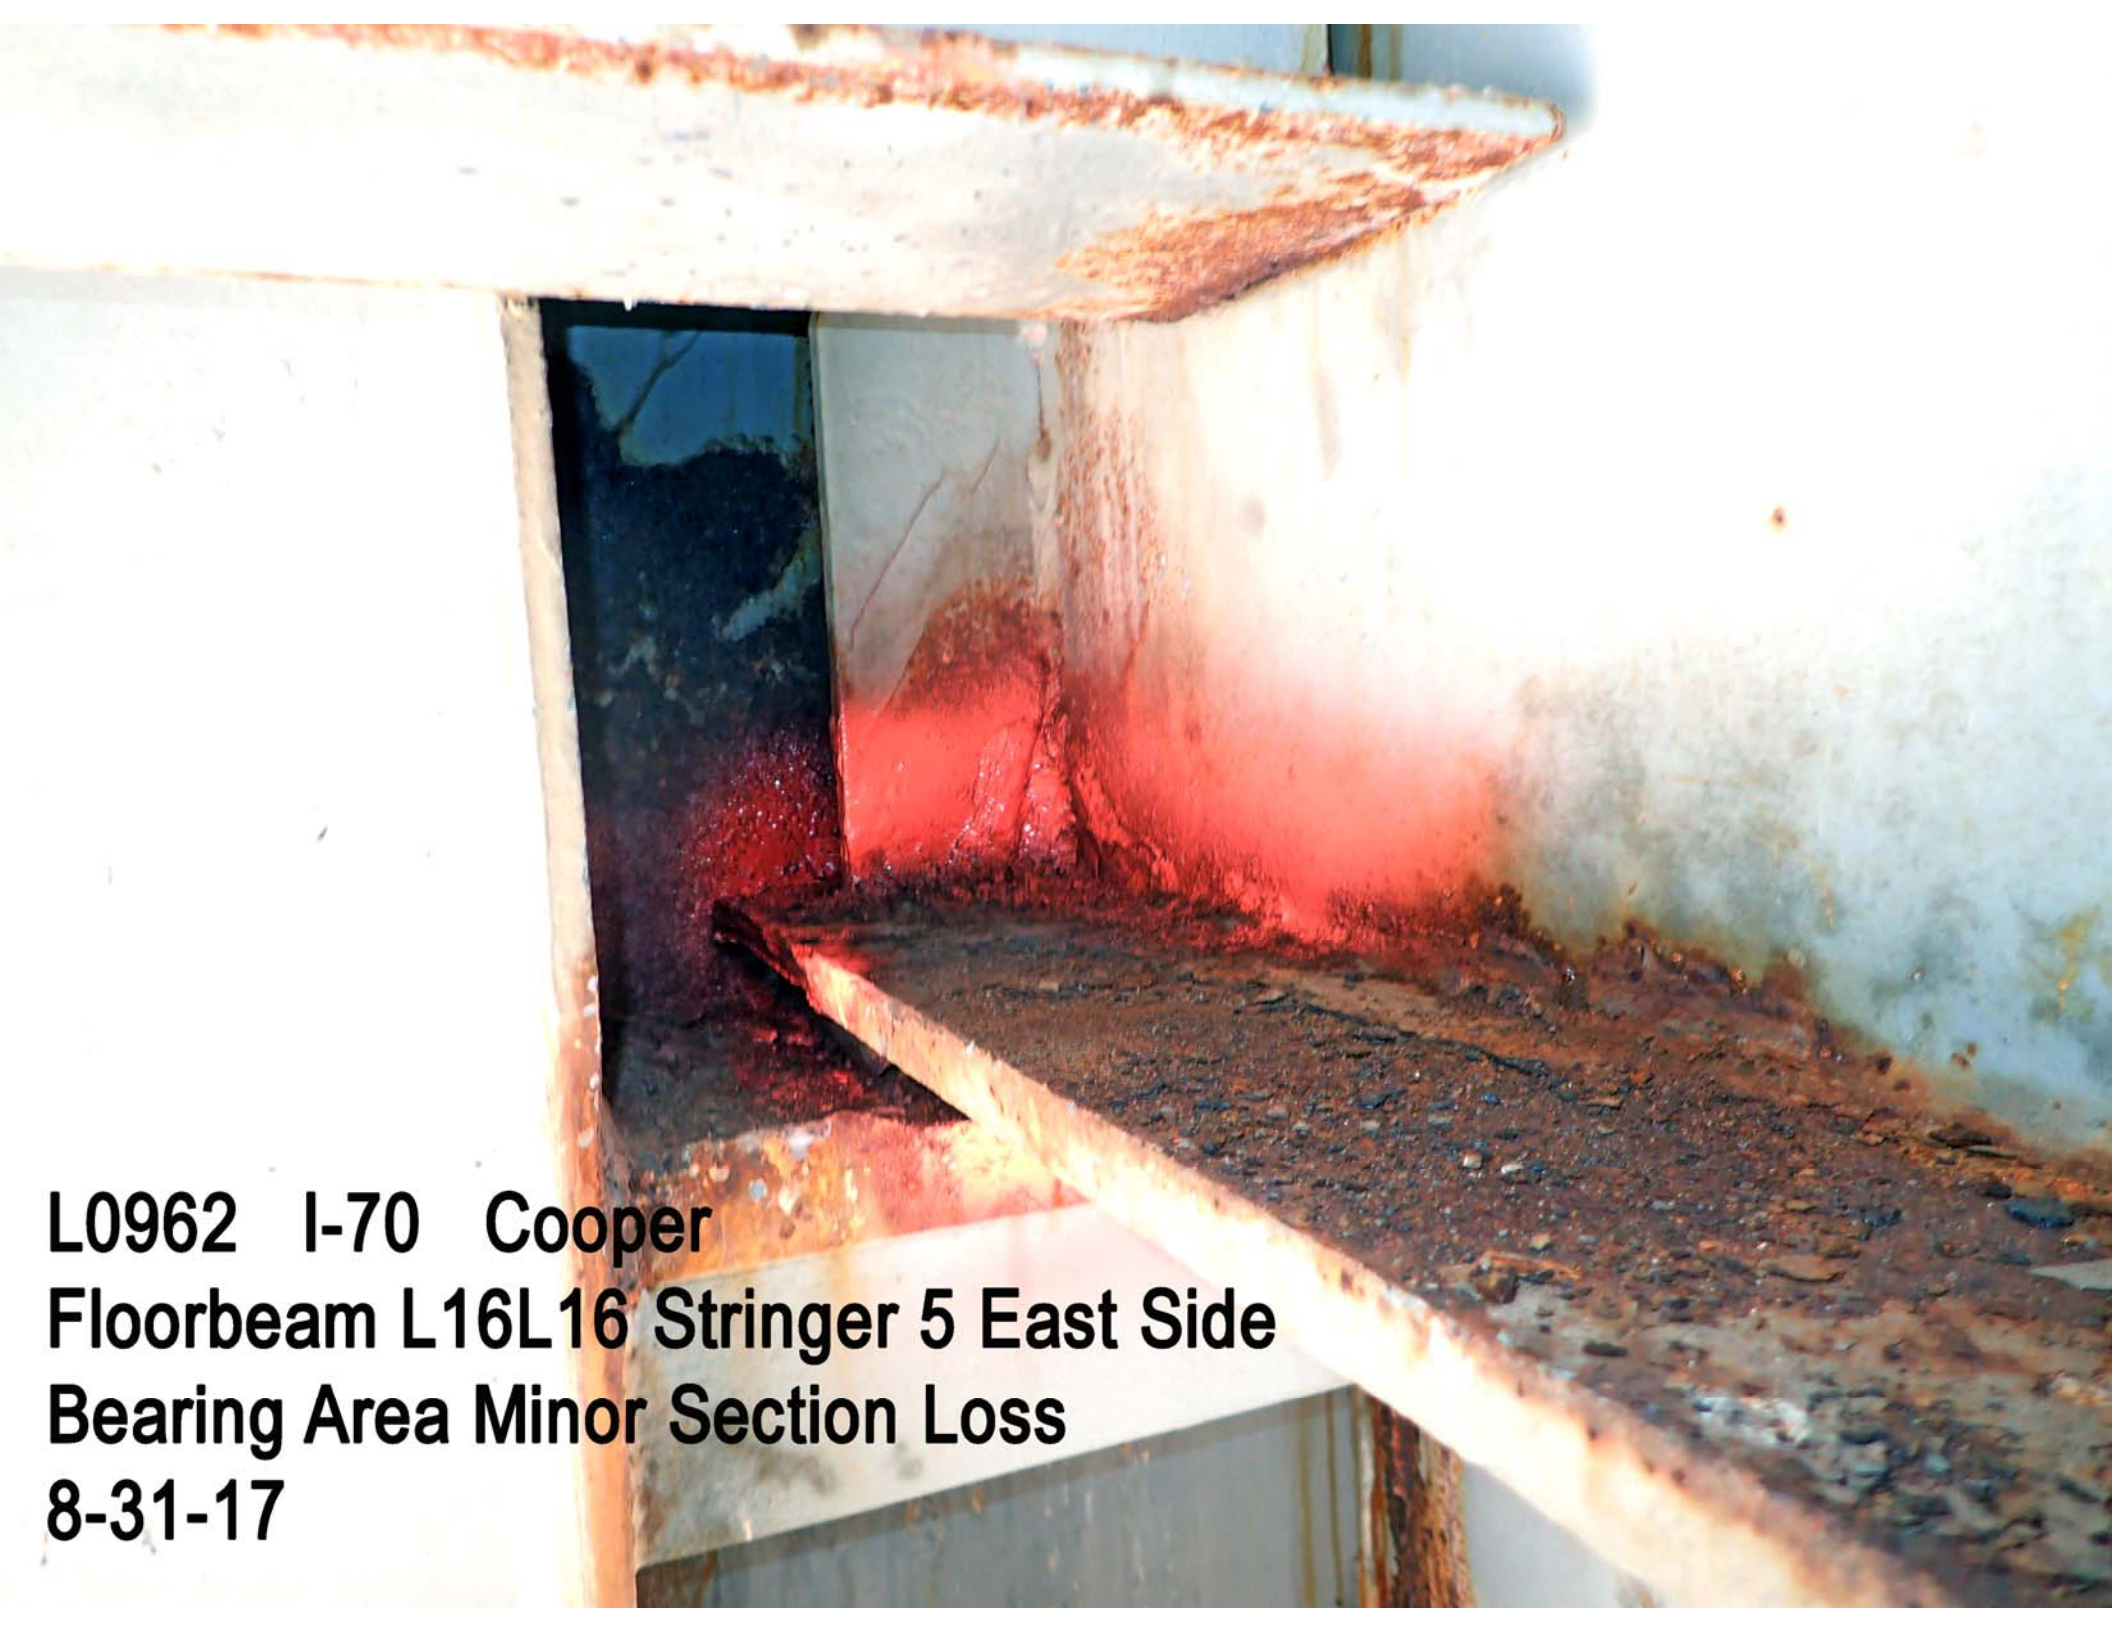
**L0962 I-70 Cooper
Floorbeam L16L16 Stringer 5 East Side
Bearing Area Minor Section Loss
8-31-17**
