L0962 Cooper Co.
08/28/2017
Looking West

L0962 I-70 Cooper
Pier 15 Open Expansion Joint WBL
8-28-17

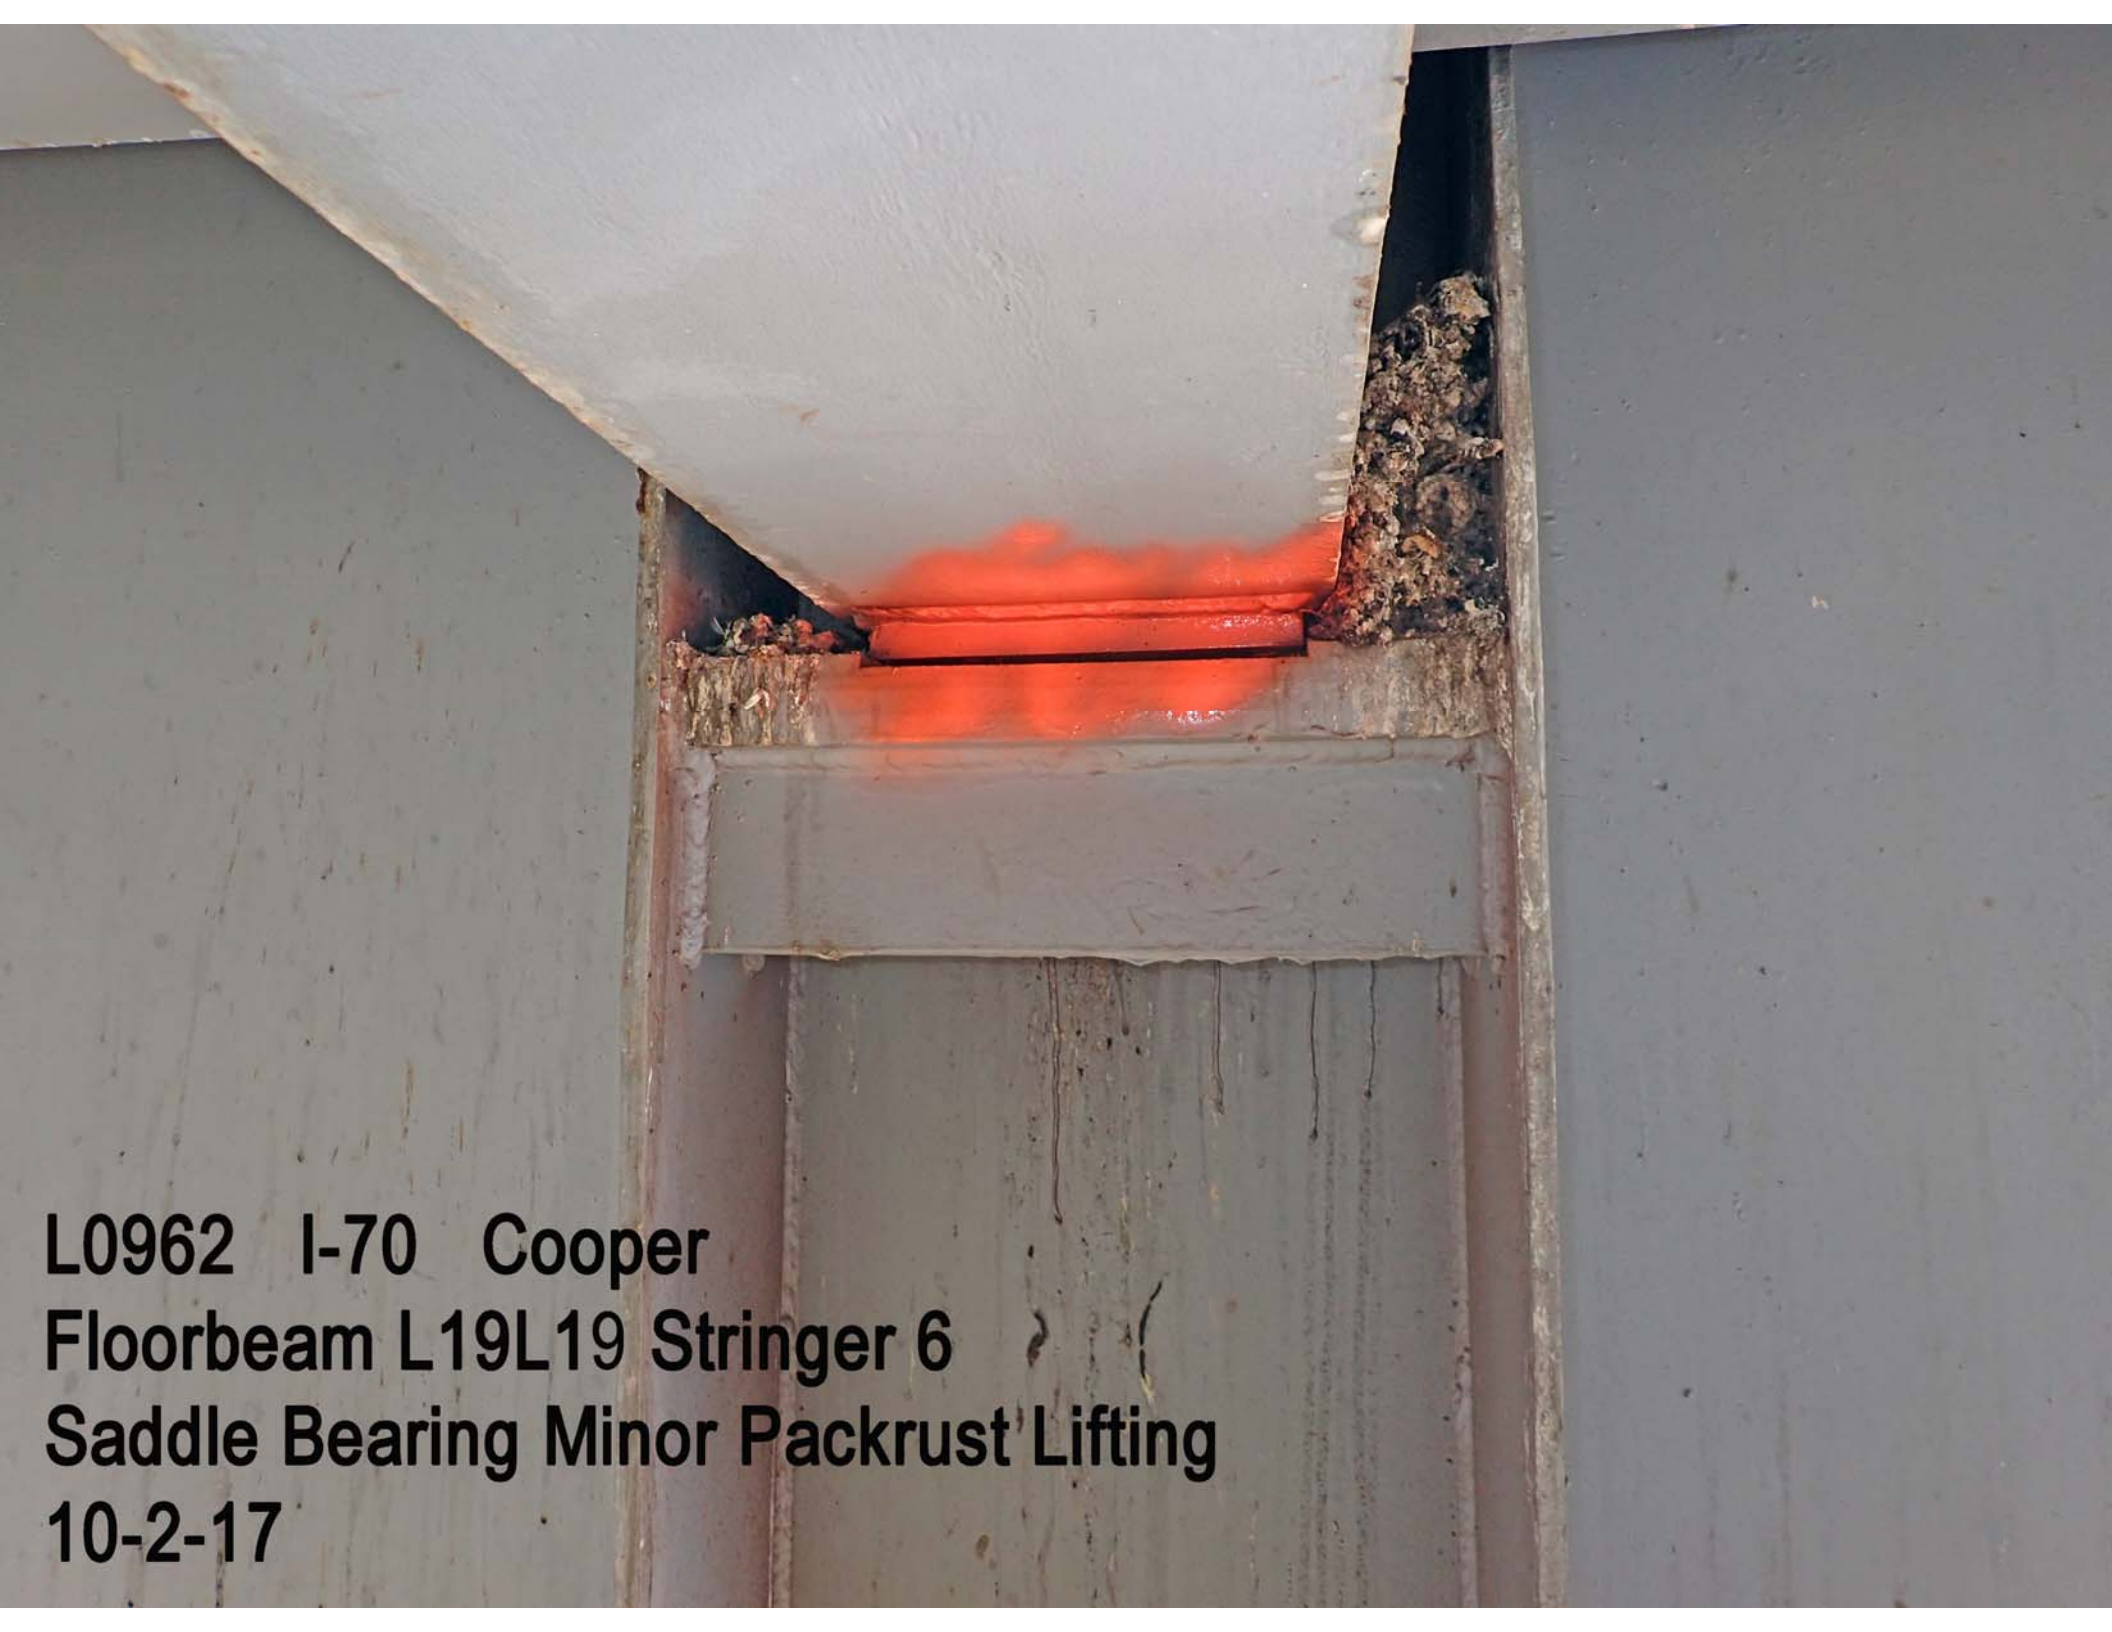
**L0962 I-70 Cooper
Floorbeam L19L19 Stringer 6
Saddle Bearing Minor Packrust Lifting
10-2-17**

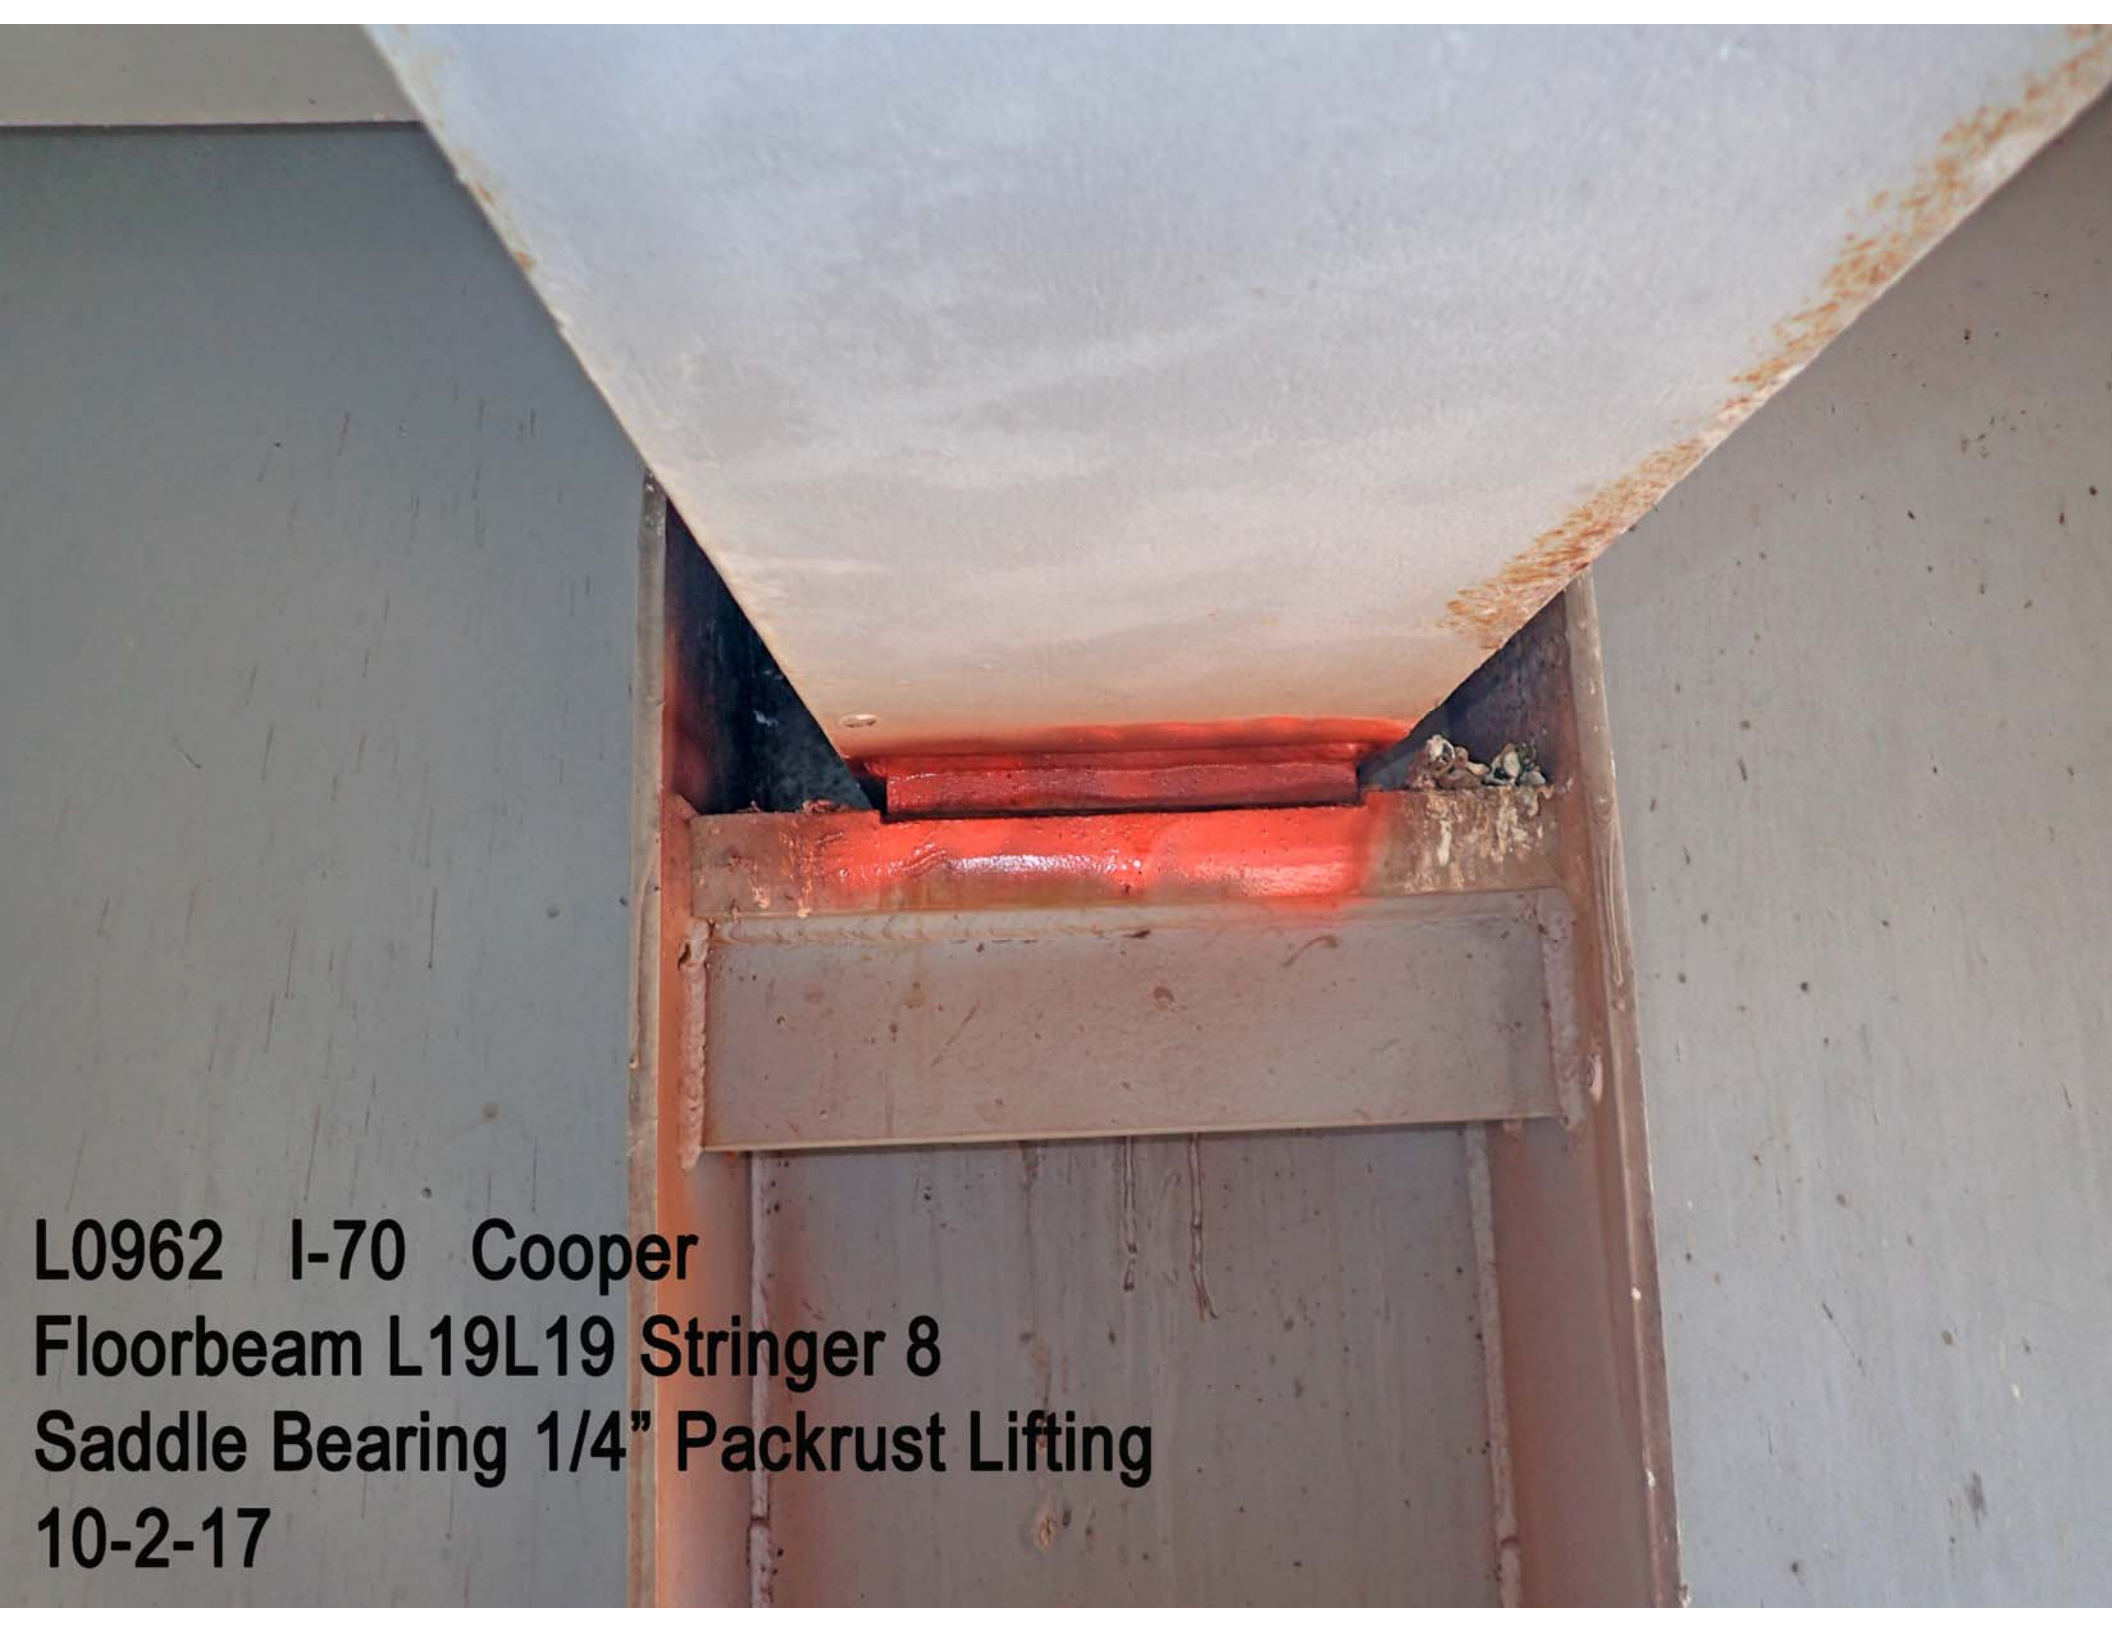
**L0962 I-70 Cooper
Floorbeam L19L19 Stringer 8
Saddle Bearing 1/4" Packrust Lifting
10-2-17**

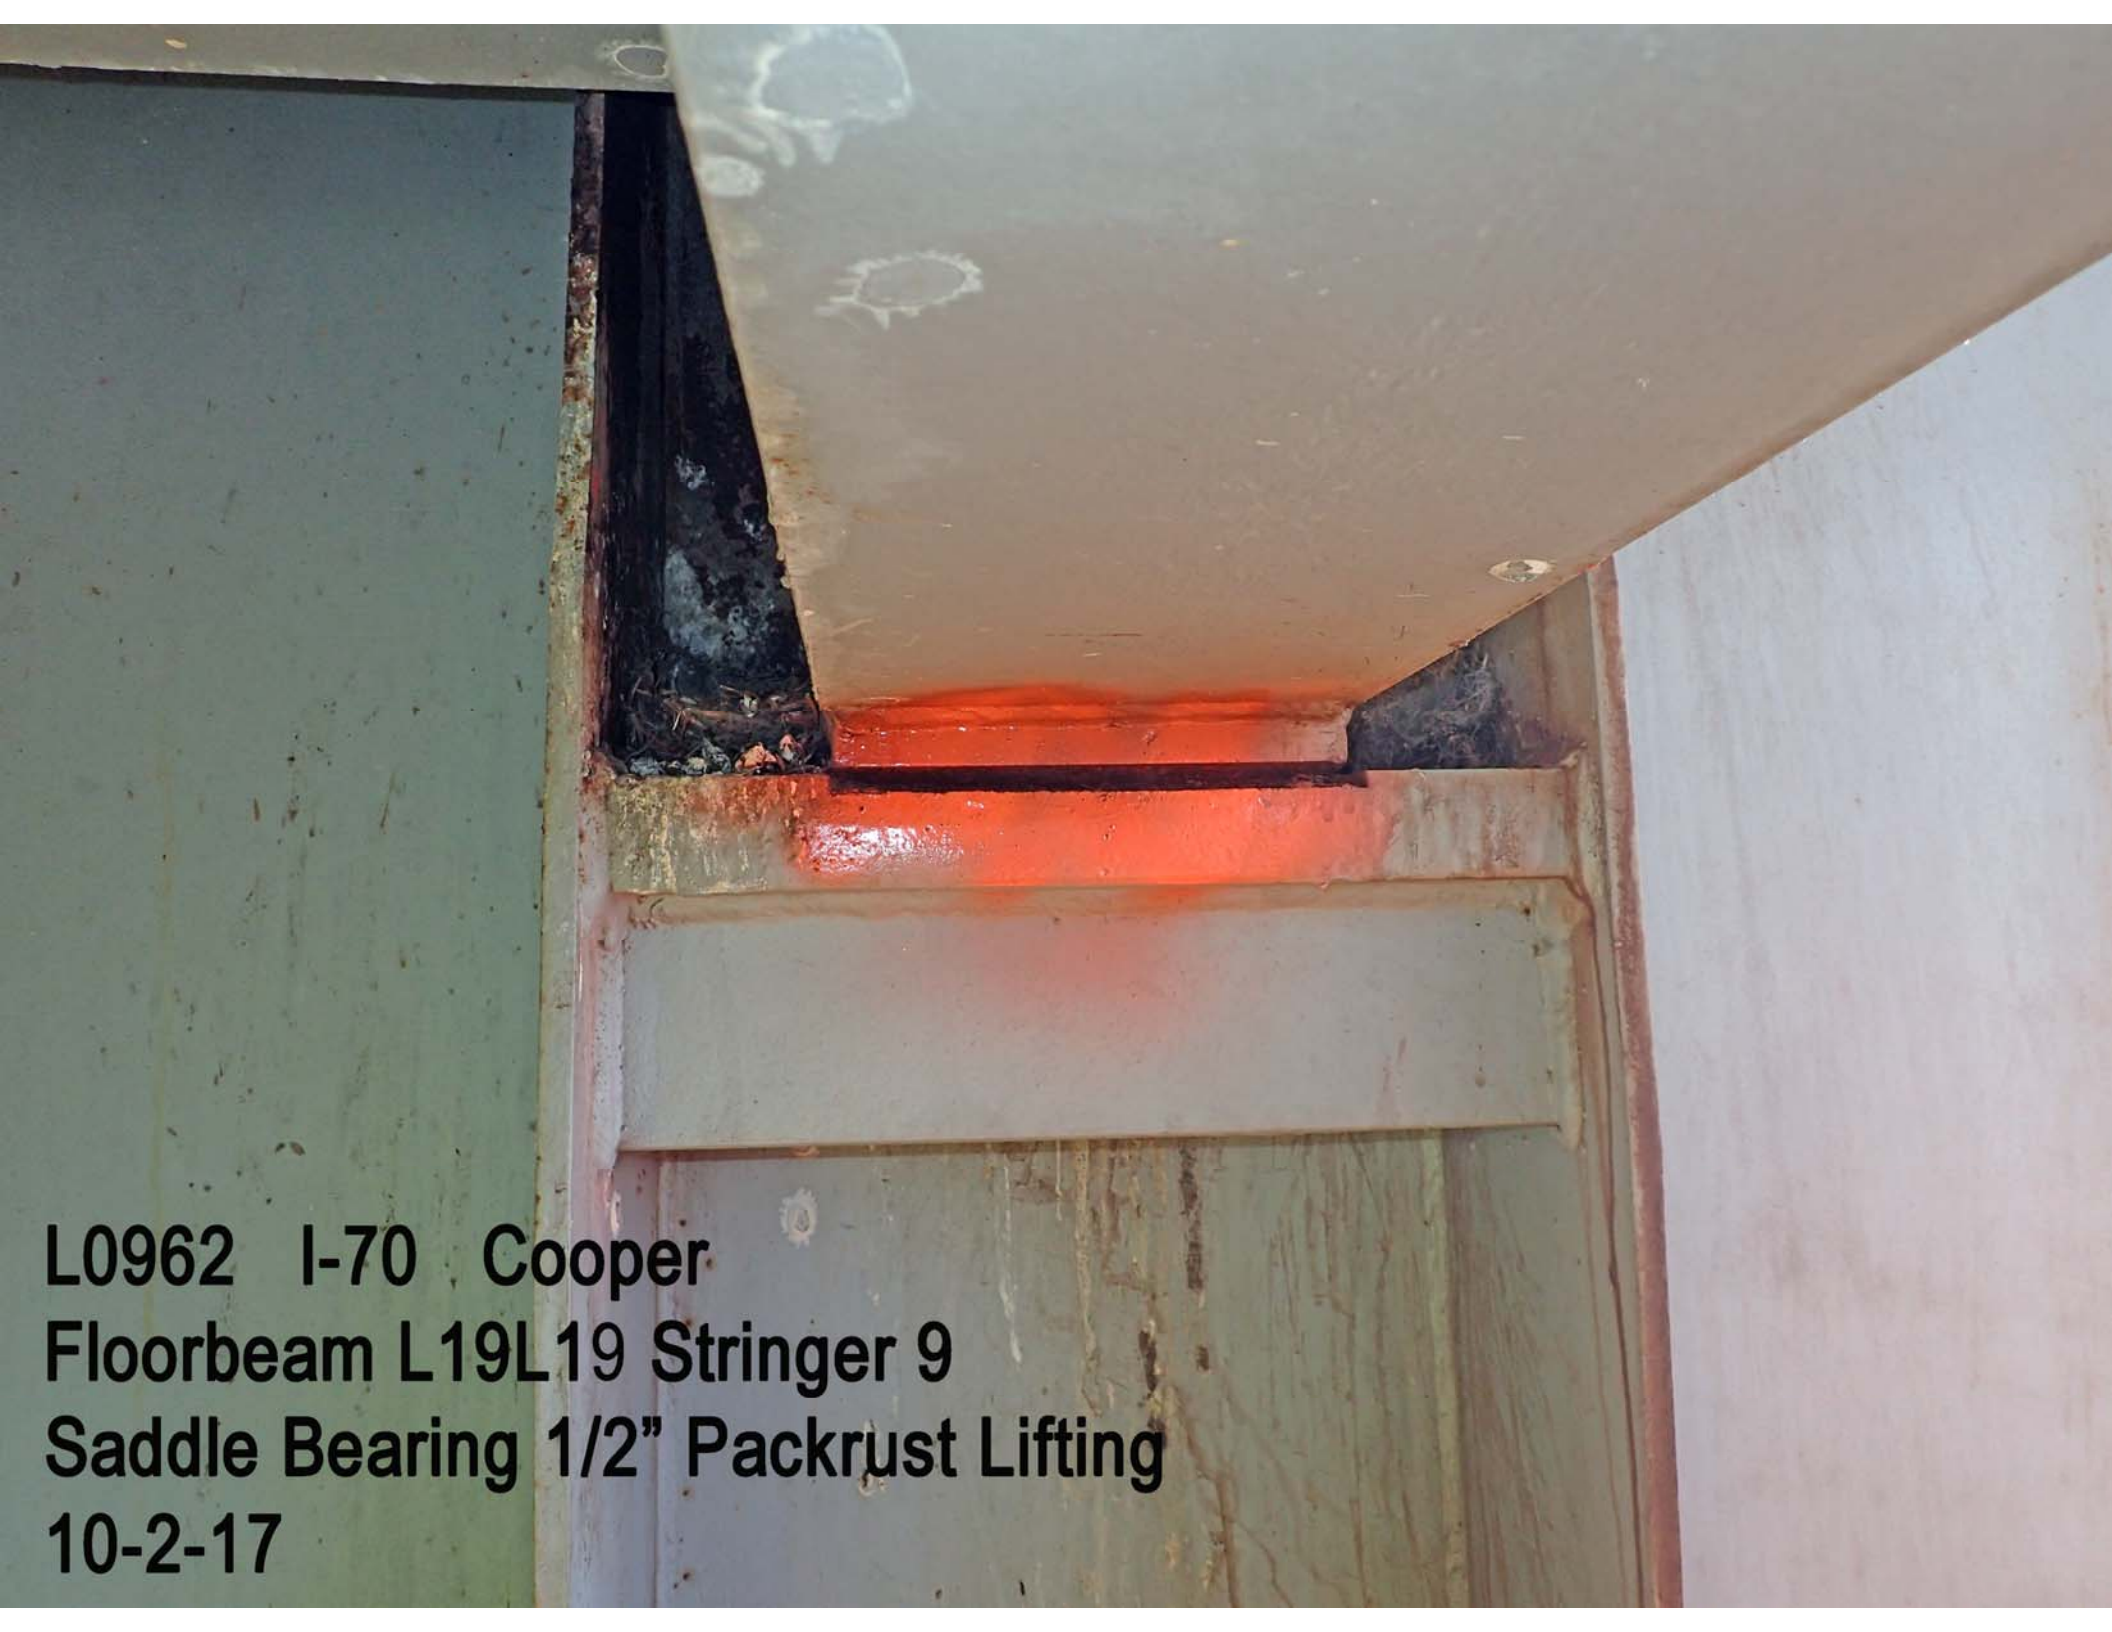
L0962 I-70 Cooper
Floorbeam L19L19 Stringer 9
Saddle Bearing 1/2" Packrust Lifting
10-2-17

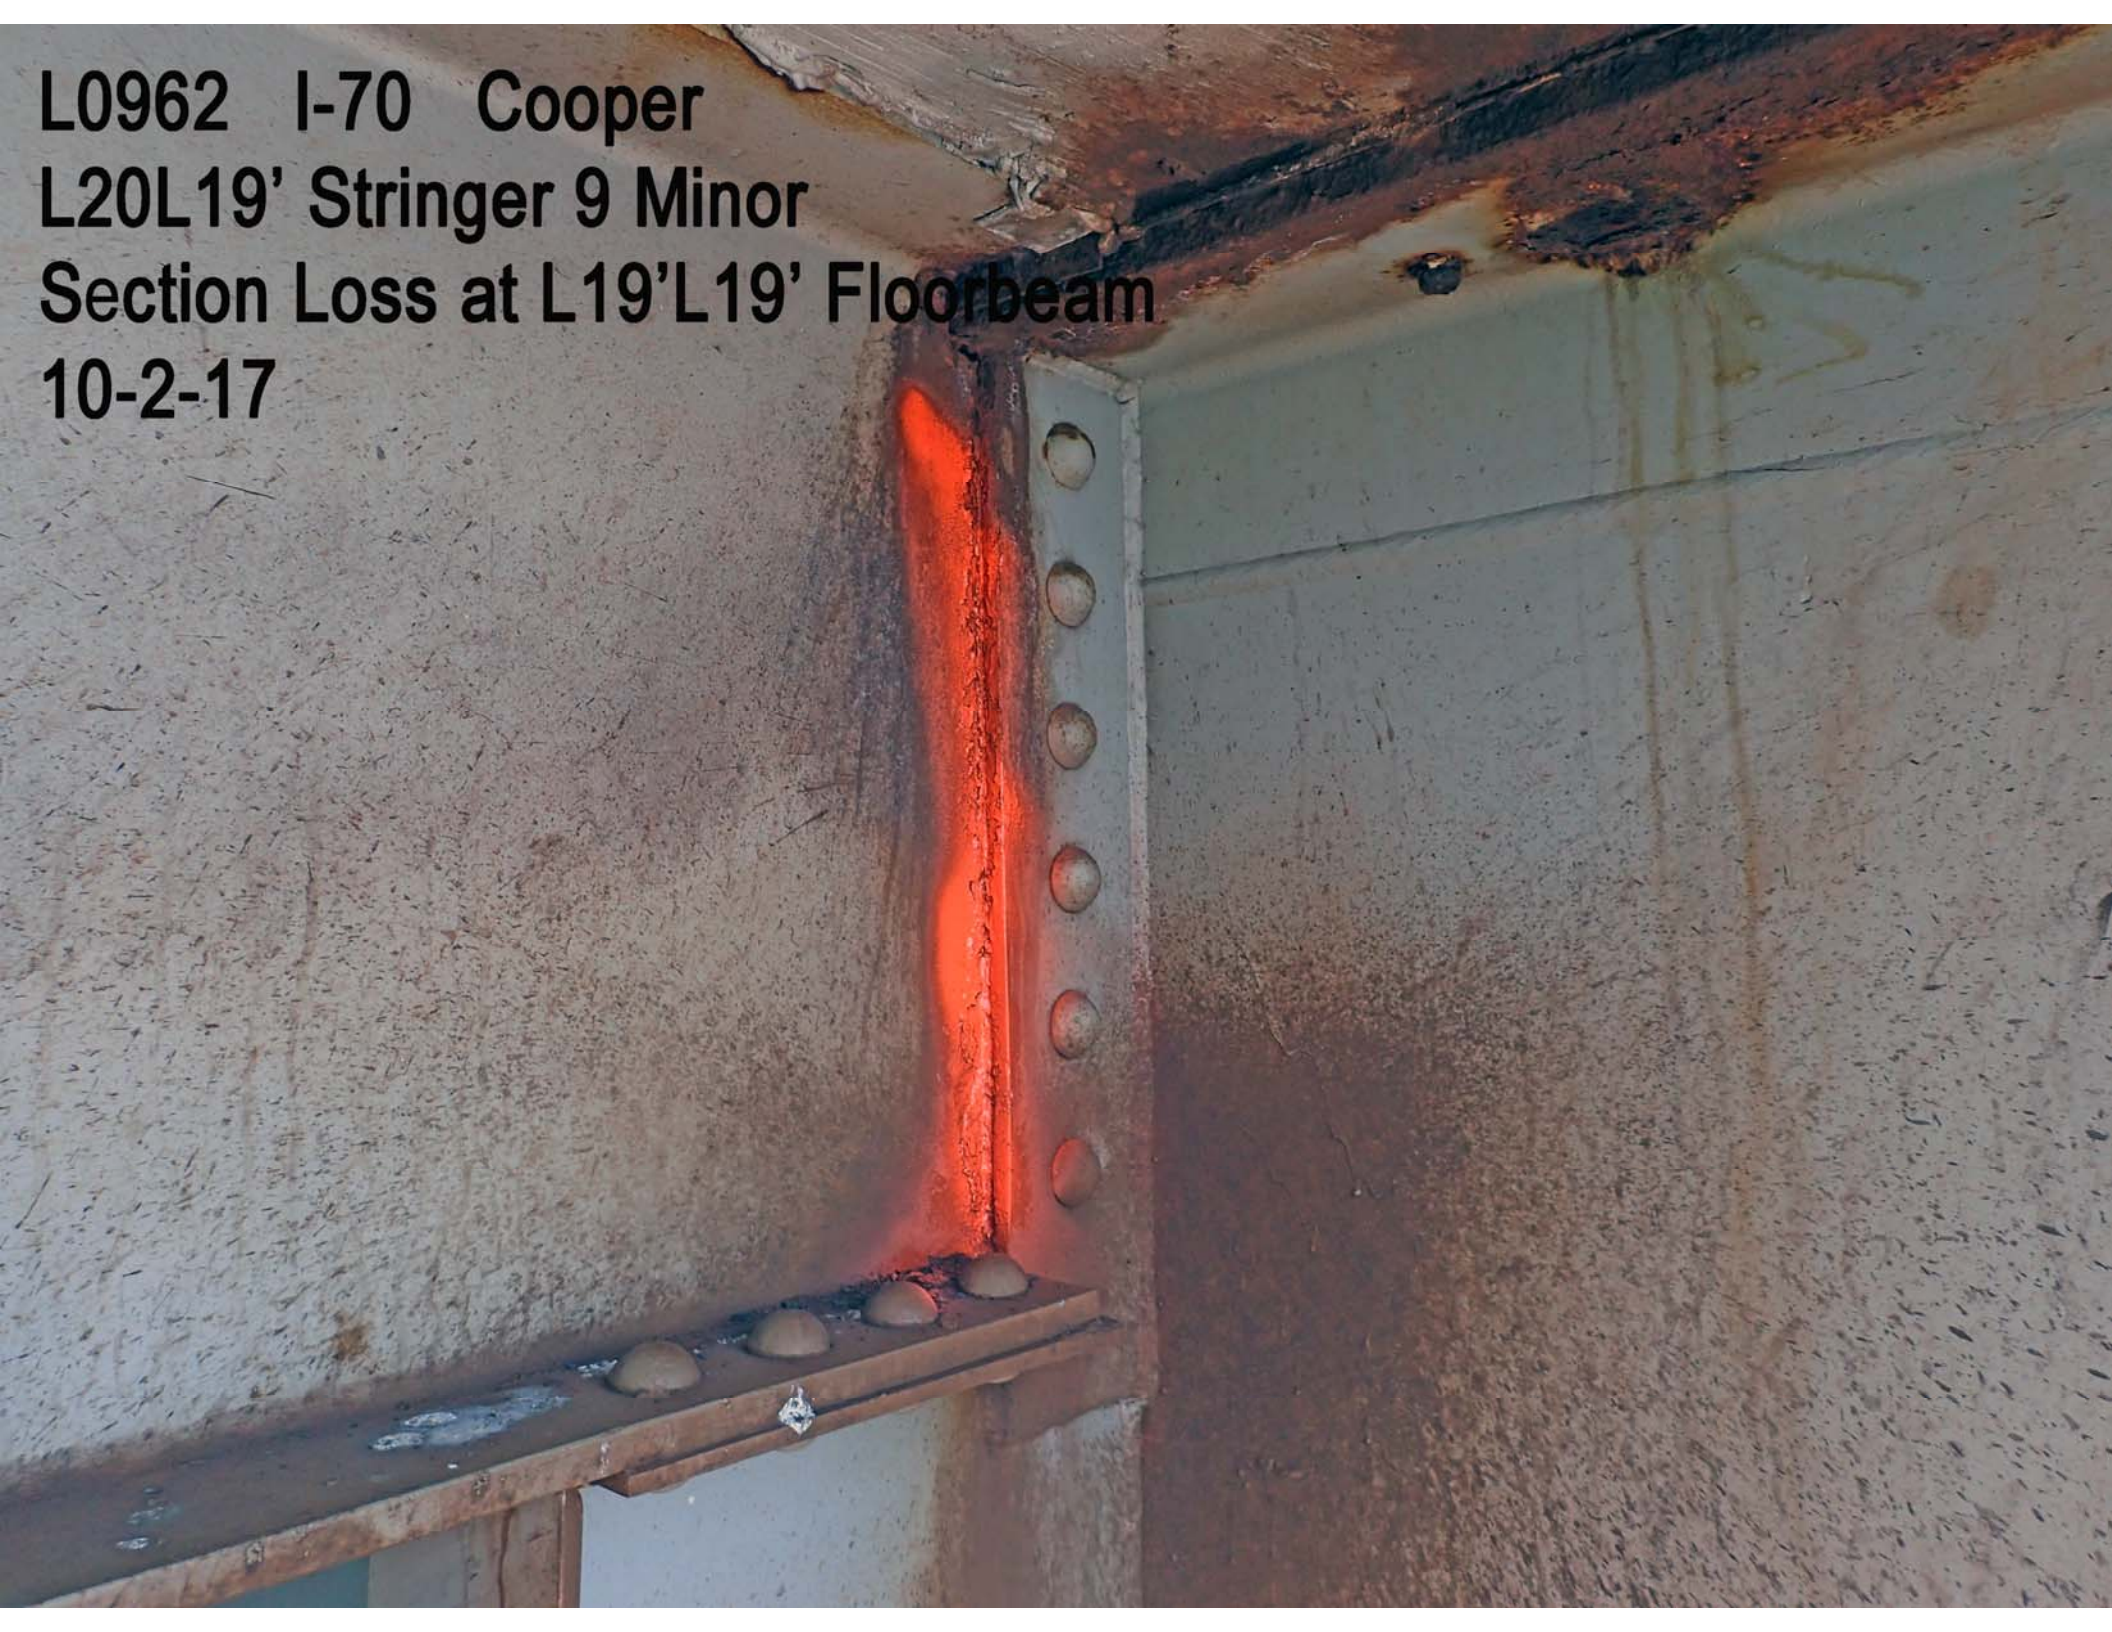
**L0962 I-70 Cooper
East Truss L19'M19' Vertical Inner
Flange Distortion at L19' Gusset Plate (typ)
10-2-17**

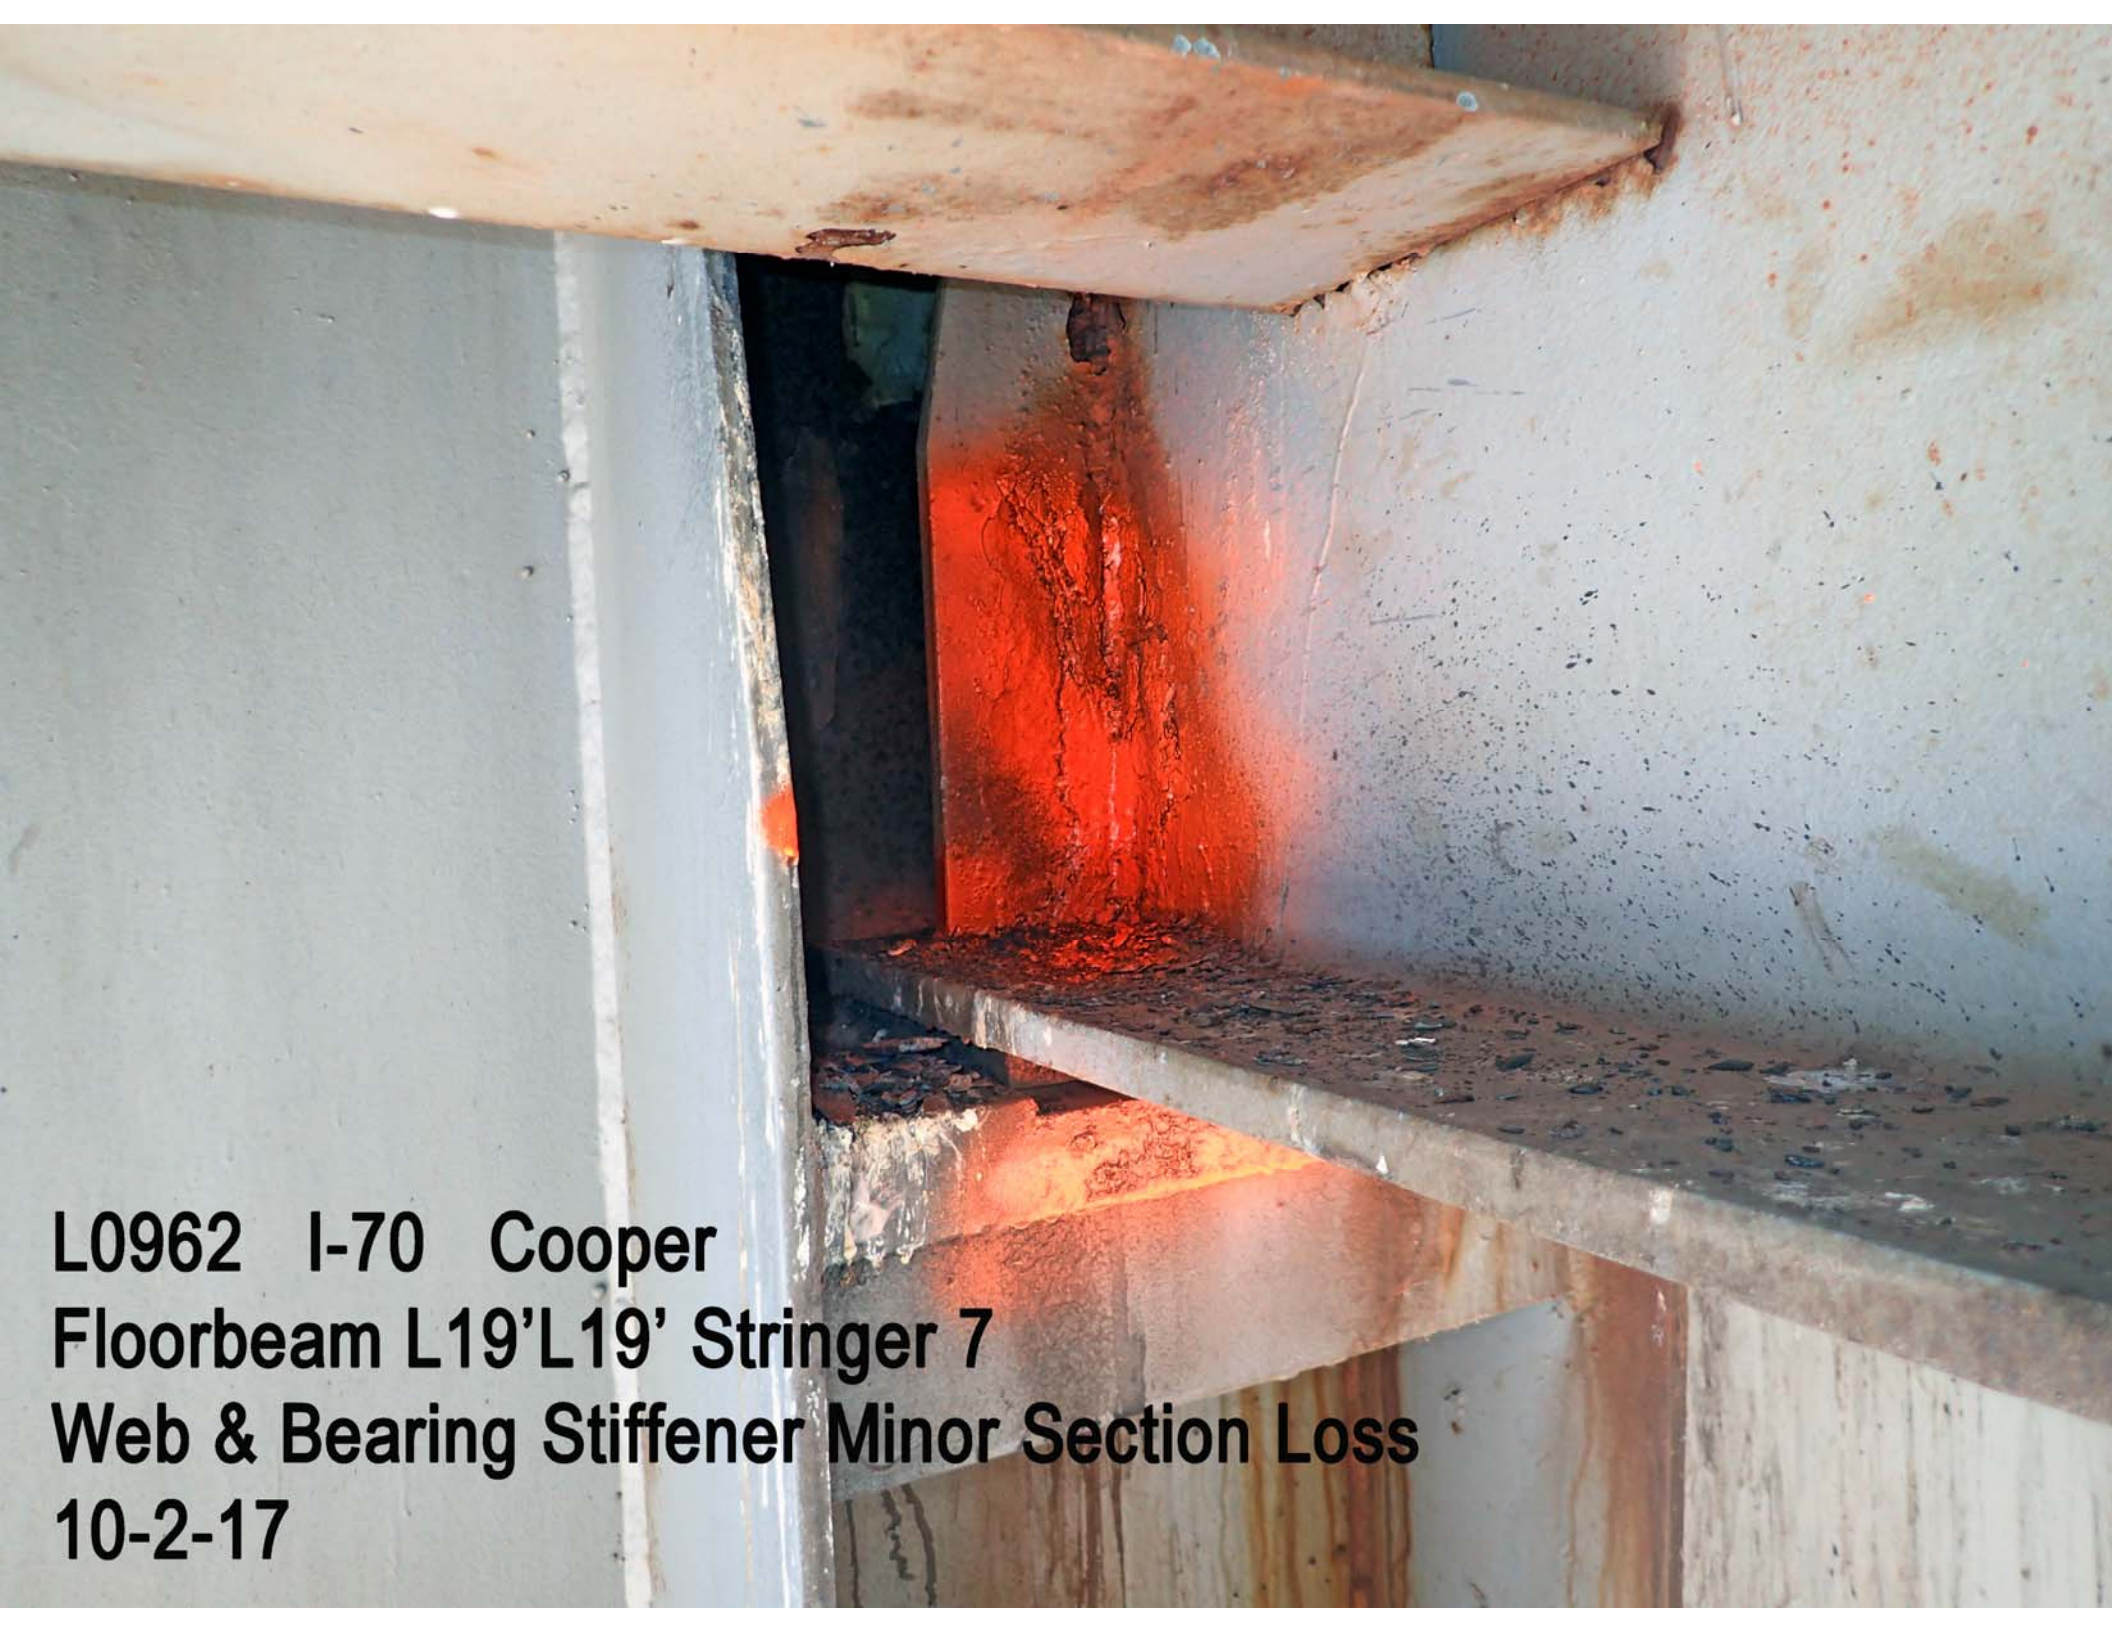
**L0962 I-70 Cooper
Floorbeam L19'L19' Stringer 7
Web & Bearing Stiffener Minor Section Loss
10-2-17**

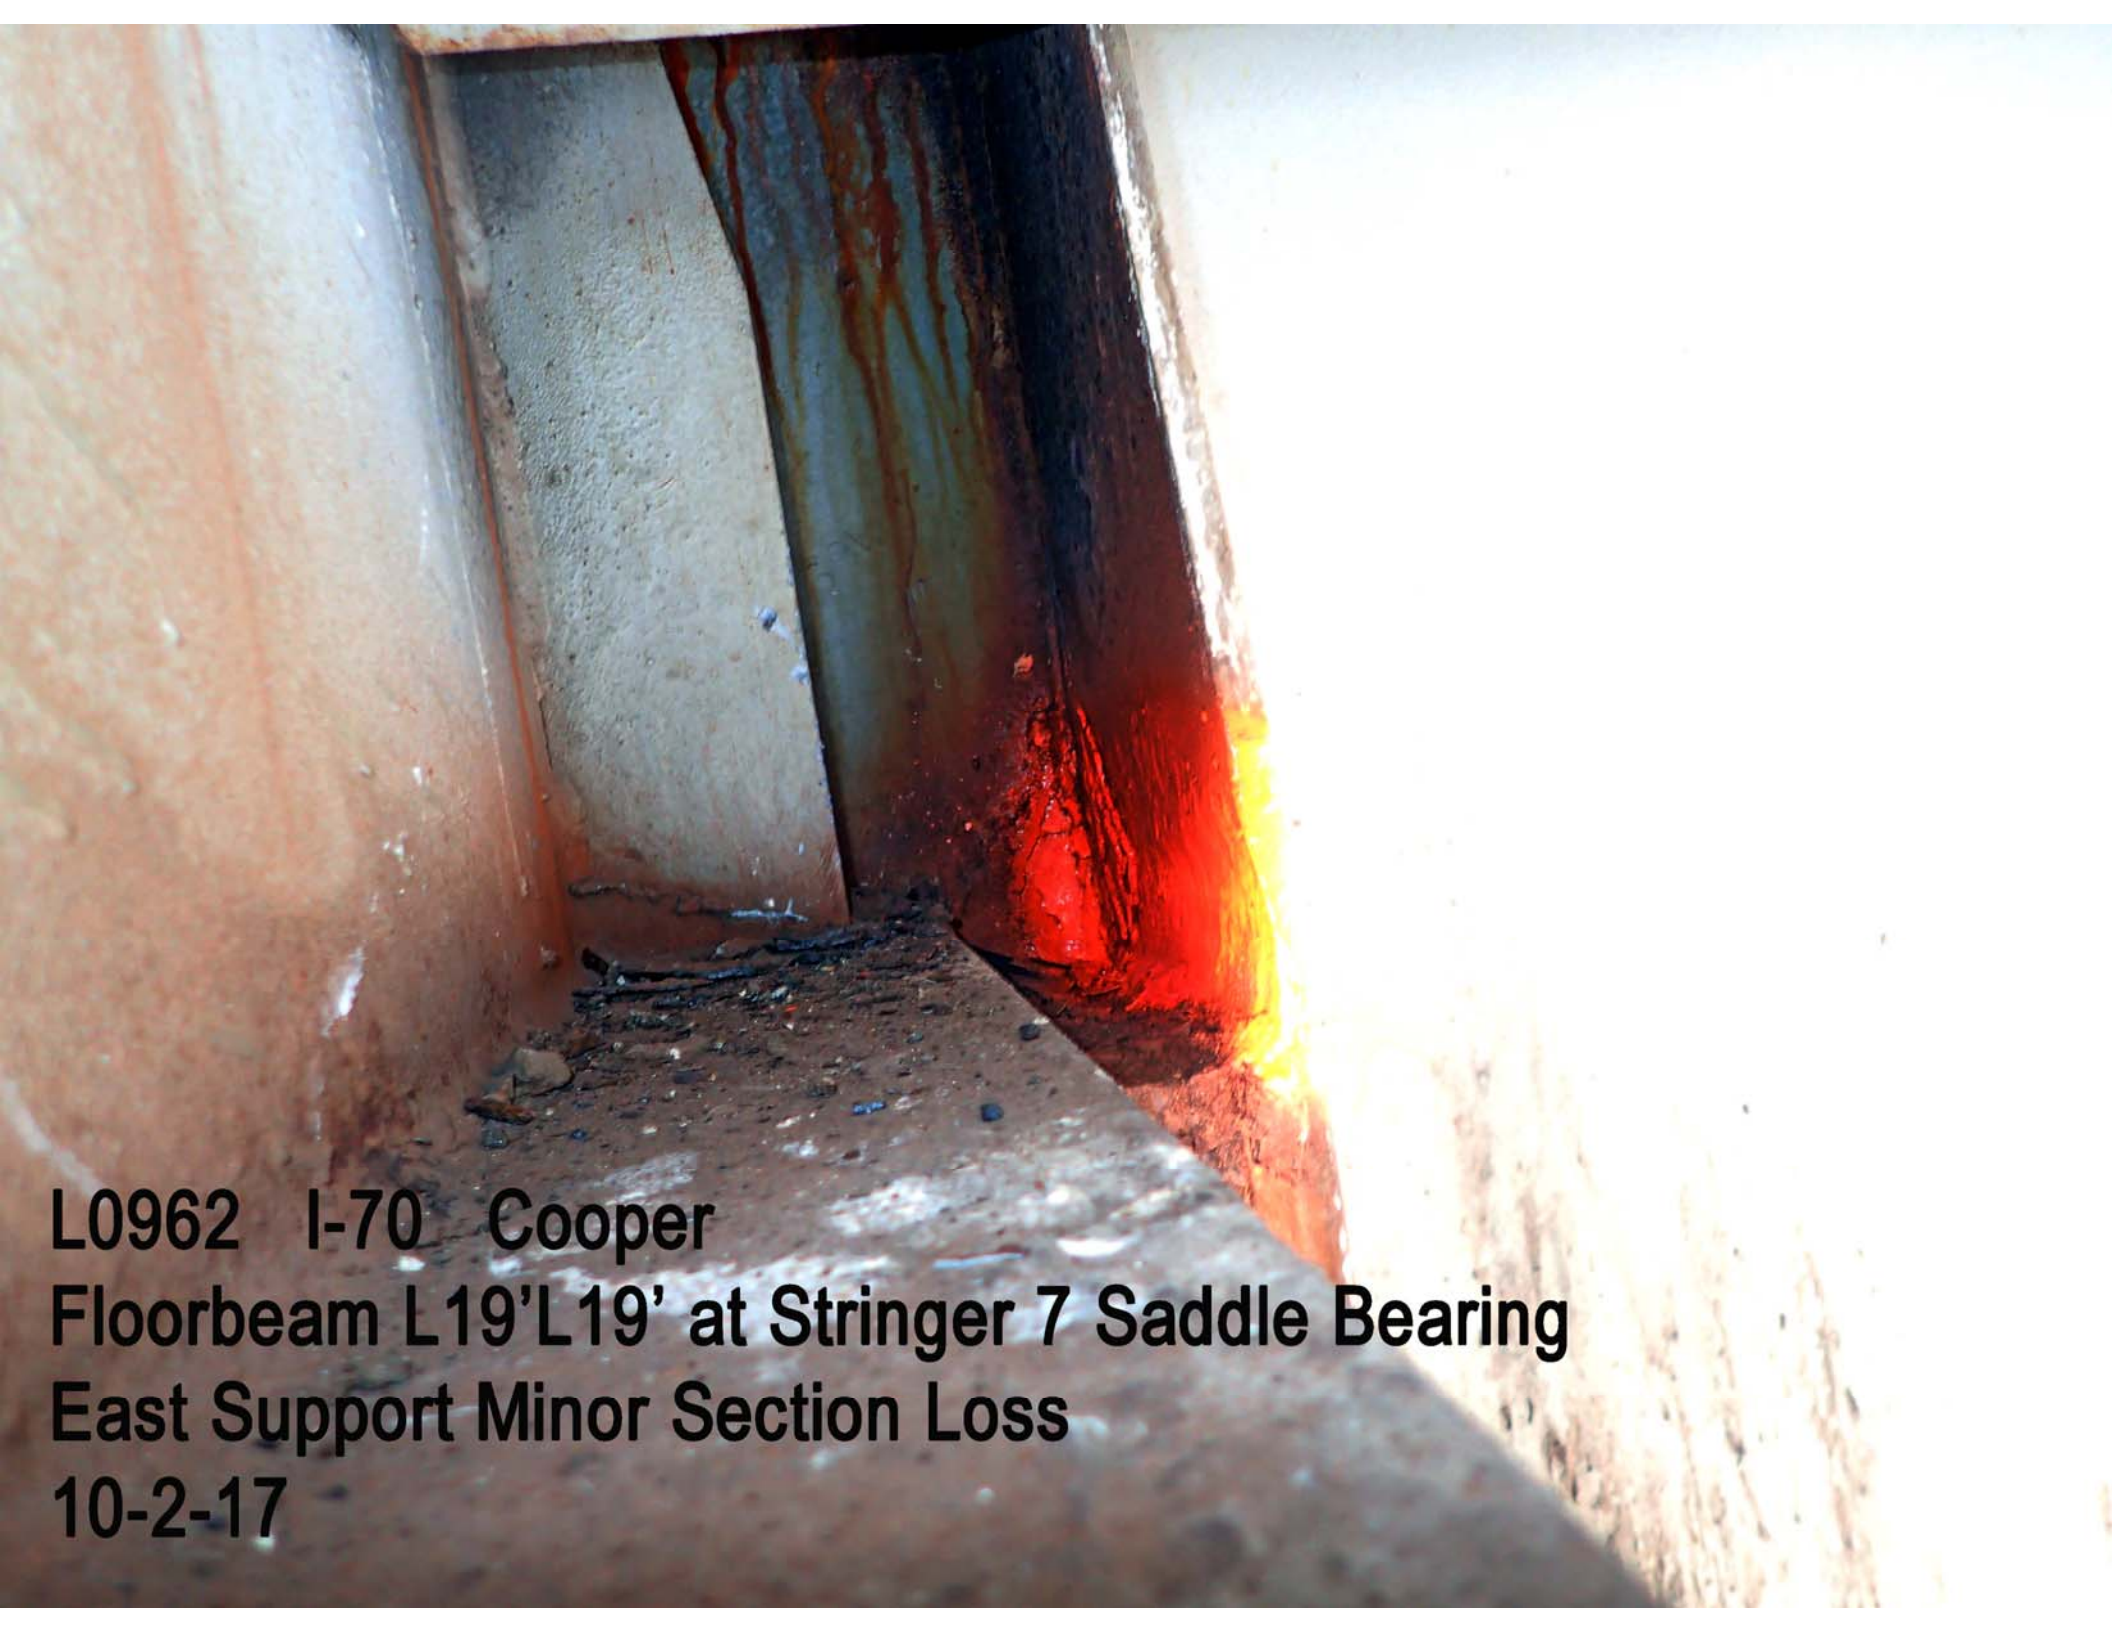
**L0962 I-70 Cooper
Floorbeam L19'L19' at Stringer 7 Saddle Bearing
East Support Minor Section Loss
10-2-17**
