L0962 Cooper Co.
08/28/2017
Looking West

L0962 I-70 Cooper
Pier 15 Open Expansion Joint WBL
8-28-17

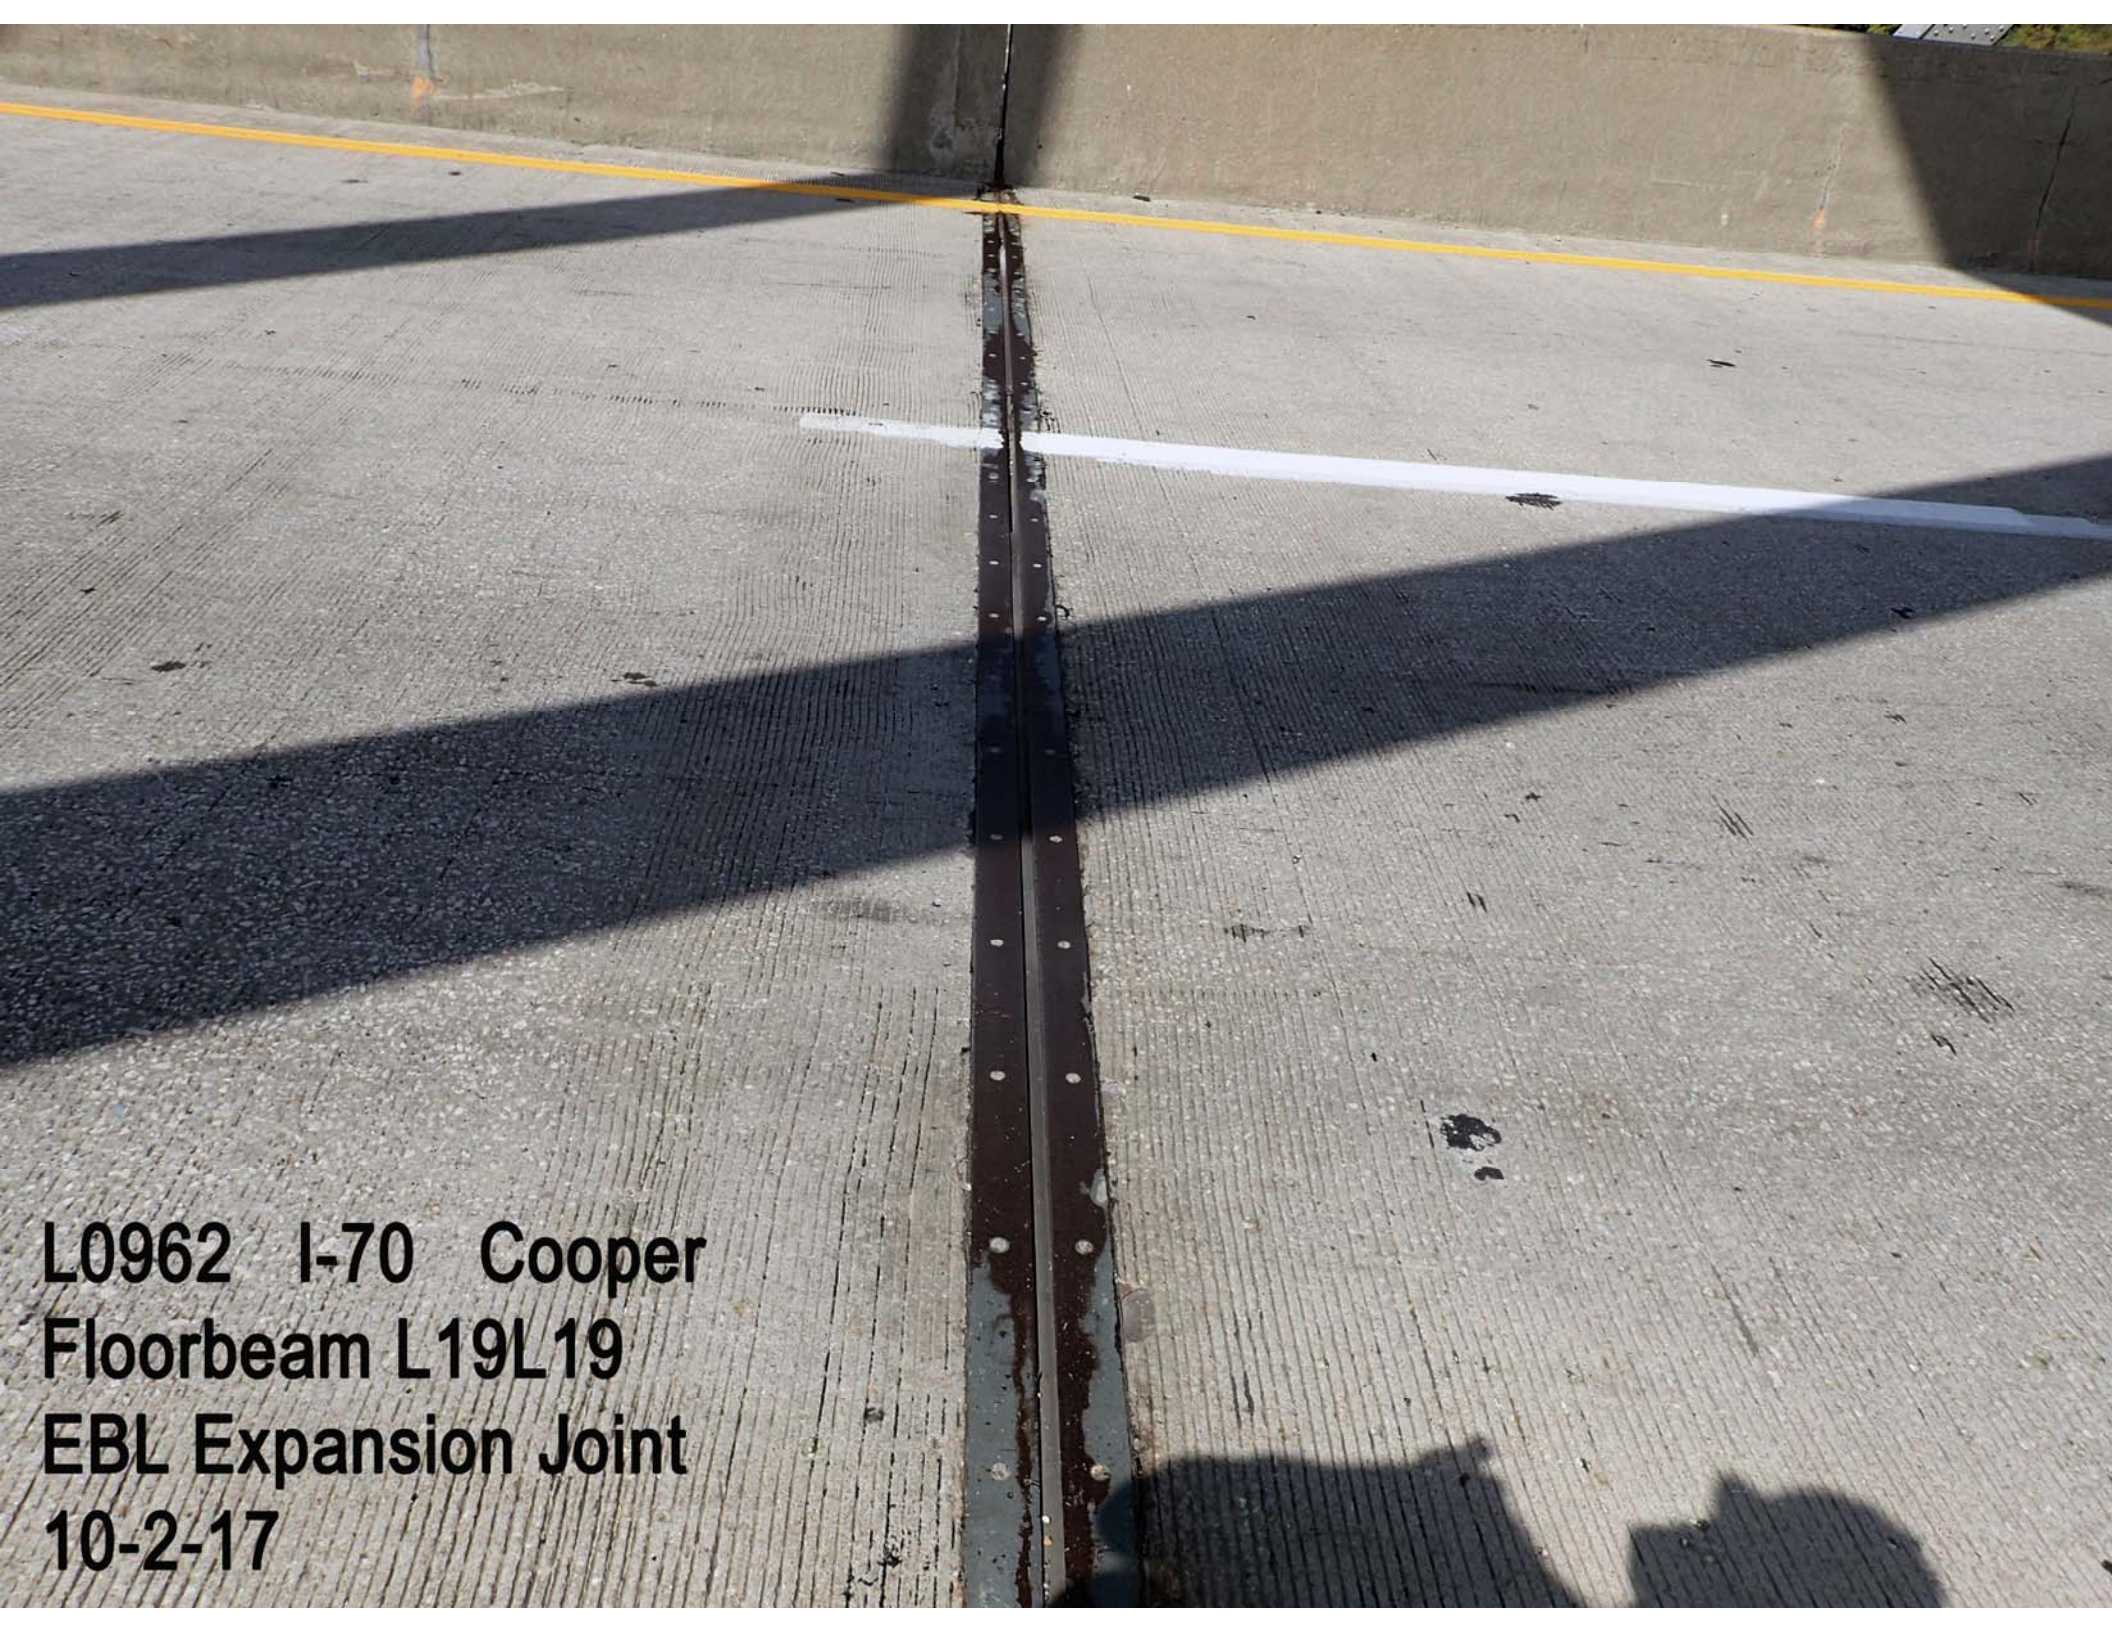
L0962 I-70 Cooper
Floorbeam L19L19
EBL Expansion Joint
10-2-17

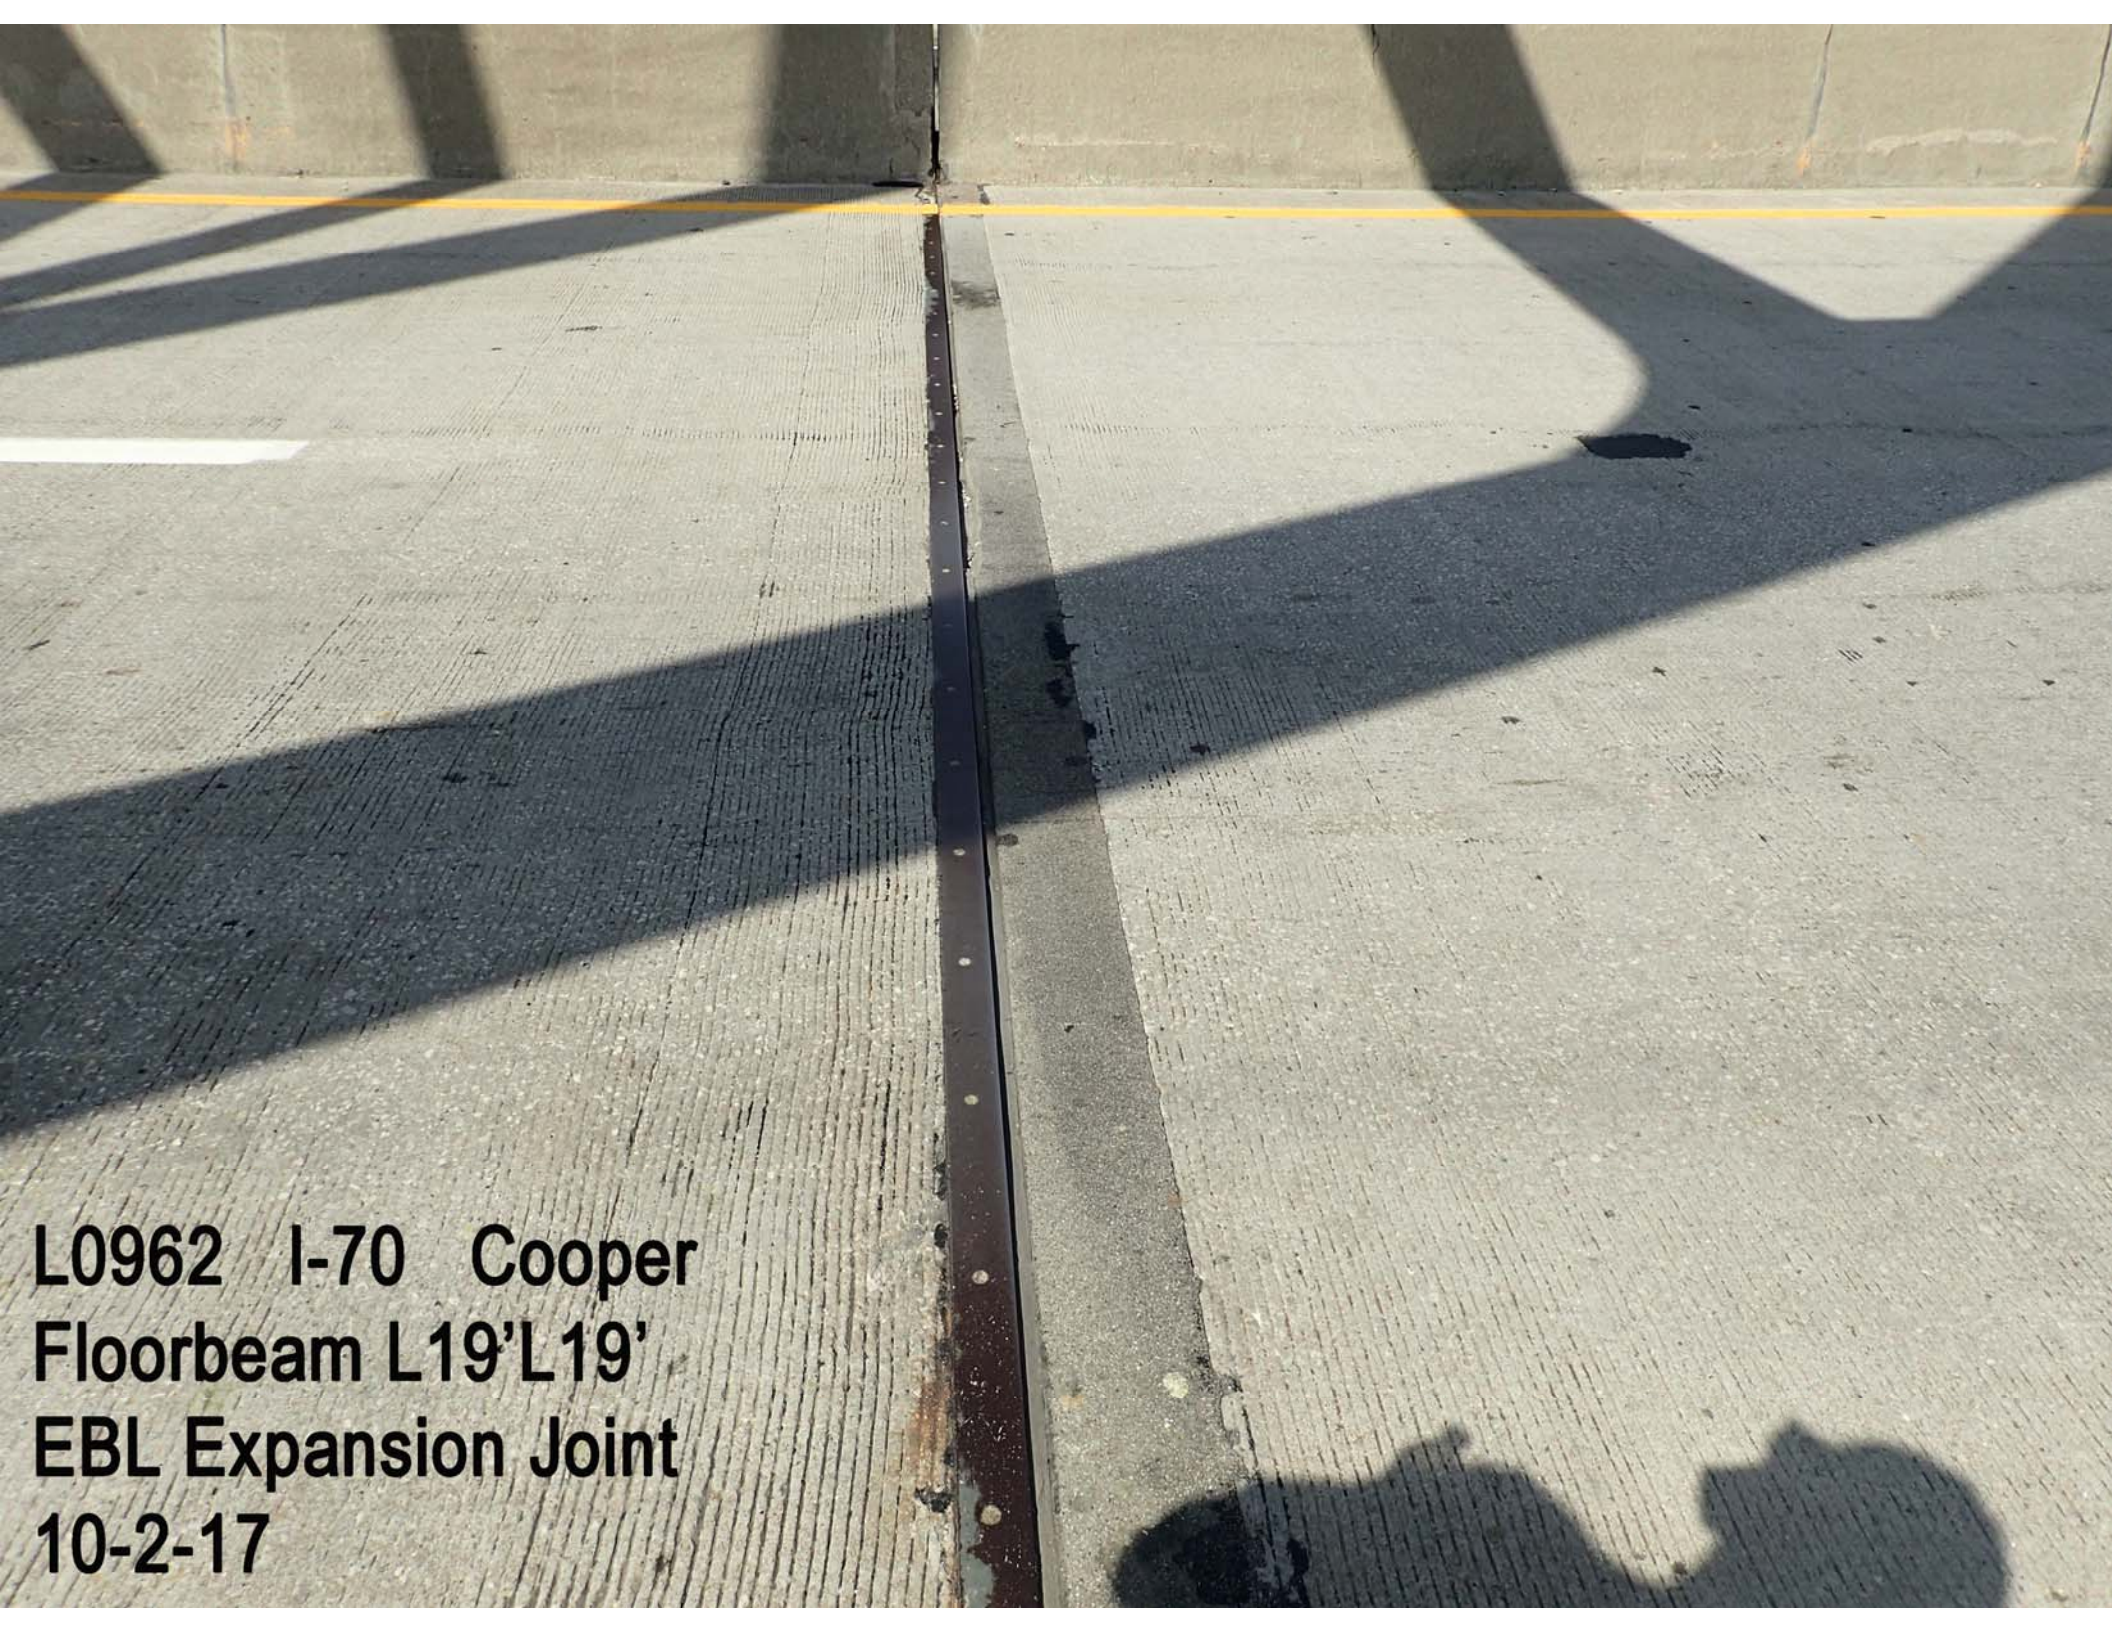
**L0962 I-70 Cooper
Floorbeam L19'L19'
EBL Expansion Joint
10-2-17**

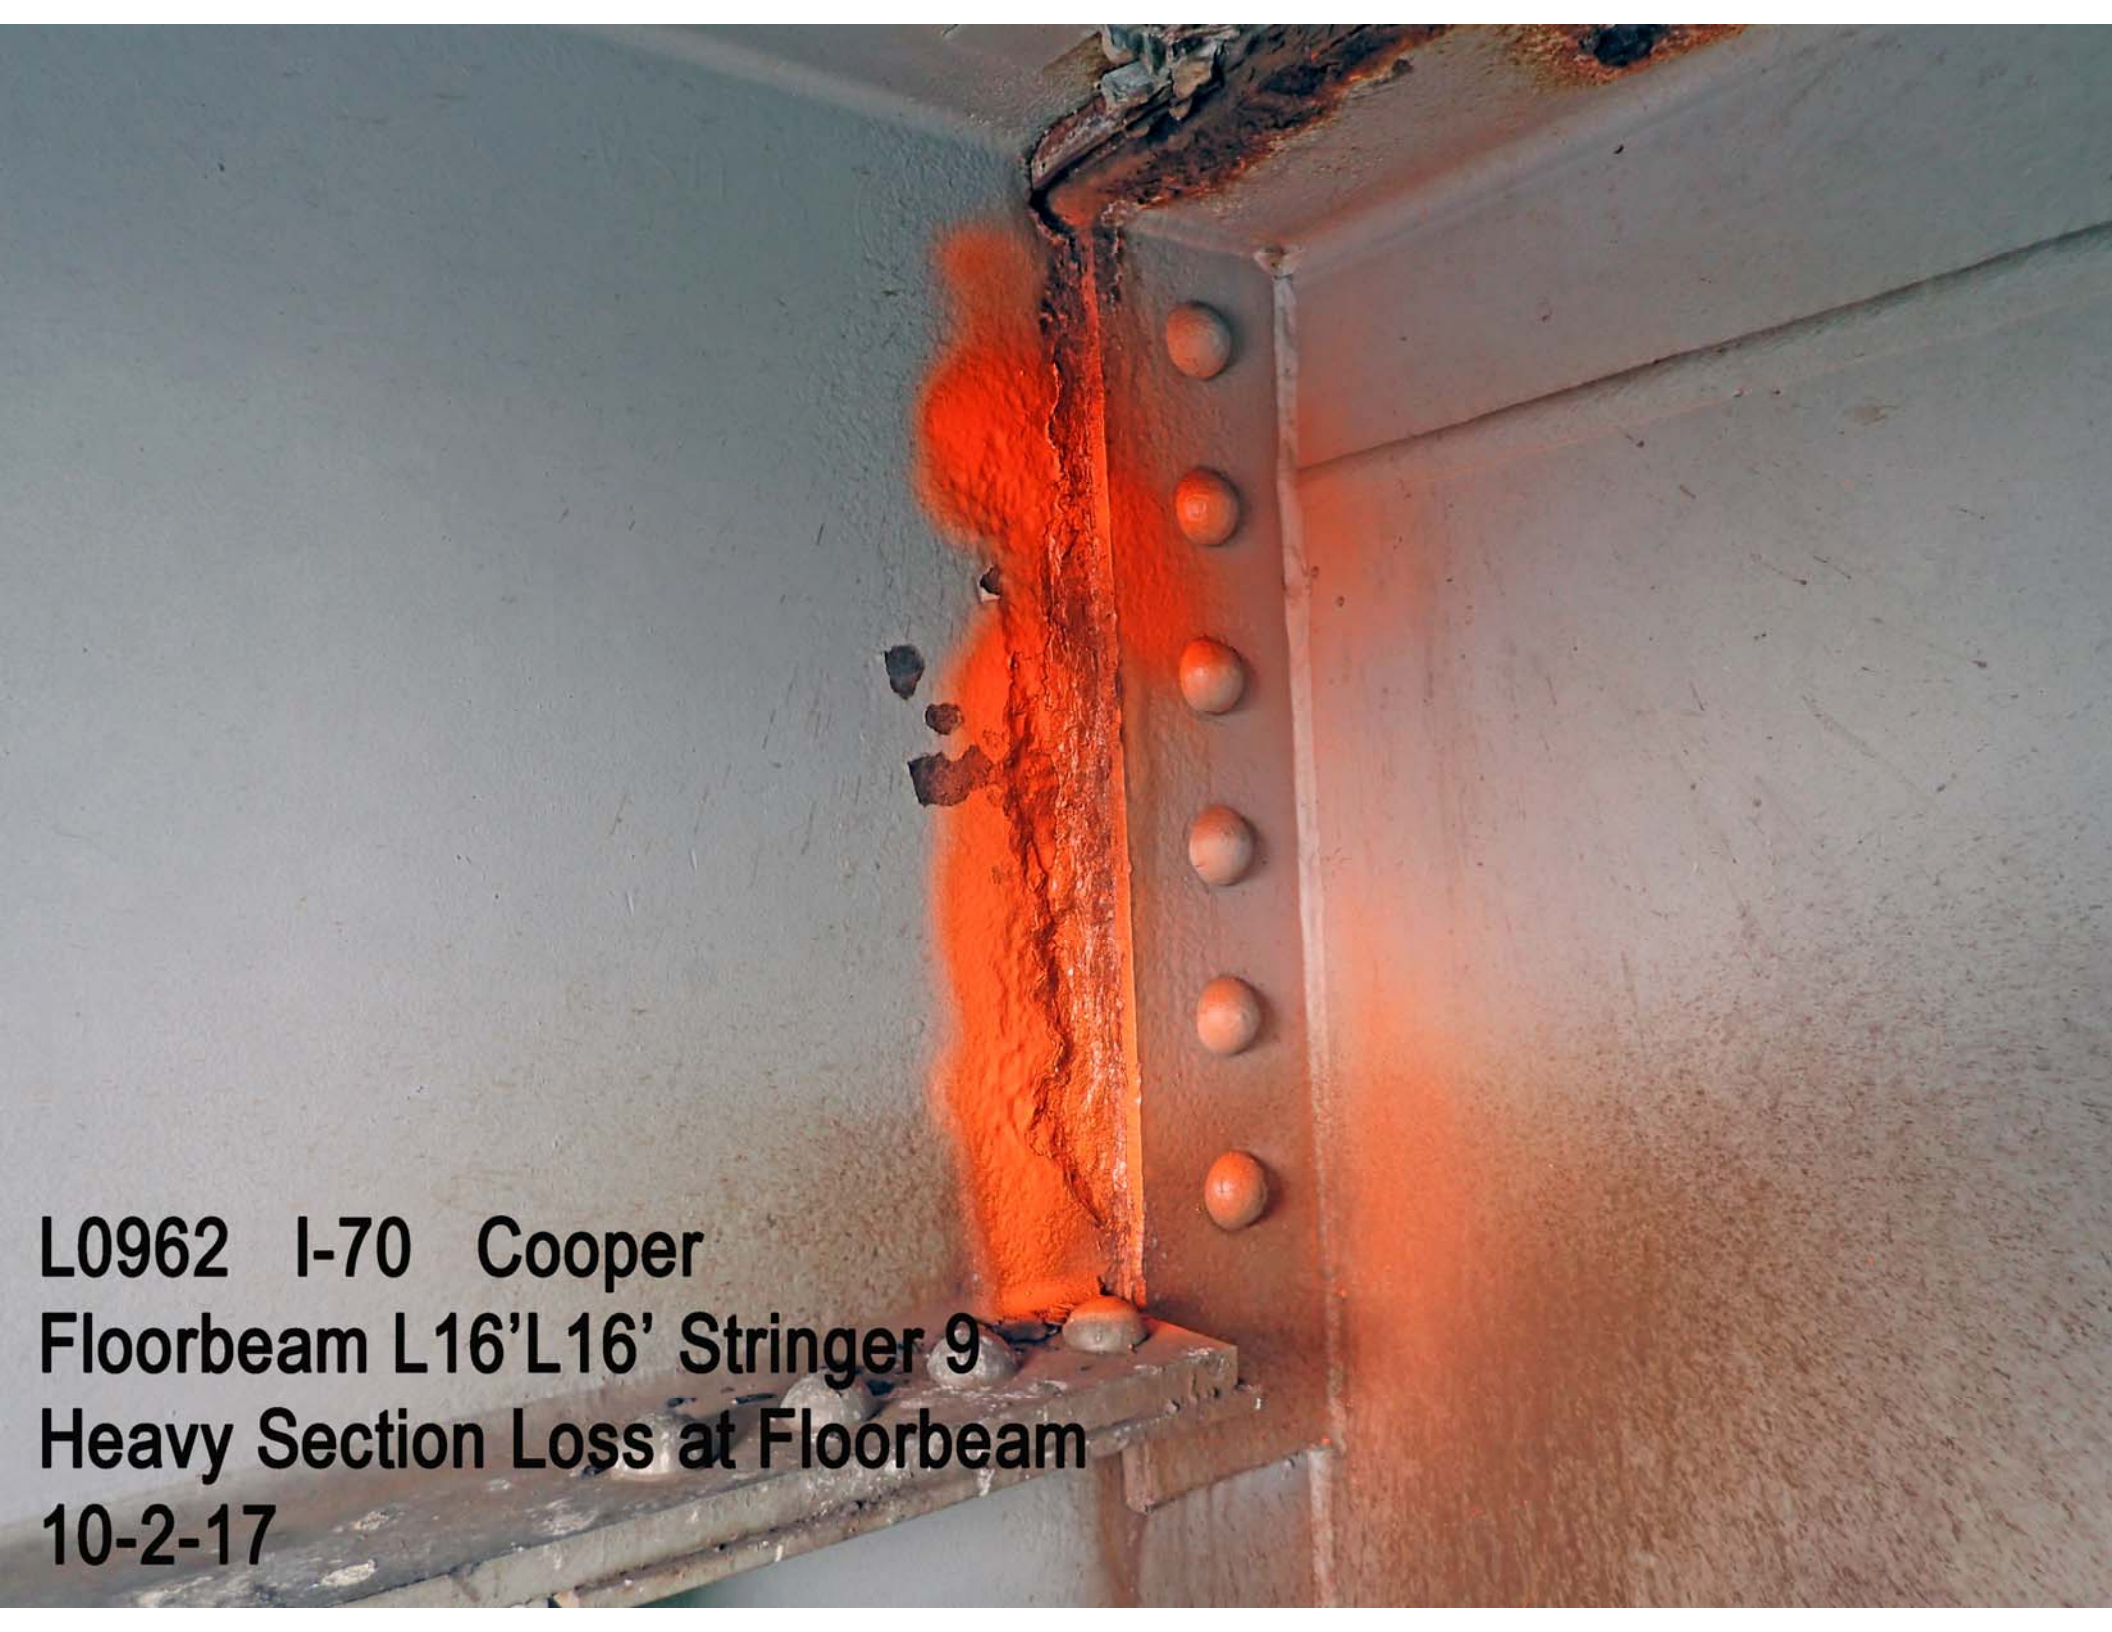
L0962 I-70 Cooper
Floorbeam L16'L16' Stringer 9
Heavy Section Loss at Floorbeam
10-2-17

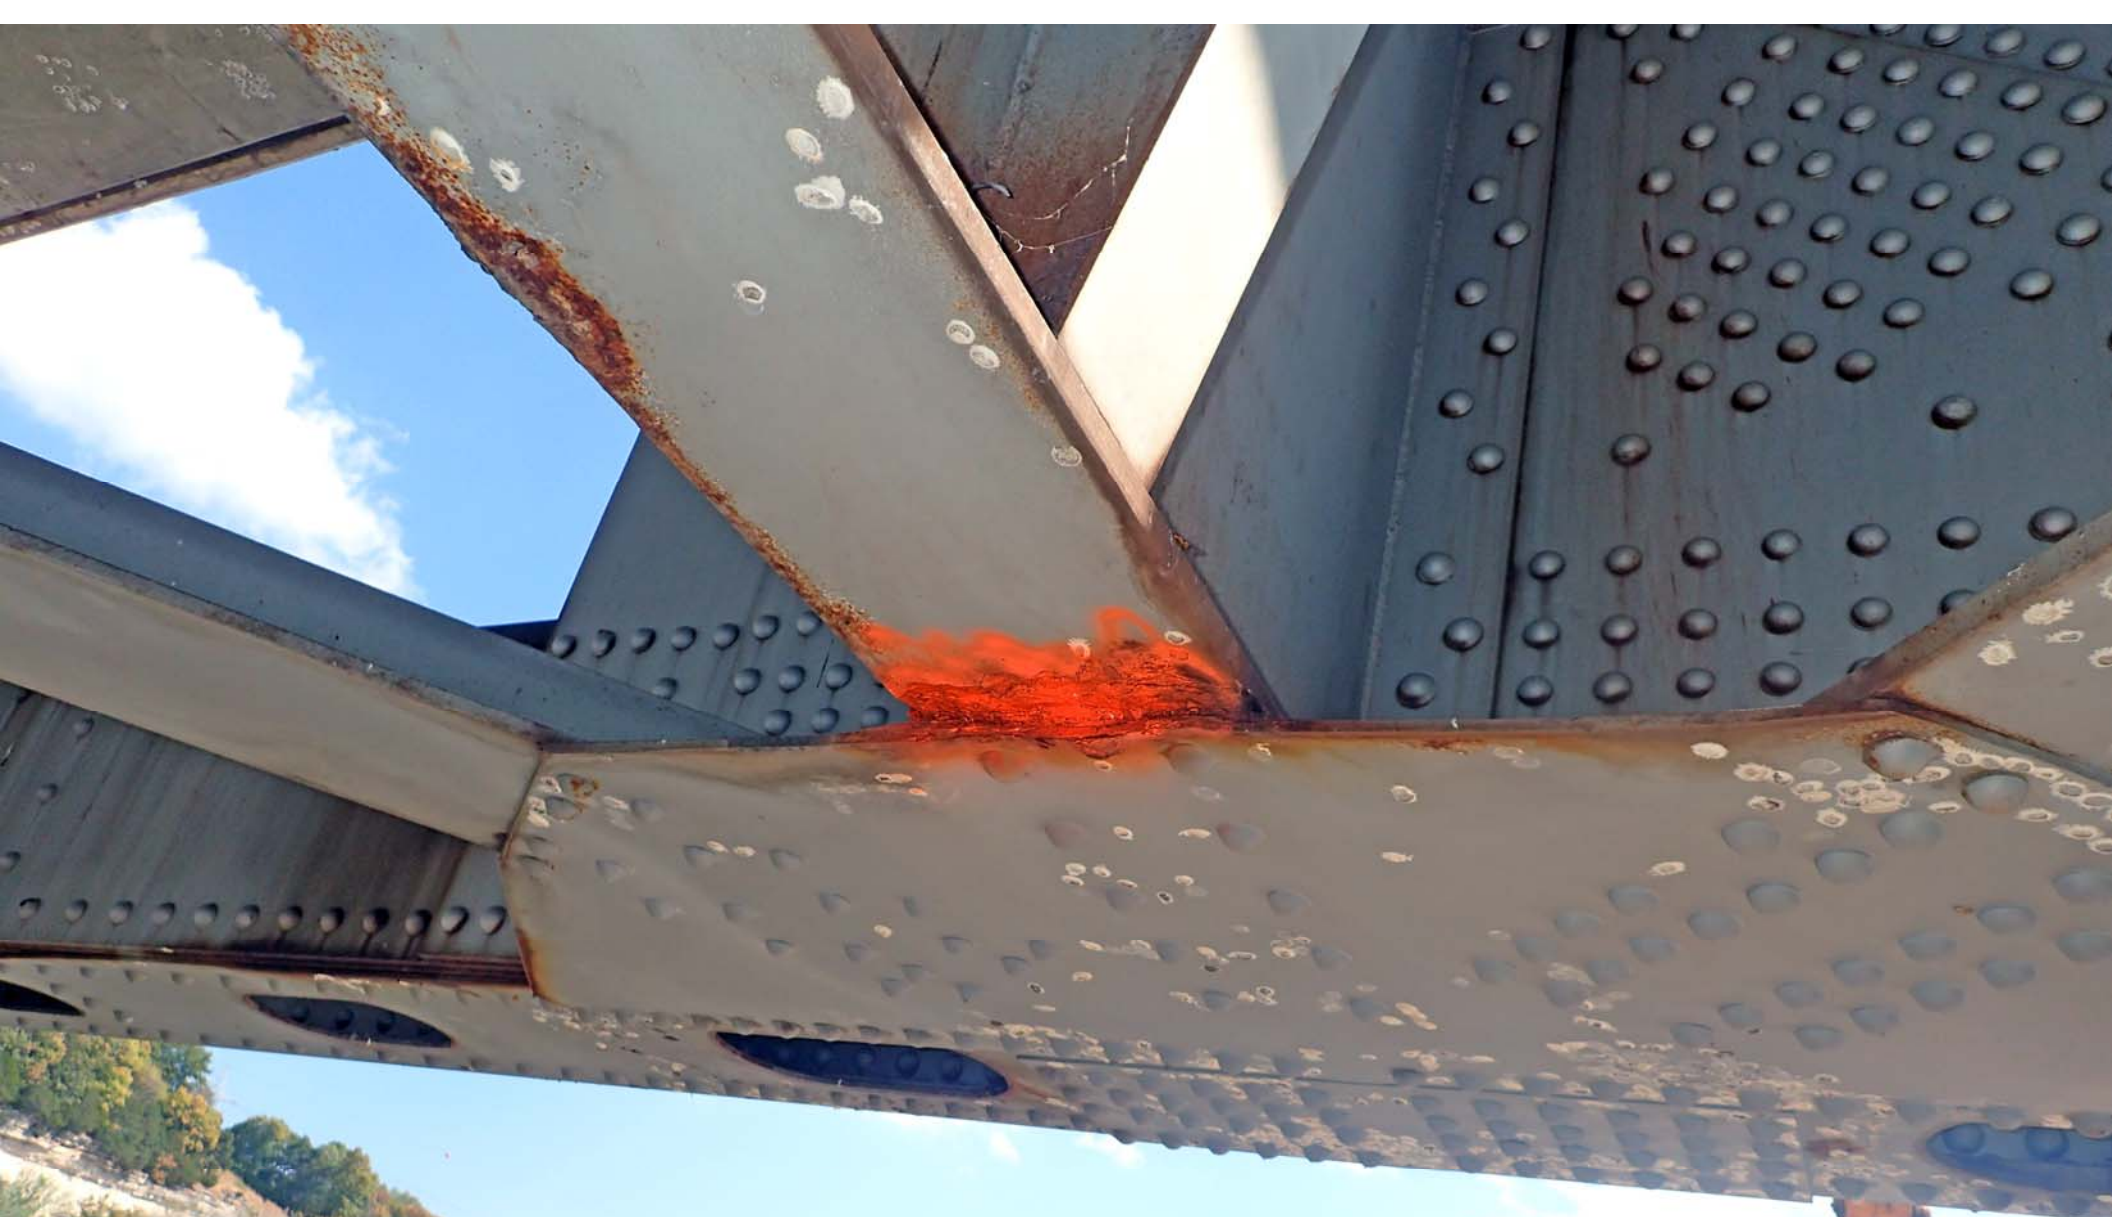
L0962 I-70 Cooper
Floorbeam L16'L16' East End
Bottom Flange Heavy Section Loss
10-2-17

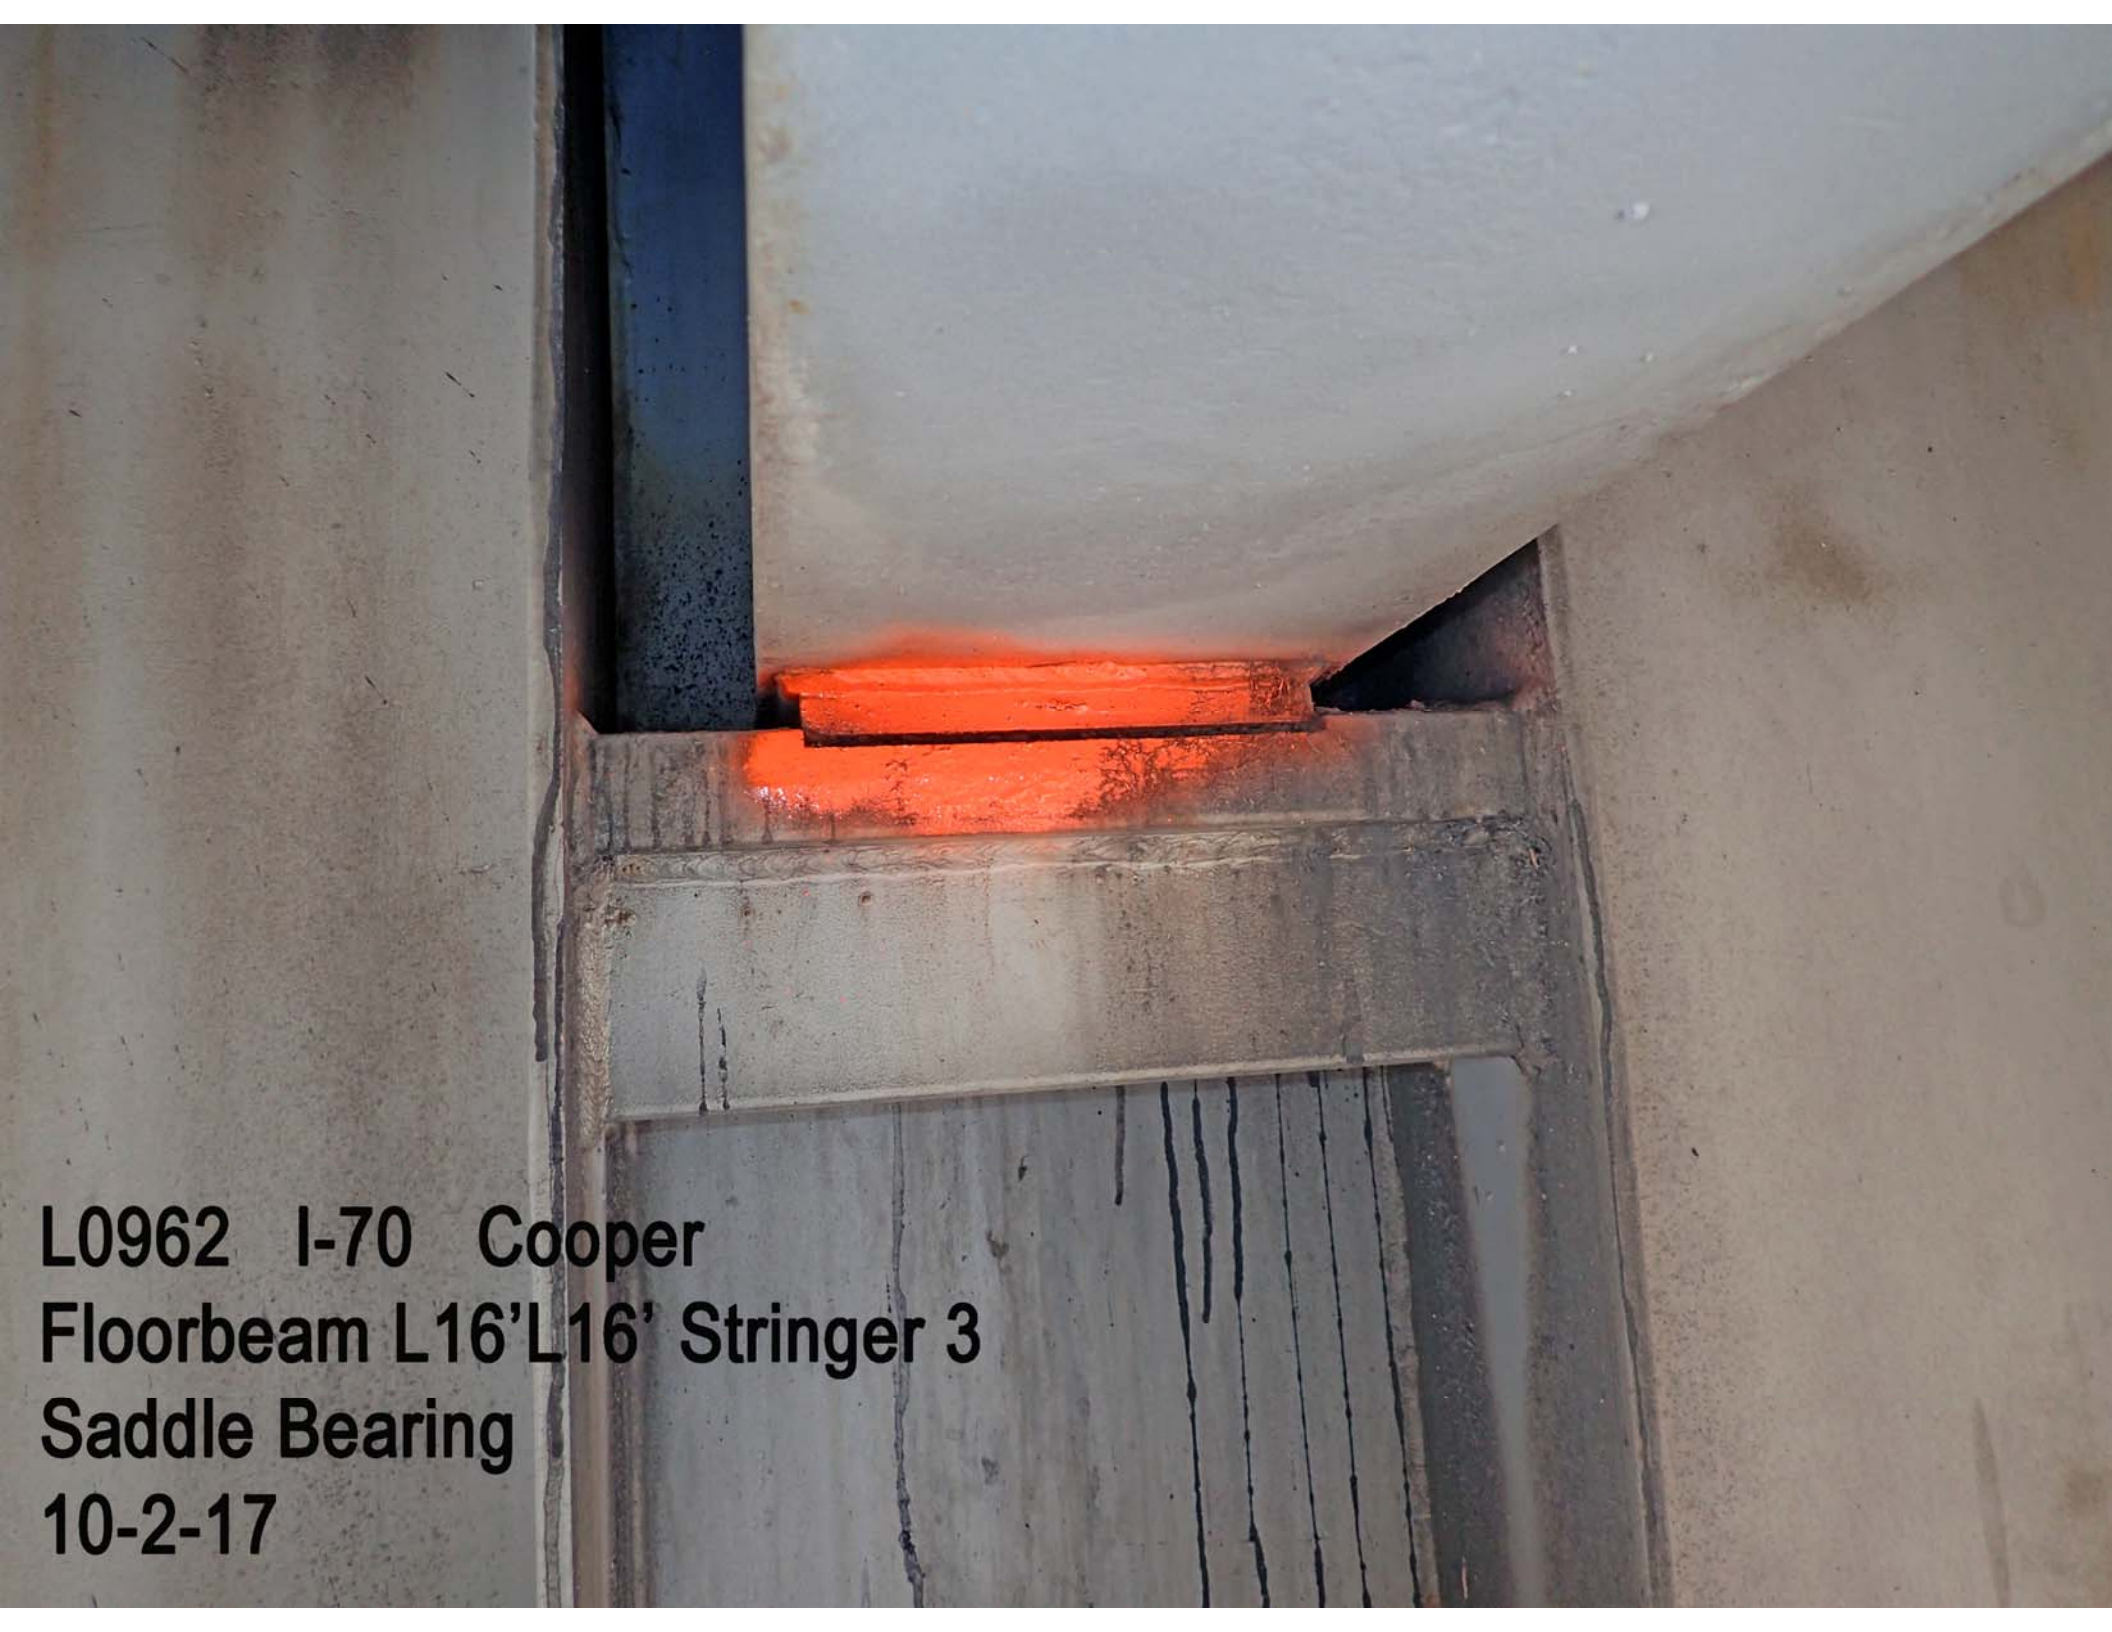
L0962 I-70 Cooper
Floorbeam L16'L16' Stringer 3
Saddle Bearing
10-2-17

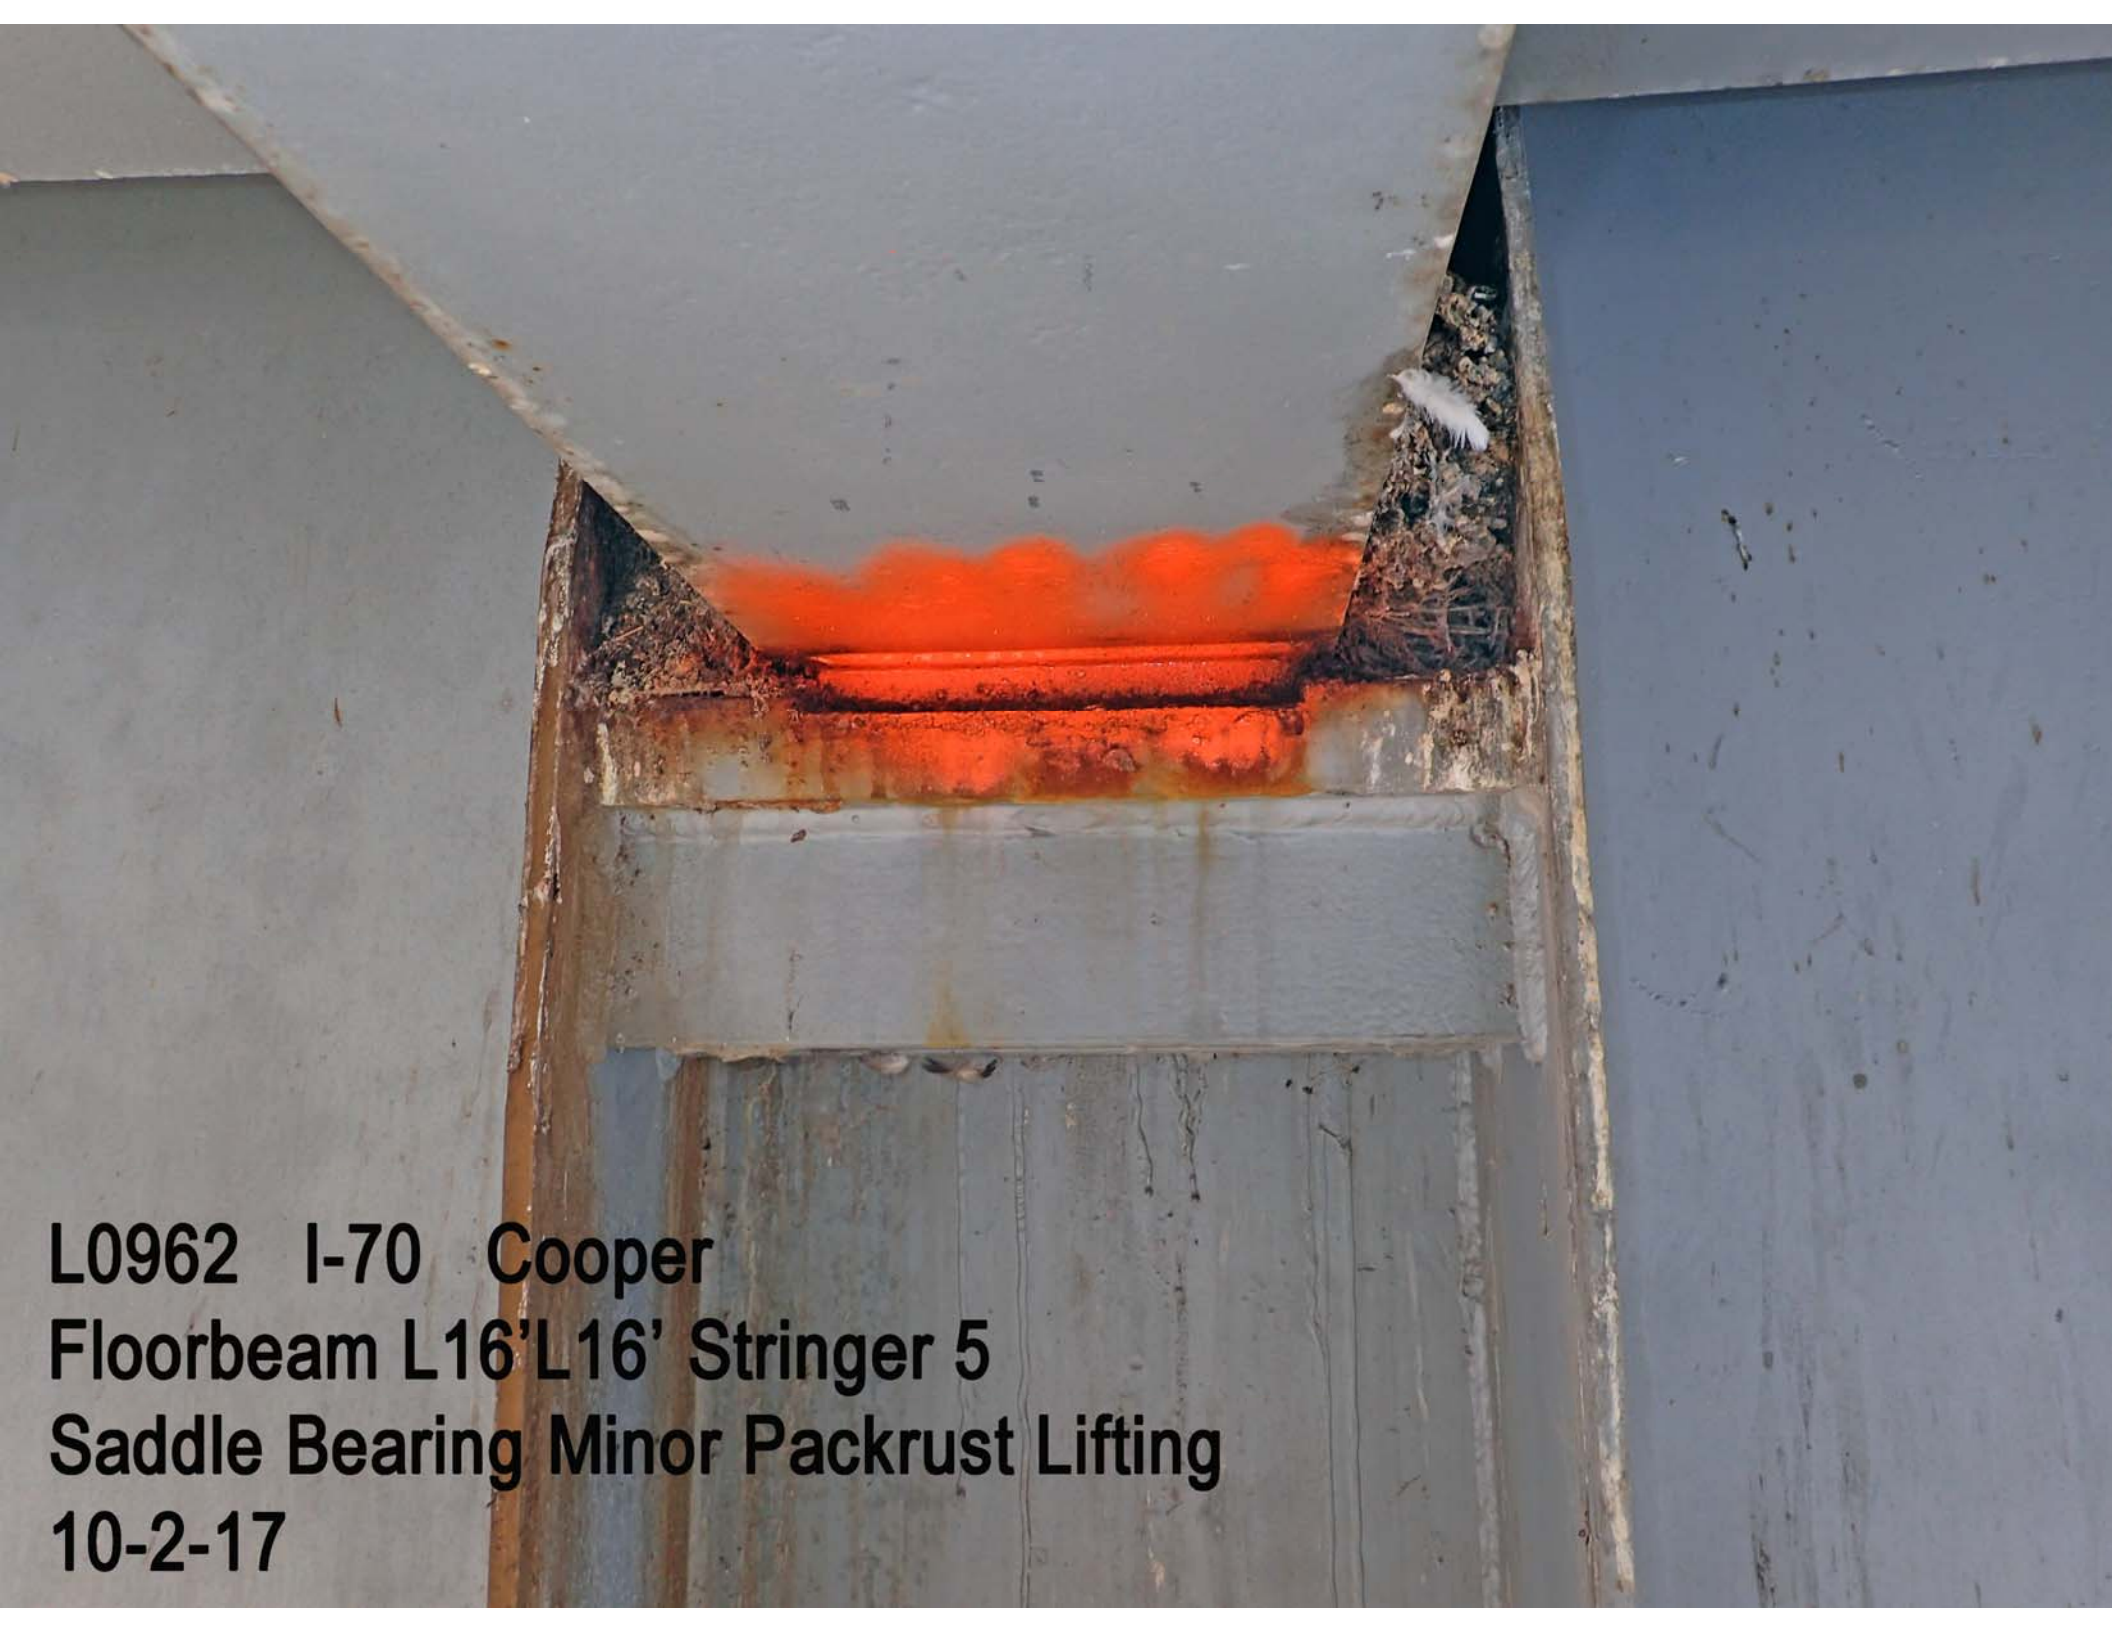
**L0962 I-70 Cooper
Floorbeam L16'L16' Stringer 5
Saddle Bearing Minor Packrust Lifting
10-2-17**

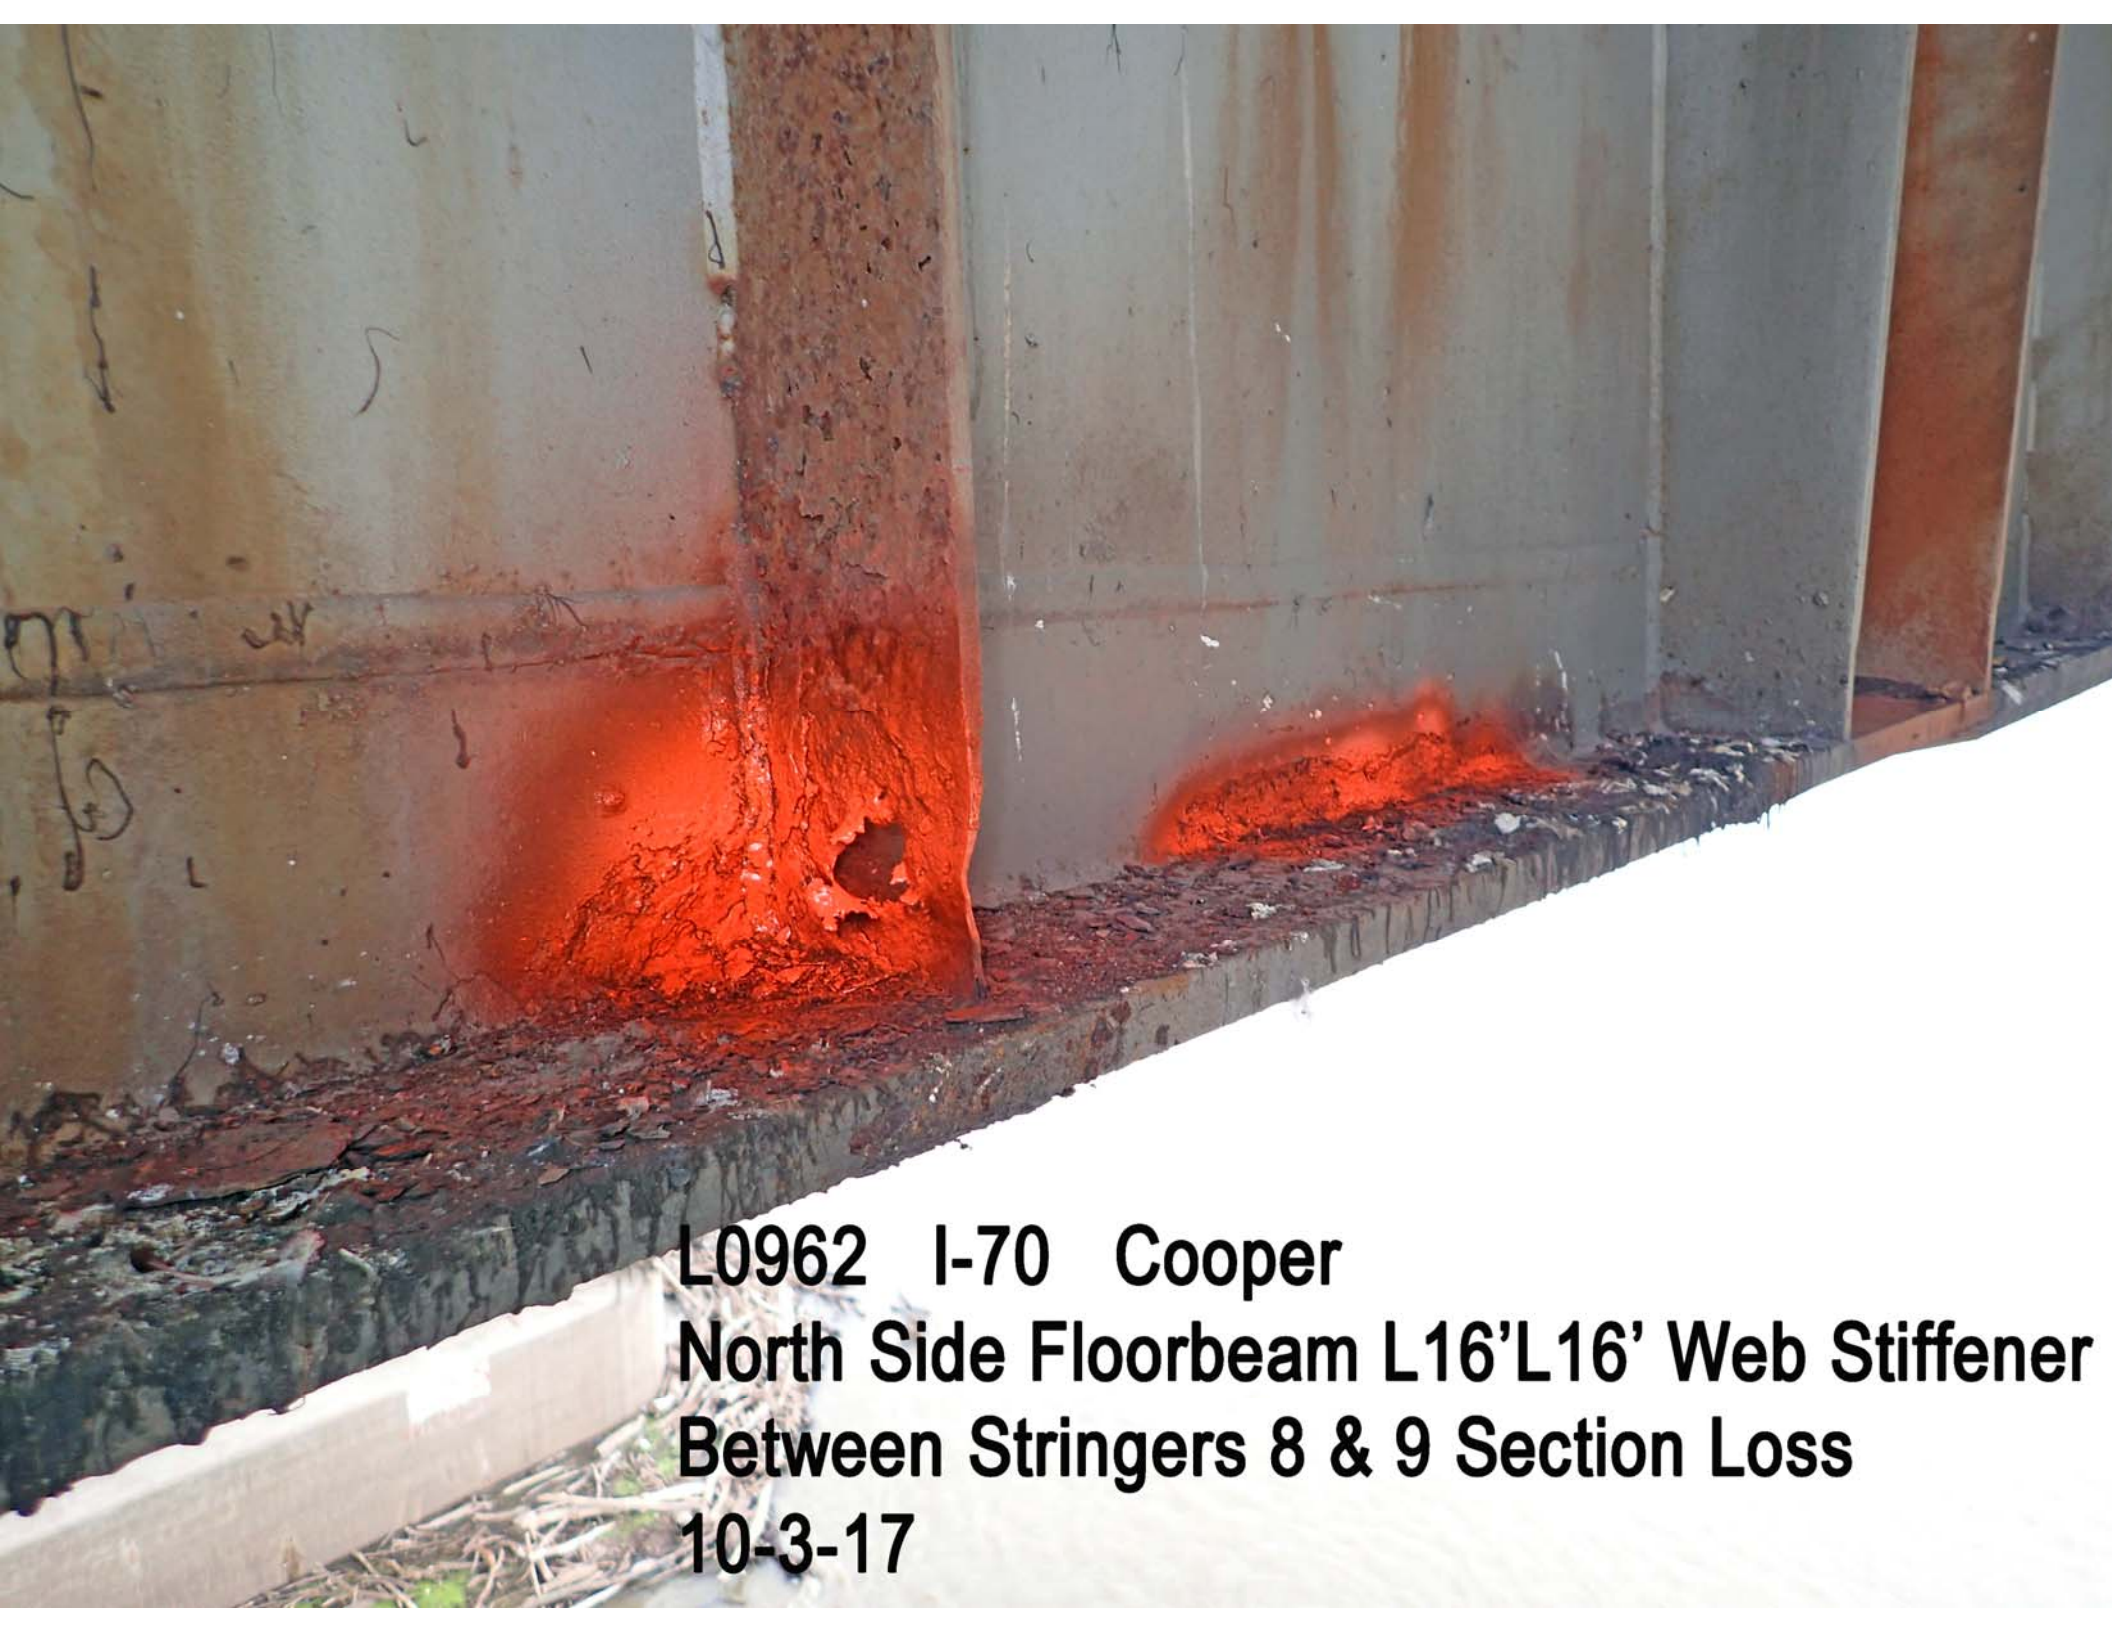
**L0962 I-70 Cooper
North Side Floorbeam L16'L16' Web Stiffener
Between Stringers 8 & 9 Section Loss
10-3-17**
