L0962 Cooper Co.
08/28/2017
Looking West

L0962 I-70 Cooper
Pier 15 Open Expansion Joint WBL
8-28-17

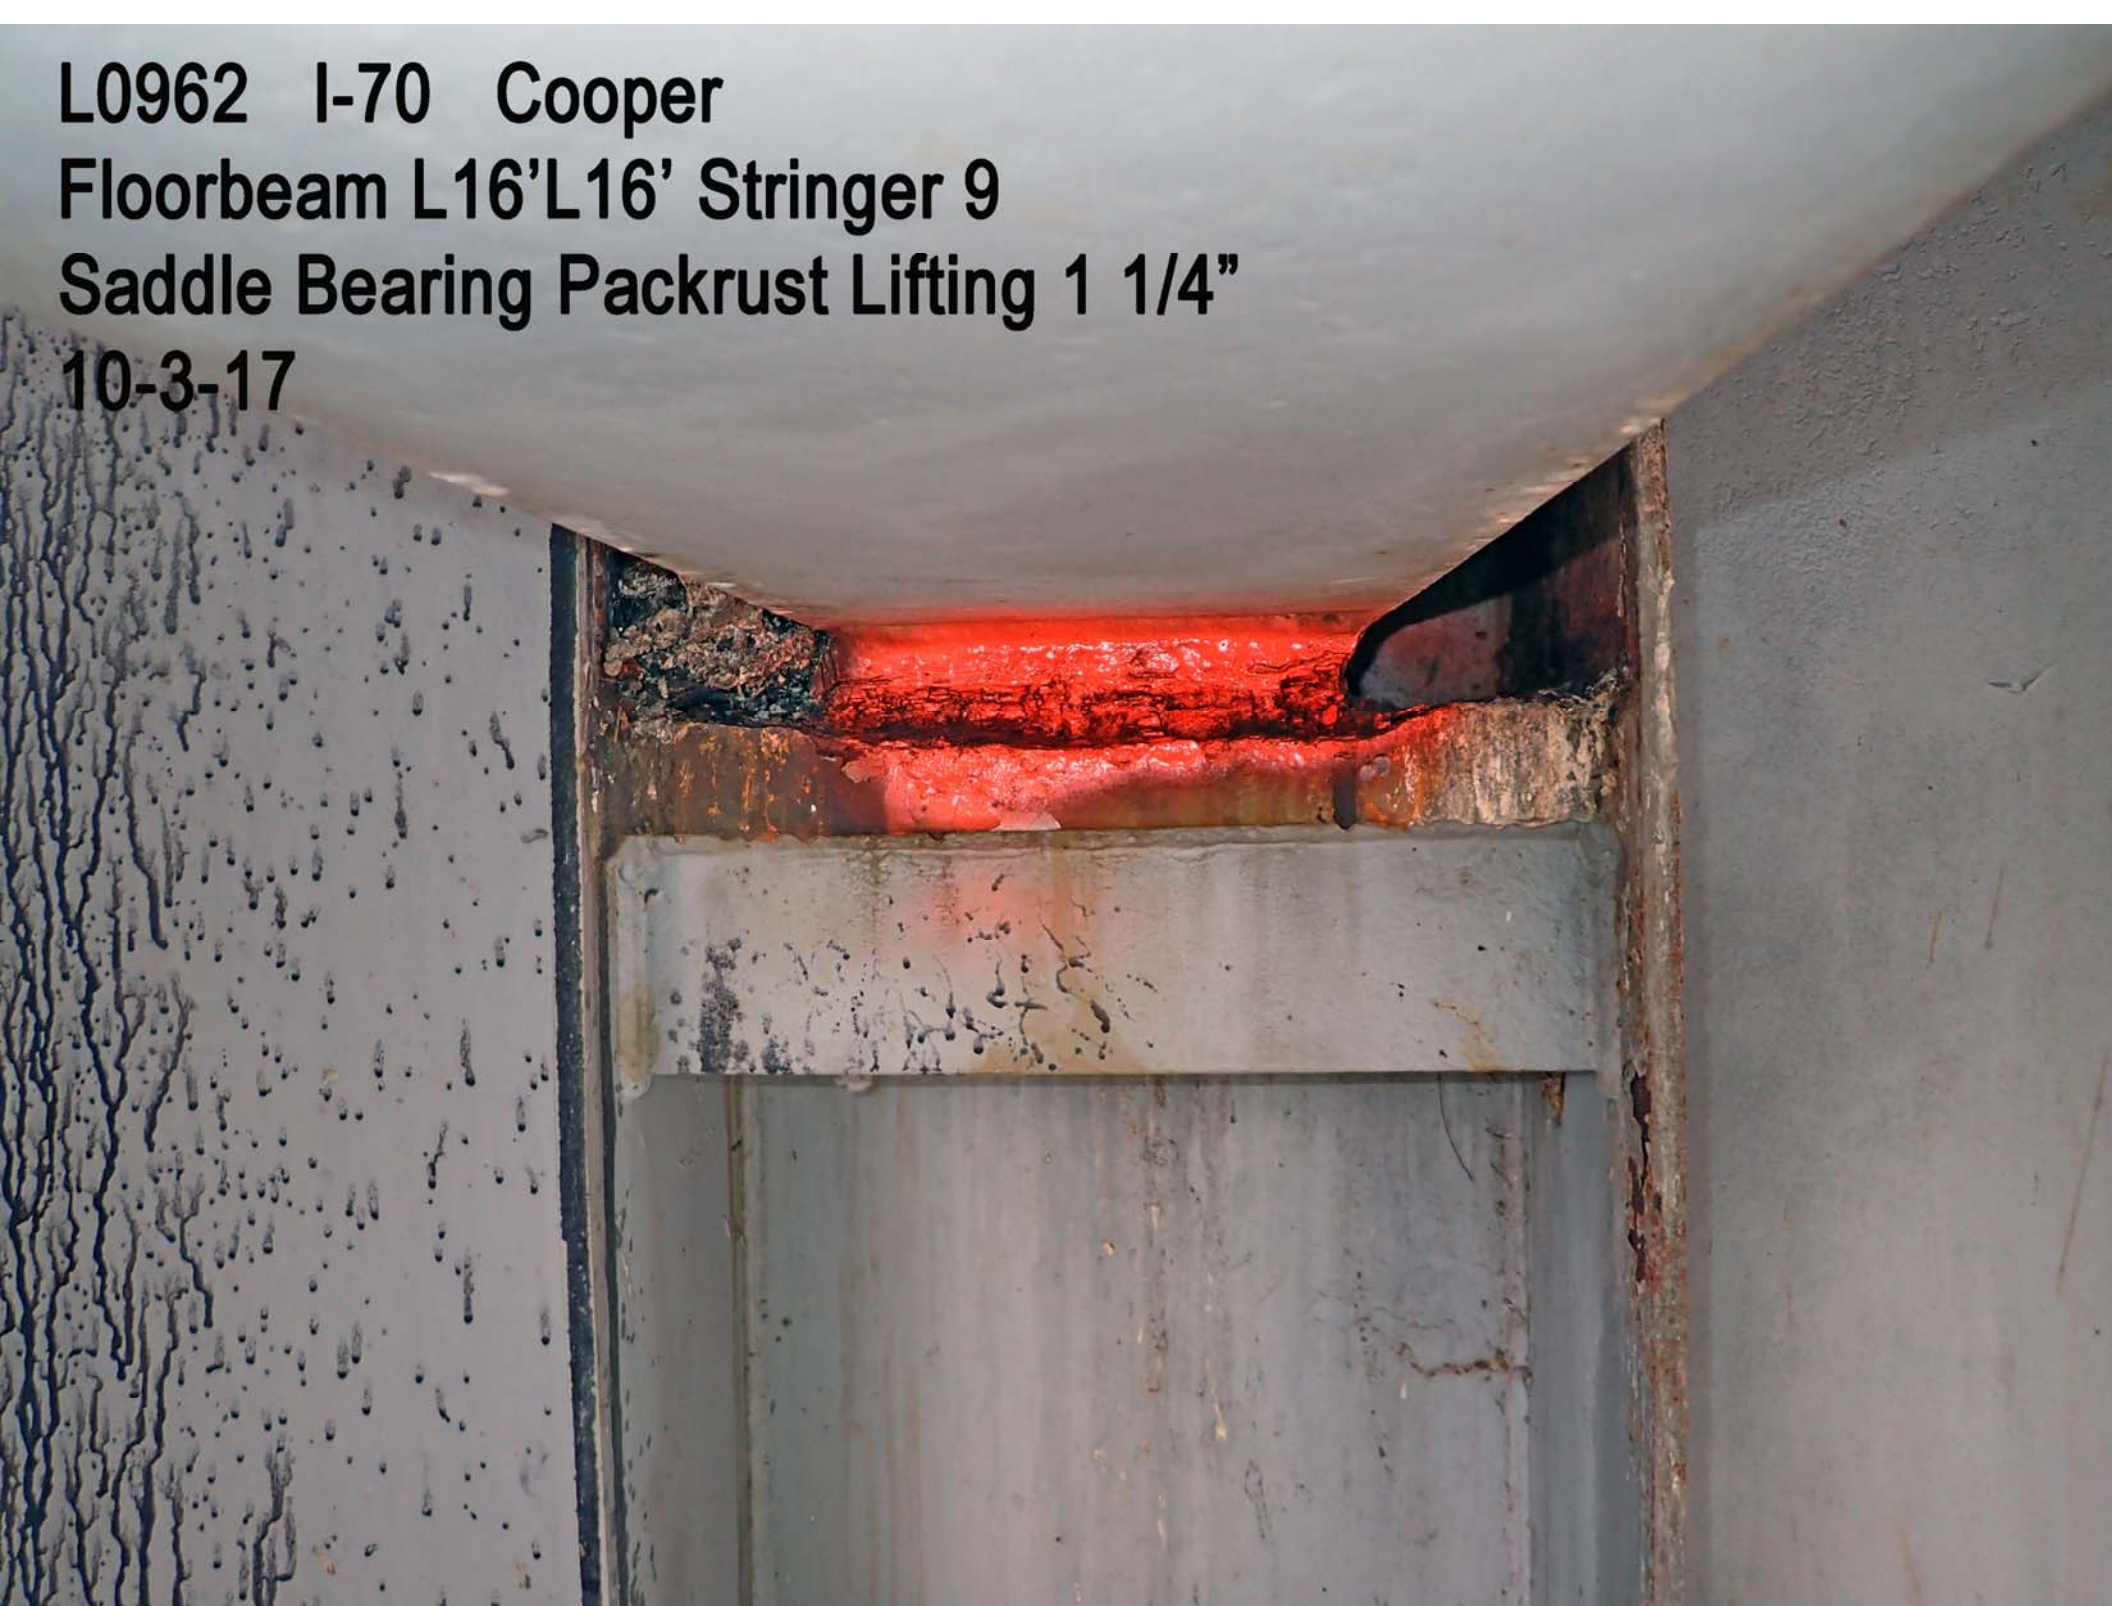
L0962 I-70 Cooper
East Truss Outside Lower Gusset Plate
L16' Heavy Section Loss (50%)
10-3-17

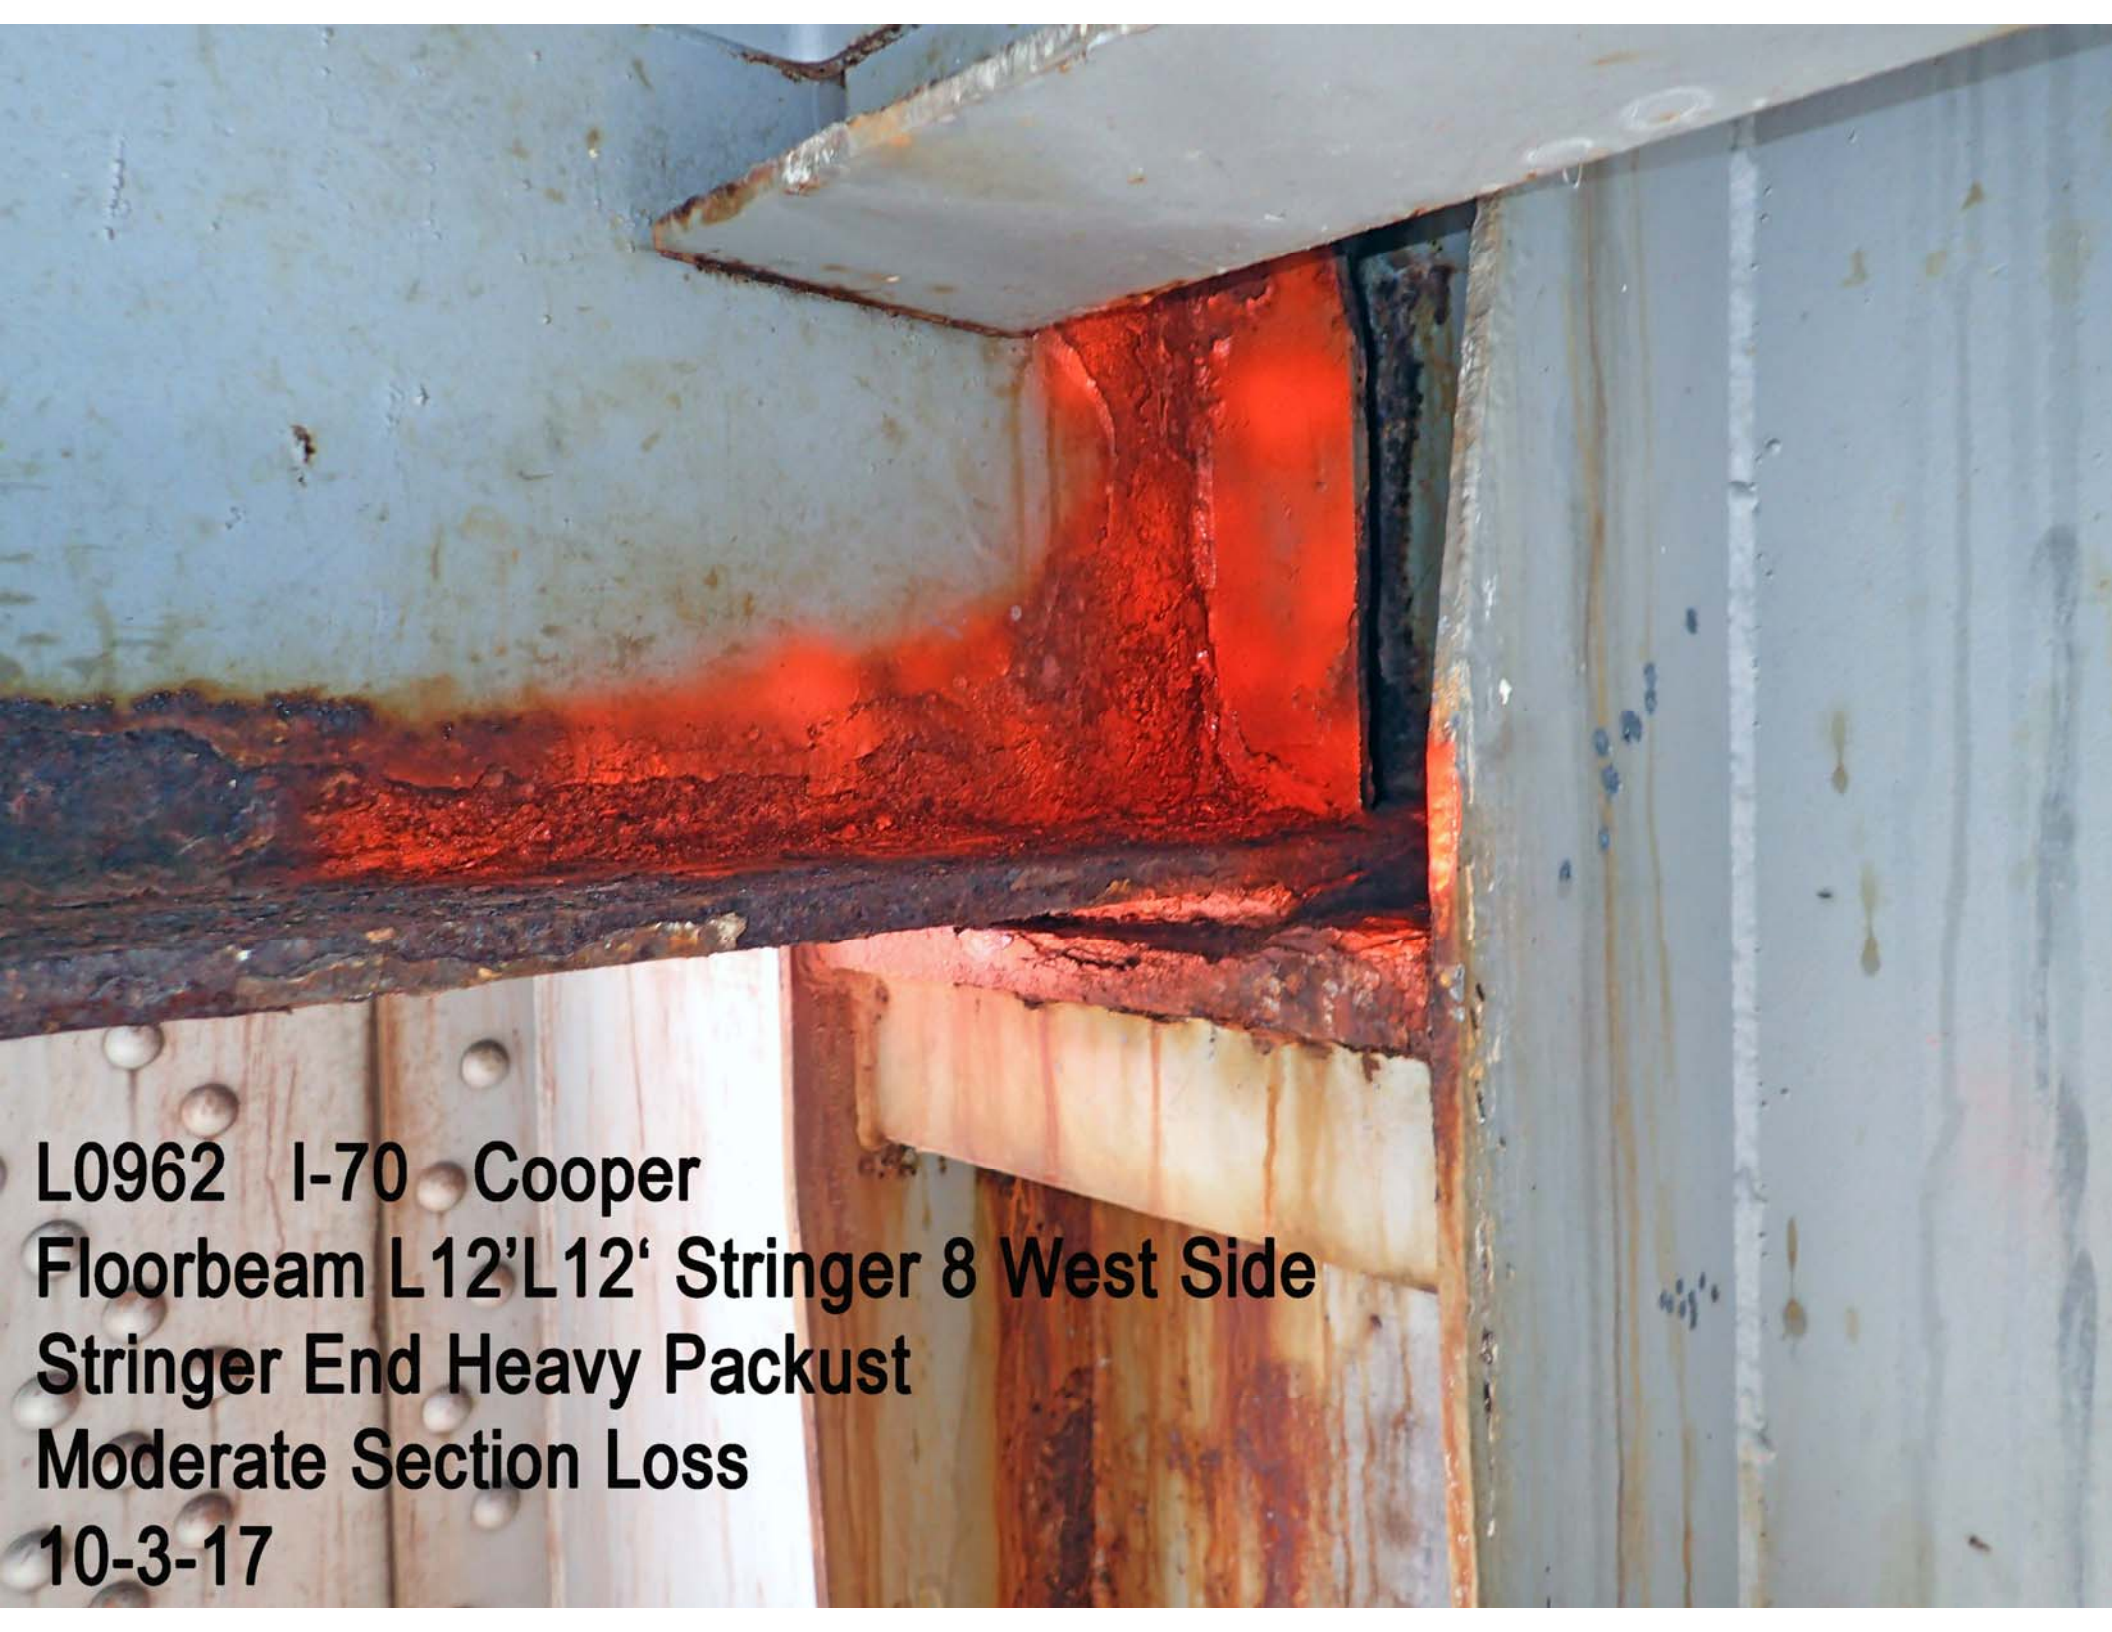
**L0962 I-70 Cooper
Floorbeam L12'L12' Stringer 8 West Side
Stringer End Heavy Packust
Moderate Section Loss
10-3-17**

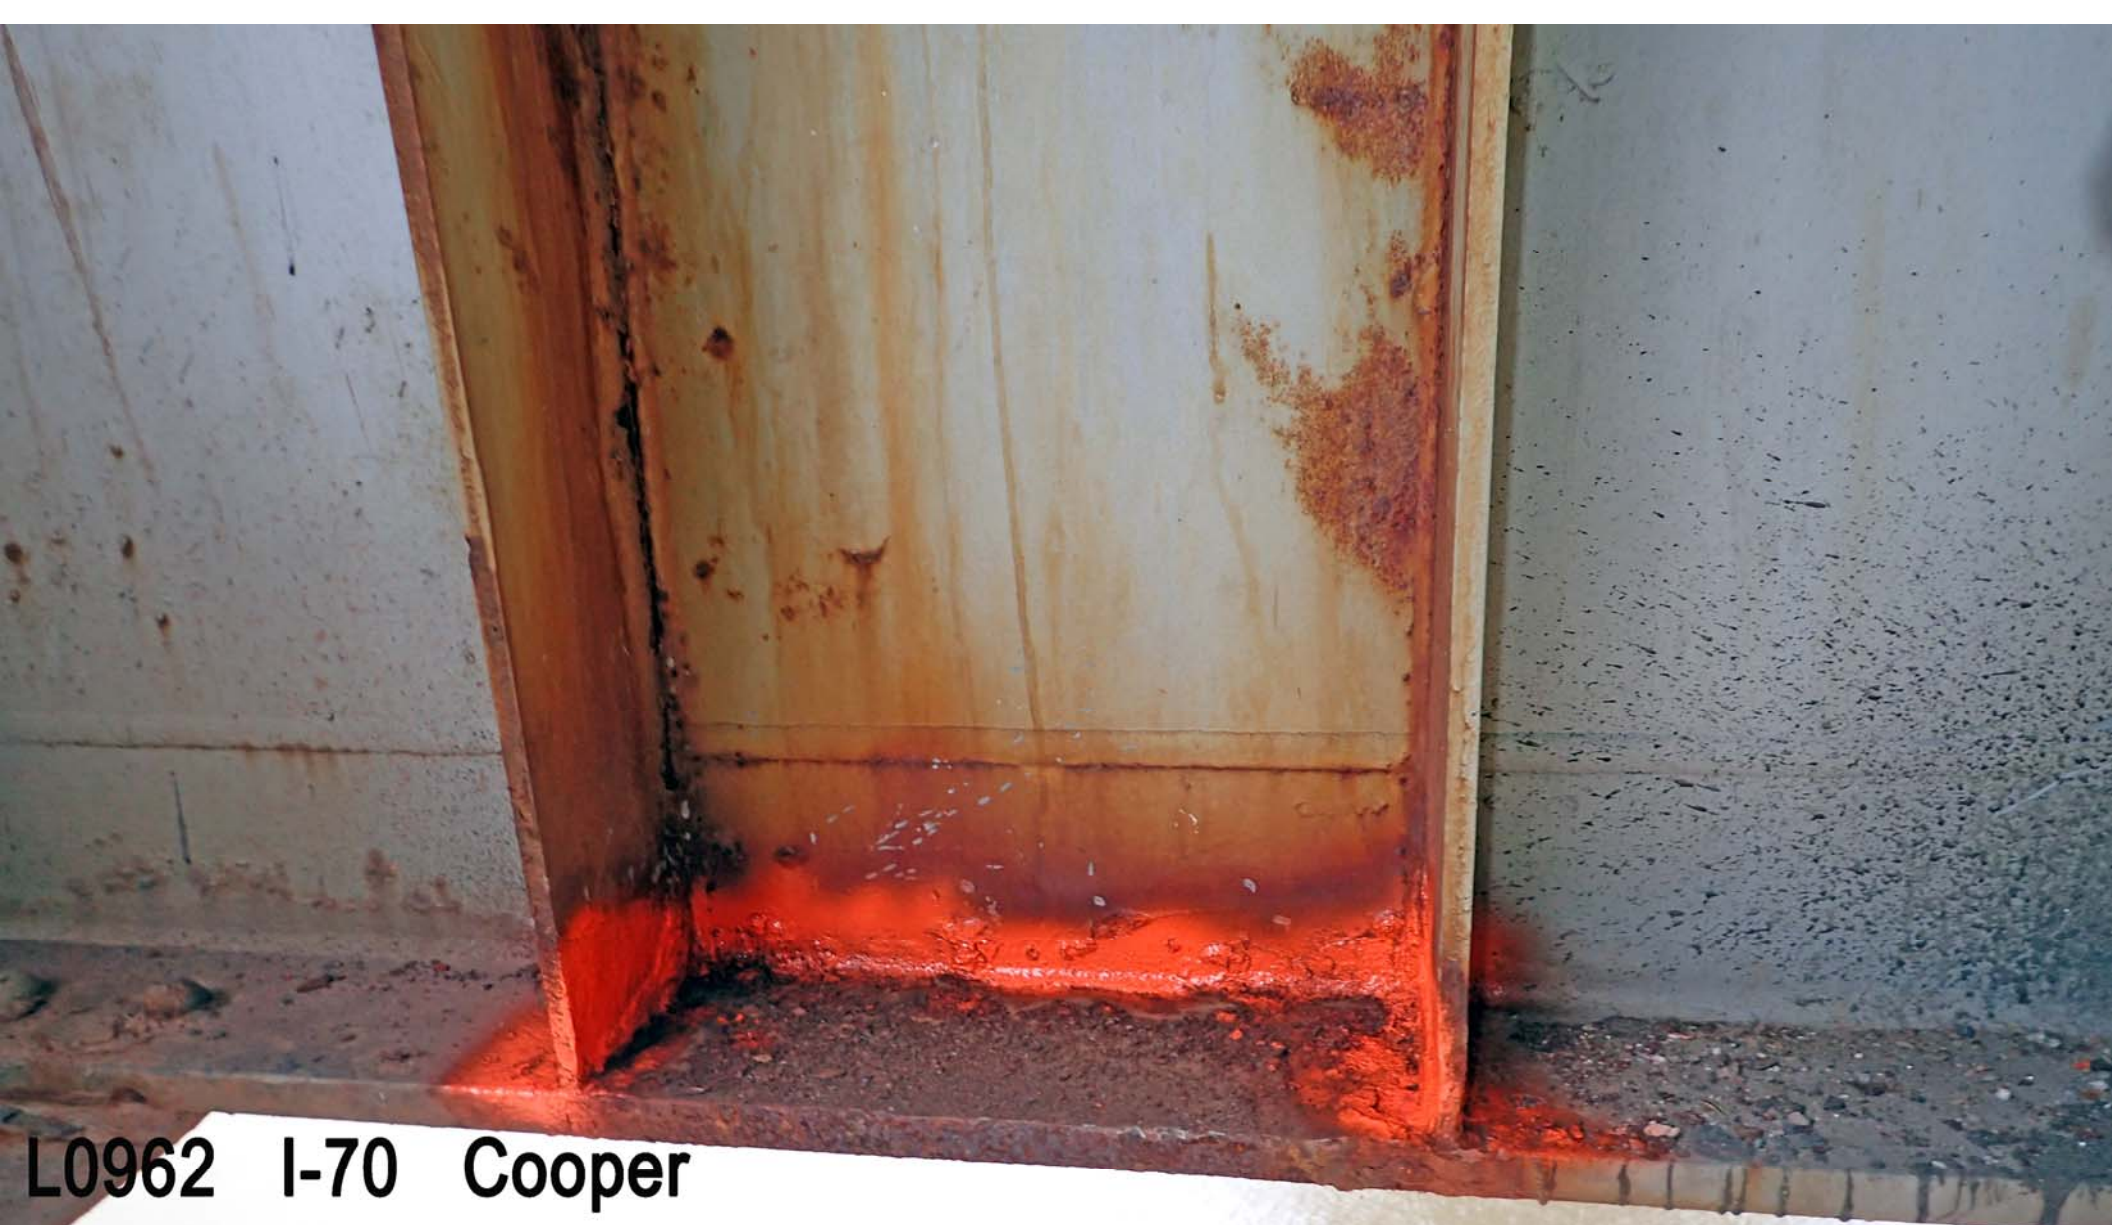
**L0962 I-70 Cooper
Floorbeam L12'L12' at Stringer 9 Bottom
Flange, Web, and Bottom of Bearing Supports
Moderate Section Loss
10-3-17**

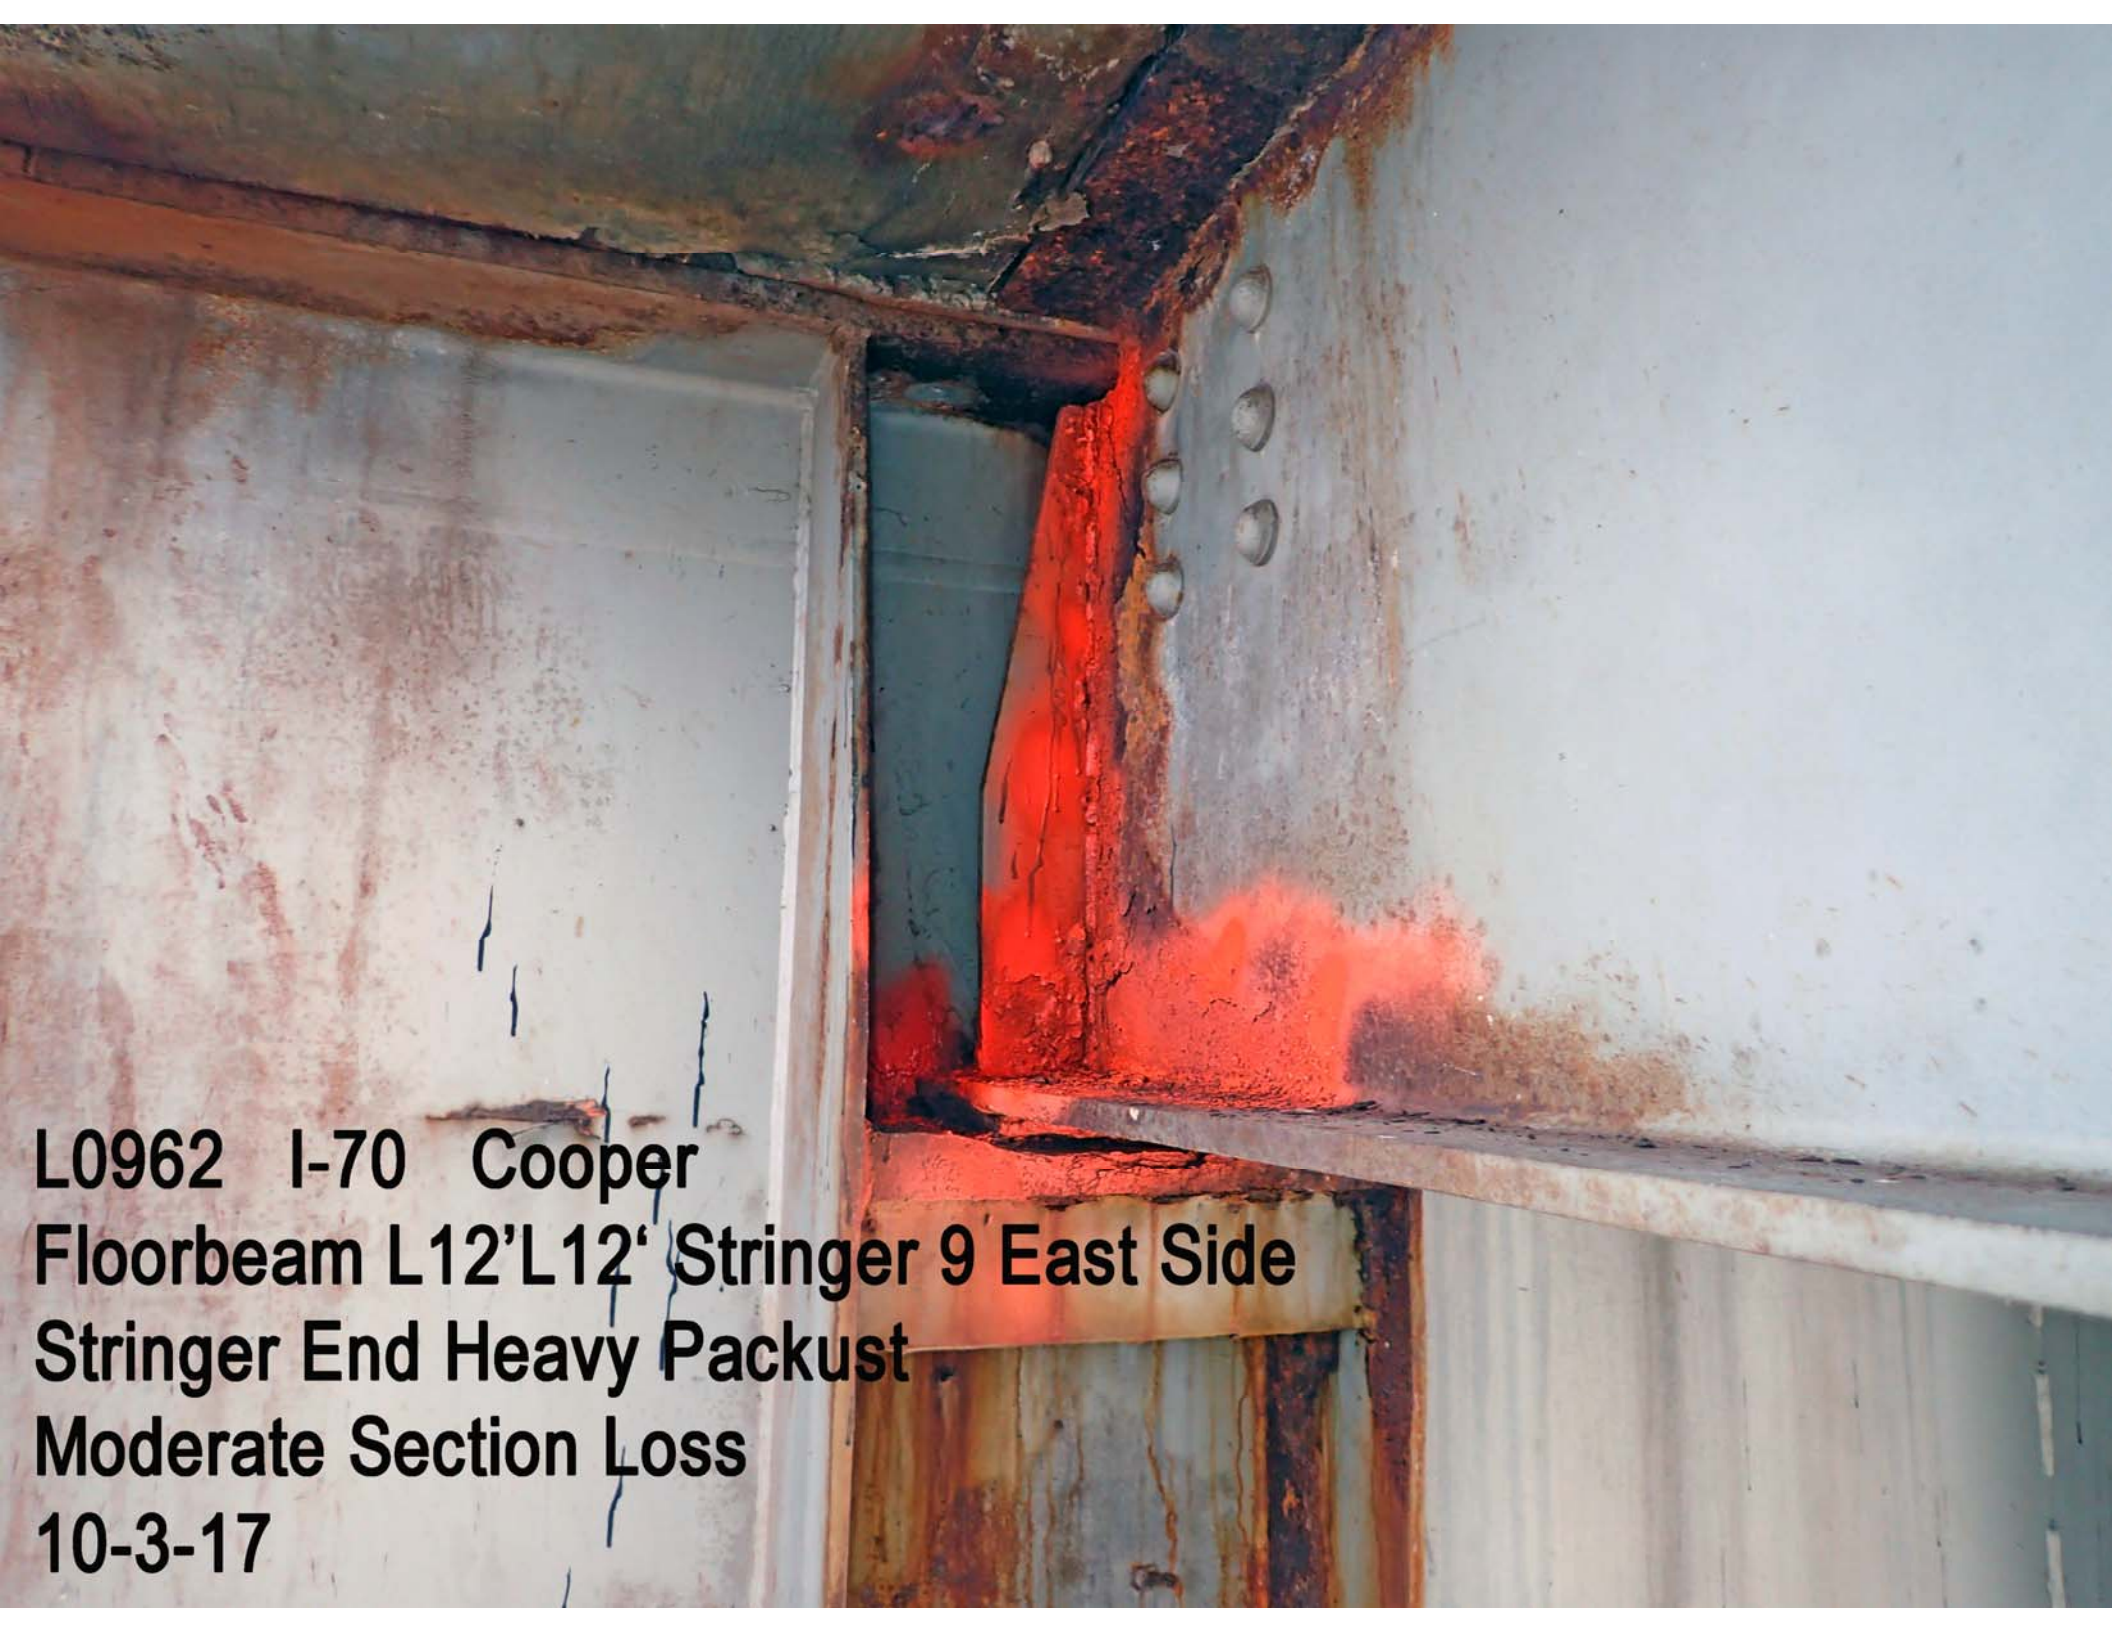
**L0962 I-70 Cooper
Floorbeam L12'L12' Stringer 9 East Side
Stringer End Heavy Packust
Moderate Section Loss
10-3-17**

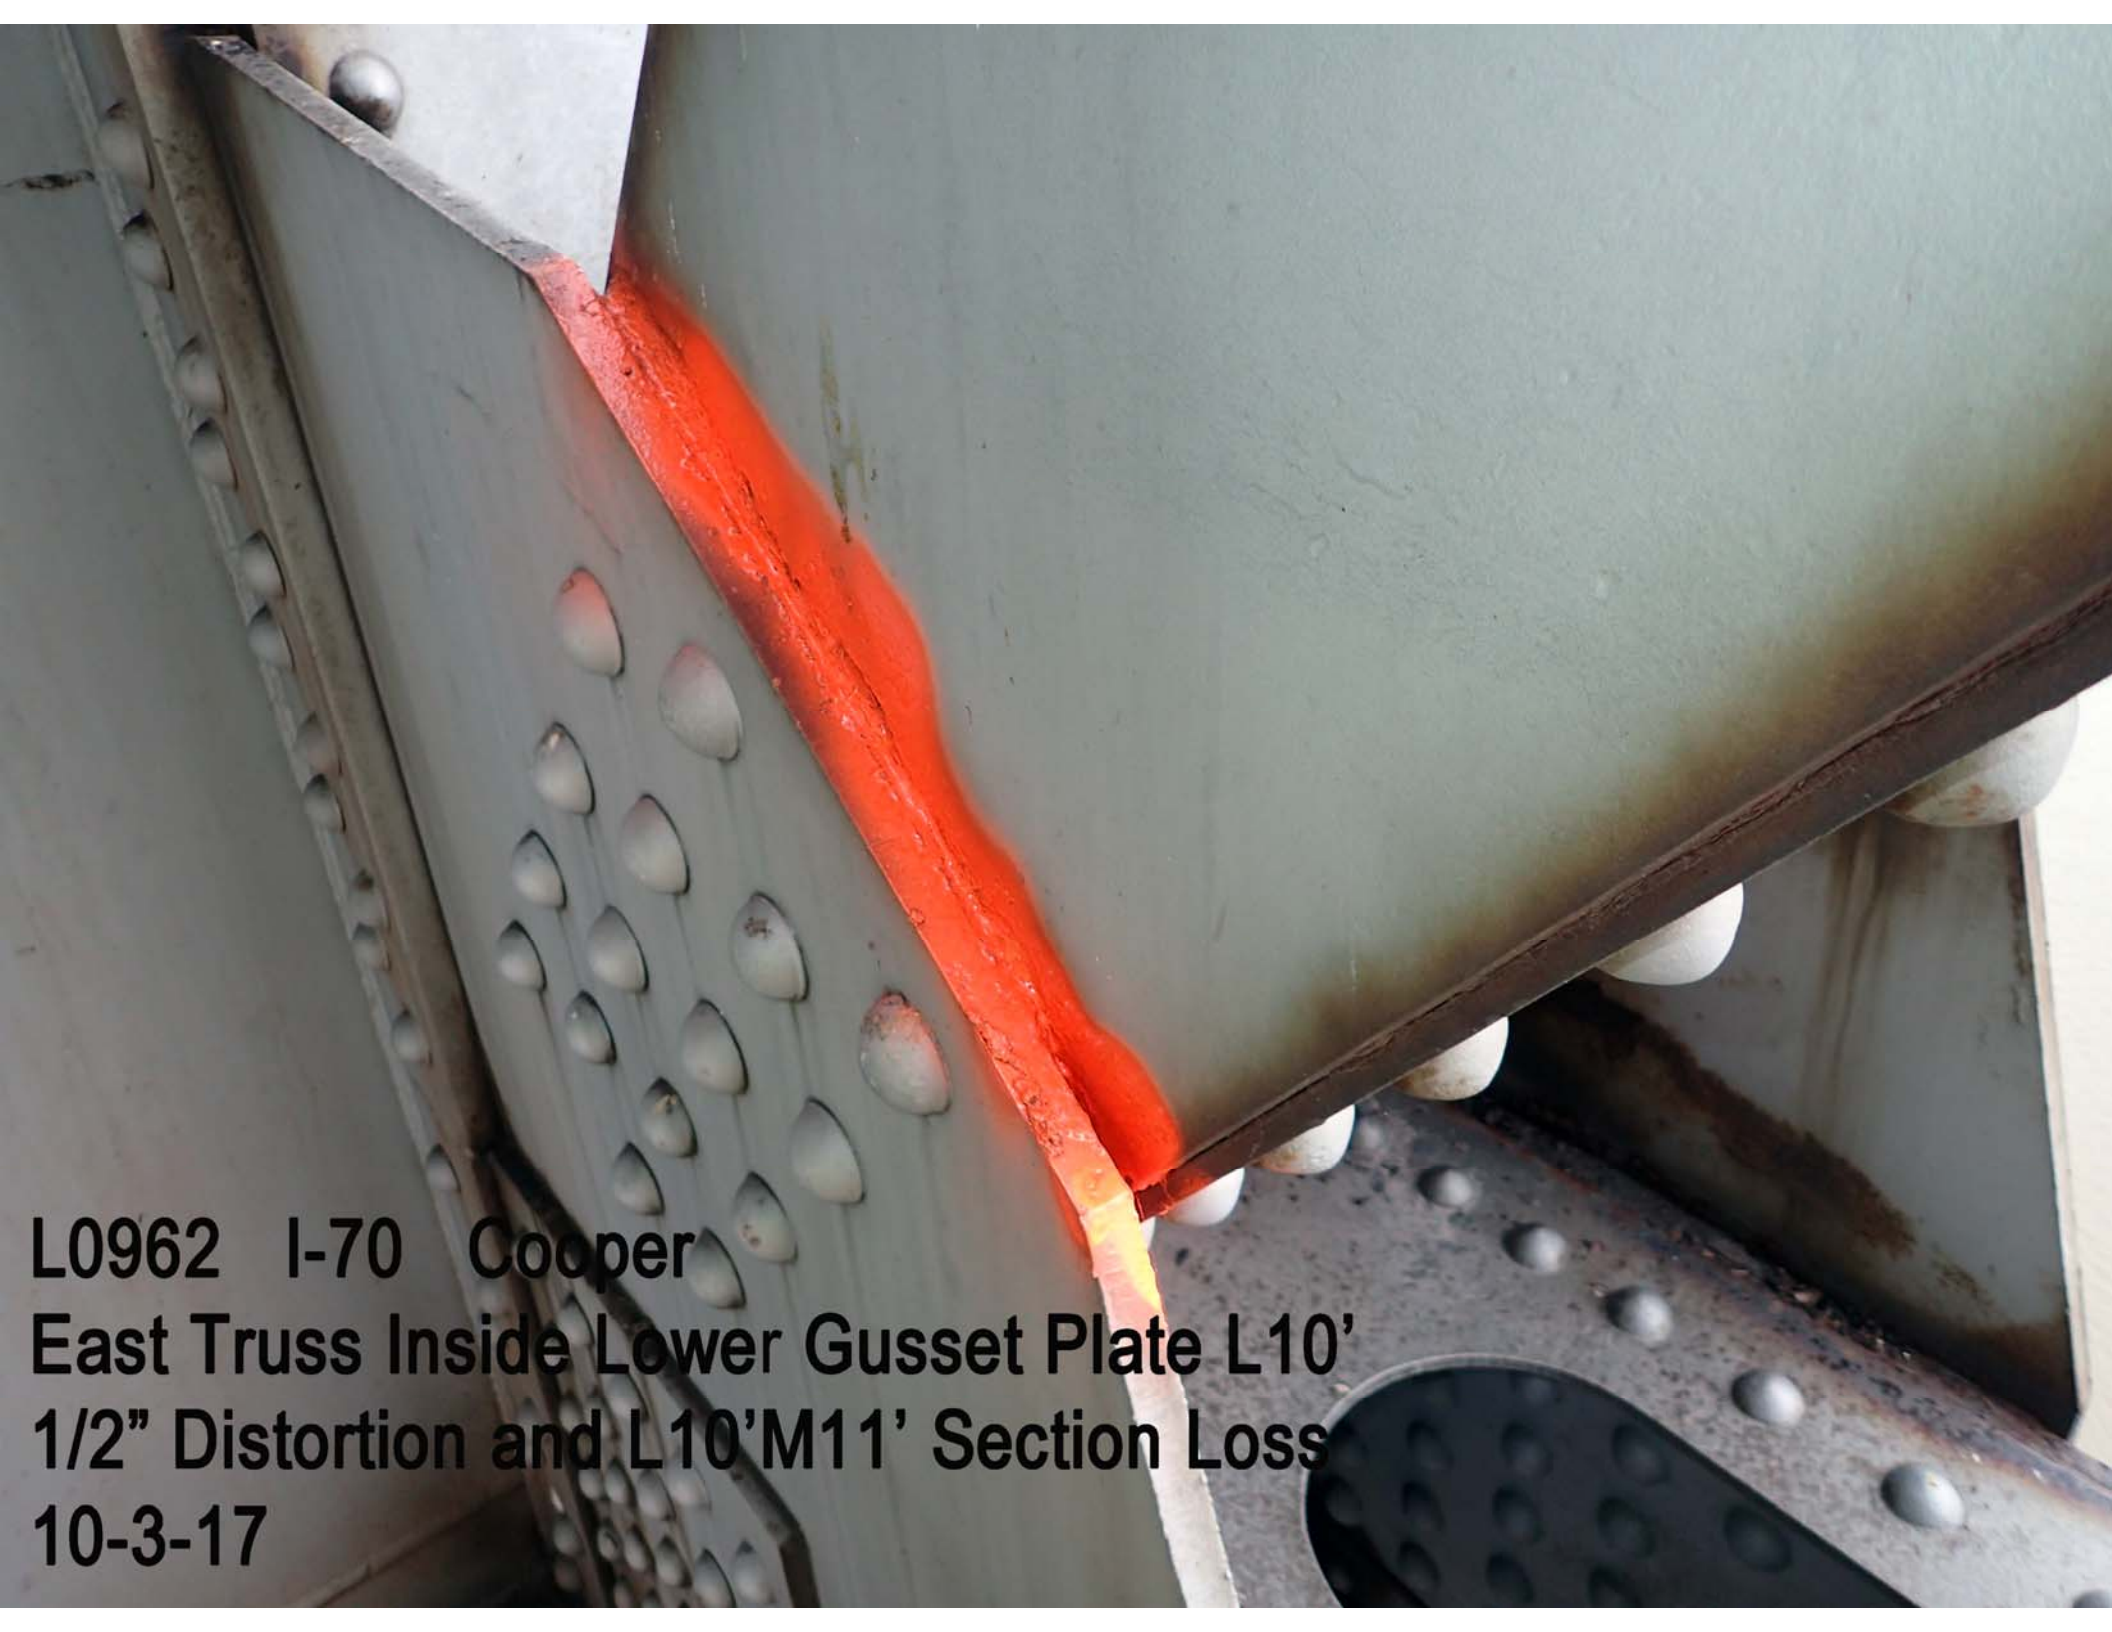
L0962 I-70 Cooper
East Truss Inside Lower Gusset Plate L10'
1/2" Distortion and L10'M11' Section Loss
10-3-17

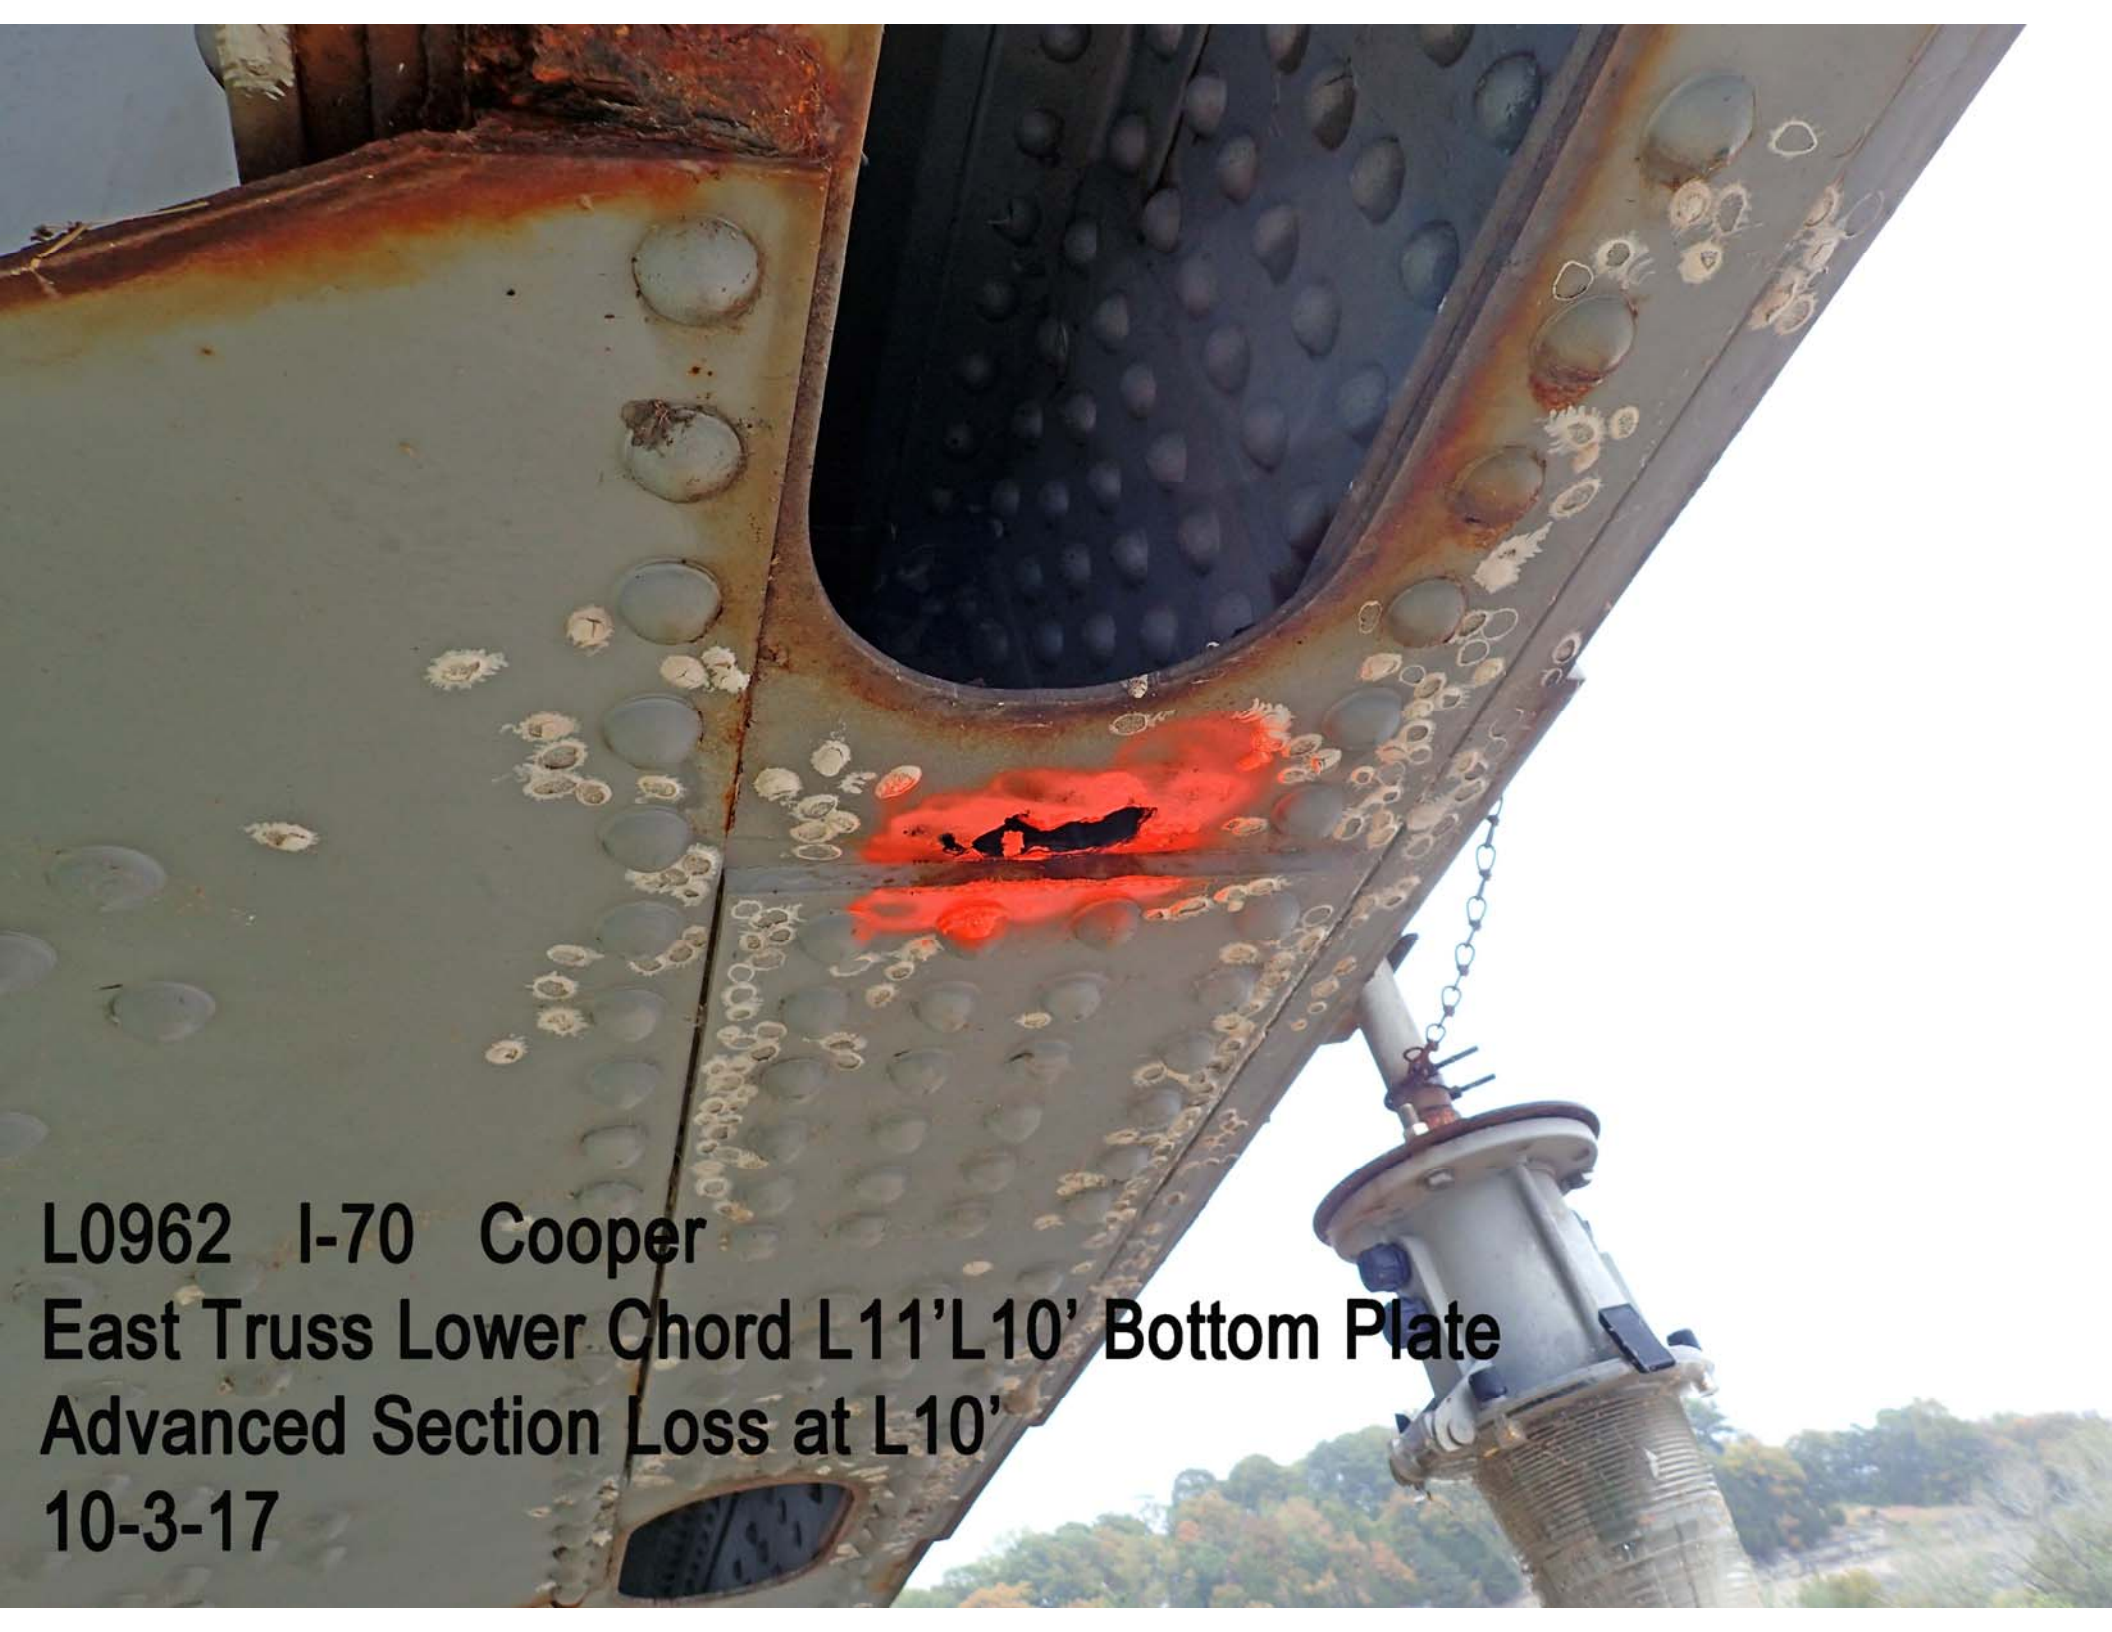
L0962 I-70 Cooper
East Truss Lower Chord L11'L10' Bottom Plate
Advanced Section Loss at L10'
10-3-17

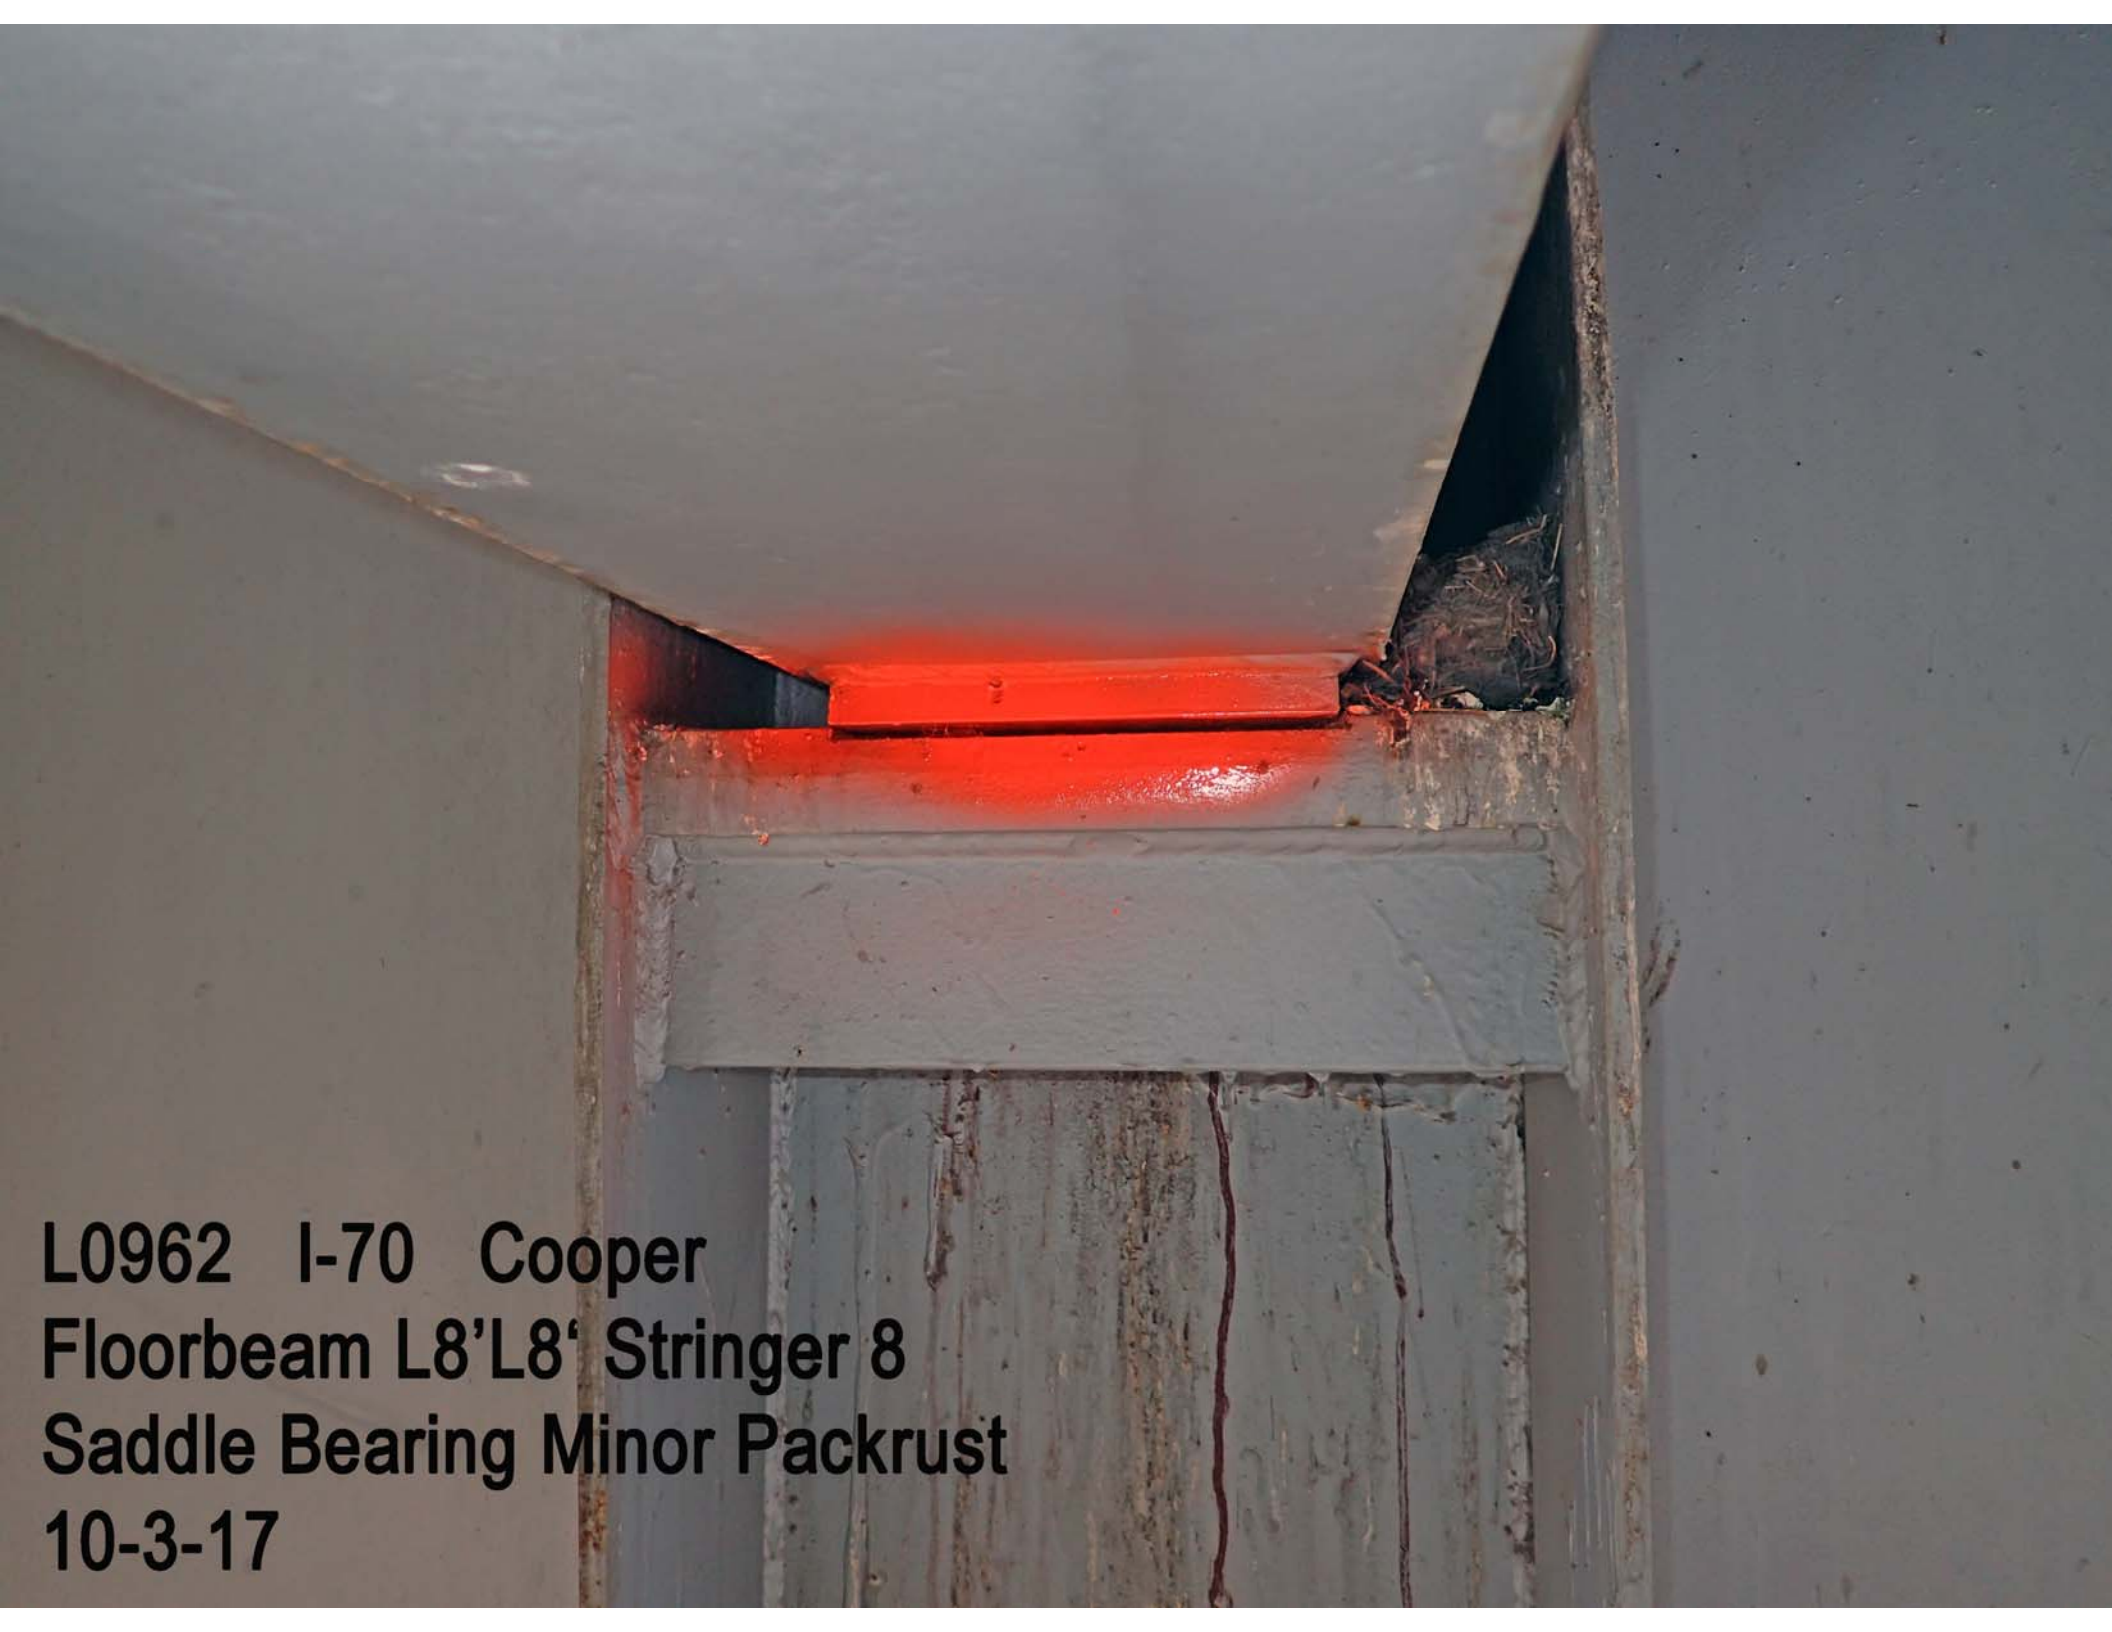
**L0962 I-70 Cooper
Floorbeam L8'L8' Stringer 8
Saddle Bearing Minor Packrust
10-3-17**
