L0962 Cooper Co.
08/28/2017
Looking West

L0962 I-70 Cooper
Pier 15 Open Expansion Joint WBL
8-28-17

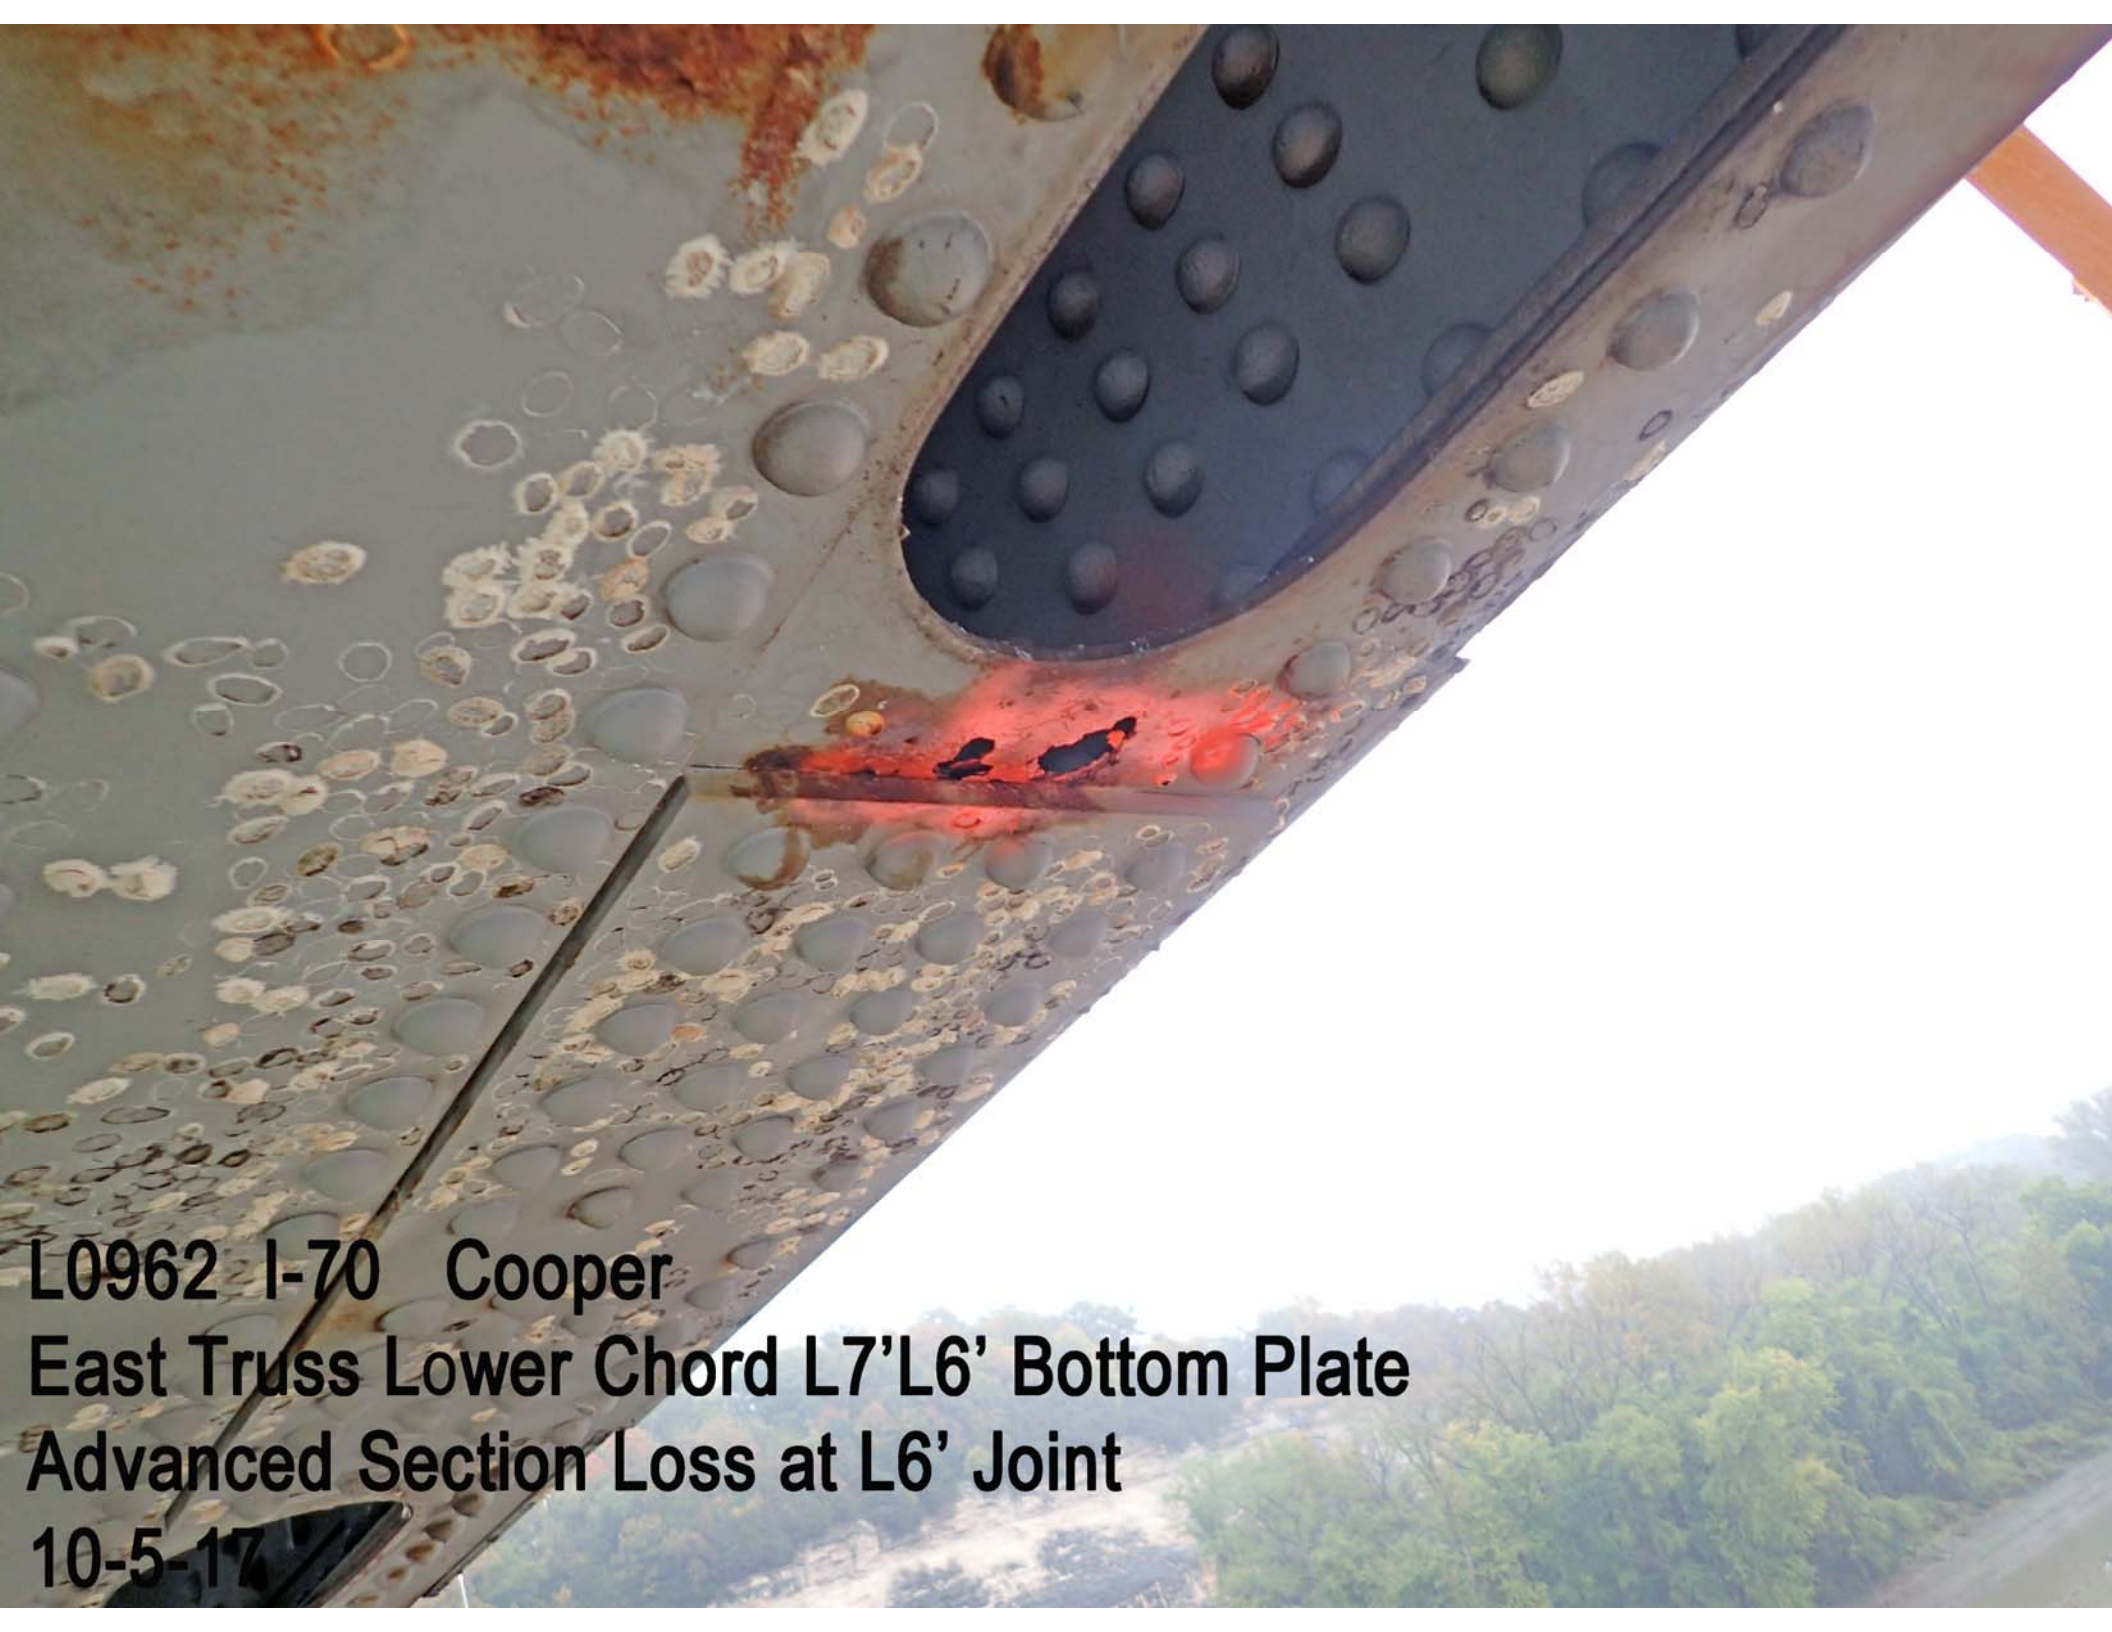
L0962 I-70 Cooper
L7'L6' Stringer 9 at Flooream L6'L6'
Heavy Web Section Loss (50%)

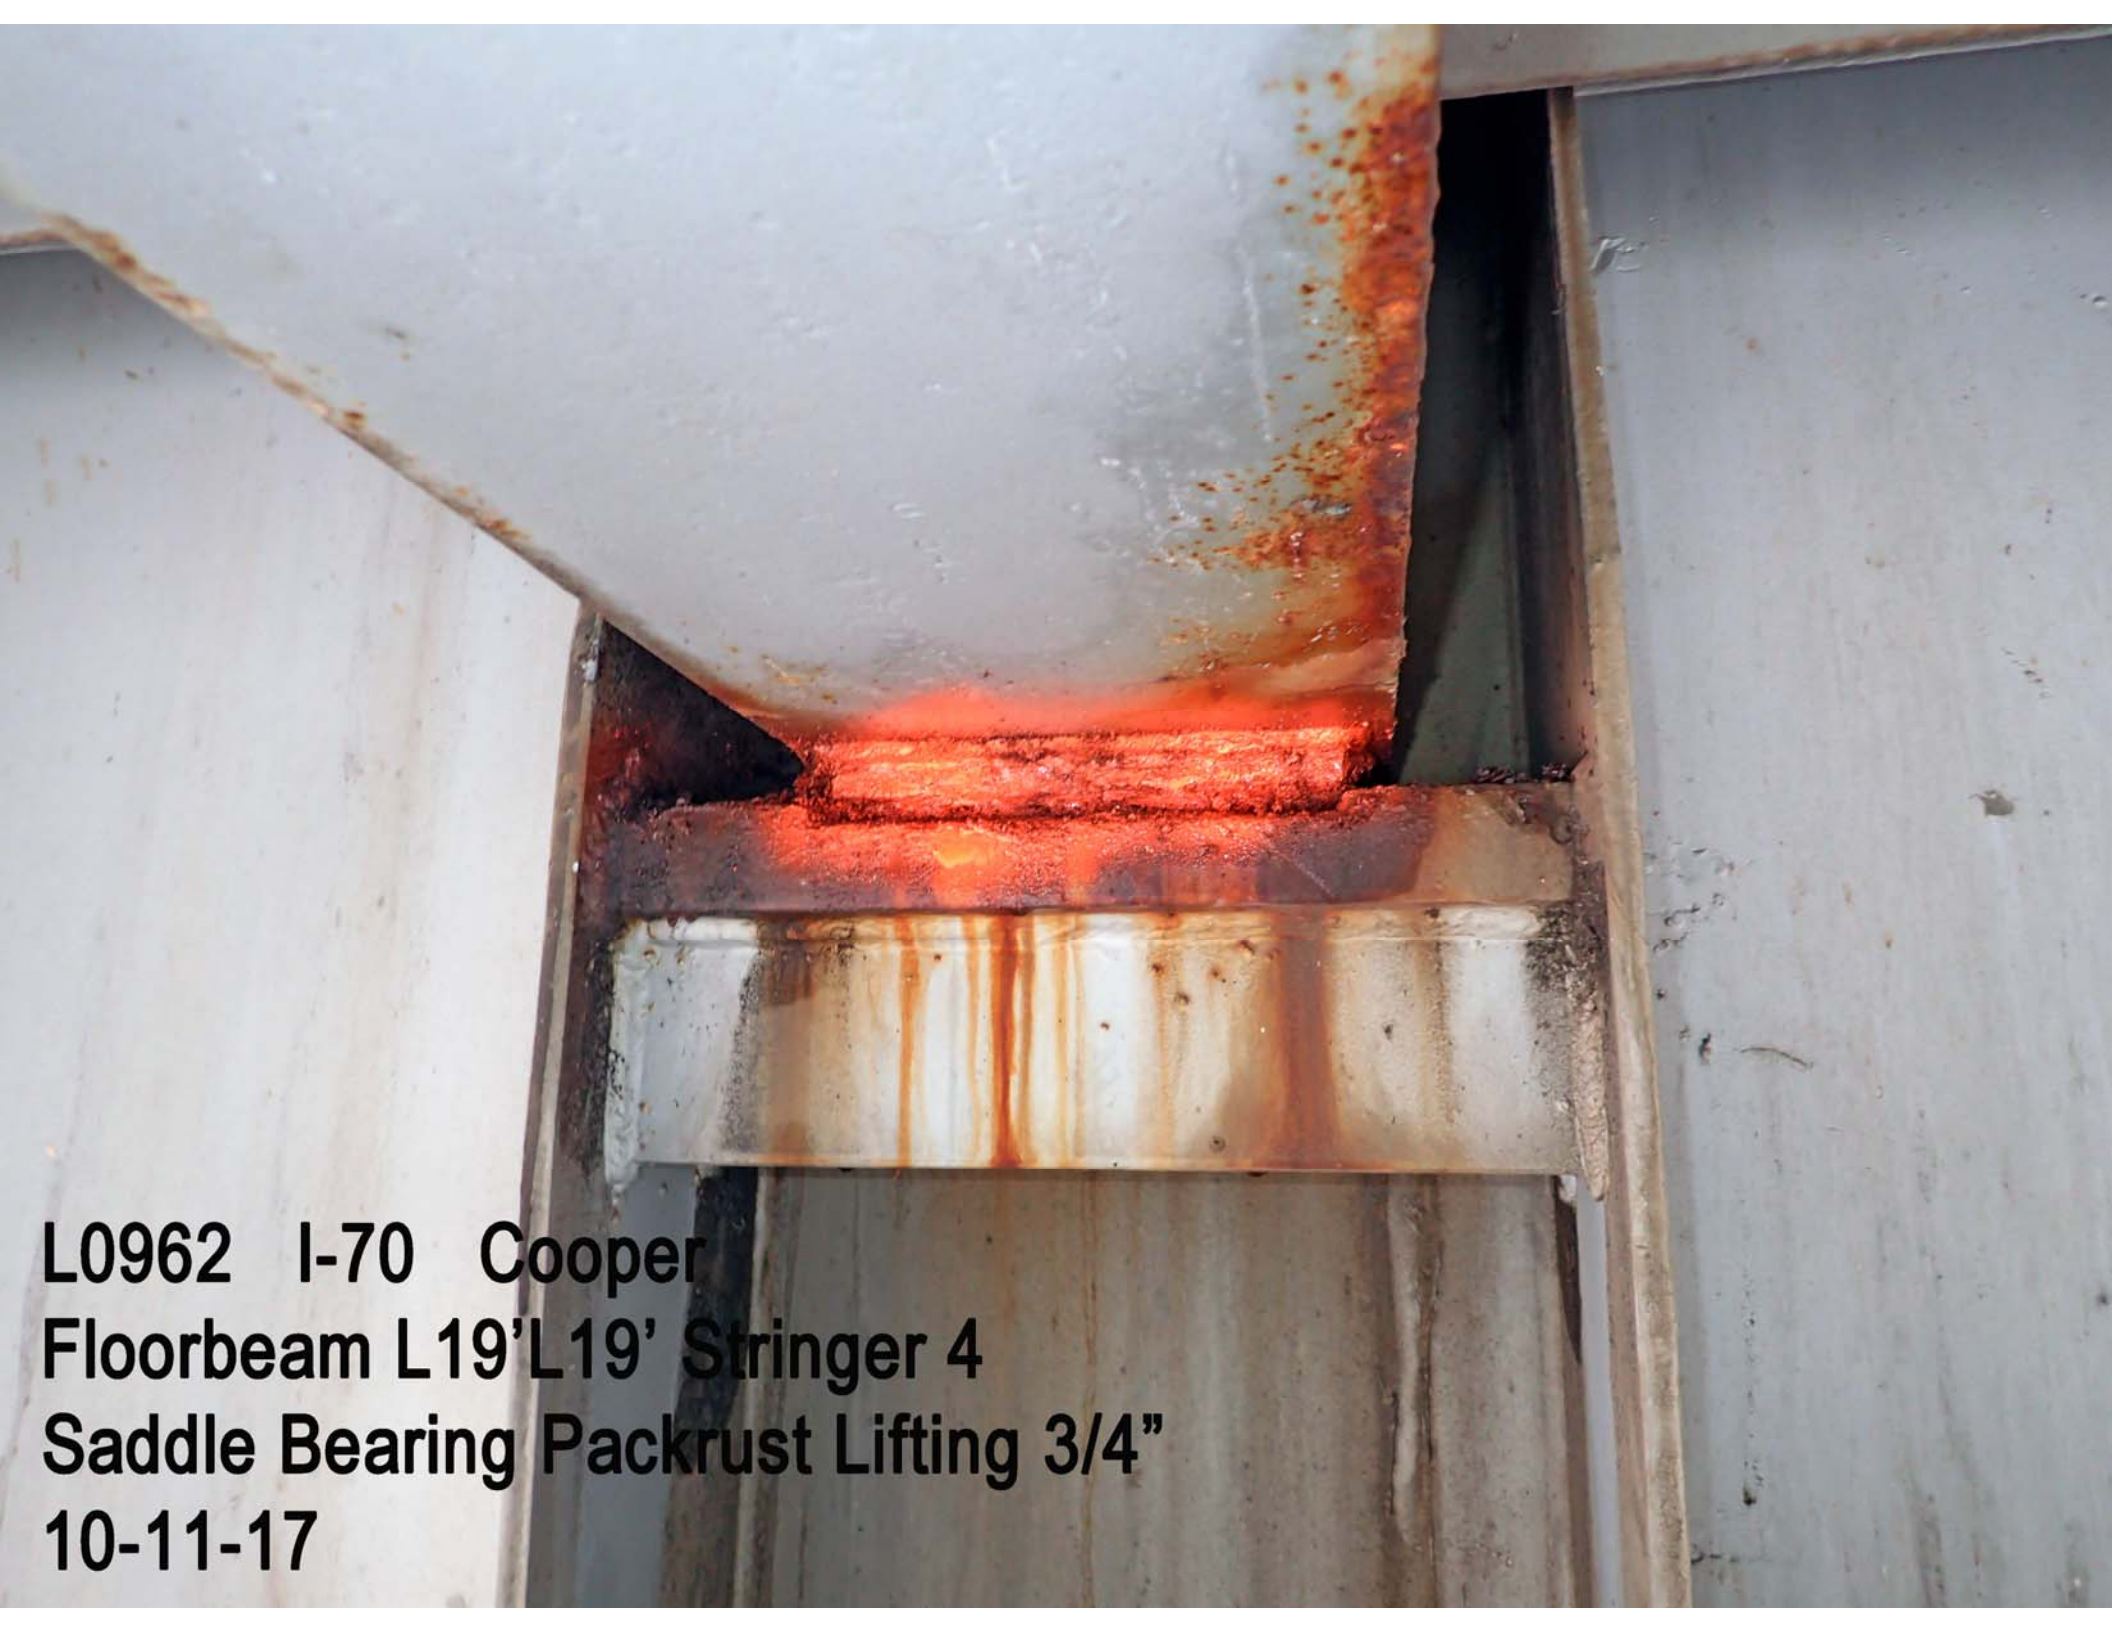
L0962 I-70 Cooper
Floorbeam L16'L16' Stringer 2
Saddle Bearing Packrust Lifting 1/2"
10-11-17

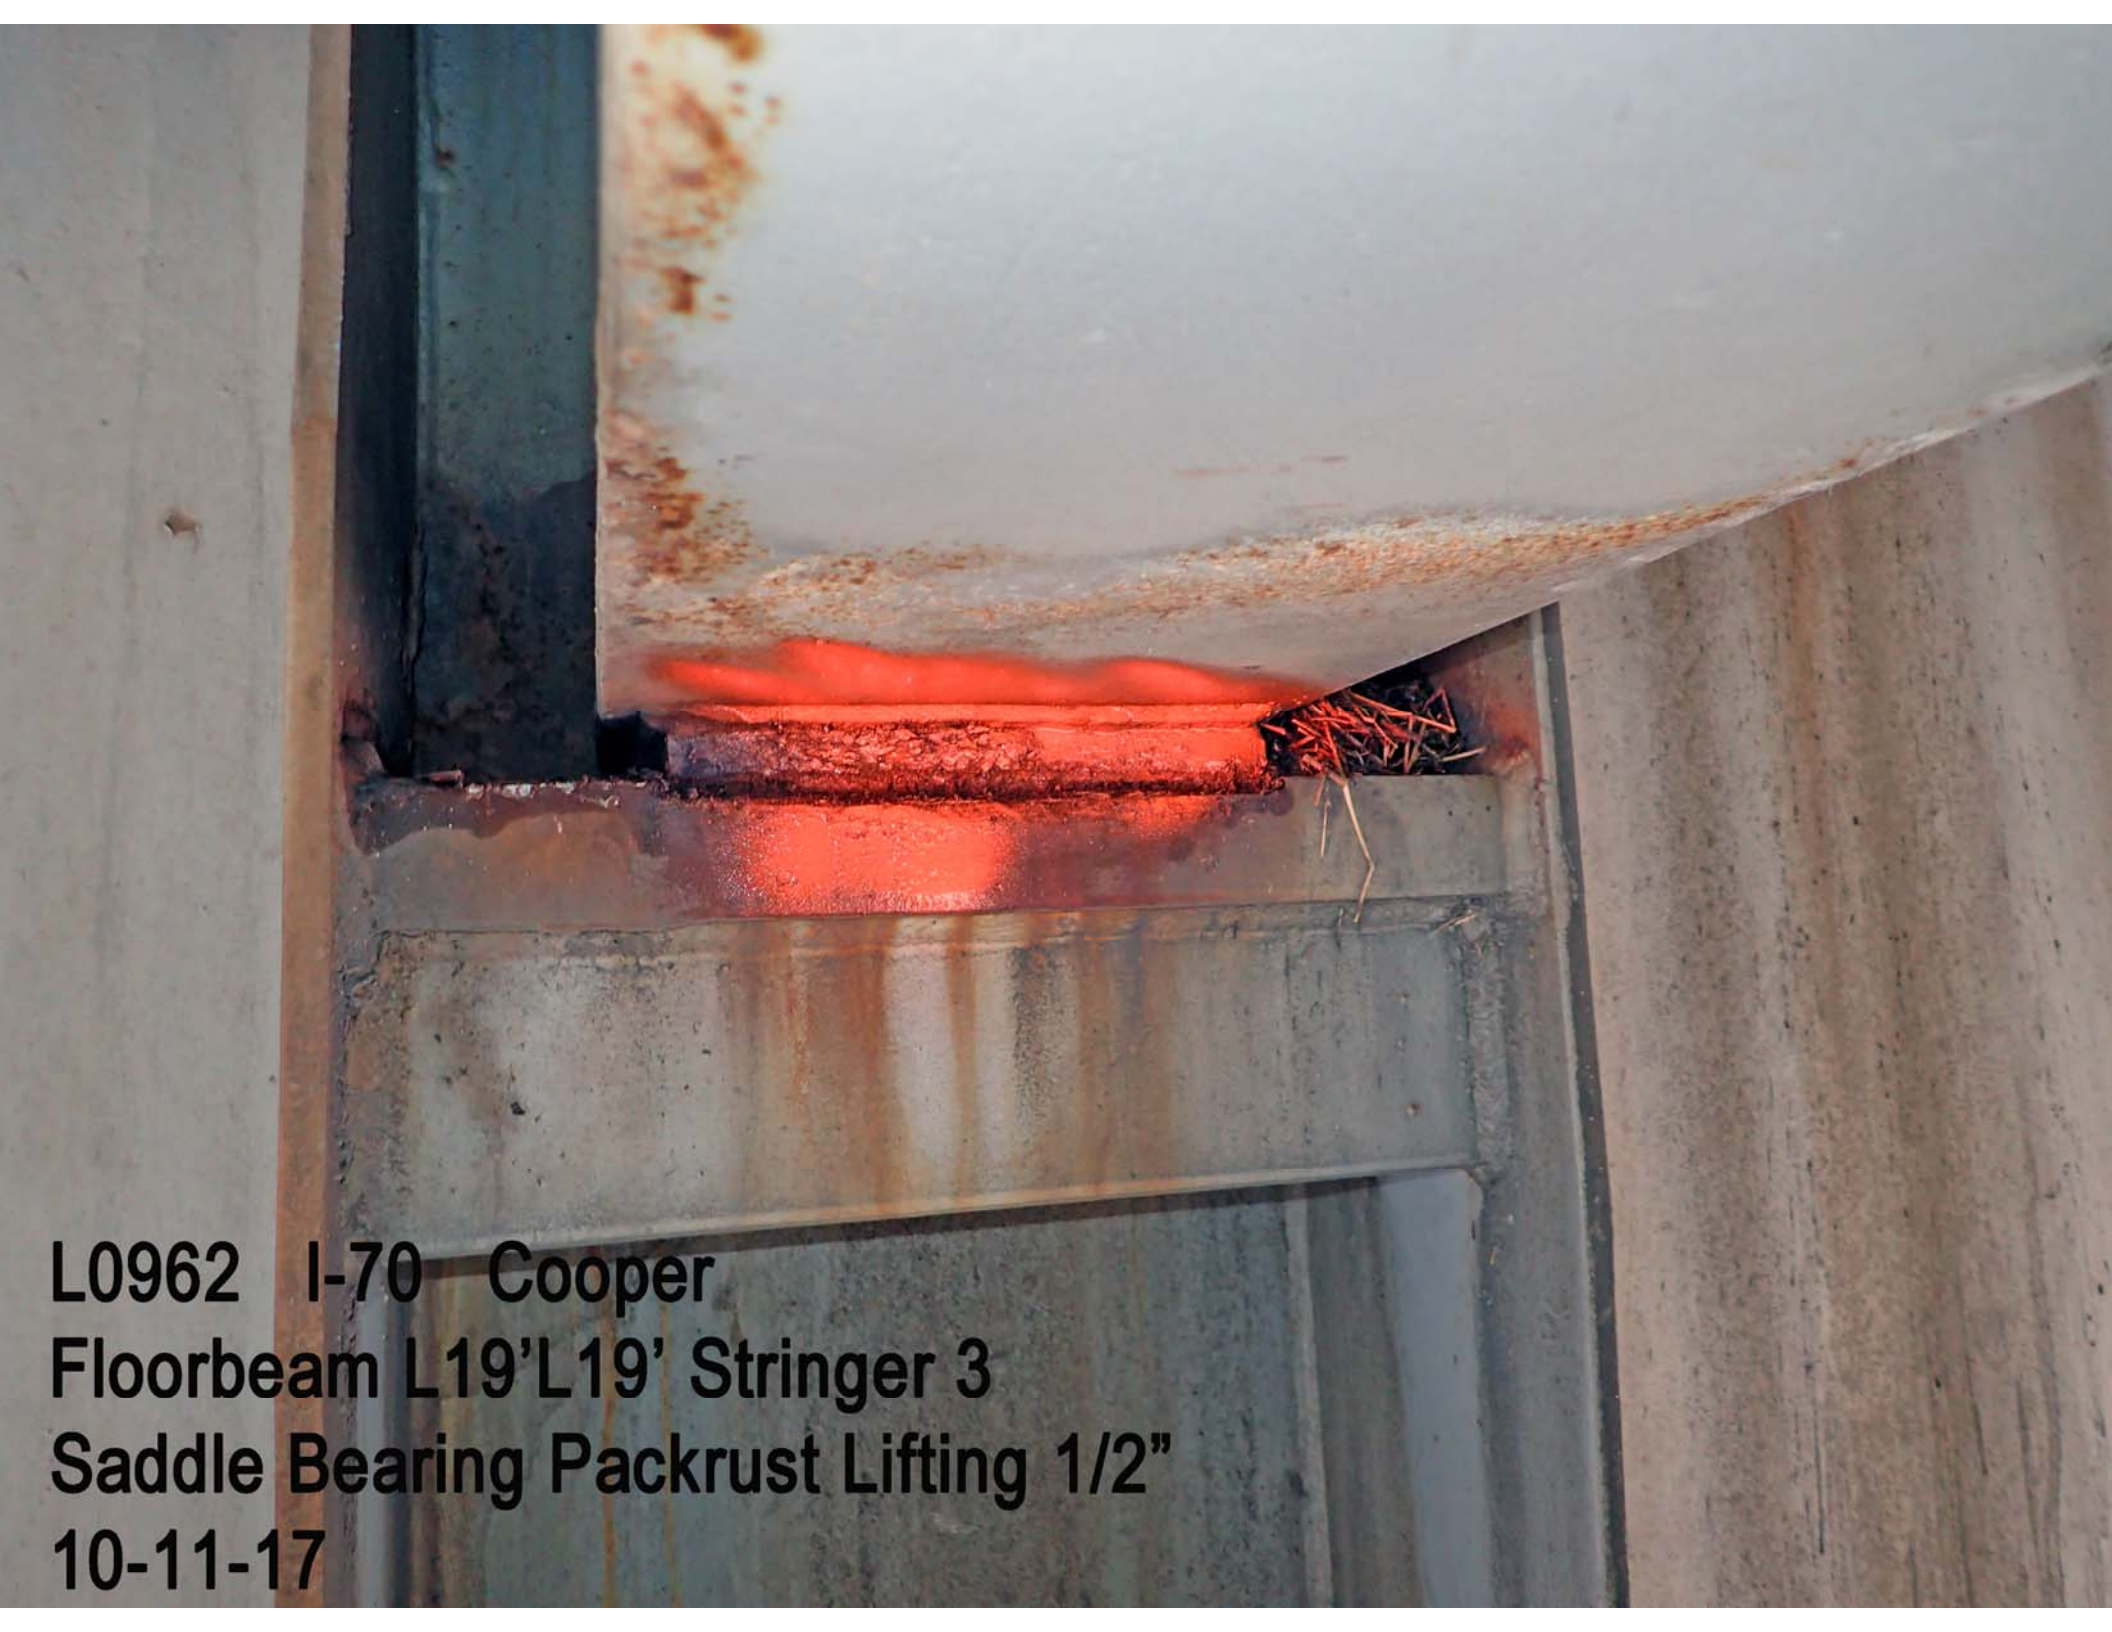
**L0962 I-70 Cooper
Floorbeam L19'L19' Stringer 4
Saddle Bearing Packrust Lifting 3/4"
10-11-17**

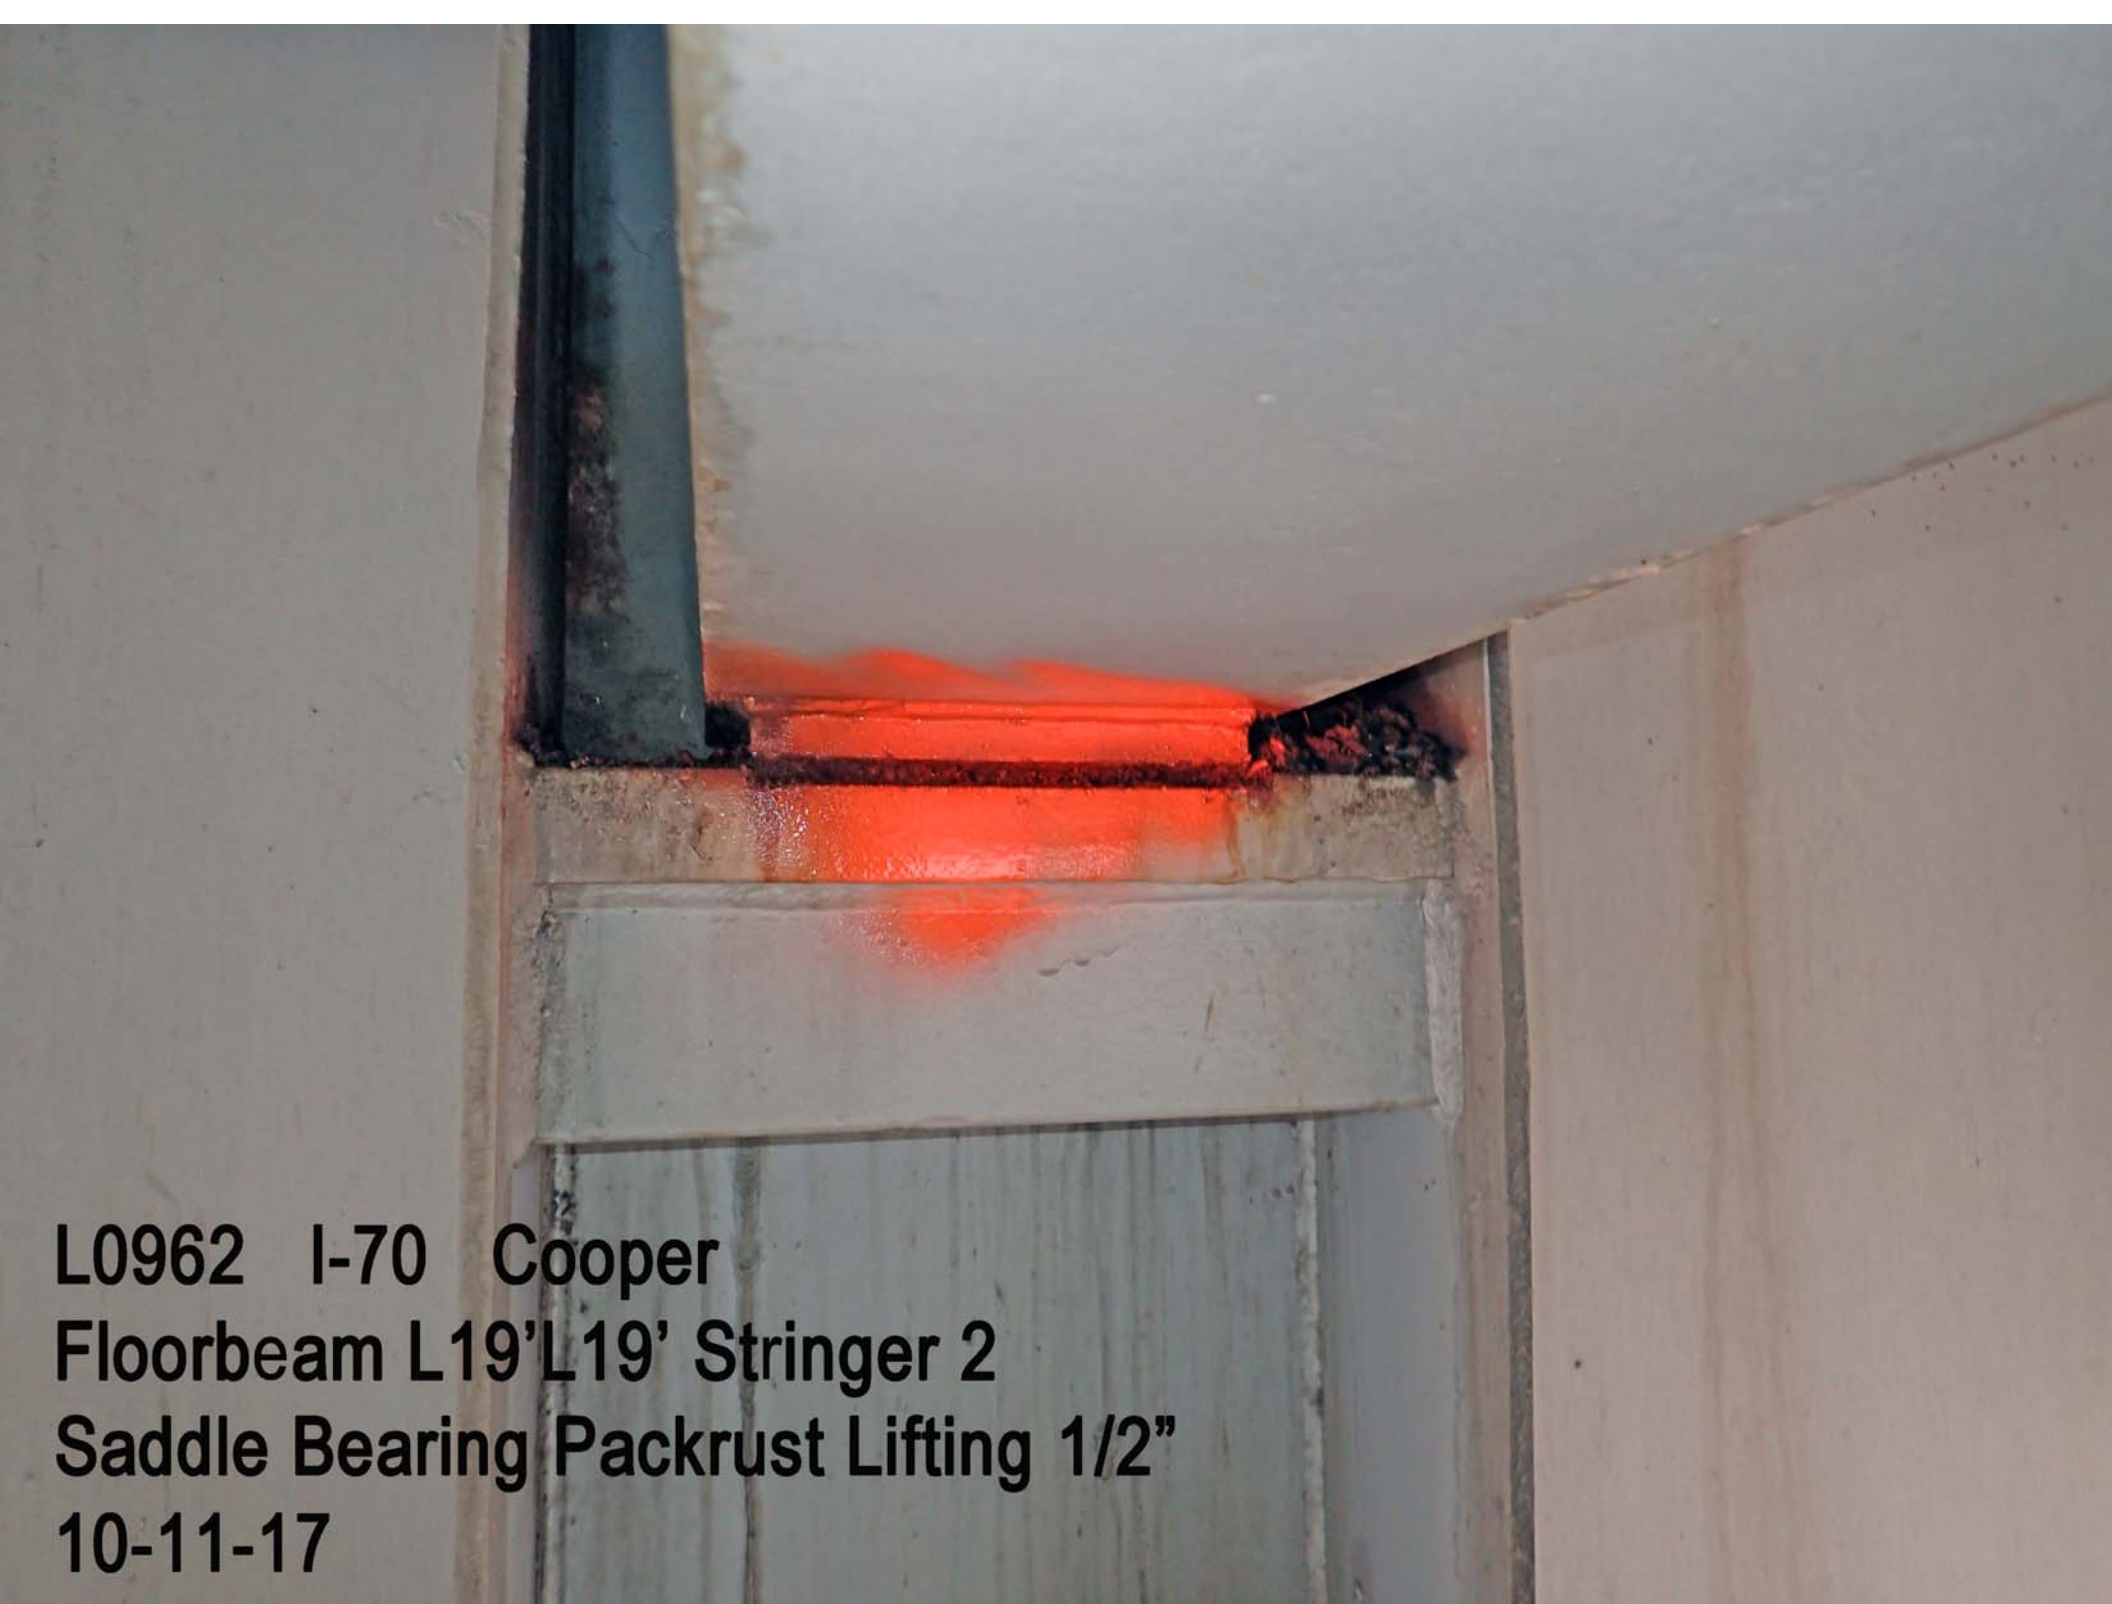
L0962 I-70 Cooper
Floorbeam L19'L19' Stringer 3
Saddle Bearing Packrust Lifting 1/2"
10-11-17

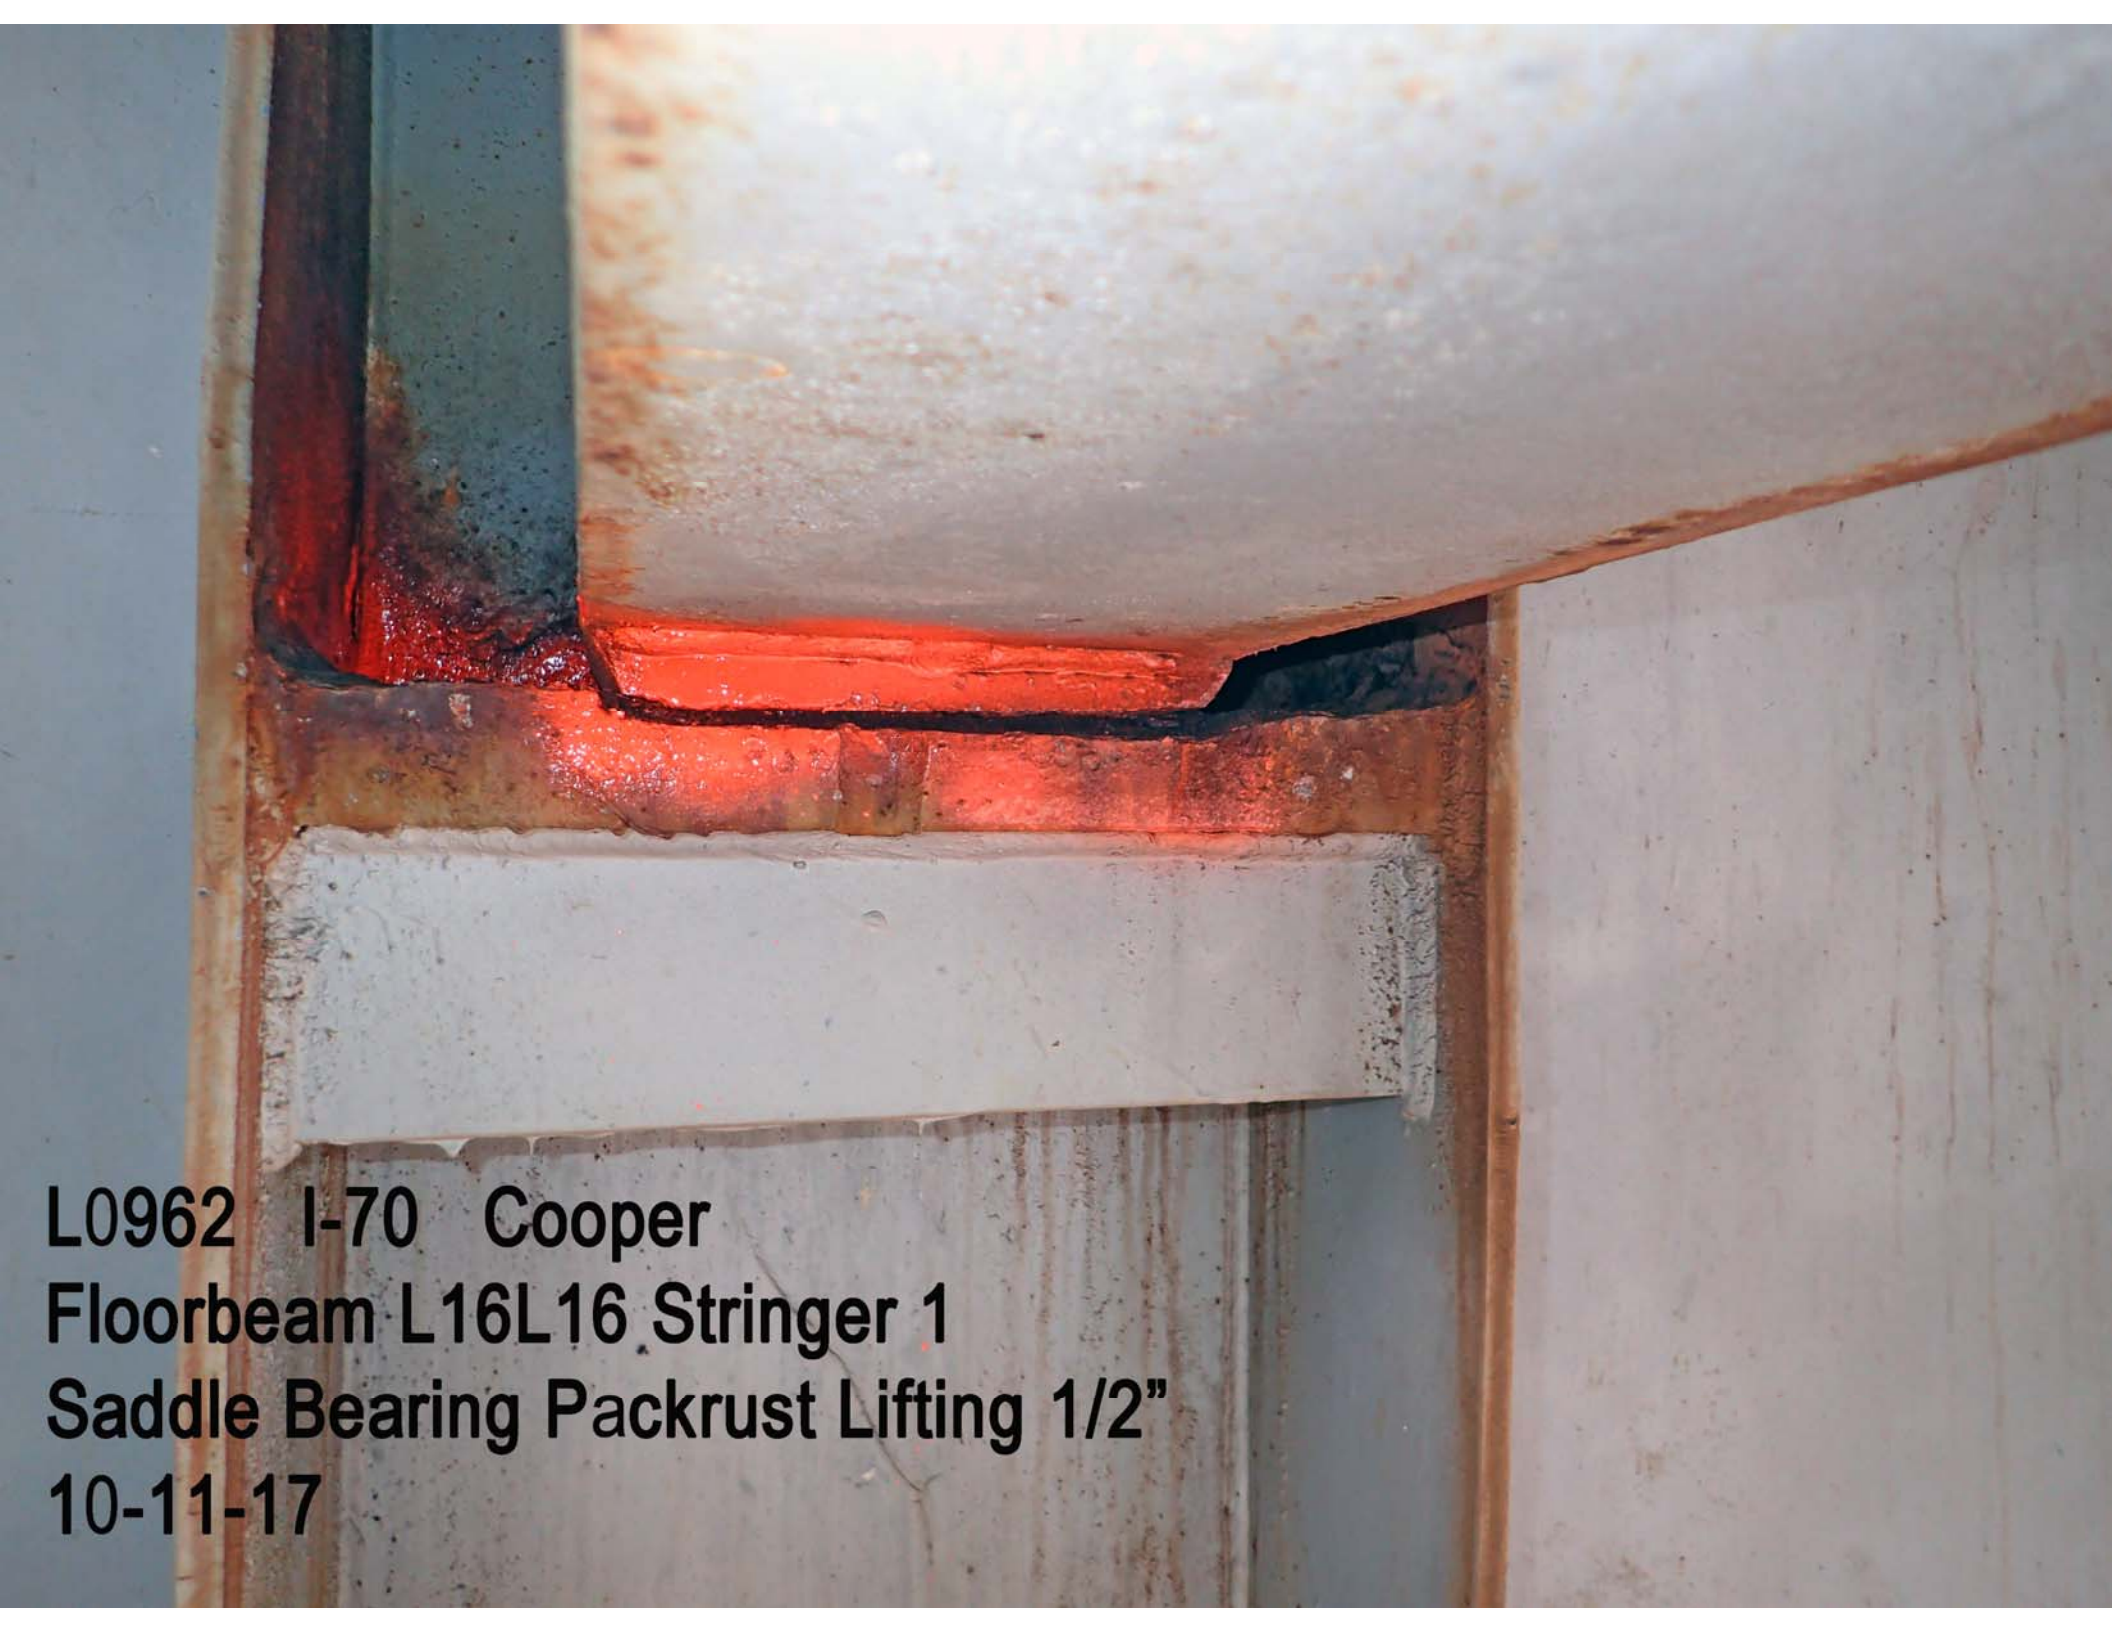
**L0962 I-70 Cooper
Floorbeam L16L16 Stringer 1
Saddle Bearing Packrust Lifting 1/2"
10-11-17**

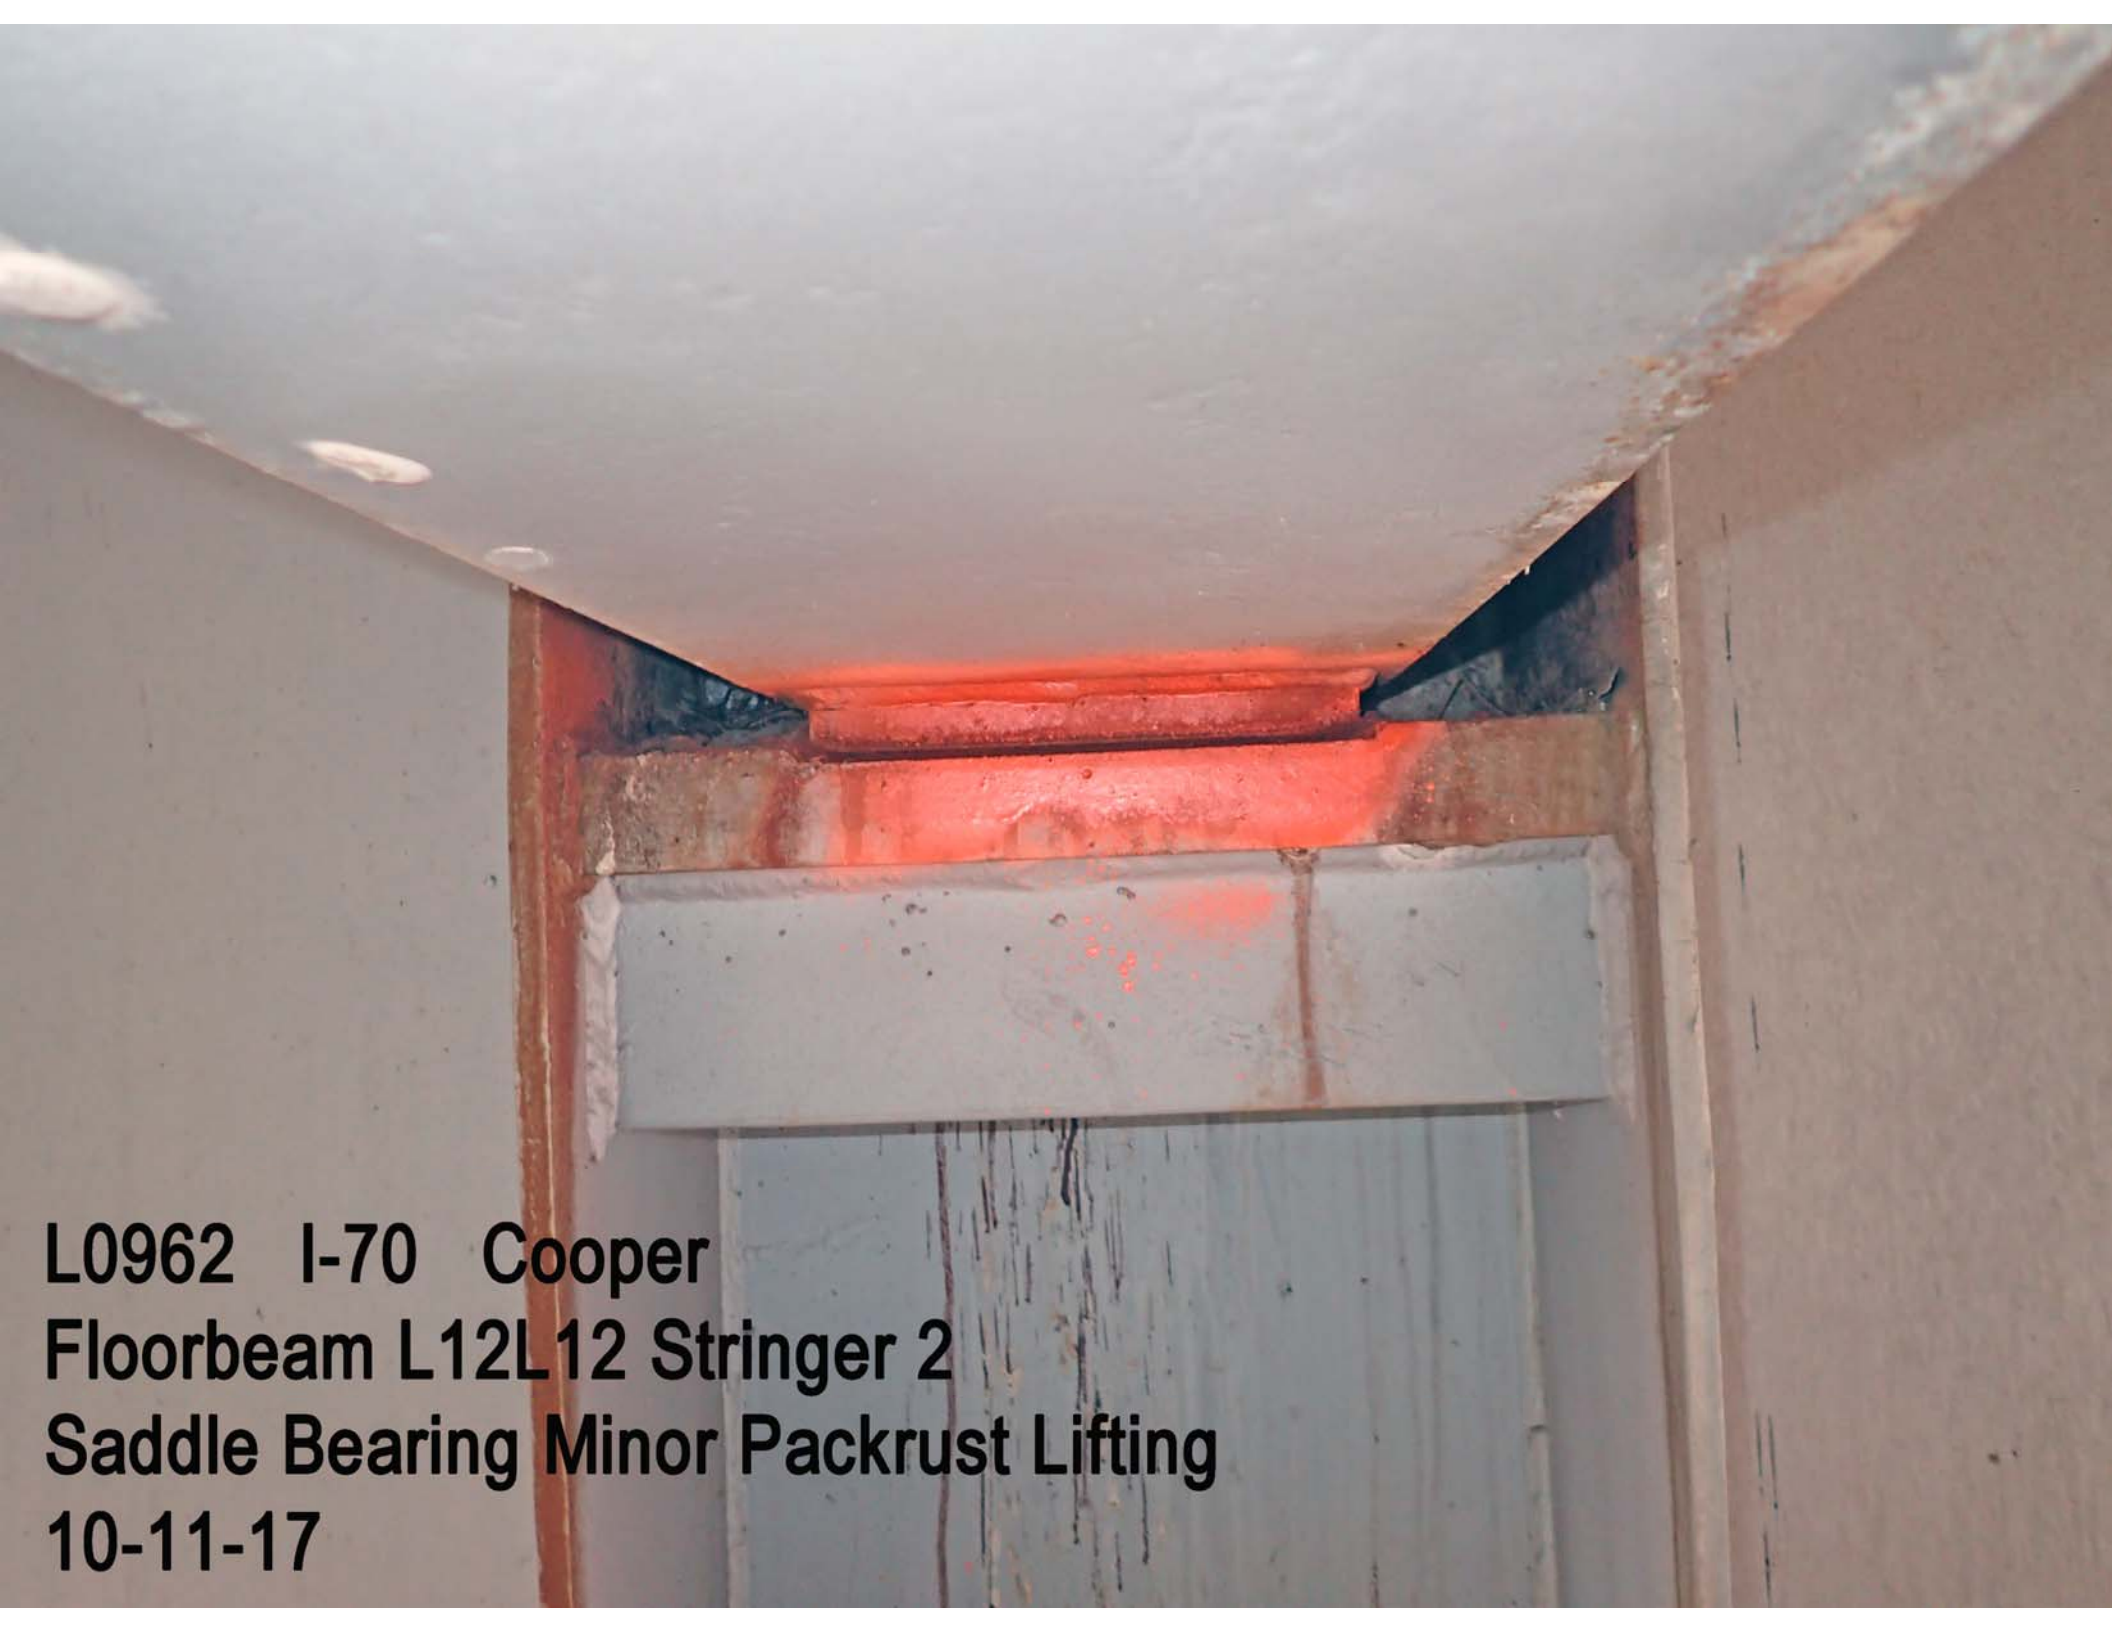
**L0962 I-70 Cooper
Floorbeam L12L12 Stringer 2
Saddle Bearing Minor Packrust Lifting
10-11-17**
