L0962 Cooper Co.
08/28/2017
Looking West

L0962 I-70 Cooper
Pier 15 Open Expansion Joint WBL
8-28-17

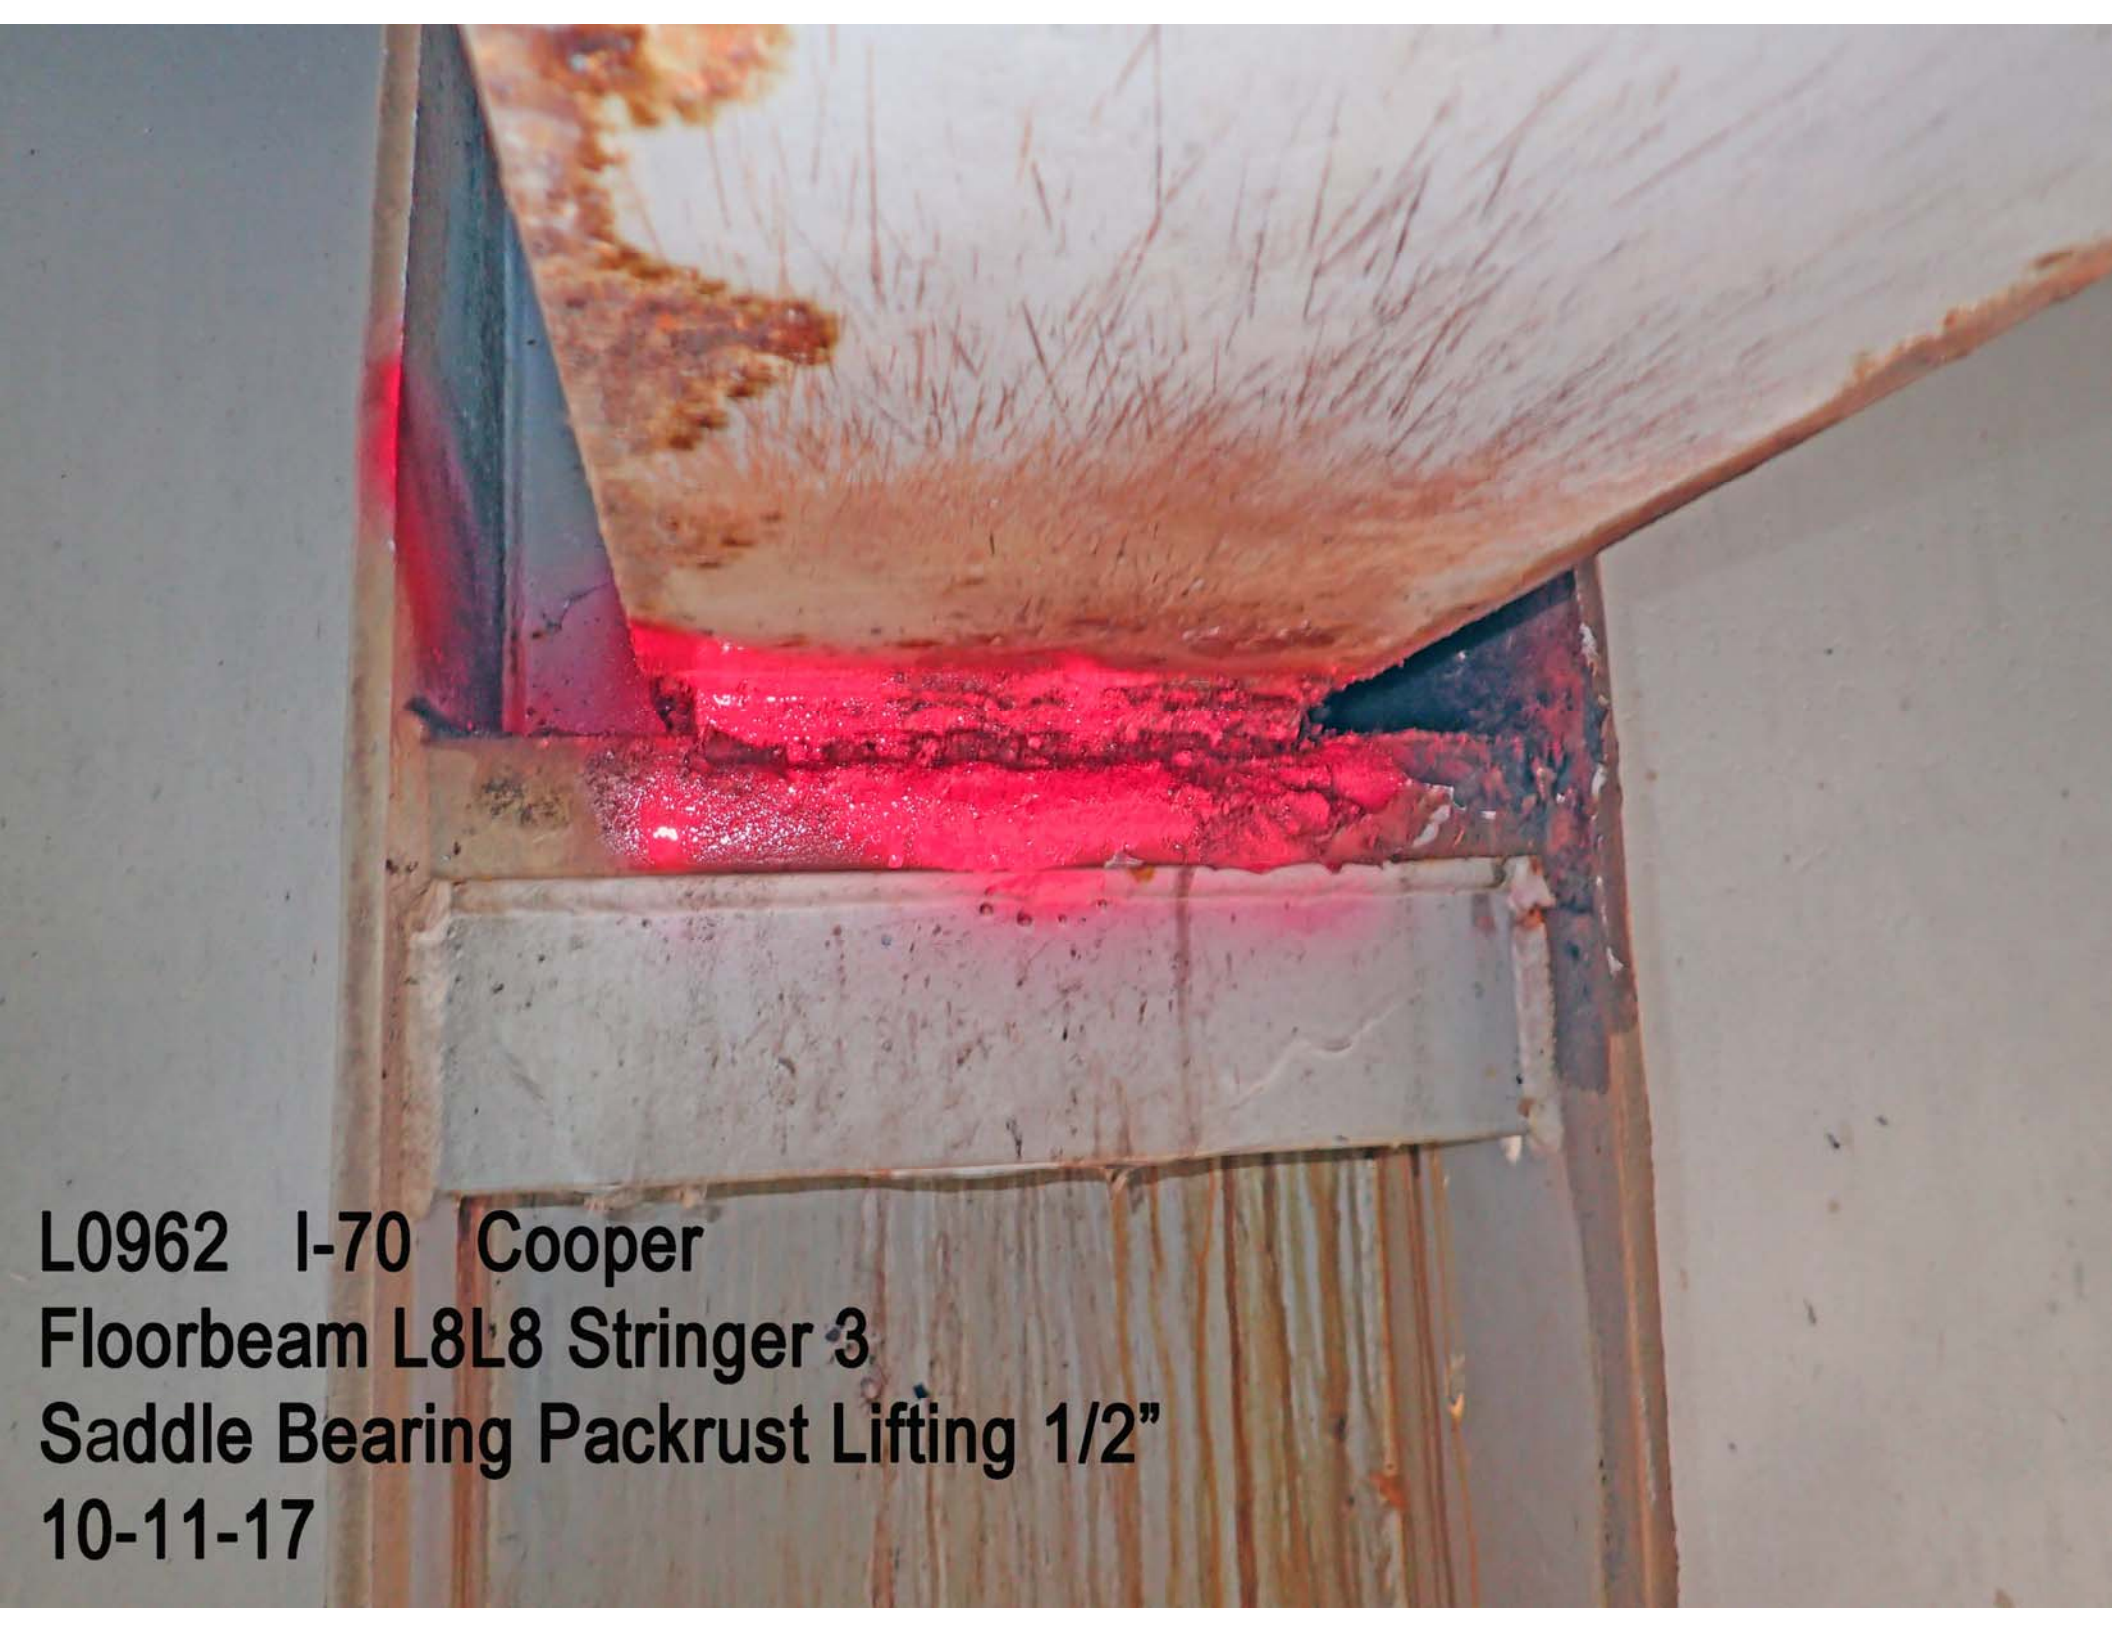
L0962 I-70 Cooper
Floorbeam L8L8 Stringer 3
Saddle Bearing Packrust Lifting 1/2"
10-11-17

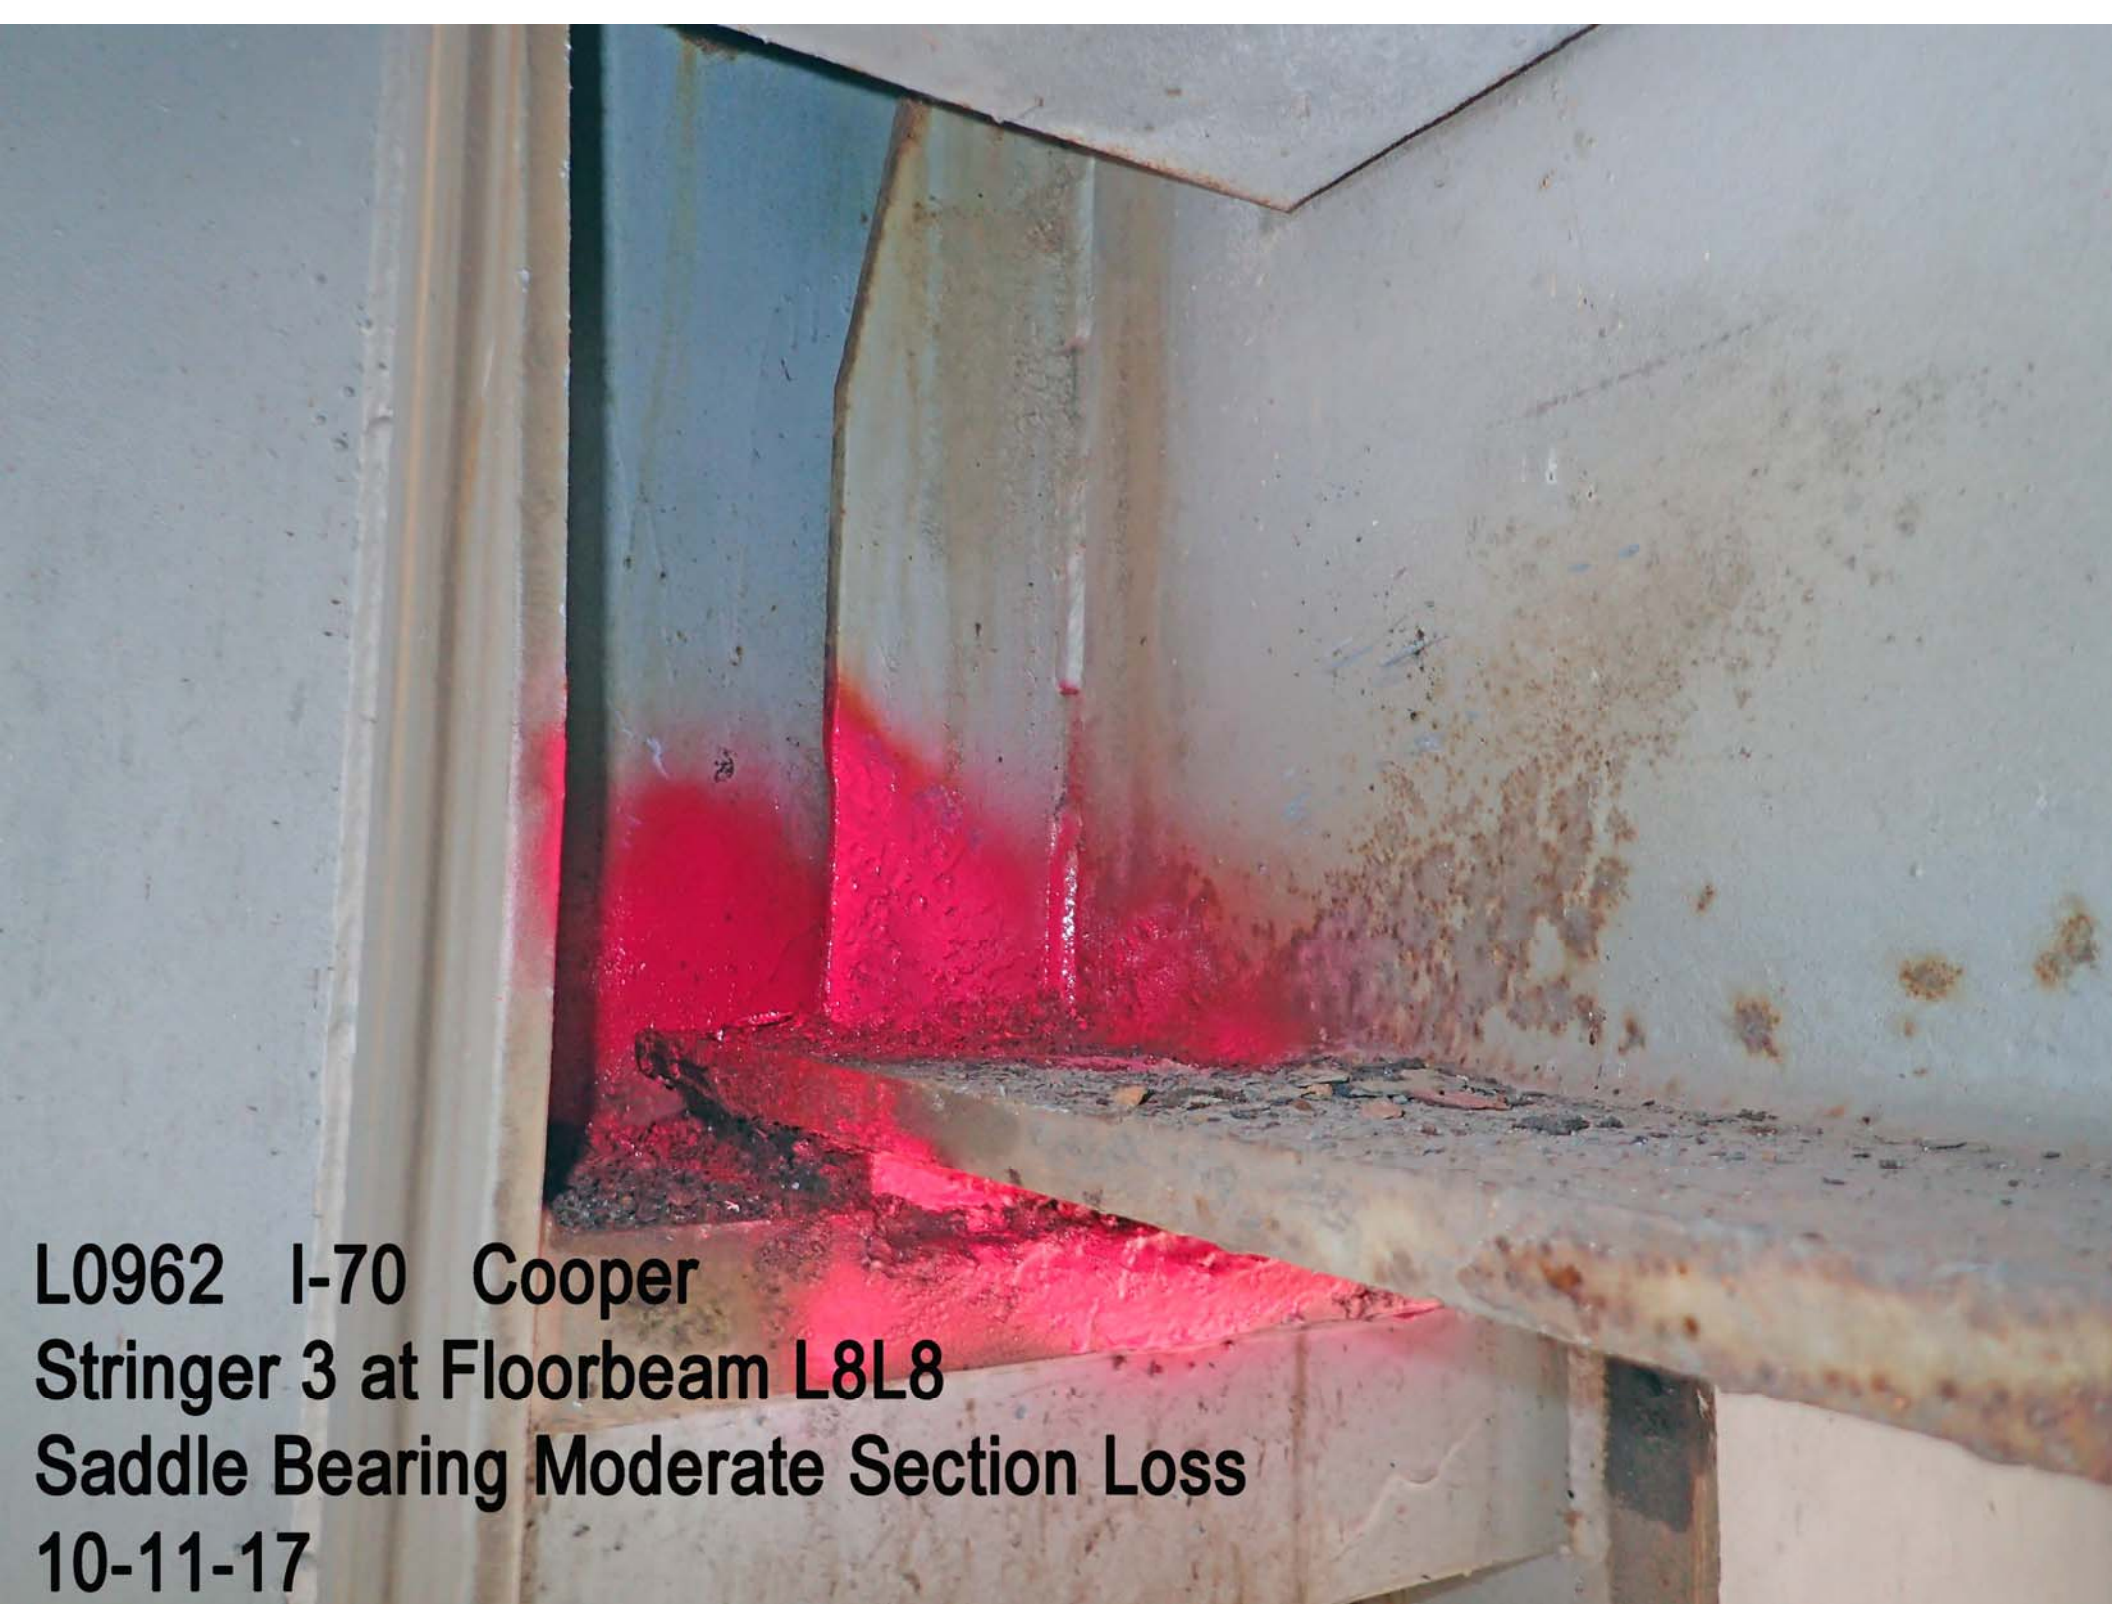
L0962 I-70 Cooper
Stringer 3 at Floorbeam L8L8
Saddle Bearing Moderate Section Loss
10-11-17

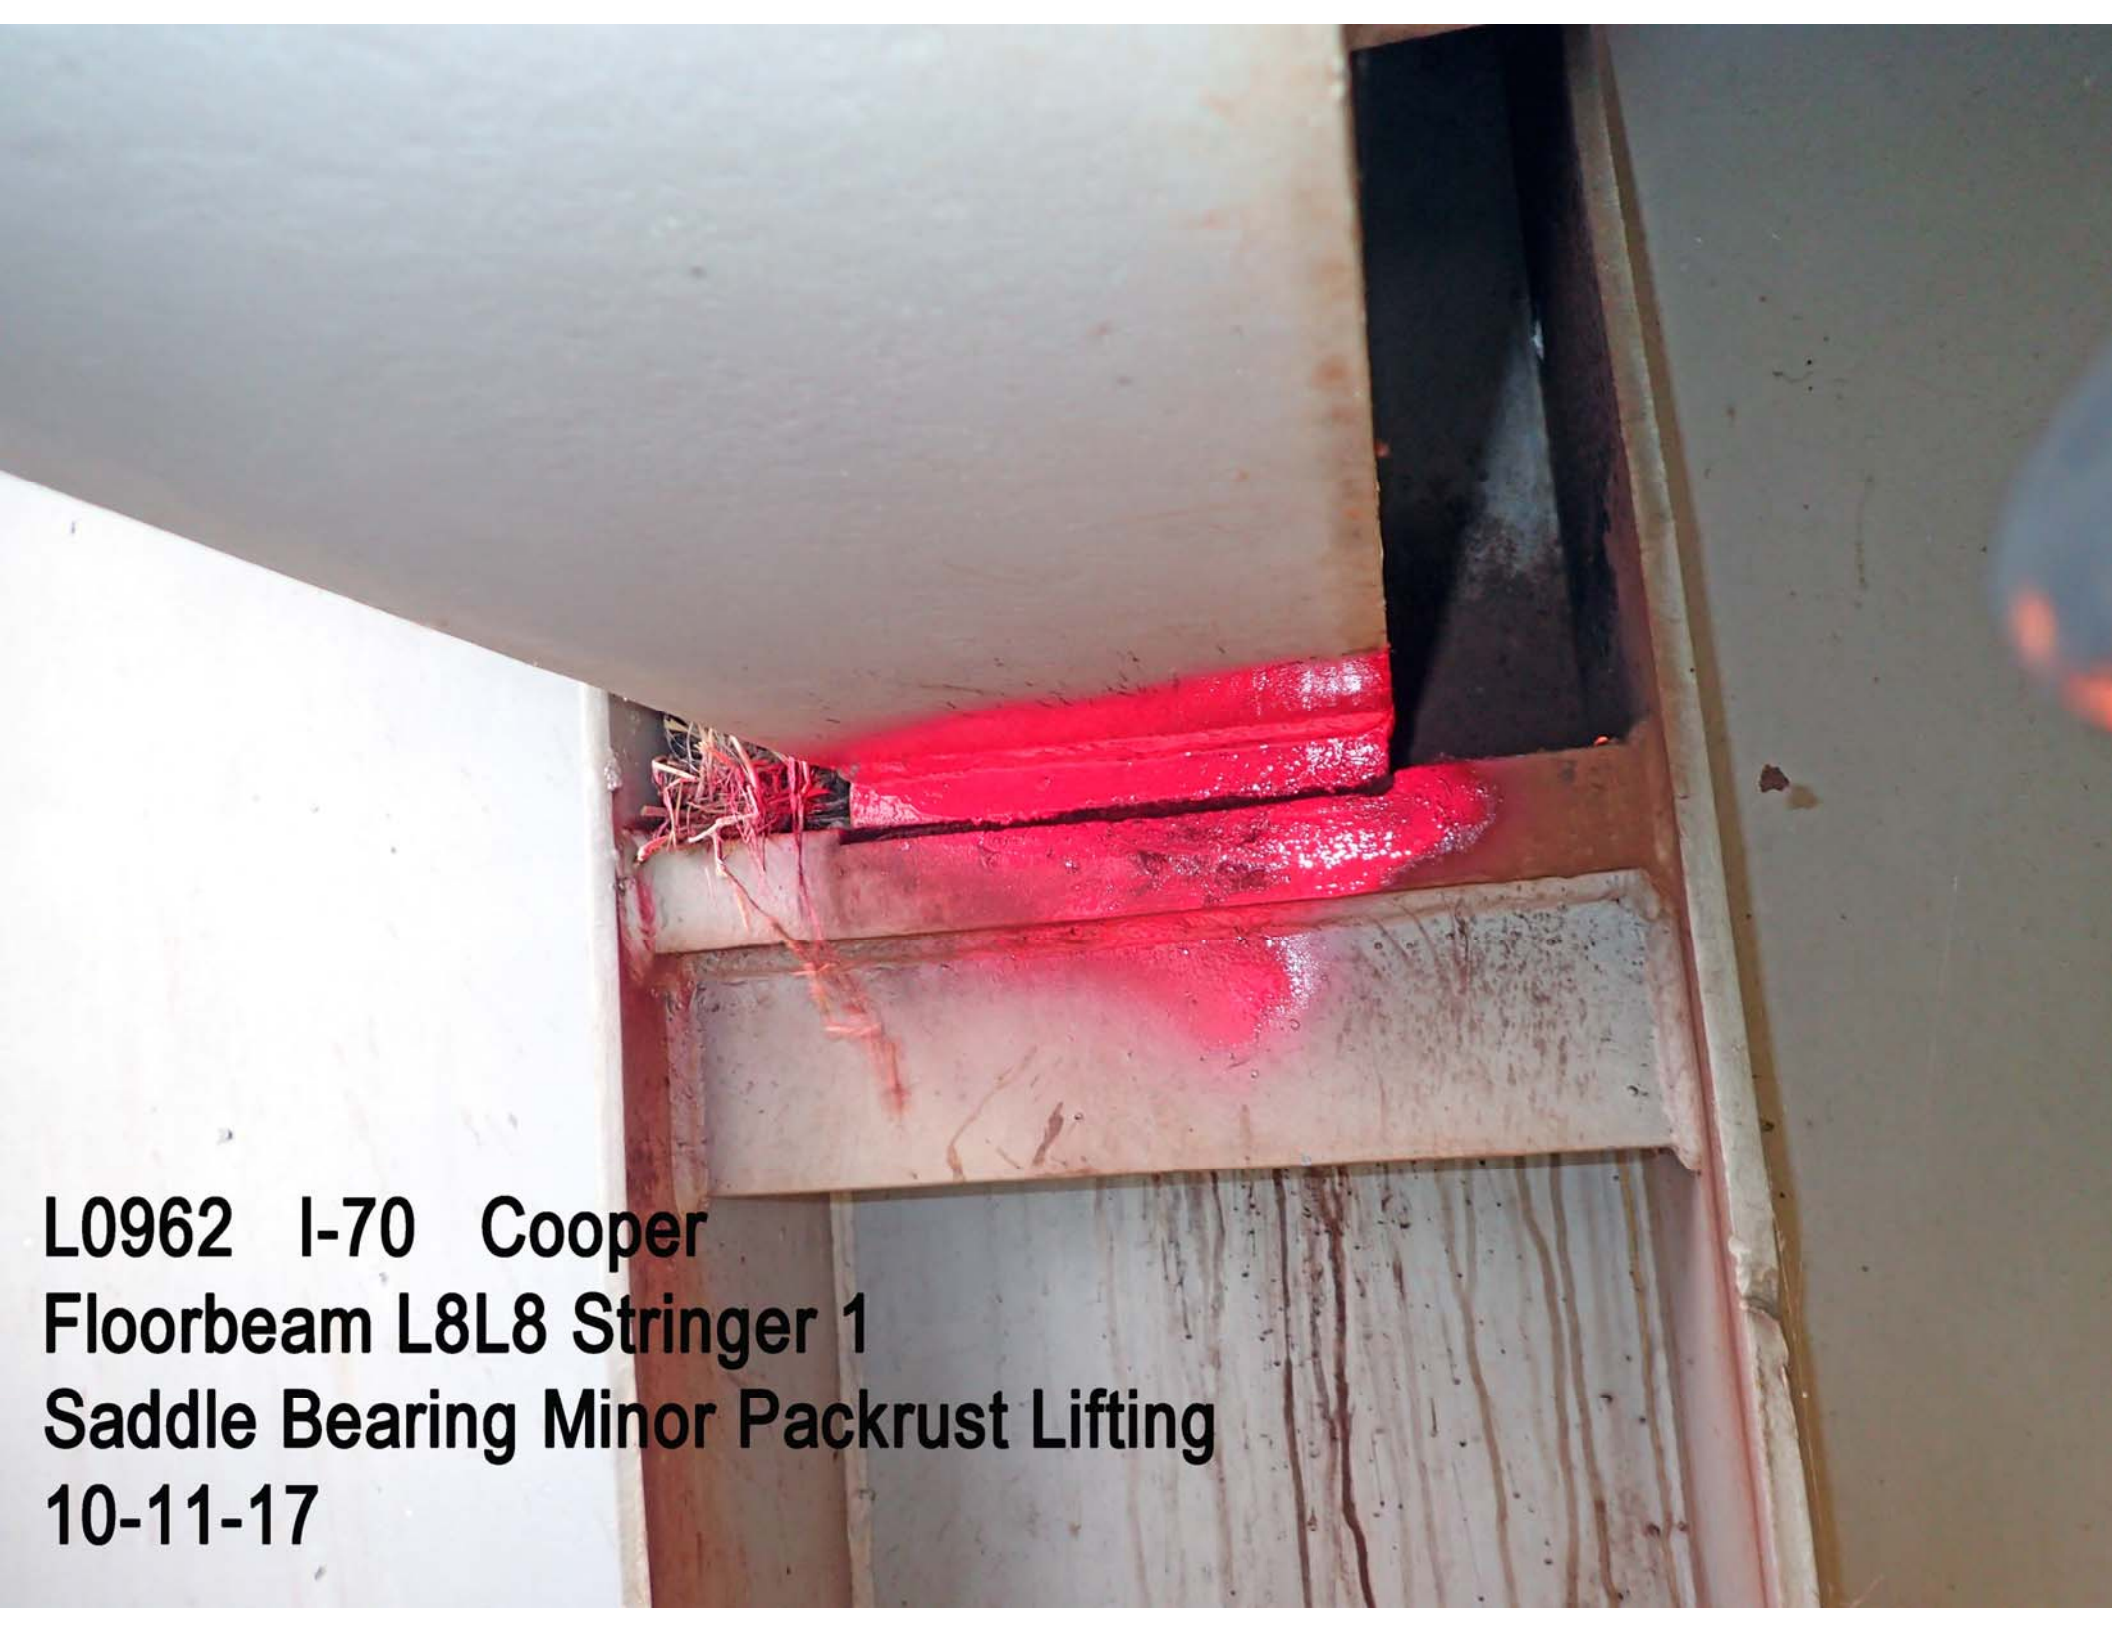
**L0962 I-70 Cooper
Floorbeam L8L8 Stringer 1
Saddle Bearing Minor Packrust Lifting
10-11-17**

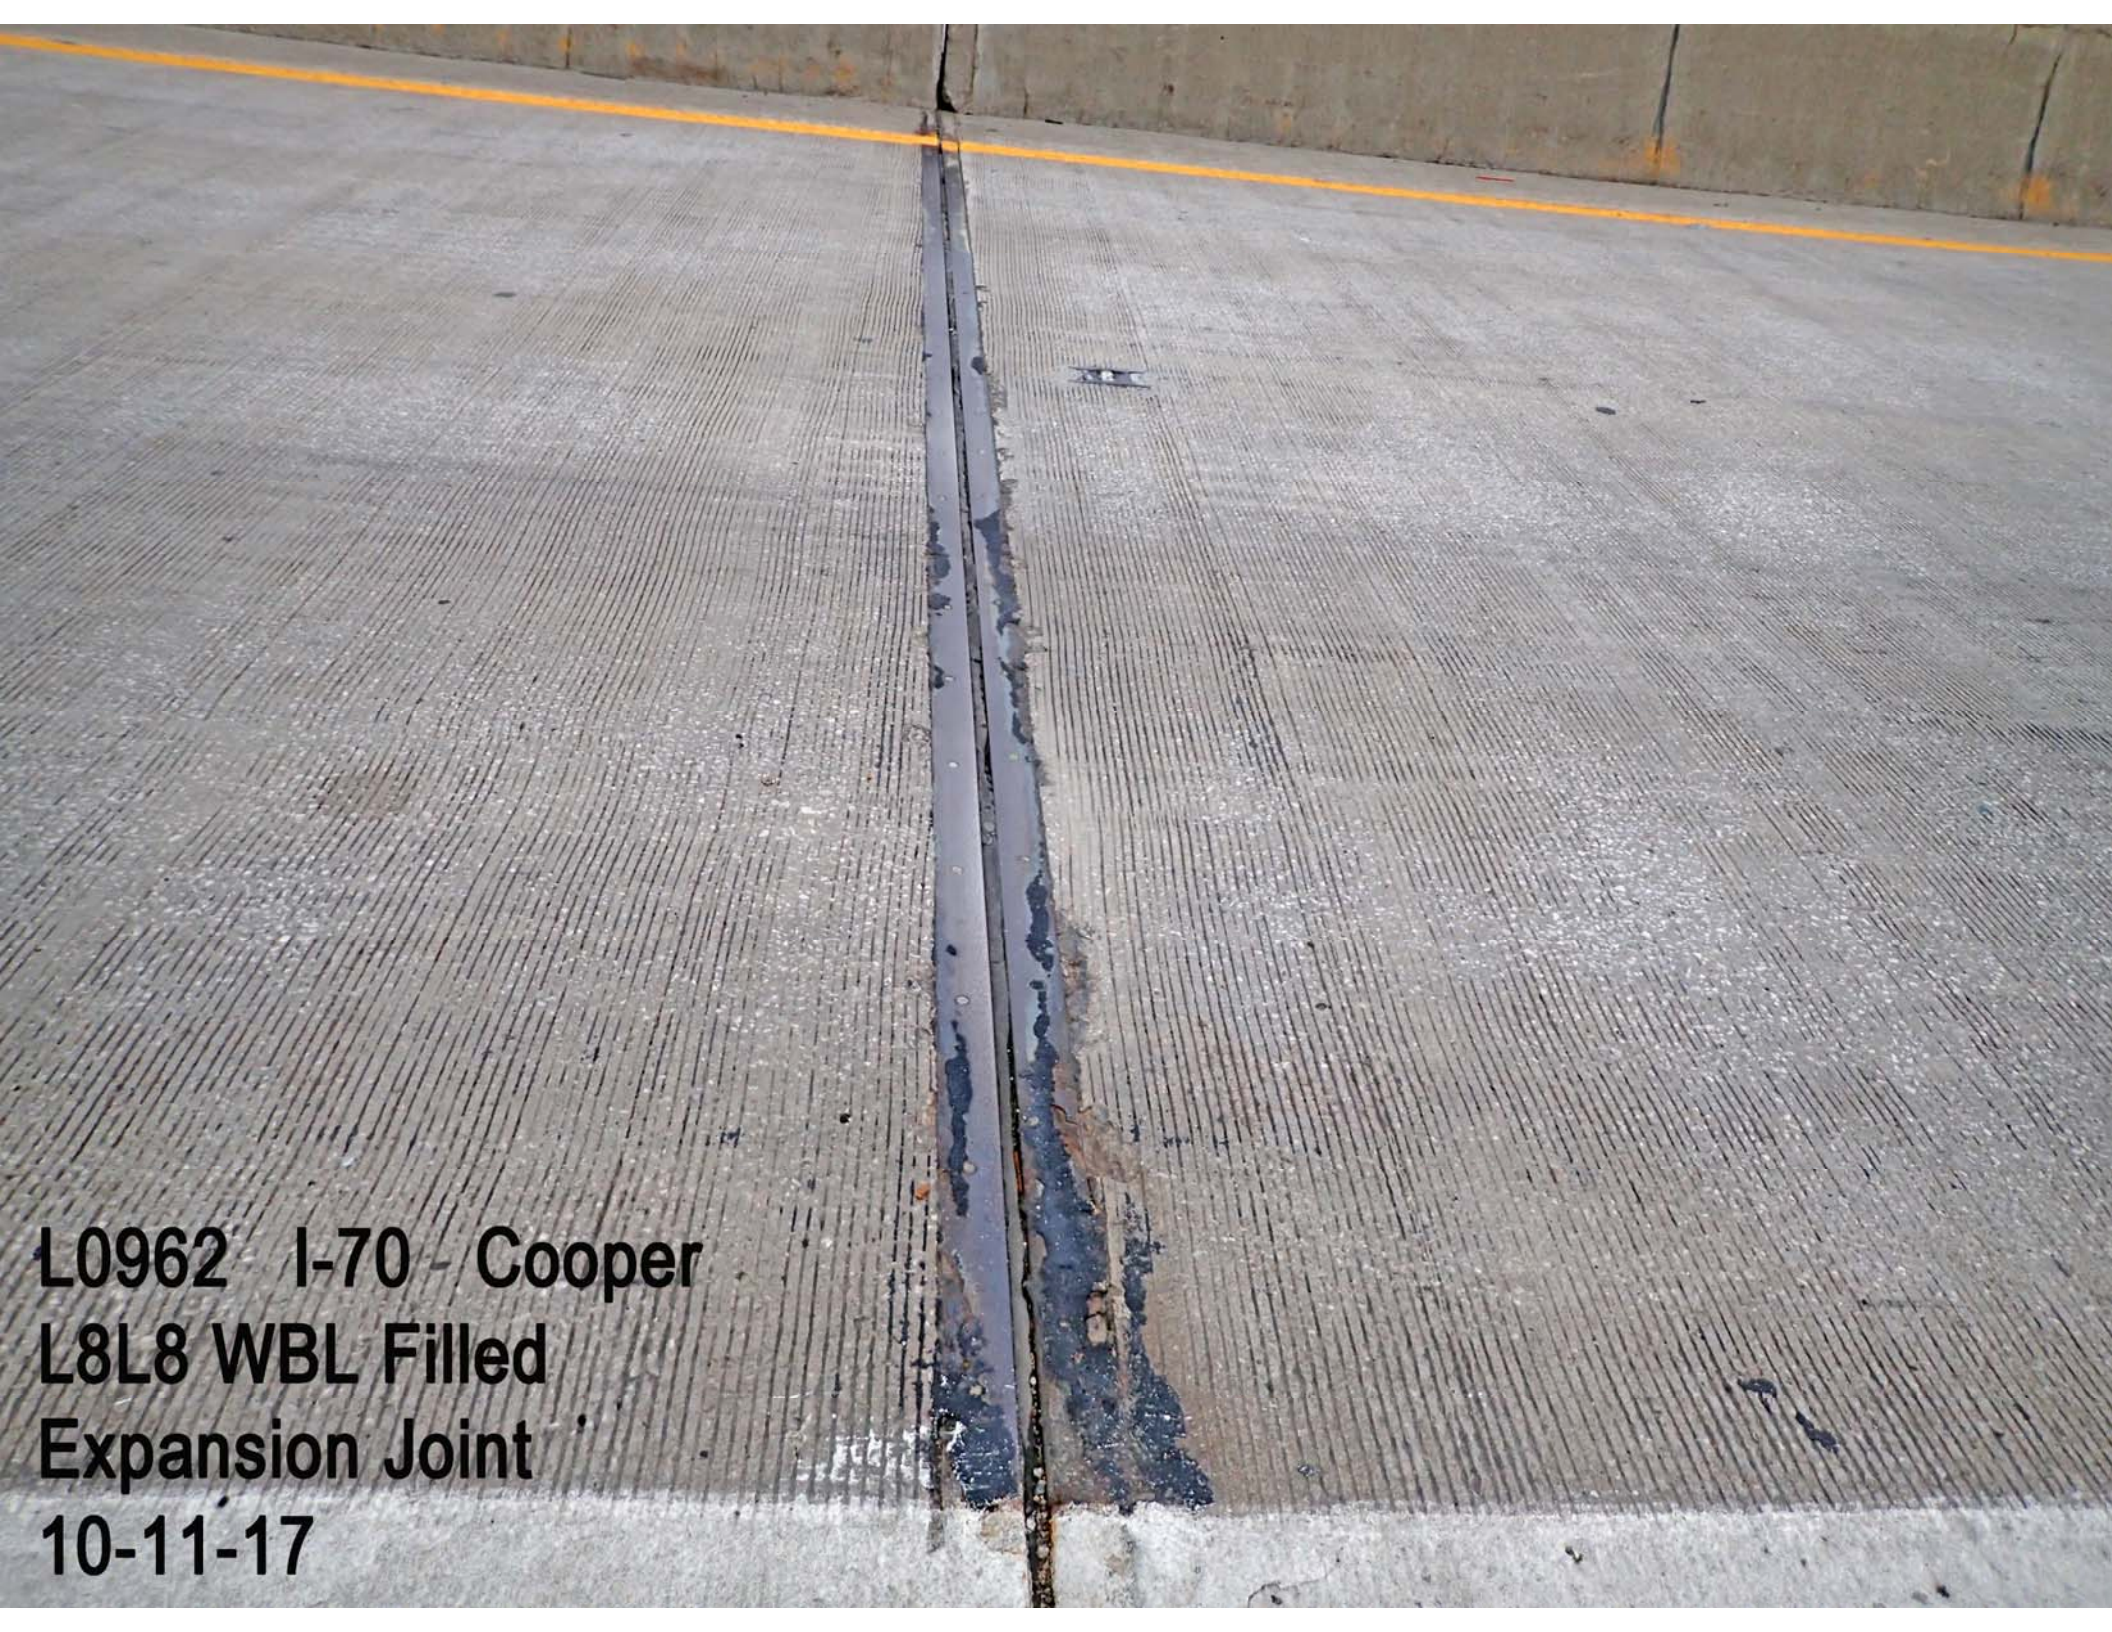
L0962 I-70 - Cooper
L8L8 WBL Filled
Expansion Joint
10-11-17

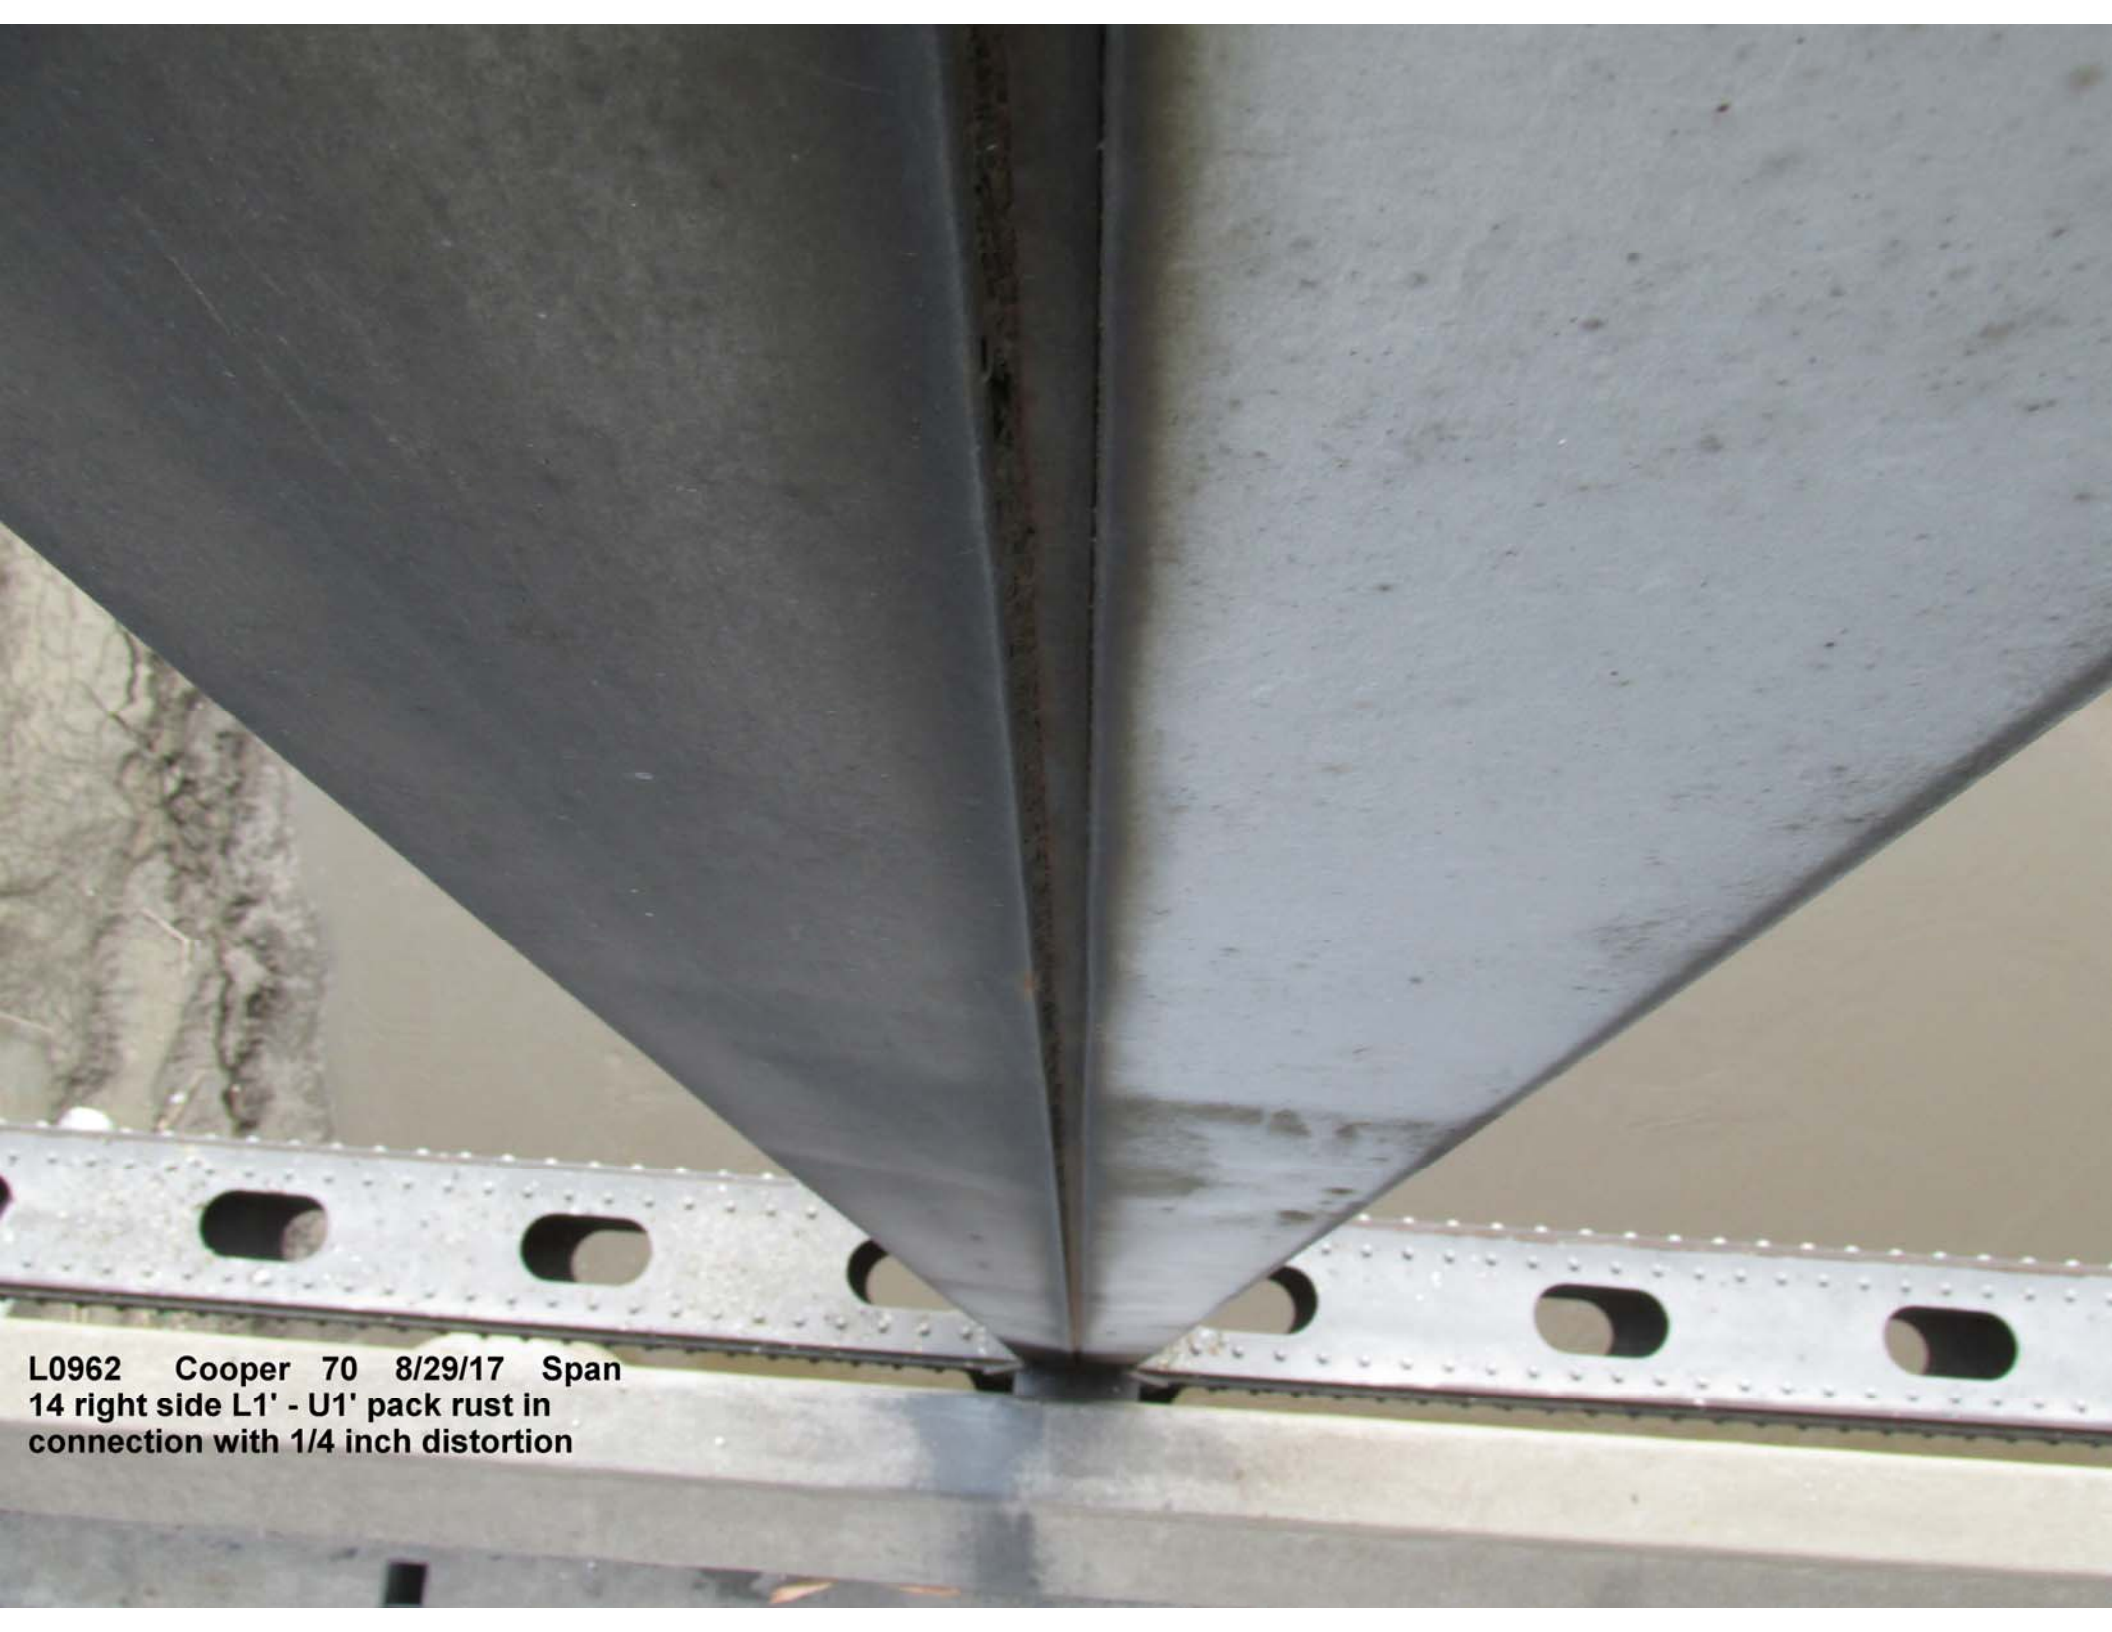
L0962 Cooper 70 8/29/17 Span
14 right side L1' - U1' pack rust in
connection with 1/4 inch distortion

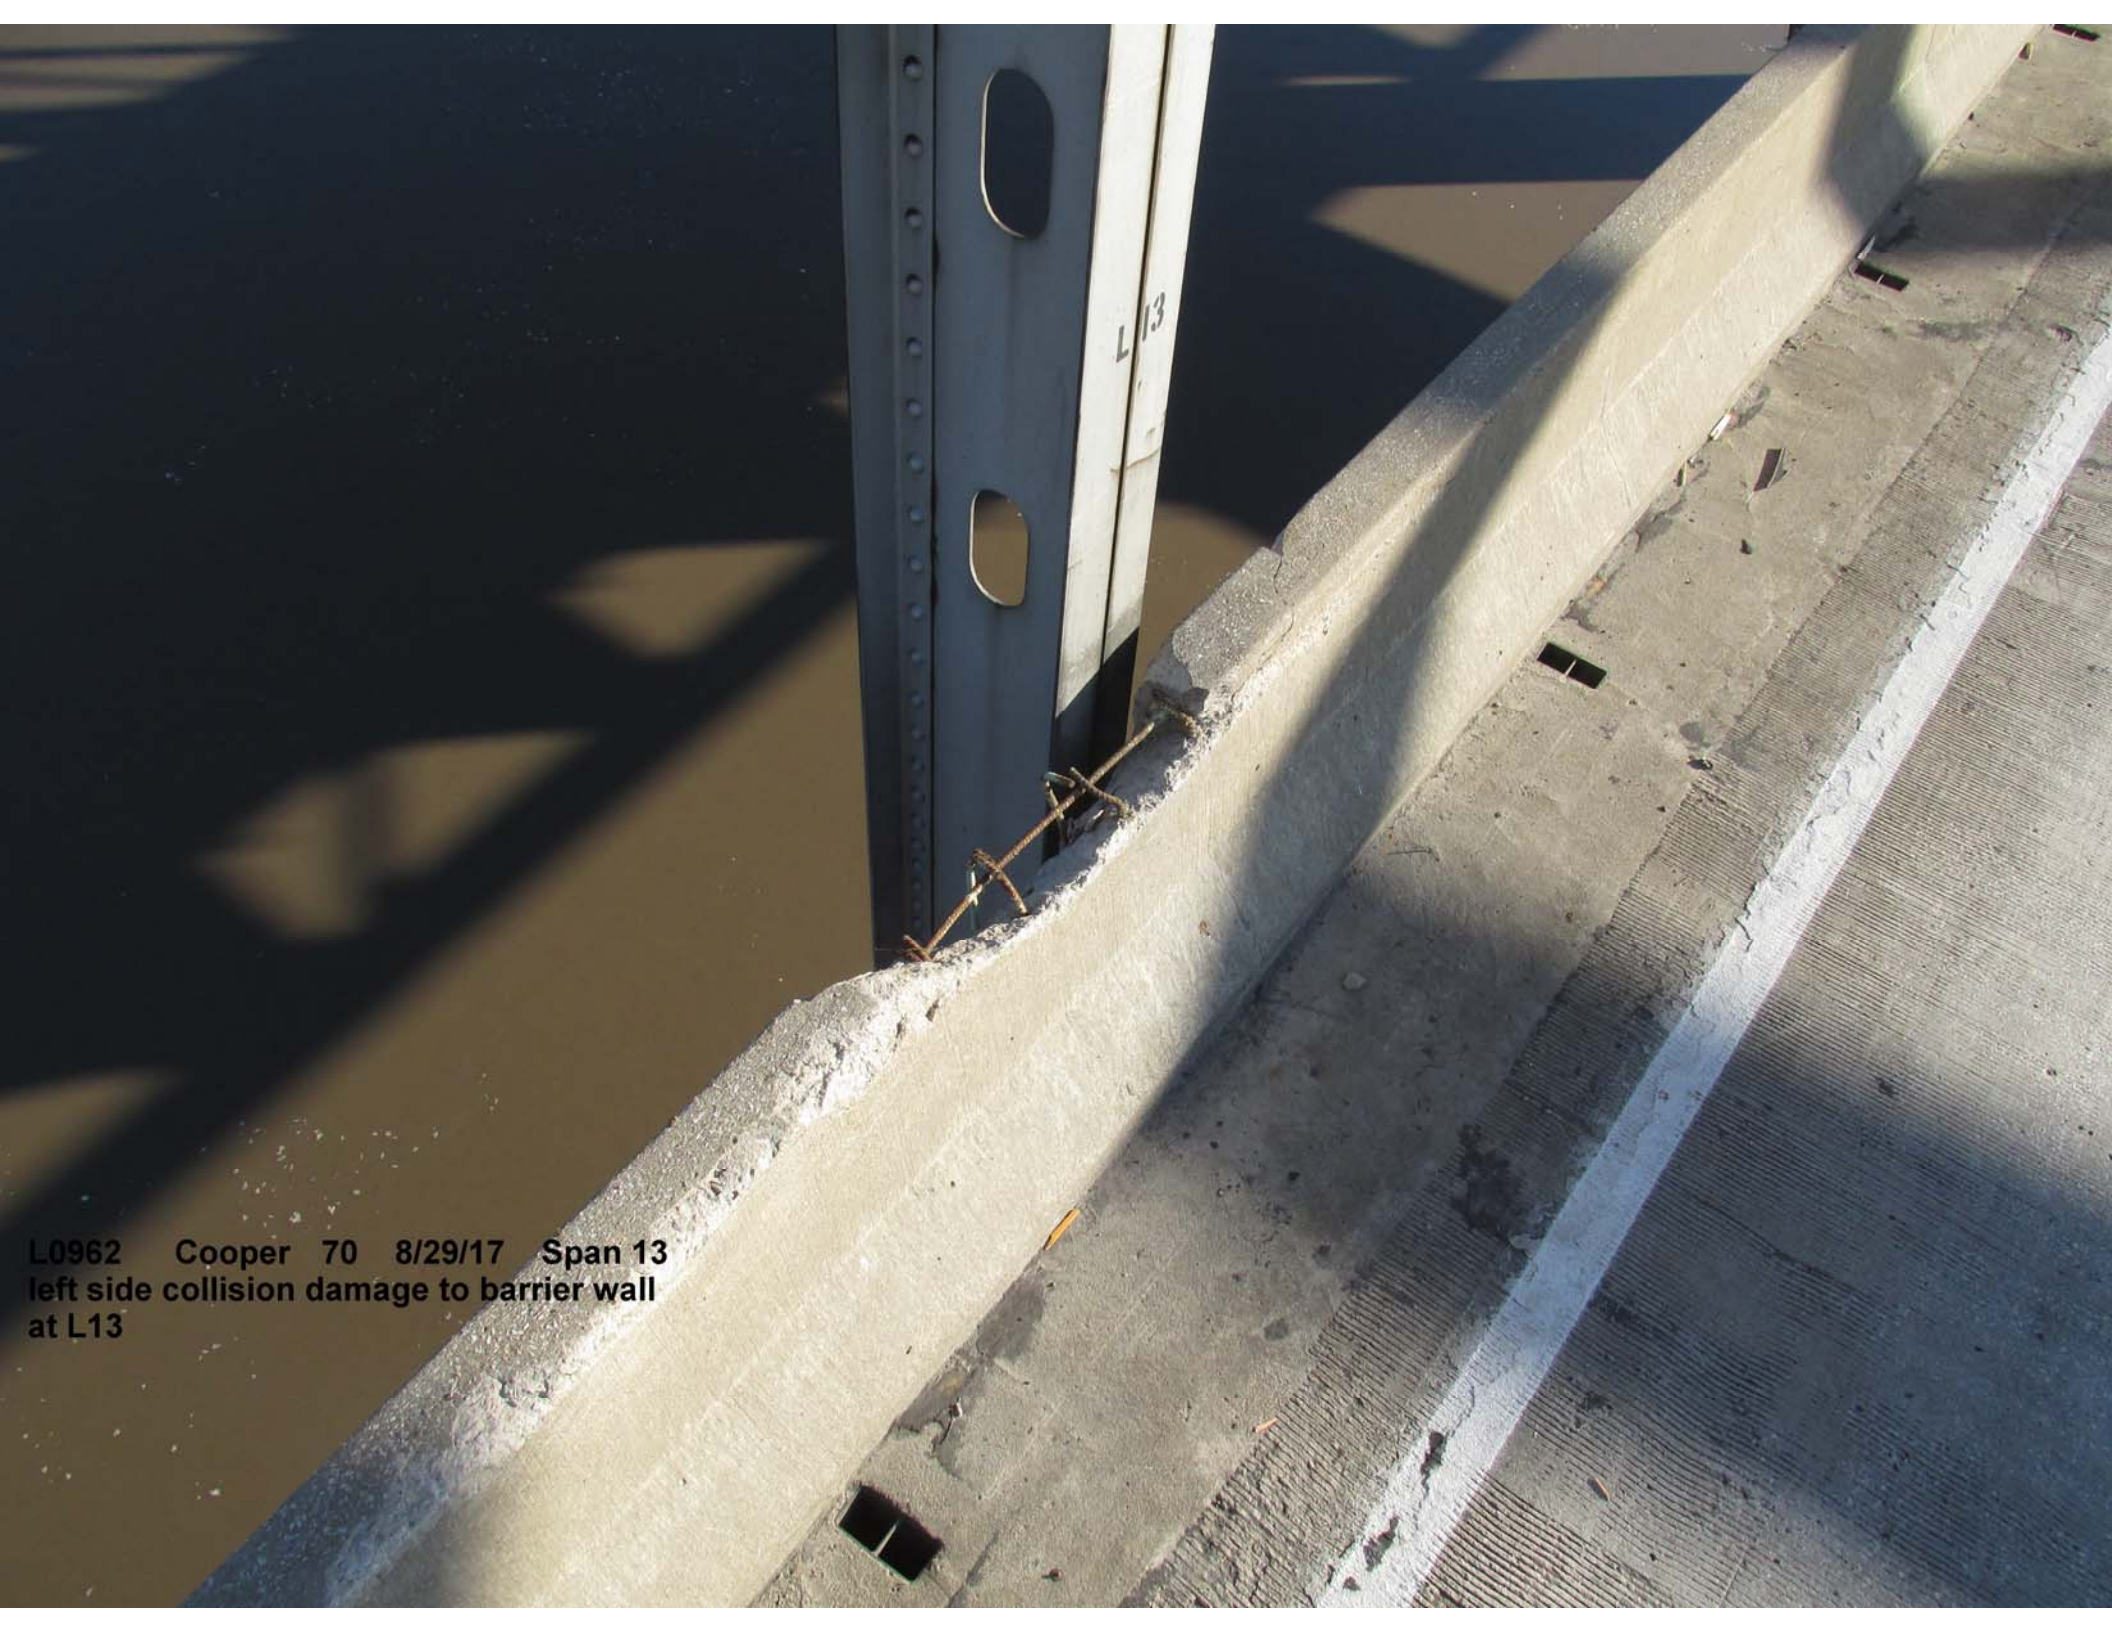
L0962 Cooper 70 8/29/17 Span 13
left side collision damage to barrier wall
at L13
