L0962 Cooper Co.
08/28/2017
Looking West

L0962 I-70 Cooper
Pier 15 Open Expansion Joint WBL
8-28-17

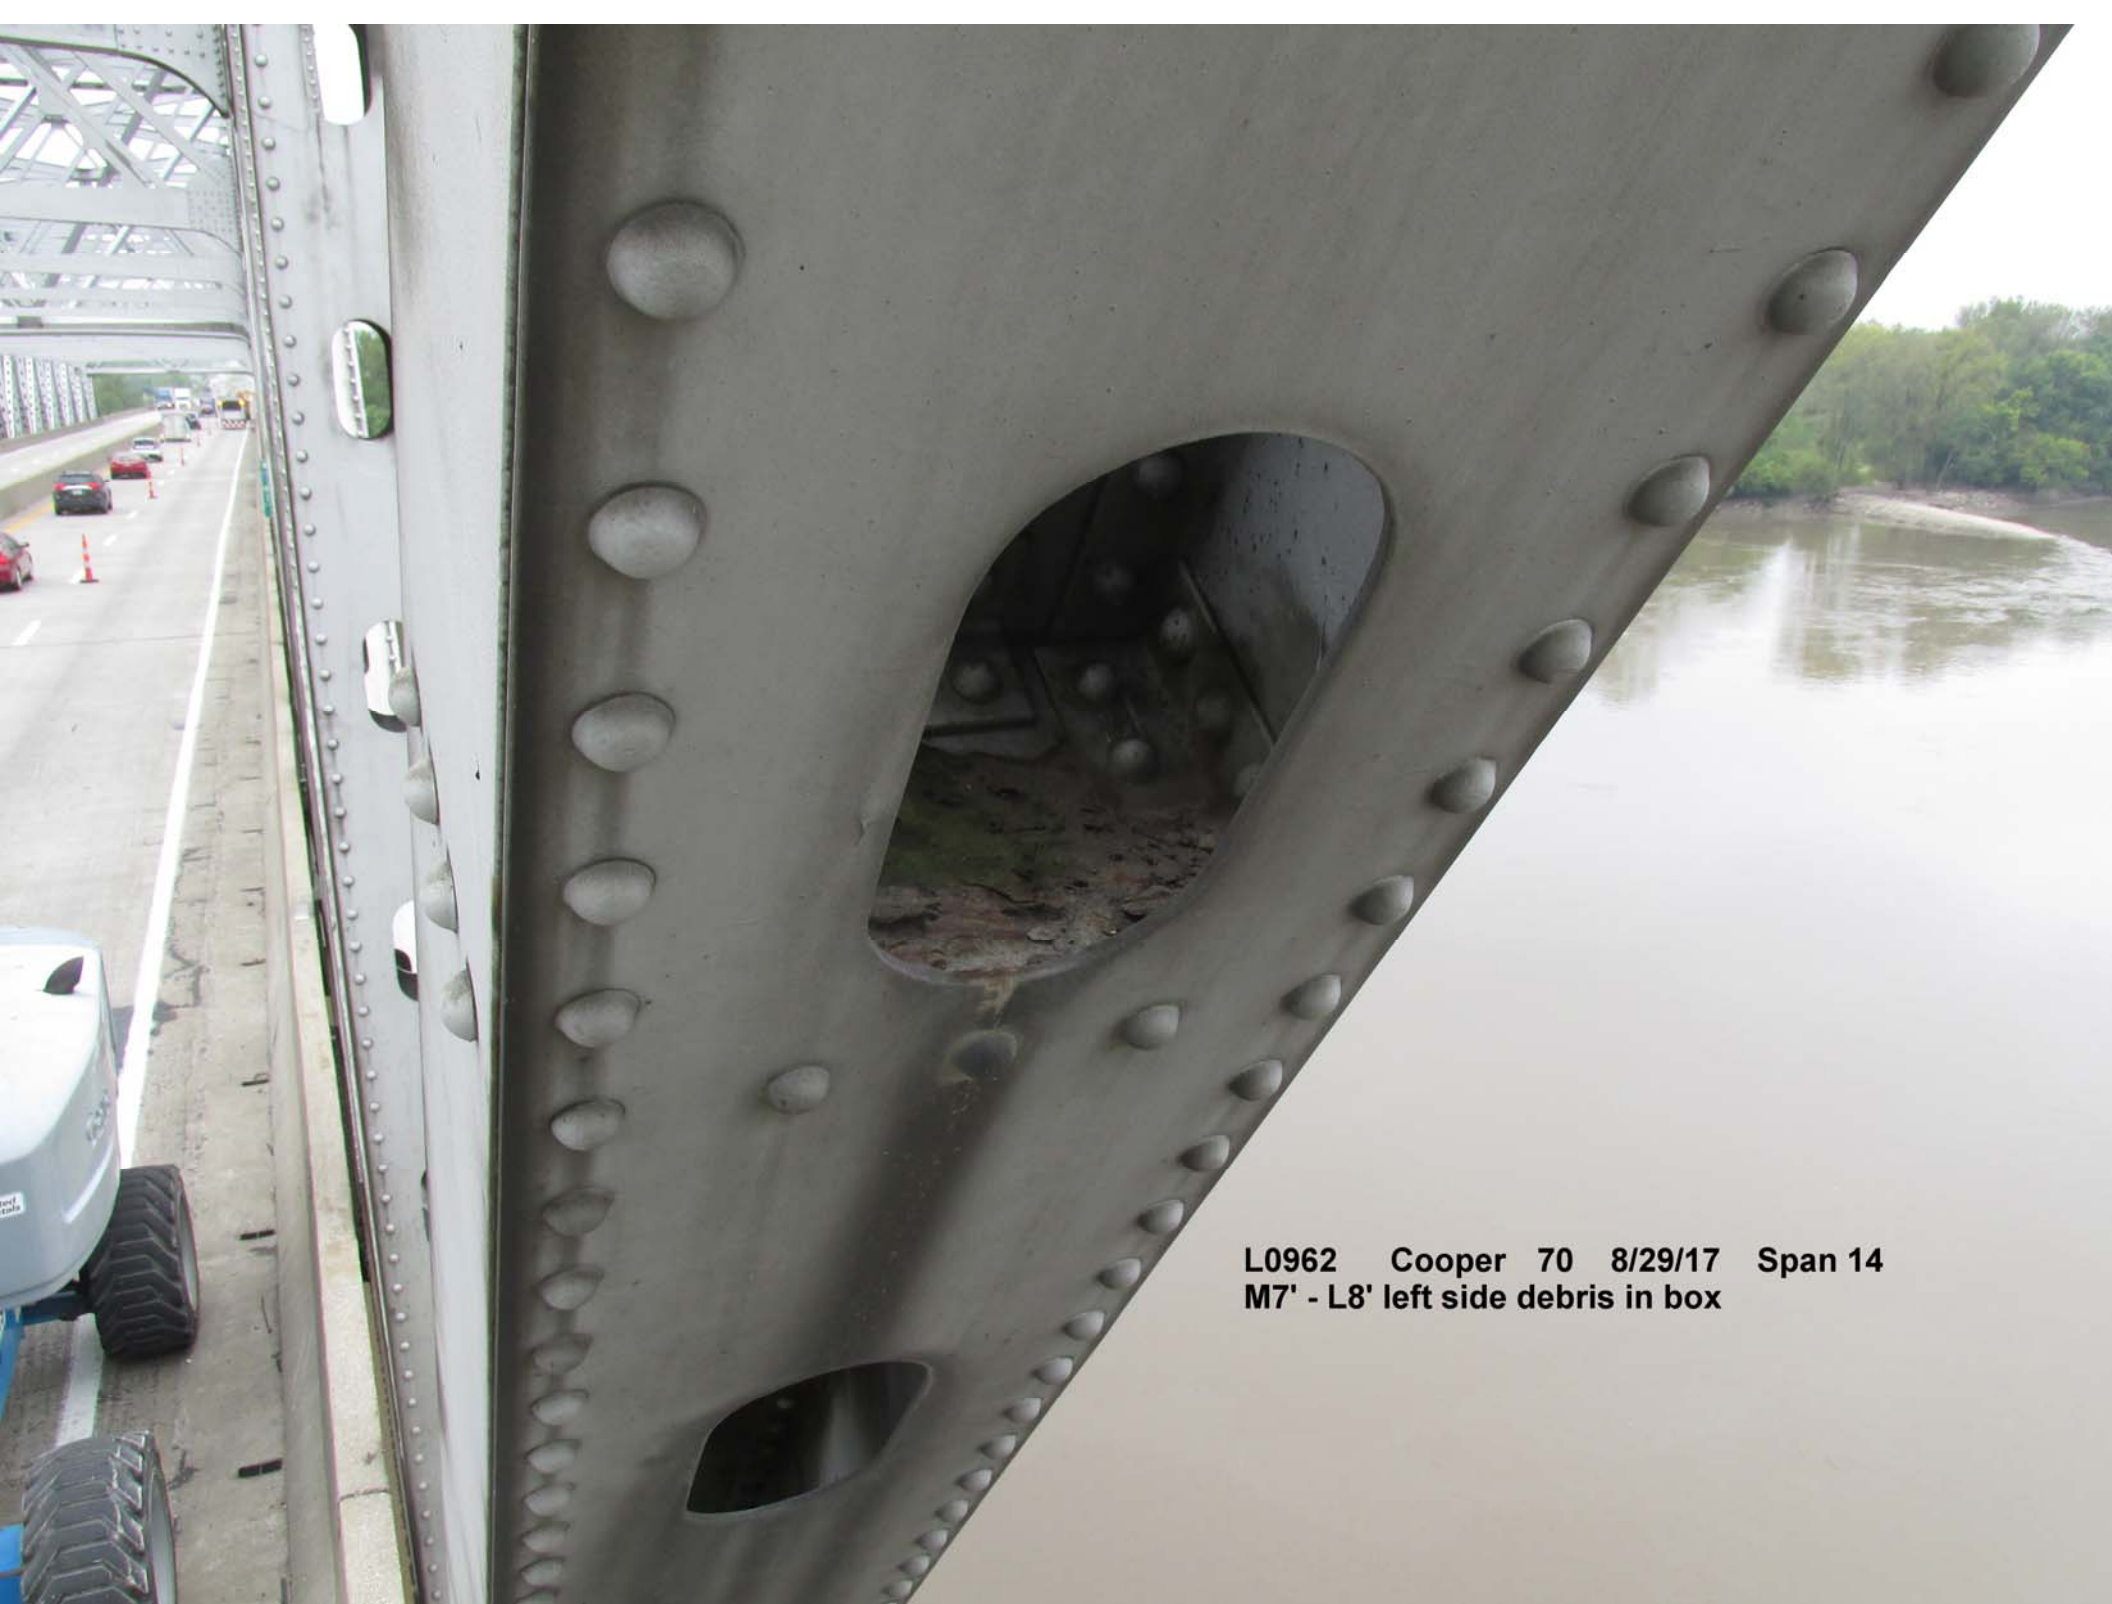
L0962 Cooper 70 8/29/17 Span 14
M7' - L8' left side debris in box

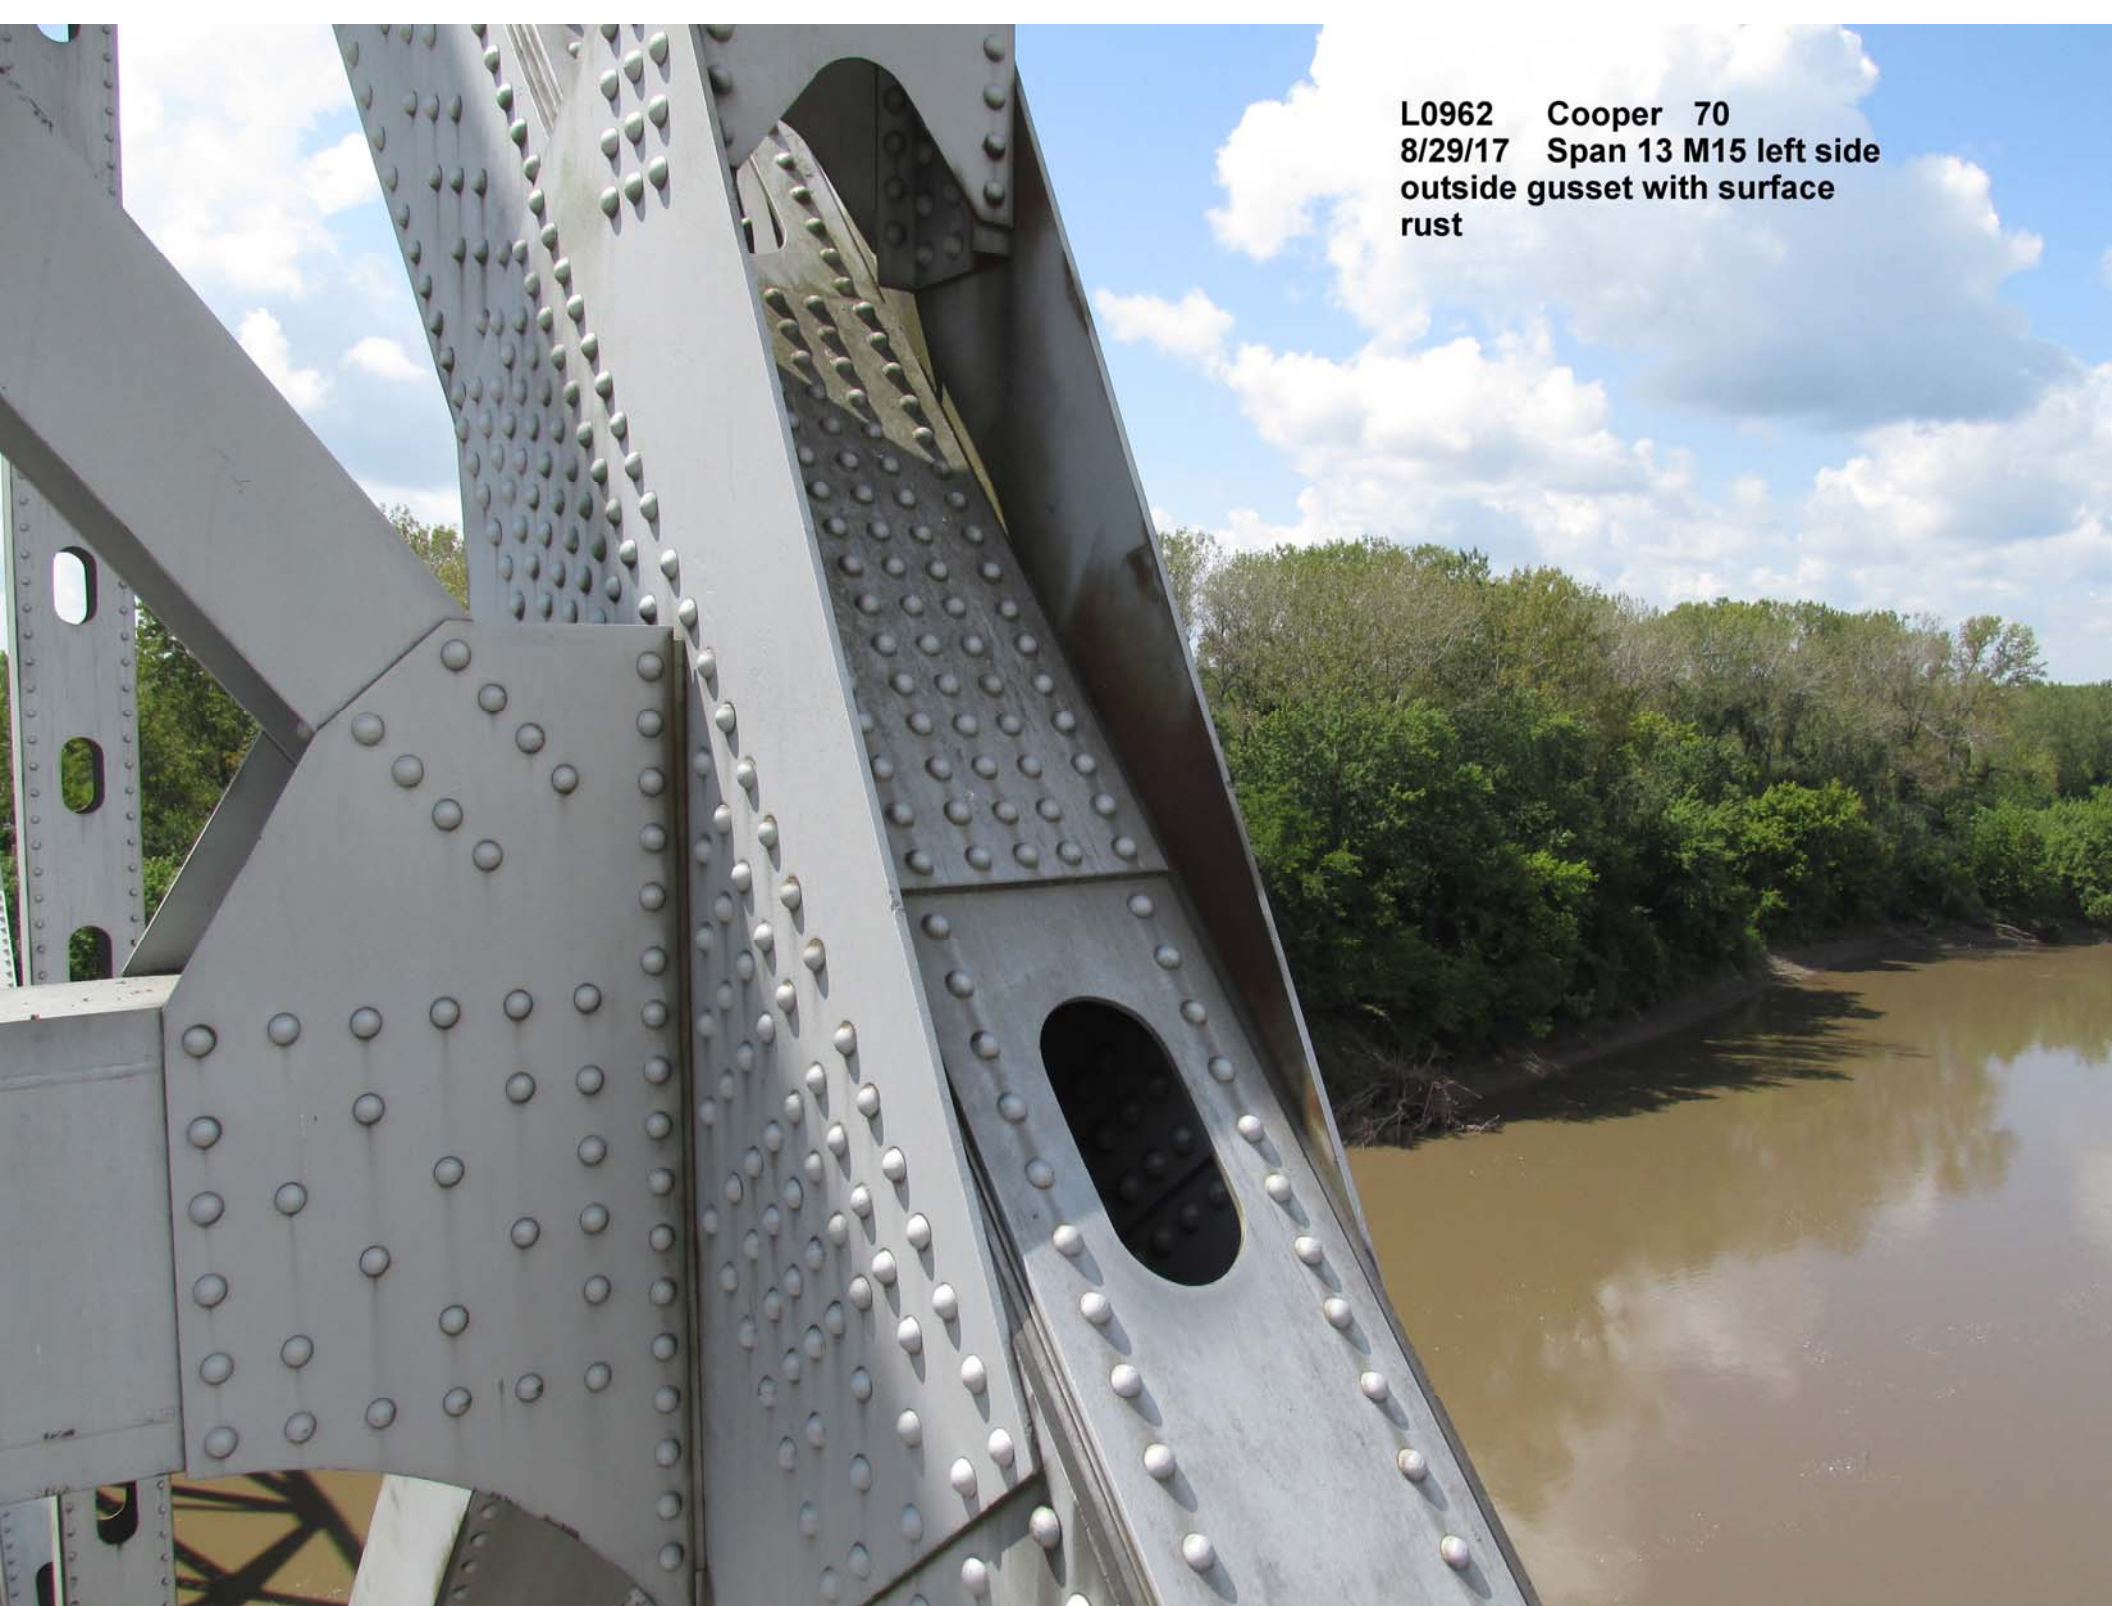
L0962 Cooper 70 8/29/17
Span 13 I20 - M19 left side grass
growing in portal connection

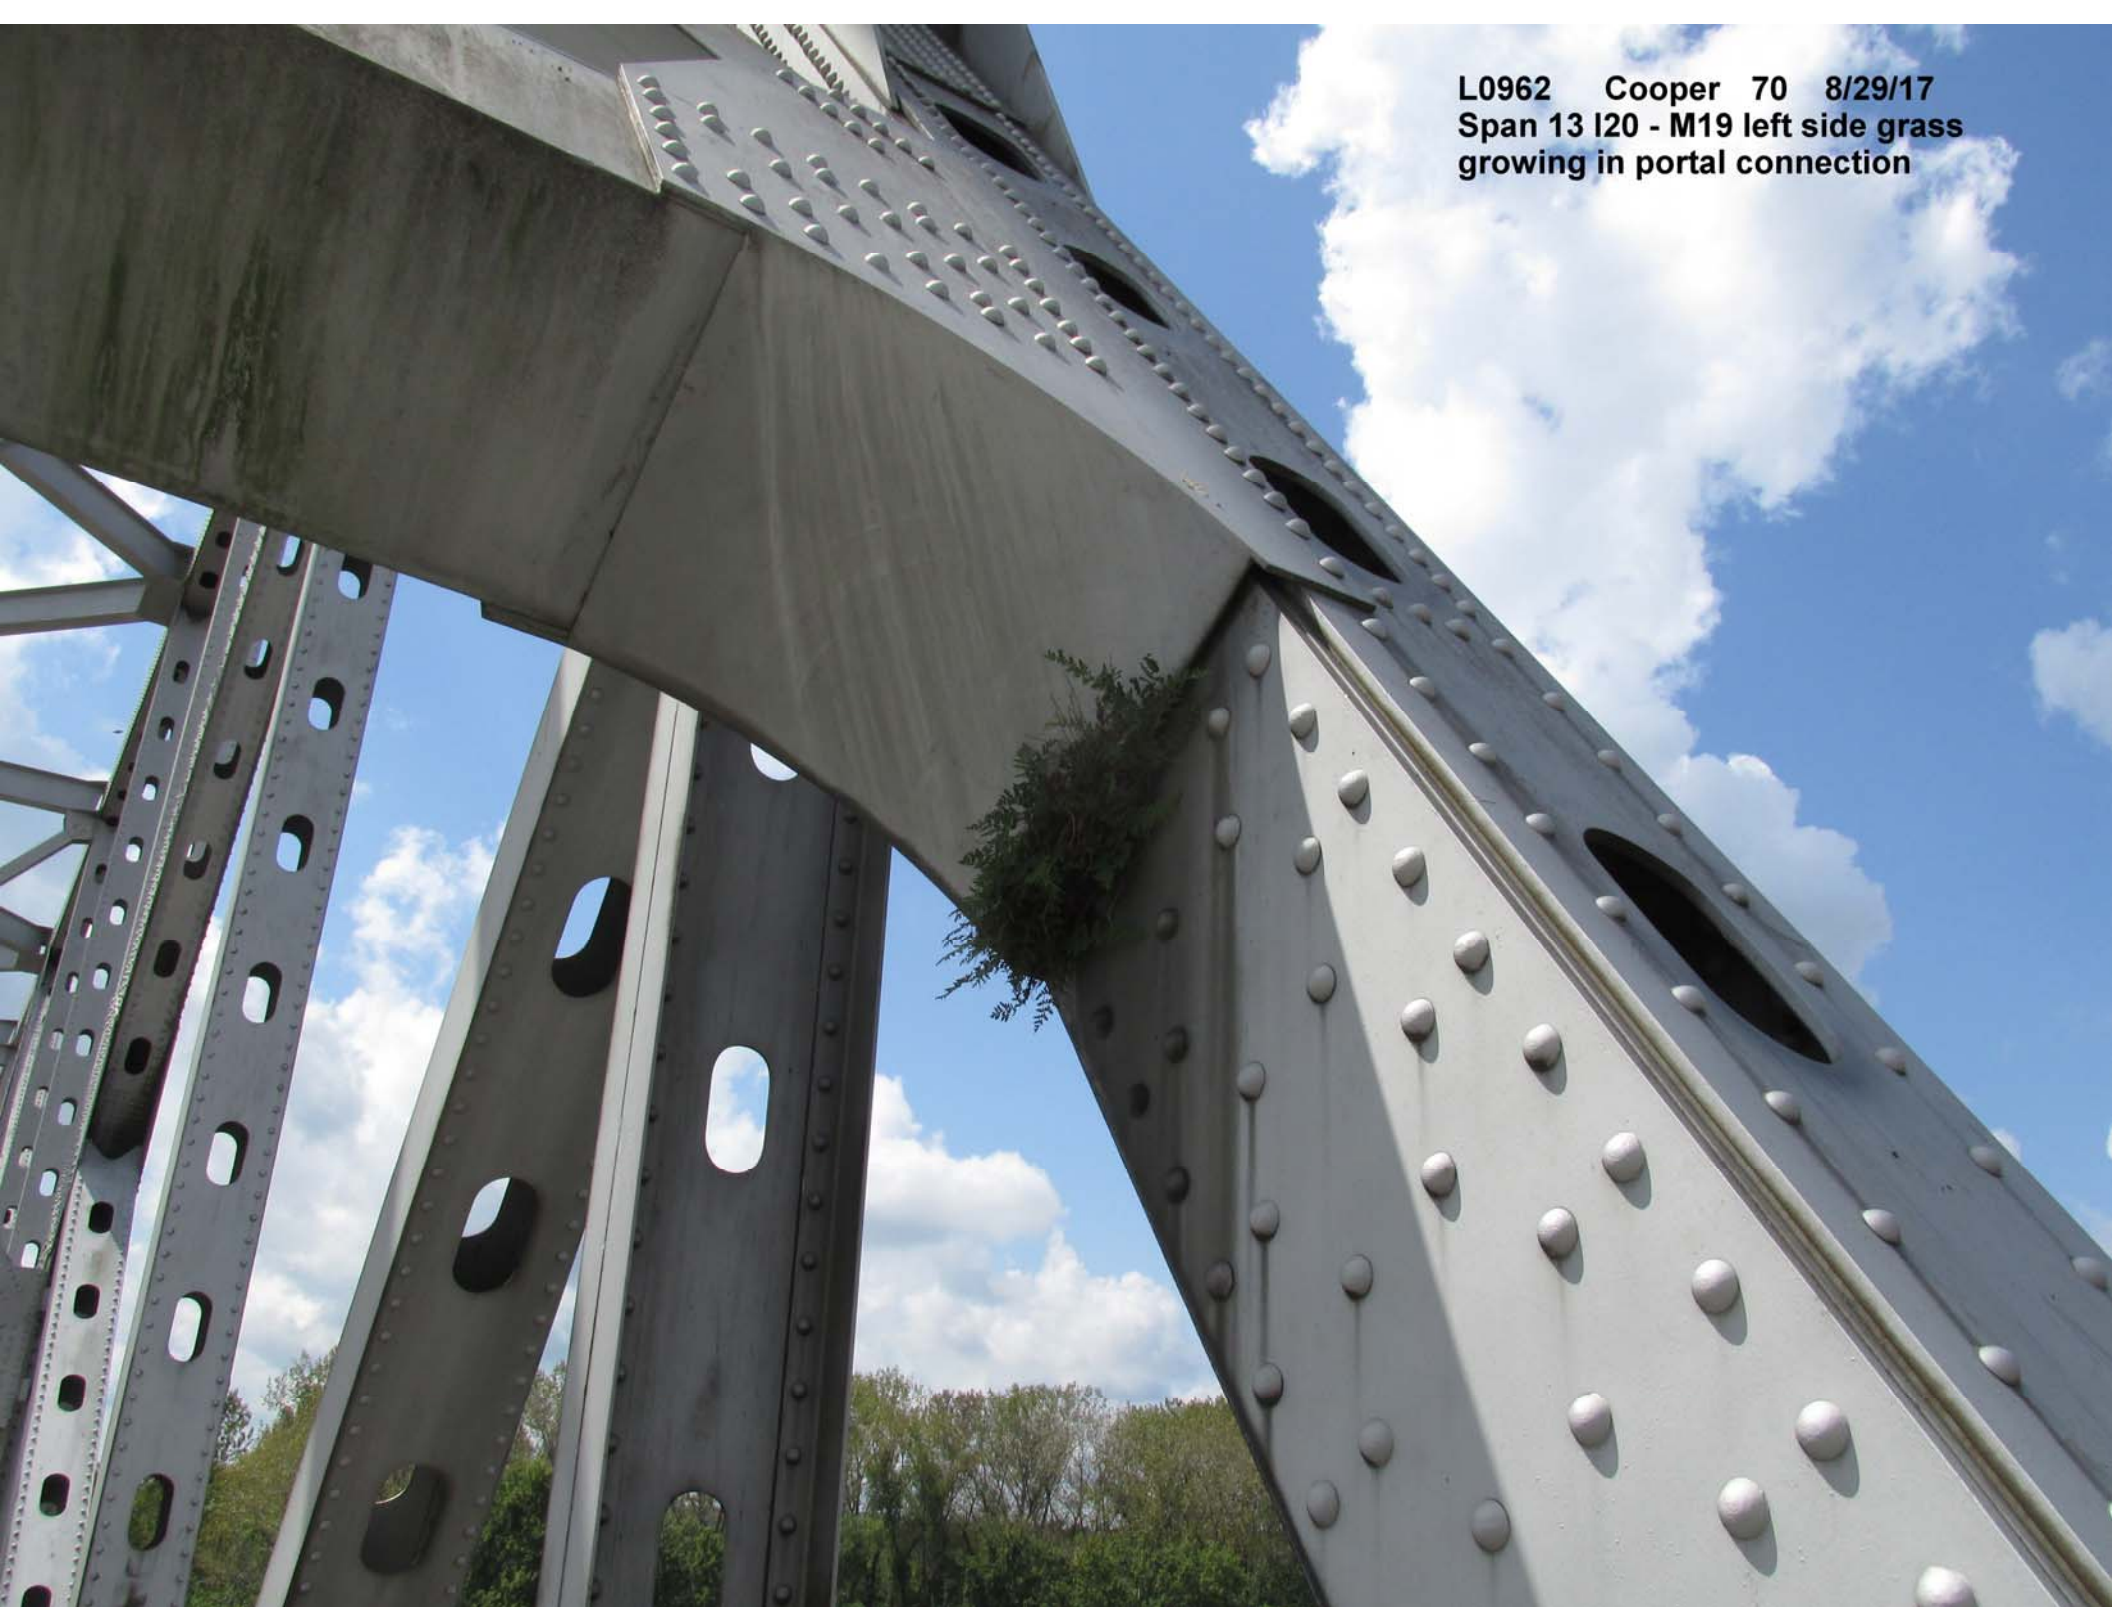
L0962 Cooper 70 8/29/17
Span 14 M7' - L7' vertical minor
surface rust
