**Route 19 over Current River (Br. G0804)  
Rehabilitation / Replacement Concept Study  
Report of Field Investigation**

**MoDOT Project No.: J9P3305**

**Route 19 over Spring Valley (Br. J0420)  
Rehabilitation / Replacement Concept Study  
Report of Field Investigation**

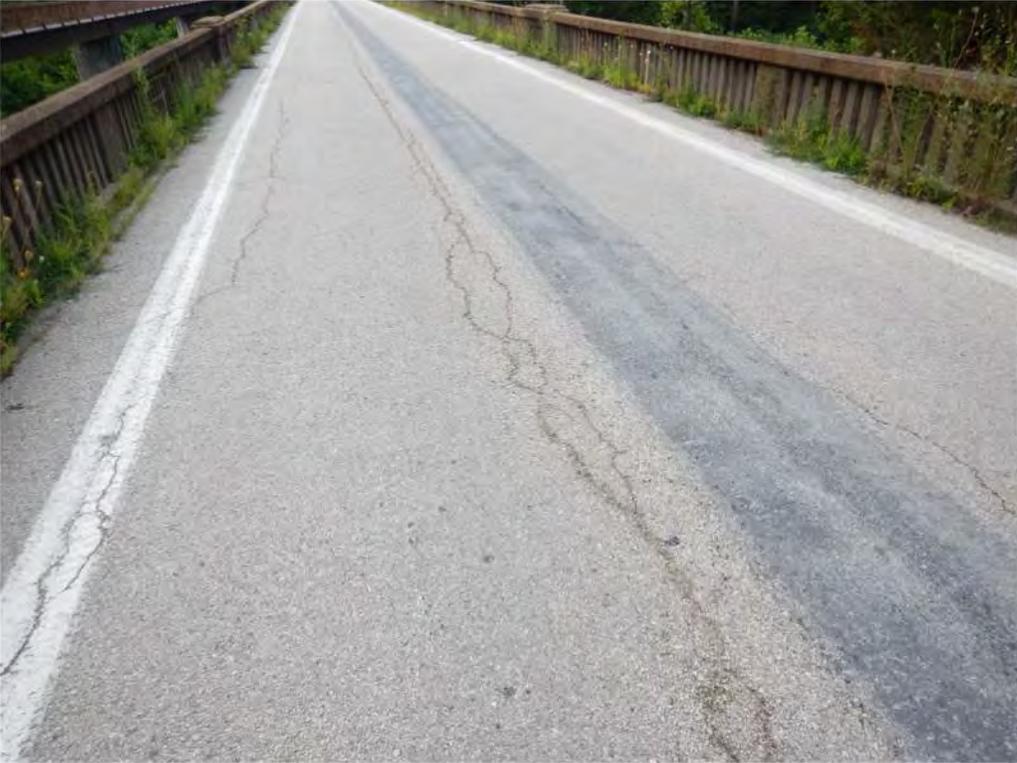
Pic. 001: Typical view of pavement, north end shown.

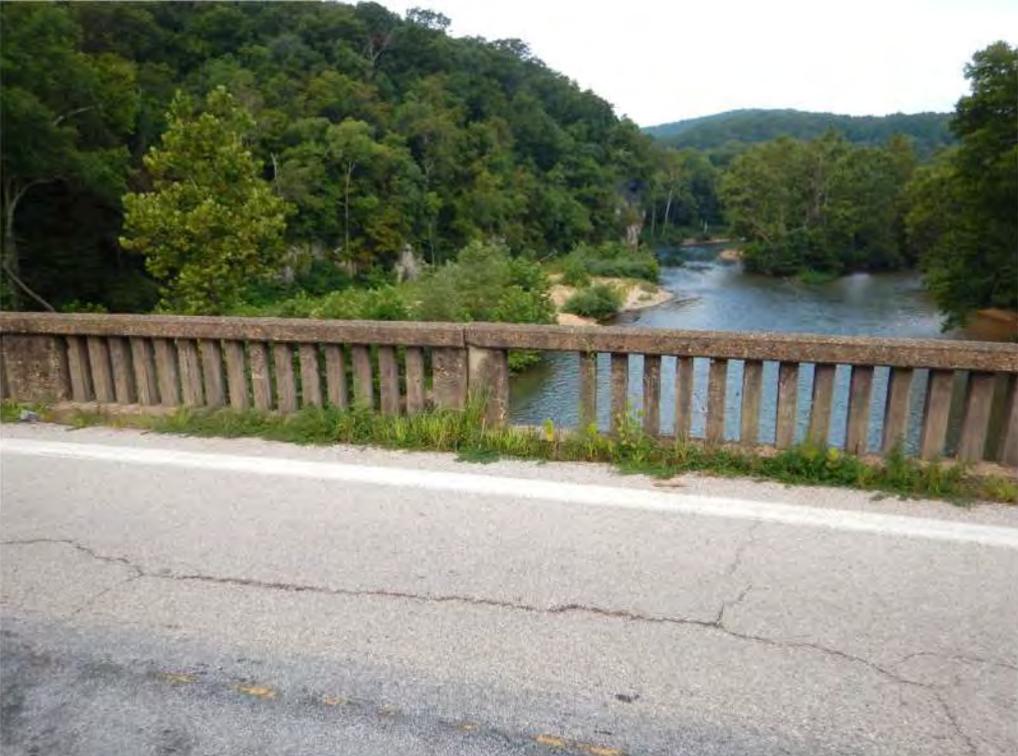
Pic. 003: West barrier, Span (2-3)

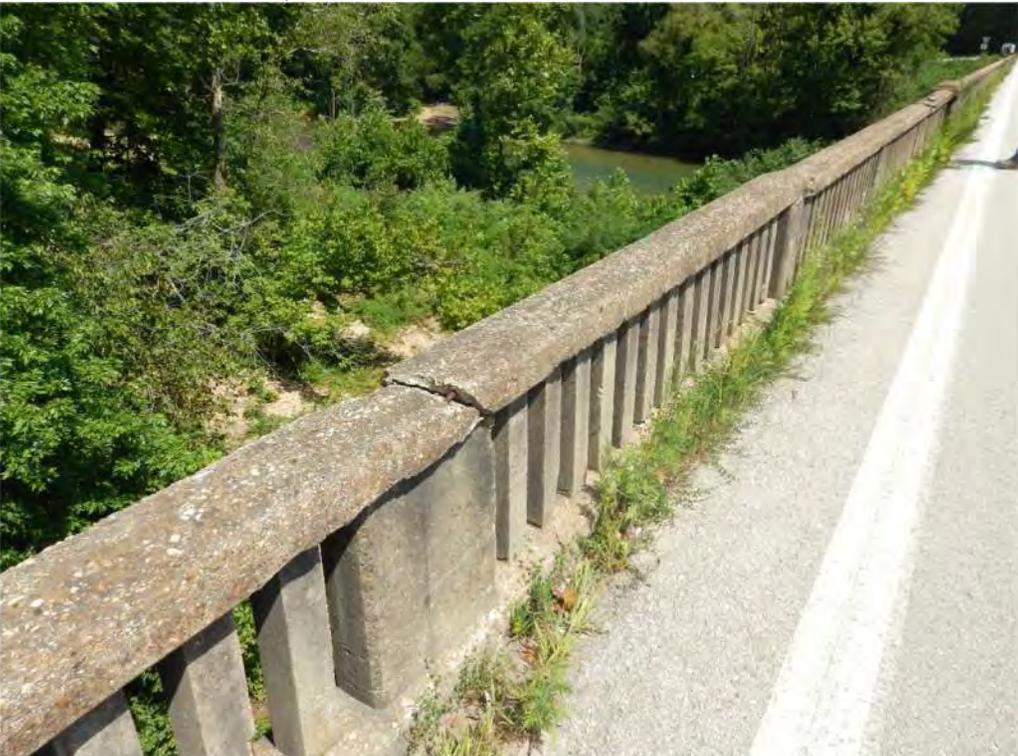
Pic. 004: West barrier, Span (4-5)

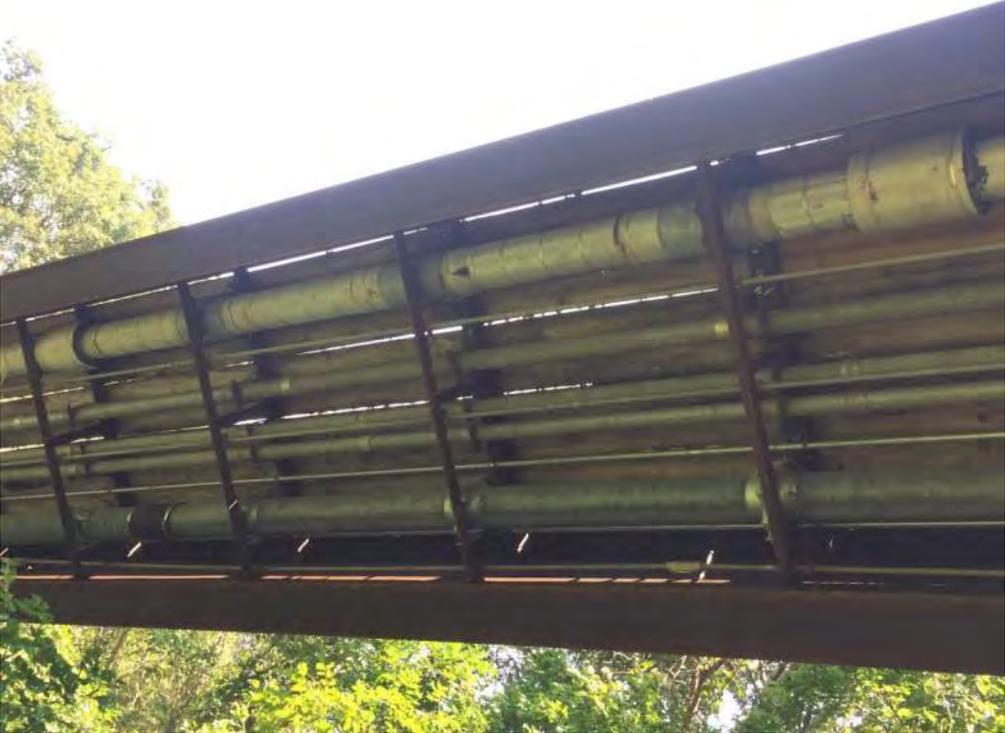
Pic. 010: Utilities on adjacent pedestrian / utility crossing

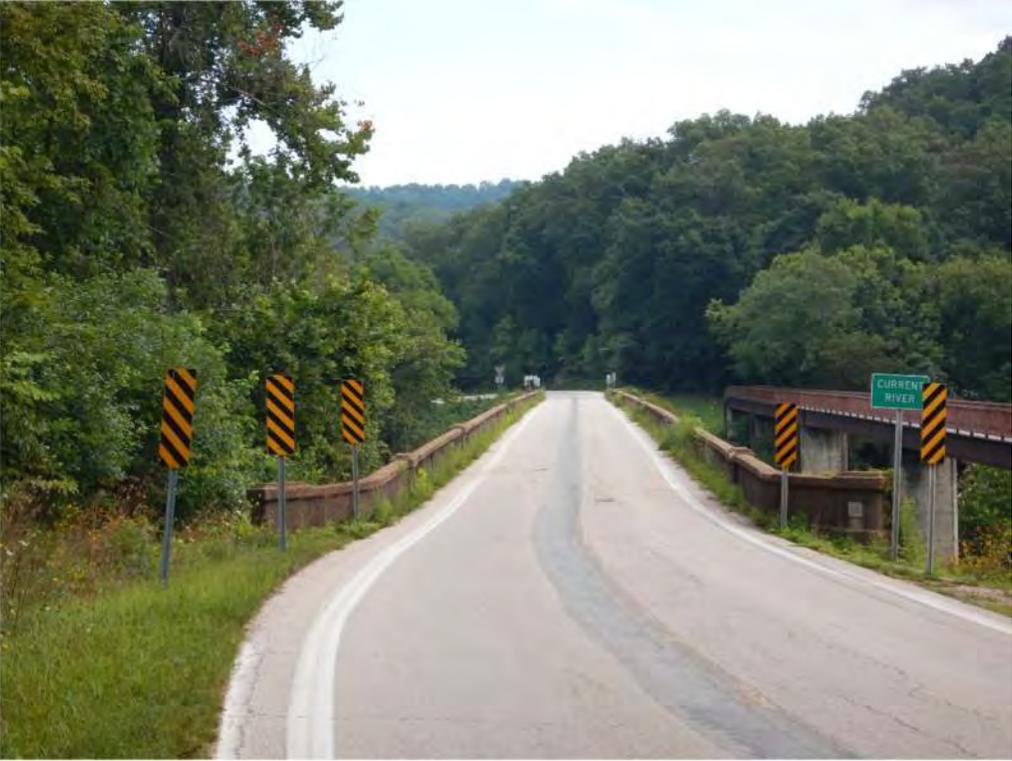
Pic. 013: Roadway over bridge looking north

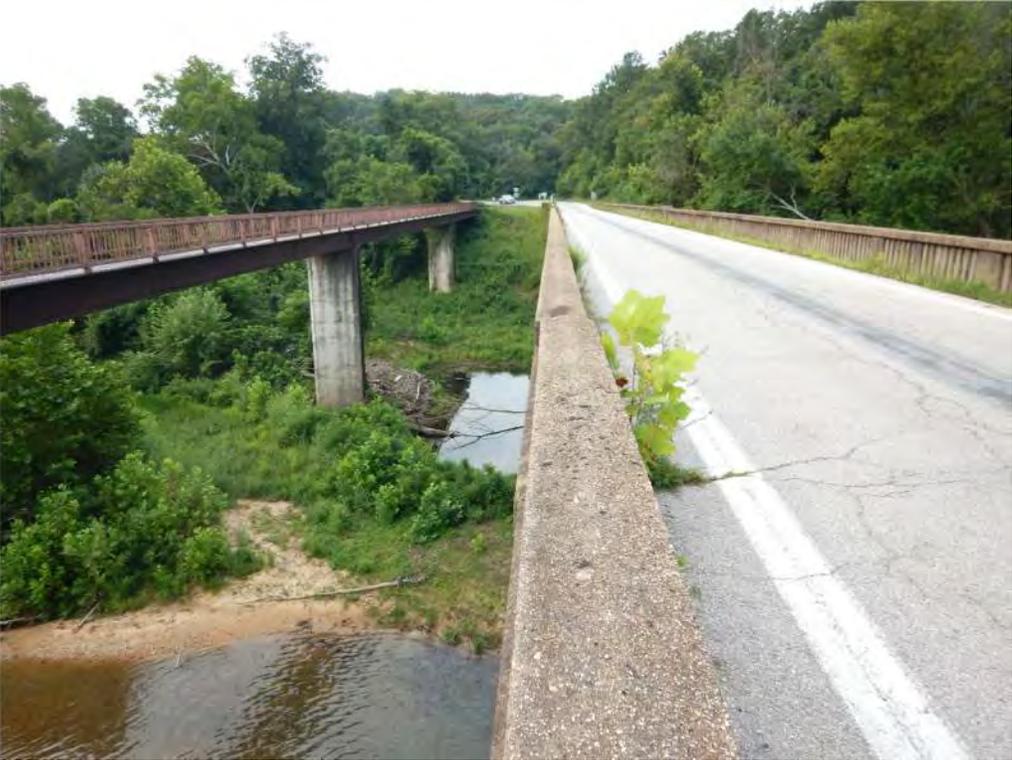
Pic. 014: Pedestrian / utility crossing east of highway, looking south

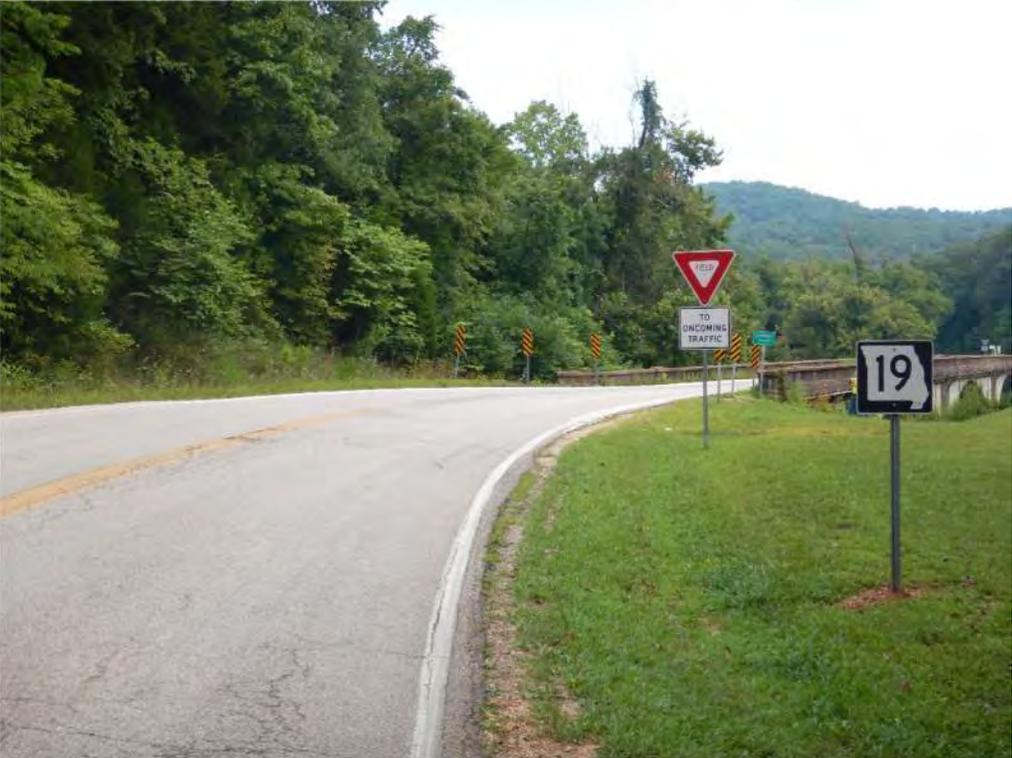
Pic. 015: Reduction to single lane with yield sign, south end of bridge

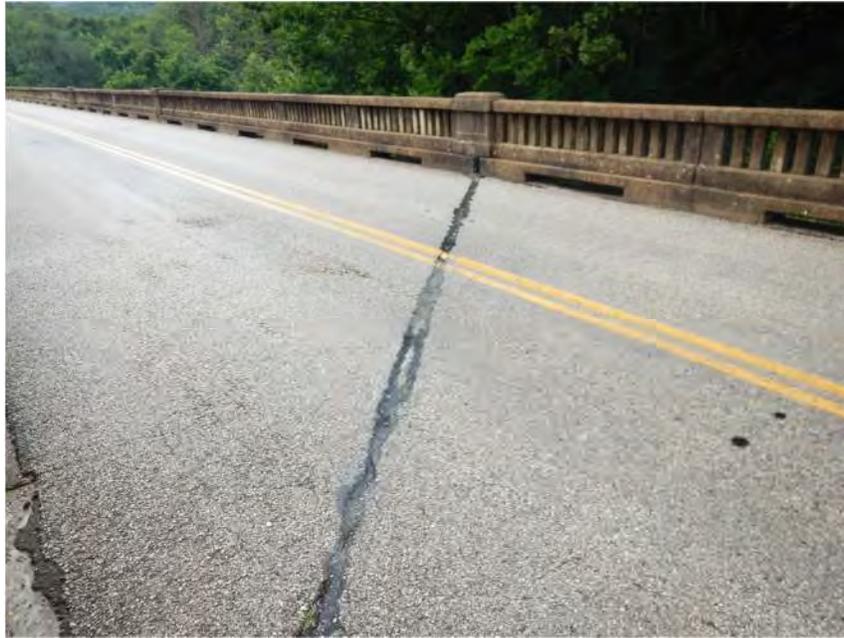
Typical Slab Expansion Joint

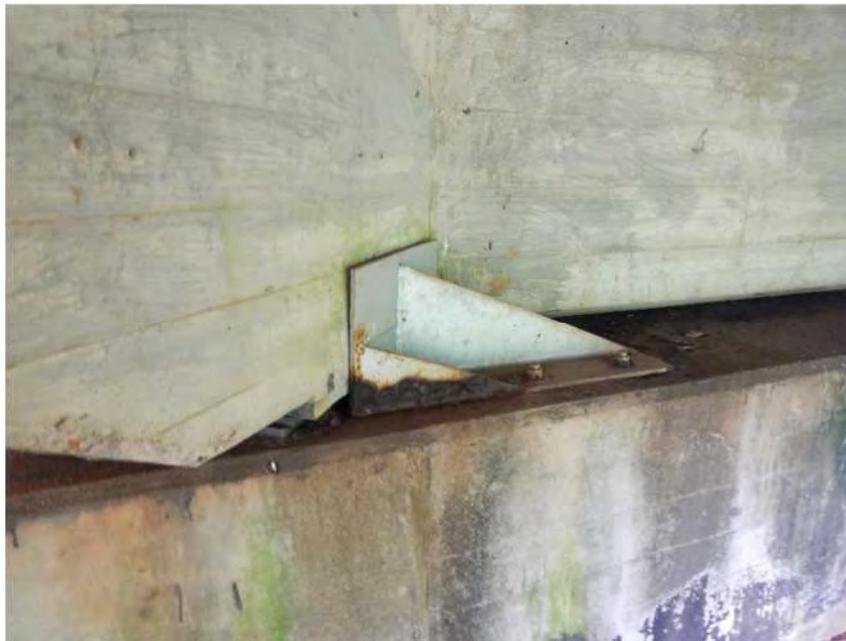
Typical Girder Restraint Bracket

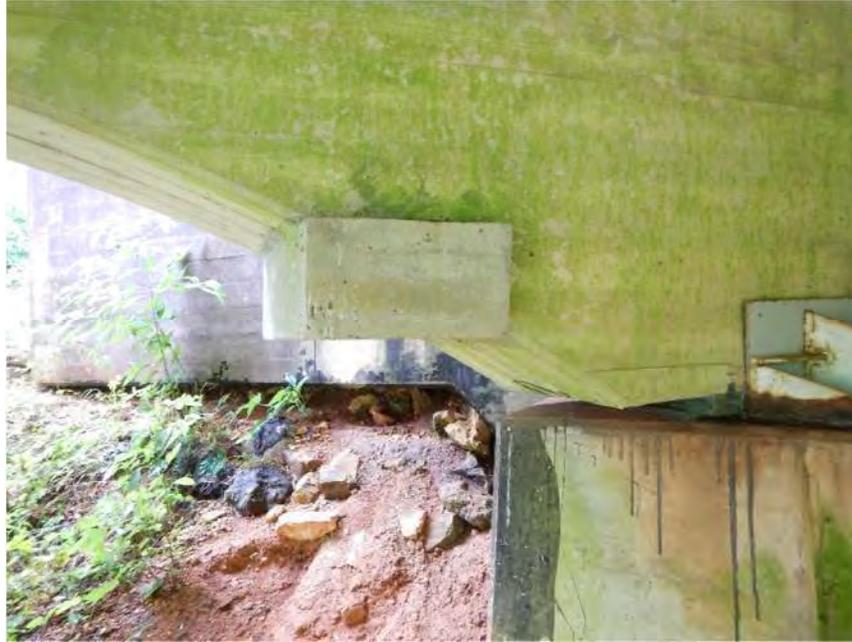
East Girder at Bent 9

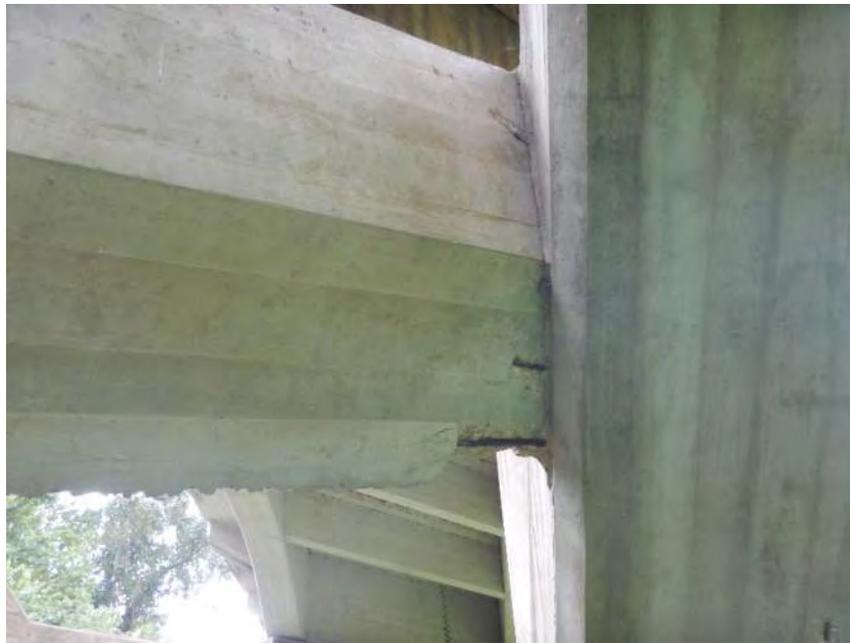
Lateral Bracing Between the Arch Ribs

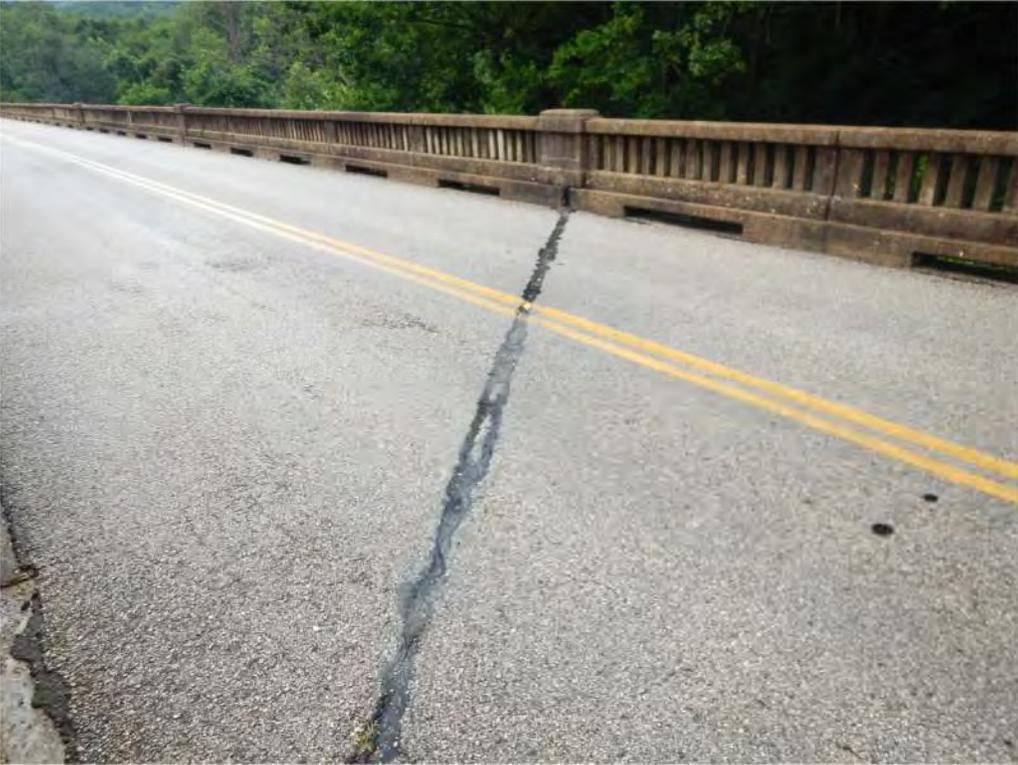
Pic. 001: Typical view of surface over bridge deck

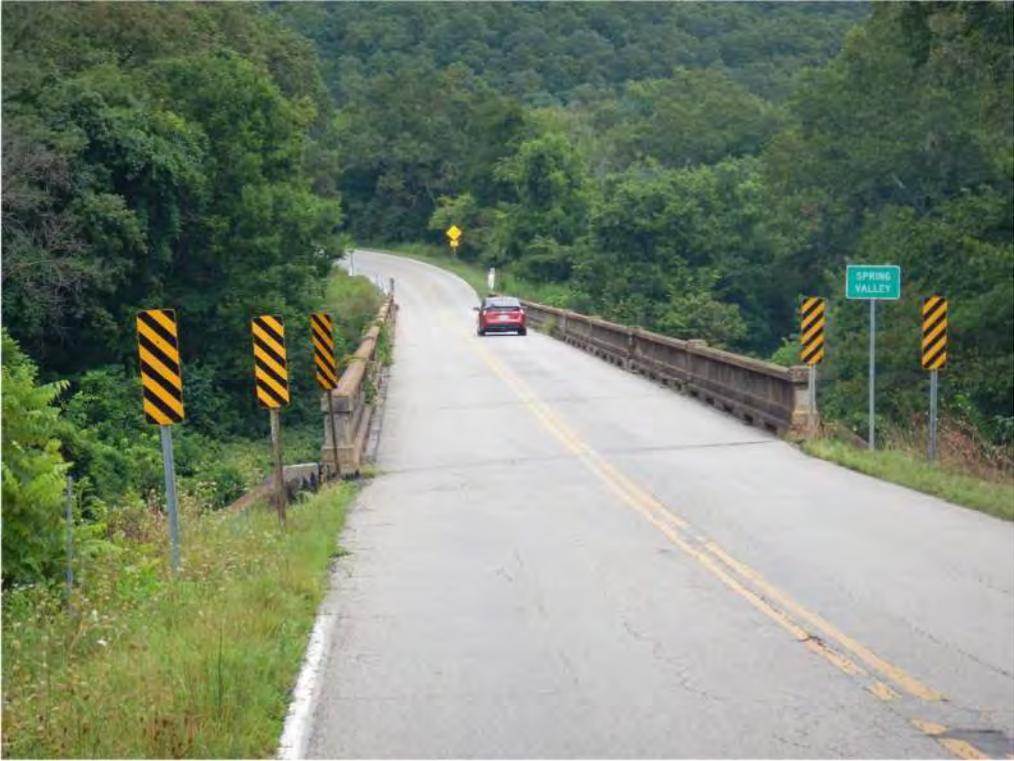
Pic. 013: Roadway over bridge looking north
